NC DEPARTMENT OF TRANSPORTATION
 DIVISION OF HIGHWAYS
 STRUCTURE MANAGEMENT UNIT

ATTENTION: **prompt action request, sketches revised, horizontal clearances revised**

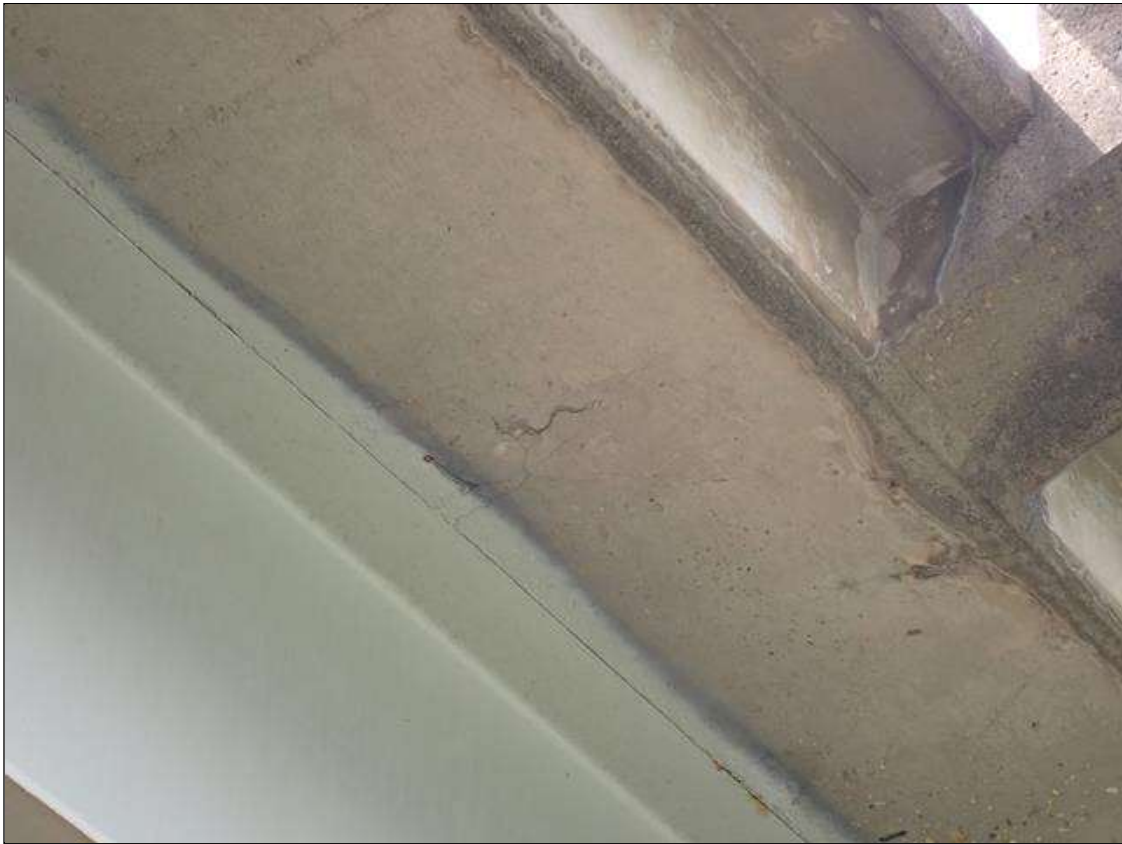
Span 4 Deck: right overhang, near midspan, delamination (10 inch x 6 inch)

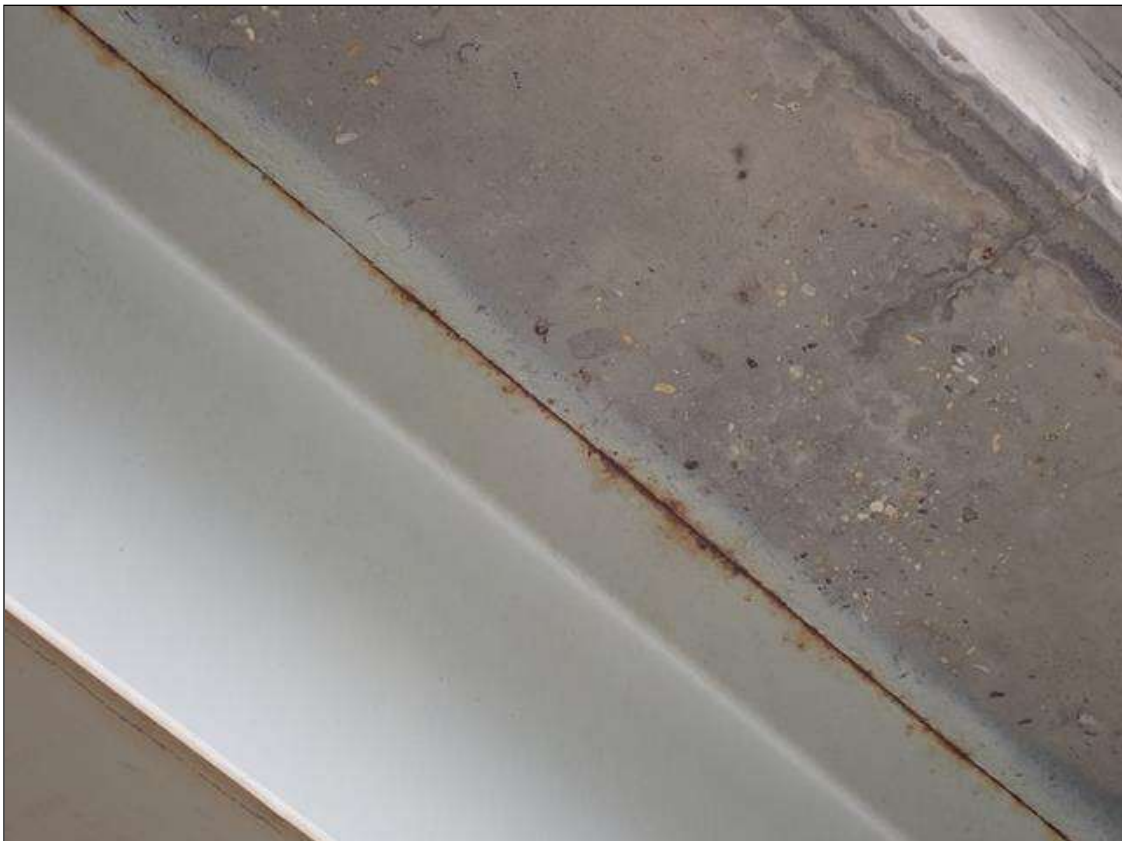
Span 4 Beam 4: along the edge of the top flange, surface rust at random

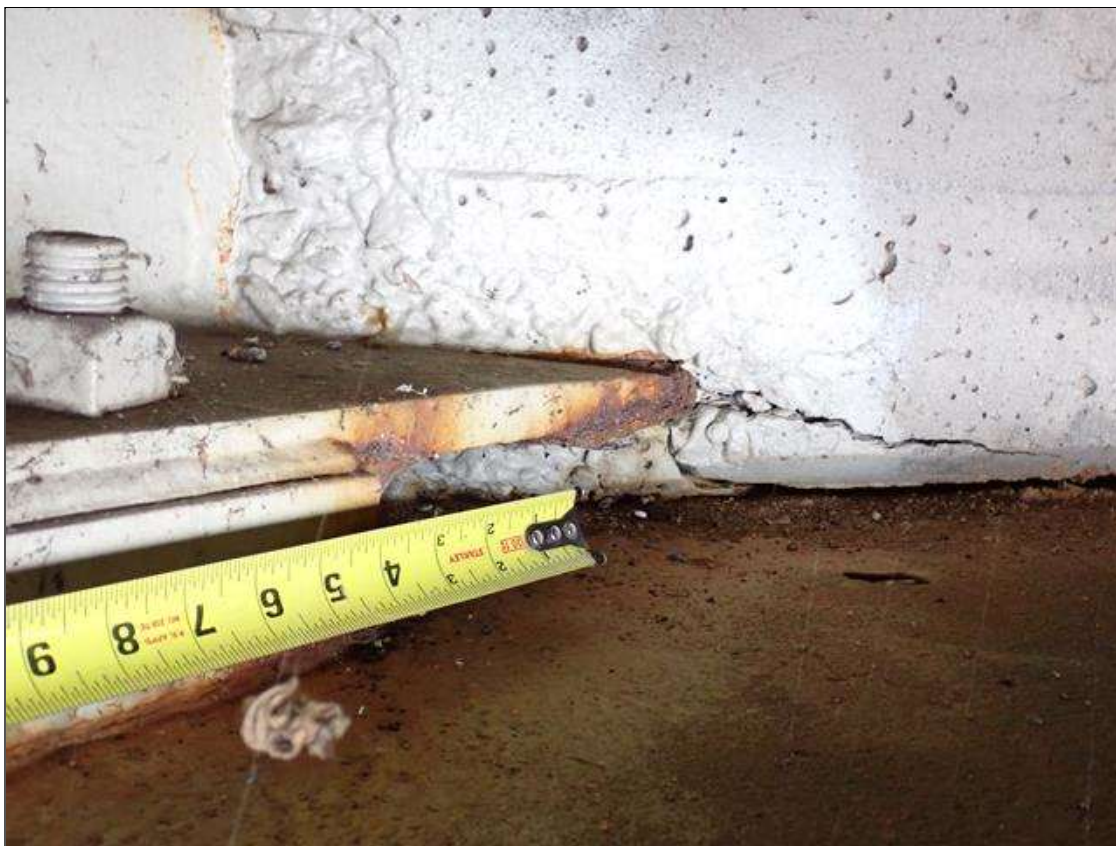
Span 4 Beam 1: at end bent 2, bottom flange, rust scale

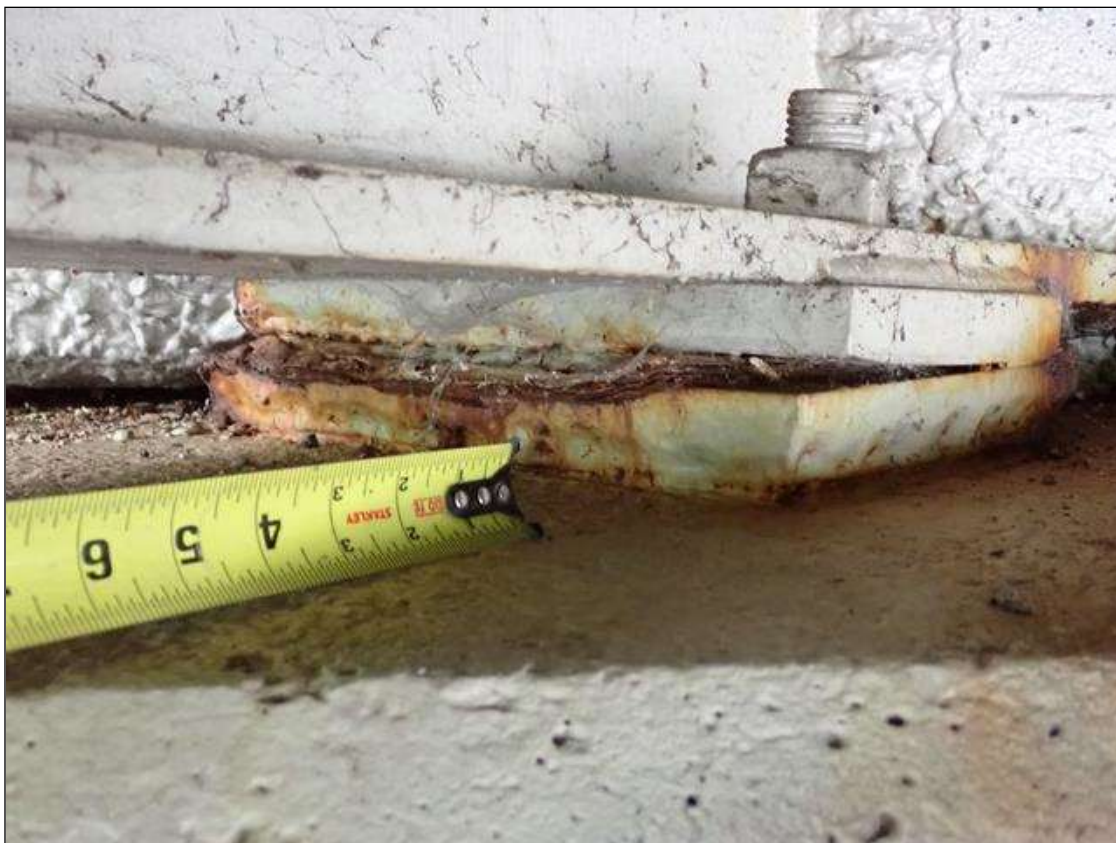
Span 4 Beam 1 - Far Bearing 1: painted over section loss (up to 1/4 inch deep) with corrosion reinitiated

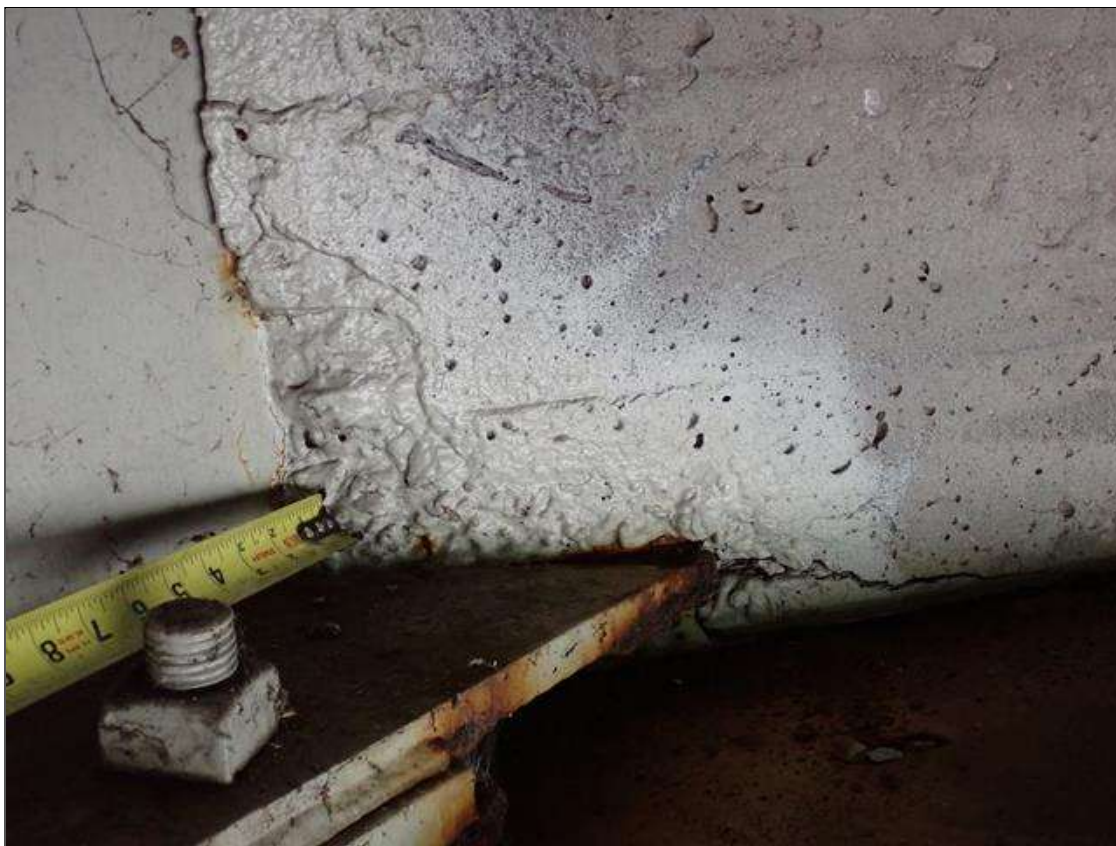
End Bent 2 Abutment: adjacent to beams, spalls/delaminations (up to 18 inch x 10 inch x 1/2 inch deep) with associated cracks (up to 1/16 inch)

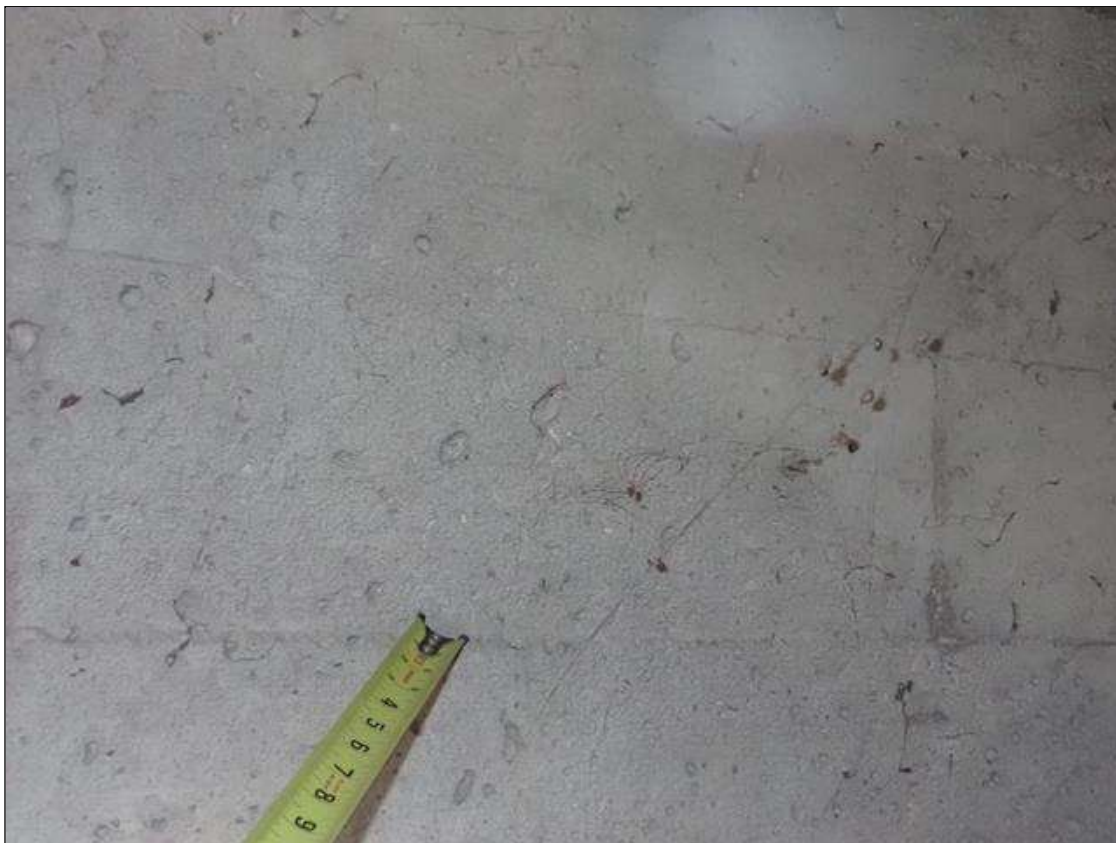
End Bent 2 Abutment: along the abutment, areas of map cracks (hairline) at random

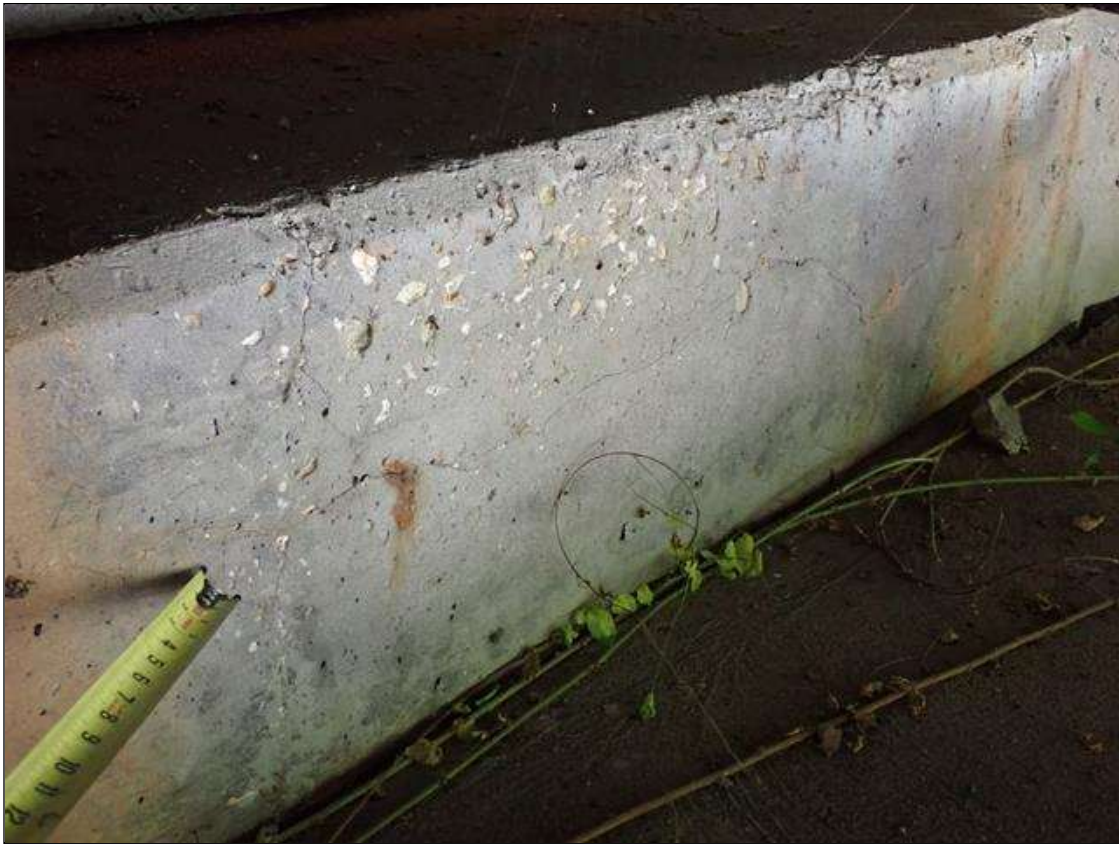
End Bent 2 Cap 1: (PAR) along the length of the cap, vertical and longitudinal cracks (up to 1/32 inch x 5 feet), some with rust stains at random

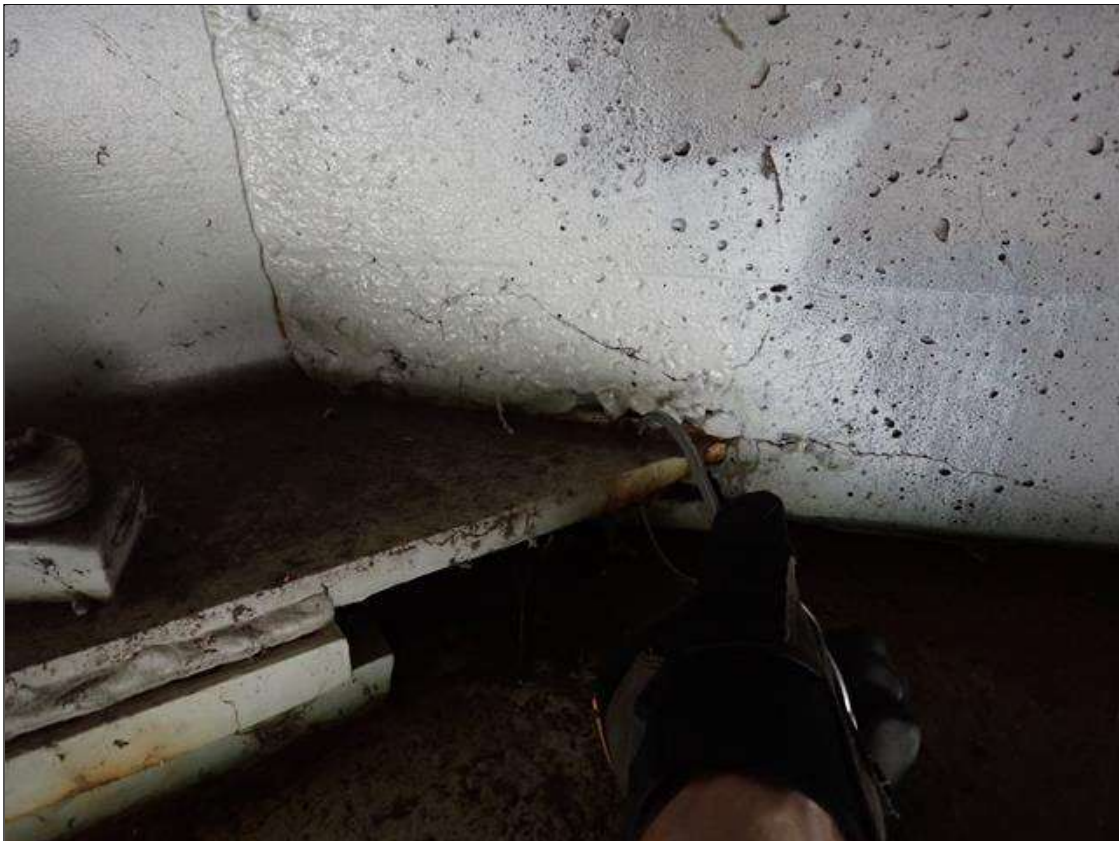
Span 4 Beam 2: at end bent 2, bottom flange, behind bearing, painted over section loss (0.83 inch average remaining x 2 inches) with corrosion reinitiated

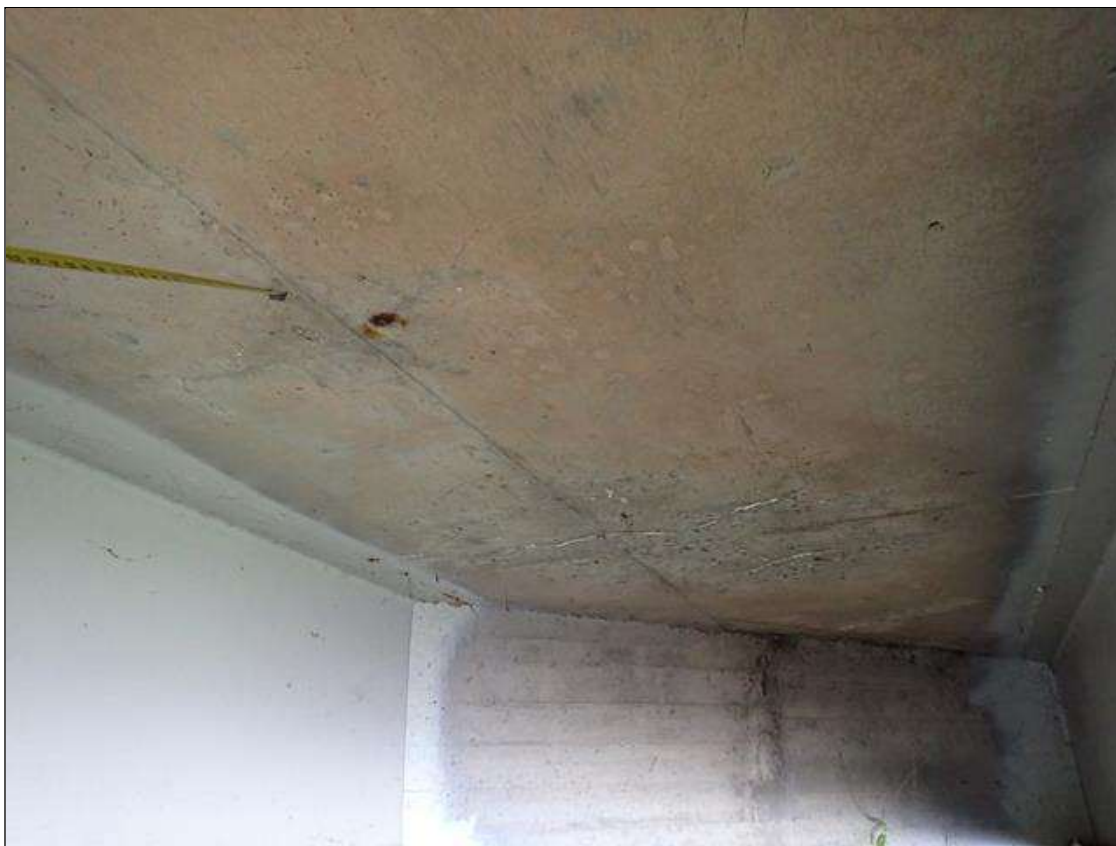
Span 4 Deck: (PAR) throughout underside of deck, transverse cracks (up to 1/32 inch x full bay width) and map cracks (hairline), some with efflorescence buildup and rust stains at random

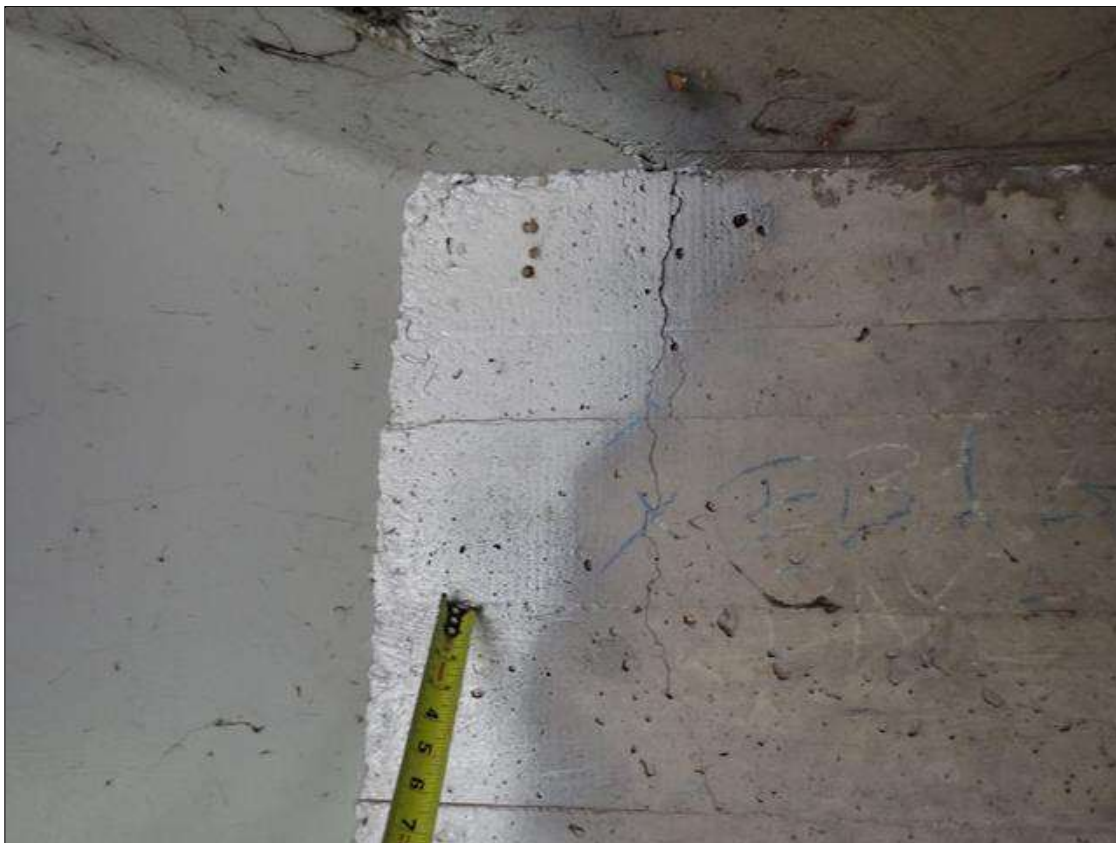
End Bent 2 Abutment: adjacent to beams, spalls/delaminations (up to 18 inch x 10 inch x 1/2 inch deep) with associated cracks (up to 1/16 inch)

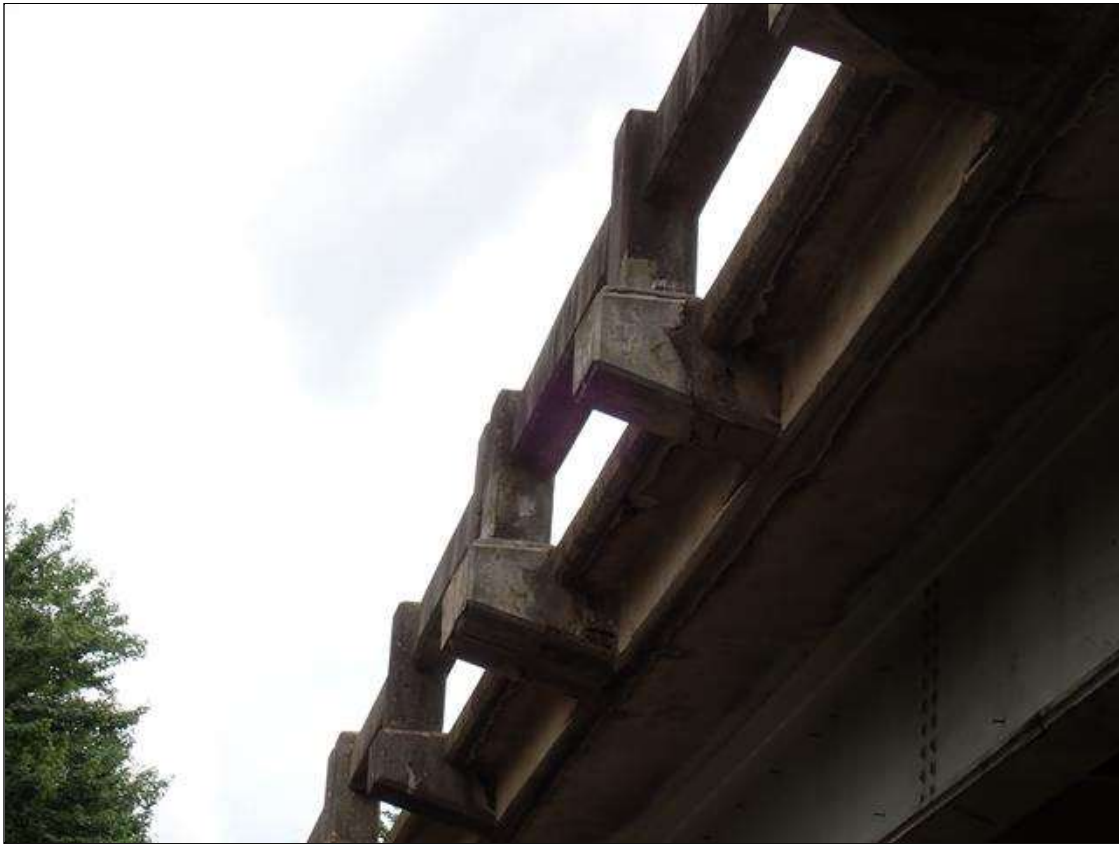
Span 3 Right Bridge Rail: (PAR) within patched area over left and right travel lanes of I-40, area of delamination with cracking (up to 1/16 inch) and rust stain, could possibly fall into traffic below

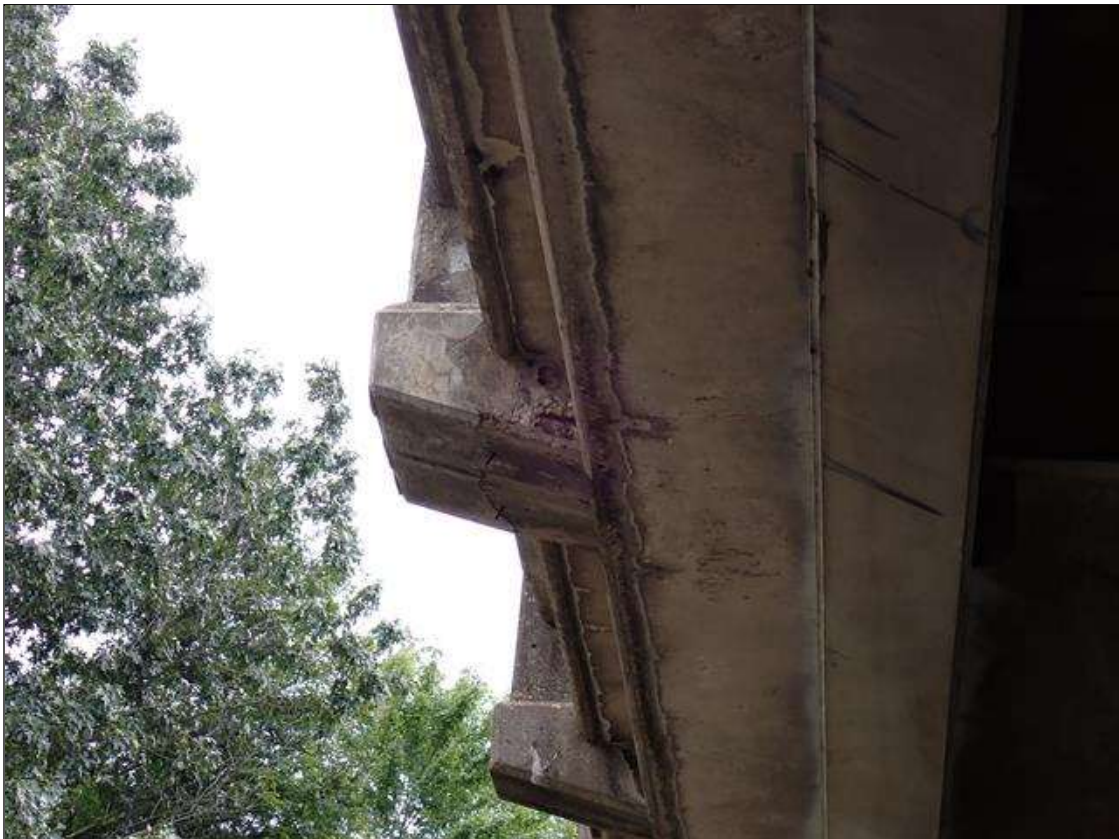
Span 3 Right Bridge Rail: underside of rail section and outriggers, shallow rebar at random

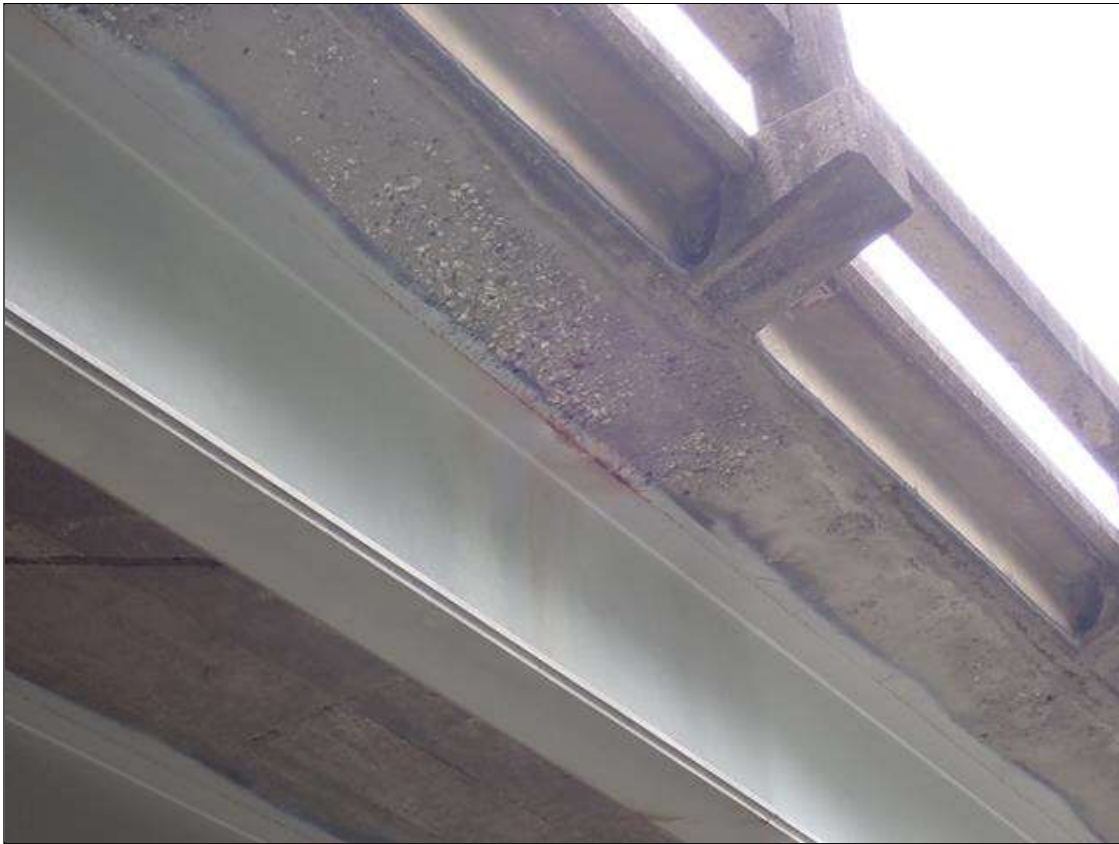
Span 3 Beam 1: along the edge of the top flange, surface rust at random

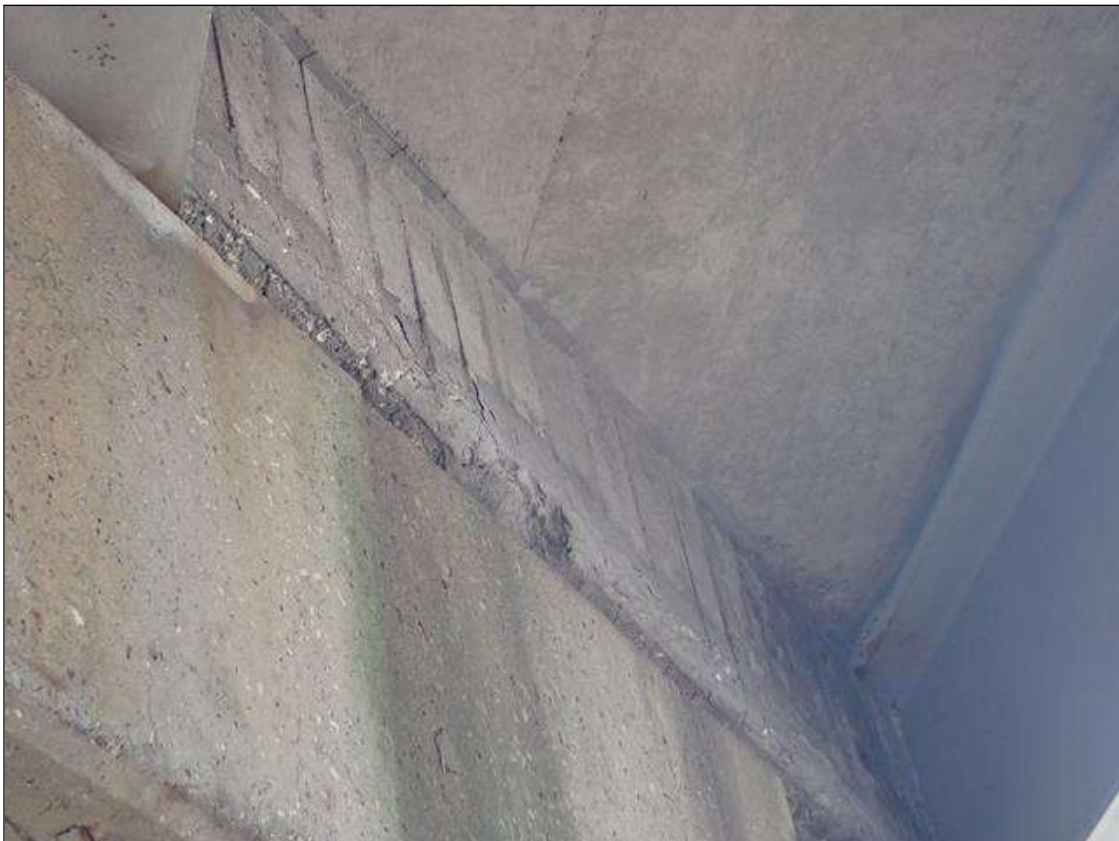
Span 3 Deck: at bents 2 and 3, end diaphragms in all bays, unsound patches/delaminations/spalls (up to full bay width x 8 inch x 1.5 inch deep), some with exposed rusted rebar

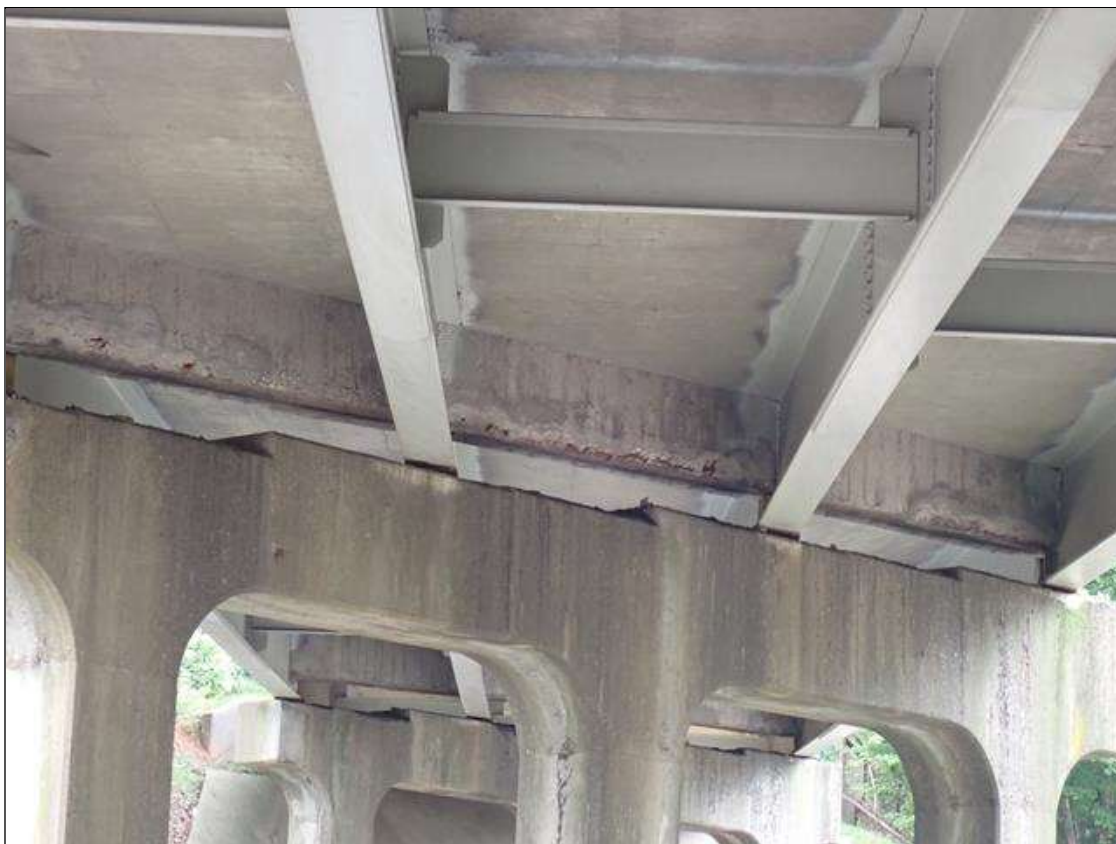
Span 3 Deck: at bents 2 and 3, end diaphragms in all bays, unsound patches/delaminations/spalls (up to full bay width x 8 inch x 1.5 inch deep), some with exposed rusted rebar

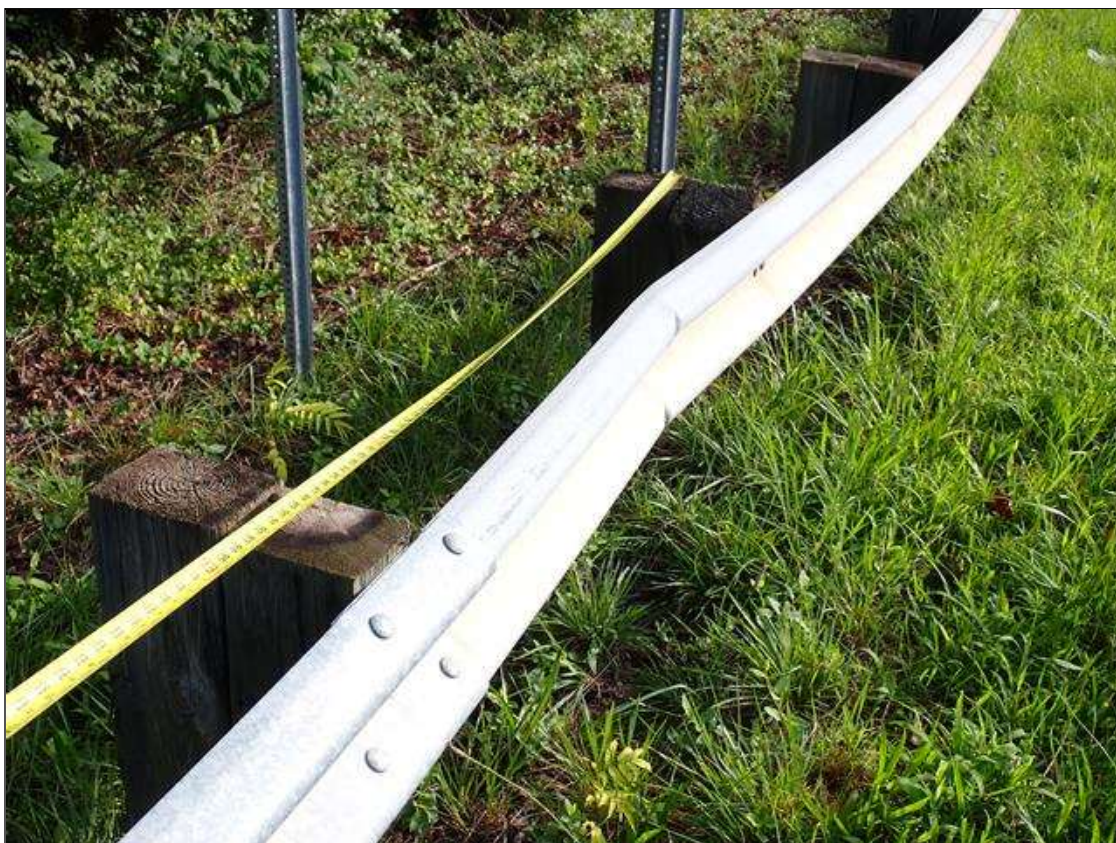
(PAR) southwest guardrail, areas of impact damage (up to 15 feet long, 30 feet total)

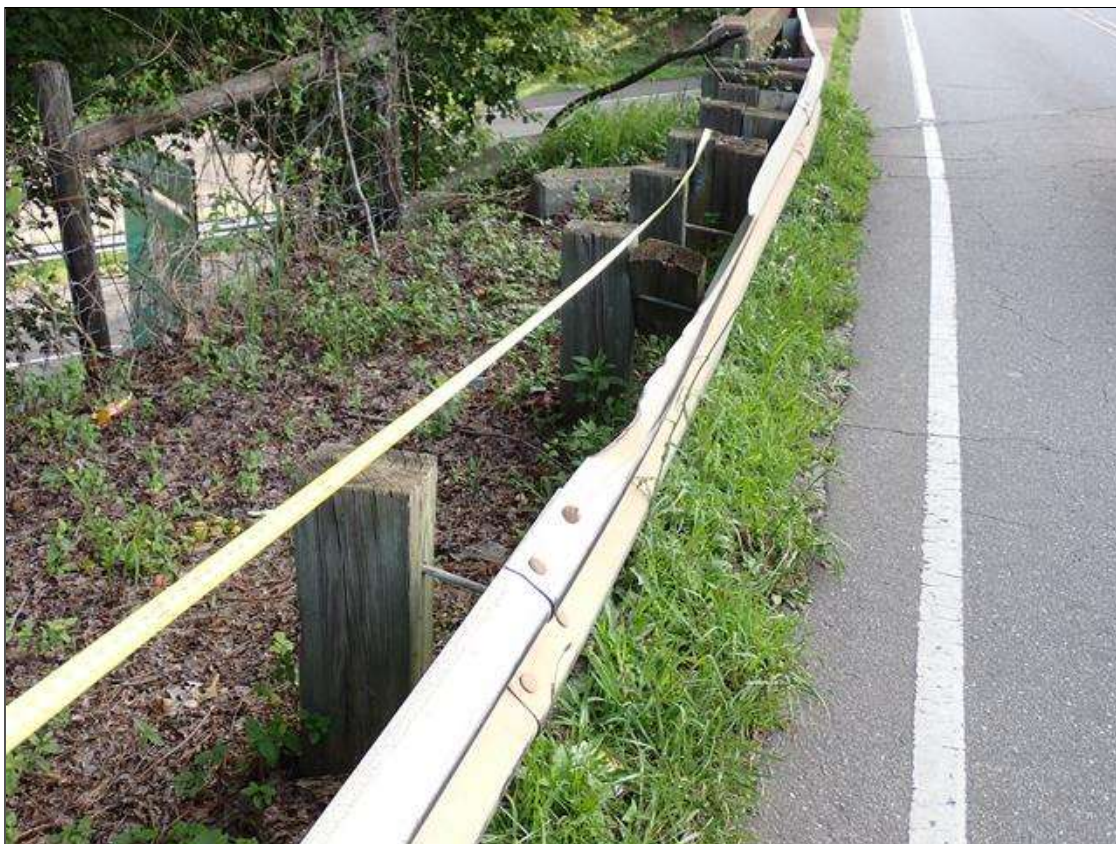
(PAR) southwest guardrail, areas of impact damage (up to 15 feet long, 30 feet total)

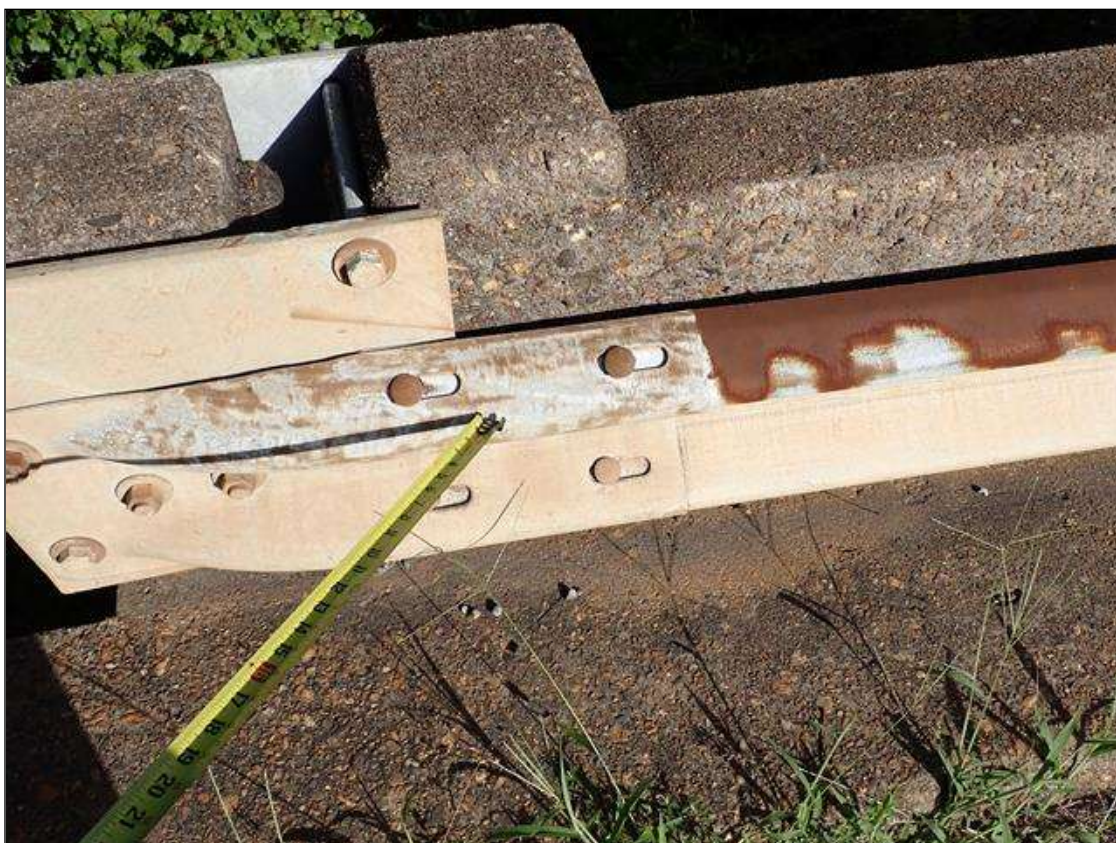
(PAR) northwest guardrail attachment, improper lap

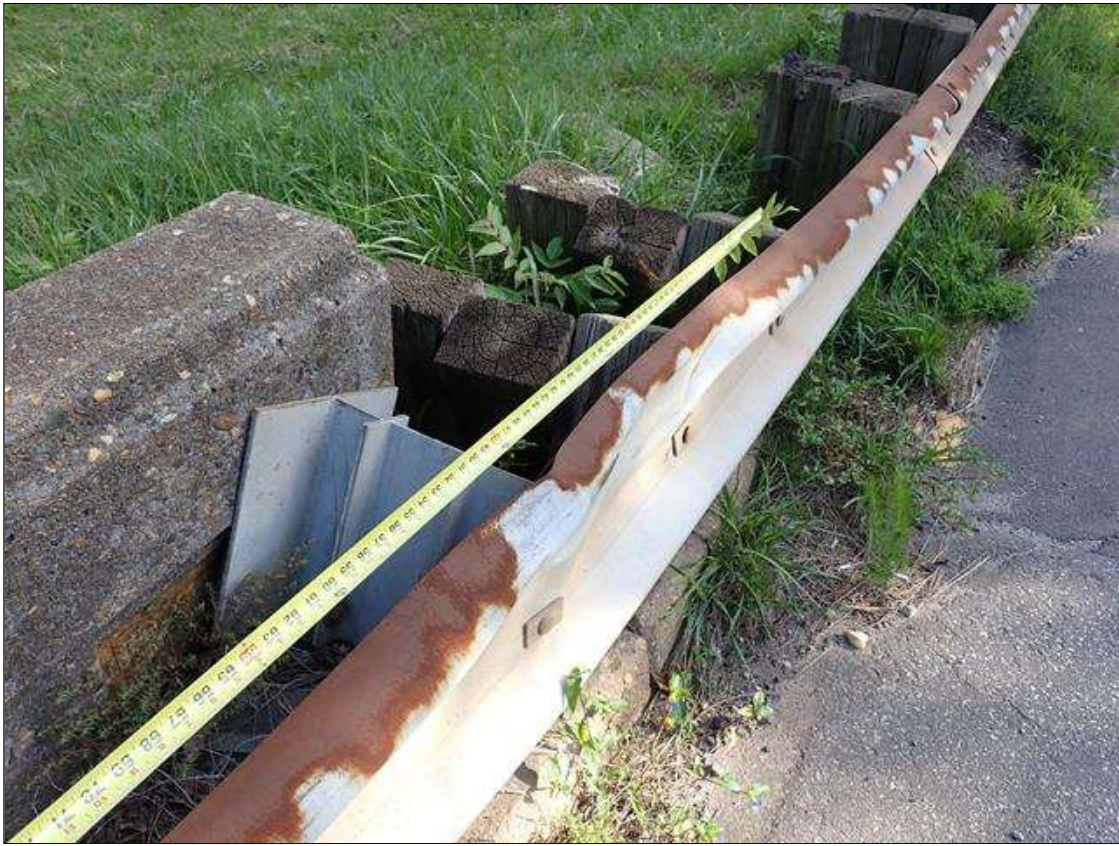
(PAR) northwest guardrail transition, impact damage (5 feet)

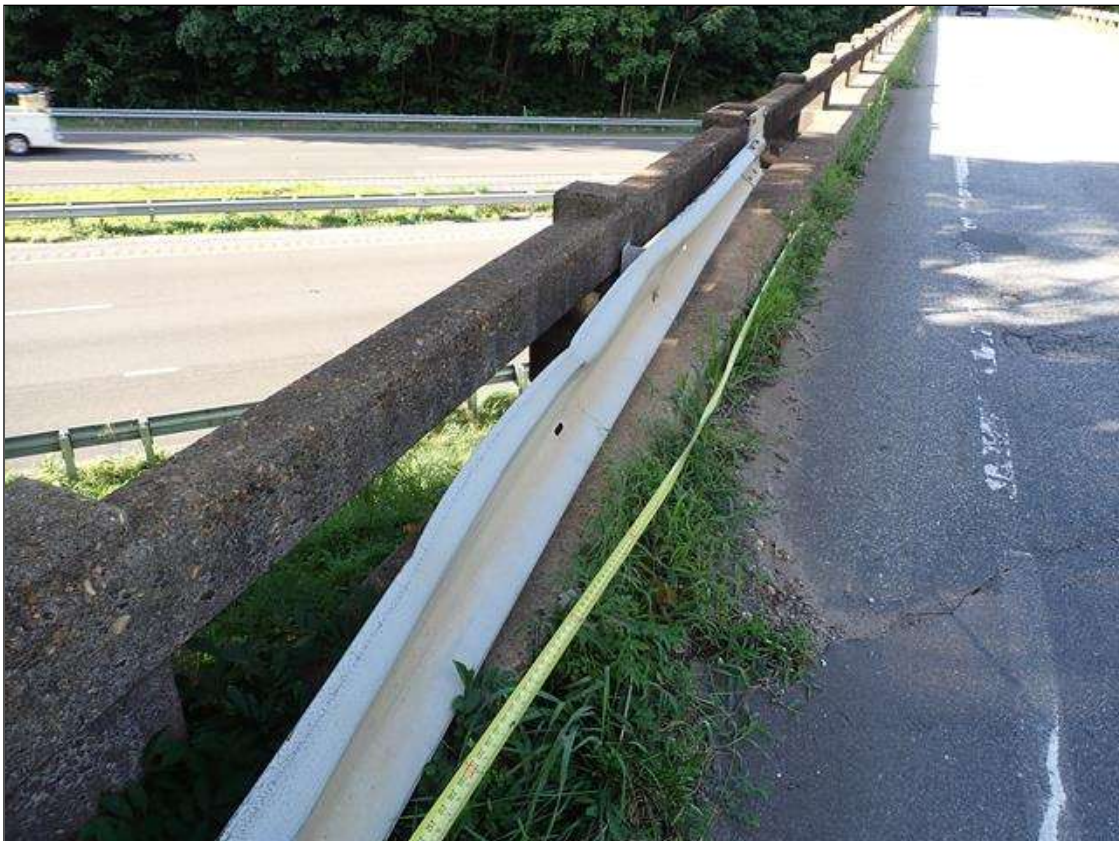
(PAR) northeast guardrail and transition, areas of impact damage (up to 15 feet long, 30 feet total)

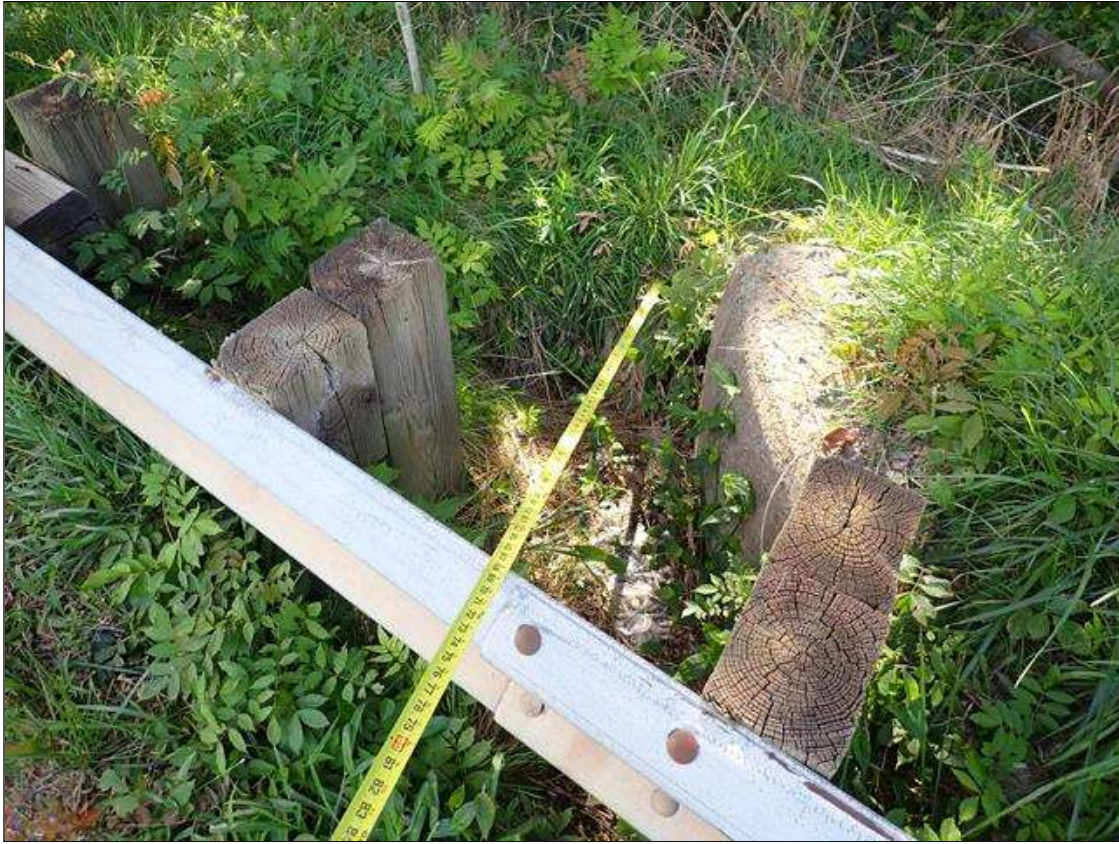
behind northeast approach curb, area of erosion (7 feet x 4 feet x 1.5 feet deep)

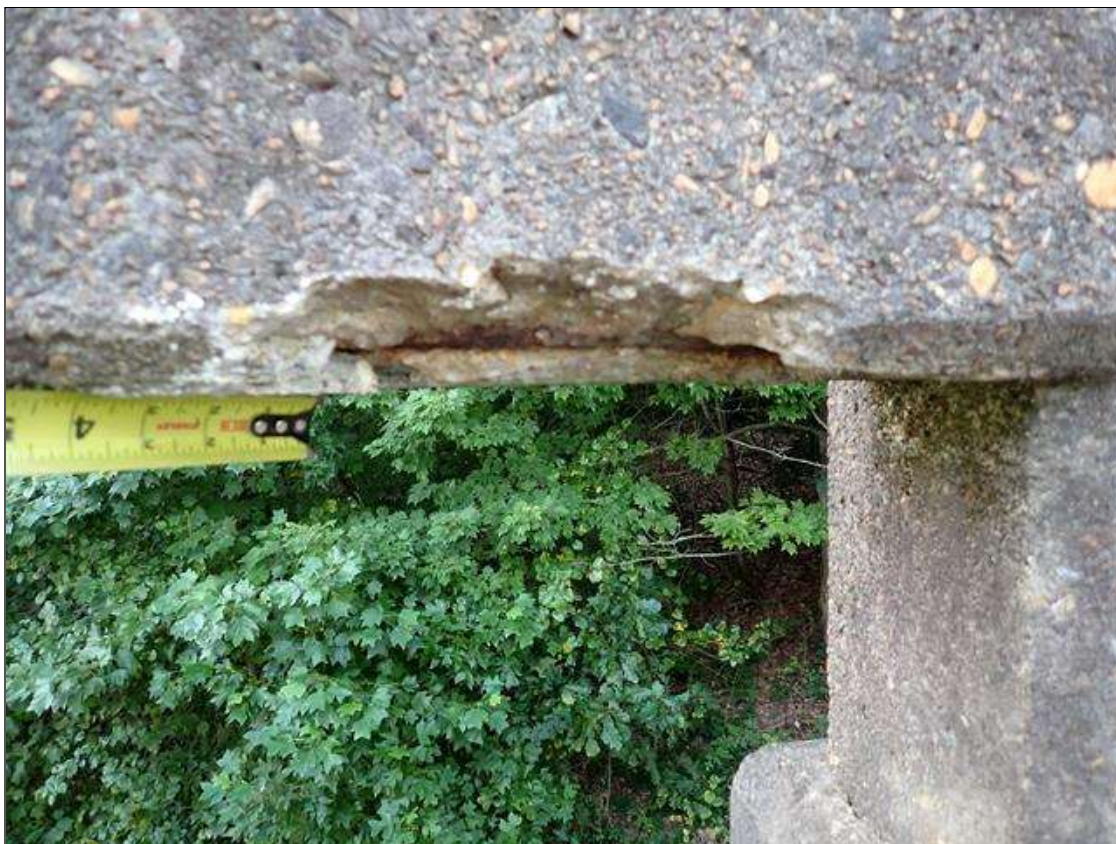
Span 1 Right Bridge Rail: underside of rail section 7, spall (10 inch x 3 inch x 1.5 inch deep) with exposed rusted rebar

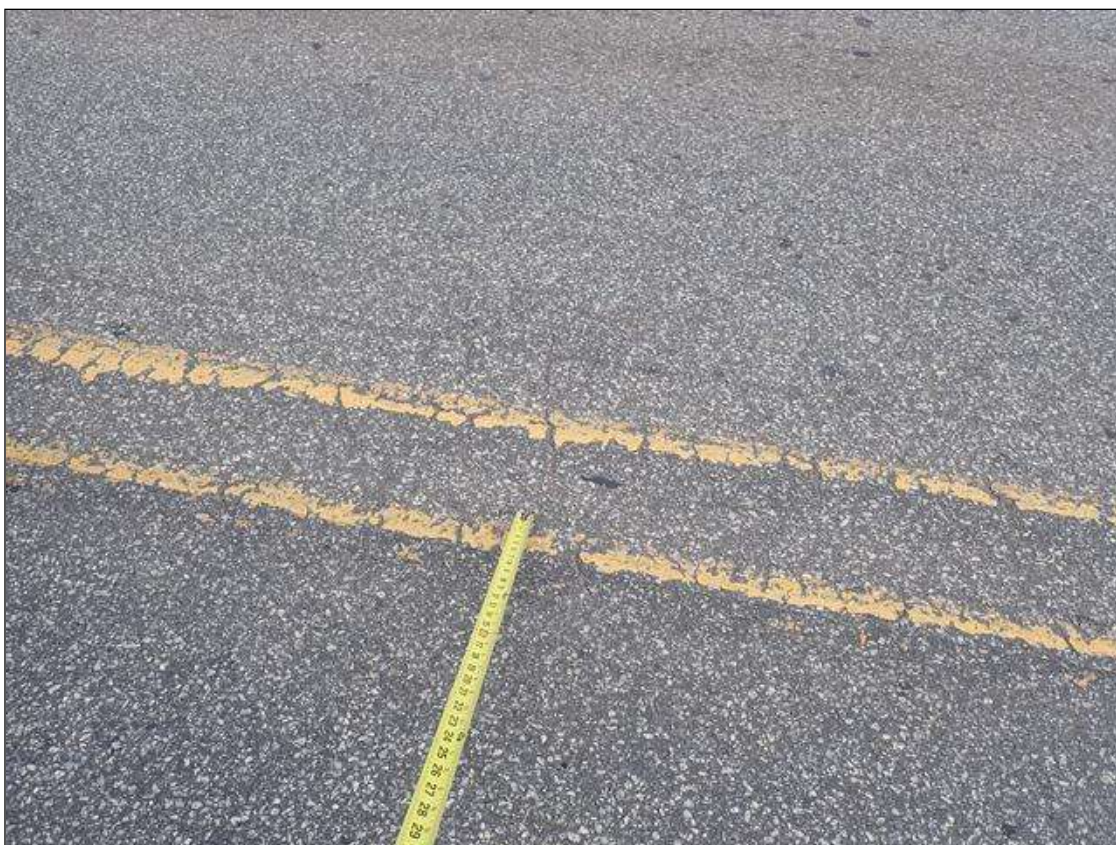
Span 1 Wearing Surface: SPAN 1 WEARING SURFACE HAS SCATTERED TRANSVERSE AND LONGITUDINAL CRACKS UP TO 1/8 INCH.
