NC DEPARTMENT OF TRANSPORTATION
 DIVISION OF HIGHWAYS
 STRUCTURE MANAGEMENT UNIT

ATTENTION: **prompt action request, sketches revised, horizontal clearances revised**

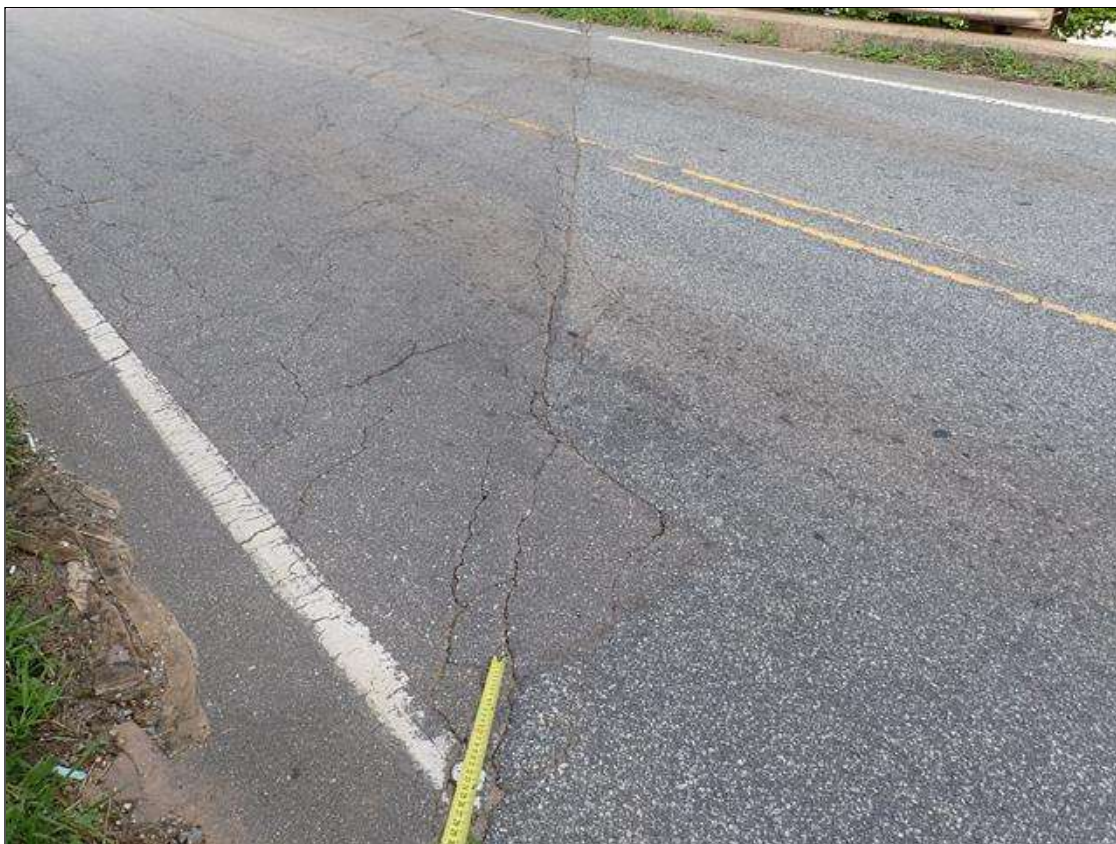
Span 1 Wearing Surface: over end bent 1, transverse cracks, full width x up to 1/2 inch

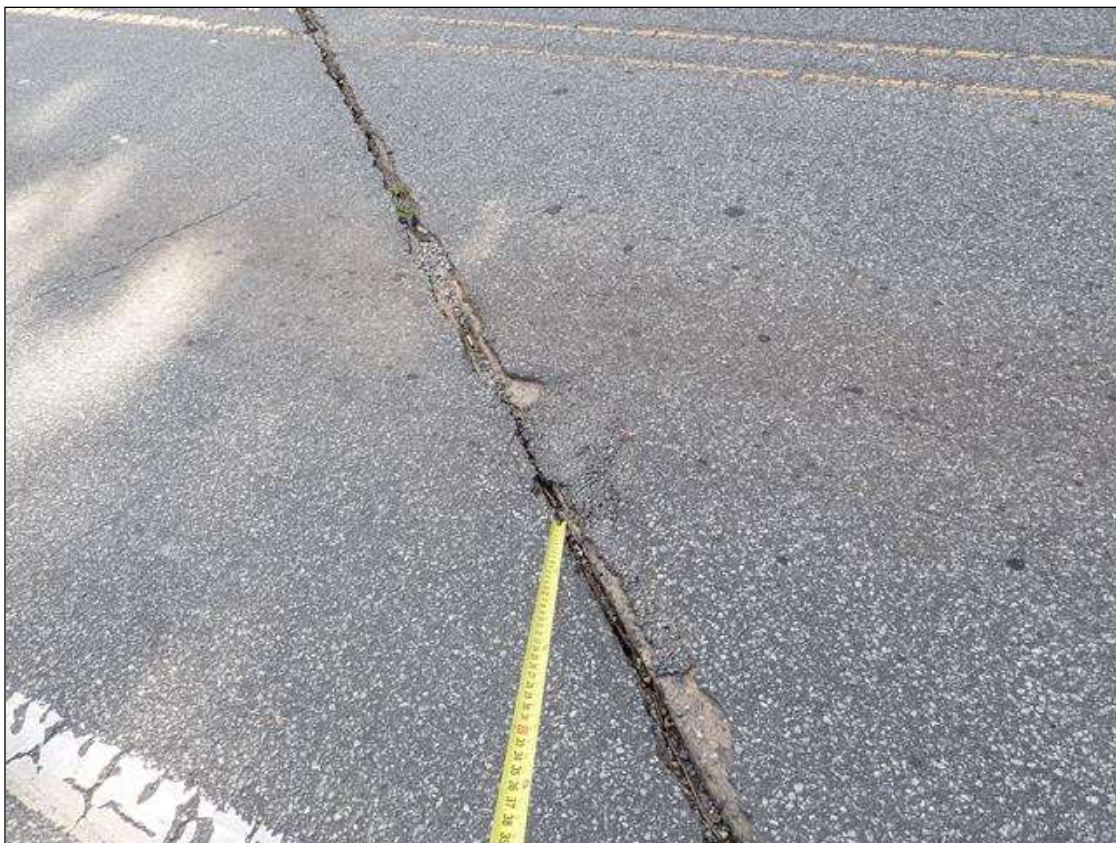
Span 1 Wearing Surface: 2023 previously repaired, previously noted as: 1 FOOT X 4 FOOT AREA OF MISSING ASPHALT WEARING SURFACE IN SOUTHBOUND LANE AT BENT 1

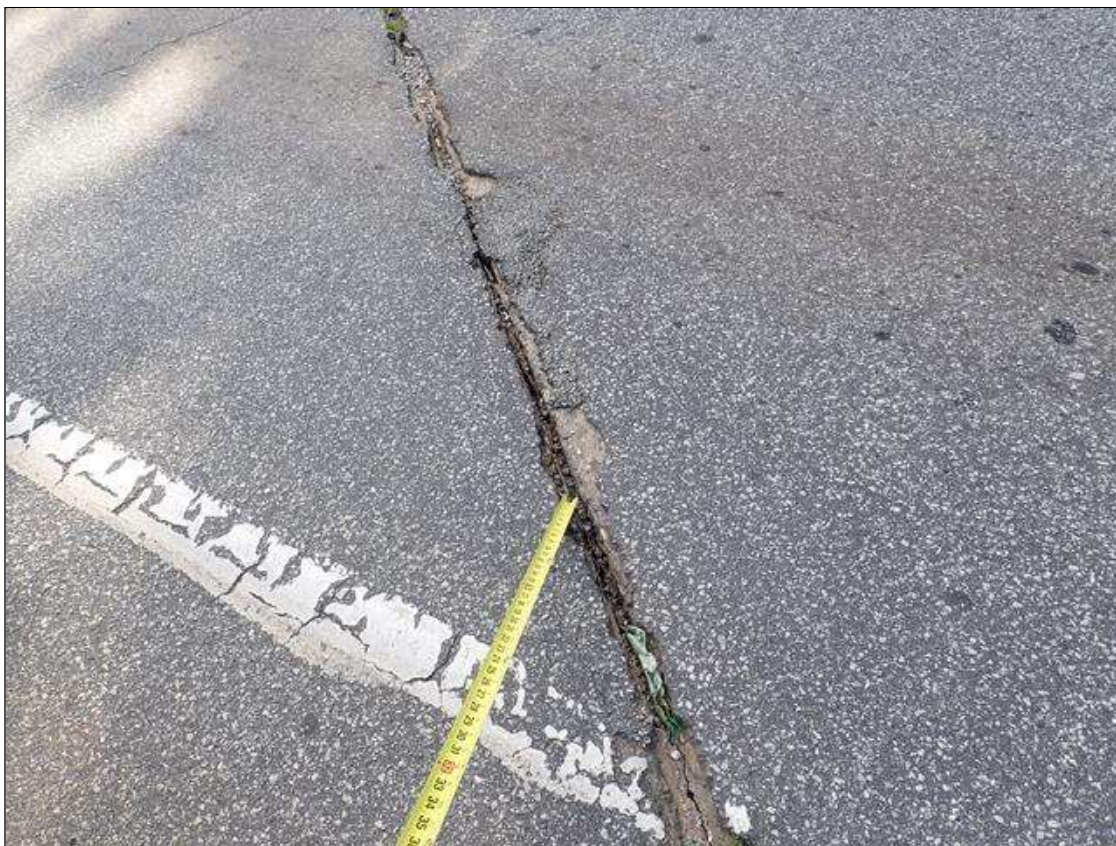
Span 1 Wearing Surface: (PAR) at bent 1, areas of missing asphalt (up to 1 foot x 4 inch)

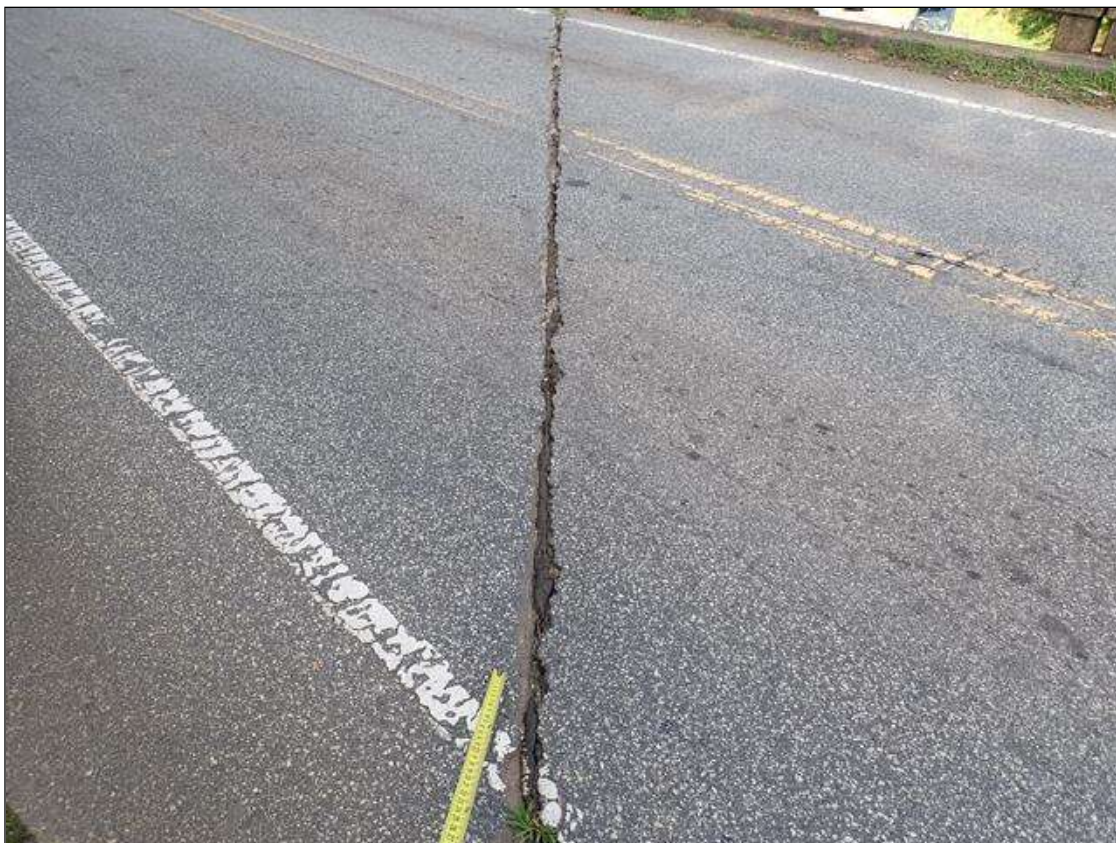
Span 2 Bent 1 Joint: along the length of the joint, seal deteriorated (full length)

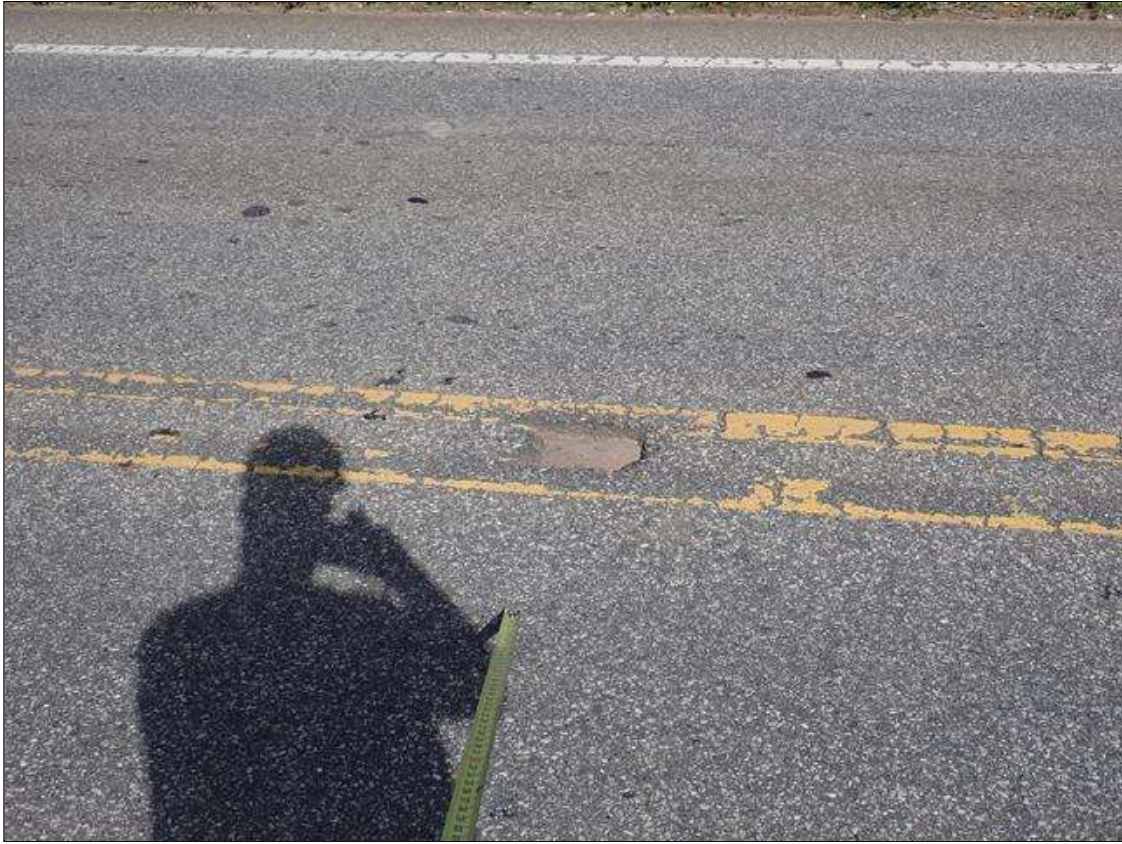
Span 2 Wearing Surface: (PAR) along centerline of roadway, approximately 25 feet from bent 2, spall (11 inch x 6 inch x full depth)

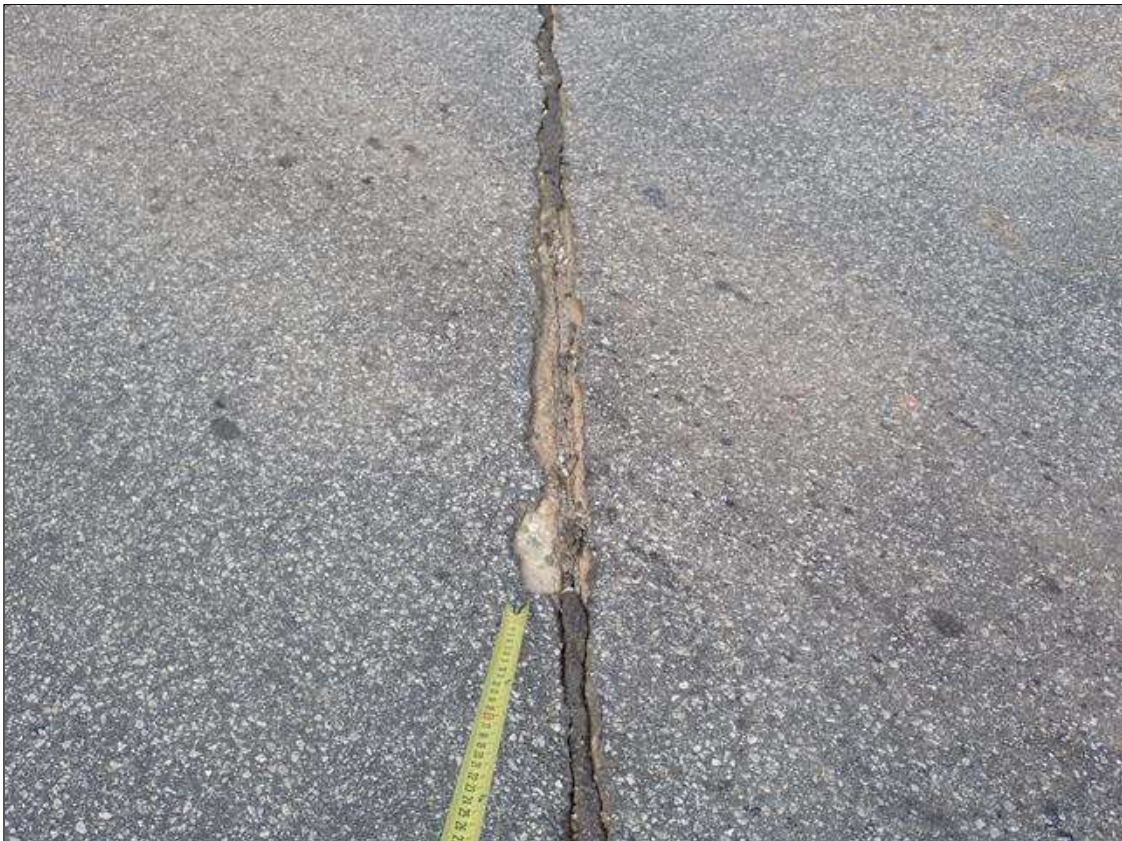
Span 2 Wearing Surface: (PAR) at bent 2, areas of missing asphalt (up to 2 feet x 3 inch) at random

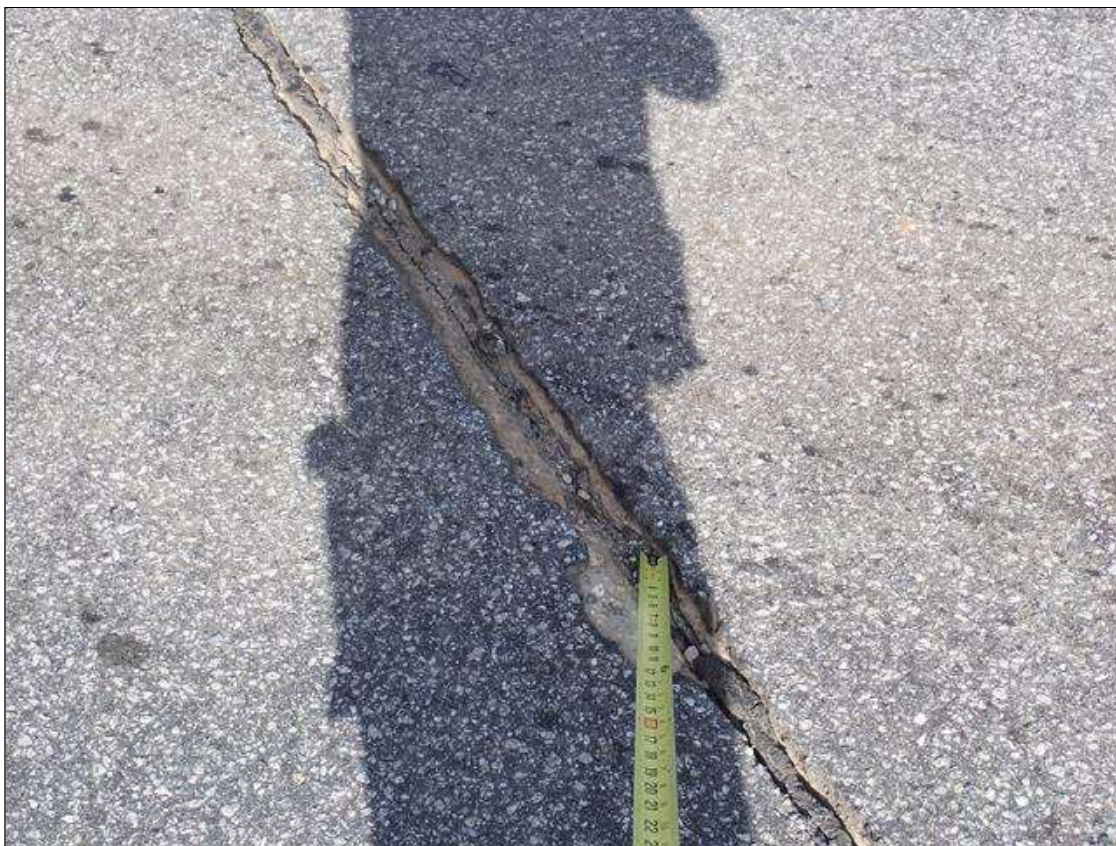
Span 3 Wearing Surface: (PAR) at bent 2, areas of missing asphalt (up to 3 feet x 2 inches) at random; northbound lane, at bent 3, areas of missing asphalt (up to 3.5 feet x 2 feet)

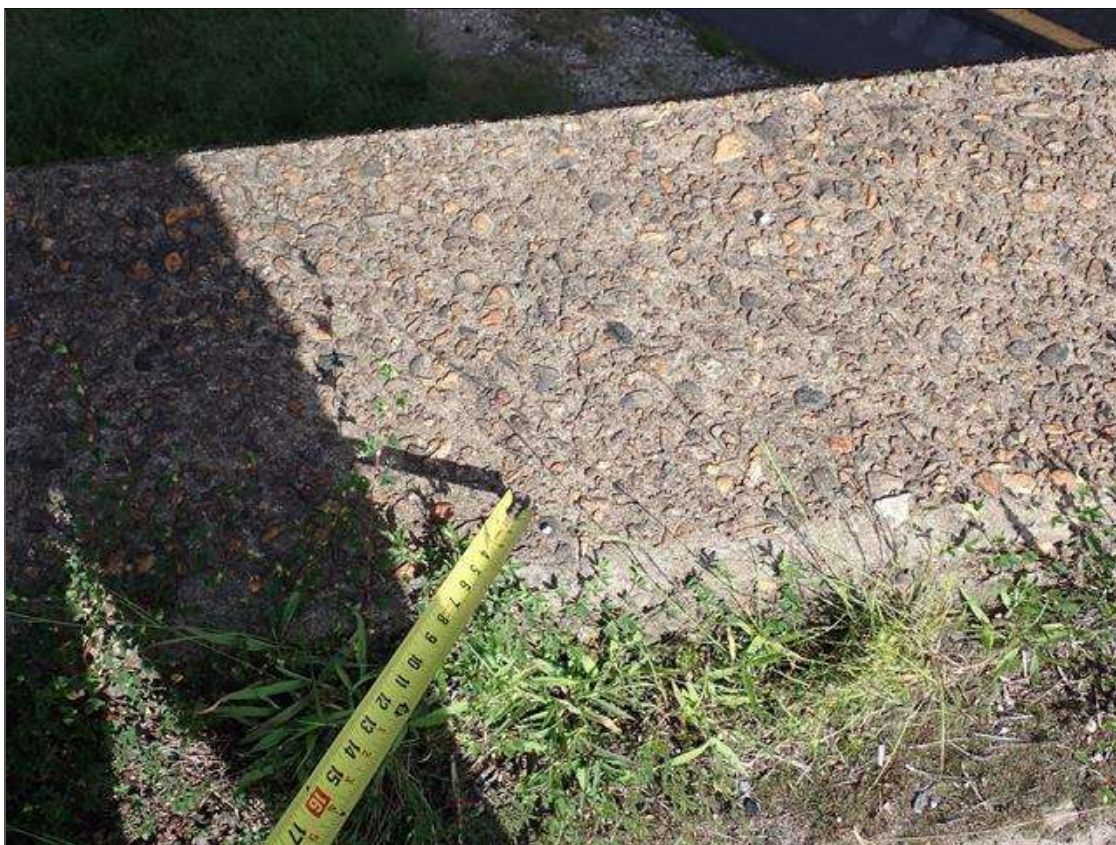
Span 2 Left Bridge Rail: WEST RAIL HAS SCATTERED CRACKS UP TO 1/32 INCH.

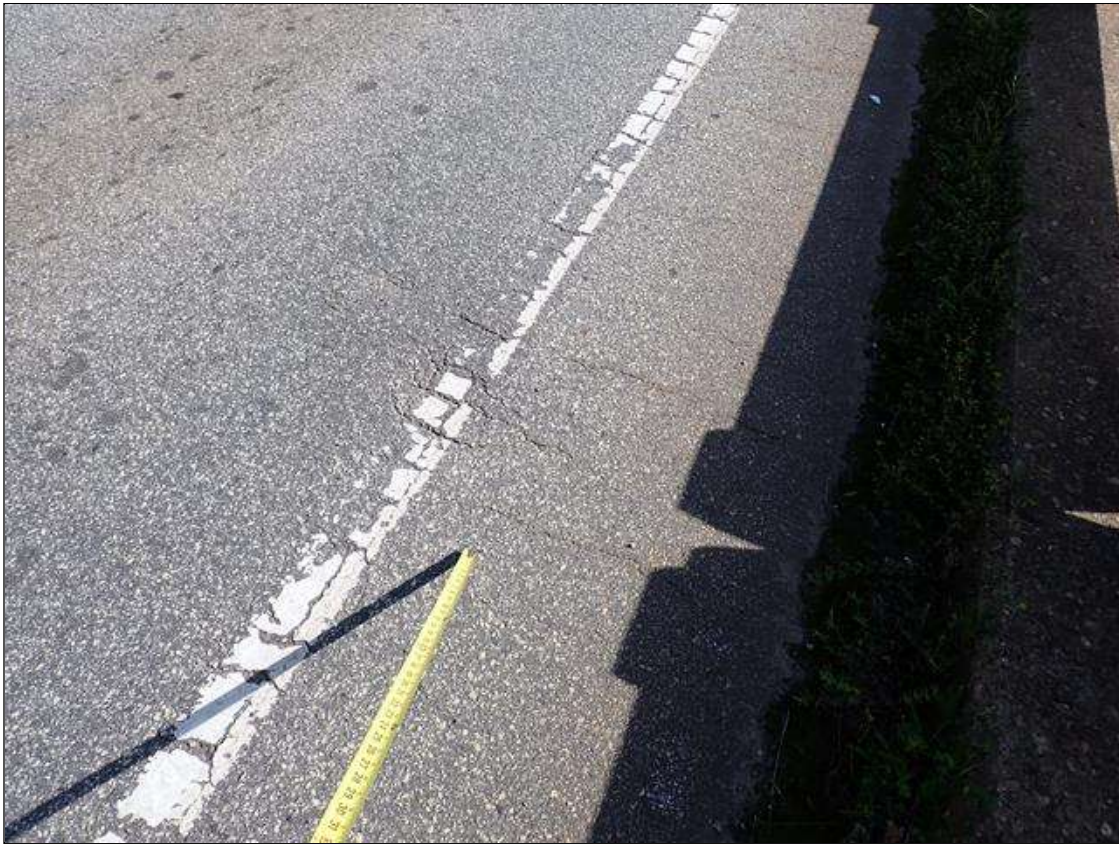
Span 3 Wearing Surface: SPAN 3 WEARING SURFACE HAS SCATTERED MAP/TRANSVERSE AND LONGITUDINAL CRACKS UP TO 1/8 INCH.

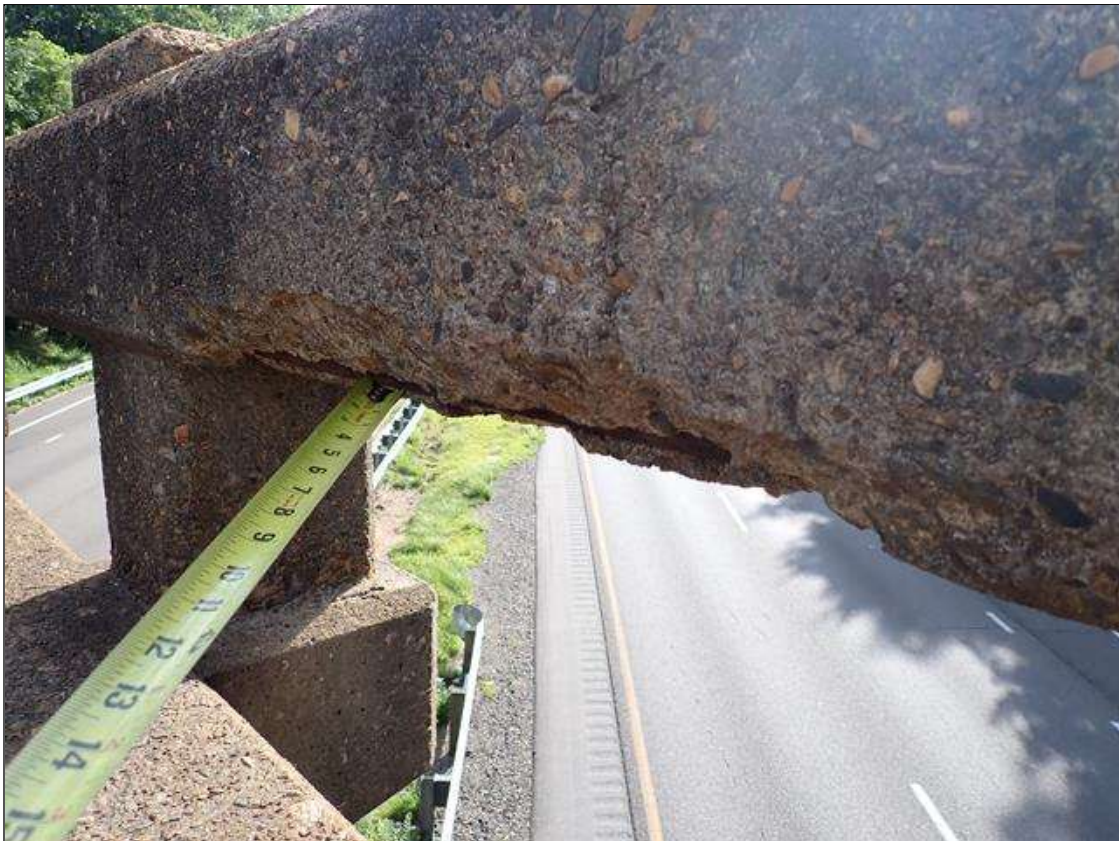
Span 2 Right Bridge Rail: rail section 2 from bent 2, spall (27 inch x 4 inch x 1.5 inch deep) with exposed rusted rebar; adjacent post with diagonal crack (up to 1/32 inch x 6 inches)

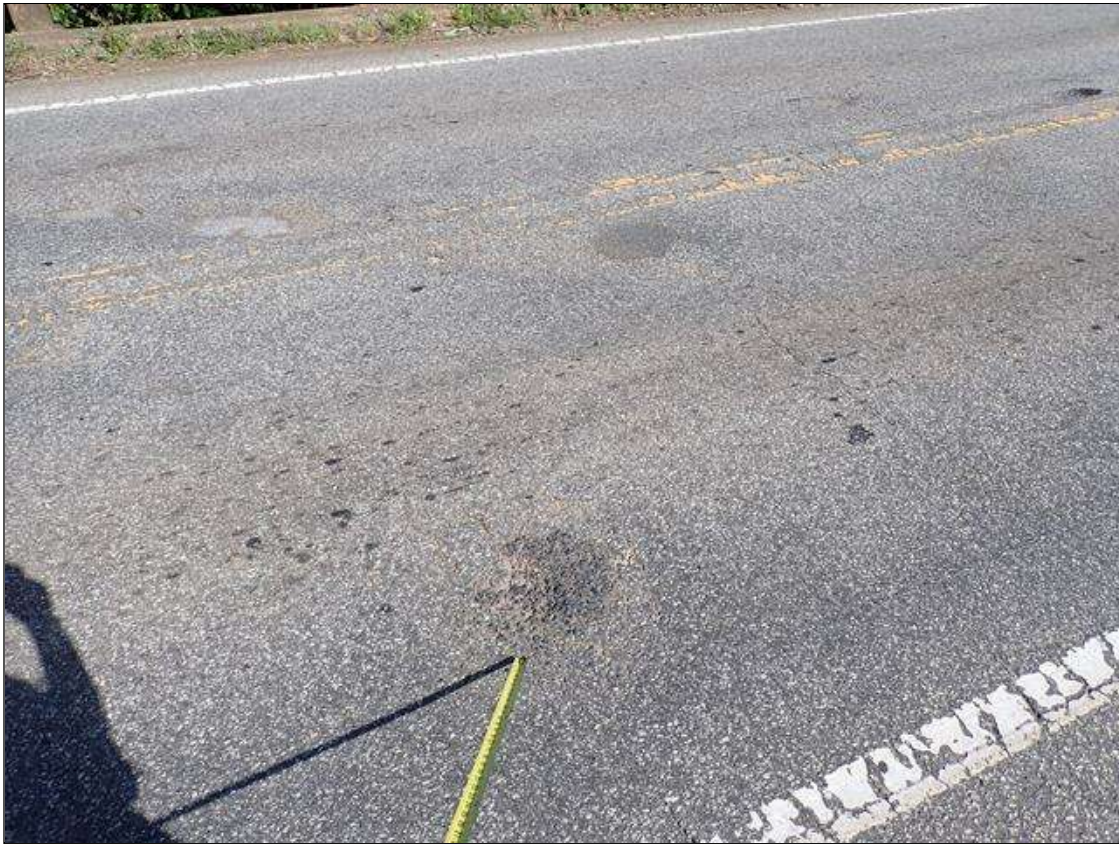
Span 3 Wearing Surface: WEARING SURFACE HAS SCATTERED PATCHED AREAS WITH SOME MAP CRACKING.

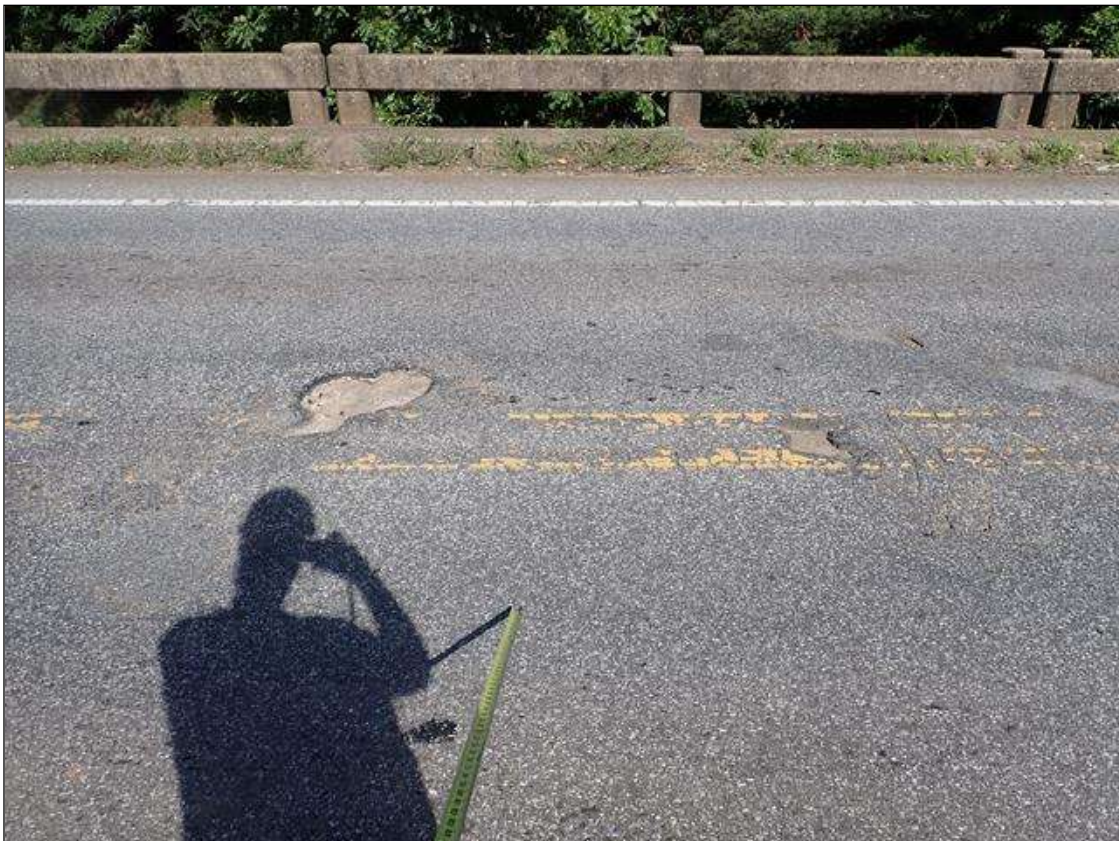
Span 3 Wearing Surface: (PAR) at bent 2, areas of missing asphalt (up to 3 feet x 2 inches) at random; northbound lane, at bent 3, areas of missing asphalt (up to 3.5 feet x 2 feet)

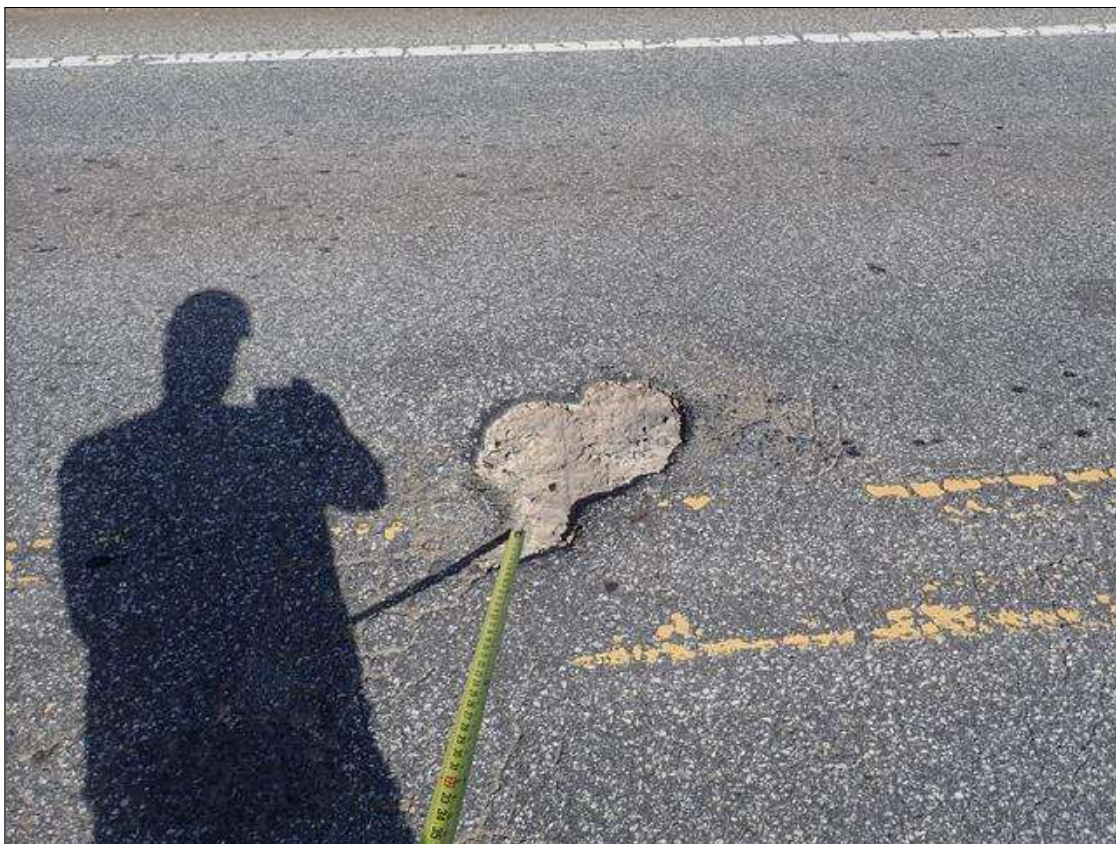
Span 3 Deck: (PAR) top of deck near bent 2, spall (2 feet x 15 inch x 1.5 inch deep) with exposed rusted rebar at area of missing asphalt

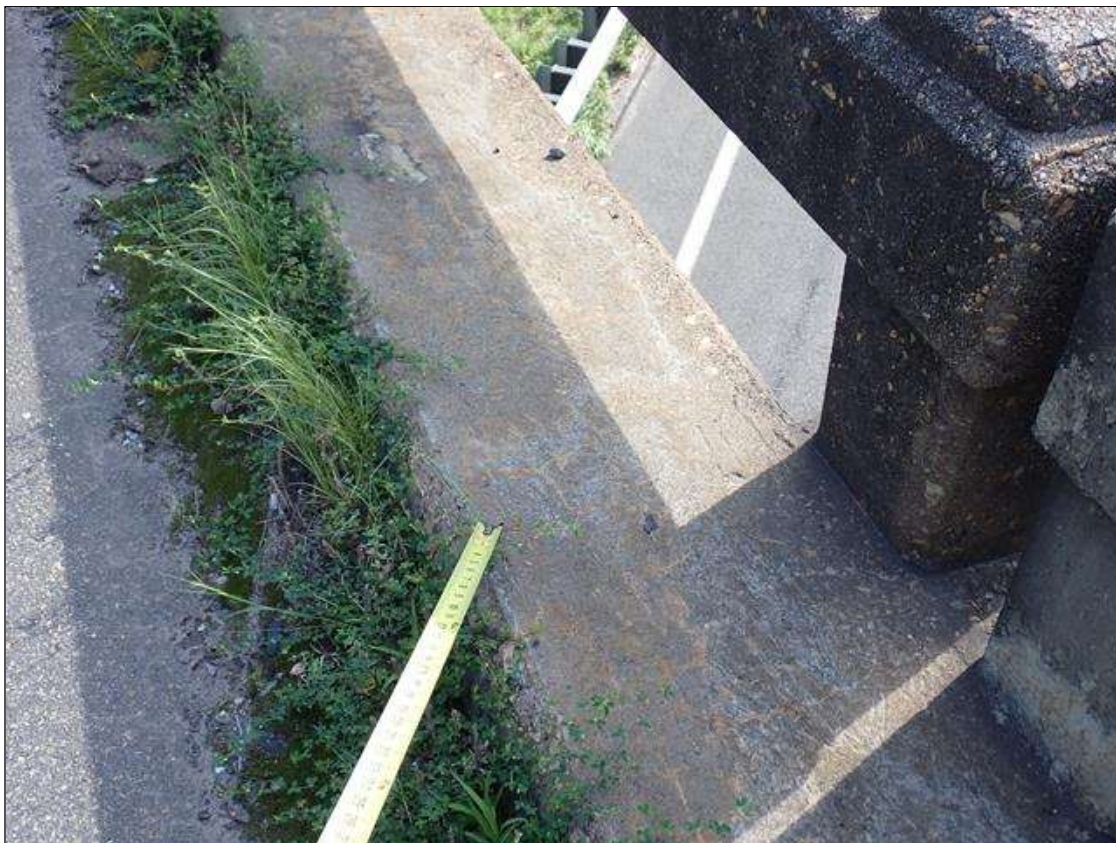
Span 3 Right Bridge Rail: along the safety walk, transverse cracks (up to 1/32 inch) and map cracks (hairline) at random

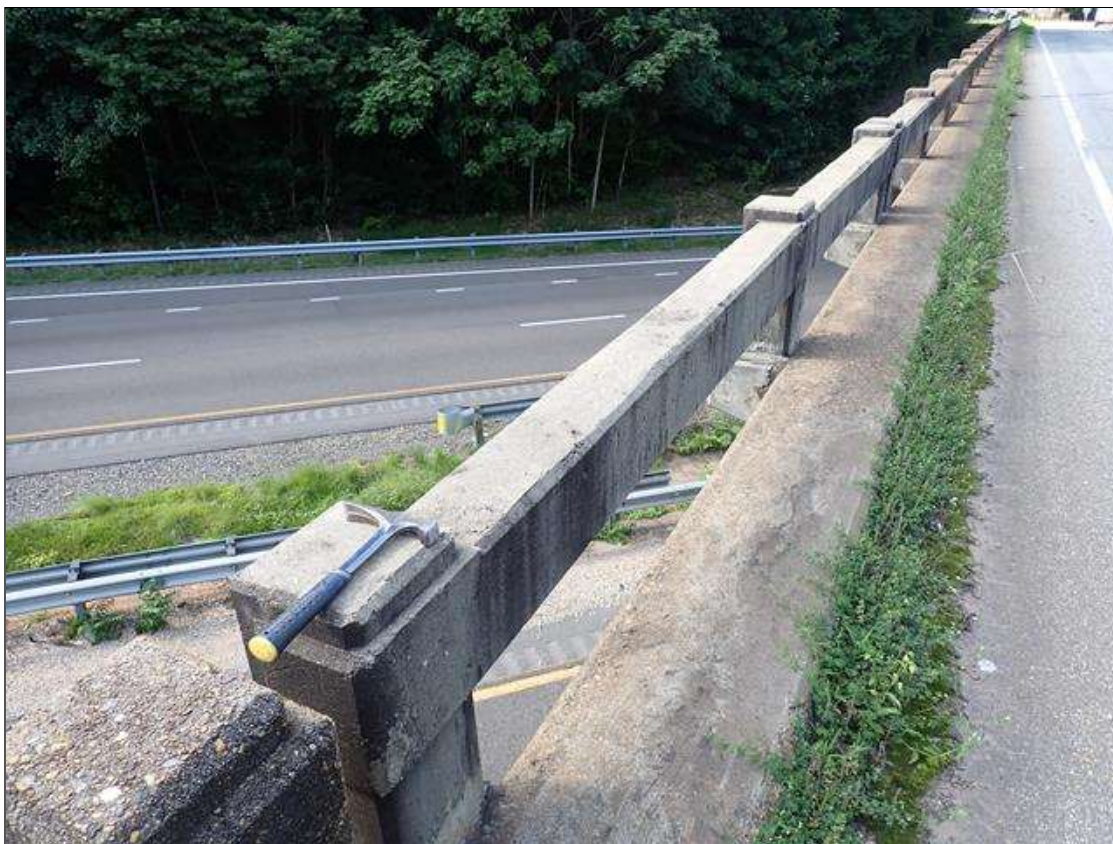
Span 3 Right Bridge Rail: 26 FOOT CONCRETE BRIDGE RAIL REPAIR NEAR MIDSPAN.

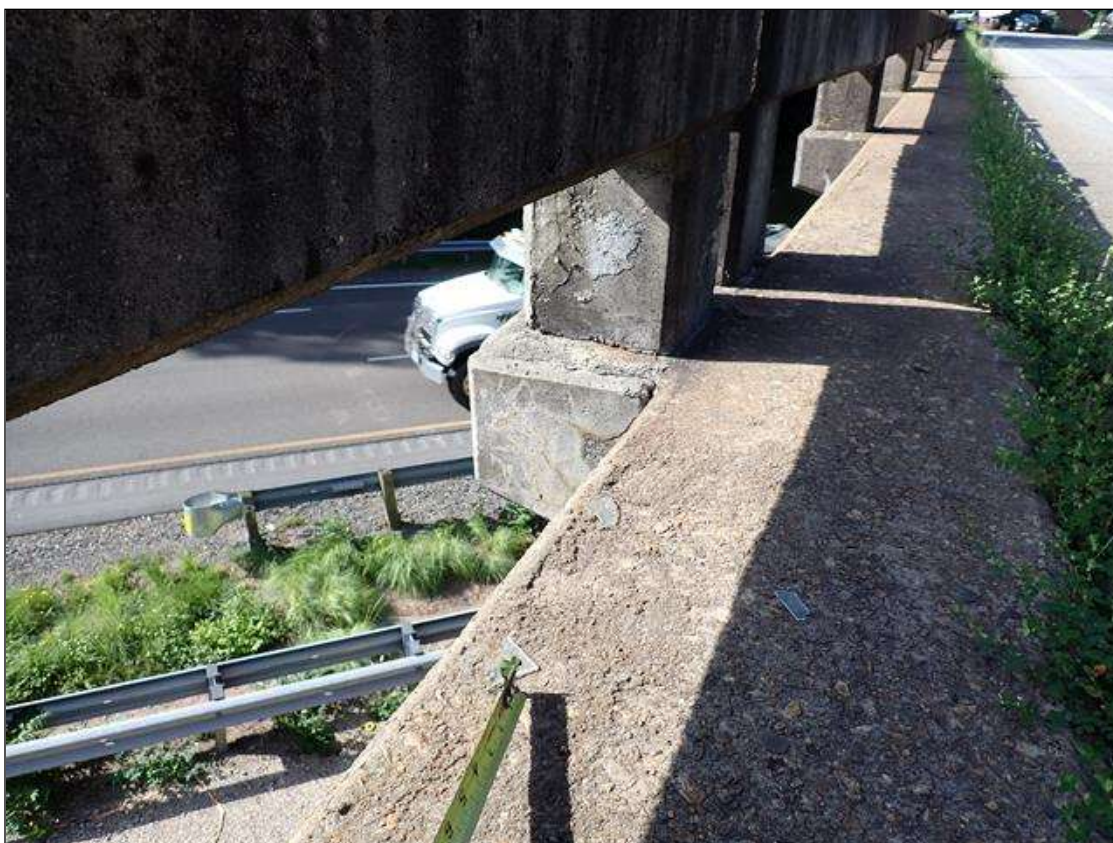
Span 3 Right Bridge Rail: (PAR) within patched area over left and right travel lanes of I-40, area of delamination with cracking (up to 1/16 inch), could possibly fall into traffic below

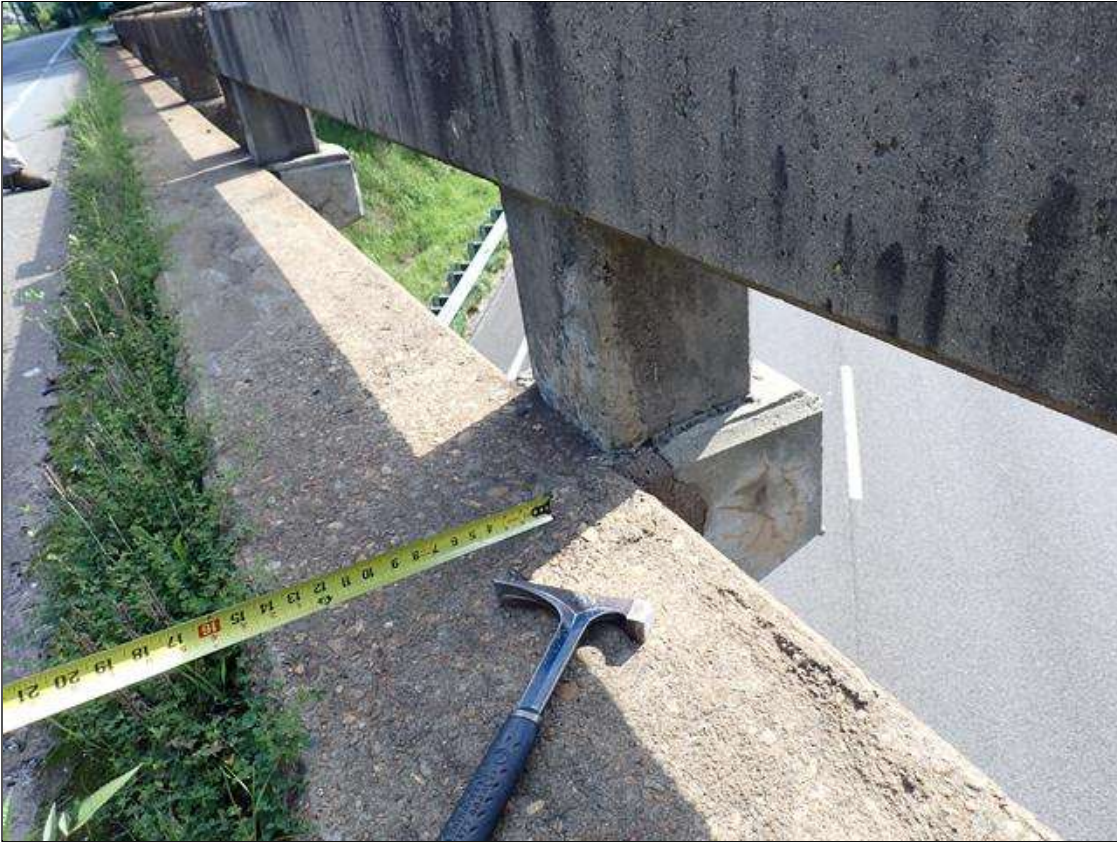
Span 3 Right Bridge Rail: (PAR) within patched area over left and right travel lanes of I-40, area of delamination with cracking (up to 1/16 inch), could possibly fall into traffic below

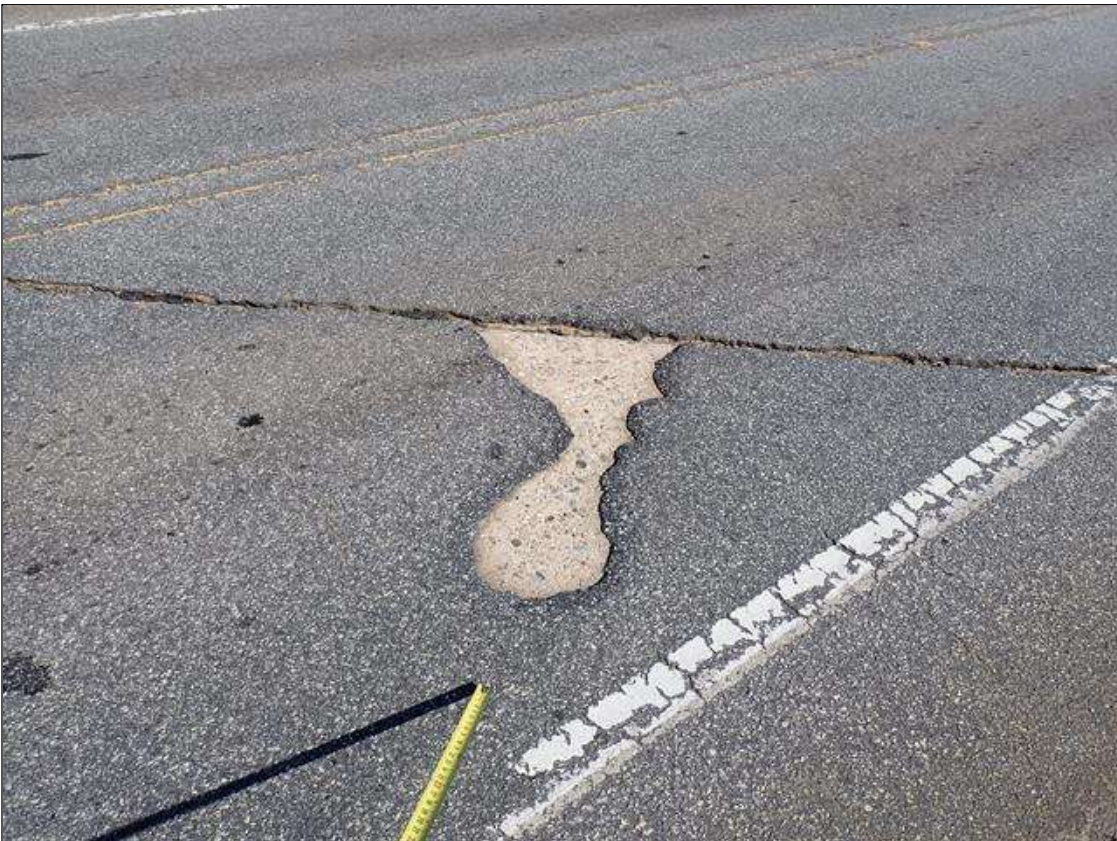
Span 3 Wearing Surface: (PAR) at bent 2, areas of missing asphalt (up to 3 feet x 2 inches) at random; northbound lane, at bent 3, area of missing asphalt (3.5 feet x 2 feet)

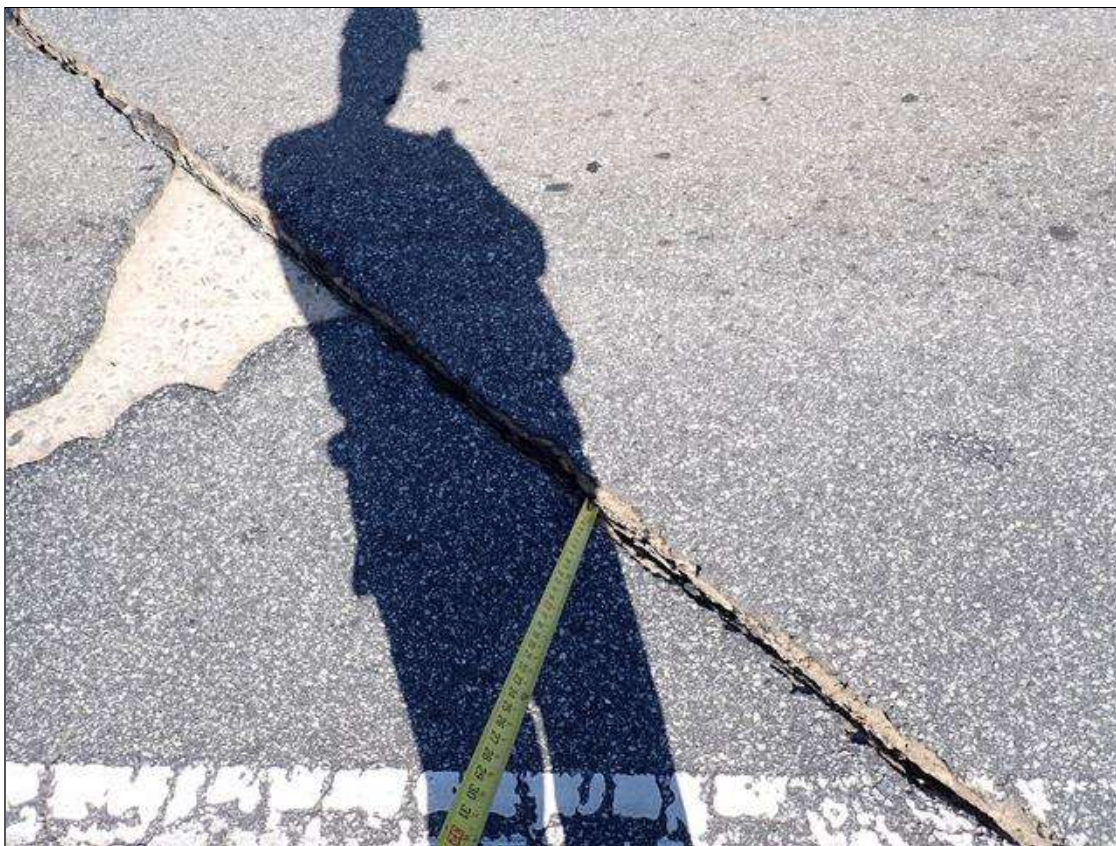
Span 4 Wearing Surface: (PAR) at bent 3, areas of missing asphalt (up to 2 feet x 2 inch) at random

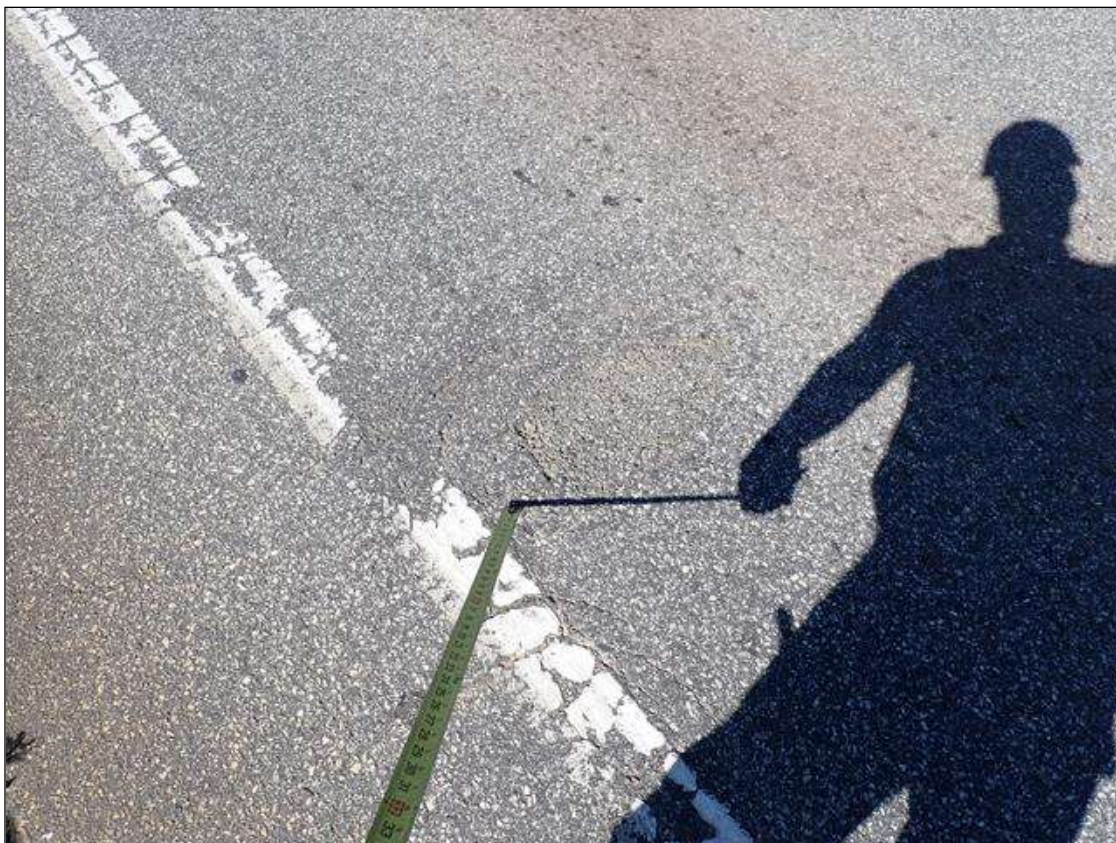
Span 4 Wearing Surface: 2023 previously repaired, previously noted as: midspan Northbound lane near shoulder, pothole, 3 inch x 4 inch x full depth

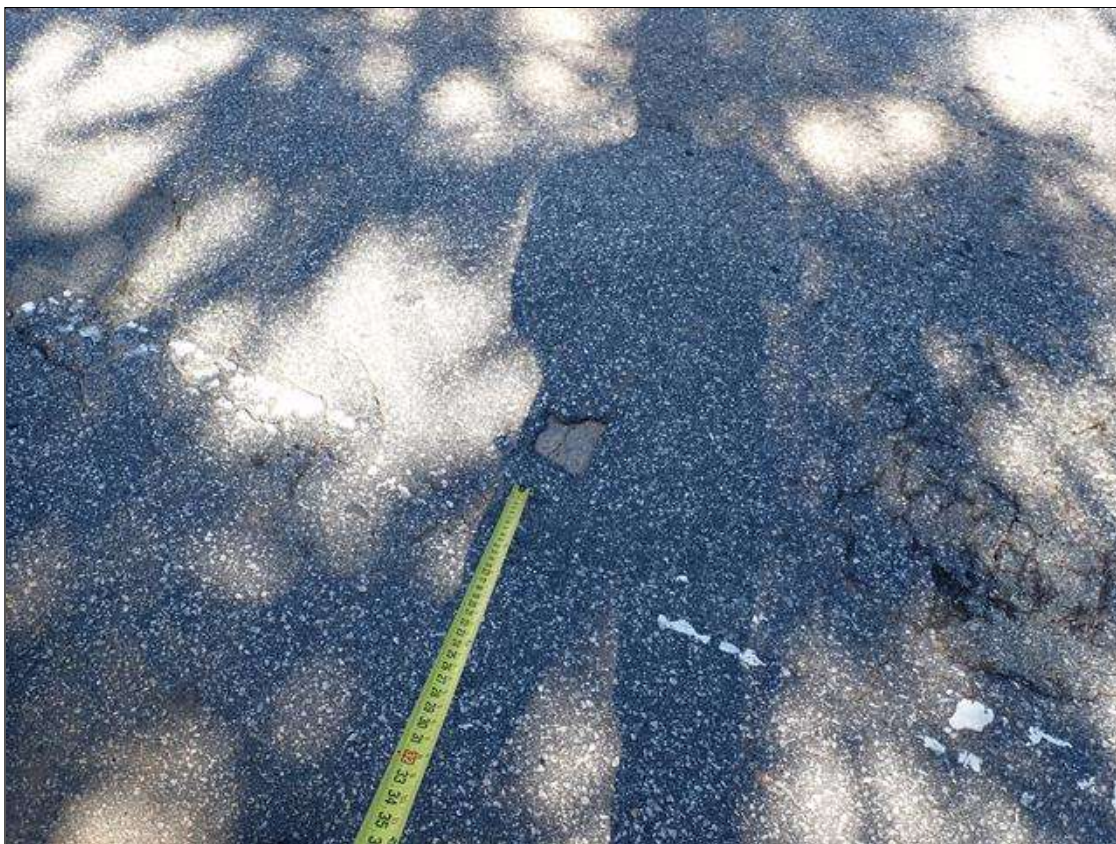
Span 4 Wearing Surface: (PAR) throughout wearing surface, scattered areas of missing asphalt (up to 5 inch diameter)

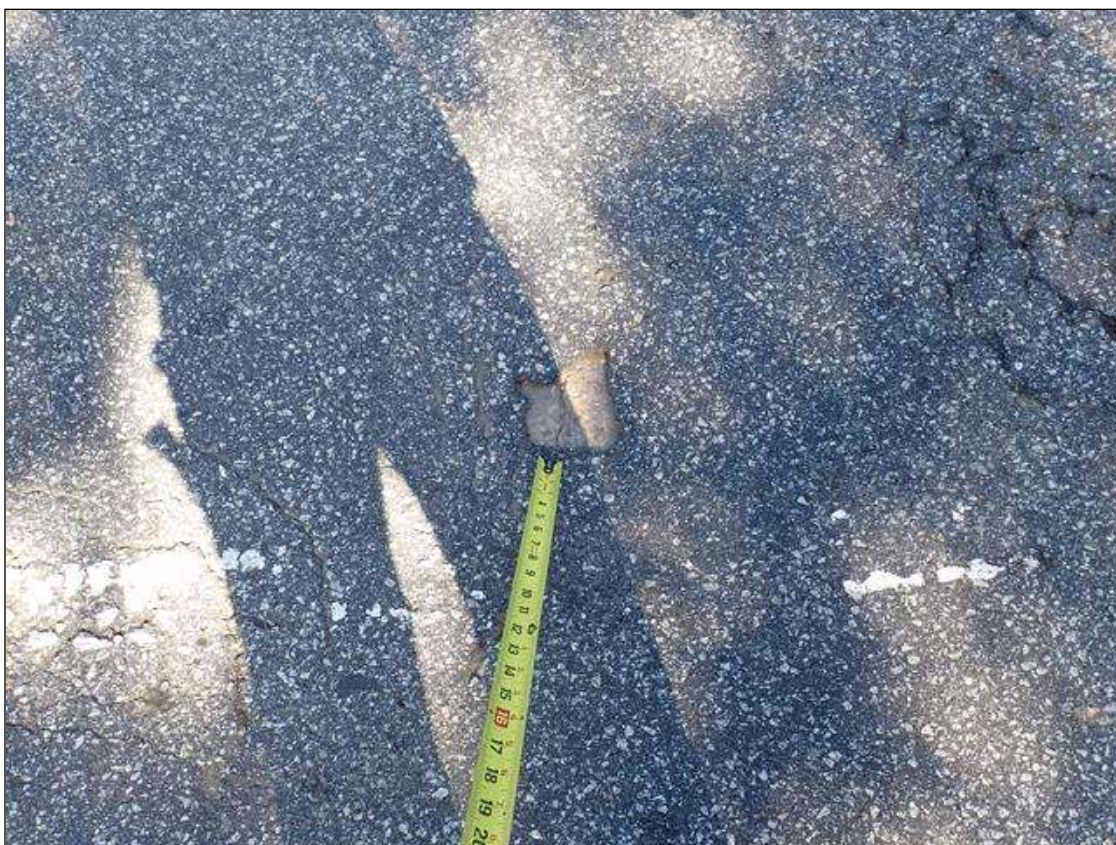
Span 4 Deck: top of deck, northbound lane, near end bent 2, transverse crack (up to 1/32 inch) at area of missing asphalt

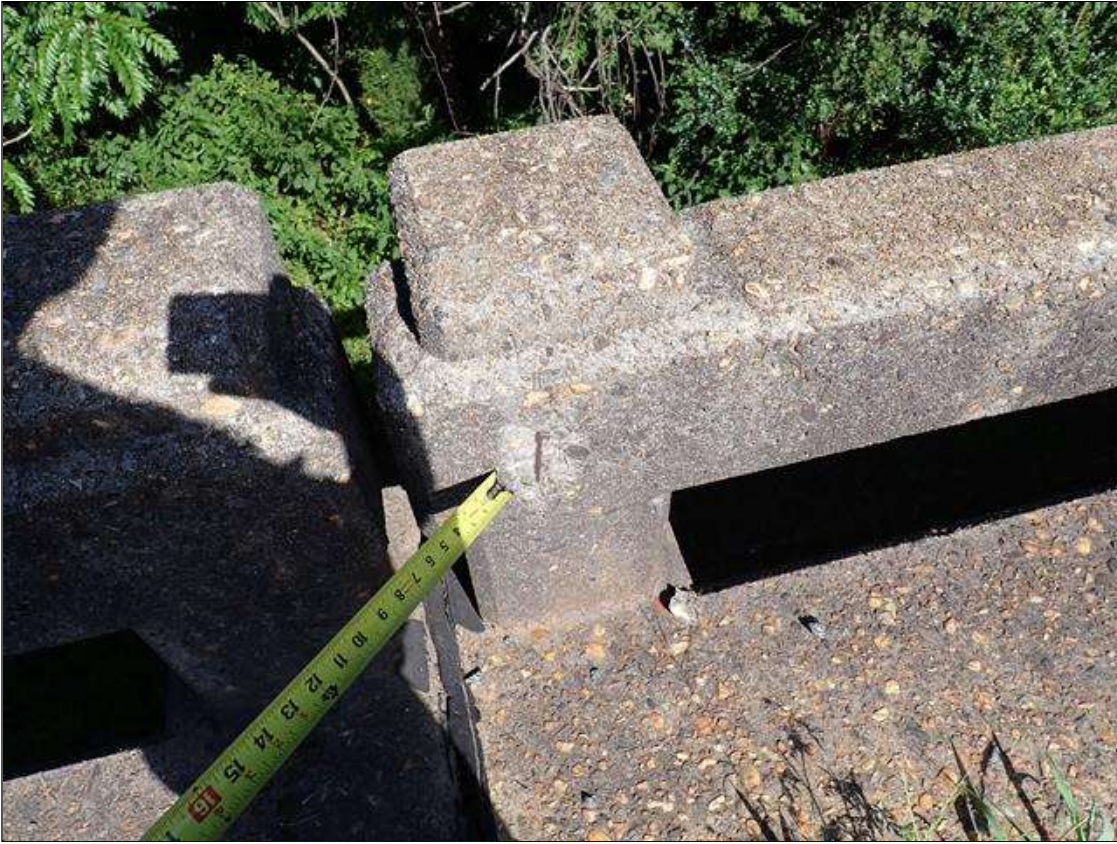
Span 4 Left Bridge Rail: at rail post 1, spall (5 inch x 3 inch x 1/2 inch deep) with exposed rusted rebar
