NC DEPARTMENT OF TRANSPORTATION
 DIVISION OF HIGHWAYS
 STRUCTURE MANAGEMENT UNIT

ATTENTION: **prompt action request, sketches revised, horizontal clearances revised**

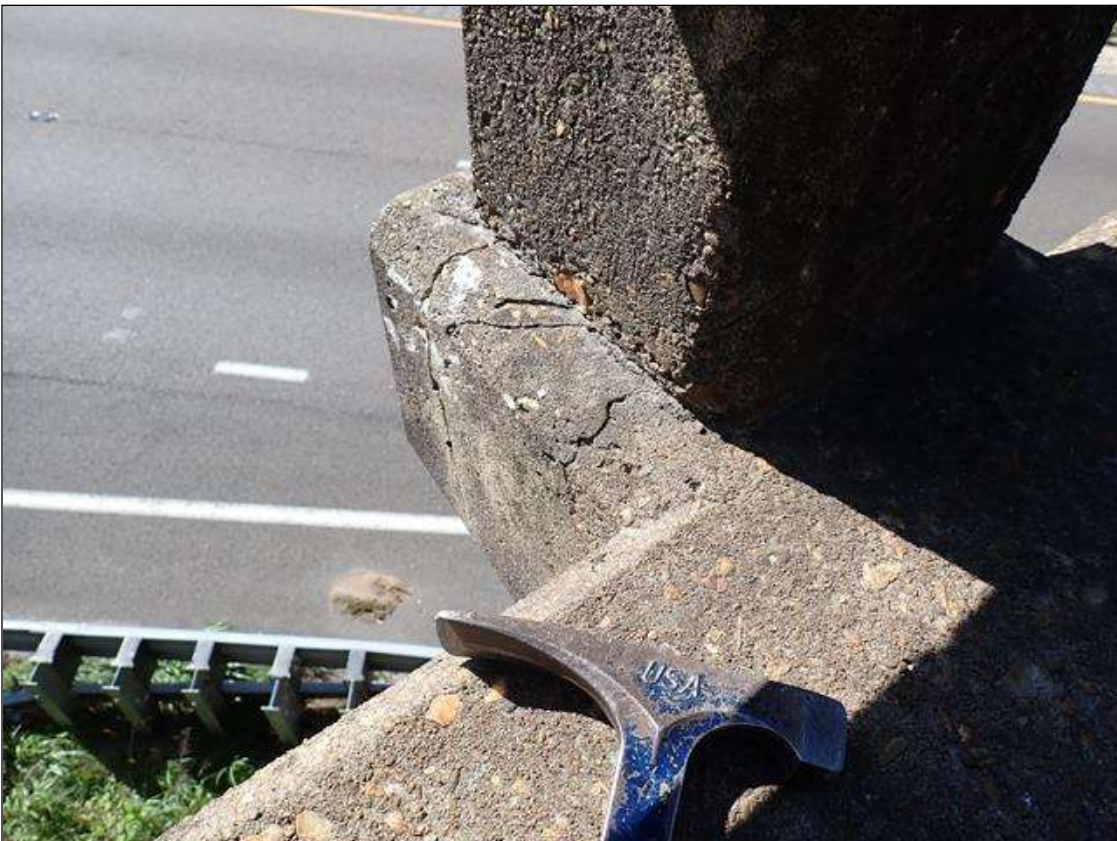
Span 4 Right Bridge Rail: at rail post 2, cracks (up to 1/16 inch wide); adjacent rail section, vertical crack (up to 1/32 inch)

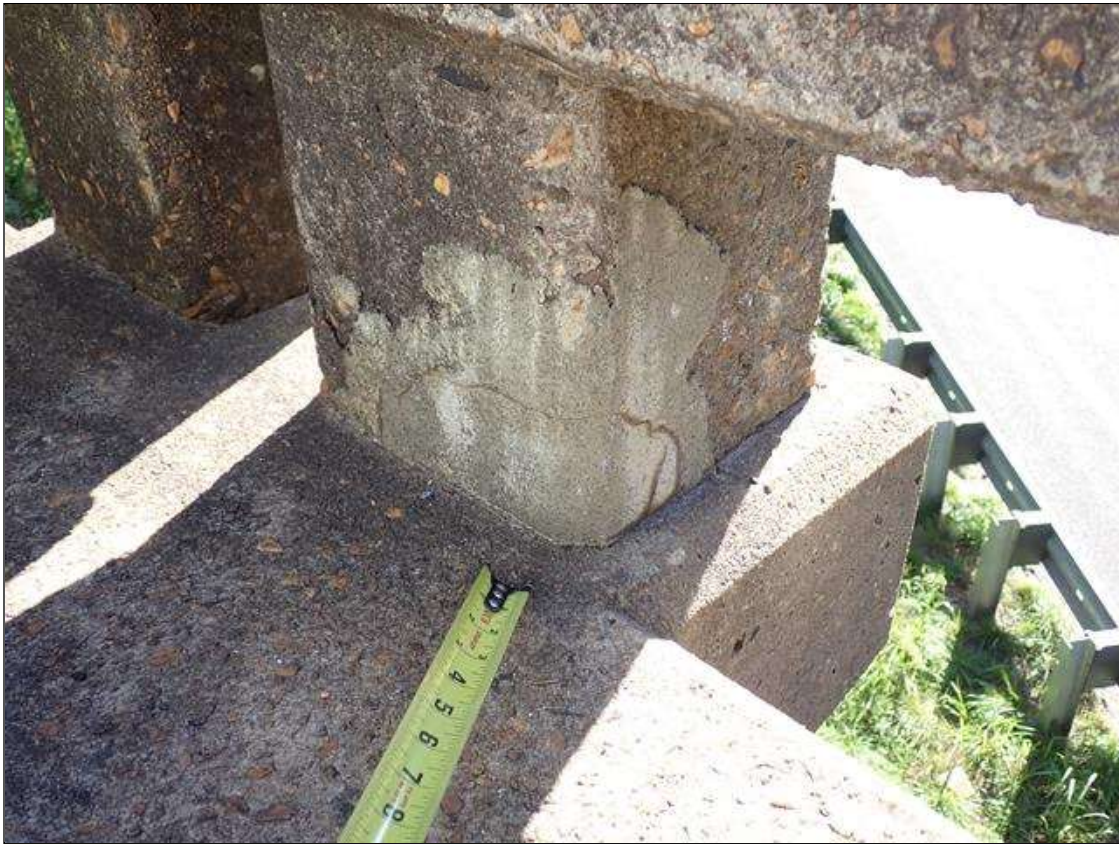
Span 4 Right Bridge Rail: rail post 3, patched area (8 inch x 10 inch) with hairline cracks

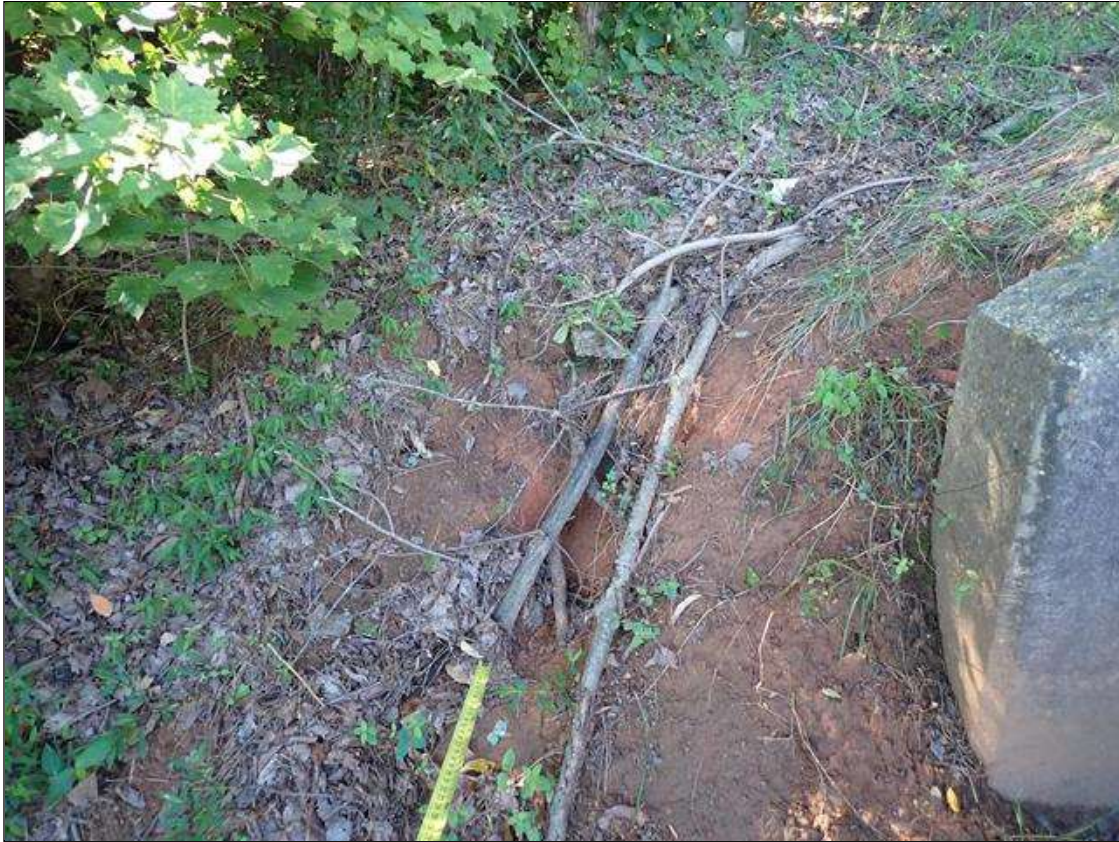
(PAR) east side of span 1, extending from behind southeast wingwall to toe of end bent 1 slope protection, erosion channel (approximately 100 feet long x 3 feet long x 1.5 feet deep) undermining slope protection (up to 1 foot high x 1.5 foot deep)

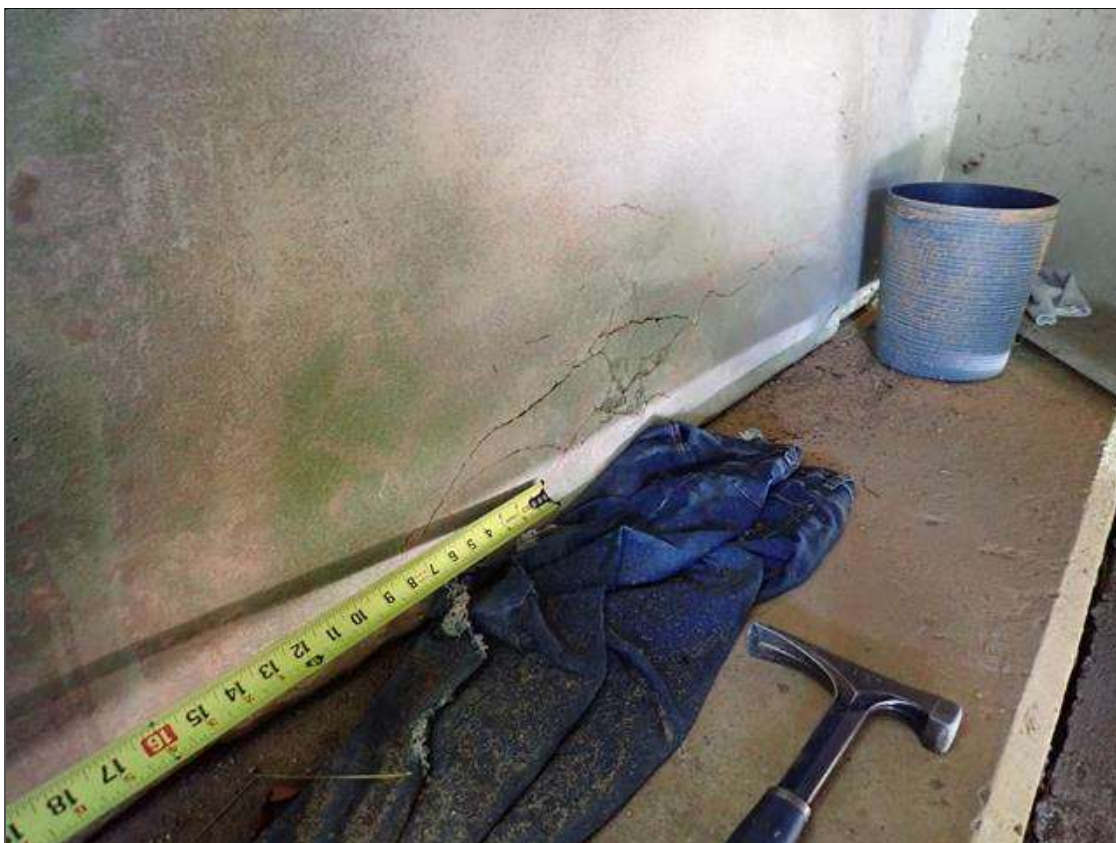
End Bent 1 Abutment: right side of beam 4, delamination 3.5 feet x up to 1 foot, with cracks up to 1/16 inch

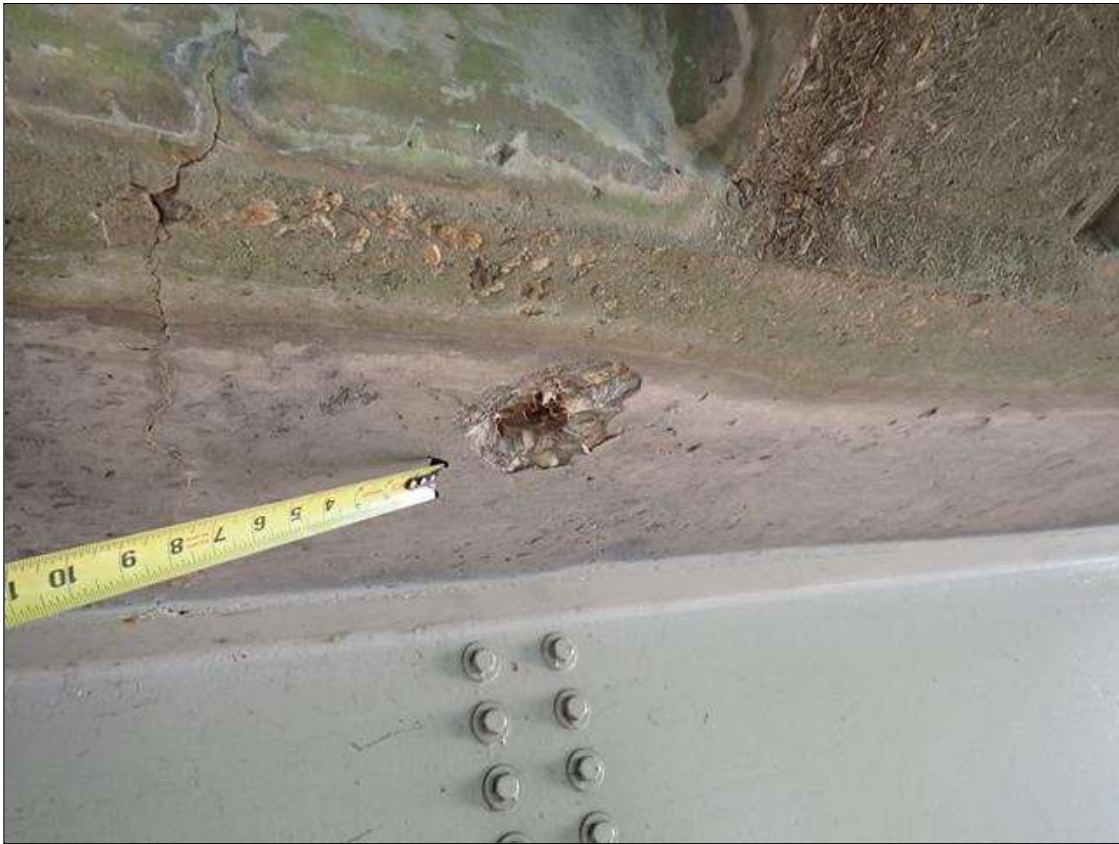
Span 1 Deck: (PAR) left and right overhangs, near end bent 1, spalls (up to 6 inch x 4 inch x 1 inch deep) with exposed rusted rebar

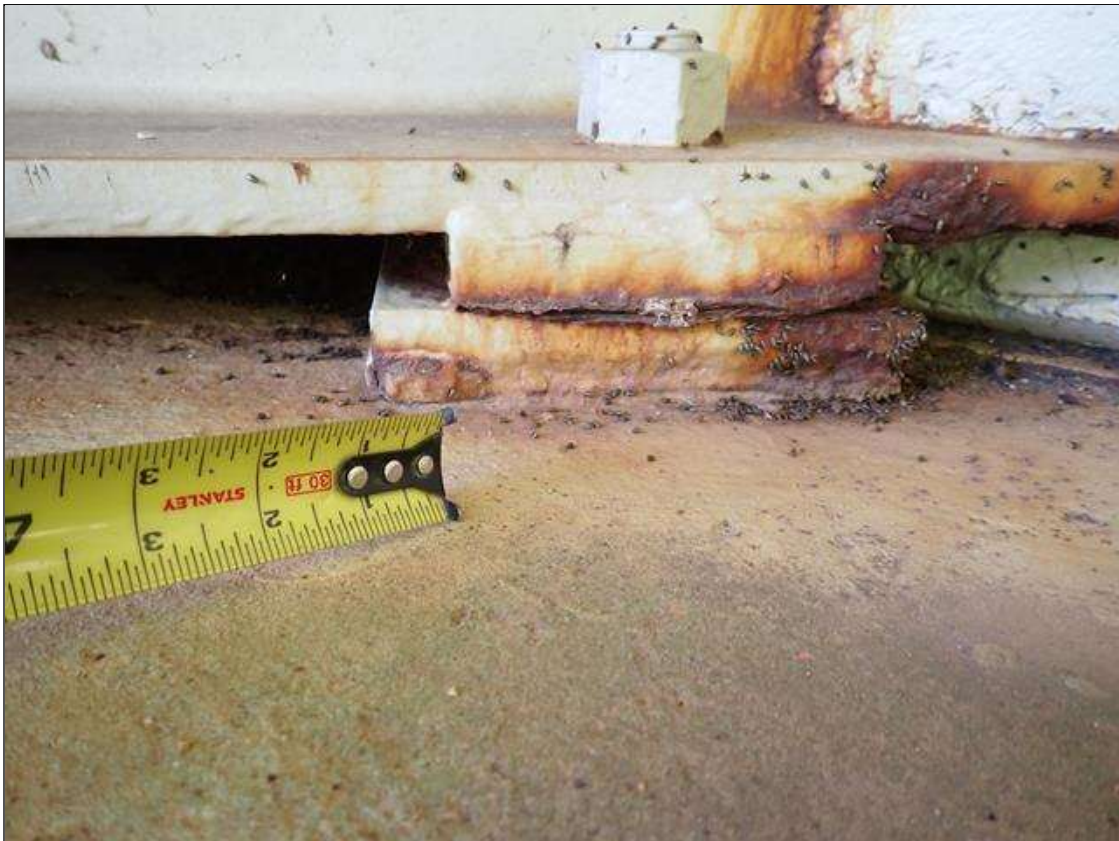
Span 1 Beam 1 - Near Bearing 1: painted over section loss (up to 3/16 inch deep) with corrosion reinitiated

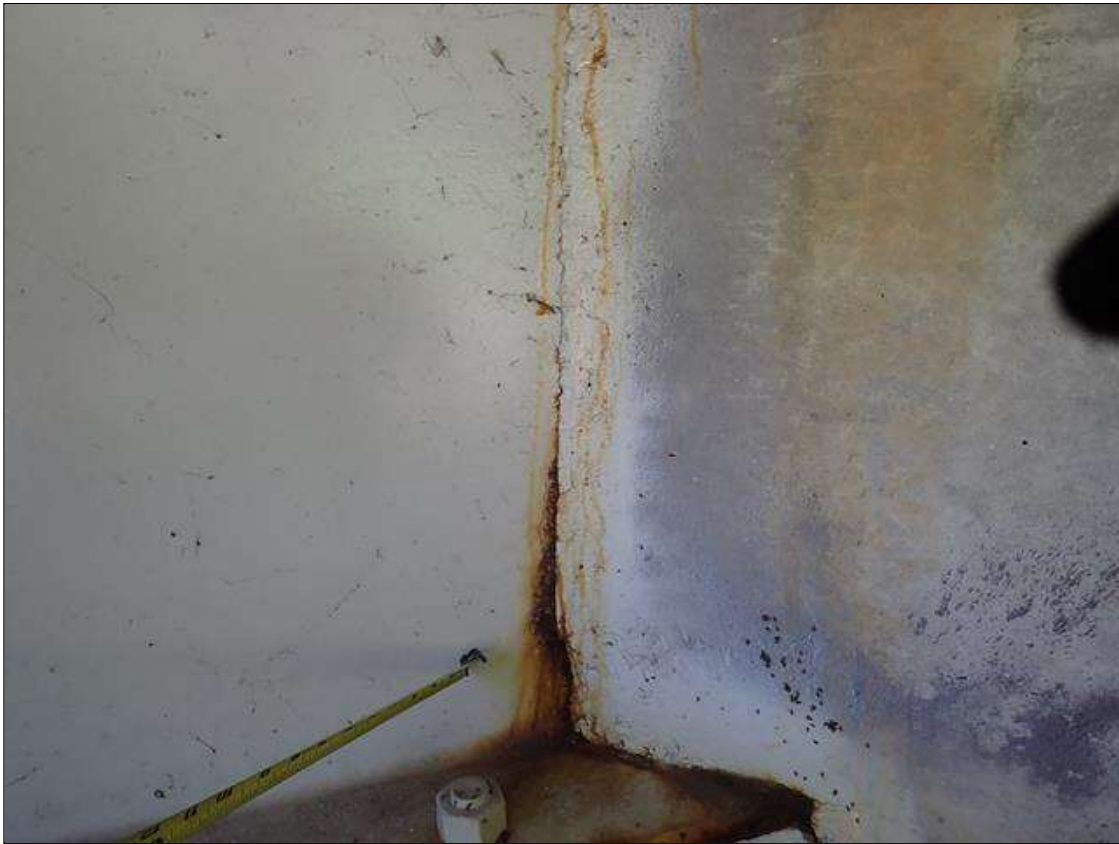
Span 1 Beam 1: at end bent 1, web and bottom flange, rust scale

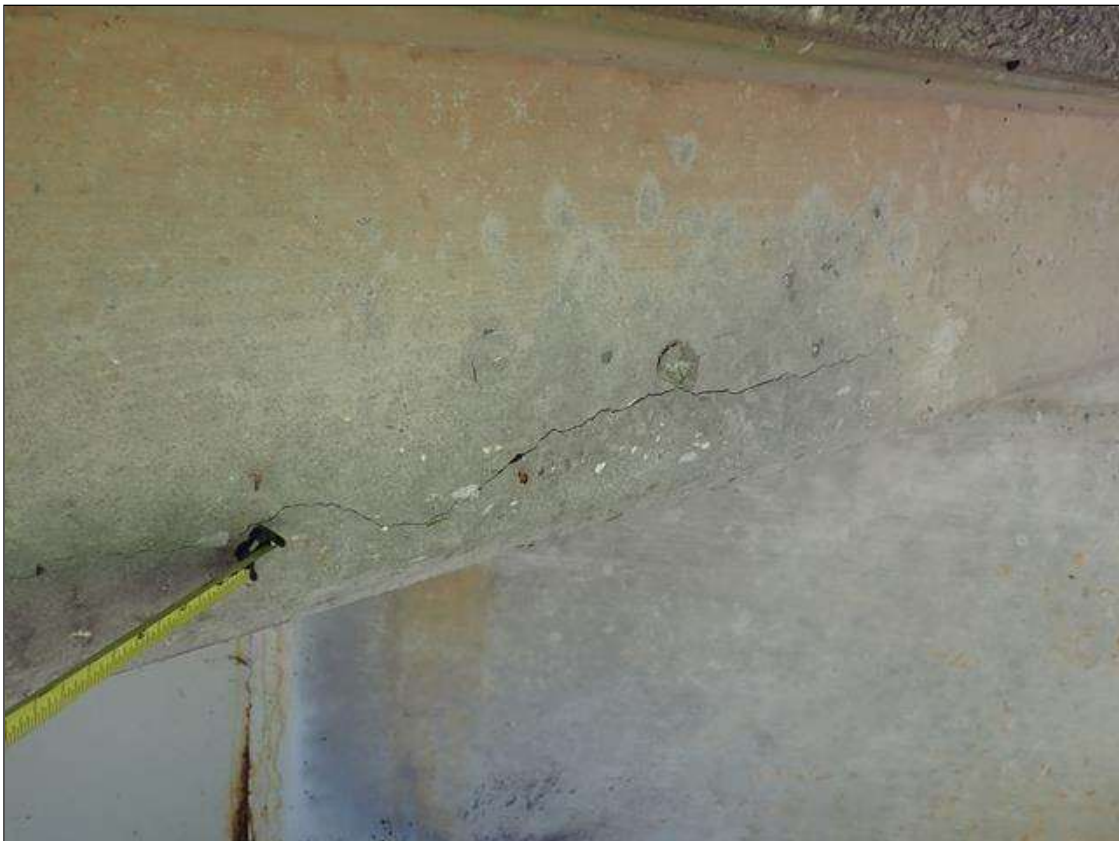
Span 1 Deck: left overhang, near end bent 1, longitudinal crack (1/32 inch x 3 feet)

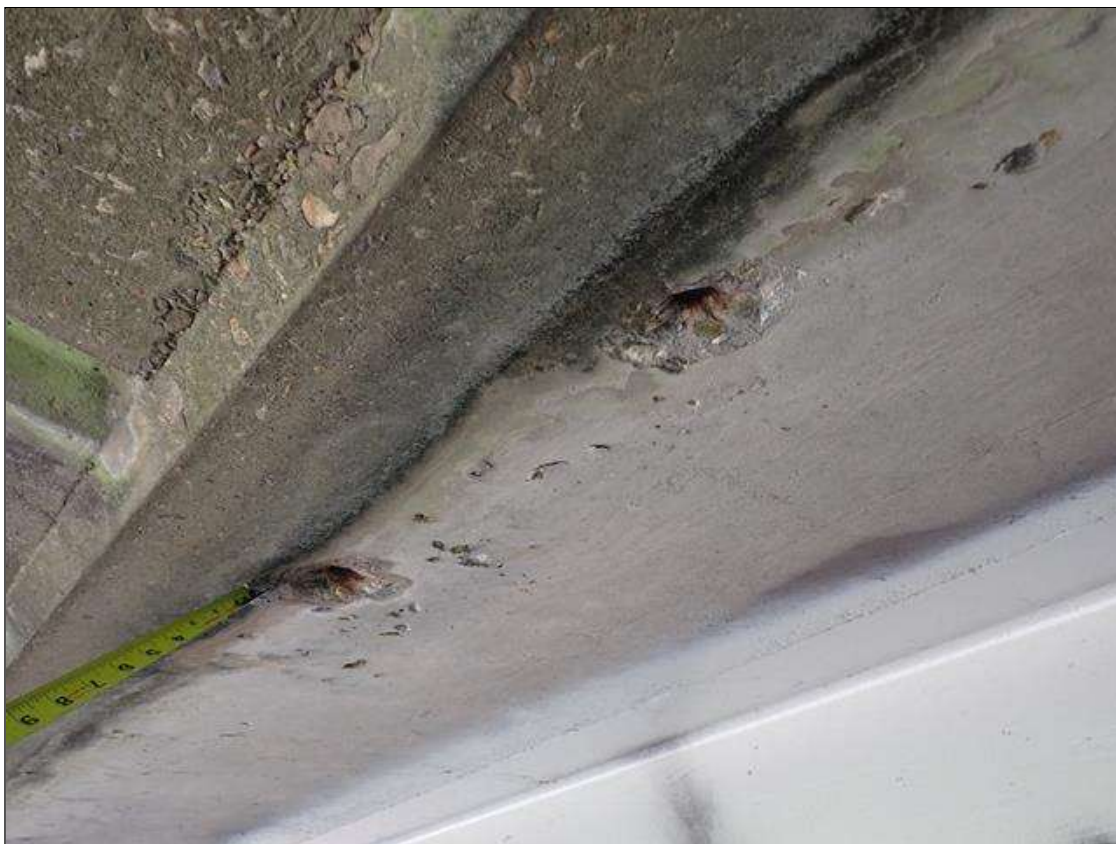
Span 1 Deck: (PAR) left and right overhangs, near end bent 1, spalls (up to 6 inch x 4 inch x 1 inch deep) with exposed rusted rebar

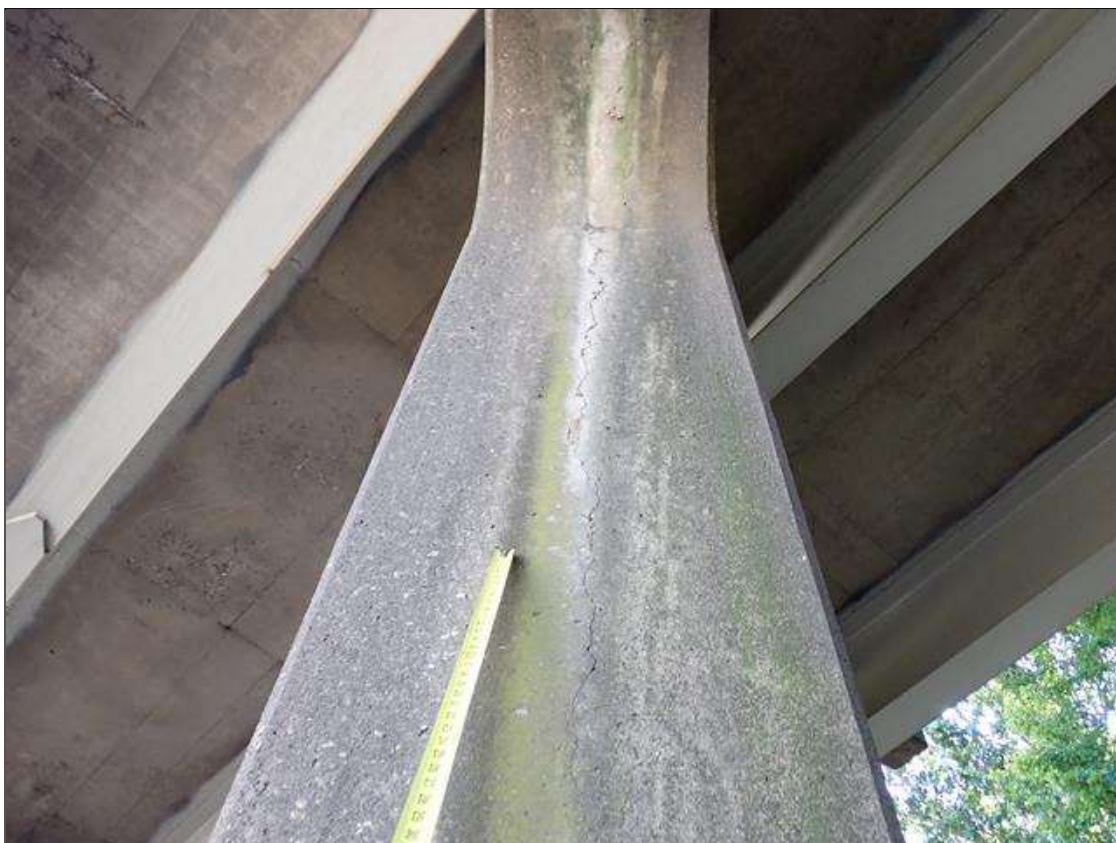
Bent 1 Pile 2: West face at top, vertical crack 9 feet x up to 1/16 inch with adjacent delamination 5 feet x 8 inches

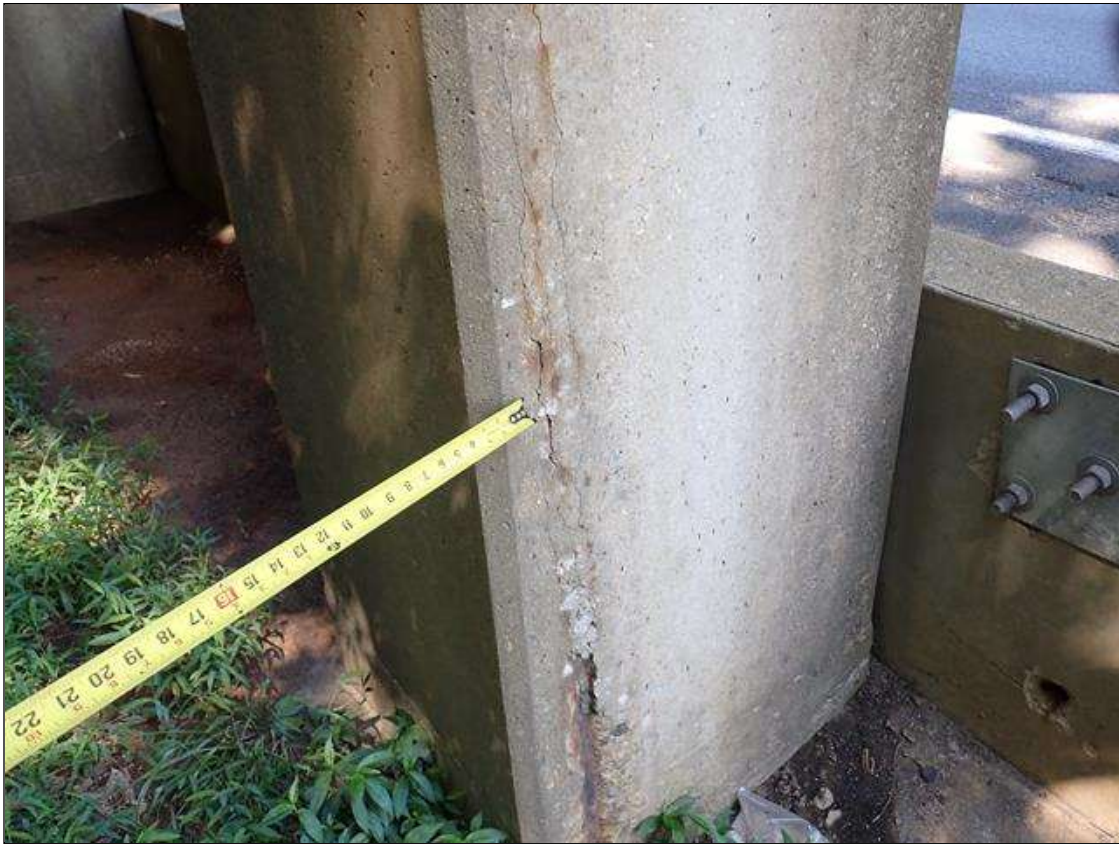
Bent 1 Pile 3: (PAR) southeast and northeast corners, vertical cracks (up to 1/16 inch x 5.5 feet) with rust stains, and adjacent delaminations (up to 4 feet x 6 inch); southeast corner, at ground, spall (2 feet x 6 inch x 1.5 inch deep) with exposed rusted primary reinforcement

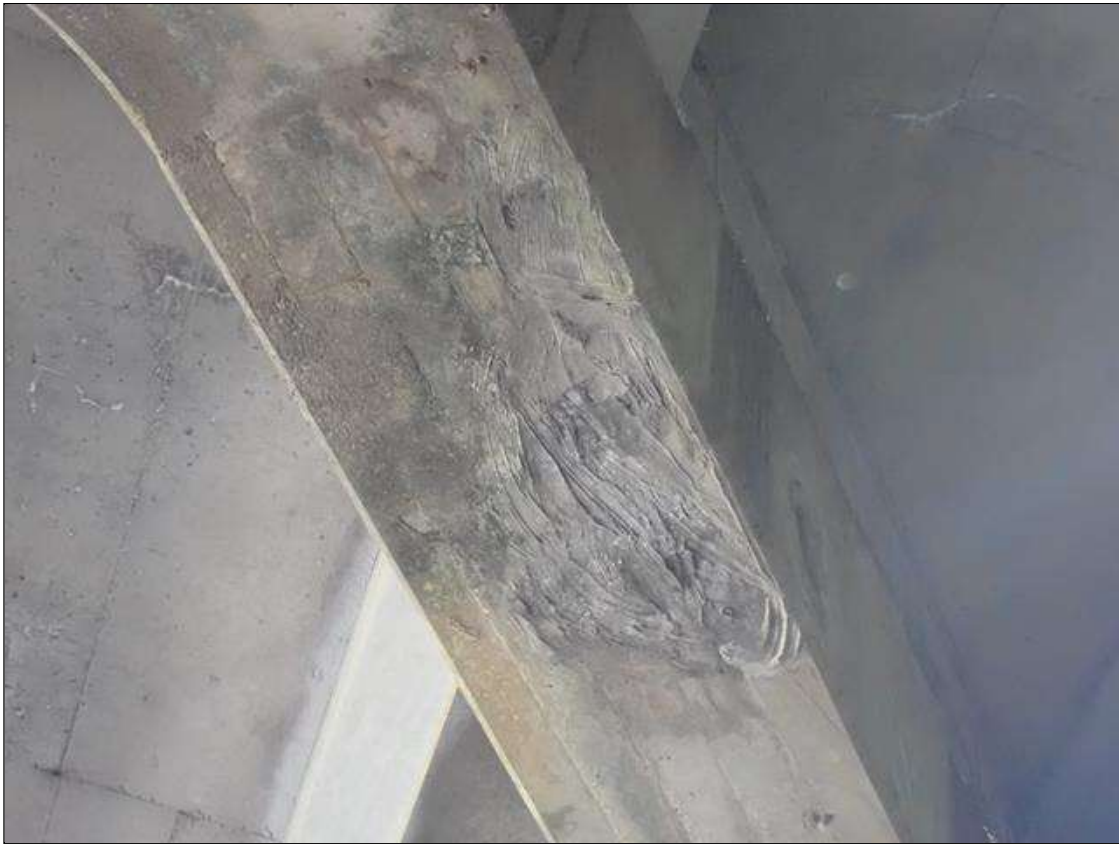
Bent 1 Cap 1: SOUTH FACE AND BOTTOM OF WEST END, AND BETWEEN COLUMNS 2 AND 3. HAS PATCHED AREAS UP TO 3 FEET X 15 INCHES WITH SOME HAIRLINE CRACKS AND EFFLORESCENCE VISIBLE.

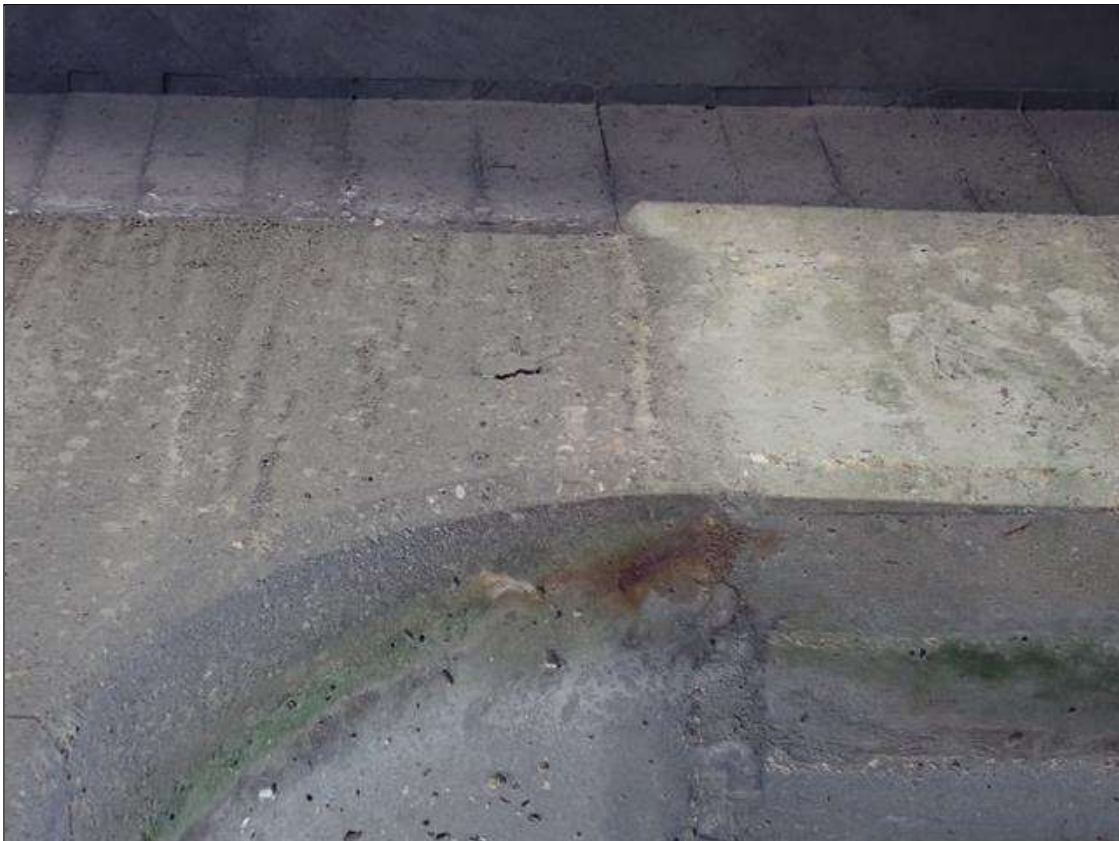
Bent 1 Cap 1: (PAR) BENT 1 CAP HAS SCATTERED CRACKS UP TO 1/32 INCH, SOME WITH RUST STAINS.

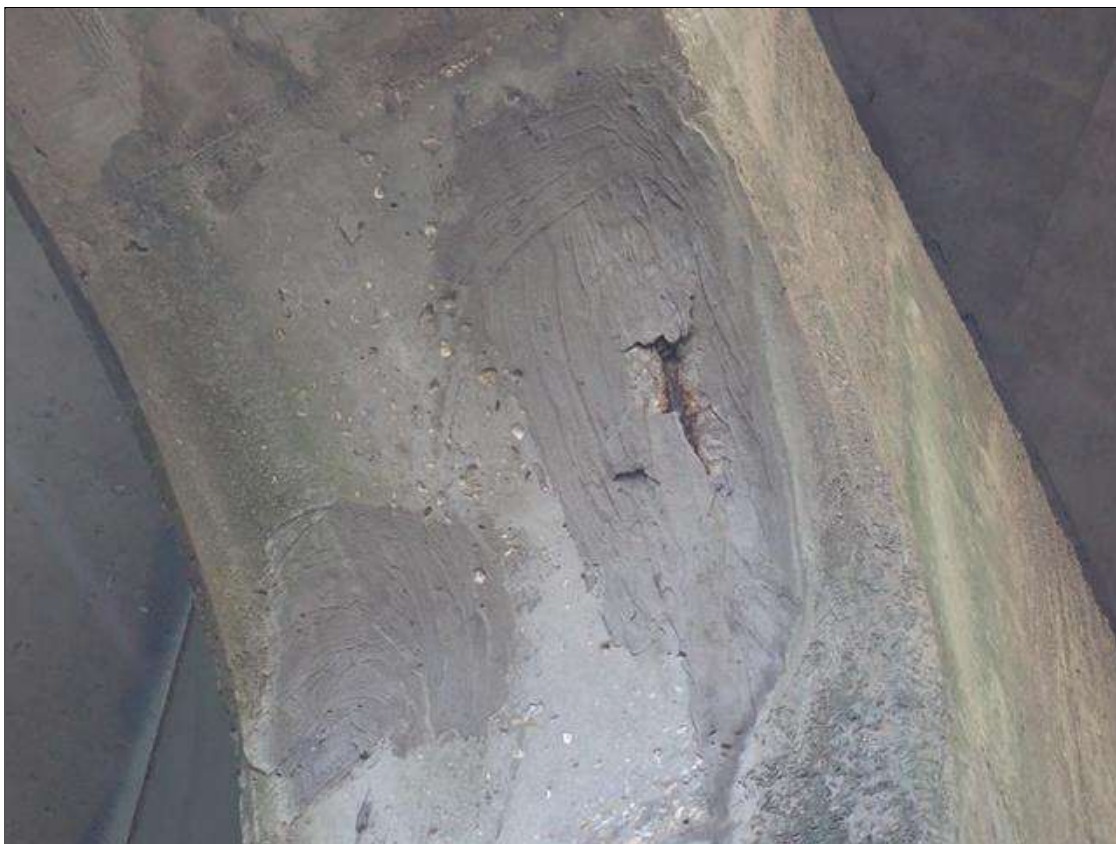
Bent 1 Cap 1: underside, at east end, unsound patched areas (up to 2 feet x 1 foot x 1 inch deep) with exposed rusted rebar

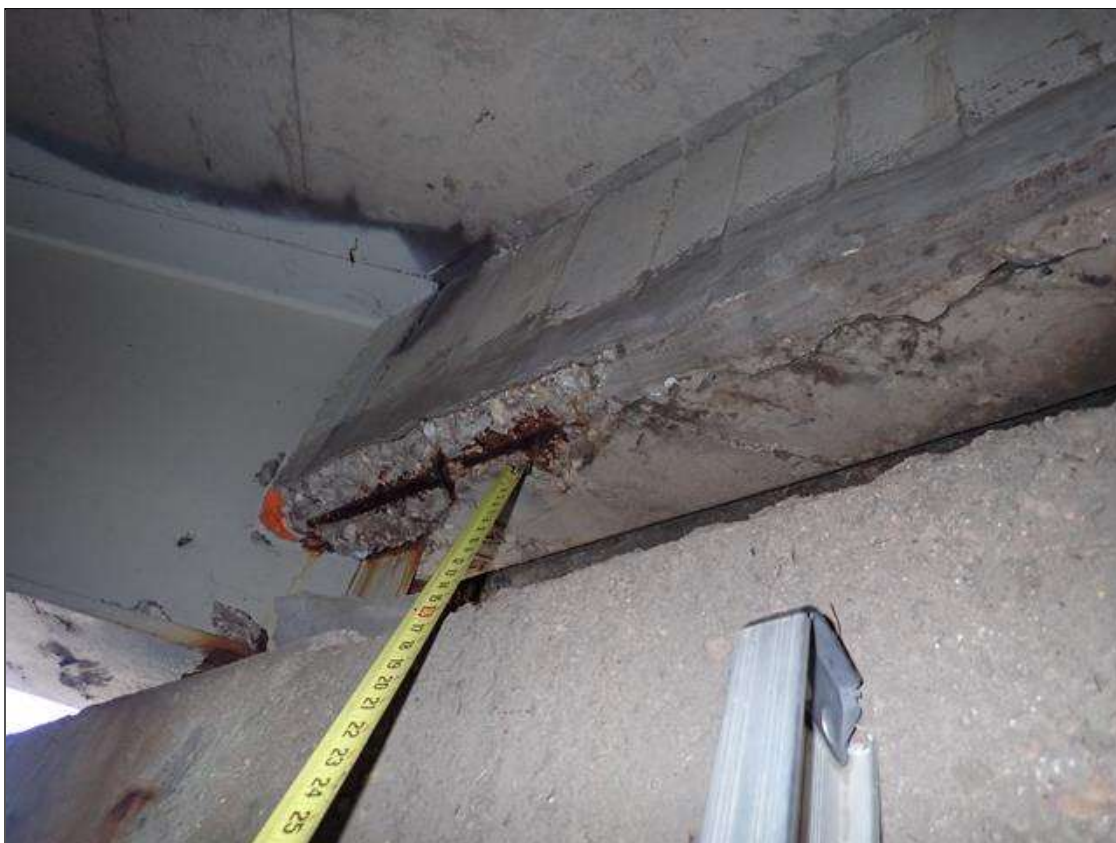
Span 1 Deck: at bent 1, end diaphragm in all bays, spalls/delaminations (up to full bay width x 8 inch x 2 inches deep) with exposed rusted rebar and cracks (up to 1/8 inch)

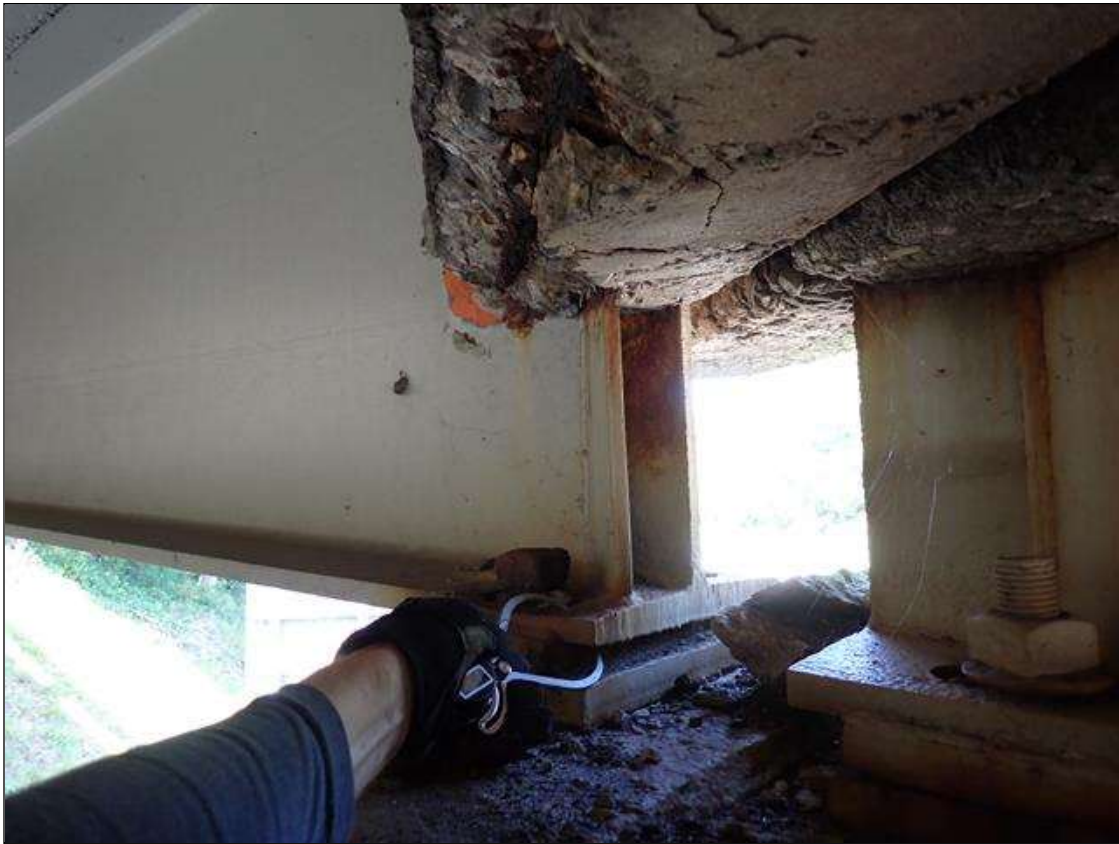
Span 1 Beam 1: at bent 1, painted over section loss: web adjacent to diaphragm (9/16 inch average remaining x 3 inch x 4 inch); bottom flange (0.85 inch x 6 inches) with corrosion reinitiated

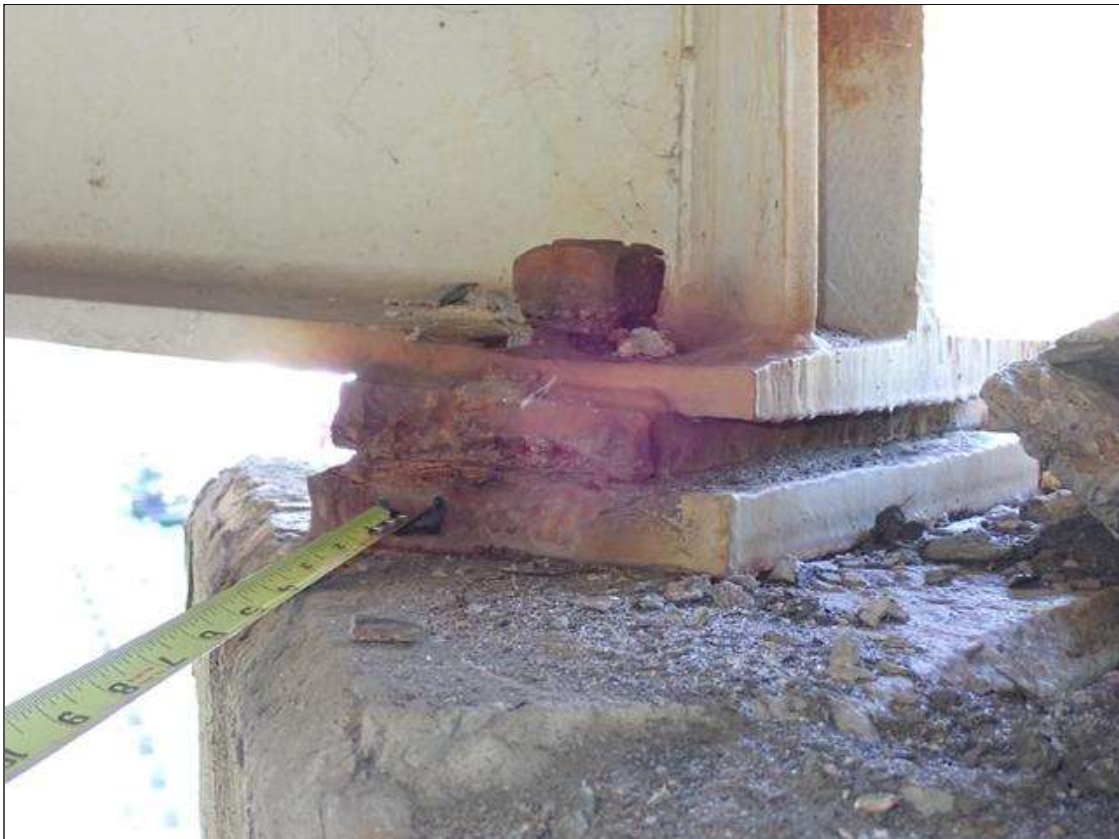
Span 1 Beam 1 - Far Bearing 1: painted over section loss (up to 1/8 inch deep) with corrosion reinitiated; pack rust

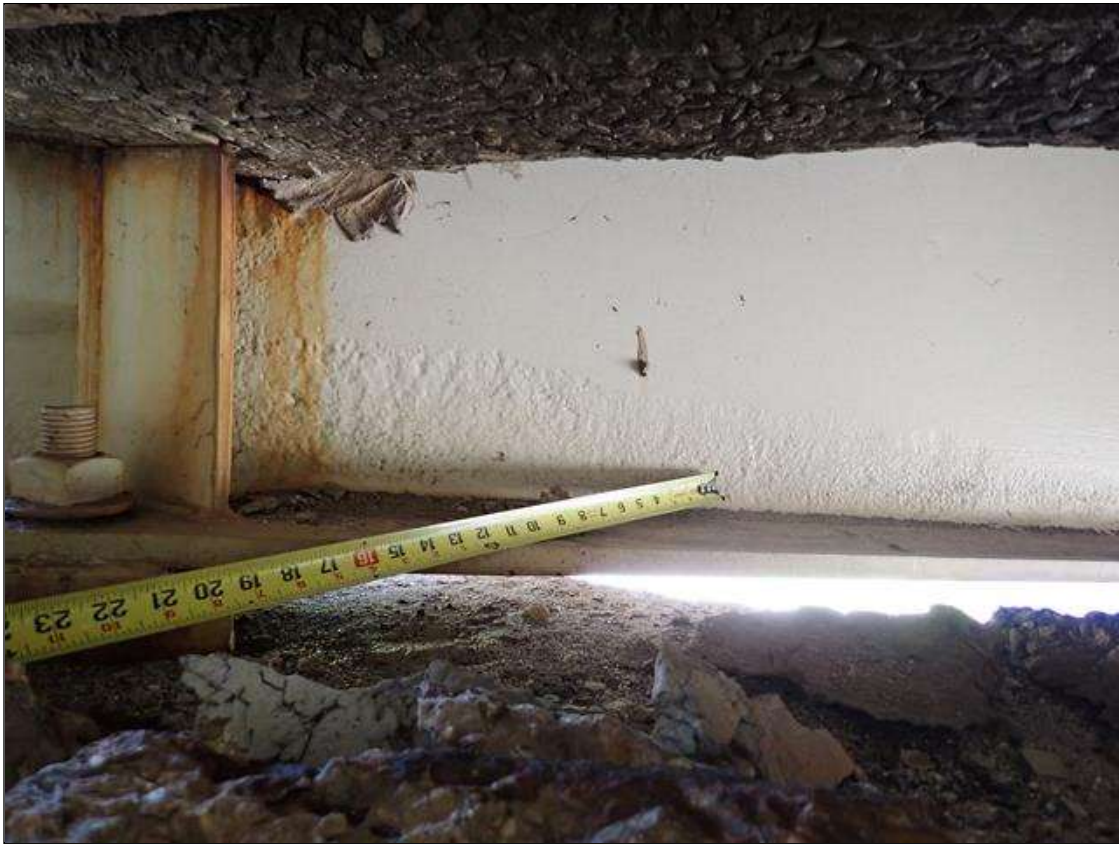
Span 2 Beam 1: at bent 1, lower web, painted over section loss (9/16 inch average remaining x 5.5 feet x up to 10 inches) with corrosion reinitiated

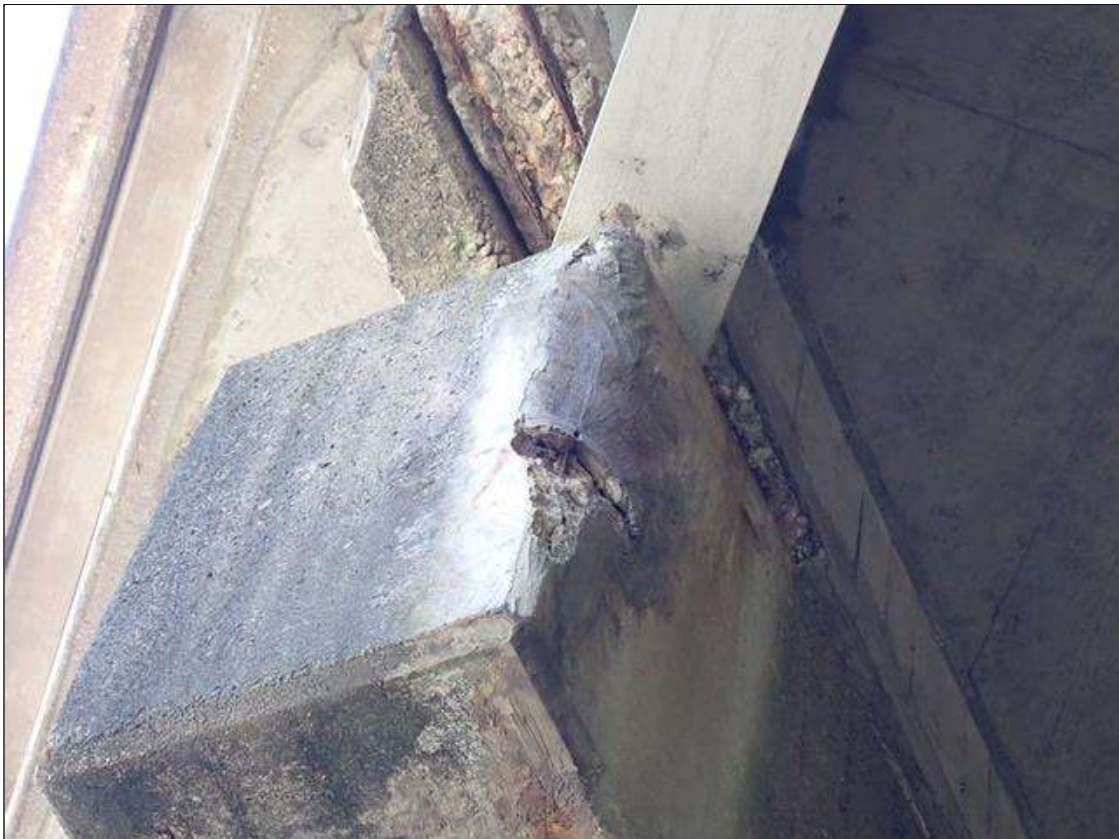
Bent 1 Cap 1: southwest corner, failed patch (full height x 18 inch x up to 2 inches deep) with exposed rusted rebar

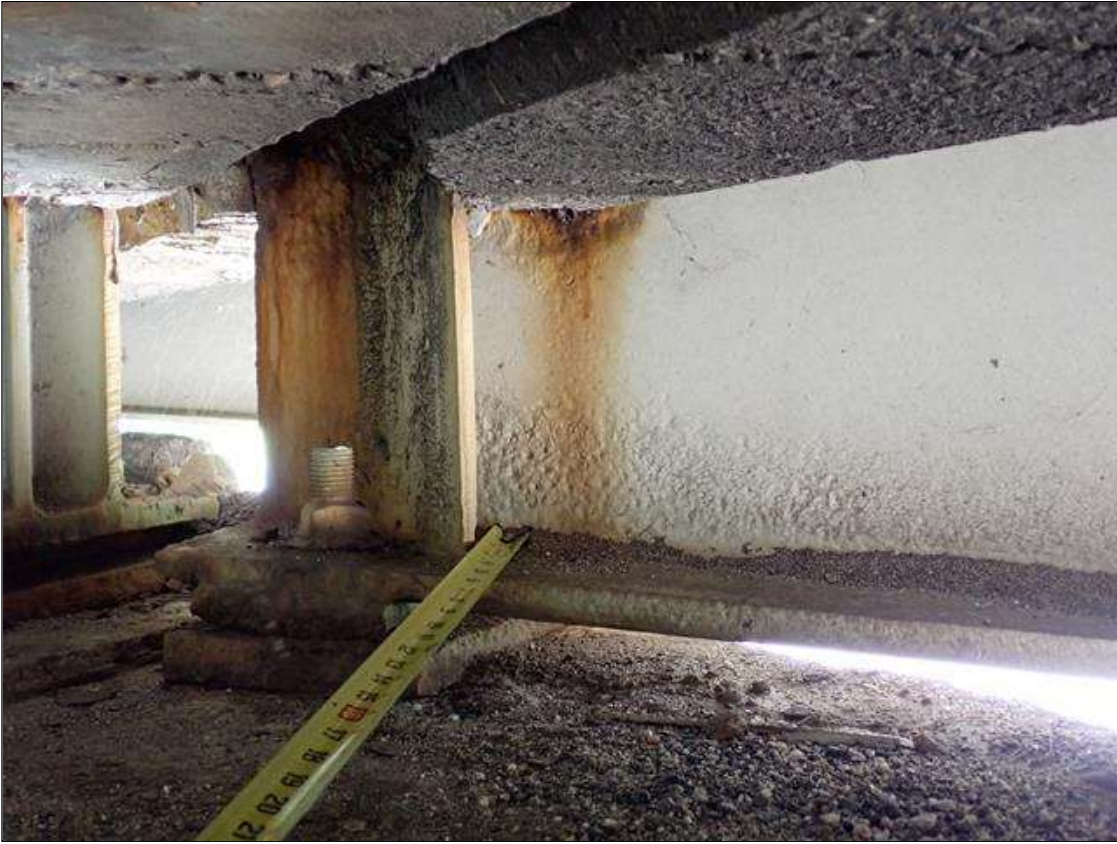
Span 2 Beam 2: at bent 1, painted over section loss: web adjacent to diaphragm (9/16 inch average remaining x 14 inch x 2 inch); lower web (9/16 inch average remaining x 2 feet x 4 inch) with corrosion reinitiated

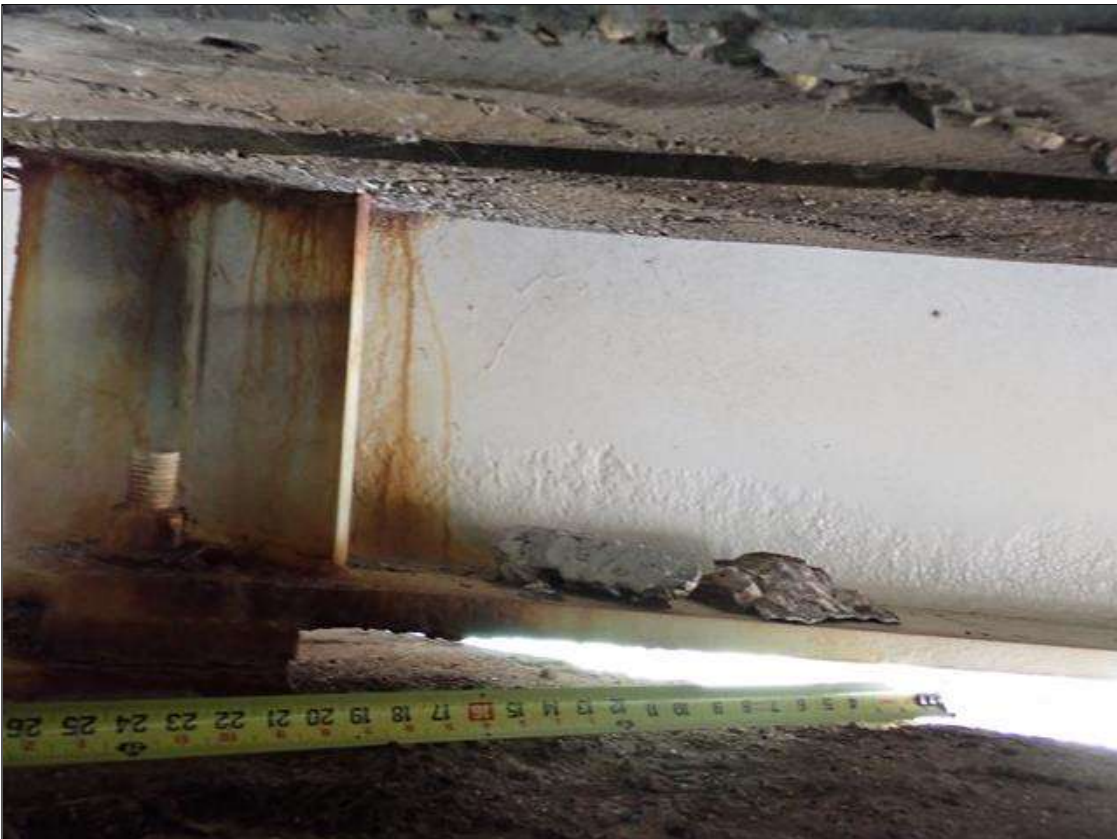
Span 2 Beam 3: at bent 1, painted over section loss: web adjacent to diaphragm (5/8 inch average remaining x 10 inch x 2 inch); lower web (9/16 inch average remaining x 7 feet x 4 inch) with corrosion reinitiated; bottom flange, rust scale

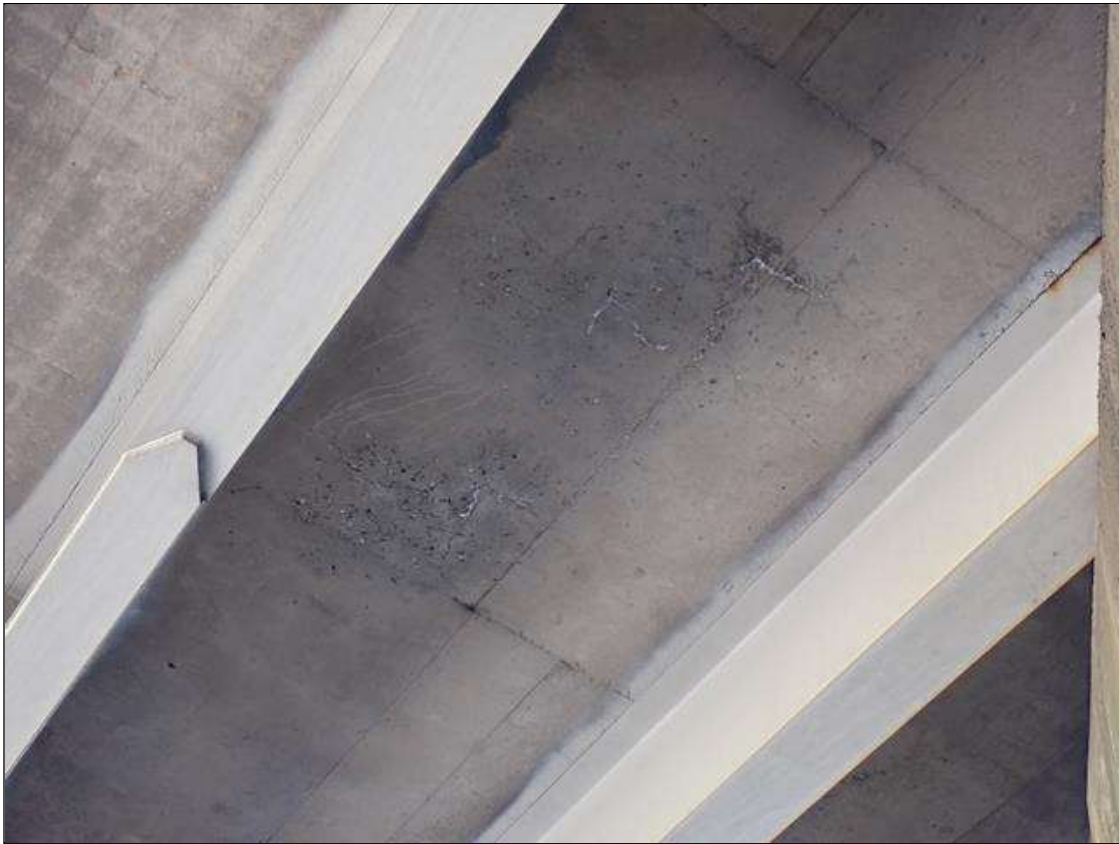
Span 2 Deck: underside of deck, in all bays and overhangs, areas of map cracks (hairline), some with efflorescence; both overhangs, transverse cracks (up to 1/32 inch x full width) at random

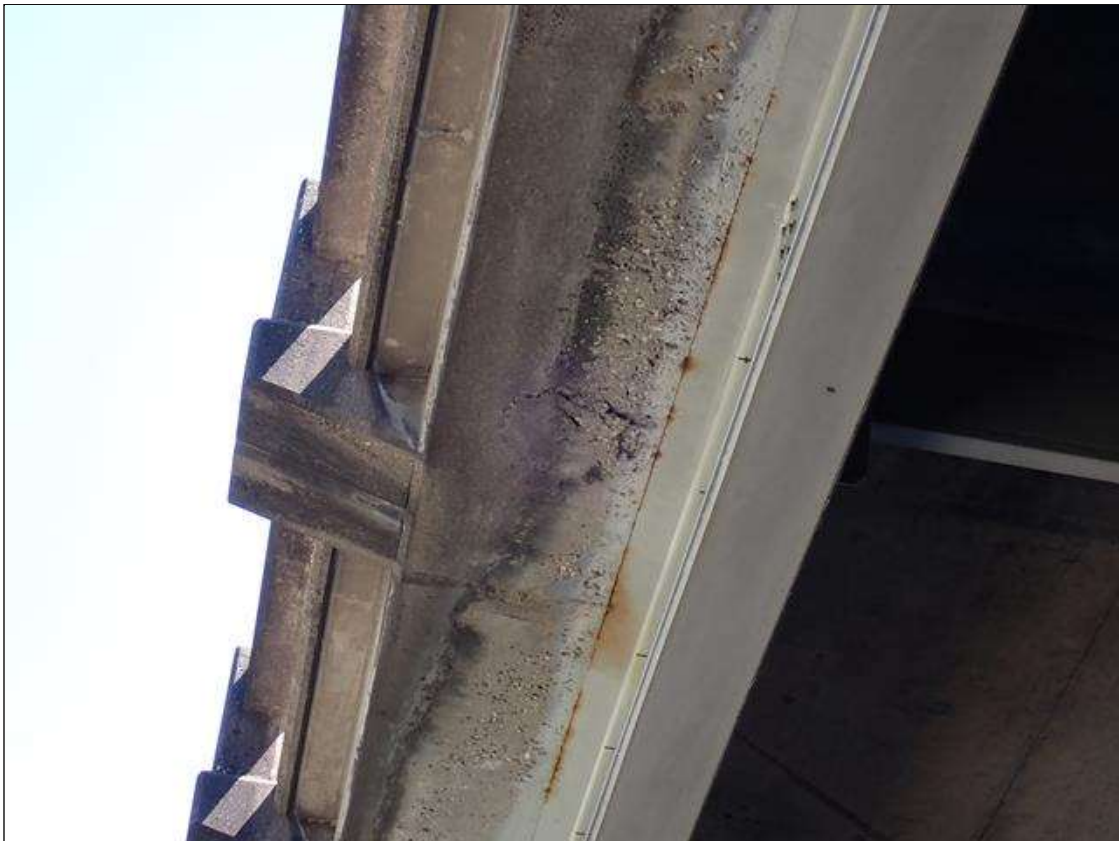
Span 2 Deck: (PAR) both overhangs, delaminations (approximately 1 foot diameter) with cracks (up to 1/8 inch); some areas over travel lanes
