NC DEPARTMENT OF TRANSPORTATION
 DIVISION OF HIGHWAYS
 STRUCTURE MANAGEMENT UNIT

ATTENTION: **prompt action request, sketches revised, horizontal clearances revised**

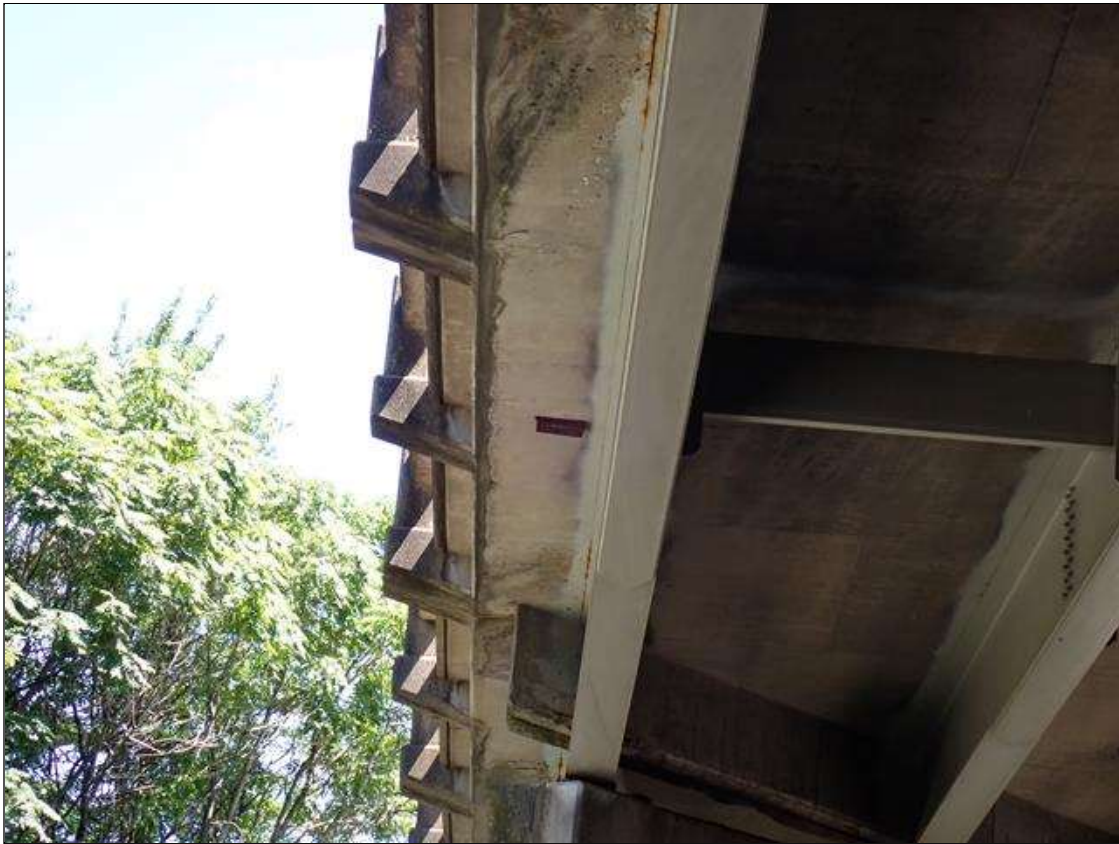
Span 2 Deck: left overhang, near bent 2, formwork left in place

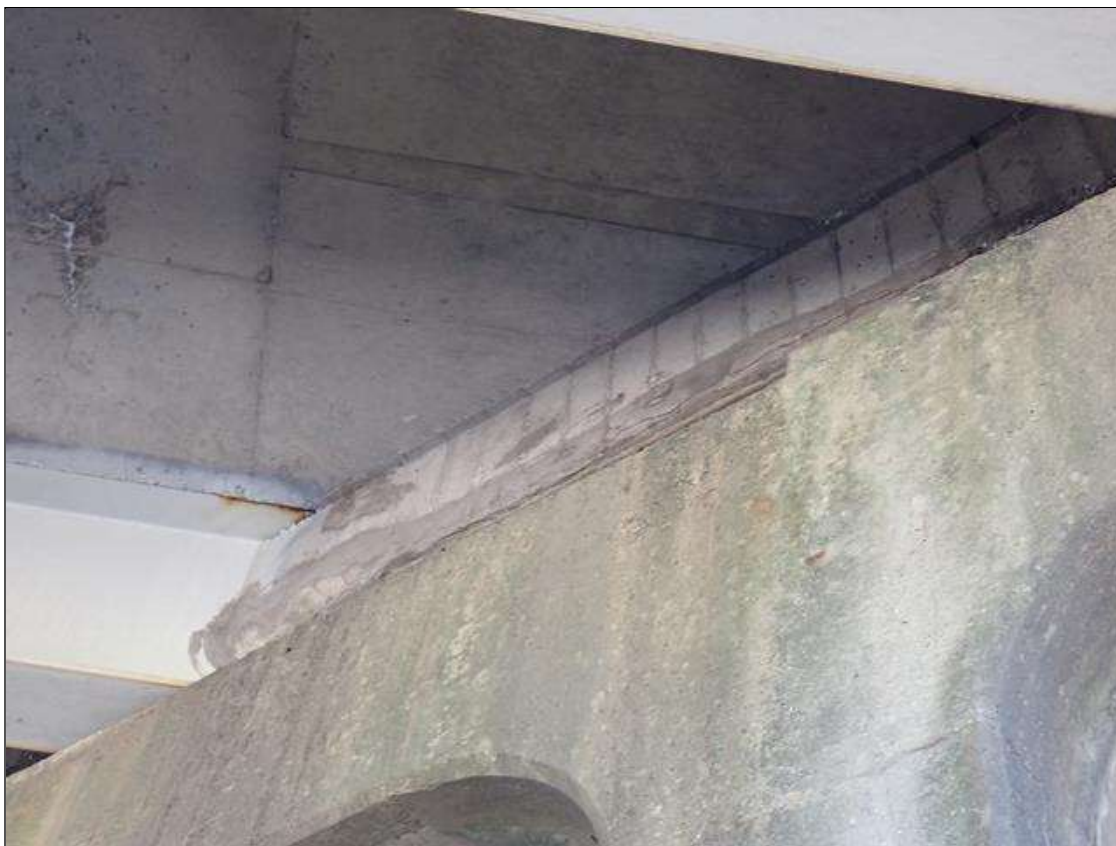
Span 2 Deck: at bent 1, end diaphragms in all bays, and bay 3 diaphragm at bent 2, unsound patches (up to full bay with x 8 inch) with cracks (up to 1/16 inch)

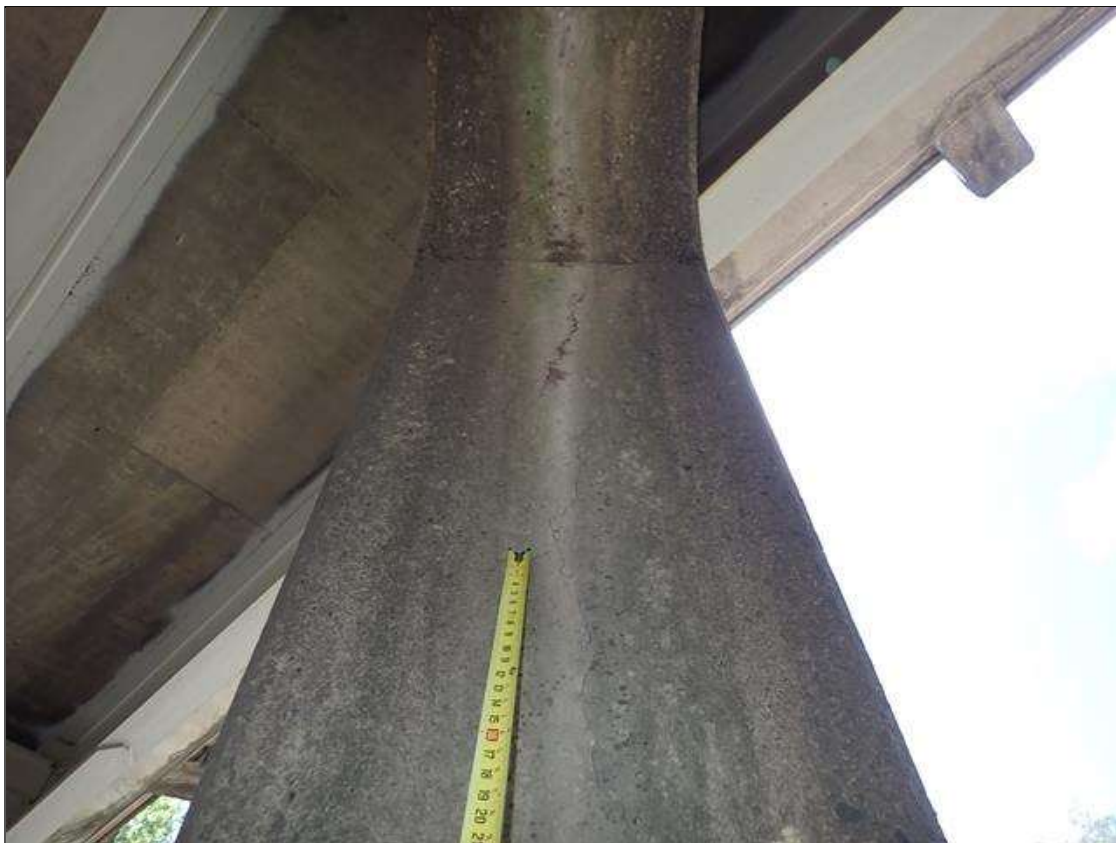
Bent 2 Pile 1: WEST AND EAST FACES, UP TO 1/16 INCH VERTICAL CRACKS AT RANDOM THROUGHOUT.

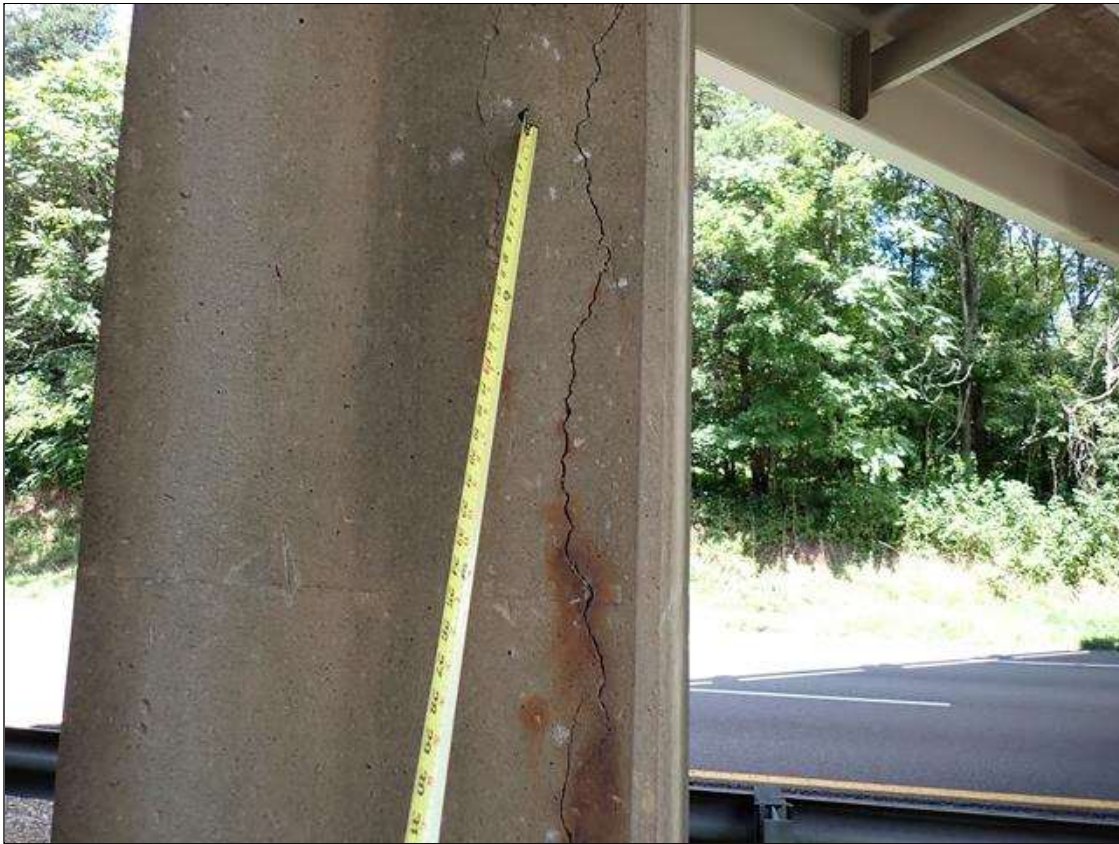
Bent 2 Pile 2: (PAR) at southeast corner, vertical cracks (up to 1/8 inch x full height) with rust stains and adjacent delaminations (up to 4 feet x 6 inch)

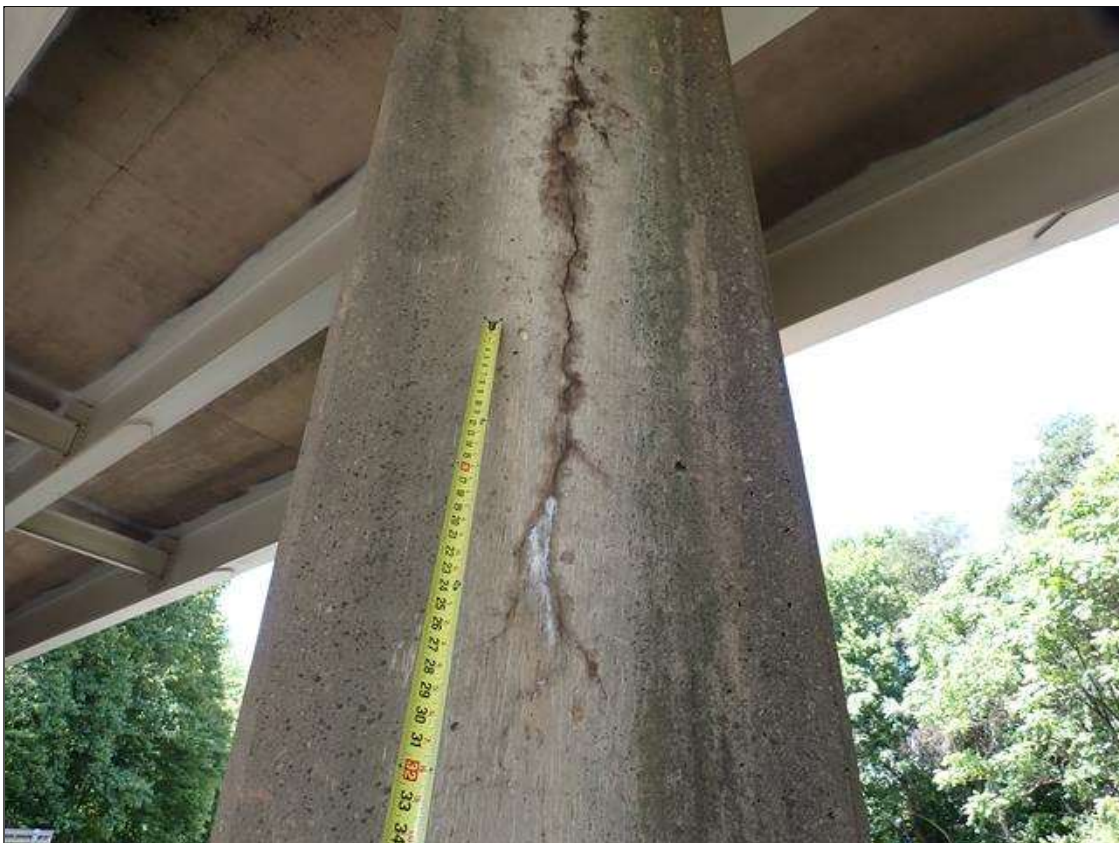
Bent 2 Pile 2: 6 FOOT X UP TO 1/16 INCH VERTICAL CRACK WITH EFFLORESCENCE EAST FACE AT BOTTOM OF CAP. (SIMILAR ON WEST FACE)

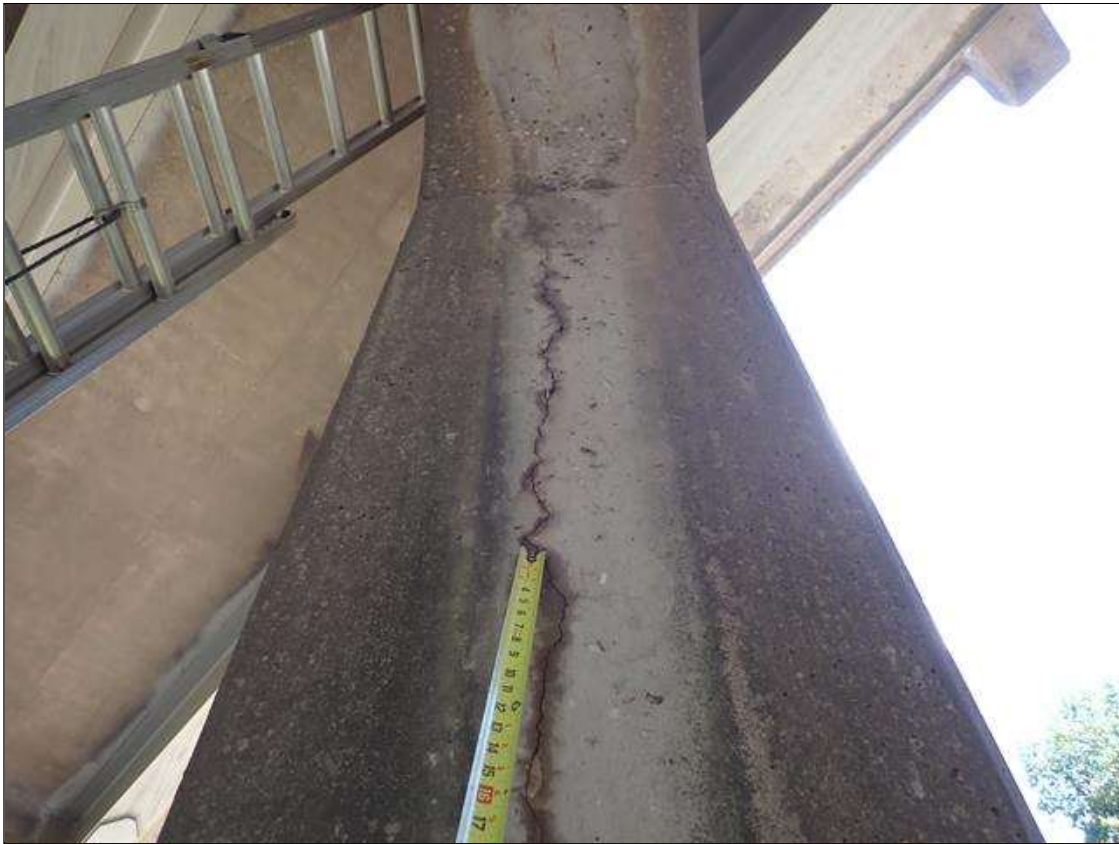
Bent 2 Pile 3: (PAR) UP TO 1/8 INCH VERTICAL CRACKS WITH RUST STAINS AT RANDOM THROUGHOUT with adjacent delaminations up to 6 feet x 1 foot

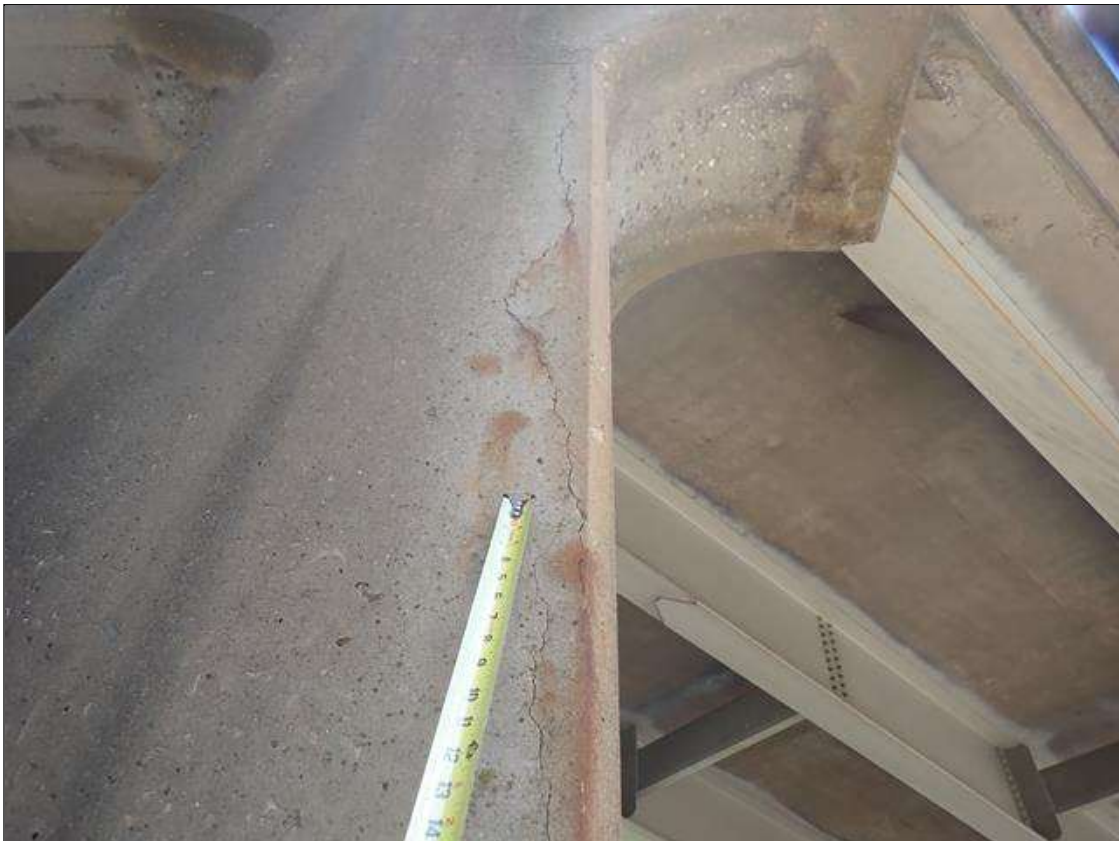
Bent 2 Pile 3: (PAR) UP TO 1/8 INCH VERTICAL CRACKS WITH RUST STAINS AT RANDOM THROUGHOUT with adjacent delaminations up to 6 feet x 1 foot

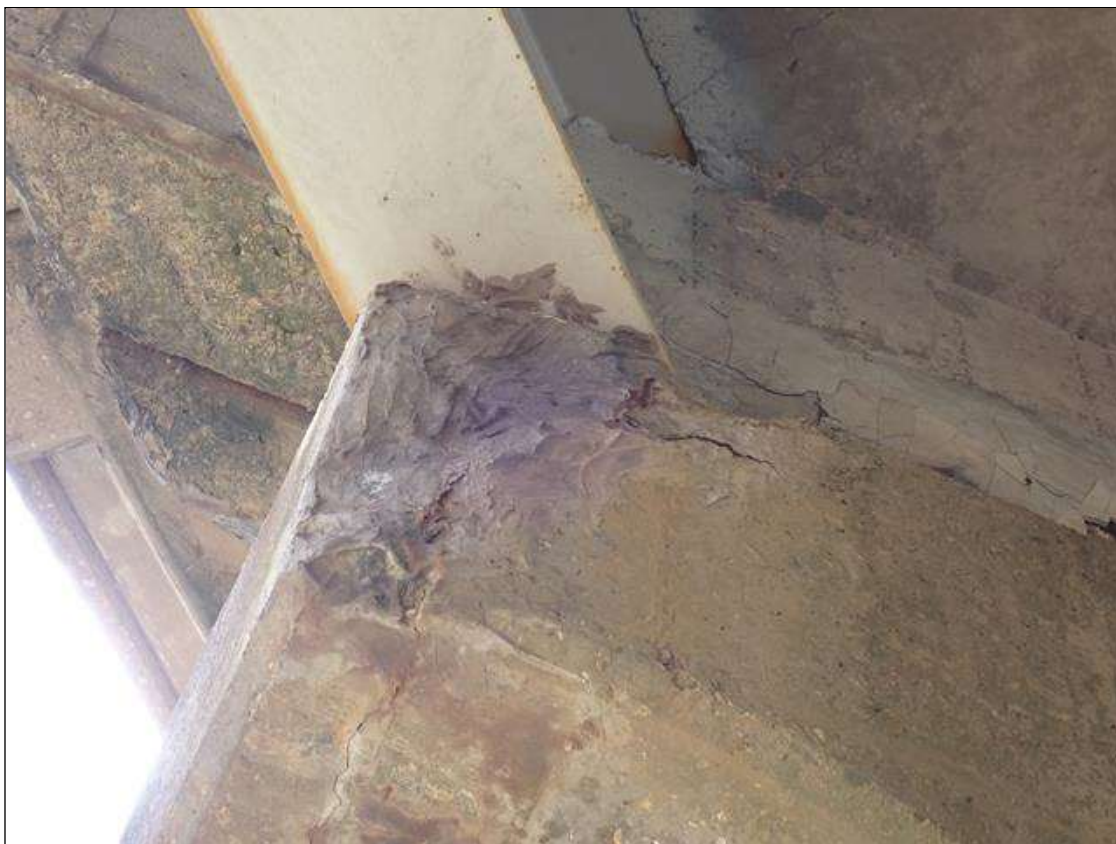
Bent 2 Cap 1: Northeast corner, failed patch with adjacent delamination, 14 inch x 14 inch, and transverse crack, 1/16 inch x full width, on underside of cap

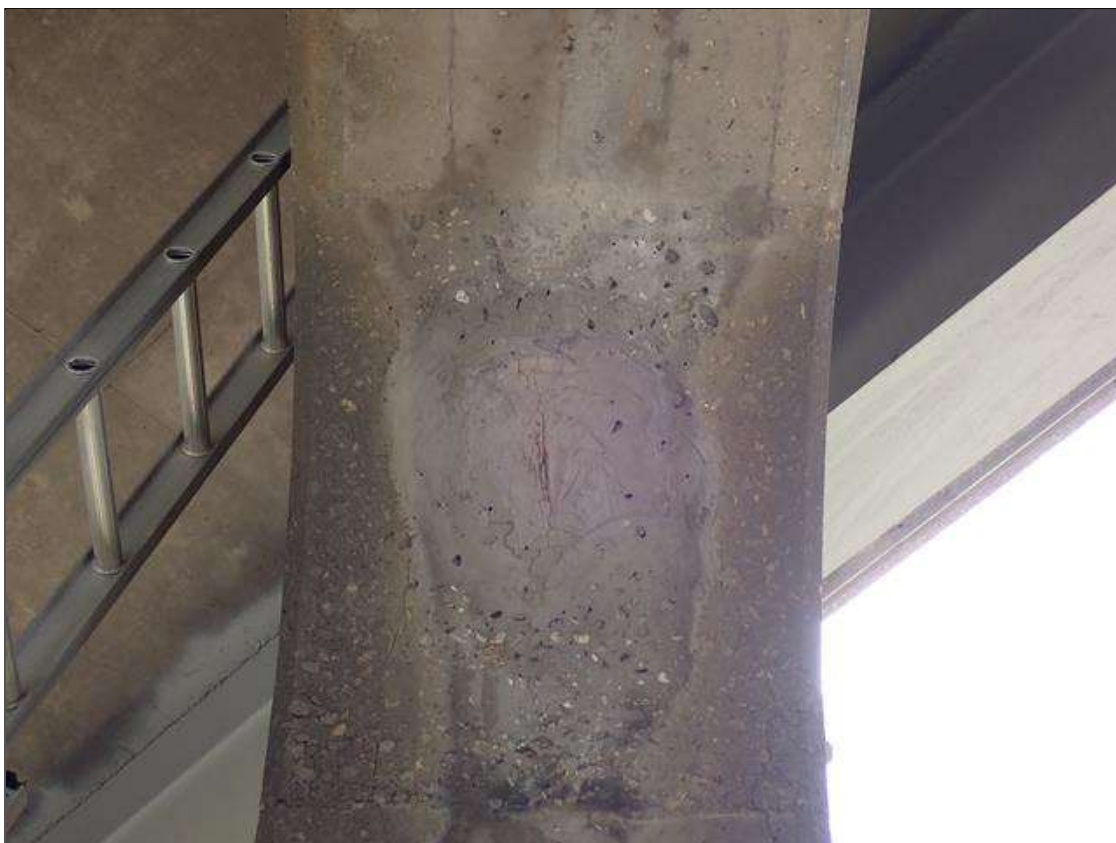
Bent 2 Cap 1: (PAR) underside of cap, adjacent to column 3, patched area (2 feet x 18 inch) with cracks (up to 1/32 inch) and rust stains

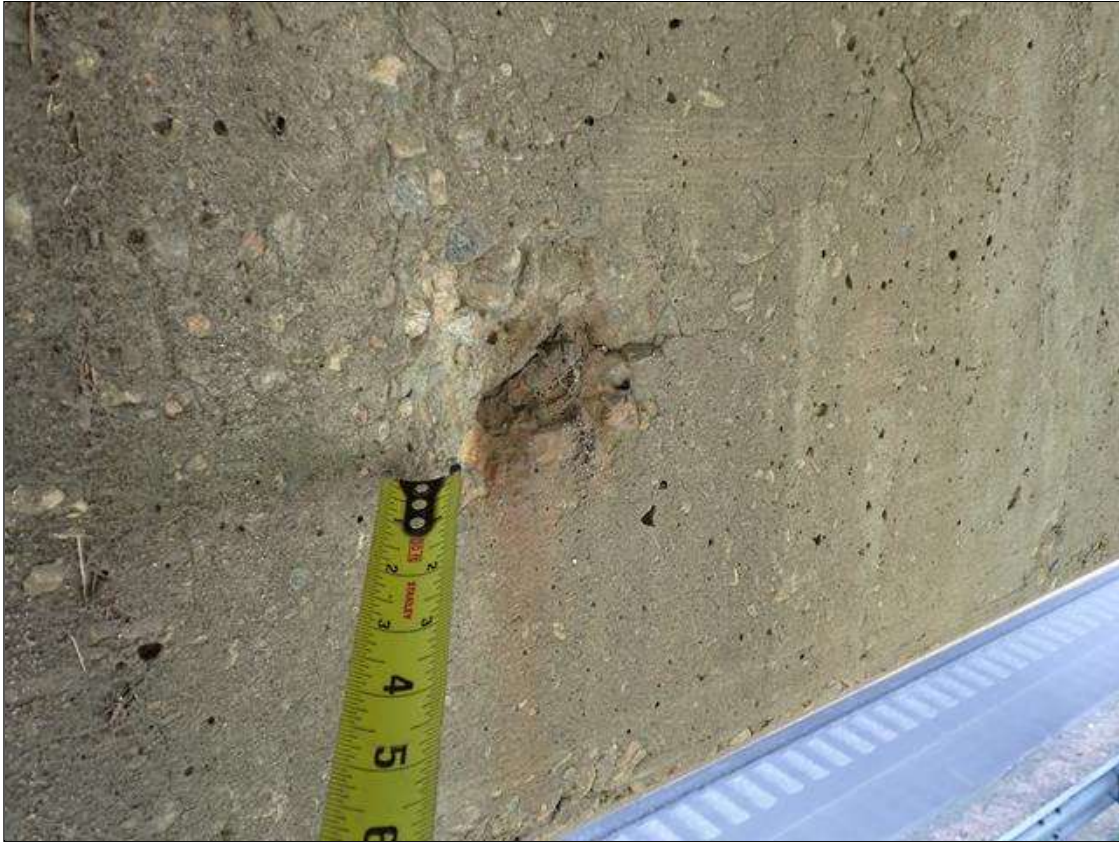
Bent 2 Cap 1: north face, below bay 3, spall (4 inch diameter x 1 inch deep) with exposed rusted rebar

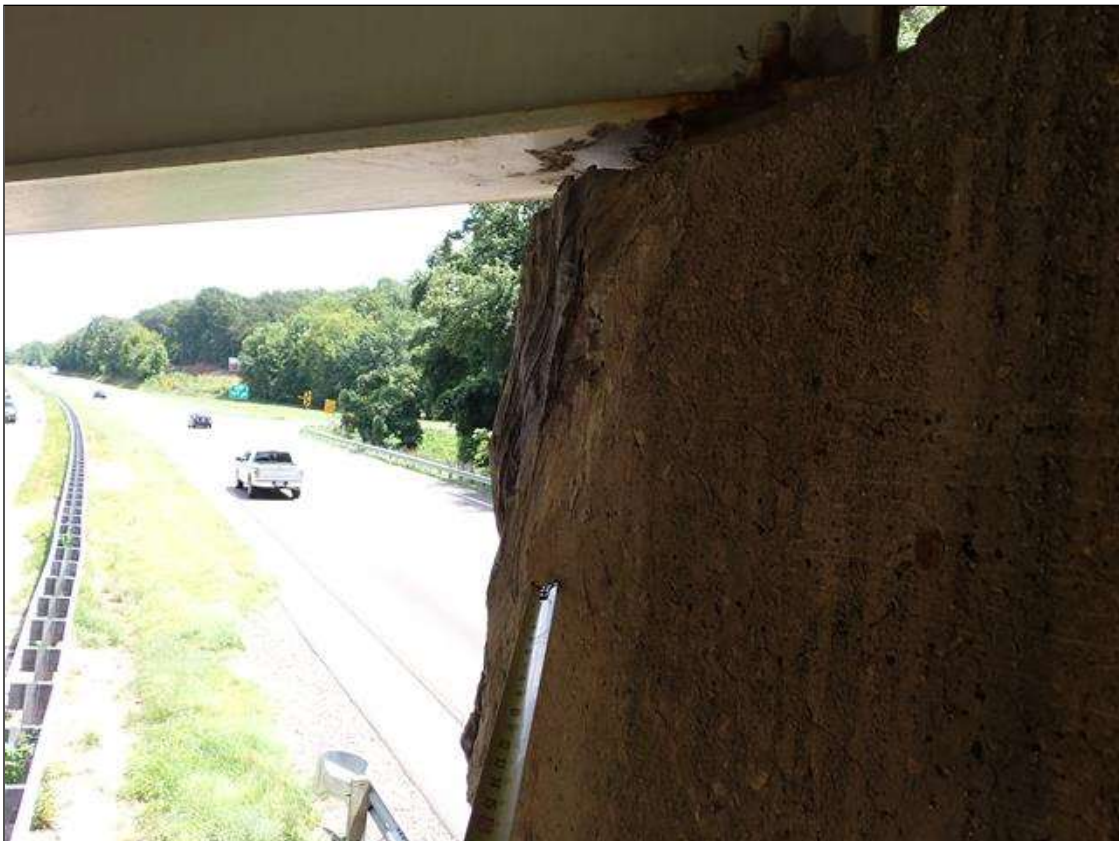
Bent 2 Cap 1: Northeast corner, failed patch with adjacent delamination, 14 inch x 14 inch, and transverse crack, 1/16 inch x full width, on underside of cap

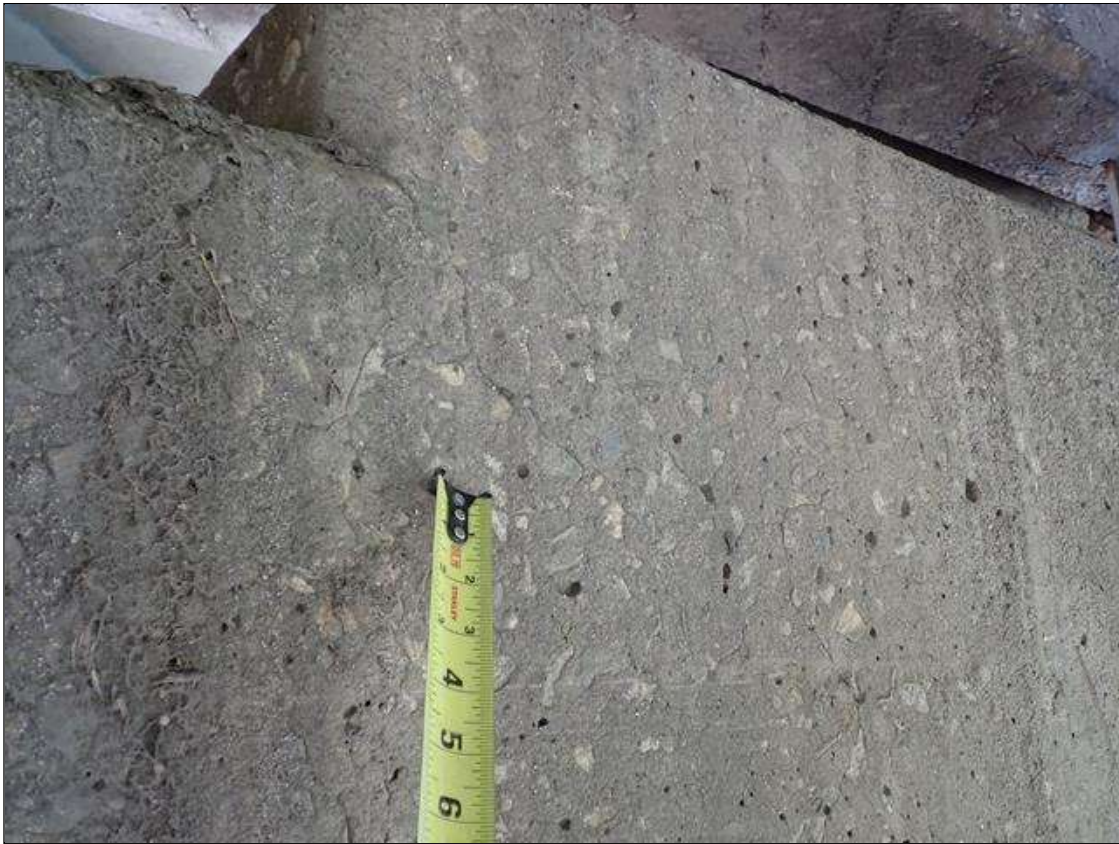
Bent 2 Cap 1: south and north face, areas of map cracks (hairline) at random

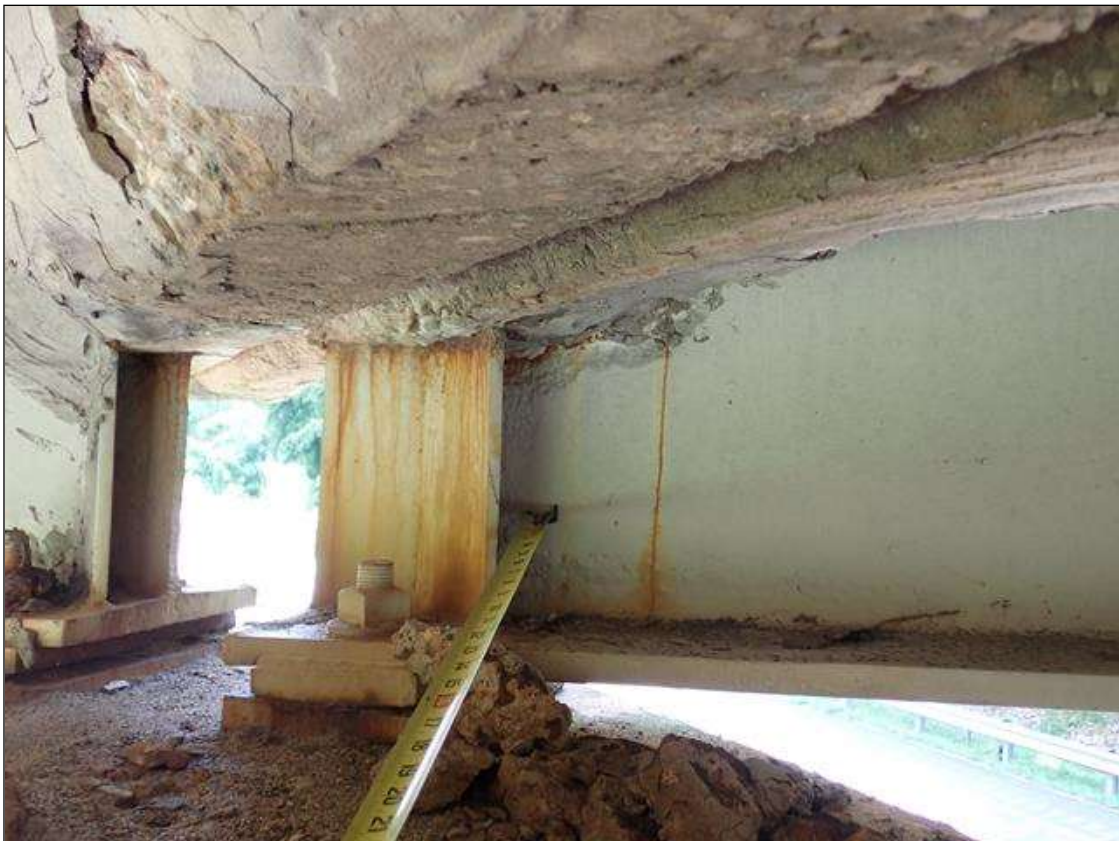
Span 2 Beam 4: at bent 2, painted over section loss: web adjacent to diaphragm (9/16 inch average remaining x 9 inch x 2 inch); lower web (9/16 inch average remaining x 1.5 feet x 3 inches) with corrosion reinitiated

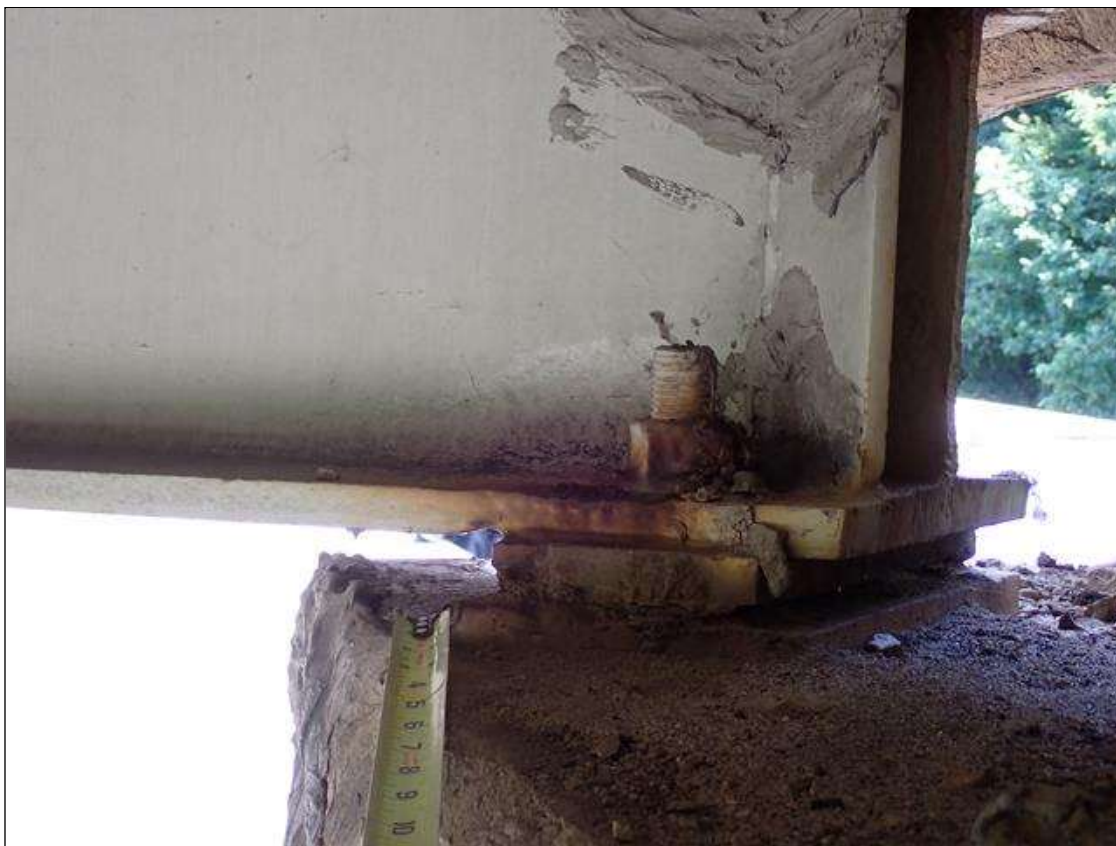
Span 3 Beam 4: at bent 2, painted over section loss: web adjacent to diaphragm (9/16 inch average remaining x 8 inch x 2 inch); lower web (9/16 inch average remaining x 15 inch x 3 inches); bottom flange (1 inch average remaining x 3 inches) with corrosion reinitiated

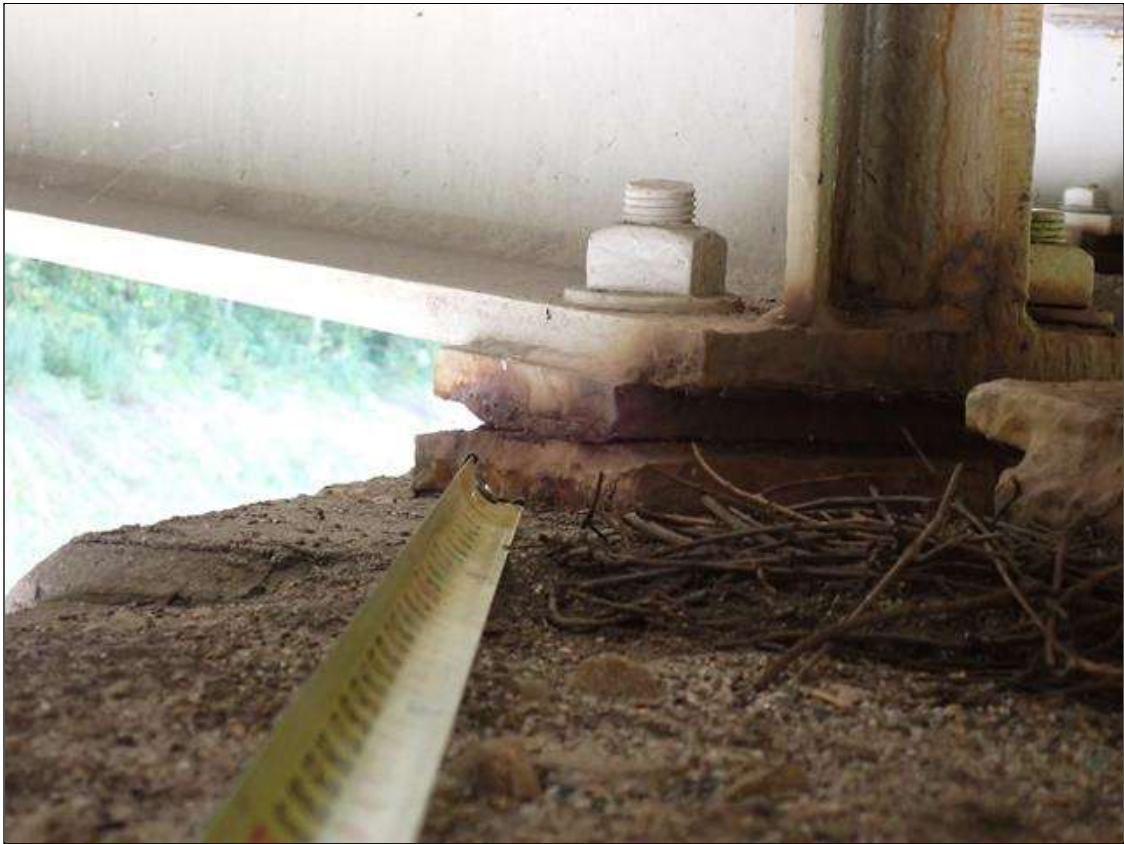
Span 2 Beam 3 - Far Bearing 3: painted over section loss (up to 3/16 inch deep) with corrosion reinitiated; pack rust

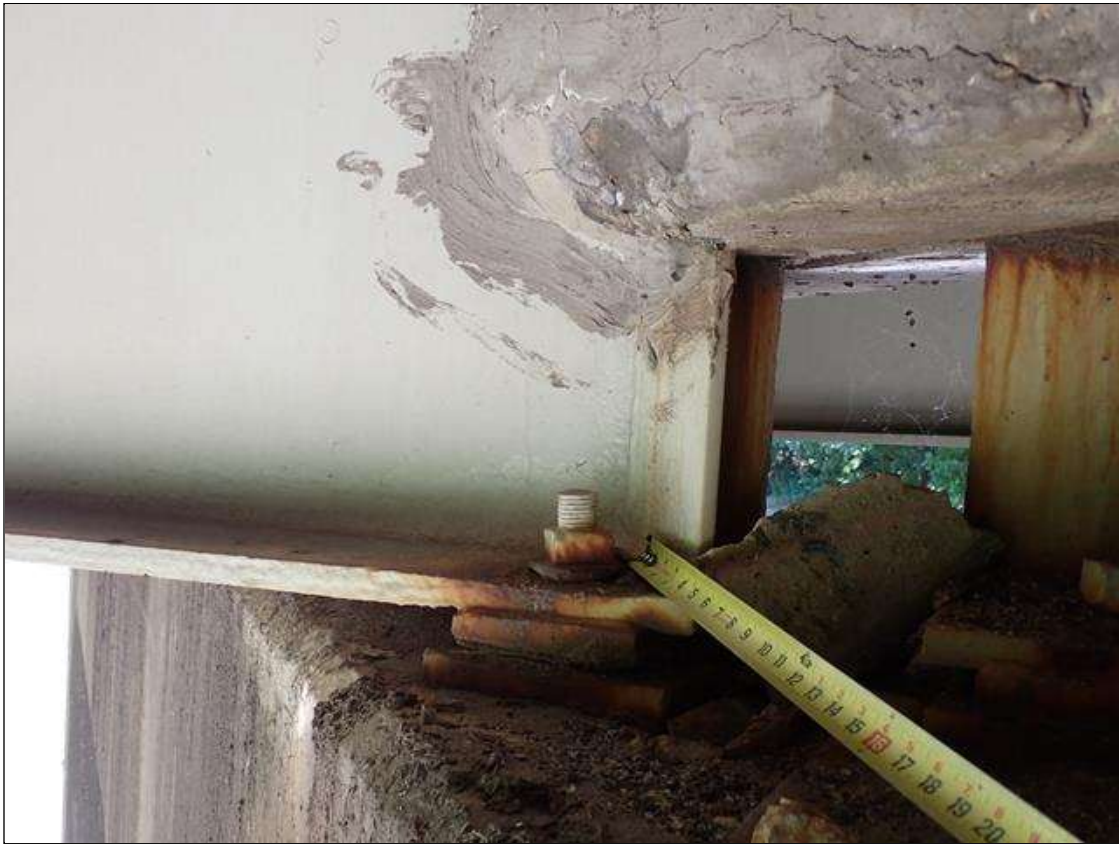
Span 3 Beam 2: at bent 2, painted over section loss: web adjacent to diaphragm (9/16 inch average remaining x 4 inch x 2 inch); lower web (5/8 inch average remaining x 14 inch x 4 inches); bottom flange (1 inch average remaining x 10 inches) with corrosion reinitiated

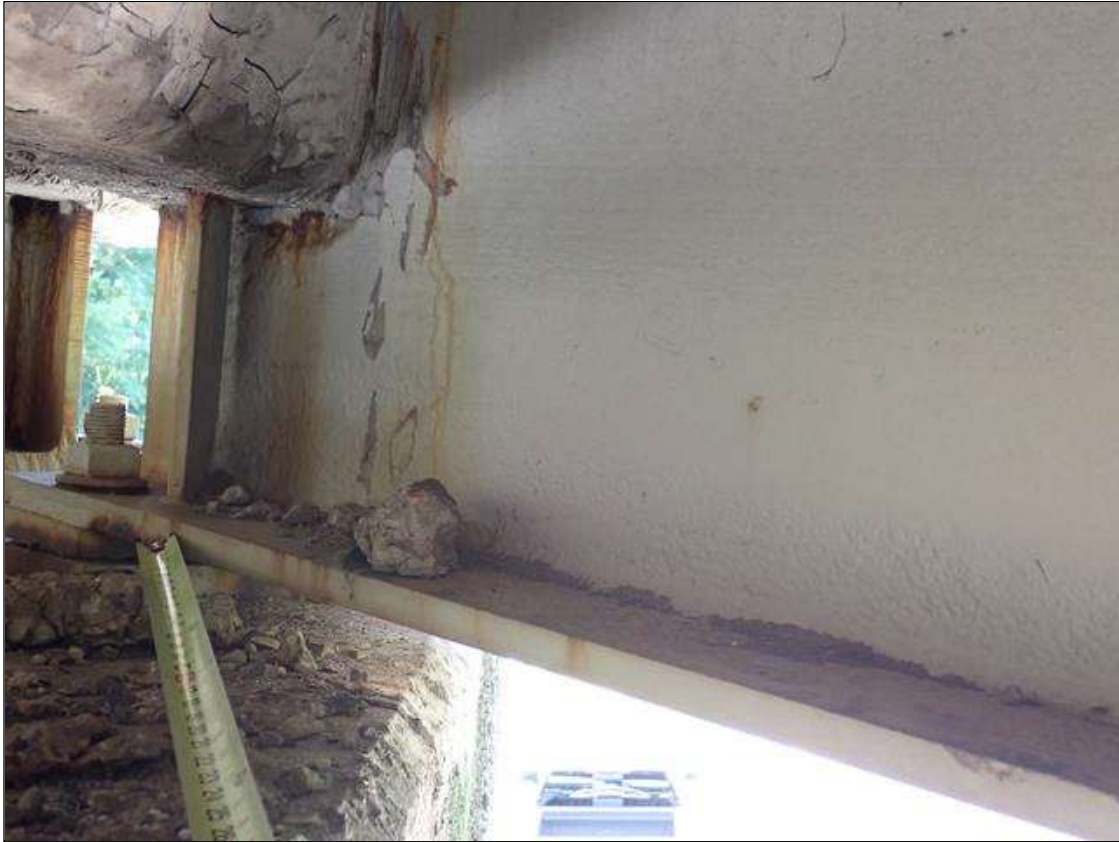
Span 3 Beam 1: at bent 2, web adjacent to diaphragm, painted over section loss (9/16 inch average remaining x 8 inch x 3 inch); lower web, painted over pitting (up to 1/8 inch deep x 7 feet x up to 4 inch) with corrosion reinitiated; bottom flange, rust scale

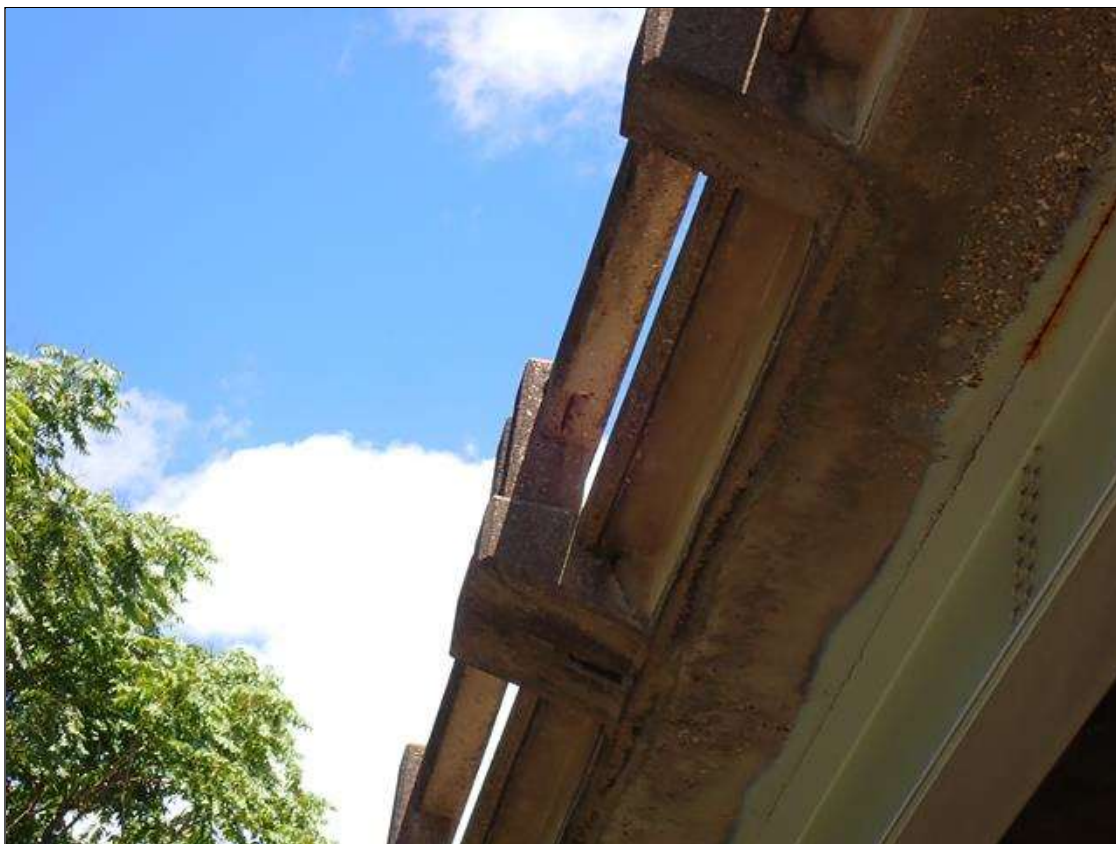
Span 3 Left Bridge Rail: underside of rail, and outriggers, shallow rebar at random

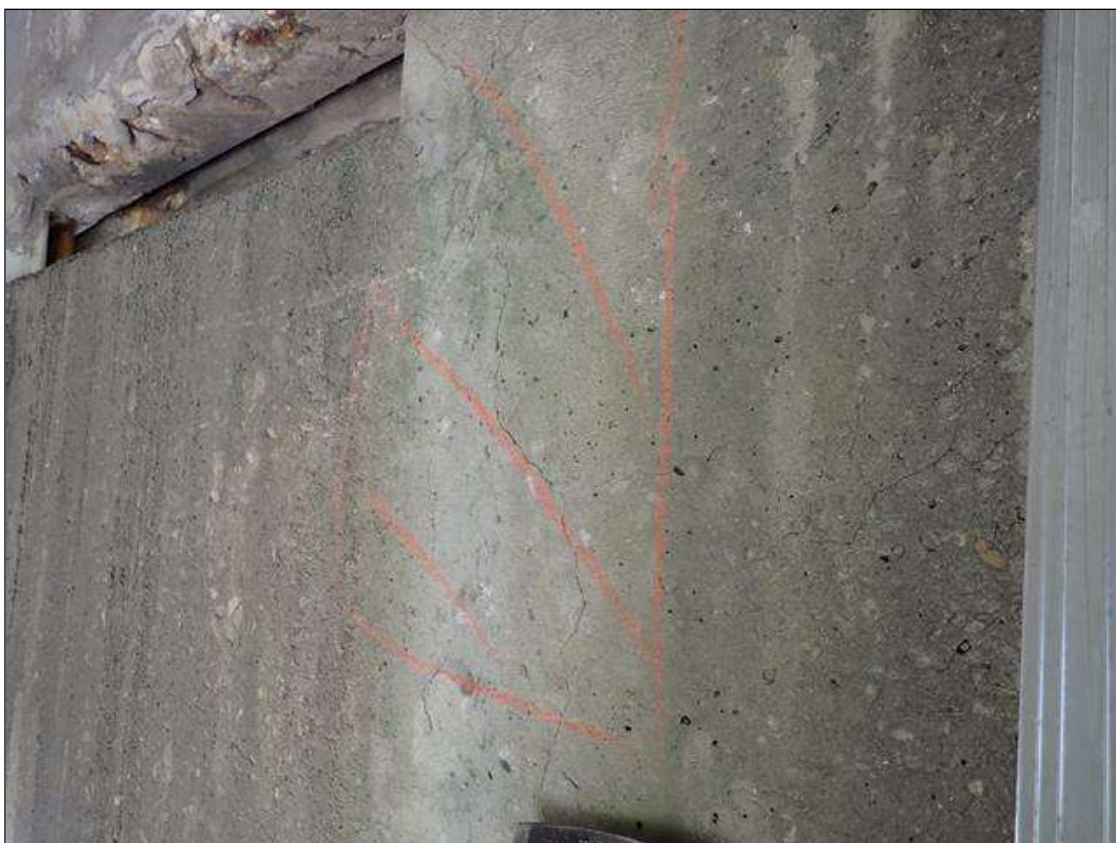
Bent 2 Cap 1: North face over column 2, vertical crack, 1/32 inch x full height, extends up from vertical crack on column 2, with adjacent delamination, 26 inch x 15 inch

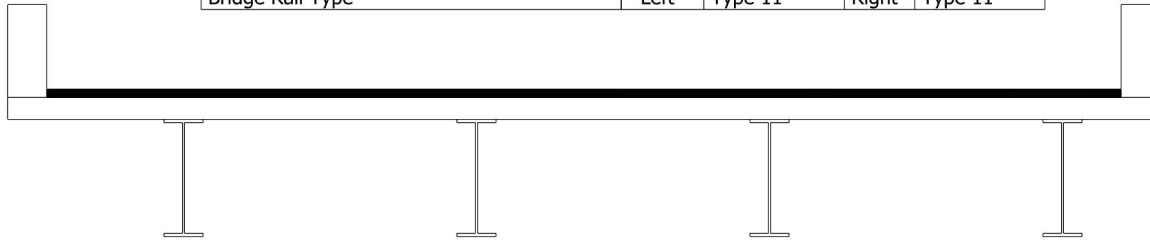
Measurements for Span #	1-4		
Deck Thickness	6.75in	Left Overhang	4.5ft
Top of Rail to Bottom of Beam (Avg)	5.937ft	Right Overhang	4.5ft

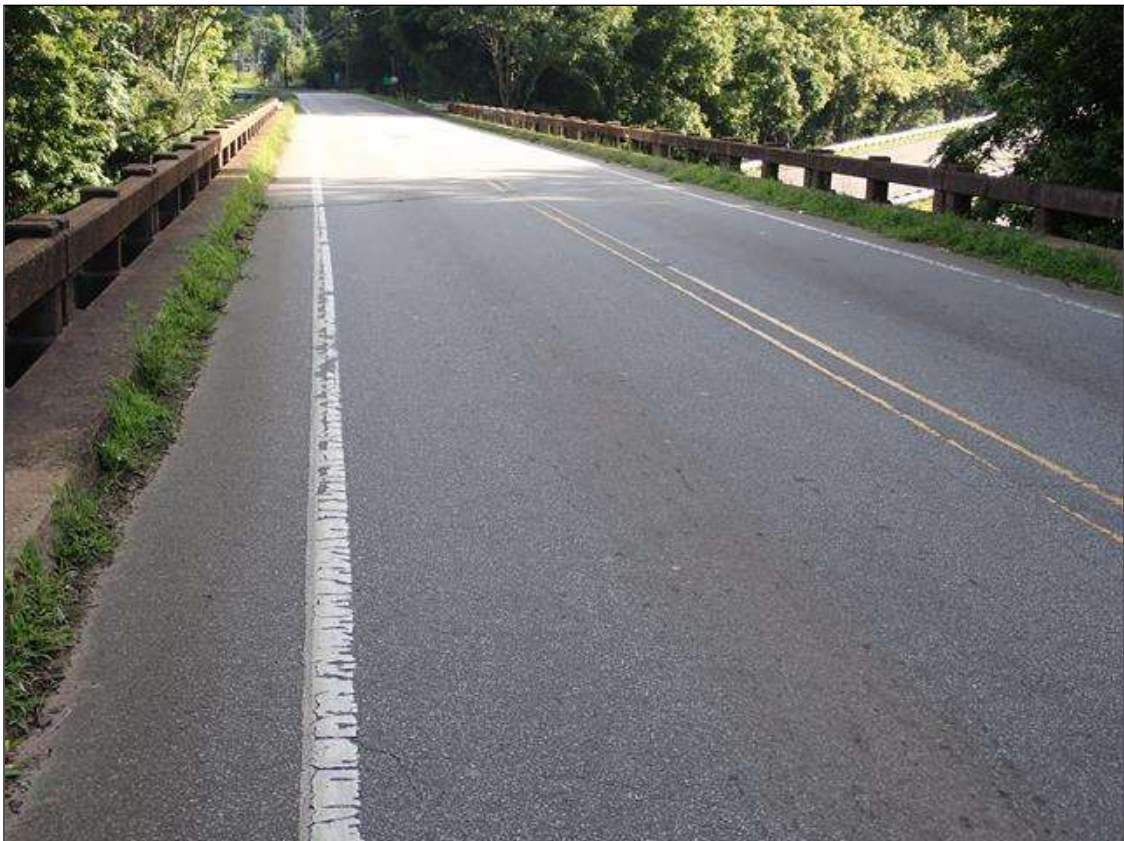
asphalt wearing surface

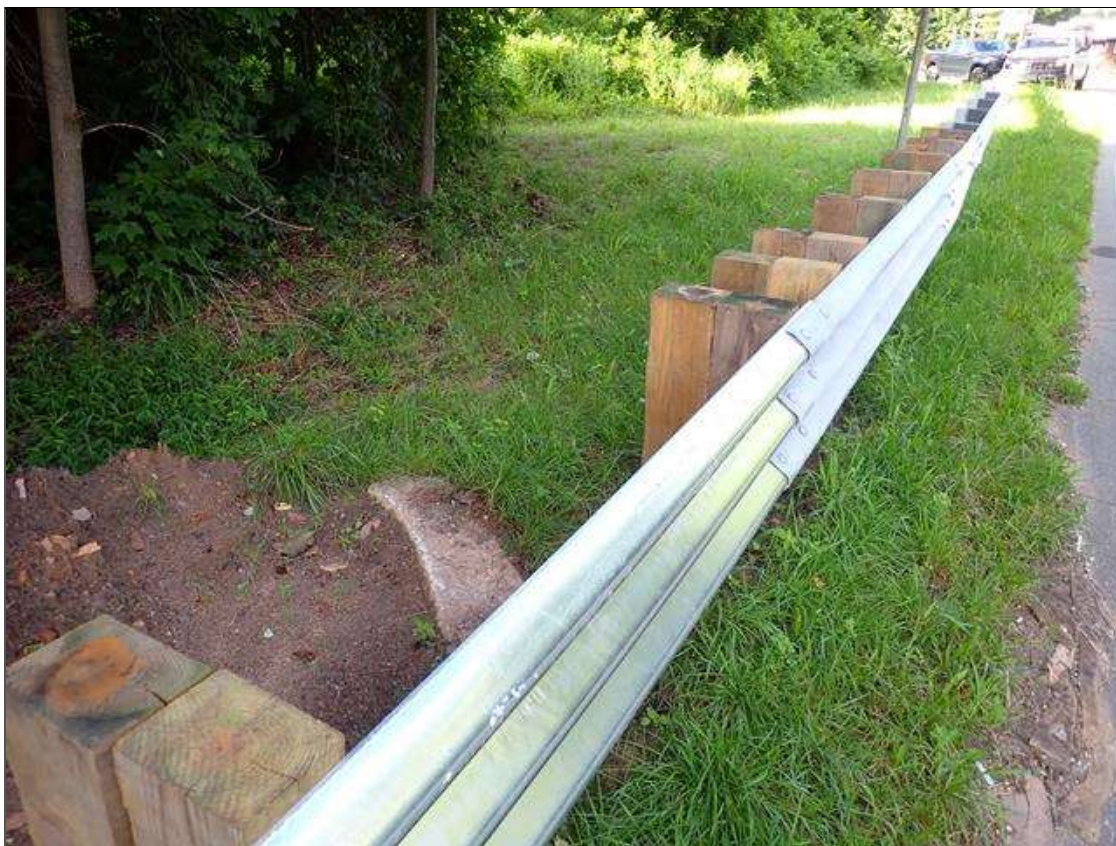
southeast guardrail transition
