NC DEPARTMENT OF TRANSPORTATION
 DIVISION OF HIGHWAYS
 STRUCTURE MANAGEMENT UNIT

ATTENTION: **prompt action request; sketches updated; route sign attached to span 3 beam 1**

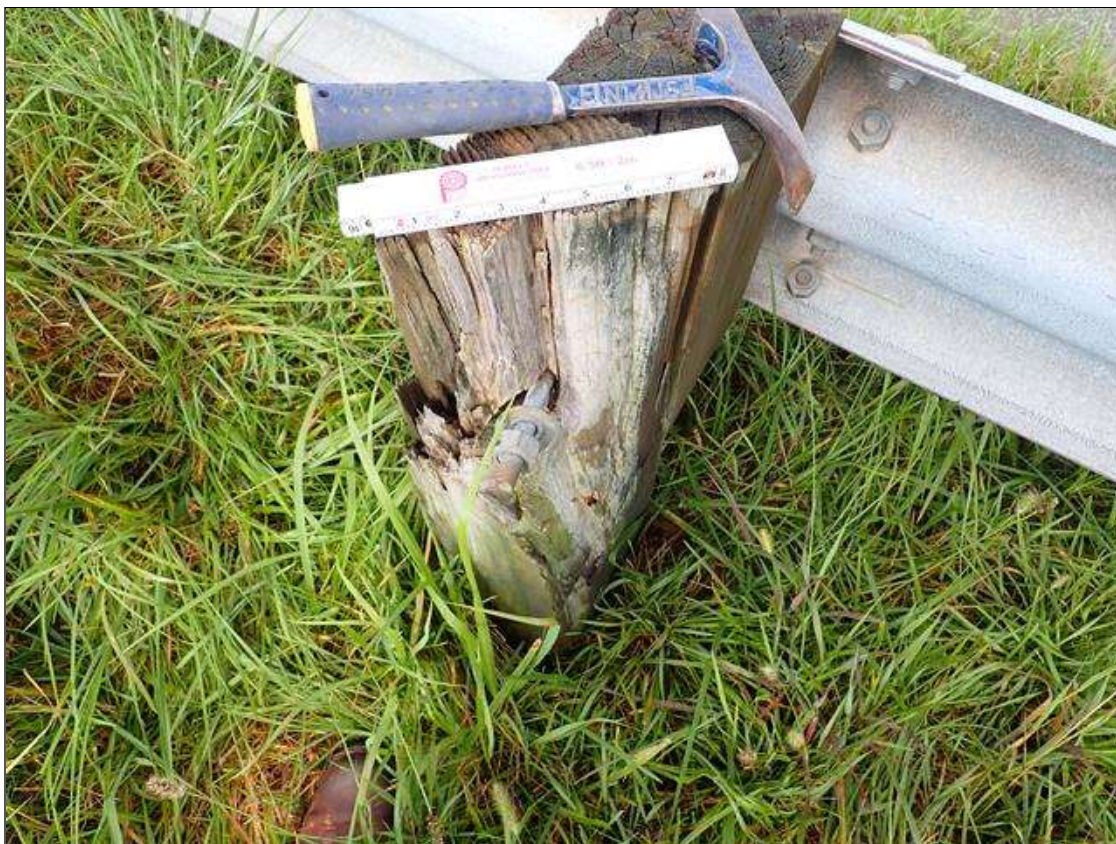
(PAR) northeast guardrail, 3rd and 12th timber posts from end bent 2, decay/section loss (up to full width x full height x full depth)

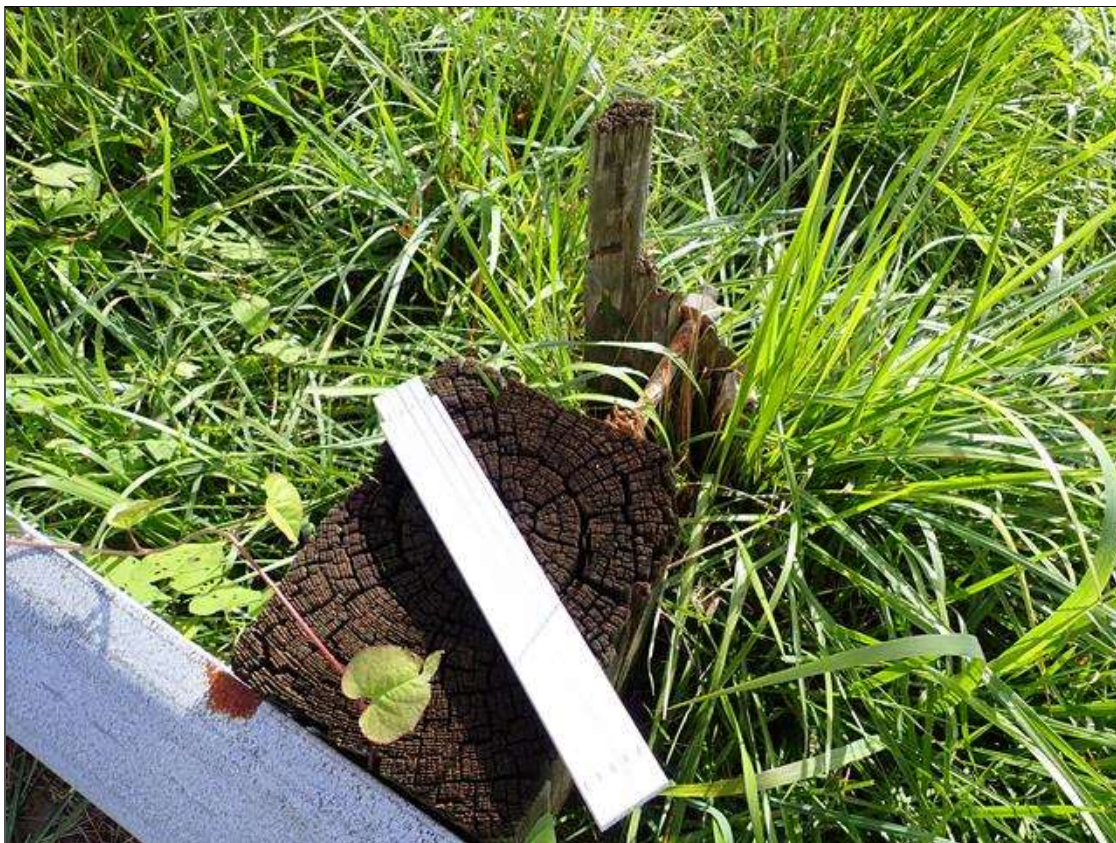
(PAR) northeast guardrail, 3rd and 12th timber posts from end bent 2, decay/section loss (up to full width x full height x full depth)

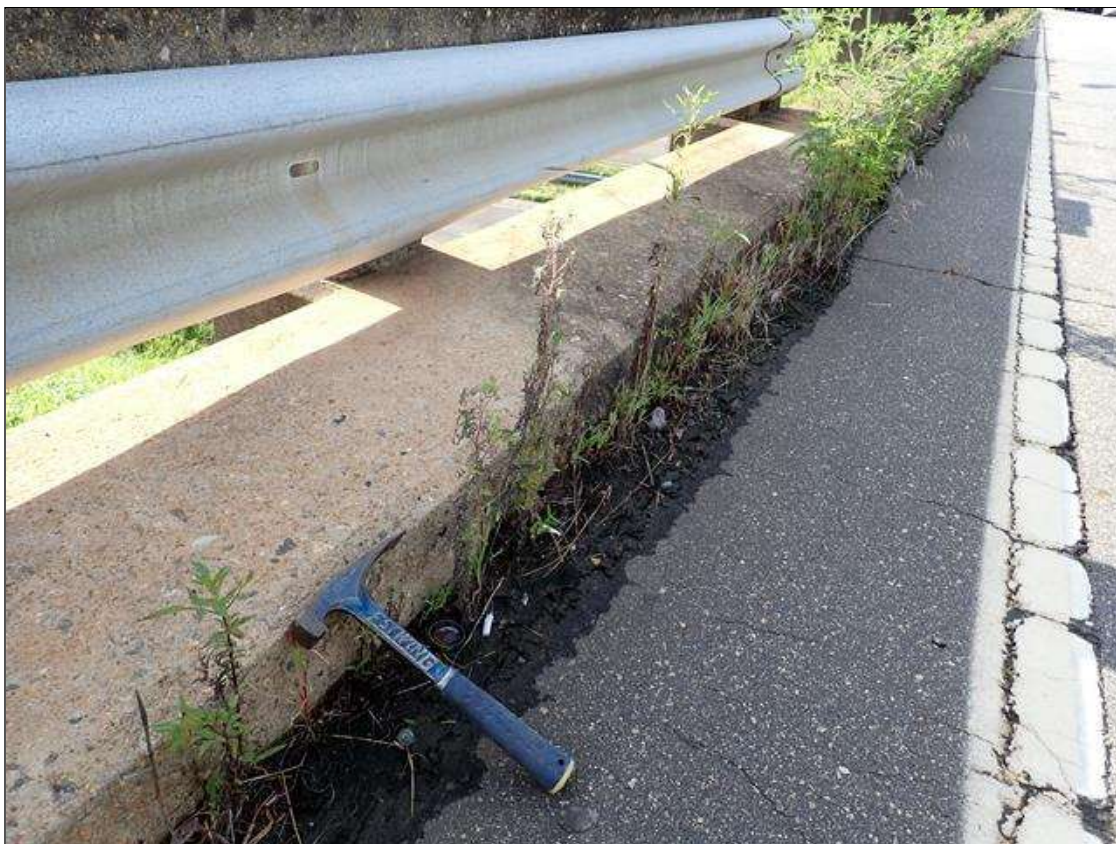
along curblines, debris accumulation (up to 1 foot x full length) with vegetation growth; partially obstructing drainage

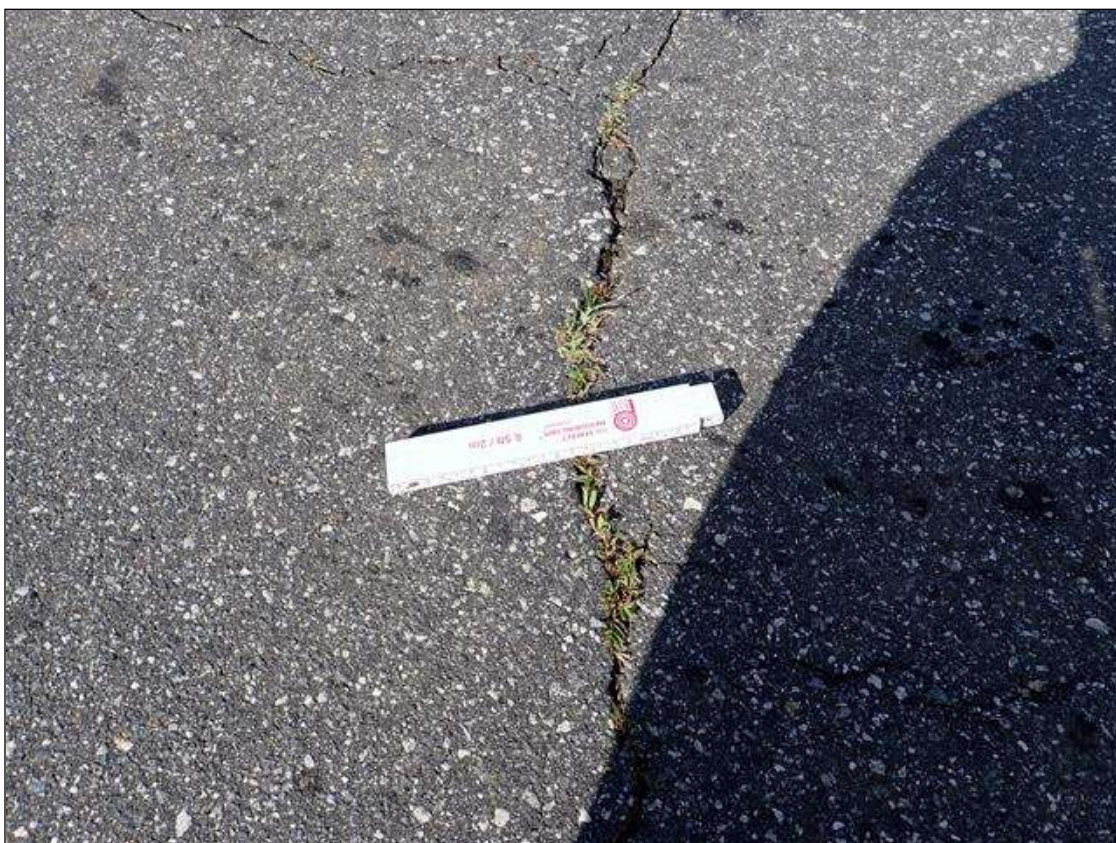
Span 5 Wearing Surface: 30 FOOT X UP TO 1/4 INCH TRANSVERSE CRACK OVER END BENT 2.

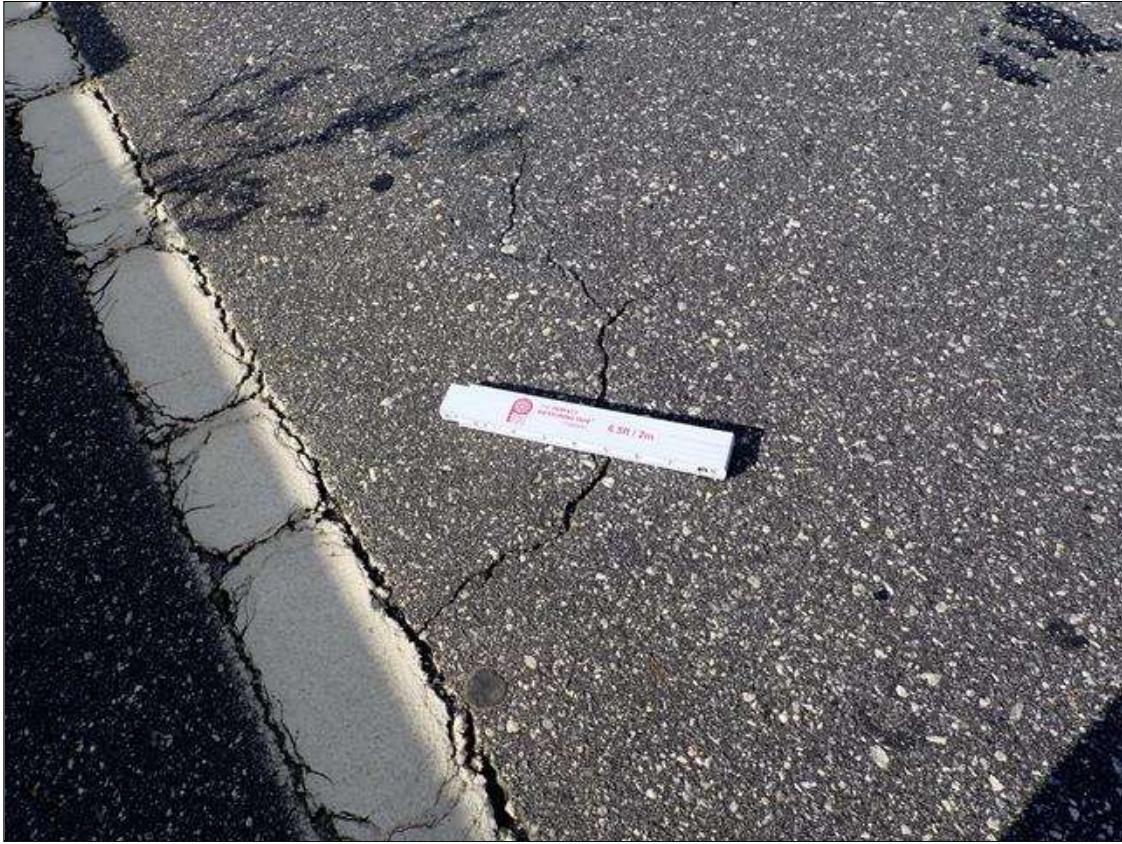
Span 5 Wearing Surface: WEARING SURFACE HAS SCATTERED TRANSVERSE AND LONGITUDINAL CRACKS UP TO 1/8 INCH

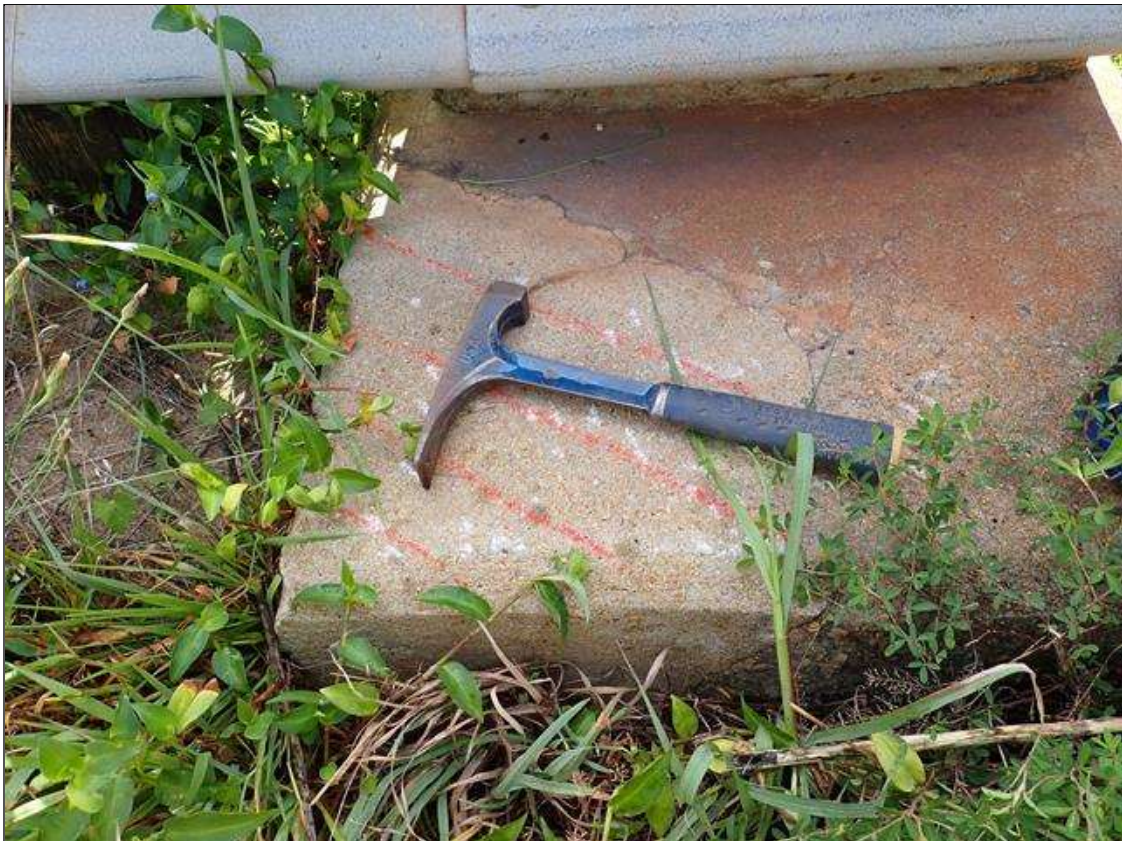
Span 5 Right Bridge Rail: at far end of right sidewalk, partially sound patch [14 inch x 16 inch]

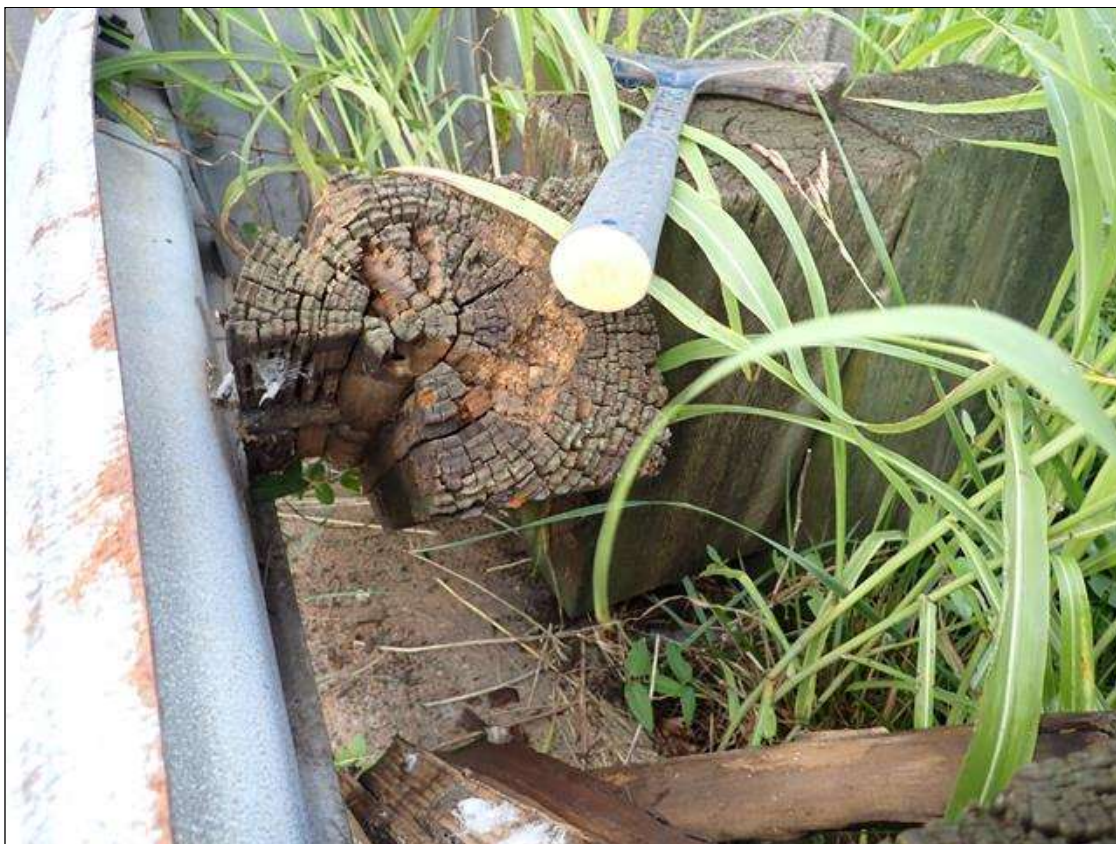
(PAR) northwest guardrail, 1st timber spacer from end bent 2, decay/section loss (full height x 3 inch x 3 inch deep)

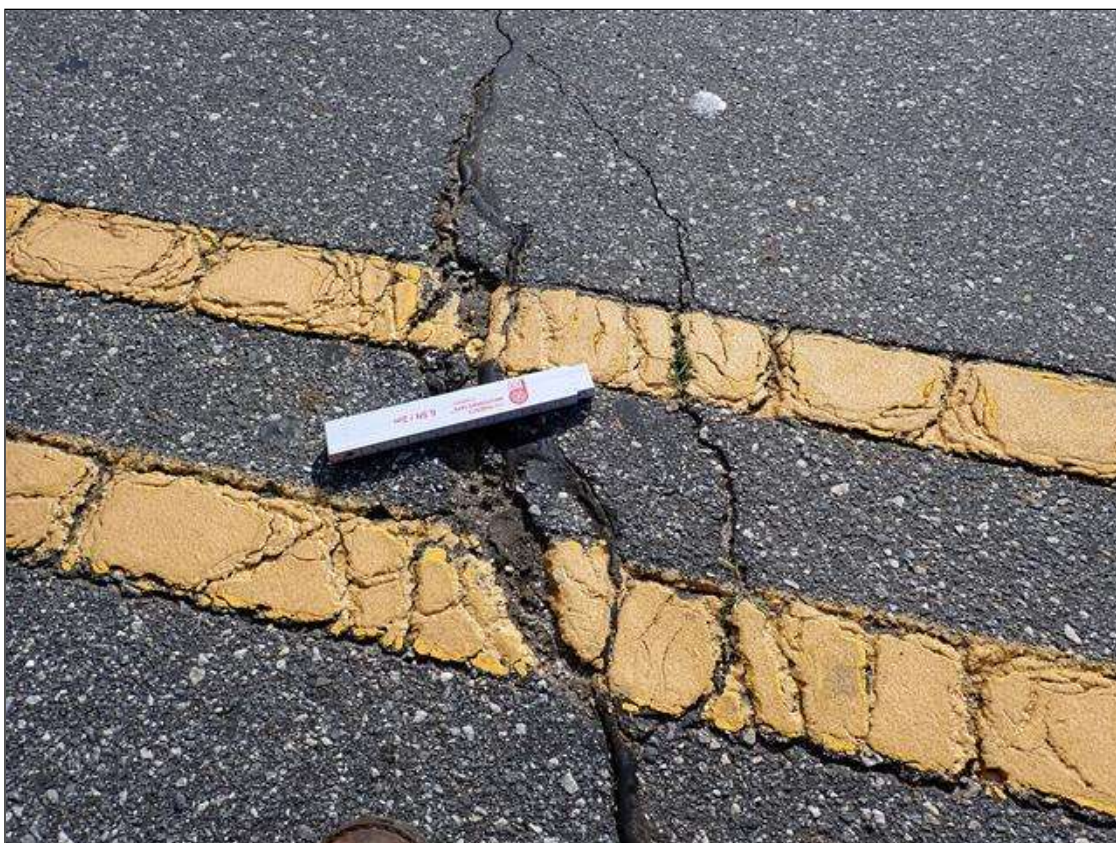
Span 4 Wearing Surface: over bent 4, partially sealed transverse crack (1/8 inch x full width) with edge spalling (up to 2 foot x 2 inch x 1/2 inch deep) with vegetation growth

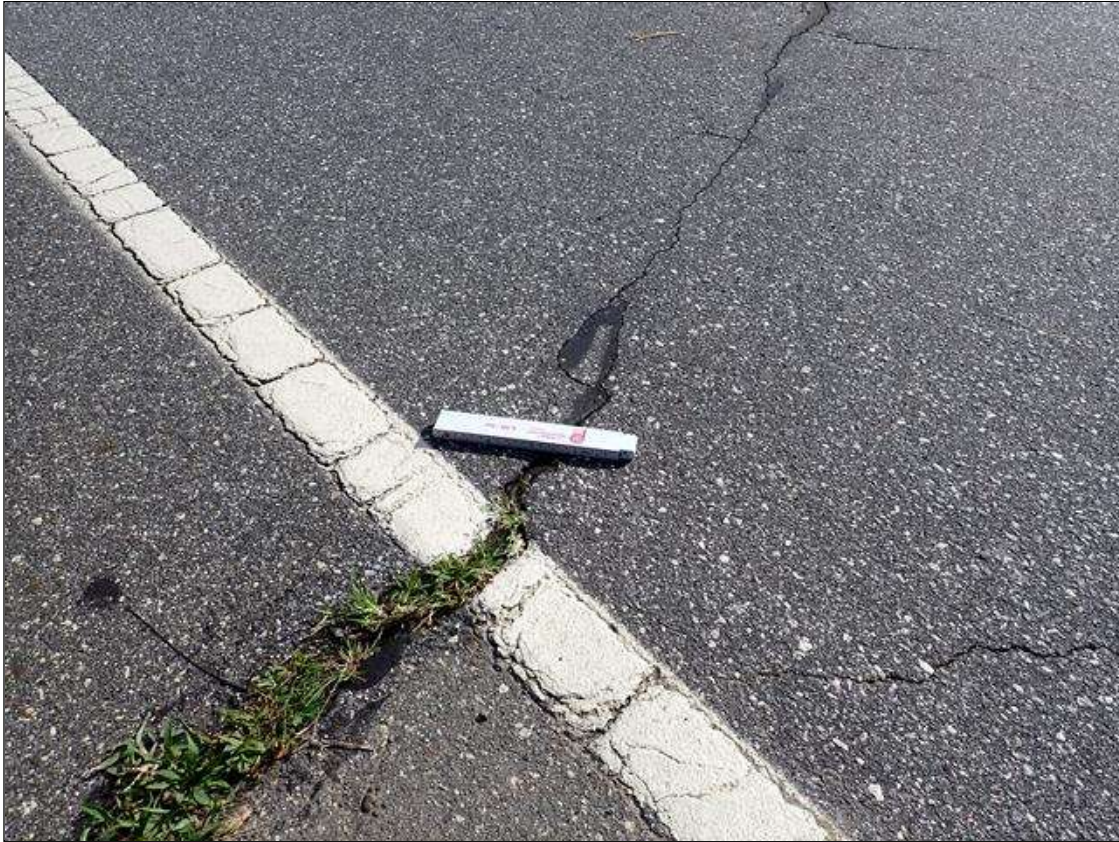
Span 4 Wearing Surface: over bent 4, partially sealed transverse crack (1/8 inch x full width) with edge spalling (up to 2 foot x 2 inch x 1/2 inch deep) with vegetation growth

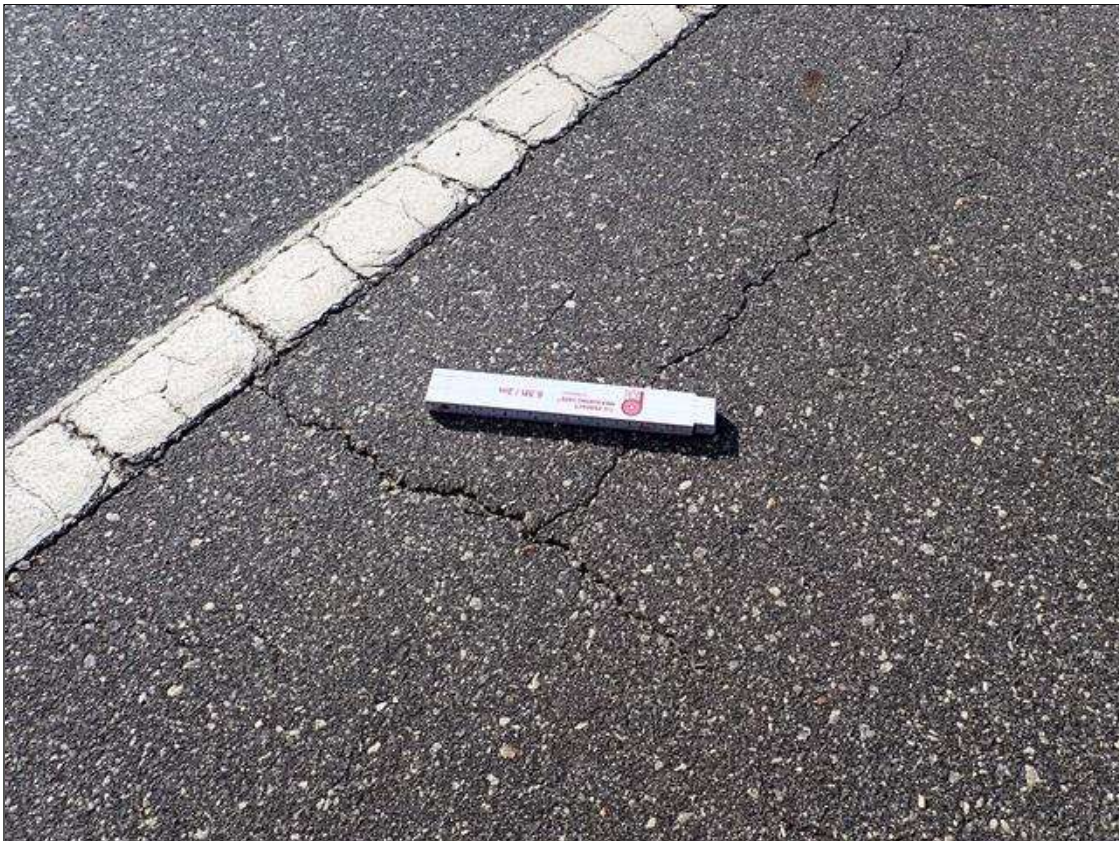
Span 4 Wearing Surface: WEARING SURFACE HAS SCATTERED TRANSVERSE AND LONGITUDINAL CRACKS UP TO 1/8 INCH

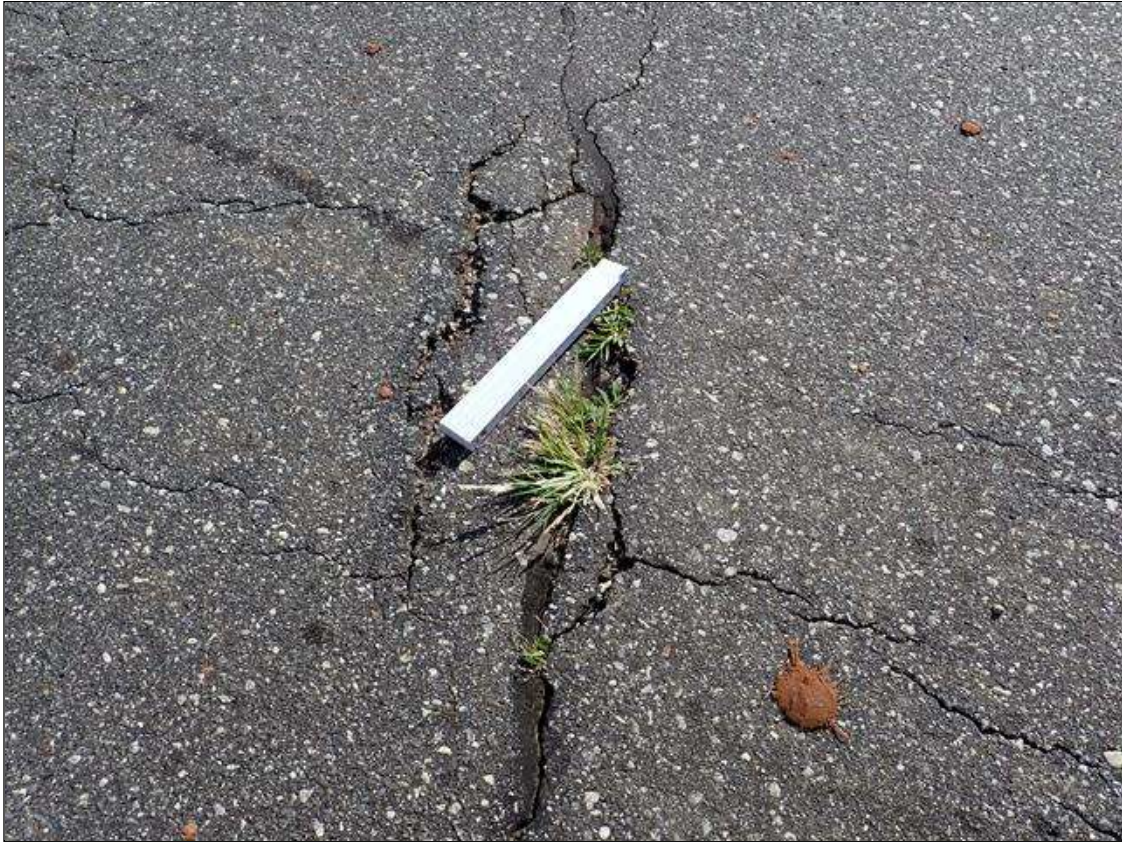
Span 3 Wearing Surface: over bent 3, partially sealed transverse crack (1/8 inch x full width) with edge spalling (up to 2 foot x 2 inch x 1/2 inch deep) with vegetation growth

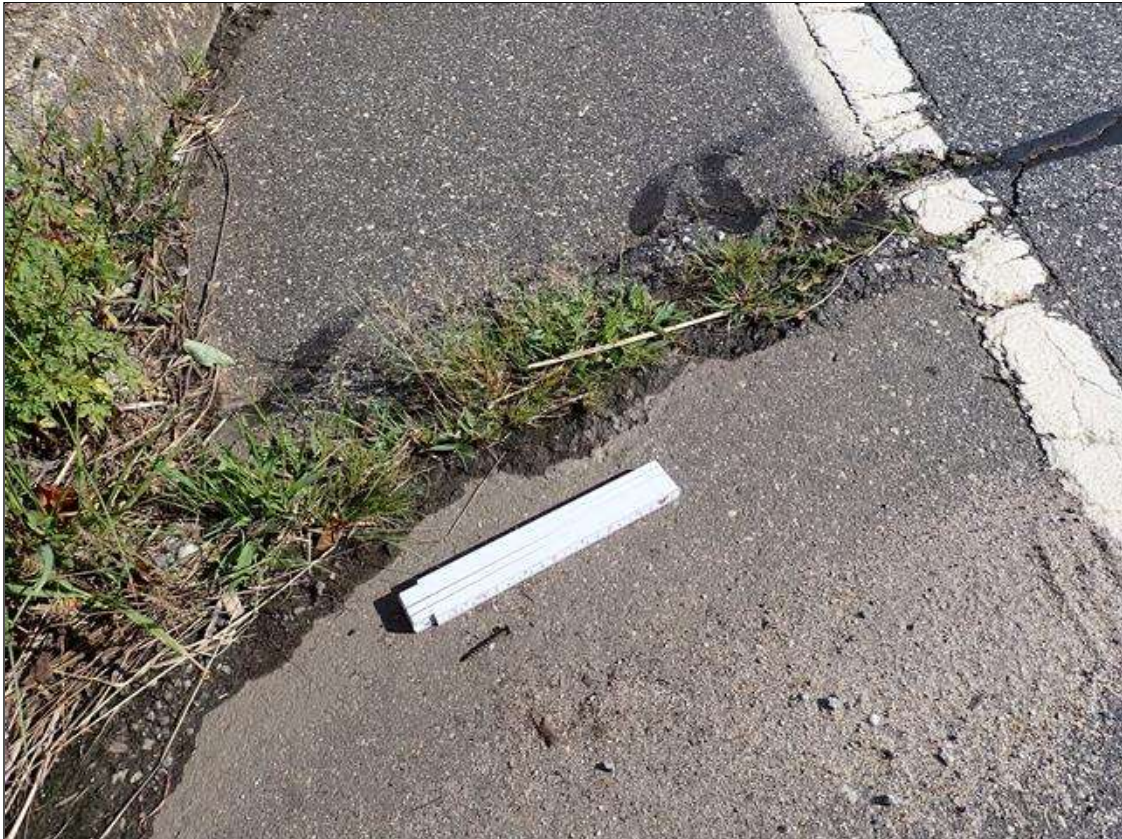
Span 2 Wearing Surface: over bent 2, partially sealed transverse crack (1/8 inch x full width) with edge spalling (up to 3 foot x 5 inch x 1/2 inch deep) with vegetation growth

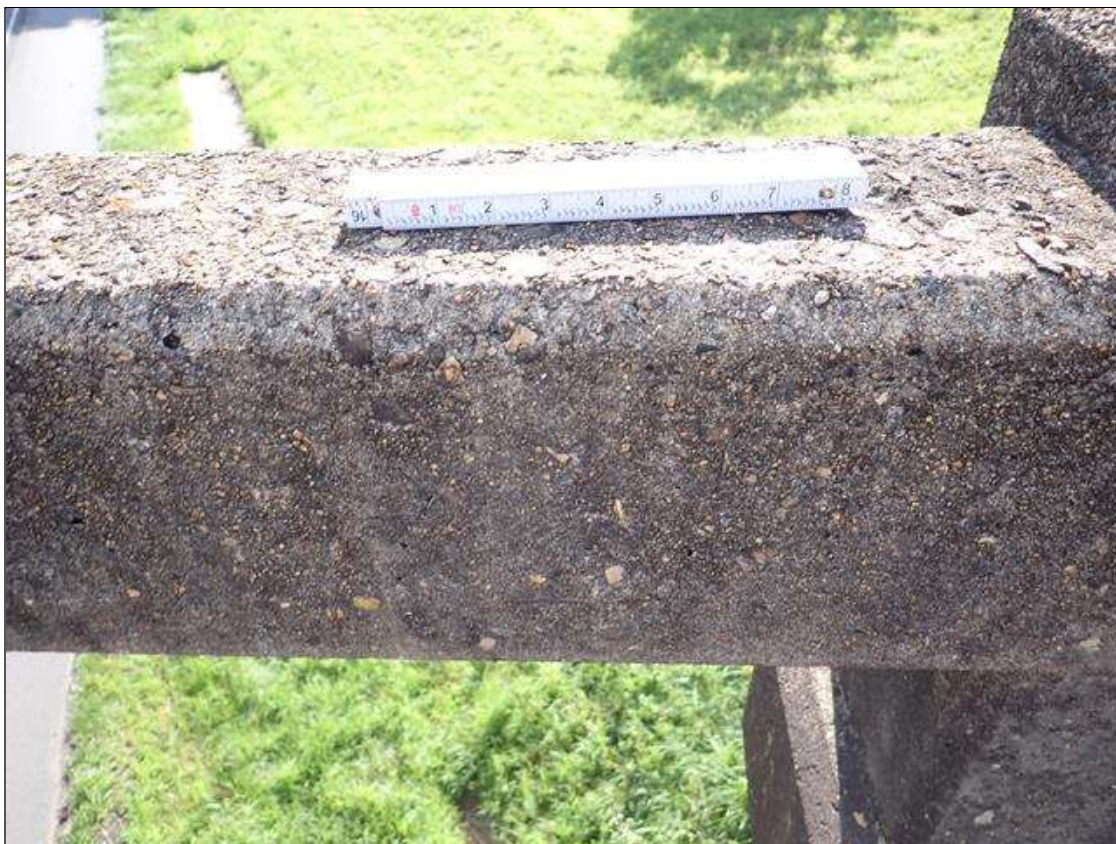
Span 2 Right Bridge Rail: (NOT FOUND 2023) RIGHT RAIL HAS SCATTERED MAP CRACKING UP TO 1/64 INCH

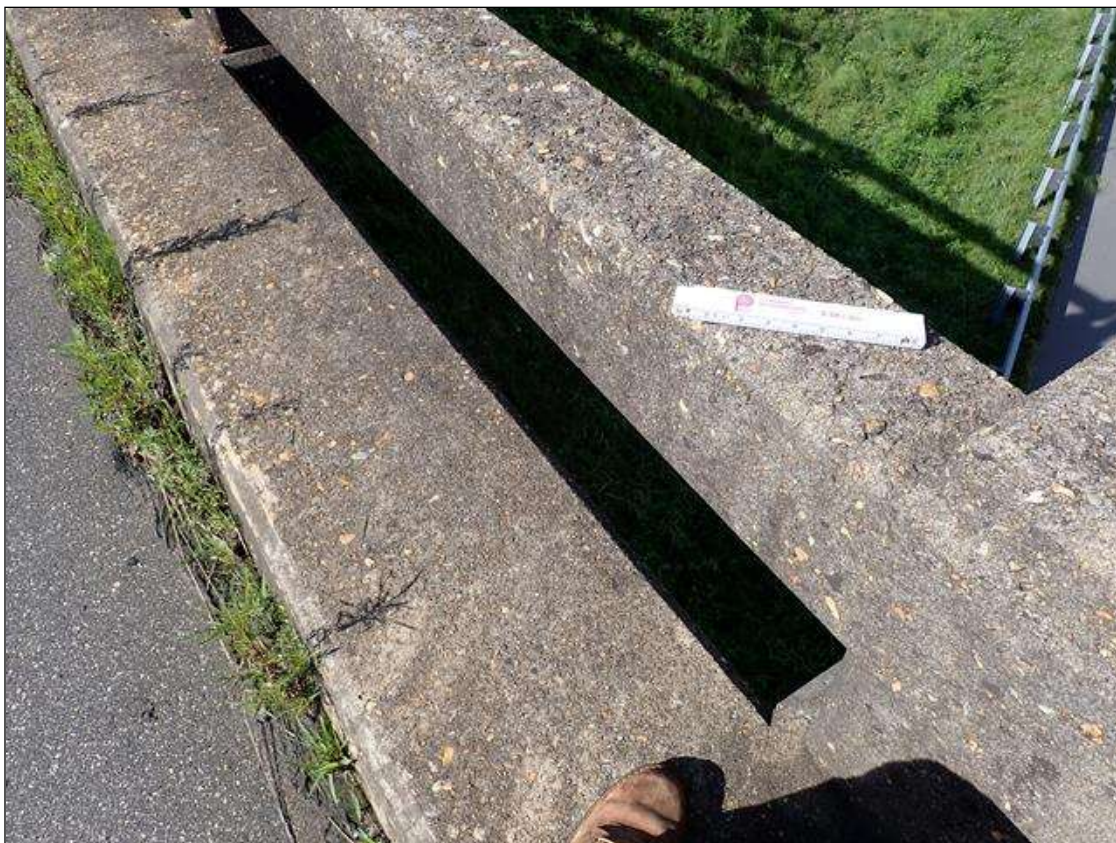
Span 2 Left Bridge Rail: (NOT FOUND 2023) LEFT RAIL HAS SCATTERED MAP CRACKING UP TO 1/64 INCH

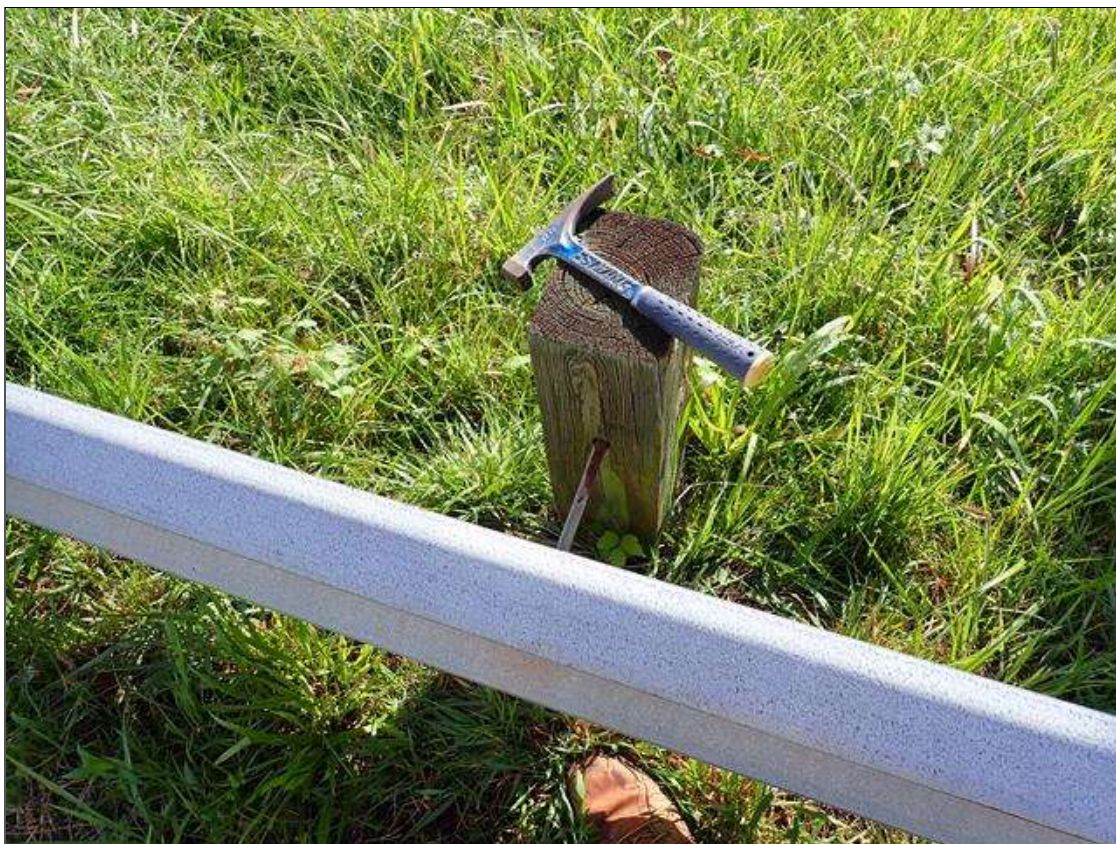
(PAR) southeast guardrail, 9th timber spacer from end bent 1, missing

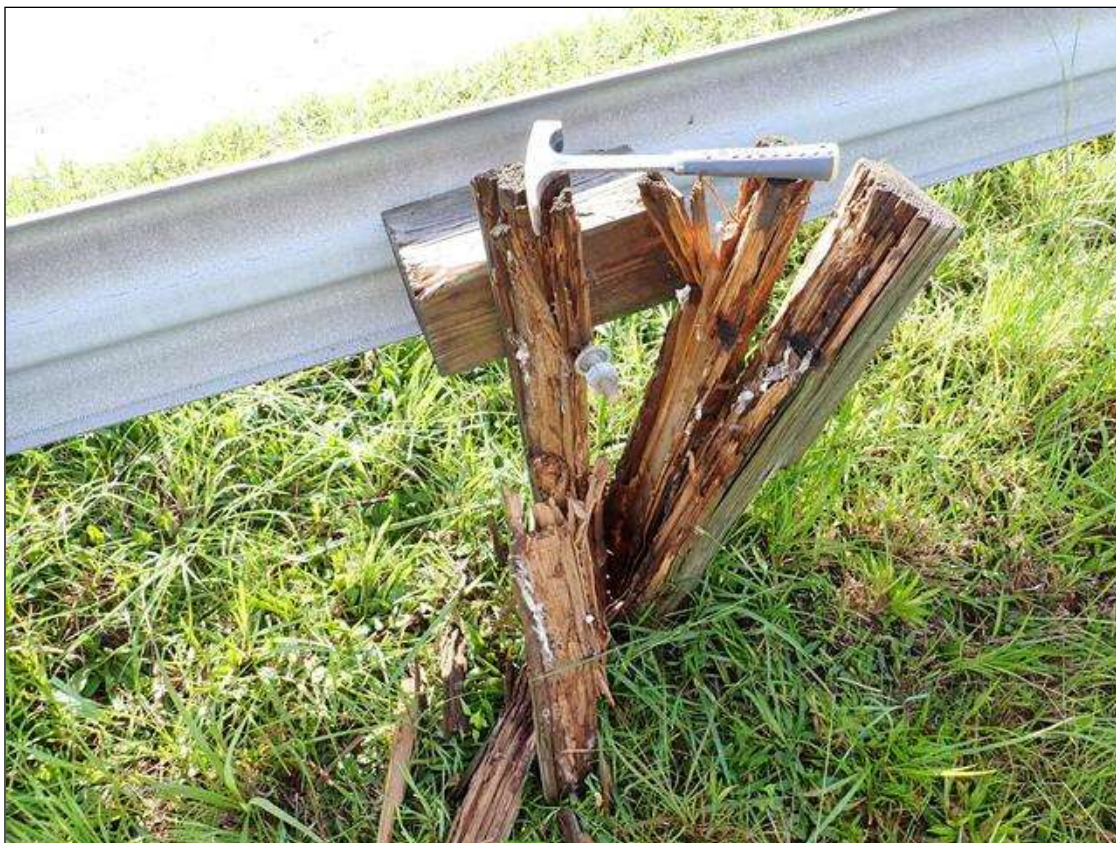
(PAR) southwest guardrail, 13th timber post from end bent 1, decay/section loss (up to full width x full height x full depth)

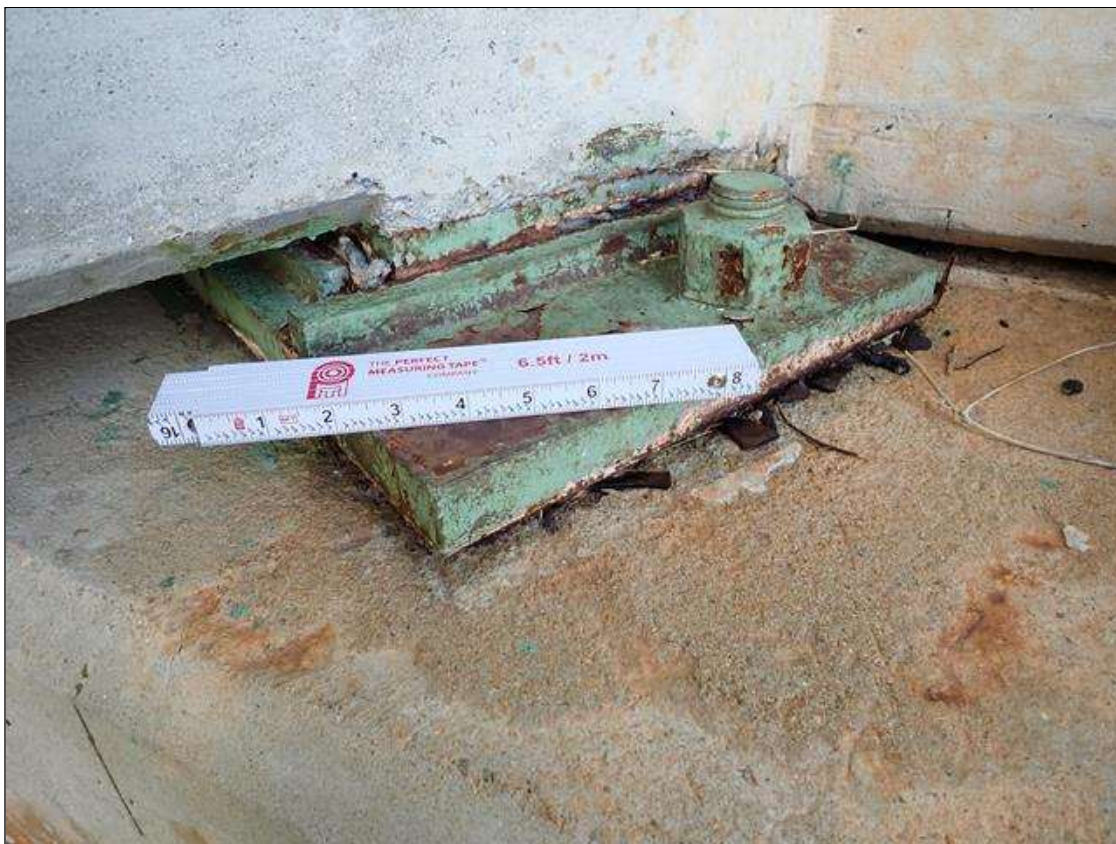
Span 1 Near Bearing 1: SURFACE RUST

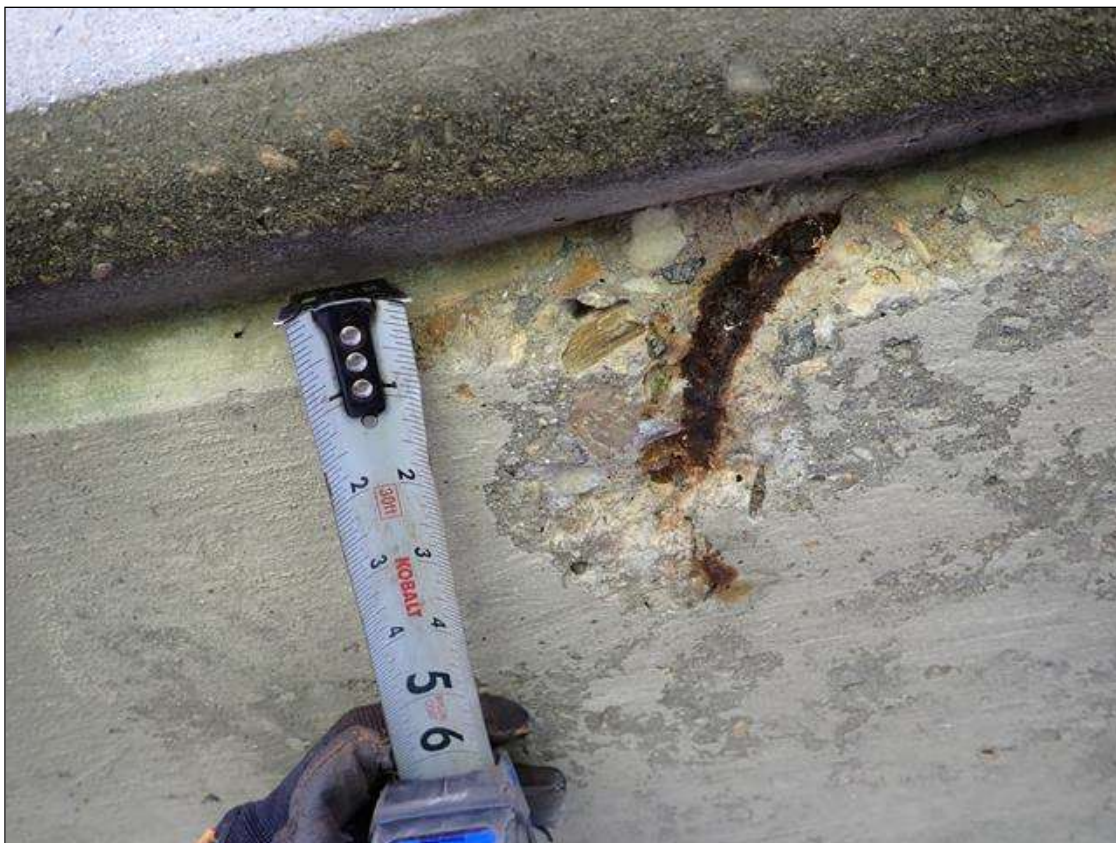
Span 1 Deck: (PAR) west overhang 10 foot from end bent 1, spall (5 inch x 5 inch x 1/2 inch deep) with exposed rusted rebar

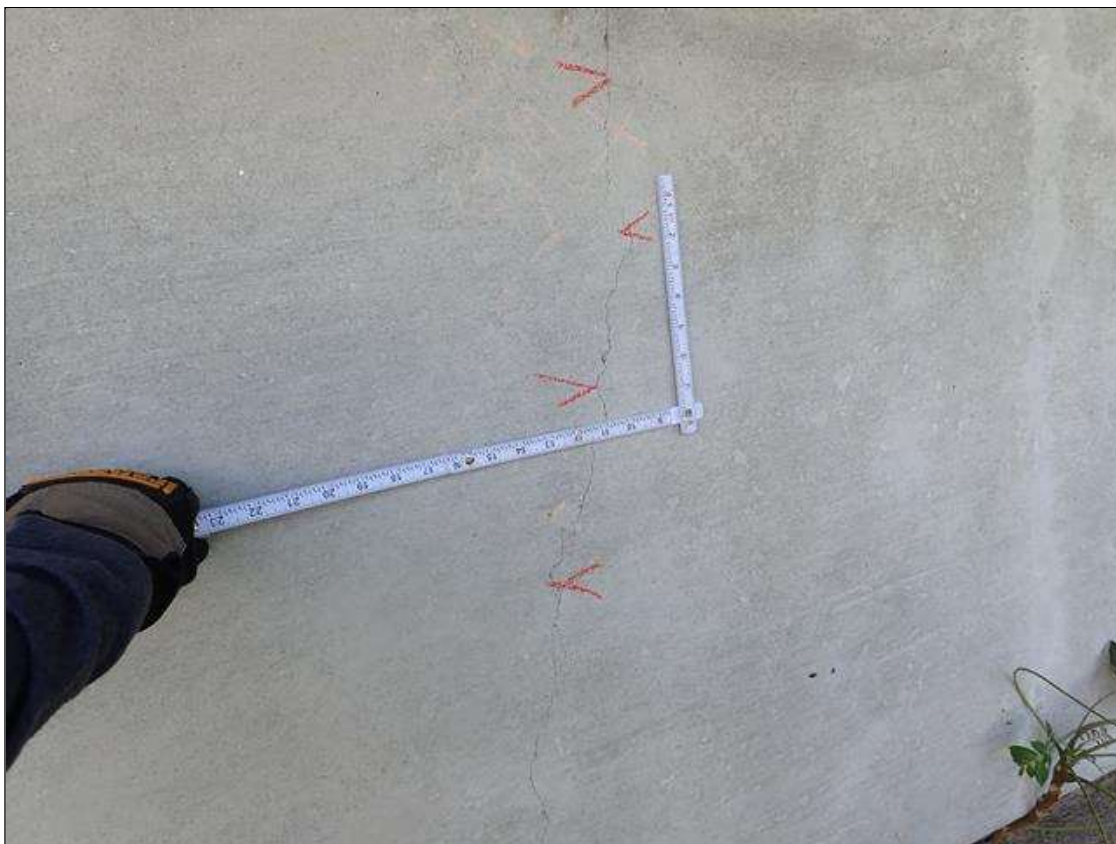
Span 1 Beam 1: along the length of the beam, vertical cracks (up to 1/32 inch x full height) at random

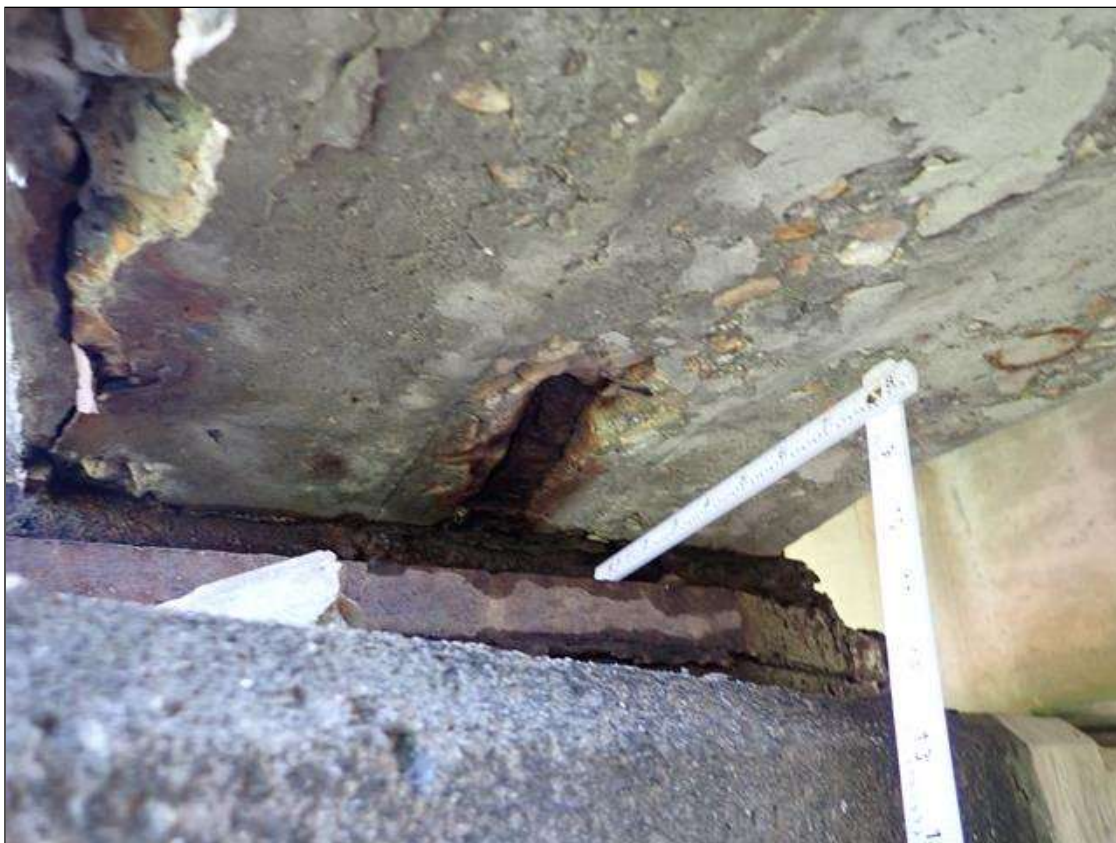
Span 1 Beam 1: (PAR) at bent 1, west face and underside, (2) spalls/delamination (up to 2.5 foot x 2 foot x 2 inch deep) with exposed rusted rebar (approximately 25 percent loss)

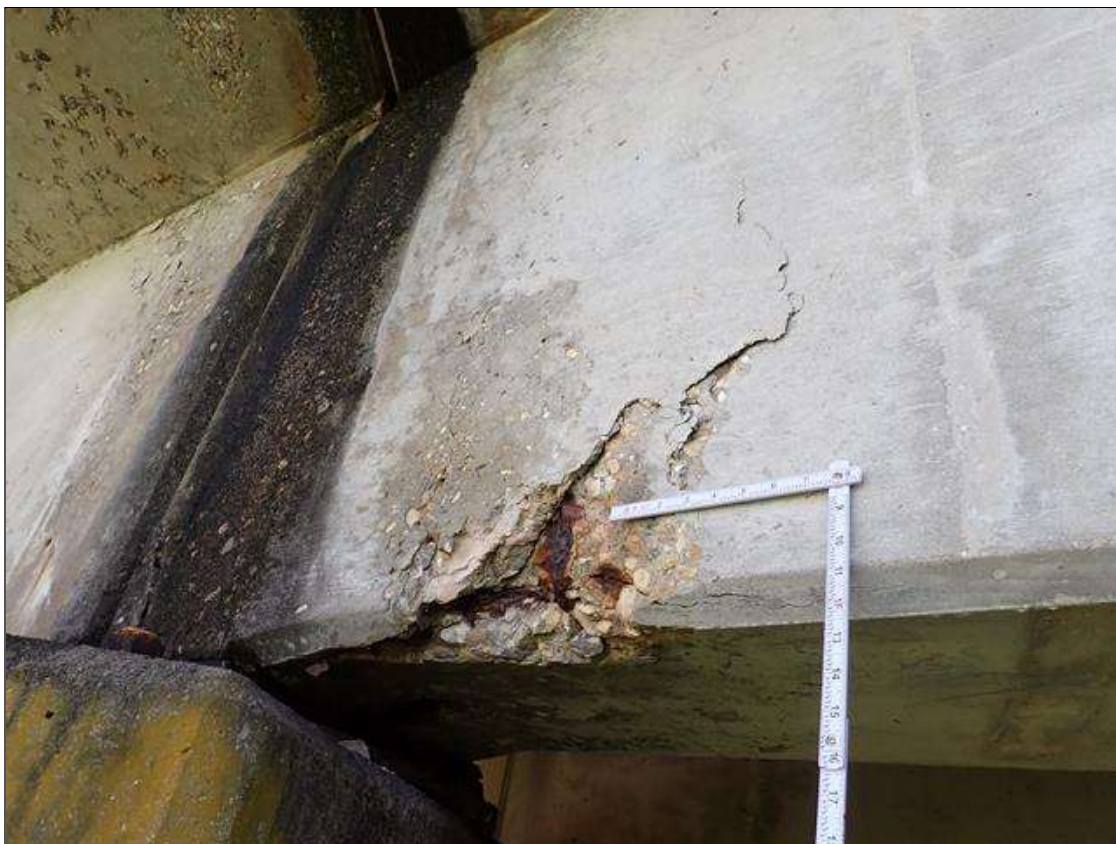
Span 1 Beam 1: (PAR) at bent 1, west face and underside, (2) spalls/delamination (up to 2.5 foot x 2 foot x 2 inch deep) with exposed rusted rebar (approximately 25 percent loss)

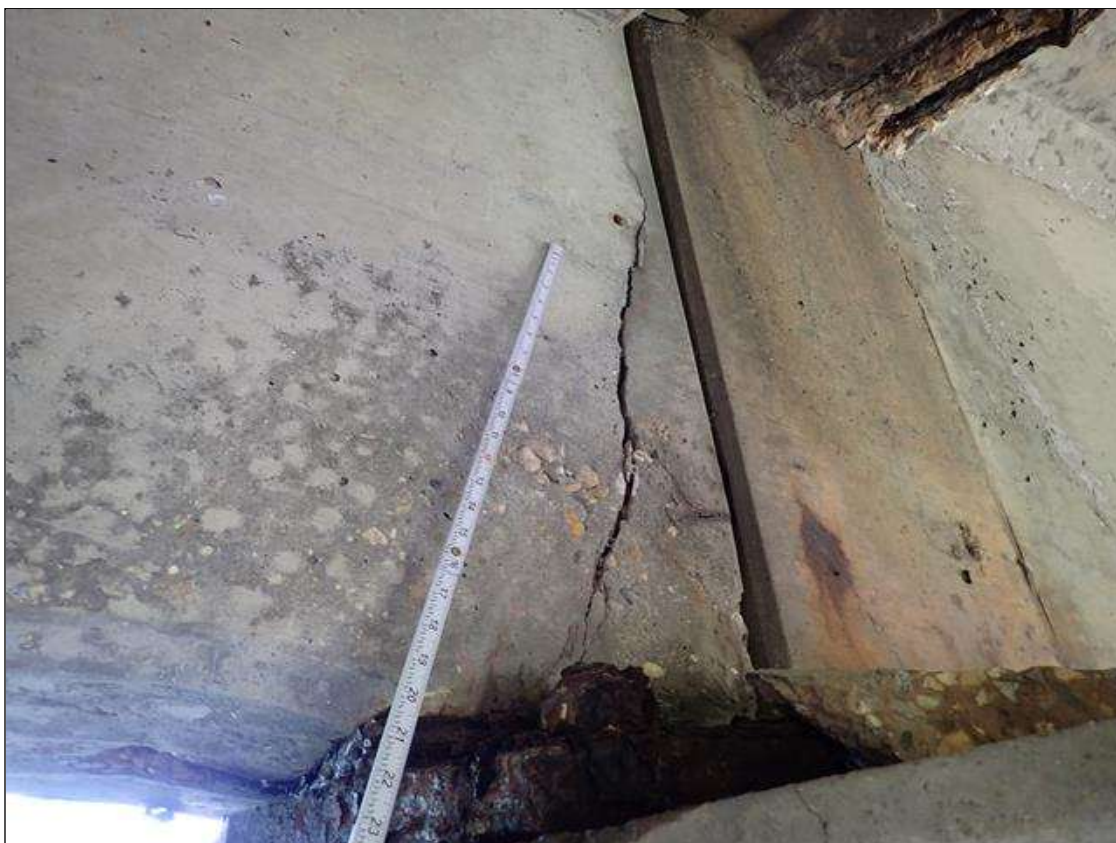
Span 1 Beam 1: at bent 1, east face, delamination (26 inch x 6 inch) with cracks (up to 1/2 inch)

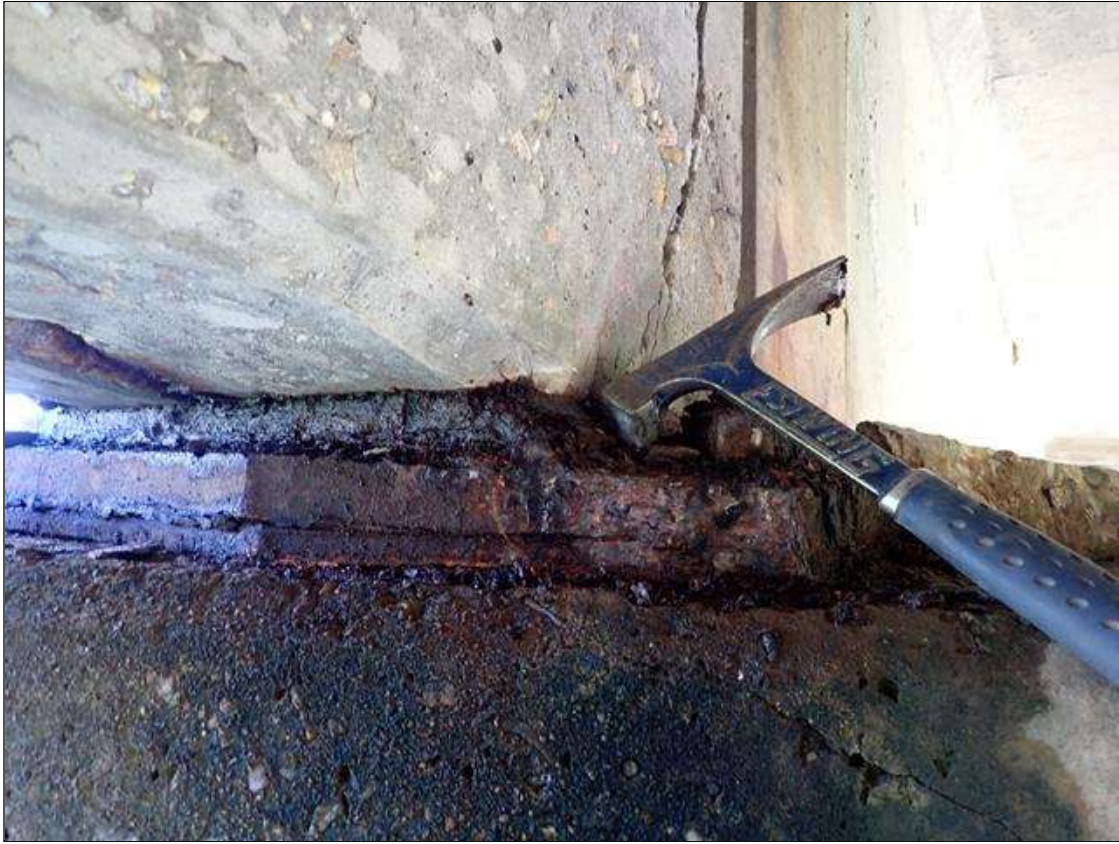
Span 1 Far Bearing 1: corrosion with section loss [up to 1/16 inch loss]
