NC DEPARTMENT OF TRANSPORTATION
 DIVISION OF HIGHWAYS
 STRUCTURE MANAGEMENT UNIT

ATTENTION: **prompt action request; sketches updated; route sign attached to span 3 beam 1**

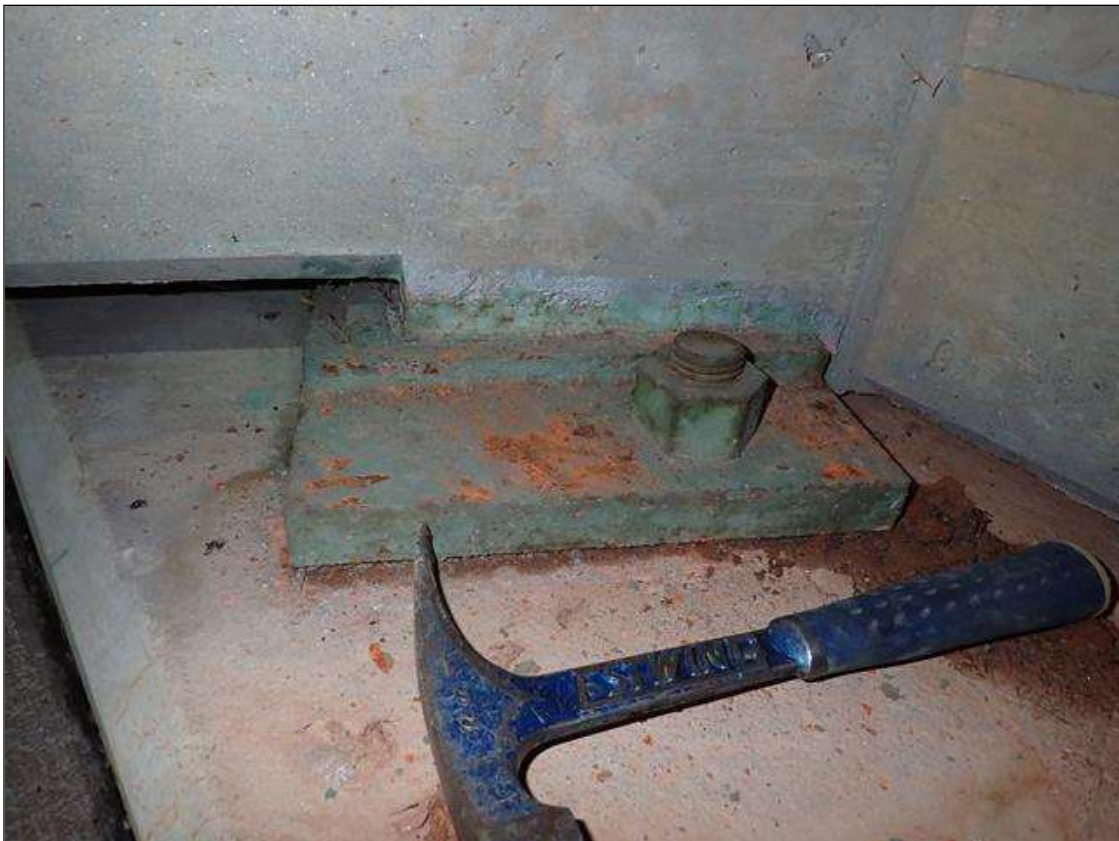
Span 1 Near Bearing 2: freckled rust

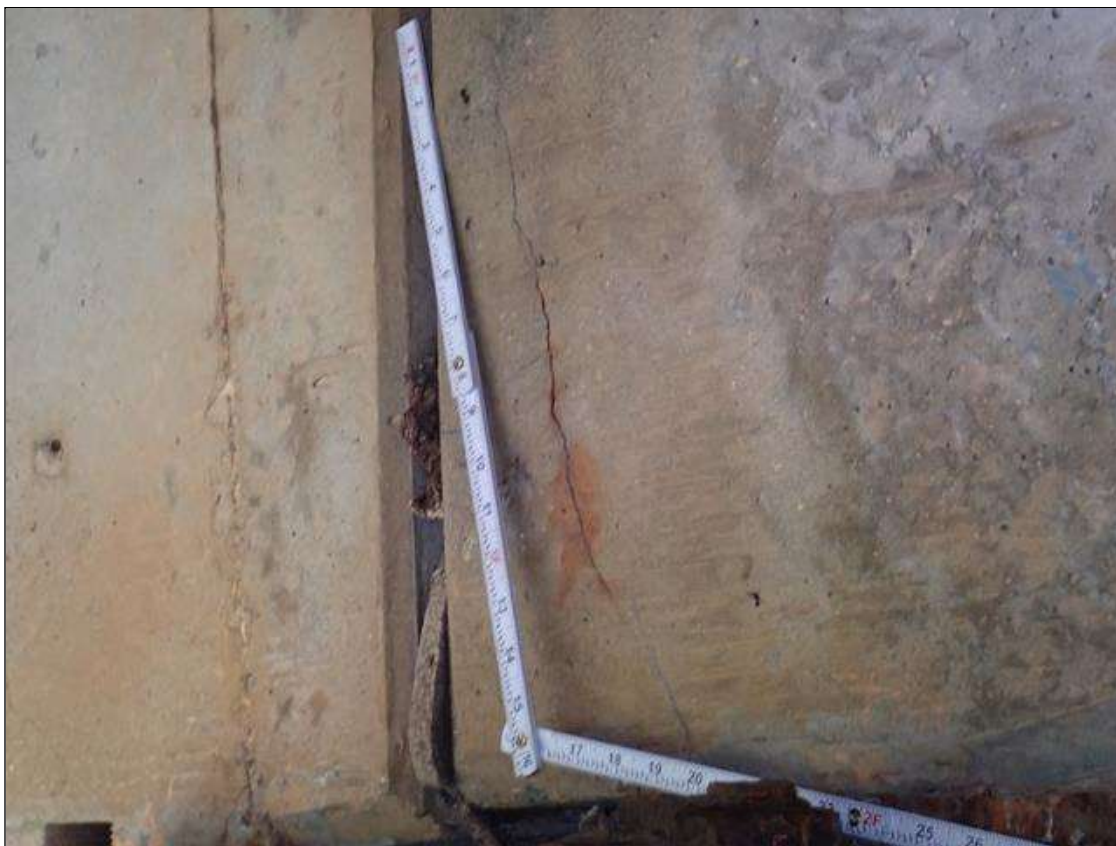
Span 1 Beam 3: (PAR) West face at far end, diagonal crack [18 inch x 1/32 inch] with rust stain

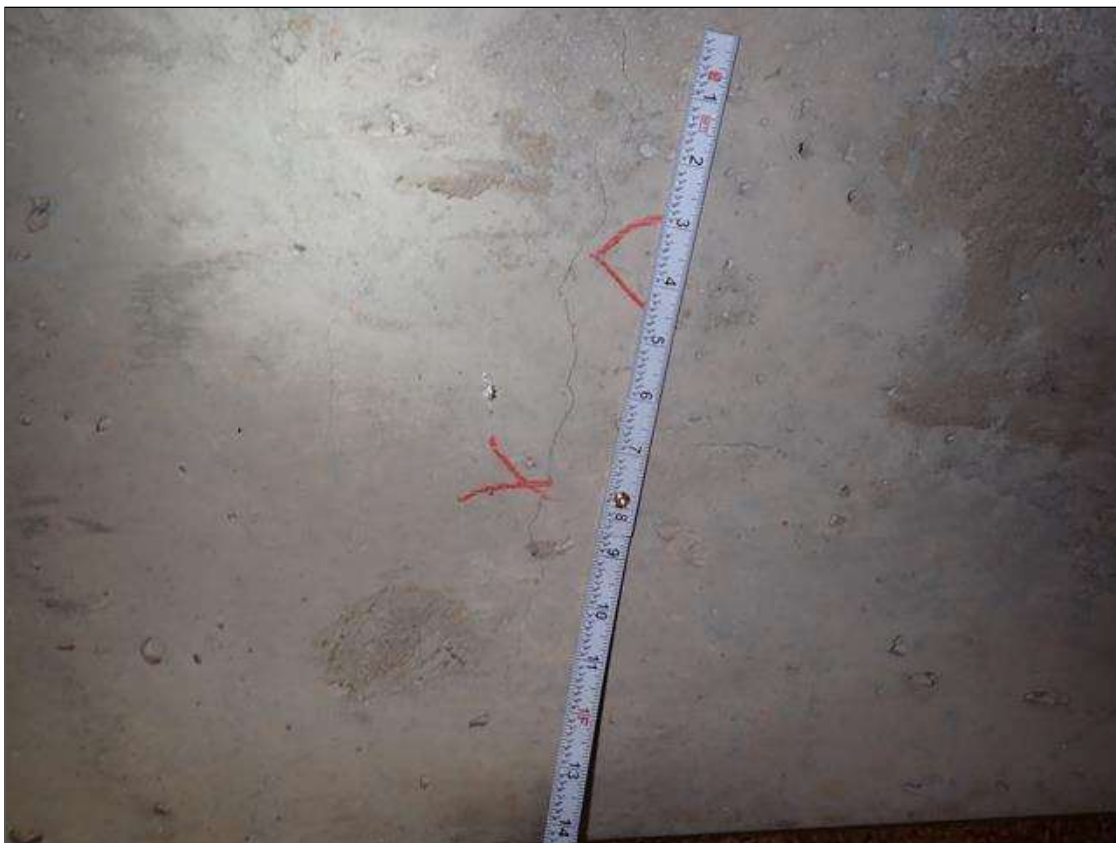
Span 1 Beam 3: along far half of beam, vertical/diagonal cracks (up to 1/64 inch x full height)

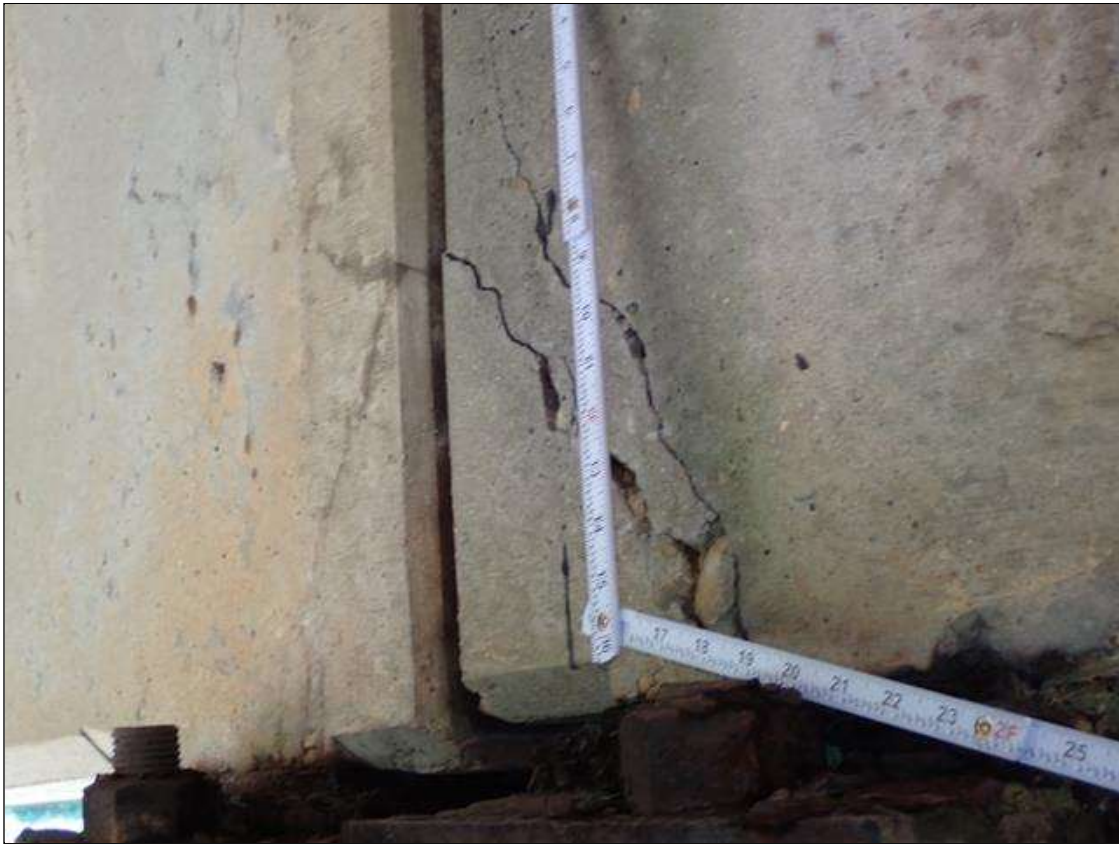
Span 1 Beam 4: (PAR) at bent 1, west and east faces and underside, multiple spalls/delaminations (up to 8 inch x 12 inch x 1/2 inch deep) with exposed rusted rebar (approximately 25 percent loss) and cracks (up to 1/8 inch)

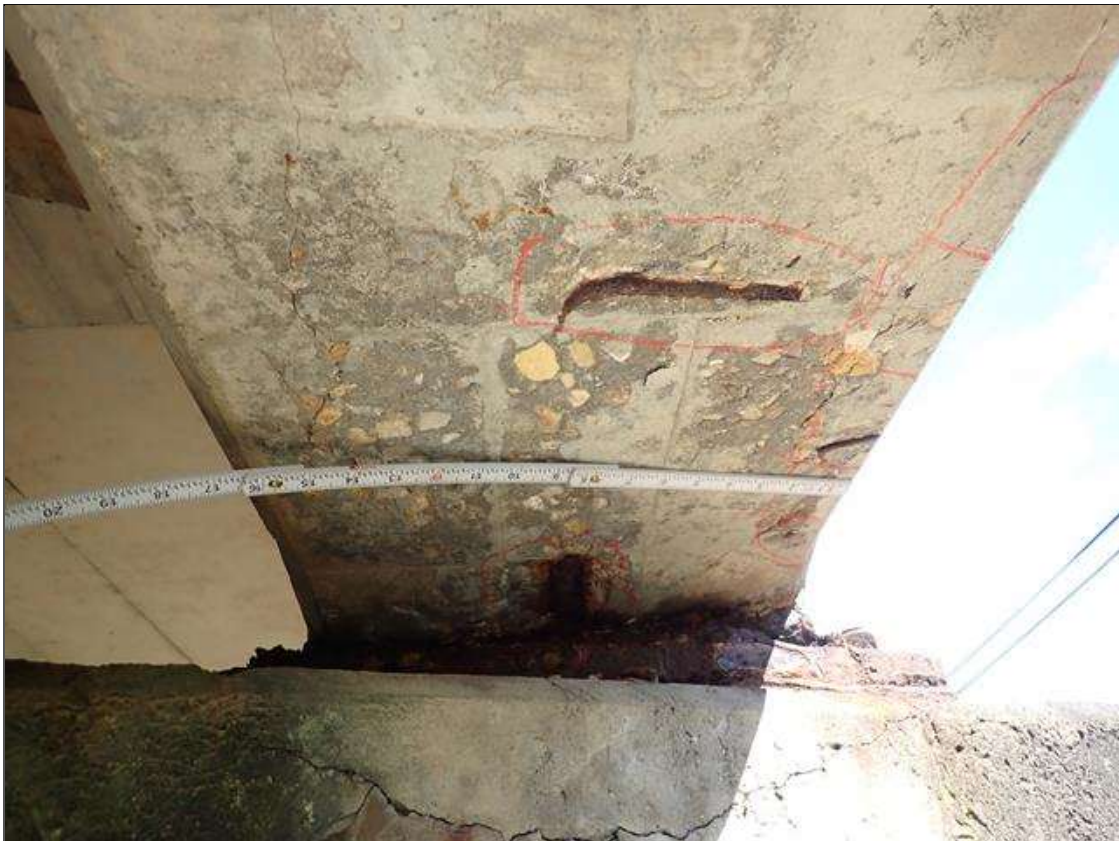
Span 1 Beam 4: (PAR) at bent 1, west and east faces and underside, multiple spalls/delaminations (up to 8 inch x 12 inch x 1/2 inch deep) with exposed rusted rebar (approximately 25 percent loss) and cracks (up to 1/8 inch)

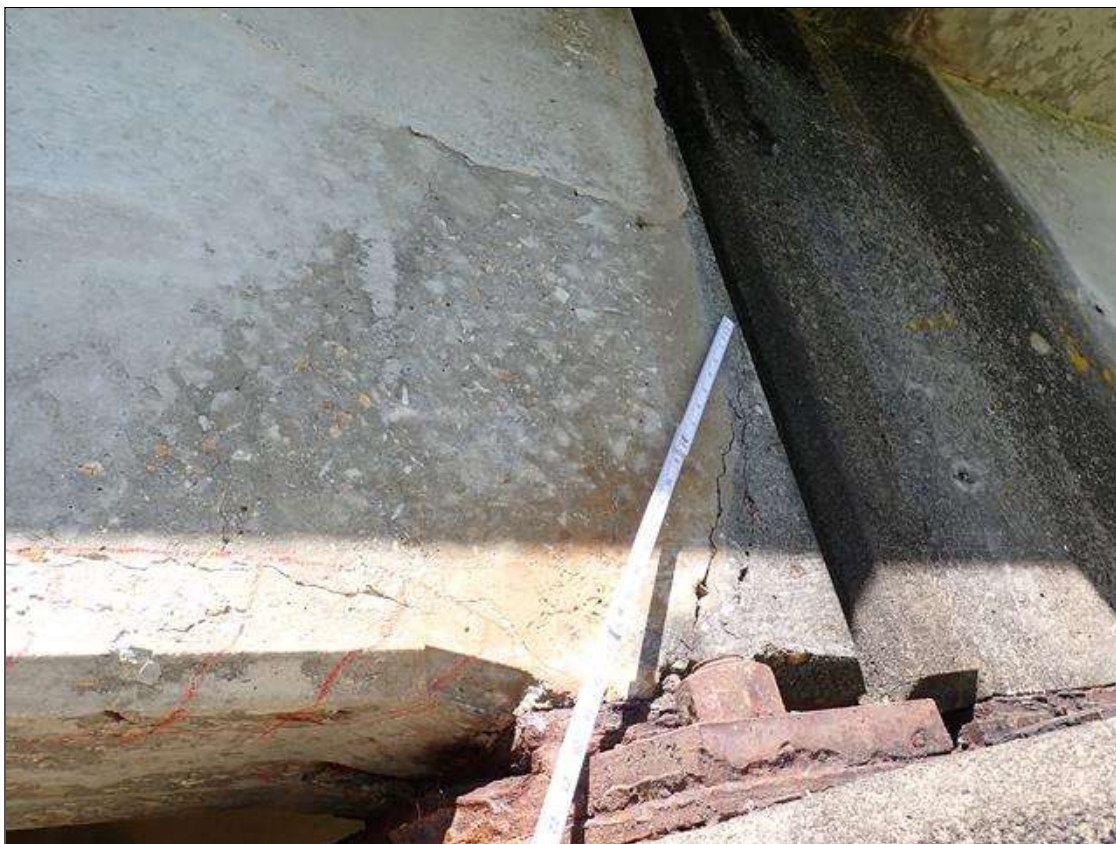
Span 1 Beam 4: (PAR) at bent 1, west and east faces and underside, multiple spalls/delaminations (up to 8 inch x 12 inch x 1/2 inch deep) with exposed rusted rebar (approximately 25 percent loss) and cracks (up to 1/8 inch)

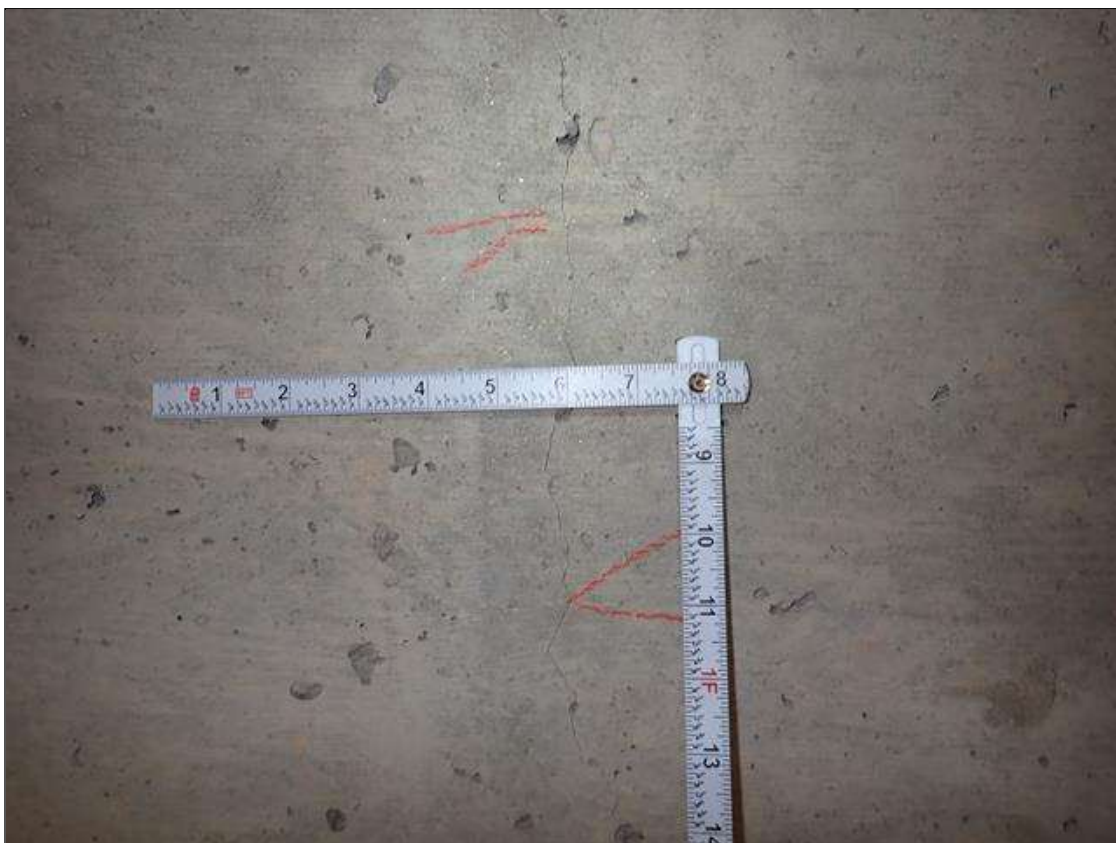
Span 1 Beam 4: along the length of the beam, vertical cracks (up to 1/64 inch x full height) at random

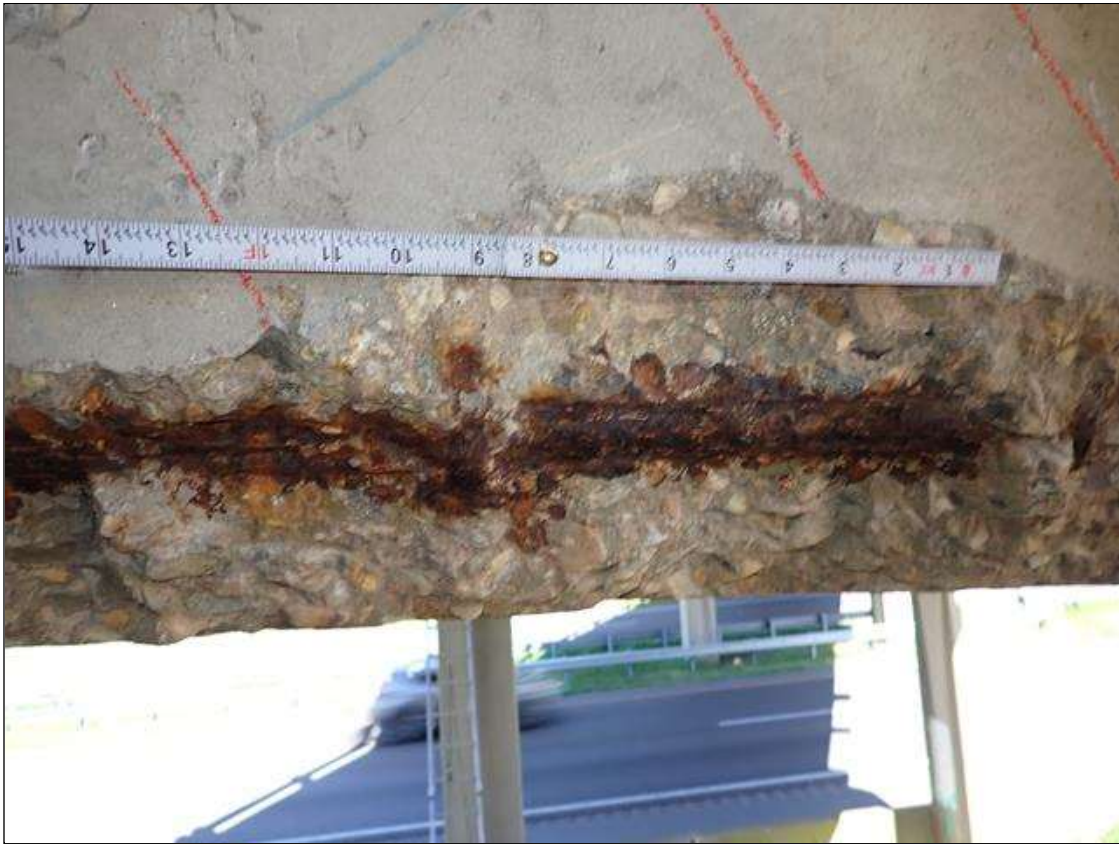
Bent 1 Cap 1: (PAR) along north and south faces, multiple spalls/delaminations (up to 16 foot x full height x 2.5 inch deep) with exposed rusted rebar (approximately 25 percent loss) and cracks (1/8 inch) at random

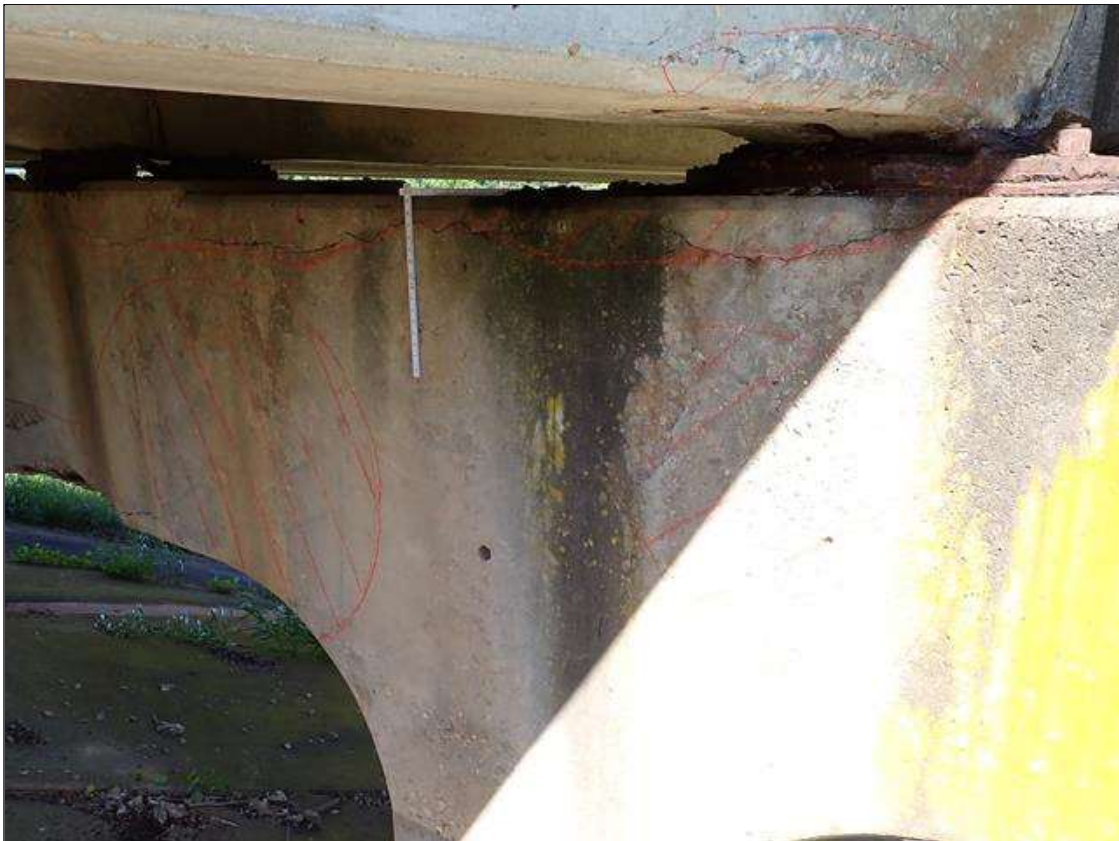
Bent 1 Cap 1: (PAR) along north and south faces, multiple spalls/delaminations (up to 16 foot x full height x 2.5 inch deep) with exposed rusted rebar (approximately 25 percent loss) and cracks (1/8 inch) at random

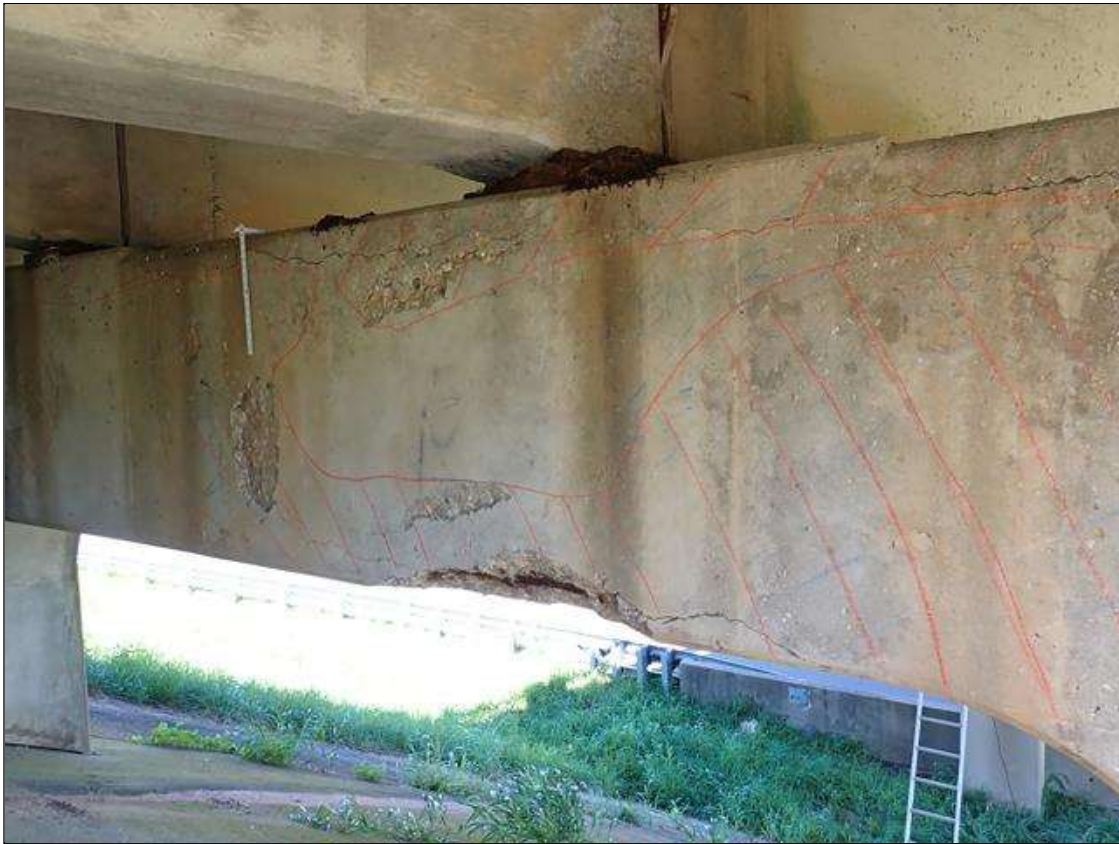
Bent 1 Cap 1: (PAR) along north and south faces, multiple spalls/delaminations (up to 16 foot x full height x 2.5 inch deep) with exposed rusted rebar (approximately 25 percent loss) and cracks (1/8 inch) at random

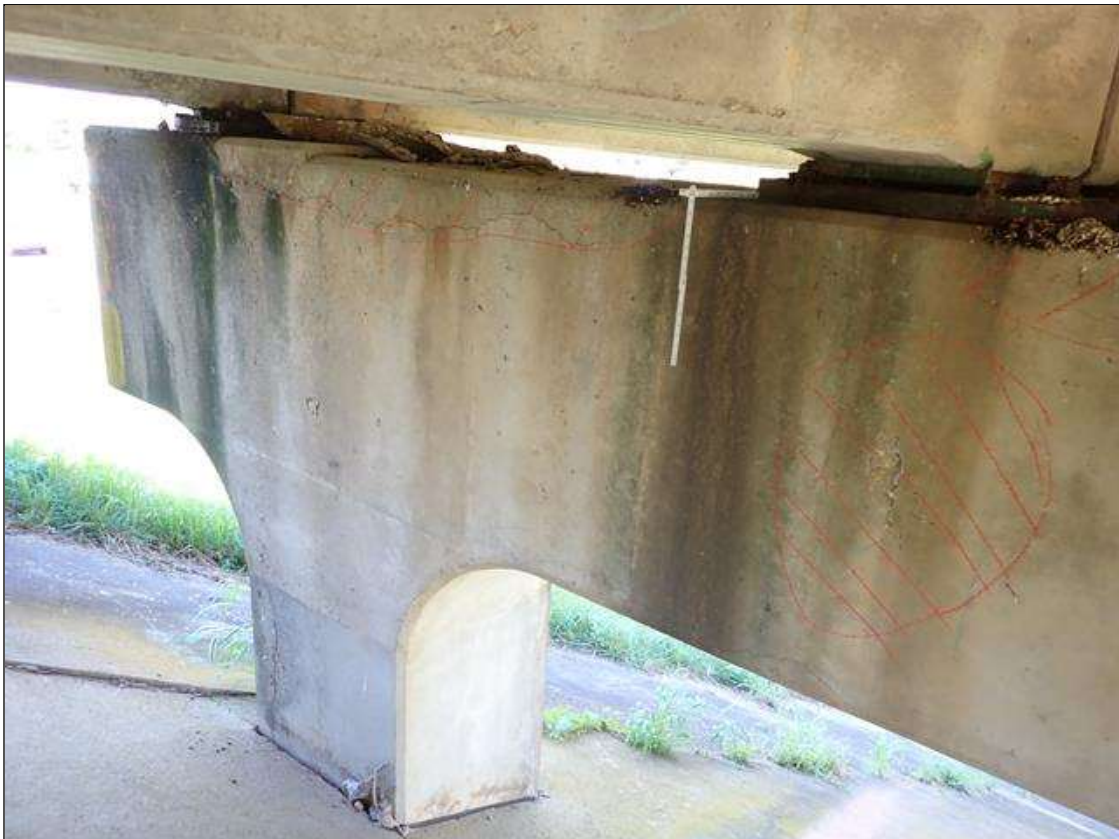
Bent 1 Cap 1: (PAR) along north and south faces, multiple spalls/delaminations (up to 16 foot x full height x 2.5 inch deep) with exposed rusted rebar (approximately 25 percent loss) and cracks (1/8 inch) at random

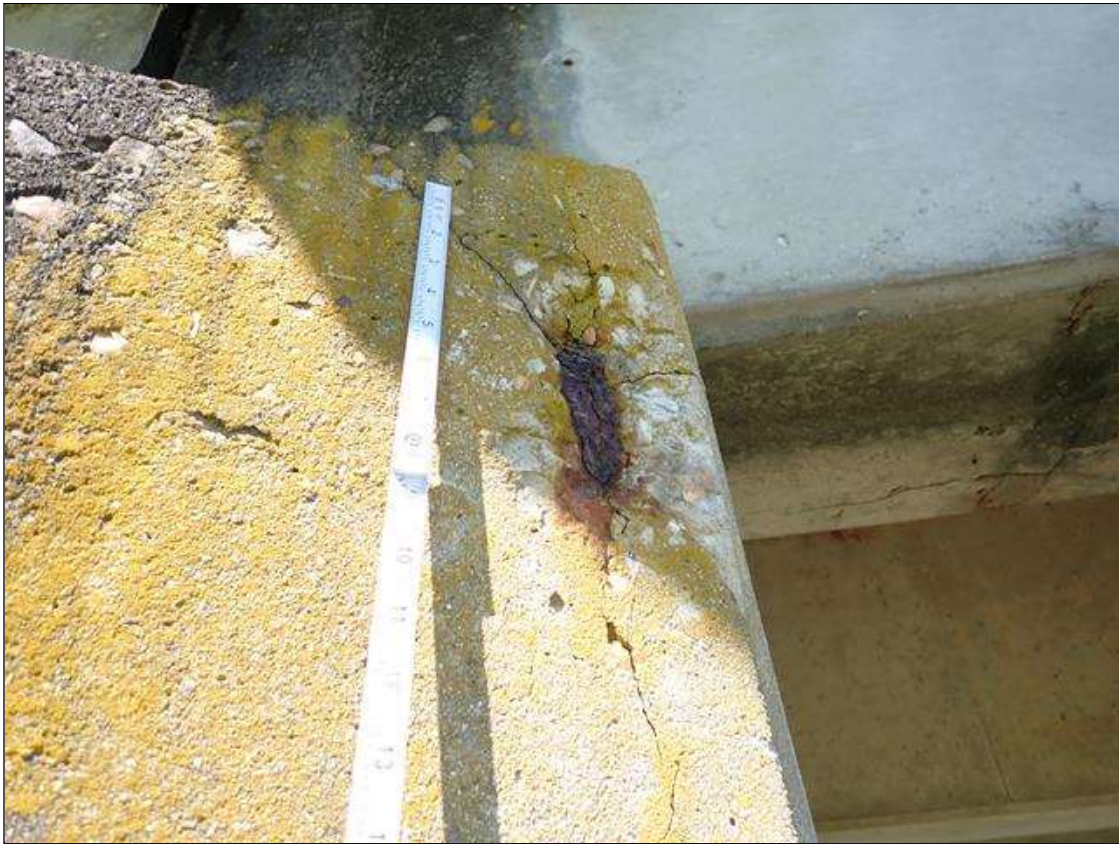
Bent 1 Cap 1: (PAR) east face, spall/delamination (12 inch x 6 inch x 1 inch deep) with exposed rusted rebar (approximately 25 percent loss)

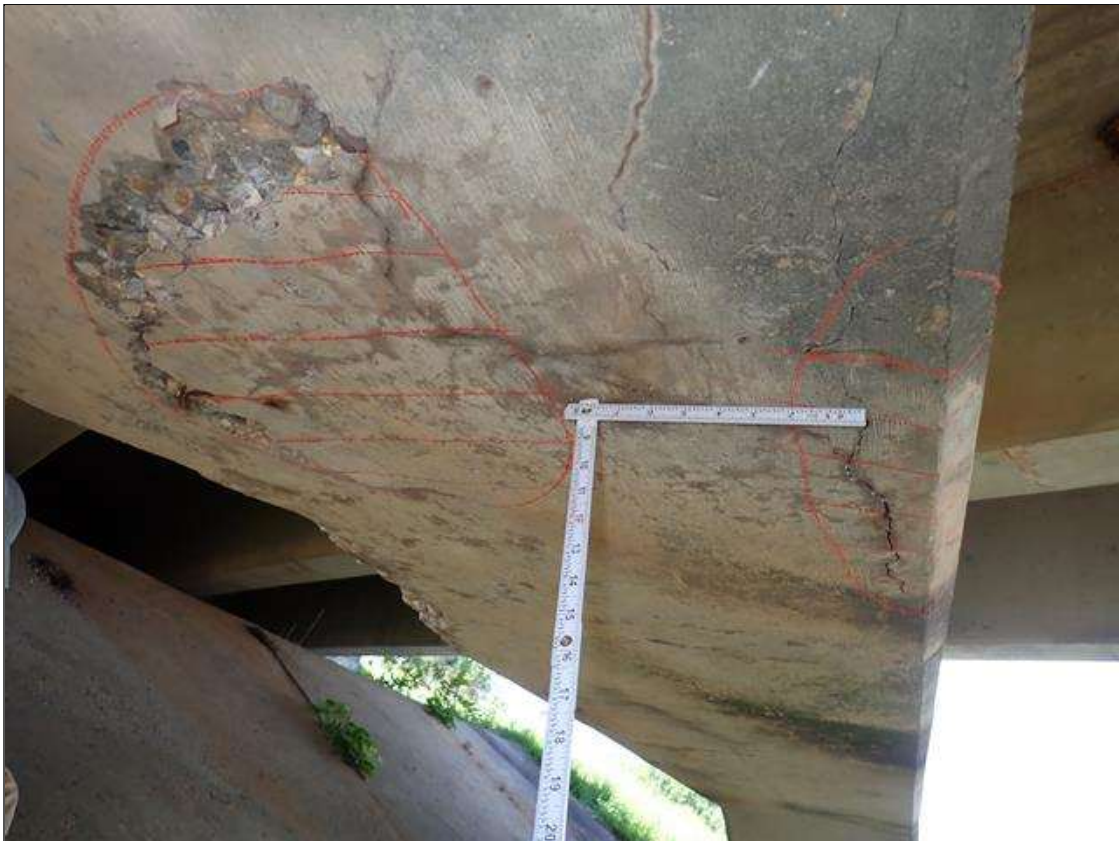
Bent 1 Cap 1: underside of cap near column 2, (2) spall/delamination (2 foot x 16 inch x 1/2 inch deep) with cracks (up to 1/16 inch)

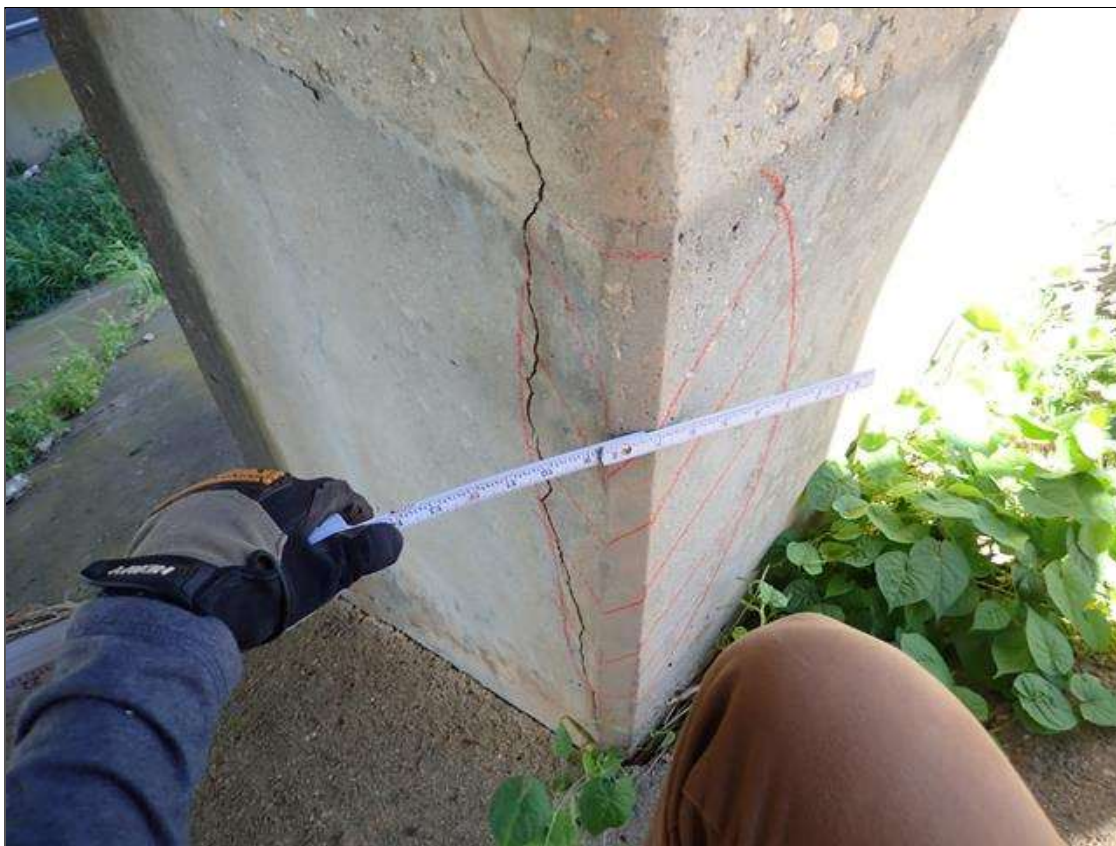
Bent 1 Pile 2: at Southwest corner, delamination [full height x 12 inch] with cracks (up to 1/8 inch)

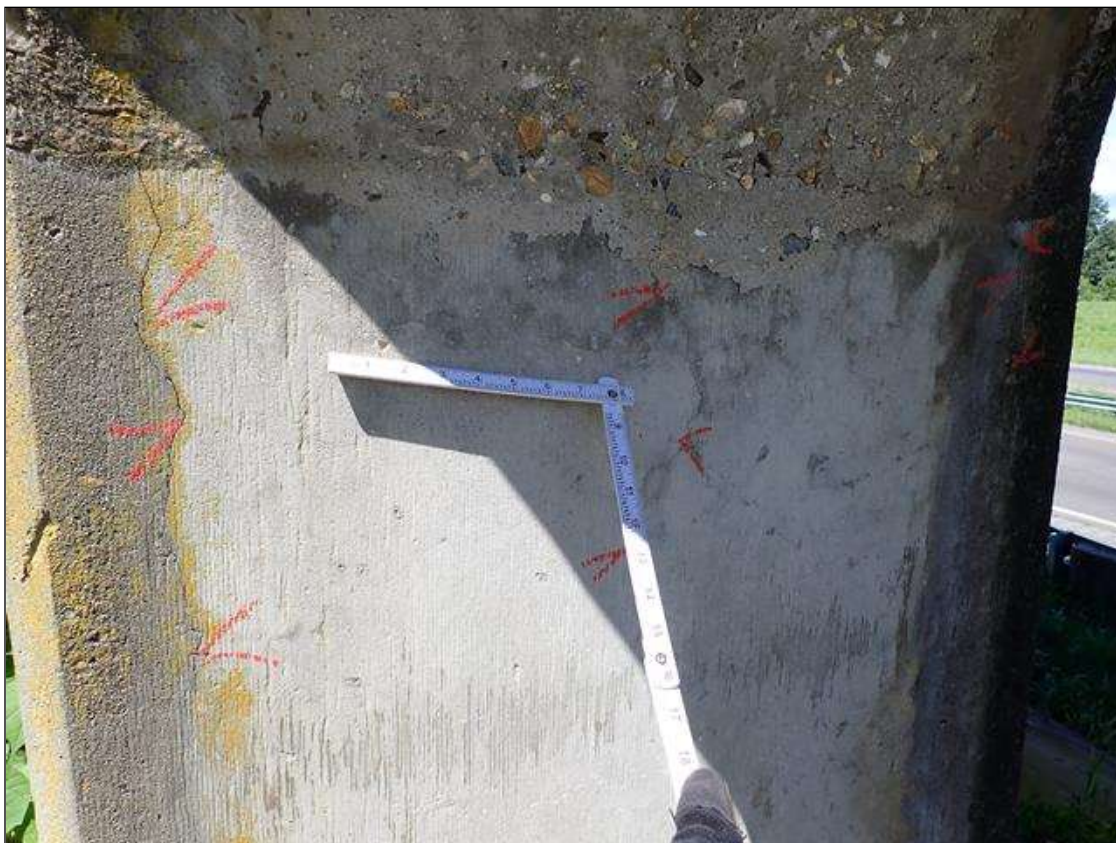
Bent 1 Pile 2: UP TO 4 FOOT X UP TO 1/32 INCH VERTICAL CRACKS, AT RANDOM THROUGHOUT.

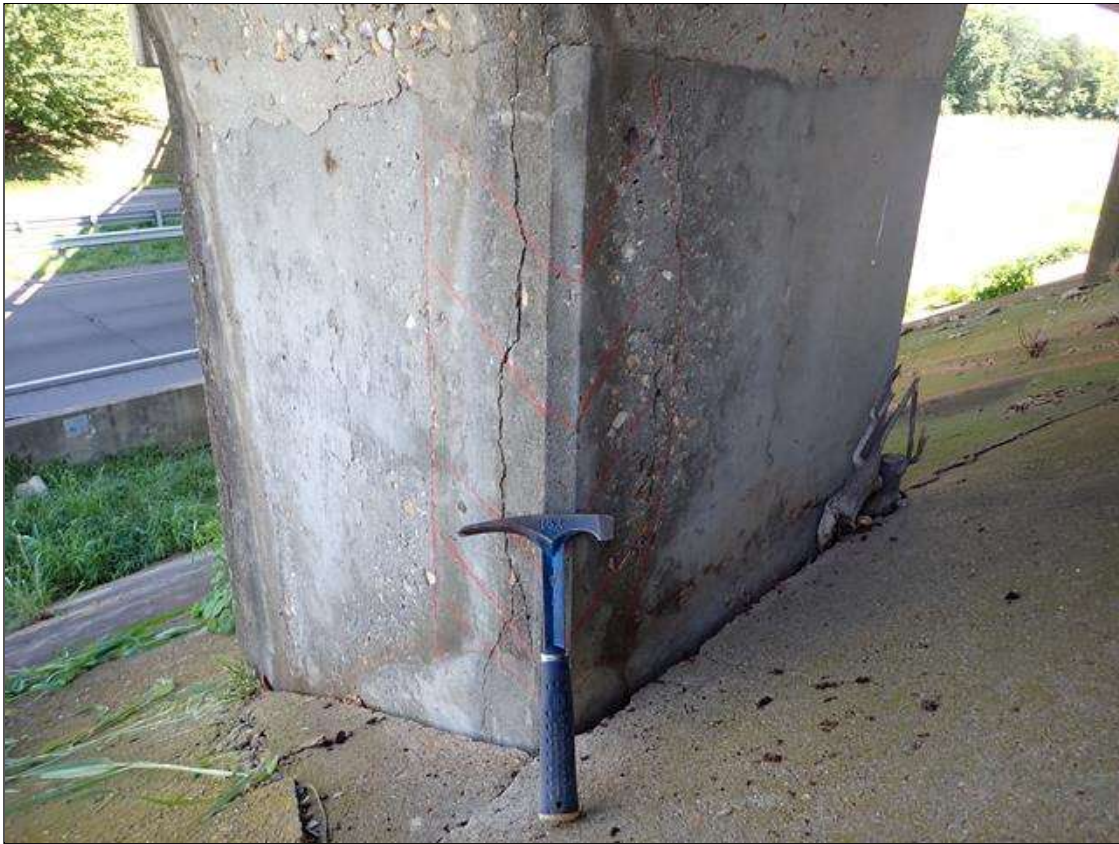
Bent 1 Pile 1: northwest, northeast and southwest corners, delaminations (up to full height x 16 inch) with cracks (up to 1/8 inch)

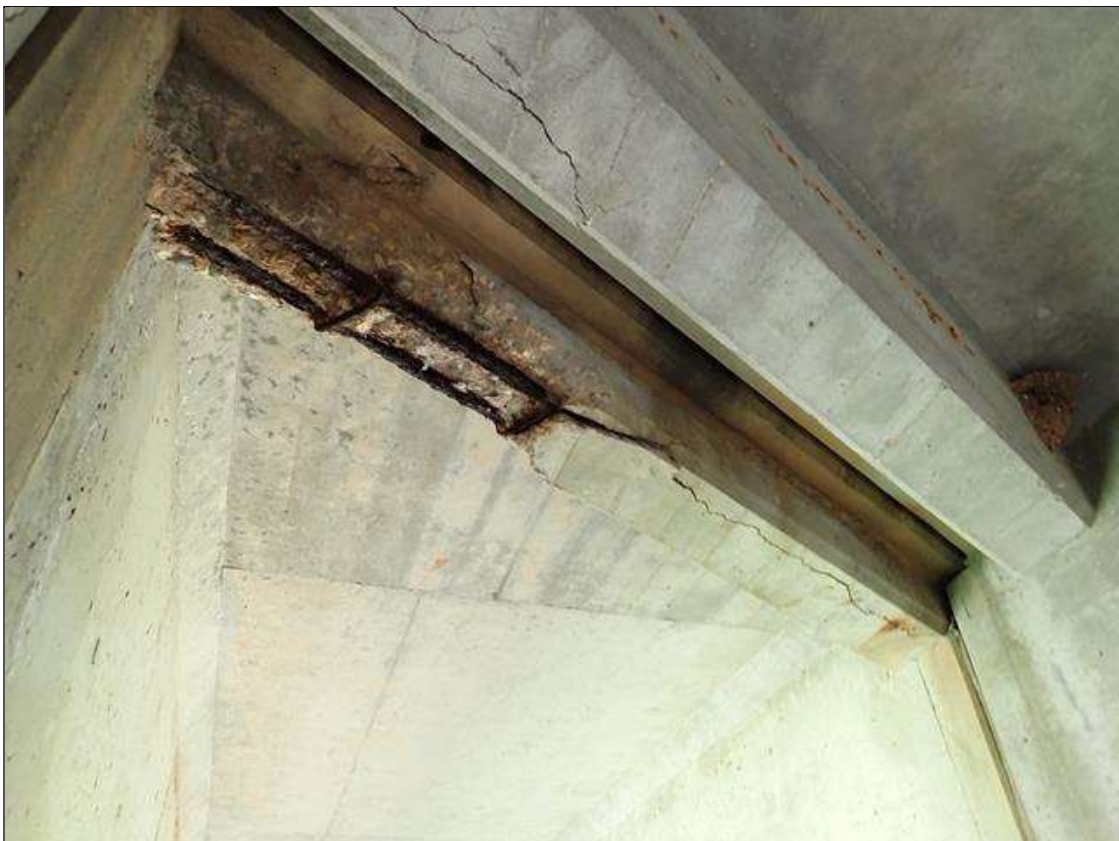
Span 2 Beam 1: (PAR) at bents 1 and 2, bay 1 end diaphragm, spalls/delaminations (up to full length x up to full height x 3 inch deep) with exposed rusted rebar (approximately 25 percent loss) and cracks (up to 1/8 inch) with rust stains

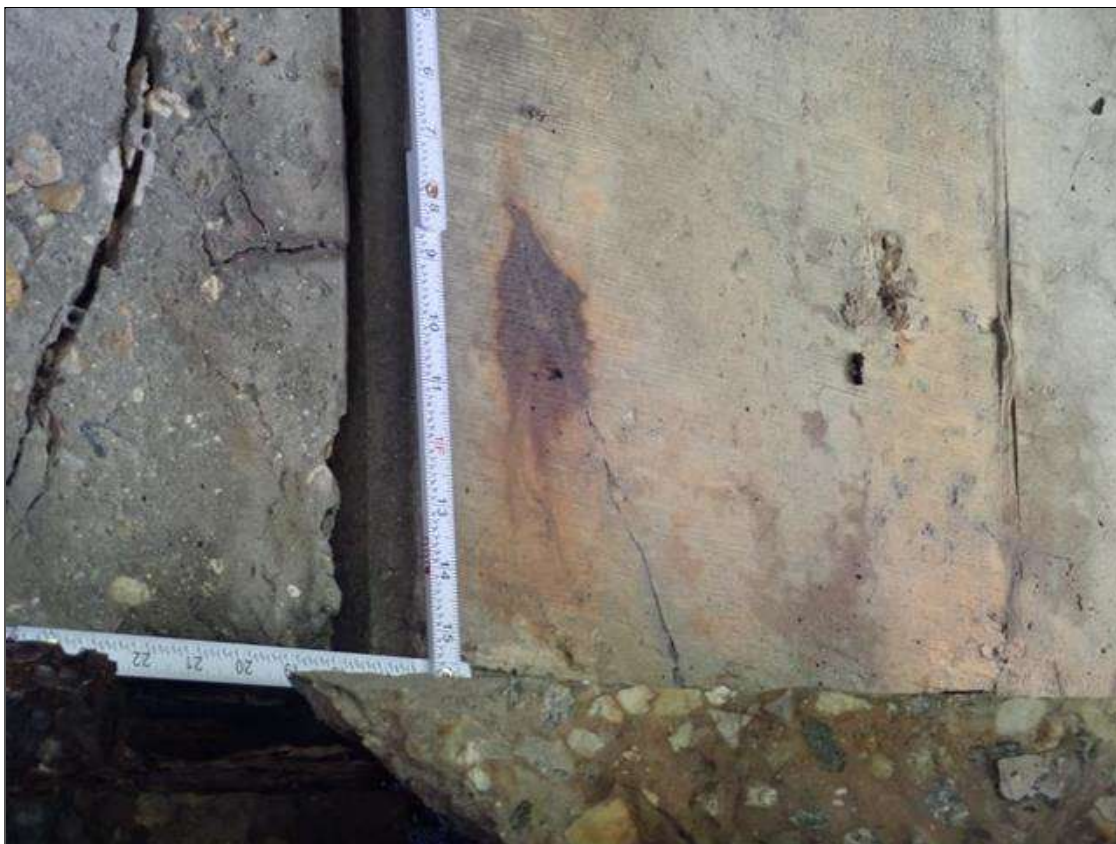
Span 2 Beam 1: (PAR) East face at near end, vertical crack [10 inch x 1/32 inch] with rust stain

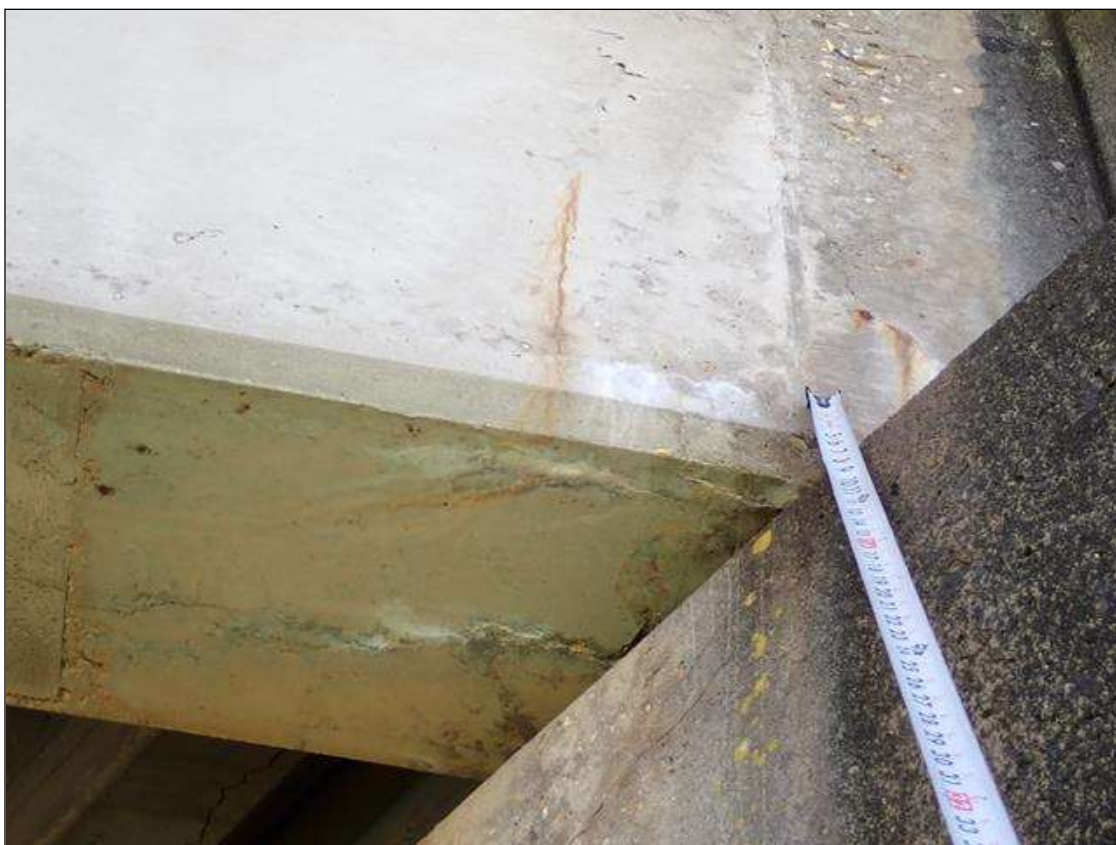
Span 2 Beam 1: (PAR) West face at near end, longitudinal crack [4 foot x 1/32 inch] and diagonal crack [full height x 1/32 inch] with rust stain and efflorescence

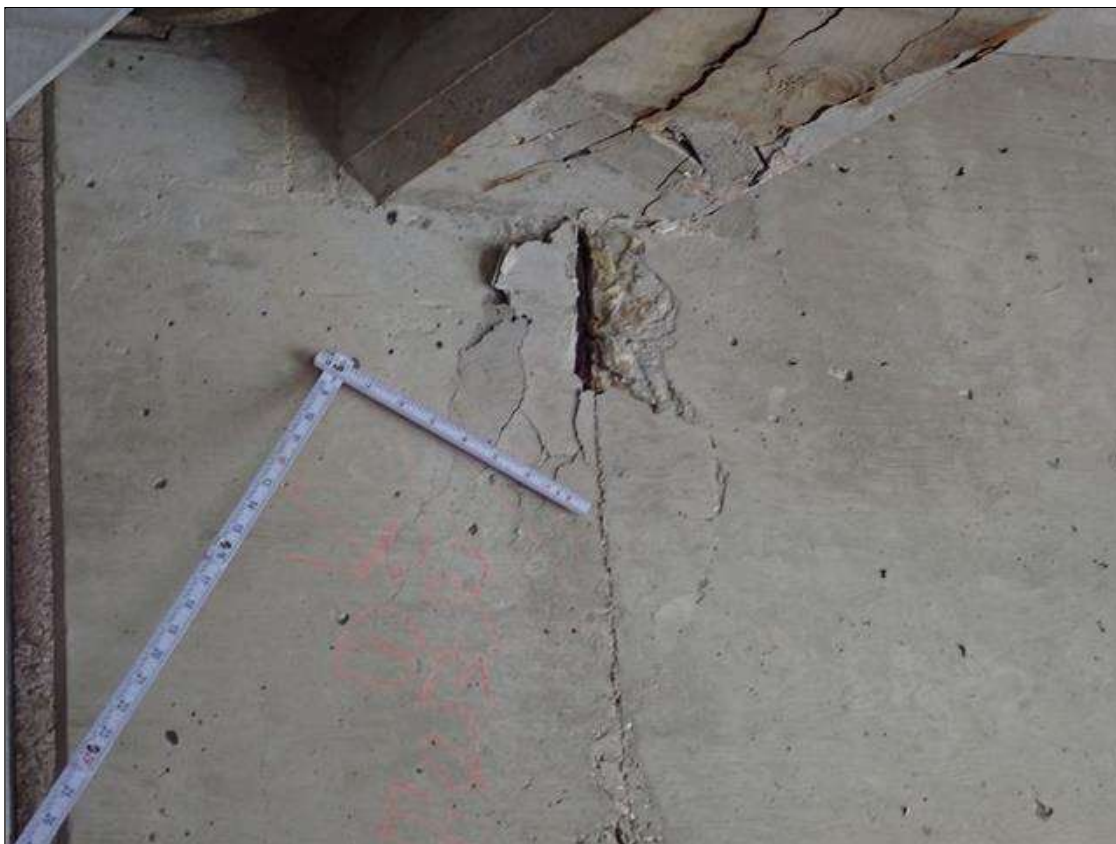
Span 2 Beam 2: East face at near end, delamination/spall [10 inch x 15 inch x up to 1/2 inch deep] with exposed rusted rebar

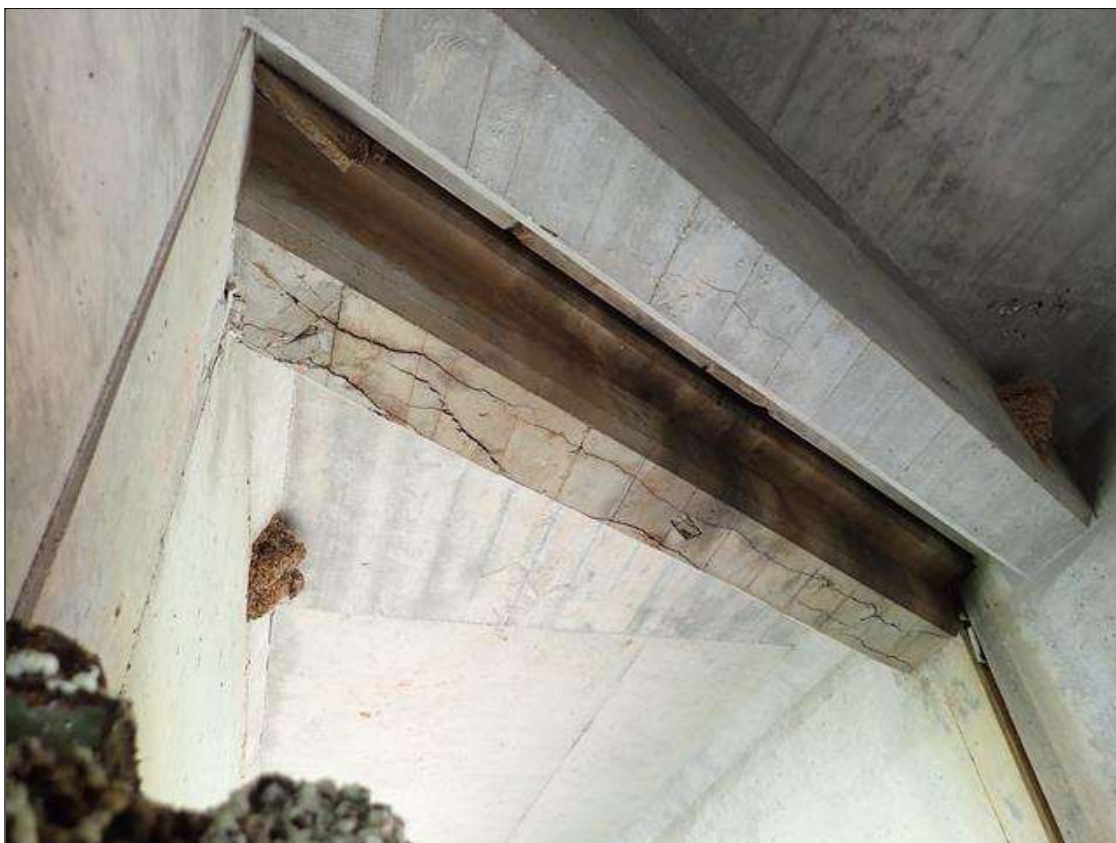
Span 2 Beam 2: at bents 1 and 2, bay 2 end diaphragm, delaminations (up to full length x full width) with cracks (up to 1/8 inch)

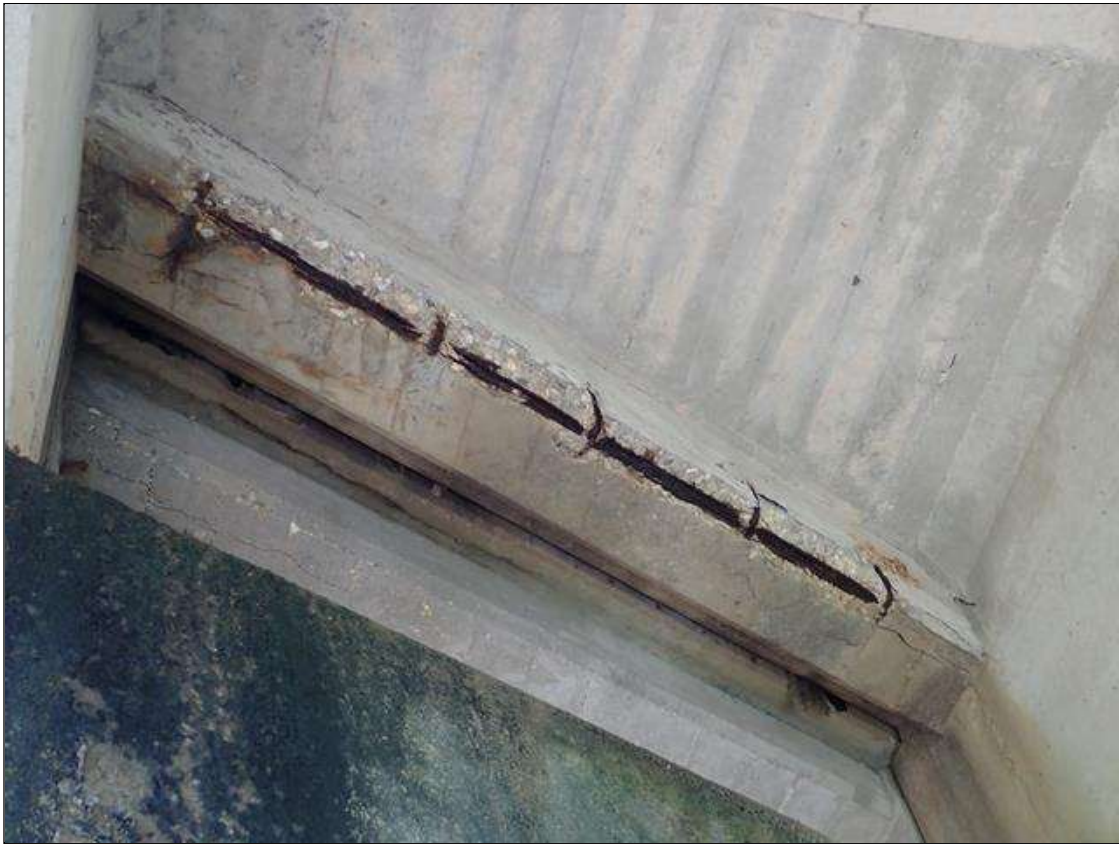
Span 2 Beam 3: (PAR) at bents 1 and 2, bay 3 end diaphragm, spalls/delaminations (up to full length x 8 inch x 1.5 deep) with exposed rusted rebar (approximately 25 percent loss)

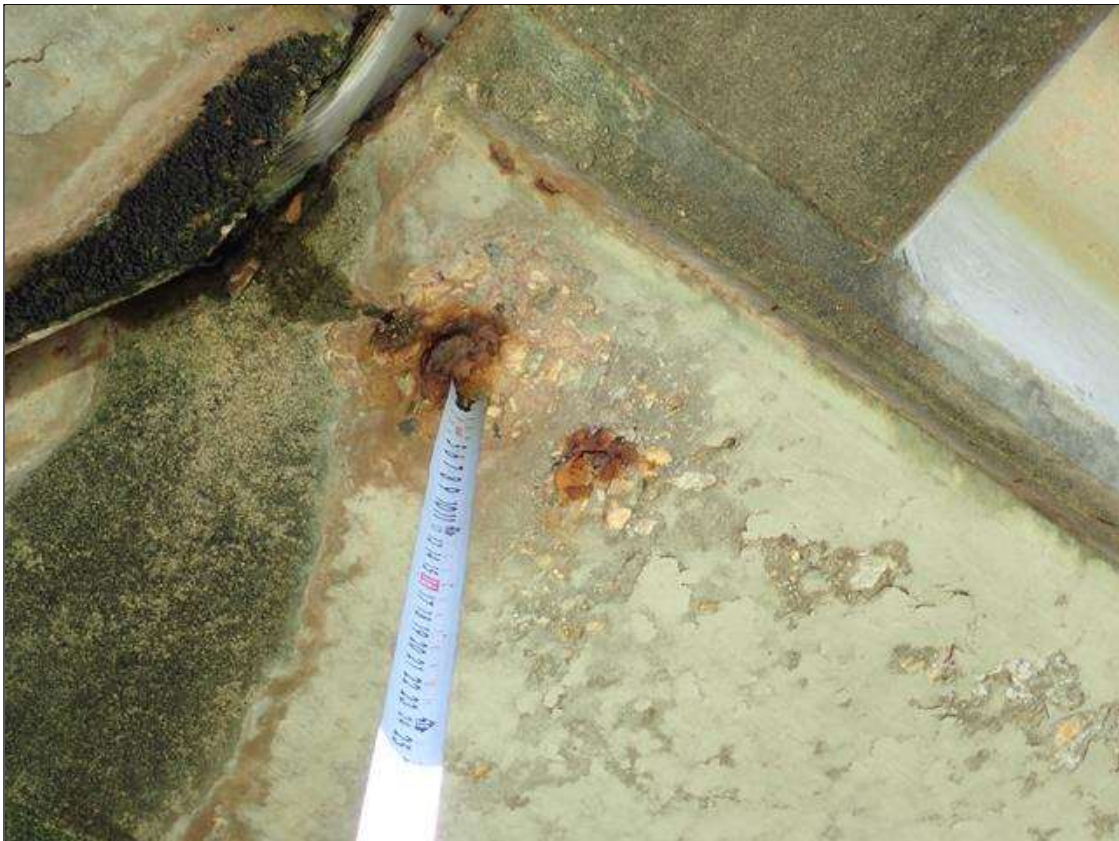
Span 2 Deck: (PAR) over bent 1, east overhang, spall (4 inch diameter x 1/2 inch deep) with exposed rusted rebar (approximately 25 percent loss)
