NC DEPARTMENT OF TRANSPORTATION
 DIVISION OF HIGHWAYS
 STRUCTURE MANAGEMENT UNIT

ATTENTION: **prompt action request; sketches updated; route sign attached to span 3 beam 1**

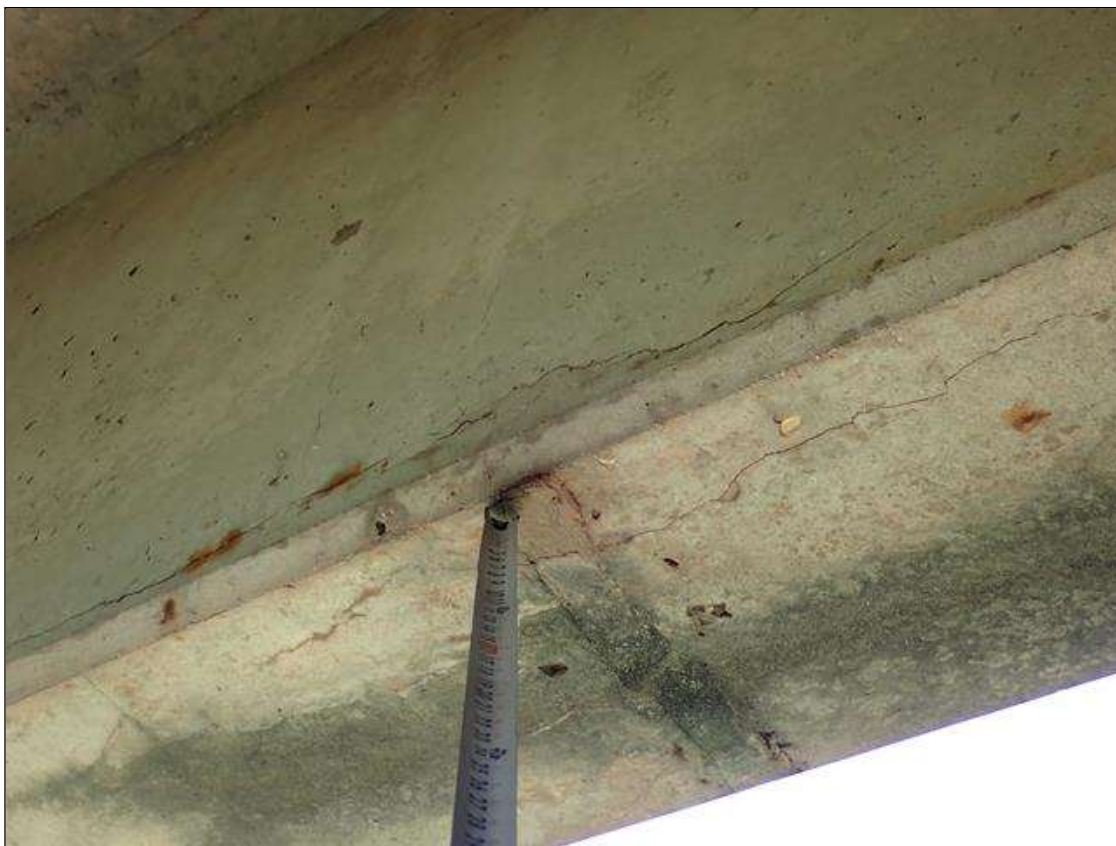
Span 2 Beam 4: (PAR) near bent 1, delamination (4 foot x 8 inch) and cracks (up to 1/16) with rust stains

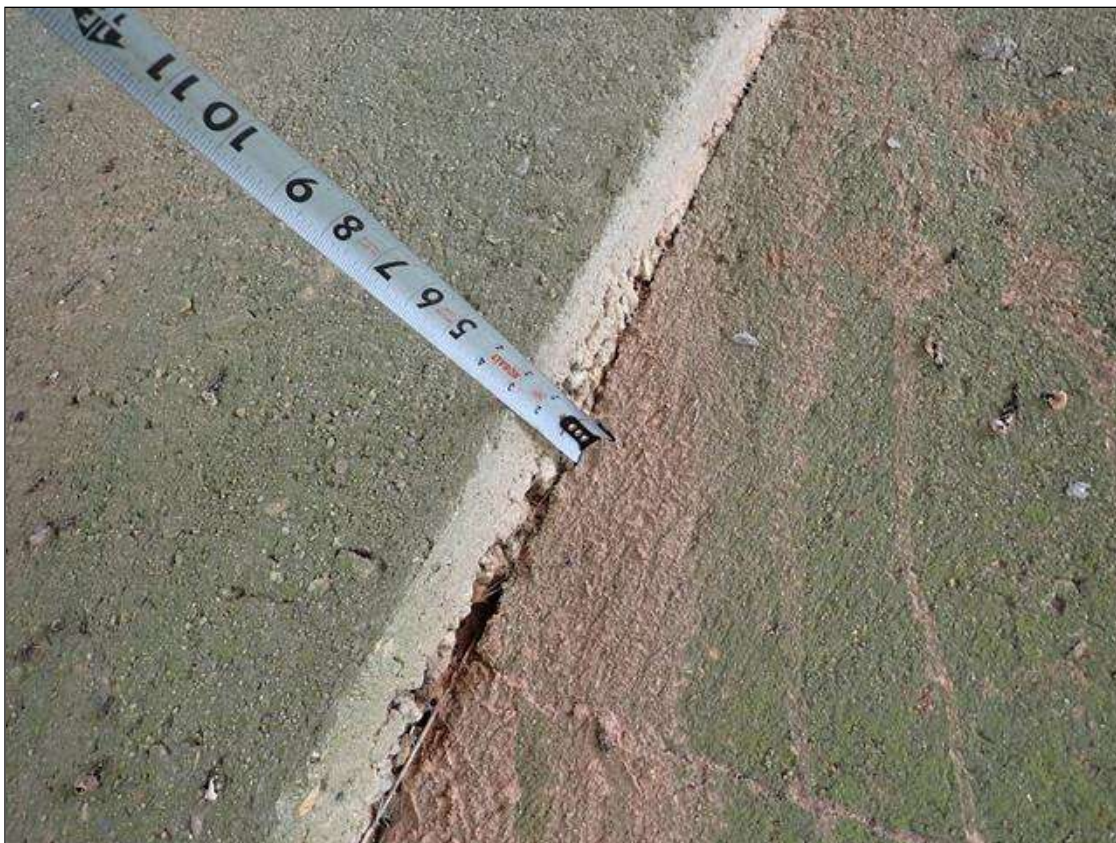
end bent 1 slope protection below bay 2, section misaligned/settled (up to 2 inch)

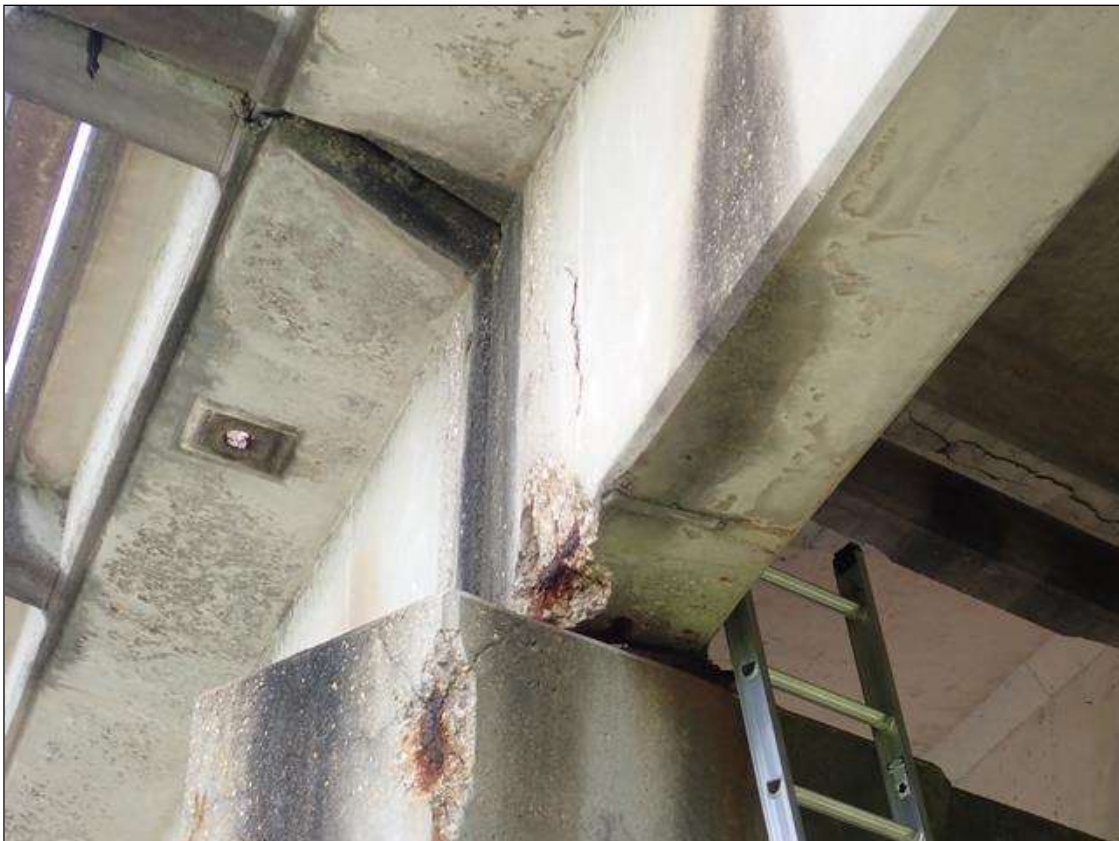
Span 2 Beam 1: (PAR) at bent 2, west face and underside, multiple spalls/delaminations (2 foot x 32 inch x 2.5 inch deep) with exposed rusted rebar (approximately 25 percent loss) and cracks (up to 1/8 inch)

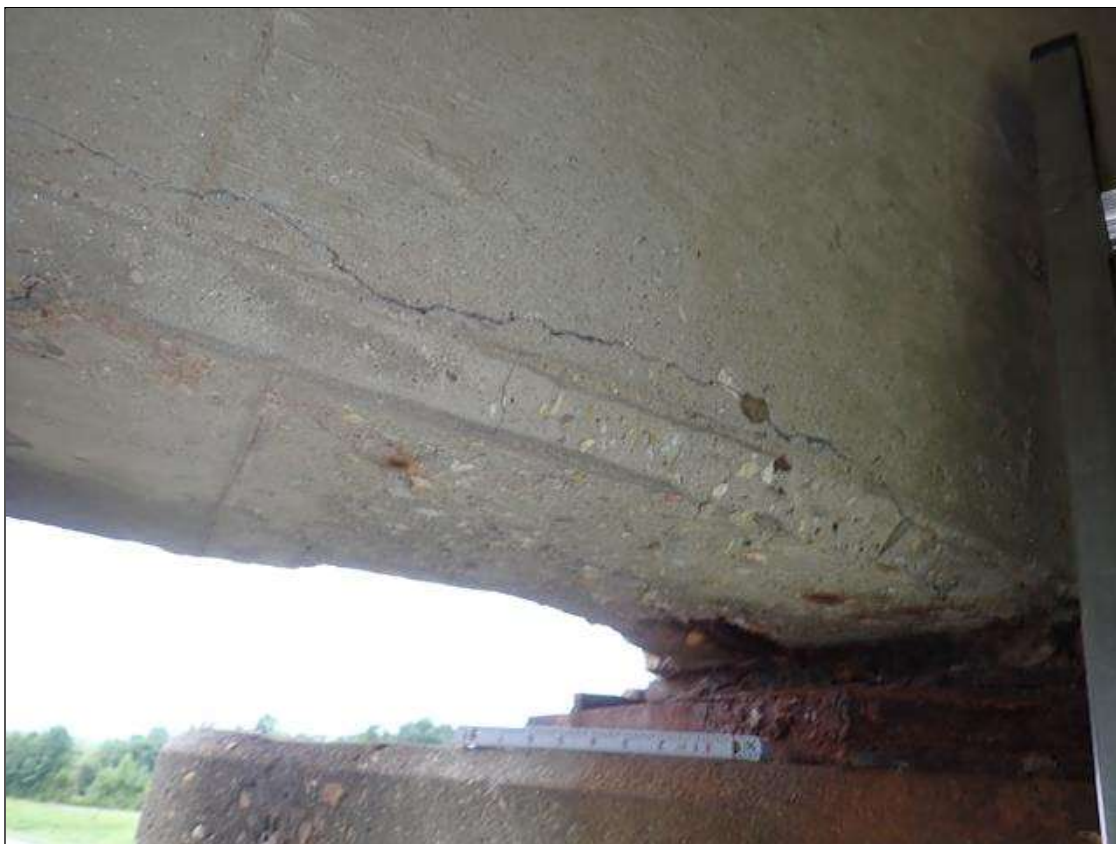
Span 2 Beam 1: (PAR) at bent 2, west face and underside, multiple spalls/delaminations (2 foot x 32 inch x 2.5 inch deep) with exposed rusted rebar (approximately 25 percent loss) and cracks (up to 1/8 inch)

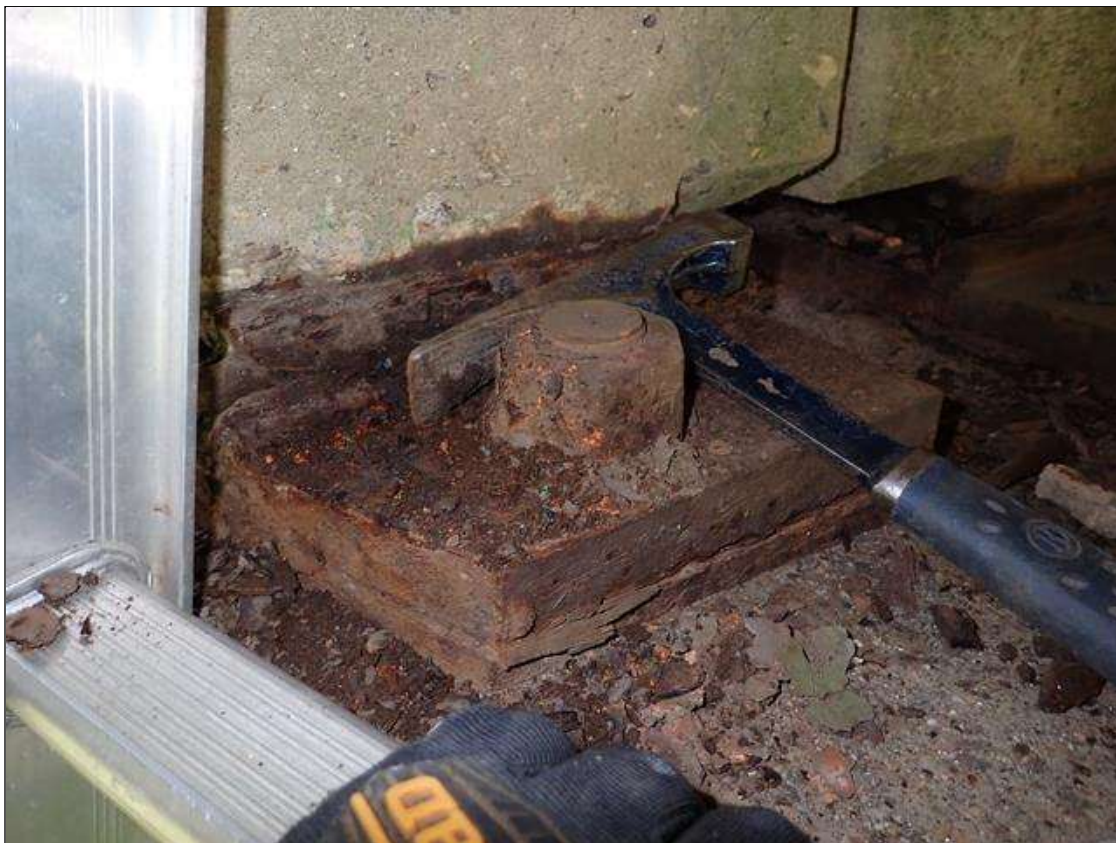
Span 2 Beam 1 - Far Bearing 1: corrosion with section loss [up to 1/8 inch loss]

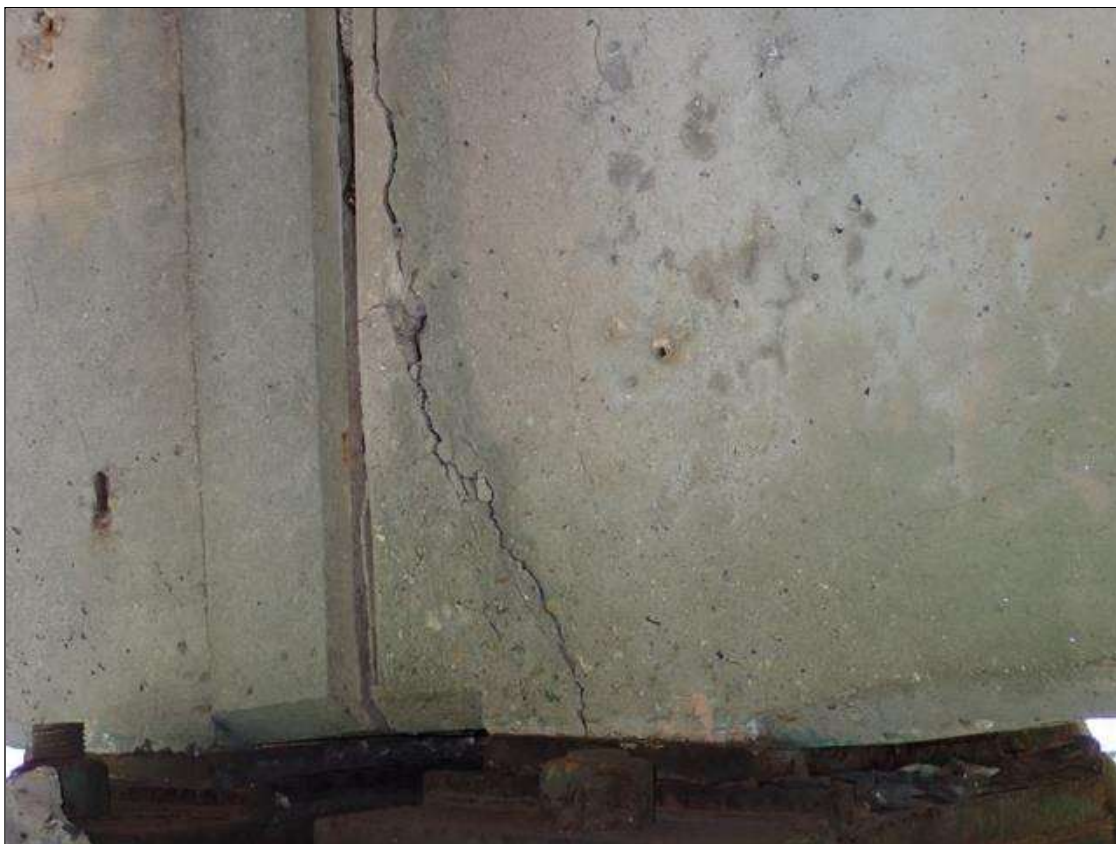
Span 2 Beam 2: West and east faces over bent 2, spalls/delaminations [up to 30 inch high x 7 inch wide x 3 inch deep] with cracks (up to 1/8 inch)

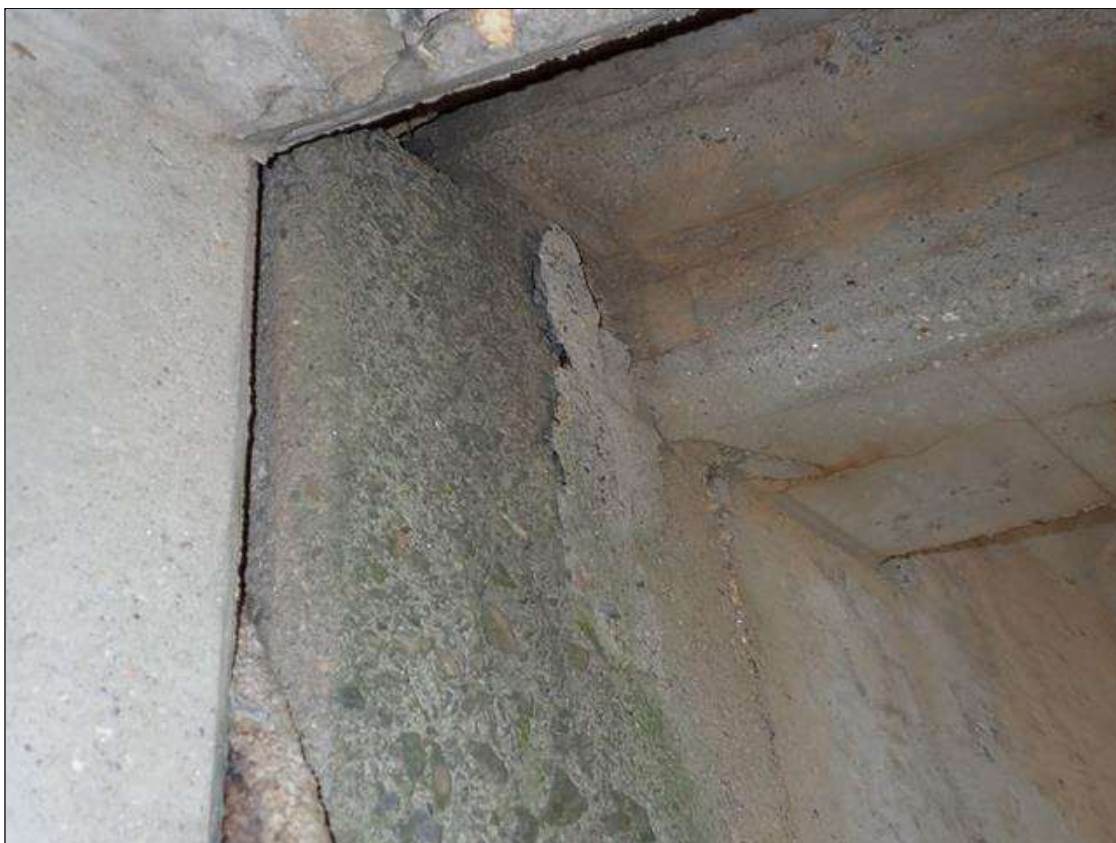
Span 3 Beam 1: at bent 2, east face at top, delamination (12 inch x 4 inch)

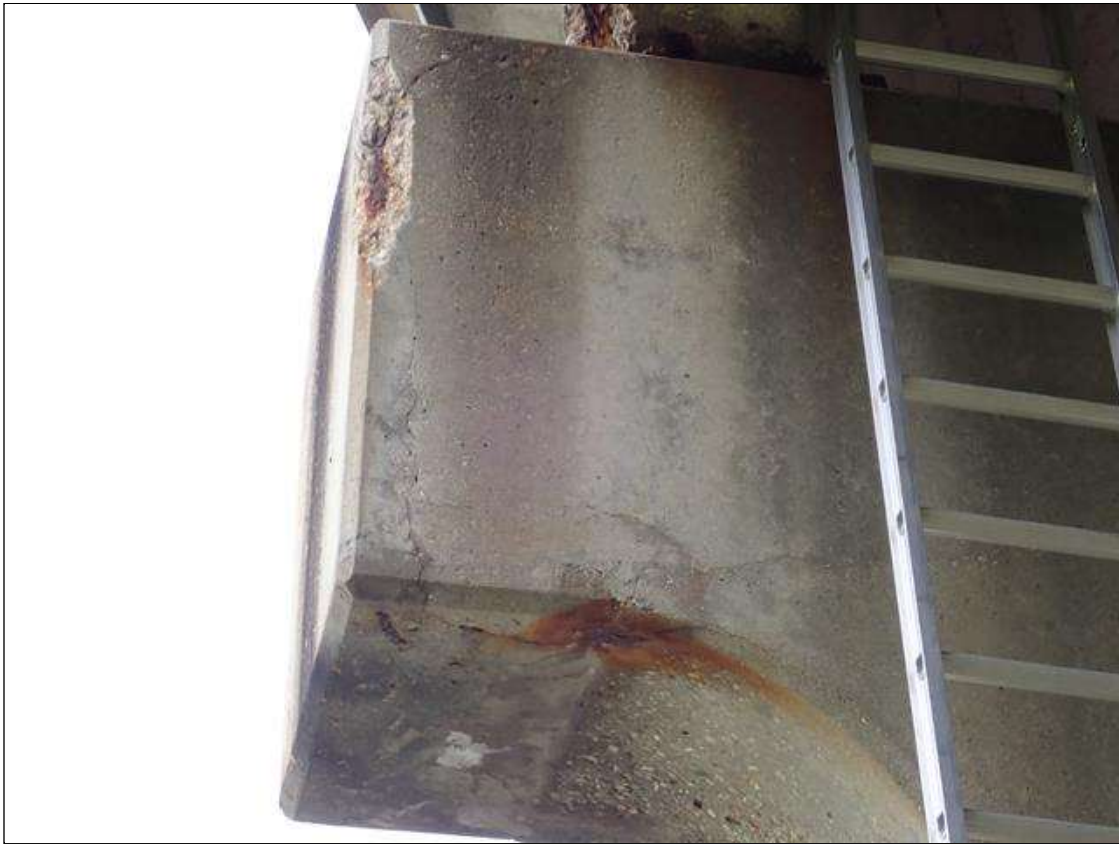
Bent 2 Cap 1: (PAR) southwest corner, spall/delamination (18 inch x 6 inch x 1 inch deep) with exposed rusted rebar and adjacent map cracks (up to 1/32 inch) with rust stains

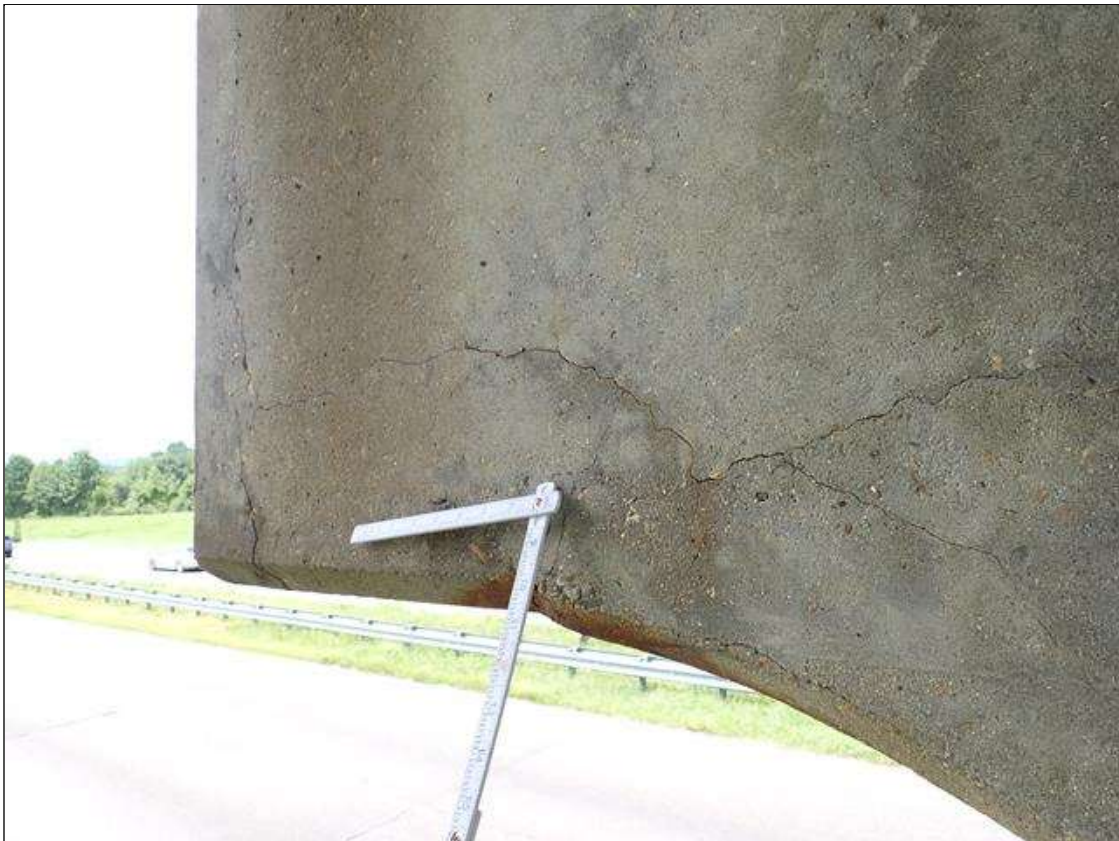
Bent 2 Cap 1: (PAR) southwest corner, spall/delamination (18 inch x 6 inch x 1 inch deep) with exposed rusted rebar and adjacent map cracks (up to 1/32 inch) with rust stains

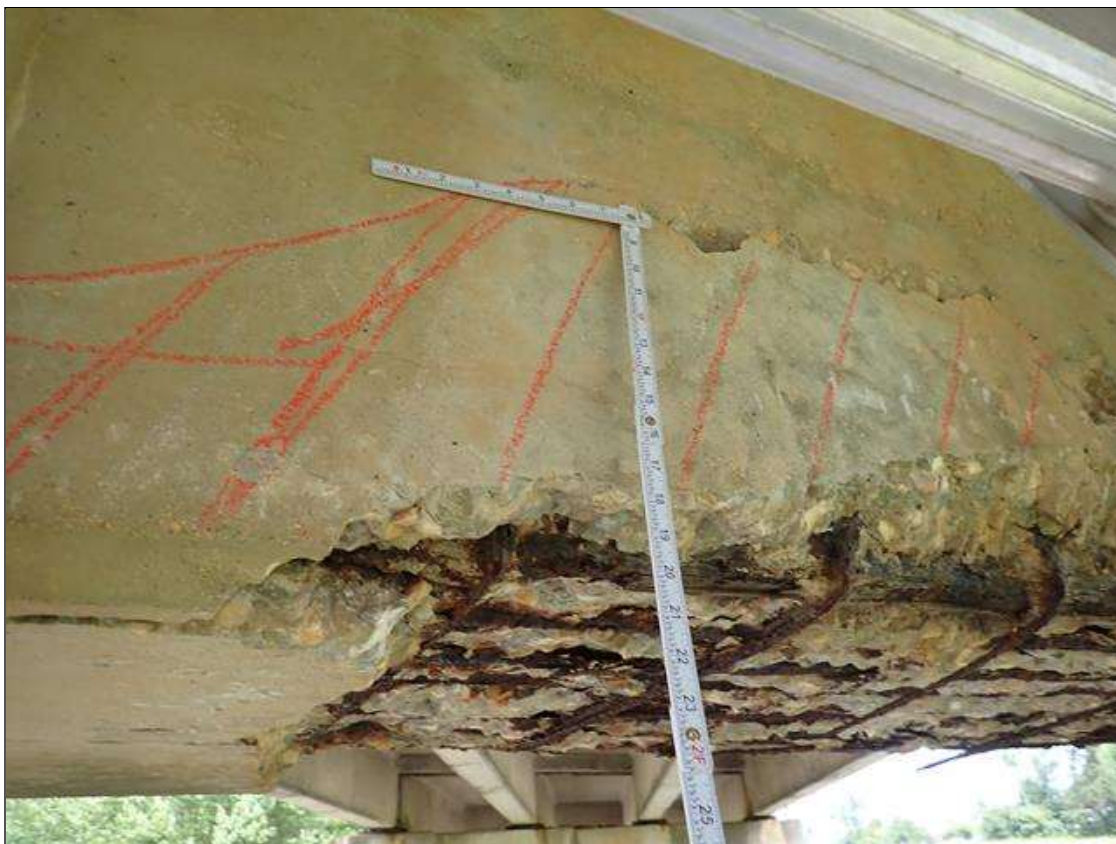
Bent 2 Cap 1: (PAR) underside of cap between columns, spall/delamination [14 foot long x full width x up to 4 inch deep] that extends onto south face [13 inch] with exposed rusted rebar and stirrups [rebars with approximately 25 percent loss; stirrups up to 100 percent loss]

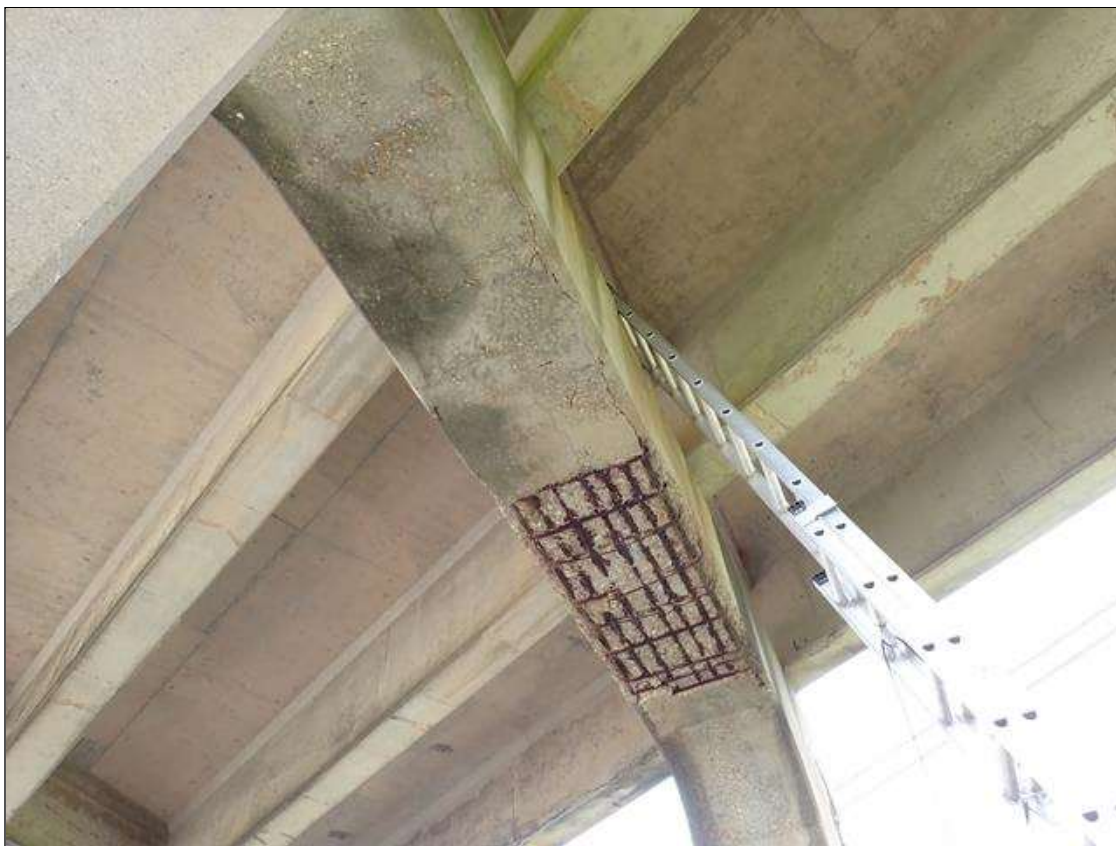
Bent 2 Cap 1: (PAR) underside of cap between columns, spall/delamination [14 foot long x full width x up to 4 inch deep] that extends onto south face [13 inch] with exposed rusted rebar and stirrups [rebars with approximately 25 percent loss; stirrups up to 100 percent loss]

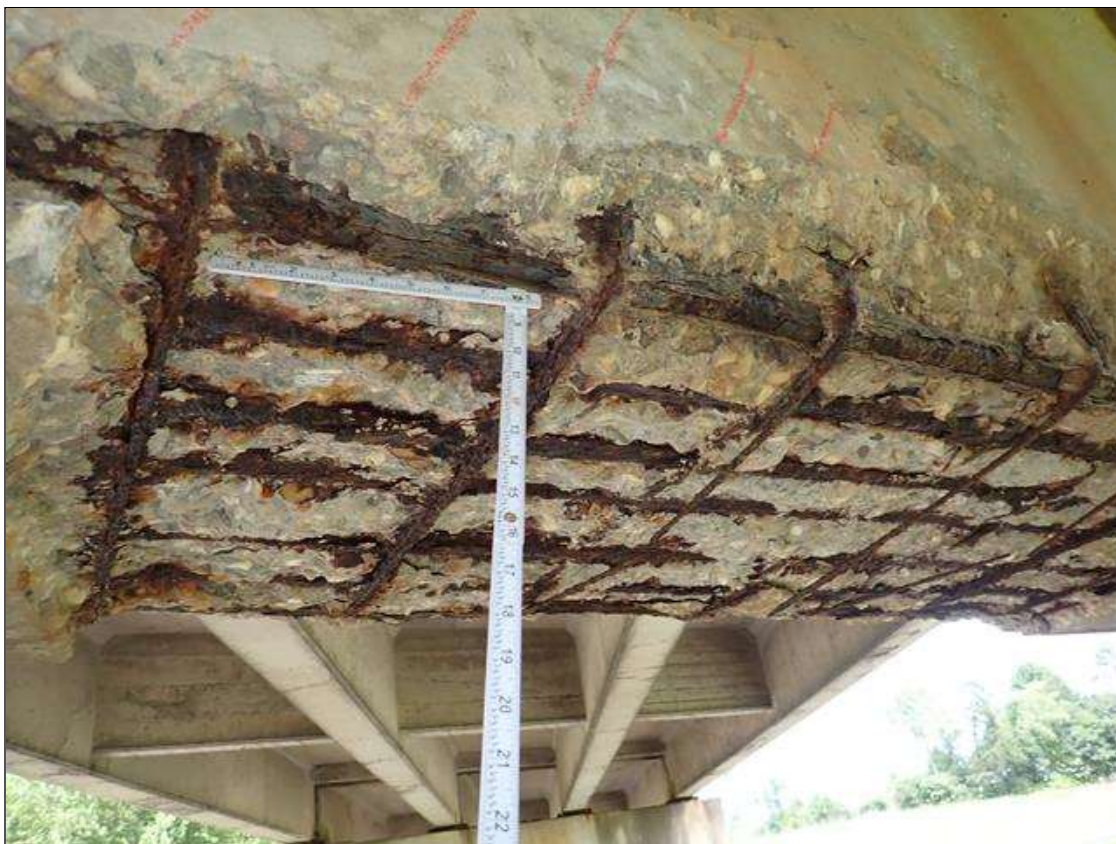
Bent 2 Cap 1: (PAR) underside of cap between columns, spall/delamination [14 foot long x full width x up to 4 inch deep] that extends onto south face [13 inch] with exposed rusted rebar and stirrups [rebars with approximately 25 percent loss; stirrups up to 100 percent loss]

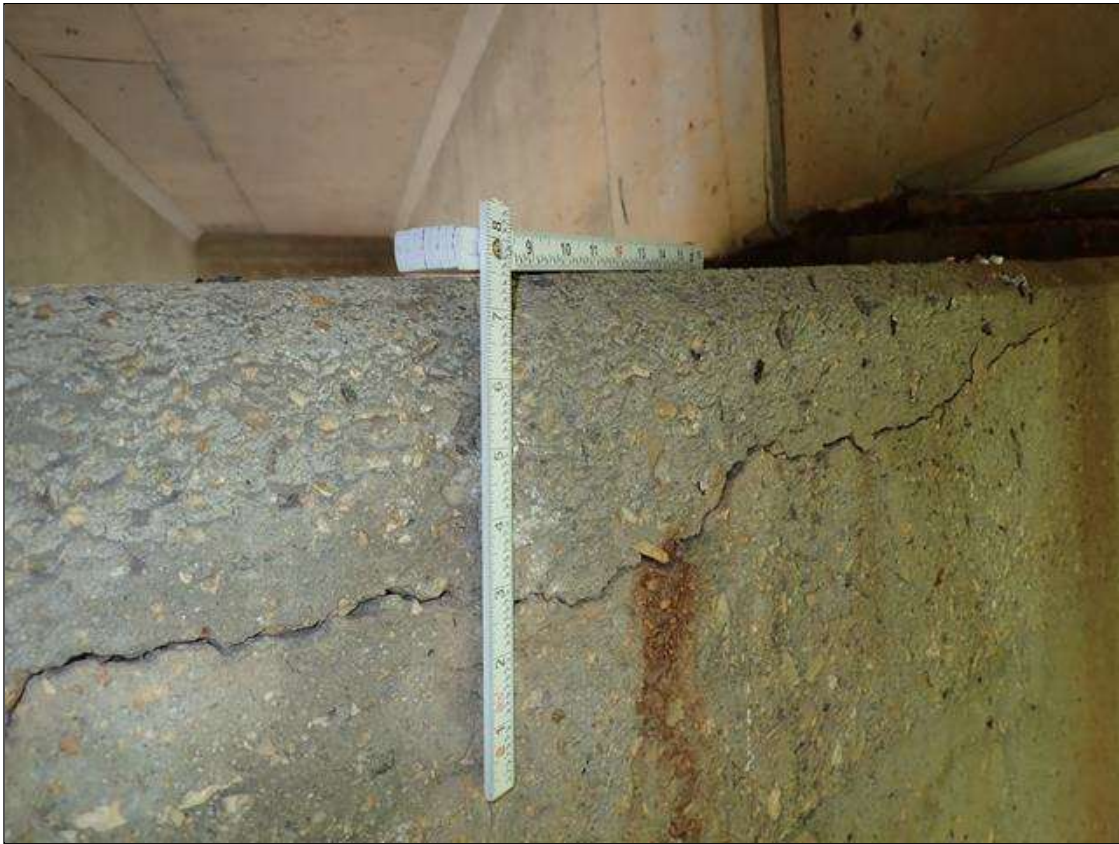
Bent 2 Cap 1: (PAR) (2)- UP TO 10 FOOT X 1/16 INCH HORIZONTAL CRACKS WITH RUST STAINS, SOUTH FACE, UNDER BAYS 2 AND 3.

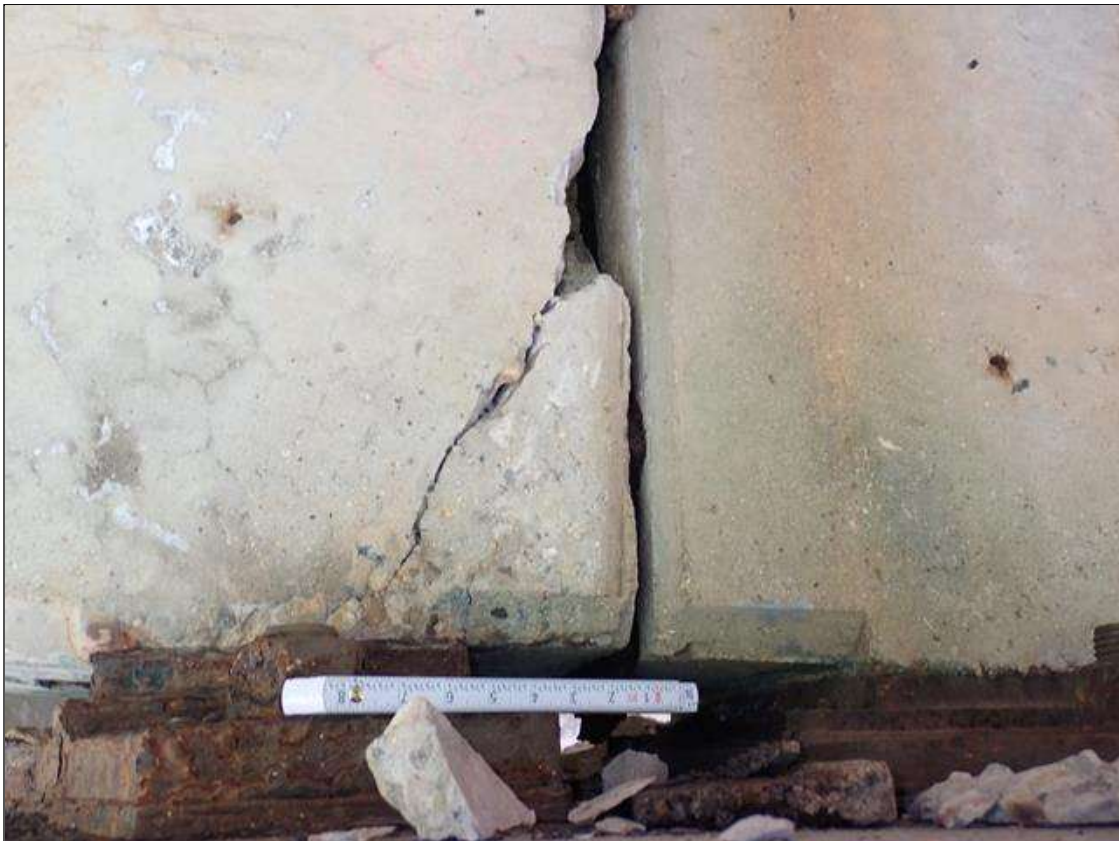
Span 2 Beam 2: West and east faces over bent 2, spalls/delaminations [up to 30 inch high x 7 inch wide x 3 inch deep] with cracks (up to 1/8 inch)

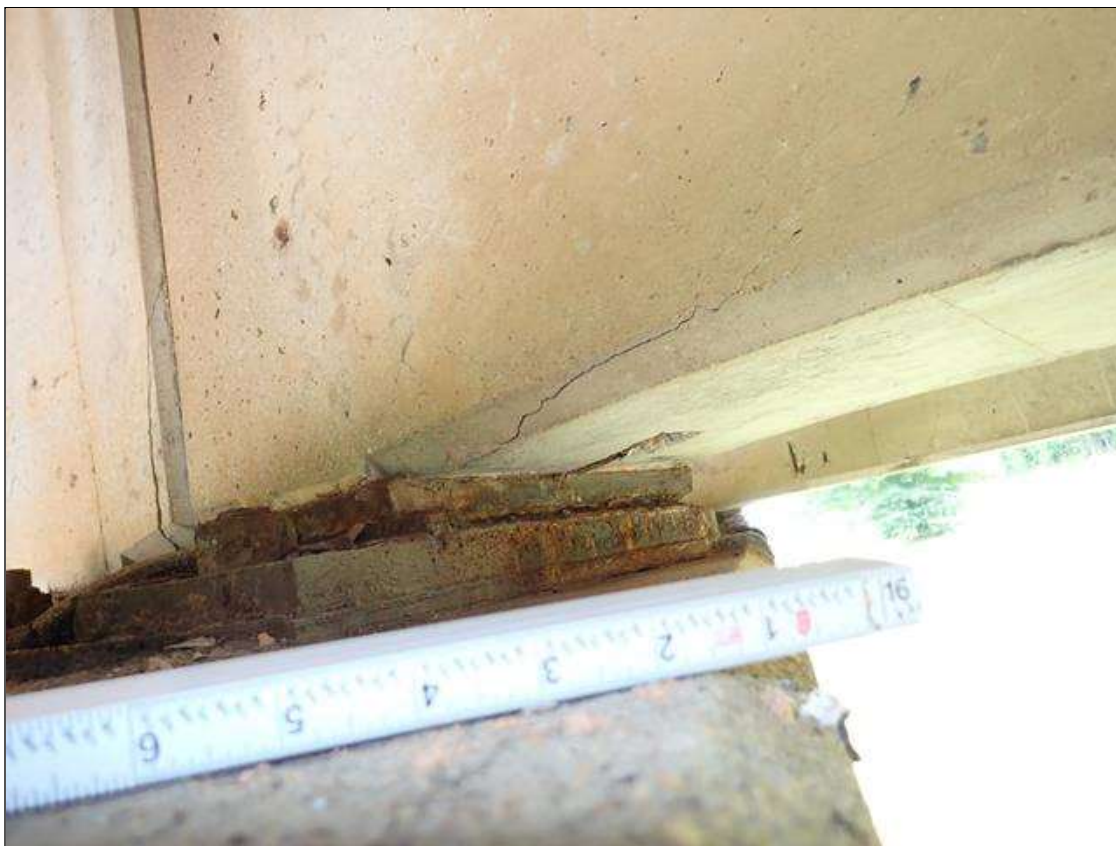
Span 2 Beam 3: at bent 2, underside, (2) spalls/delaminations (up to 1 foot x 6 inch x 1/2 inch deep) with exposed rusted rebar

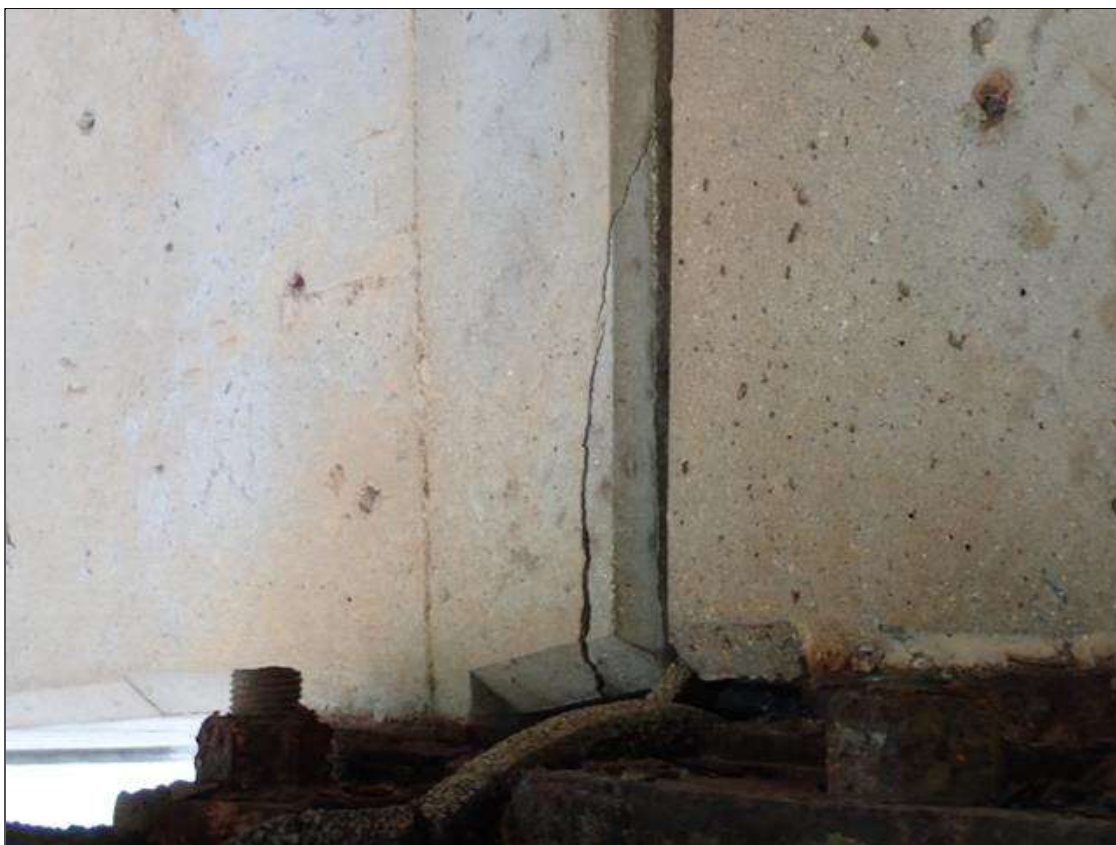
Span 3 Beam 3: at bent 2, west face, delamination (2 inch x 1 foot) with cracks (up to 1/8 inch)

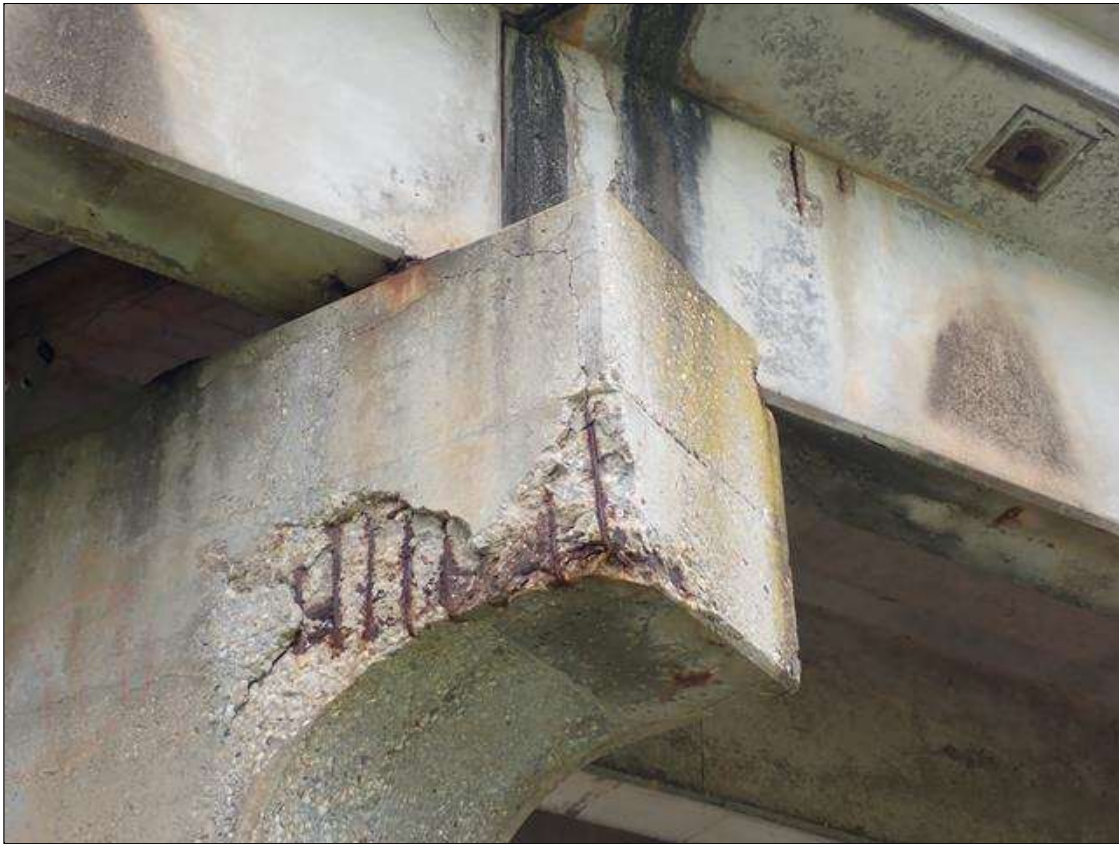
Bent 2 Cap 1: (PAR) South face at East end, spall/delamination [84 inch long x up to full height x up to 3 inch deep] with exposed rusted rebar and stirrups [rebar and stirrups with approximately 25 percent loss] and cracks [up to 1/8 inch]

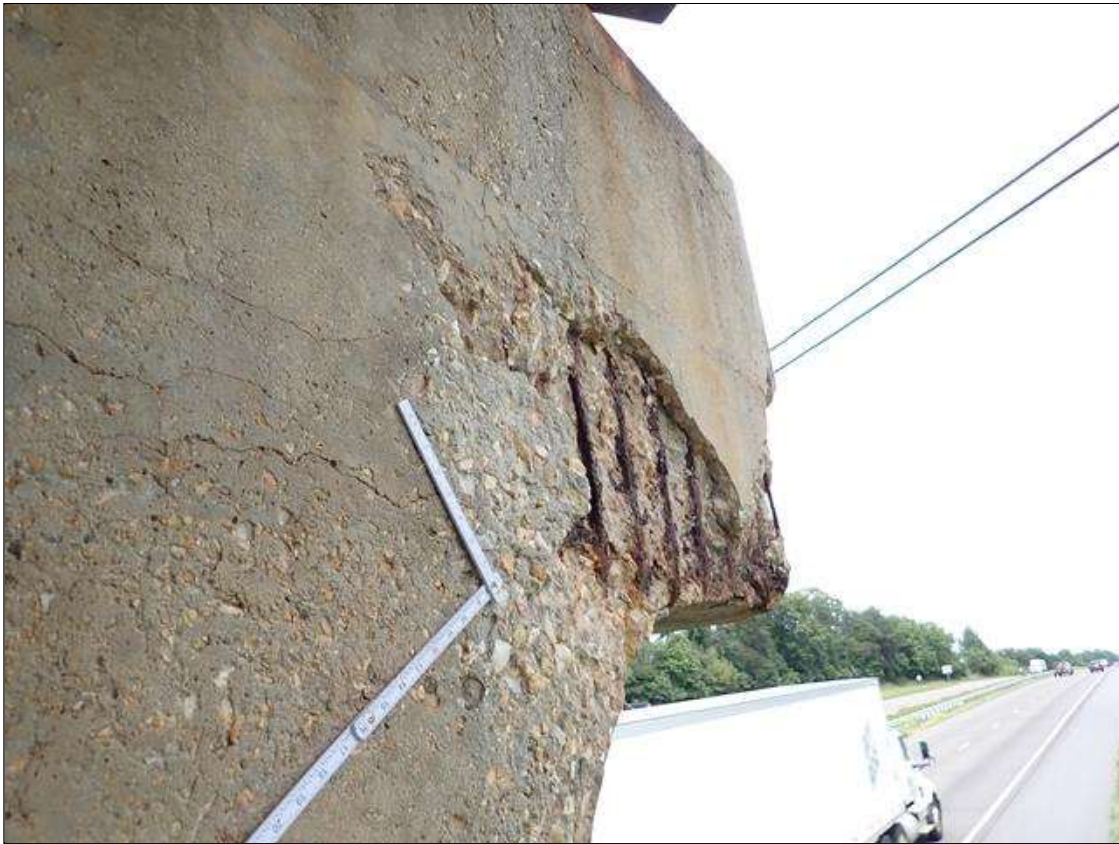
Bent 2 Cap 1: (PAR) South face at East end, spall/delamination [84 inch long x up to full height x up to 3 inch deep] with exposed rusted rebar and stirrups [rebar and stirrups with approximately 25 percent loss] and cracks [up to 1/8 inch]

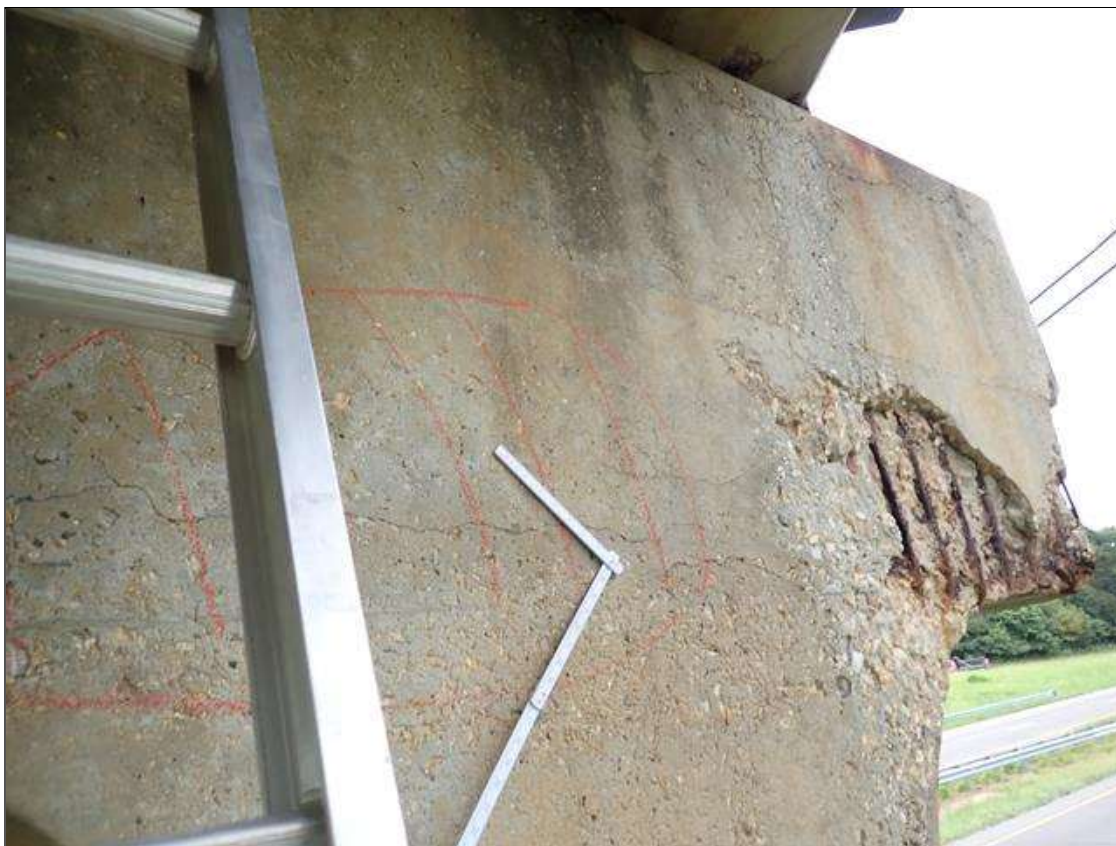
Bent 2 Cap 1: (PAR) South face at East end, spall/delamination [84 inch long x up to full height x up to 3 inch deep] with exposed rusted rebar and stirrups [rebar and stirrups with approximately 25 percent loss] and cracks [up to 1/8 inch]

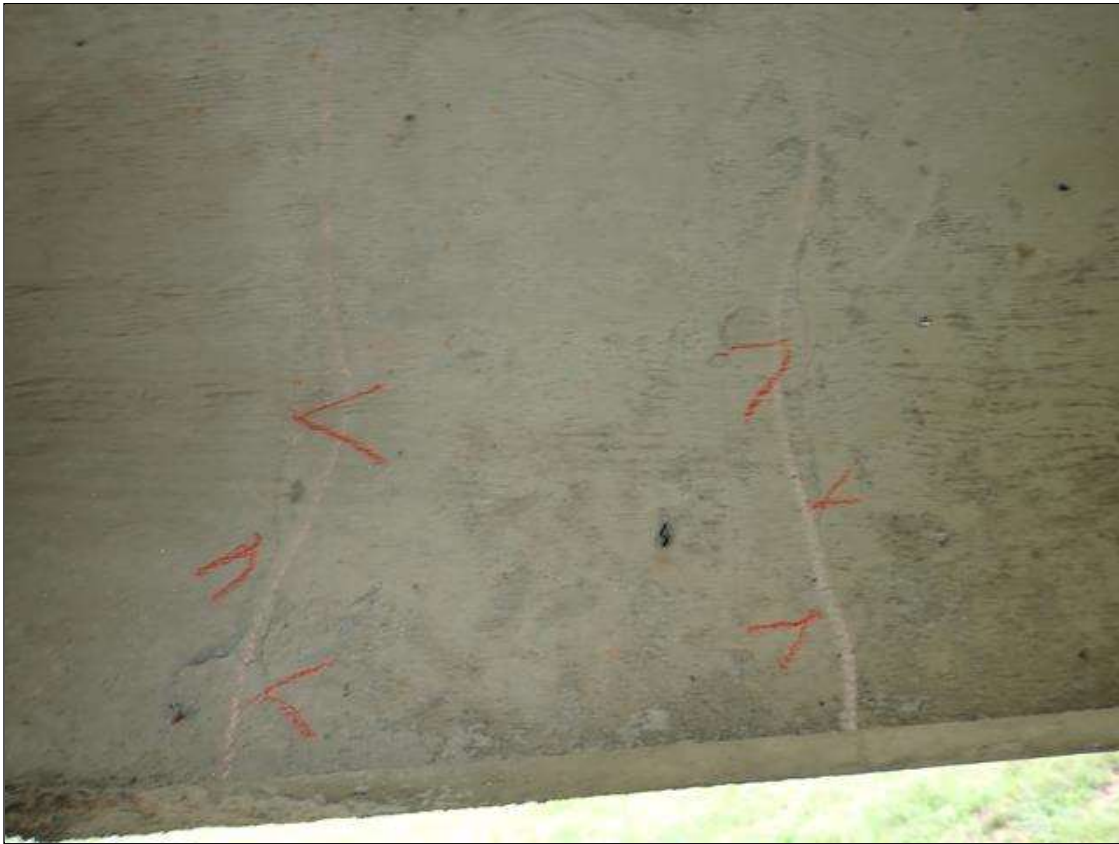
Span 2 Beam 4: TRANSVERSE AND WRAPAROUND CRACKS UP TO 1/64 INCH, AT RANDOM THROUGHOUT.

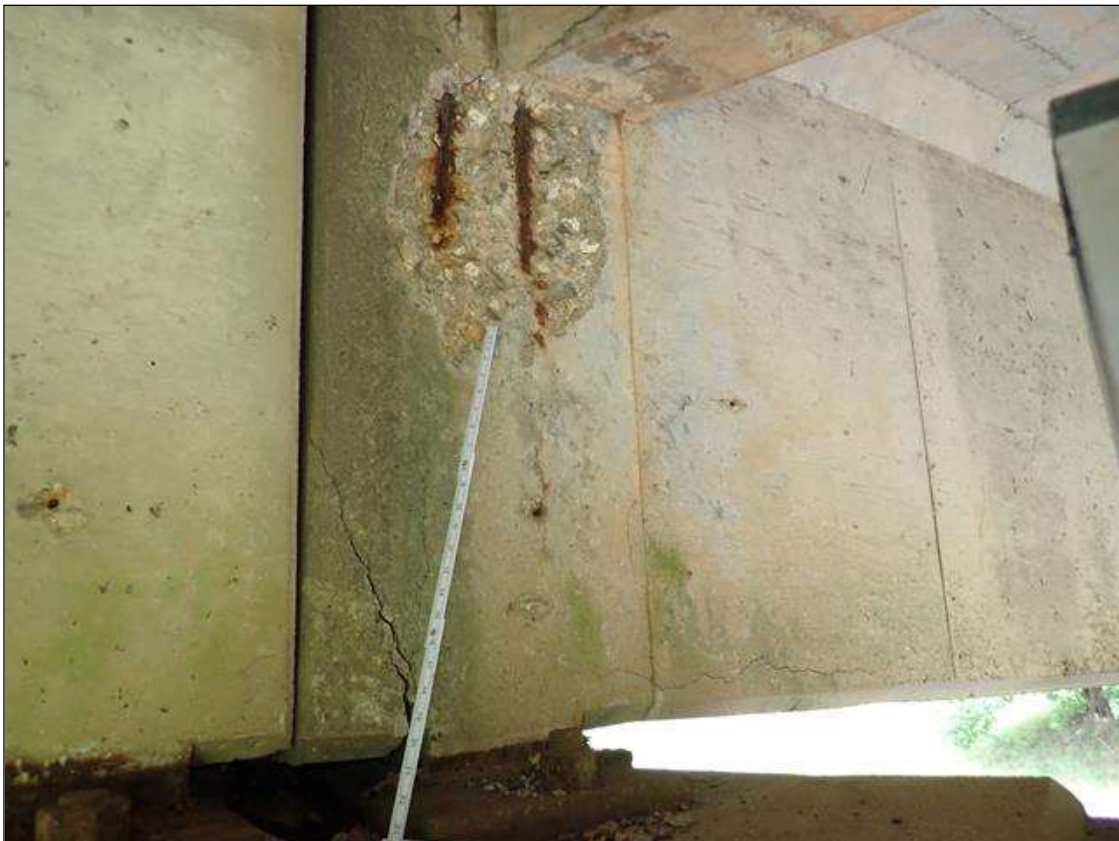
Span 3 Beam 3: (PAR) East face over bent 2, (3) spalls/delaminations [up to 17 inch long x 24 inch high x up to 2 inch deep] with exposed rusted rebar [approximately 25 percent loss] and cracks [up to 1/16 inch]

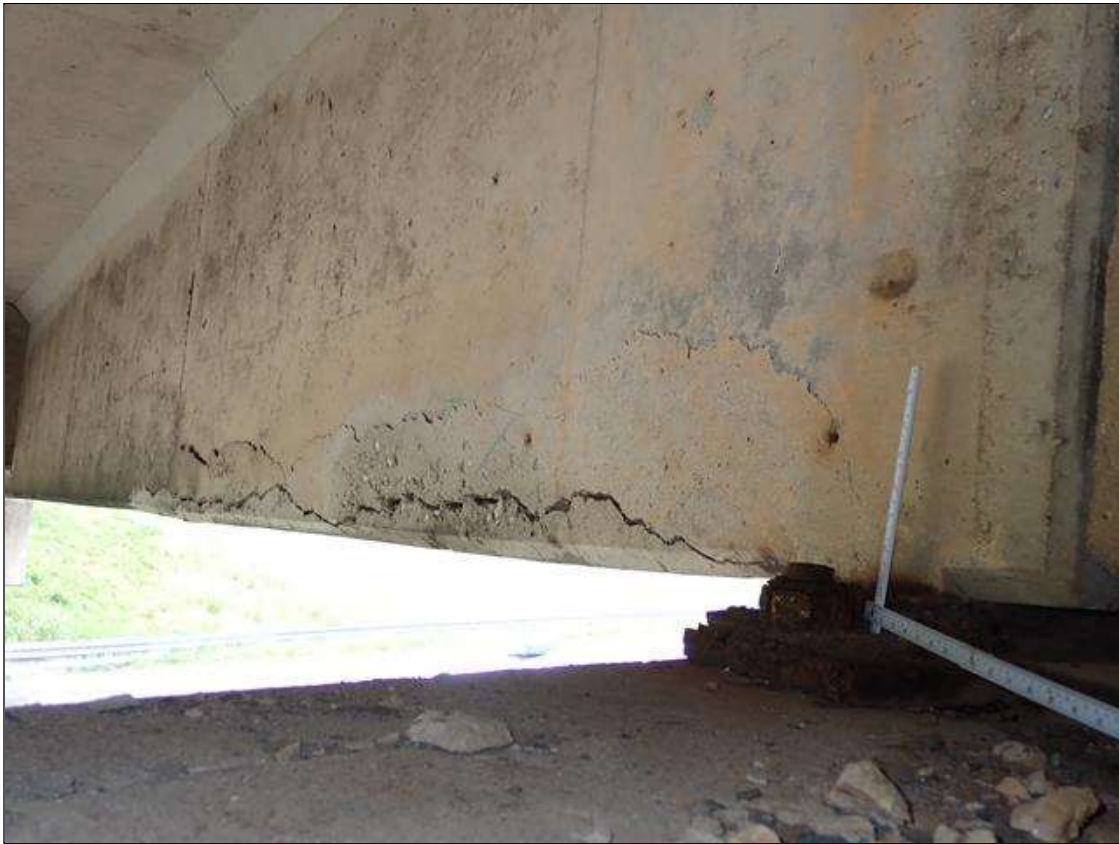
Span 3 Beam 4: (PAR) West face at near end, delamination [11 foot long x up to 9 inch high] with associated 1/2 inch crack, delamination extends to right Eastbound lane of I-40 below

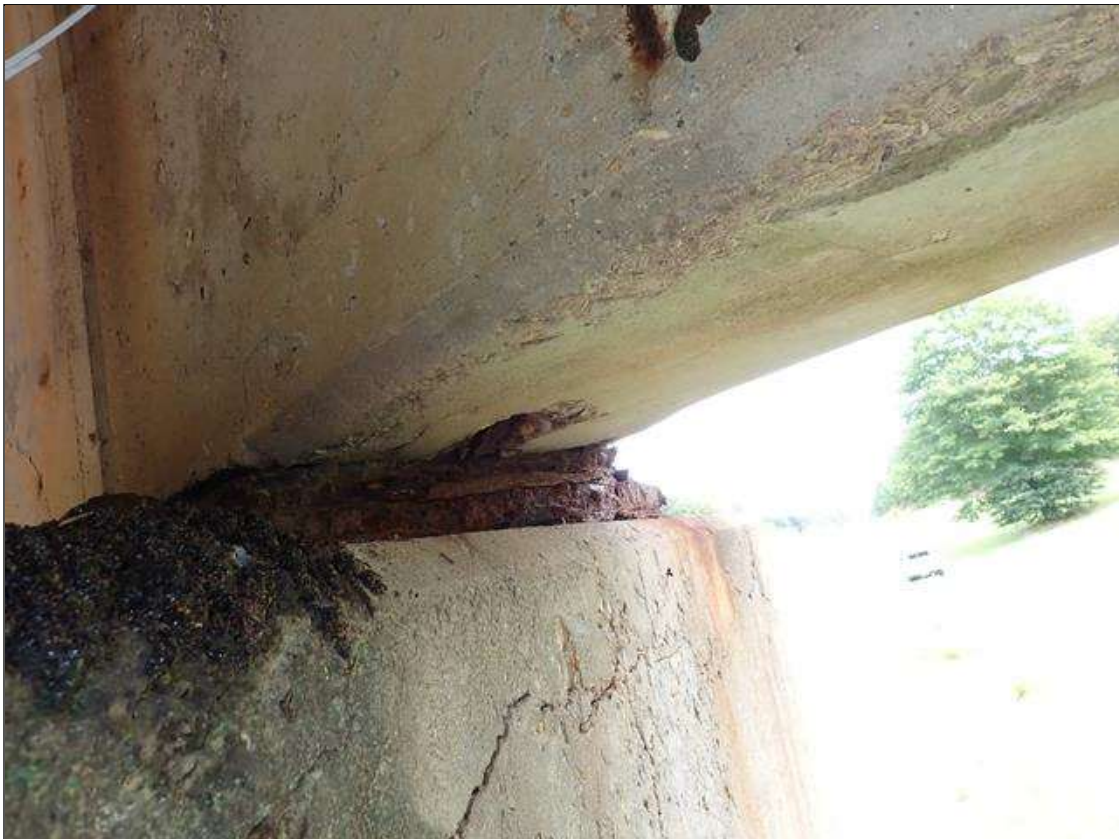
Span 2 Beam 4: (PAR) at bent 2, west and east faces and underside, multiple spalls/delaminations (up to 18 inch x 8 inch x 1 inch deep) with exposed rusted rebar (approximately 25 percent loss)
