NC DEPARTMENT OF TRANSPORTATION
 DIVISION OF HIGHWAYS
 STRUCTURE MANAGEMENT UNIT

ATTENTION: **prompt action request; sketches updated; route sign attached to span 3 beam 1**

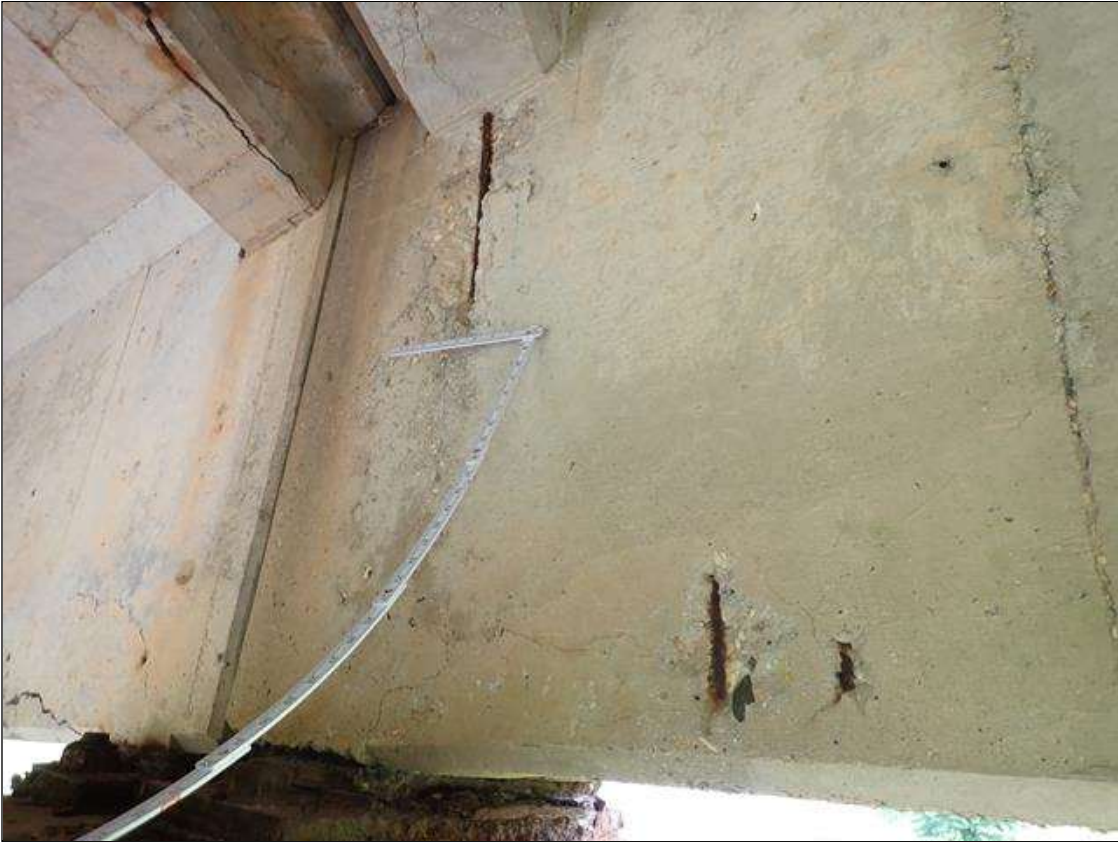
Span 2 Beam 4: (PAR) at bent 2, west and east faces and underside, multiple spalls/delaminations (up to 18 inch x 8 inch x 1 inch deep) with exposed rusted rebar (approximately 25 percent loss)

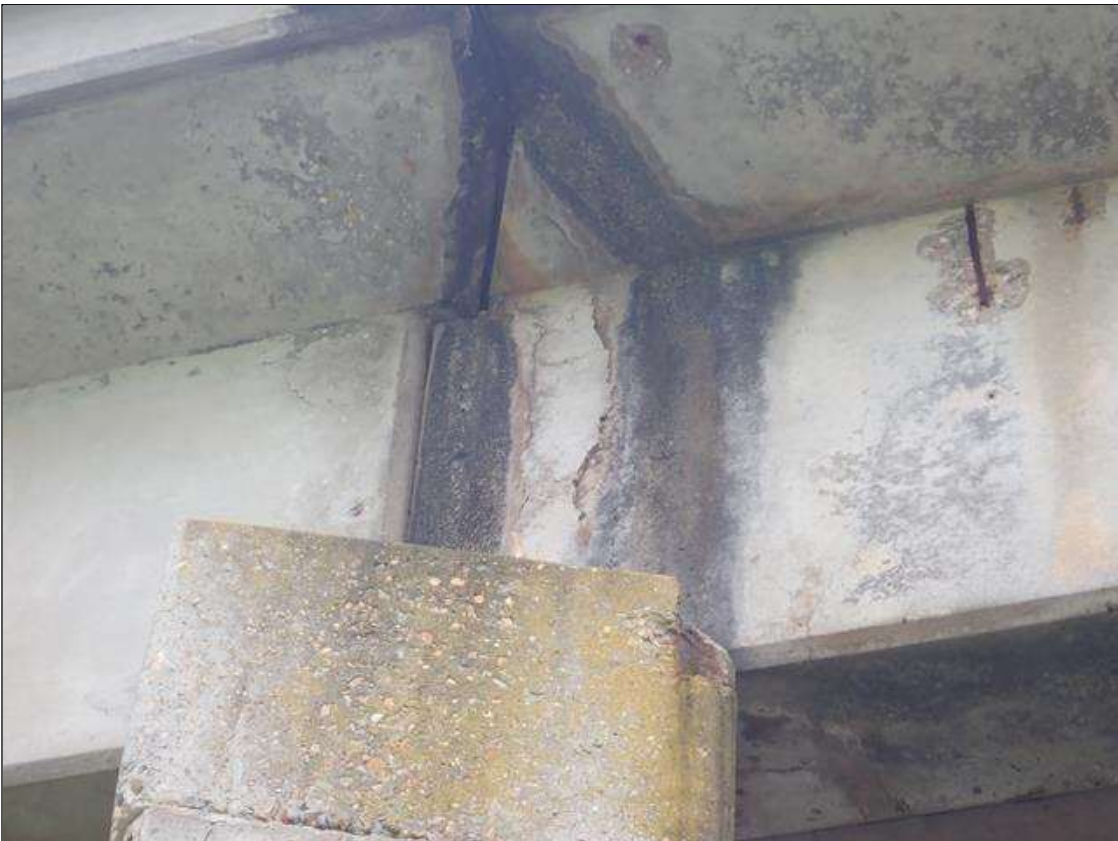
Span 3 Beam 4: EAST FACE OVER BENT 2. HAS A SPALL WITH ADJACENT DELAMINATED AREA 7 INCH FROM END OF BEAM. AREA IS: 10 INCH X 30 INCH X 1/2 INCH DEEP.

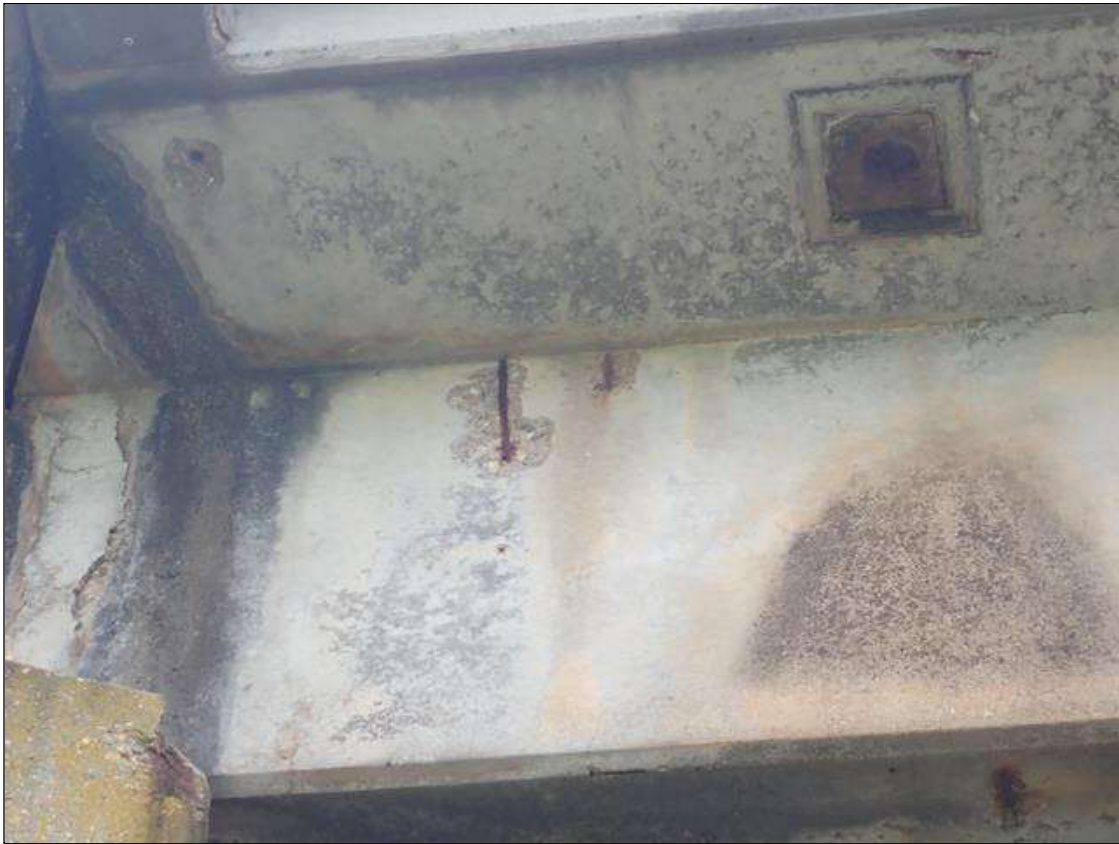
Span 3 Beam 4: EAST FACE. HAS (2) AREAS THAT ARE SPALLED WITH REBAR EXPOSED. LOCATED 38 INCH FROM END OF BEAM OVER BENT 2. AREAS ARE: UP TO 8 INCH X 14 INCH X 3/4 INCH DEEP.

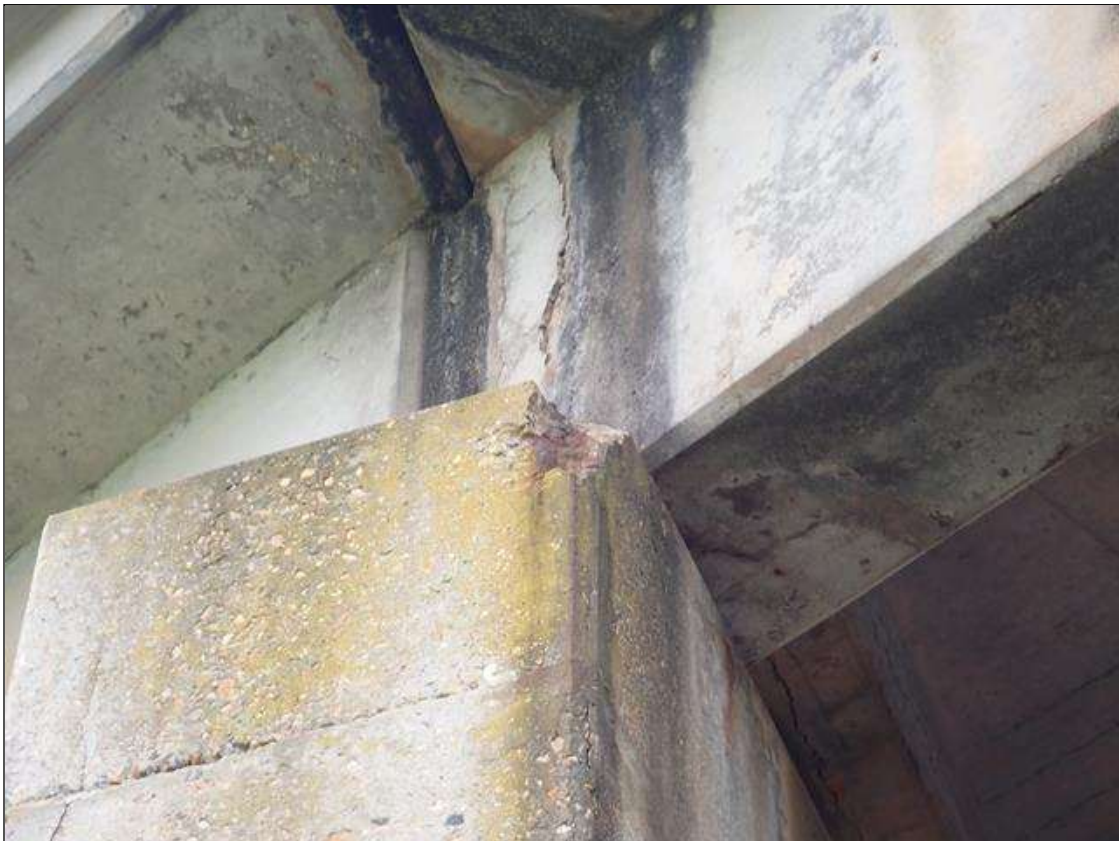
Bent 2 Cap 1: 9 INCH X 12 INCH X 2 INCH DEEP SPALL WITH EXPOSED REINFORCING ON NORTHEAST CORNER, NO LOSS NOTED ON REBAR

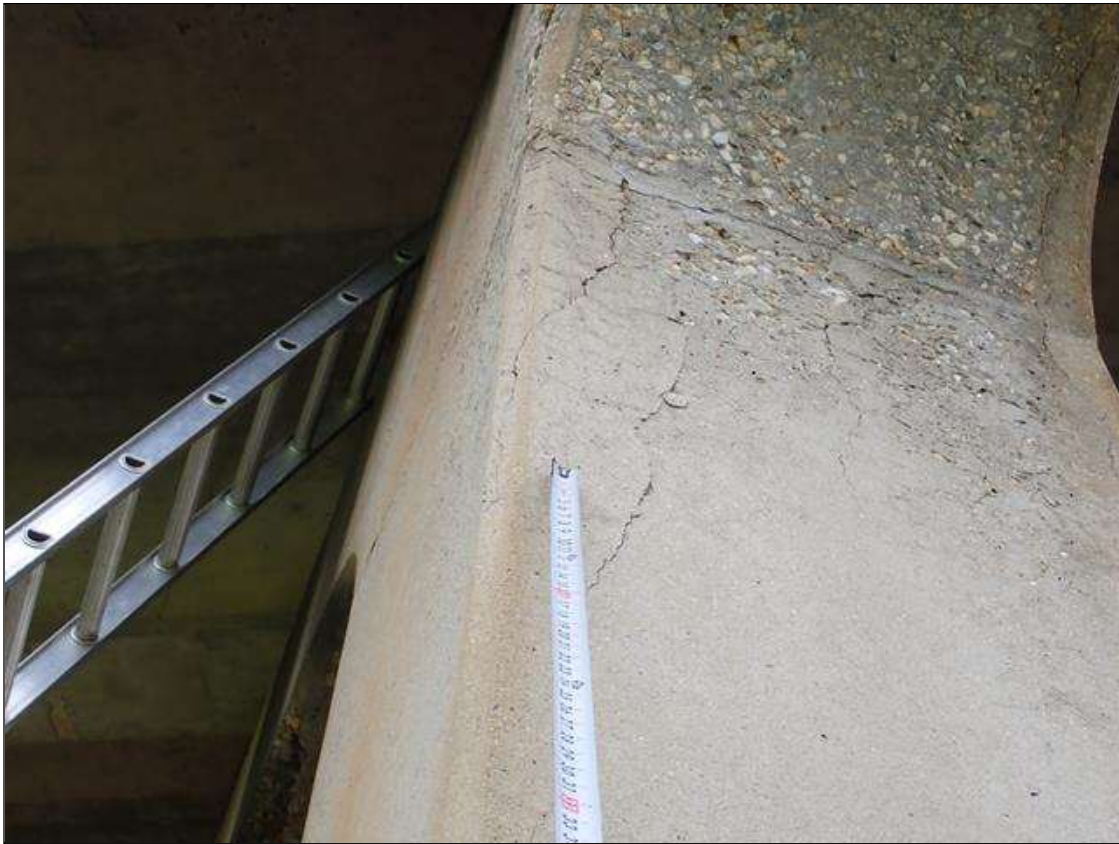
Bent 2 Pile 2: Southeast corner at corbel, delamination [54 inch x 20 inch] with cracks [up to 1/16 inch]

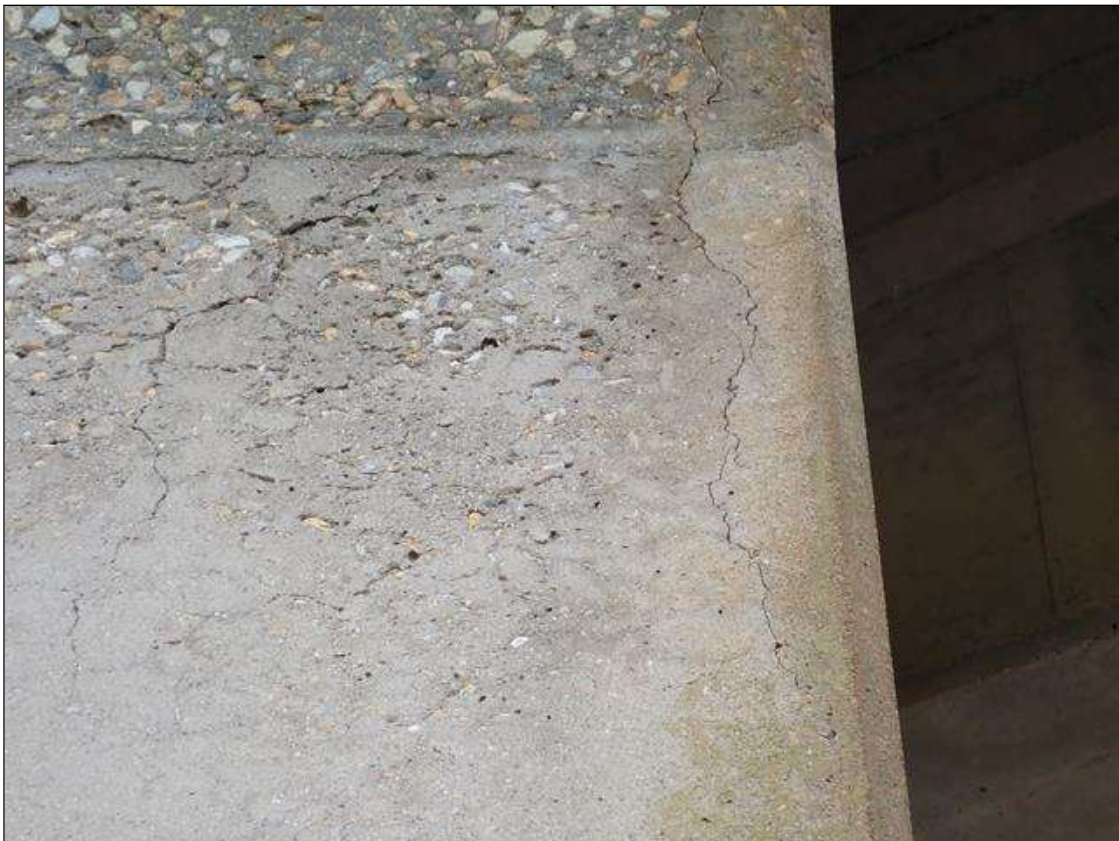
Bent 2 Pile 2: UP TO 5 FOOT X UP TO 1/16 INCH VERTICAL CRACKS, AT RANDOM THROUGHOUT, BEGINNING AT BOTTOM OF CAP.

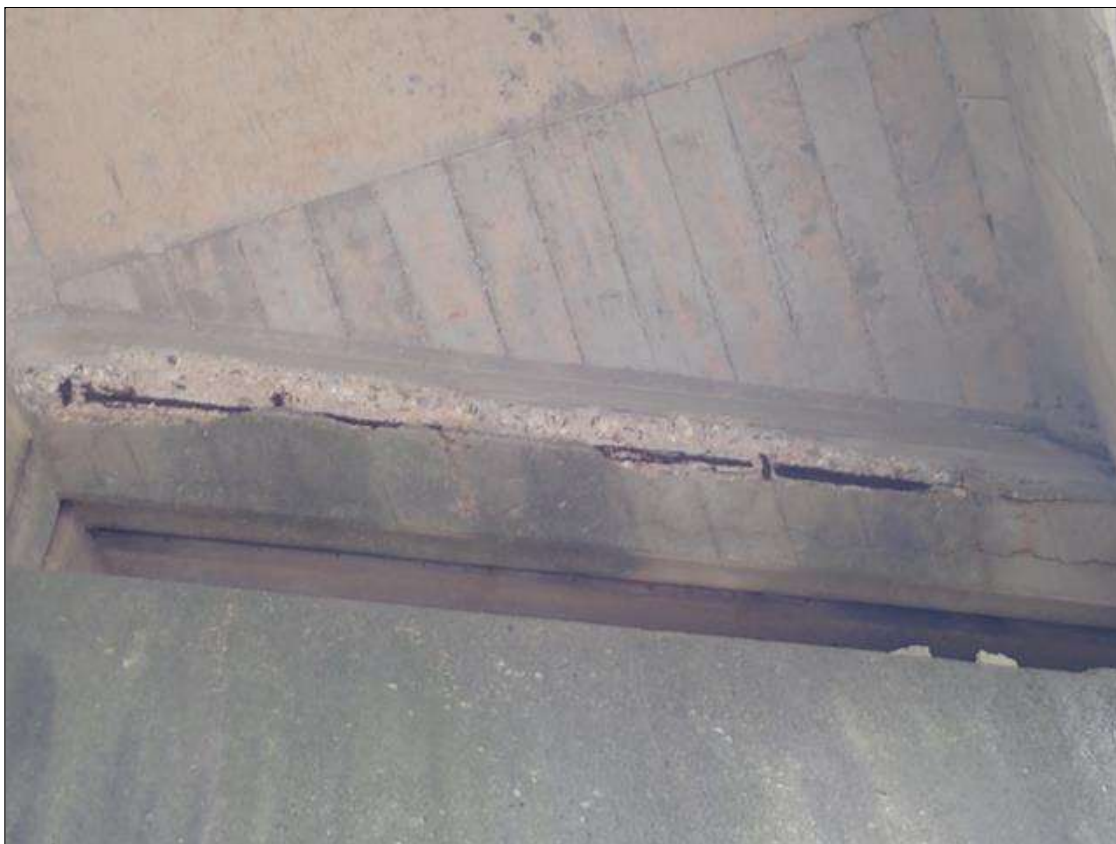
Span 3 Beam 1: (PAR) at bents 2 and 3, bay 1 end diaphragms, spalls/delaminations (up to full length x full height x up to 1.5 inch deep) with exposed rusted rebar (approximately 25 percent loss) and cracks (up to 1/8 inch)

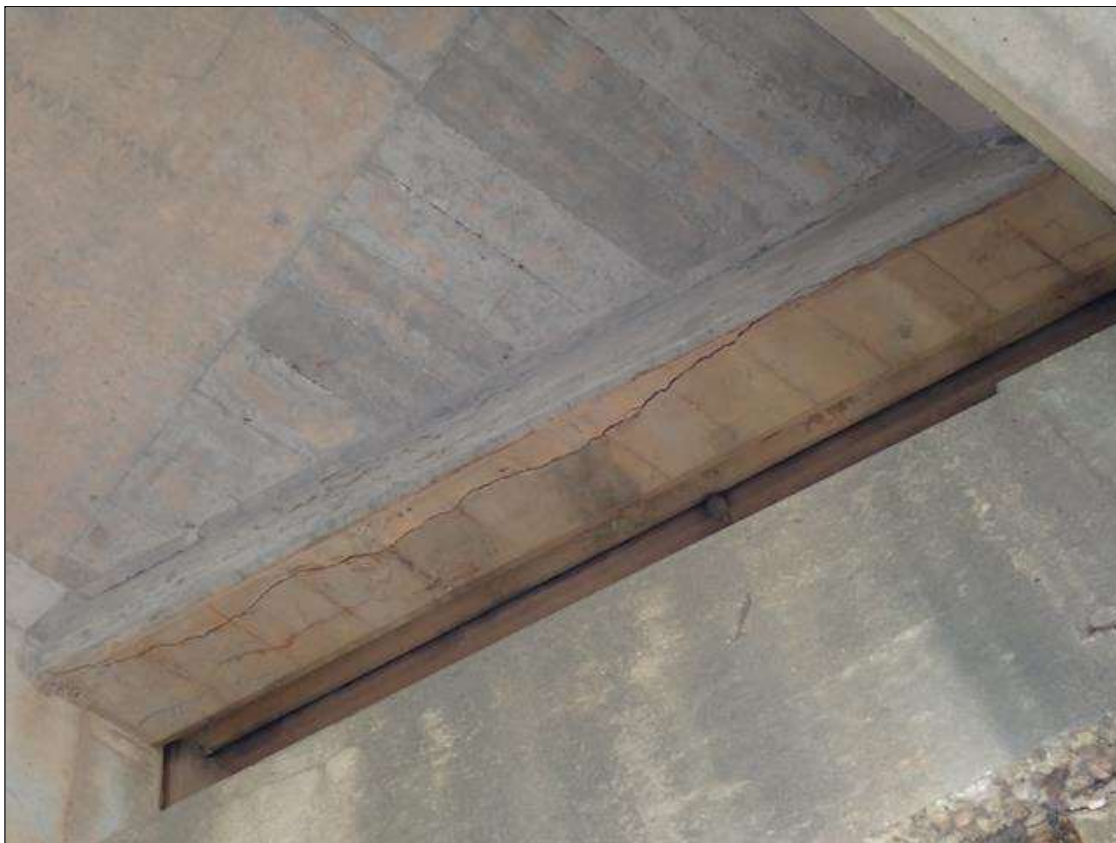
Span 3 Beam 2: at bents 2 and 3, bay 2 end diaphragms, spalls/delaminations (up to full length x full height) and cracks (up to 1/8 inch)

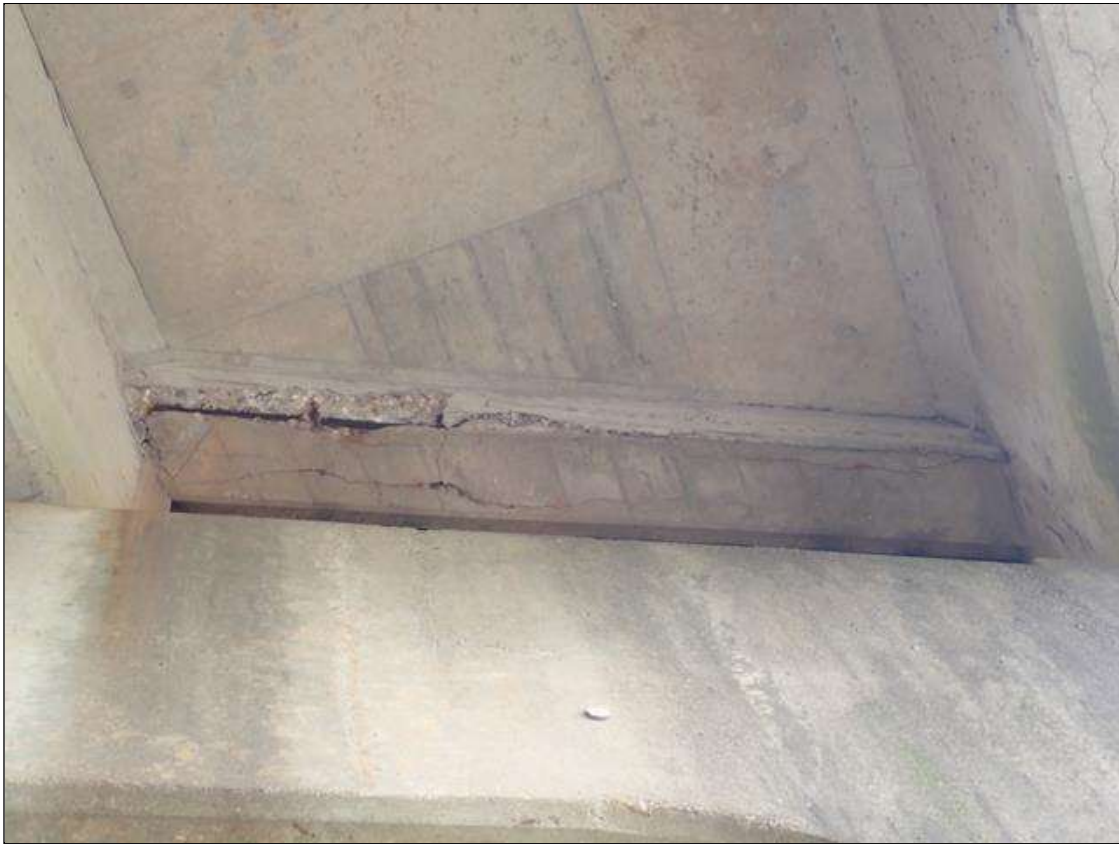
Span 4 Beam 1: (PAR) at bents 3 and 4, bay 1 end diaphragms, spalls/delaminations (up to full length x full height x up to 1.5 inch deep) with exposed rusted rebar (approximately 25 percent loss) and cracks (up to 1/8 inch) and rust stains

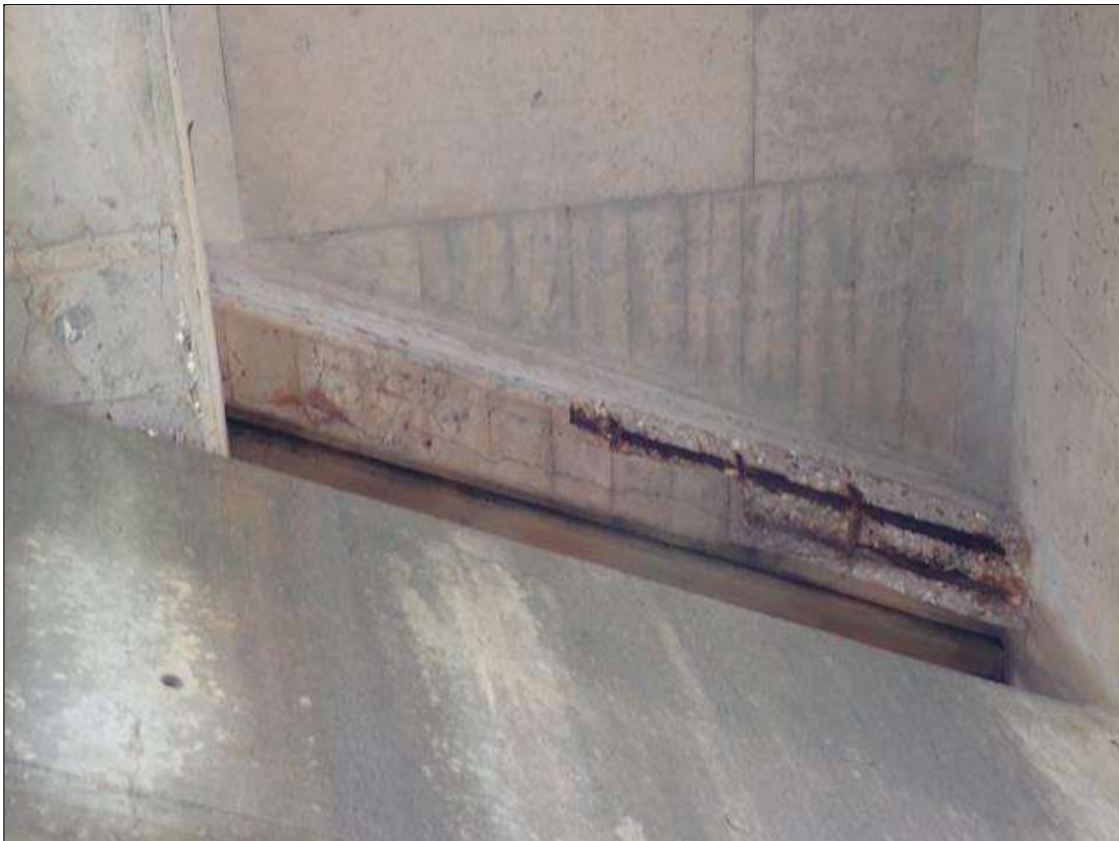
Span 4 Beam 2: (PAR) at bents 3 and 4, bay 2 end diaphragms, spalls/delaminations (up to full length x full height x up to 1.5 inch deep) with exposed rusted rebar (approximately 25 percent loss) and cracks (up to 1/8 inch) with rust stains

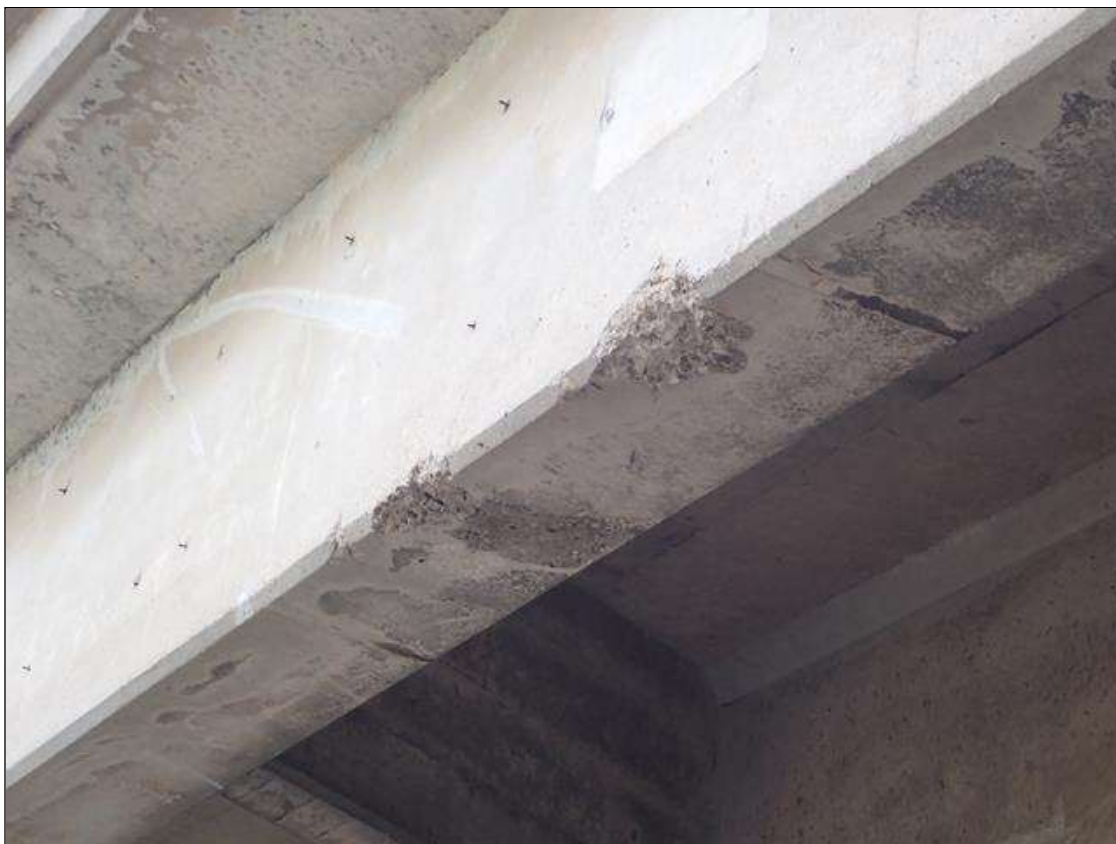
Span 4 Beam 4: EAST FACE AND BOTTOM OVER WEST BOUND RIGHT LANE. (2) 8 INCH LONG X 6 INCH X 1.5 INCH DEEP SPALLS IN MID-SPAN FROM PREVIOUS IMPACT DAMAGE.

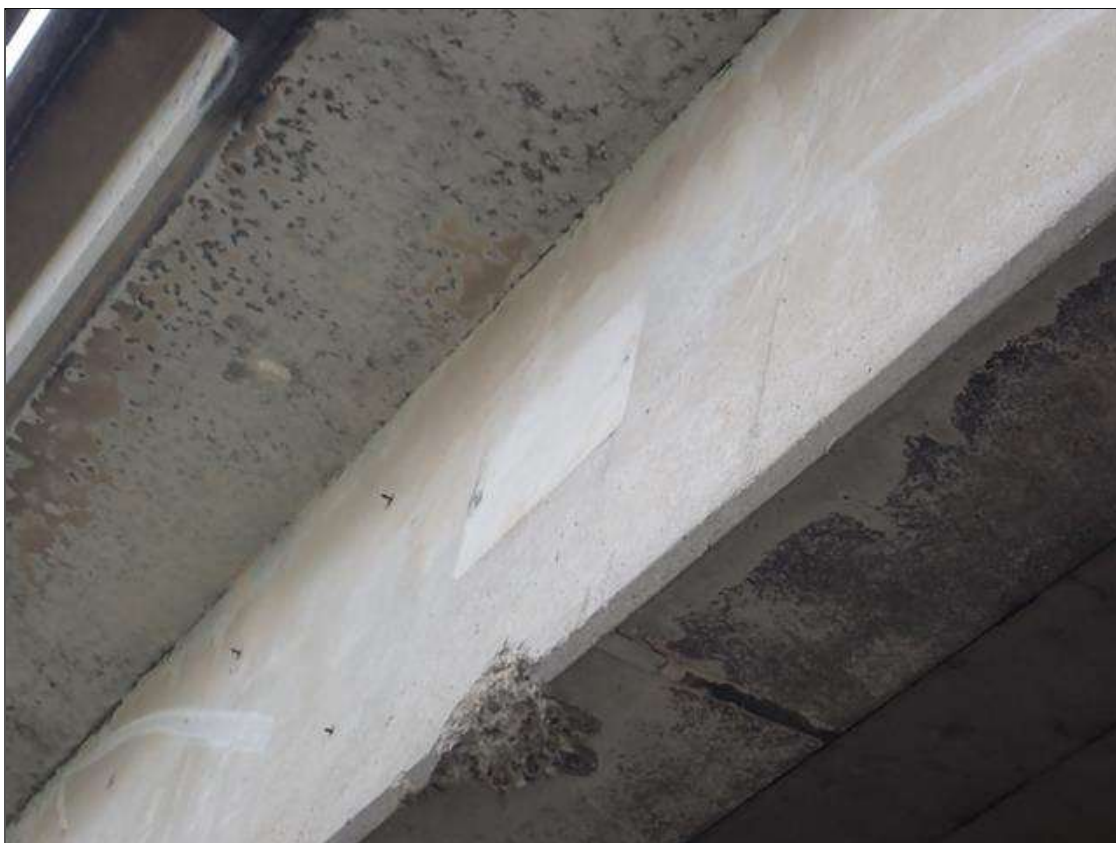
Span 4 Route Marker Sign: (PAR) route sign, missing

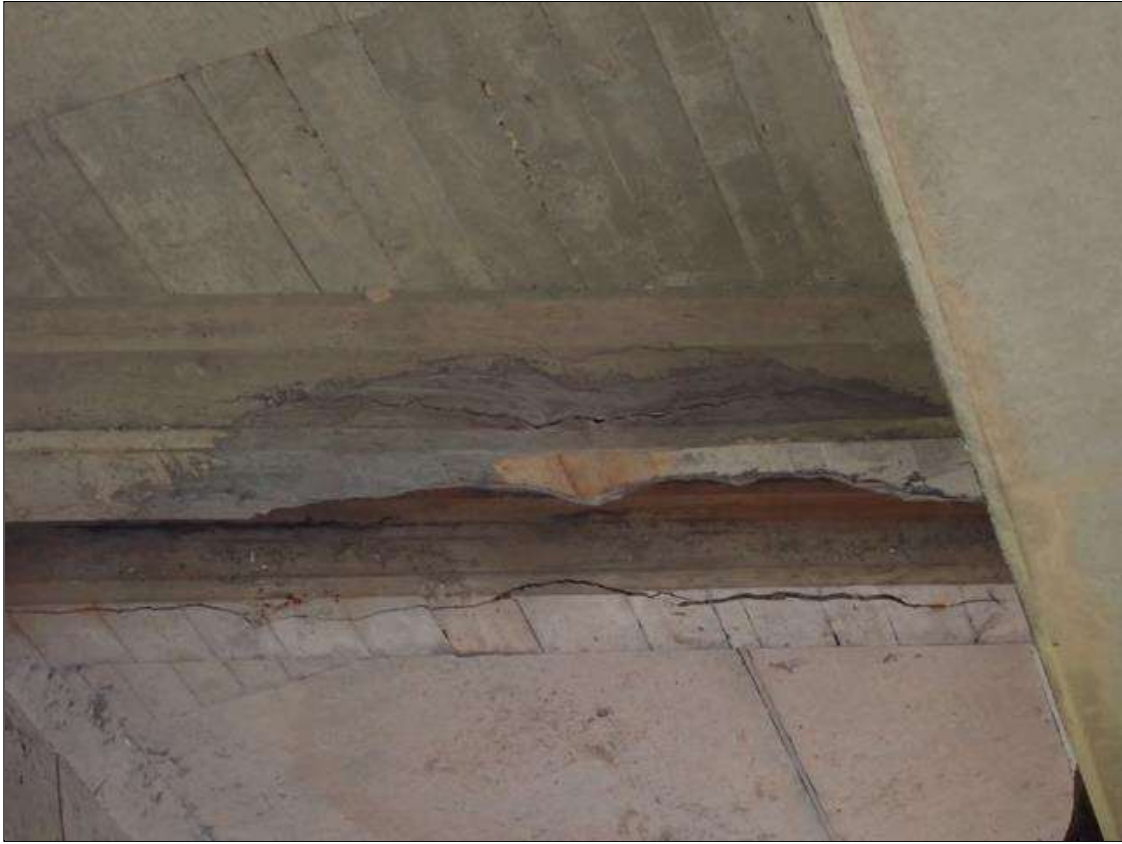
Span 5 Beam 3: 4 FOOT X 8 INCH X 8 INCH CRACKED PATCHED AREA, IN BENT 4 DIAPHRAGM, BAY 3.

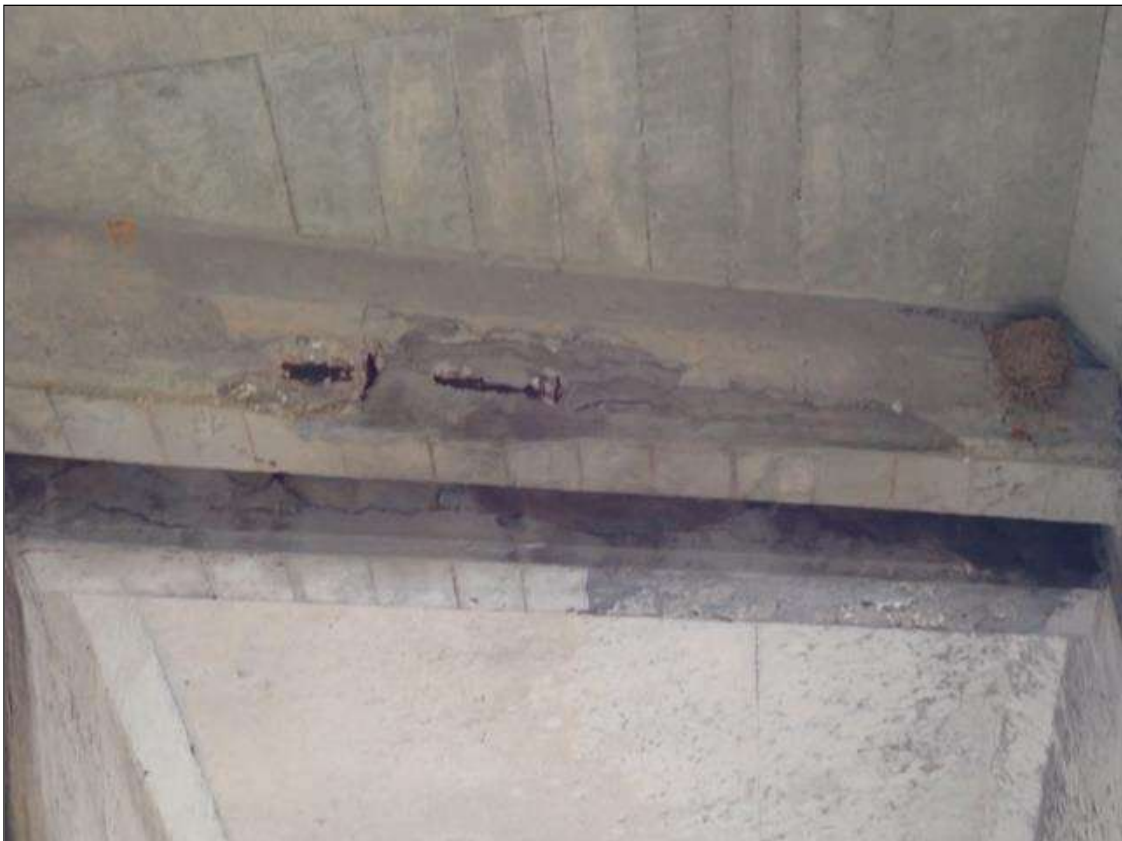
Span 5 Beam 1: 4 FOOT X 10 INCH X 1/2 INCH DEEP FAILED PATCH WITH EXPOSED REINFORCING, IN BENT 4 DIAPHRAGM, BAY 1.

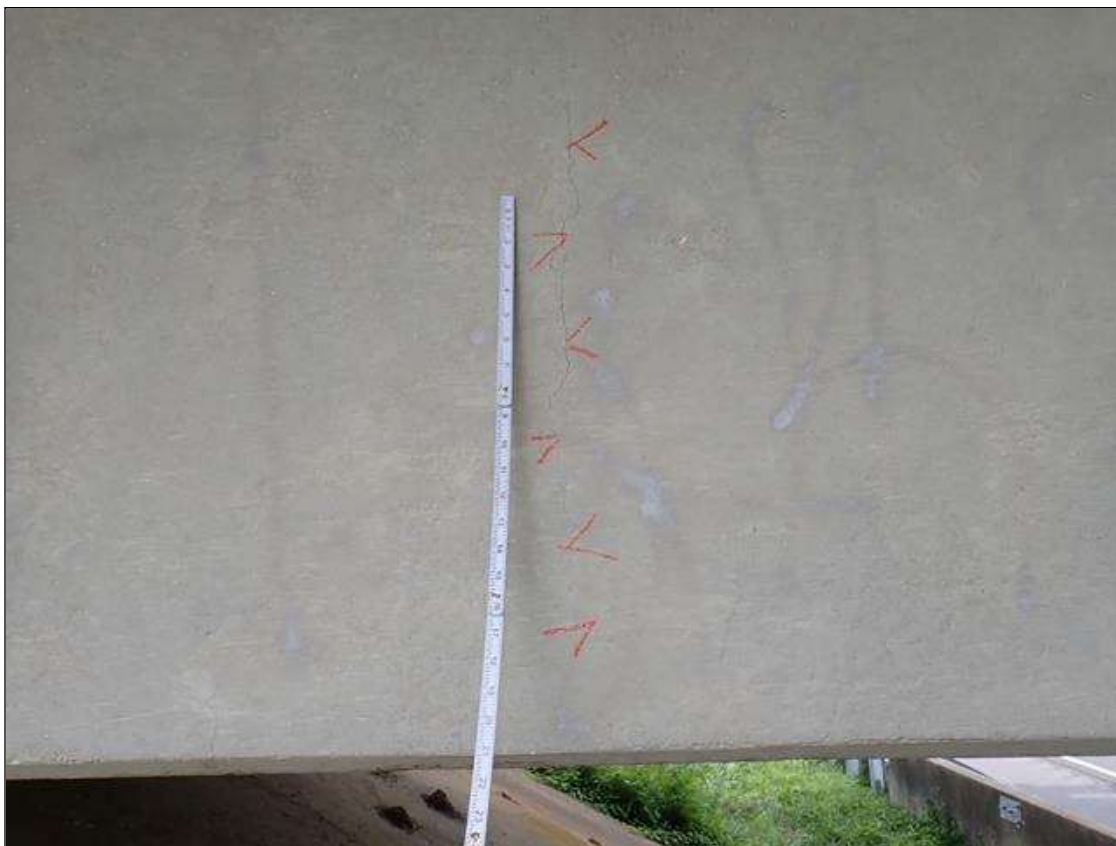
Span 5 Beam 1: TRANSVERSE AND WRAPAROUND CRACKS UP TO 1/64 INCH, AT RANDOM THROUGHOUT.

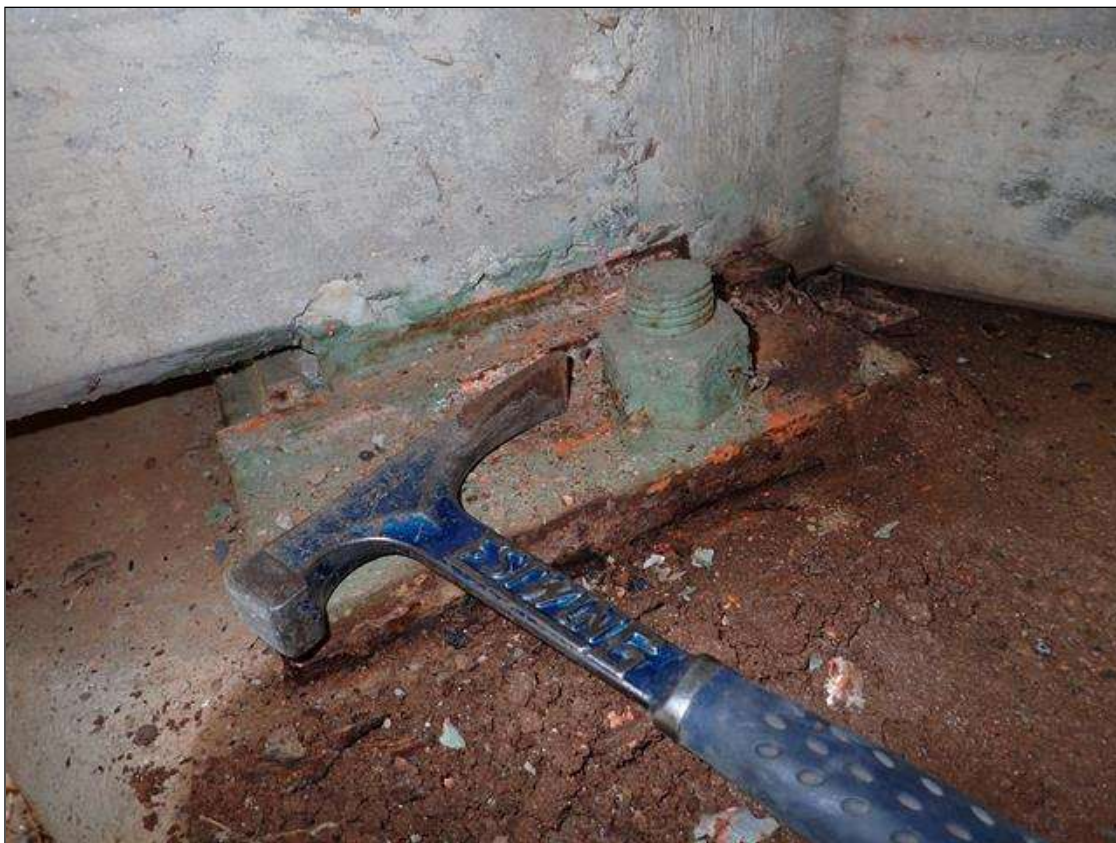
Span 5 Far Bearing 1: rust scale

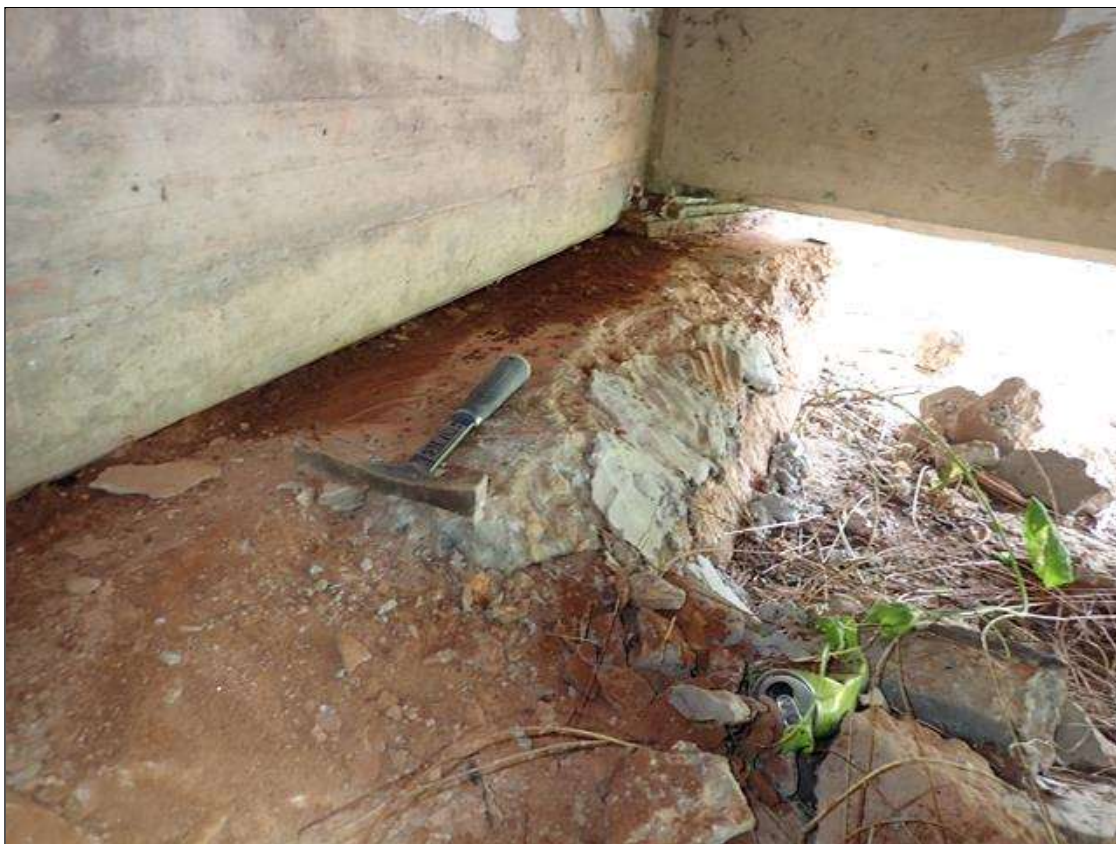
End Bent 2 Cap 1: (PAR) top of South face at bay 3, spall/delamination [10 foot x full height x full width x up to 3 inch deep] with exposed rusted rebar (approximately 25 percent loss) and cracks (up to 1/18 inch)

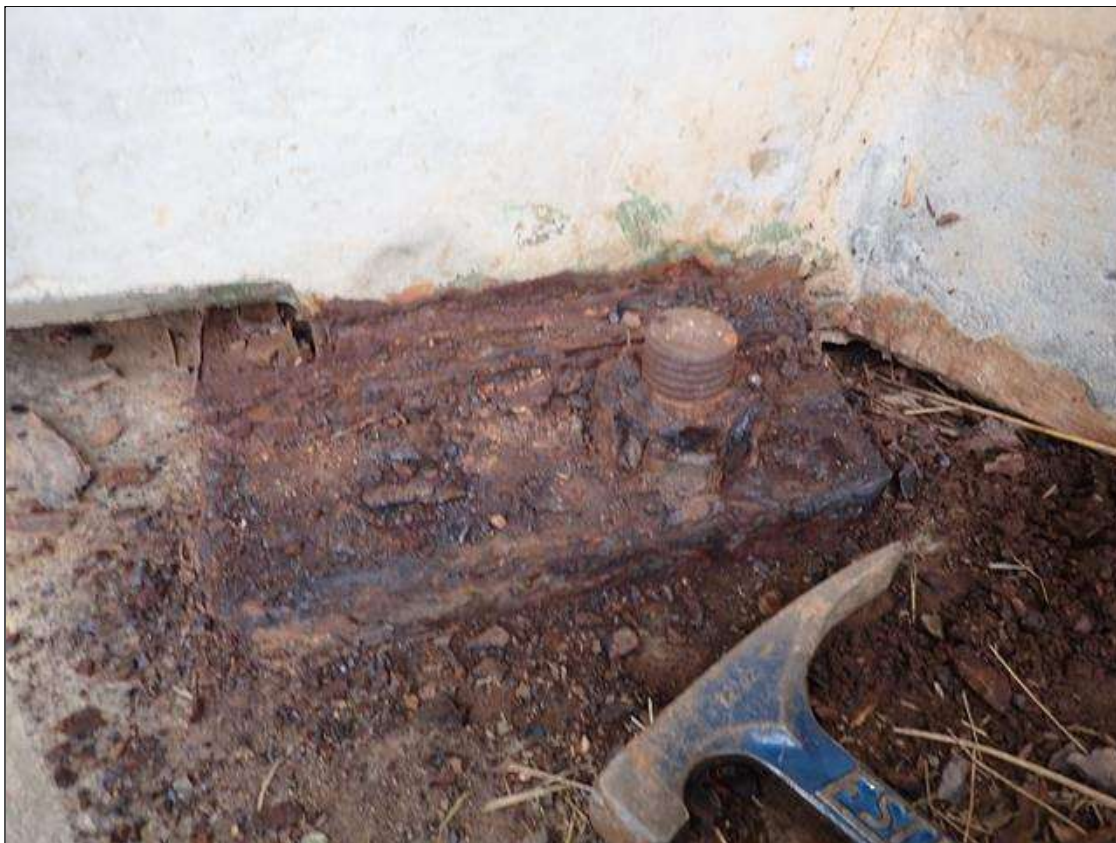
Span 5 Far Bearing 4: corrosion with section loss [up to 3/16 inch loss]

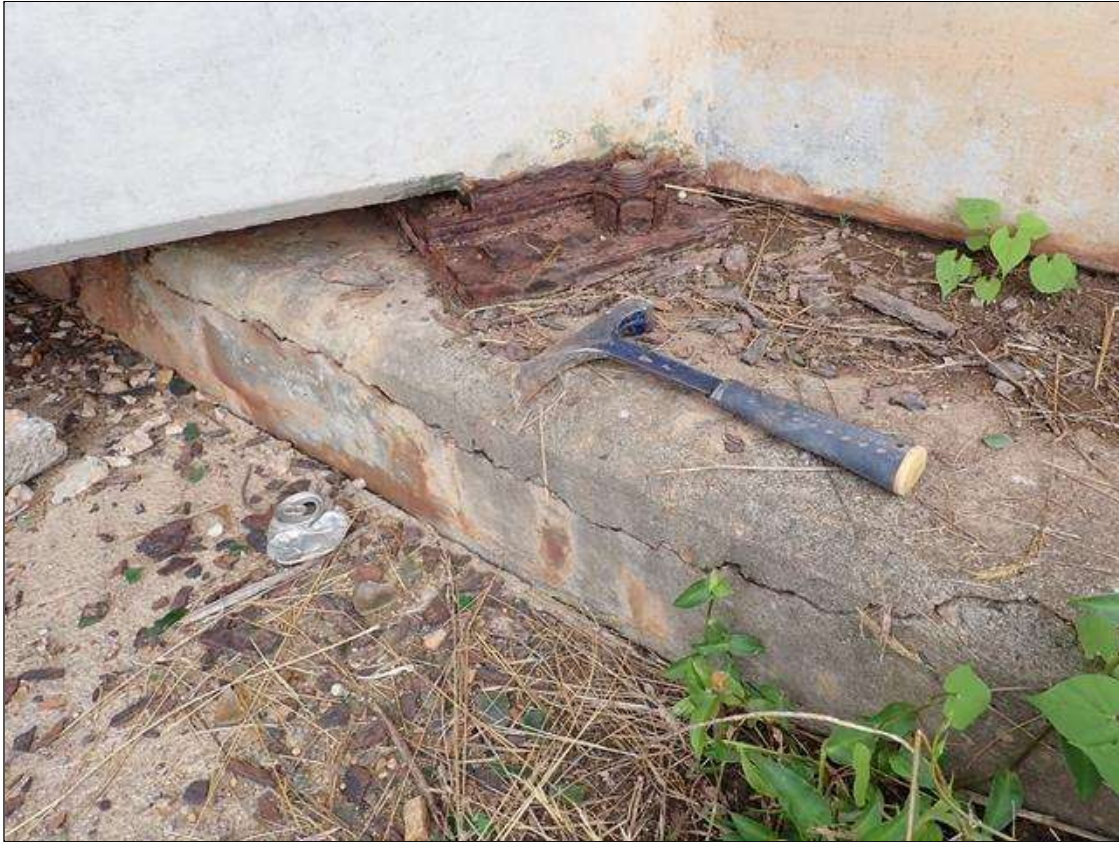
End Bent 2 Cap 1: (PAR) top of South face at bay 3, spall/delamination [10 foot x full height x full width x up to 3 inch deep] with exposed rusted rebar (approximately 25 percent loss) and cracks (up to 1/18 inch)

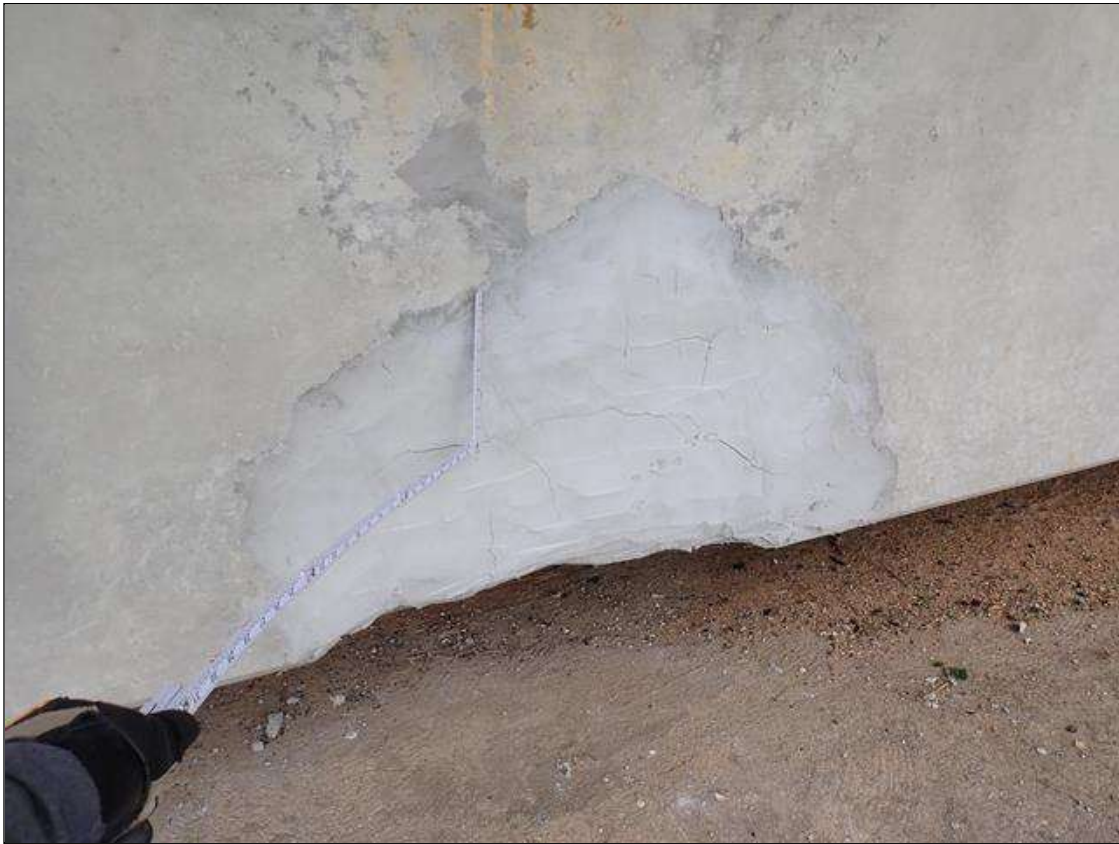
Span 5 Beam 4: 2023 previously repaired with patch (3.5 foot x 2.5 foot) with map cracks (up to 1/32 inch), previously noted as: lower East face at 12 foot from end bent 2, spall [40 inch long x 26 inch high x up 5 inch deep] with exposed primary rebar and stirrups, section loss on rebar [up to 1/16 inch]

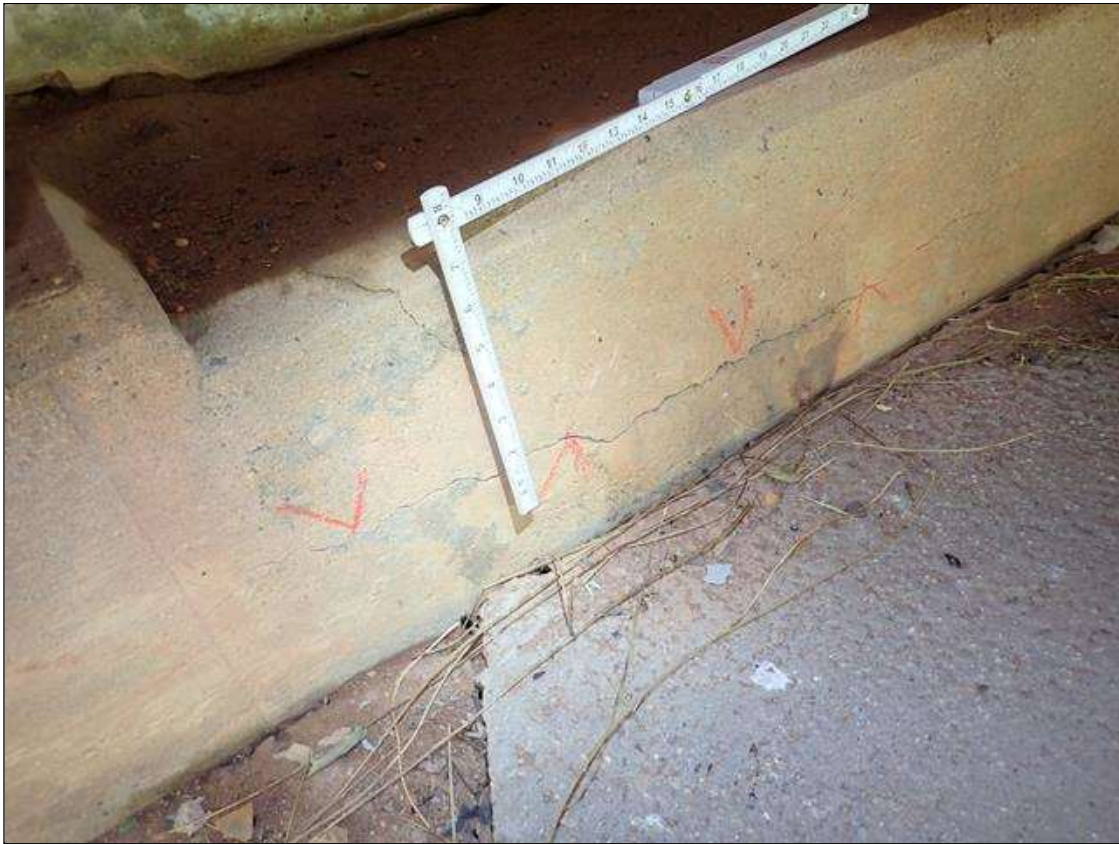
End Bent 2 Cap 1: in bay 1, horizontal crack (1/8 inch x 2.5 foot)

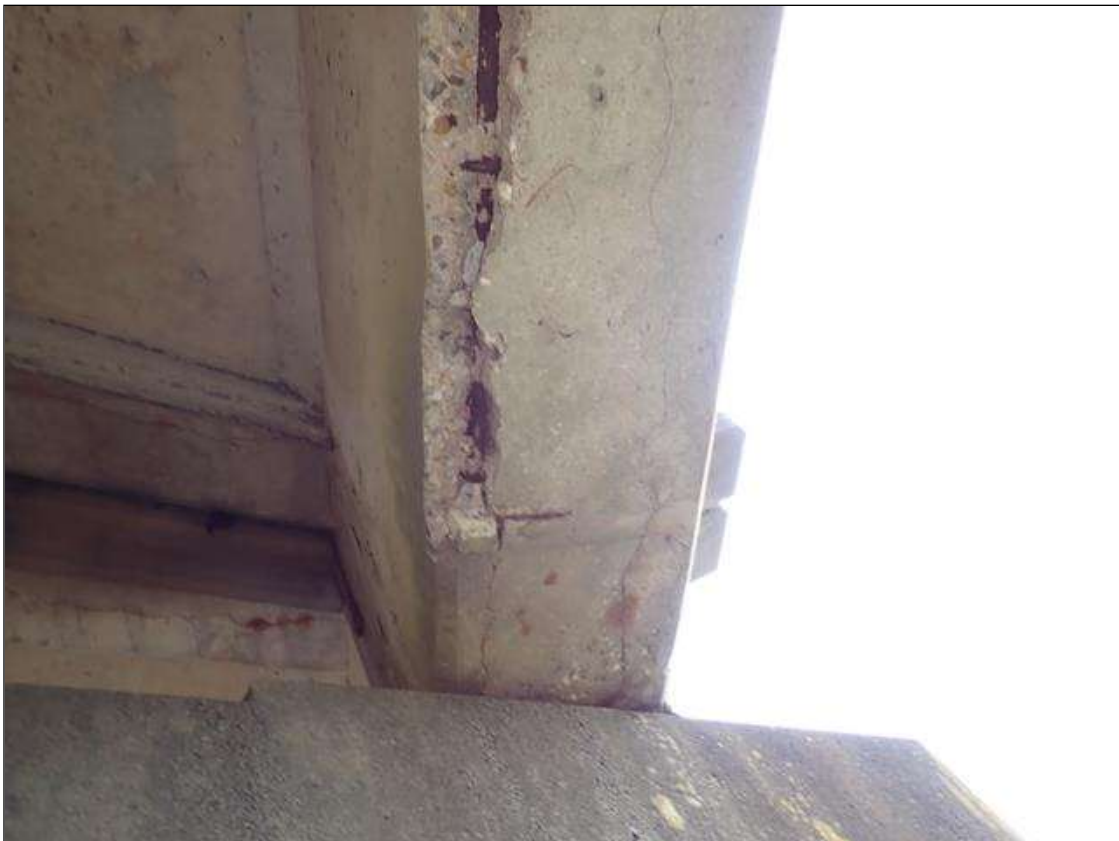
Span 4 Beam 1: (PAR) at bent 3, east face and underside, spalls/delaminations (up to 6 foot x 18 inch x 2 inch deep) with exposed rusted rebar (approximately 25 percent loss) and cracks (up to 1/16 inch)

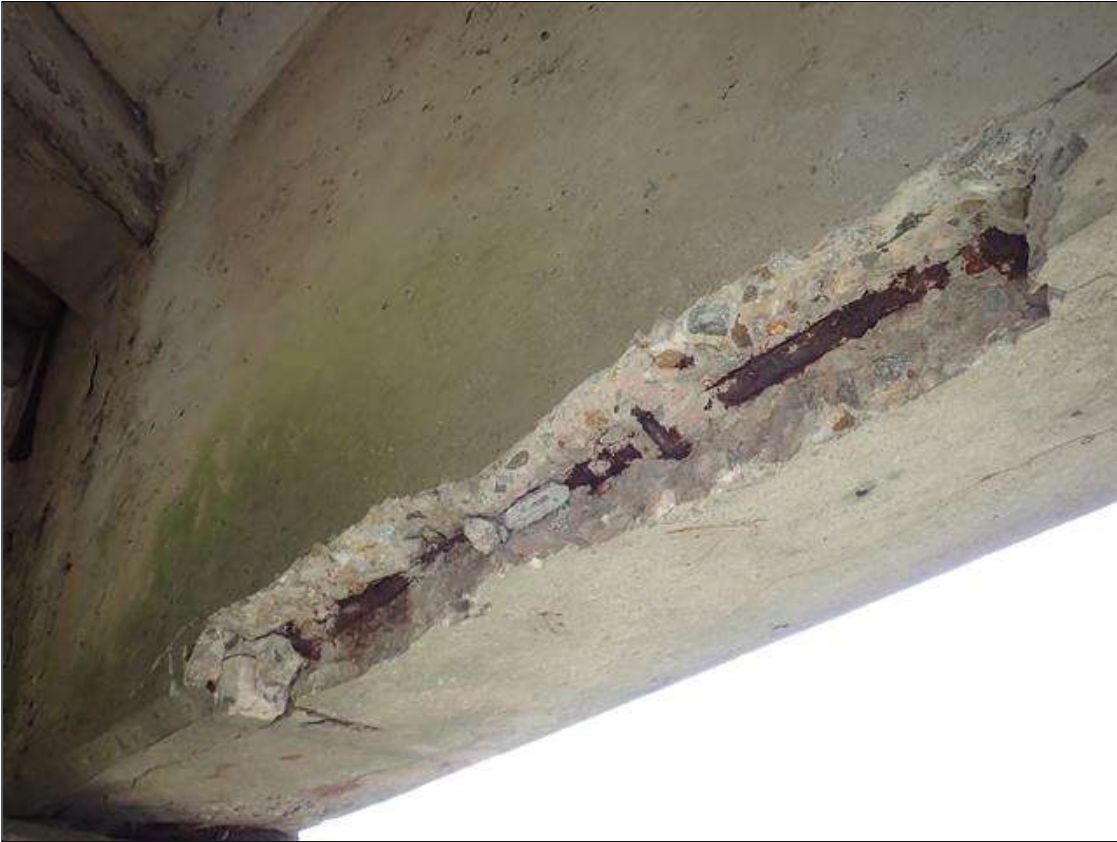
Span 4 Beam 1: (PAR) at bent 3, east face and underside, spalls/delaminations (up to 6 foot x 18 inch x 2 inch deep) with exposed rusted rebar (approximately 25 percent loss) and cracks (up to 1/16 inch)
