NC DEPARTMENT OF TRANSPORTATION
 DIVISION OF HIGHWAYS
 STRUCTURE MANAGEMENT UNIT

ATTENTION: **prompt action request; sketches updated; route sign attached to span 3 beam 1**

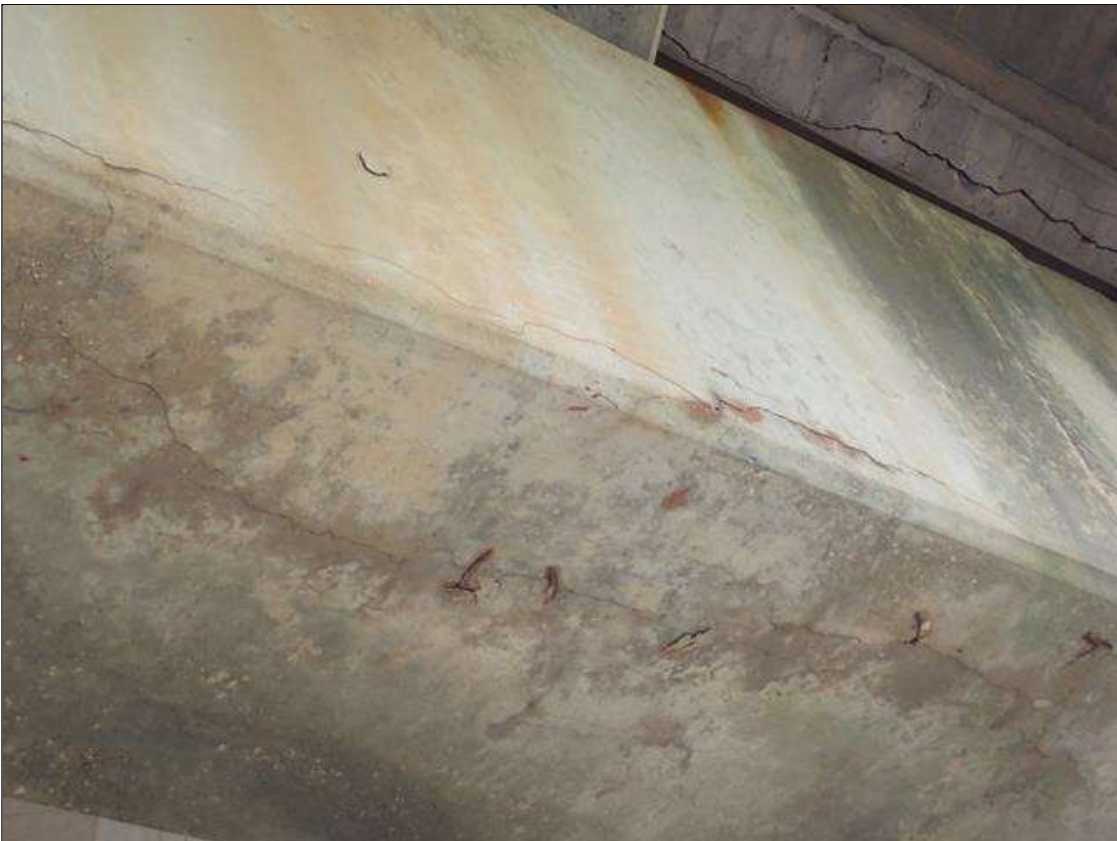
Bent 3 Cap 1: (PAR) BENT 3 CAP HAS SCATTERED CRACKS UP TO 1/16 INCH SOME WITH ADJACENT DELAMINATION (UP TO 7 FOOT X 1.5 FOOT) AND RUST STAINS.

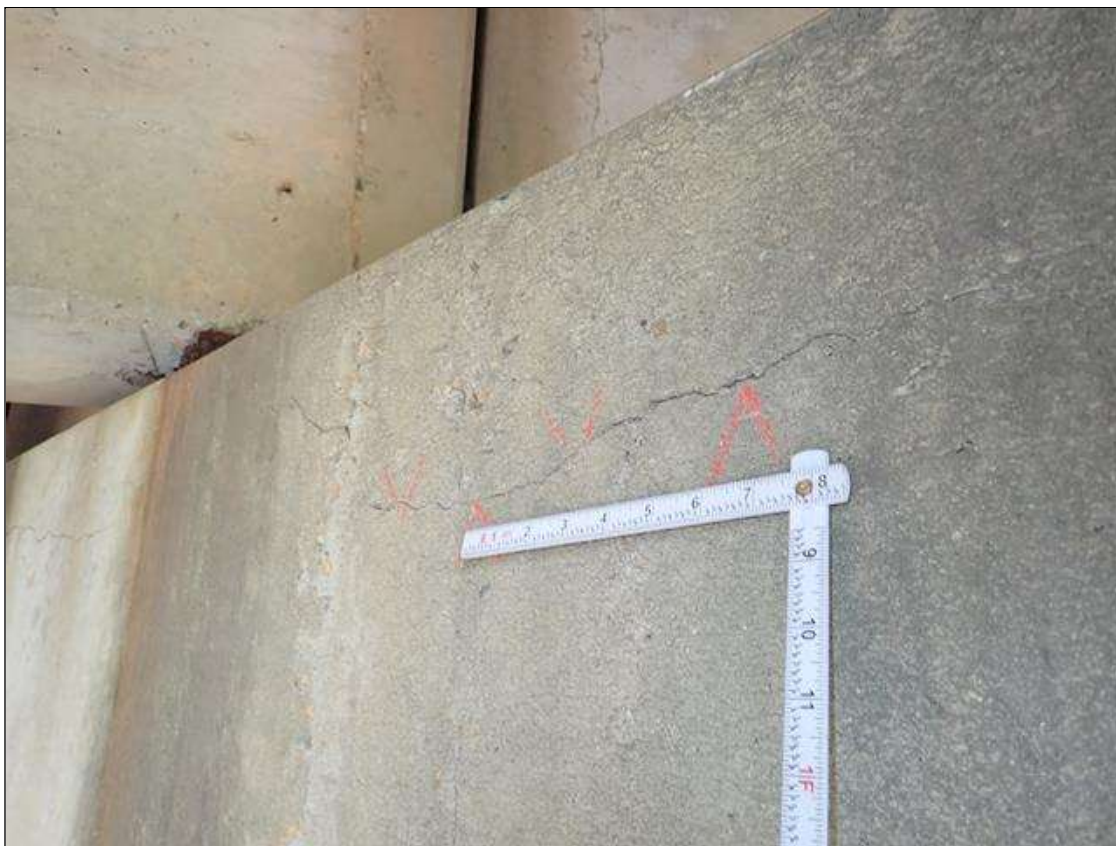
Bent 3 Cap 1: (PAR) BENT 3 CAP HAS SCATTERED CRACKS UP TO 1/16 INCH SOME WITH ADJACENT DELAMINATION (UP TO 7 FOOT X 1.5 FOOT) AND RUST STAINS.

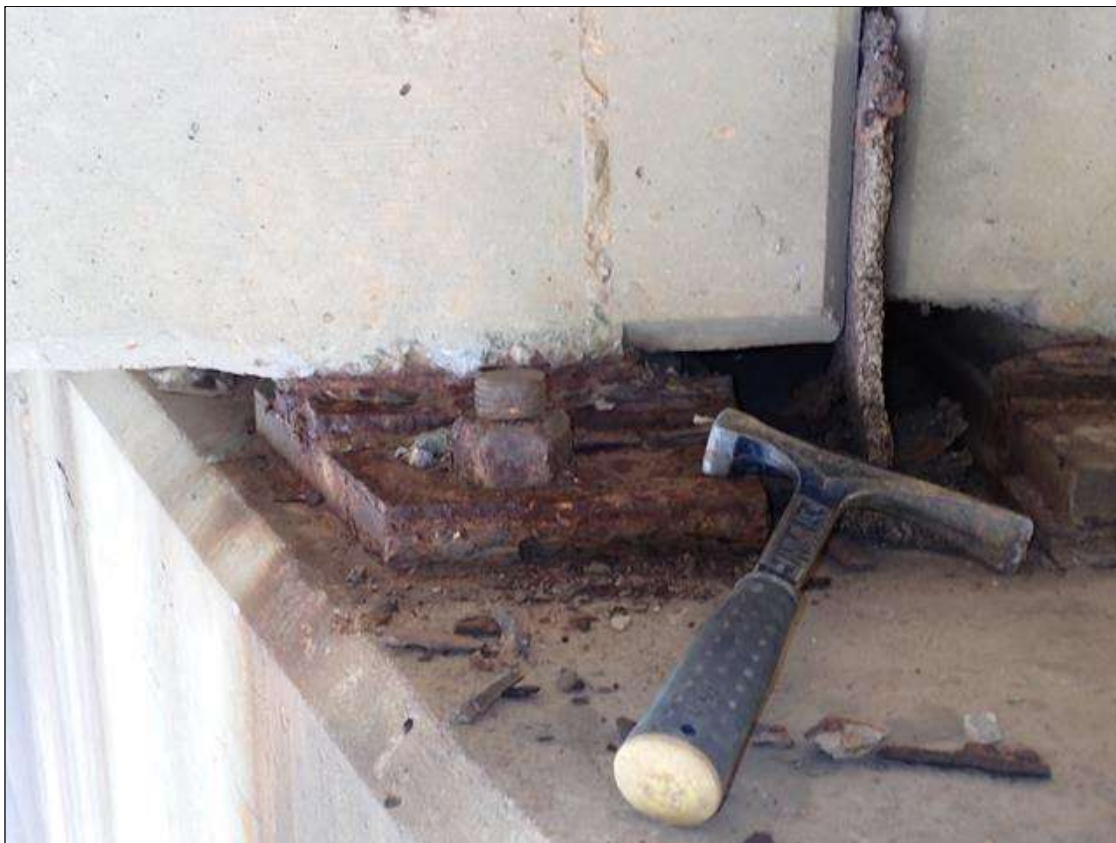
Span 4 Near Bearing 2: corrosion with section loss (up to 1/16 inch loss)

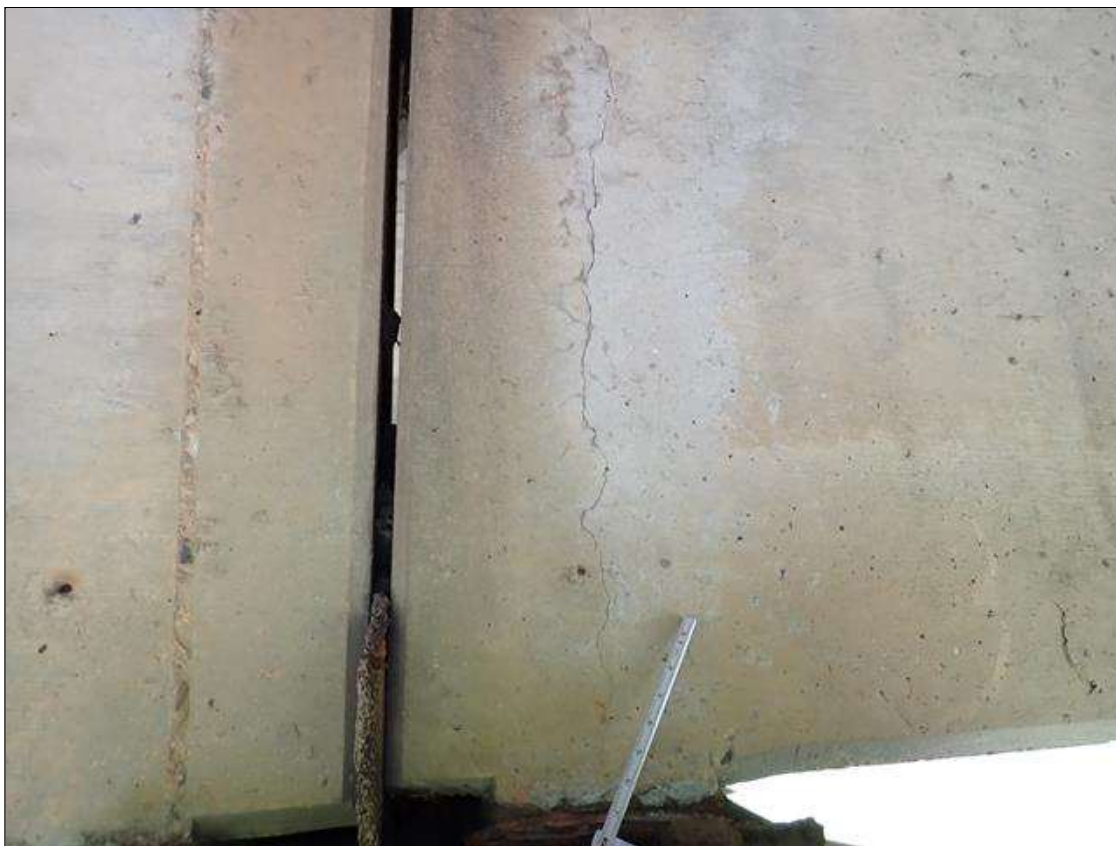
Span 3 Beam 2: TRANSVERSE AND WRAPAROUND CRACKS UP TO 1/32 INCH, AT RANDOM THROUGHOUT.

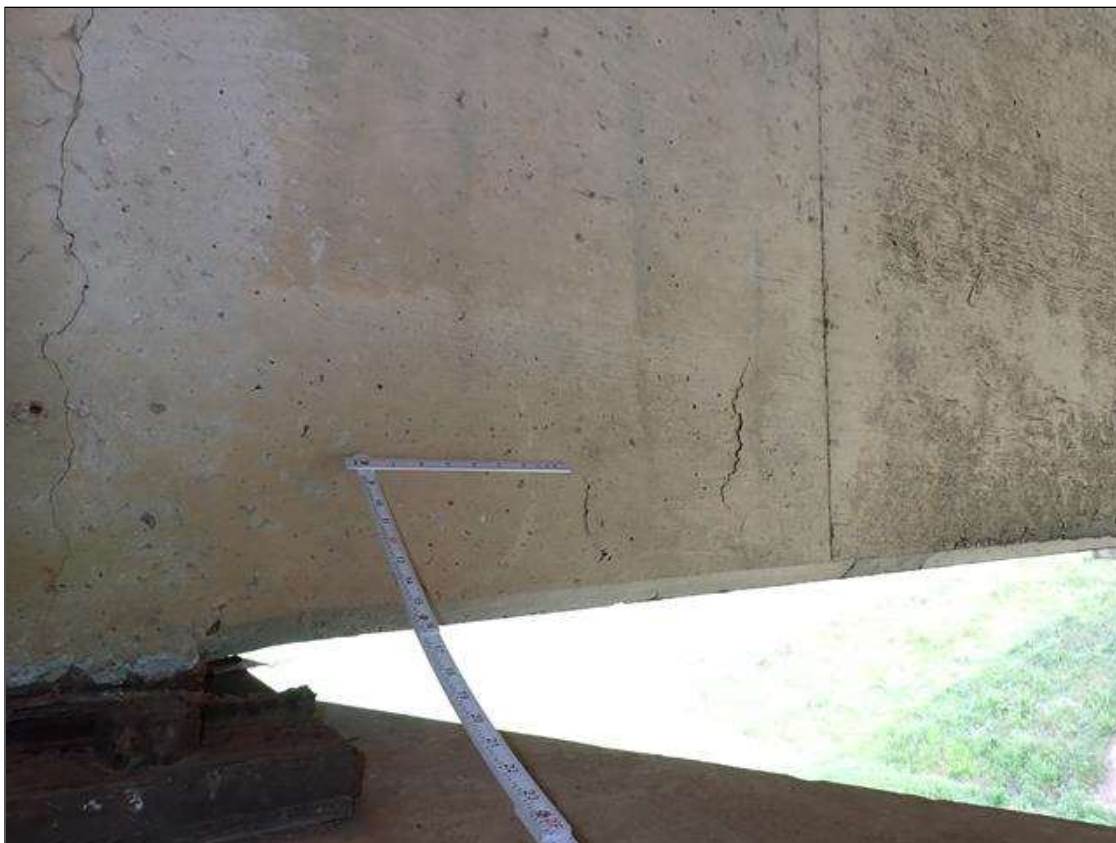
Span 3 Beam 2: near bent 3, west face, (3) delaminations (8 inch diameter) with cracks (up to 1/32 inch)

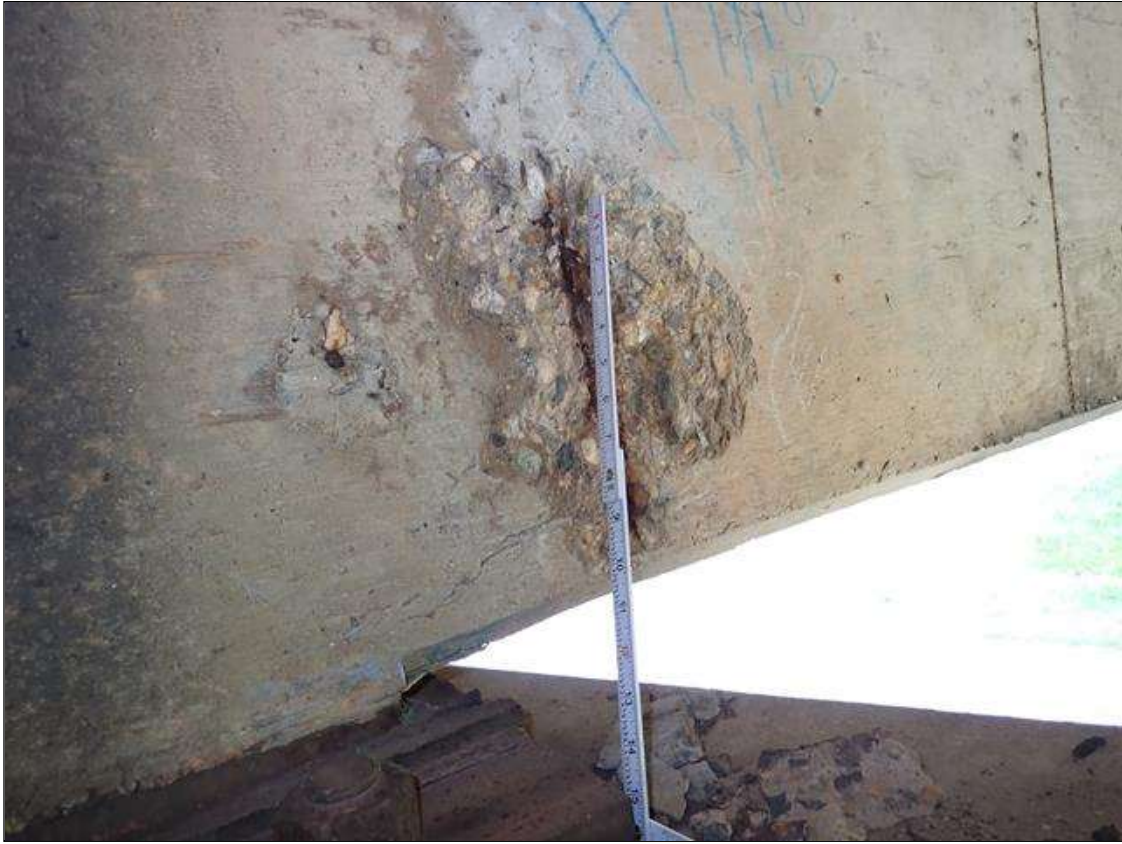
Span 3 Beam 3: (PAR) at bent 3, west face, spall/delamination (11 inch x 11 inch x 1/2 inch deep) with exposed rusted rebar (approximately 25 percent loss) and cracks (up to 1/32 inch)

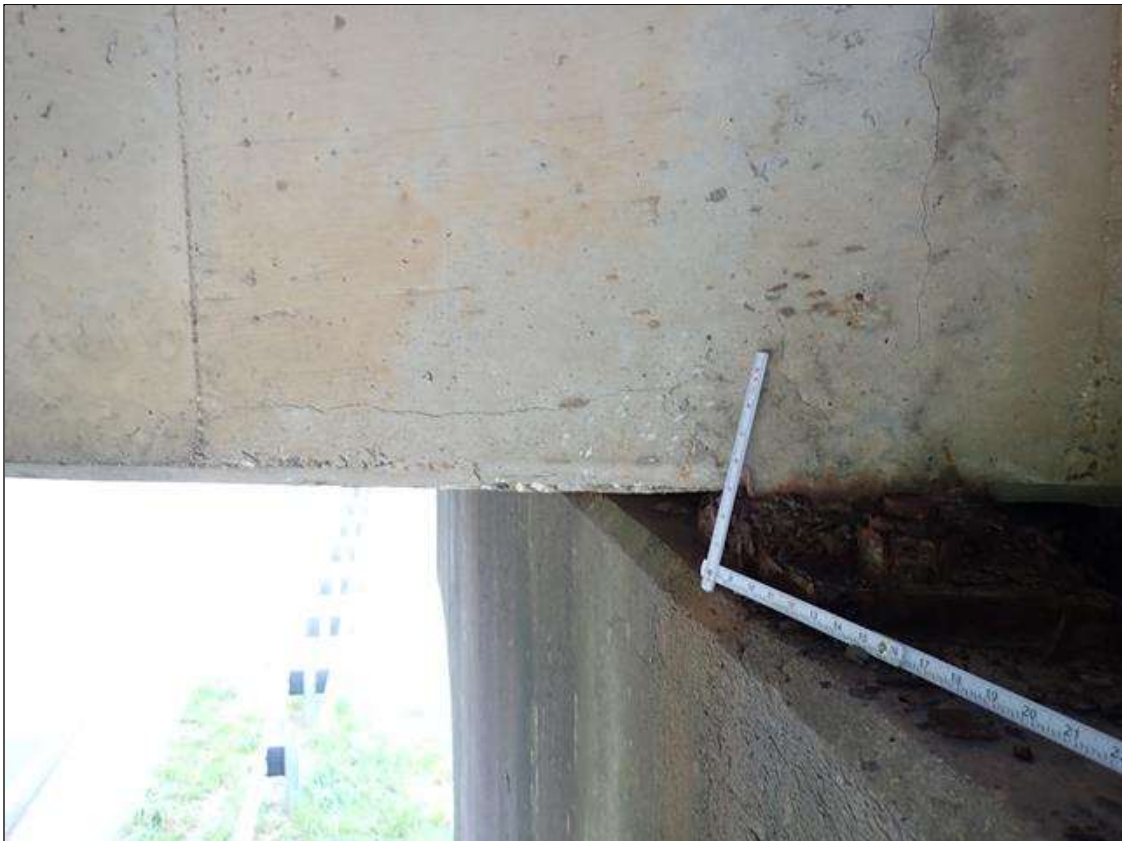
Span 4 Beam 3: near bent 3, west and east faces, longitudinal cracks (up to 1/32 inch x 2 foot)

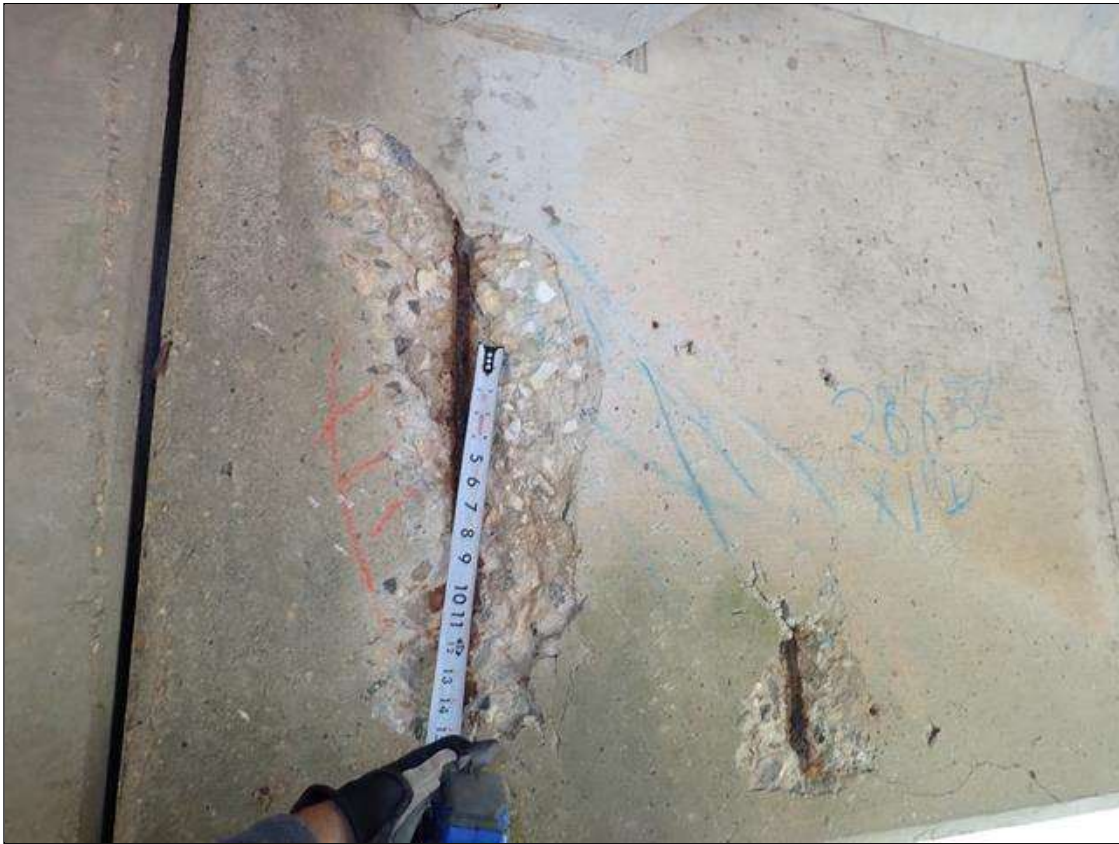
Span 3 Beam 4: (PAR) at bent 3, west face, (2) spalls/delaminations (1 foot x 30 inch x 1 inch deep) with exposed rusted rebar (approximately 25 percent loss) and cracks (up to 1/32 inch)

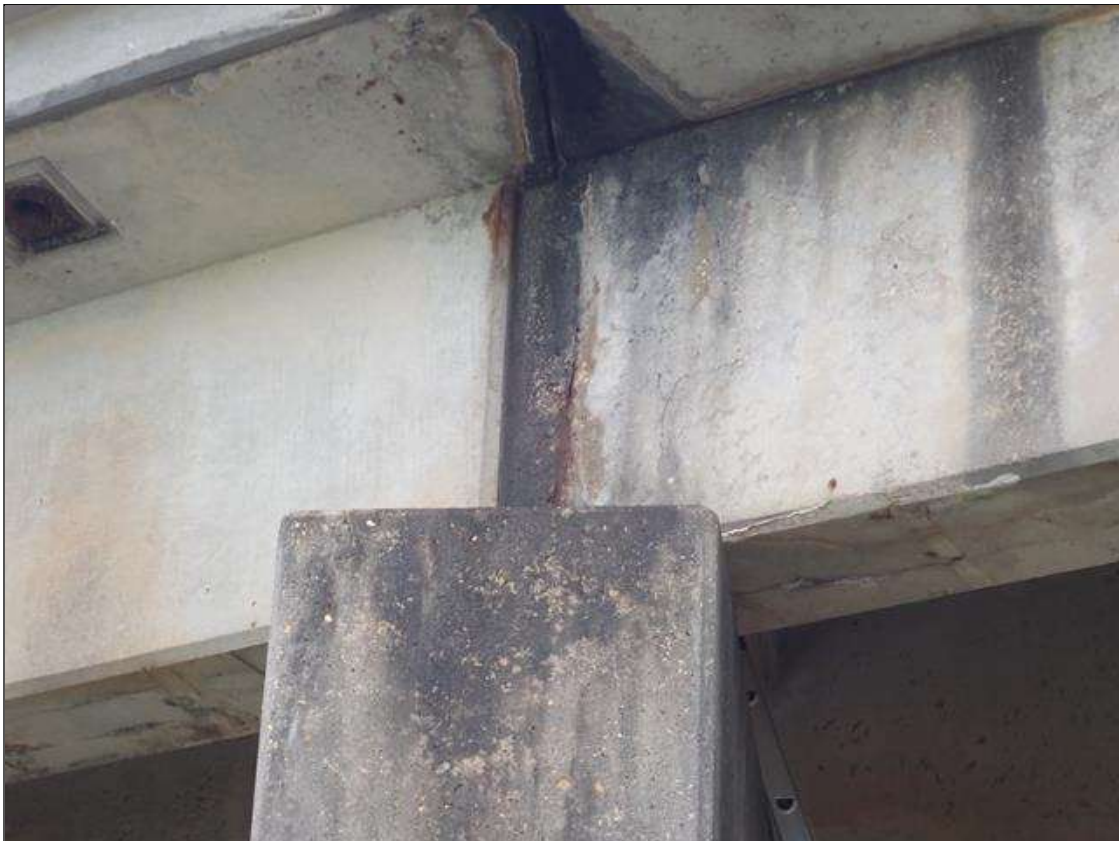
Span 4 Beam 4: (PAR) at bent 3, east face, spall/delamination (43 inch x 43 inch x 1 inch deep) with exposed rusted rebar (approximately 25 percent loss) and cracks (up to 1/32 inch)

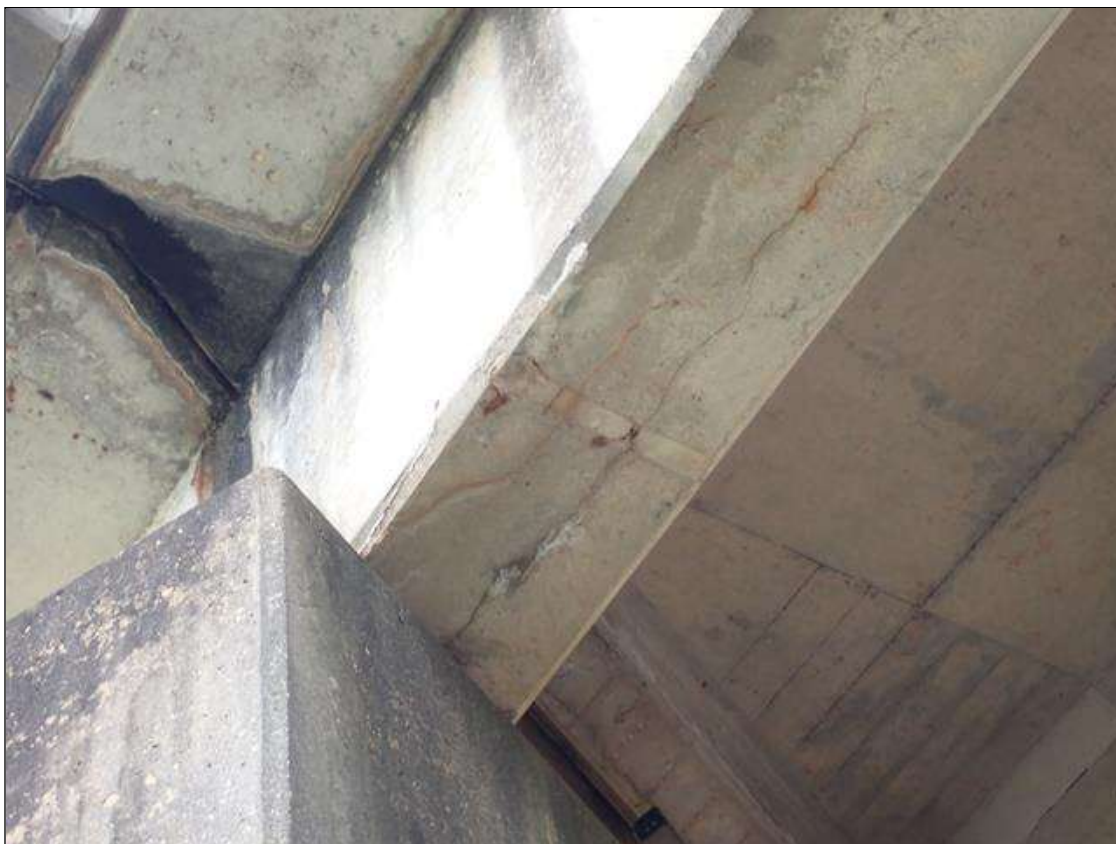
Span 4 Beam 4: (PAR) AT BENT 3, (2) UP TO 7 FOOT X 1/32 INCH LONGITUDINAL CRACKS, ON BOTTOM AND WEST FACES WITH EFFLORESCENCE AND RUST STAIN

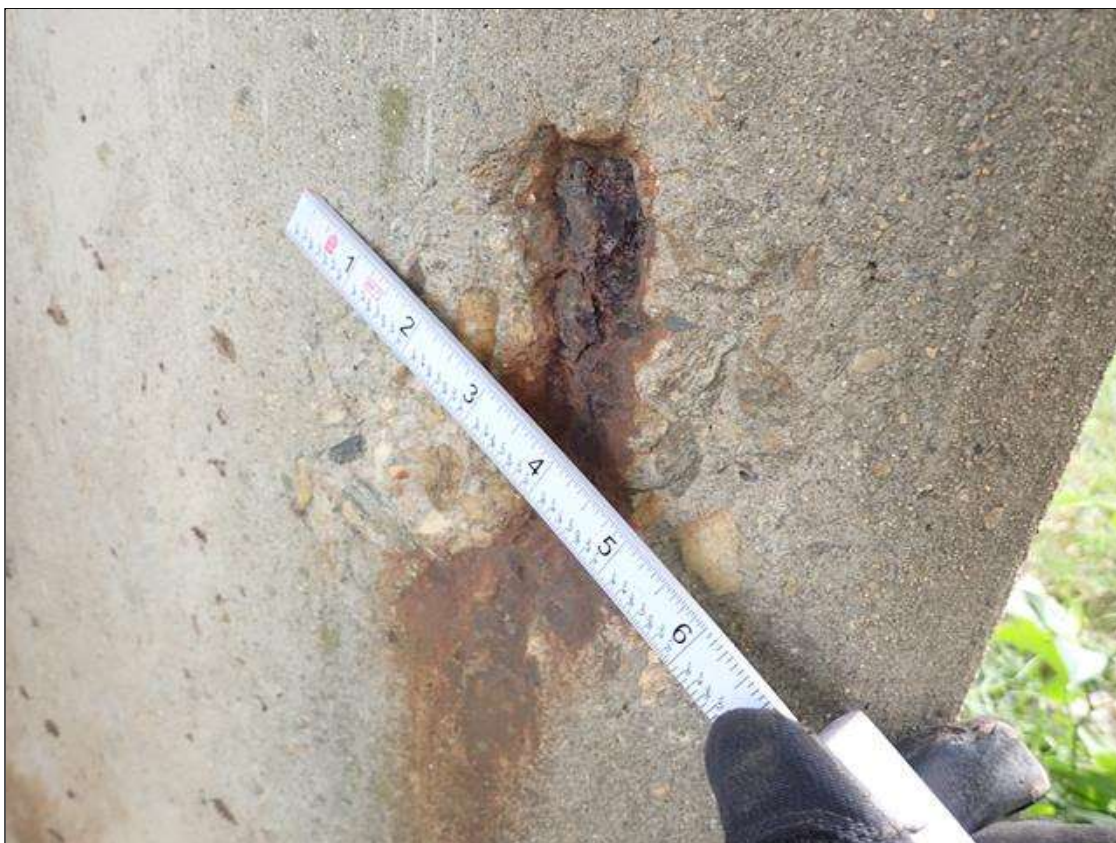
Bent 3 Pile 1: (PAR) 6 INCH DIAMETER X 1/2 INCH SPALL WITH EXPOSED REINFORCING (APPROXIMATELY 10 PERCENT LOSS) ON EAST FACE NEAR GROUNDLINE.

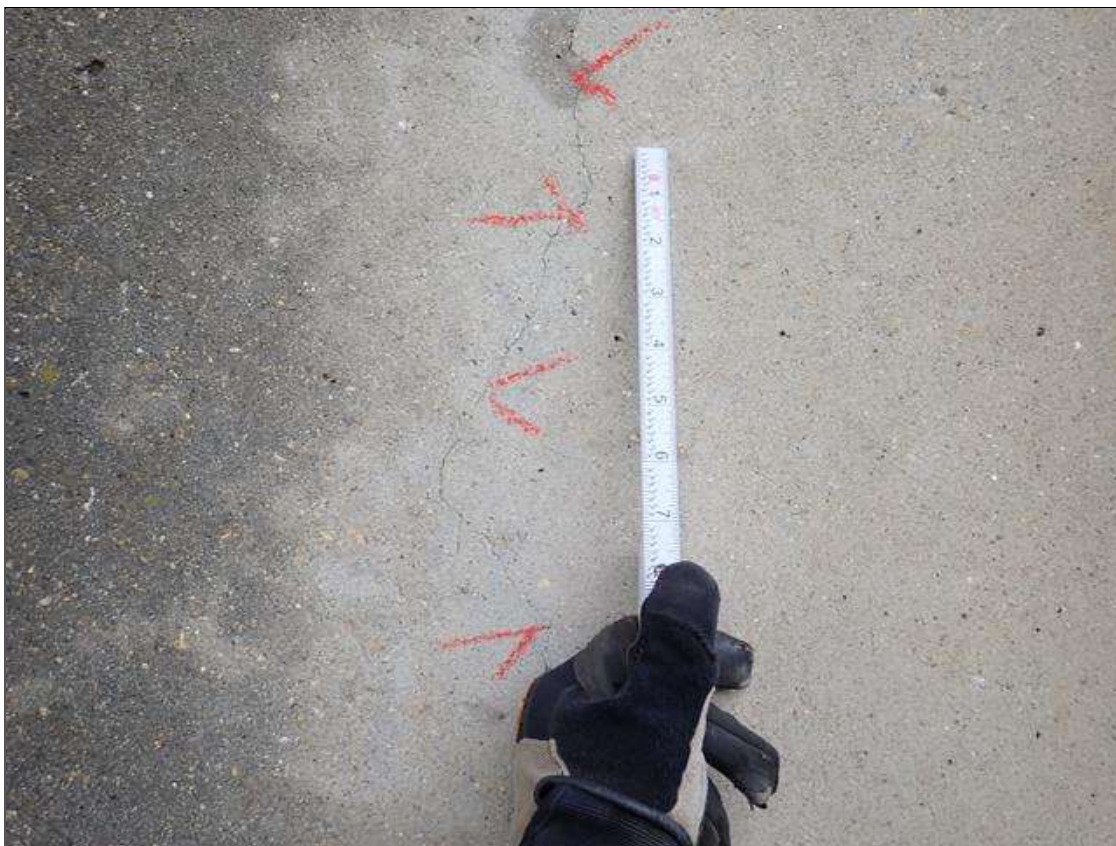
Bent 3 Pile 2: UP TO 8 FOOT X UP TO 1/32 INCH VERTICAL CRACKS, AT RANDOM THROUGHOUT.

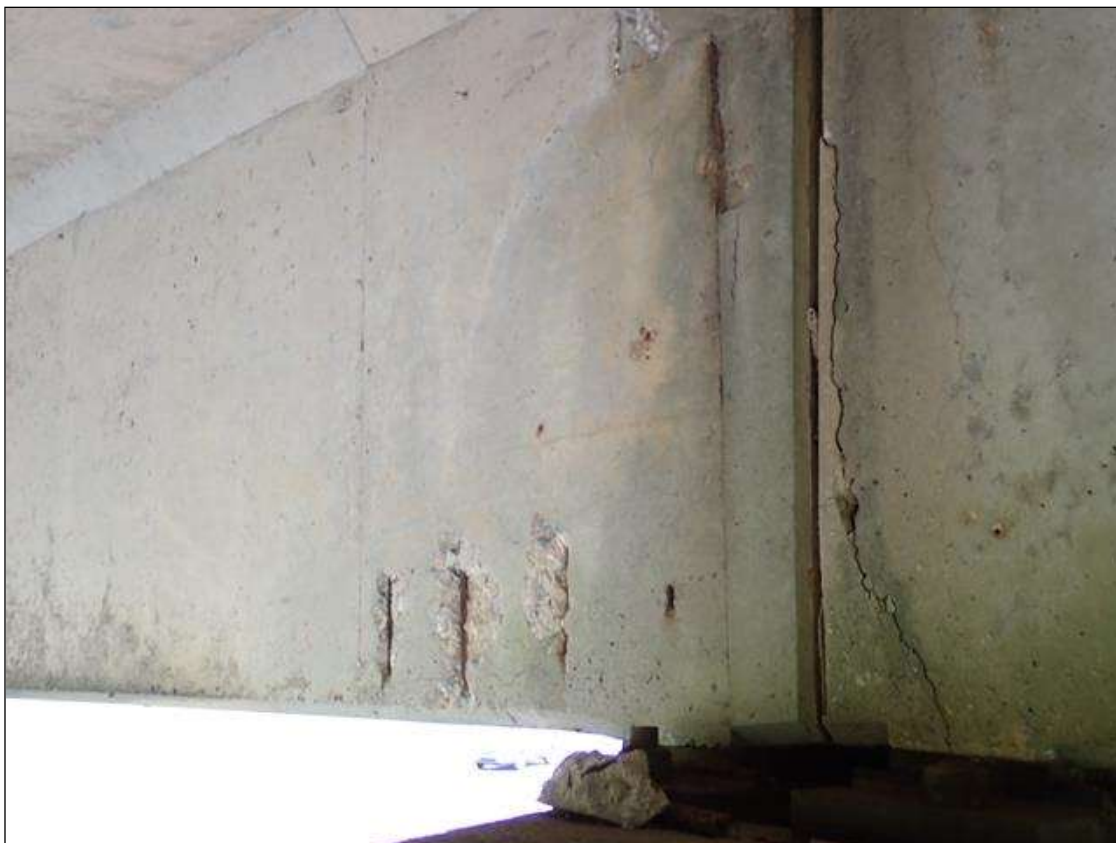
Span 3 Beam 2: (4)- UP TO 3 INCH X 12 INCH X 1 INCH SPALLS WITH EXPOSED REINFORCING, WEST FACE, AT BENT 2.

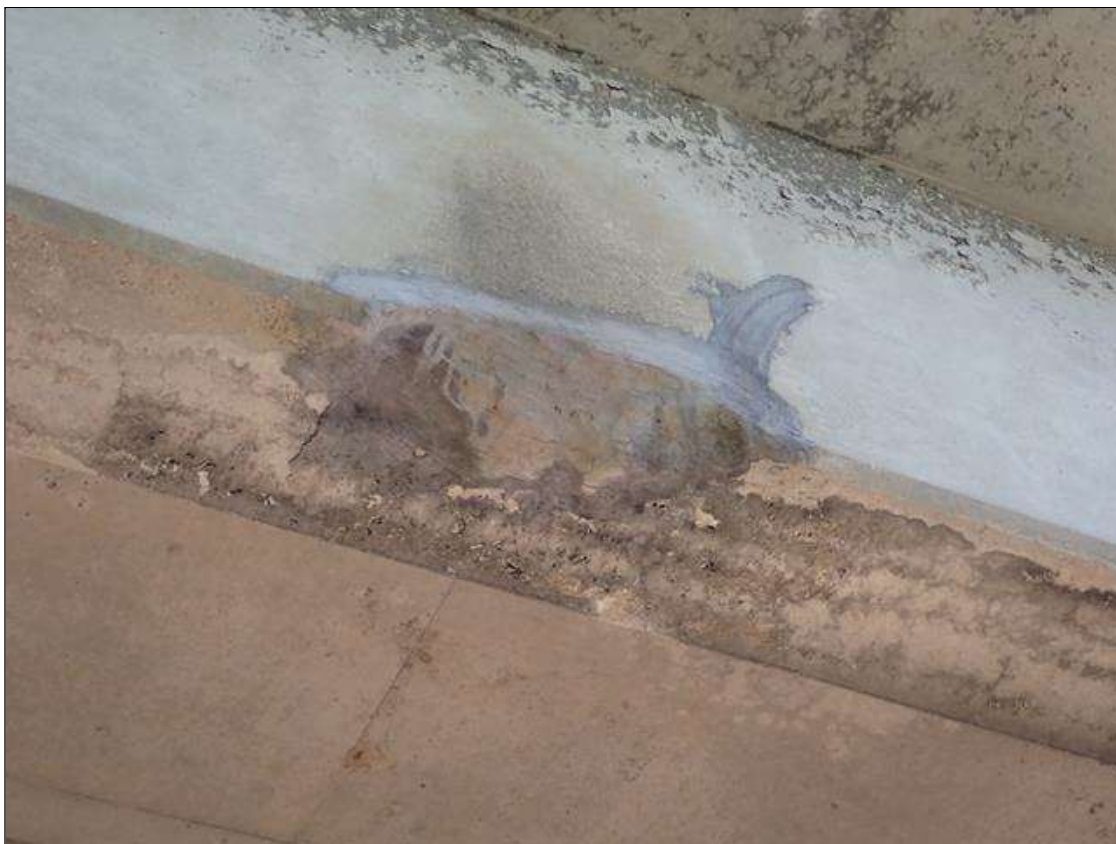
Span 4 Beam 1: WEST FACE AND BOTTOM HAS A PATCHED AREA (2.5 FOOT X 1.5 FOOT) WITH HAIRLINE MAP CRACKING.

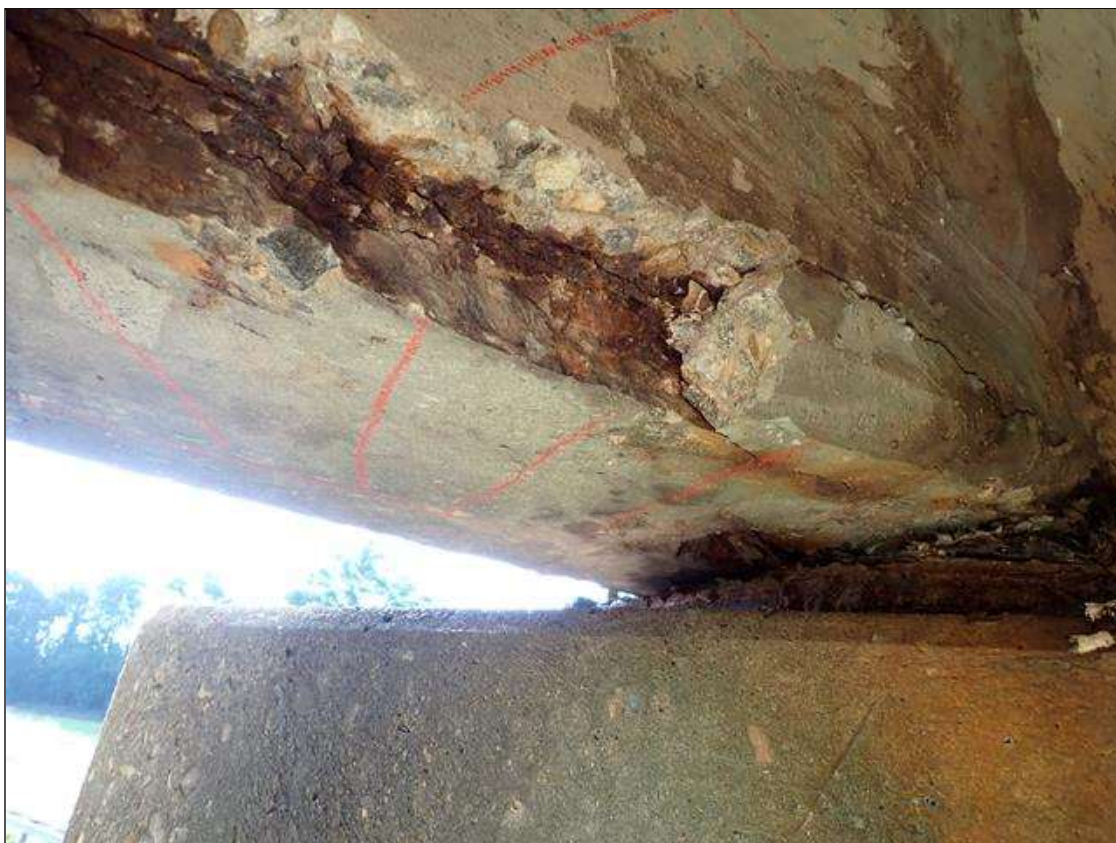
Span 5 Beam 4: (PAR) at bent 4, west face and underside, spall/delamination (6 foot x full width x up to 6 inch x 1.5 inch deep) with exposed rusted rebar (approximately 25 percent loss)

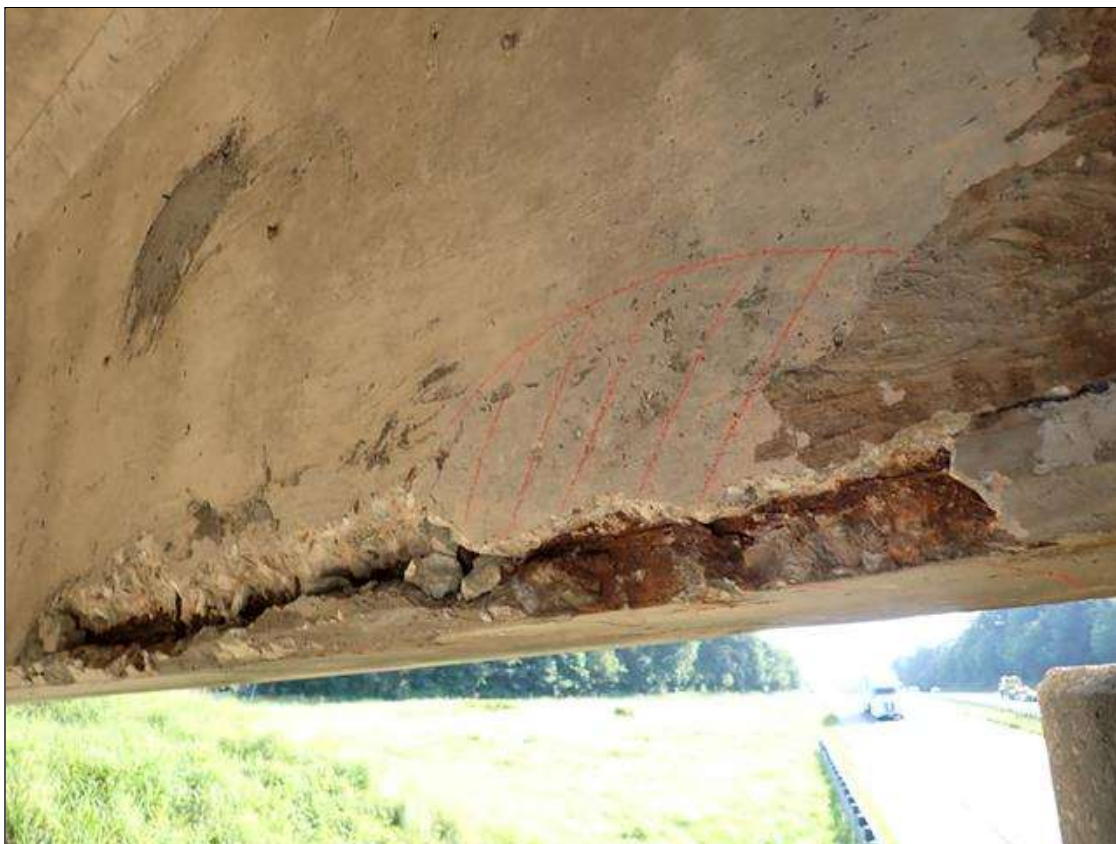
Span 5 Beam 4: (PAR) at bent 4, west face and underside, spall/delamination (6 foot x full width x up to 6 inch x 1.5 inch deep) with exposed rusted rebar (approximately 25 percent loss)

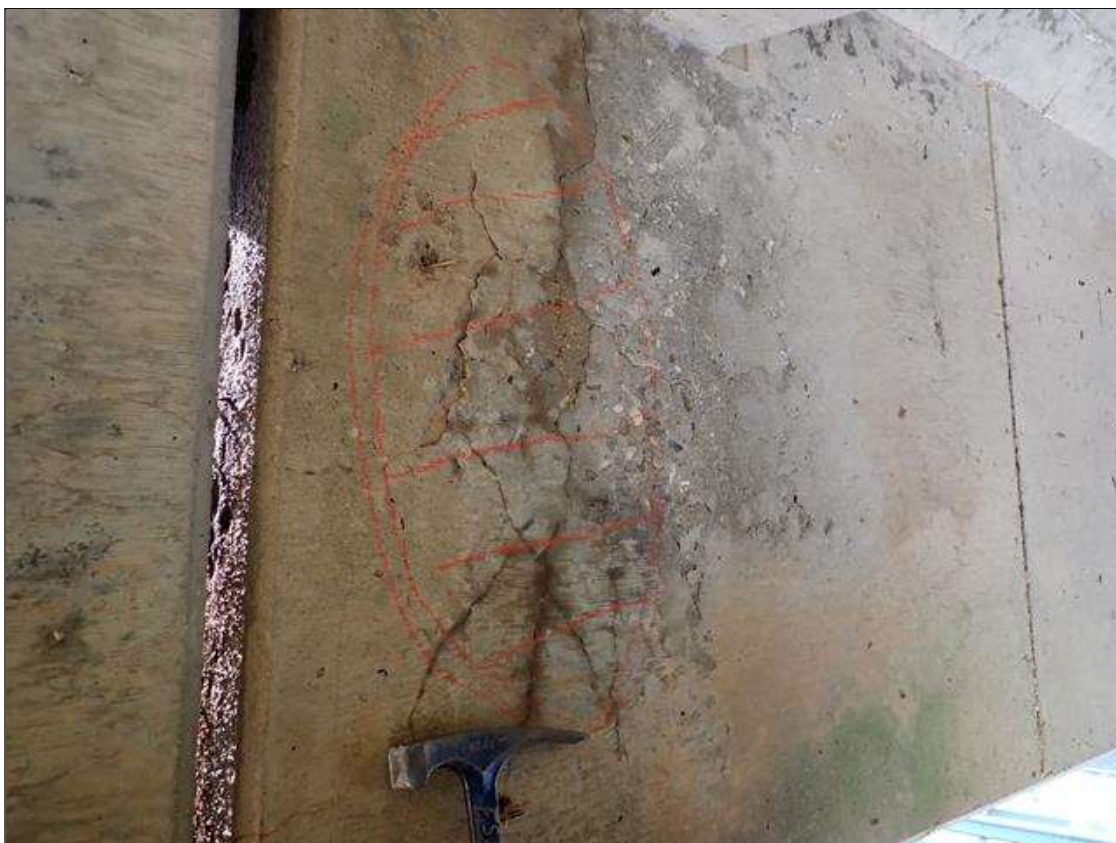
Span 4 Beam 4: West face over bent 4, delamination/spall [1 foot x 2 foot] with map cracks (up to 1/32 inch)

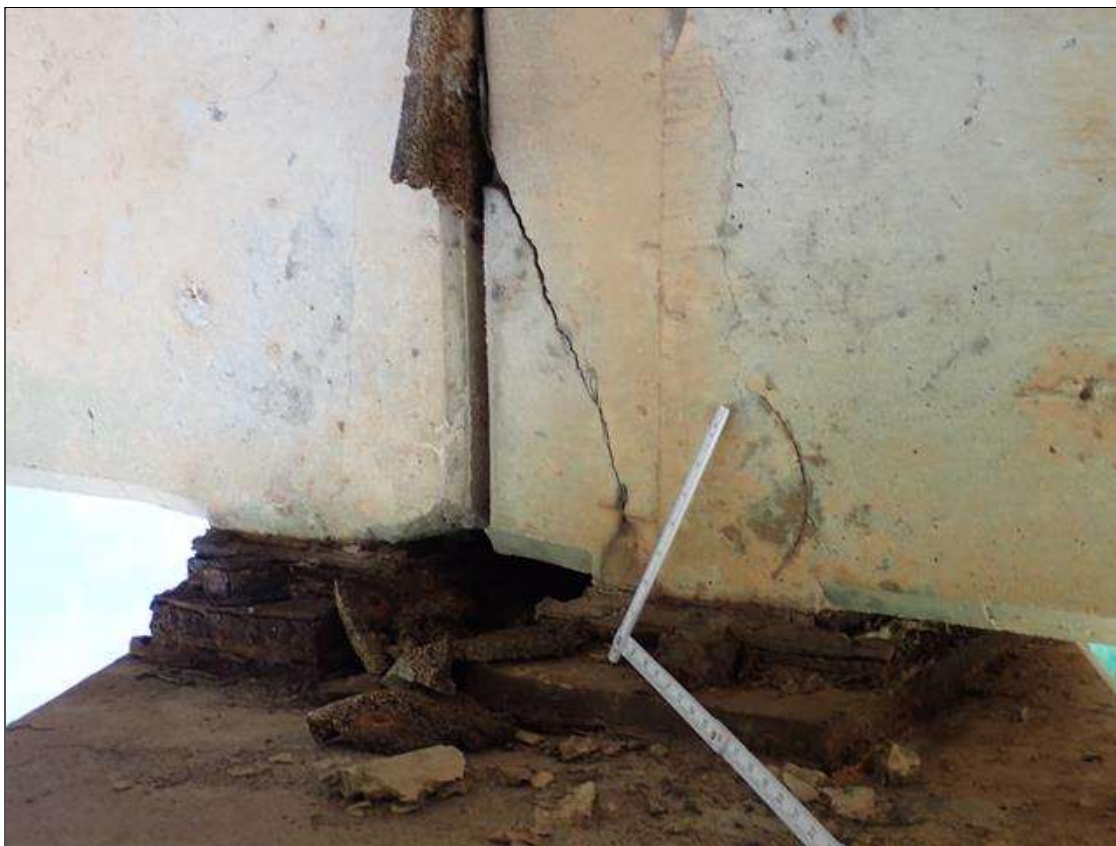
Span 5 Beam 3: East face over bent 4, delamination [16 inch x 8 inch] with cracks (up to 1/8 inch)

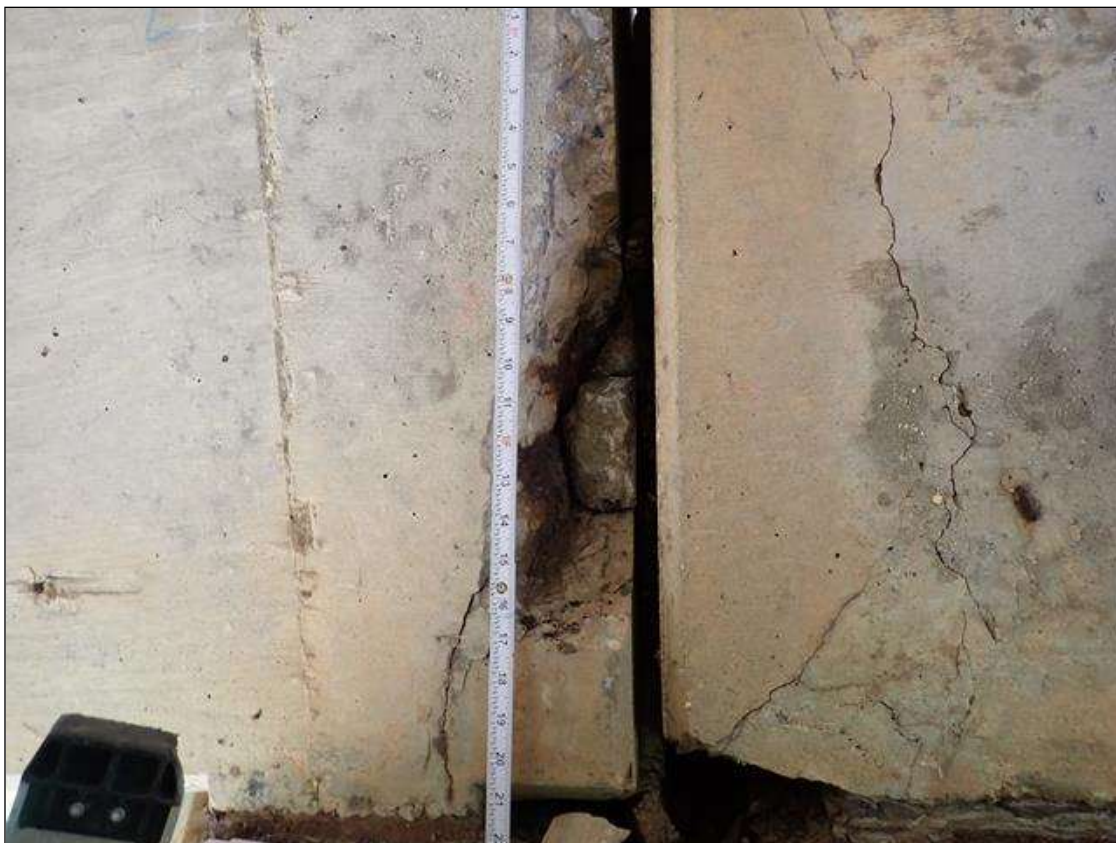
Span 5 Beam 3: (PAR) at bent 4, west face, spall/delamination (5 inch x 2 foot x 4 inch deep) with exposed rusted rebar (approximately 25 percent loss)

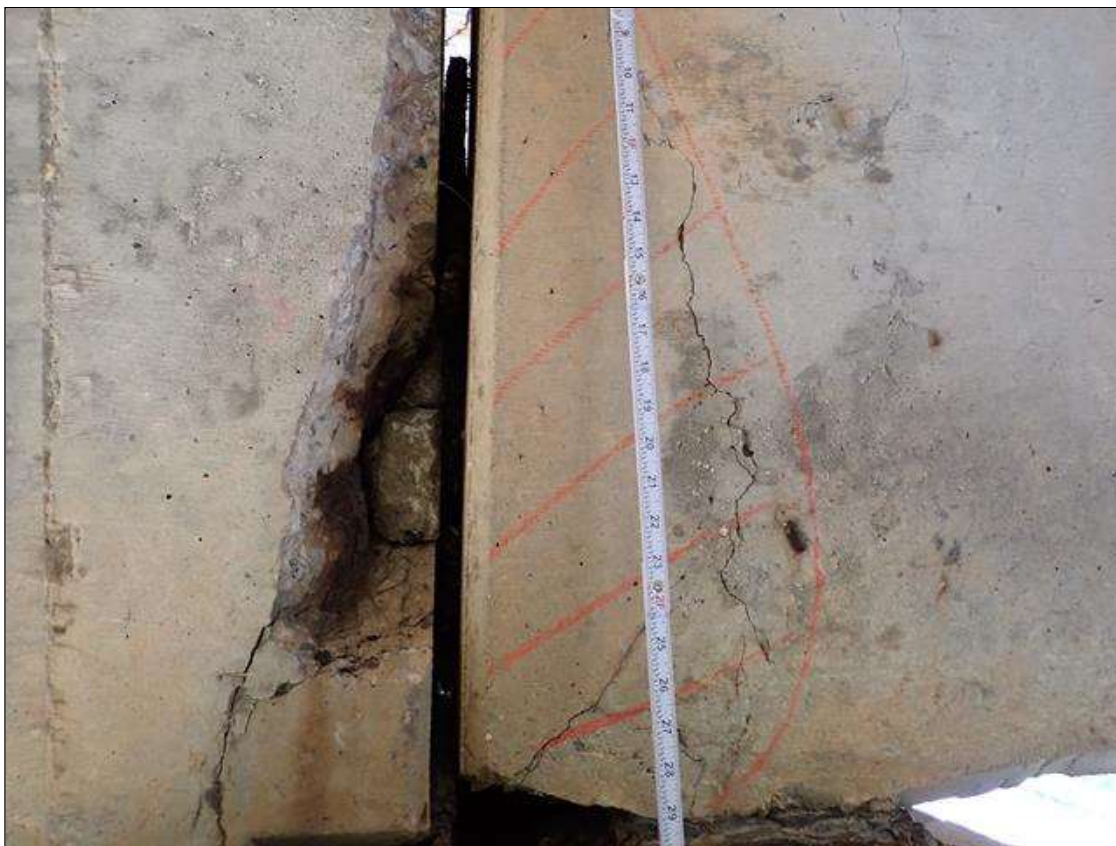
Span 4 Beam 3: SPAN 4 BEAM 3 WEST FACE OVER BENT 4. HAS A AREA THAT IS CRACKED (UP TO 1/16 INCH) AND DELAMINATED. AREA IS: (11 INCH X 31 INCH)

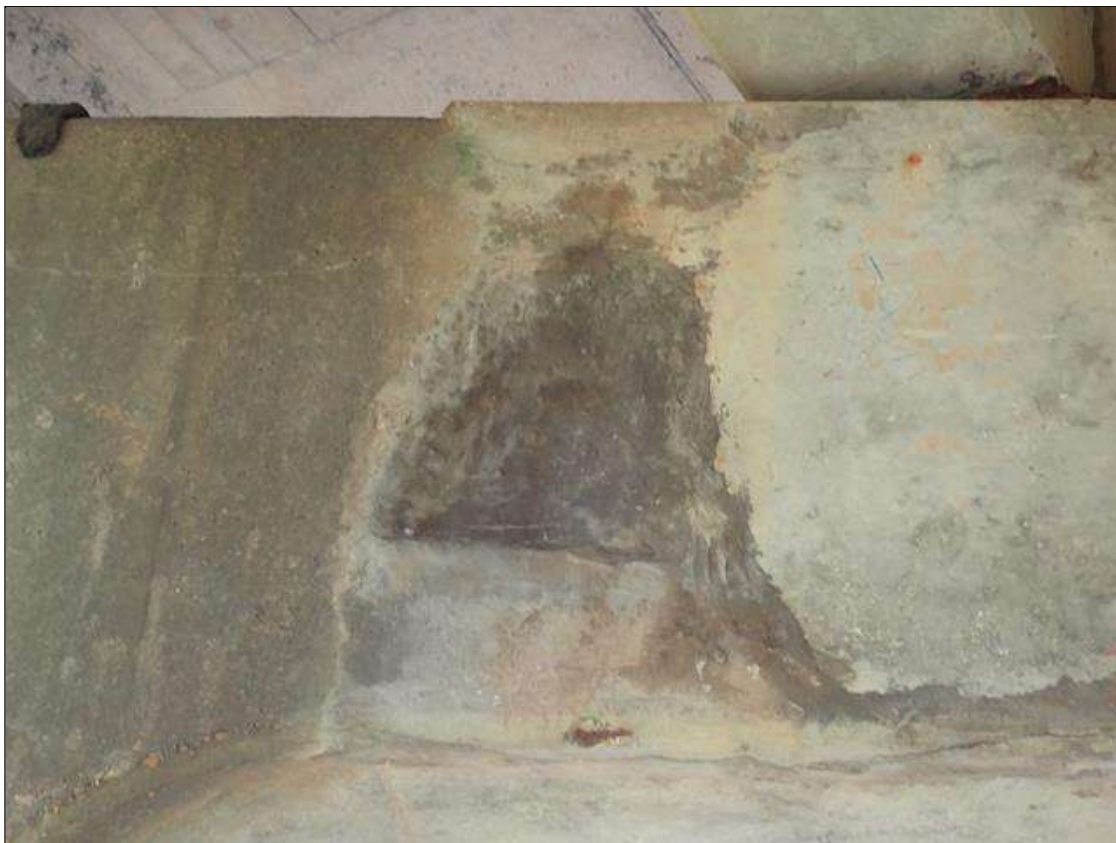
Bent 4 Cap 1: 2 FOOT X 2 FOOT UNSOUND PATCH, NORTH FACE, UNDER BAY 3.

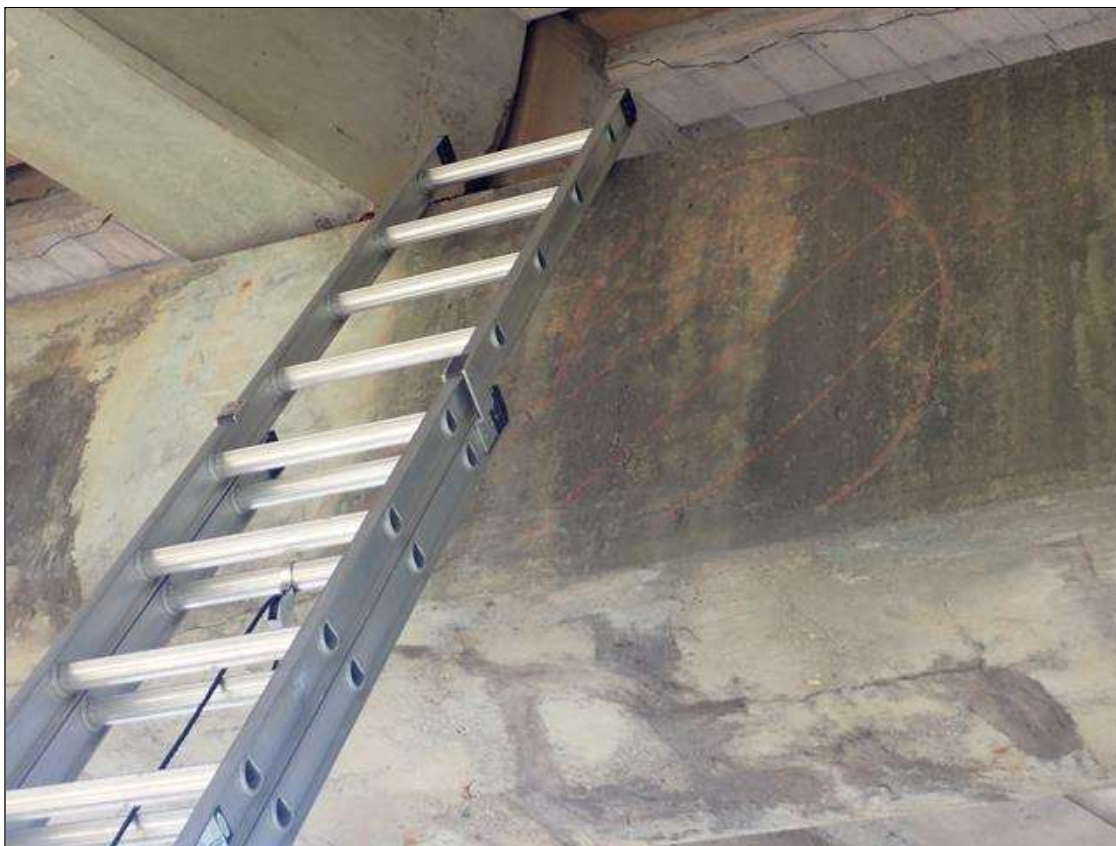
Bent 4 Cap 1: NORTH FACE BAY 2. HAS A CRACKED AND DELAMINATED AREA [UP TO FULL HEIGHT X 5.5 FOOT]

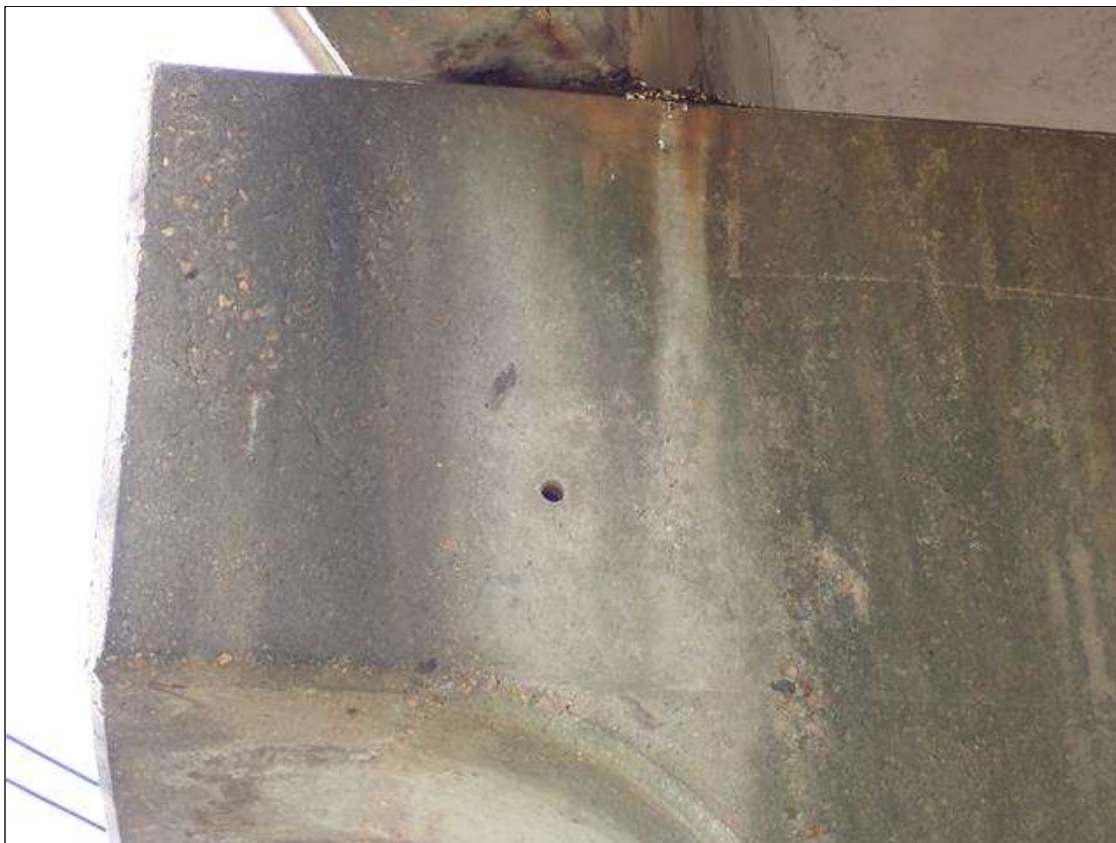
Bent 4 Cap 1: (not found 2023) North face under beam 4, delamination/spall [up to 15 inch x 17 inch x 1/4 inch deep]
