NC DEPARTMENT OF TRANSPORTATION
 DIVISION OF HIGHWAYS
 STRUCTURE MANAGEMENT UNIT

ATTENTION: **prompt action request; sketches updated; route sign attached to span 3 beam 1**

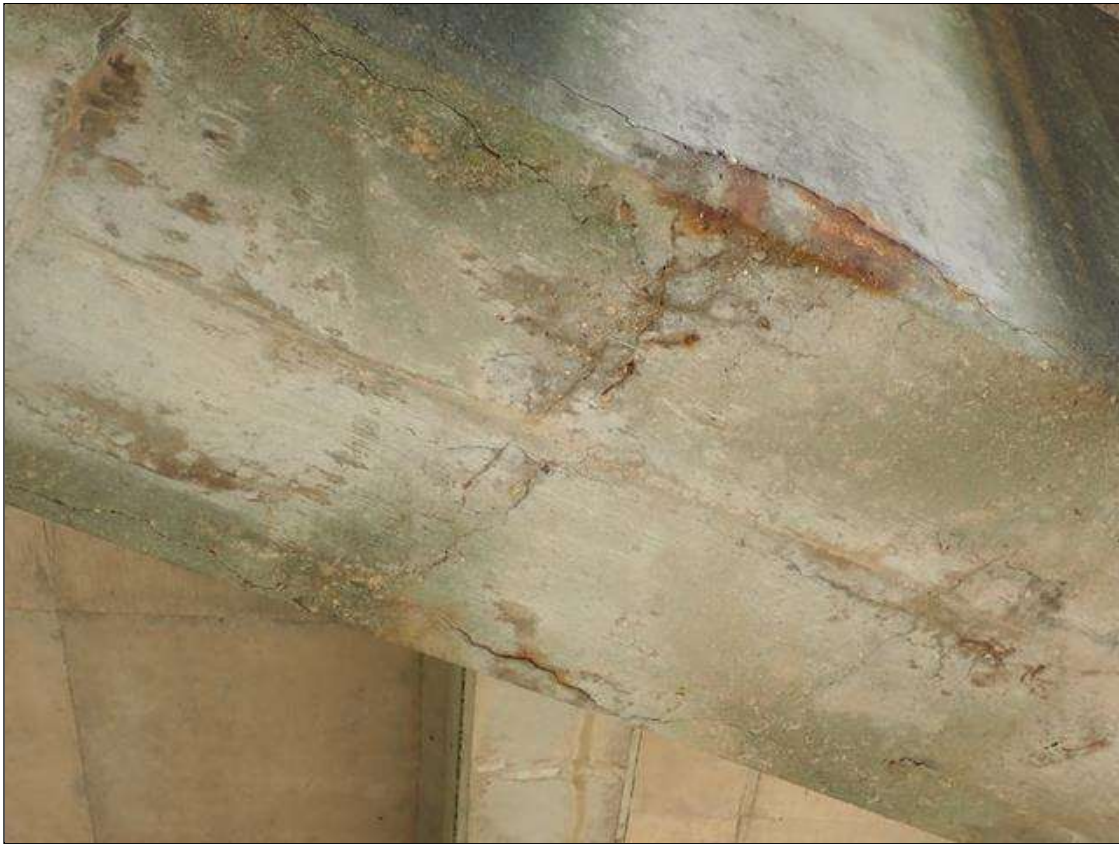
Bent 4 Cap 1: (PAR) underside of cap between columns 1 and 2, longitudinal cracks (up to 1/16 inch x 4 foot) some with rust stains and adjacent delaminations (up to 8 foot x full width)

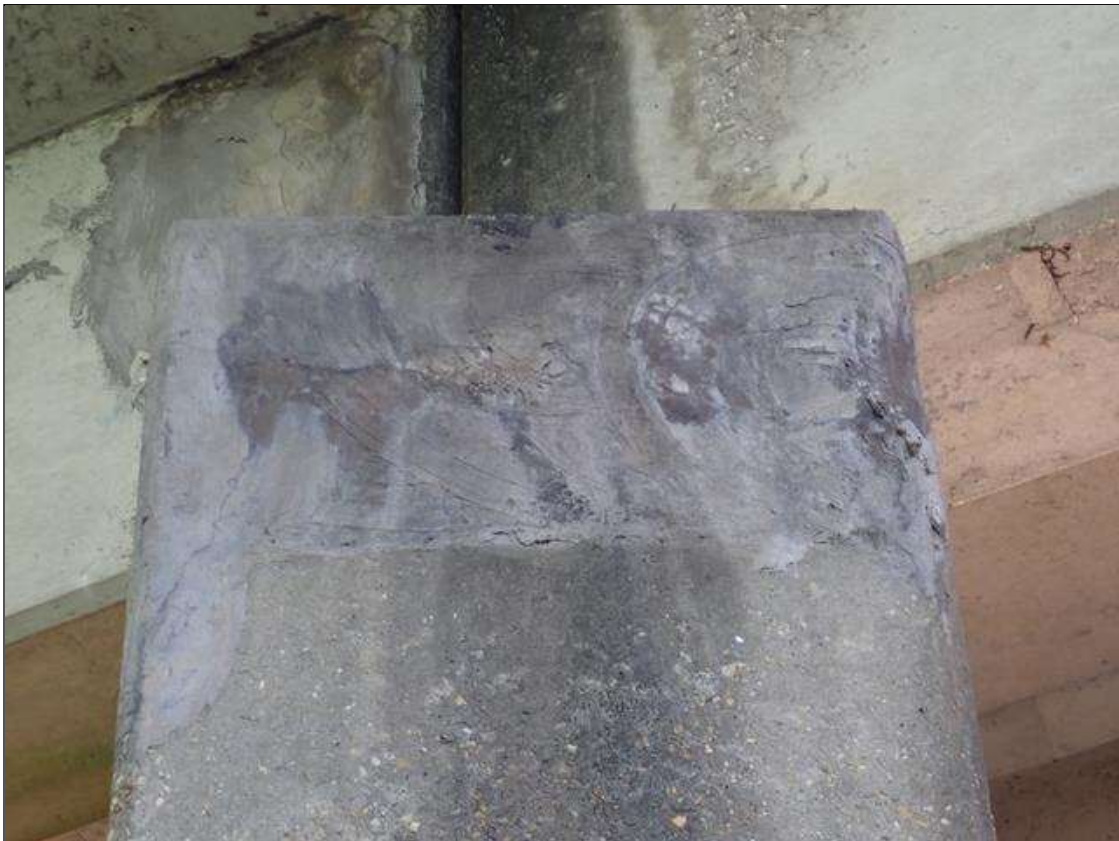
Bent 4 Cap 1: WEST FACE HAS A PATCHED AREA (3 FOOT X 2 FOOT) WITH HAIRLINE MAP CRACKING. PATCH APPEARS TO BE SOUND.

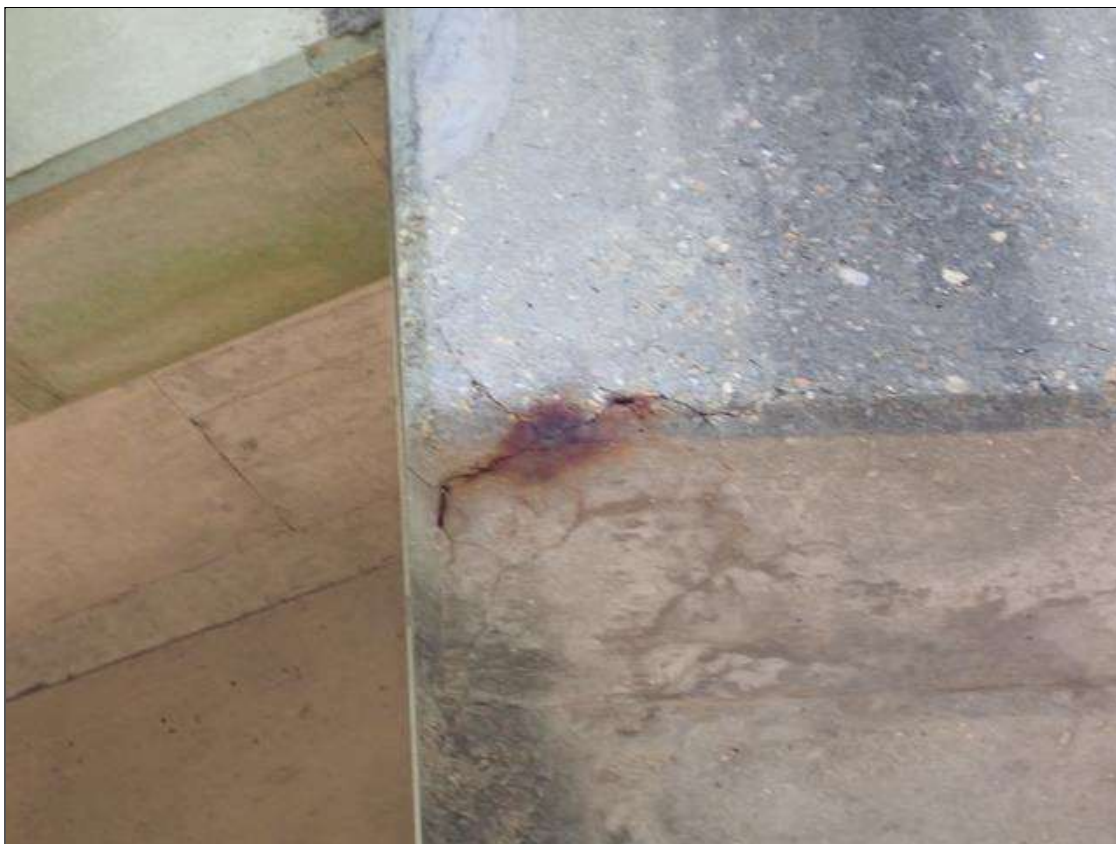
Bent 4 Cap 1: (PAR) west face at bottom corner, map cracks (up to 1/32 inch) with rust stains

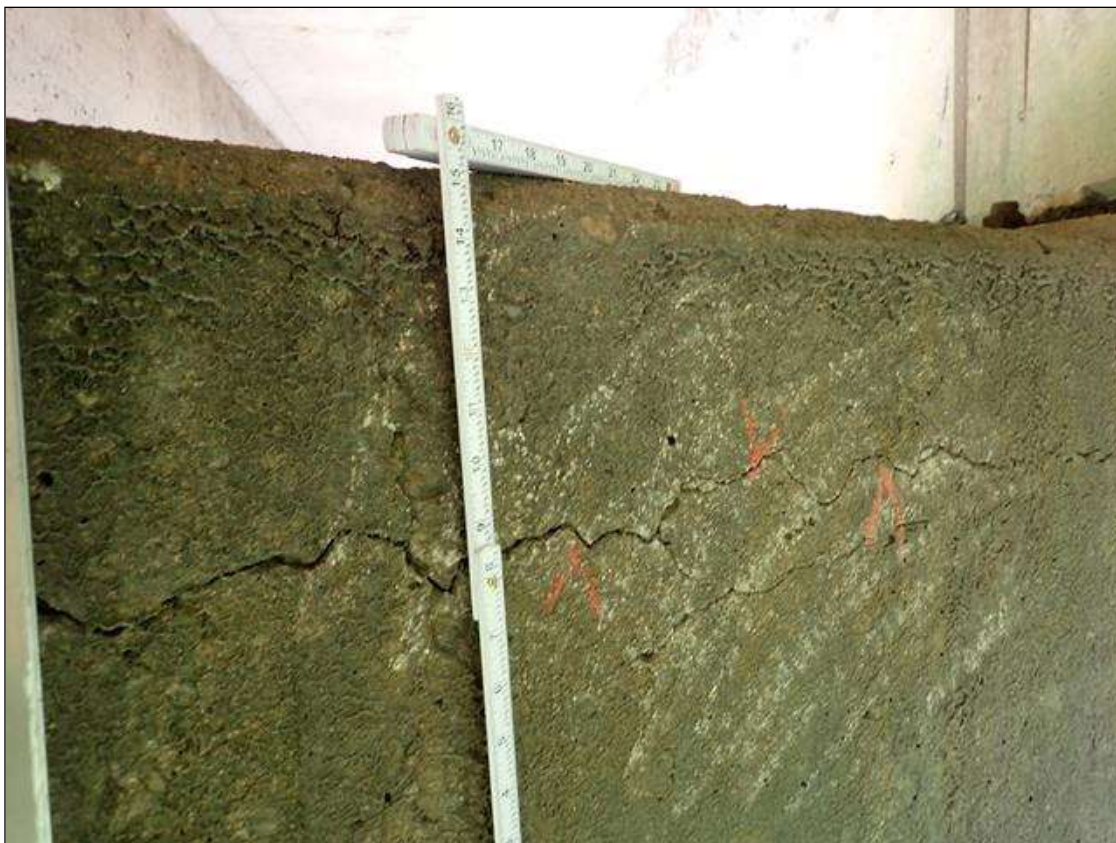
Bent 4 Cap 1: BENT 4 CAP HAS SCATTERED VERTICAL AND LONGITUDINAL CRACKS UP TO 1/16 INCH

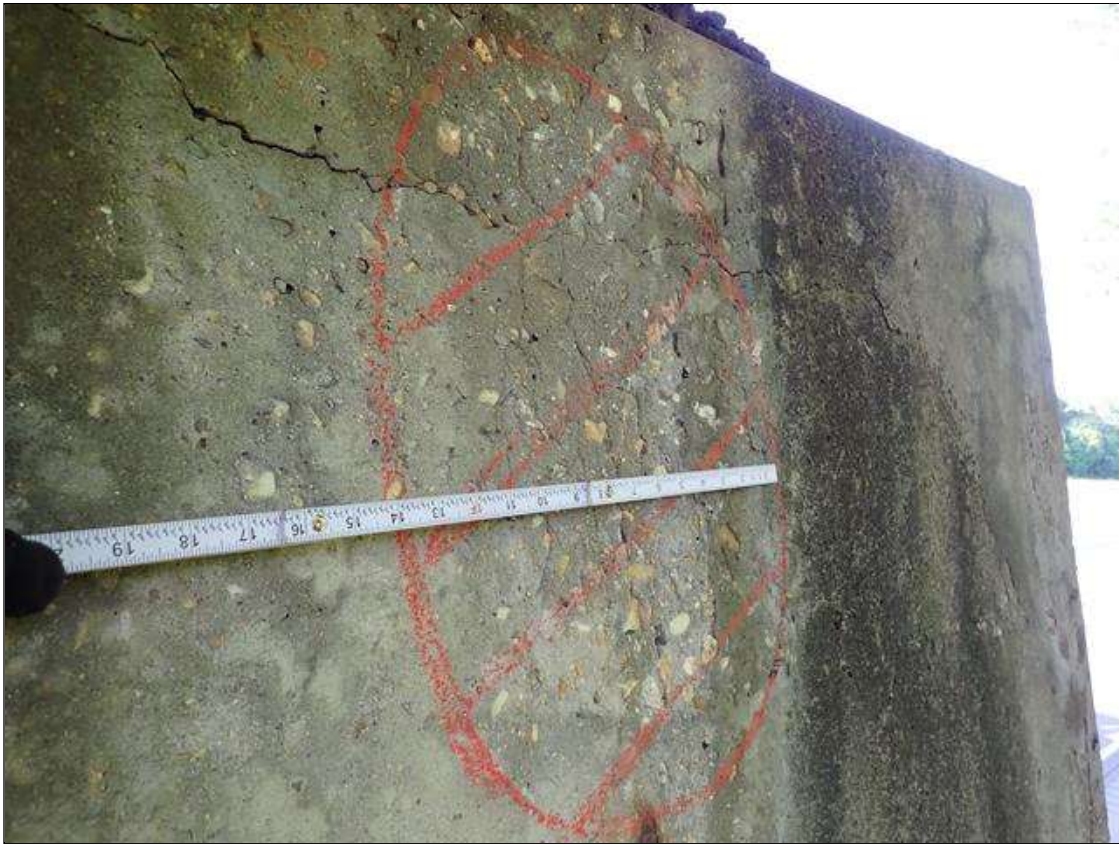
Bent 4 Cap 1: North face of cap under beam 1, delamination [14 inch x 18 inch]

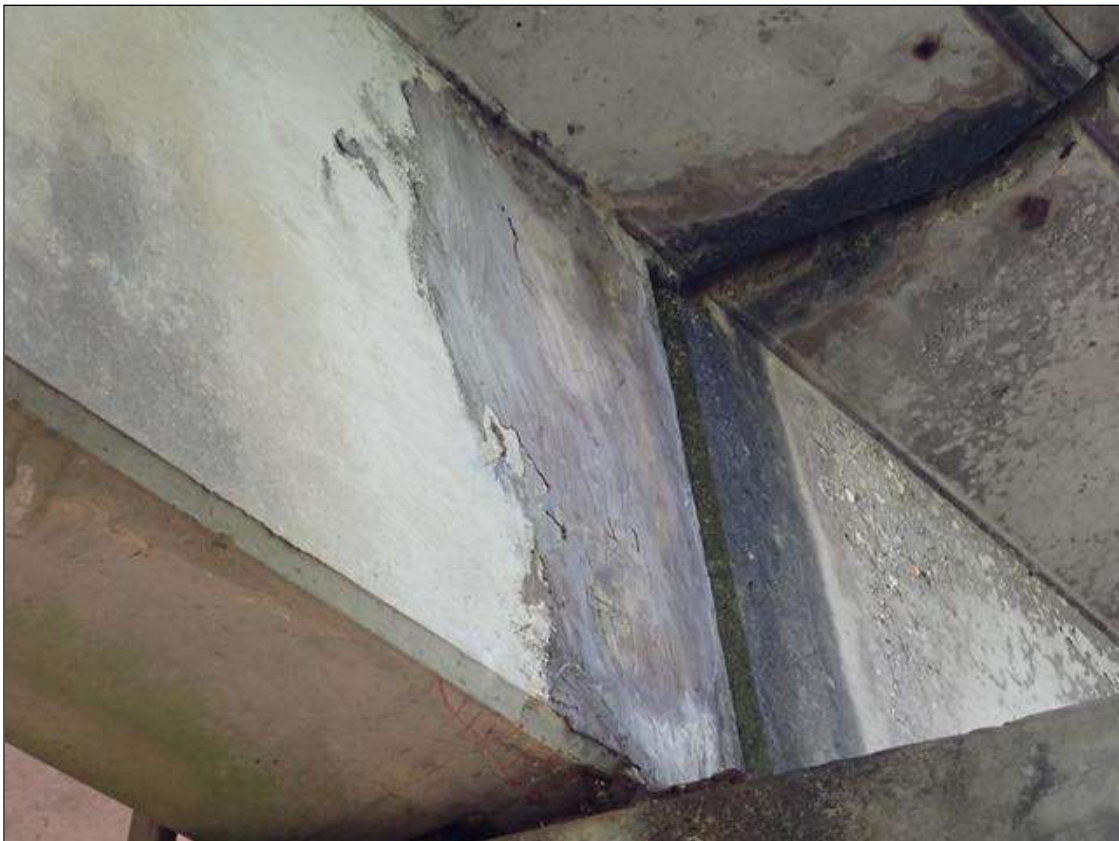
Span 5 Beam 1: WEST FACE AT BENT 4 HAS A PATCHED AREA (2 FOOT X FULL HEIGHT) THAT IS CRACKED (U TO 1/32 INCH)

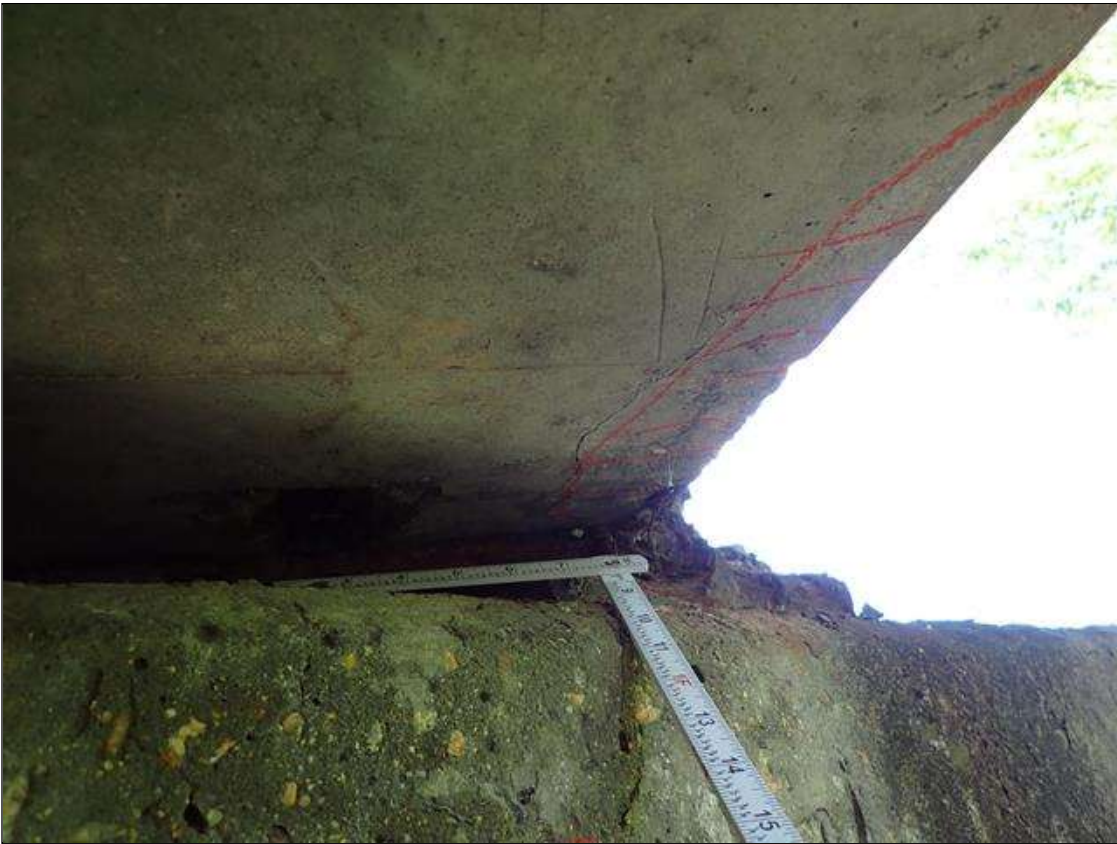
Span 5 Beam 1: at bent 4, underside, (2) spalls/delaminations (1 foot x 3 inch x 1/2 inch deep) with exposed rusted rebar

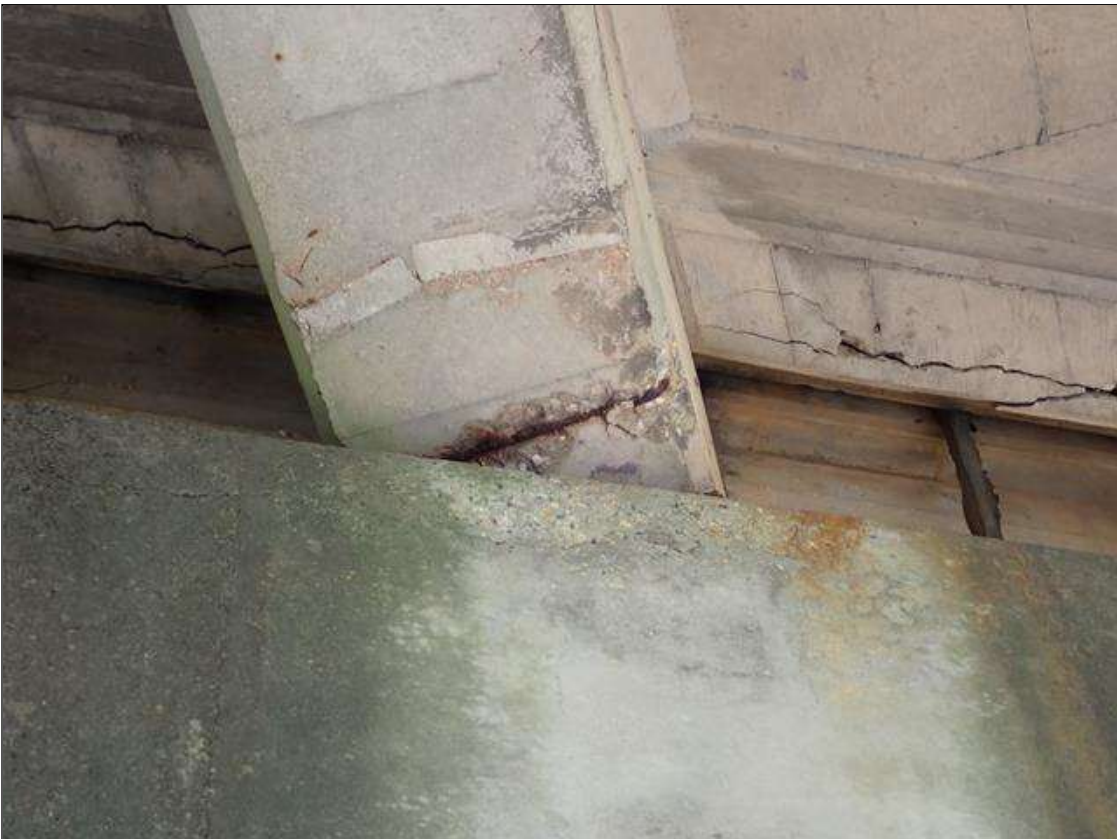
Span 4 Beam 2: BOTTOM OF BEAM 2 OVER BENT 4. HAS A CRACK/SPALL AND DELAMINATED AREA WITH REBAR EXPOSED. AREA IS: 8 INCH X FULL WIDTH X 1/2 INCH DEEP [NO LOSS NOTED]

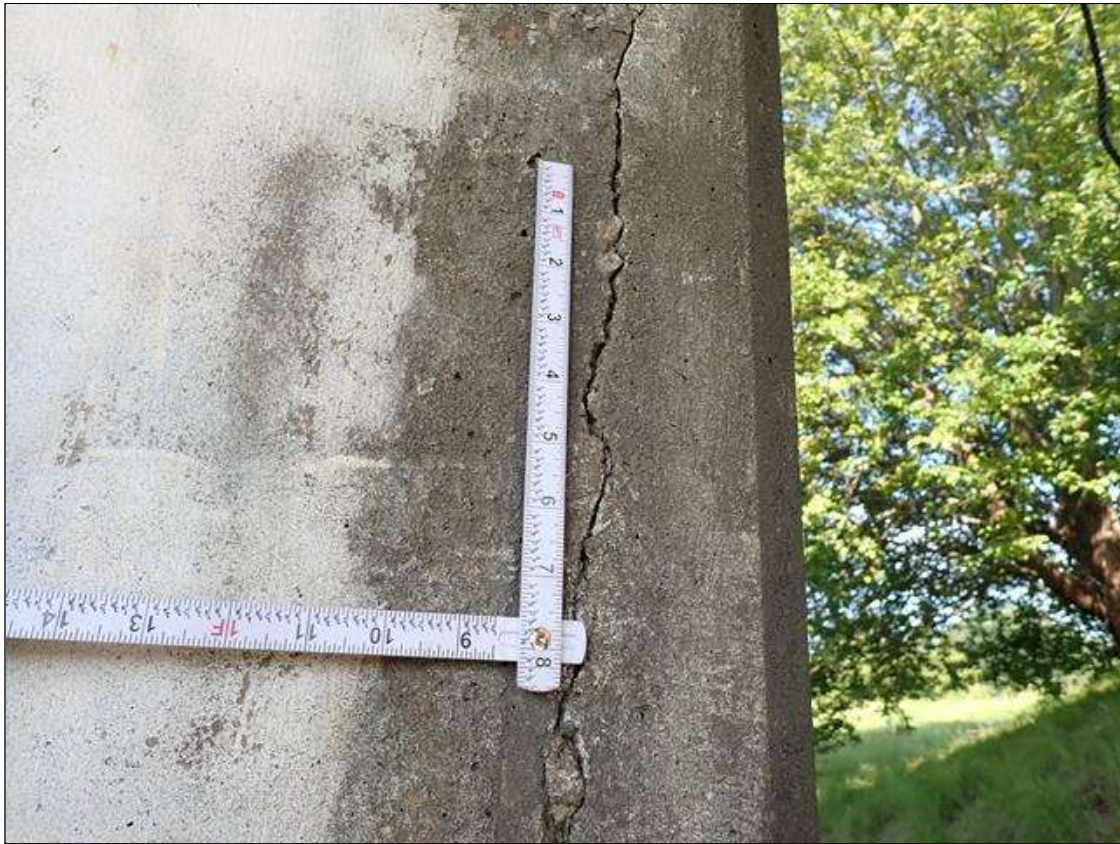
Bent 4 Pile 1: UP TO 10 FOOT X UP TO 1/16 INCH VERTICAL CRACKS, AT RANDOM THROUGHOUT.

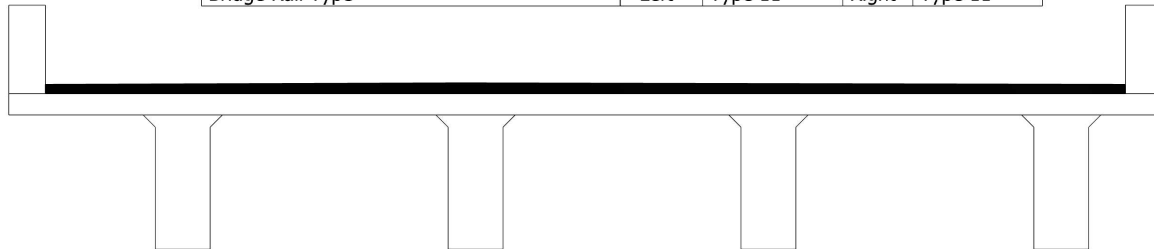
Measurements for Span #	1	All Spans Similar	
Deck Thickness	7in	Left Overhang	4.75ft
Top of Rail to Bottom of Beam (Avg)	6.667ft	Right Overhang	4.75ft

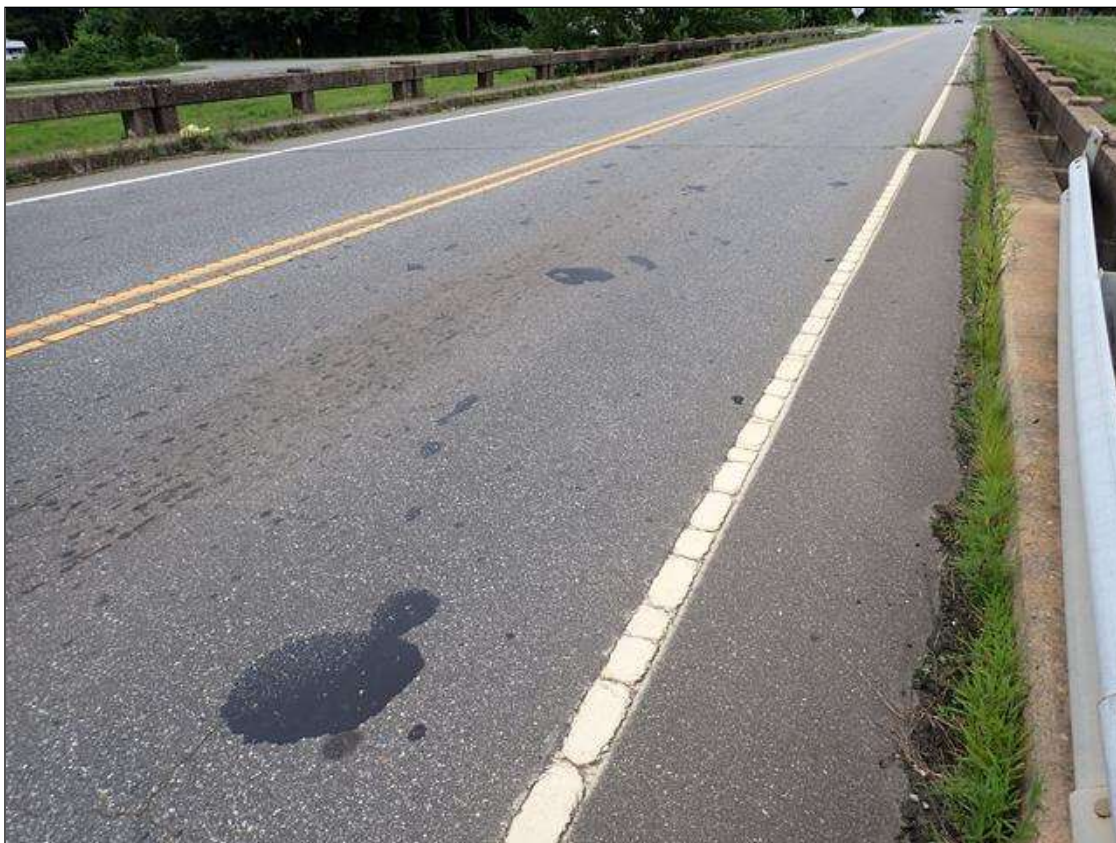
asphalt wearing surface
