NC DEPARTMENT OF TRANSPORTATION
 DIVISION OF HIGHWAYS
 STRUCTURE MANAGEMENT UNIT

Structure Safety Report

Routine Element Inspection

STRUCTURE NUMBER: 110095 SAP STRUCTURE NO: 0120095 FHWA STRUCTURE NO: 00000000230095

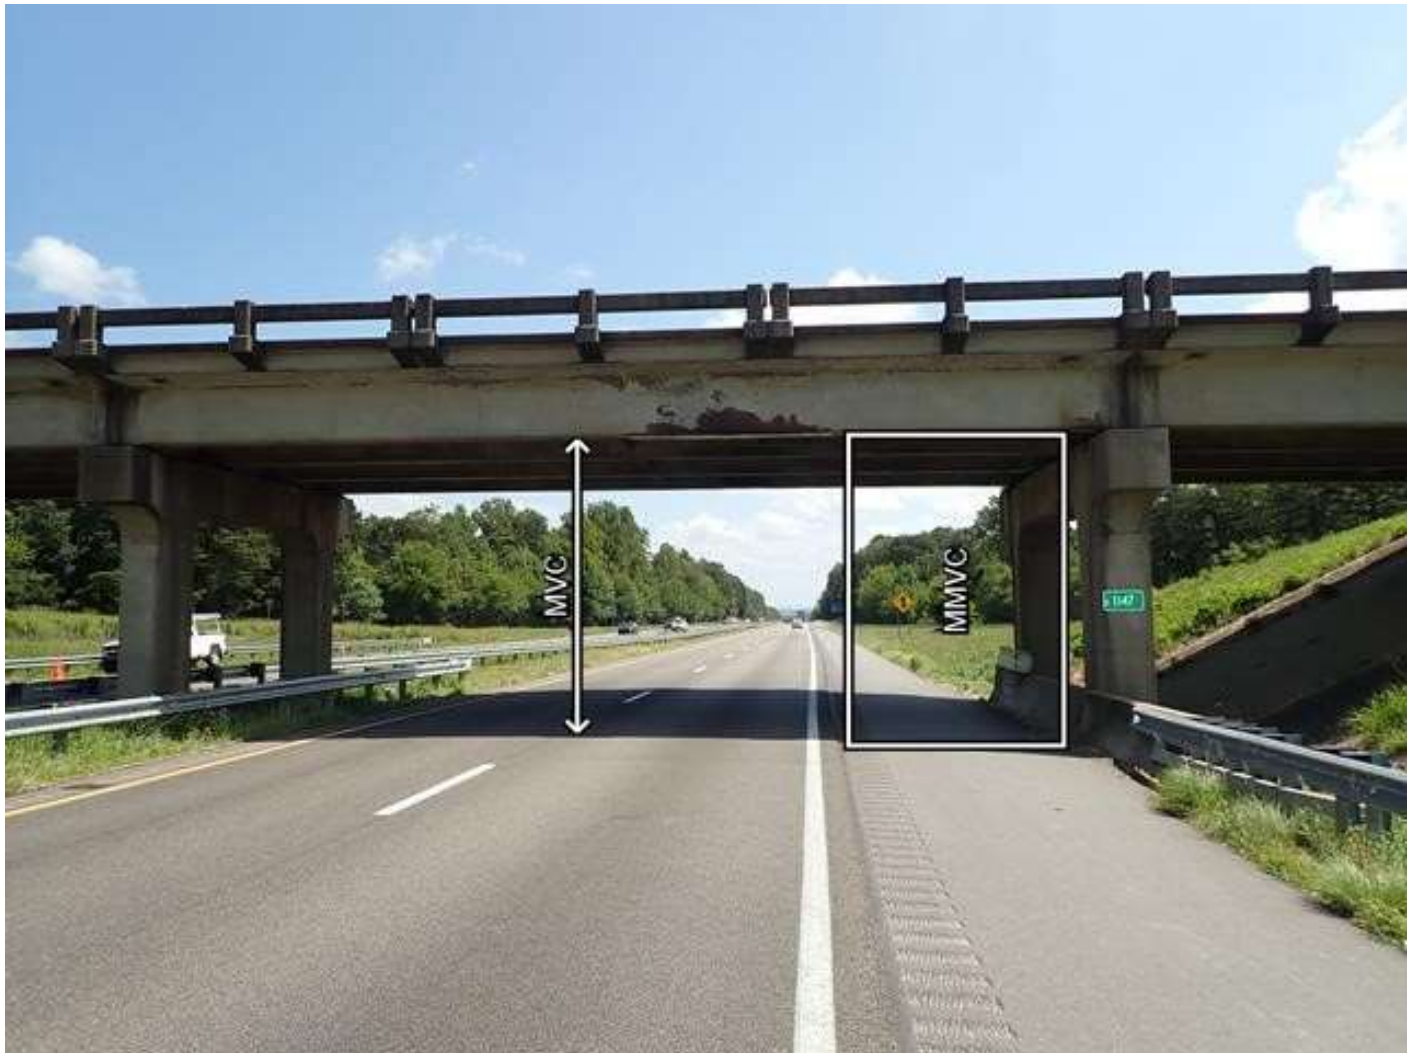
Span: 2

span 2 vertical clearance looking East

Route Number: 11000400		Route Name: I 40 E			Reference Feature: H	
Minimum Vertical Clearance 15.080 feet		Maximum Minimum Vertical Clearance 15.280 feet				
Total Horizontal Clearance 44.290 feet		Lateral Clearances: Left: 12.470 feet Right: 12.820 feet				
<input checked="" type="checkbox"/> Base Highway Network		LRS Inventory Route, Sub Route Number 10040				
Milepost: 97.690	Number of Lanes: 2	ADT: 15750	Year of ADT: 2015	Percentage of Trucks: 16		
<input checked="" type="checkbox"/> National Highway System			<input type="checkbox"/> STRAHNET Highway Designator			
Functional Classification 11 Local Principal Arterial - Interstate		Direction of Traffic: 1 1 - way traffic

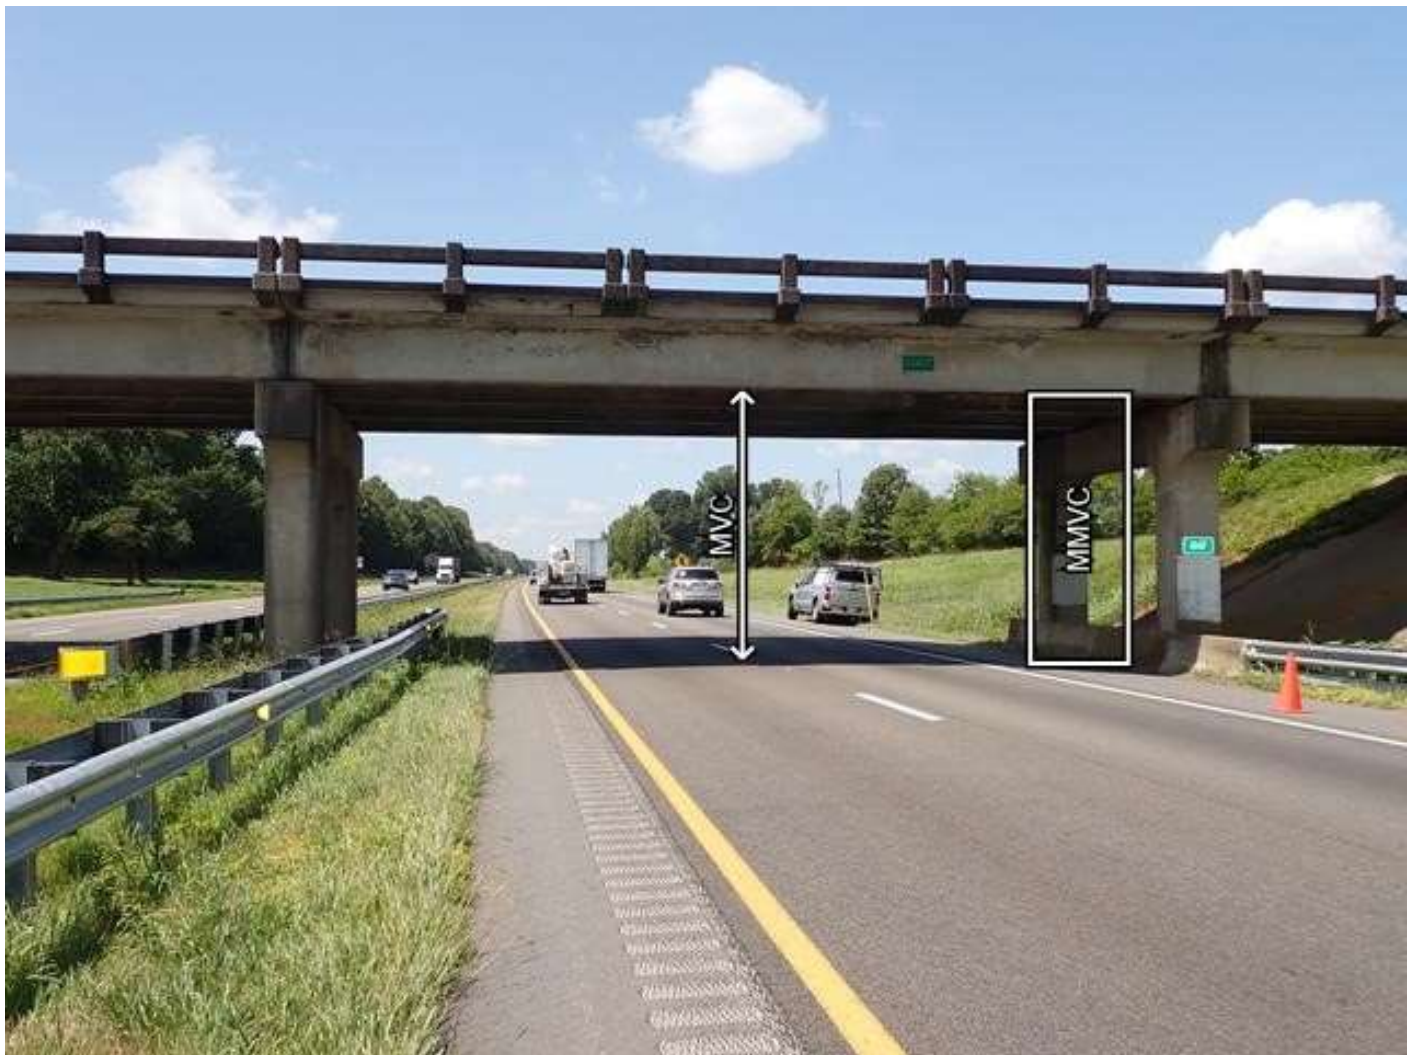
Span: 3

span 3 vertical clearance looking West

Route Number: 11000400		Route Name: I 40 W			Reference Feature: H	
Minimum Vertical Clearance 15.390 feet		Maximum Minimum Vertical Clearance 15.700 feet				
Total Horizontal Clearance 43.500 feet		Lateral Clearances: Left: 13.750 feet Right 12.000 feet				
<input checked="" type="checkbox"/> Base Highway Network		LRS Inventory Route, Sub Route Number 10040				
Milepost: 97.690	Number of Lanes: 2	ADT: 15750	Year of ADT: 2015	Percentage of Trucks: 16		
<input checked="" type="checkbox"/> National Highway System			<input type="checkbox"/> STRAHNET Highway Designator			
Functional Classification 11 Local Principal Arterial - Interstate		Direction of Traffic: 1 1 - way traffic

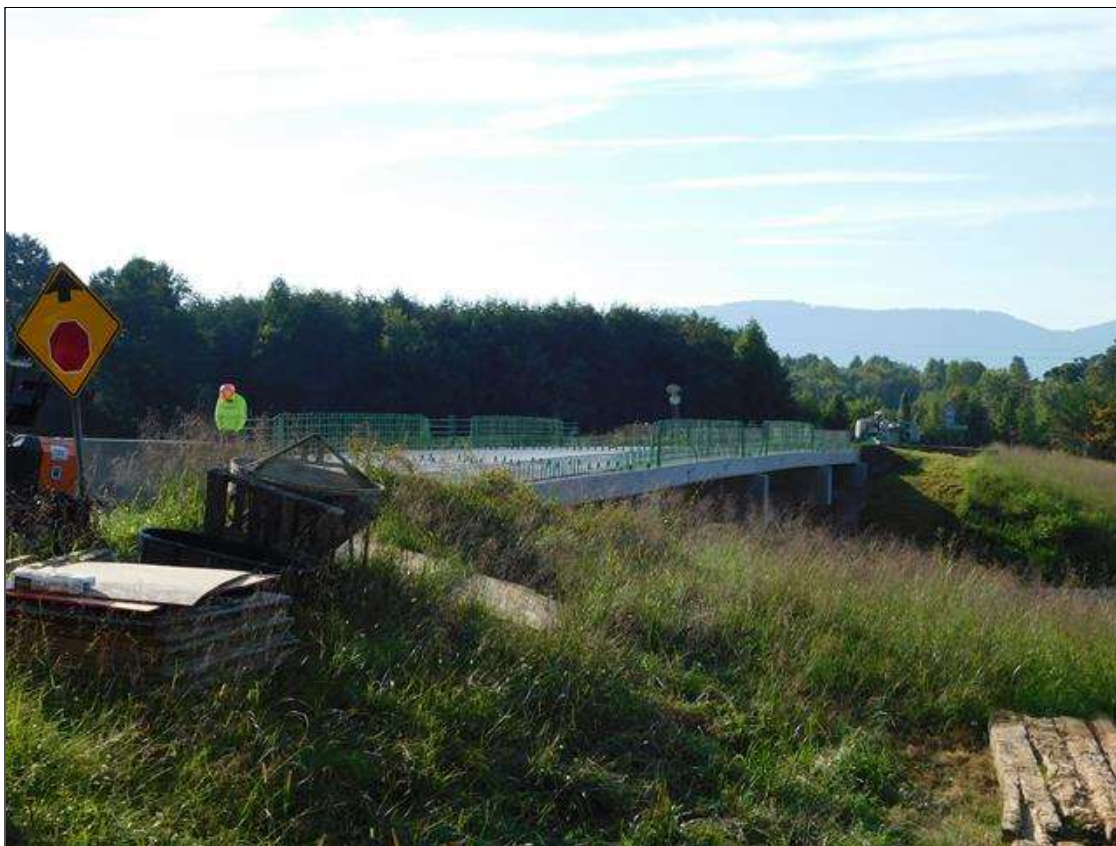
BRIDGE IS UNDER CONSTRUCTION AND CLOSED TO TRAFFIC
