NC DEPARTMENT OF TRANSPORTATION
 DIVISION OF HIGHWAYS
 STRUCTURE MANAGEMENT UNIT

ATTENTION: prompt action request; sketches updated; signs attached to beam; lateral clearance revised; new beam repairs

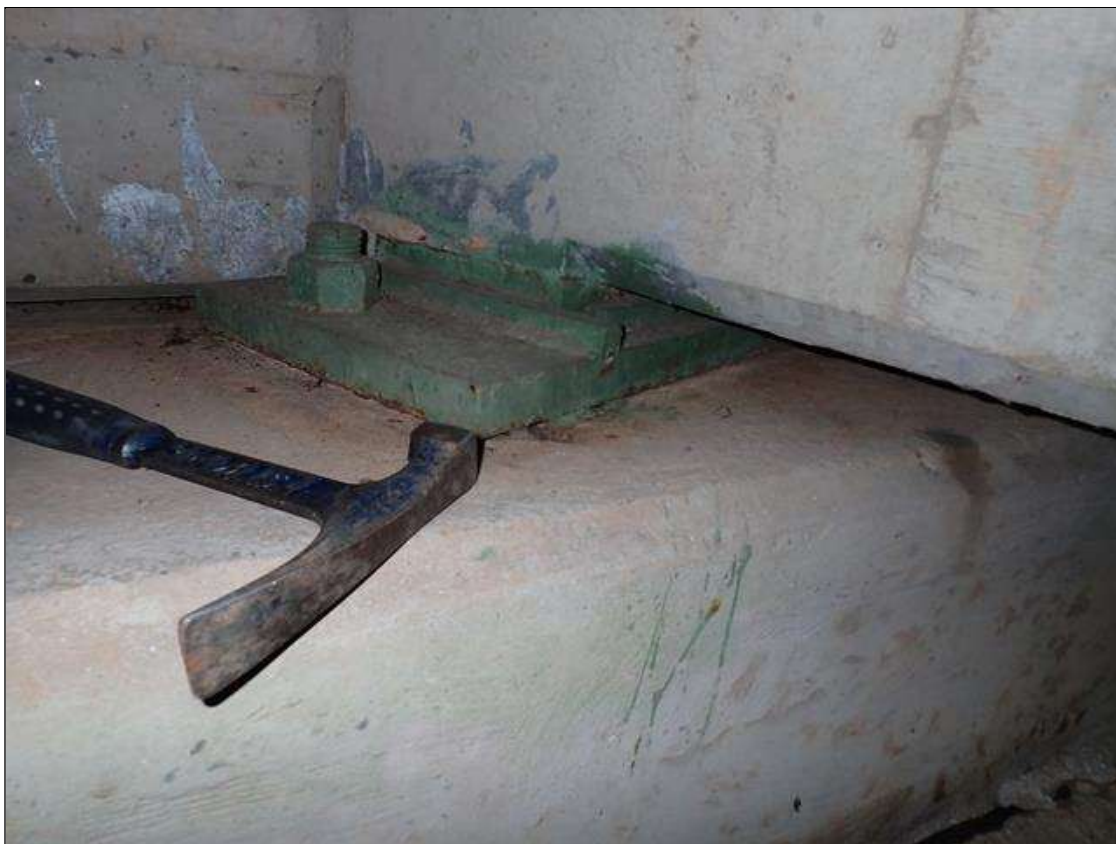
Span 1 Beam 1 - Near Bearing 1: (not found 2023) active corrosion with section loss [up to 1/16 inch] on plates

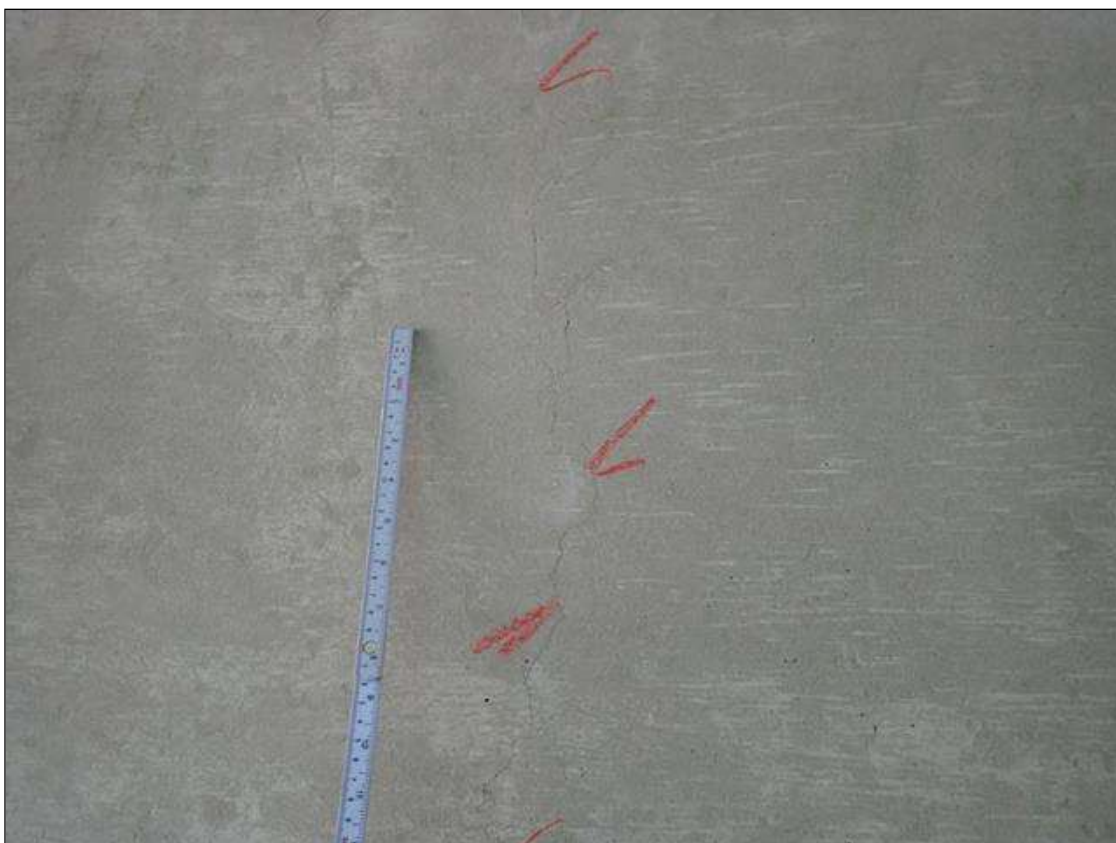
Span 1 Beam 1: TRANSVERSE AND WRAPAROUND CRACKS UP TO 1/64 INCH AT RANDOM THROUGHOUT

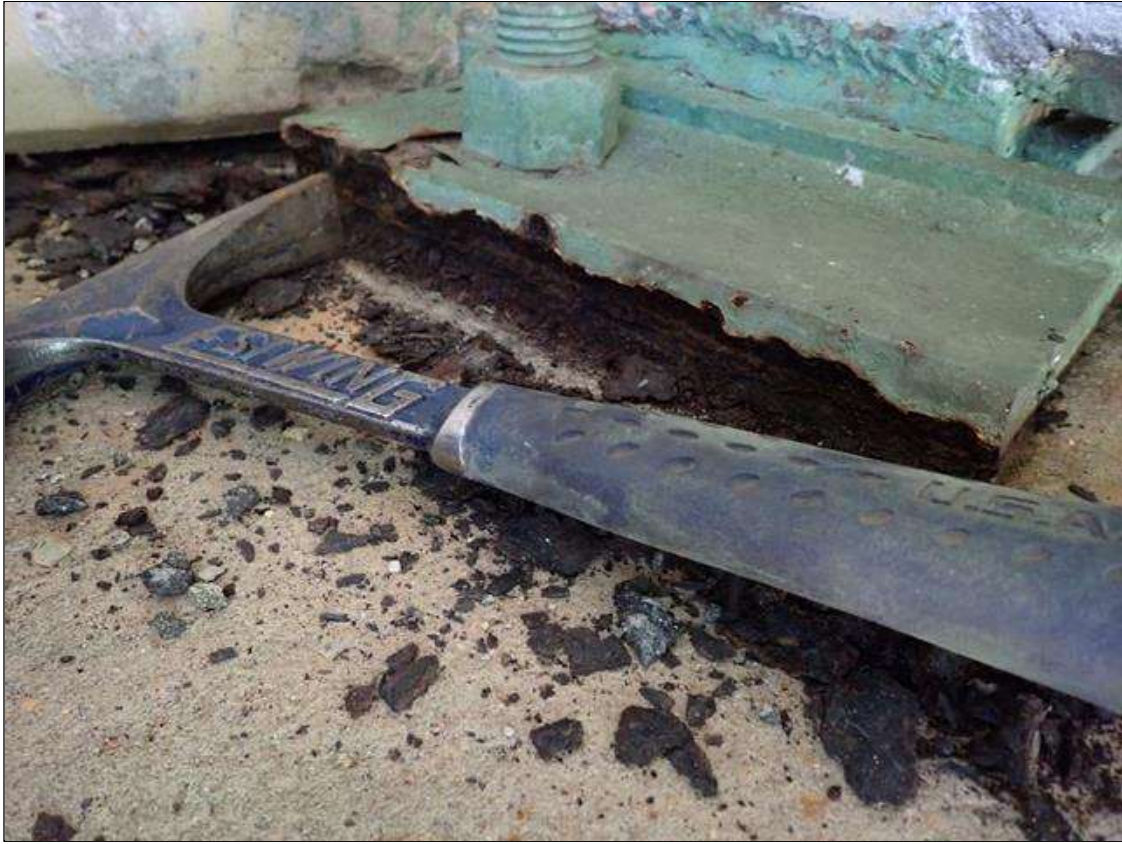
Span 1 Beam 4 - Near Bearing 4: corrosion with section loss (up to 1/8 inch deep)

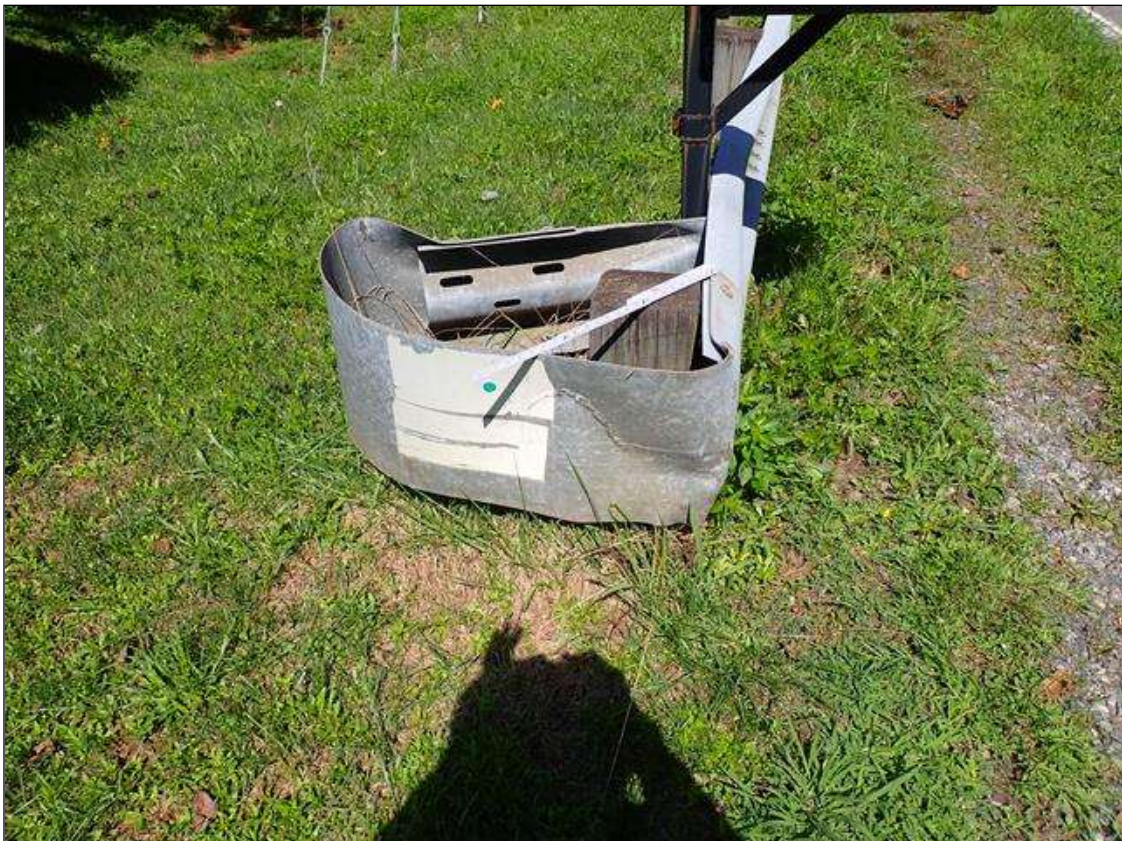
(PAR) southwest guardrail termination, impact damage

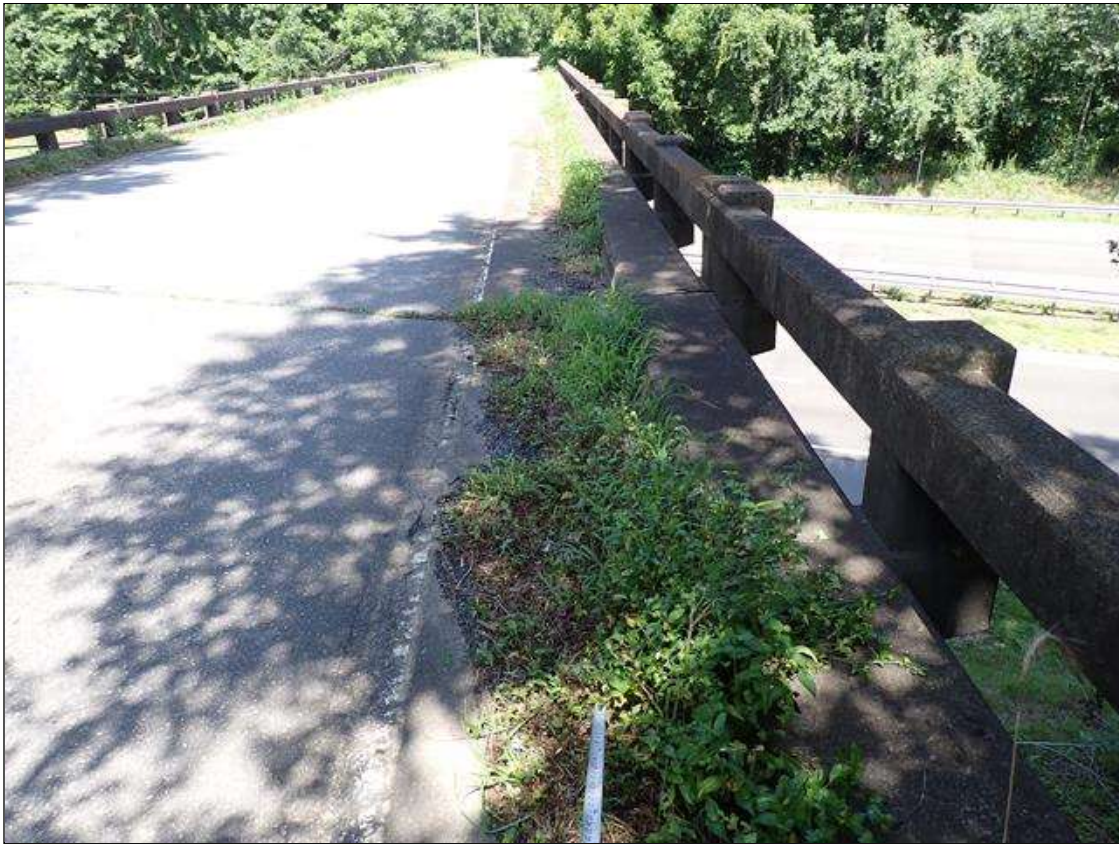
along both curblines, debris accumulation (up to 29 inch x full length) with vegetation growth; fully obstructing deck drainage

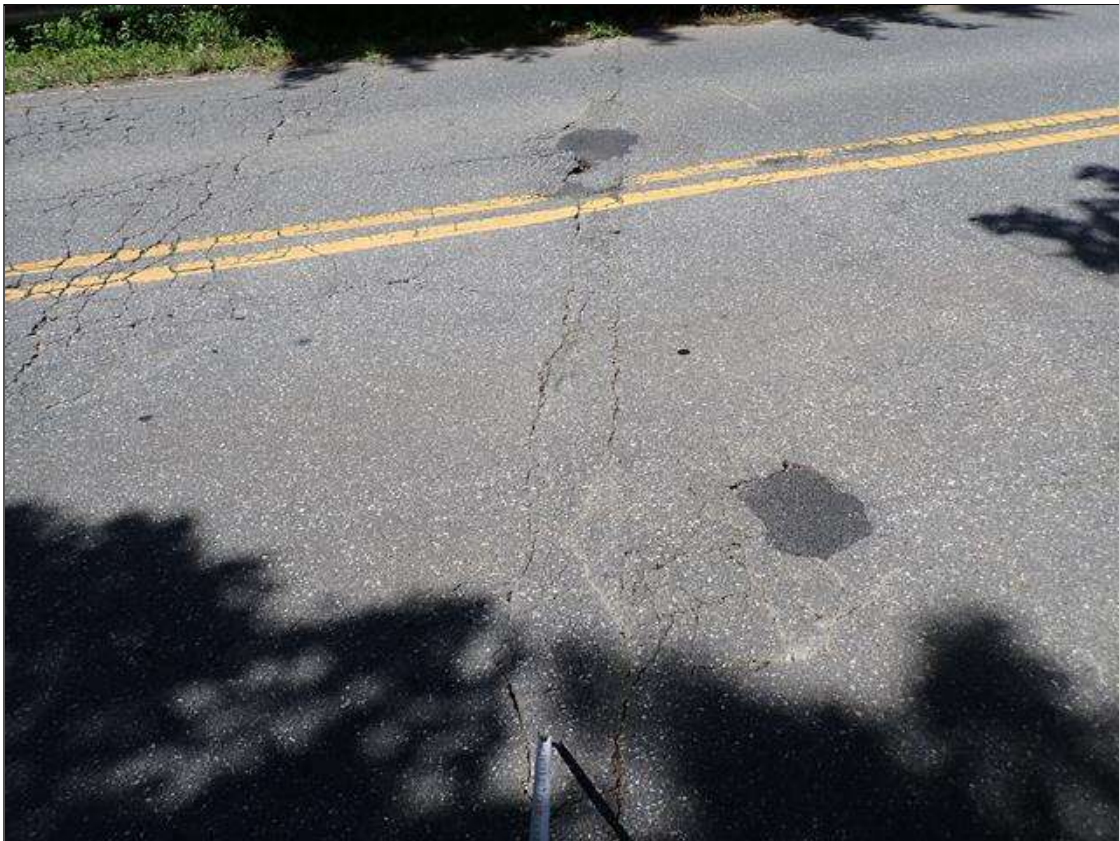
Span 1 Wearing Surface: along length of asphalt over end bent 1, transverse cracks [up to 1/4 inch x full roadway width] with edge spalling up to (1/2 inch deep) and associated sound patch [4 foot x 8 inch]

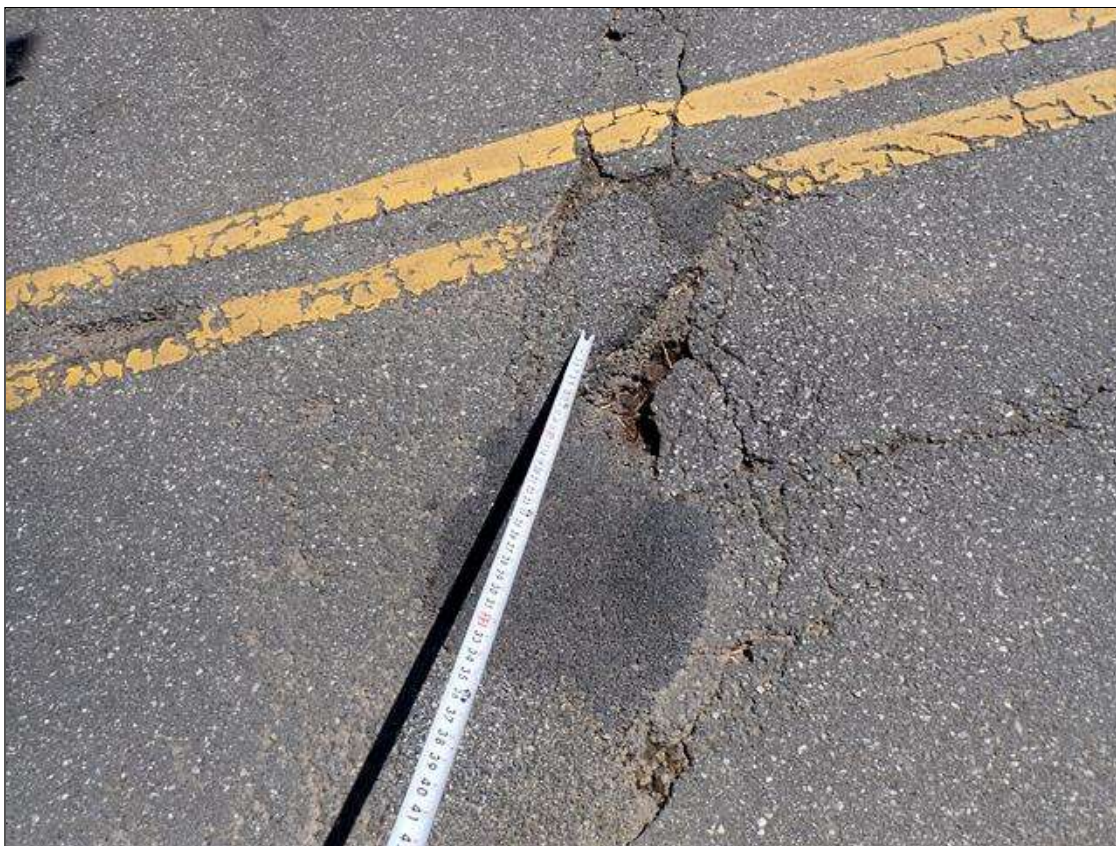
Span 1 Wearing Surface: (PAR) at centerline of roadway, pothole (14 inch x 4 inch x 3 inch deep)

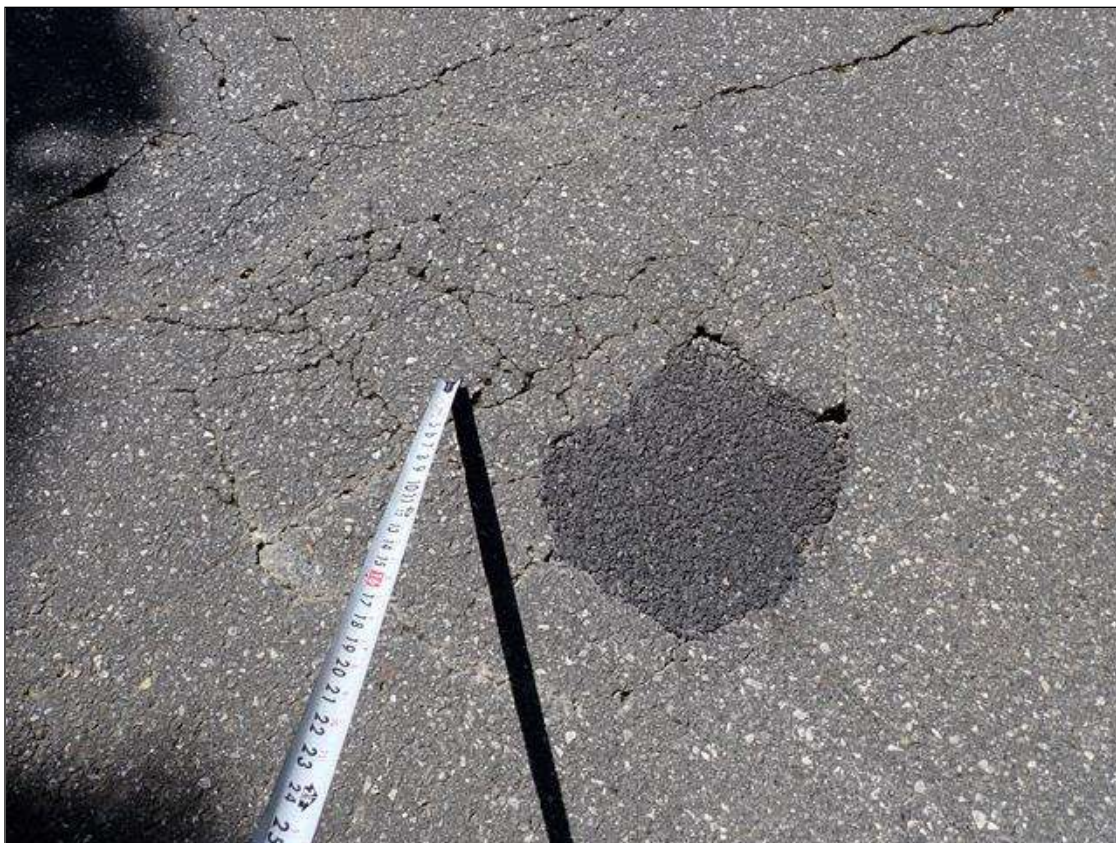
Span 1 Wearing Surface: near end bent 1, northbound lane, patched area (12 inch x 14 inch) with adjacent map cracks (up to 1/16 inch x 2 foot x 2 foot)

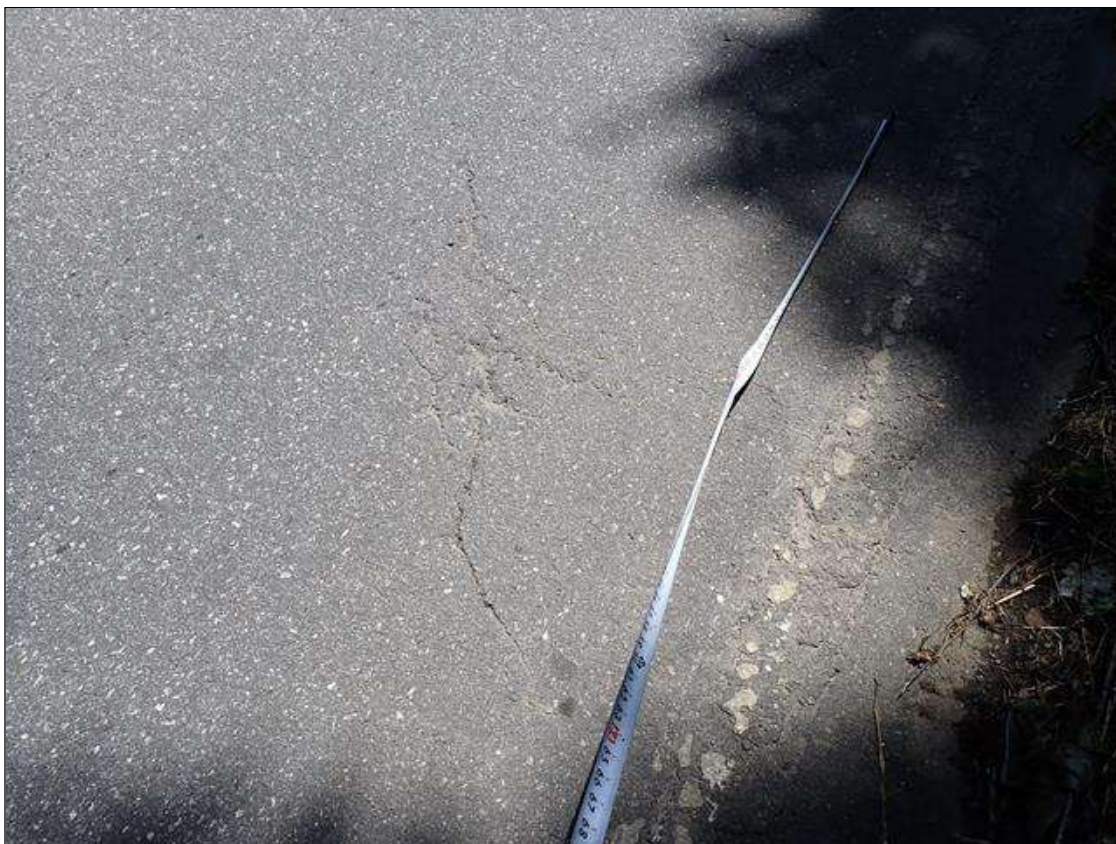
Span 1 Wearing Surface: MULTIPLE AREAS OF BROKEN ASPHALT/MAF CRACKING UP TO 1/16 INCH X 2 FOOT X 10 FOOT SOUTHBOUND LANE 7 FOOT FROM WEST CURB

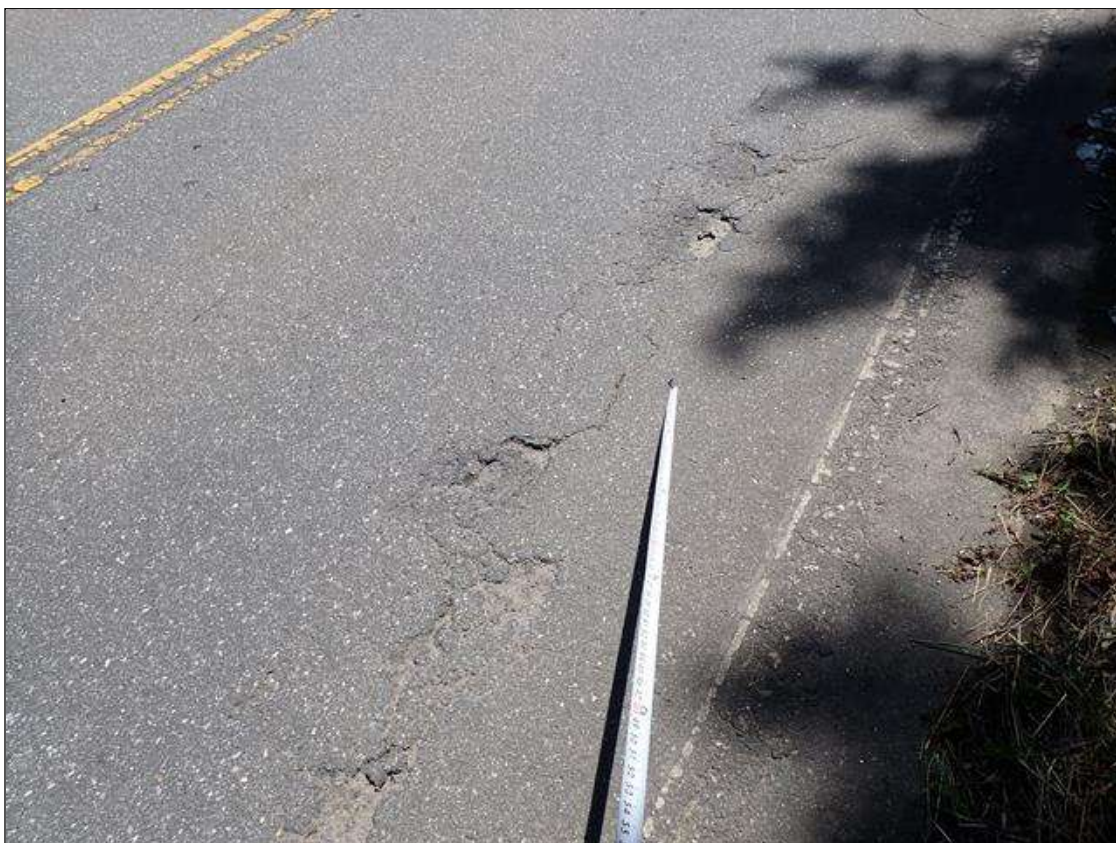
Span 1 Wearing Surface: MULTIPLE AREAS OF BROKEN ASPHALT/MAF CRACKING UP TO 1/16 INCH X 2 FOOT X 10 FOOT SOUTHBOUND LANE 7 FOOT FROM WEST CURB

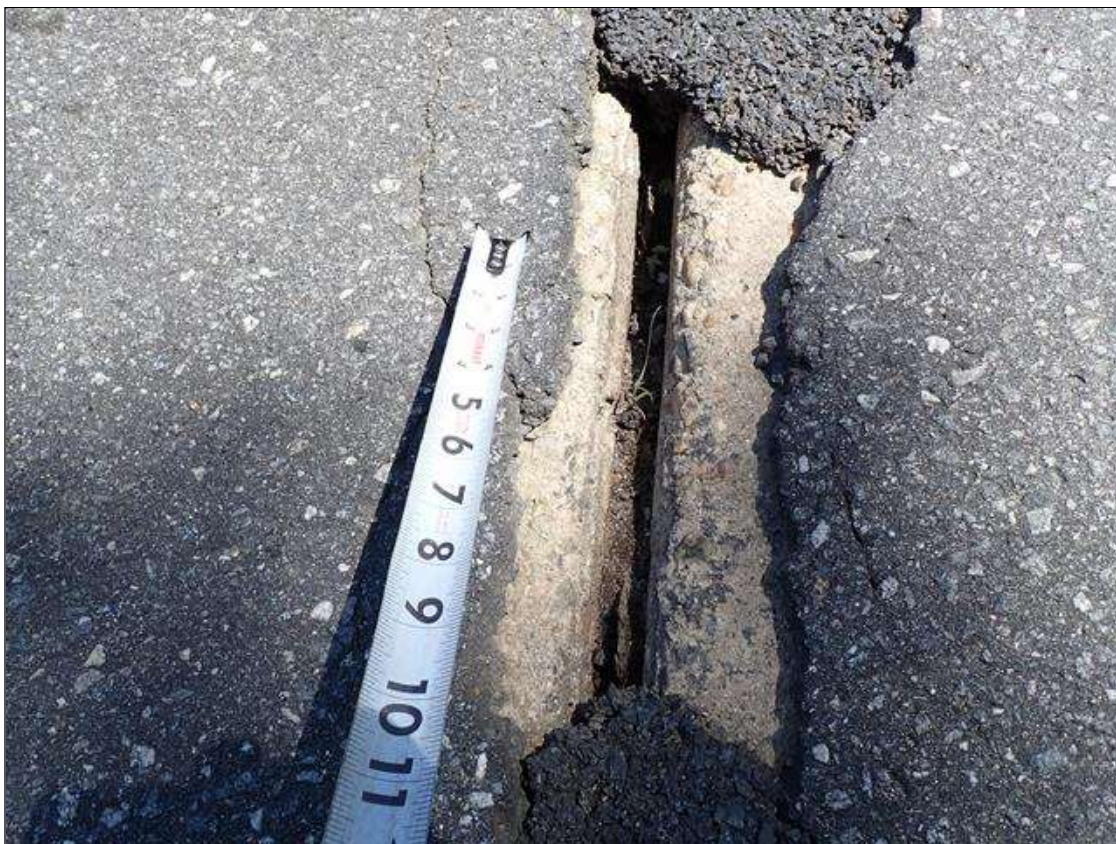
Span 2 Expansion Joint 1: along the length of the joint, joint material deteriorated/torn/missing at random

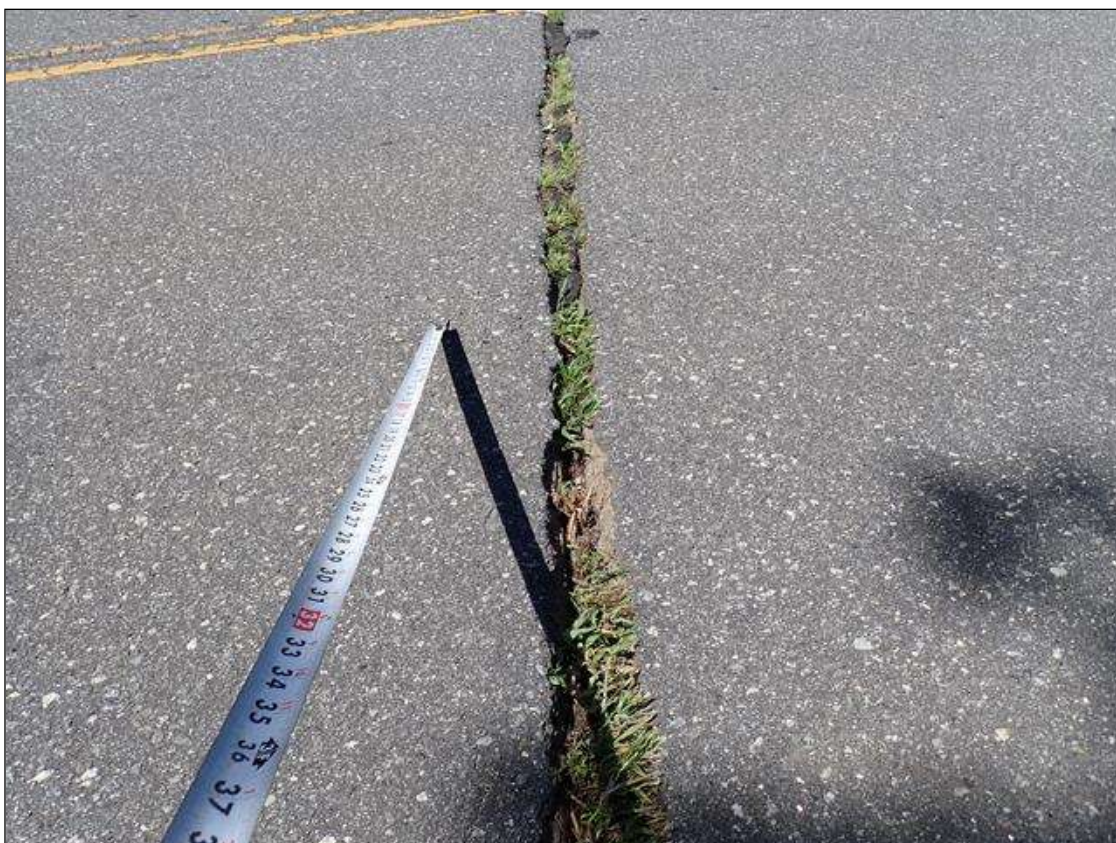
Span 2 Expansion Joint 1: along the length of the joint, joint material deteriorated/torn/missing at random

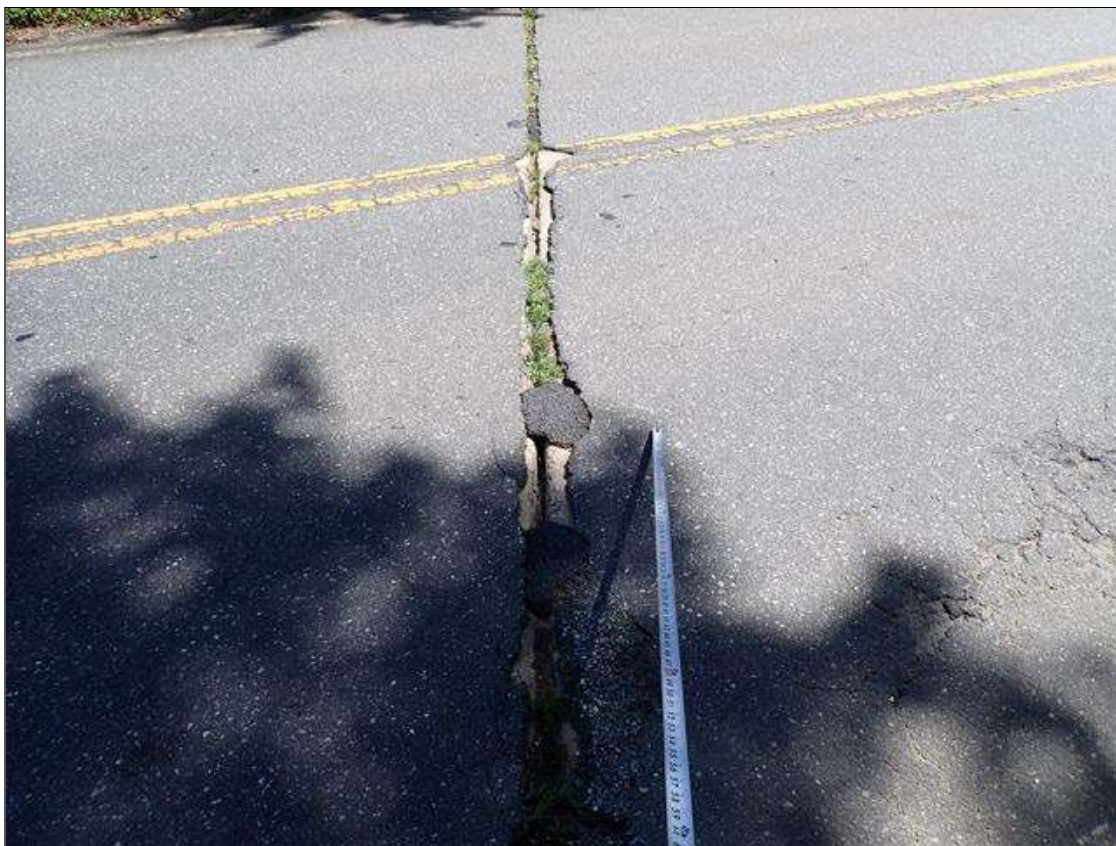
Span 1 Wearing Surface: (PAR) at bent 1, southbound lane, partially patched pothole (13 foot x 6 inch x full depth)

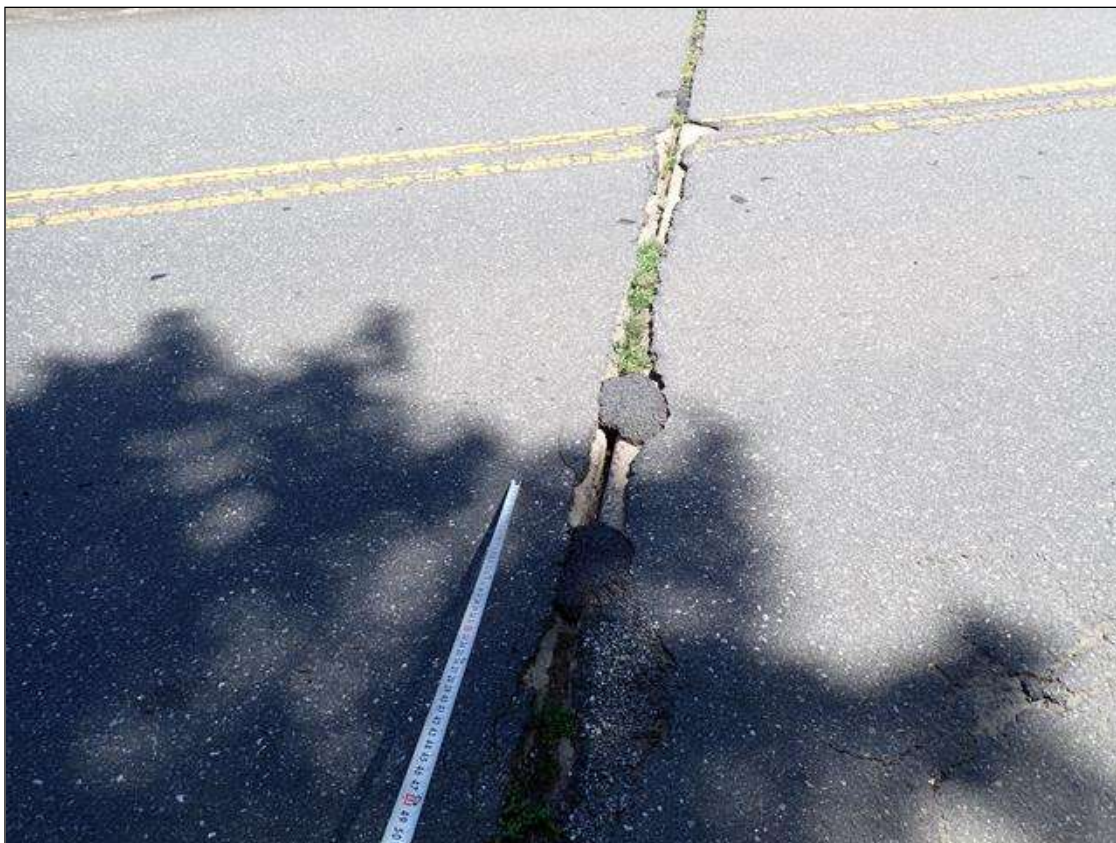
Span 2 Wearing Surface: (PAR) at bent 1, southbound lane, partially patched pothole (13 foot x 6 inch x full depth)

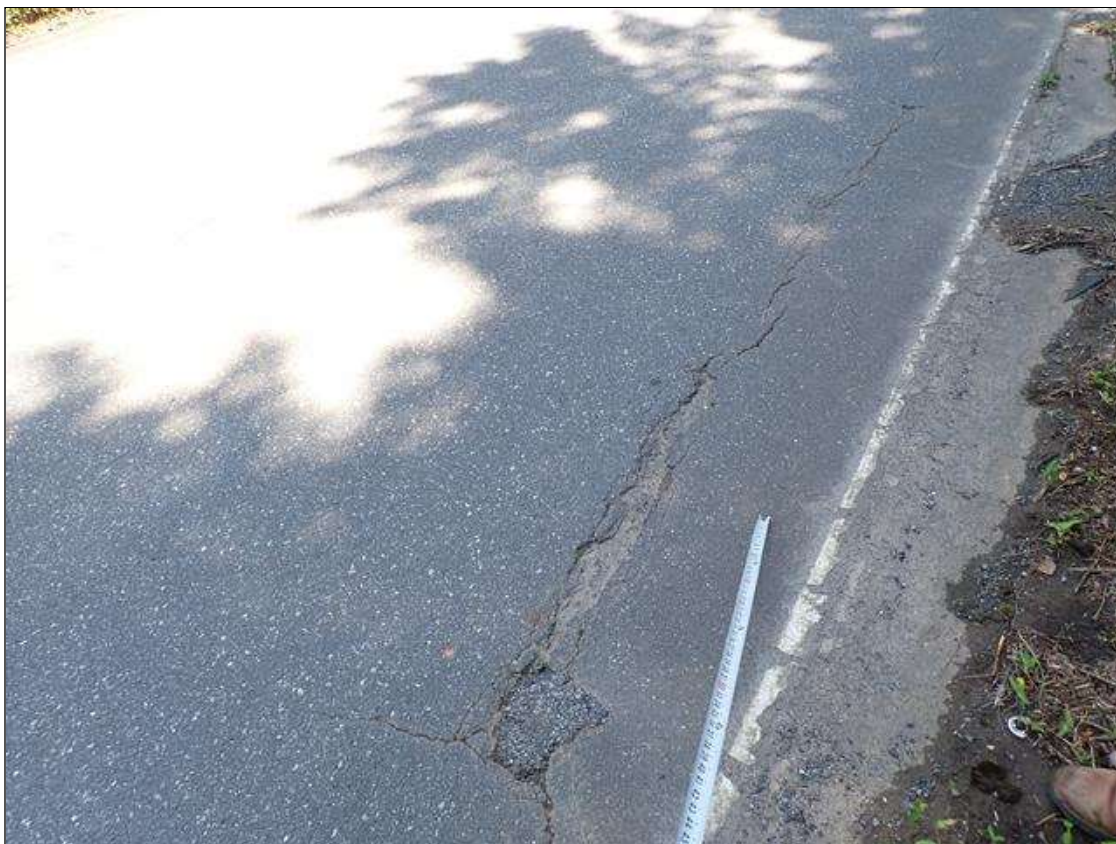
Span 2 Wearing Surface: Southbound lane, shallow pothole/patched area [12 foot long x up to 10 inch x up to 1/2 inch deep]

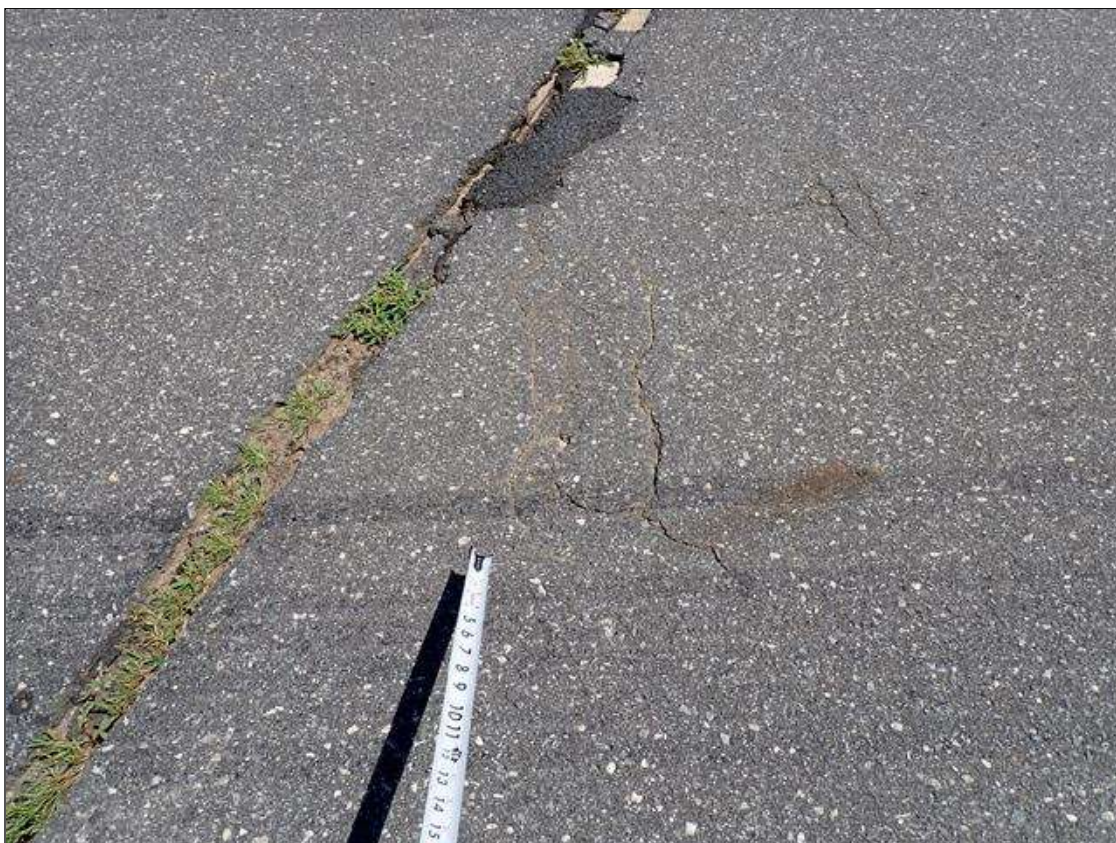
Span 2 Wearing Surface: throughout topside of deck, multiple transverse and longitudinal cracks [up to 16 inch x up to 1/4 inch]

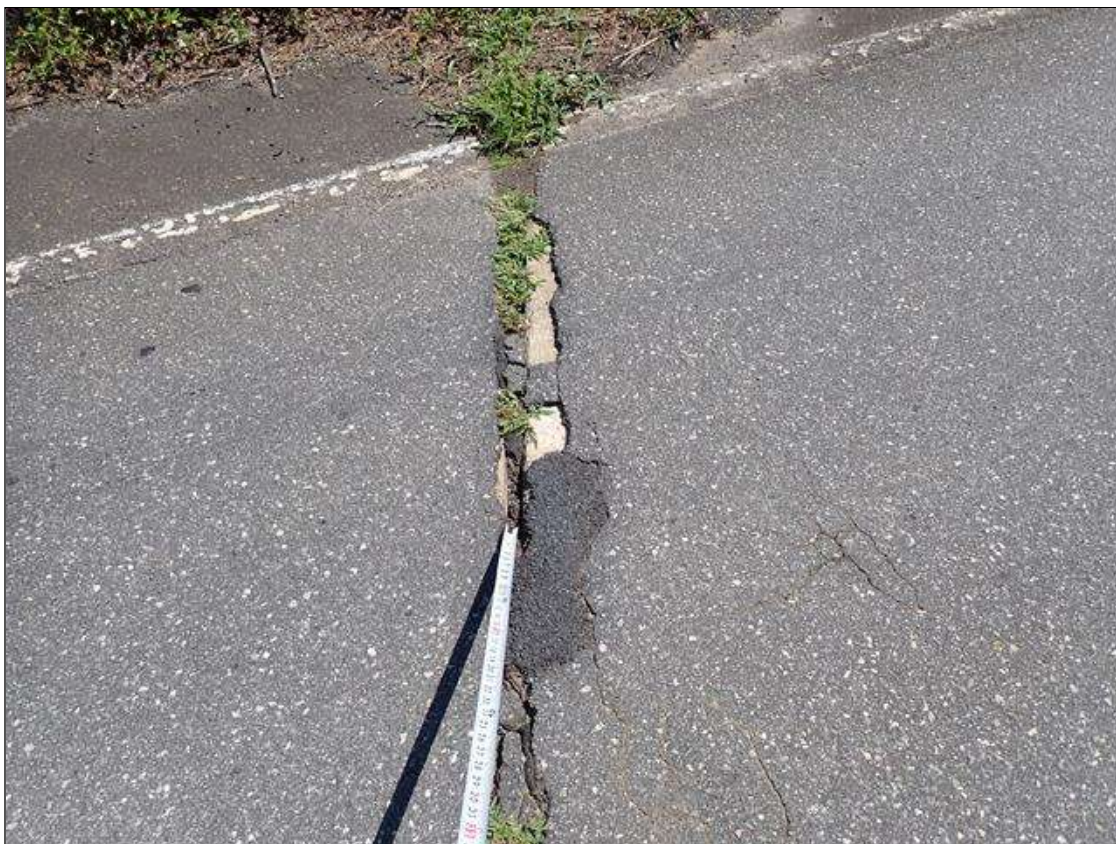
Span 2 Wearing Surface: (PAR) at bent 2, partially patched potholes (up to 16 inch x 6 inch x full depth)

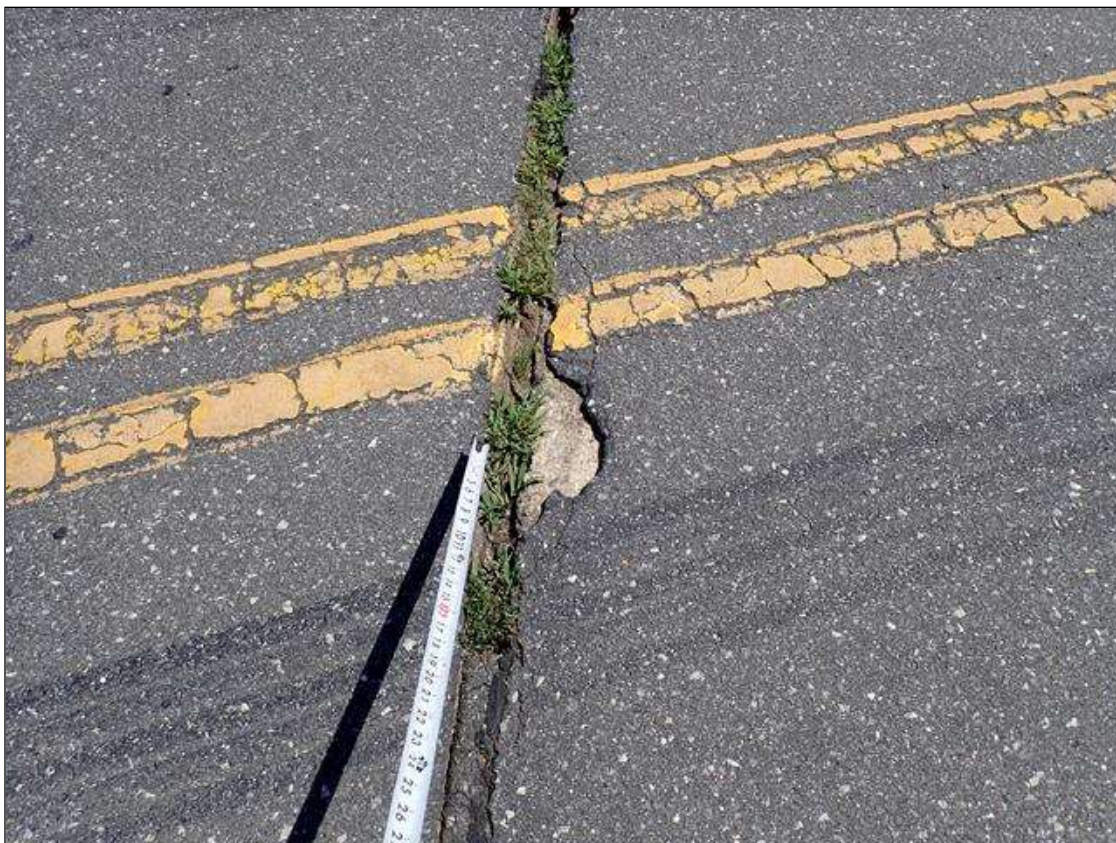
Span 2 Wearing Surface: (PAR) at bent 2, partially patched potholes (up to 16 inch x 6 inch x full depth)

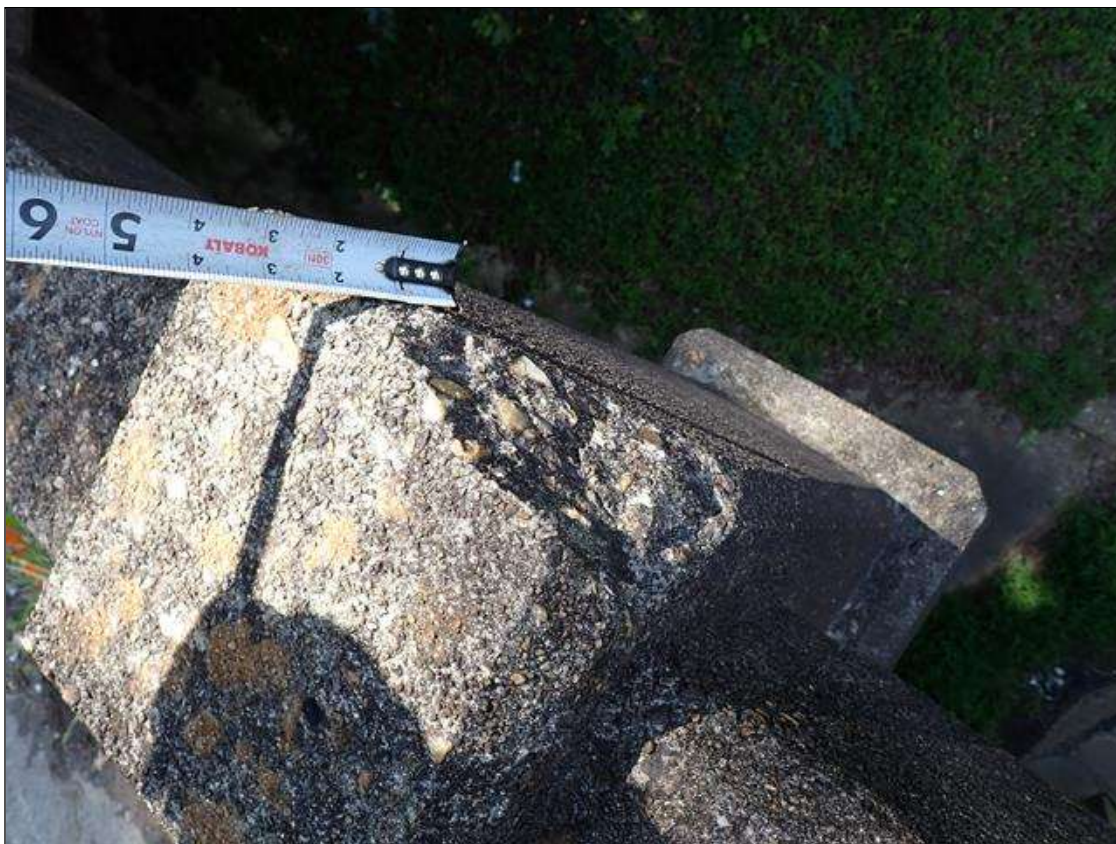
Span 2 Left Bridge Rail: at 5th rail post from bent 1, top corner, spall [4 inch x 3 inch x up to 3/4 inch] no exposed reinforcing

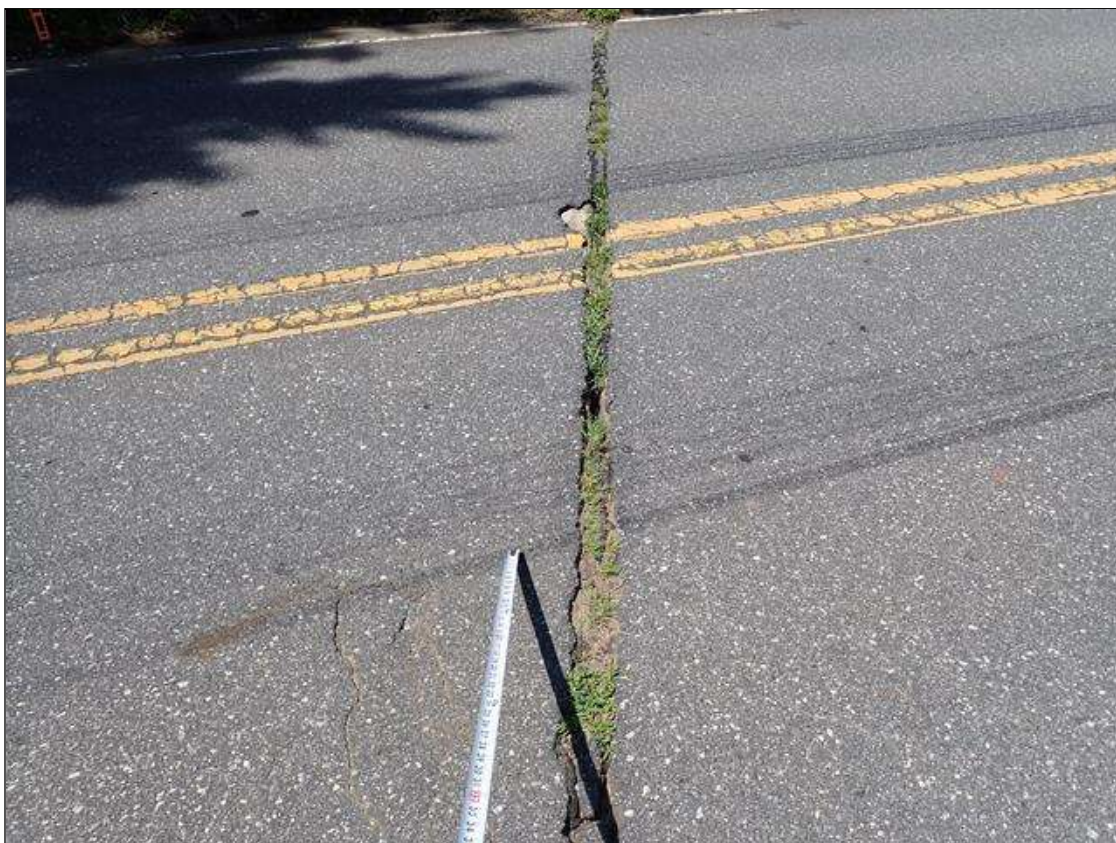
Span 3 Expansion Joint 2: along the length of the joint, joint material deteriorated/torn/missing at random

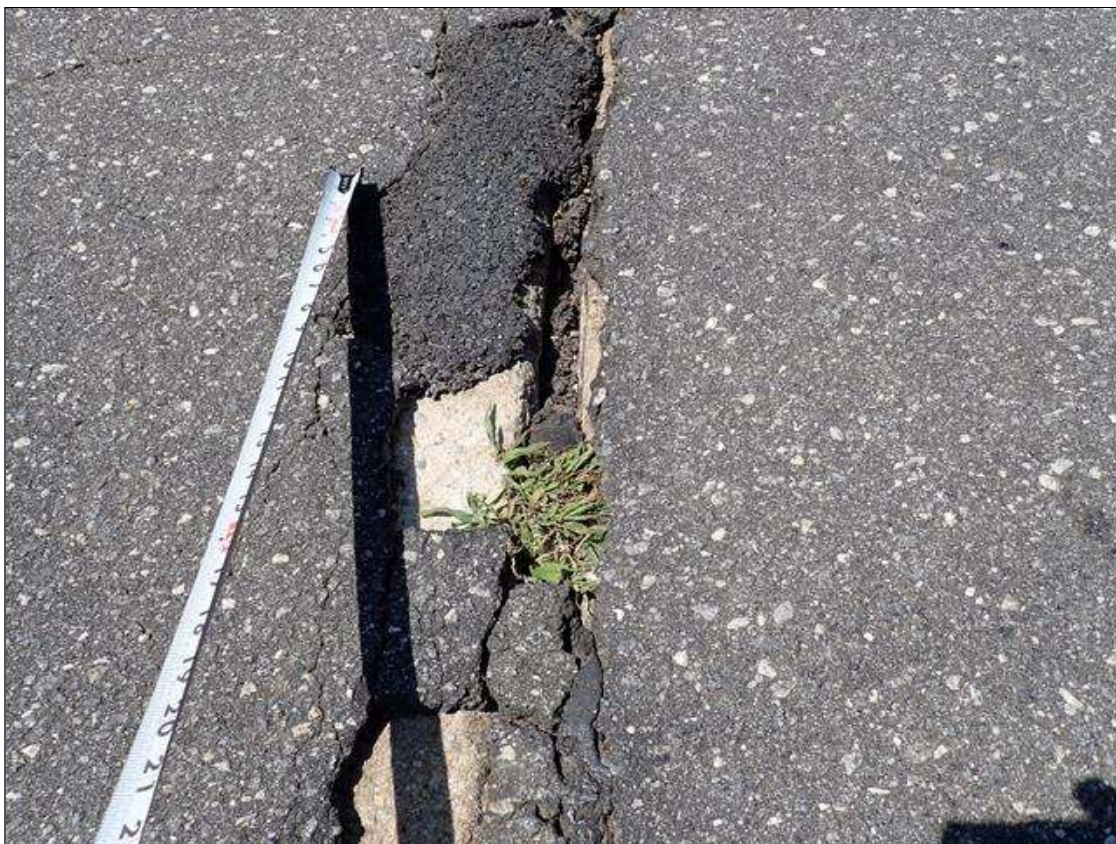
Span 3 Expansion Joint 2: along the length of the joint, joint material deteriorated/torn/missing at random

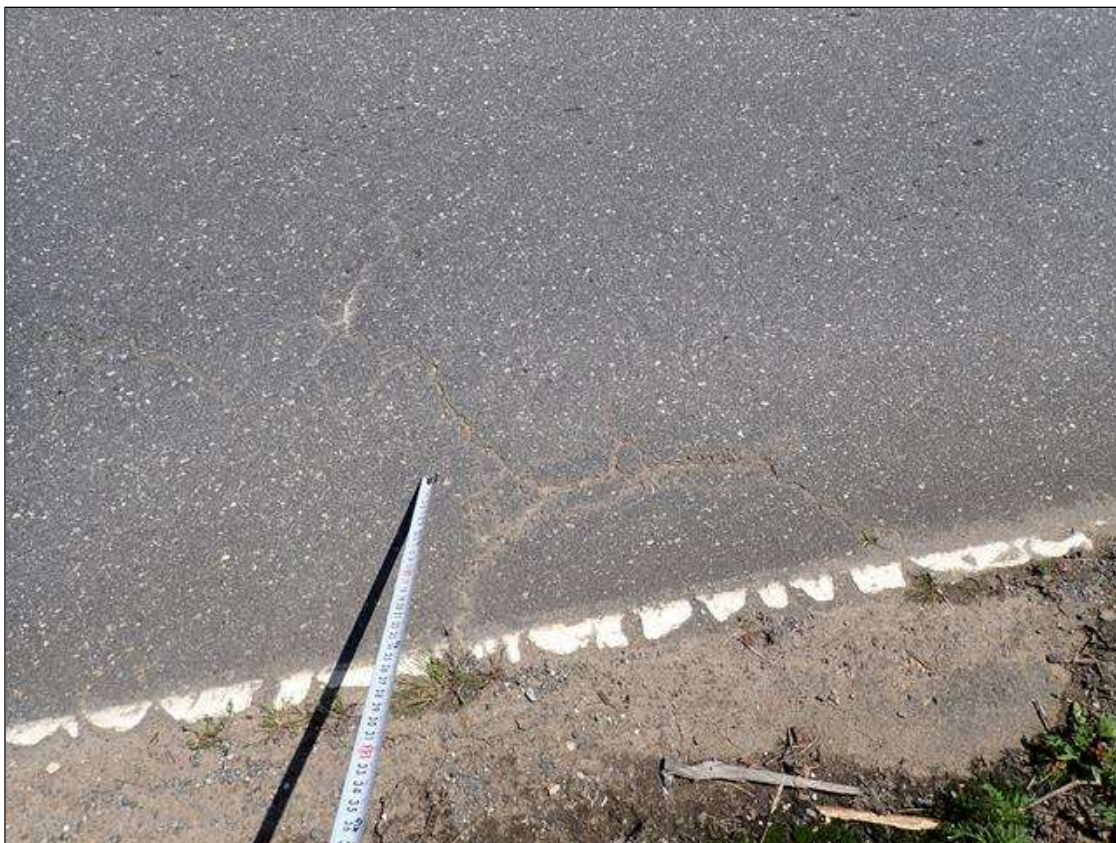
Span 3 Wearing Surface: MAP CRACKING UP TO 1/4 INCH SOUTHBOUND LANE 3 FOOT FROM WEST CURB

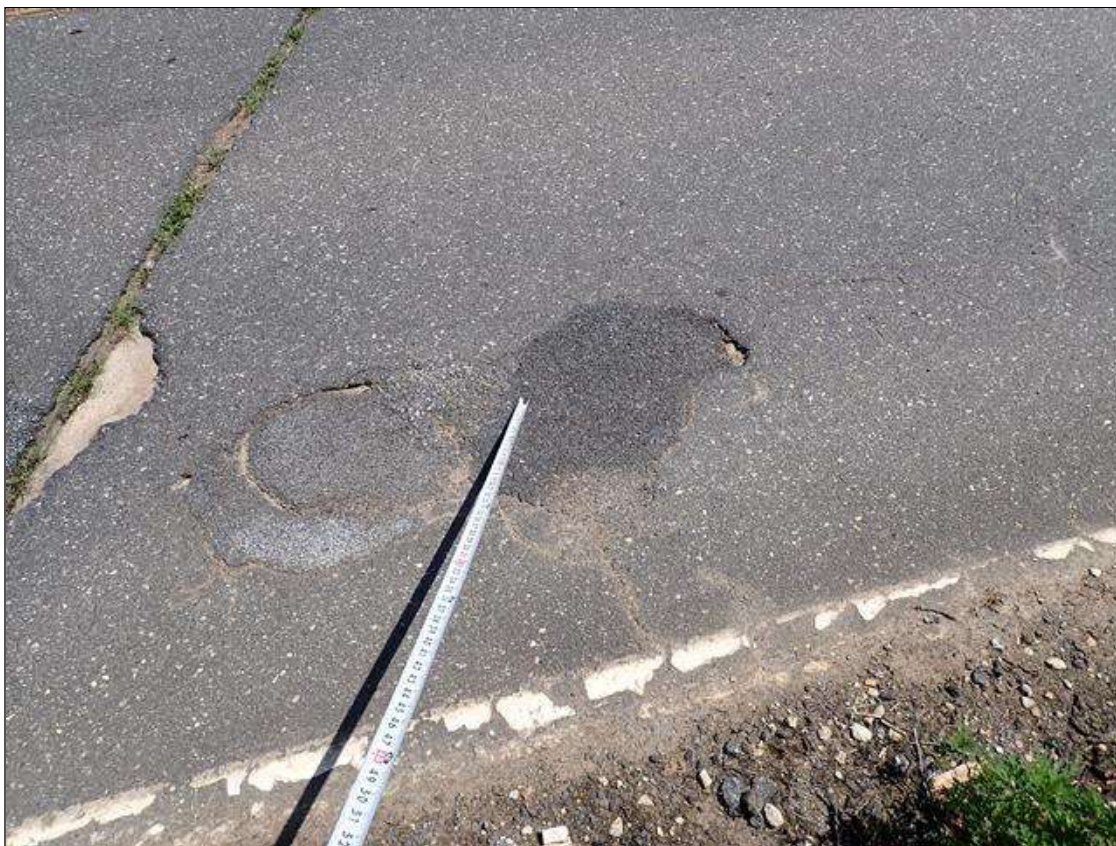
Span 3 Wearing Surface: SOUTHBOUND LANE NEAR BENT 3 UNSOUND PATCHED AREA (4 FOOT X 2 FOOT) WITH CRACKING AND EDGE SPALLING (UP TO FULL DEPTH)
