NC DEPARTMENT OF TRANSPORTATION
 DIVISION OF HIGHWAYS
 STRUCTURE MANAGEMENT UNIT

ATTENTION: prompt action request; sketches updated; signs attached to beam; lateral clearance revised; new beam repairs

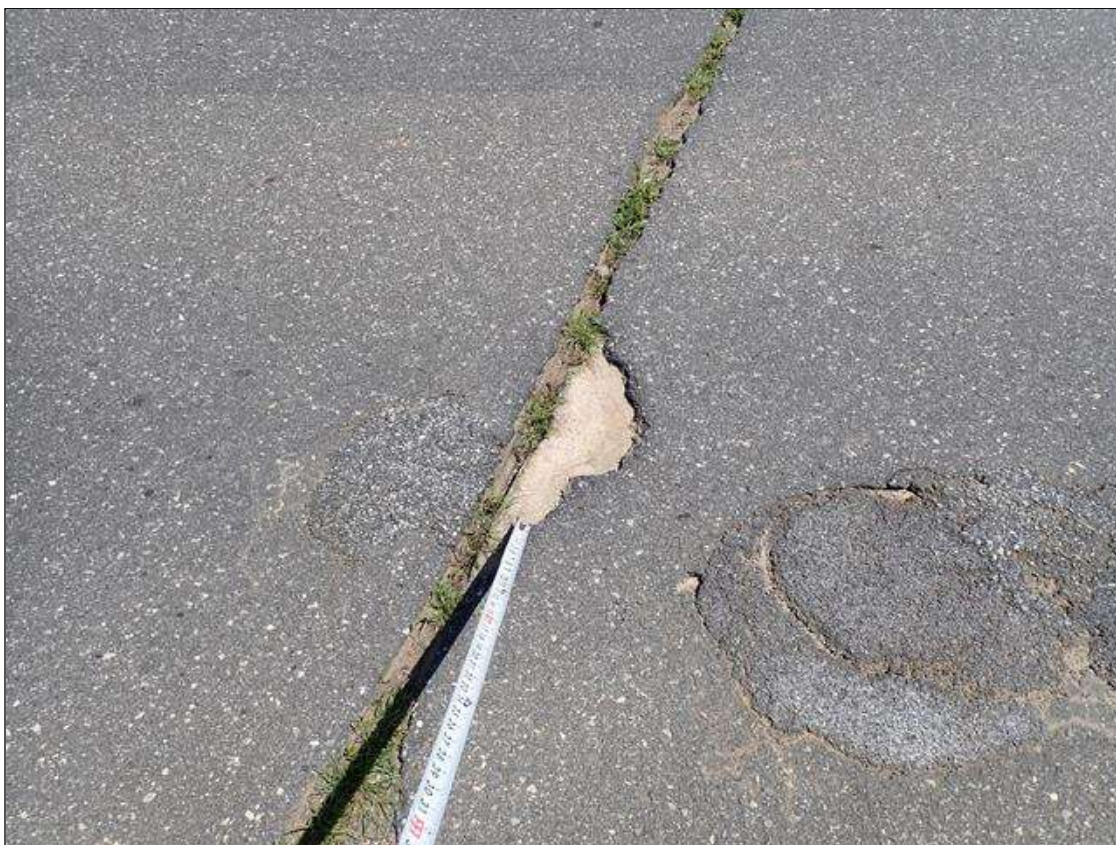
Span 3 Wearing Surface: (PAR) at bent 3, southbound lane, pothole (2 foot x 9 inch x full depth)

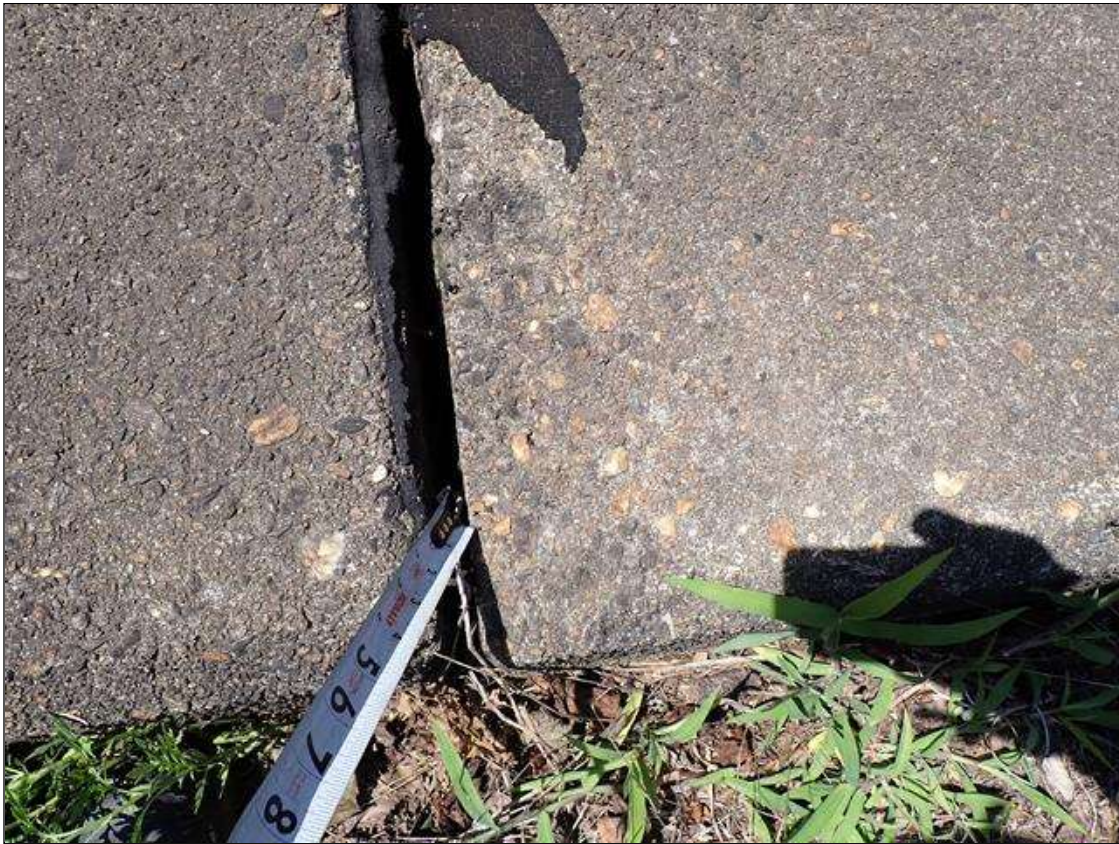
Span 4 Left Bridge Rail: at bent 3 top of curb, spall [3 inch x 11 inch x up to 3/4 inch] no exposed rusted reinforcing

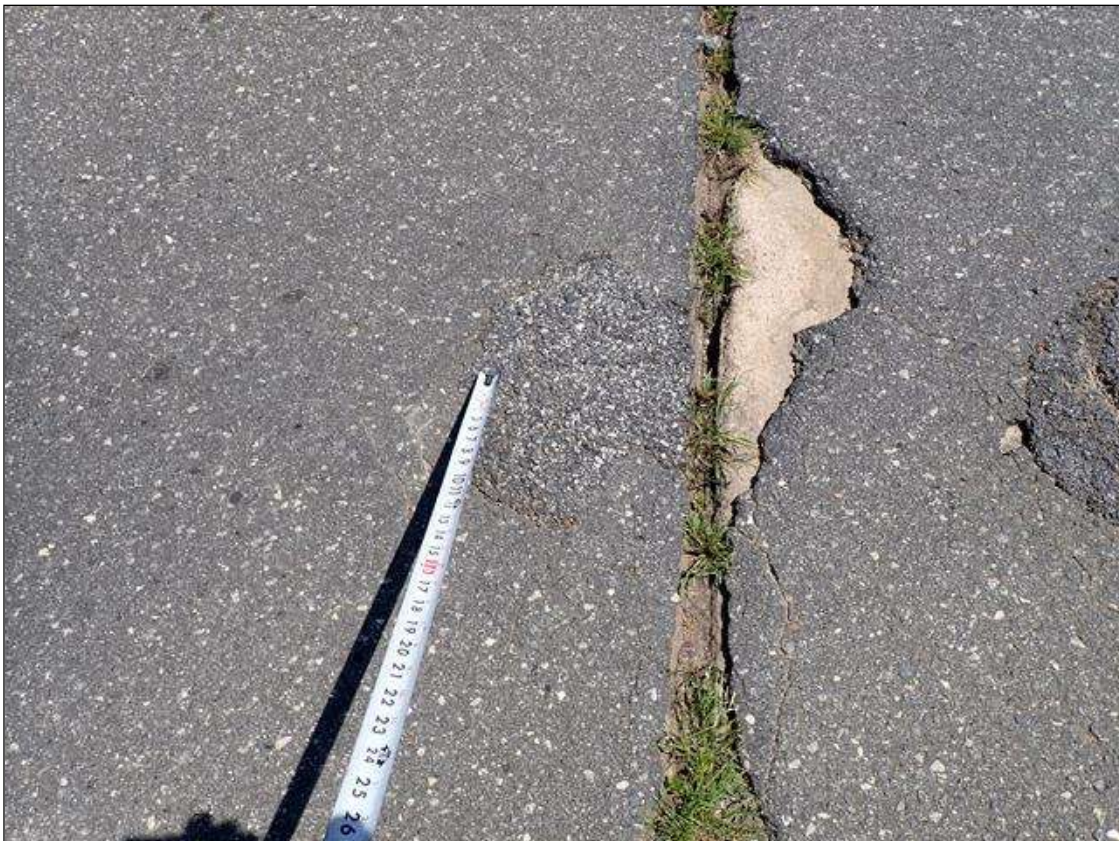
Span 4 Wearing Surface: 1 FOOT DIAMETER PATCH SOUTHBOUND LANE BENT 3.

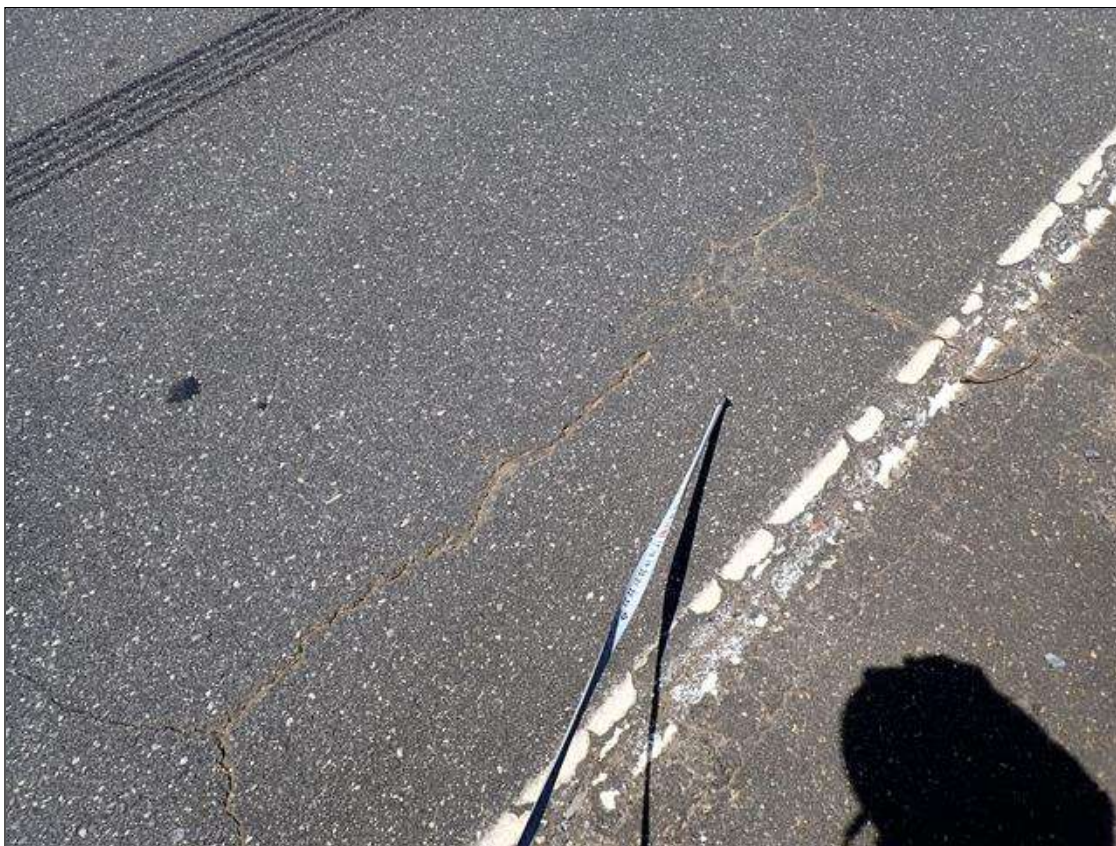
Span 4 Wearing Surface: MAP CRACKING UP TO 1/4 INCH AT RANDOM THROUGHOUT TOPSIDE OF DECK

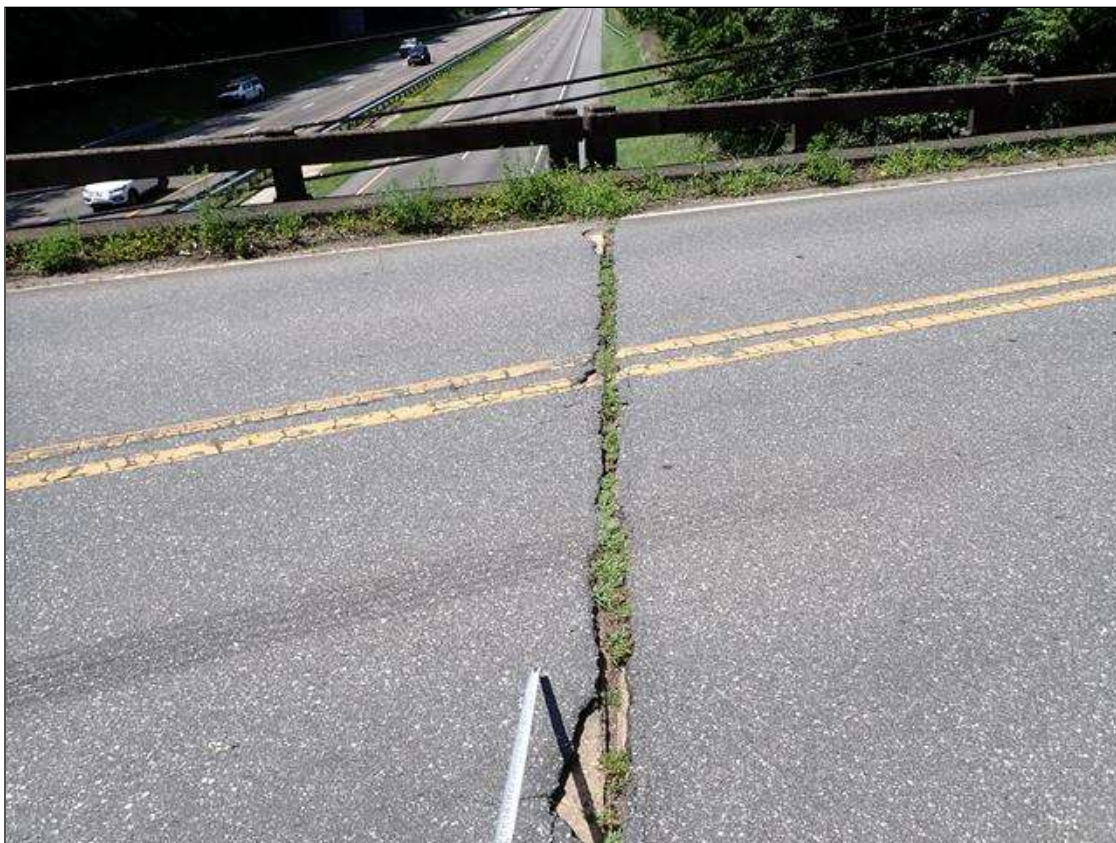
Span 4 Wearing Surface: (PAR) at bent 4, (3) potholes (up to 3 foot x 8 inch x full depth)

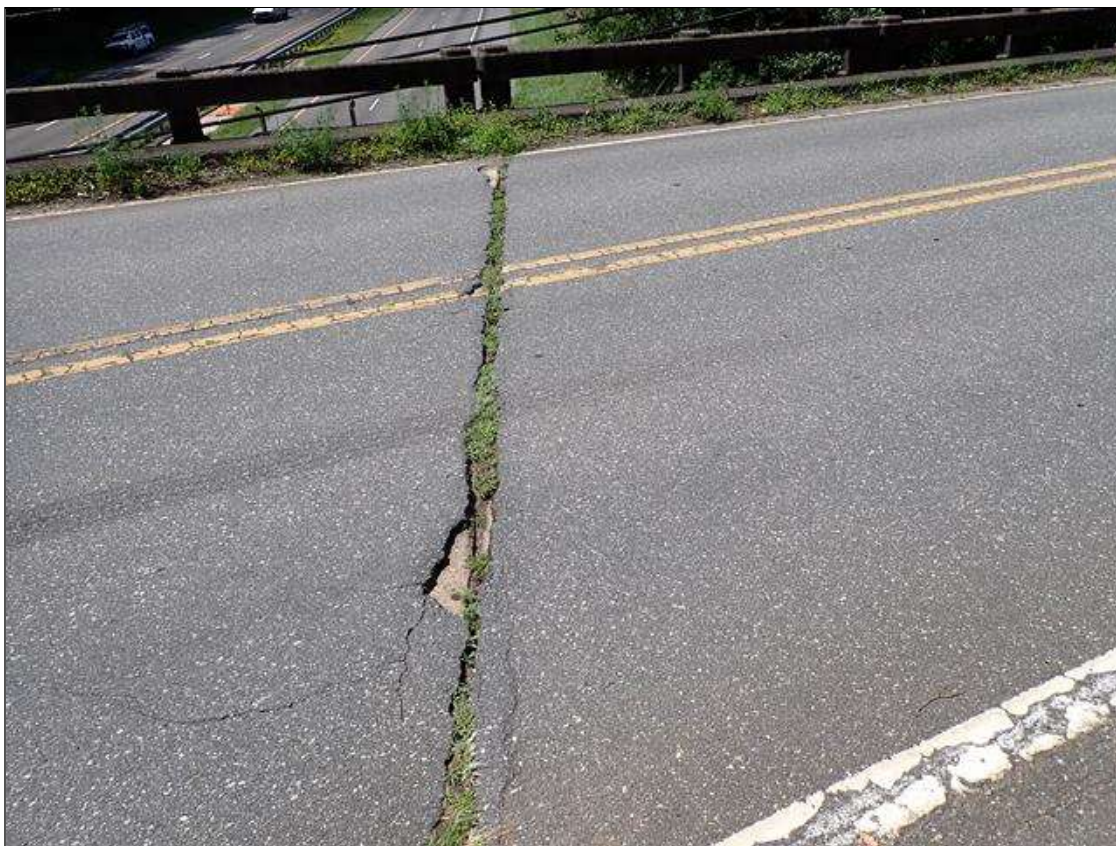
Span 5 Wearing Surface: (not found 2023) 31 INCH X UP TO 1 FOOT X 1 INCH FULL DEPTH POT HOLE OVER BENT 4

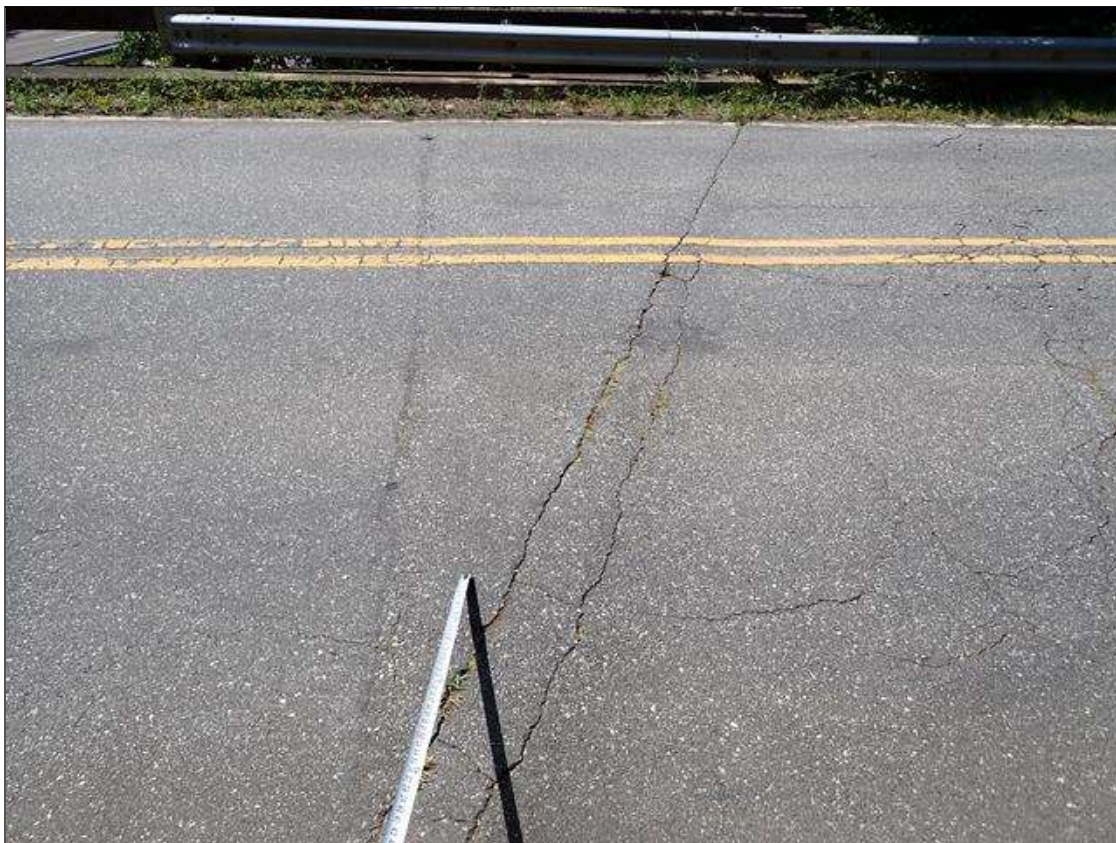
Span 5 Wearing Surface: along length of asphalt over end bent 2, transverse cracks [up to 1/4 inch x full roadway width]

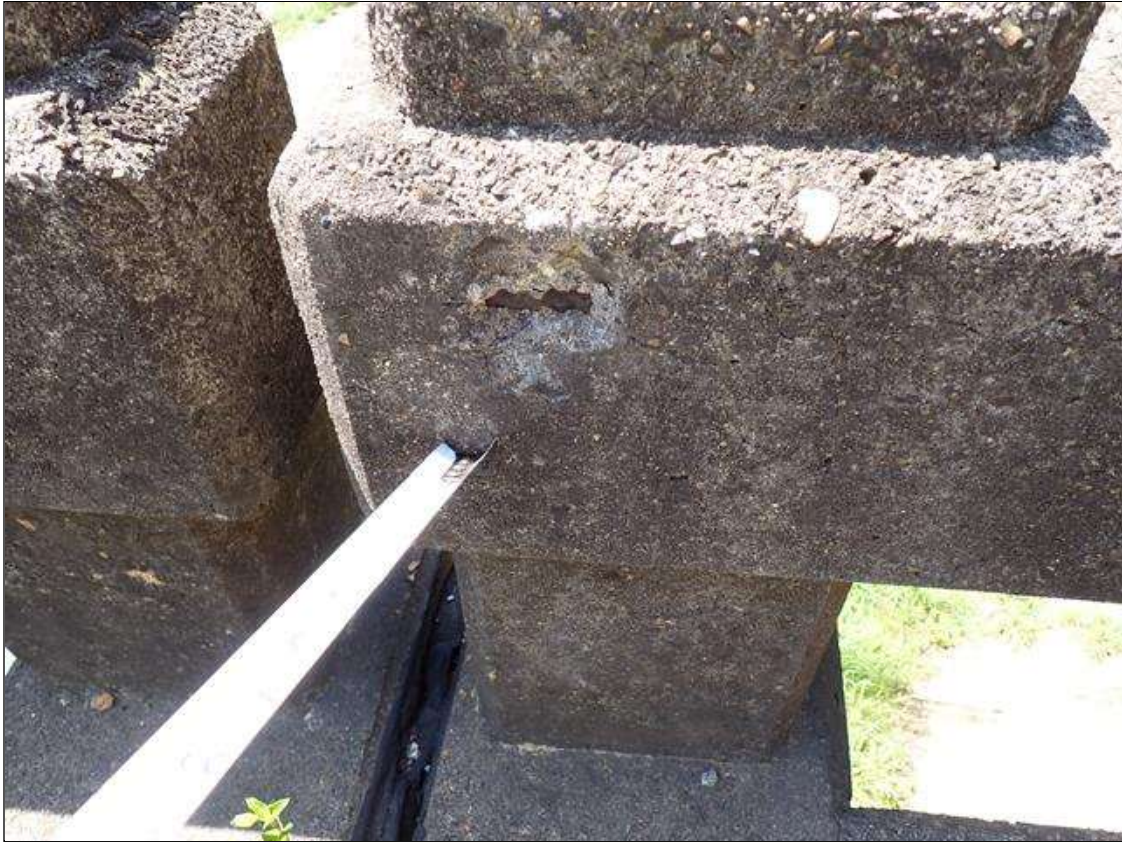
Span 5 Left Bridge Rail: at 1st rail post, spall [3 inch diameter x up to 1 inch deep] with exposed rusted reinforcing [no section loss noted]

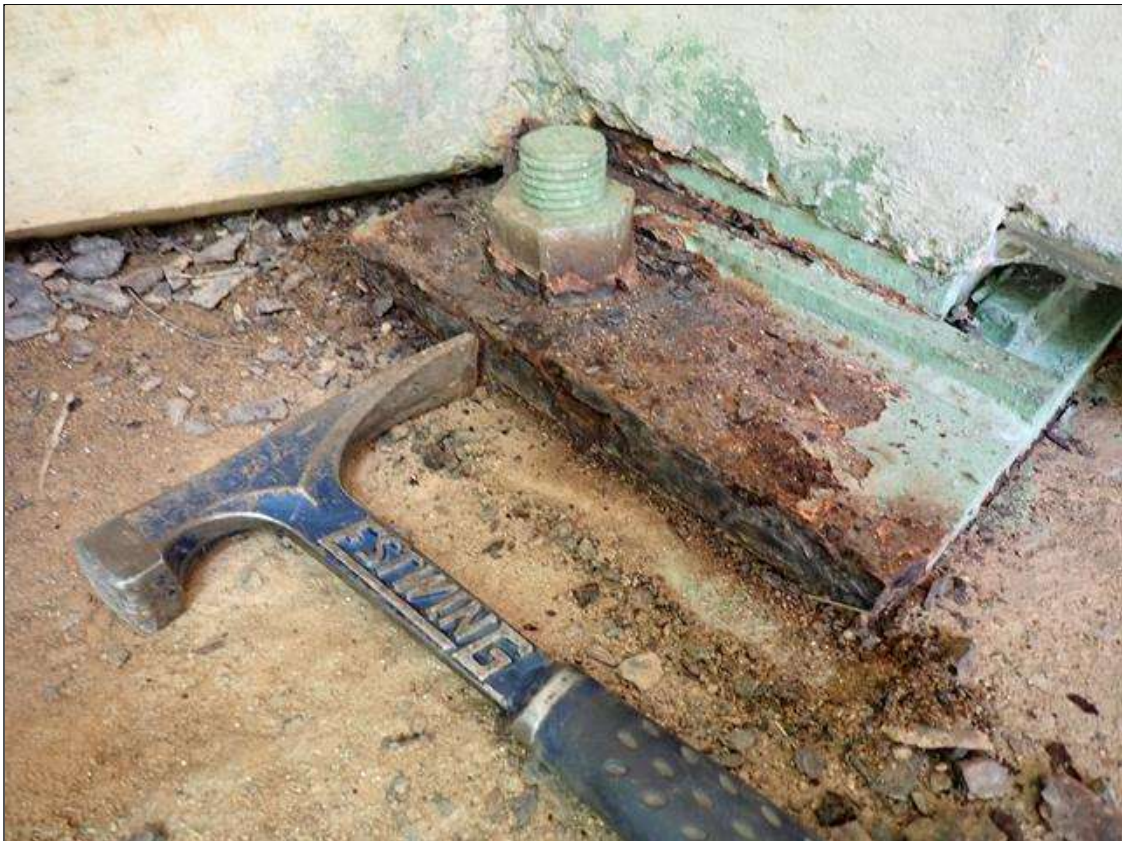
Span 5 Beam 1 - Far Bearing 1: active corrosion with section loss [up to 1/8 inch] on plates

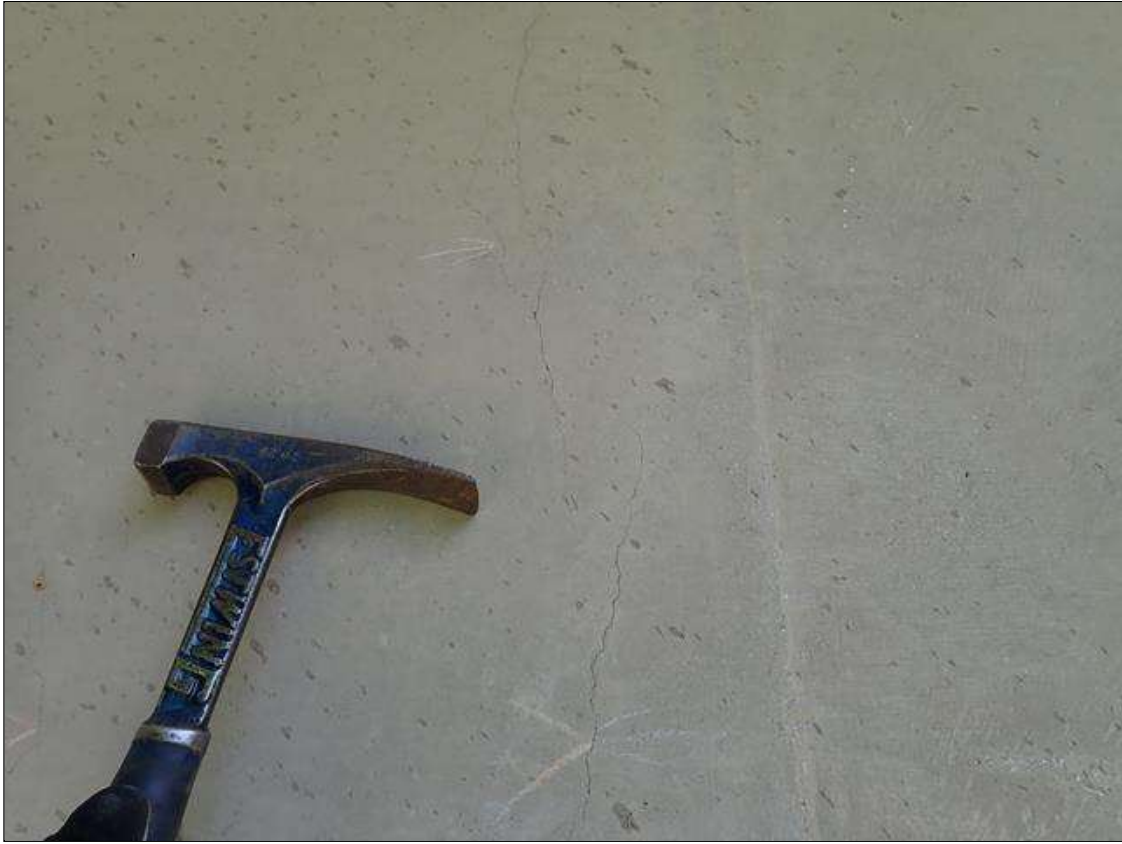
Span 5 Beam 1: VERTICAL CRACKS AND TRANSVERSE AND WRAPAROUND CRACKS UP TO 1/32 INCH AT RANDOM THROUGHOUT

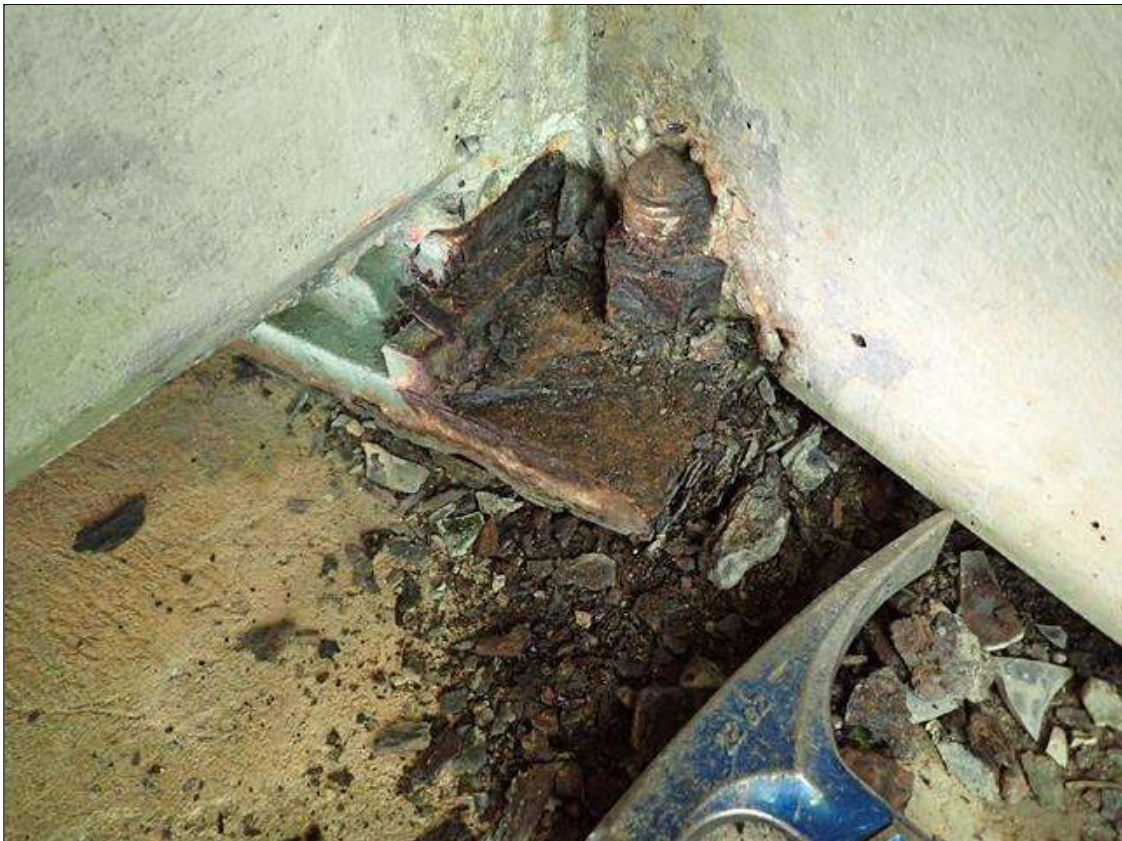
Span 5 Beam 4 - Far Bearing 4: active corrosion with section loss [up to 1/8 inch] on plates

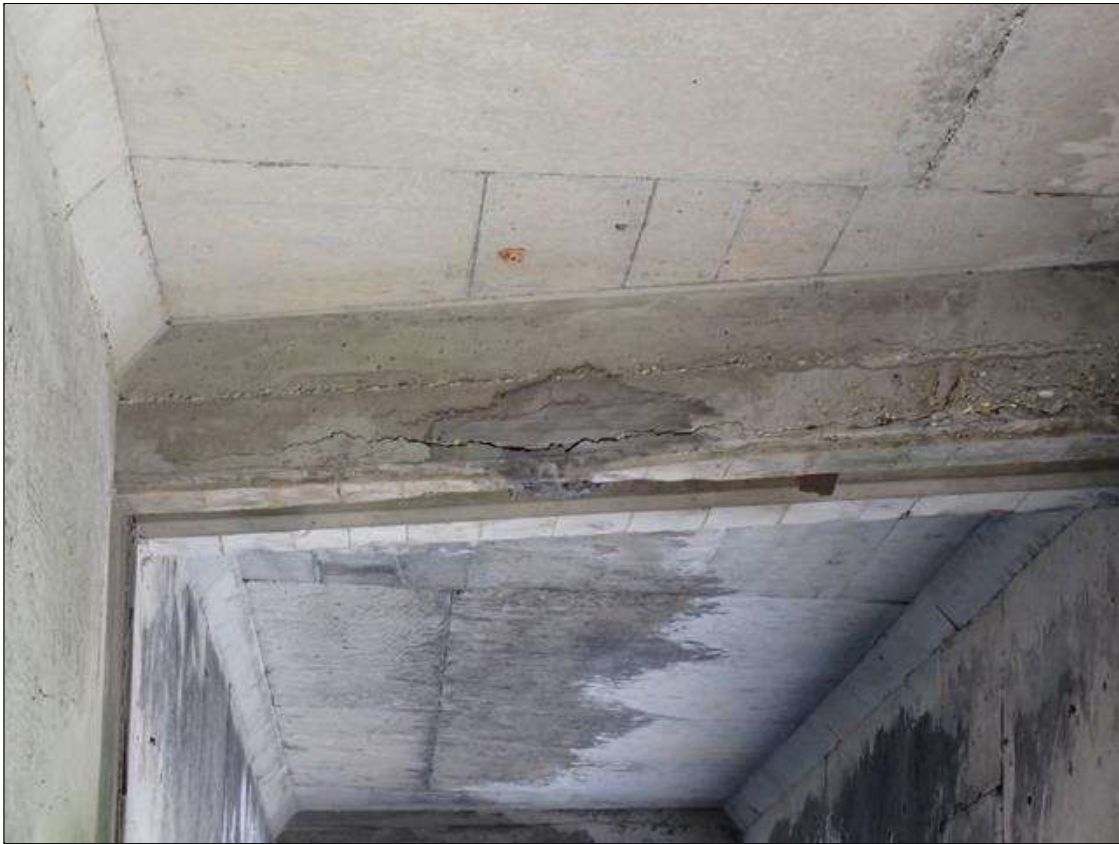
Span 5 Beam 1: span 5 bay 1 near diaphragm failed patch with crack (up to 1/4 inch x full width)

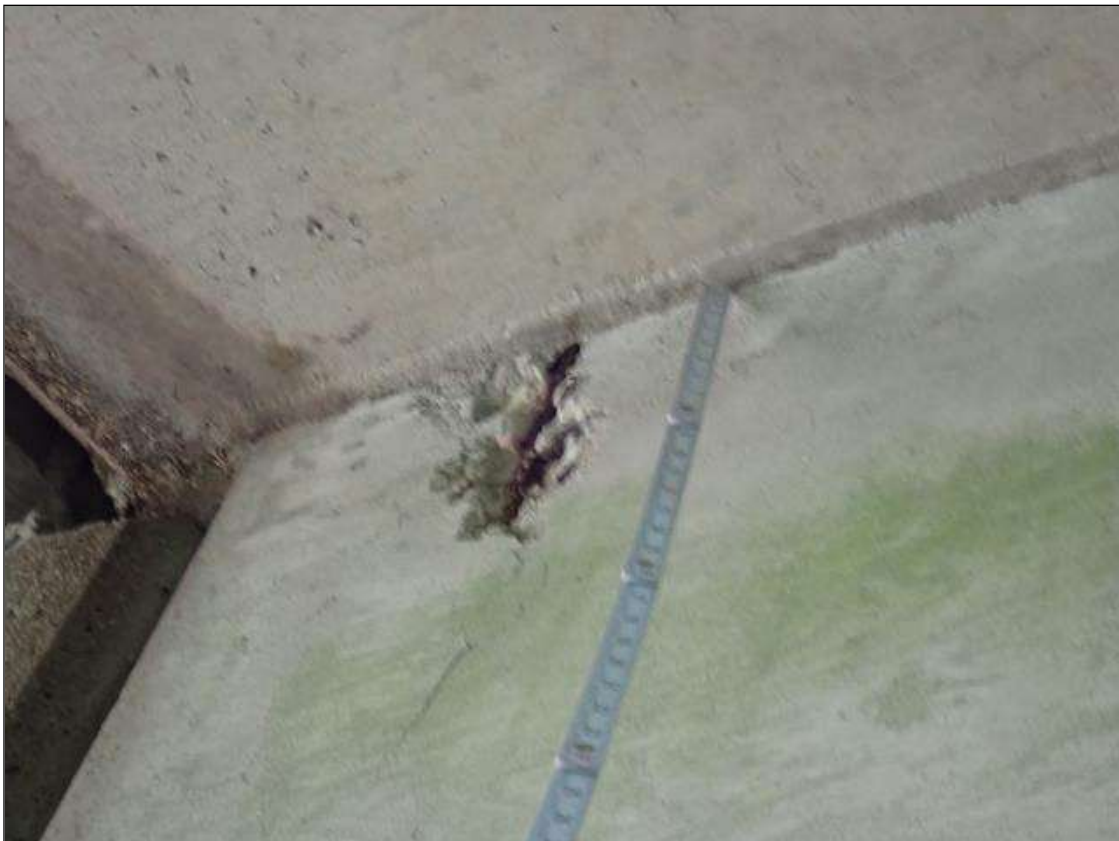
Span 1 Beam 1: West face at bent 1, spall/delamination [12 inch x 3 inch x 1 inch deep] with exposed rusted rebar

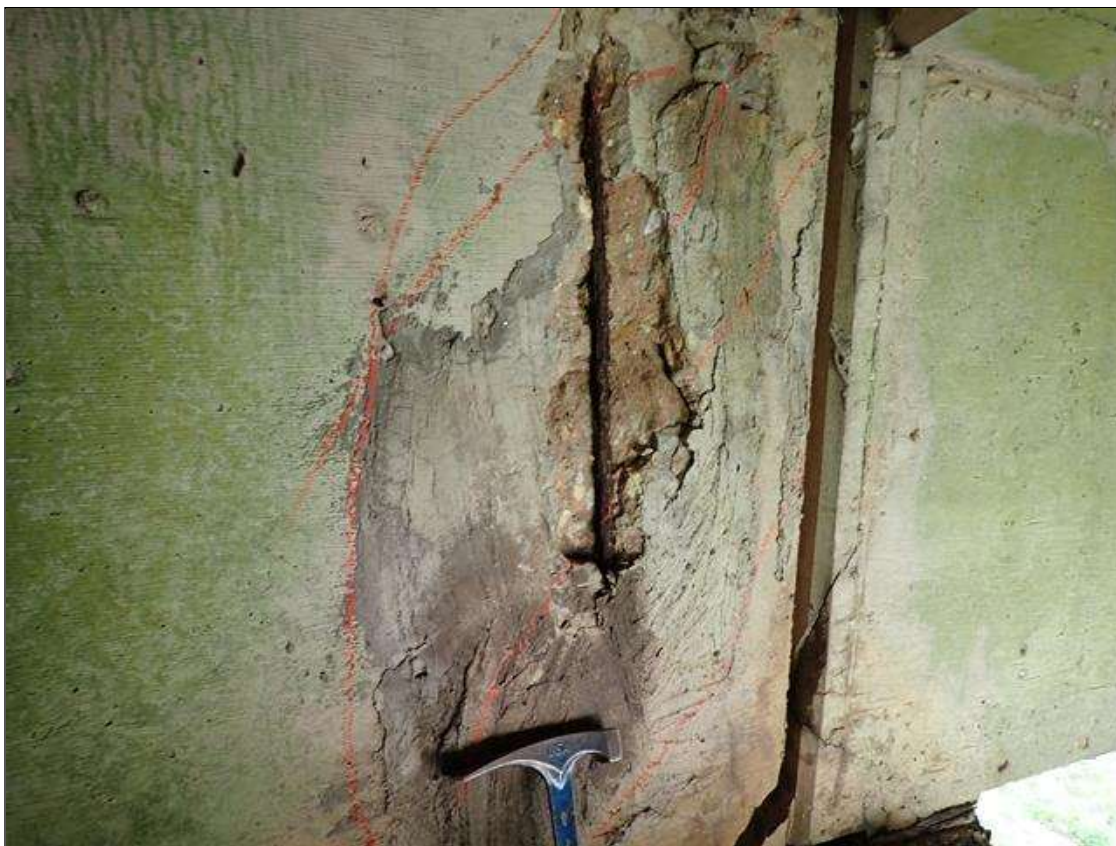
Span 1 Beam 1: (PAR) at bent 1, east face, failed patch (19 inch x full height x 1.5 inch deep) with exposed rusted rebar (approximately 25 percent loss)

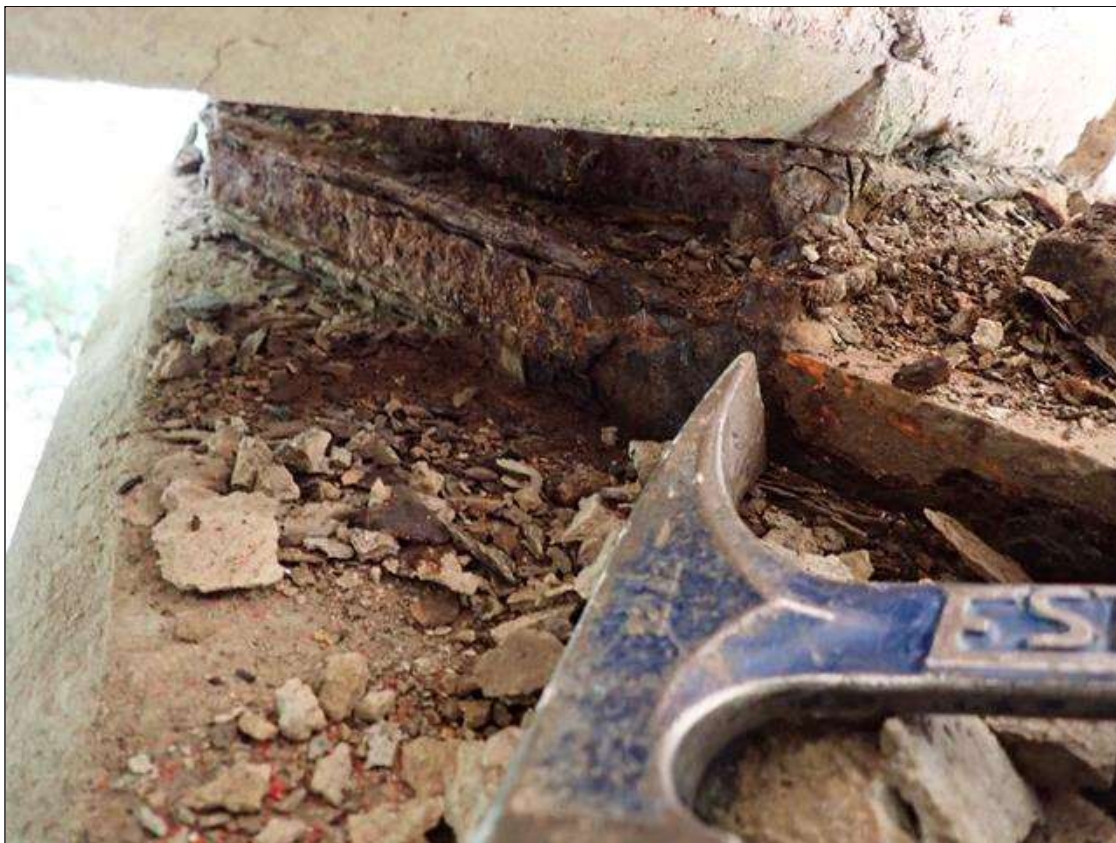
Span 1 Beam 1 - Far Bearing 1: active corrosion with section loss [up to 1/8 inch] on plates

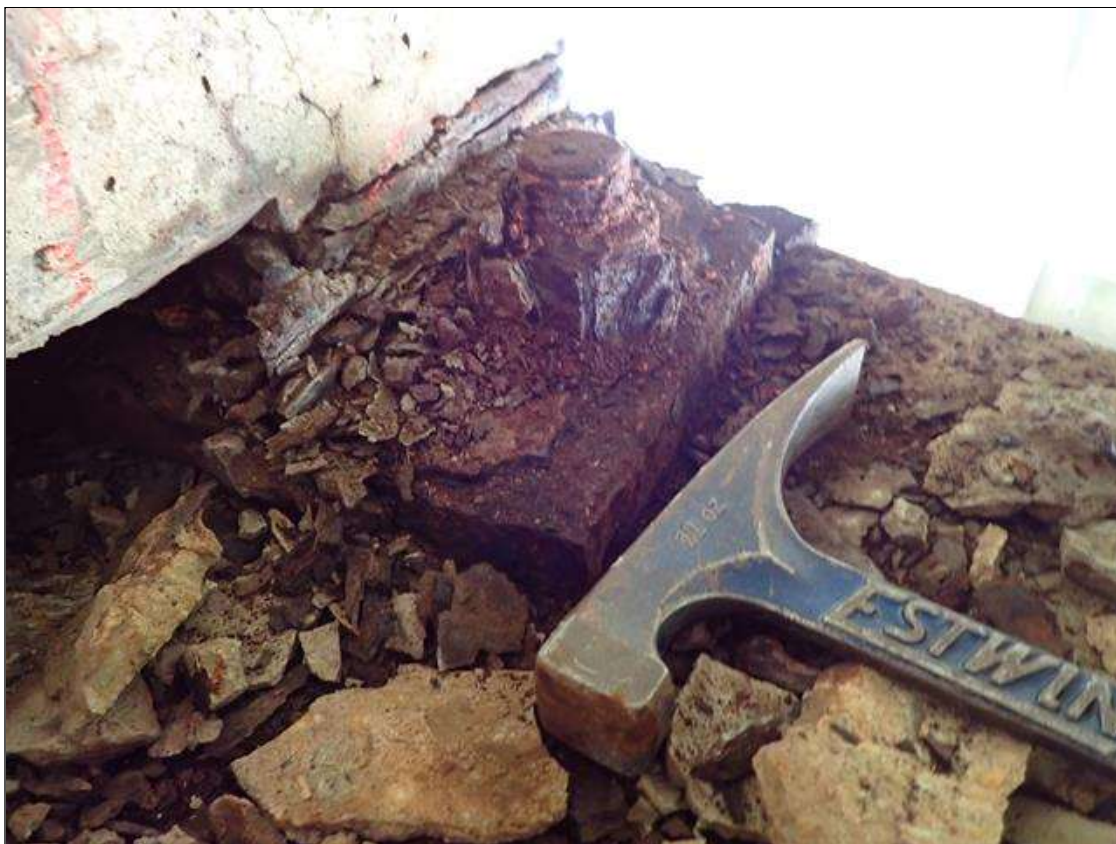
Span 2 Beam 1 - Near Bearing 1: corrosion with section loss (up to 1/8 inch)

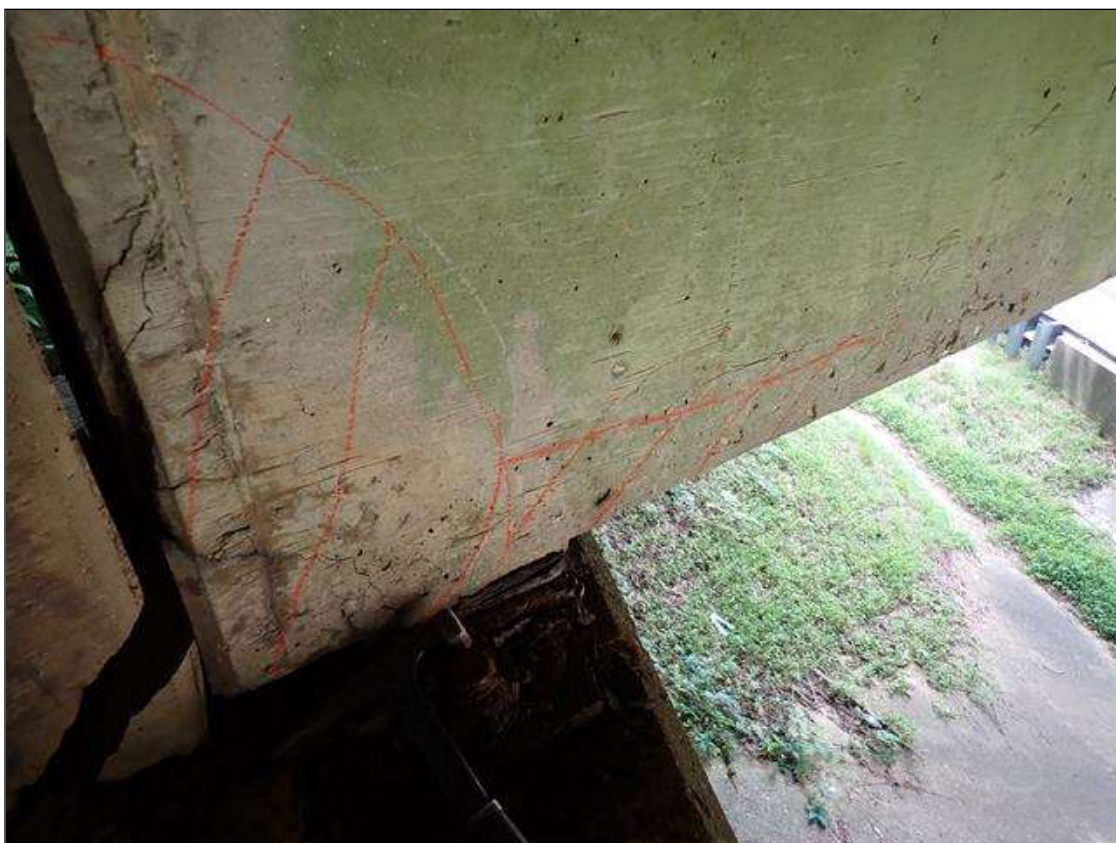
Span 2 Beam 1: east face at bent 1, delamination (32 inch x 18 inch) with cracks (up to 1/32 inch)

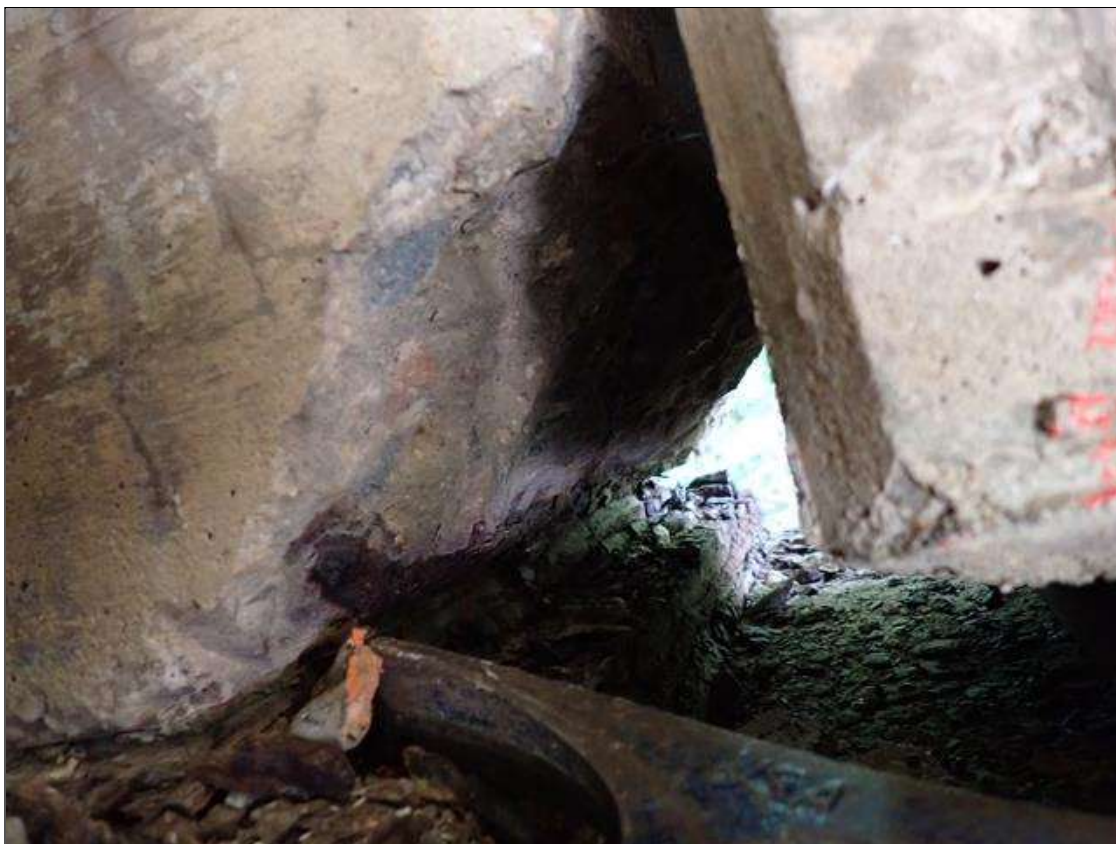
Span 1 Beam 1: (PAR) at bent 1, east face, bottom of beam, spall (full width x 5 inch x 2 inch deep) with exposed rusted rebar (approximately 25 percent loss)

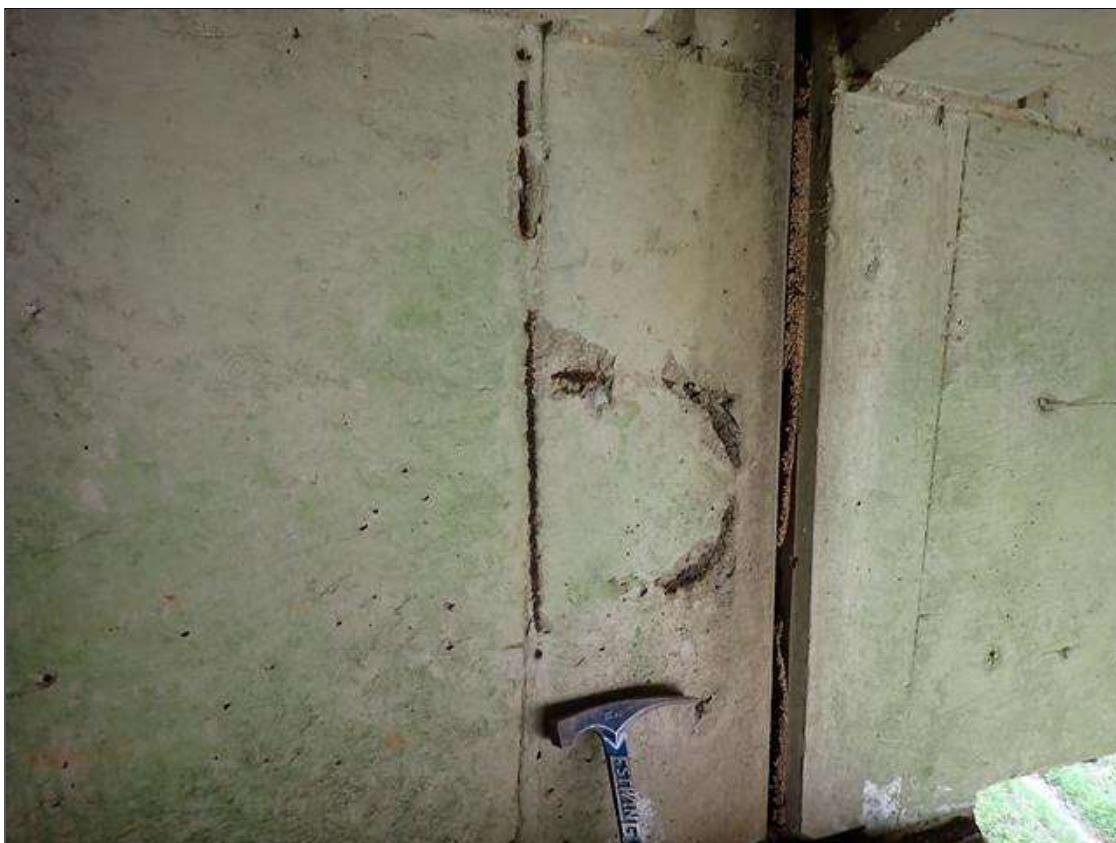
Span 1 Beam 2: east face at bent 1, multiple spalls/delaminations (up to 10 inch x 11 inch x 1/2 inch deep) with exposed rusted rebar

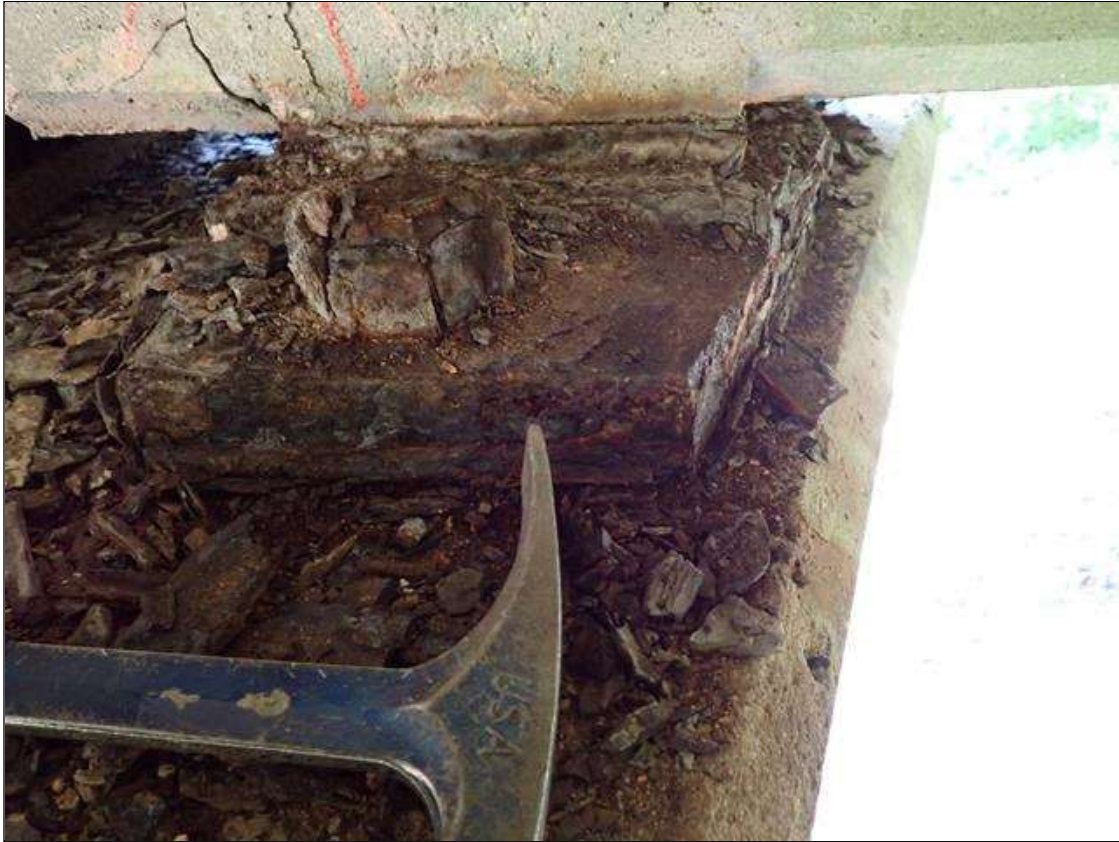
Span 1 Beam 4 - Near Bearing 4: corrosion with section loss (up to 1/8 inch deep)

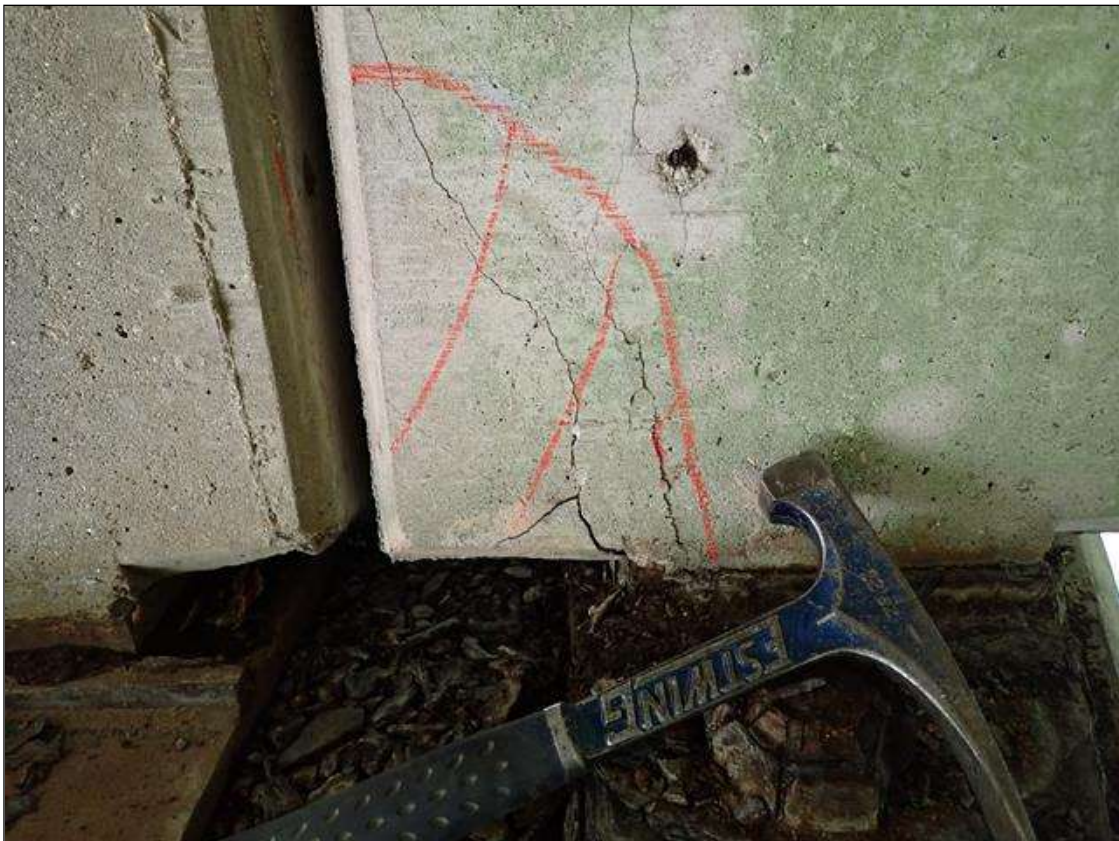
Span 1 Beam 4: at bent 1, west face, delamination (8 inch x 6 inch) with cracks (up to 1/16 inch)

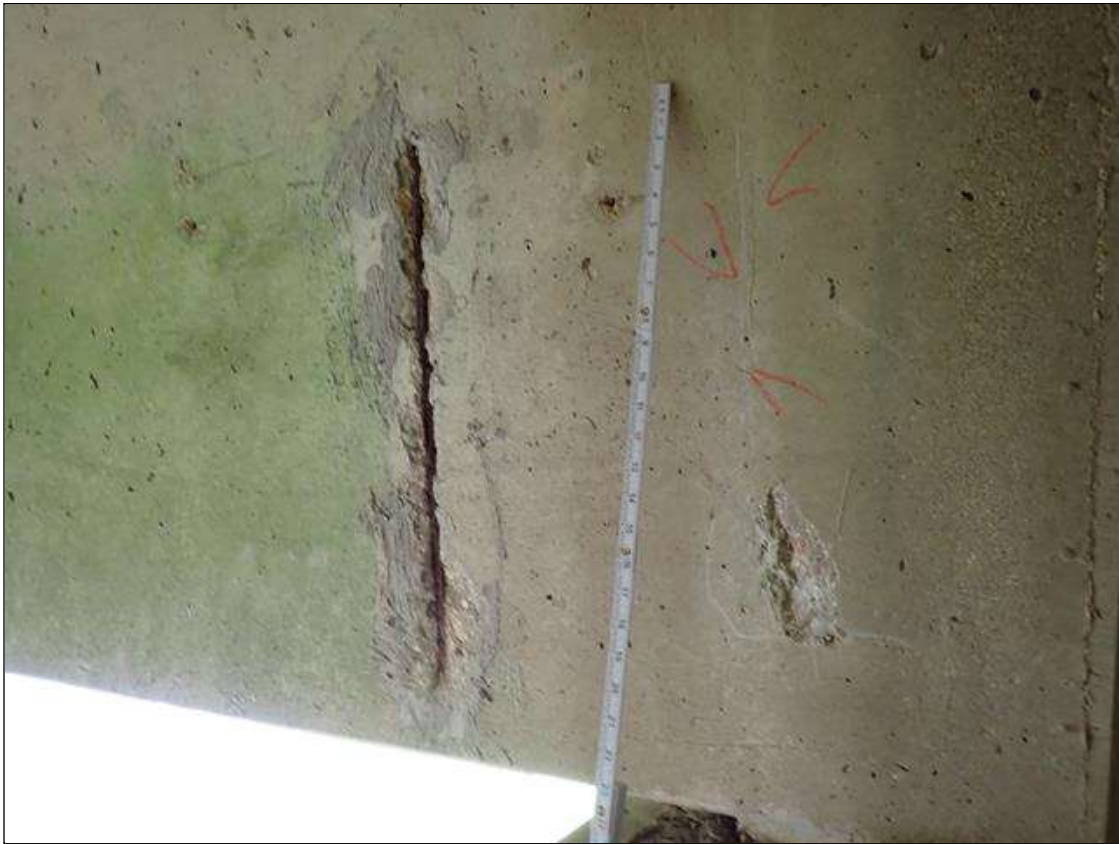
Span 2 Beam 4: at bent 1, west face, (2) delaminations/spalls (up to 3 inch x 2 foot x 1/2 inch deep) with exposed rusted rebar and adjacent cracks (up to 1/32 inch)

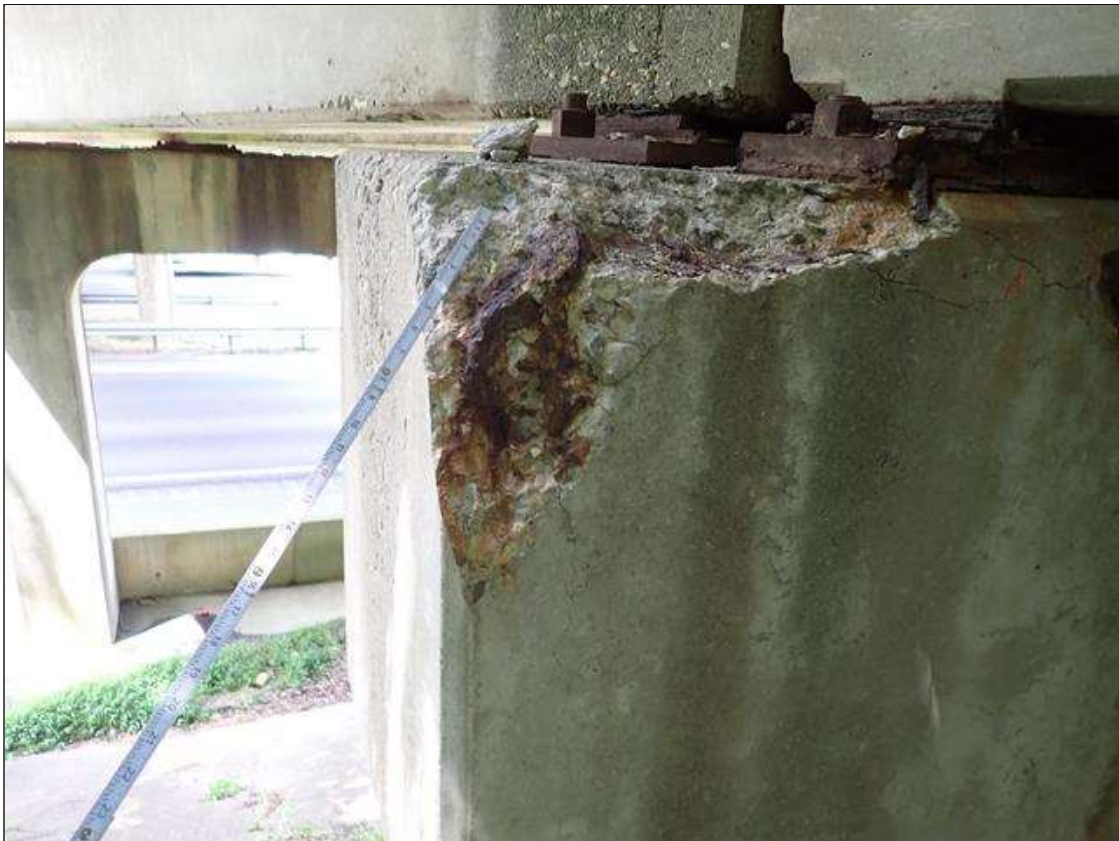
Bent 1 Cap 1: (PAR) 2 FOOT X UP TO 16 INCH X 3 INCH DEEP SPALL WITH EXPOSED RUSTED PRIMARY REINFORCING [SECTION LOSS UP TO 1/8 INCH] AT SOUTHWEST CORNER
