NC DEPARTMENT OF TRANSPORTATION
 DIVISION OF HIGHWAYS
 STRUCTURE MANAGEMENT UNIT

ATTENTION: prompt action request; sketches updated; signs attached to beam; lateral clearance revised; new beam repairs

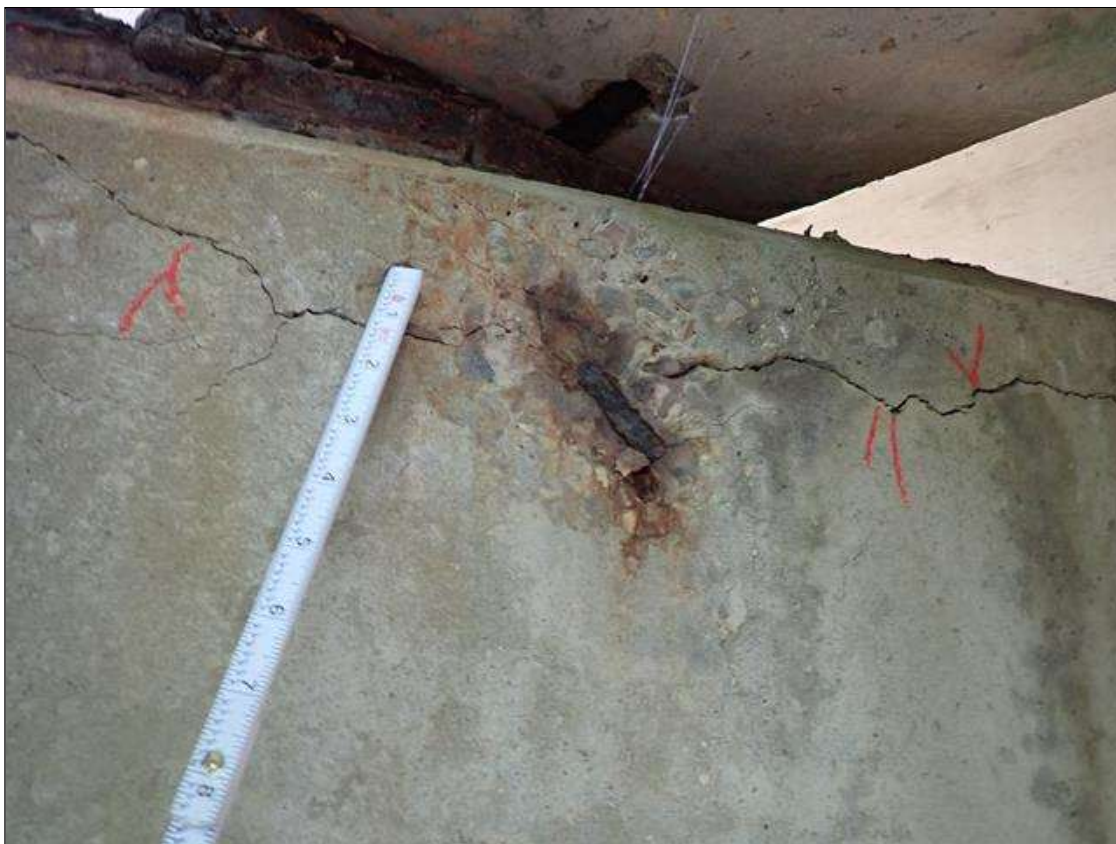
Bent 1 Cap 1: (PAR) 6 INCH DIAMETER X 1 INCH SPALL WITH EXPOSED REINFORCING APPROXIMATELY 25 PERCENT SECTION LOSS SOUTH FACE UNDER BEAM 1

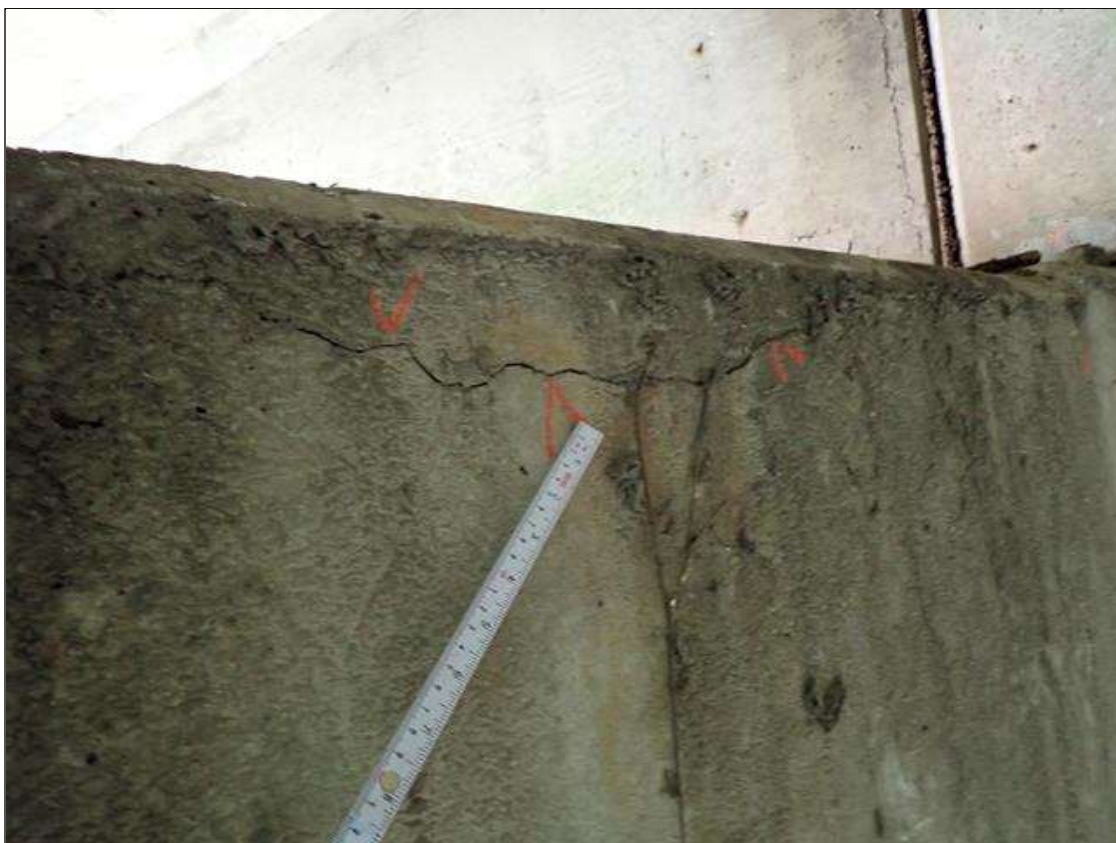
Bent 1 Cap 1: (3) UP TO 3 FOOT X 1/16 INCH HORIZONTAL CRACKS SOUTH AND NORTH FACE BAY 1

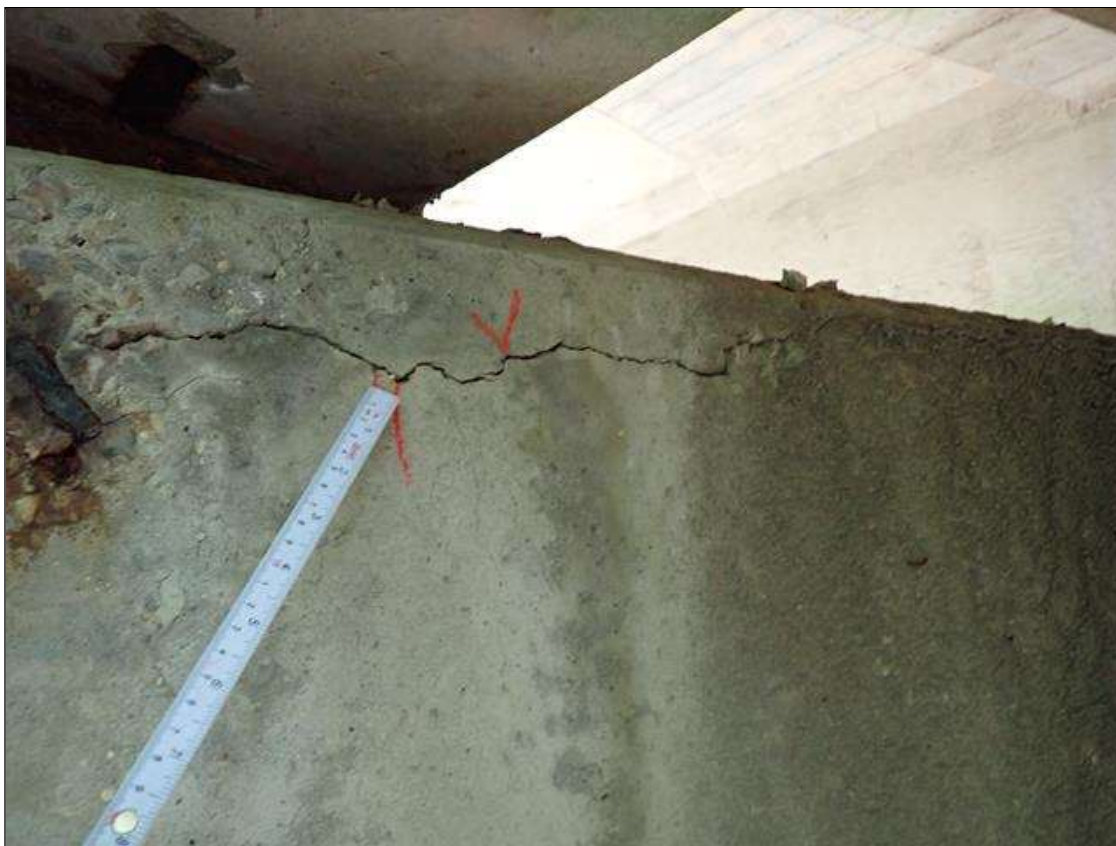
Bent 1 Cap 1: (3) UP TO 3 FOOT X 1/16 INCH HORIZONTAL CRACKS SOUTH AND NORTH FACE BAY 1

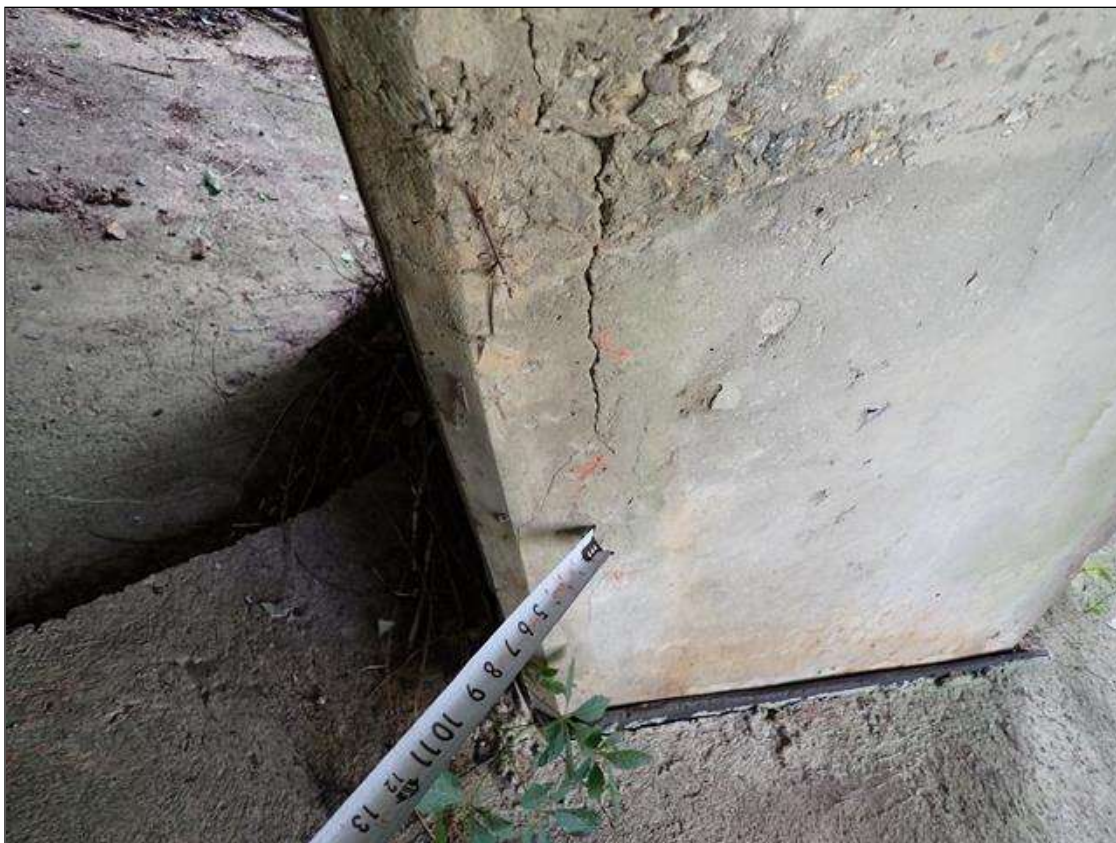
Bent 1 Pile 1: at top of column, southwest corner, delamination (3 foot x 11 inch); southeast corner, vertical crack (up to 1/16 inch x 2 foot)

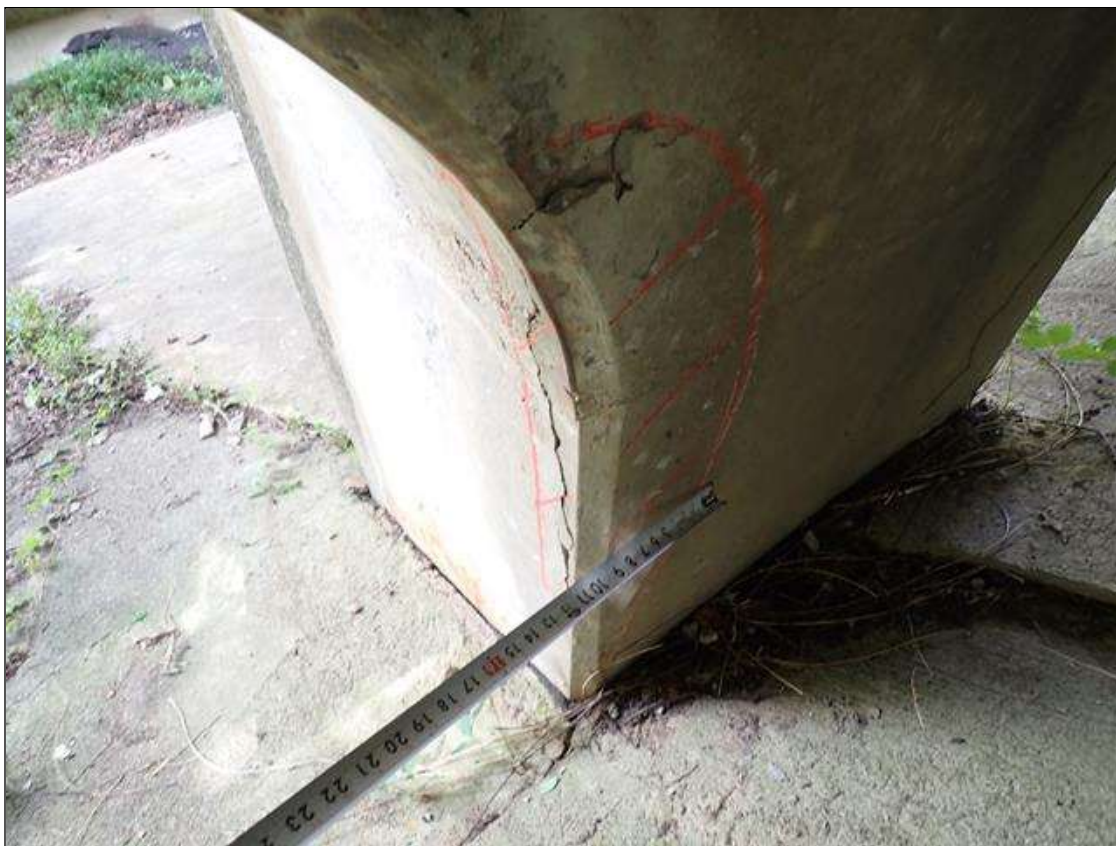
Bent 1 Pile 1: at top of column, southwest corner, delamination (3 foot x 11 inch); southeast corner, vertical crack (up to 1/16 inch x 2 foot)

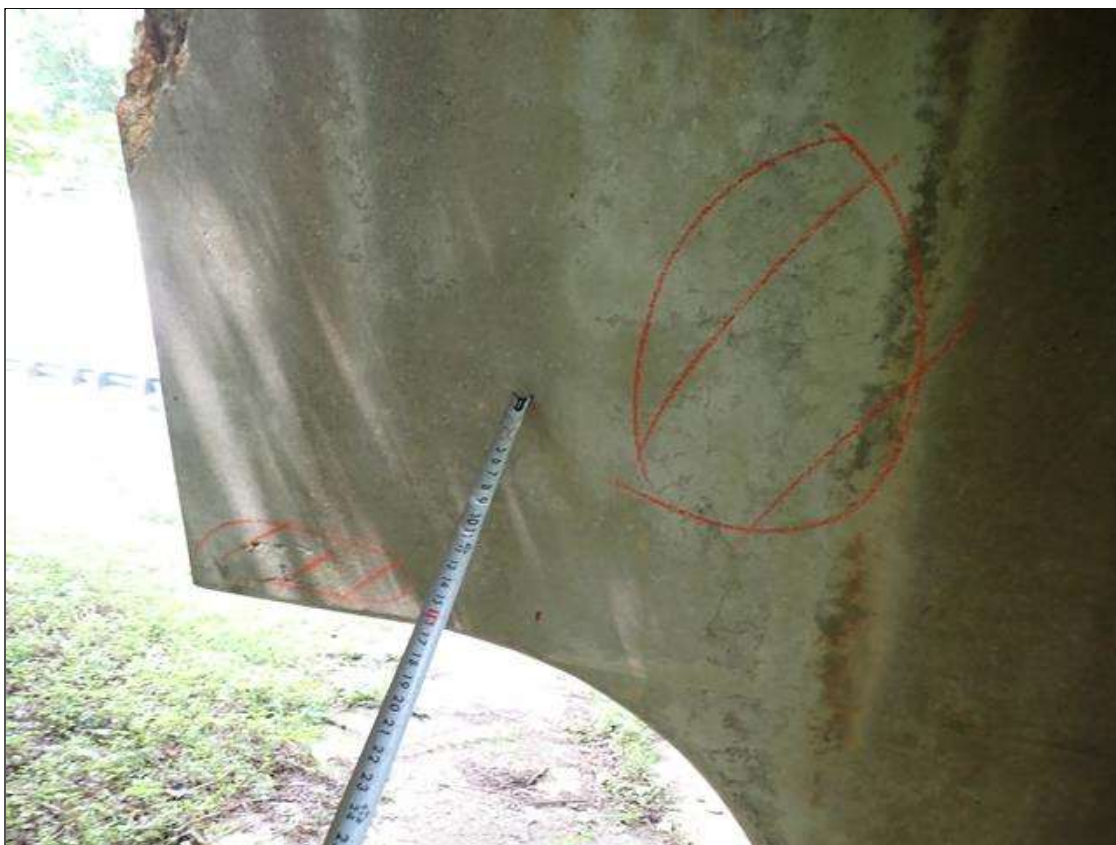
Bent 1 Cap 1: south face, west end, (2) delaminations (up to 13 inch x 19 inch)

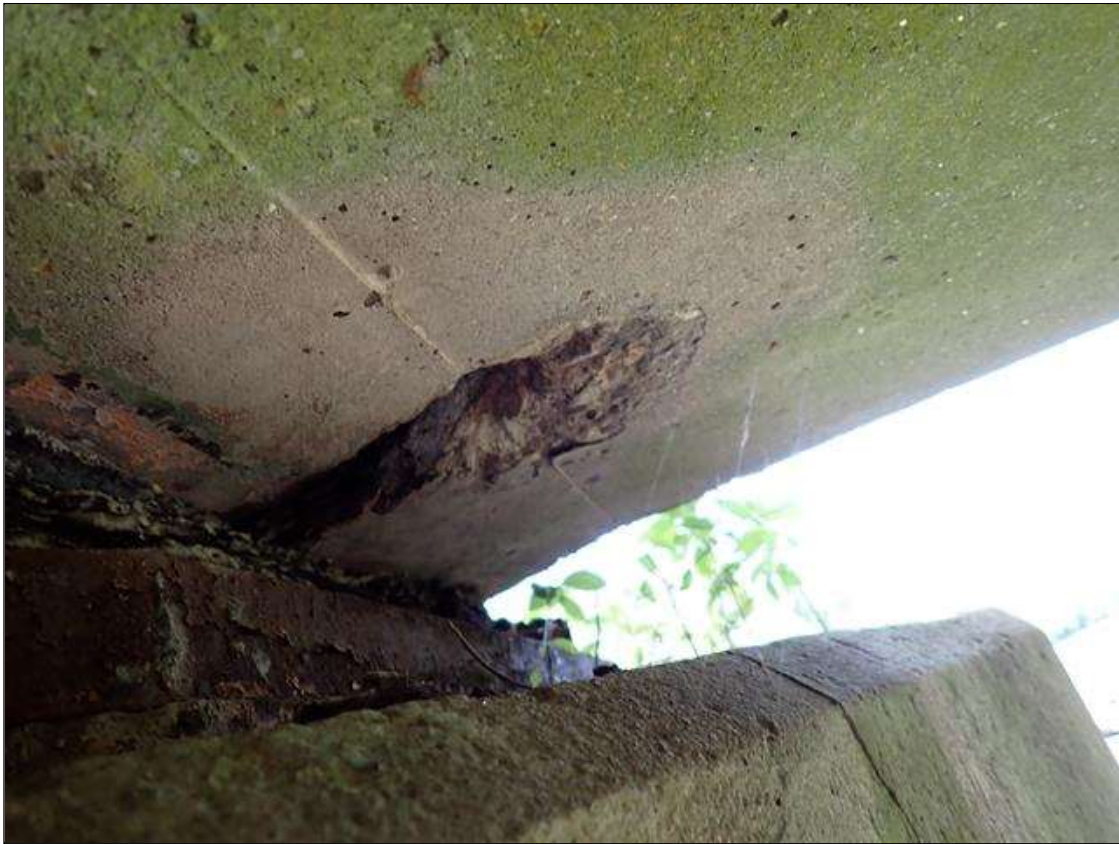
Span 2 Beam 4: (PAR) at bent 2, west face and underside, multiple spalls/delaminations (up to 21 inch x 5 inch x 1 inch deep) with exposed rusted rebar (approximately 25 percent loss)

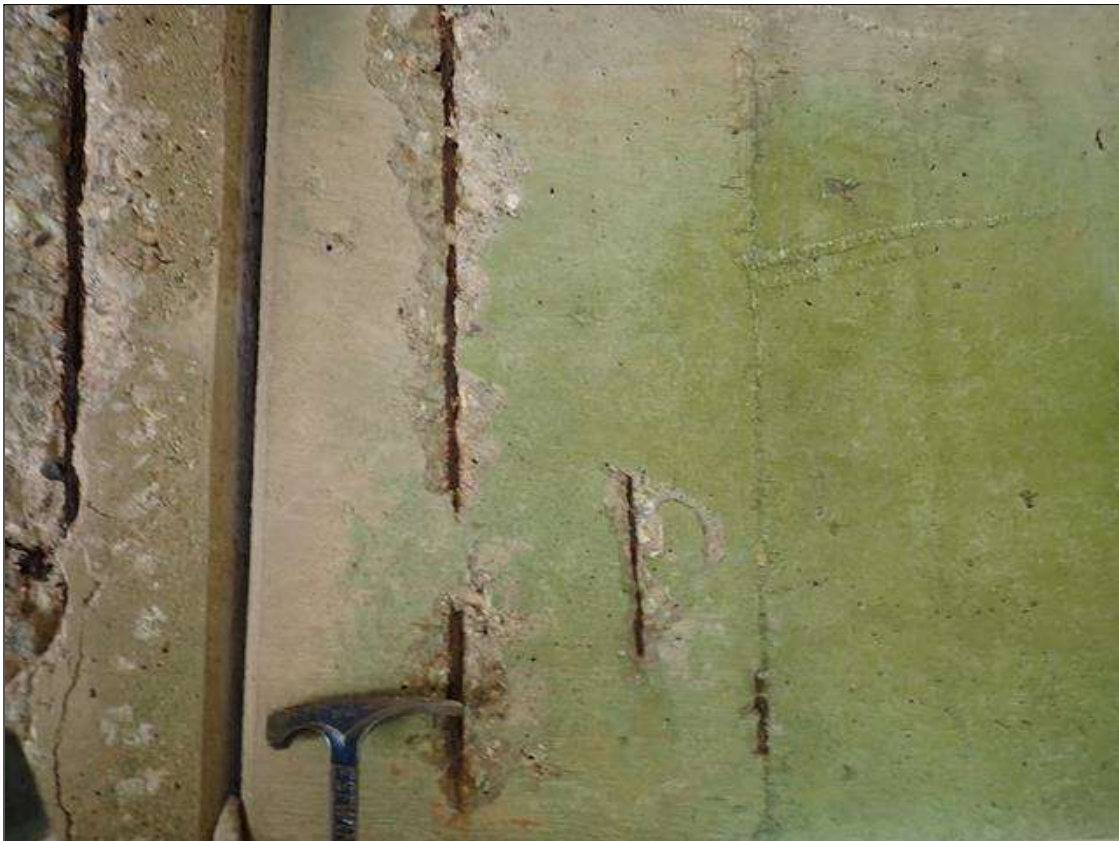
Span 2 Beam 4: (PAR) at bent 2, west face and underside, multiple spalls/delaminations (up to 21 inch x 5 inch x 1 inch deep) with exposed rusted rebar (approximately 25 percent loss)

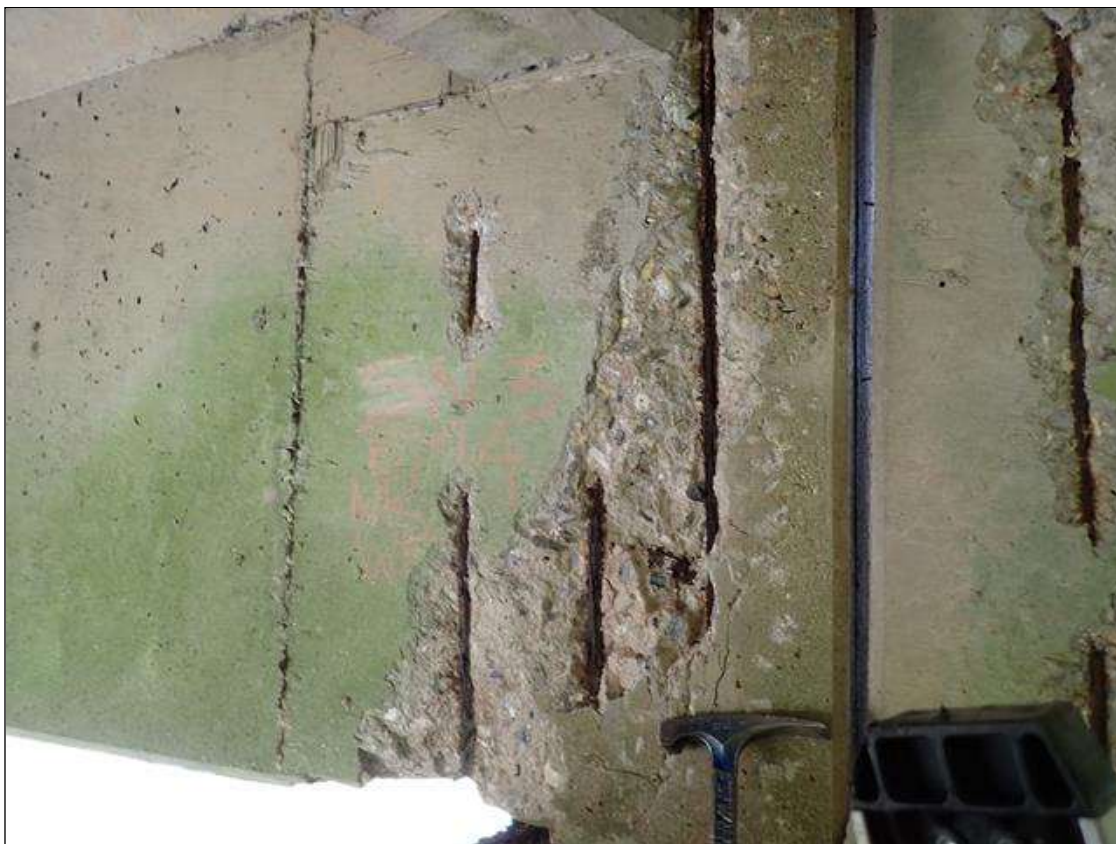
Span 3 Beam 4: (PAR) west face web and underside at bent 2, spall/delamination [30 inch x up to full height x up to 2 inch deep] with exposed rusted primary reinforcing [approximately 25 percent loss]

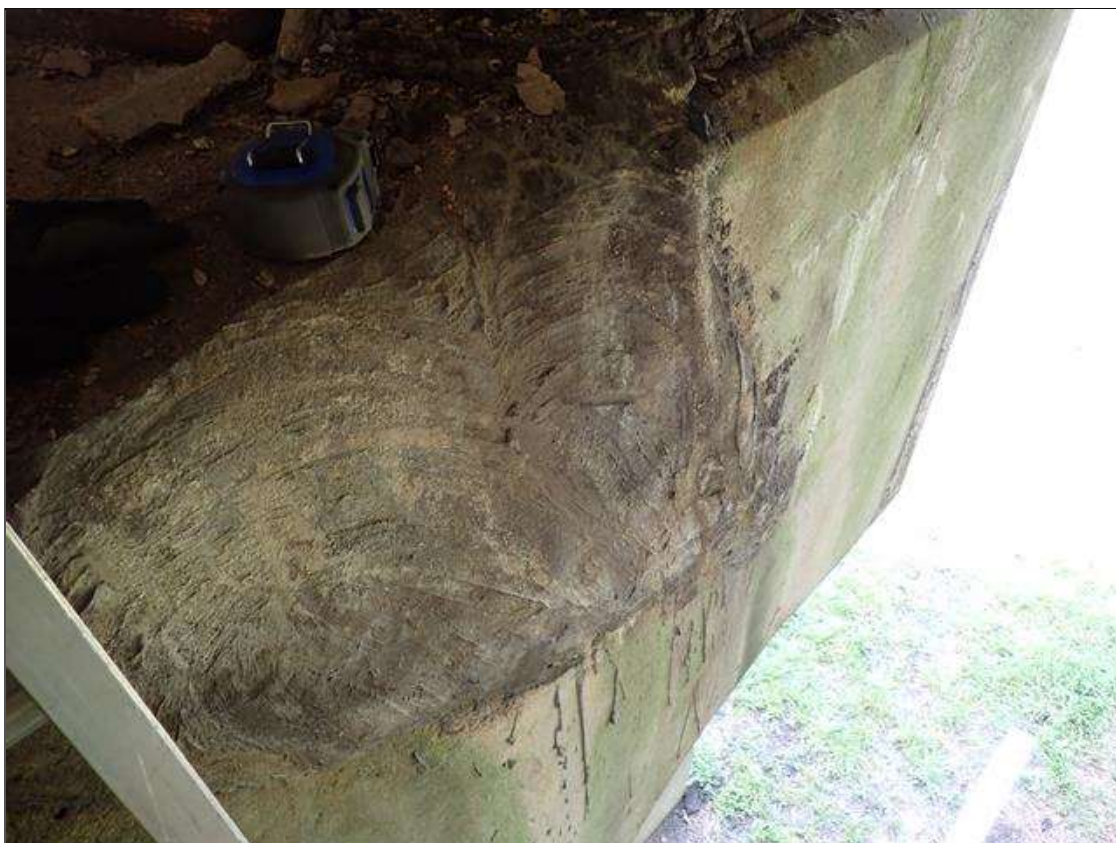
Bent 2 Cap 1: 3 FOOT X UP TO 3 FOOT PATCHED AREA SOUTH FACE UNDER BAY 3 NEAR BEAM 4

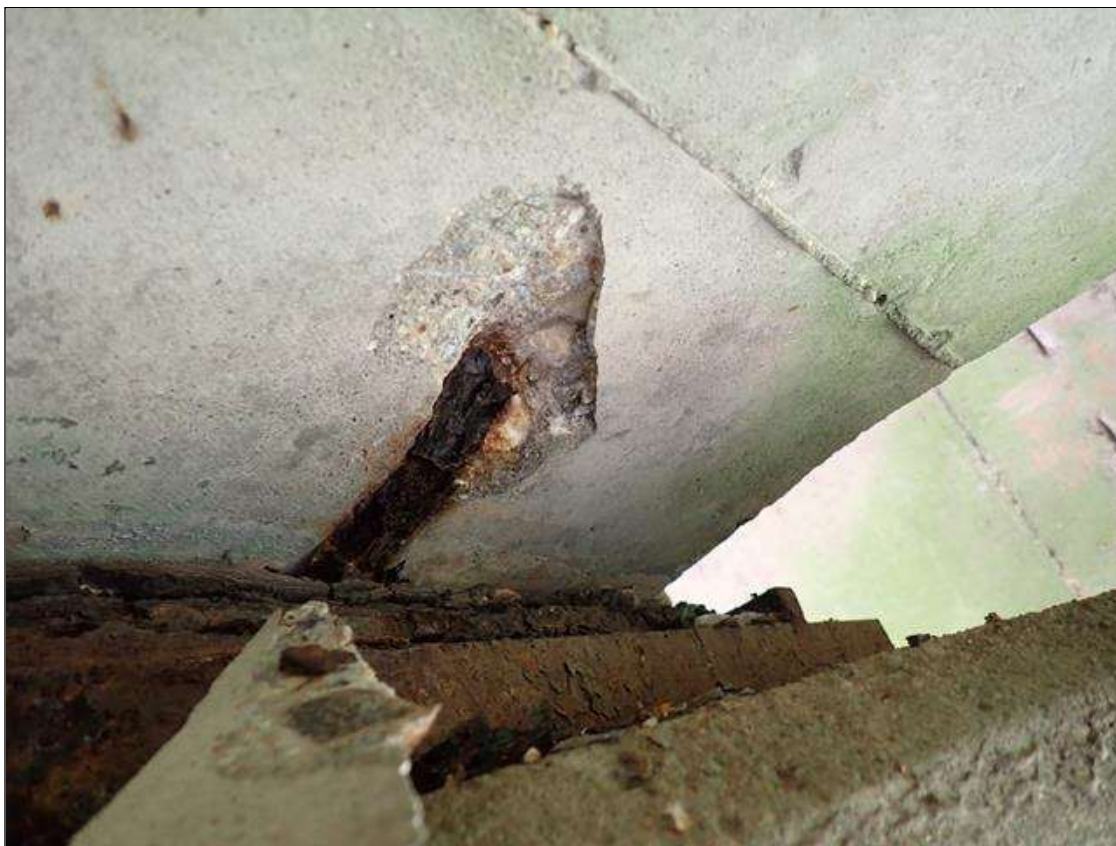
Span 2 Beam 3: at bent 2, underside, spall (6 inch x 3 inch x 1/2 inch deep) with exposed rusted rebar

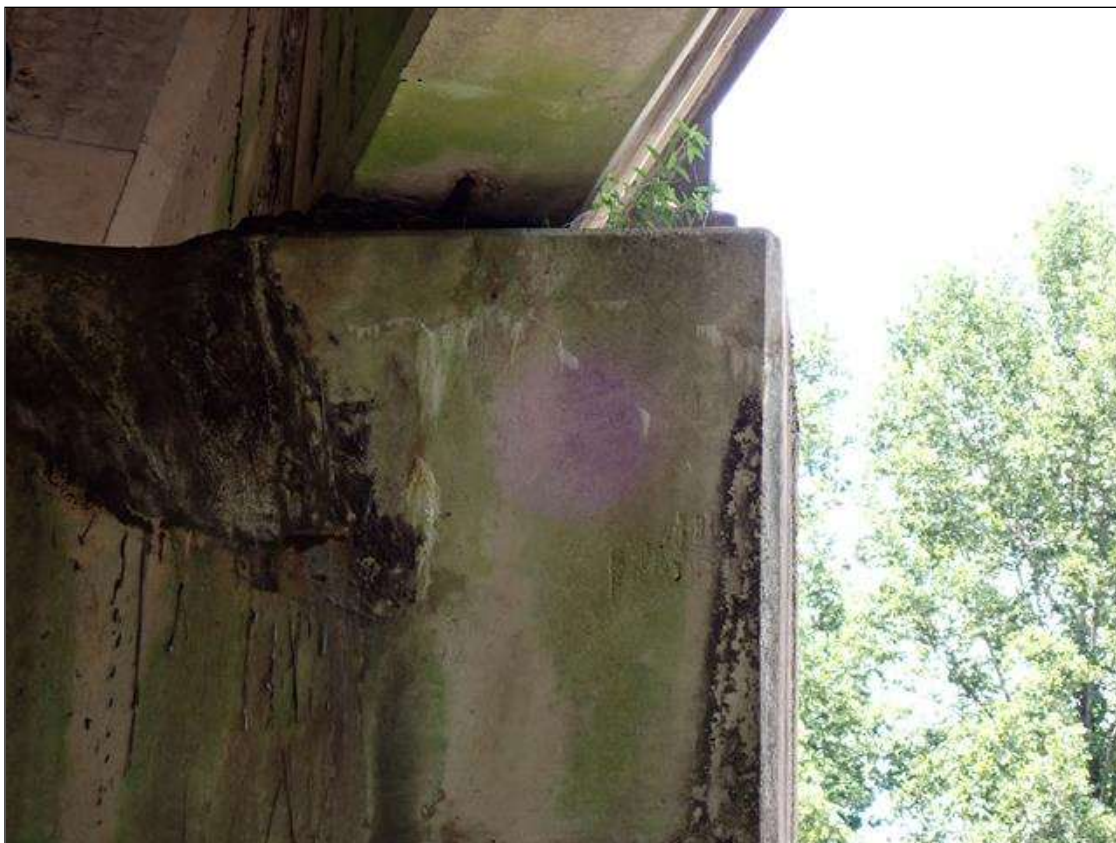
Bent 2 Cap 1: 3 FOOT X UP TO 1/64 INCH HORIZONTAL CRACK WITH EFFLORESCENCE AND ADJACENT 3 FOOT X 8 INCH X 4 INCH DELAMINATION ON TOP SOUTHEAST CORNER

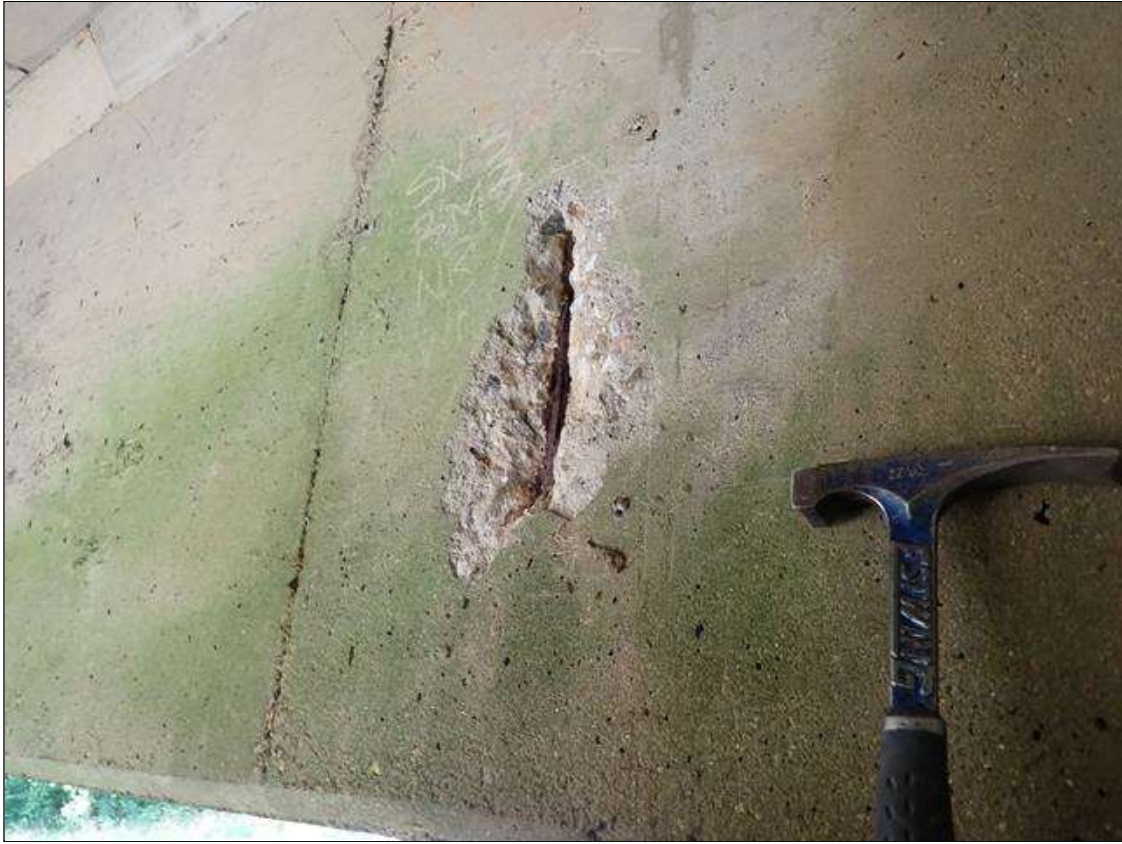
Span 3 Beam 3: west face at bent 2, spall [14 inch x up to 8 inch x 1 inch deep] with exposed rusted reinforcing [no loss noted]; underside at bent 2 bearing, spall [4 inch x 4 inch x 1/2 inch deep] with exposed rusted reinforcing [no loss noted]

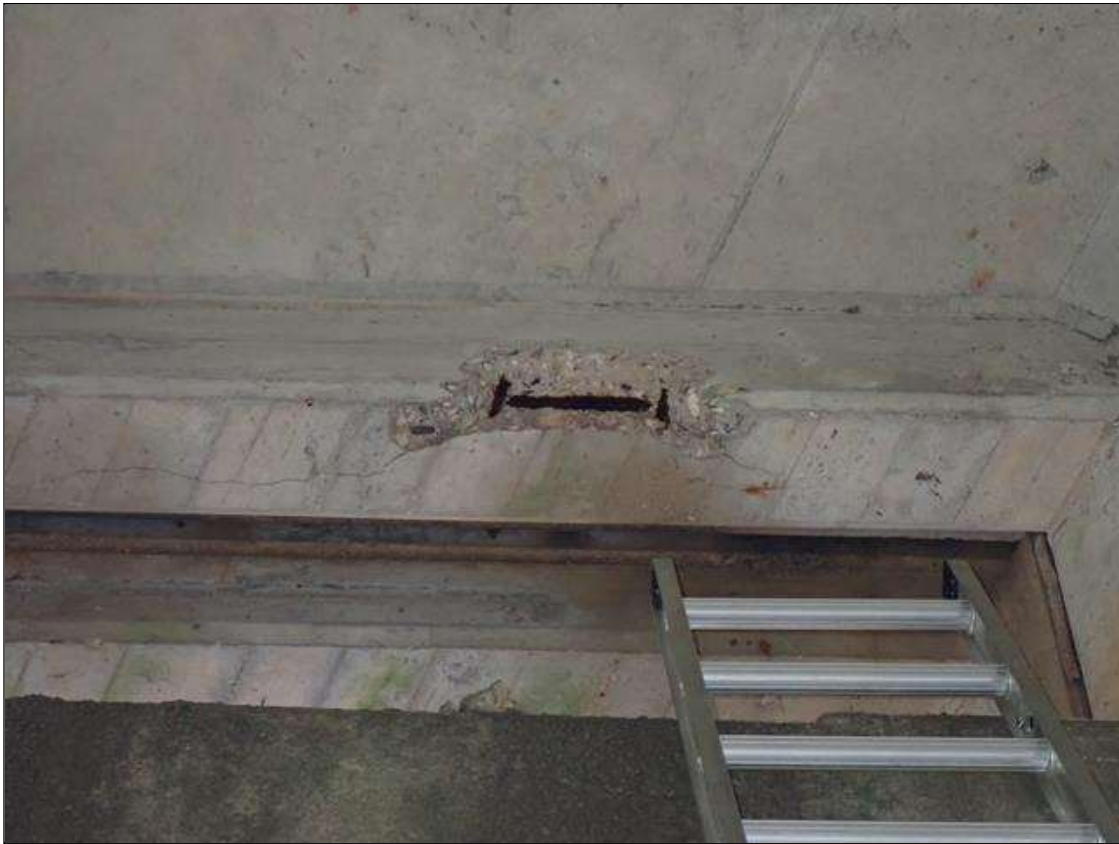
Span 2 Beam 2: at bent 2 bay 2 end diaphragm, spall [22 inch x 3 inch x 3 inch with exposed rusted reinforcing [no loss noted] with cracks [up to 1/16 inch]

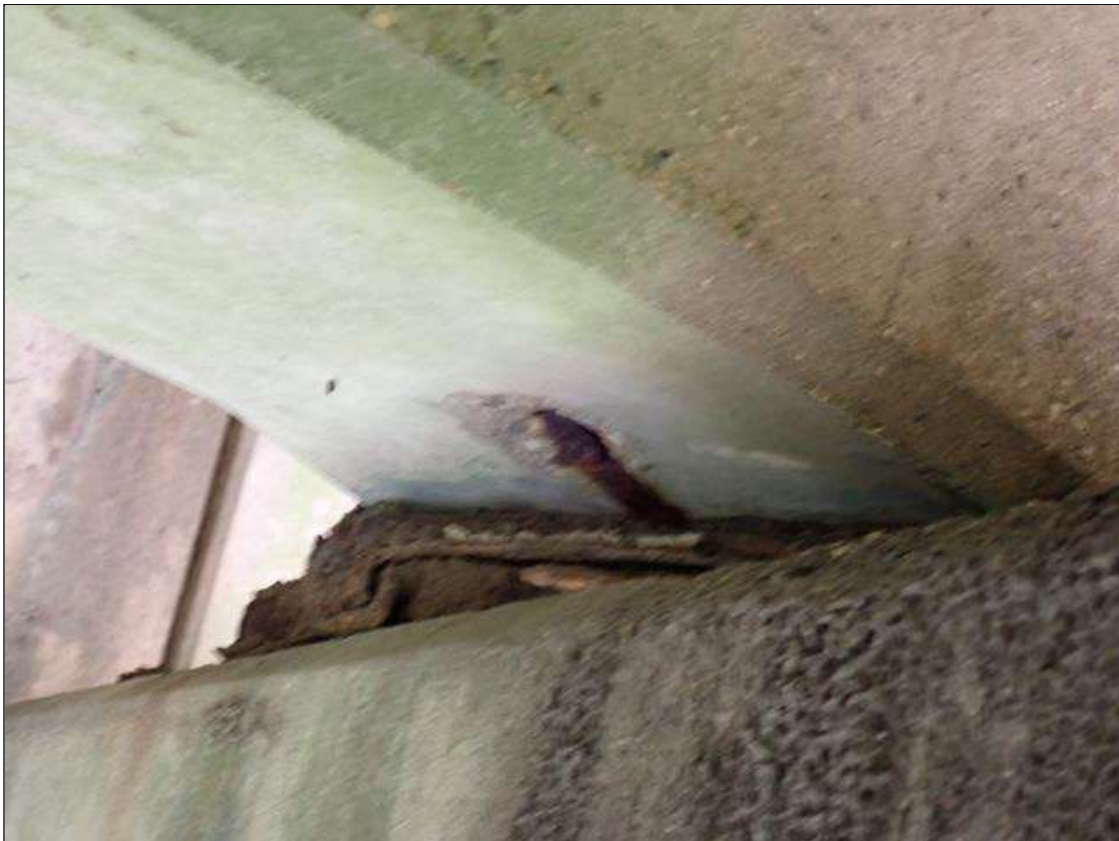
Span 2 Beam 2: at bent 2, underside, spall (6 inch x 3 inch x 1/2 inch deep) with exposed rusted rebar

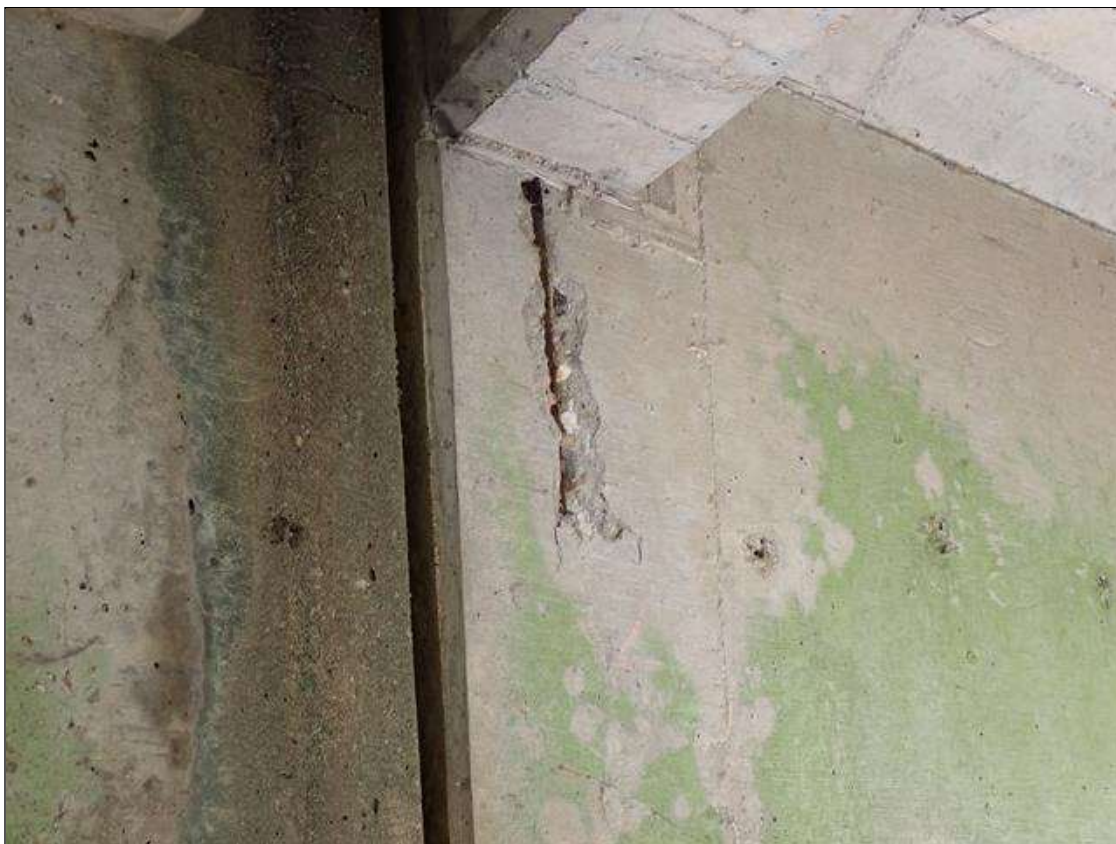
Span 3 Beam 1: east face web at bent 2, spall [12 inch x 2 inch x 1/2inch deep] with exposed rusted reinforcing

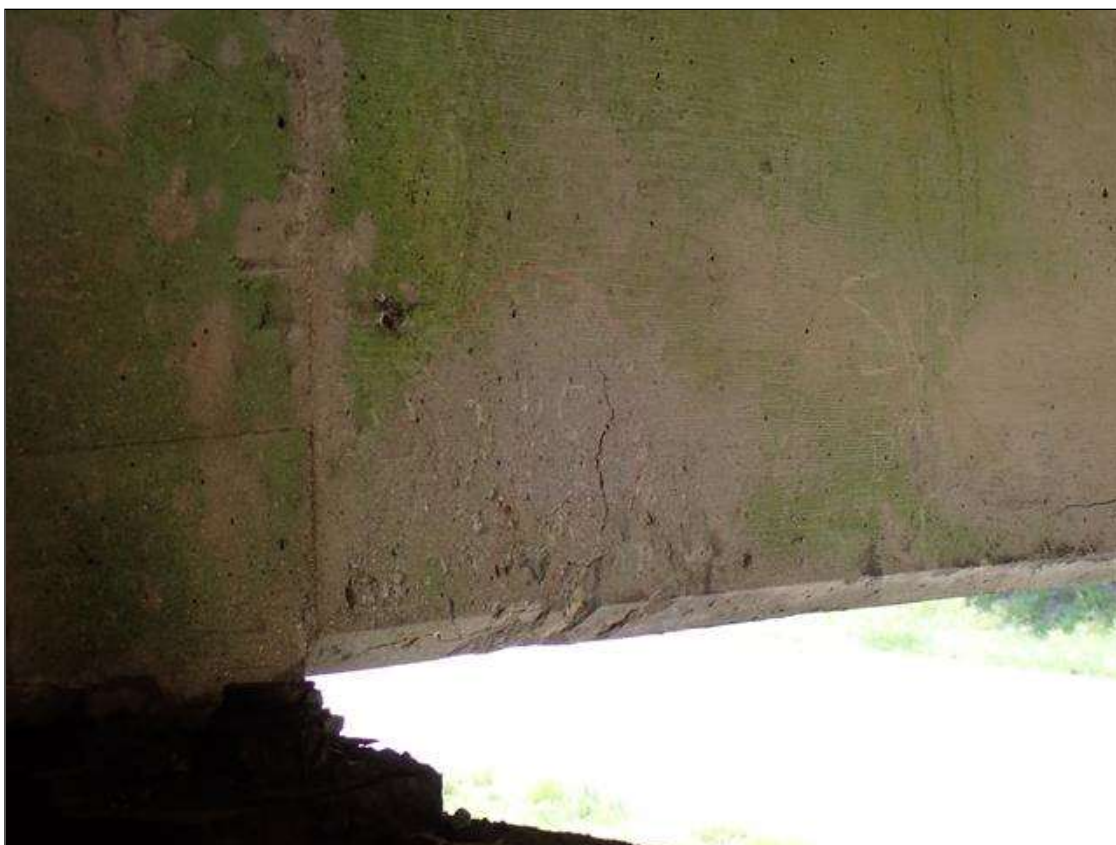
Span 3 Beam 1: east face web at bent 2, delamination [12 inch x 10 inch]

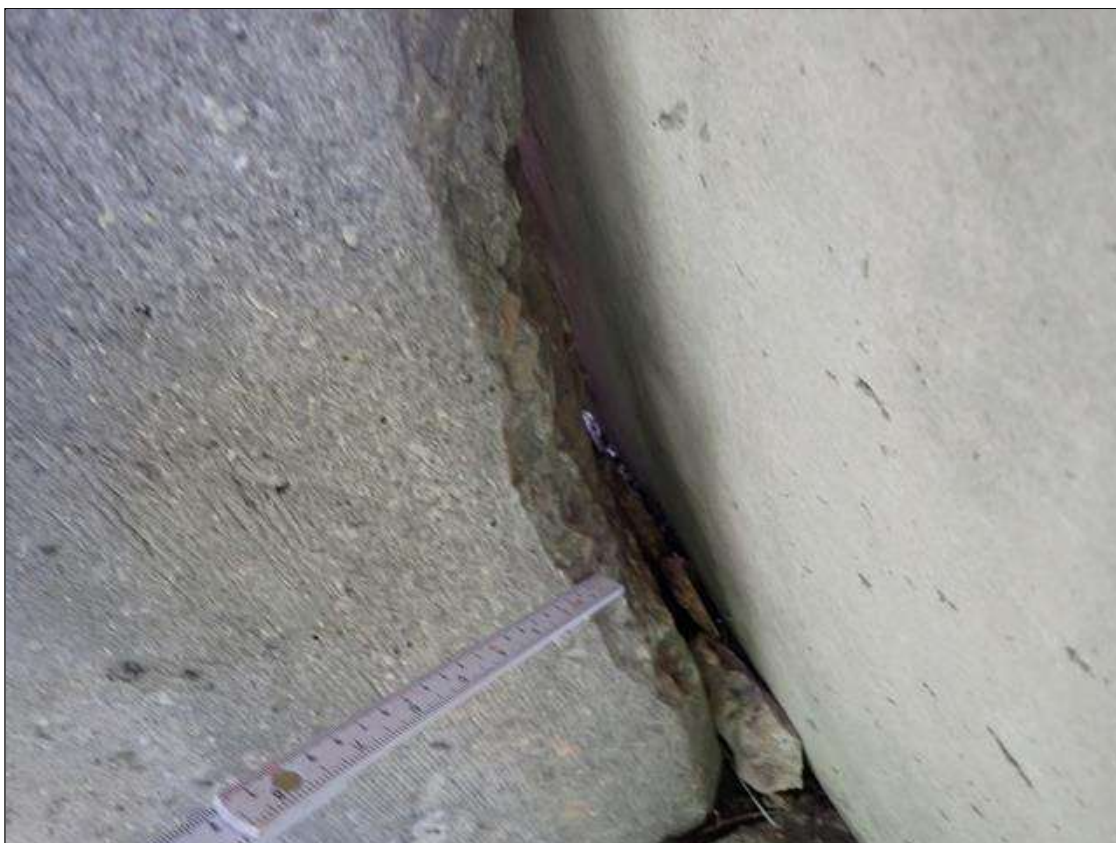
Bent 2 Pile 1: base of column at northeast corner, spall [16 inch x 8 inch x 2 inch deep] with exposed rusted primary reinforcing [no loss noted]

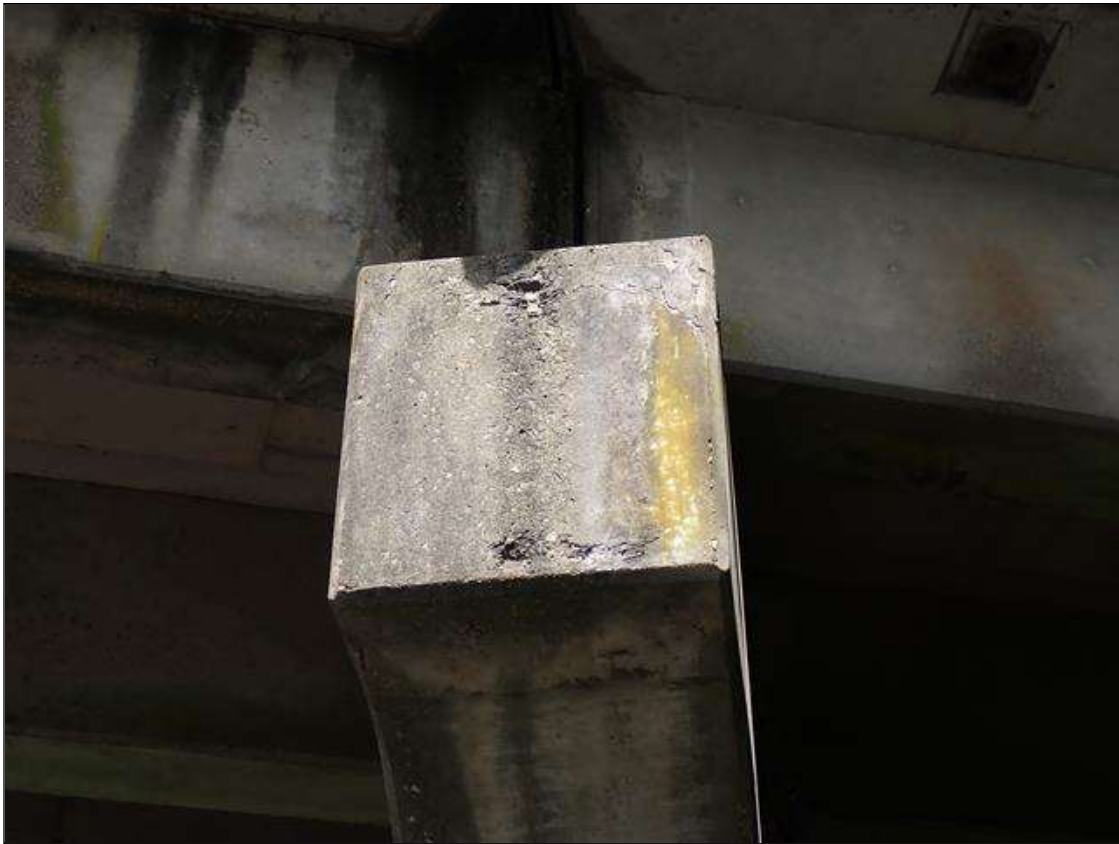
Bent 2 Cap 1: WEST END. HAS SCATTERED AREAS THAT ARE CRACKED UP TO 1/32 INCH AND DELAMINATED WITH SOME POP-OUTS UP TO 1/2 INCH DEEP

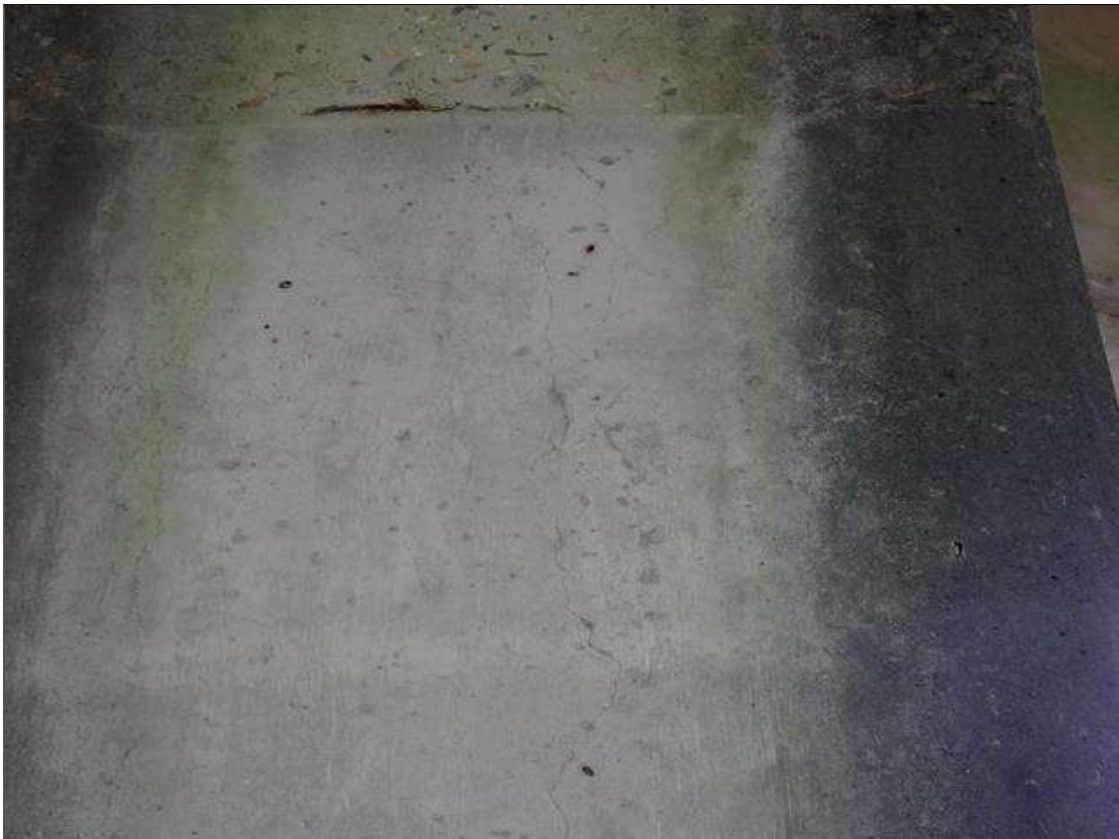
Bent 2 Pile 1: 7 FOOT X UP TO 1/32 INCH VERTICAL CRACKS NEAR BOTTOM OF CAP

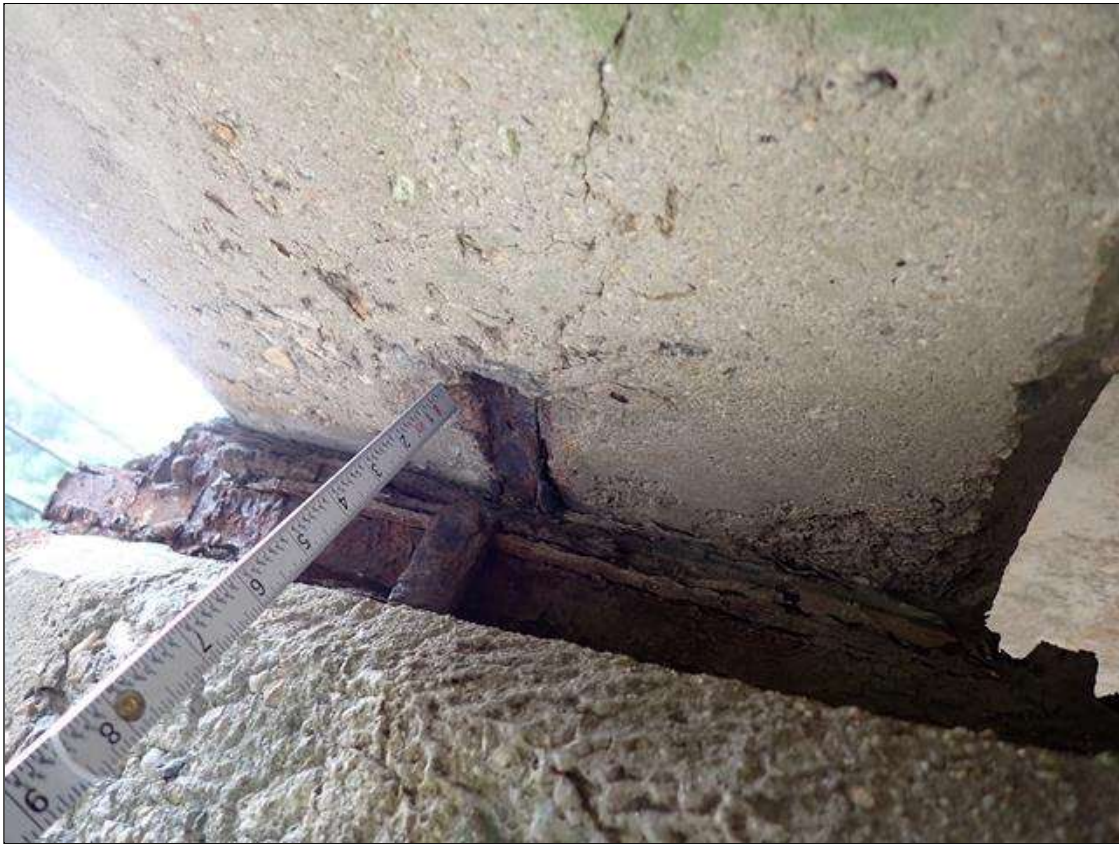
Span 3 Beam 1: at bent 3, east face, spall/delamination (8 inch x 12 inch x 1/2 inch deep); underside, spall (4 inch x 3 inch x 1/2 inch deep) with exposed rusted rebar

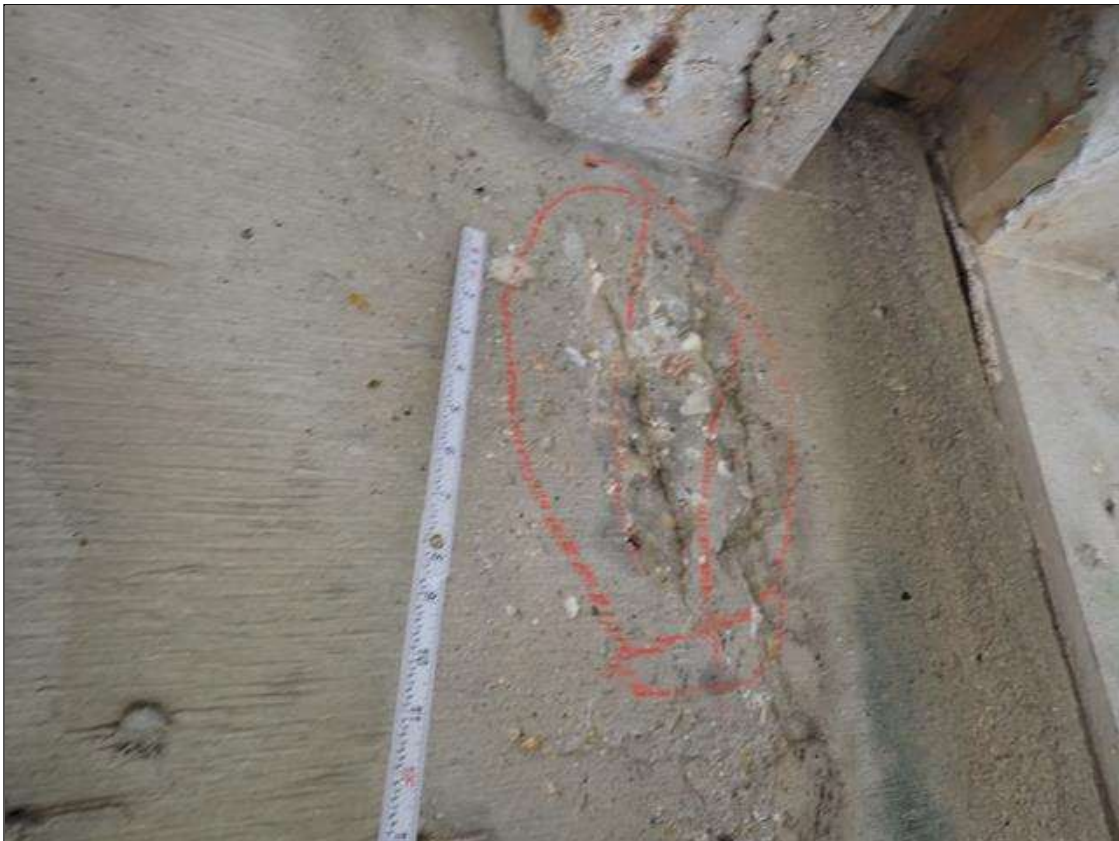
Span 3 Beam 1: at bent 3, east face, spall/delamination (8 inch x 12 inch x 1/2 inch deep); underside, spall (4 inch x 3 inch x 1/2 inch deep) with exposed rusted rebar

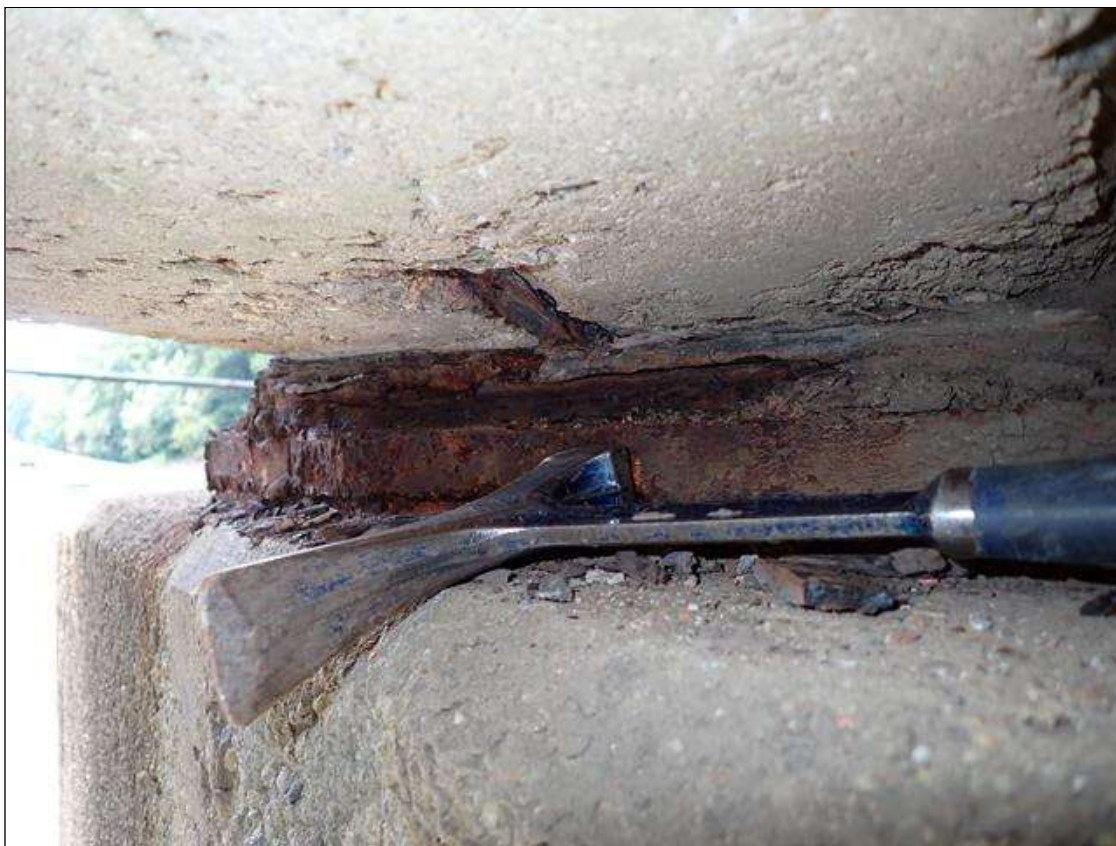
Span 3 Beam 1 - Far Bearing 1: corrosion with section loss (up to 1/16 inch)
