NC DEPARTMENT OF TRANSPORTATION
 DIVISION OF HIGHWAYS
 STRUCTURE MANAGEMENT UNIT

ATTENTION: prompt action request; sketches updated; signs attached to beam; lateral clearance revised; new beam repairs

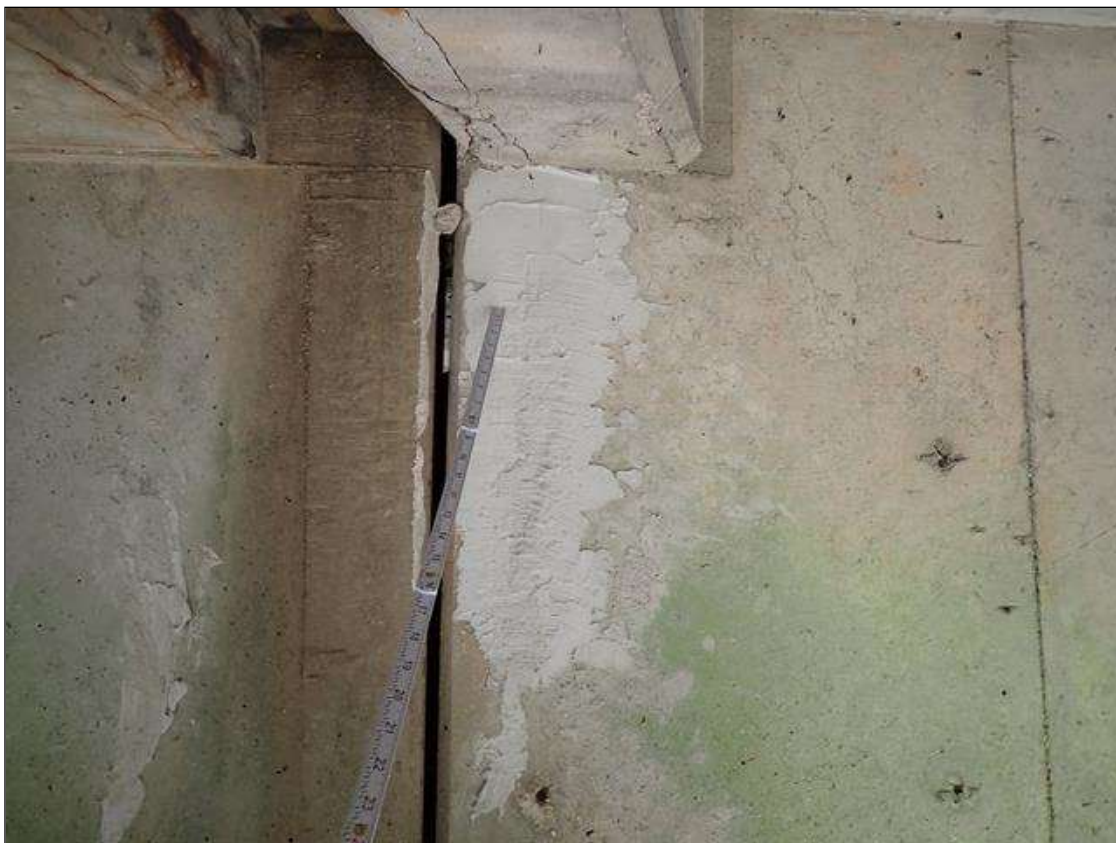
Span 3 Beam 2: 2023 previously repaired, patch (7 inch x 2 foot), previously noted as: West face at bent 3, delamination/spall [5 inch x 3 foot high x up to 3/4 inch deep] with exposed rusted reinforcing no section loss

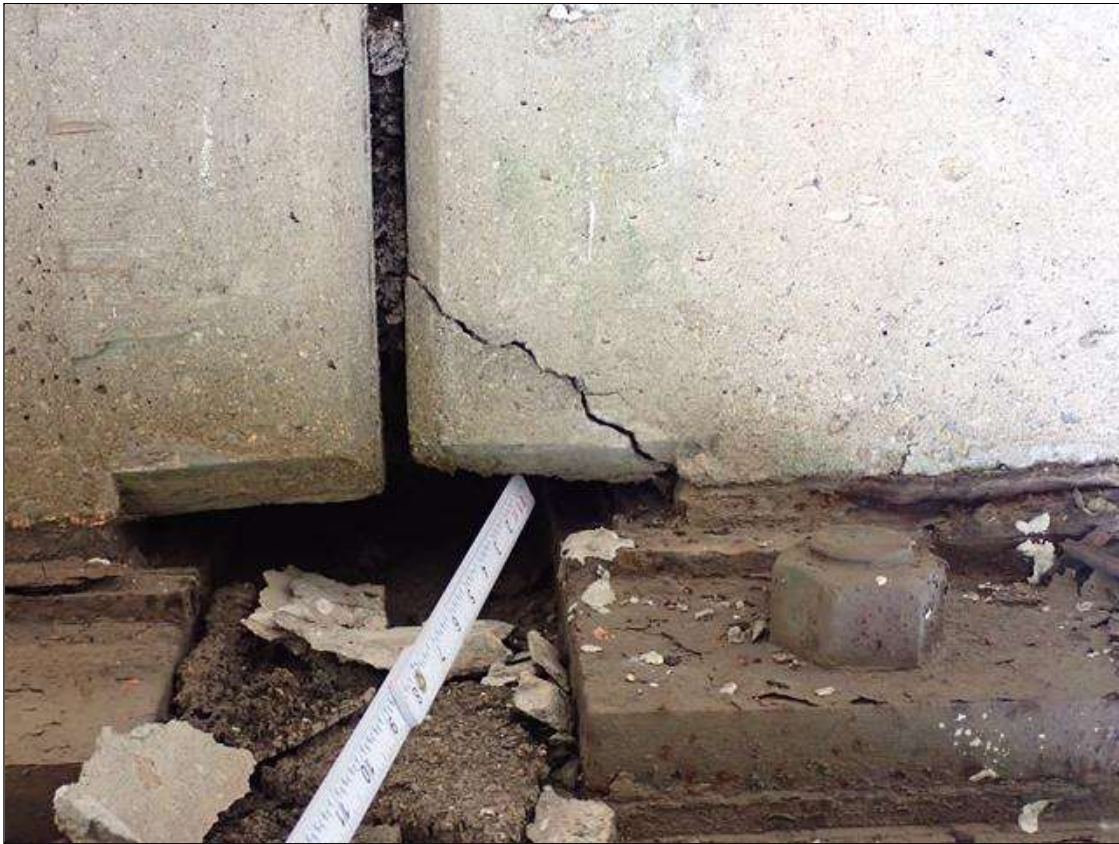
Span 3 Beam 2: at bottom of beam west face at bent 3, delamination (5 inch x 4 inch) with cracks (up to 1/16 inch)

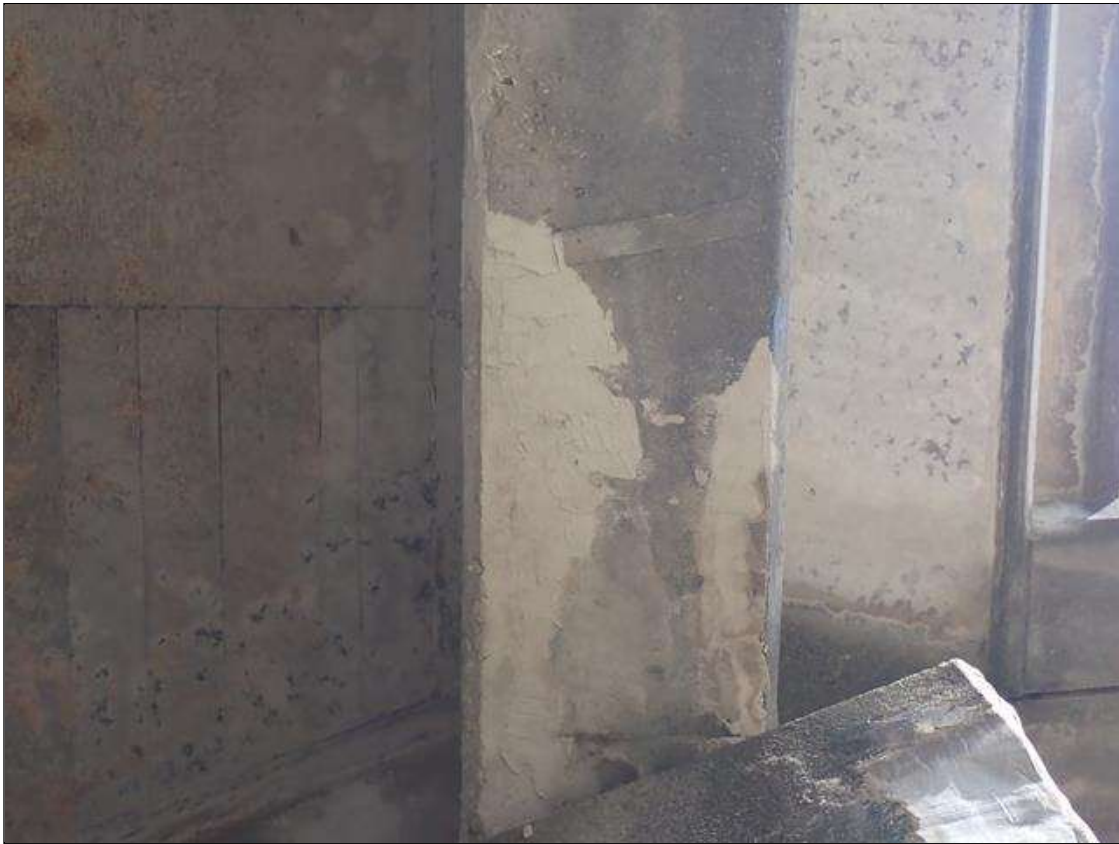
Span 4 Beam 1: 2023 NEW REPAIR, PATCHED AREAS (UP TO 2.5 FOOT X FULL WIDTH), PREVIOUSLY NOTED AS: LONGITUDINAL CRACKS [UP TO 3 FOOT X UP TO 1/8 INCH] ON BOTTOM FACE AT BENT 3 WITH ASSOCIATED DELAMINATION THAT WRAPS AROUND TO EAST FACE [3 FOOT X 5 FOOT]

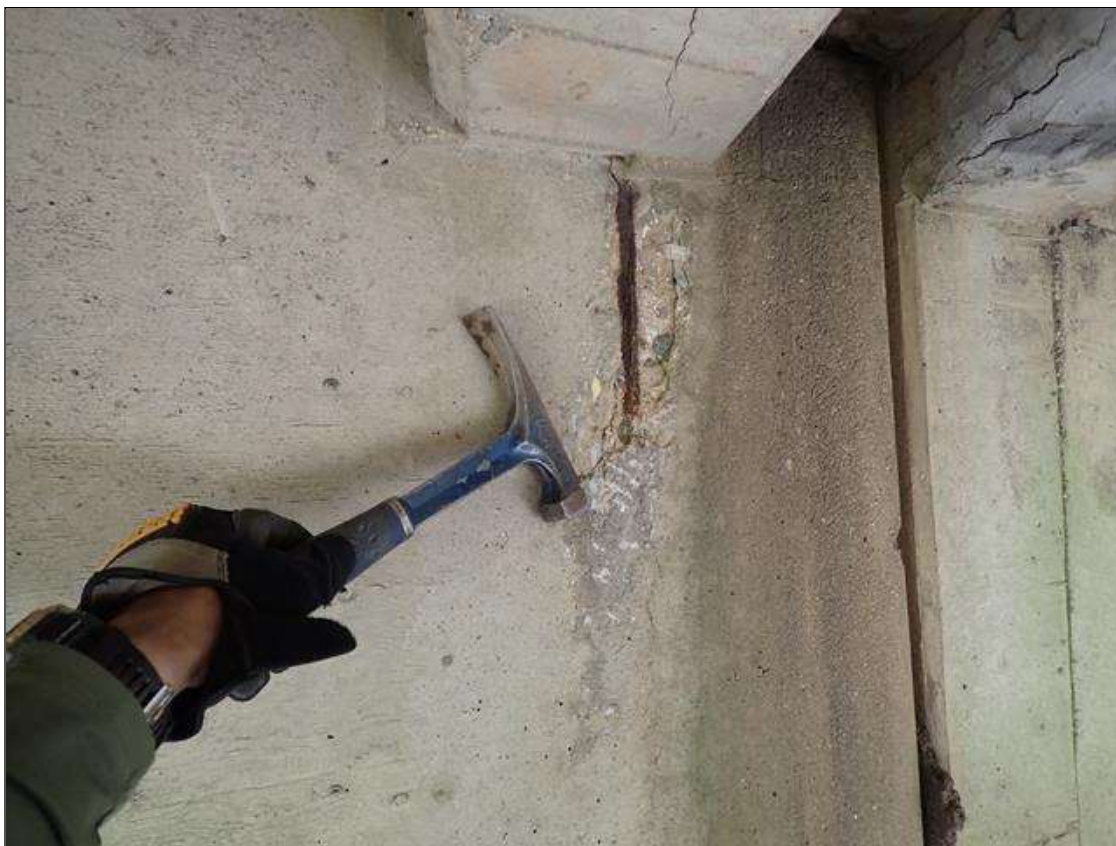
Span 3 Beam 2: east face at bent 3, delamination/spall [3 inch x 1 foot x up to 3/4 inch deep] with exposed rusted reinforcing no section loss

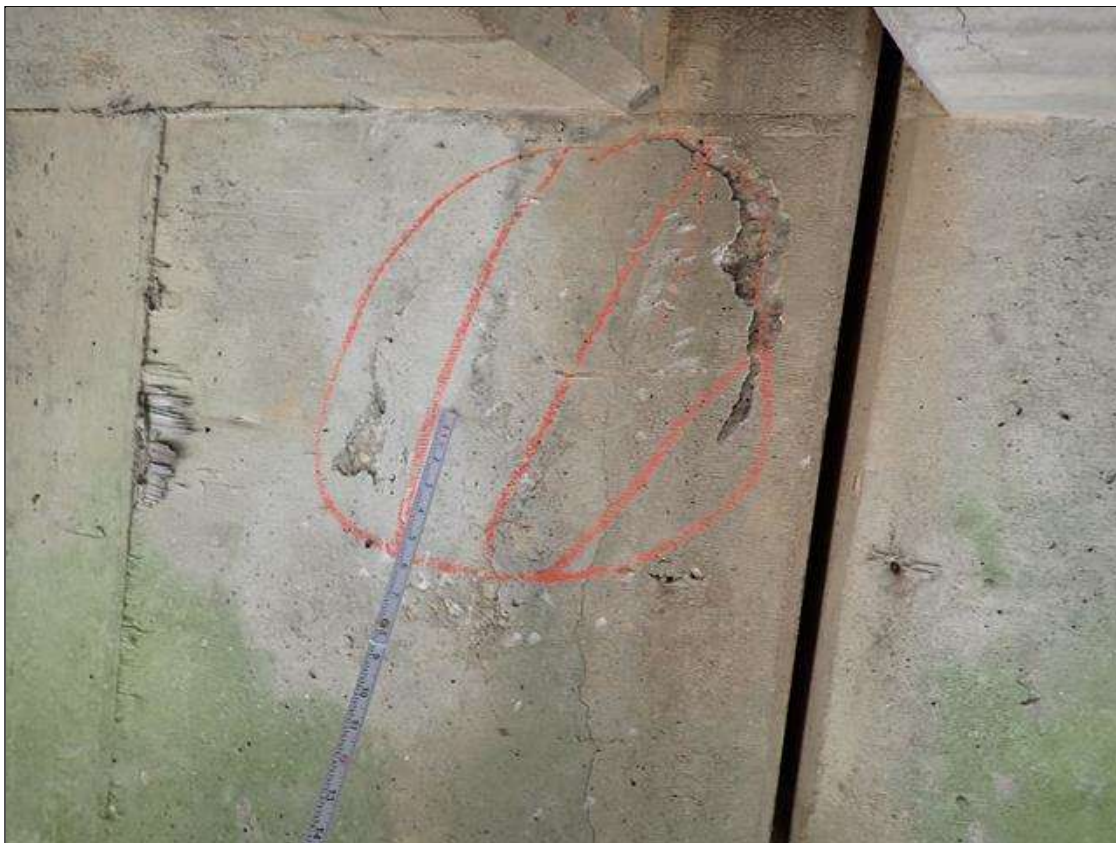
Span 4 Beam 3: west face at bent 3, delamination [16 inch diameter] with cracks [up to 1/32 inch]

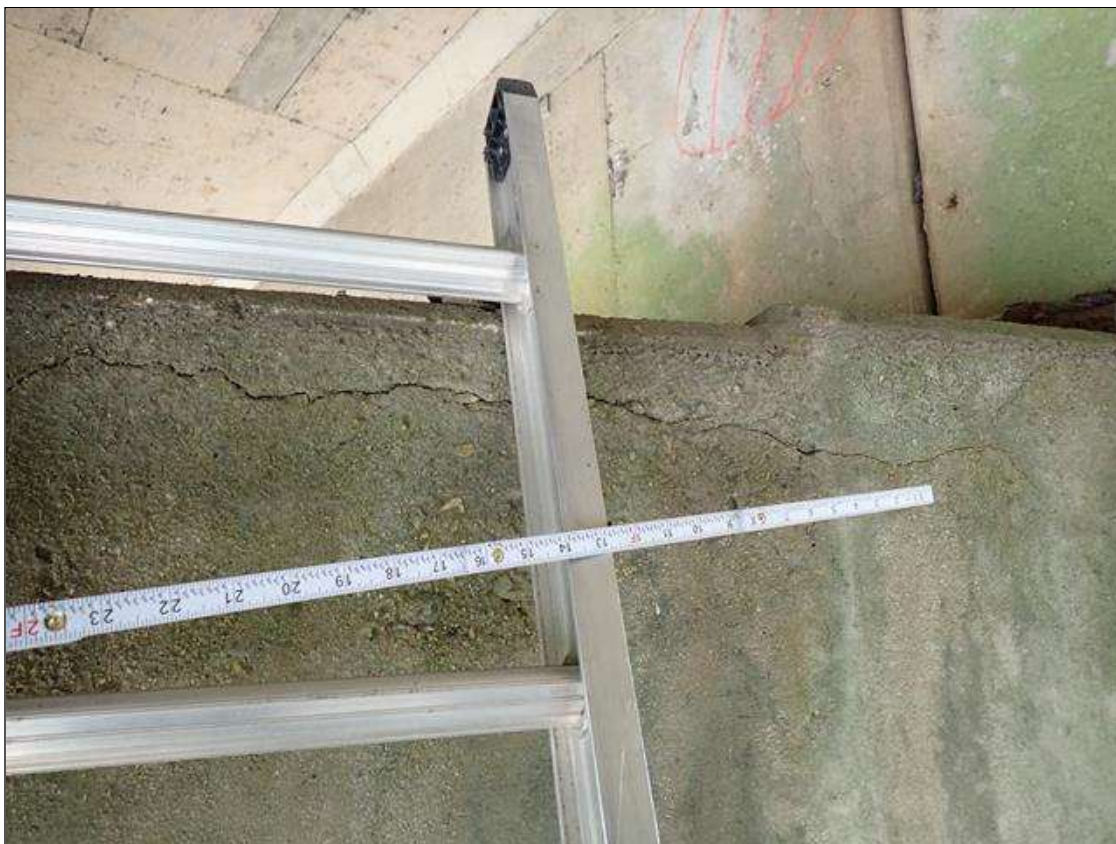
Bent 3 Cap 1: along the length of the cap, vertical cracks (up to 1/64 inch x full height) and longitudinal cracks (up to 1/32 inch x 6 foot) at random

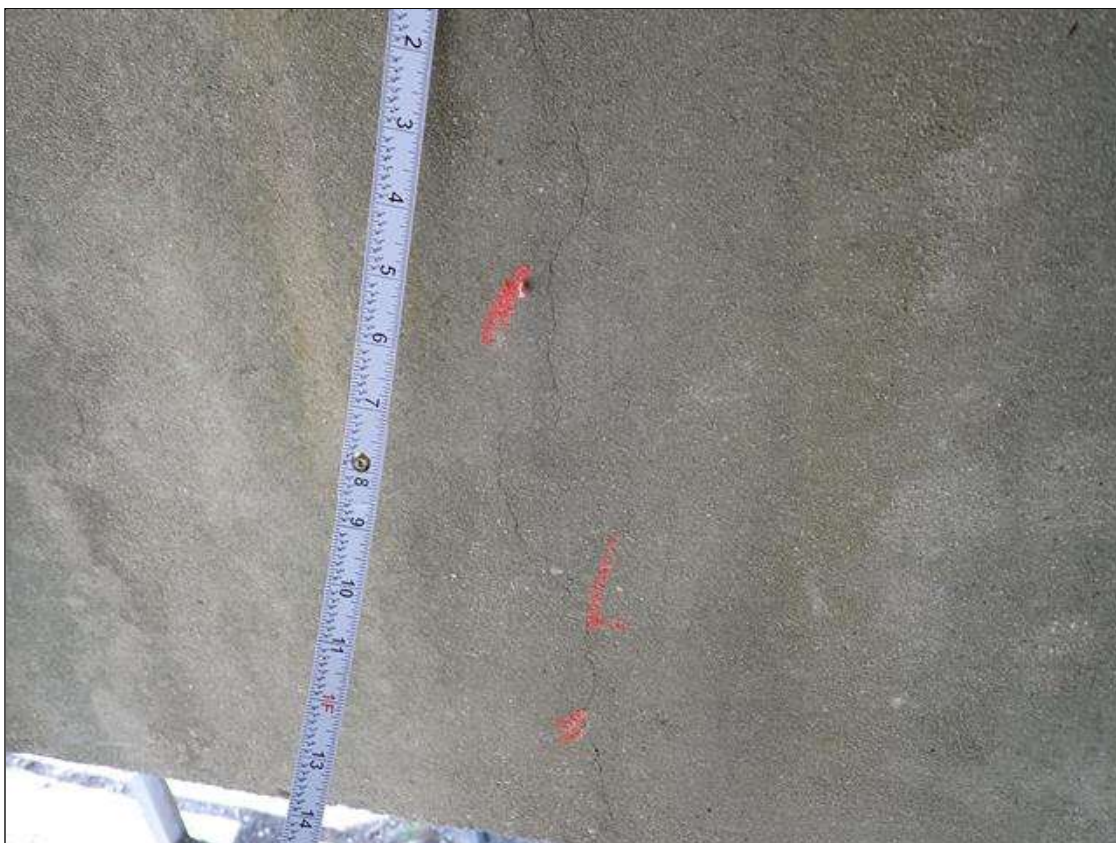
Bent 3 Cap 1: along the length of the cap, vertical cracks (up to 1/64 inch x full height) and longitudinal cracks (up to 1/32 inch x 6 foot) at random

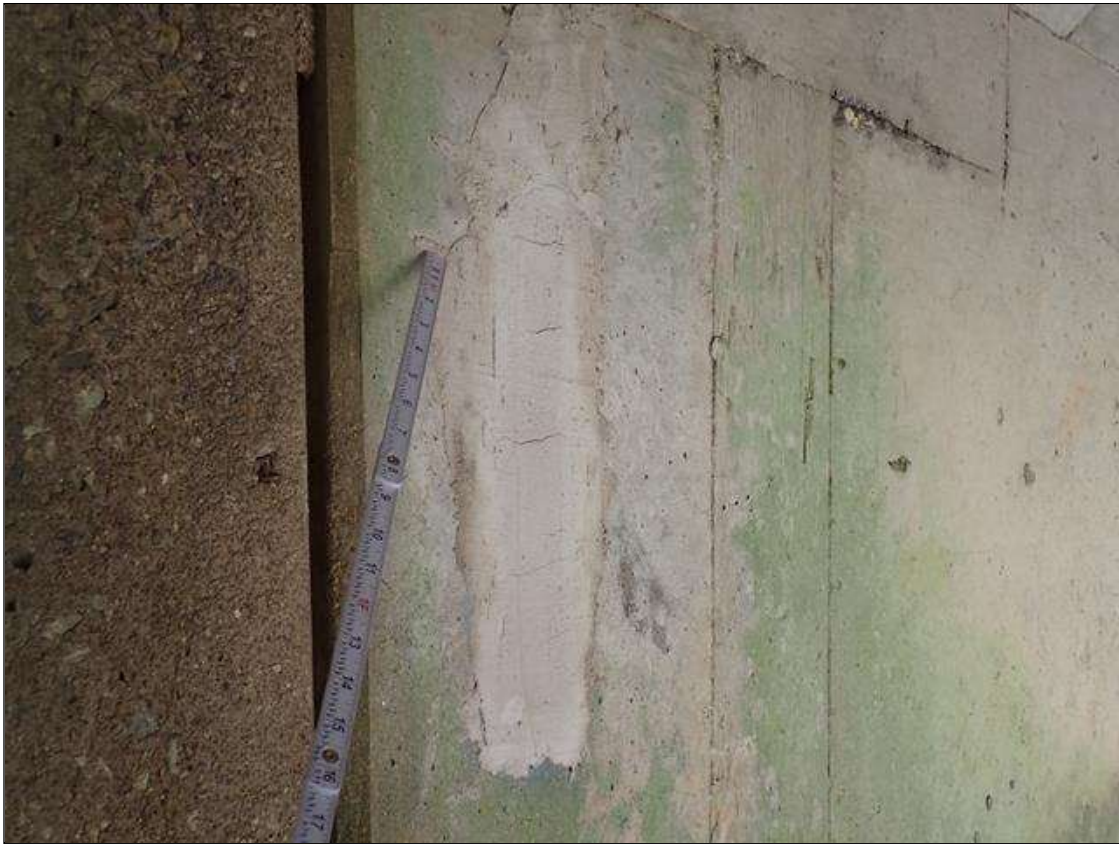
Span 4 Beam 3: 2023 PREVIOUSLY REPAIRED, PATCHED AREA (7 INCH X 2 FOOT) WITH CRACKS (UP TO 1/32 INCH),(PREVIOUSLY NOTED AS: EAST FACE AT BENT 3, DELAMINATION/SPALL [5 INCH X UP TO 4 FOOT X 3/4 INCH DEEP] WITH EXPOSED RUSTED REINFORCING NO SECTION LOSS

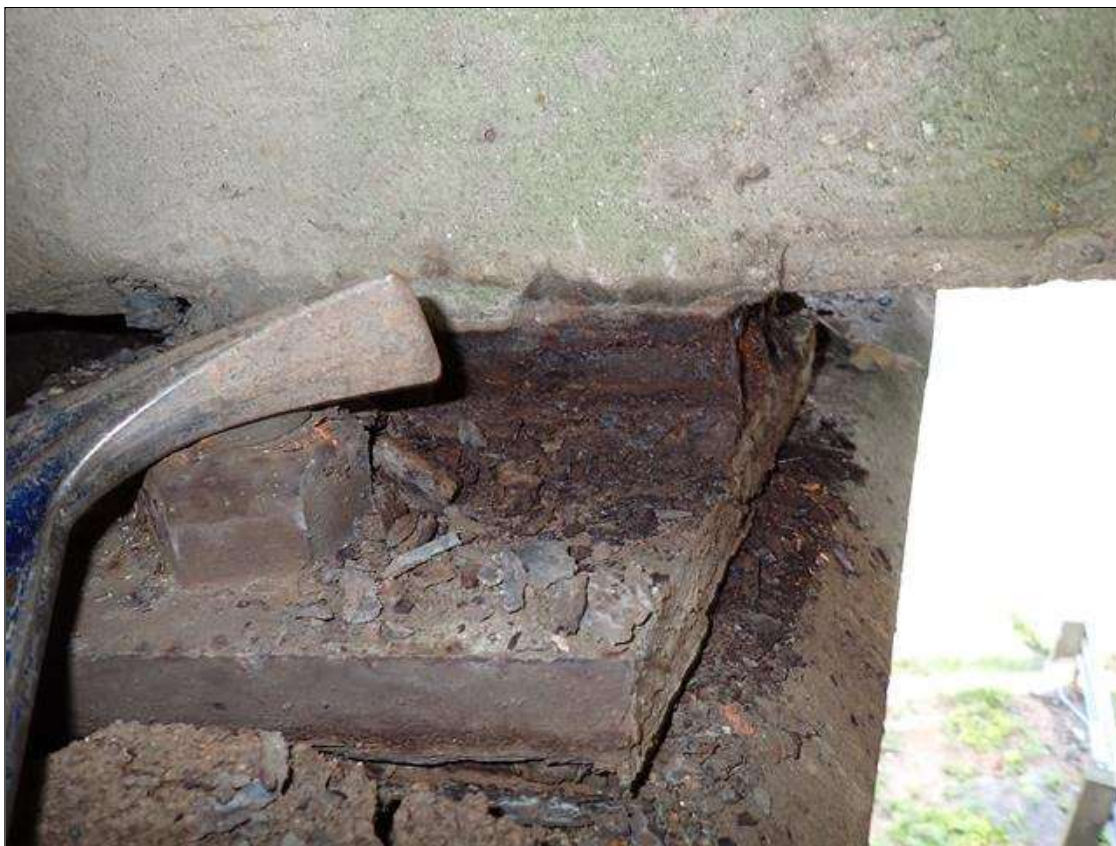
Span 3 Beam 4 - Far Bearing 4: corrosion with section loss (up to 1/8 inch)

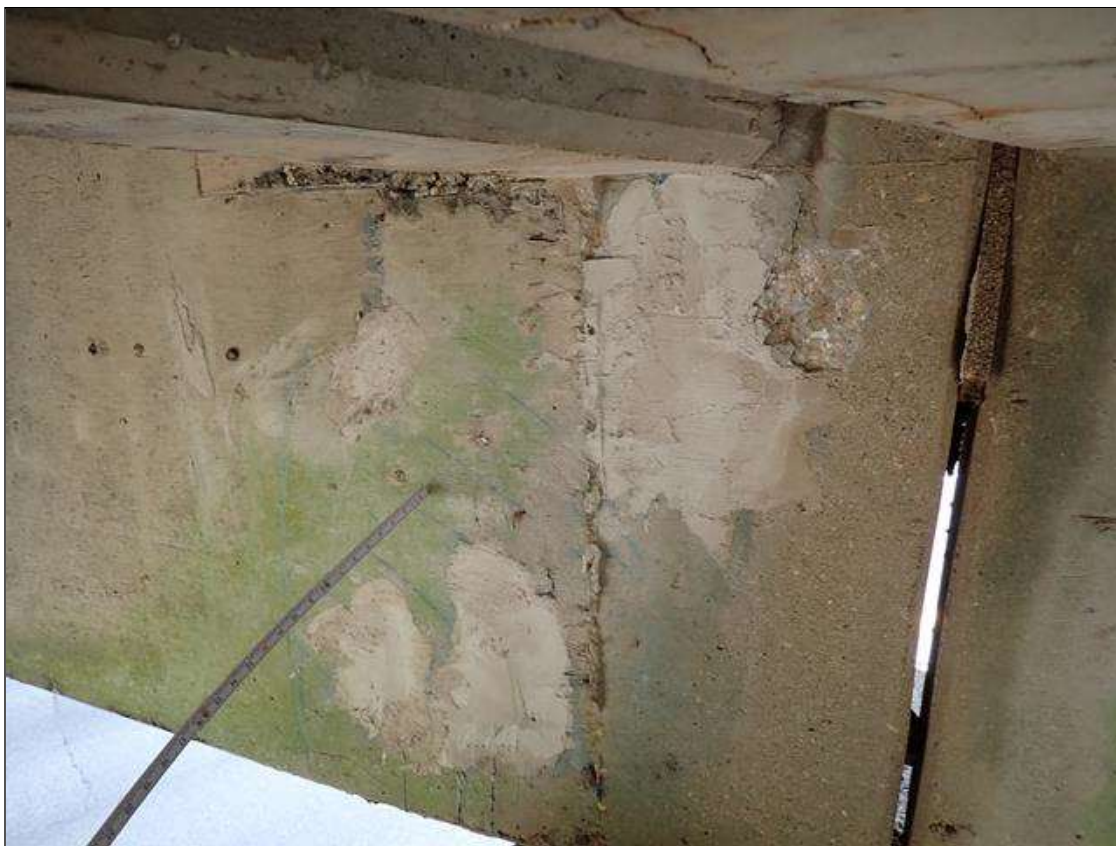
Span 4 Beam 4: 2023 previously repaired, partially sound patches (up to 17 inch x 11 inch x 1 inch deep), previously noted as: West face at bent 3, delamination/spall [4.5 foot x 2 foot x 1.25 inch deep] with (3) exposed rusted reinforcing [section loss up to 1/32 inch]

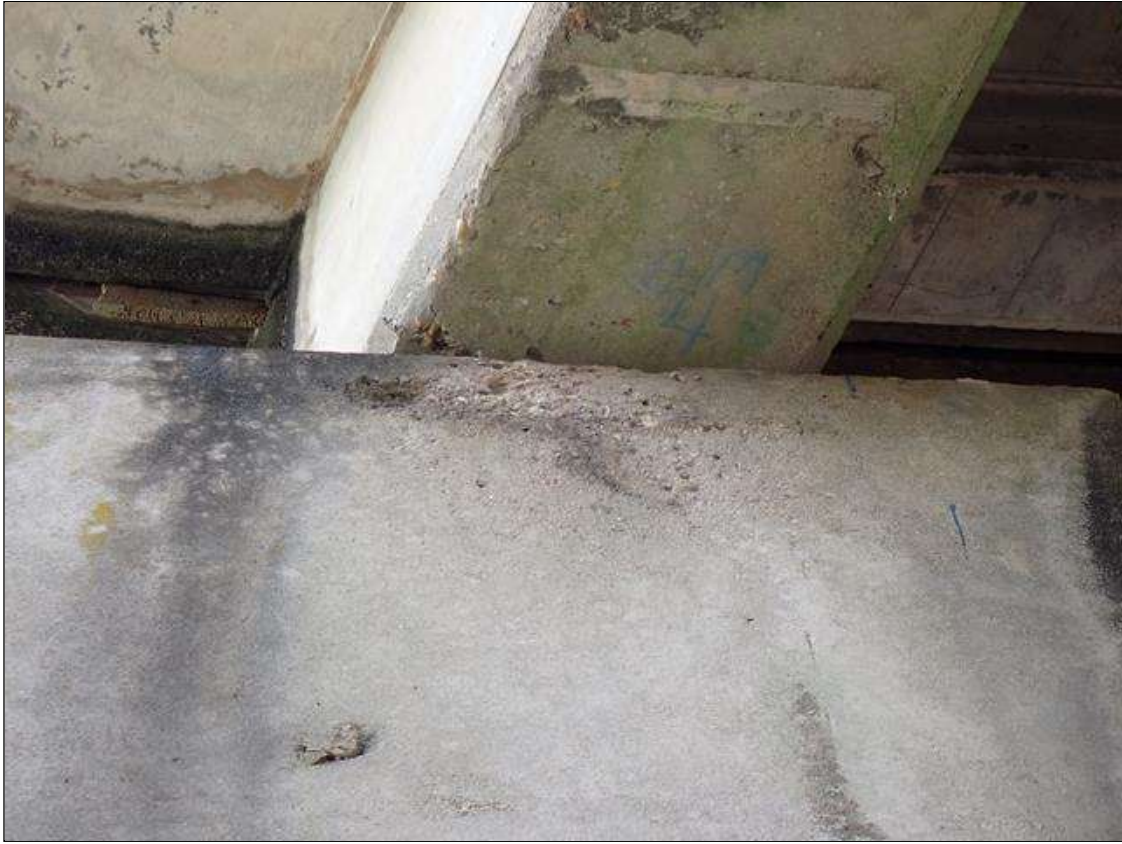
Bent 3 Cap 1: north face under beam 4 delamination [2.5 foot x 1.5 foot] with associated map cracking [up to 1/64 inch] and honeycombing

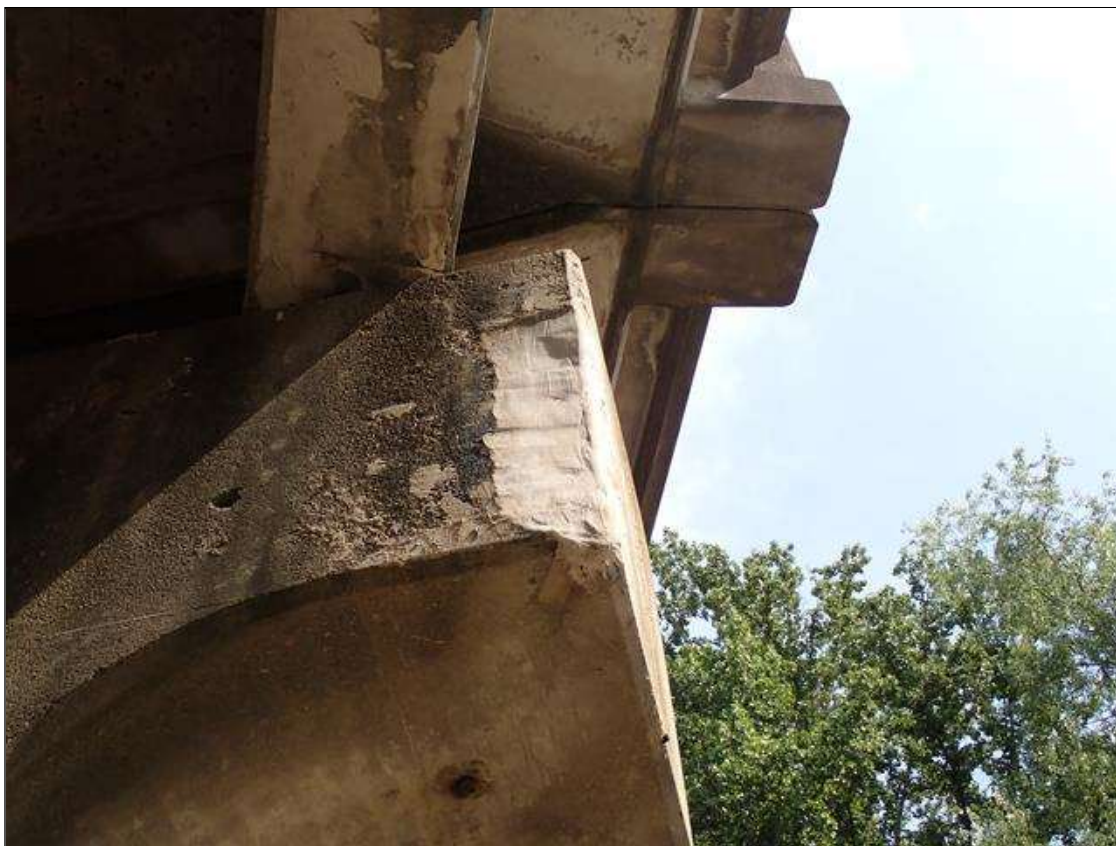
Bent 3 Cap 1: 2023 PREVIOUSLY REPAIRED, PATCHED AREA (3 FOOT X 12 INCH), PREVIOUSLY NOTED AS: 9 INCH X FULL HEIGHT X 10 INCH SPALL WITH EXPOSED RUSTED REINFORCING [SECTION LOSS UP TO 1/16 INCH] NORTH WEST CORNER BENT 3

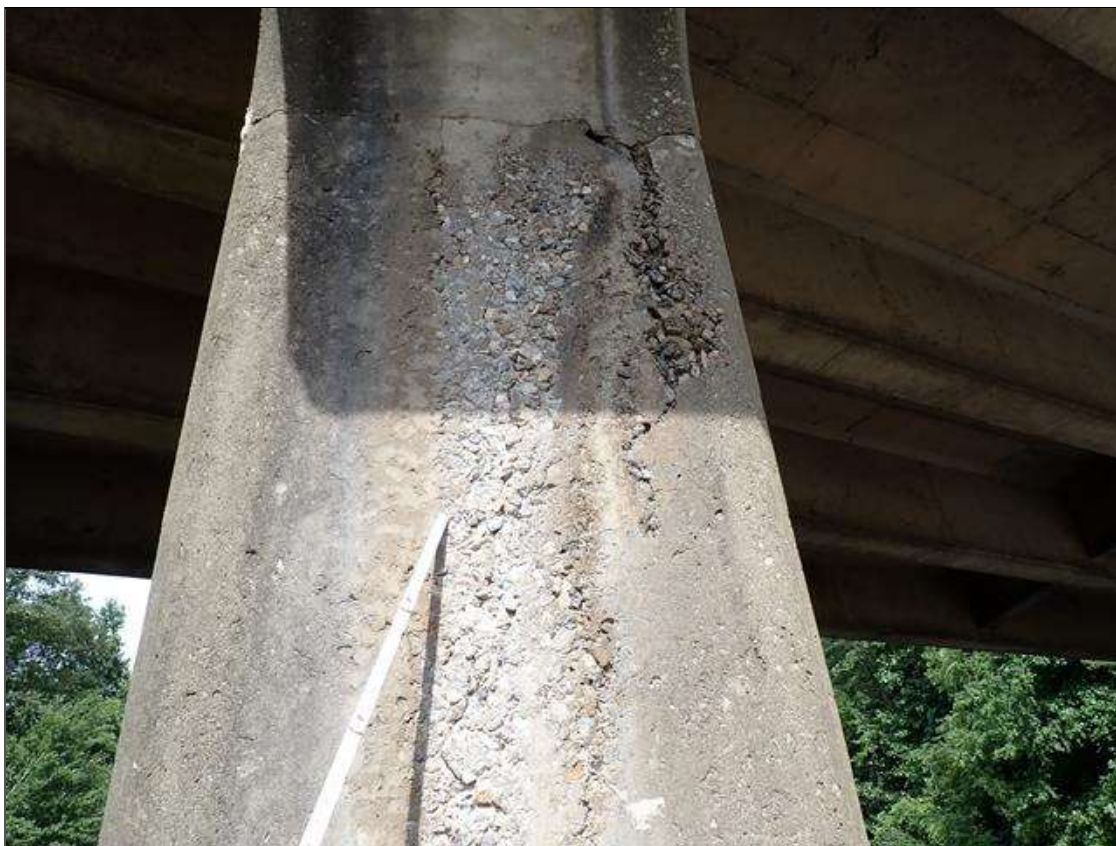
Bent 3 Pile 1: FULL HEIGHT X UP TO 2 FOOT X 1 INCH DEEP AREA OF HONEYCOMBING WEST FACE

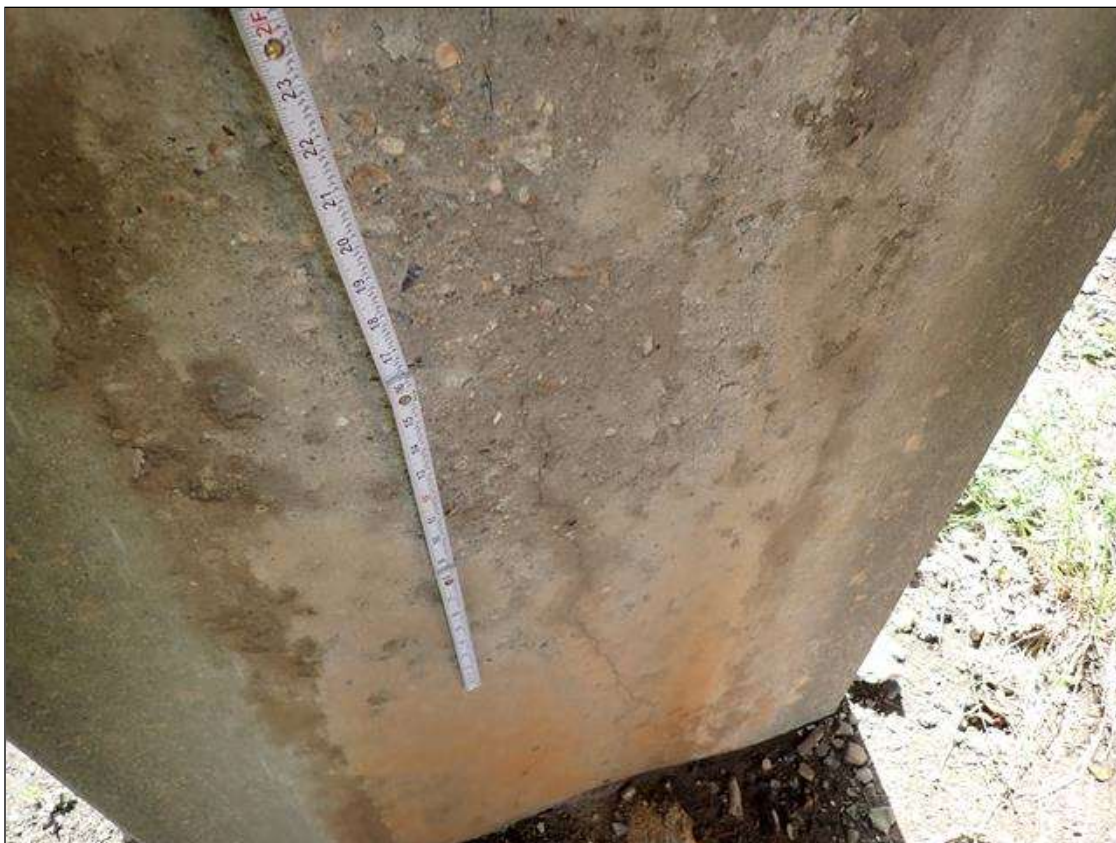
Bent 3 Pile 1: along length of the column, vertical cracks (up to 1/32 inch x full height) at random

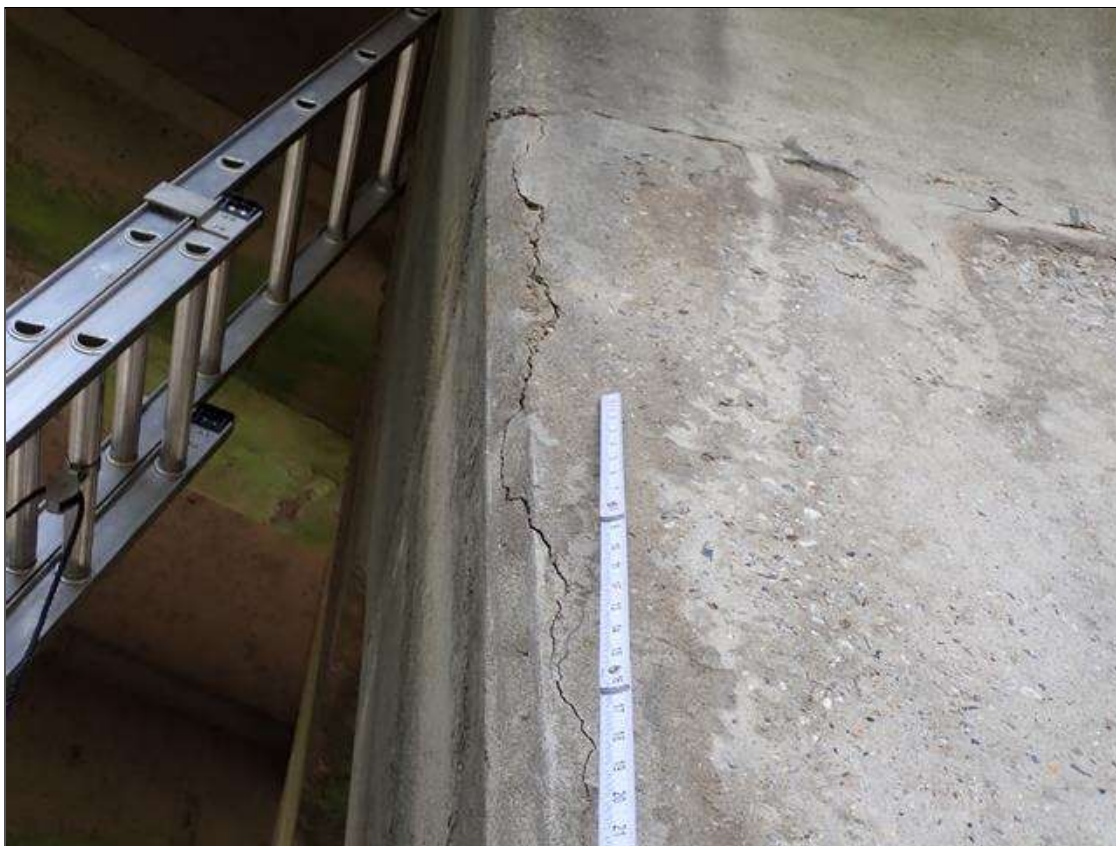
Bent 3 Pile 2: 4 FOOT X UP TO 1/16 INCH VERTICAL CRACK EAST FACE NEAR BOTTOM OF CAP

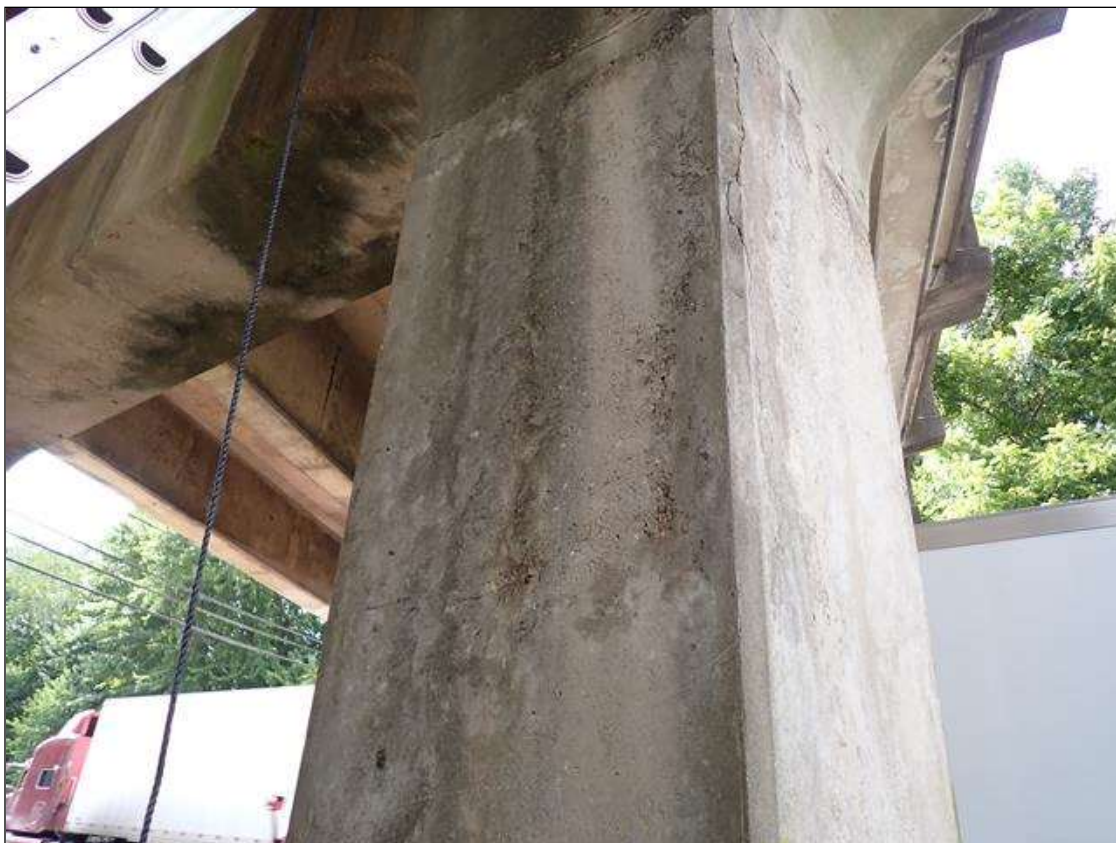
Bent 3 Pile 2: (not found 2023) South face of pile, delamination [2 foot x 6 foot]

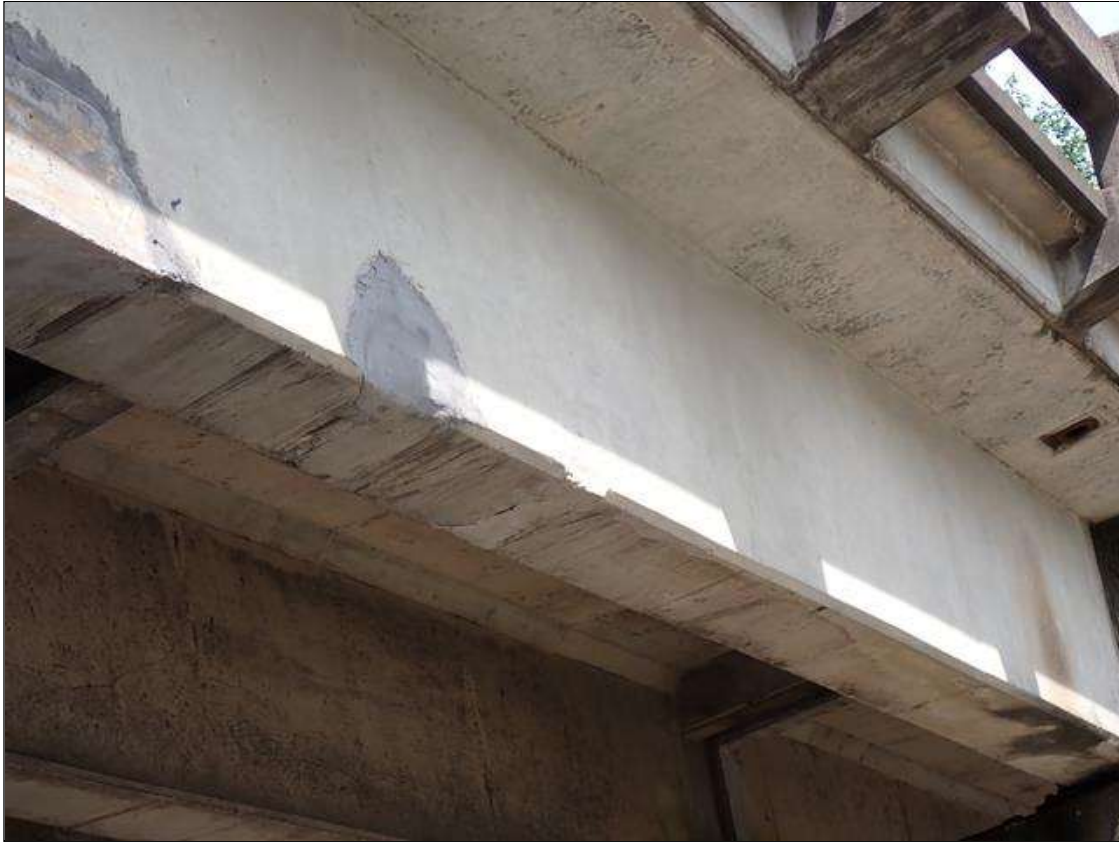
Span 4 Beam 1: 2023 NEW REPAIR, PATCHED AREAS, PREVIOUSLY NOTED AS: SUPPLEMENTAL INSPECTION IMPACT DAMAGE 2021 EAST FACE LOWER WEB OVER I-40 LEFT WESTBOUND LANE, TWO [2] SPALLS/IMPACT DAMAGE [UP TO 14 INCH X FULL WIDTH X 6 INCH] WITH ADJACENT DELAMINATION [UP TO 10 INCH X 8 INCH]

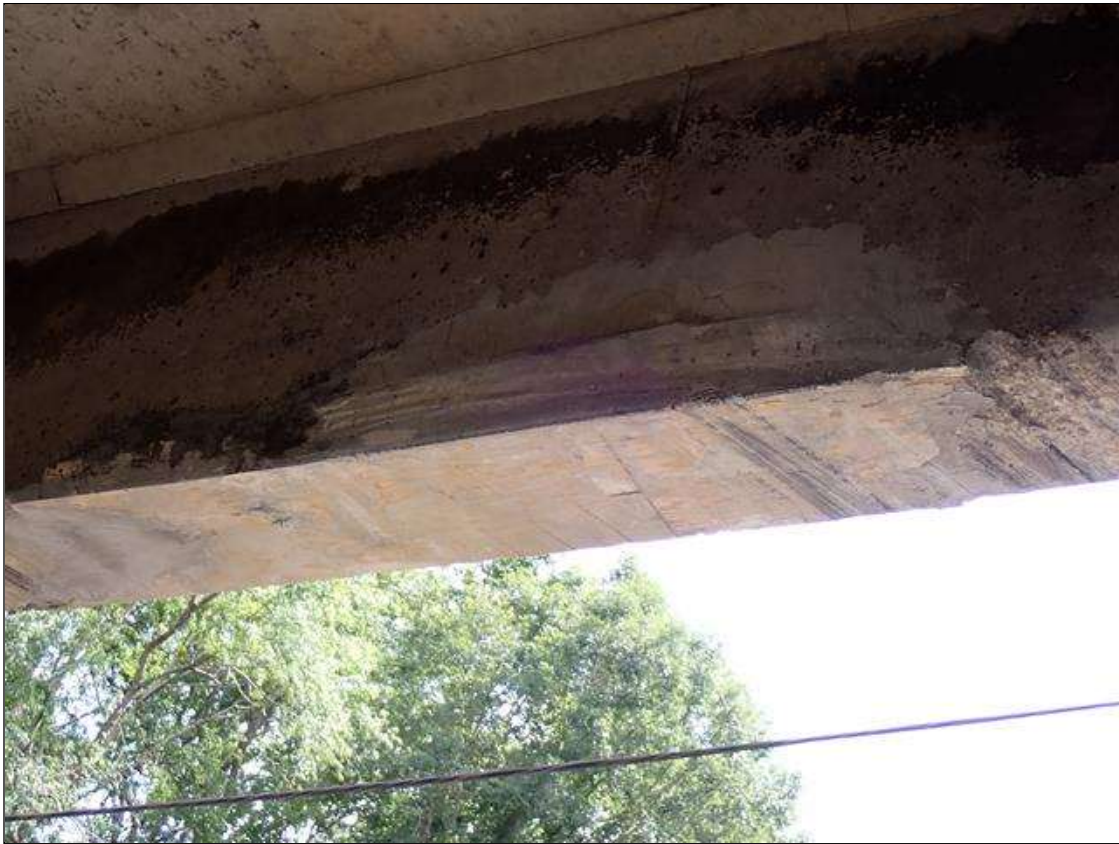
Span 4 Beam 1: 2023 NEW REPAIR, PATCHED AREA, PREVIOUSLY NOTED AS: SUPPLEMENTAL INSPECTION IMPACT DAMAGE 11/23/2021 [PAR] EAST FACE LOWER WEB OVER I-40 RIGHT WESTBOUND LANE, SPALL/IMPACT DAMAGE [14 FOOT X UP TO FULL WIDTH X UP TO 15 INCH UP BOTH FACES X UP TO 3.5 INCH DEEP] WITH MULTIPLE EXPOSED RUSTED PRIMARY REINFORCING [SECTION LOSS UP TO 1/16 INCH] WITH ADJACENT DELAMINATIONS [UP TO 18 INCH X 10 INCH]

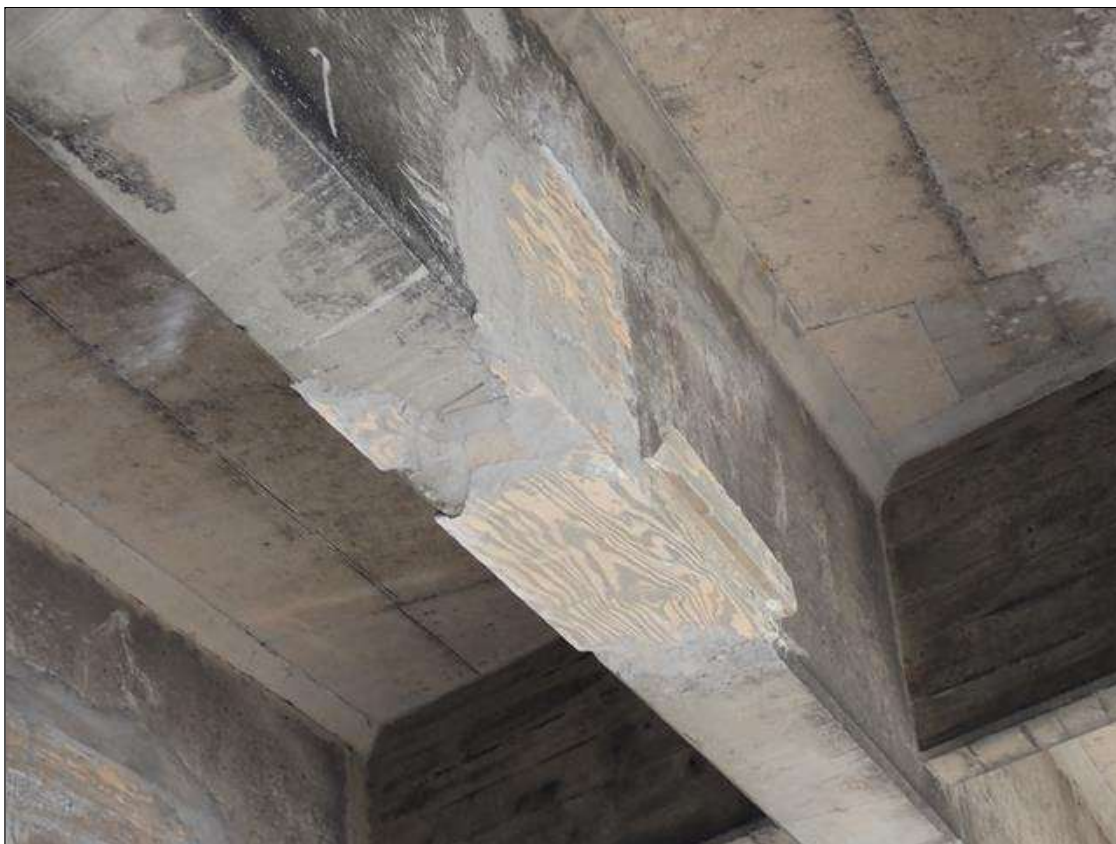
Span 4 Beam 2: 2023 NEW REPAIR, PATCHED AREA, PREVIOUSLY NOTED AS: SUPPLEMENTAL INSPECTION
IMPACT DAMAGE 2021 : 2 - UP TO 1.5 FOOT X 10 INCH X 6 INCH SPALLS EAST AND BOTTOM FACE OVER
WESTBOUND LANE

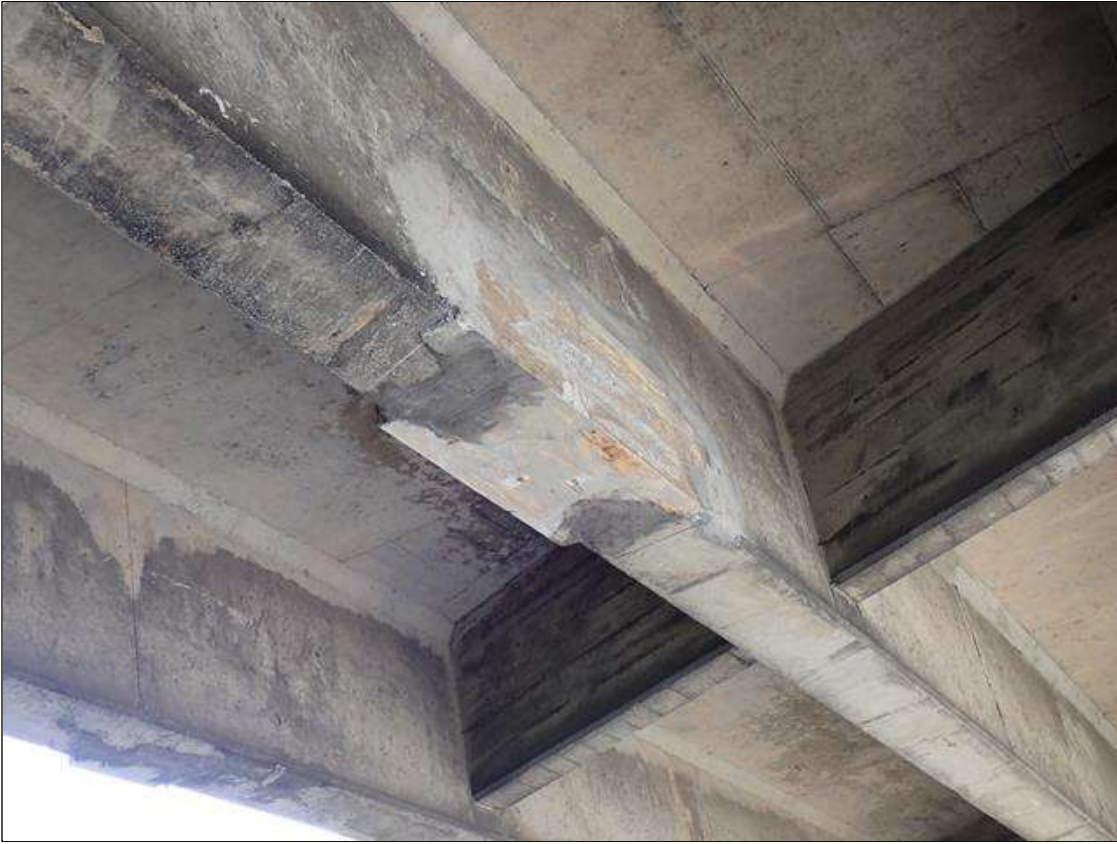
Span 4 Beam 3: 2023 NEW REPAIR, PATCHED AREA, PREVIOUSLY NOTED AS: SUPPLEMENTAL INSPECTION IMPACT DAMAGE 2021 : 4 FOOT X UP TO 10 INCH X 4 INCH SPALL WITH EXPOSED REINFORCING EAST AND BOTTOM FACE OVER WESTBOUND LANE

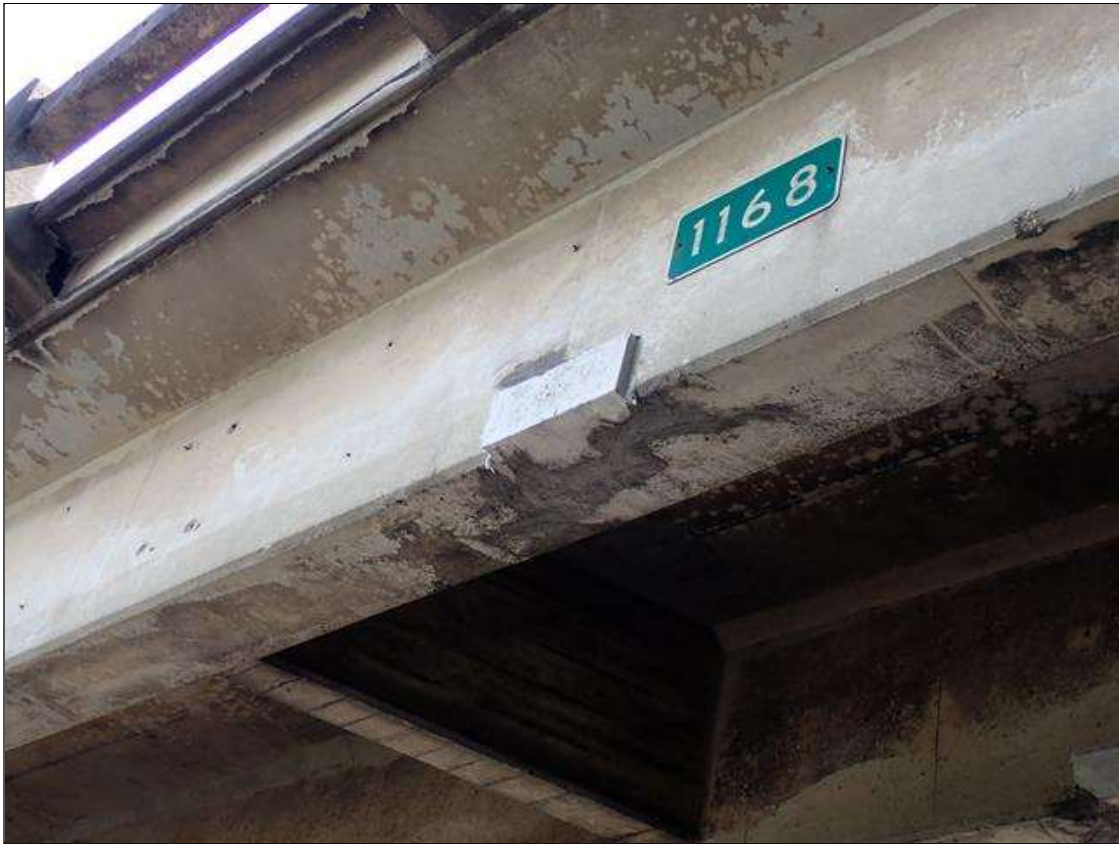
Span 4 Beam 4: 2023 NEW REPAIR, PATCHED AREA, PREVIOUSLY NOTED AS: SUPPLEMENTAL INSPECTION IMPACT DAMAGE 2021 UNDERSIDE OVER I-40 RIGHT WESTBOUND LANE, MULTIPLE SPALLS/AREAS IMPACT DAMAGE [UP TO 3 INCH X 2 INCH X 1/2 INCH DEEP]

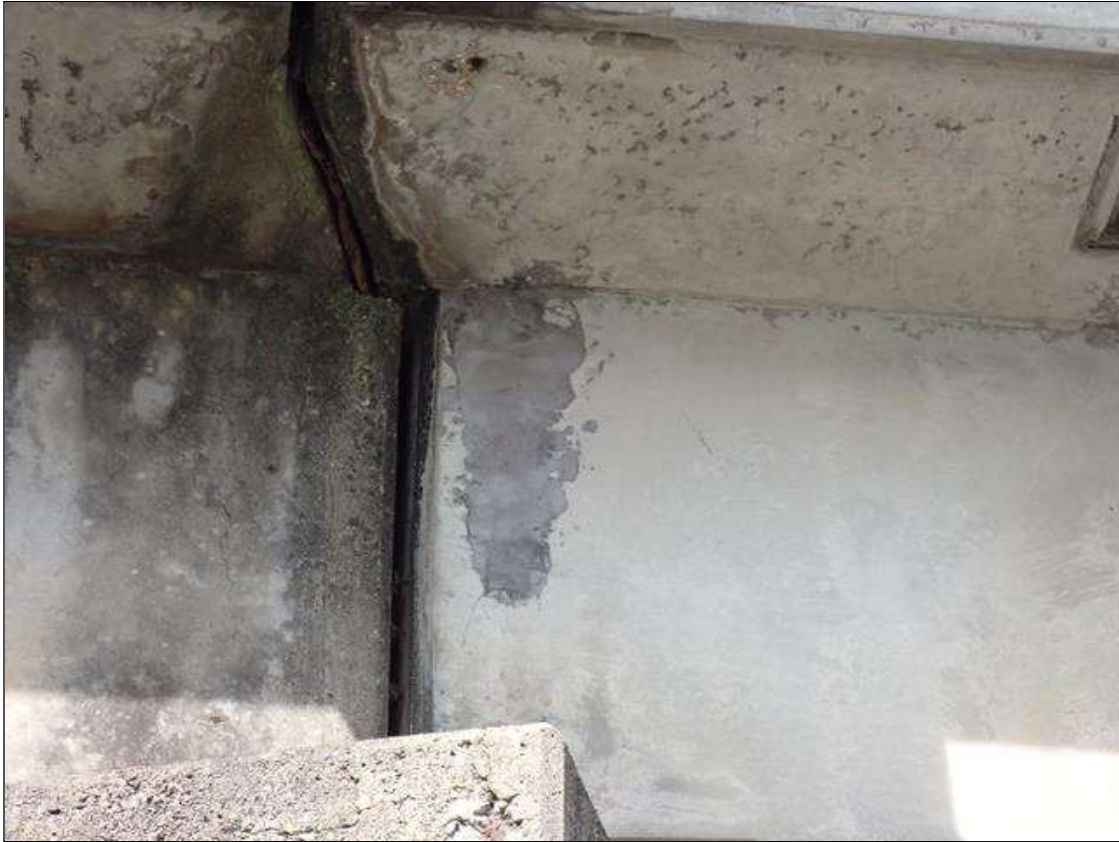
Span 4 Beam 1: 2023 PREVIOUSLY REPAIRED, PATCHED AREA, PREVIOUSLY NOTED AS: SUPPLEMENTAL INSPECTION IMPACT DAMAGE 2021 : 9 INCH X 14 INCH X 3/4 INCH SPALL WITH EXPOSED RUSTED REINFORCING NO SECTION LOSS WEST FACE AT BENT 4

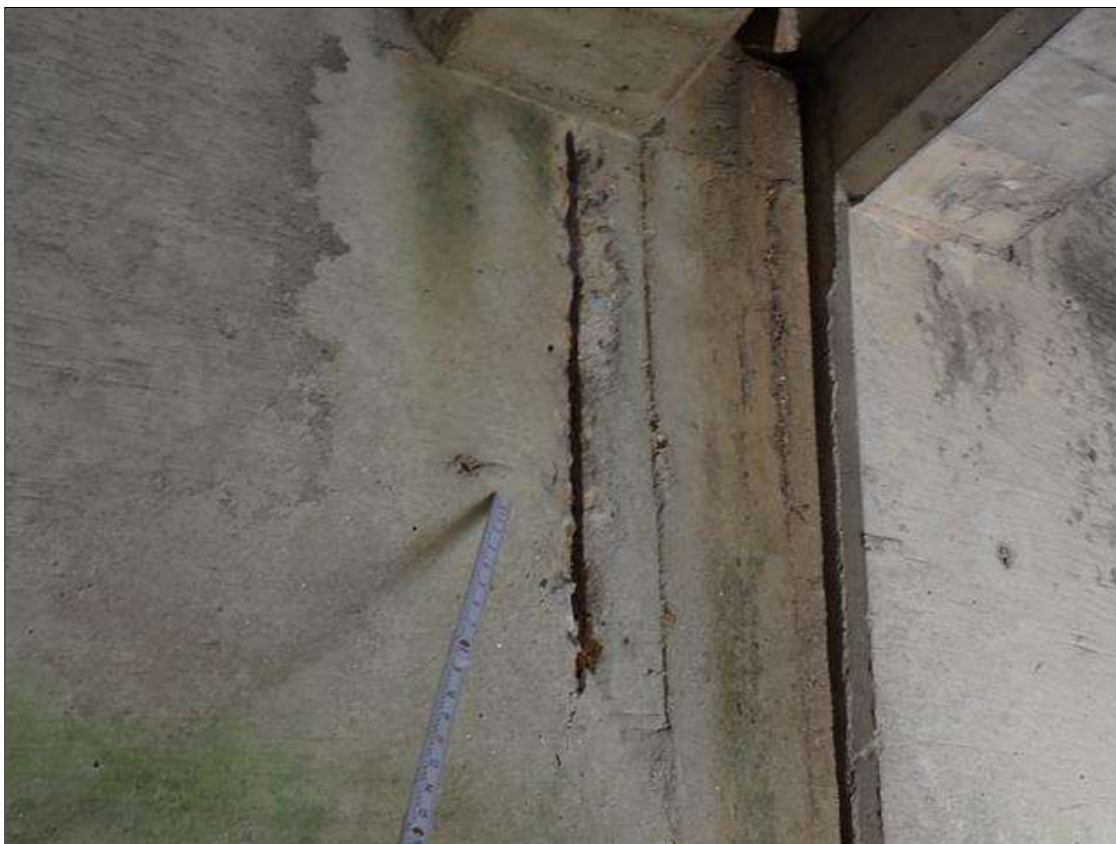
Span 5 Beam 3: west face at bent 4, spall/delamination [2 foot x 3 inch wide x 1/2 inch deep]
