NC DEPARTMENT OF TRANSPORTATION
 DIVISION OF HIGHWAYS
 STRUCTURE MANAGEMENT UNIT

ATTENTION: prompt action request; sketches updated; signs attached to beam; lateral clearance revised; new beam repairs

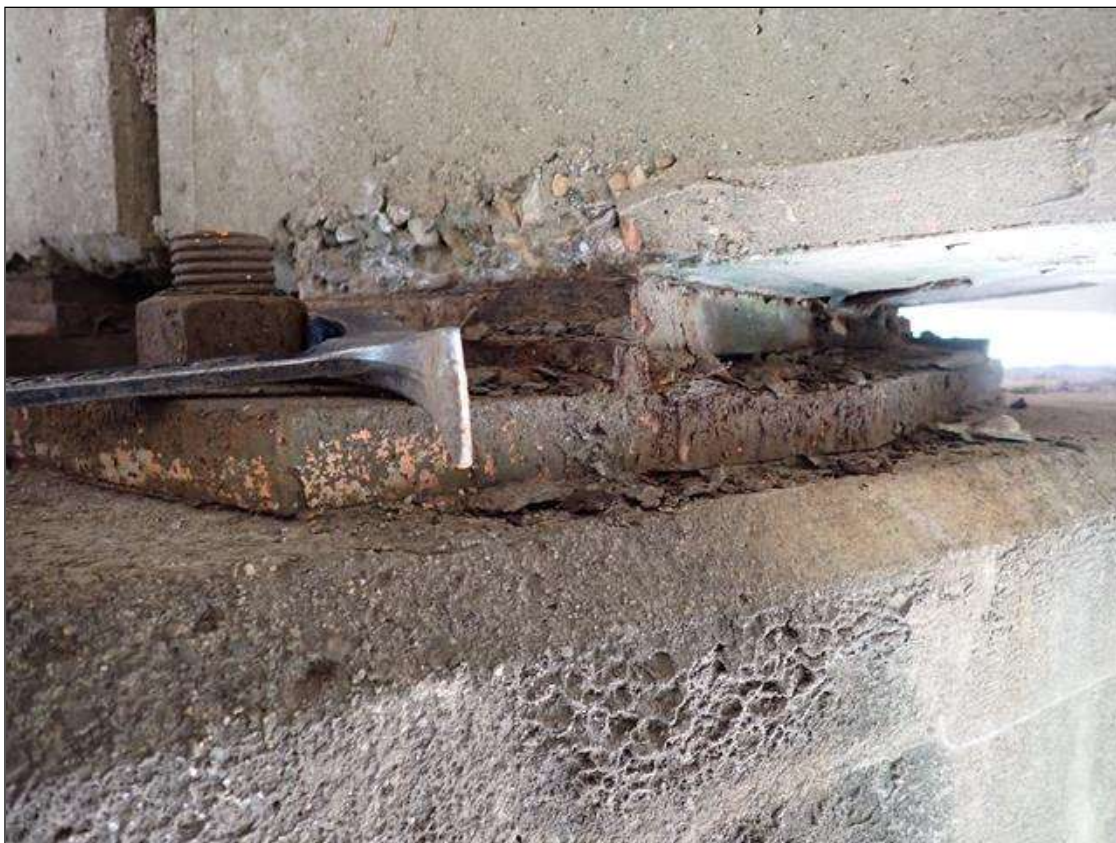
Span 5 Beam 2 - Near Bearing 2: surface rust/rust scale

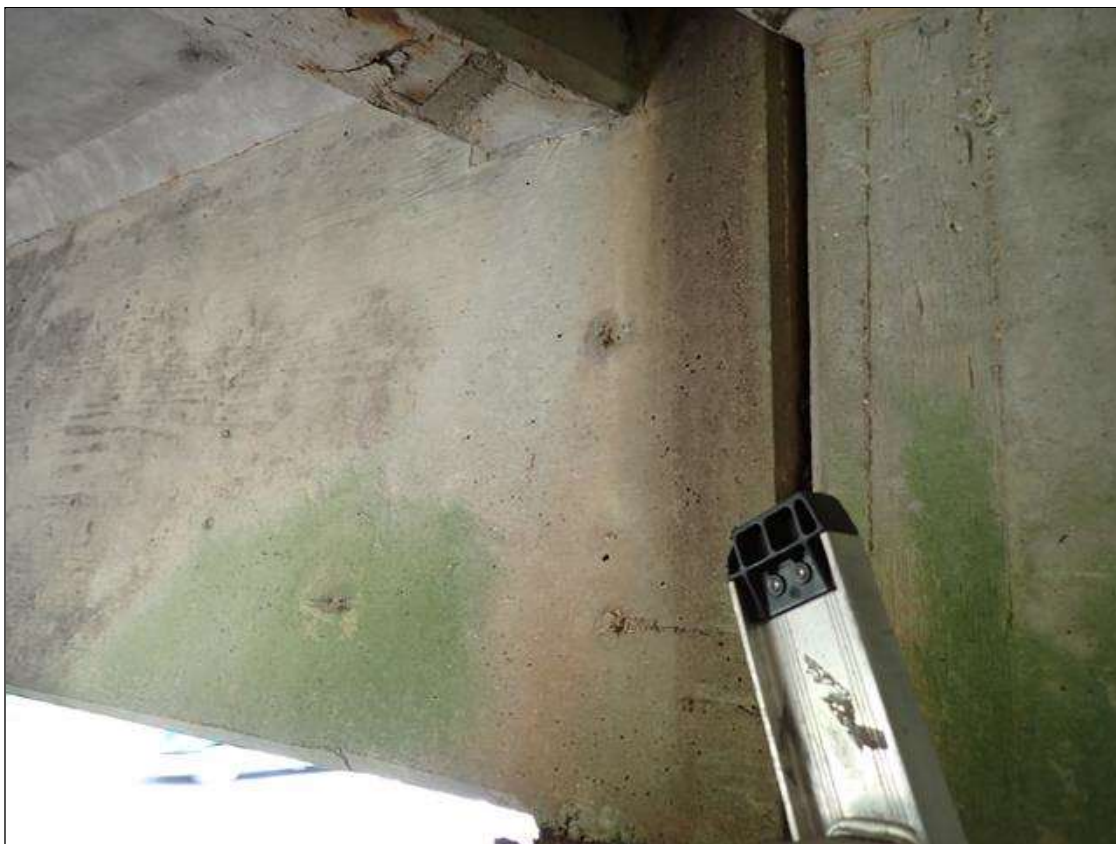
Span 4 Beam 3: (not found 2023) SUPPLEMENTAL INSPECTION IMPACT DAMAGE 2021 : SPALL AT FAR END ABOVE interior. BENT 4 , 4 INCH LONG X 4 INCH WIDE X 1 INCH DEEP.

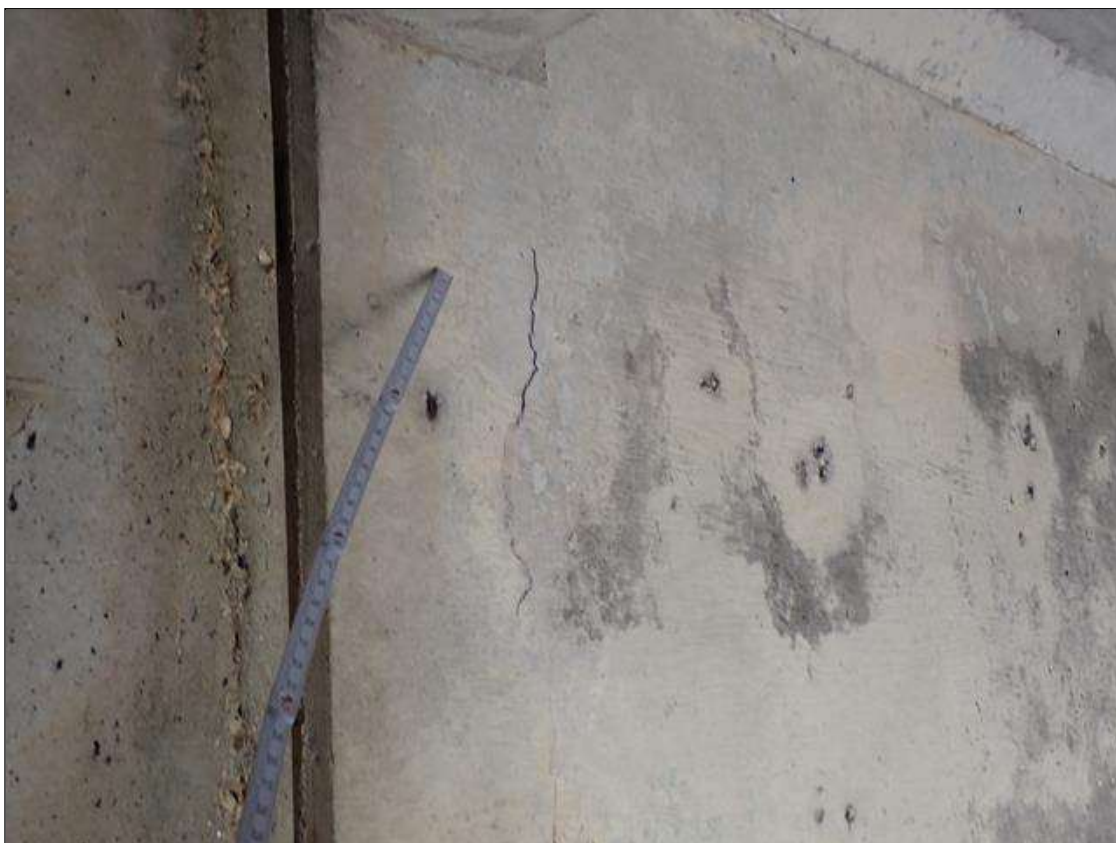
Span 4 Beam 4: at bent 4, west face, delamination (3 inch x 16 inch)

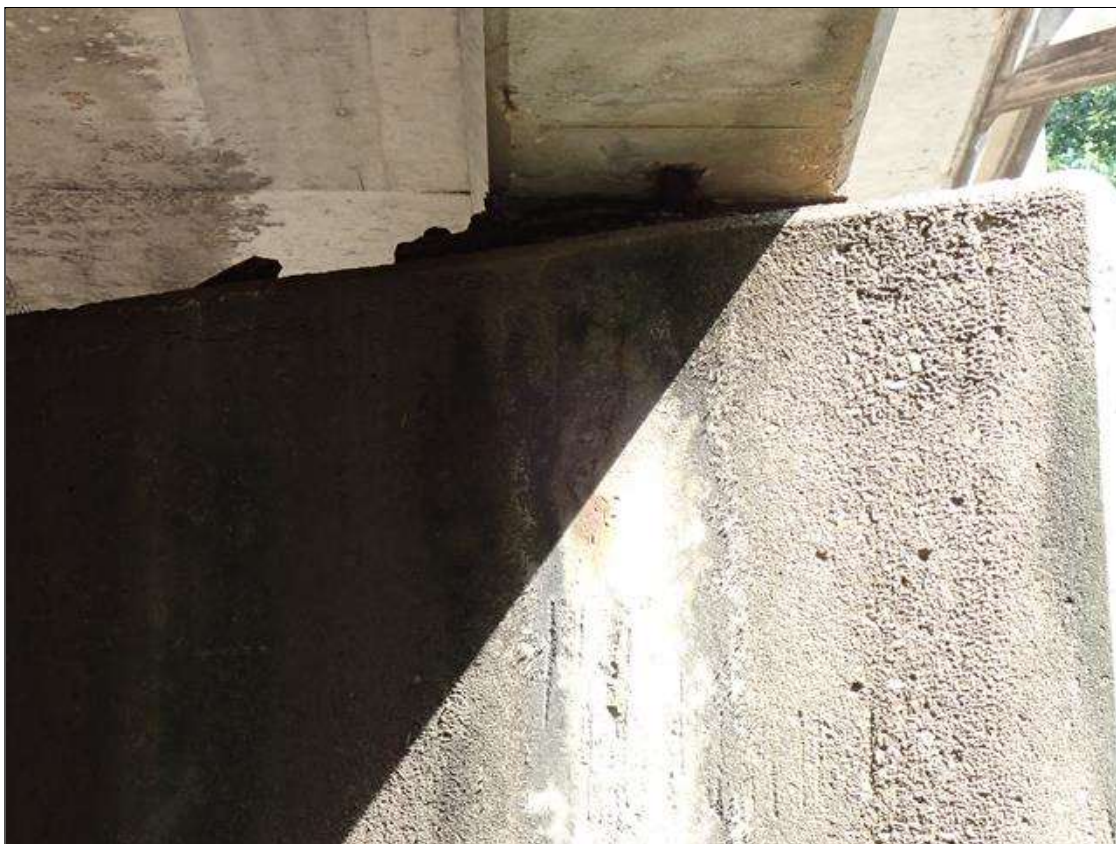
Bent 4 Cap 1: (PAR) 16 INCH X UP TO 1/32 INCH VERTICAL CRACK WITH RUST STAIN NORTH FACE UNDER BEAM 1

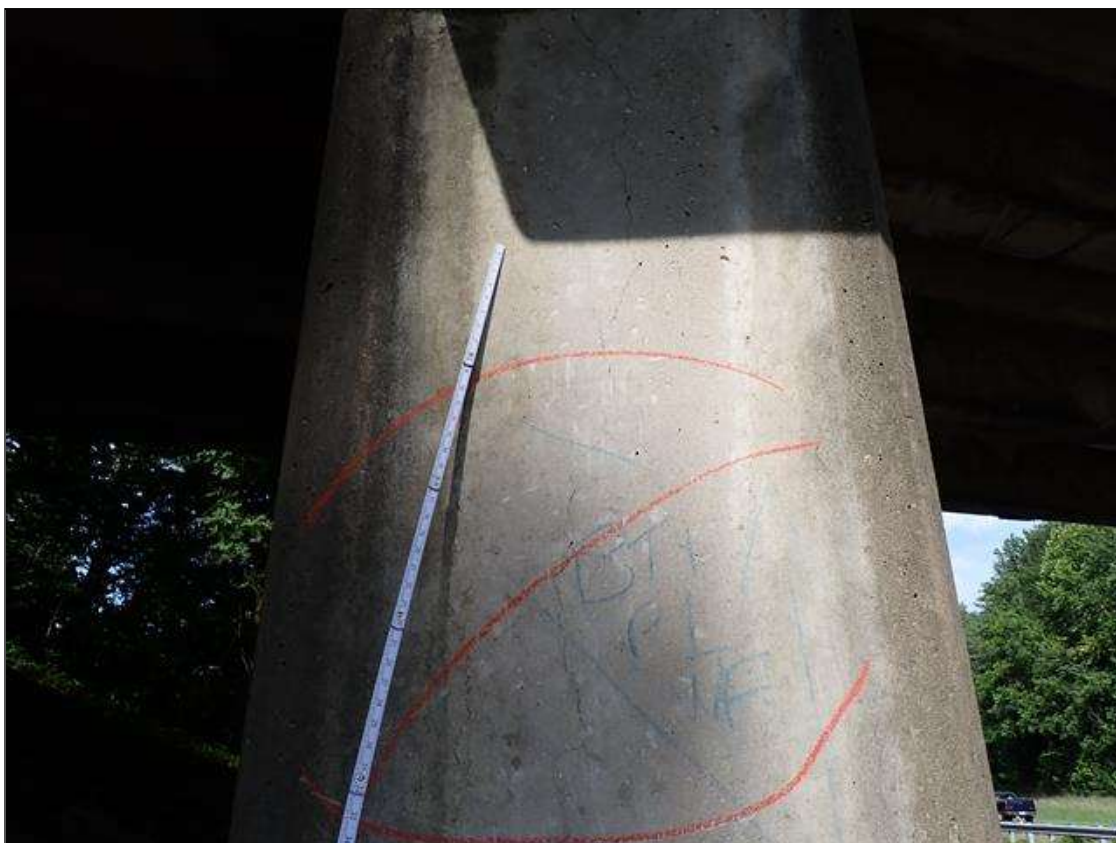
Bent 4 Pile 1: on east and west faces, delamination [up to 4.5 foot x 2 foot] with cracks (up to 1/32 inch)

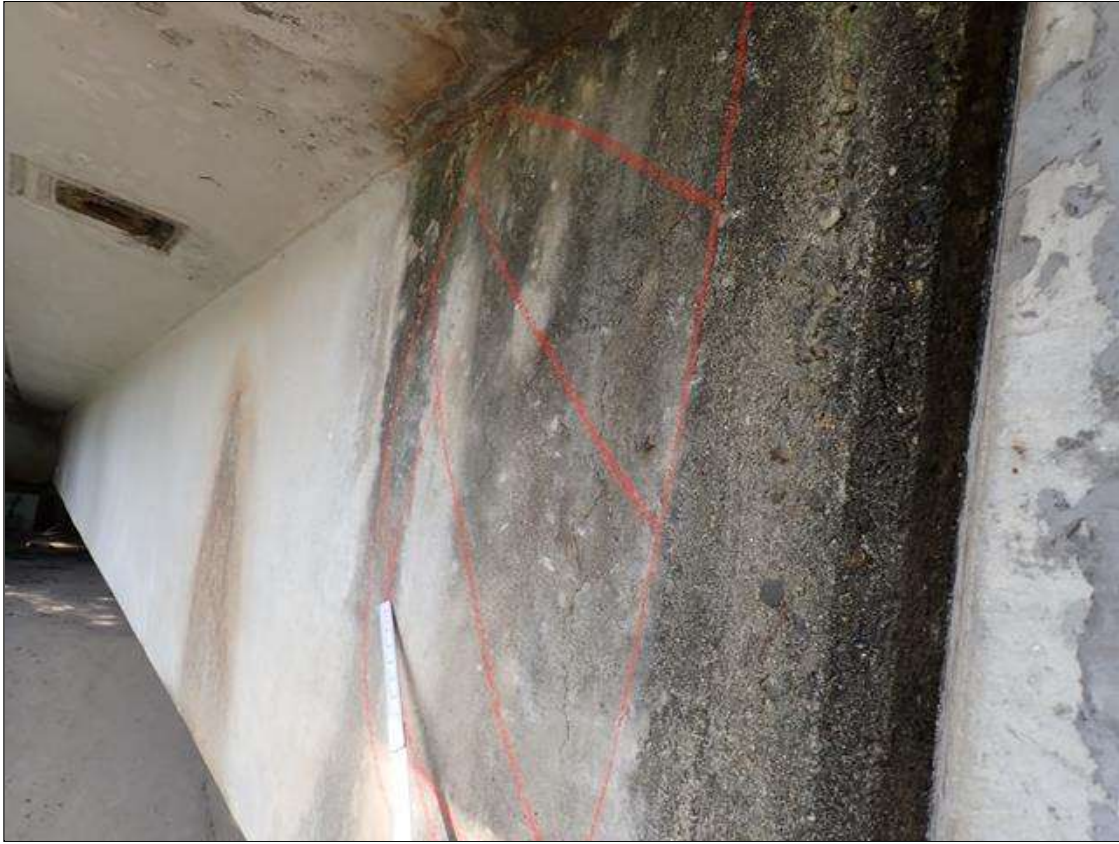
Span 5 Beam 1: SPAN 5 BEAM 1 WEST FACE WEB OVER BENT 4. HAS A CRACKED AND DELAMINATED AREA.
AREA IS: 24 INCH X 32 INCH

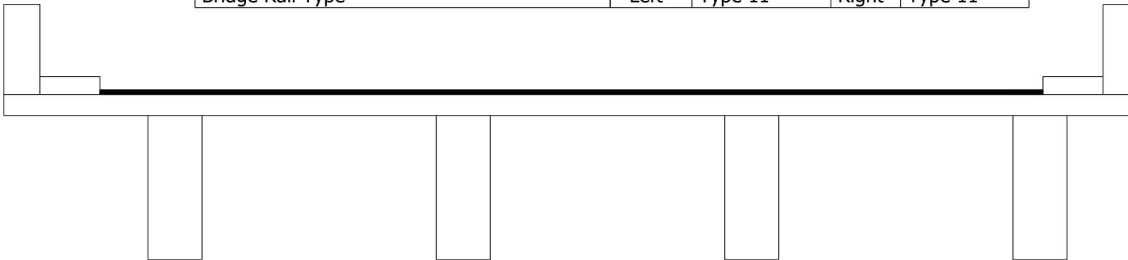
Measurements for Span #	1	ALL SPANS SIMILAR	
Deck Thickness	7in	Left Overhang	4.75ft
Top of Rail to Bottom of Beam (Avg)	7.083ft	Right Overhang	4.75ft

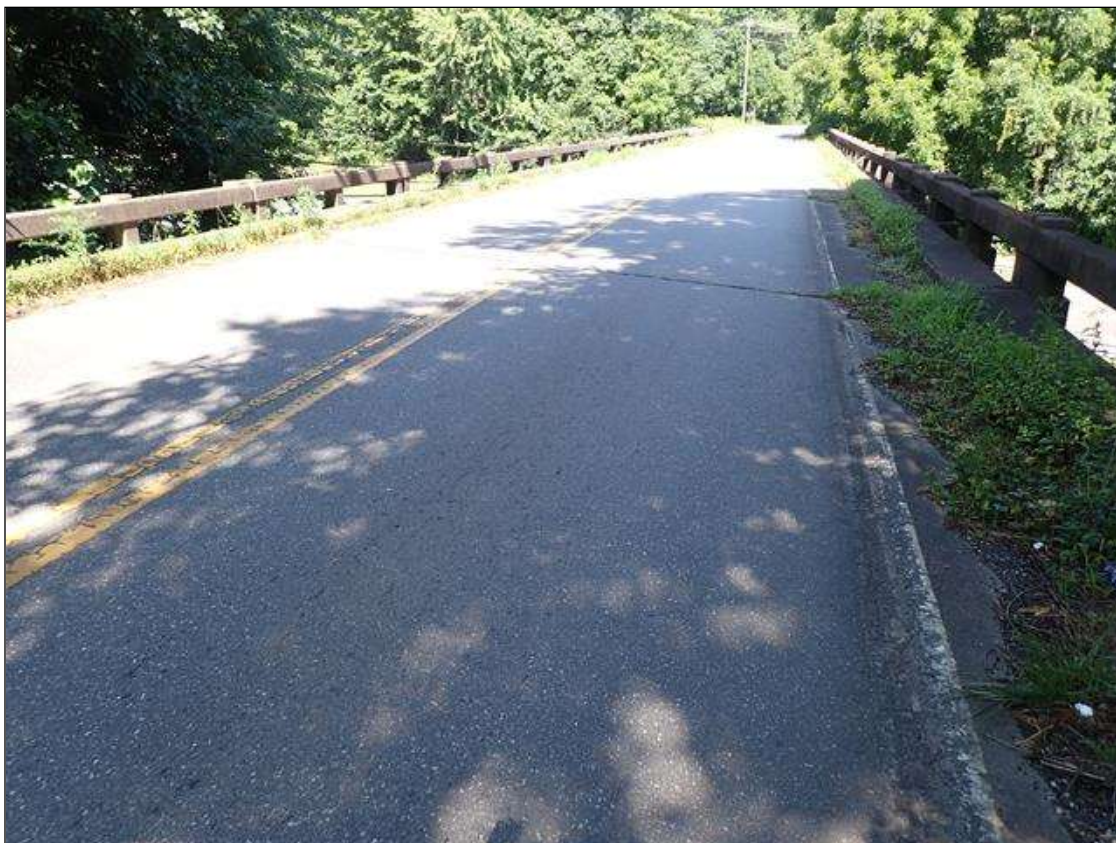
asphalt wearing surface
