NC DEPARTMENT OF TRANSPORTATION
 DIVISION OF HIGHWAYS
 STRUCTURE MANAGEMENT UNIT

ATTENTION: prompt action request; sketches updated; span 2 clearances updated; new repairs

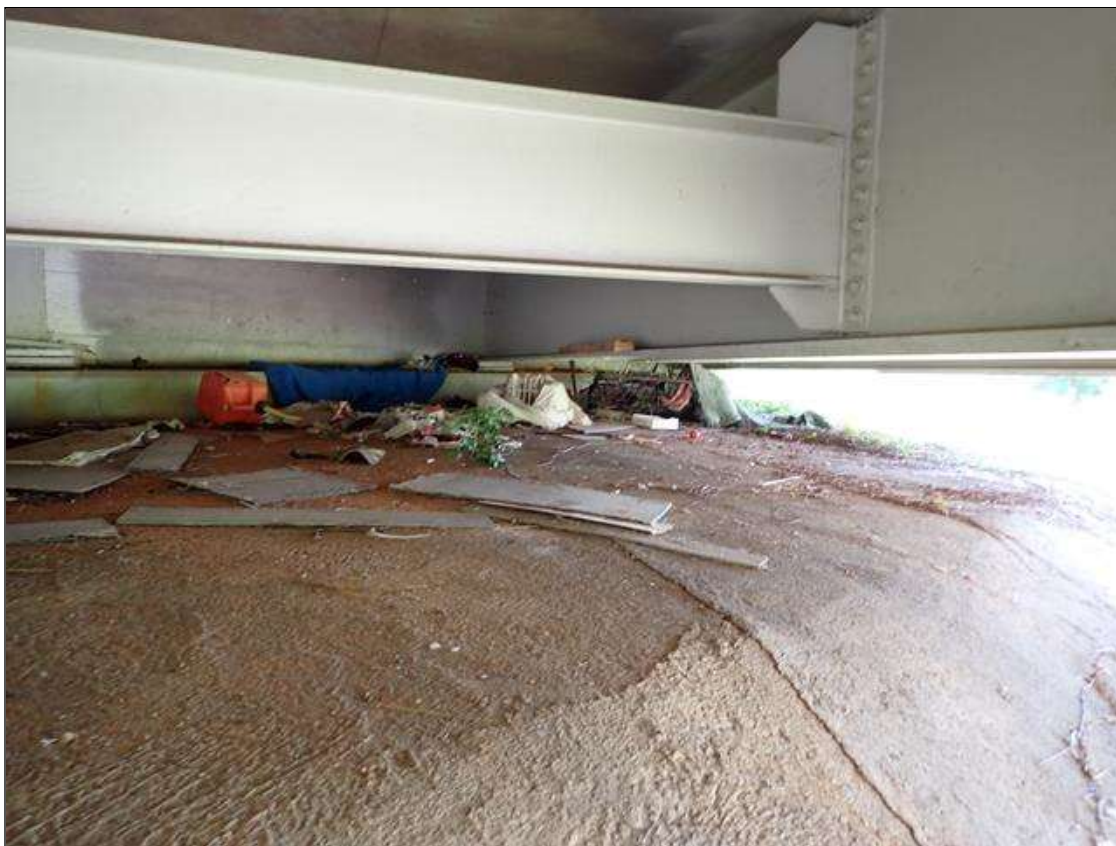
at end bent 2, slope protection, homeless debris

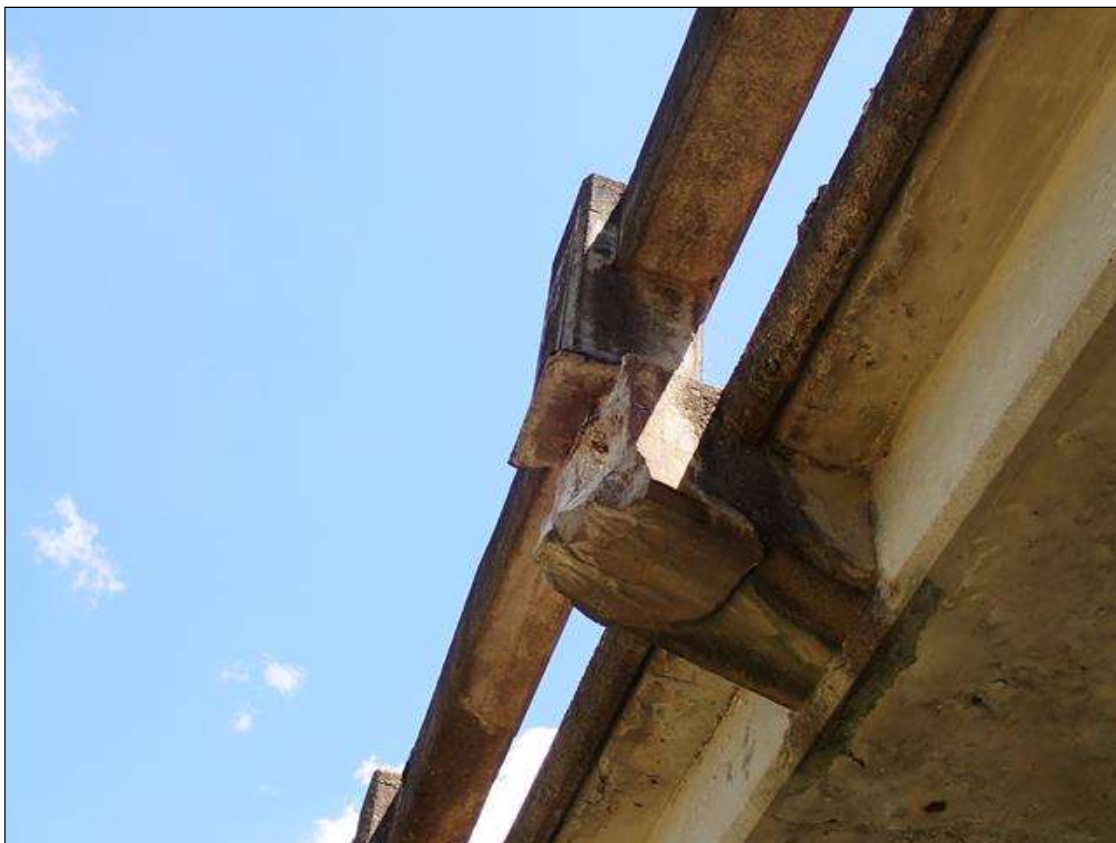
Span 1 Left Bridge Rail: [PAR] at base of rail post 8, spall [12 inch x 7 inch x up to 4 inch deep] with exposed rusted reinforcing with no loss

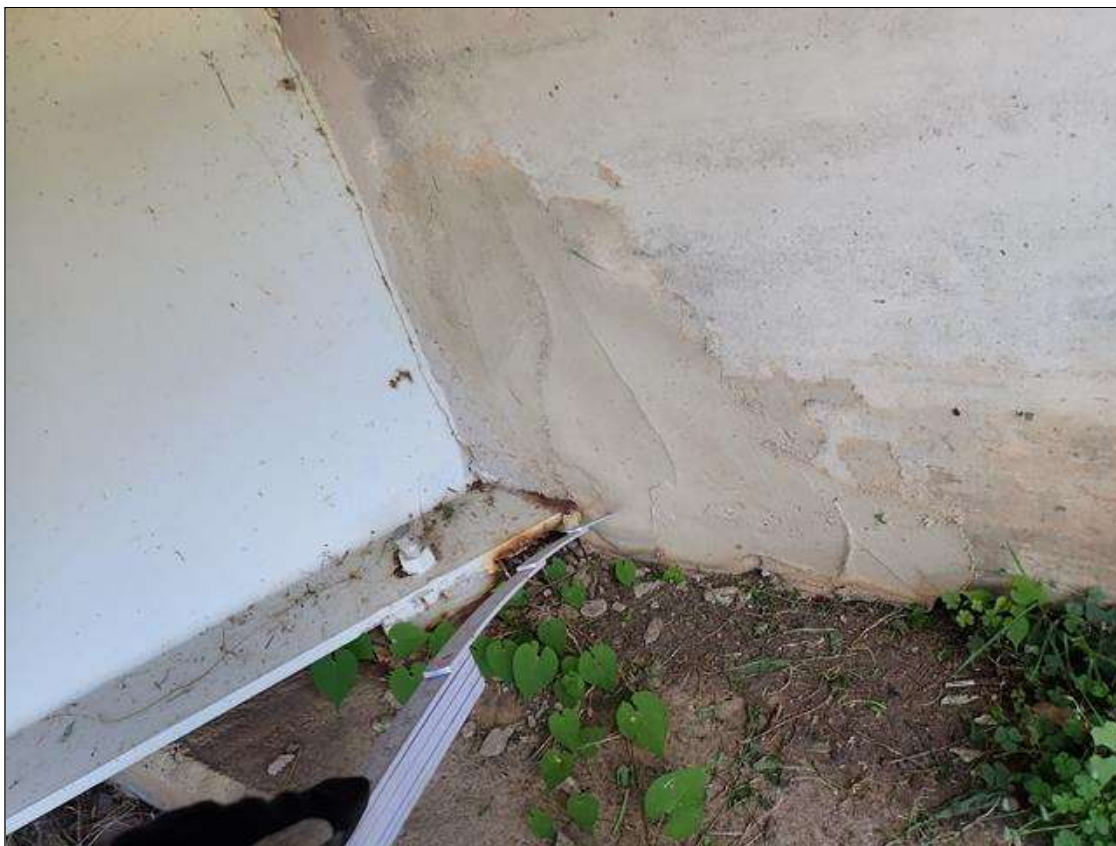
End Bent 1 Abutment: 16 INCH X UP TO 20 INCH PATCH WEST OVERHANG OF ABUTMENT

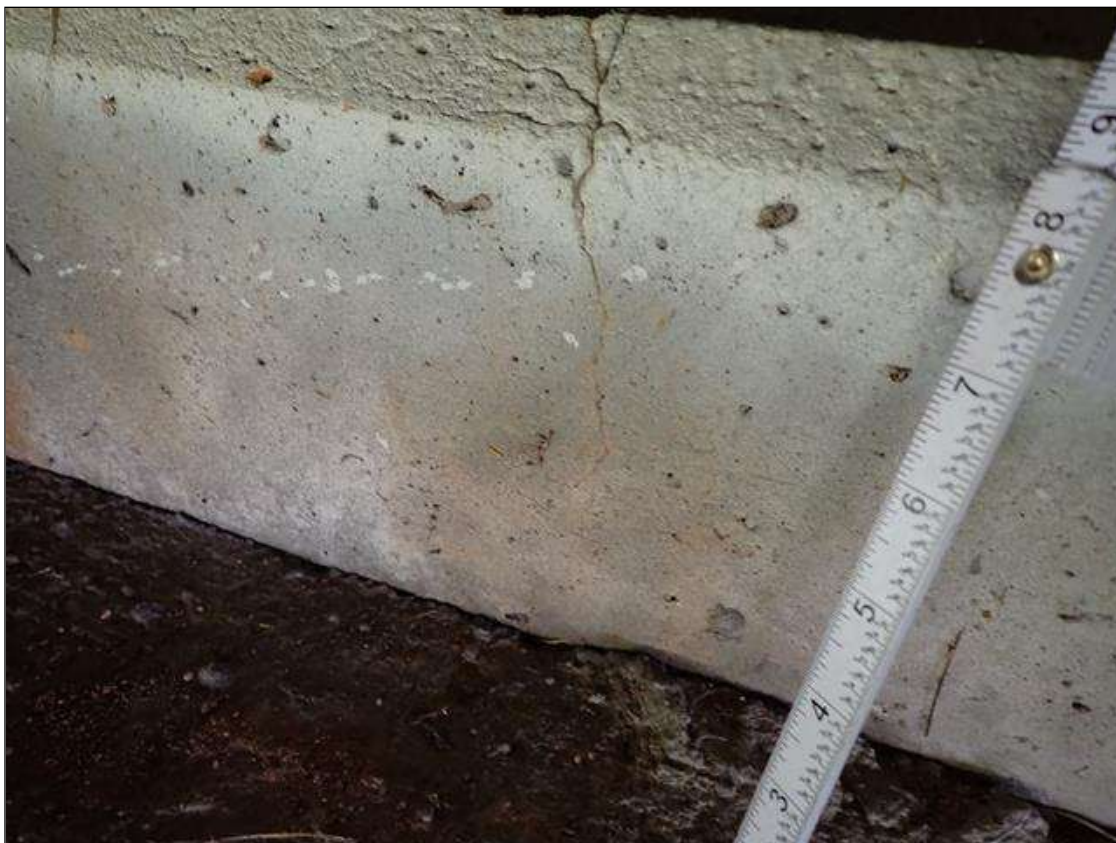
End Bent 1 Cap 1: at multiple locations throughout in all bays, wraparound vertical cracks [up to full height x 1/32 inch]

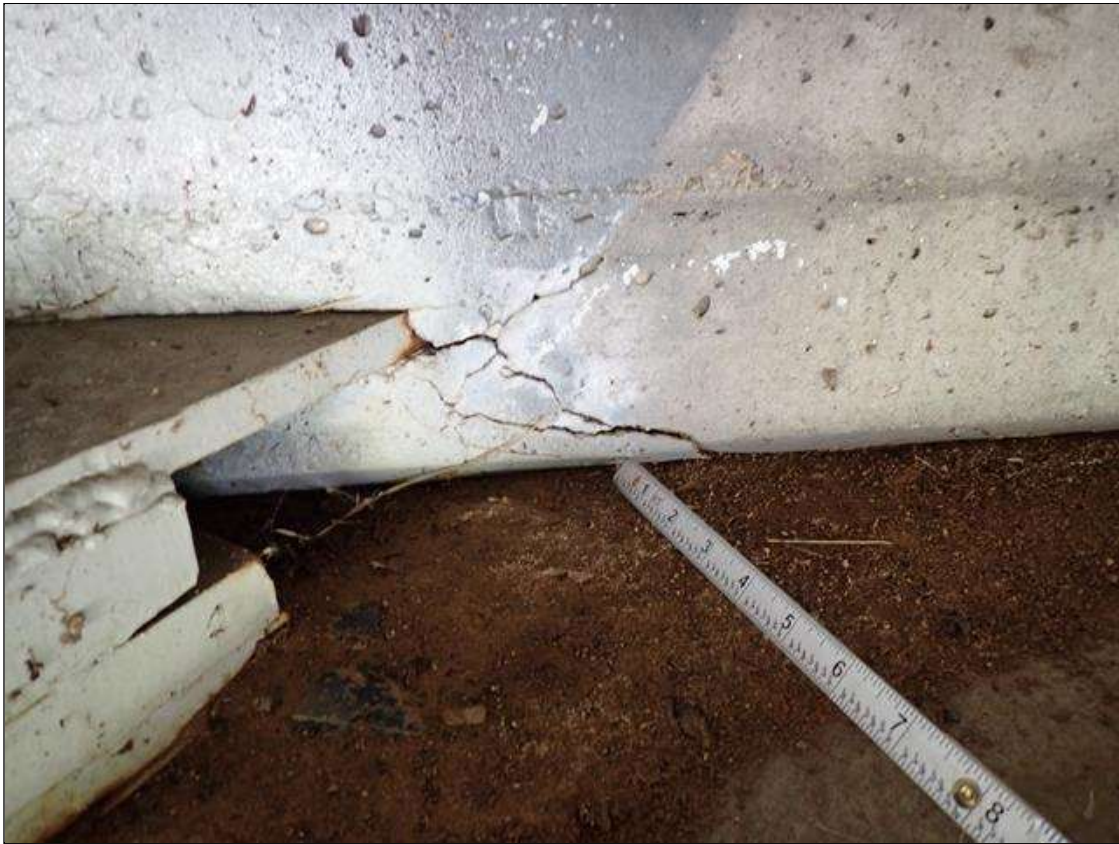
End Bent 1 Abutment: along the length of the abutment, at bottom flange penetrations, delaminations (up to 7 inch x 3 inch) with cracks (up to 1/16 inch)

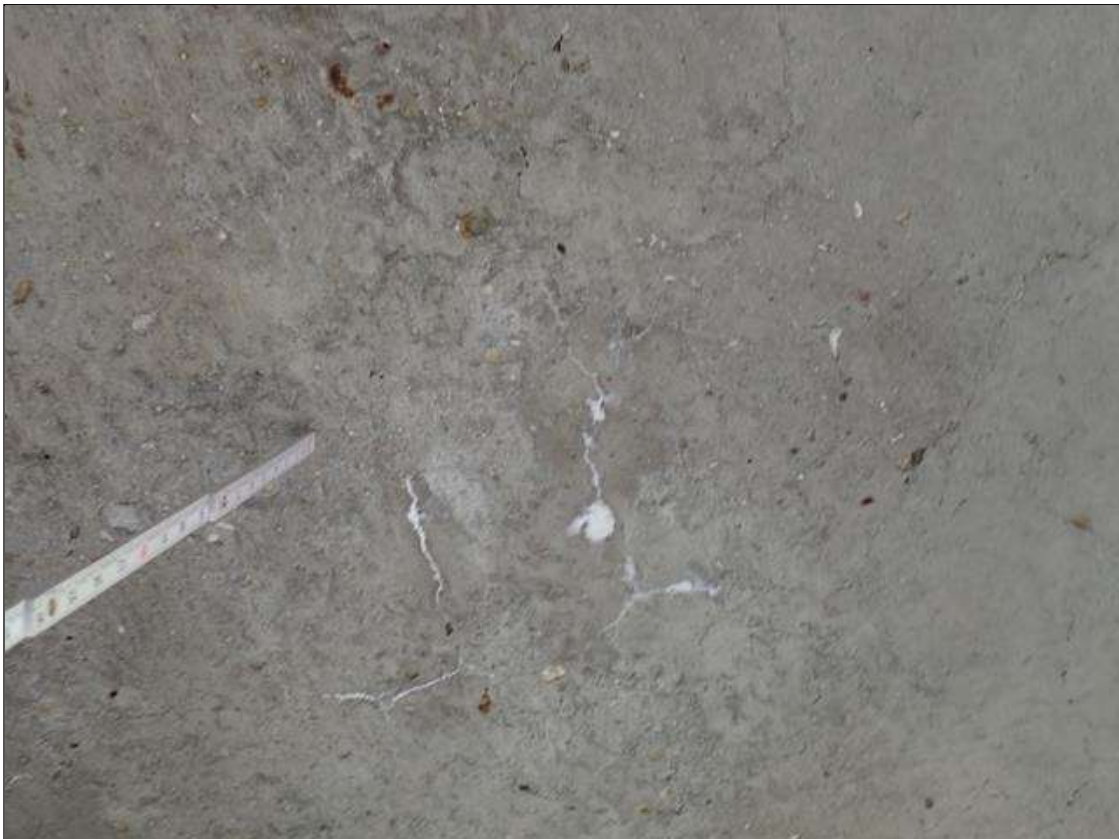
Span 1 Deck: MAP CRACKING UP TO 1/64 INCH SOME WITH EFFLORESCENCE DECK UNDERSIDE AT RANDOM THROUGHOUT

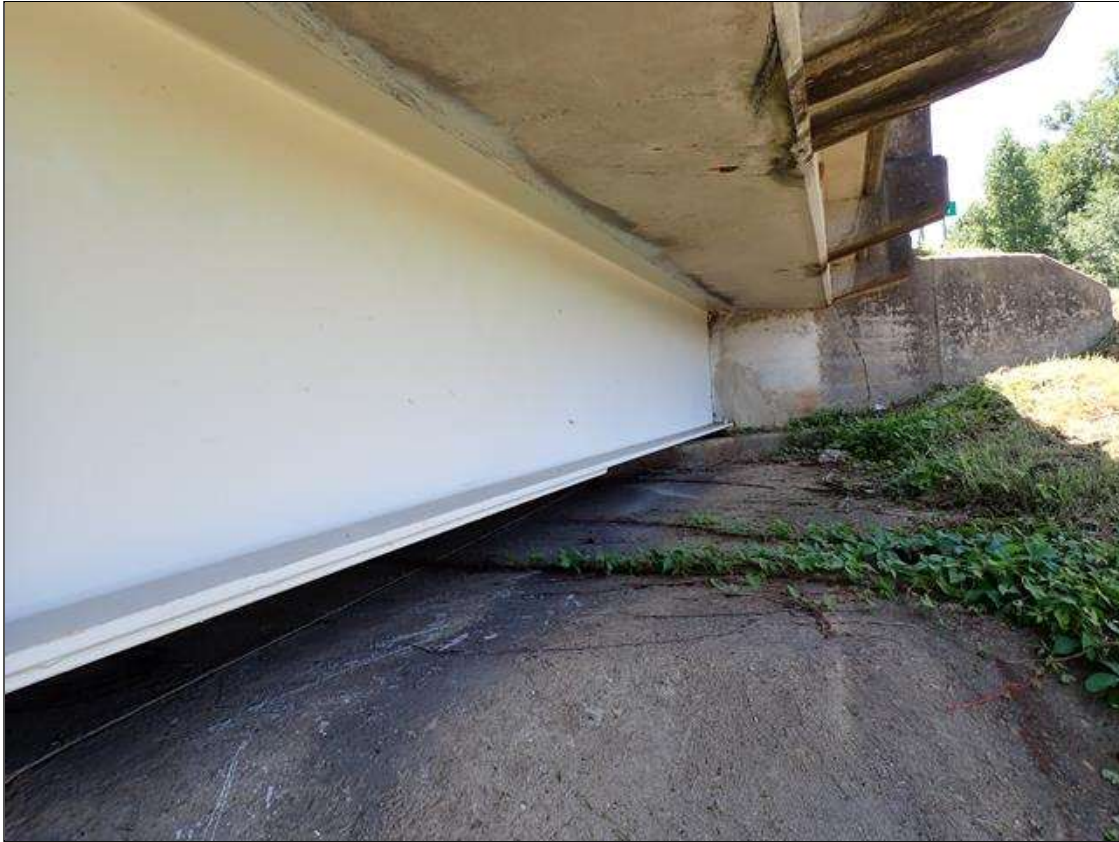
Span 1 Beam 1: 2023 new repair, previously noted as: IMPACT DAMAGE - THE SOUTH MOST 30 FOOT DEFLECTED 1 INCH EASTWARD . SCATTERED SCRAPES WITH 1/16 INCH INDENTIONS THROUGH OUT A 7 FOOT LONG X 2 FOOT-7 INCH HIGH AREA AT 12 FOOT OUT FROM END BENT 1 (POINT OF IMPACT). THERE IS A 1 FOOT-8 INCH LONG X 1/2 INCH WIDE X 1/16 INCH DEEP SCRAPE ON THE BOTTOM FLANGE AT 12 FOOT OUT FROM END BENT 1 .

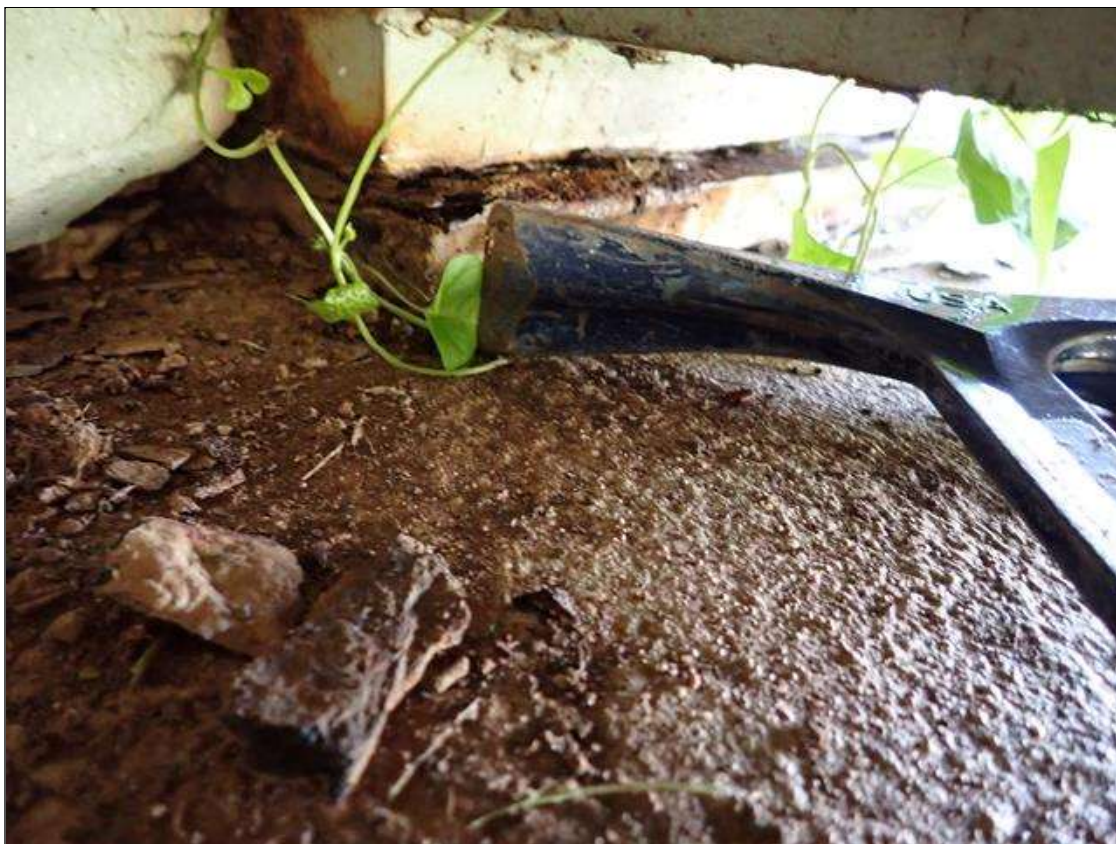
Span 1 Beam 1 - Near Bearing 1 - Protective System: surface rust/rust scale

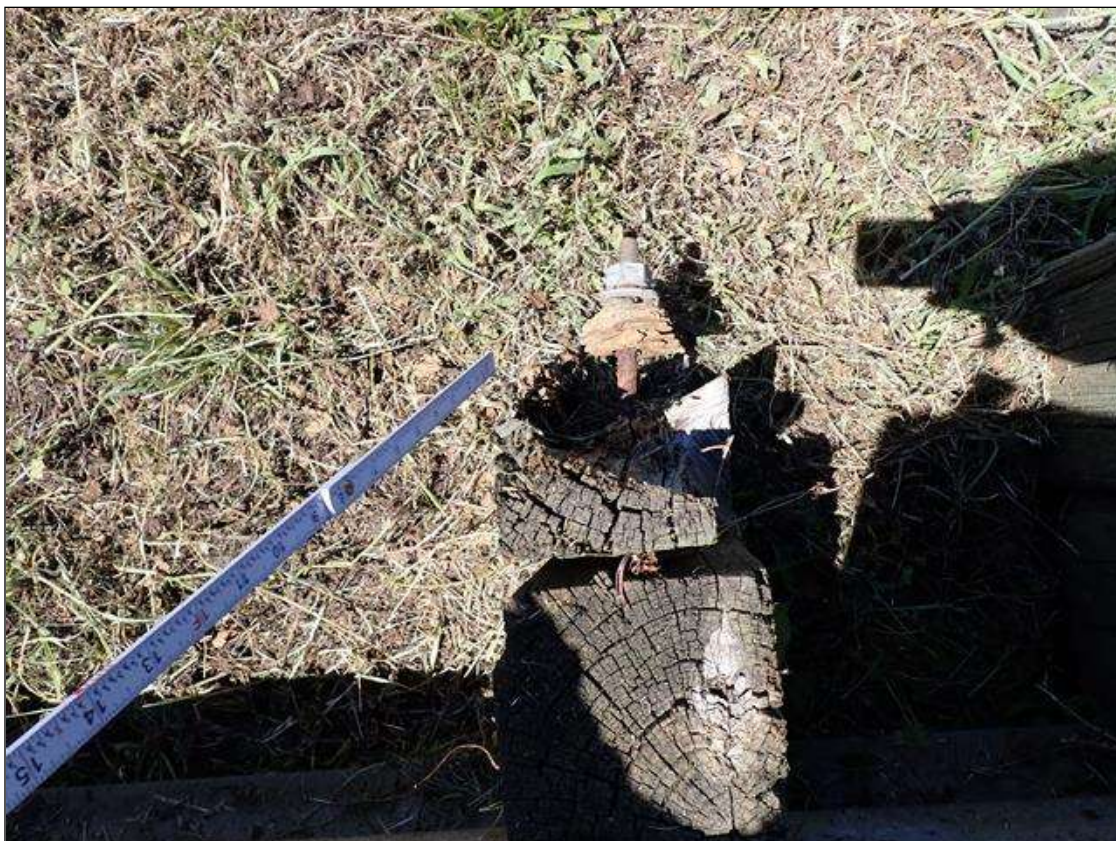
(PAR) southwest guardrail, 2nd post from end bent 1, decay (full height x full width x full depth)

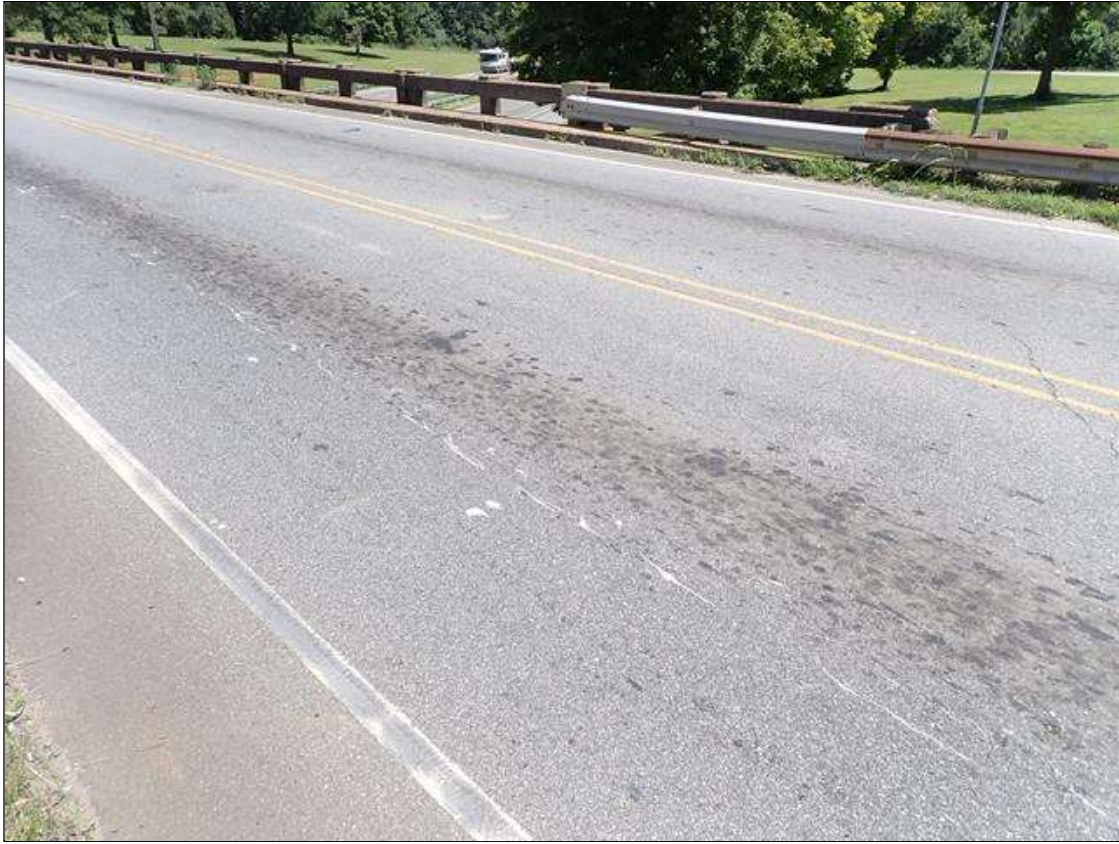
Span 1 Wearing Surface: (not found 2023) SPAN 1 WEARING SURFACE HAS SCATTERED PATCHED AREAS WITH SOME HAIRLINE CRACKS. PATCHES APPEAR TO BE SOUND. - NOT FOUND AT TIME OF INSPECTION. TDG
8/5/21

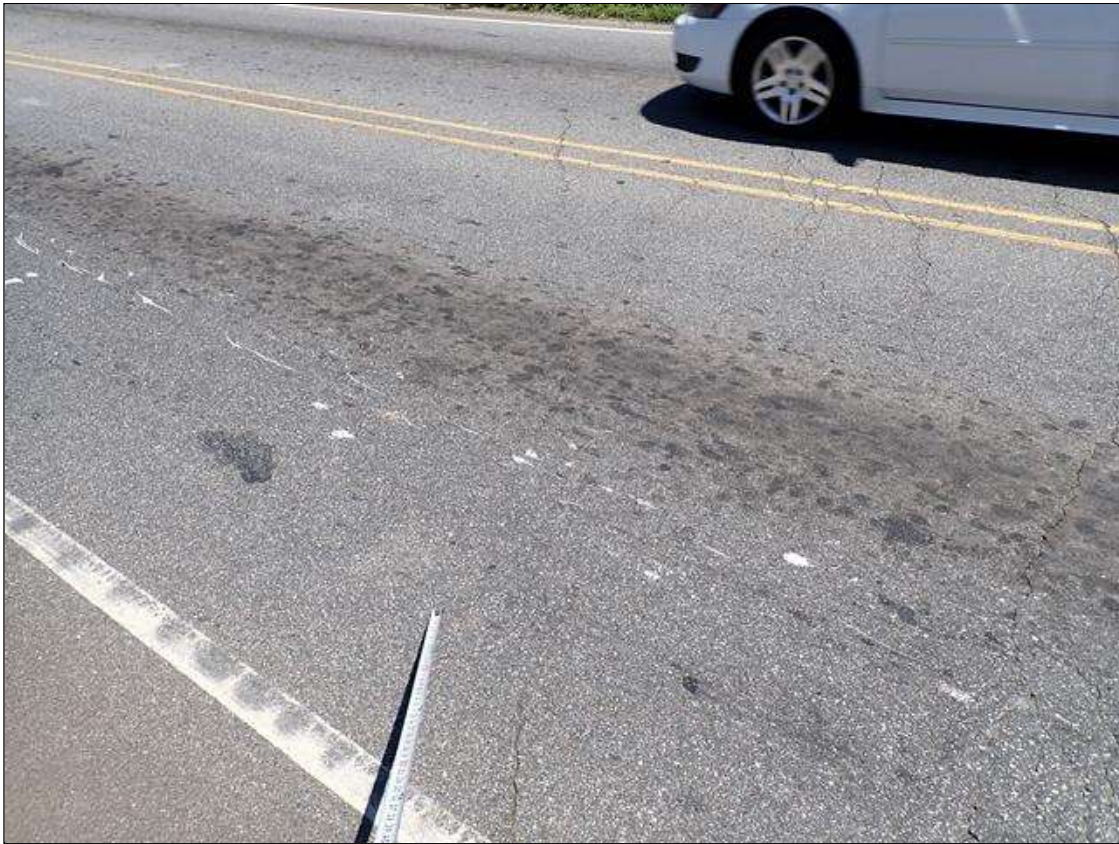
Span 1 Wearing Surface: 32 FOOT X UP TO 1/4 INCH TRANSVERSE CRACKS OVER END BENT 1 AND BENT 1 WITH VEGETATION GROWTH

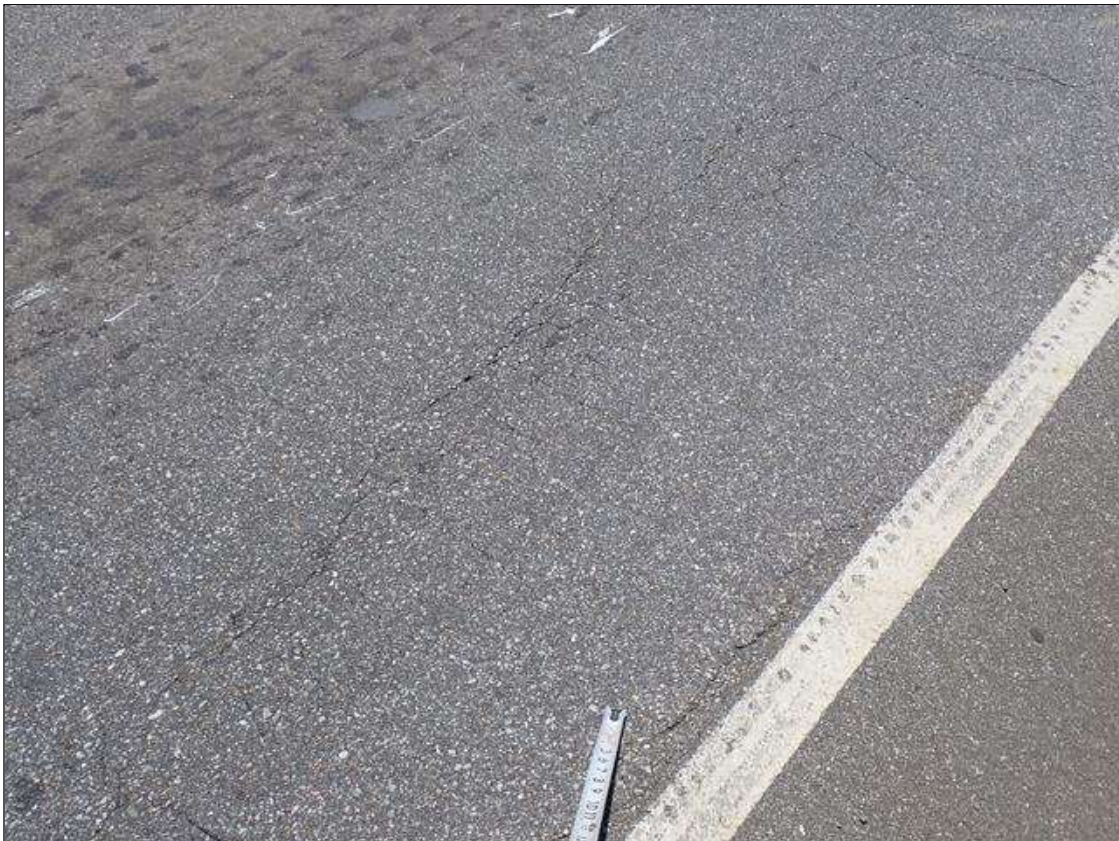
Span 1 Wearing Surface: scattered throughout, multiple transverse and longitudinal cracks [up to 6 foot x up to 1/32 inch]

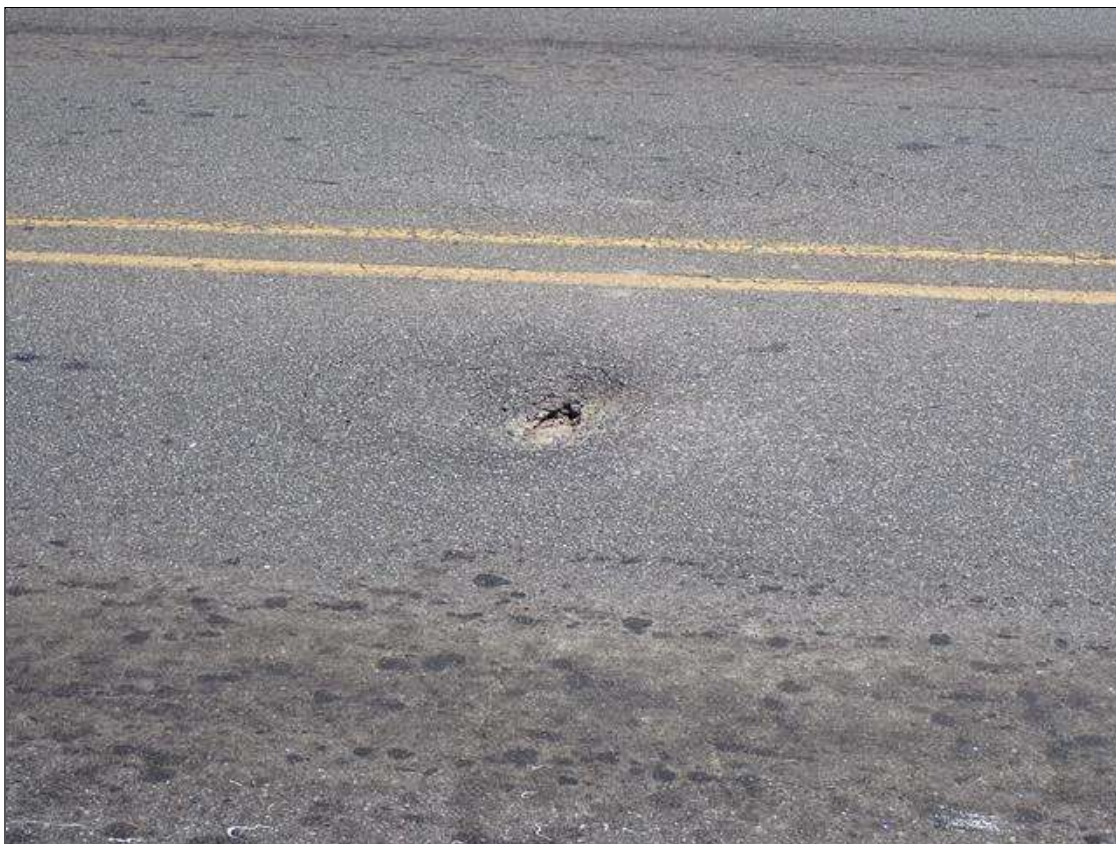
Span 1 Wearing Surface: near midspan, southbound lane, pothole/broken asphalt [5 inch x 11 inch x up to 1 inch deep]

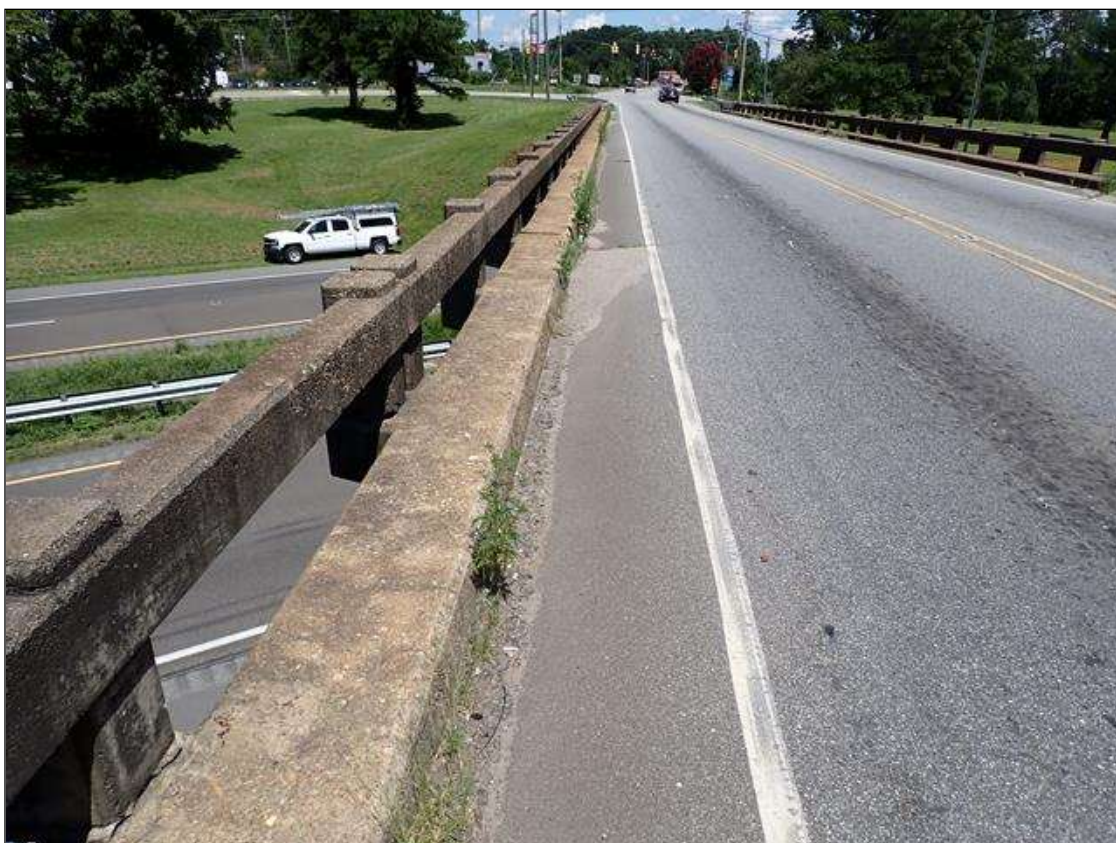
along both curblines, debris accumulation (up to 33 inch x full length) with vegetation growth; partially obstructing drainage

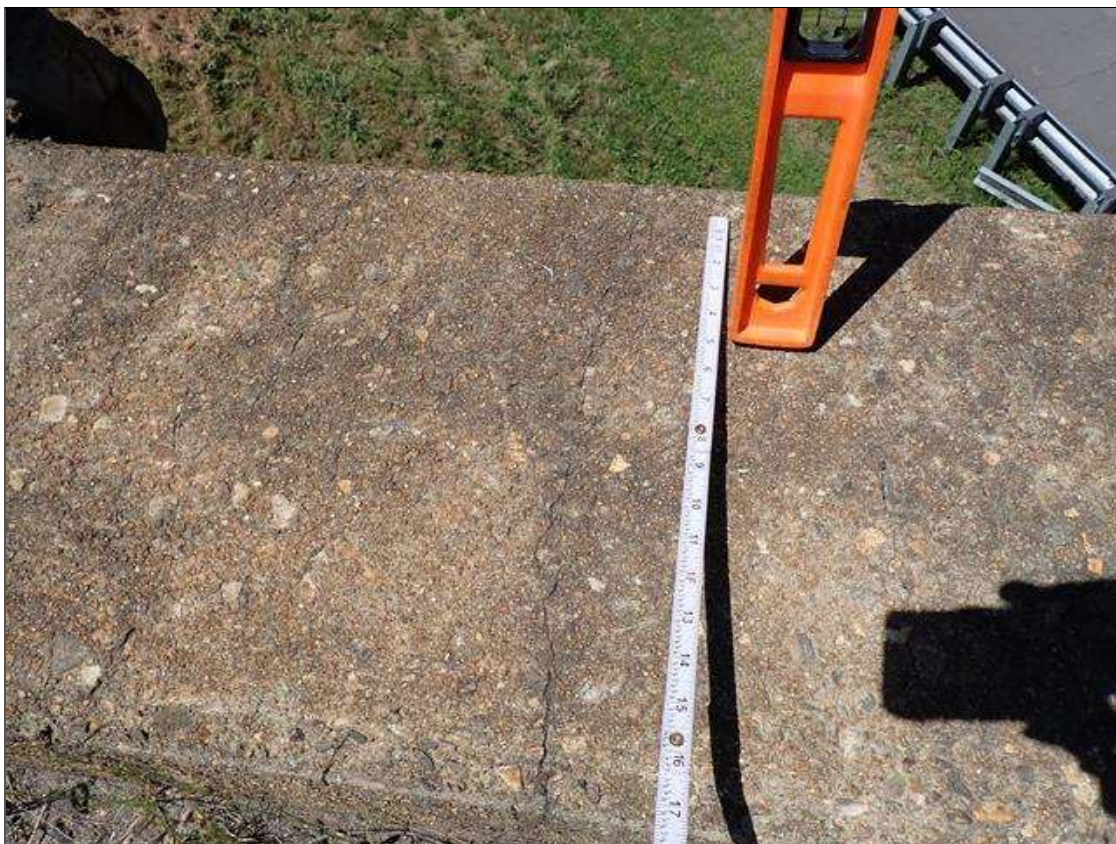
Span 1 Left Bridge Rail: along sidewalk multiple transverse cracks [up to 1/32 inch x full width]

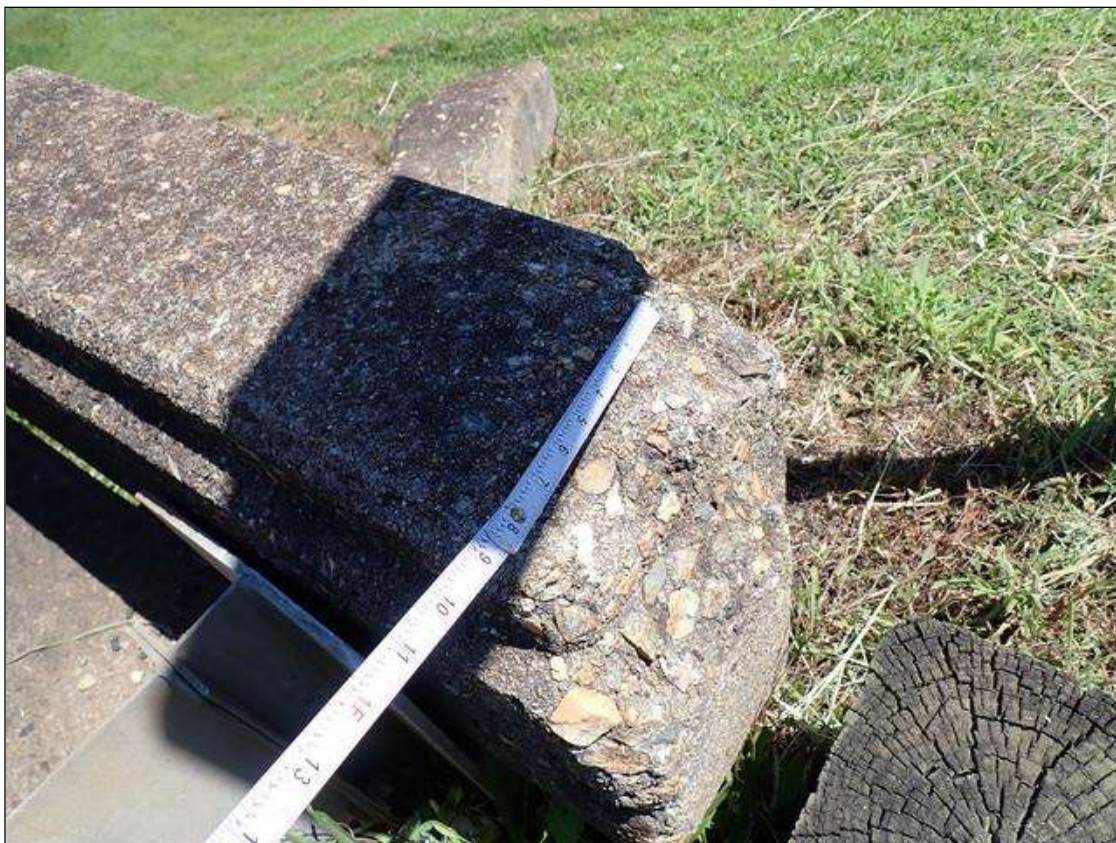
Span 1 Right Bridge Rail: at Southeast corner, spall [5 inch x full width x 1/2 inch deep]

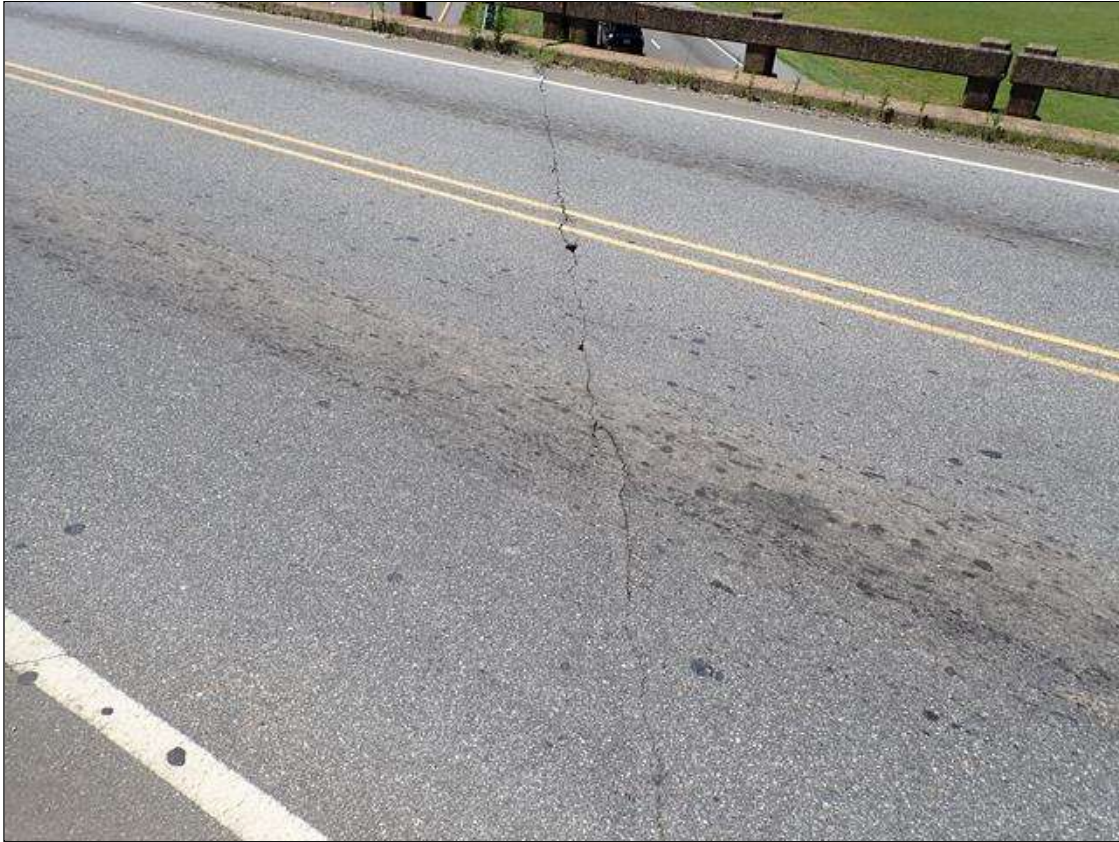
Span 2 Wearing Surface: 32 FOOT X UP TO 1/4 INCH TRANSVERSE CRACKS OVER BENT 2 WITH MULTIPLE AREAS OF BROKEN ASPHALT

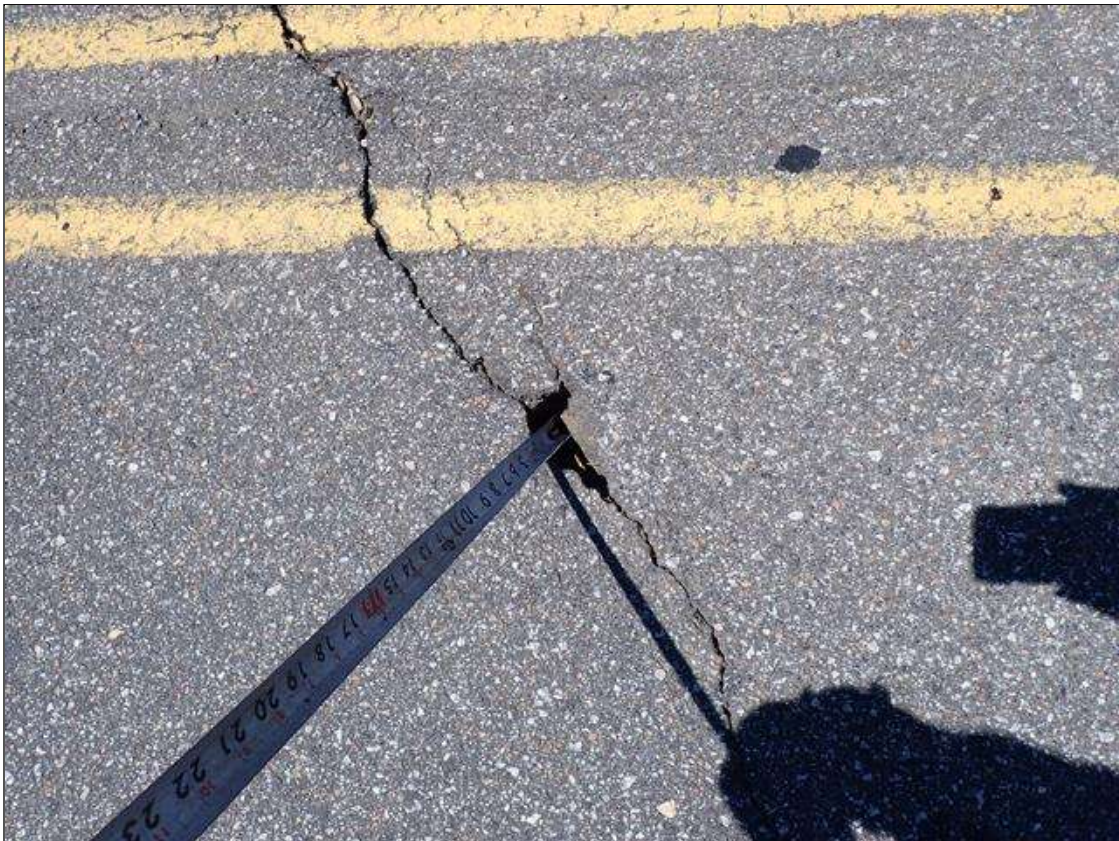
Span 2 Wearing Surface: at bent 2 beside white line in Southbound lane, pothole [9 inch x up to 3 inch x full depth] and by centerline pothole [3 inch diameter x full depth]

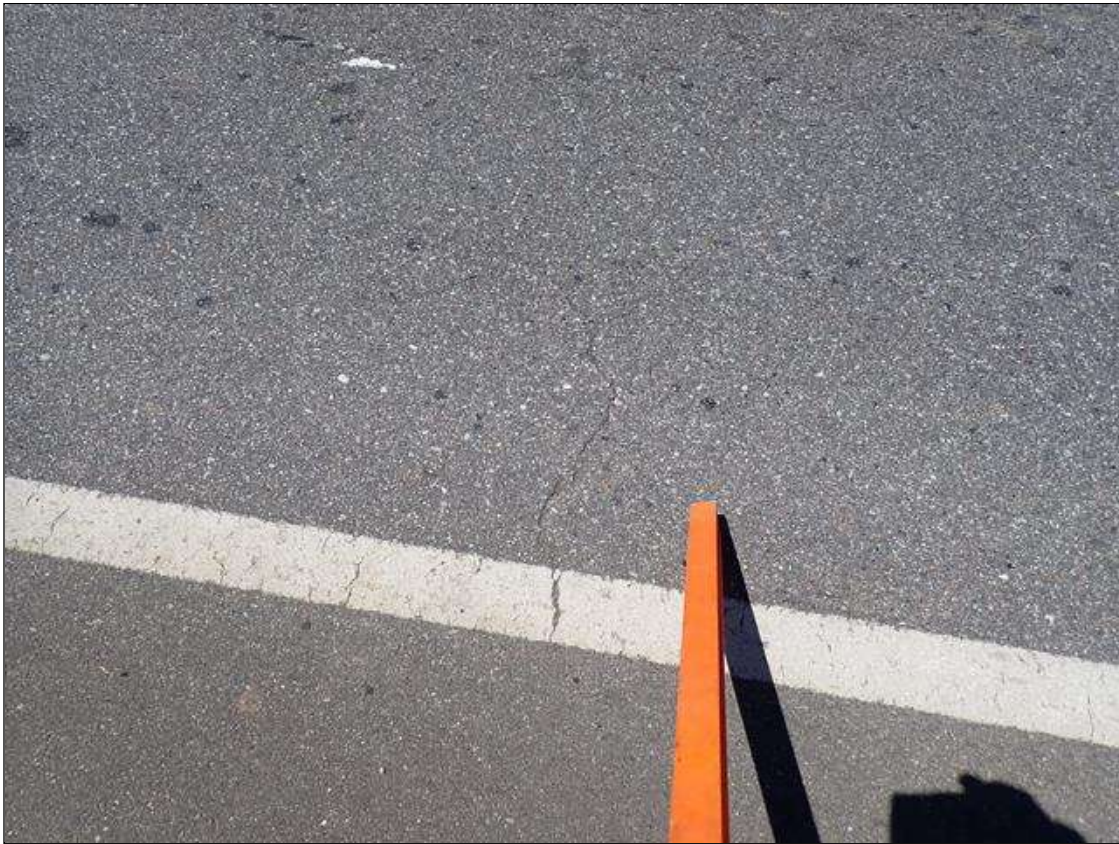
Span 2 Wearing Surface: scattered throughout, multiple transverse and longitudinal cracks [up to 4 foot x up to 1/32 inch]

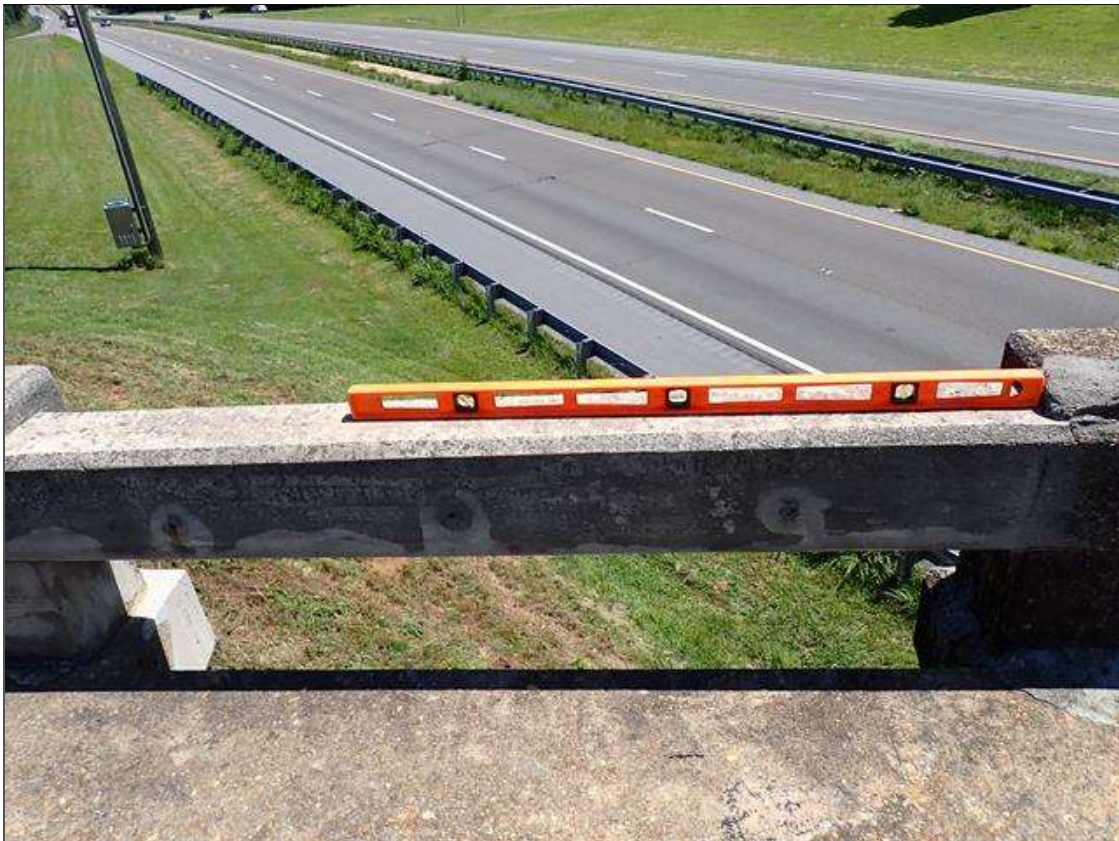
Span 4 Right Bridge Rail: SPAN 4 RIGHT RAIL HAS A REPAIR AREA BETWEEN POSTS 5 AND 6.

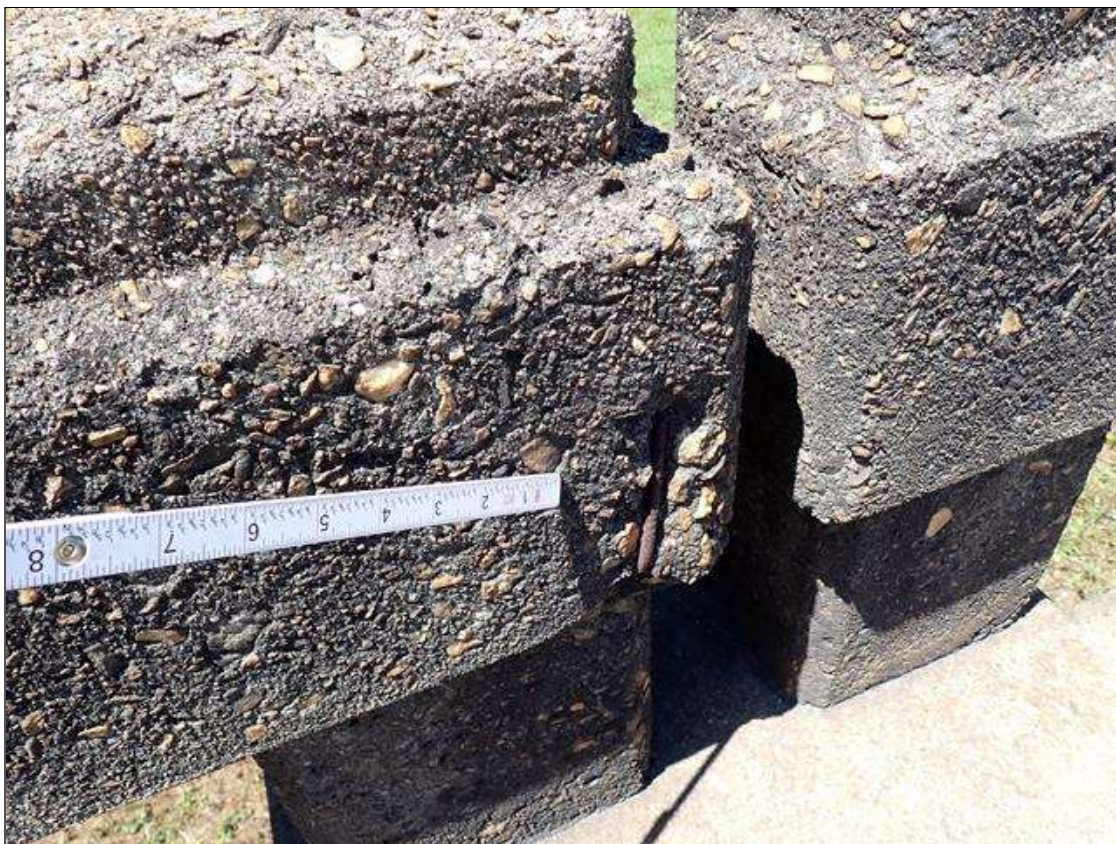
Span 4 Left Bridge Rail: 6th post from bent 3, spall (2 inch x 6 inch x 1 inch deep) with exposed rusted rebar

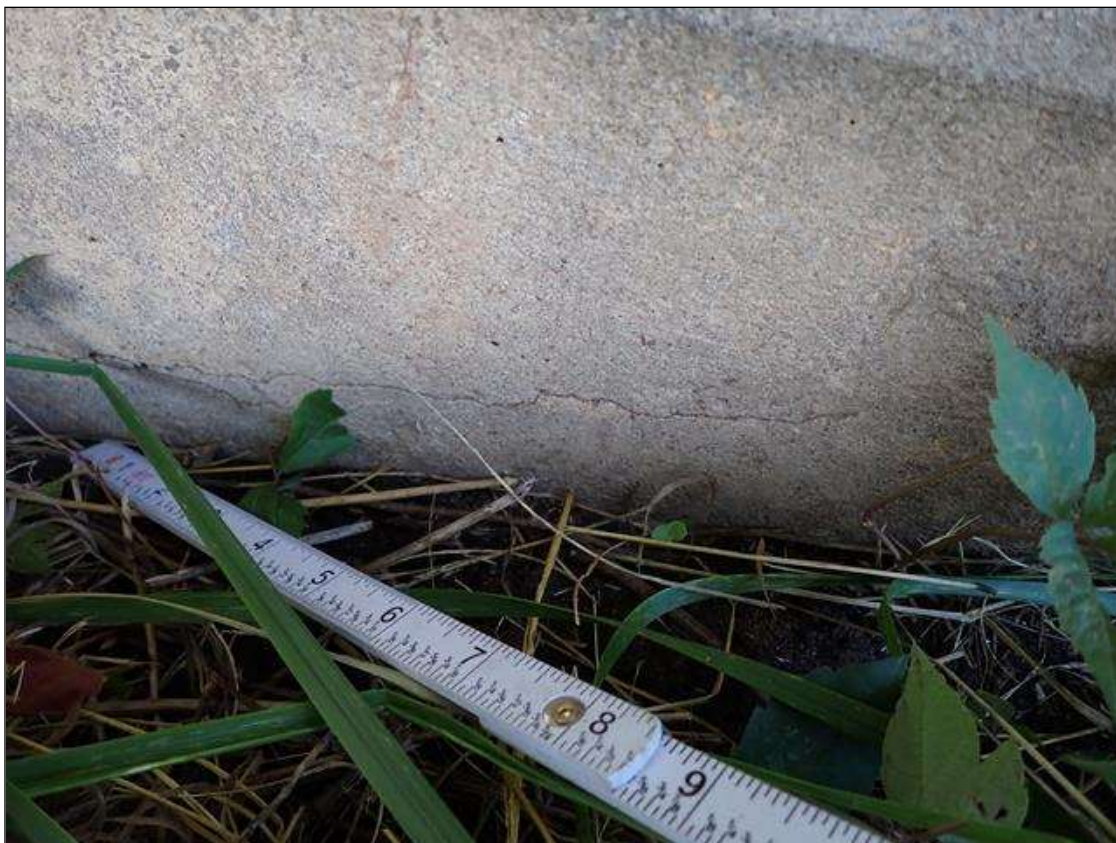
End Bent 2 Cap 1: 16 FOOT X UP TO 1/16 INCH HORIZONTAL CRACK SOUTH FACE BEGINNING AT EAST END

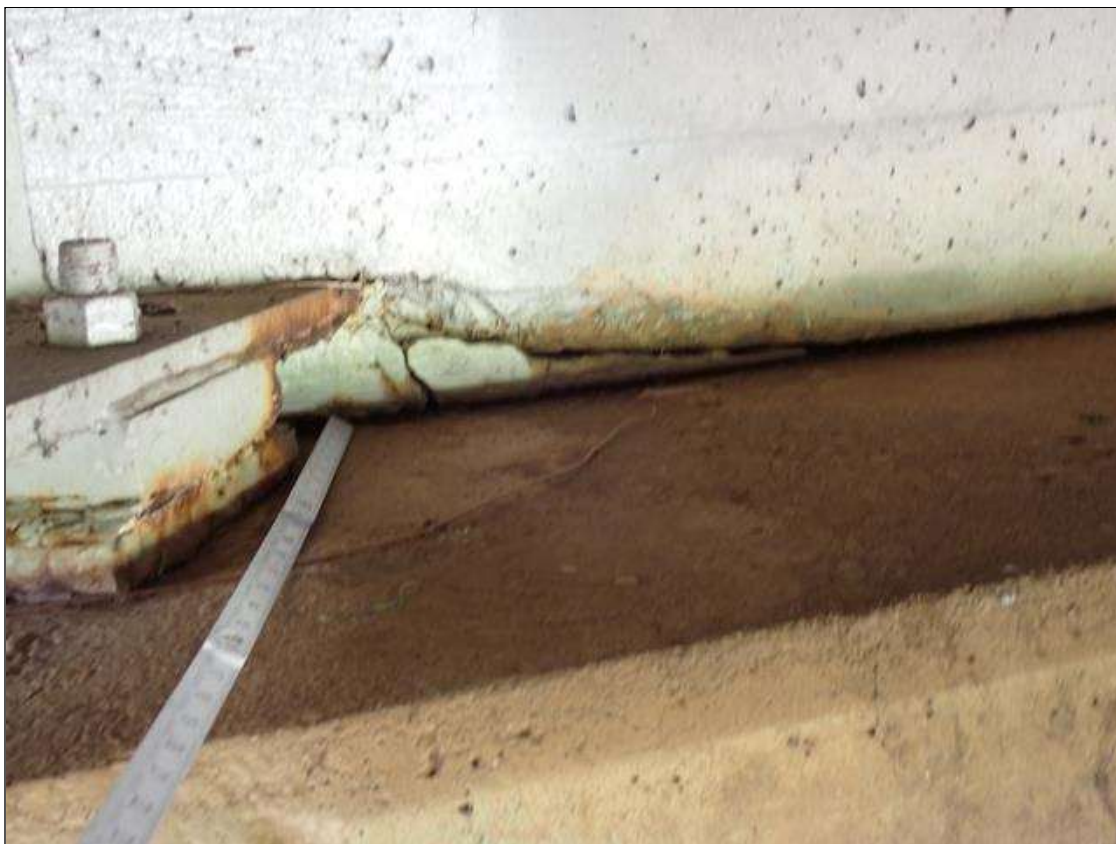
End Bent 2 Abutment: along the length of the abutment, at bottom flange penetrations, spall/delaminations (up to 1.5 foot x 3 inch x 1 inch) with cracks (up to 1/16 inch)
