NC DEPARTMENT OF TRANSPORTATION
 DIVISION OF HIGHWAYS
 STRUCTURE MANAGEMENT UNIT

ATTENTION: prompt action request; sketches updated; span 2 clearances updated; new repairs

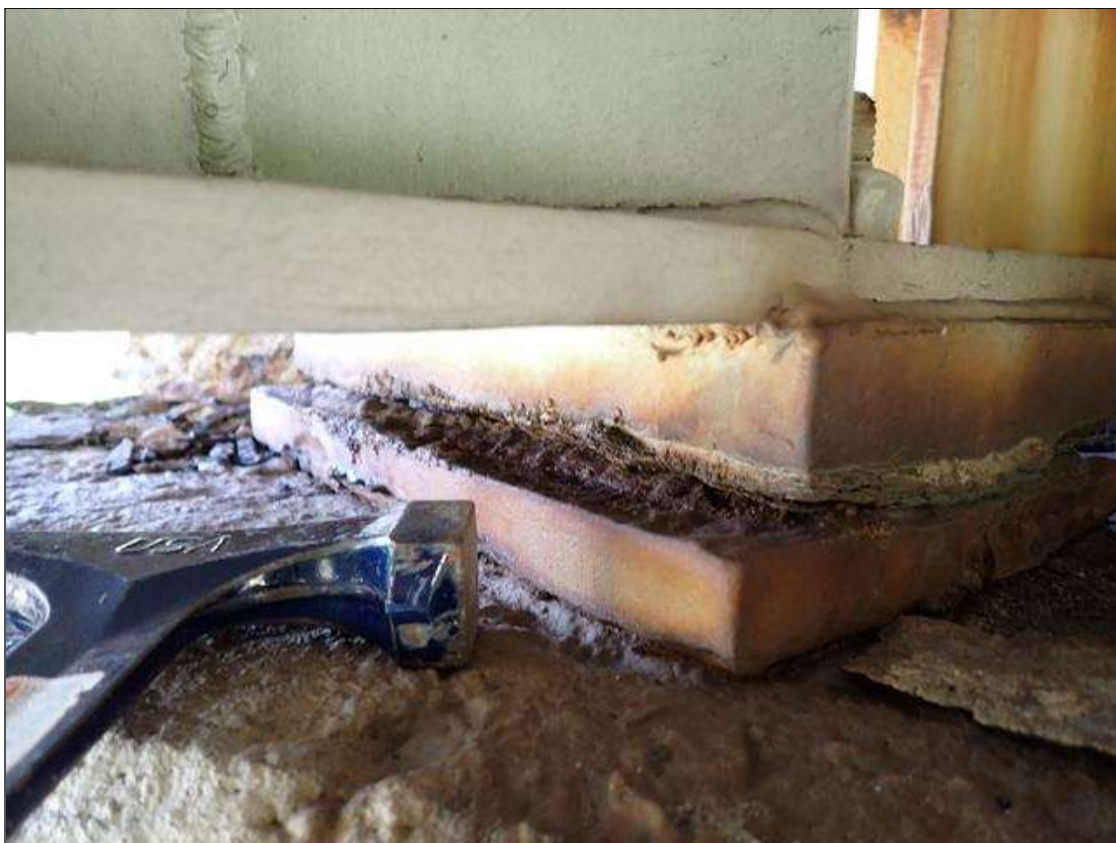
Span 3 Beam 1 - Far Bearing 1: corrosion with section loss (up to 1/8 inch loss) with pack rust (up to 3/8 inch)

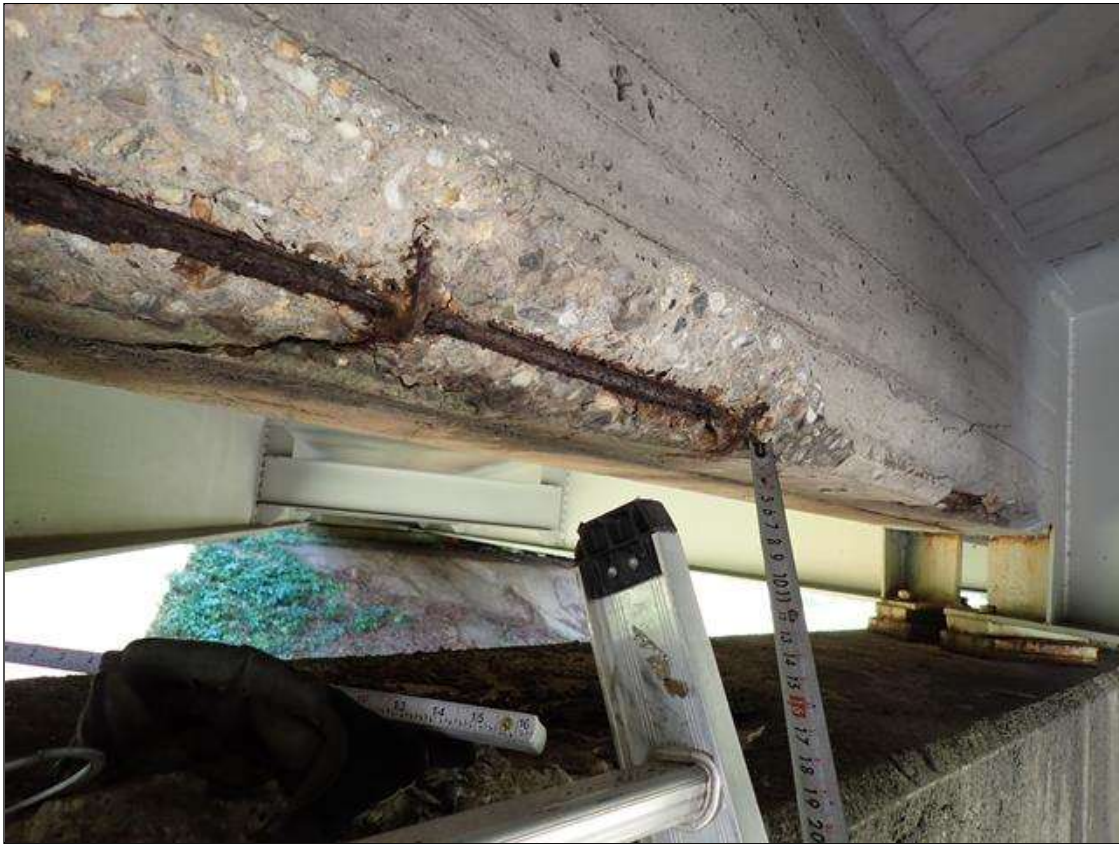
Span 3 Beam 1: (PAR) UP TO 8 FOOT X 10 INCH X 2 INCH DIAPHRAGM SPALL/DELAMINATION WITH EXPOSED REINFORCING APPROXIMATELY 25 PERCENT LOSS, BAY 1 OVER BENT 3

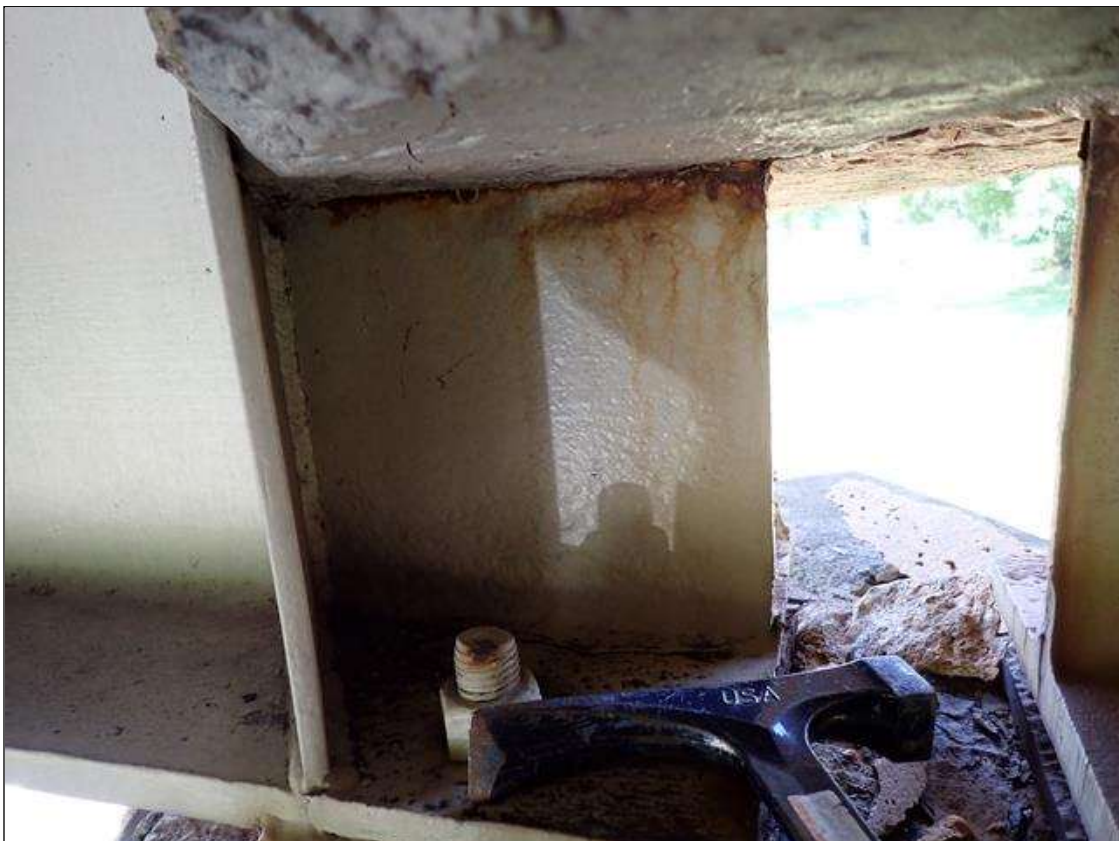
Span 3 Beam 1: at far end arrested metal loss with corrosion reactivating, web at diaphragm [10 inch x 1 inch x 1/2 inch average remaining]; arrested metal loss, lower web [8 inch x 1.5 inch x 9/16 inch average remaining]

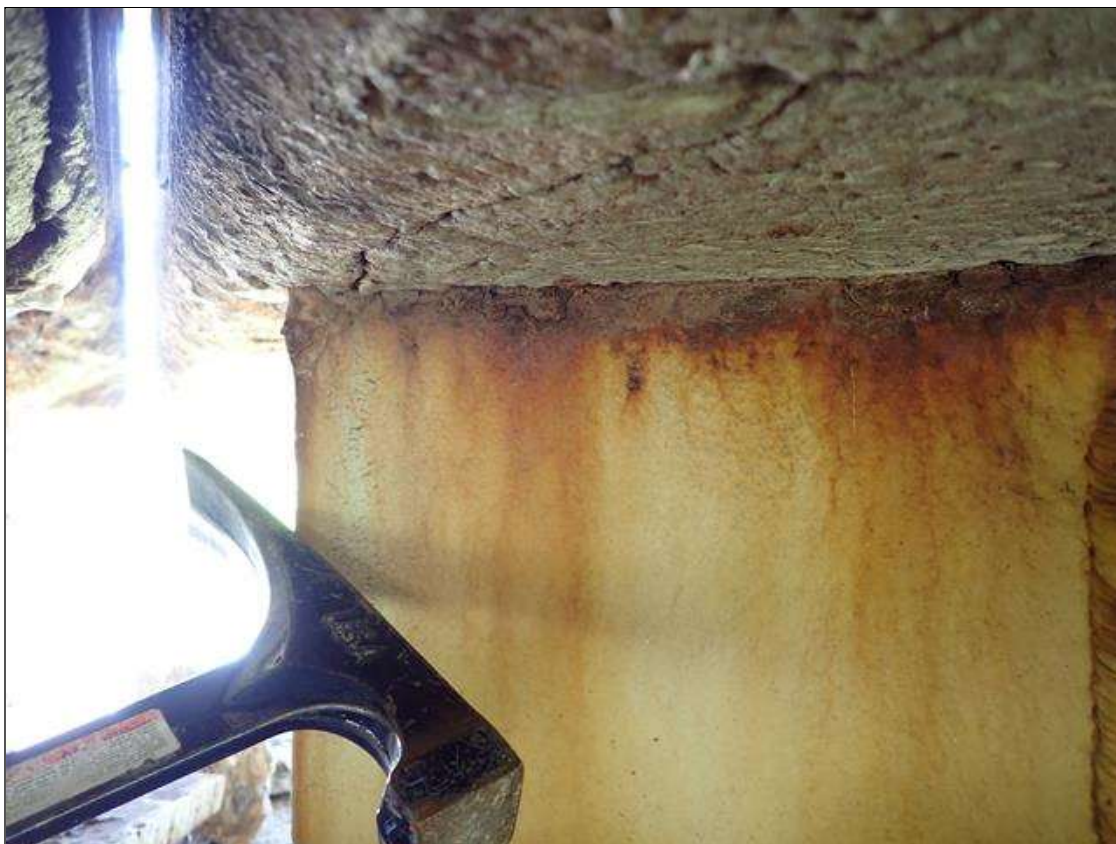
Span 4 Beam 1: at near end, arrested metal loss with corrosion reactivating, web at diaphragm [10 inch x 1/2 inch x 9/16 inch average remaining]

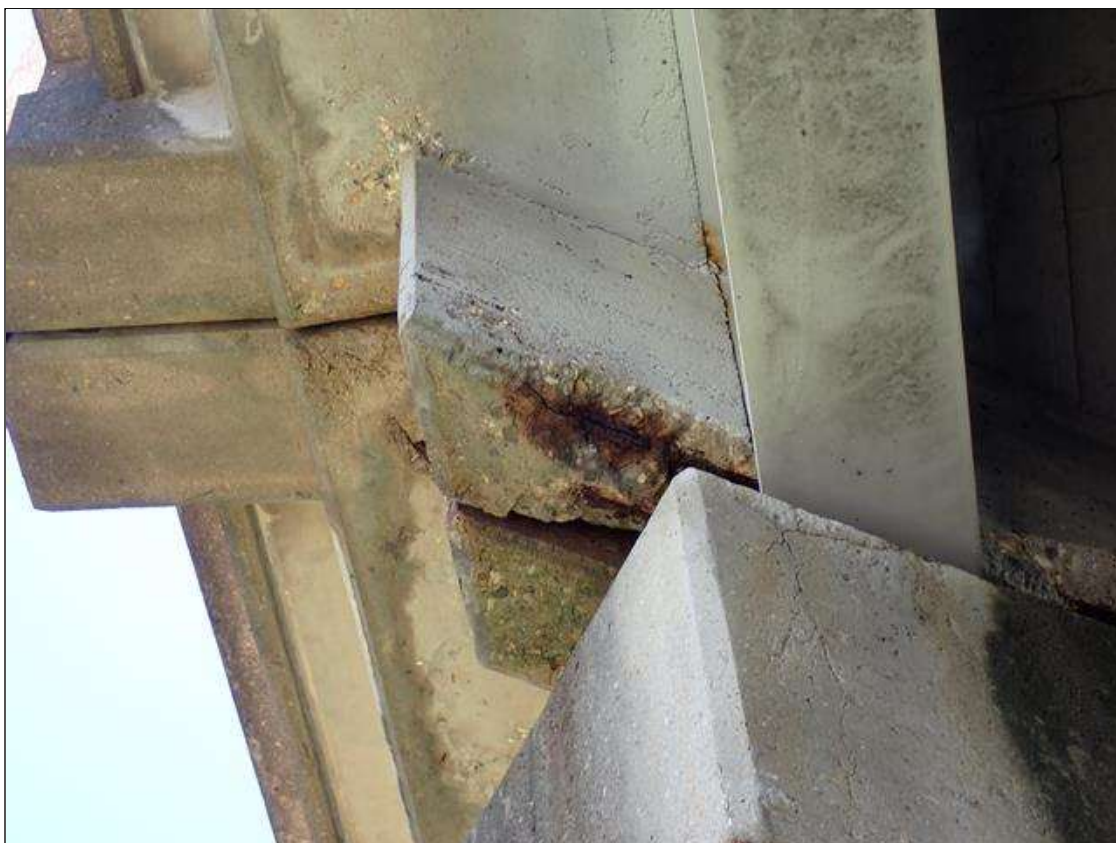
Span 3 Beam 1: (PAR) 16 INCH X 10 INCH X 6 INCH DIAPHRAGM SPALL WITH EXPOSED REINFORCING WEST OVERHANG AT BENT 3

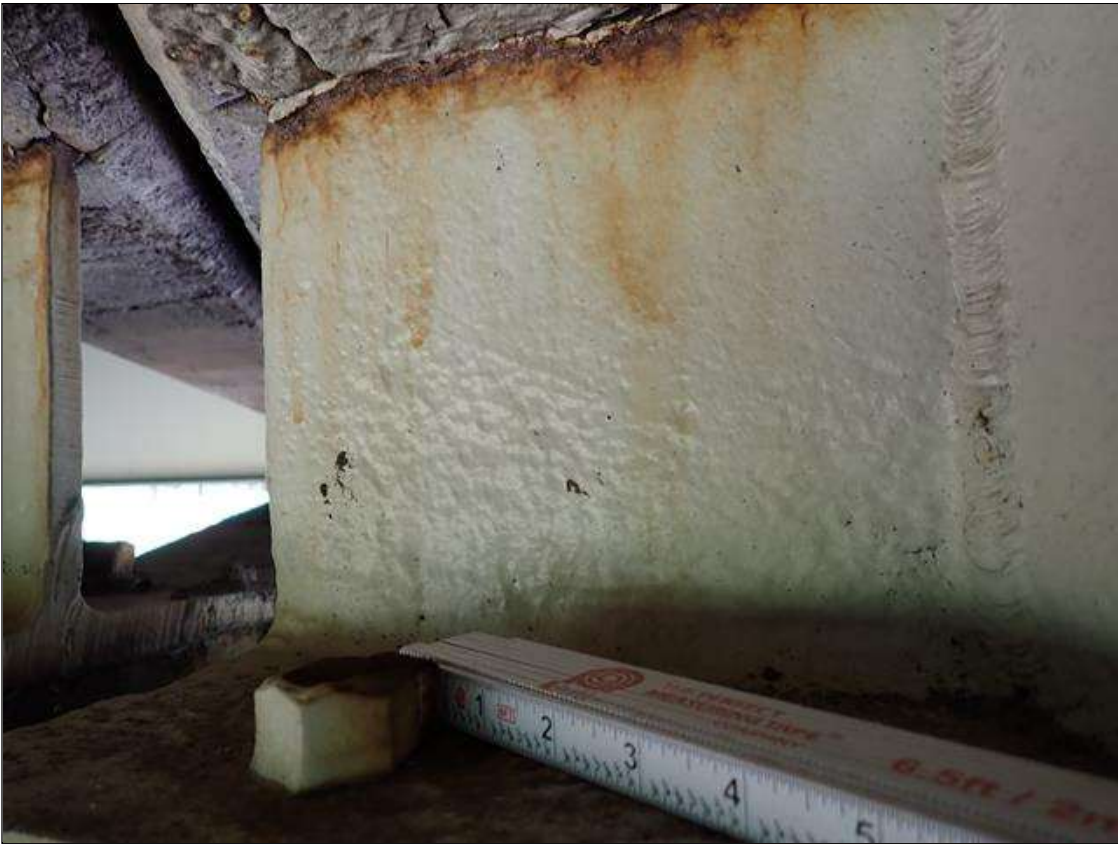
Span 3 Beam 2: at far end, arrested metal loss with corrosion reactivating, web at diaphragm [10 inch x 1 inch x 9/16 inch average remaining]; pitting [up to 1/8 inch deep]

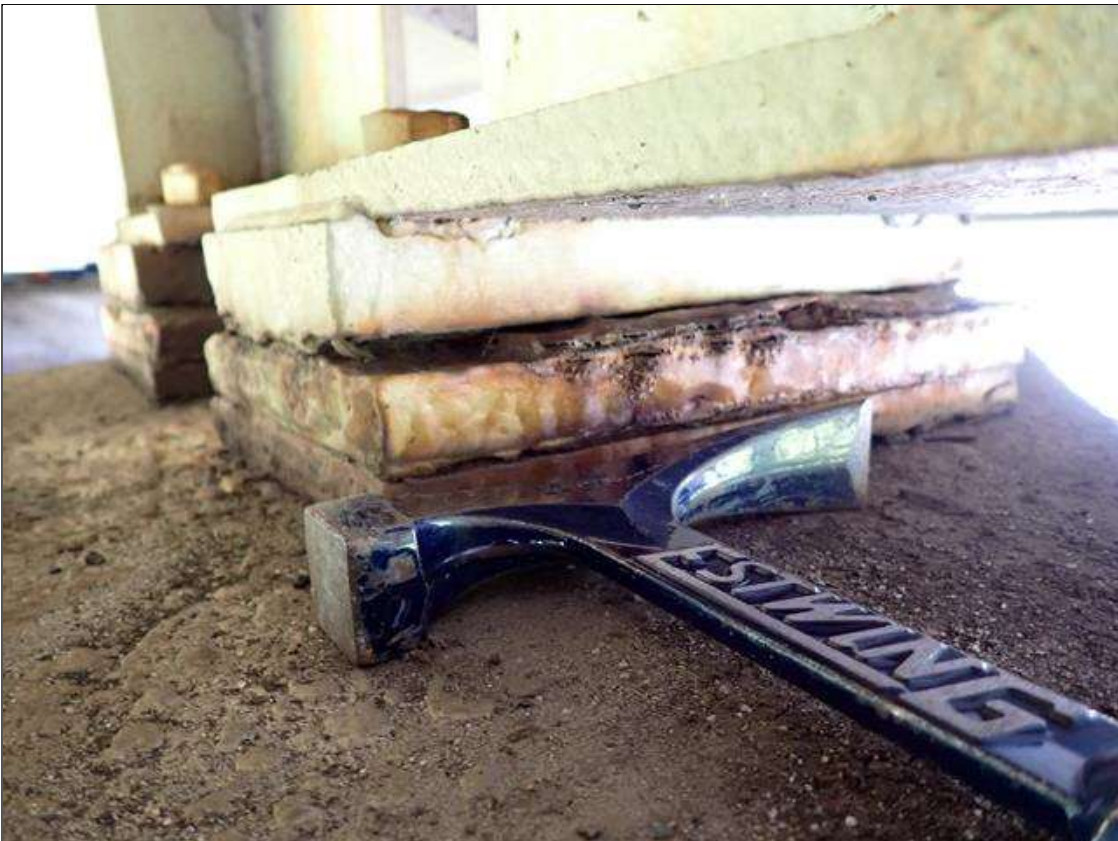
Span 3 Beam 2 - Far Bearing 2: corrosion with section loss (up to 1/16 inch deep) with pack rust (up to 3/8 inch)

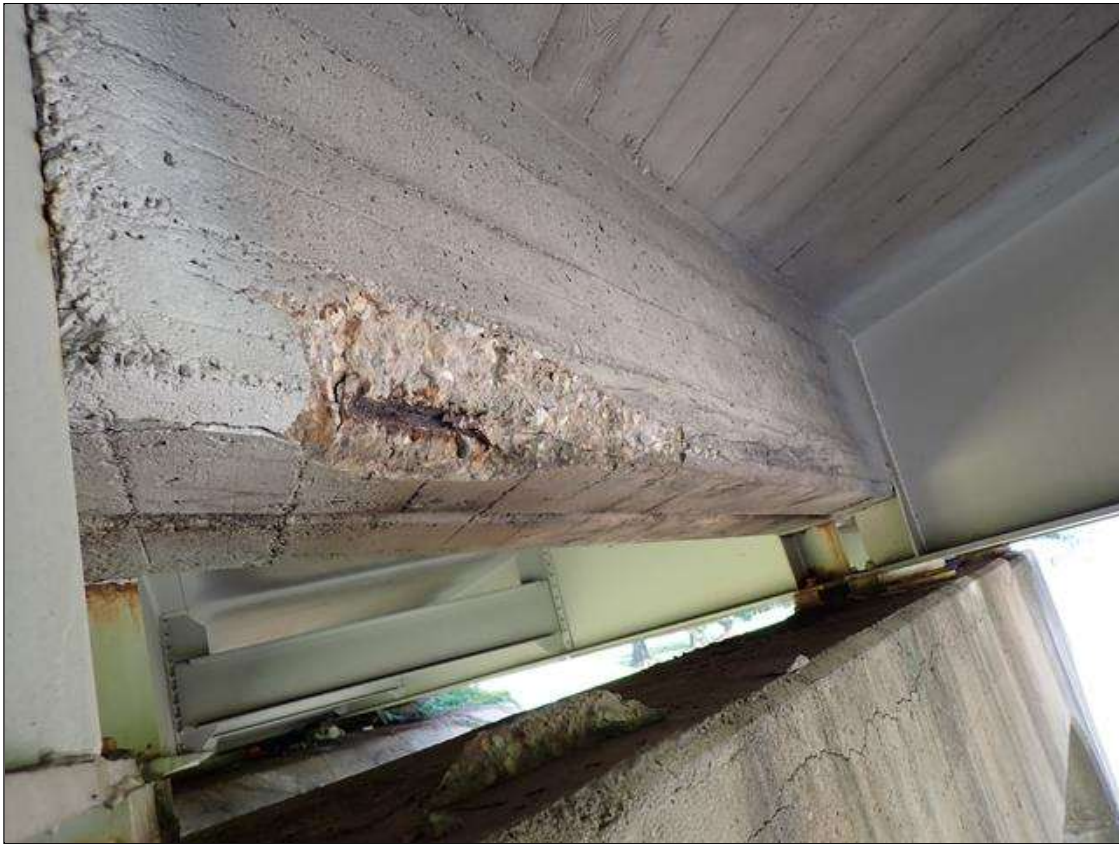
Span 3 Beam 2: (PAR) 4 FOOT X 10 INCH X 6 INCH X 2.5 INCH DEEP DIAPHRAGM SPALL/DELAMINATION WITH EXPOSED REINFORCING APPROXIMATELY 25 PERCENT LOSS, BAY 2 OVER BENT 3

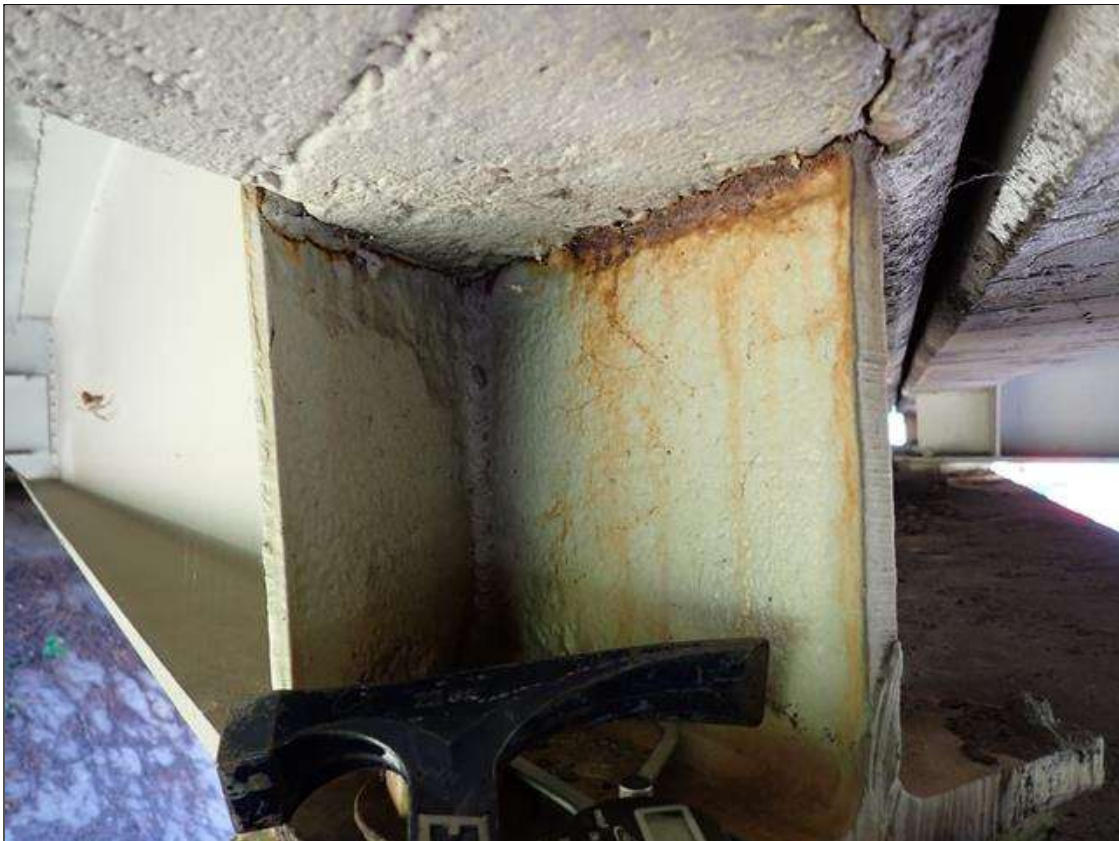
Span 4 Beam 2: at near end, arrested metal loss with corrosion reactivating, web at diaphragm [10 inch x 1/2 inch x 1/2 inch average remaining]; left stiffener [0.35 average remaining x full width x full height]

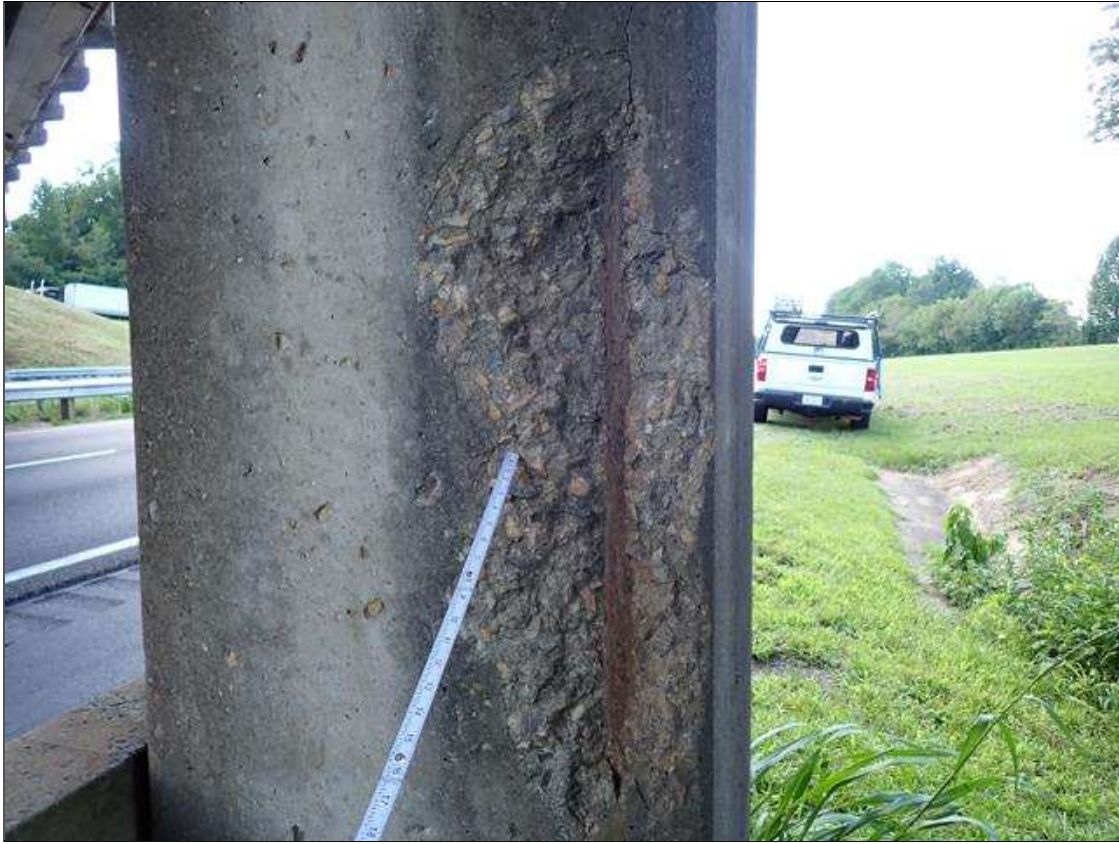
Bent 3 Pile 1: (PAR) 34 INCH X UP TO 13 INCH X 1.5 INCH DEEP SPALL WITH EXPOSED REINFORCING APPROXIMATELY 25 PERCENT LOSS, 8 FOOT FROM BOTTOM OF CAP EAST FACE

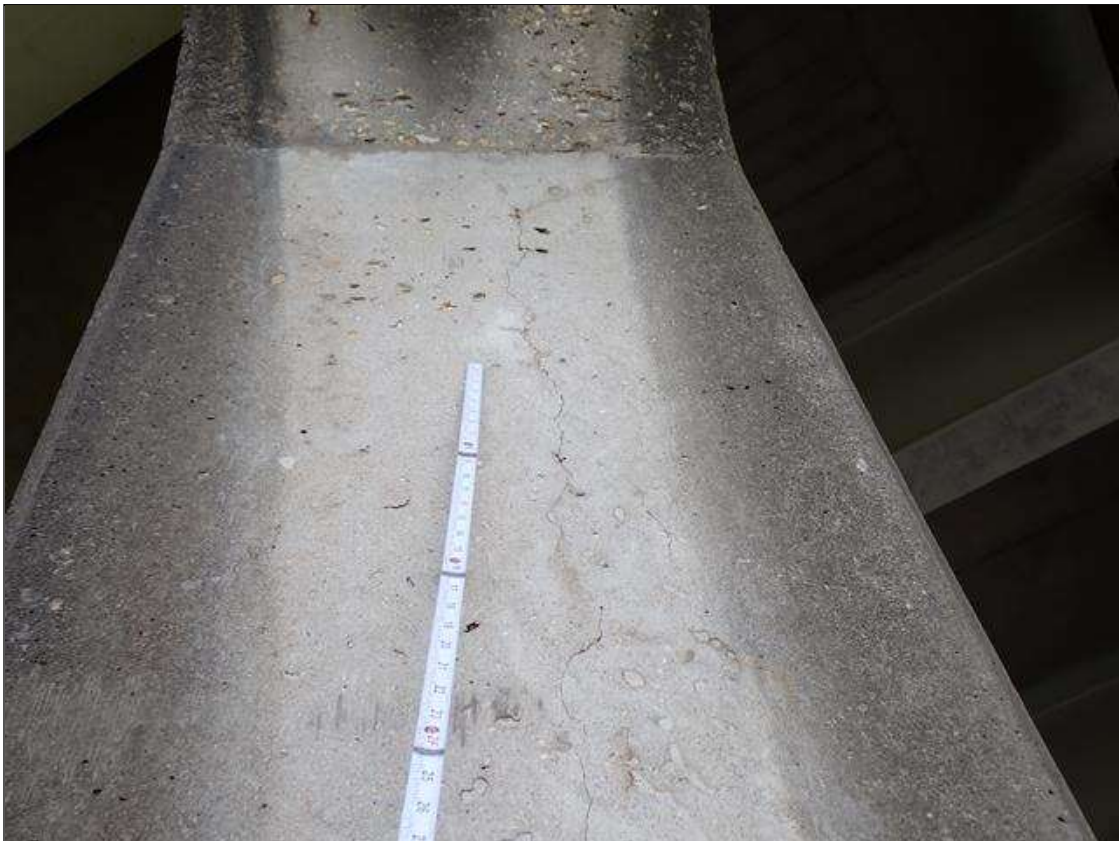
Bent 3 Pile 1: at East and West face, multiple vertical cracks [up to 8 foot x up to 1/32 inch]

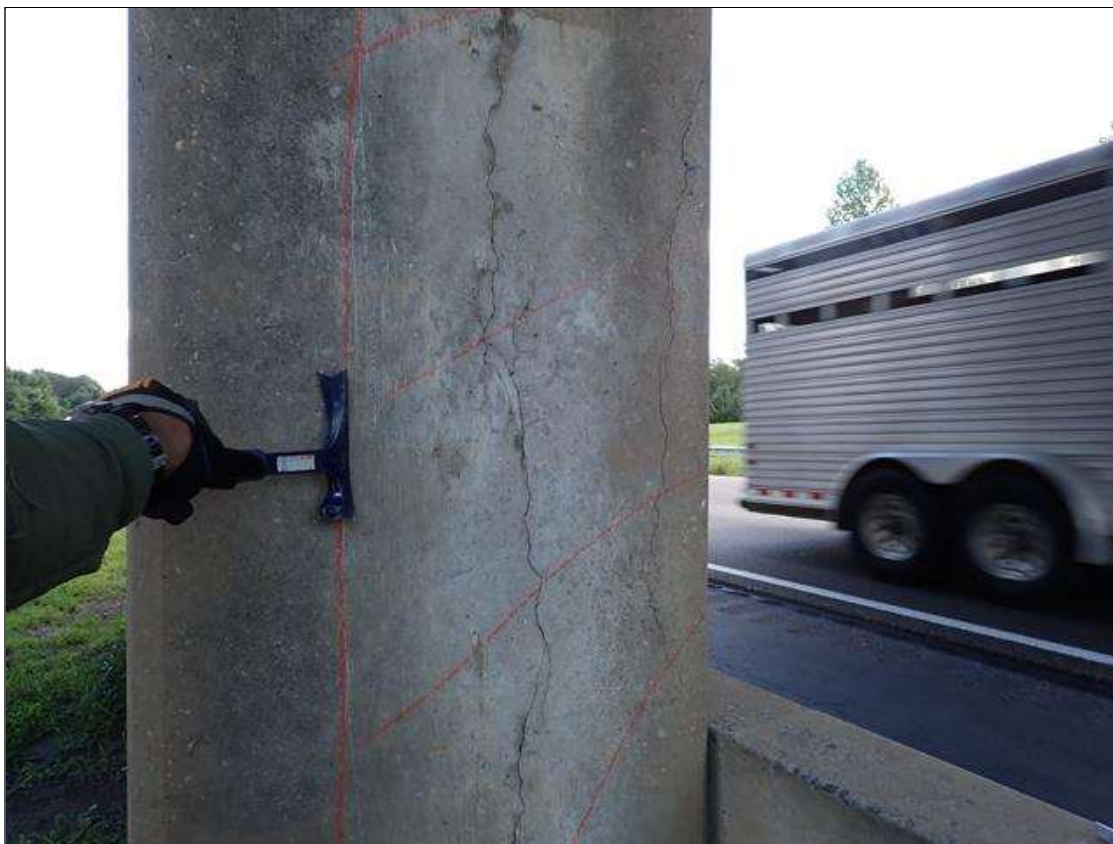
Bent 3 Pile 2: 2 - VERTICAL CRACKS UP TO 9 FOOT X 1/16 INCH WITH ADJACENT DELAMINATION 9 FOOT X 2 FOOT ON WEST FACE

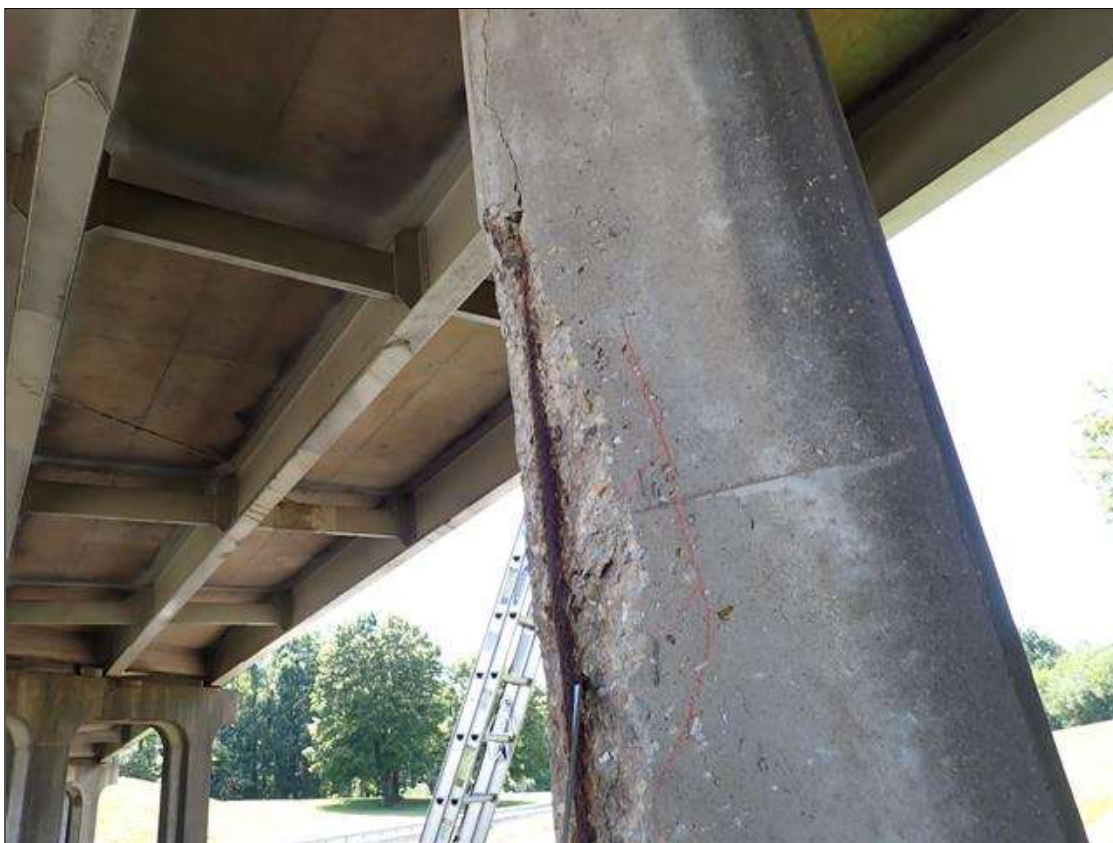
Bent 3 Pile 2: [PAR] at Southeast corner, spall [8.5 foot x 11 inch x 2.5 inch deep] with exposed rusted reinforcing [section loss up to 1/8 inch]

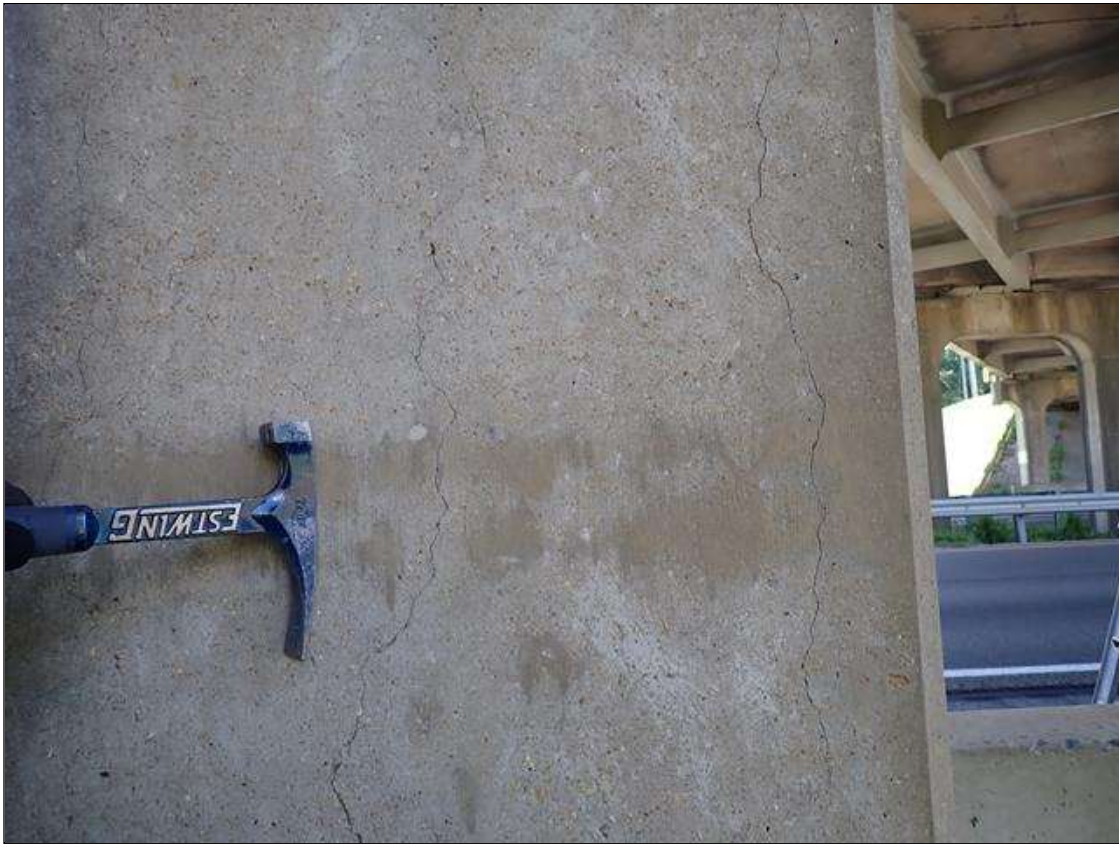
Bent 3 Pile 2: all faces, multiple vertical cracks [1/32 inch x full height]

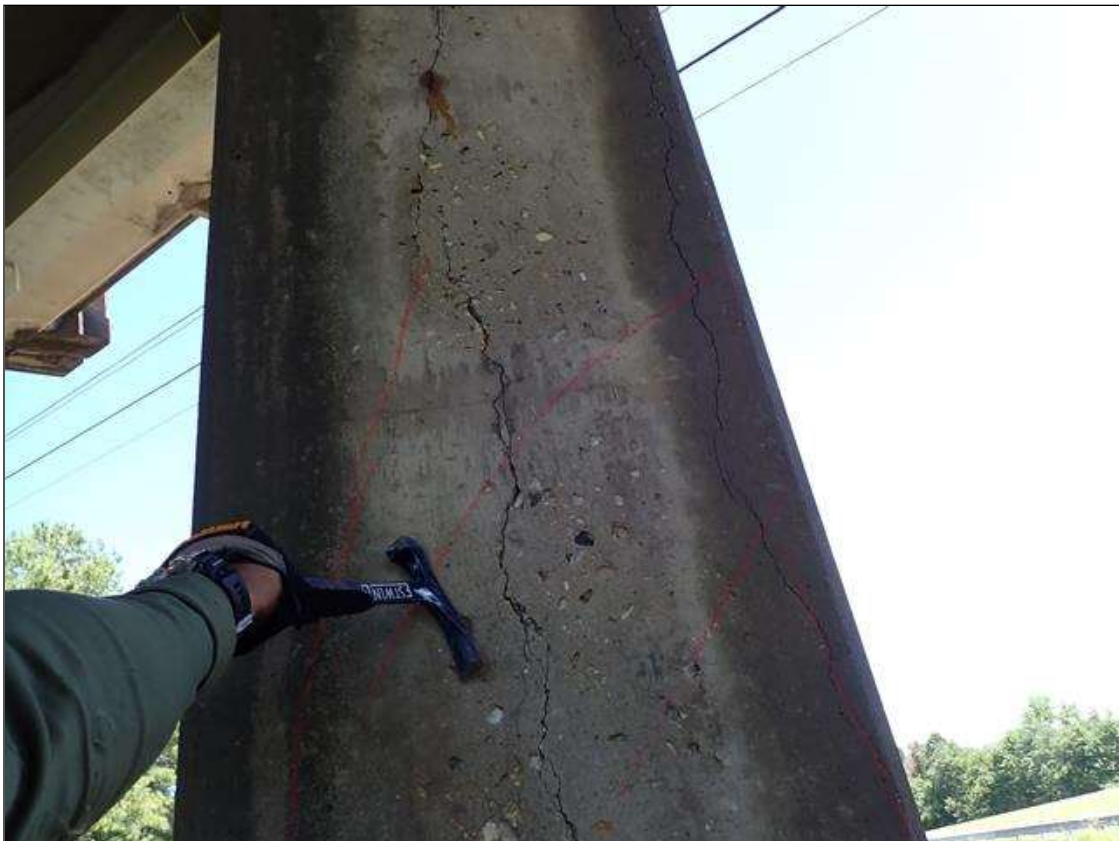
Bent 3 Pile 3: (PAR) 2 - VERTICAL CRACKS UP TO FULL HEIGHT X UP TO 1/8 INCH WITH RUST STAINS AND ADJACENT DELAMINATION FULL HEIGHT X 2 FOOT ON WEST FACE

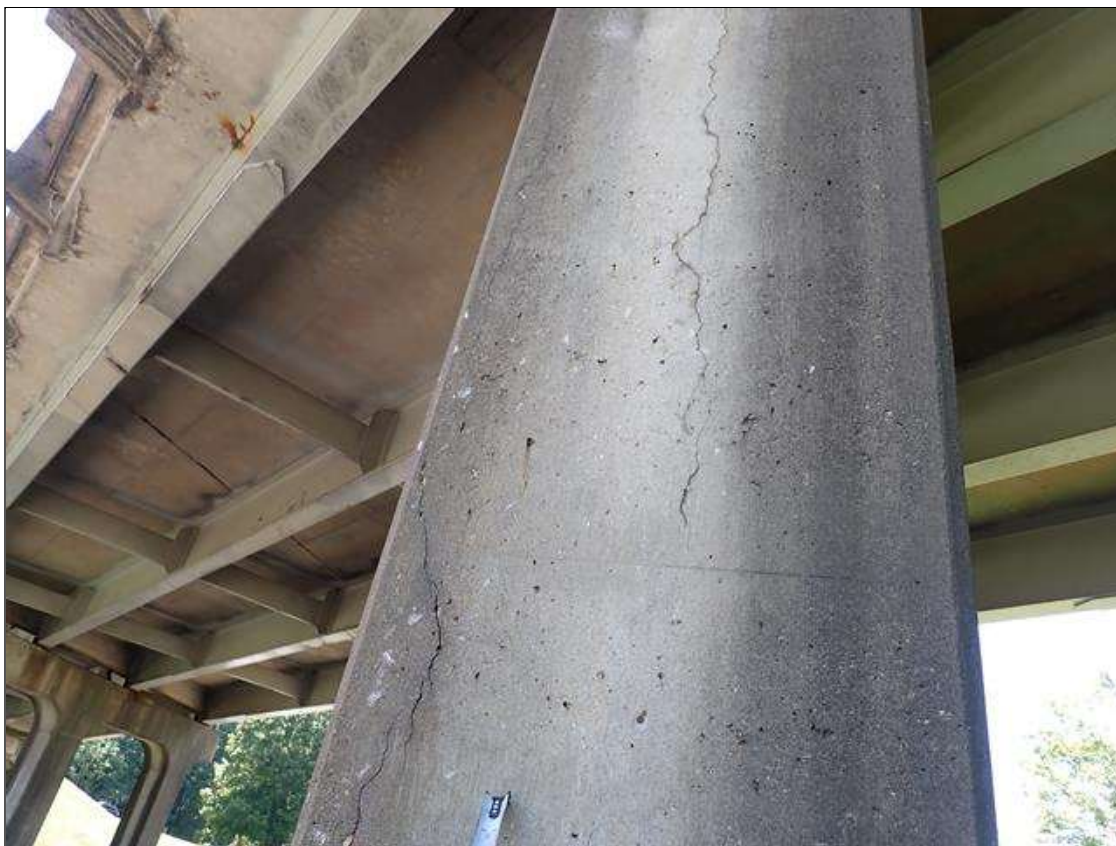
Bent 3 Pile 3: East face, multiple vertical cracks (up to full height x 1/8 inch wide) with adjacent delamination (up to full height x 1.5 foot)

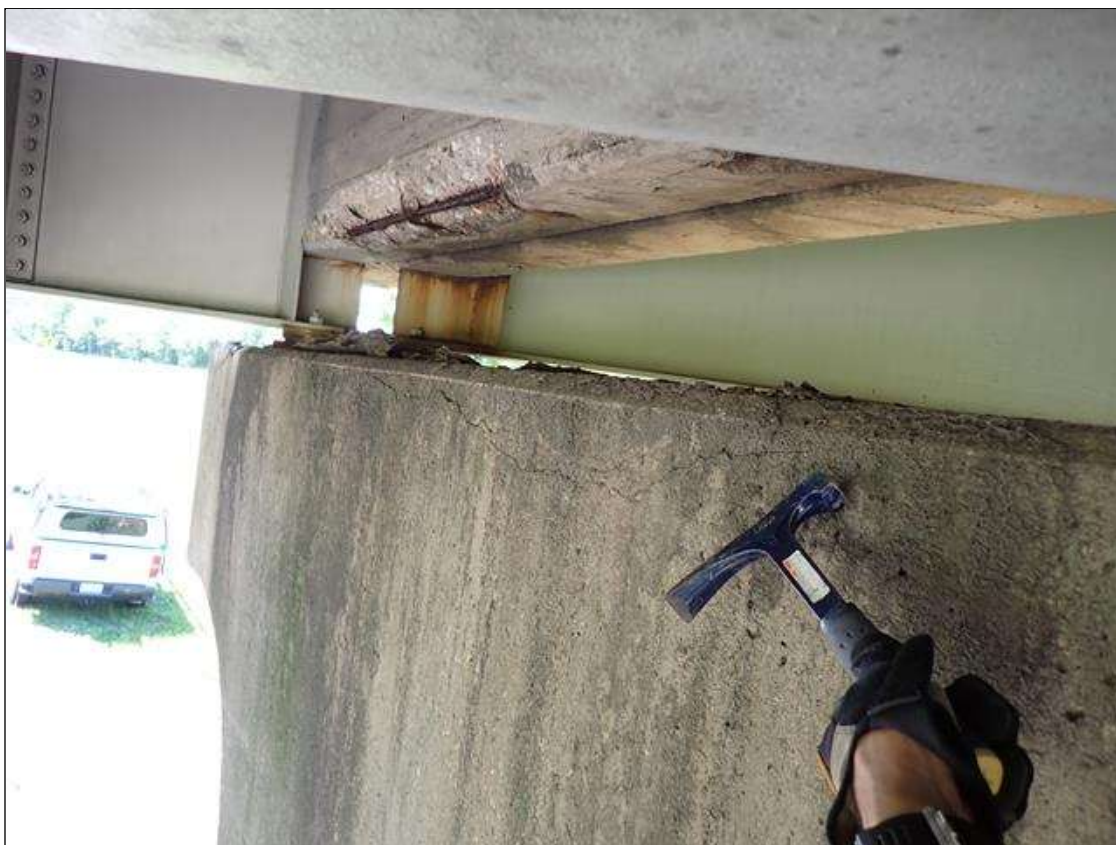
Bent 3 Cap 1: along the length of the cap, near top and bottom corners, horizontal cracks (up to 1/8 inch x 9 foot)

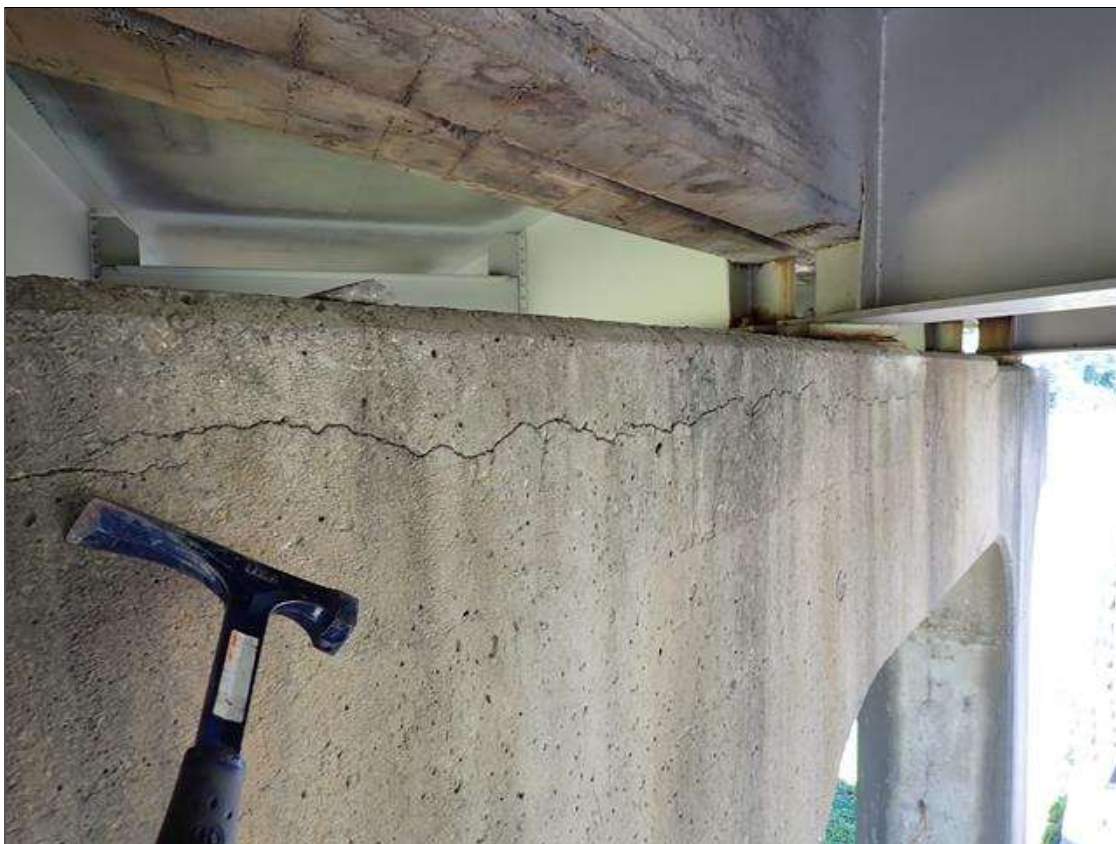
Bent 3 Cap 1: along the length of the cap, near top and bottom corners, horizontal cracks (up to 1/8 inch x 9 foot)

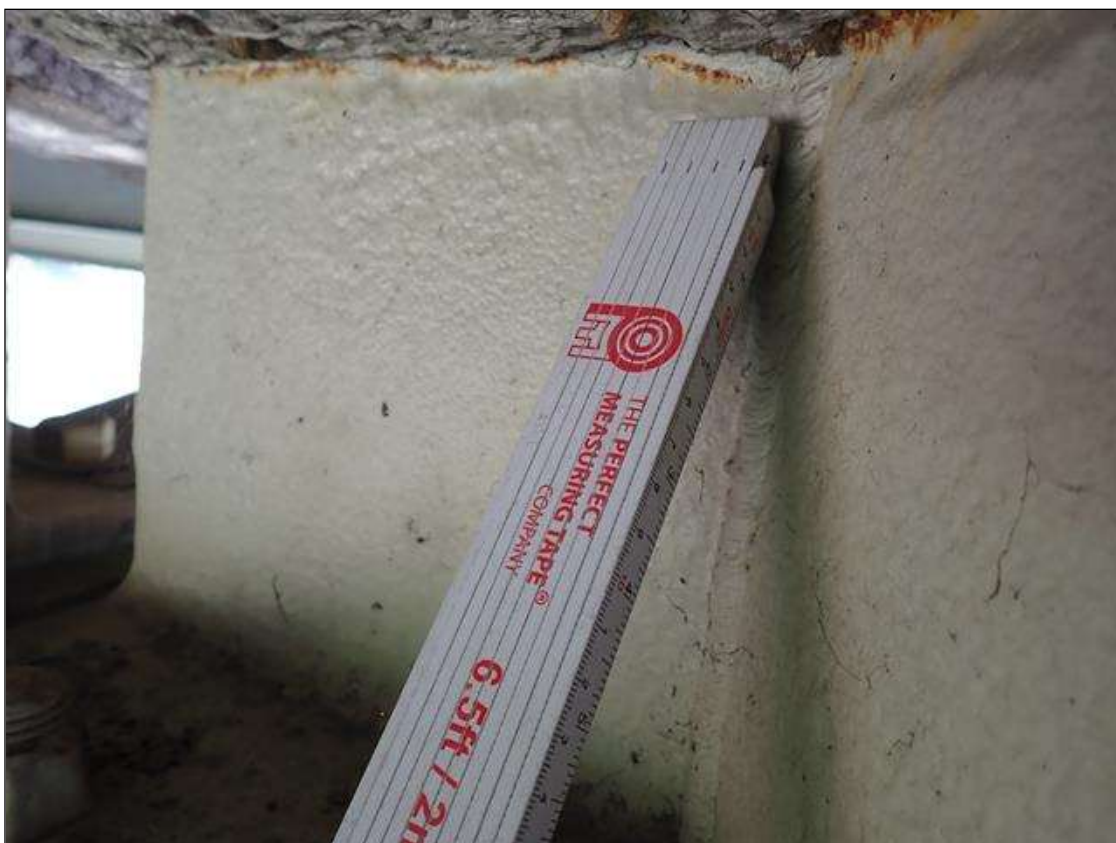
Span 3 Beam 3: at far end arrested metal loss/pitting with corrosion reactivating, web at diaphragm [10 inch x 3 inch x 1/16 inch deep]

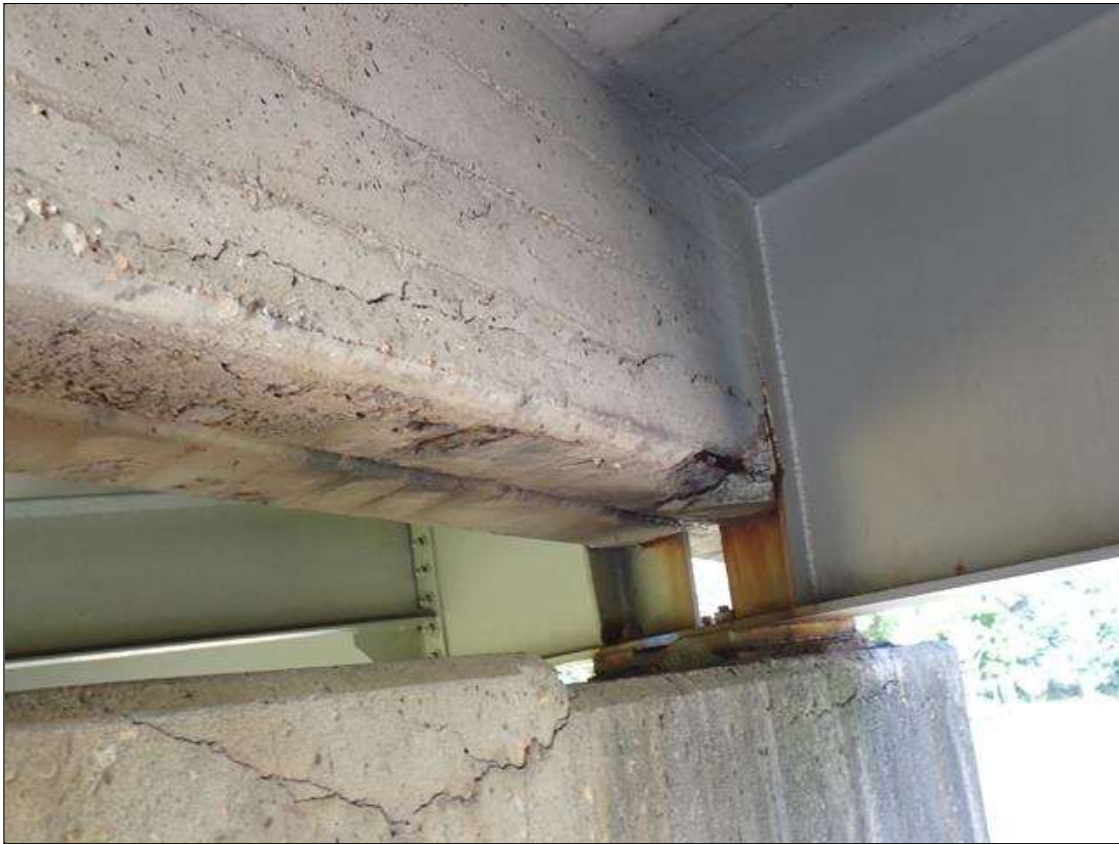
Span 3 Beam 3: (PAR) 5 FOOT X UP TO 12 INCH X 2.5 INCH DIAPHRAGM SPALL/DELAMINATION WITH EXPOSED RUSTED REBAR APPROXIMATELY 25 PERCENT LOSS, BAY 3 OVER BENT 3

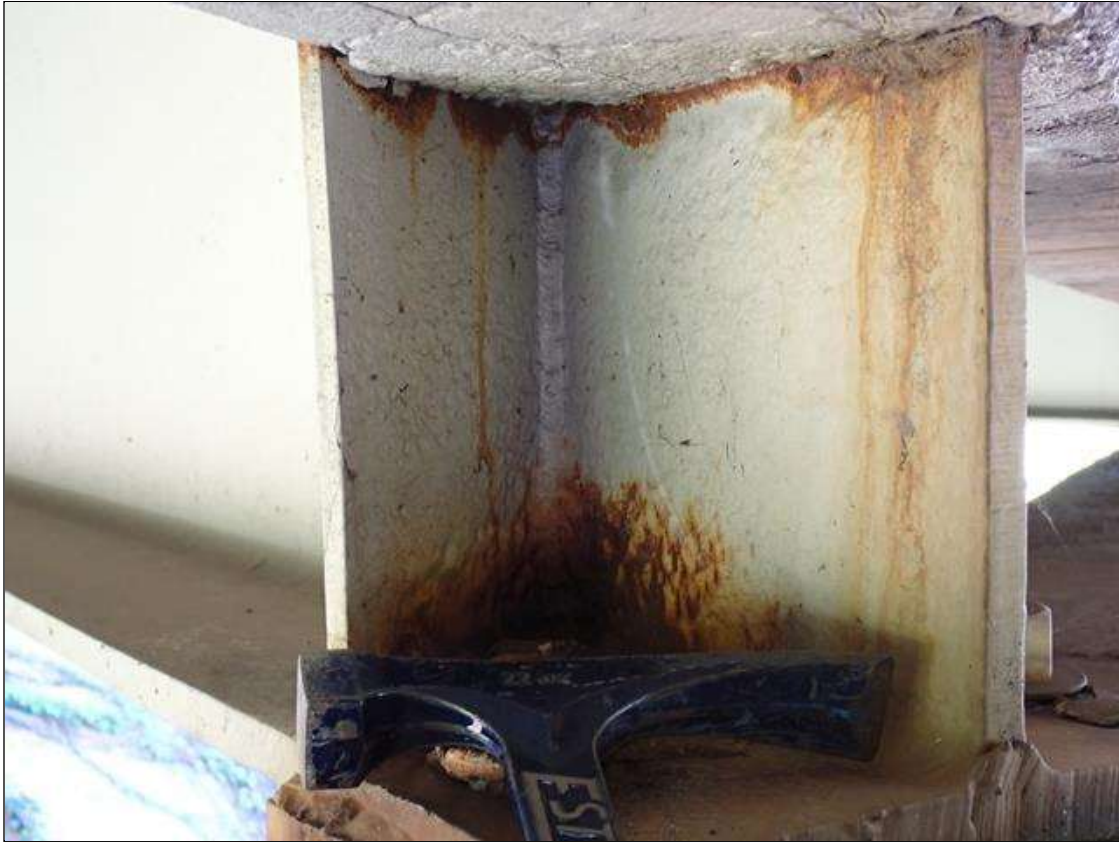
Span 4 Beam 3: at near end, arrested metal loss with corrosion reactivating, web at diaphragm [10 inch x 1 inch x 9/16 inch average remaining]; lower web, pitting [10 inch x 3 inch x up to 1/16 inch deep]; left stiffener, pitting [up to 1/8 inch deep x full width x 4 inch]

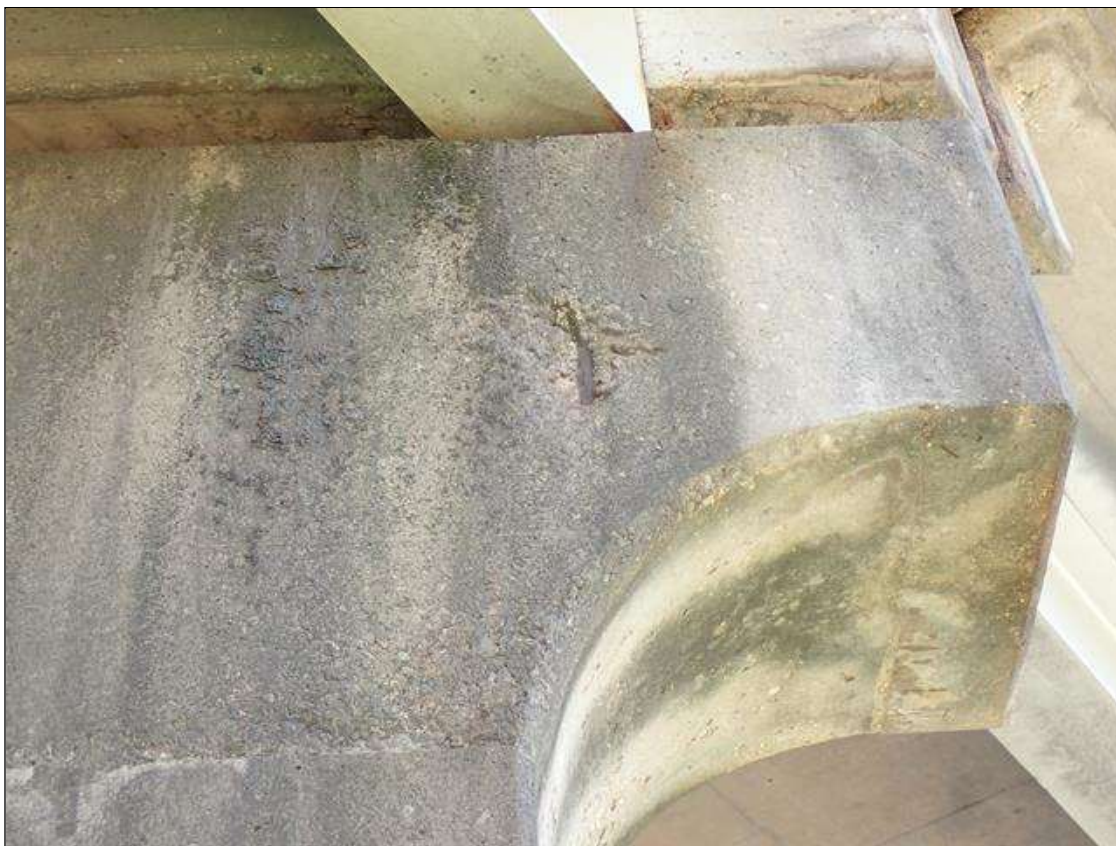
Bent 3 Cap 1: (PAR) North face below beam 1, spall [13 inch x 15 inch x 1 inch deep] with exposed rusted reinforcing [section loss up to 1/16 inch]

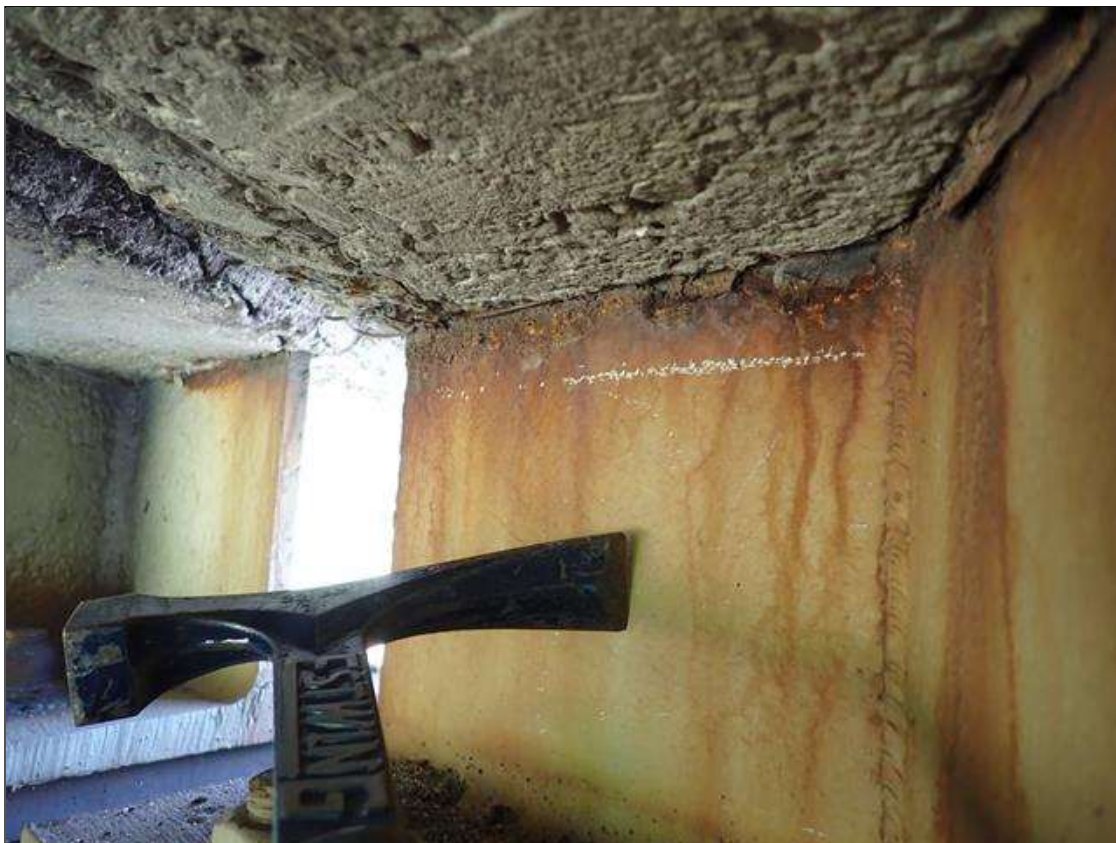
Span 3 Beam 4: at bent 3, web adjacent to diaphragm, rust scale (10 inch)
