NC DEPARTMENT OF TRANSPORTATION
 DIVISION OF HIGHWAYS
 STRUCTURE MANAGEMENT UNIT

ATTENTION: prompt action request; sketches updated; span 2 clearances updated; new repairs

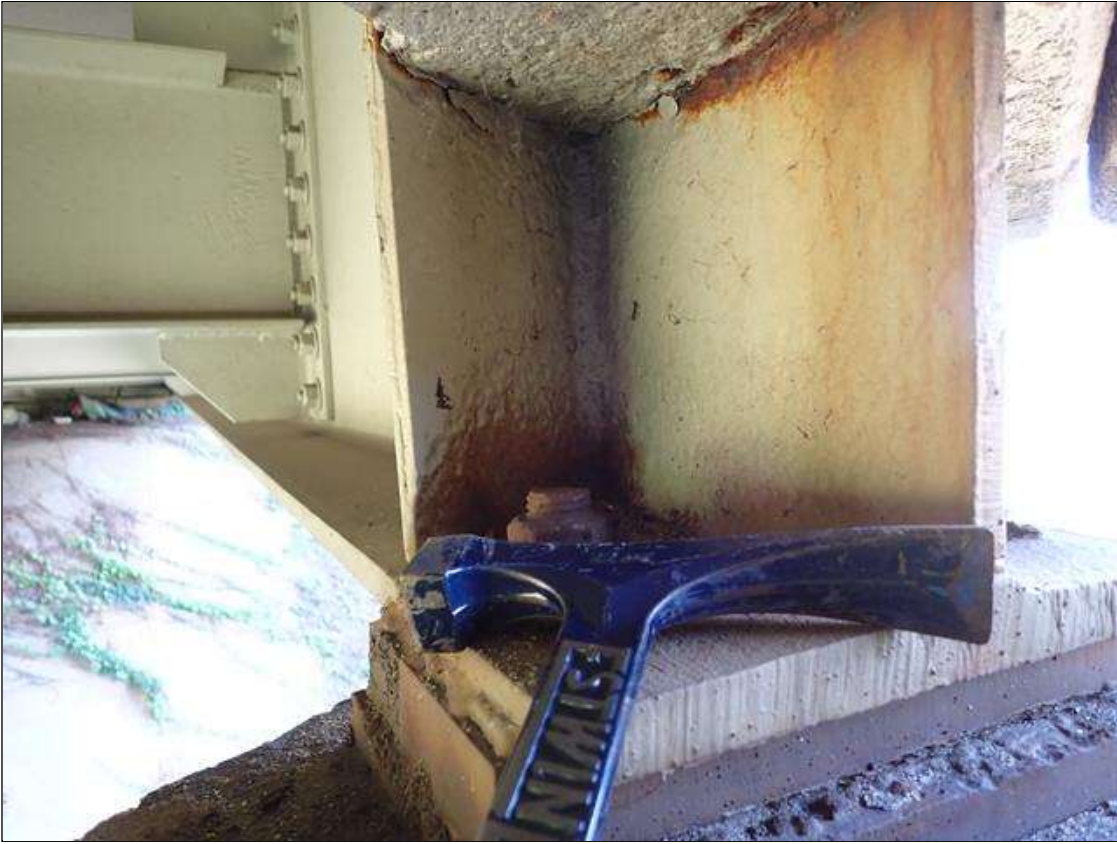
Span 4 Beam 4: at near end, arrested metal loss with corrosion reactivating: web at diaphragm [10 inch x 1/2 inch x 9/16 inch average remaining]; left stiffener [0.30 inch average remaining x full width x full height]; lower web, pitting [up to 1/16 inch deep x 10 inch x 3 inch]

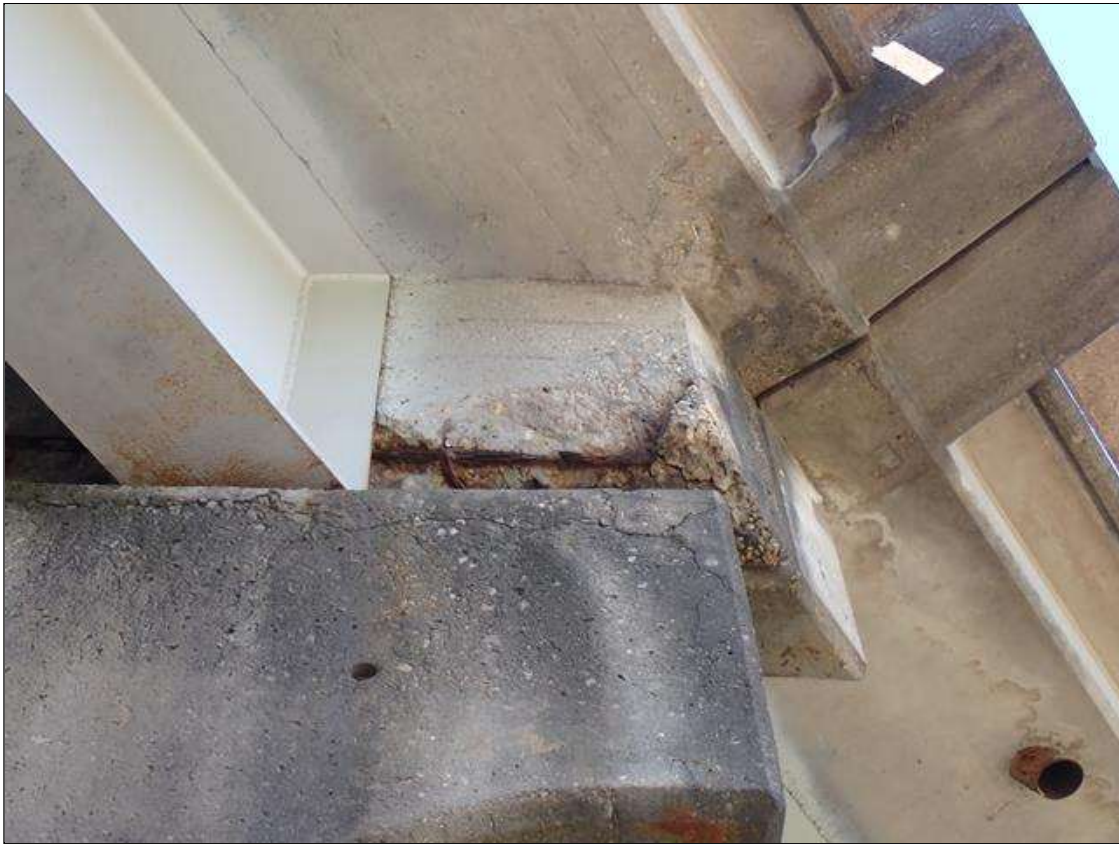
Span 3 Beam 4: (PAR) 2 FOOT X 10 INCH X 8 INCH DIAPHRAGM SPALL WITH EXPOSED REINFORCING APPROXIMATELY 25 PERCENT LOSS, EAST OVERHANG AT BENT 3

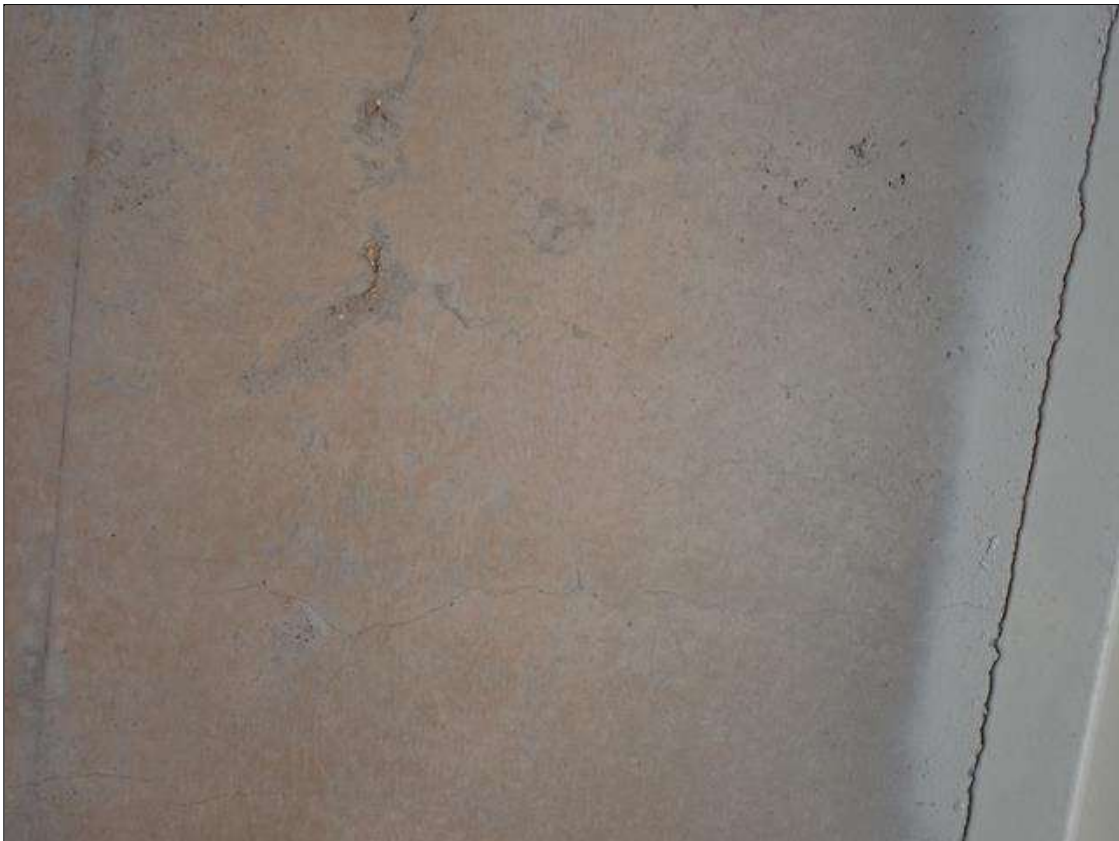
Span 3 Deck: SPAN 3 BOTTOM OF DECK HAS SCATTERED MAP CRACKS HAIRLINE AND TRANSVERSE CRACKS UP 1/32 INCH X FULL WIDTH

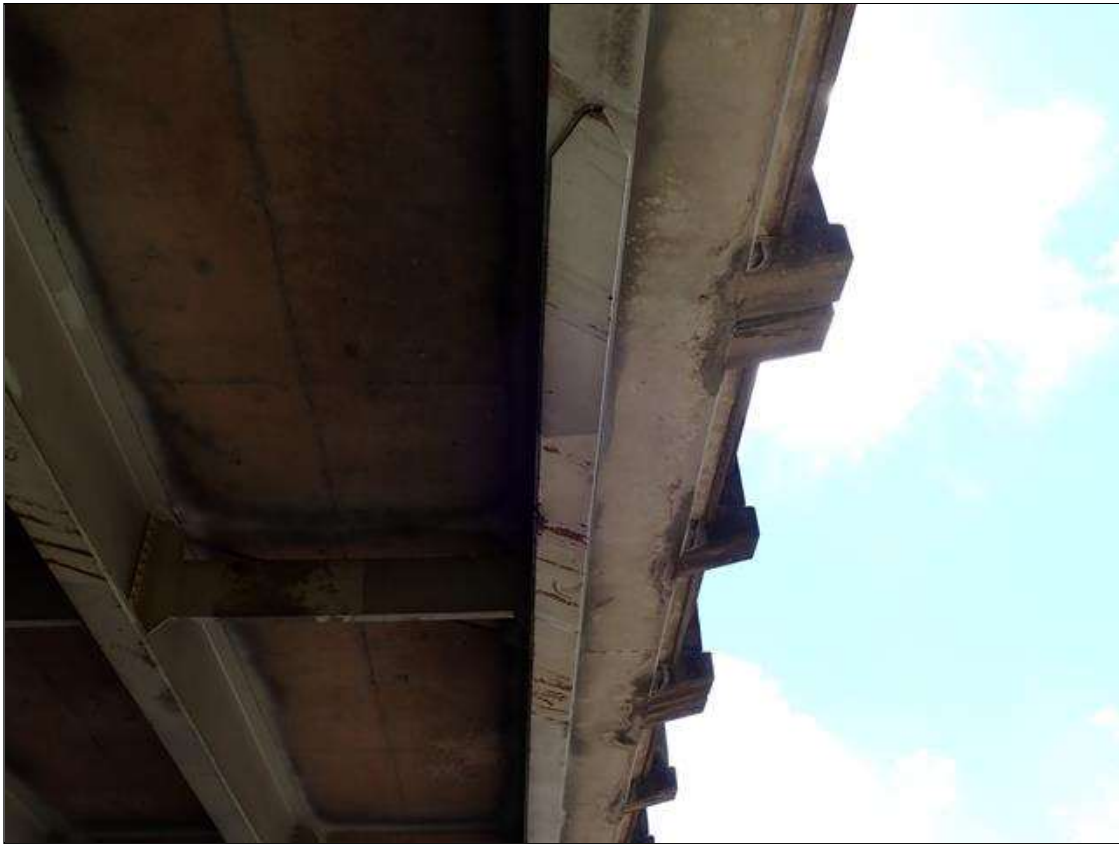
Span 3 Beam 1: underside of coverplate over right travel lane, impact scrapes with surface rust

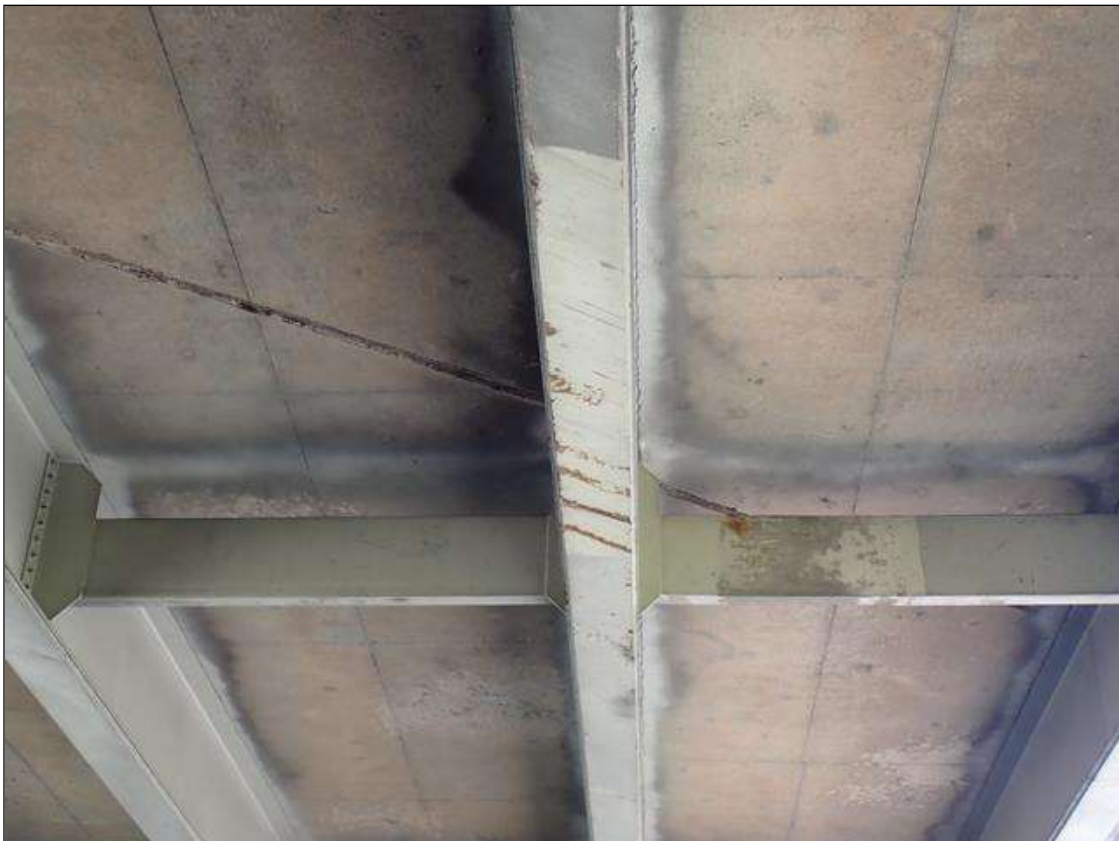
Span 3 Beam 2: underside of coverplate over right travel lane, impact scrapes with surface rust

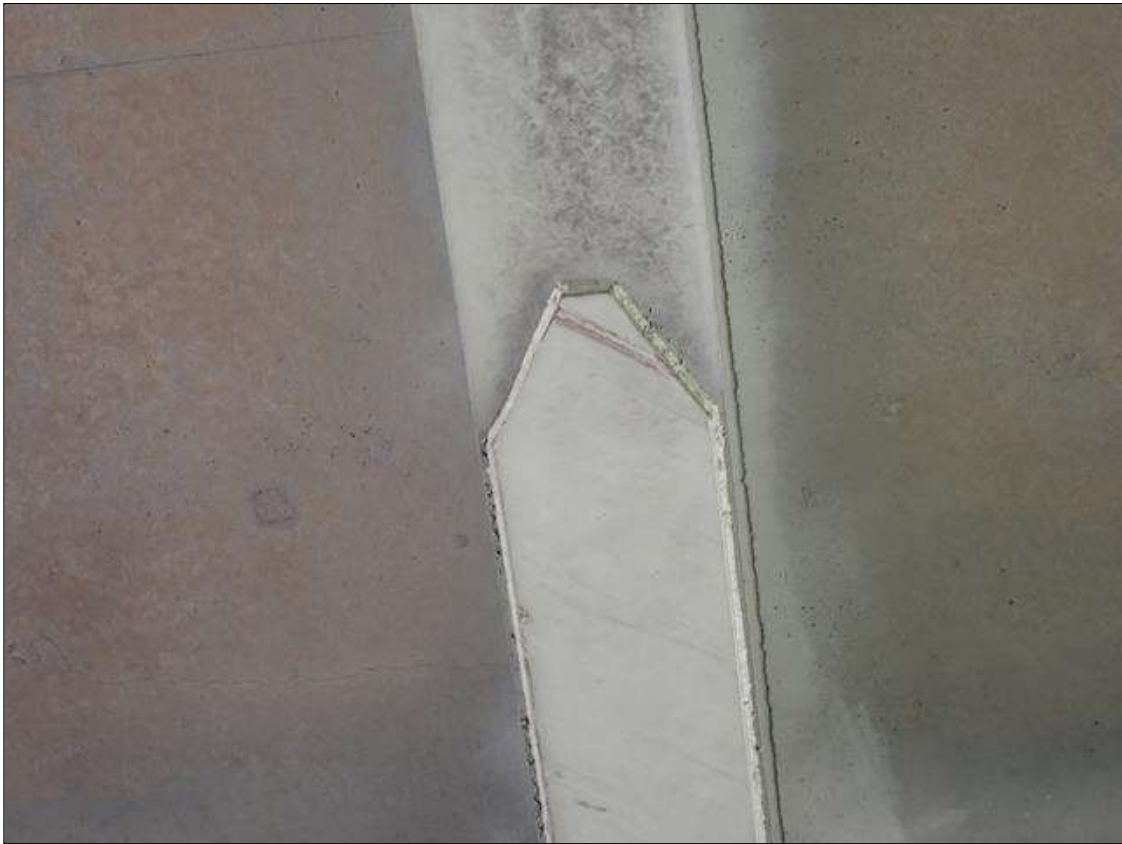
Span 3 Beam 3: underside of coverplate over both travel lanes, impact scrapes with surface rust

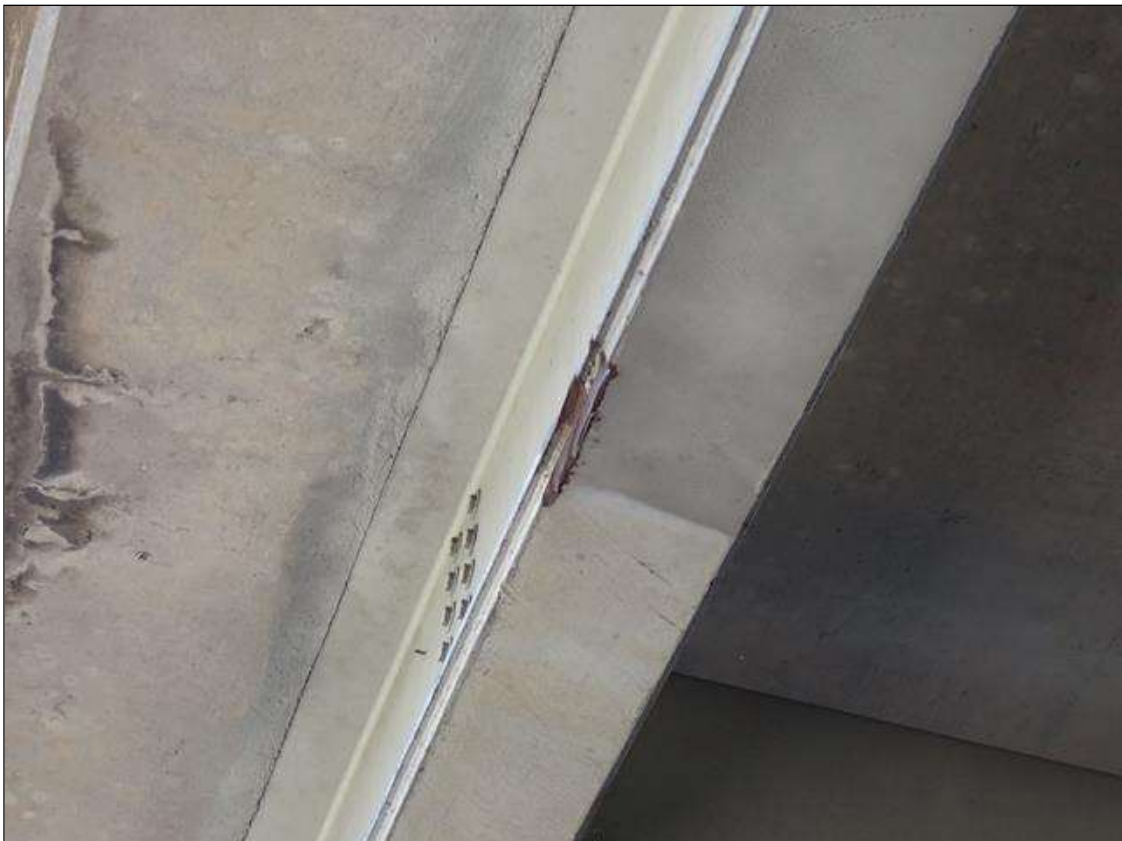
Span 3 Beam 4: (PAR) over right travel lane, impact damage with distortion (12 inch x 1 inch x 1/4 inch deep) and scrapes and surface rust

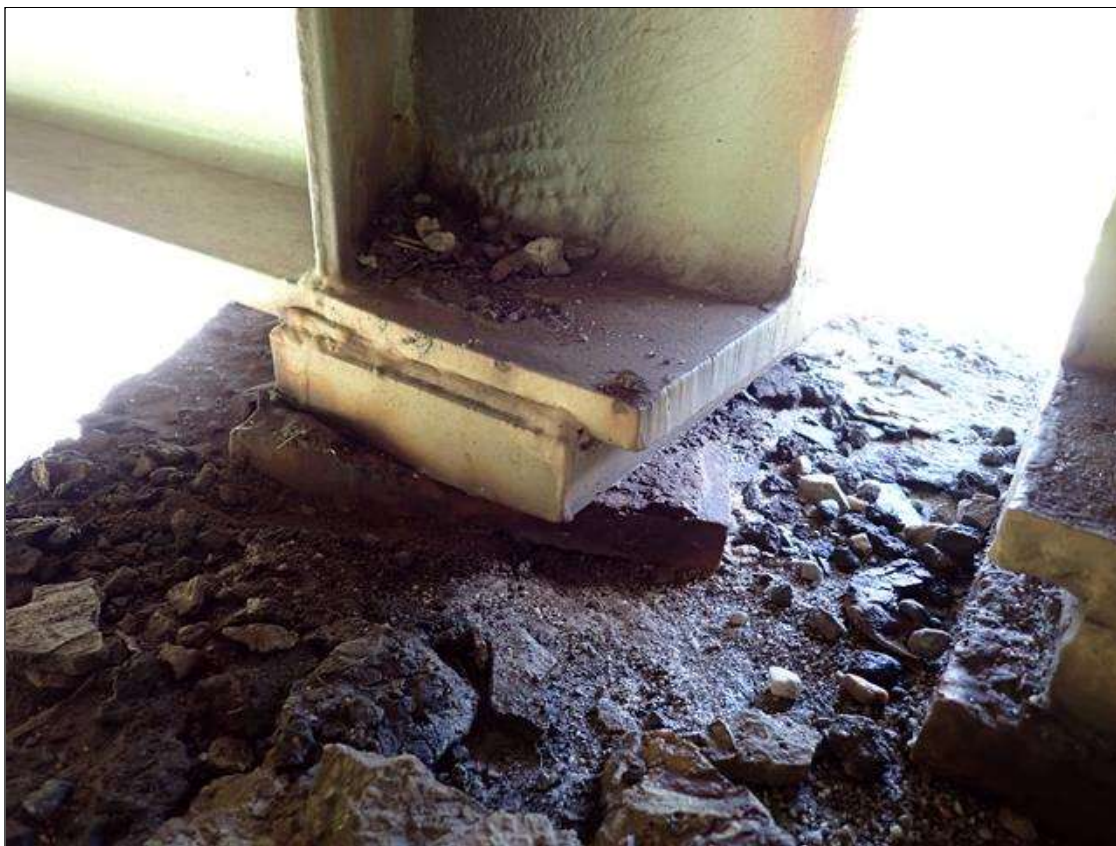
Span 3 Beam 4 - Near Bearing 4: [PAR] right and left attachment bolt sheared, masonry plate rotated

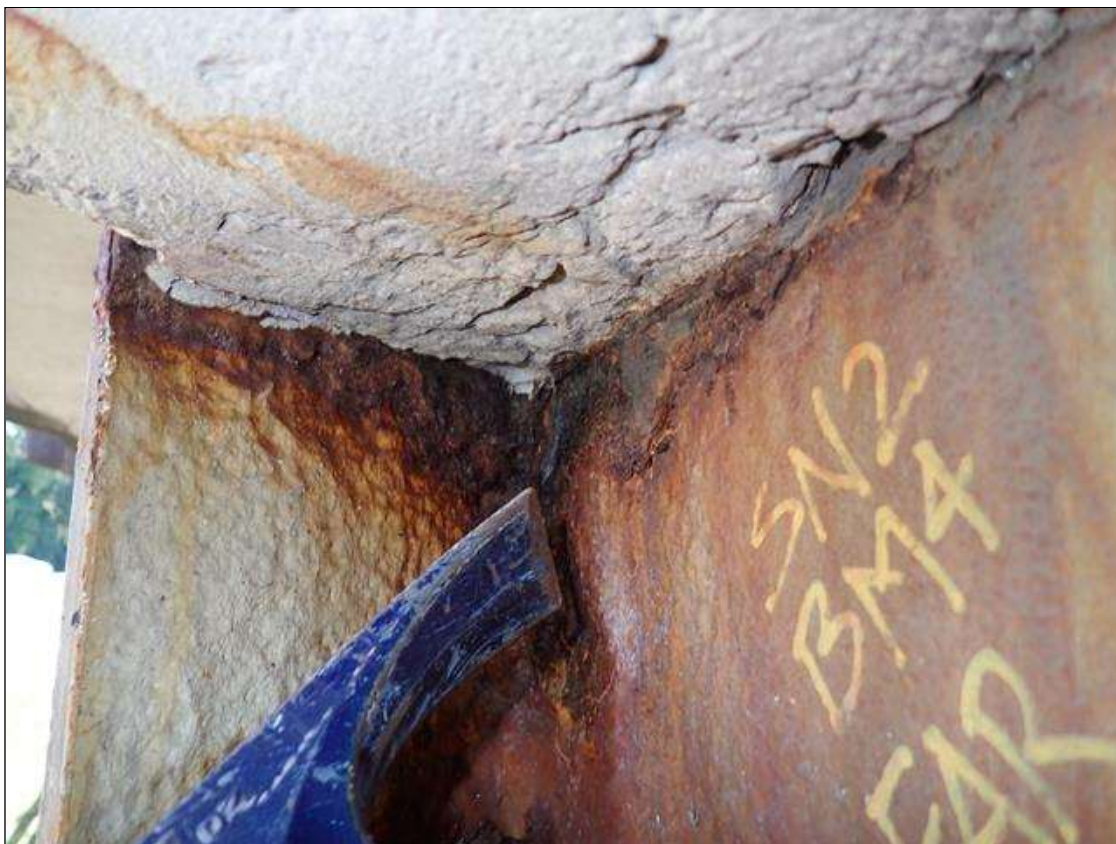
Span 2 Beam 4: [PAR] at far end, corrosion with section loss: web below diaphragm [11 inch x 2 inch x 7/16 inch average remaining]; right stiffener [0.30 inch average remaining x full width x full height]

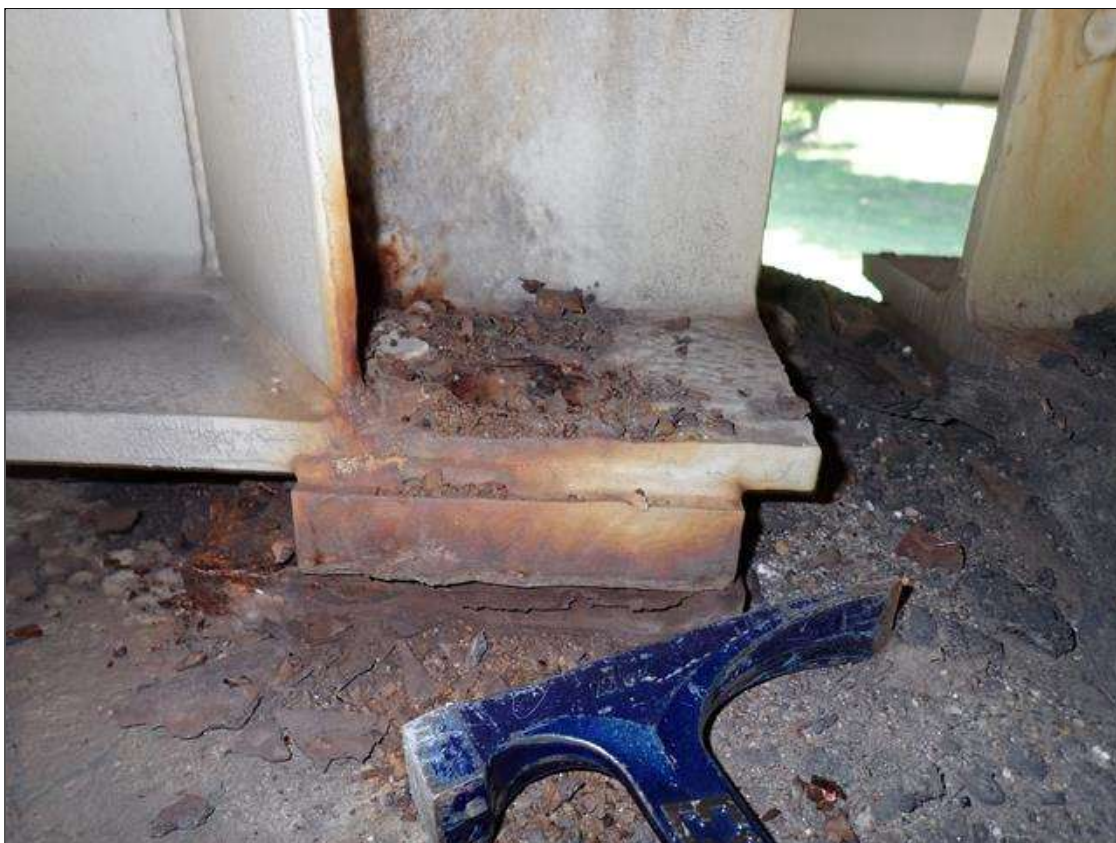
Span 3 Beam 3 - Near Bearing 3: [PAR] right and left attachment bolt sheared

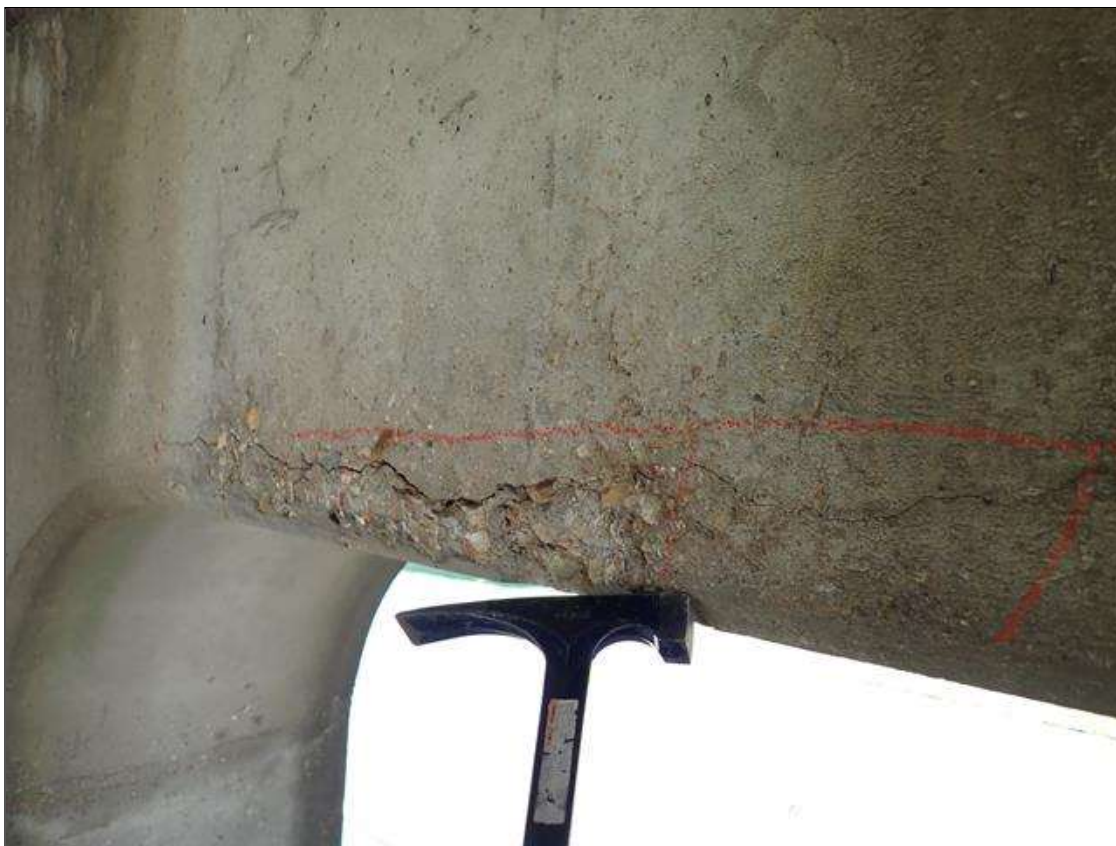
Bent 2 Cap 1: North face below beam 3, delamination [29 inch x 3 inch] with cracks [up to 1/16 inch]

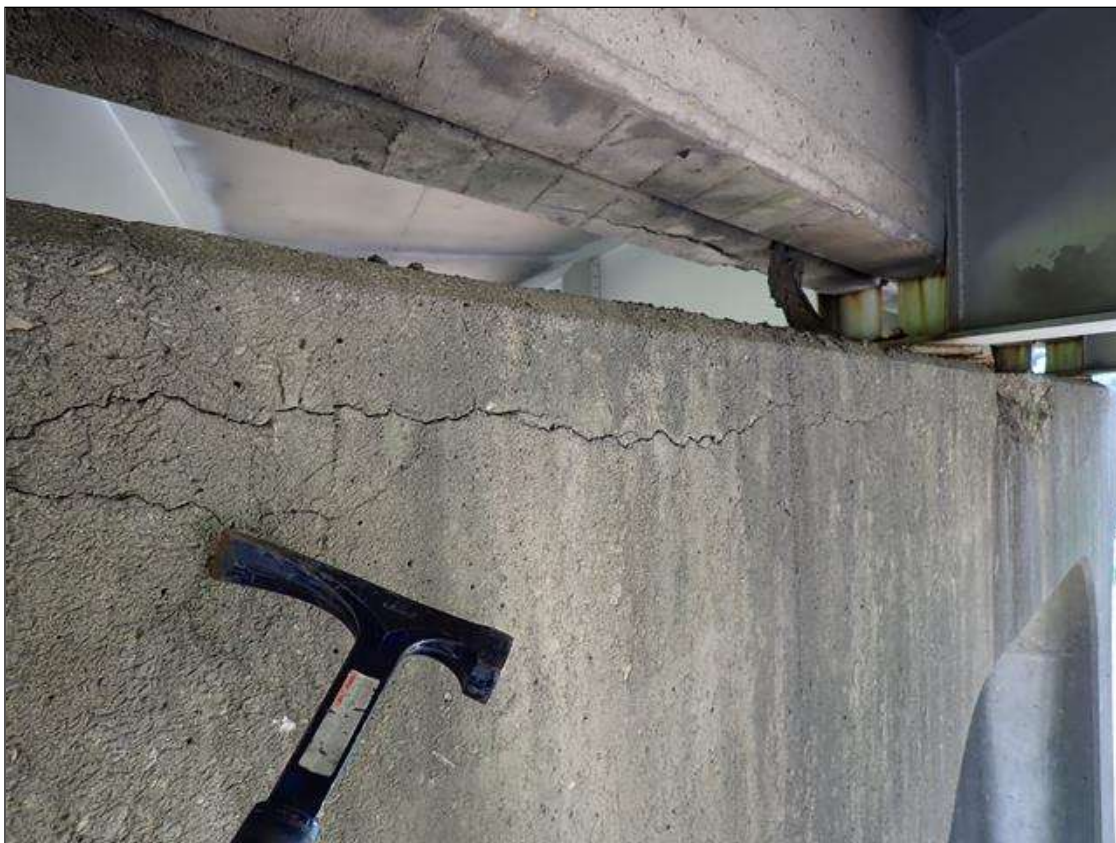
Bent 2 Cap 1: ALONG THE LENGTH OF THE CAP, SCATTERED LONGITUDINAL CRACKS UP TO 1/16 INCH

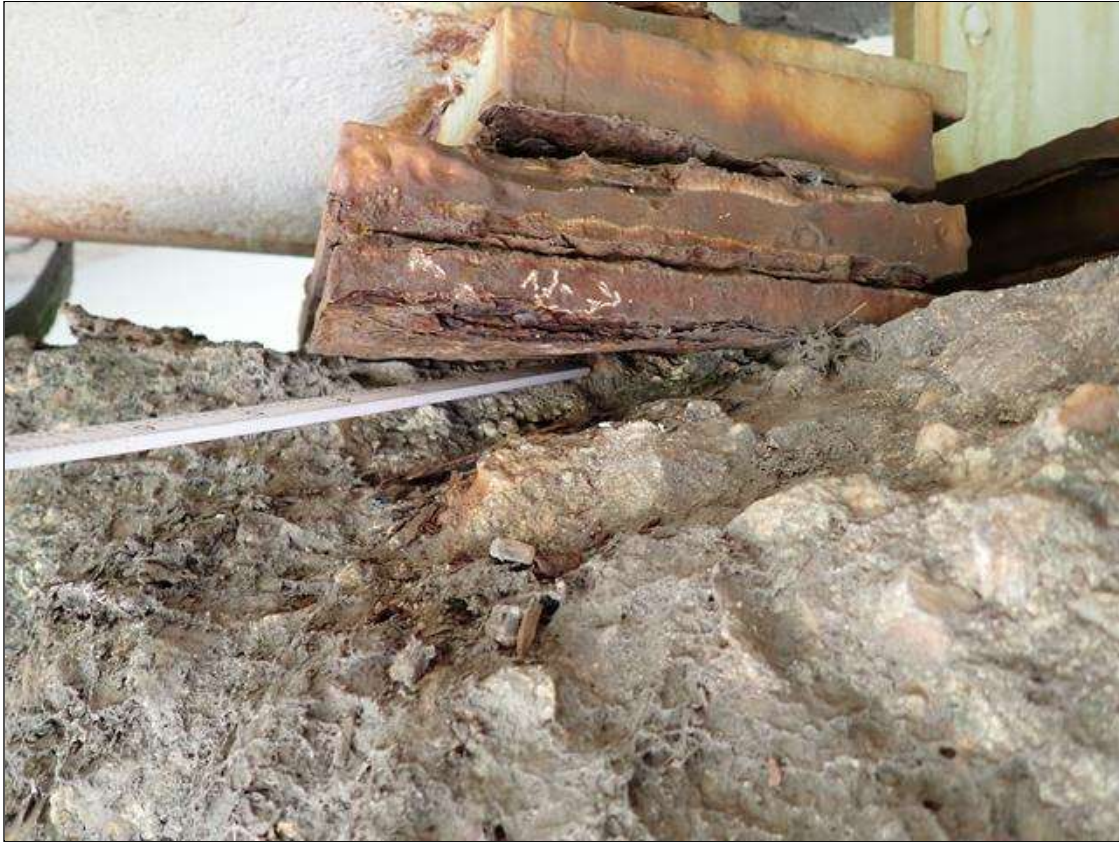
Span 3 Beam 2 - Near Bearing 2: [PAR] SPAN 3 BEAM 2 NEAR BEARING NORTHWEST CORNER HAS 5 INCH X 3 INCH X 4 INCH DEEP AREA OF BEARING LOSS. DUE TO BENT 2 CAP SPALLED AREA.

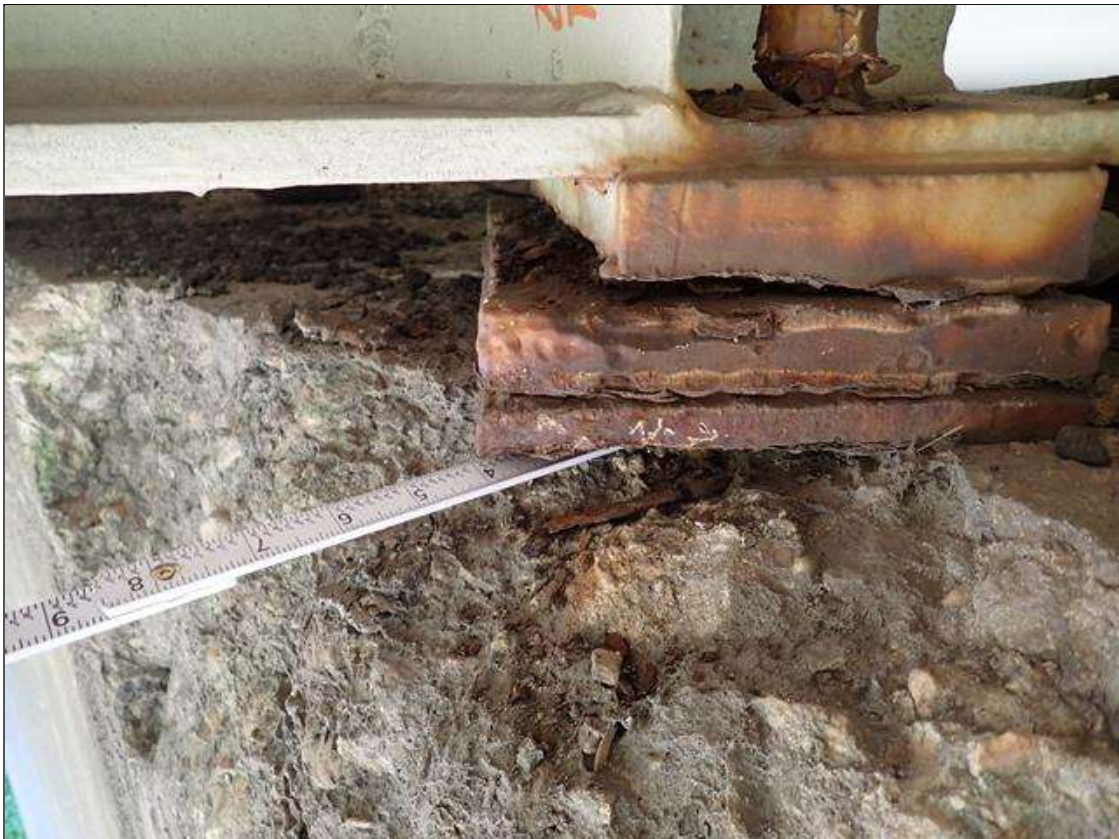
Span 3 Beam 2 - Near Bearing 2: [PAR] SPAN 3 BEAM 2 NEAR BEARING NORTHWEST CORNER HAS 5 INCH X 3 INCH X 4 INCH DEEP AREA OF BEARING LOSS. DUE TO BENT 2 CAP SPALLED AREA.

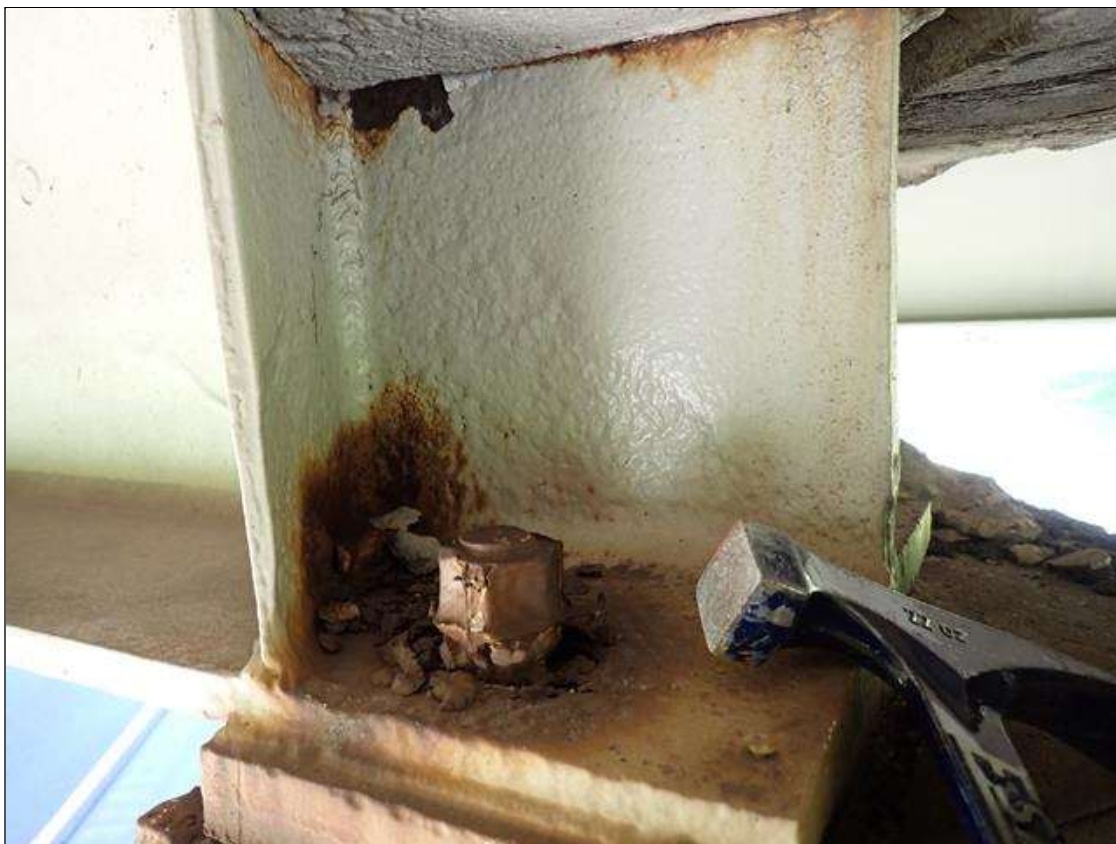
Span 3 Beam 2: at bent 2, painted over pitting with corrosion reactivating: web (up to 1/16 inch x 10 inch x full height)

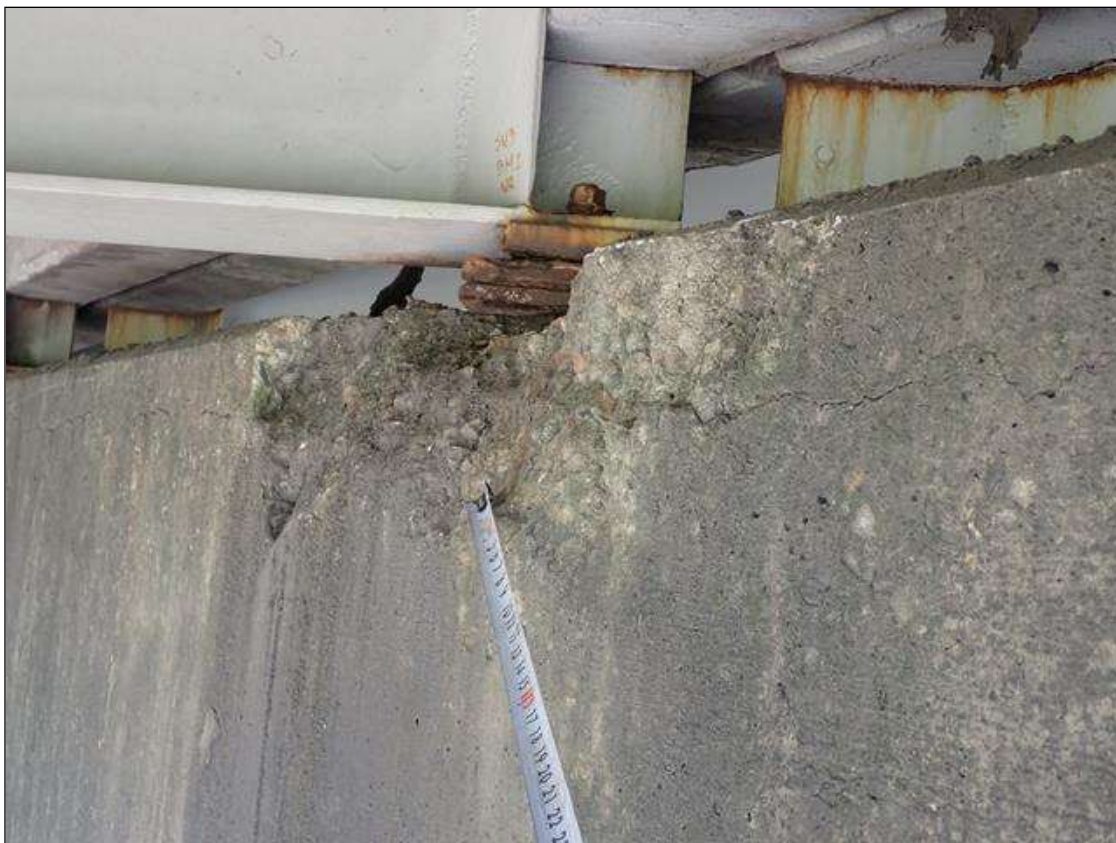
Bent 2 Cap 1: (PAR) 4 FOOT X 1 FOOT X 1 FOOT X 3 INCH DEEP CORNER SPALL WITH EXPOSED REINFORCING APPROXIMATELY 25 PERCENT LOSS, NORTH FACE UNDER BEAM 2; UNDERMINING BEARING

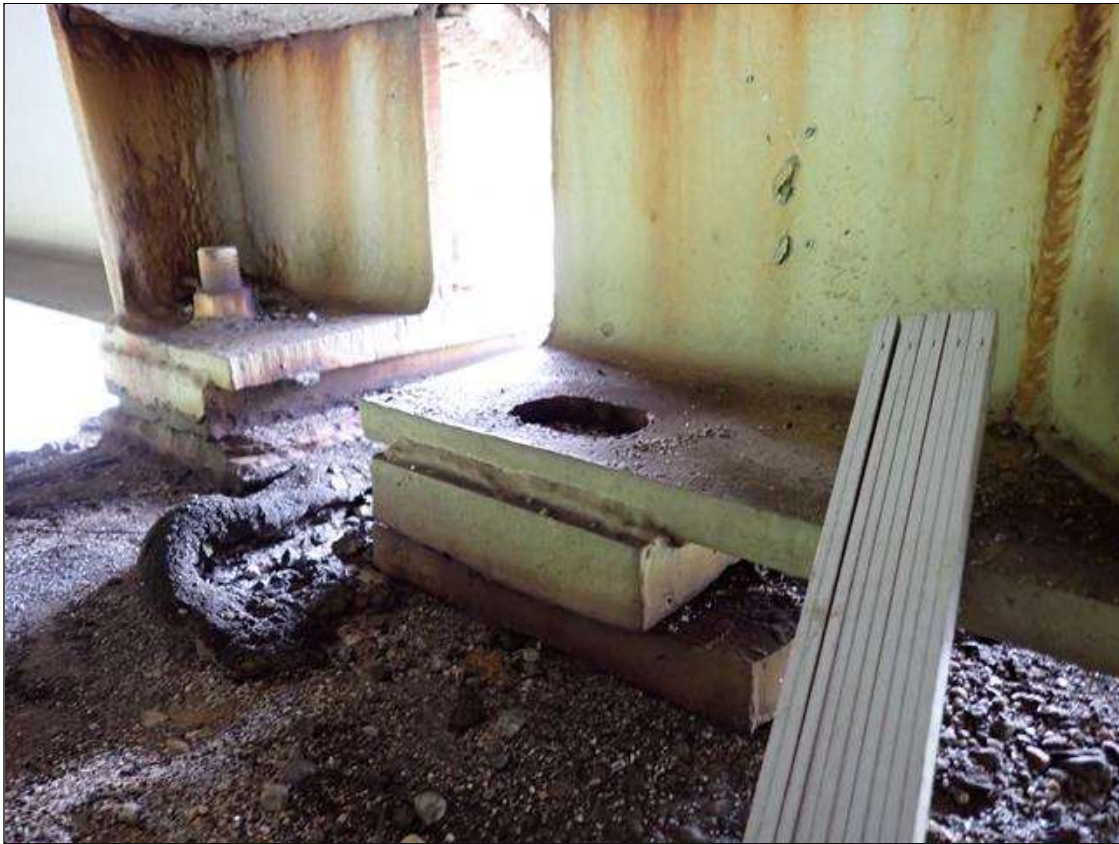
Span 3 Near Bearing 1: [PAR] right and left attachment bolt sheared

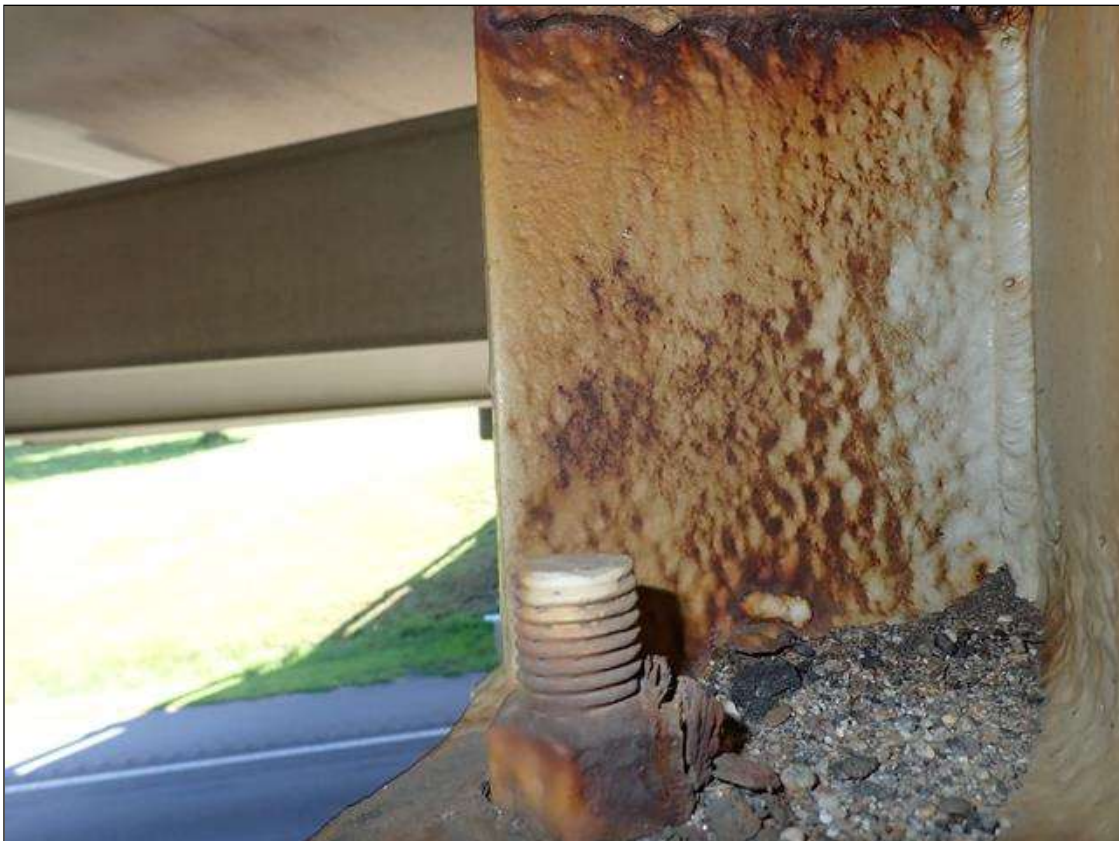
Span 2 Beam 1: at bent 2, corrosion with section loss: web adjacent to diaphragm (1/2 inch average remaining x 10 inch x 1 inch); right stiffener (0.30 average remaining x full width x full height)

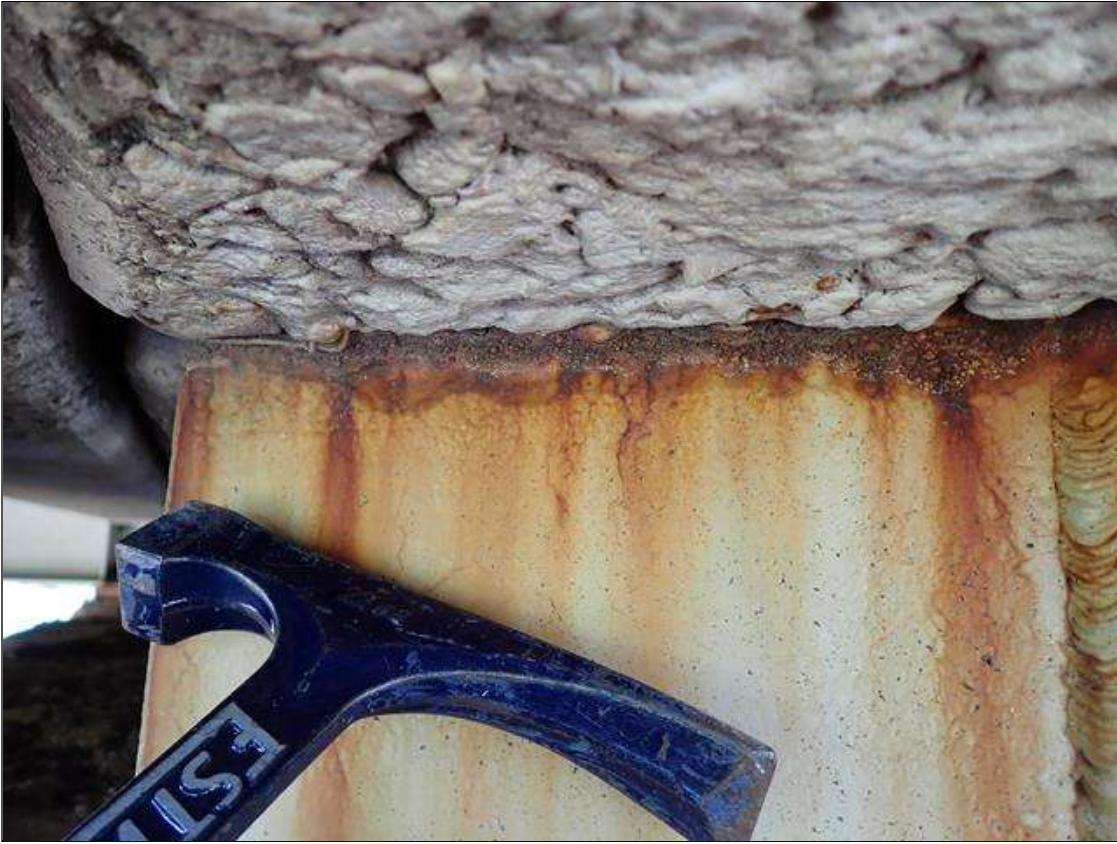
Span 2 Beam 1: at bent 2, corrosion with section loss: web adjacent to diaphragm (1/2 inch average remaining x 10 inch x 1 inch); right stiffener (0.30 average remaining x full width x full height)

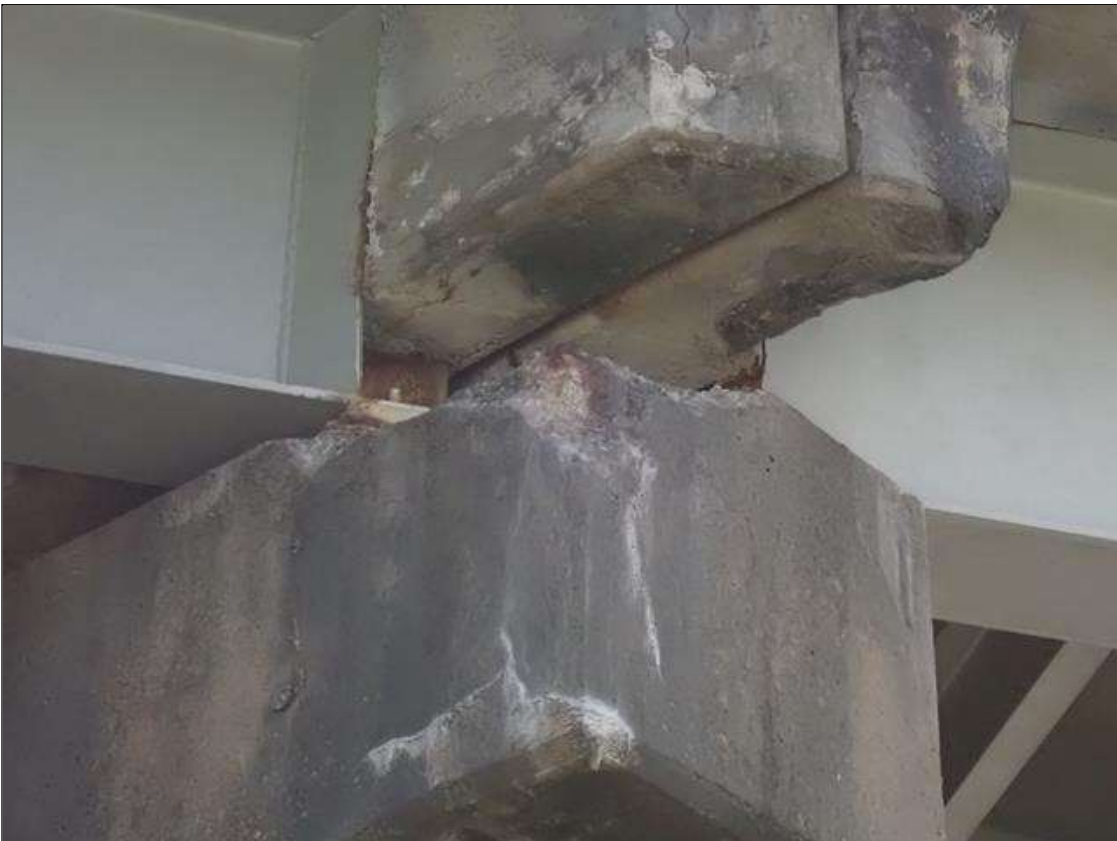
Bent 2 Cap 1: [PAR] South face at East end, corner spall [27 inch x 14 inch x 12 inch x 3 inch deep] with exposed rusted reinforcing [section loss up to 1/8 inch]

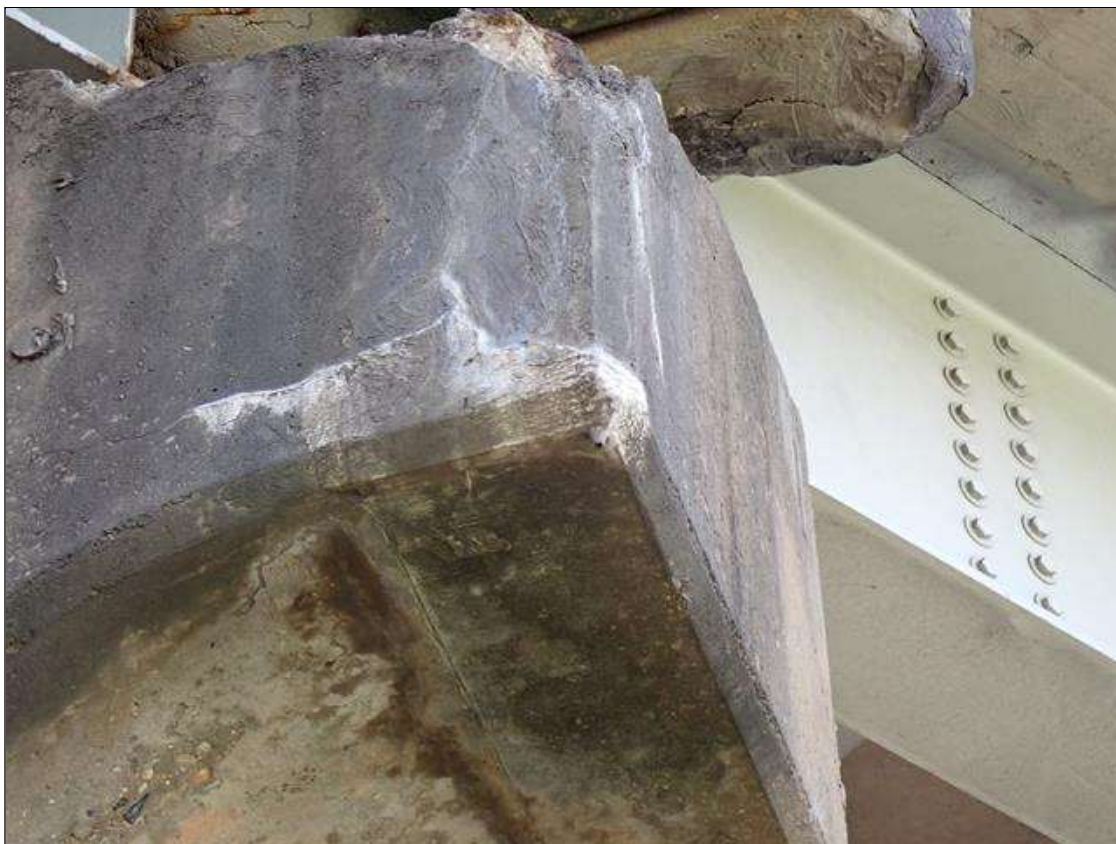
Bent 2 Cap 1: (PAR) CRACKED PATCHED AREA SOUTHEAST BOTTOM CORNER WITH EFFLORESCENCE BUILD-UP

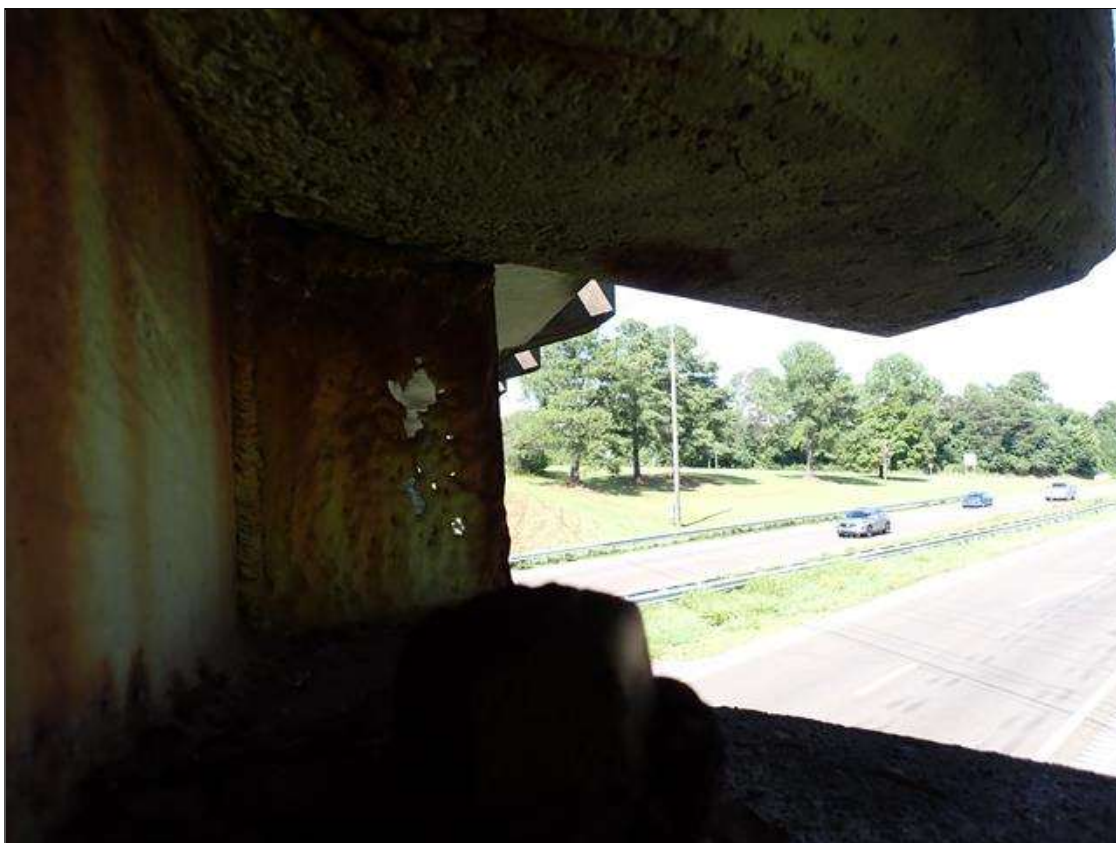
Span 2 Beam 4: (PAR) at bent 1, web adjacent to diaphragm, rust scale (10 inch); right stiffener (0.20 inch average remaining x full width x full height) with corrosion holes (up to 2 inch x 1 inch)

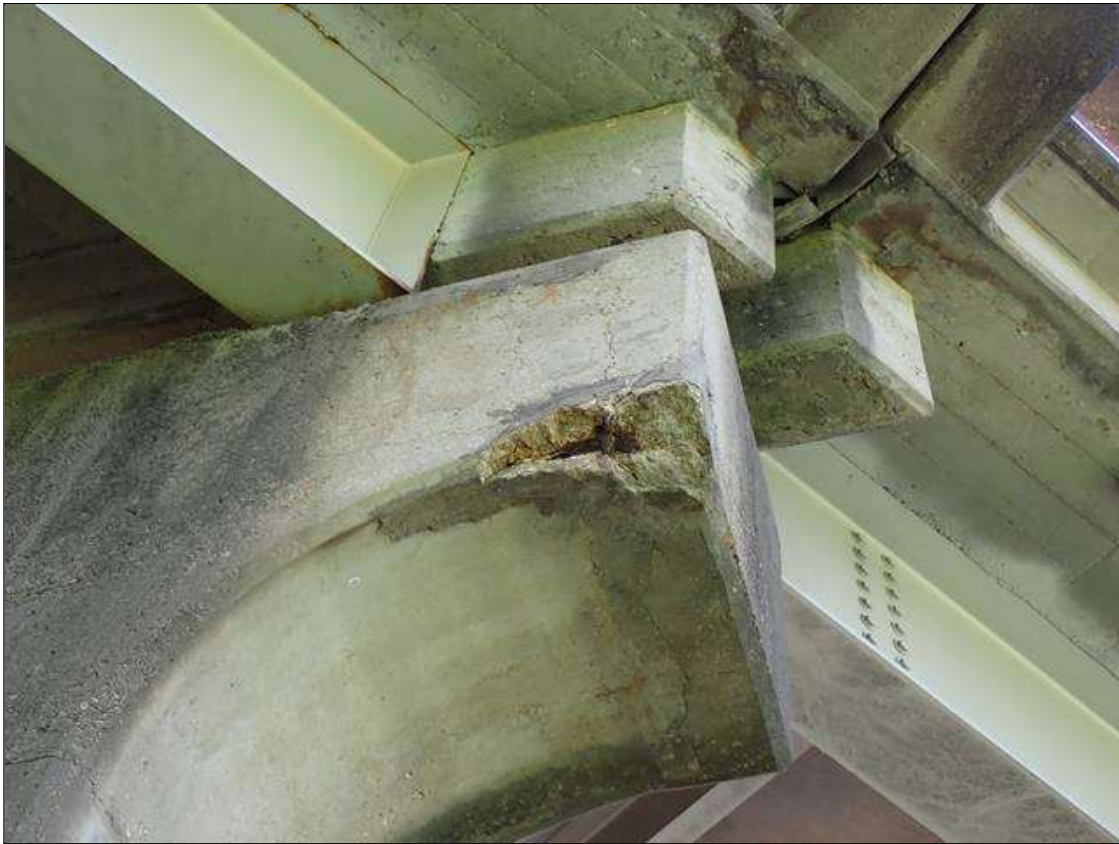
Bent 1 Cap 1: (PAR) MULTIPLE UP TO 8 FOOT X 2.5 FOOT CRACKED/FAILED PATCHED AREAS WITH EXPOSED RUSTED REBAR APPROXIMATELY 25 PERCENT LOSS, THROUGHOUT BOTTOM AND SOUTH FACE
