NC DEPARTMENT OF TRANSPORTATION
 DIVISION OF HIGHWAYS
 STRUCTURE MANAGEMENT UNIT

ATTENTION: prompt action request; sketches updated; span 2 clearances updated; new repairs

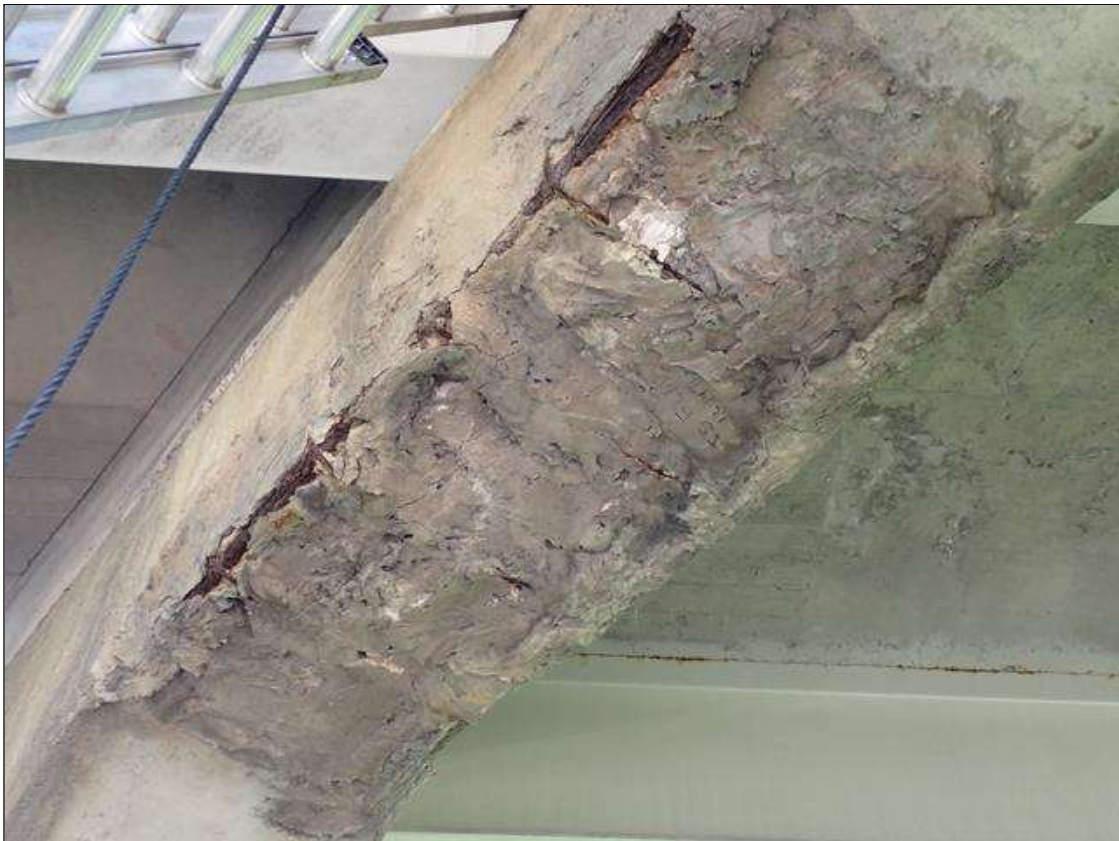
Bent 1 Cap 1: (PAR) MULTIPLE UP TO 8 FOOT X 2.5 FOOT CRACKED/FAILED PATCHED AREAS WITH EXPOSED RUSTED REBAR APPROXIMATELY 25 PERCENT LOSS, THROUGHOUT BOTTOM AND SOUTH FACE

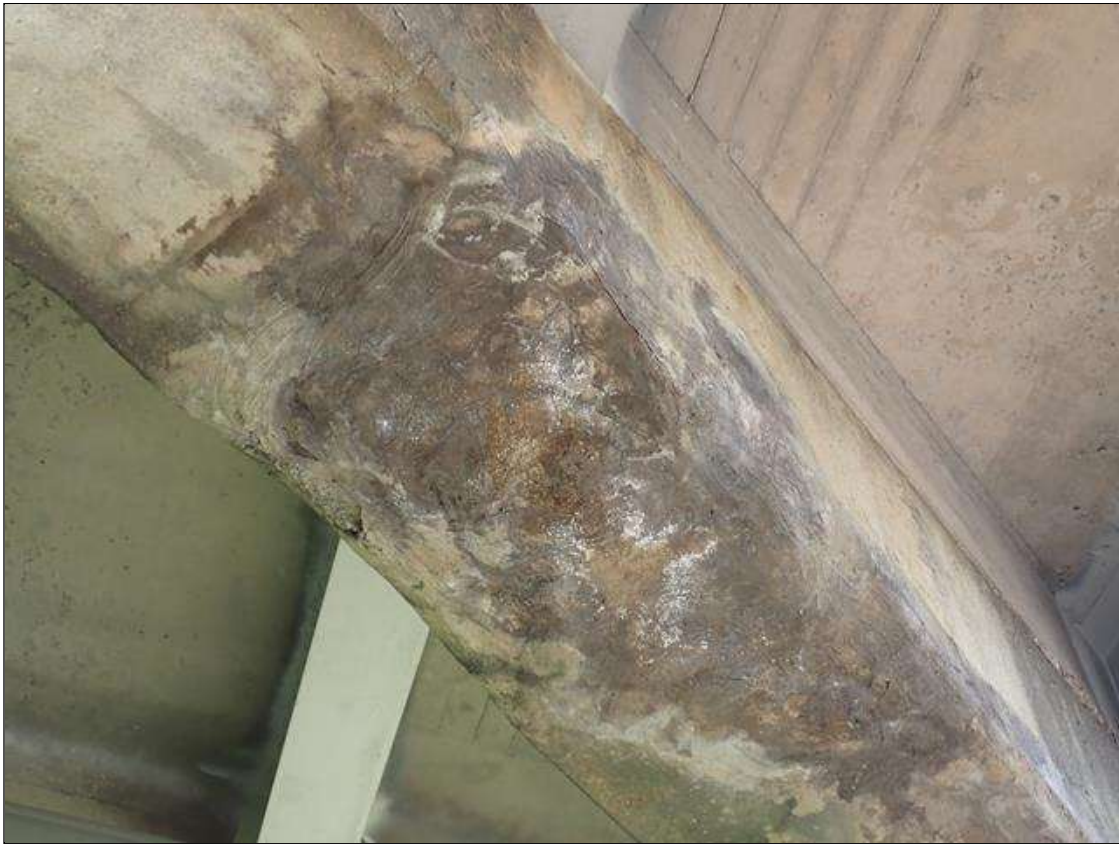
Bent 1 Cap 1: (PAR) MULTIPLE UP TO 8 FOOT X 2.5 FOOT CRACKED/FAILED PATCHED AREAS WITH EXPOSED RUSTED REBAR APPROXIMATELY 25 PERCENT LOSS, THROUGHOUT BOTTOM AND SOUTH FACE

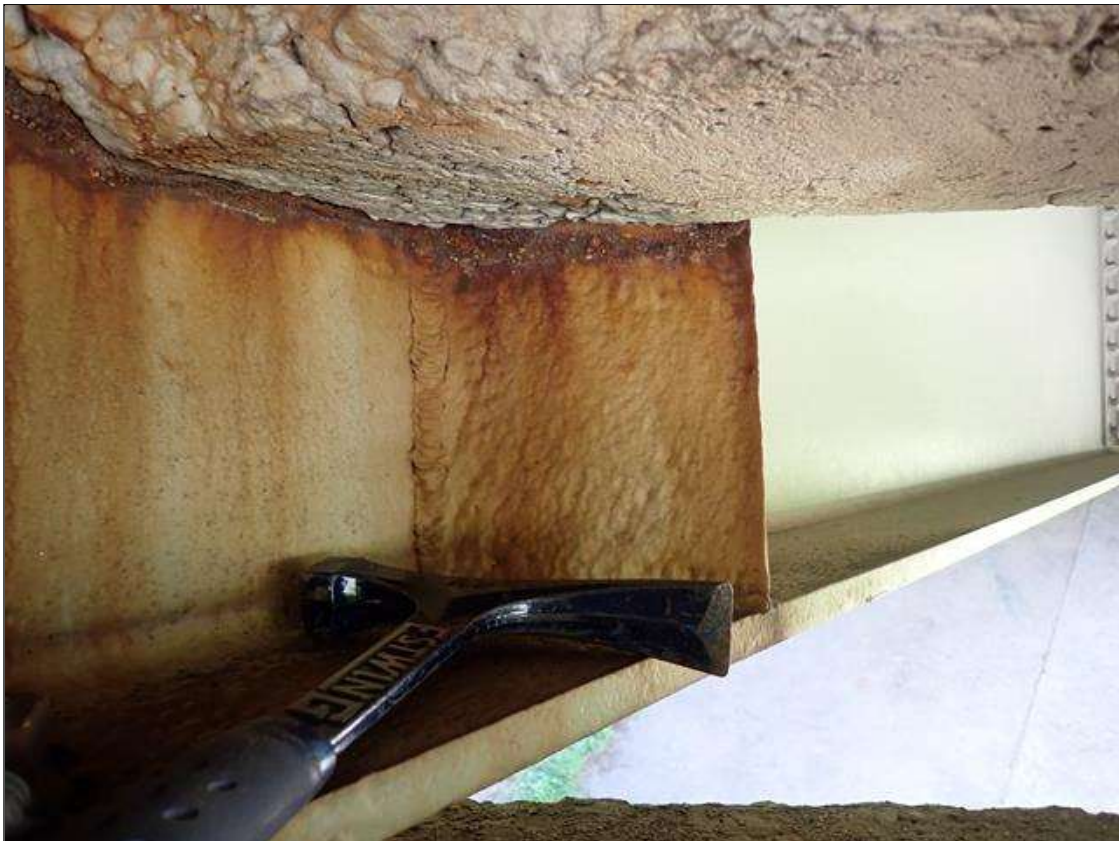
Span 1 Beam 2: at bent 1, corrosion with section loss: web adjacent to diaphragm (1/2 inch average remaining x 10 inch x 5 inch); left stiffener (0.35 inch average remaining x full width x full height)

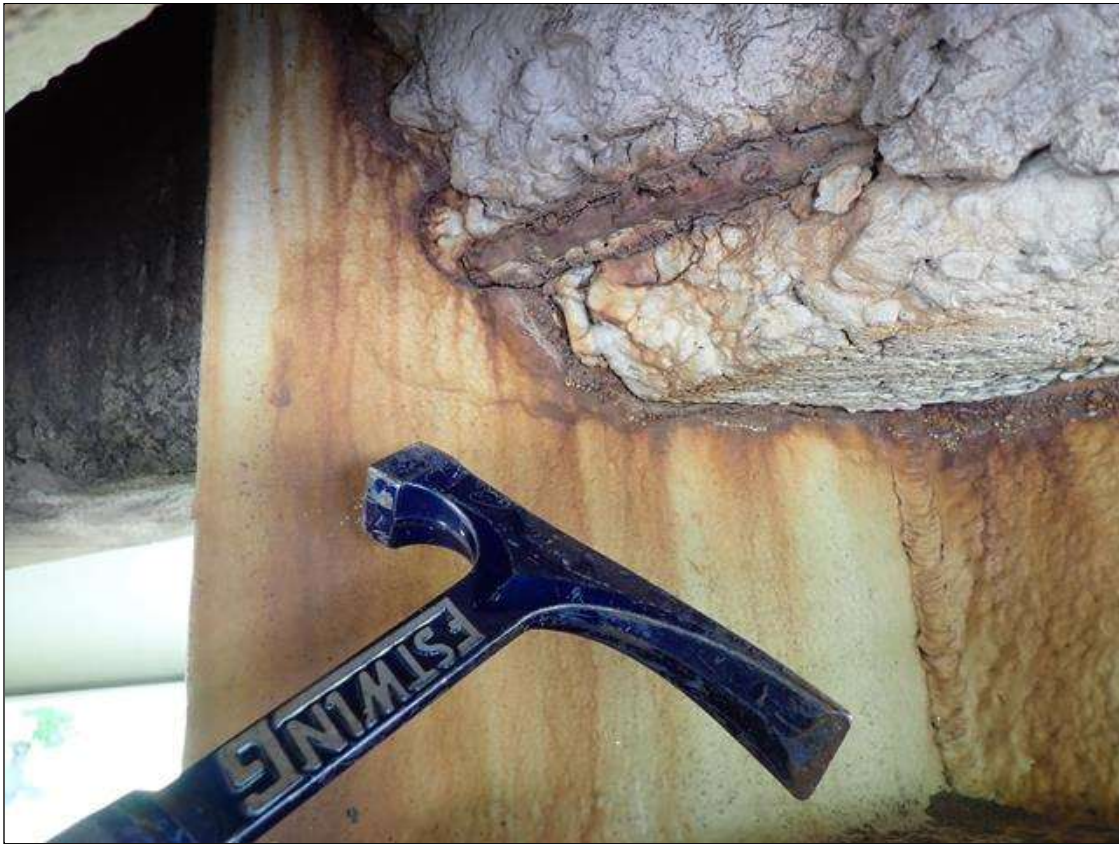
Span 1 Beam 2: at bent 1, corrosion with section loss: web adjacent to diaphragm (1/2 inch average remaining x 10 inch x 5 inch); left stiffener (0.35 inch average remaining x full width x full height)

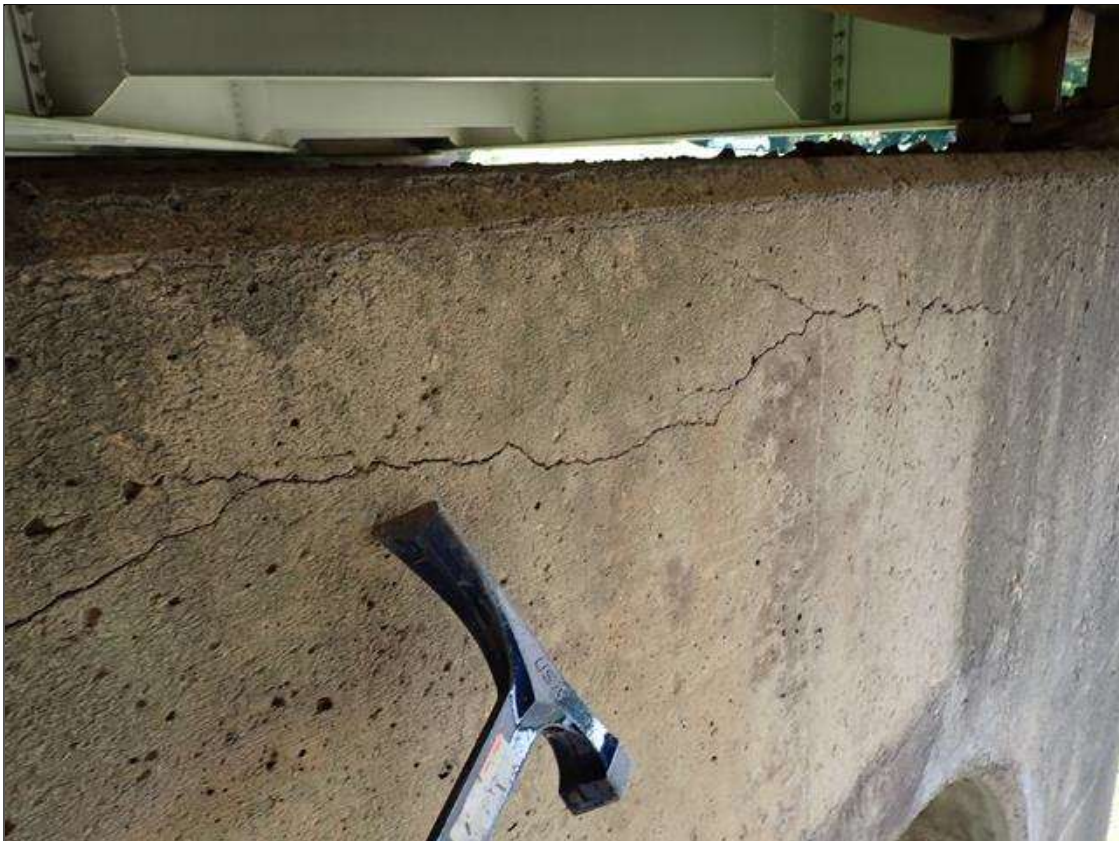
Bent 1 Cap 1: MAP CRACKING AND HORIZONTAL CRACKS UP TO 1/16 INCH AT RANDOM THROUGHOUT NORTH AND SOUTH FACES

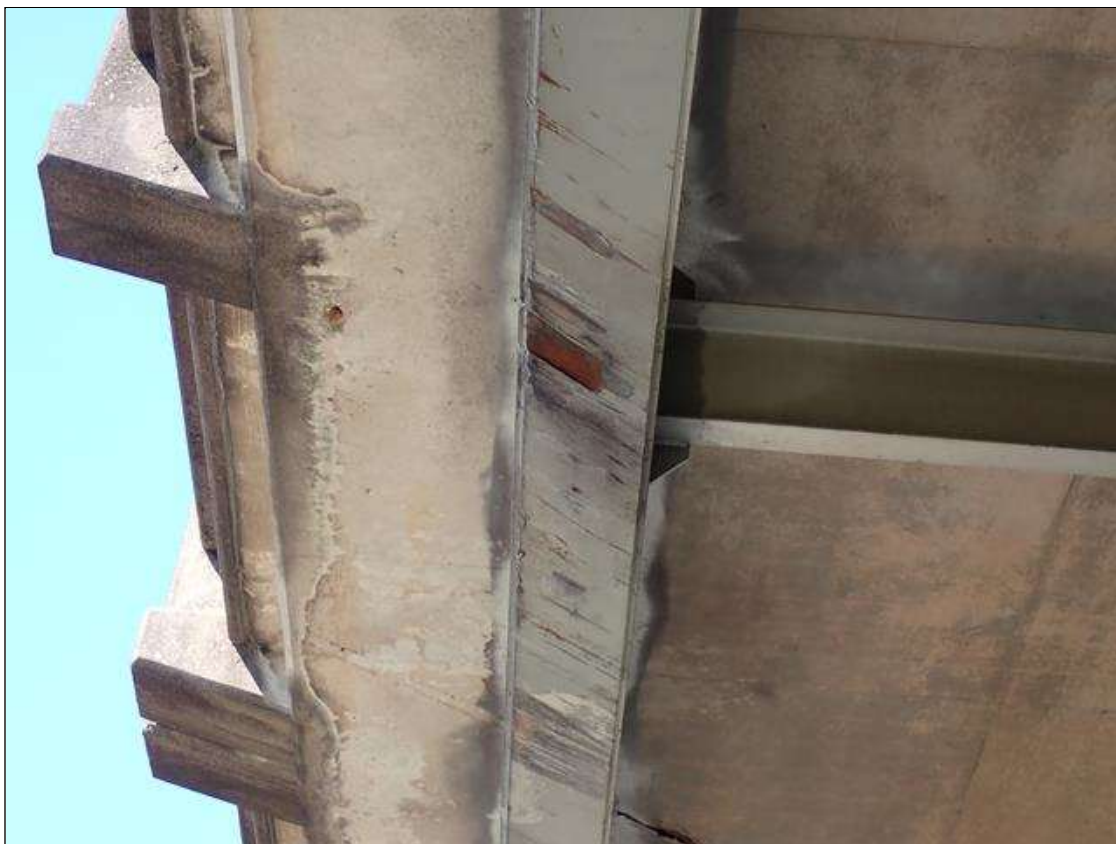
Span 2 Beam 1: (PAR) over both travel lanes, multiple vehicle impact with gouges [up to 3 inch x 1 inch x 1/2 inch deep] with surface rust

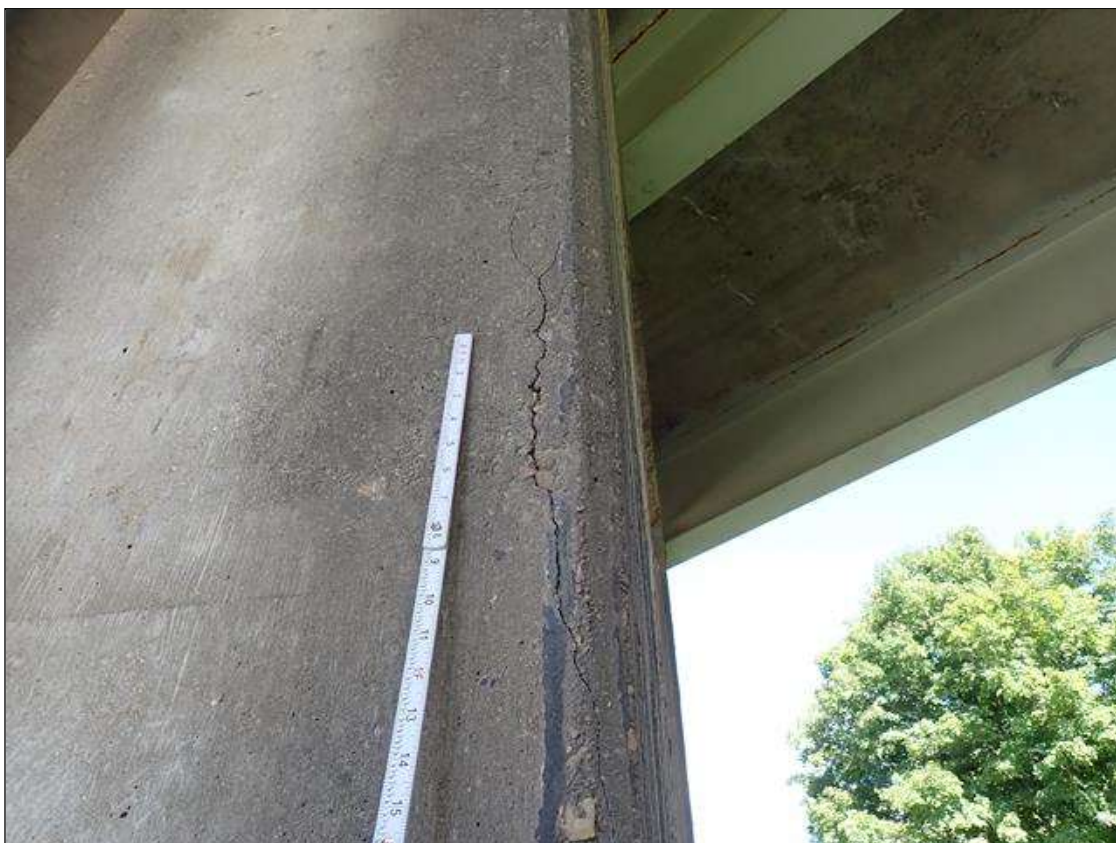
Bent 1 Pile 2: 2.5 FOOT X UP TO 1/16 INCH VERTICAL CRACK ON WEST FACE 6 INCH FROM BOTTOM OF CAP

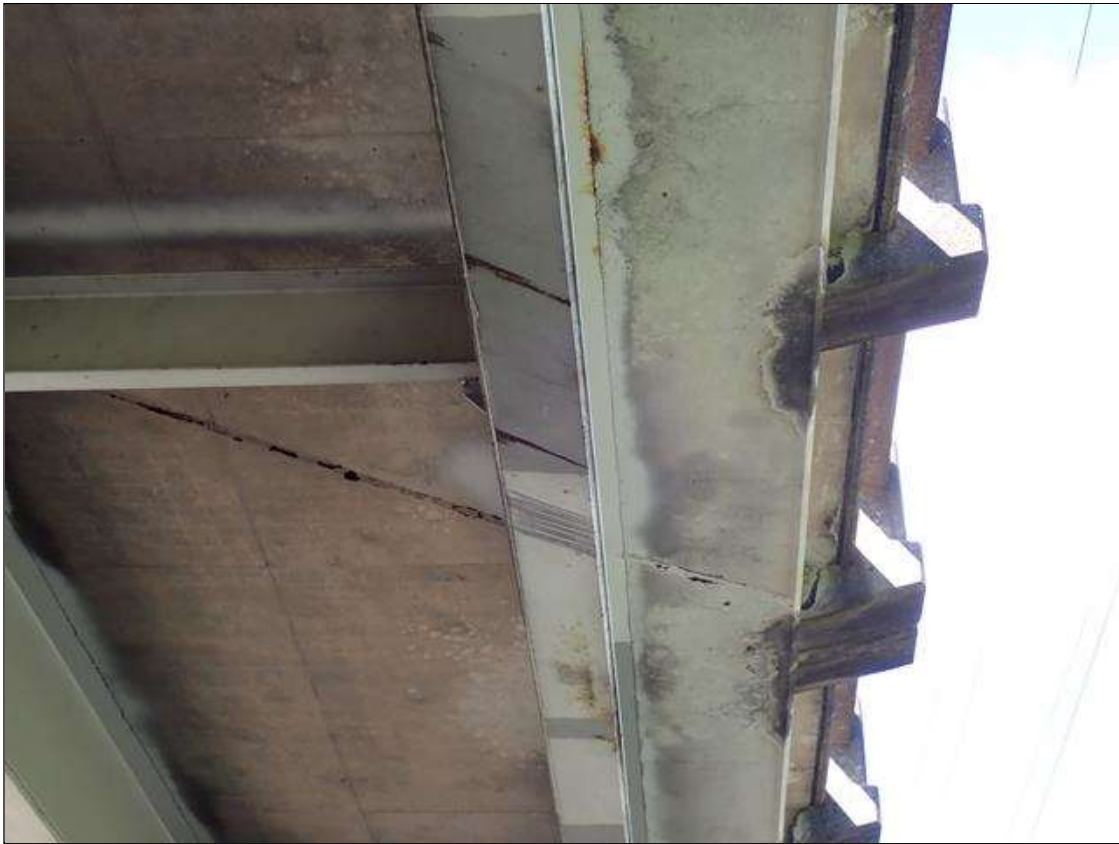
Span 2 Beam 4: underside of coverplate over right travel lane, impact scrapes with surface rust

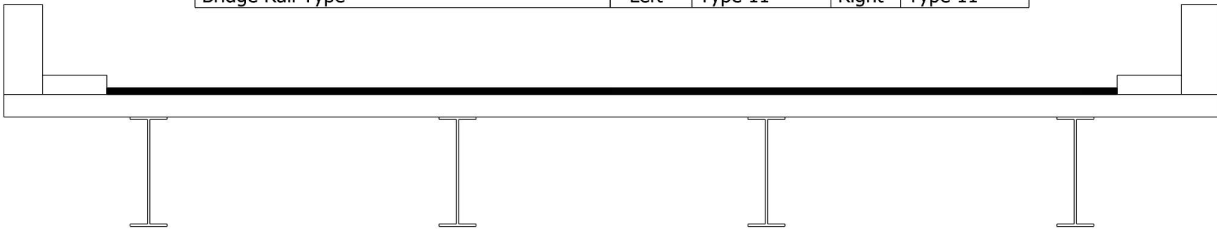
Measurements for Span #	1	ALL SPANS SIMILAR	
Deck Thickness	7in	Left Overhang	3.75ft
Top of Rail to Bottom of Beam (Avg)	5.75ft	Right Overhang	3.75ft

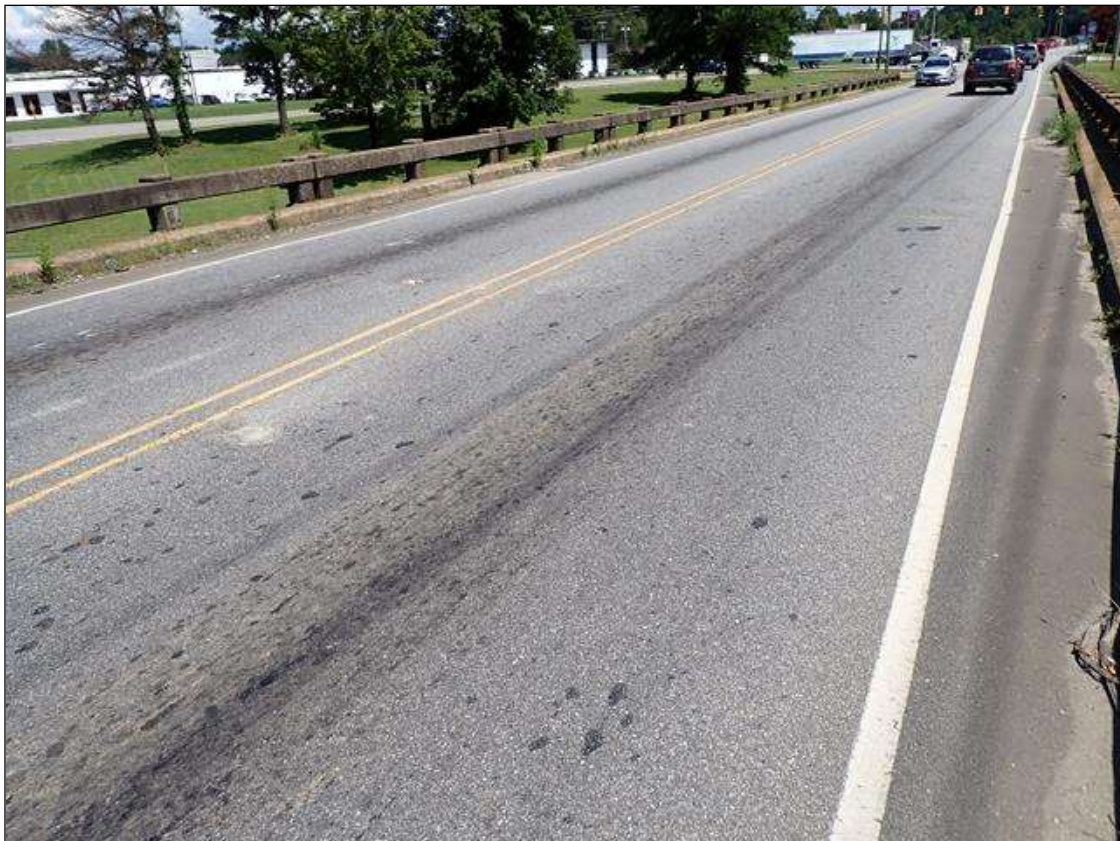
asphalt wearing surface
