NC DEPARTMENT OF TRANSPORTATION
 DIVISION OF HIGHWAYS
 STRUCTURE MANAGEMENT UNIT

ATTENTION: prompt action request; sketches revised; span 3 total horizontal clearances revised; new repairs

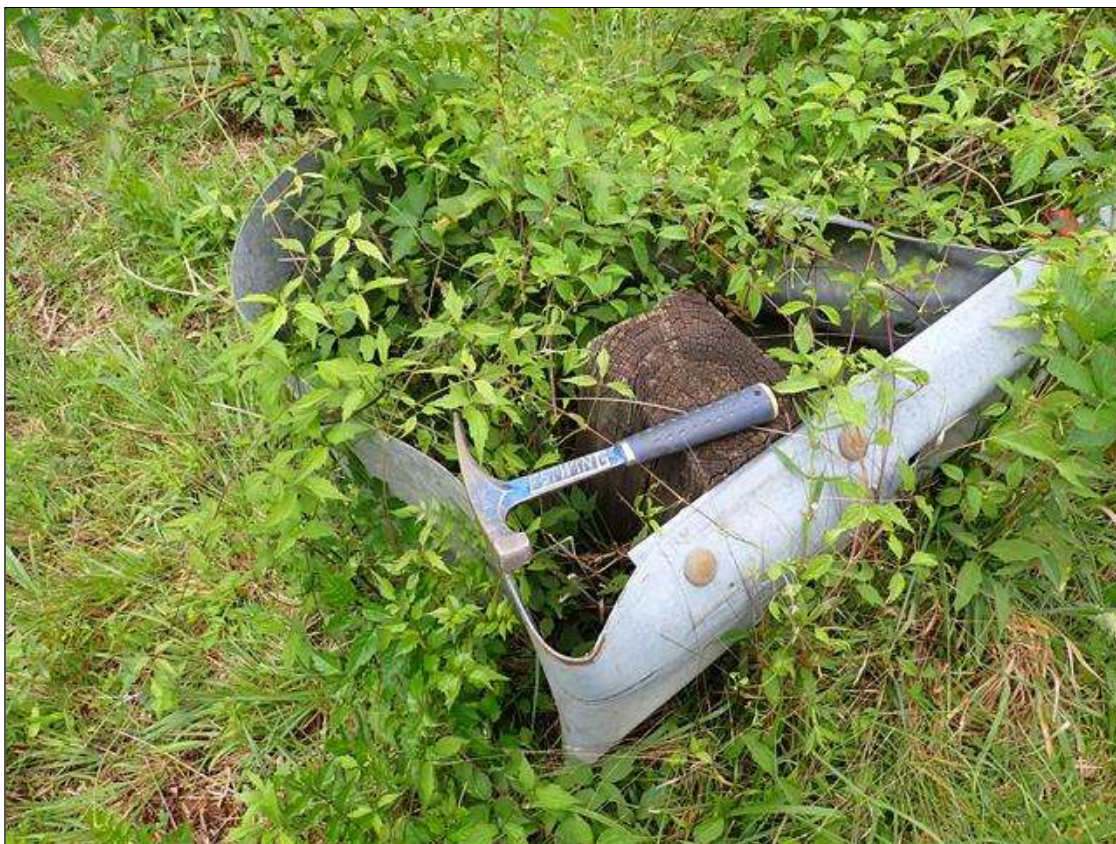
(PAR) northeast guardrail termination, impact damage

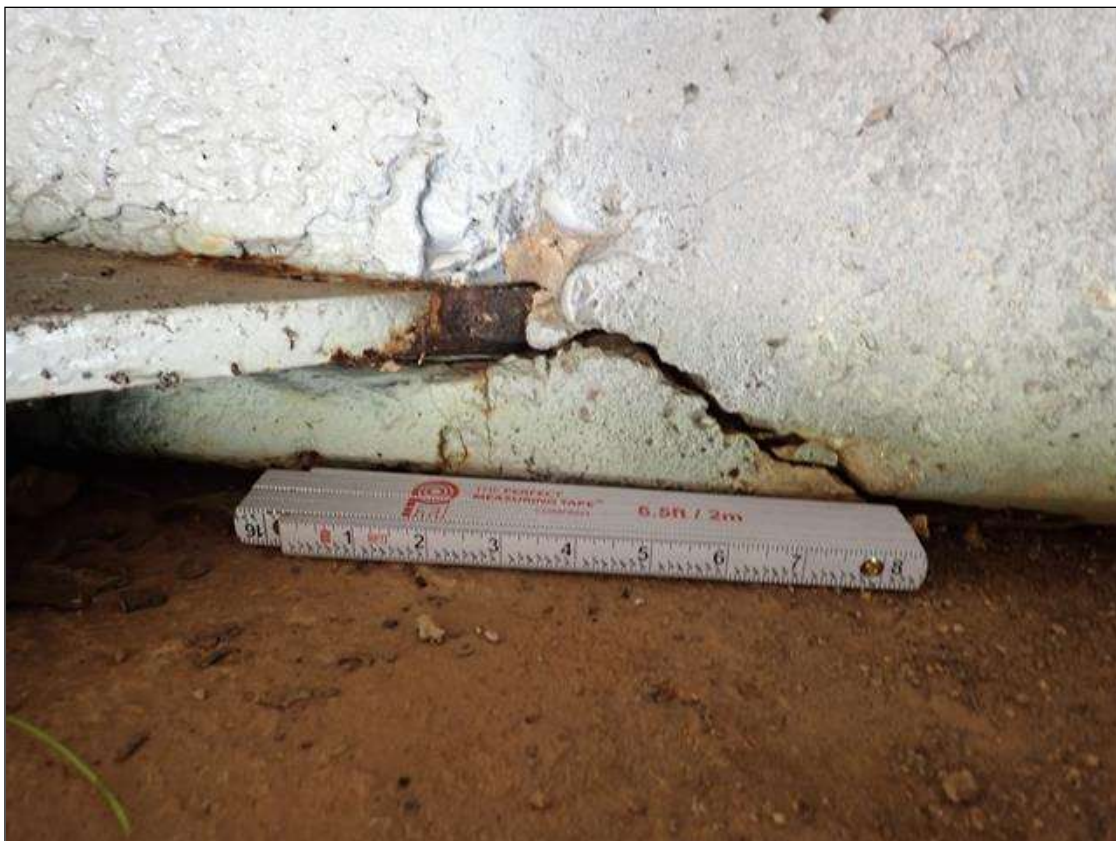
End Bent 1 Abutment: AT ALL BEAM PENETRATIONS, MULTIPLE SPALLS/DELAMINATIONS [UP TO 9 INCHES X 5 INCHES X 1 INCHES DEEP]

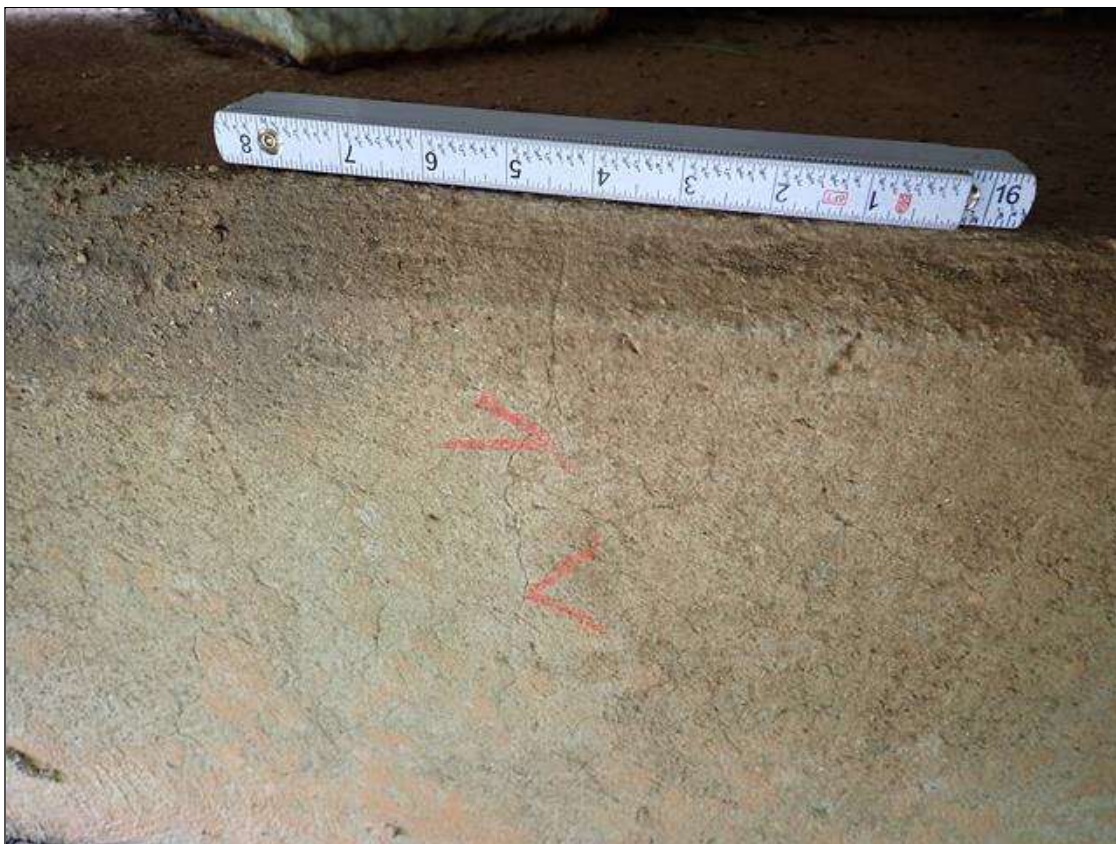
End Bent 1 Cap 1: ALONG LENGTH, MULTIPLE VERTICAL CRACKS [UP TO FULL HEIGHT X 1/64 INCHES]

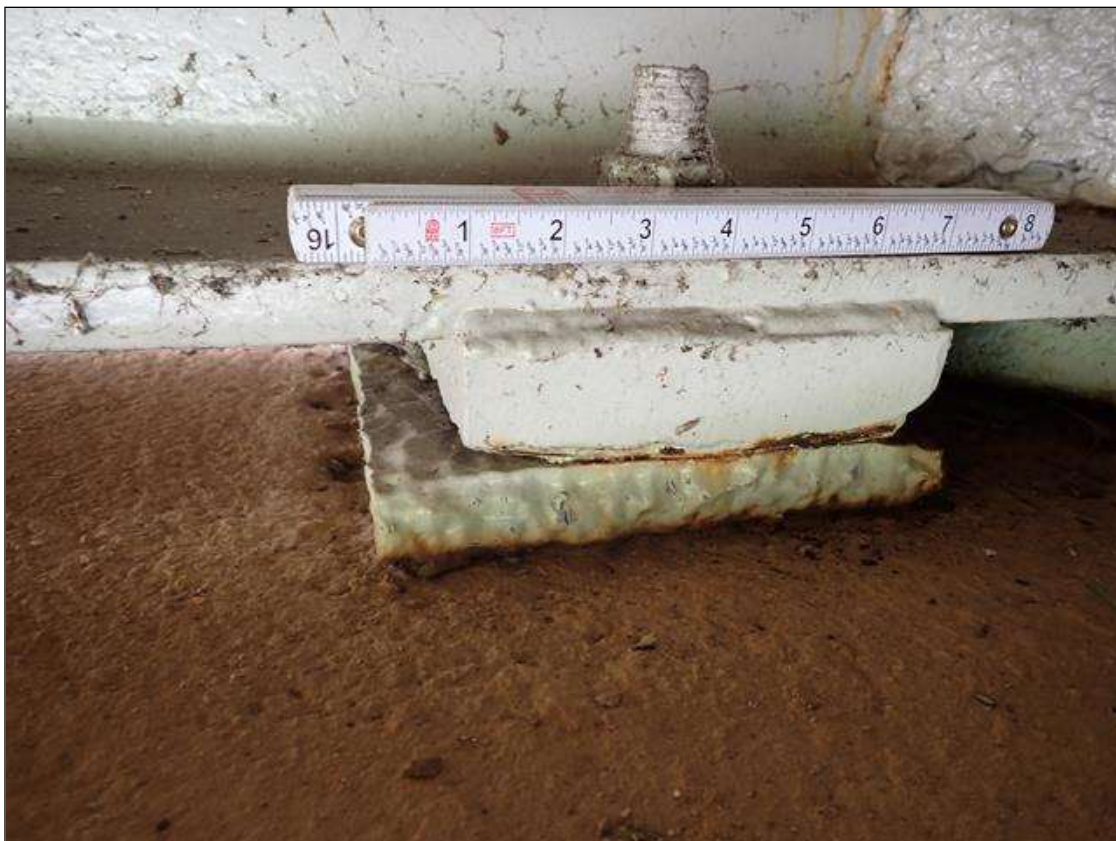
Span 1 Beam 4 - Near Bearing 4: corrosion with section loss (up to 1/8 inch loss)

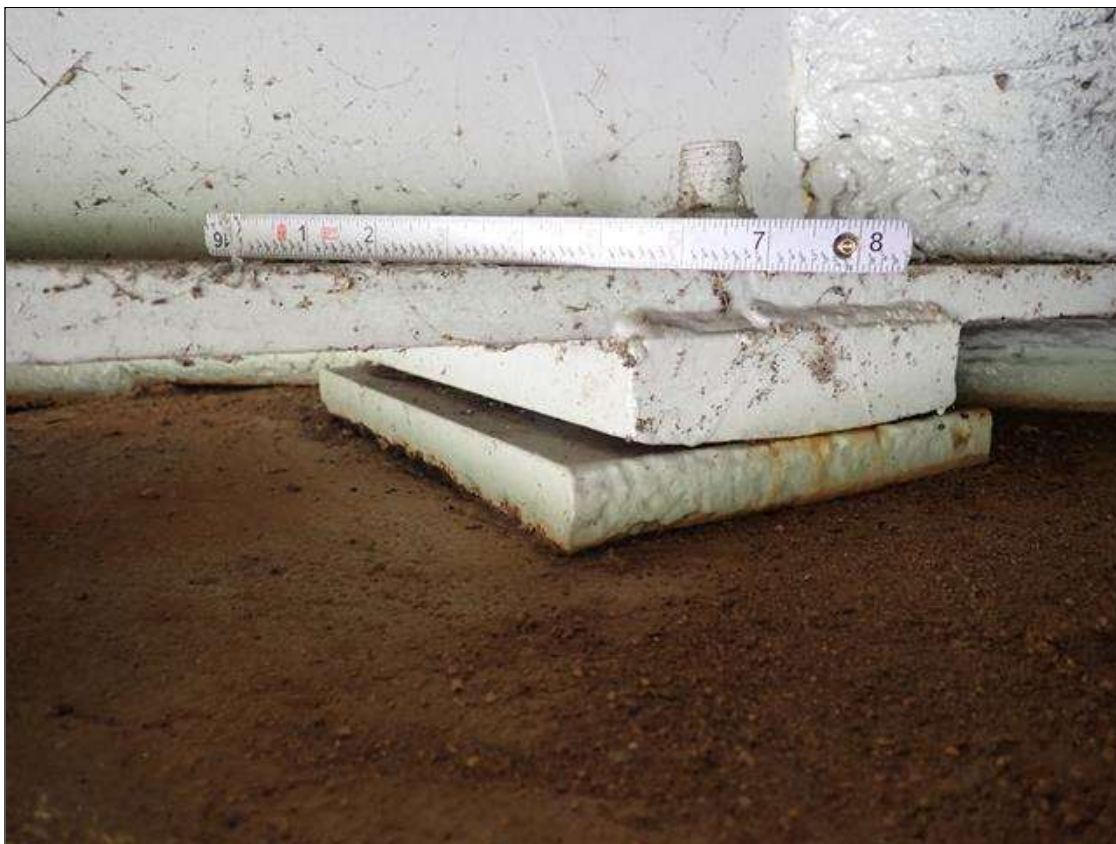
Span 1 Near Bearing 3: painted over pitting (up to 1/16 inch deep)

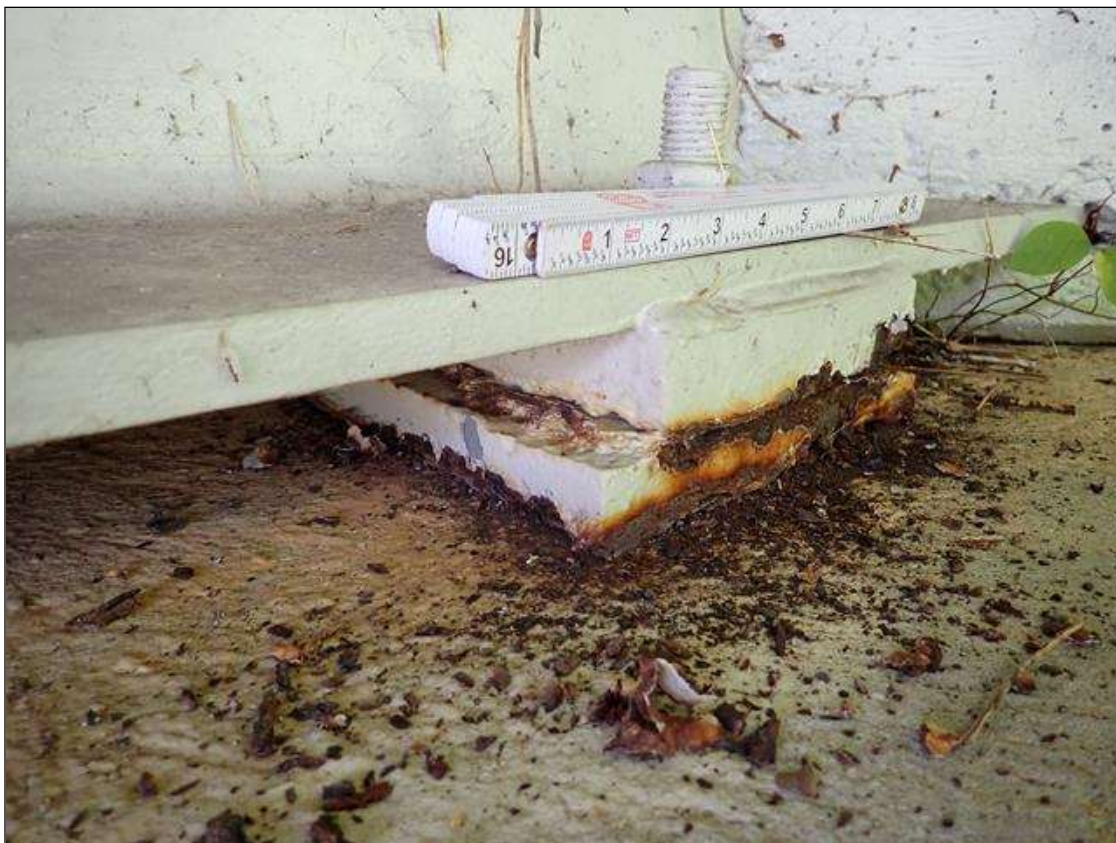
Span 1 Near Bearing 1: corrosion with section loss (up to 1/8 inch loss)

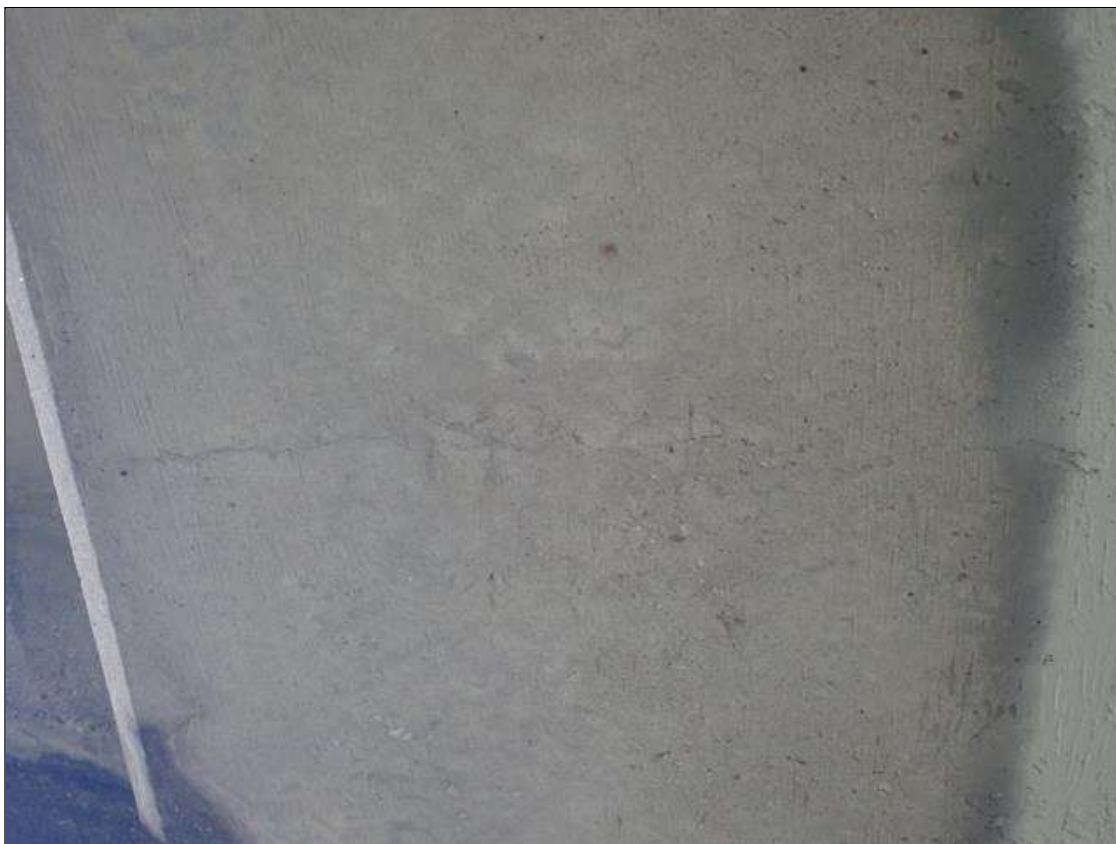
Span 1 Deck: ALONG BOTH OVERHANGS, TRANSVERSE CRACKS UP TO 1/32 INCH X FULL WIDTH

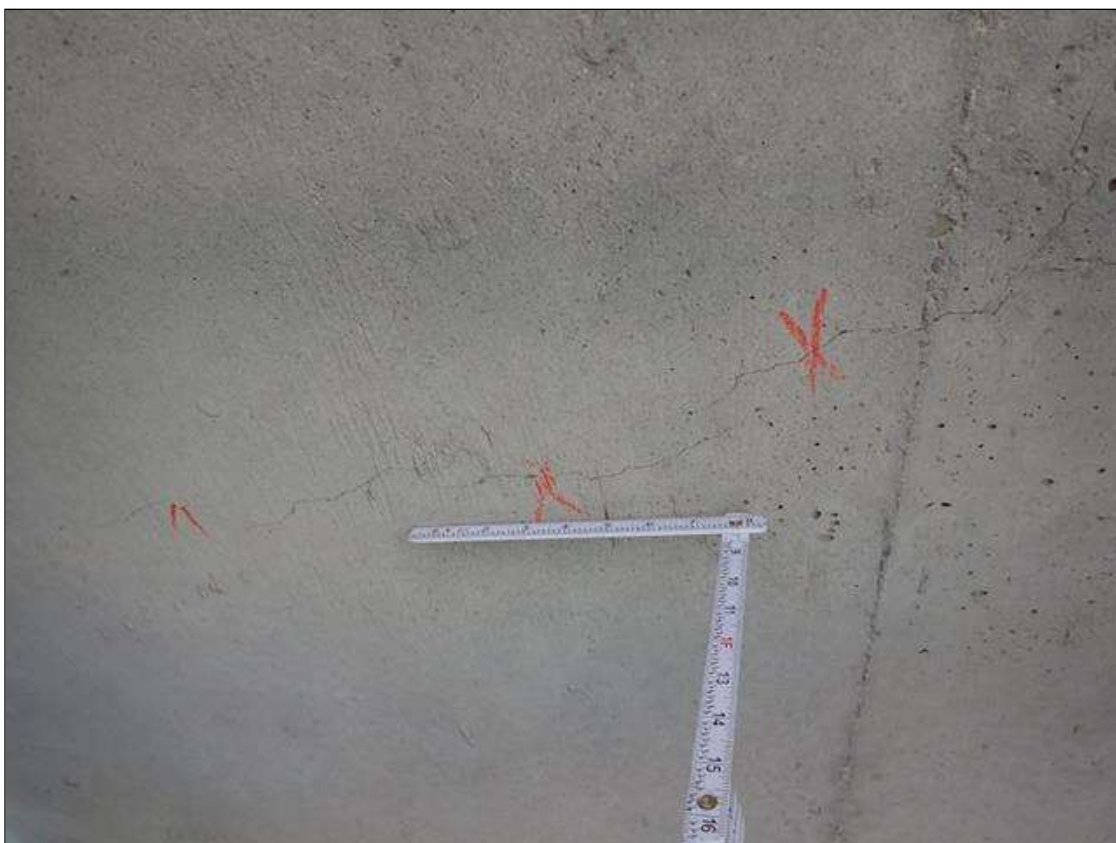
Span 1 Deck: BOTTOM OF DECK HAS SCATTERED AREAS OF TRANSVERSE CRACKS UP TO 1/32 INCHES X FULL WIDTH SOME WITH EFFLORESCENCE AT RANDOM THROUGHOUT

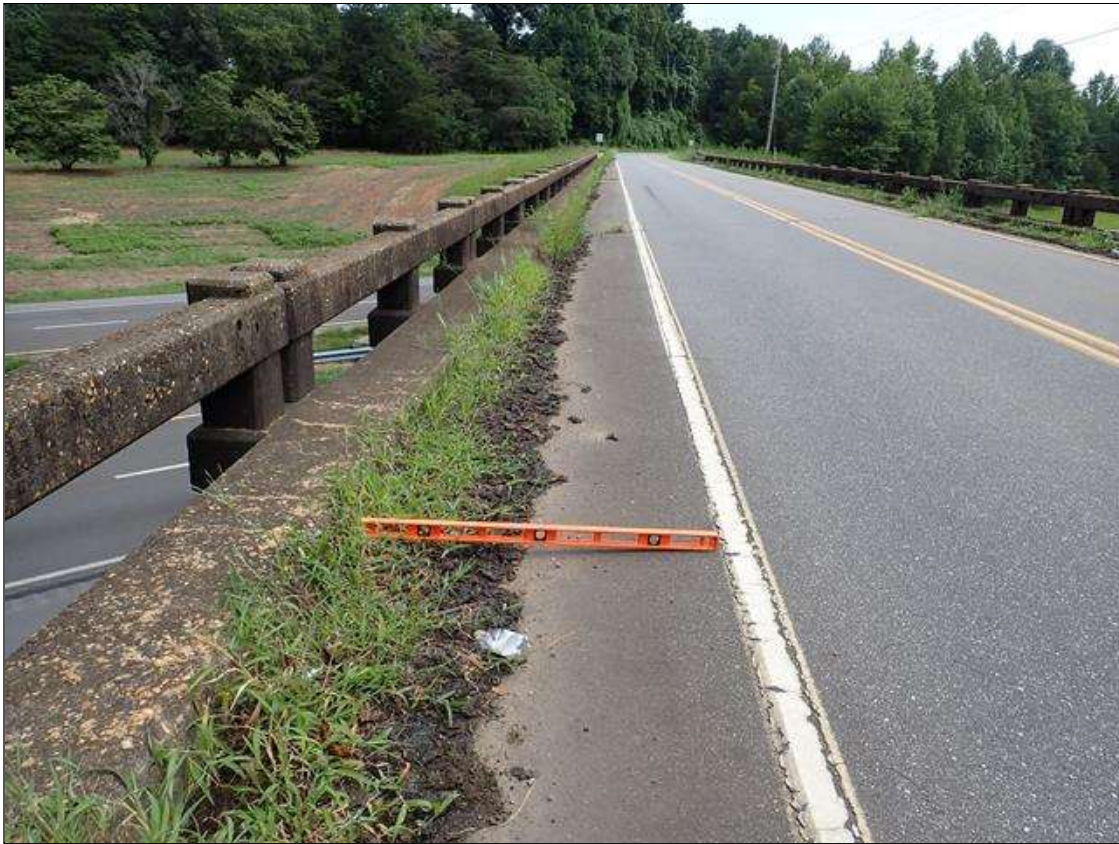
along both curblines, debris accumulation (up to 2 foot wide x full length); fully obstructing drainage

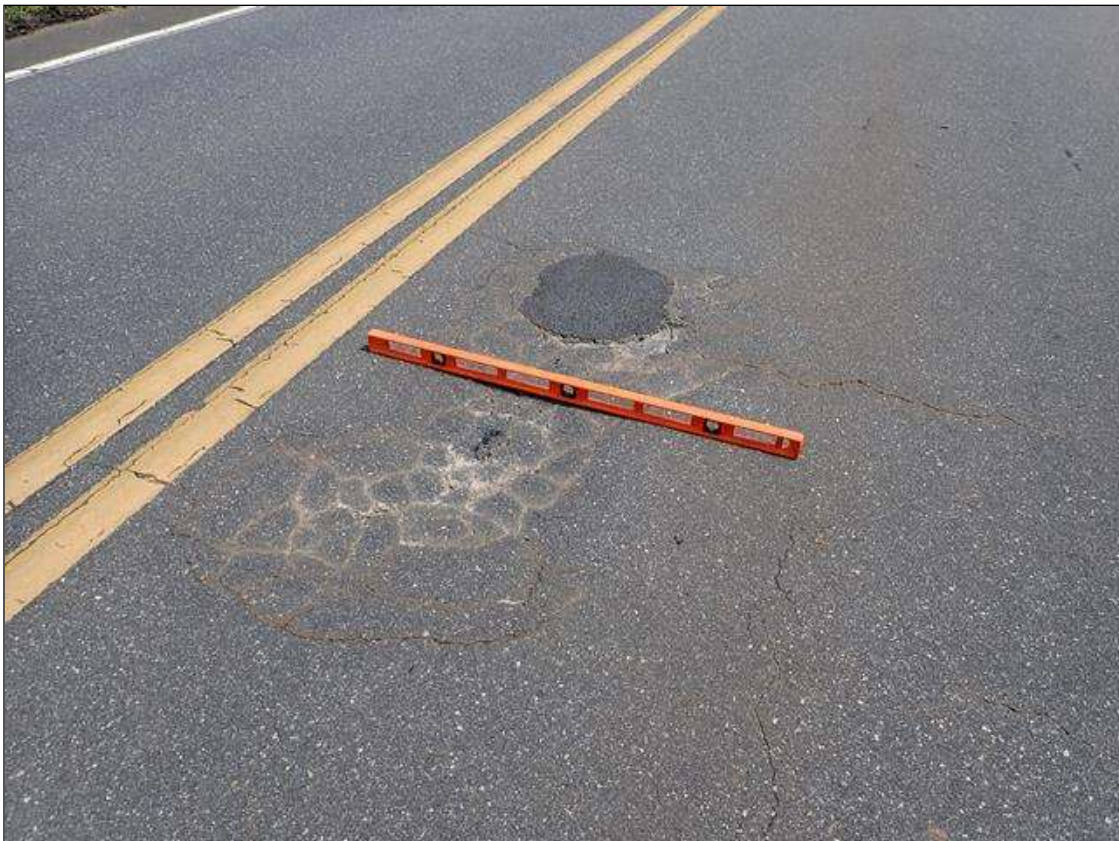
Span 1 Wearing Surface: ASPHALT WEARING SURFACE IS BROKEN UP/PARTIALLY PATCH AND DEPRESS IN A FEET X 6 FEET X 1 INCH DEEP AREA 12 FEET FROM END BENT 1 AND 9 FEET FROM RIGHT CURB.

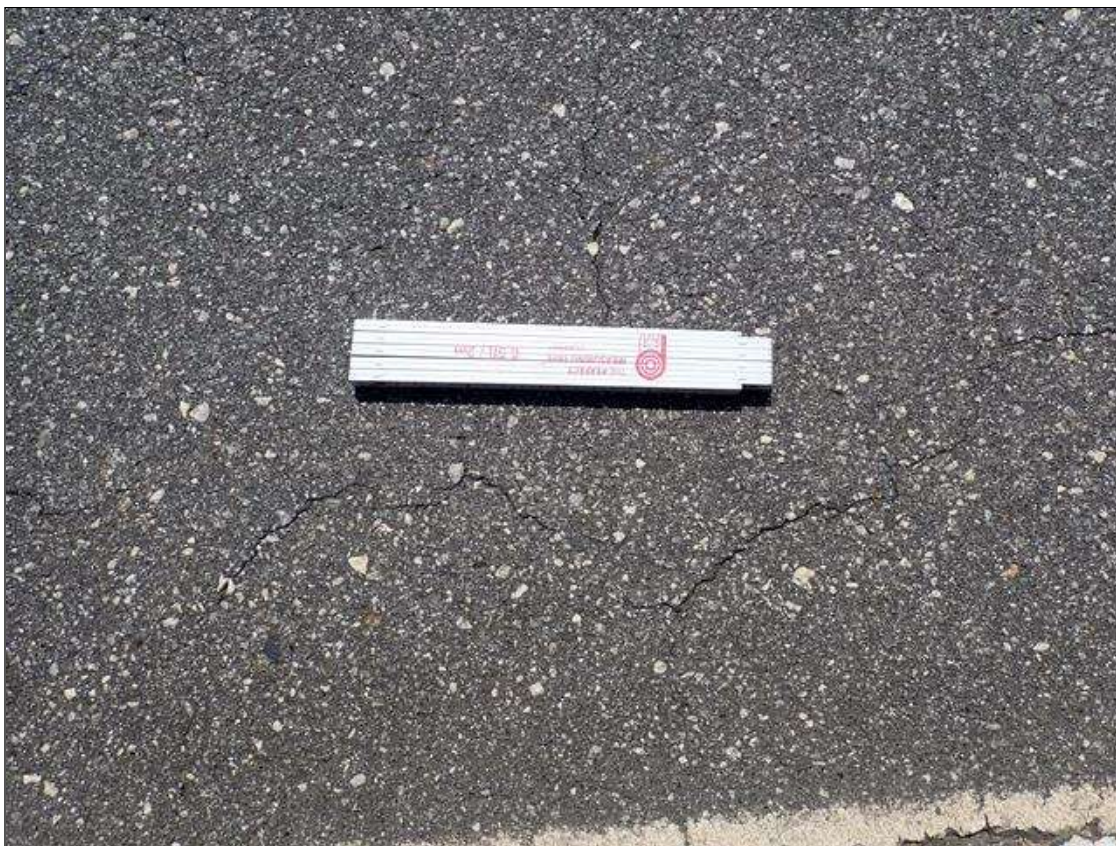
Span 1 Wearing Surface: ASPHALT WEARING SURFACE HAS SCATTERED MAP CRACKING UP TO 1/32 INCHES THROUGH OUT

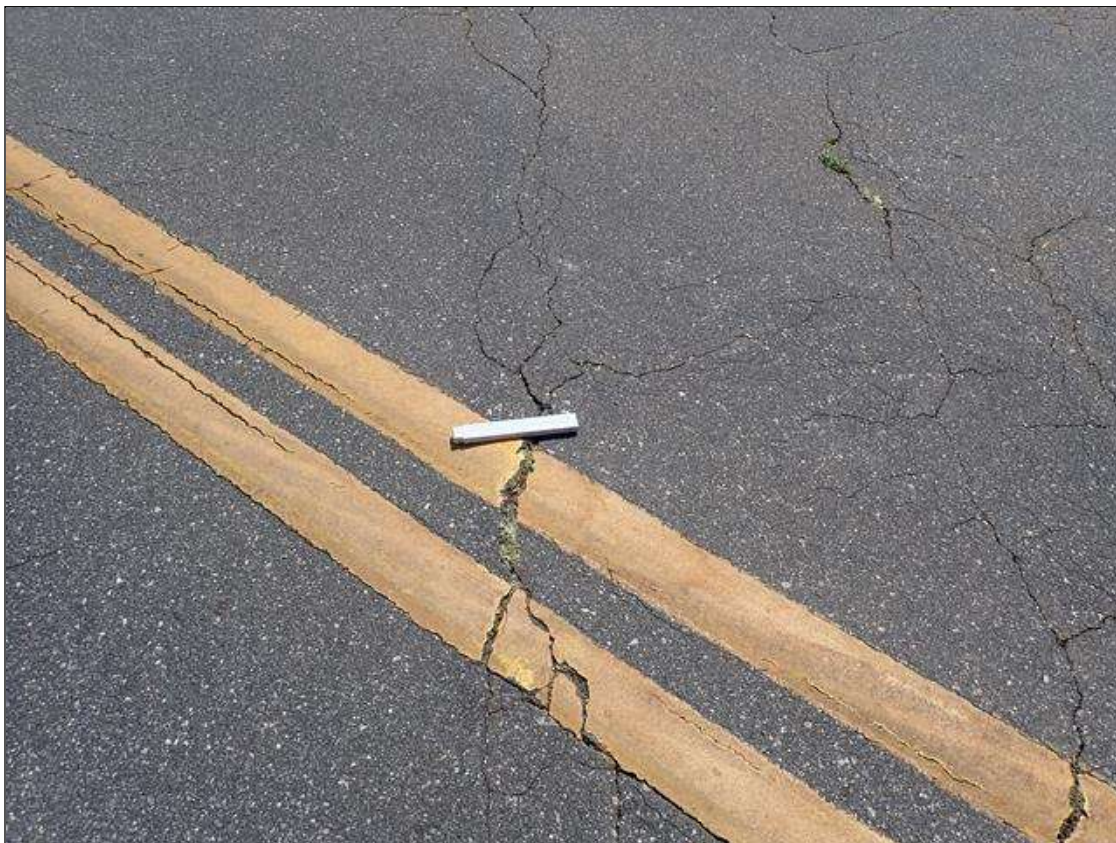
Span 1 Wearing Surface: 35 FEET X UP TO 1/4 INCHES TRANSVERSE CRACK OVER END BENT 1

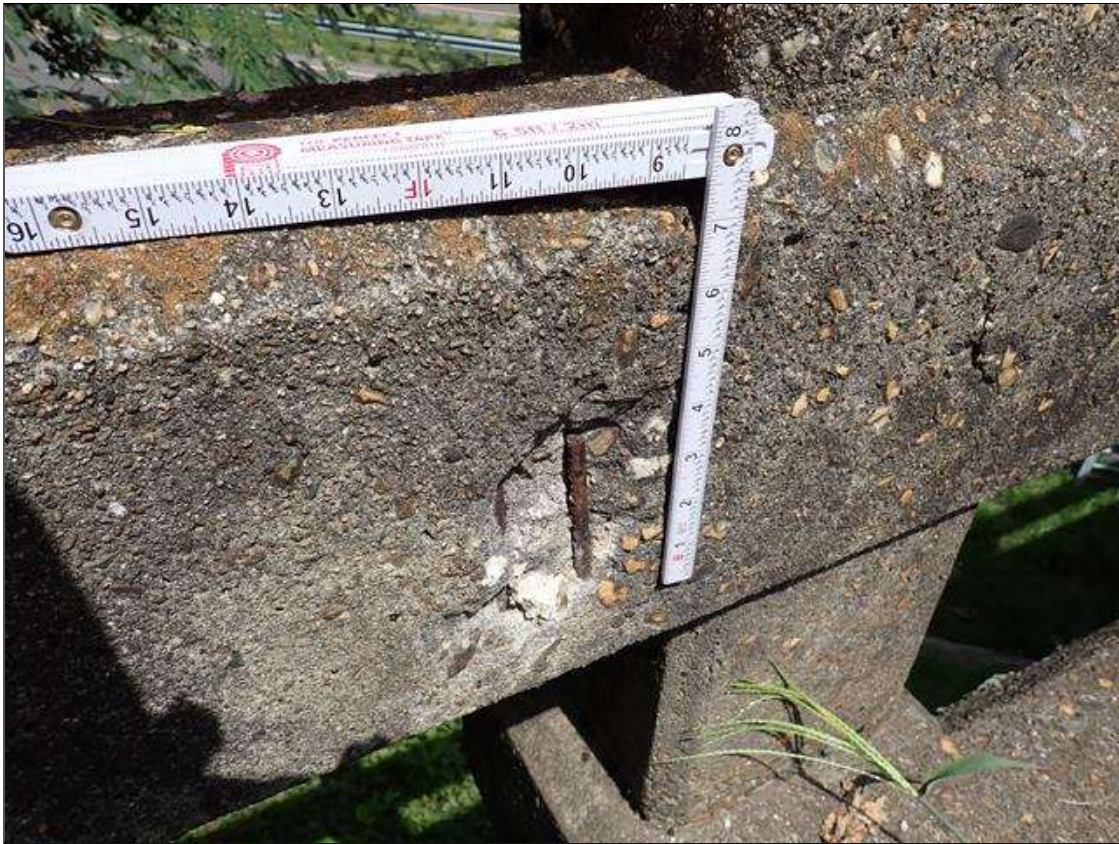
Span 1 Left Bridge Rail: (4) UP TO 5 INCHES DIAMETER X 1/2 INCHES SPALLS WITH EXPOSED REINFORCING 20 FEET FROM END BENT 1 NO SECTION LOSS

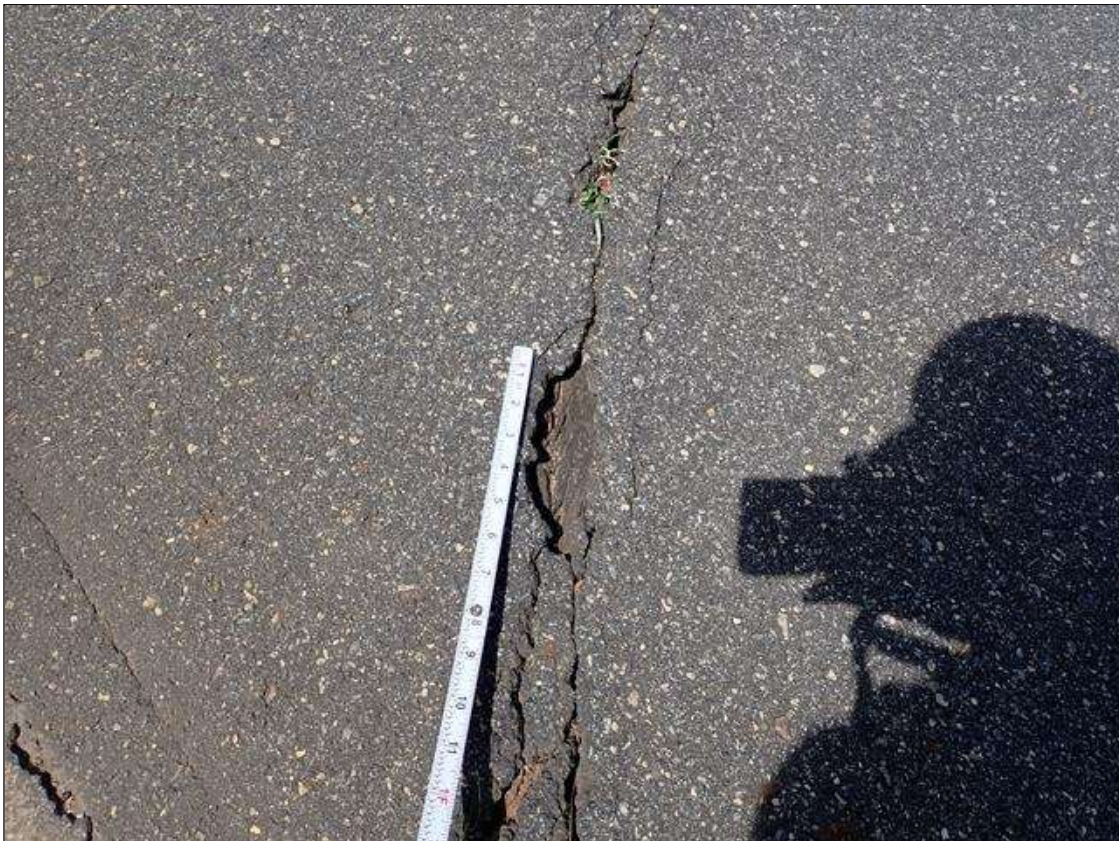
Span 2 Wearing Surface: 35 FEET X UP TO 1/8 INCHES TRANSVERSE CRACK OVER BENT 1 WITH EDGE SPALLS UP TO 3 INCH X 1 INCH DEEP

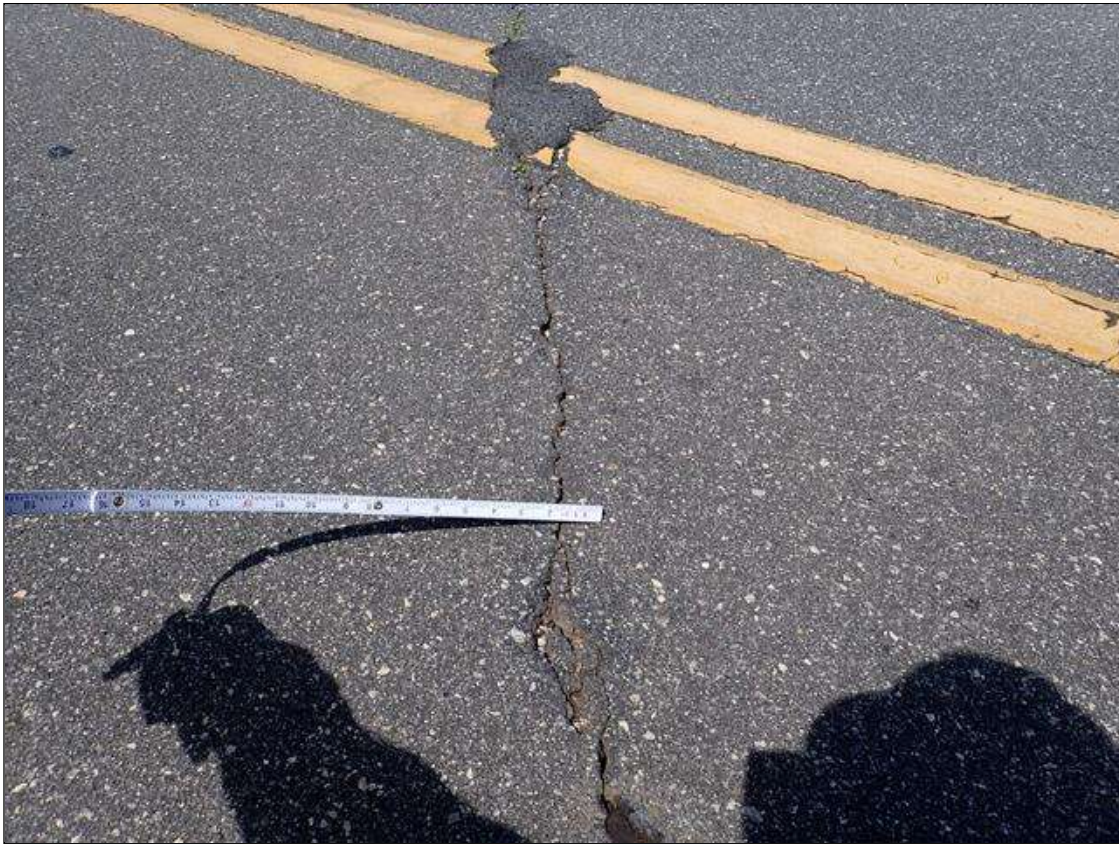
Span 2 Wearing Surface: 35 FEET X UP TO 1/8 INCHES TRANSVERSE CRACK OVER BENT 1 WITH EDGE SPALLS UP TO 3 INCH X 1 INCH DEEP

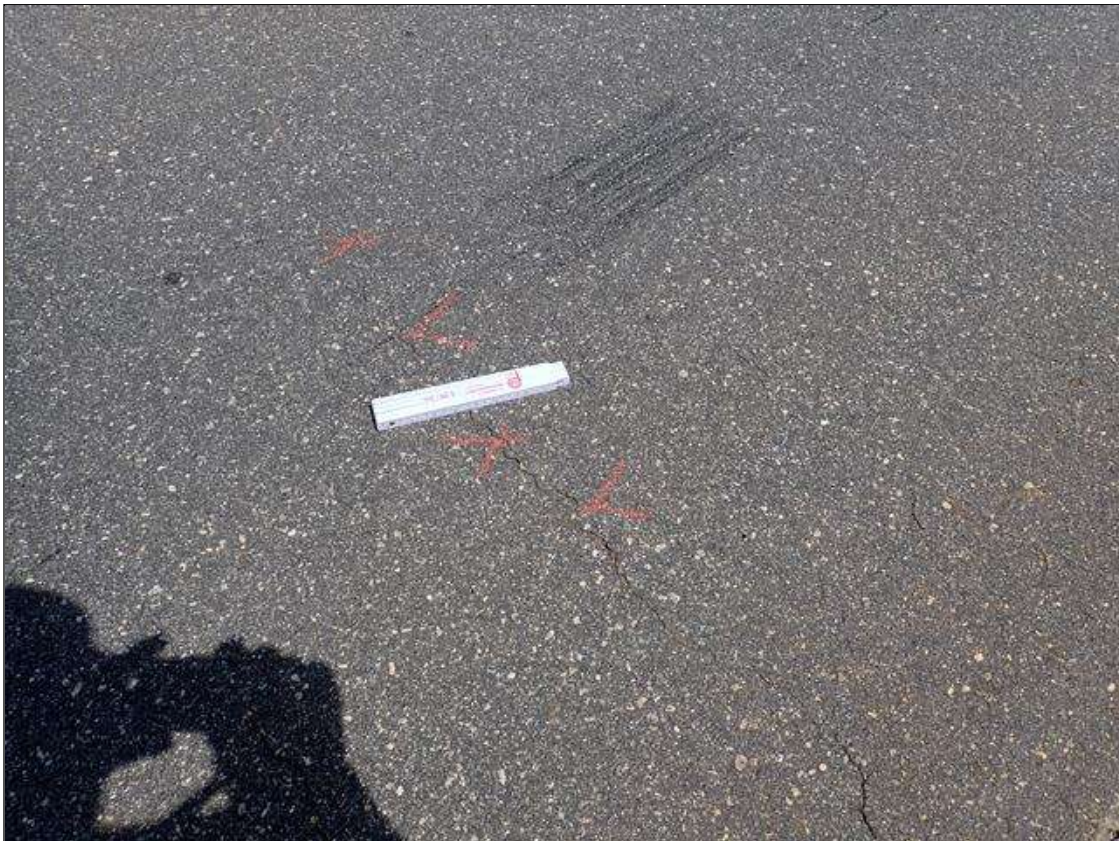
Span 2 Wearing Surface: TRANSVERSE CRACKS UP TO 1/16 FEET INCH X 12 FOOT AND MAP CRACKS UP TO 1/32 AT RANDOM THROUGHOUT

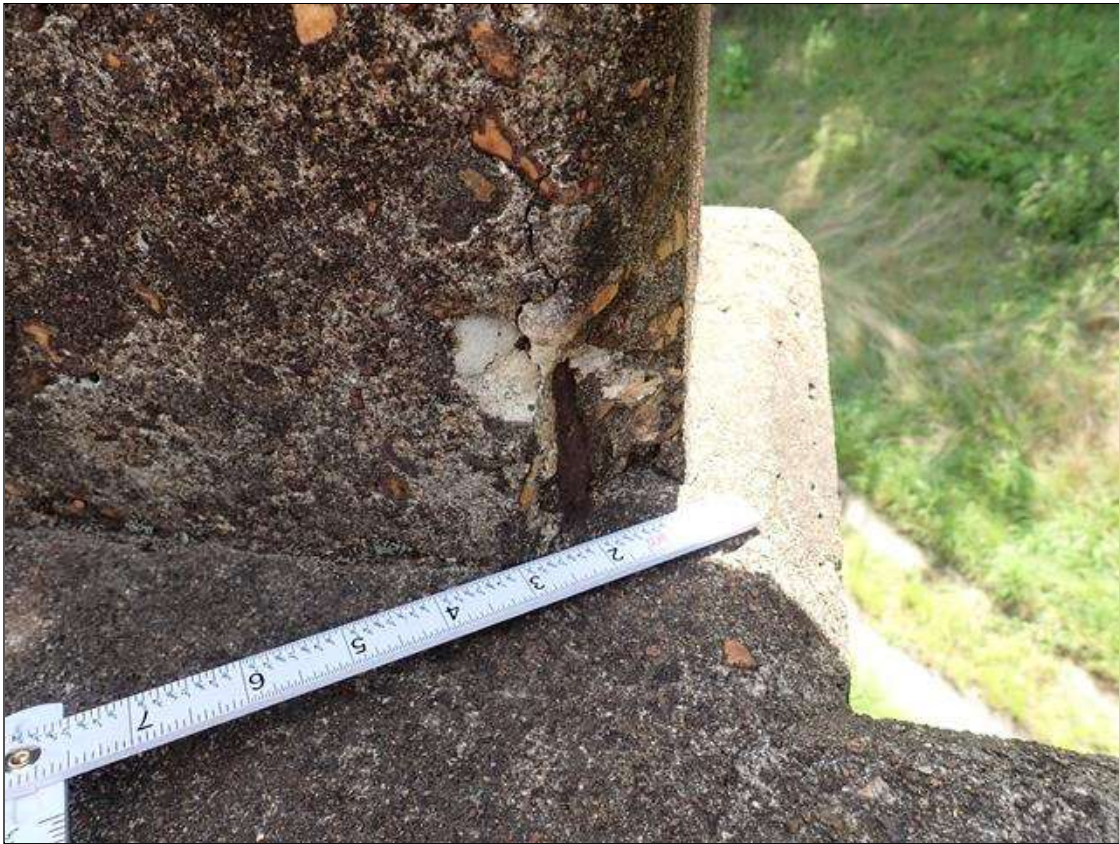
Span 2 Right Bridge Rail: (2) UP TO 4 INCH DIAMETER X 1/2 INCH SPALLS WITH EXPOSED REINFORCING 22 FEET FROM BENT 1 NO SECTION LOSS

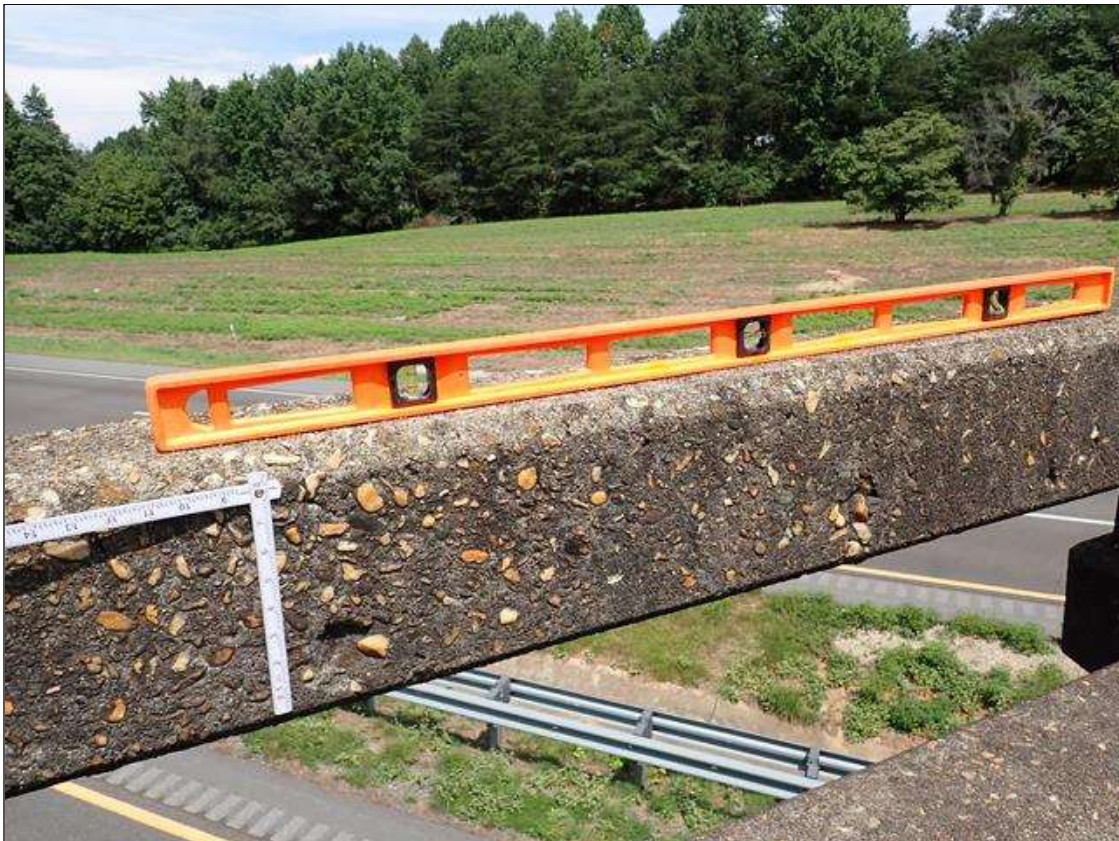
Span 2 Left Bridge Rail: at midspan, (2) spalls (3 inch diameter x 1/2 inch deep) with exposed rusted rebar

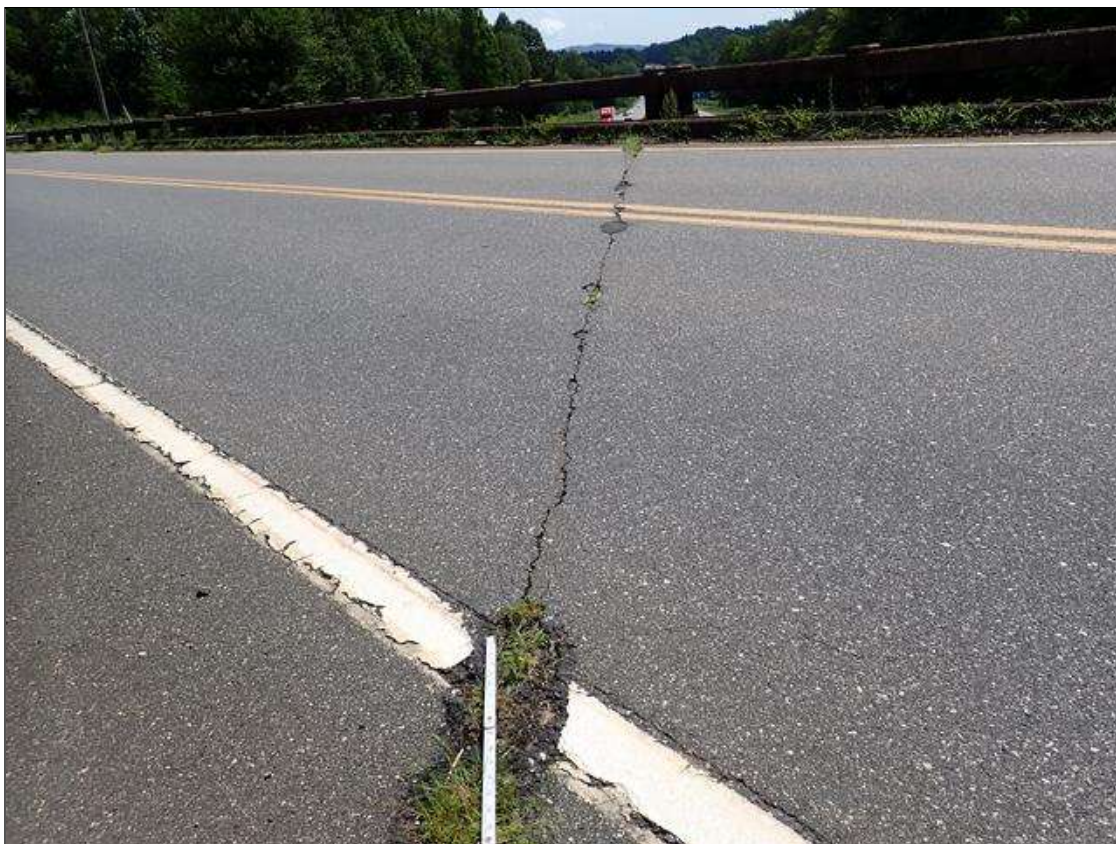
Span 3 Wearing Surface: 35 FEET X UP TO 1/8 INCHES TRANSVERSE CRACK WITH EDGE SPALLS UP TO 2 FOOT X 4 INCH X 1 INCH DEEP WITH VEGETATION GROWTH OVER BENT 2

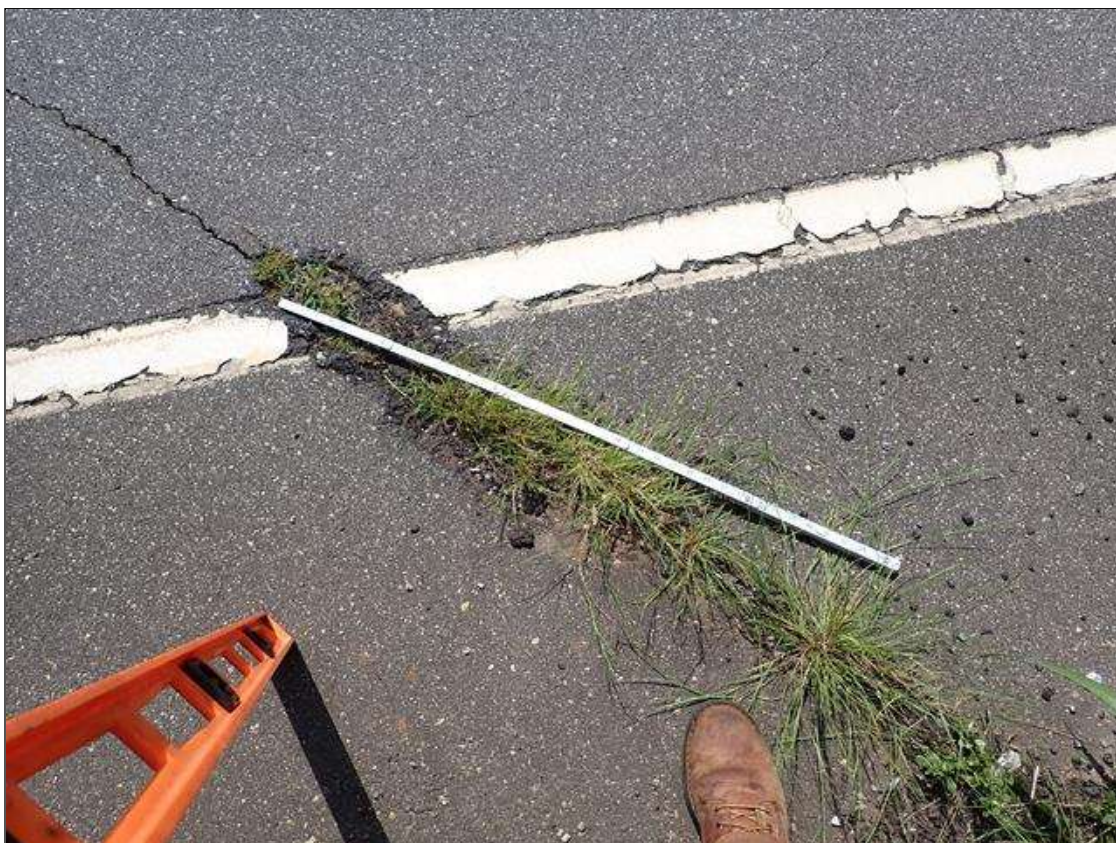
Span 3 Wearing Surface: 35 FEET X UP TO 1/8 INCHES TRANSVERSE CRACK WITH EDGE SPALLS UP TO 2 FOOT X 4 INCH X 1 INCH DEEP WITH VEGETATION GROWTH OVER BENT 2

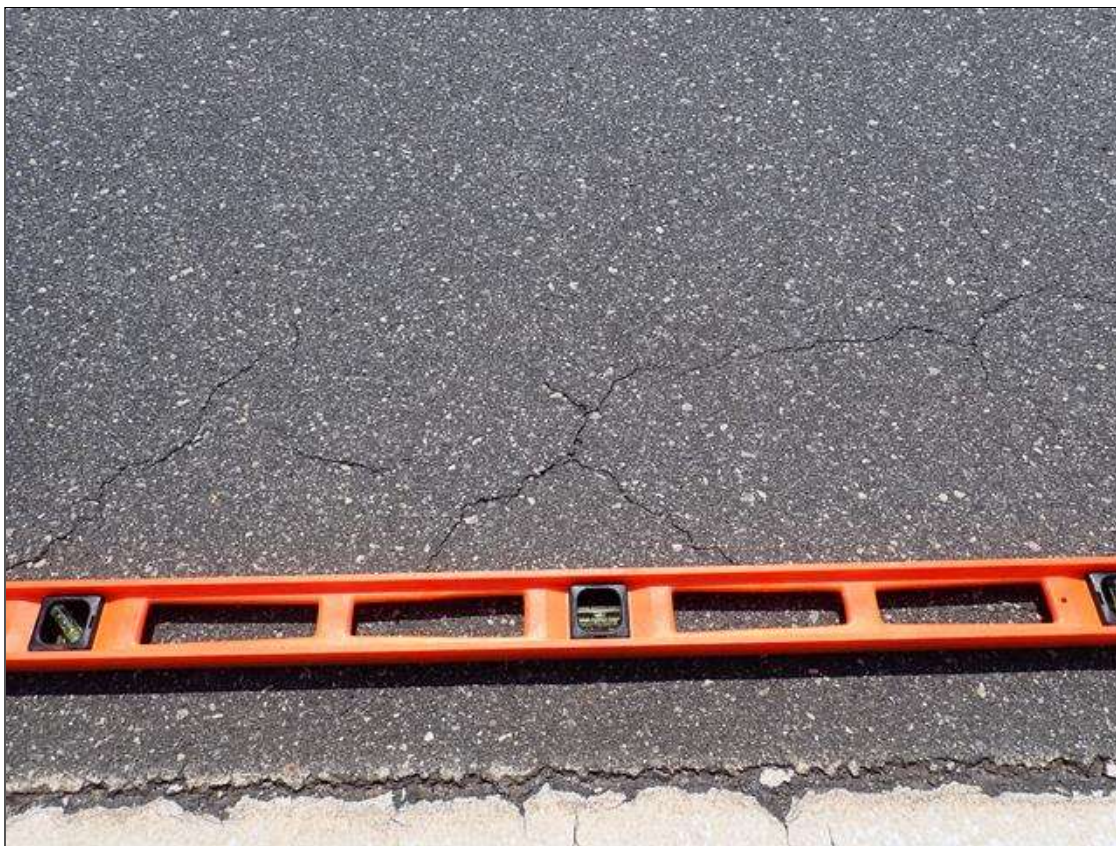
Span 3 Wearing Surface: ASPHALT WEARING SURFACE HAS SCATTERED MAP CRACKING UP TO 1/16 INCHES

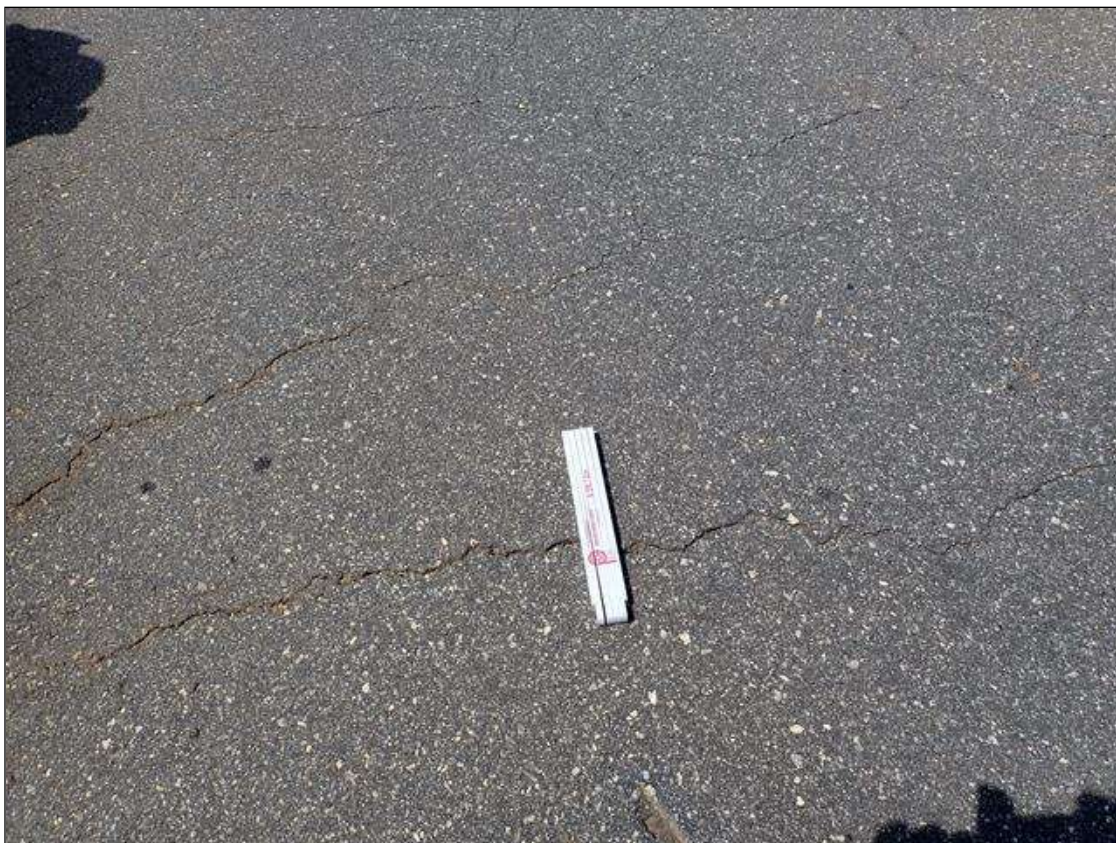
Span 4 Wearing Surface: ASPHALT WEARING SURFACE HAS SCATTERED MAP CRACKING [UP TO 1/8 INCHES] AT RANDOM THROUGHOUT

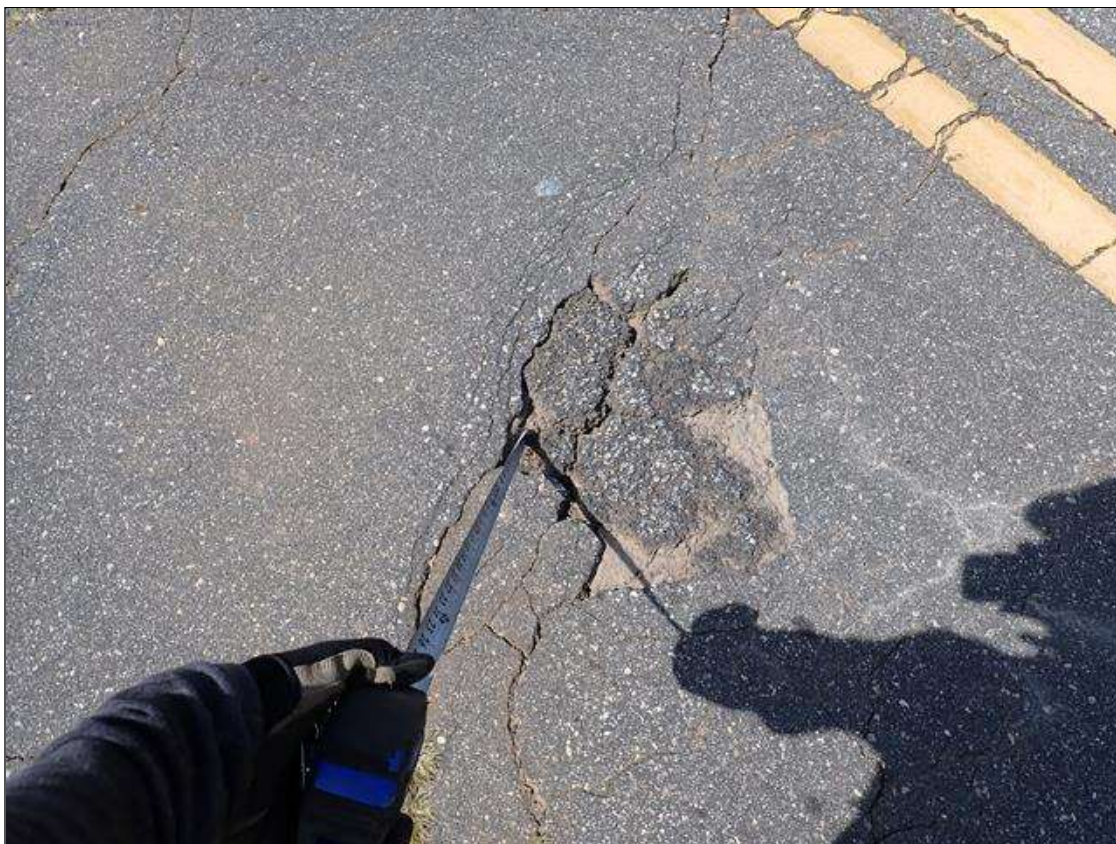
(PAR) north approach asphalt wearing surface, northbound lane near end bent 2, broken asphalt (3 foot x 2 foot x 1.5 inch deep)

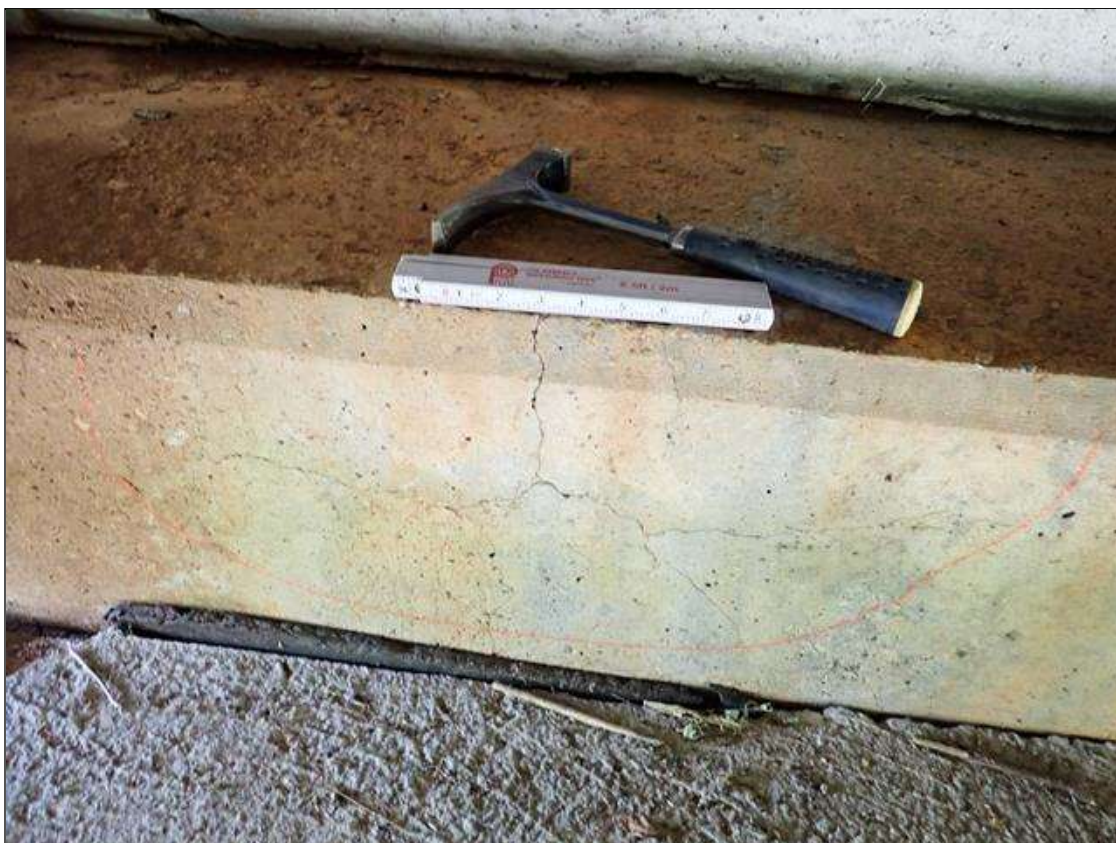
End Bent 2 Cap 1: in bay 1, map cracks (2 foot x 1 foot x up to 1/32 inch)
