NC DEPARTMENT OF TRANSPORTATION
 DIVISION OF HIGHWAYS
 STRUCTURE MANAGEMENT UNIT

ATTENTION: prompt action request; sketches revised; span 3 total horizontal clearances revised; new repairs

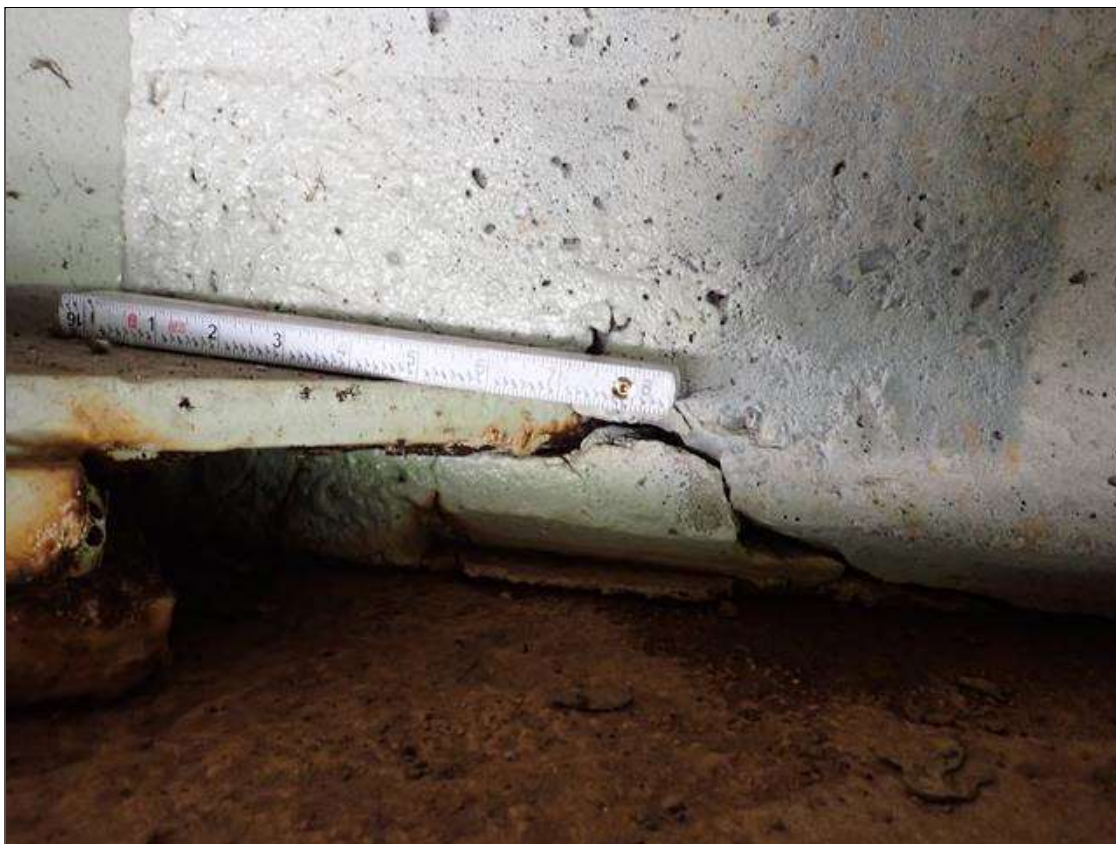
End Bent 2 Abutment: AT ALL BEAM PENETRATIONS, MULTIPLE SPALLS/DELAMINATIONS [UP TO 10 INCHES X 1 INCHES X 1 INCHES DEEP]

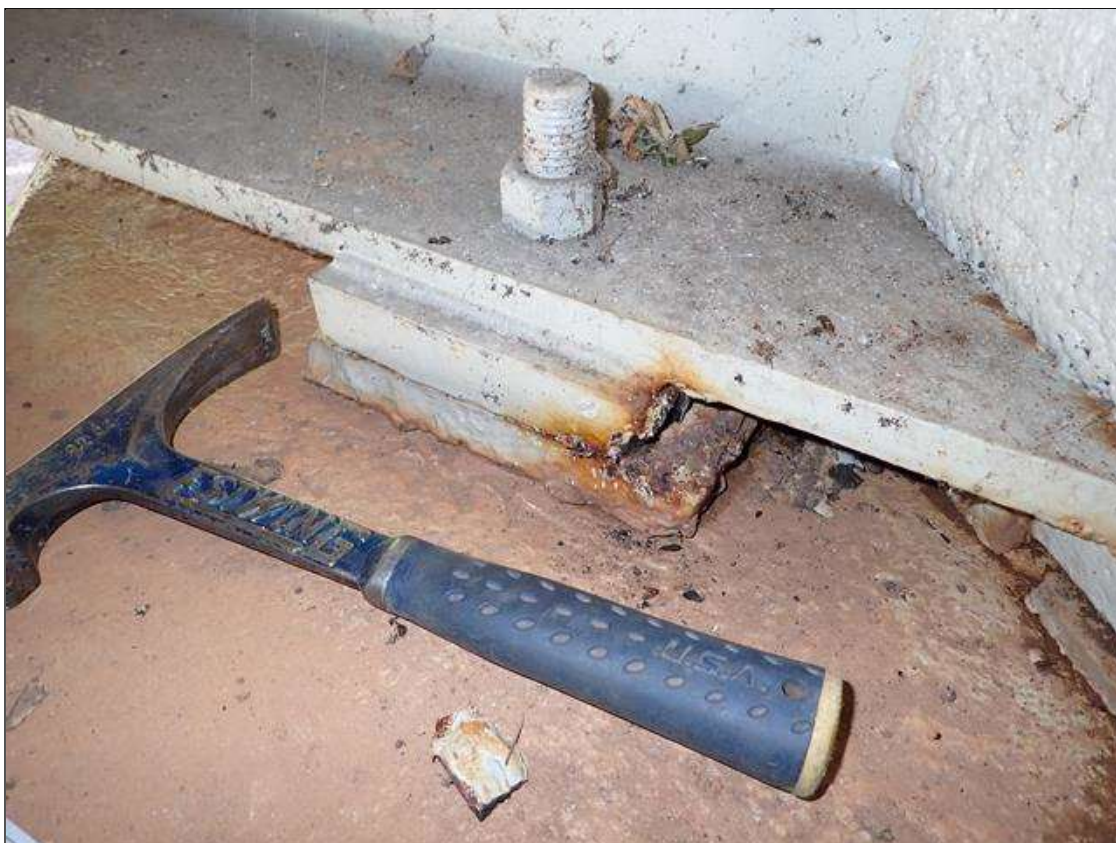
Span 4 Far Bearing 1: corrosion with section loss (up to 1/8 inch loss)

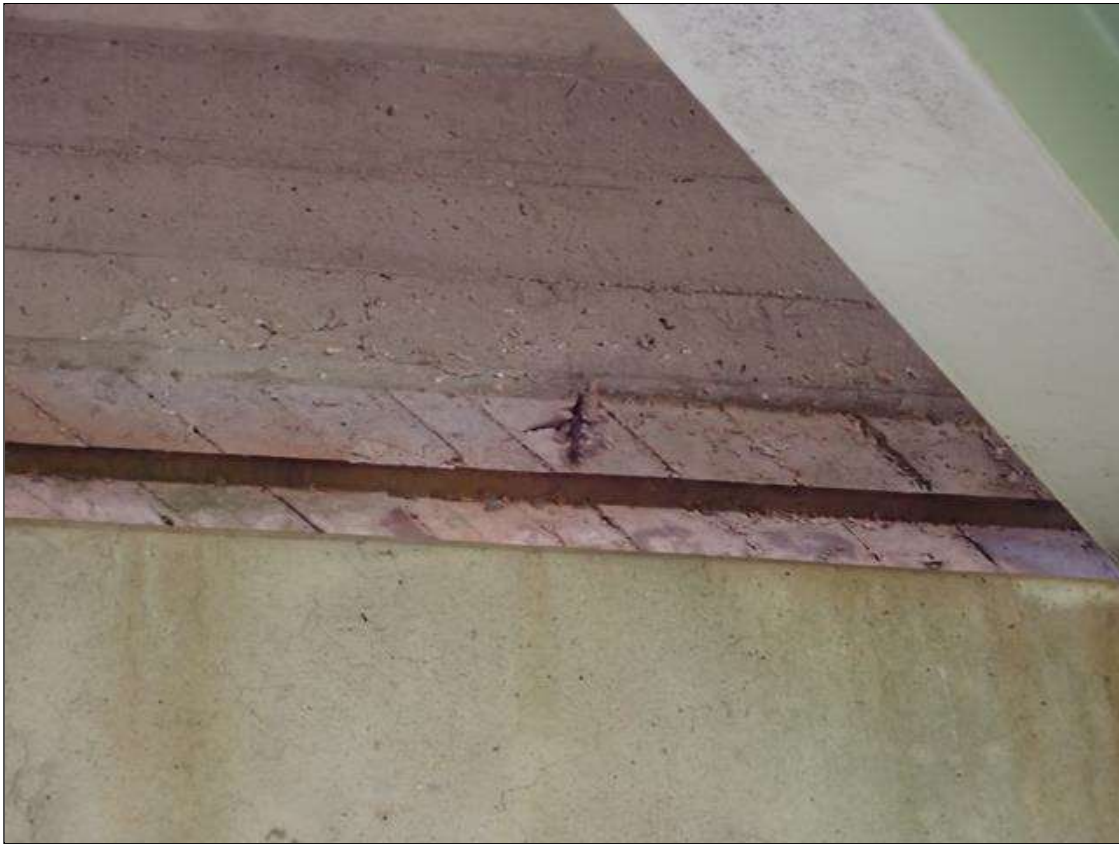
Span 4 Beam 2: BAY 2 END DIAPHRAGM OVER BENT 3, SPALL [8 INCHES X 6 INCHES X 1/2 INCHES DEEP] WITH EXPOSED RUSTED REINFORCING

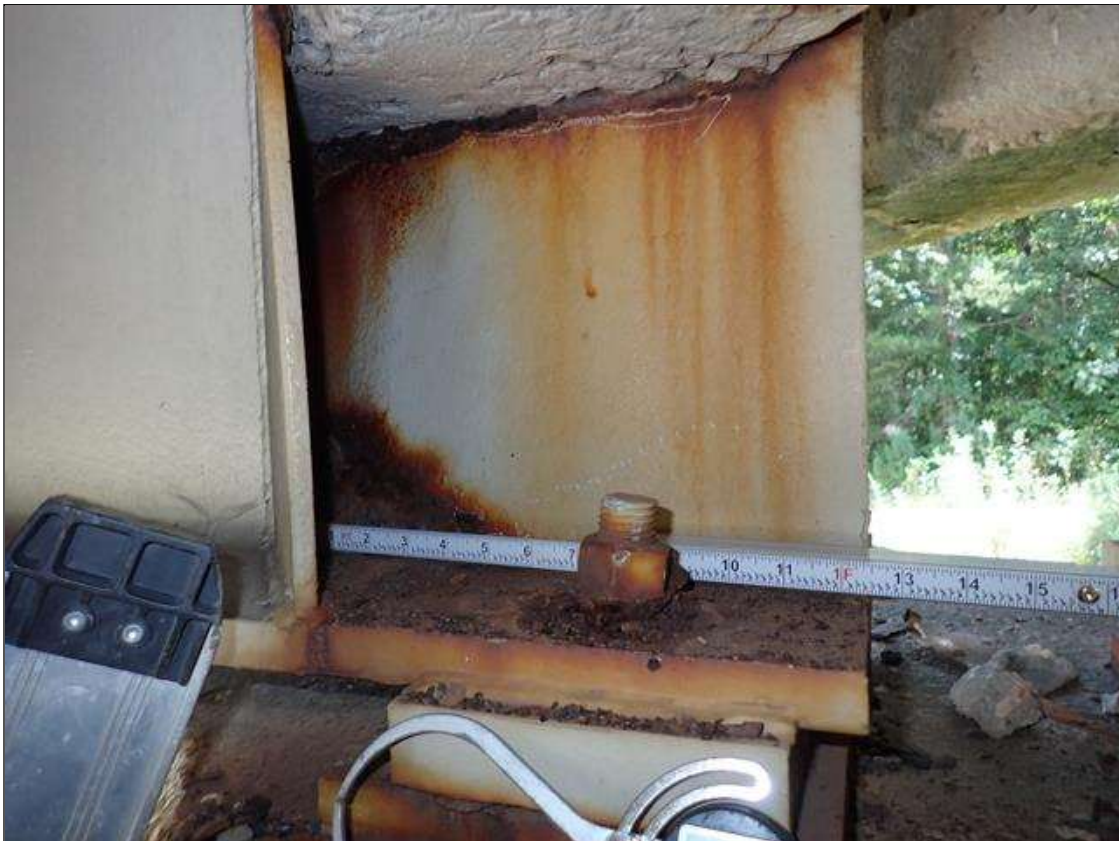
Span 2 Beam 4: at bent 1, corrosion with section loss: web (less than 1/16 inch loss x 1 foot x 10 inch); bottom flange (less than 1/16 inch loss x 1 foot)

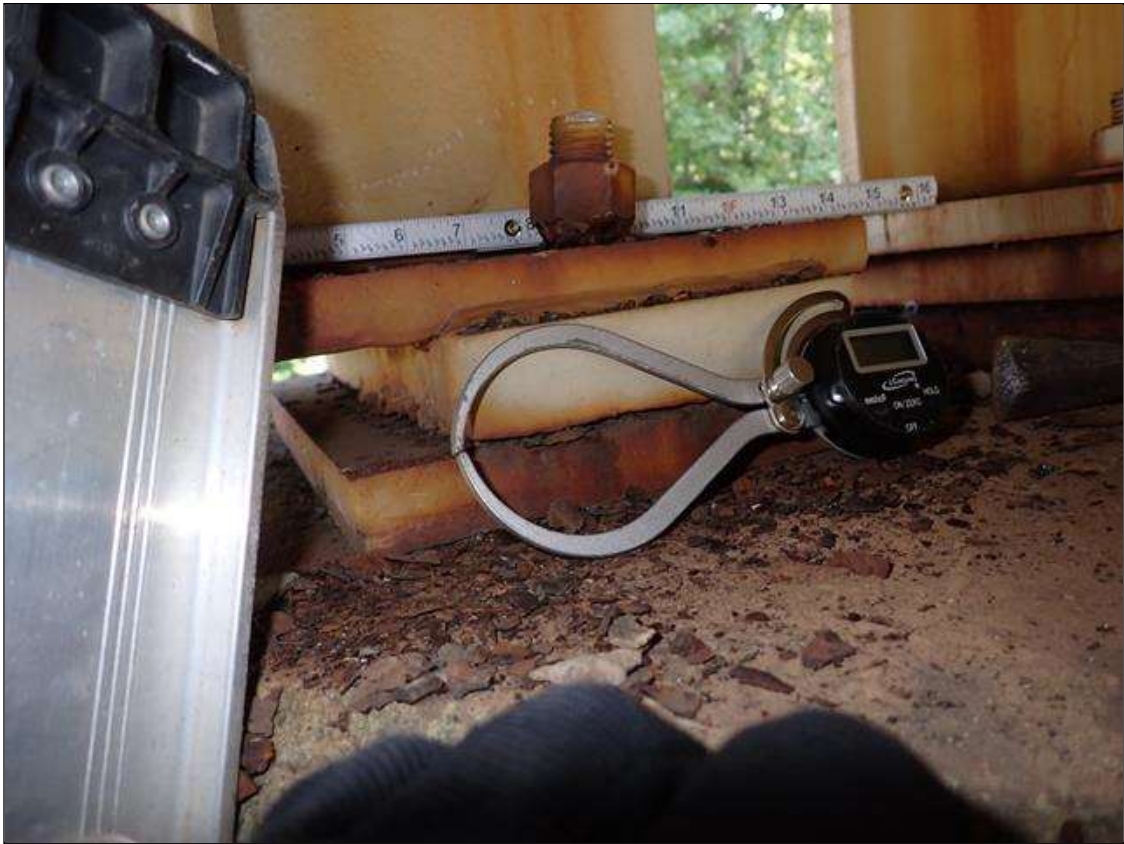
Span 2 Near Bearing 4: surface rust/rust scale

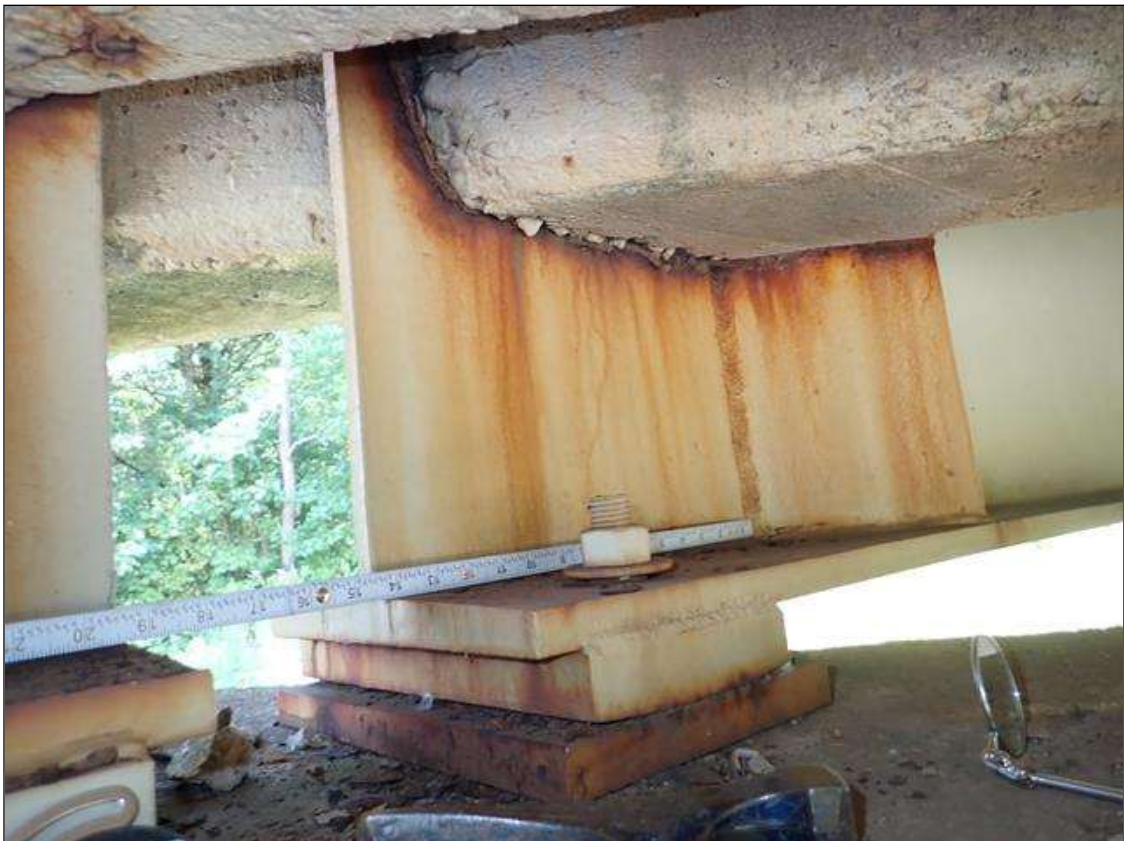
Span 1 Beam 4: at bent 1, web adjacent to end diaphragm, rust scale (13 inch)

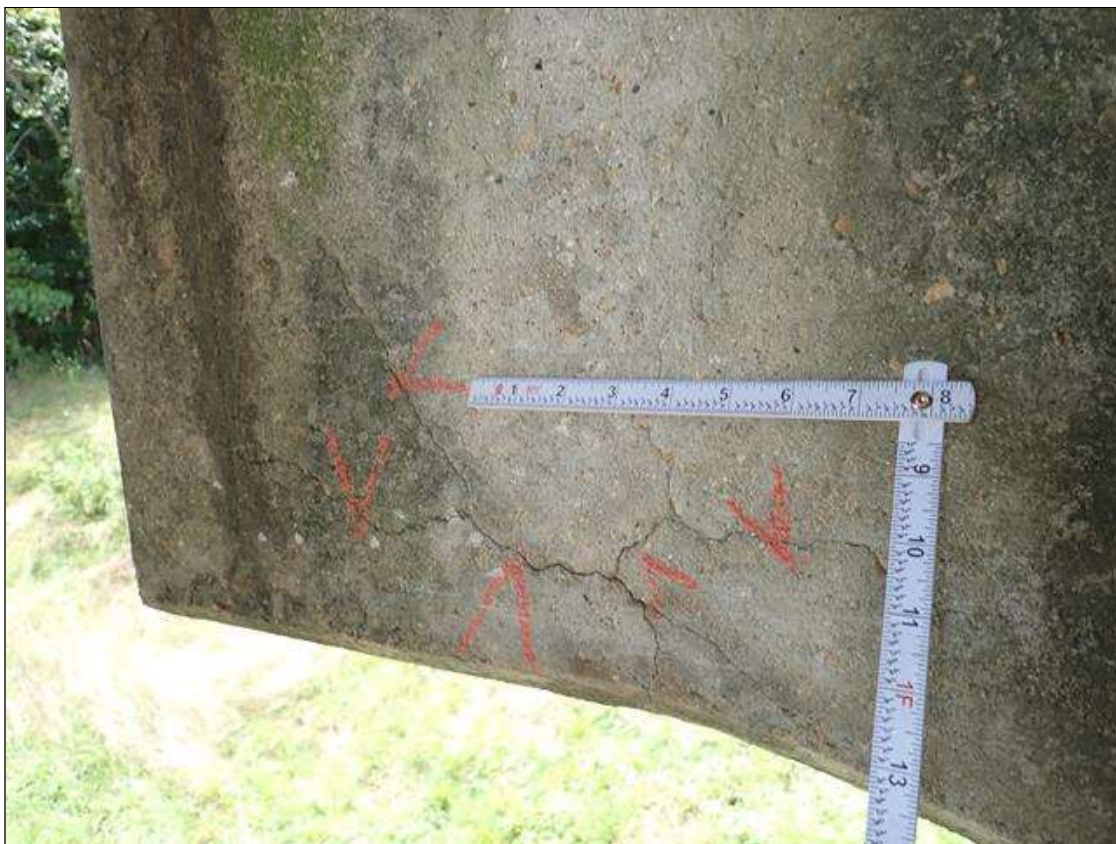
Bent 1 Cap 1: MAP CRACKS (UP TO 1/32 INCH X 2 FOOT X UP TO FULL HEIGHT) NORTHEAST BOTTOM CORNER.

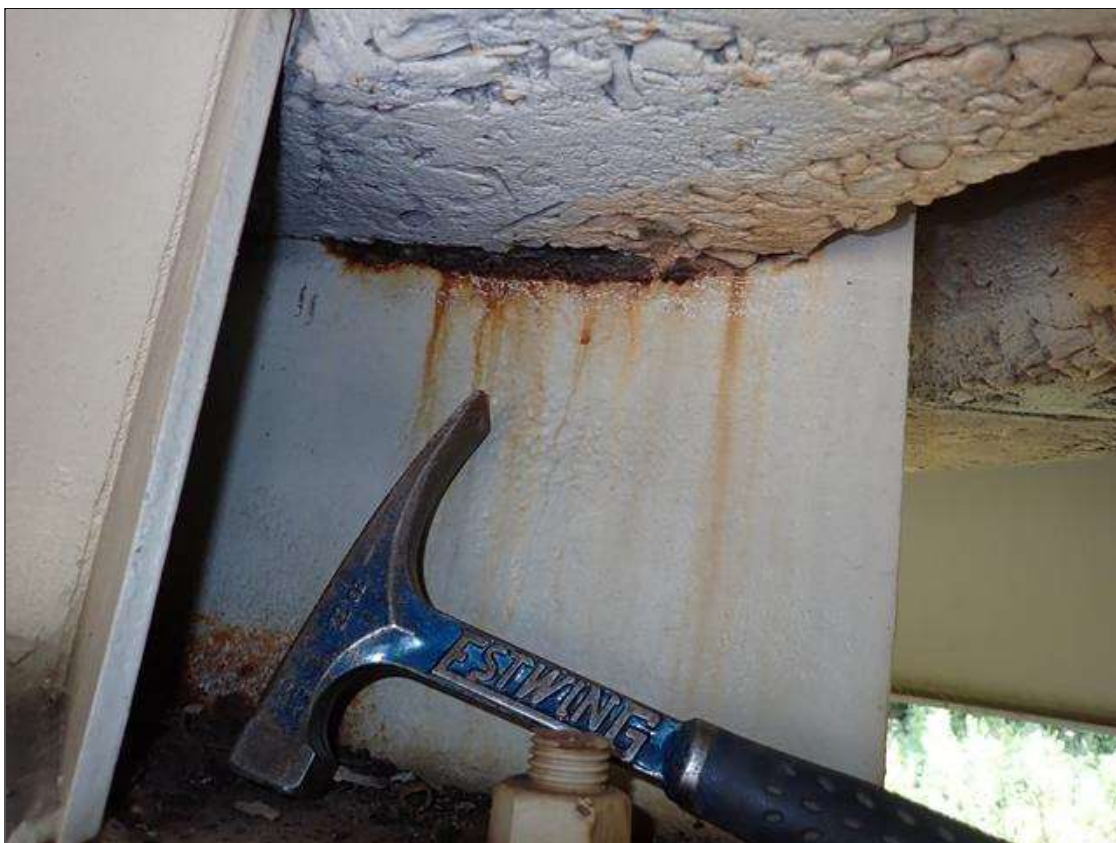
Span 2 Beam 3: at bent 1, web adjacent to end diaphragm and bottom flange, rust scale (13 inch)

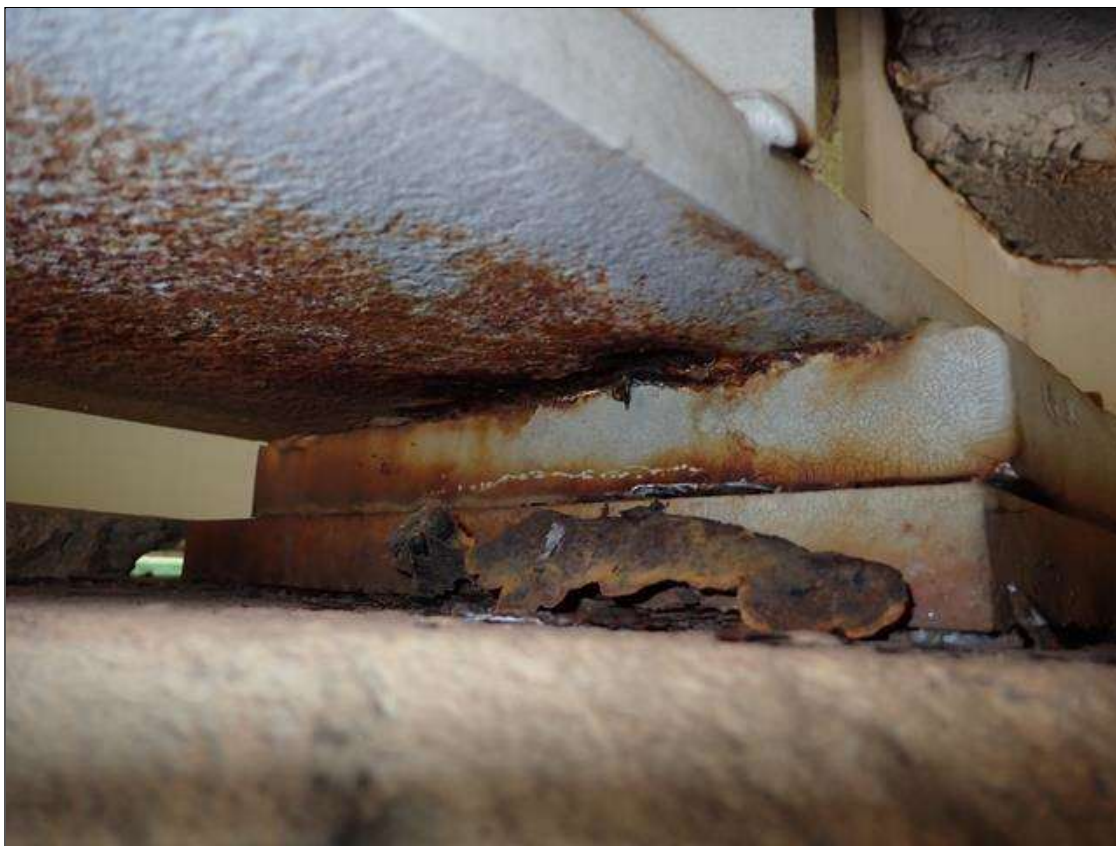
Span 2 Beam 3: at bent 1, web adjacent to end diaphragm and bottom flange, rust scale (13 inch)

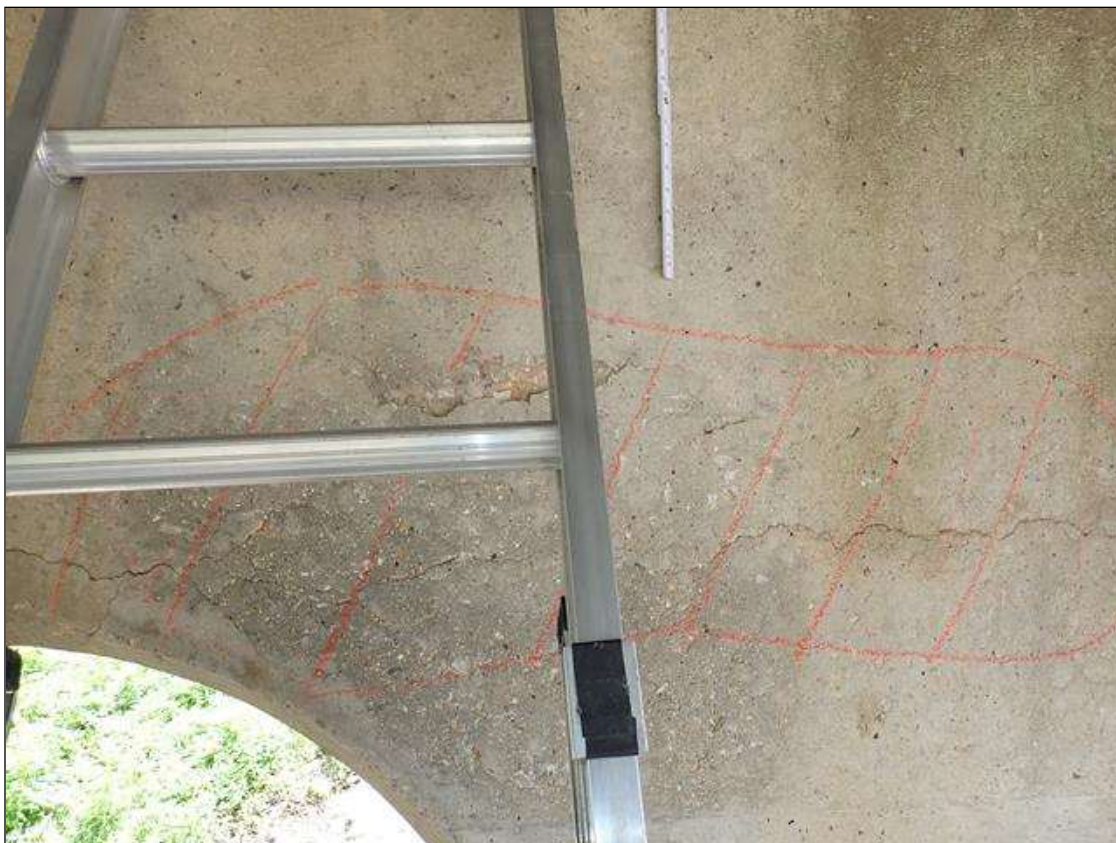
Bent 1 Cap 1: NORTH FACE OF CAP HAS A DELAMINATED/SPALLED AREA ALONG THE BOTTOM EDGE AT COLUMN 2 4 FOOT X 1.5 FOOT X 1/2 INCH DEEP WITH CRACKS UP TO 1/32 INCH

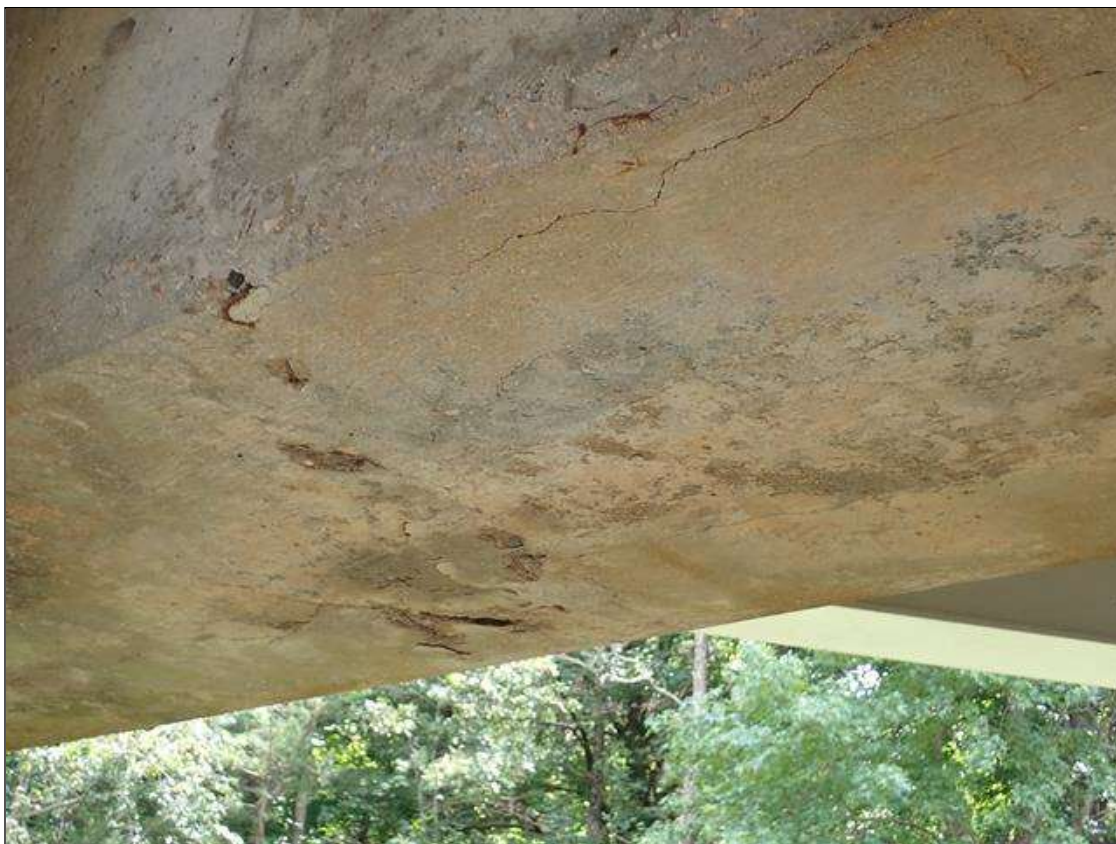
Bent 1 Cap 1: underside between columns 2 and 3, delamination (3 foot x 2 foot) with cracks (up to 1/16 inch)

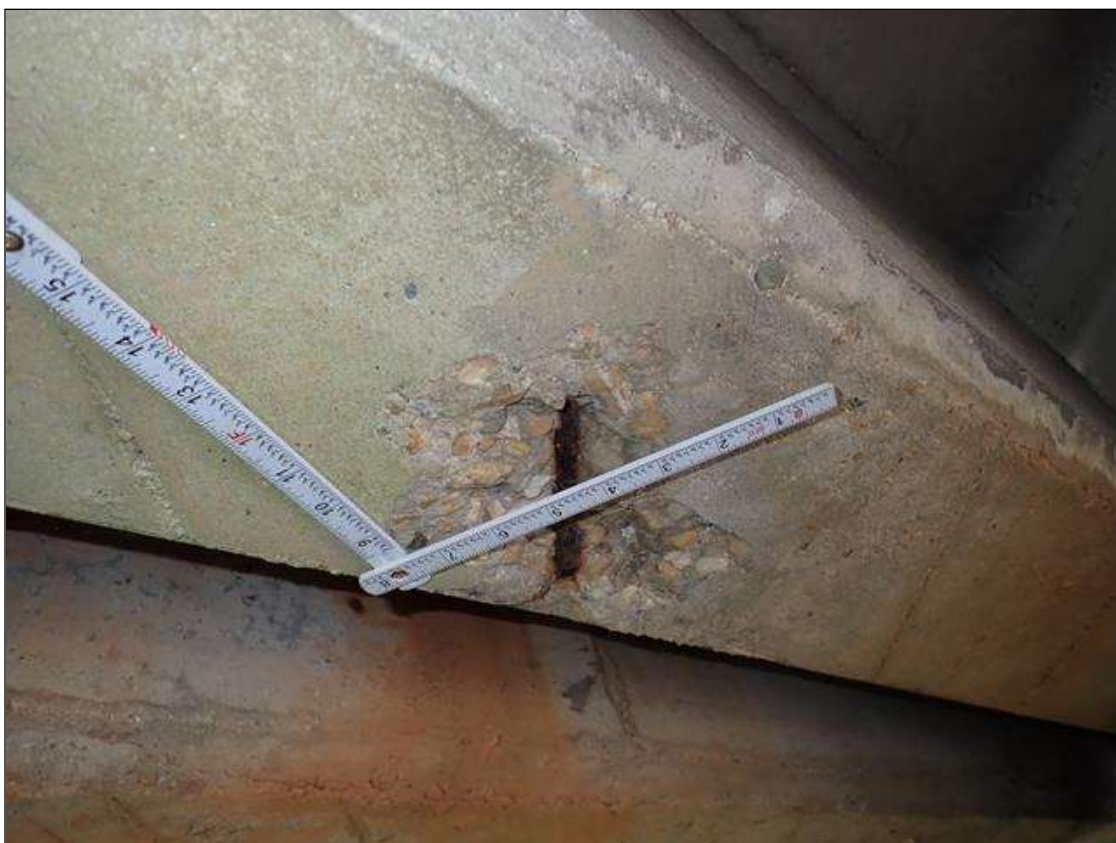
Span 2 Beam 2: 8 INCH X UP TO 5 INCH X 1/2 INCH DEEP SPALL WITH EXPOSED REINFORCING BOTTOM FACE OF BENT 1 DIAPHRAGM IN BAY 2

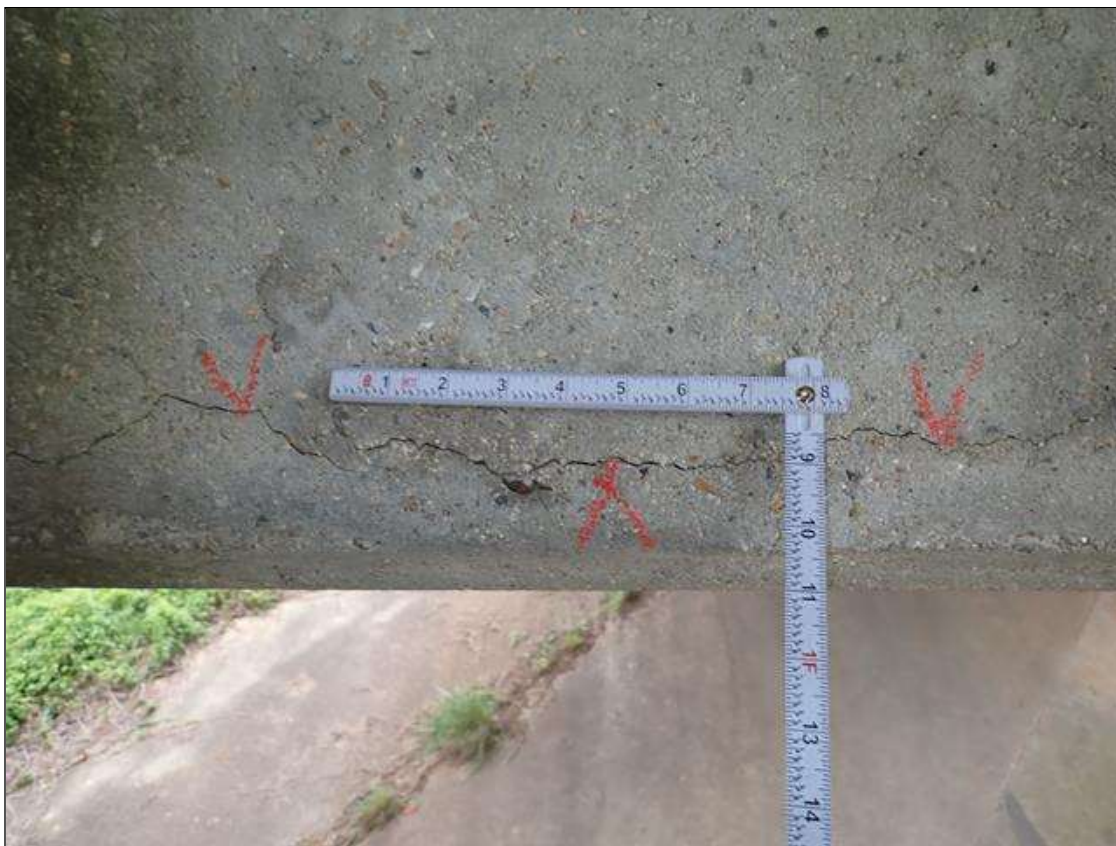
Bent 1 Cap 1: BOTH FACES OF CAP, MULTIPLE HORIZONTAL AND VERTICAL CRACKS [UP TO 7 FEET X 1/16 INCHES]

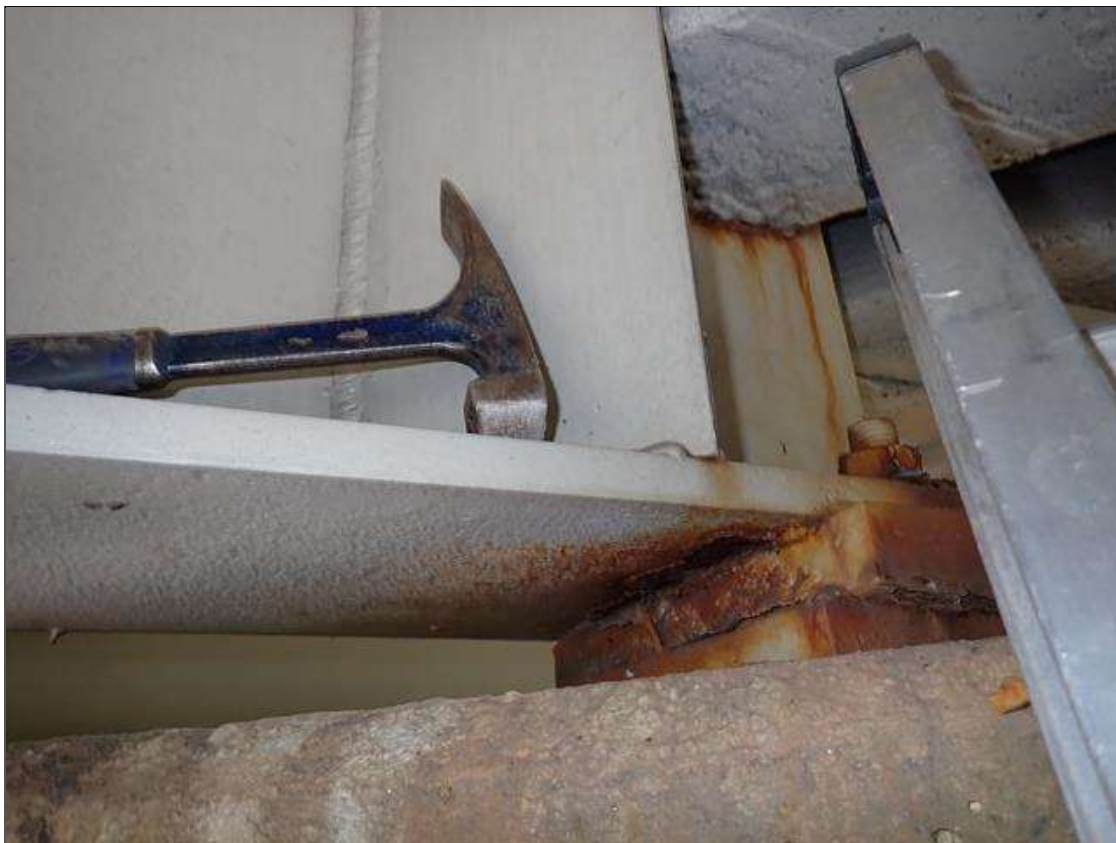
Span 2 Beam 2: at bent 1, web adjacent to end diaphragm and bottom flange, rust scale (13 inch)

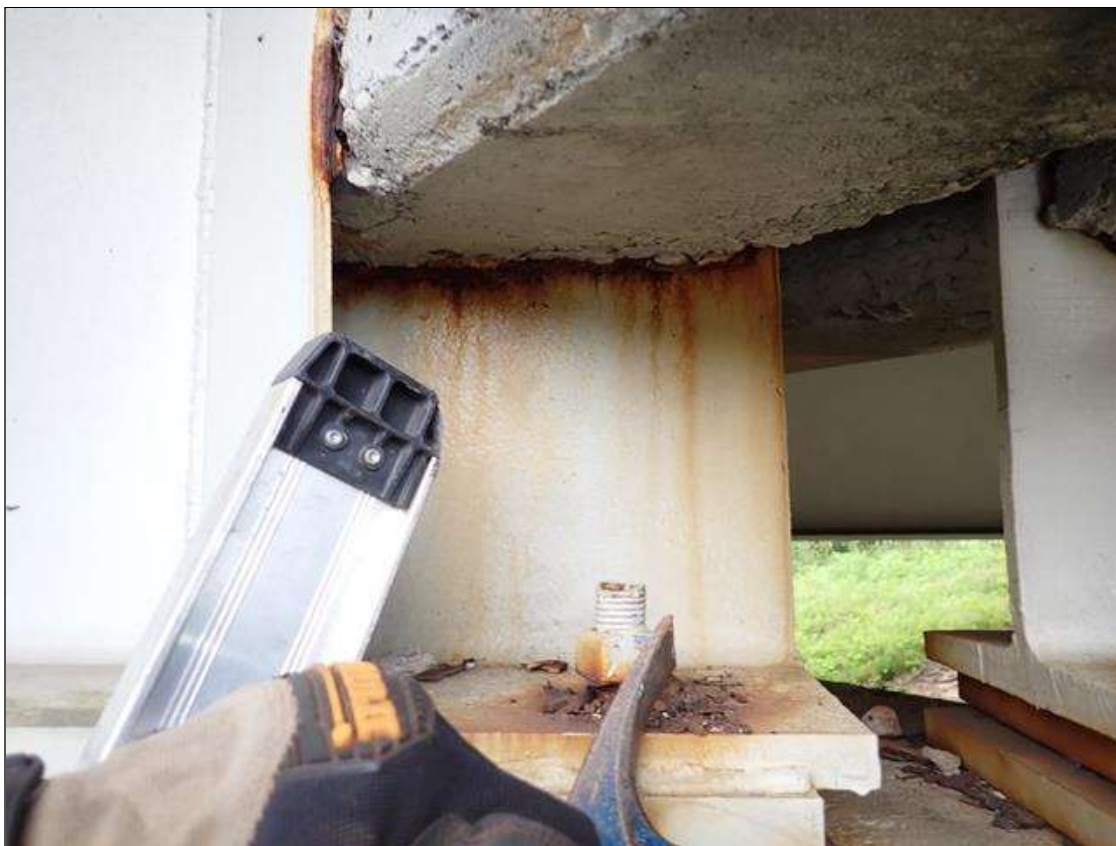
Span 2 Beam 1: at bent 1, web adjacent to end diaphragm and bottom flange, rust scale (13 inch)

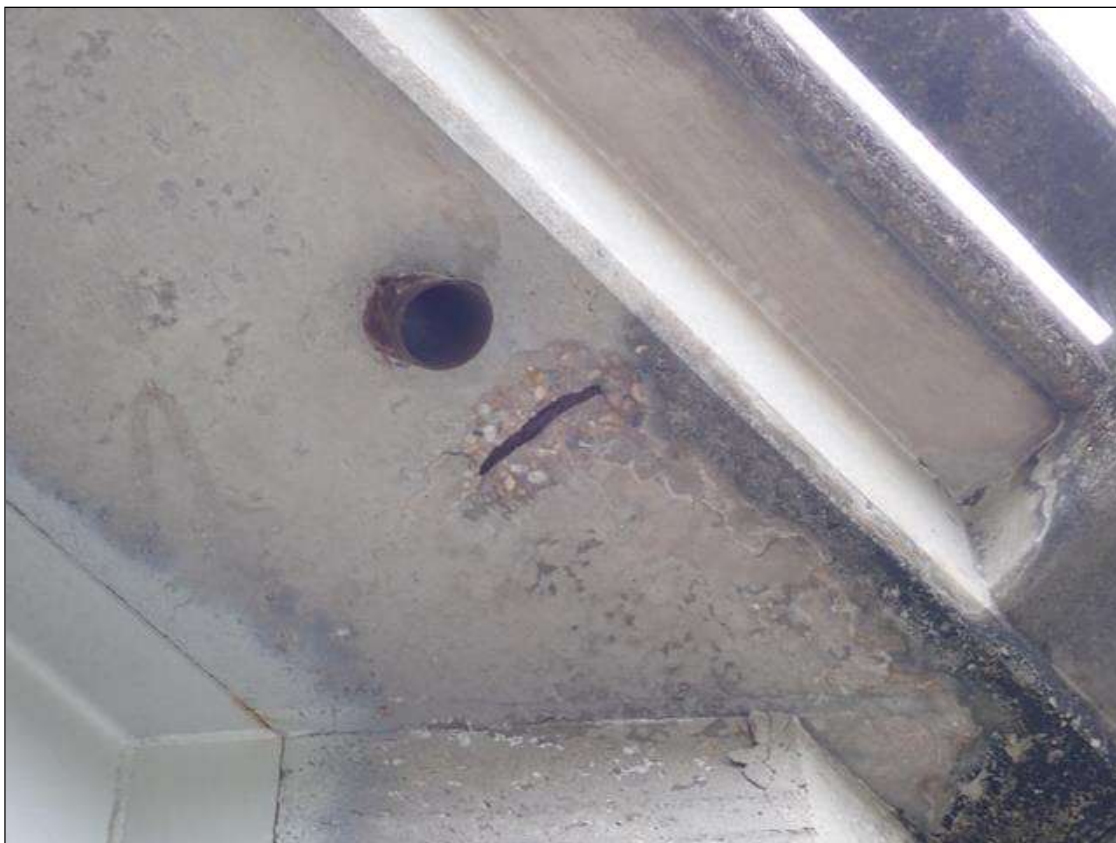
Span 2 Deck: (PAR) west overhang over bent 1, spall (18 inch x 6 inch x 1/2 inch deep) with exposed rusted rebar

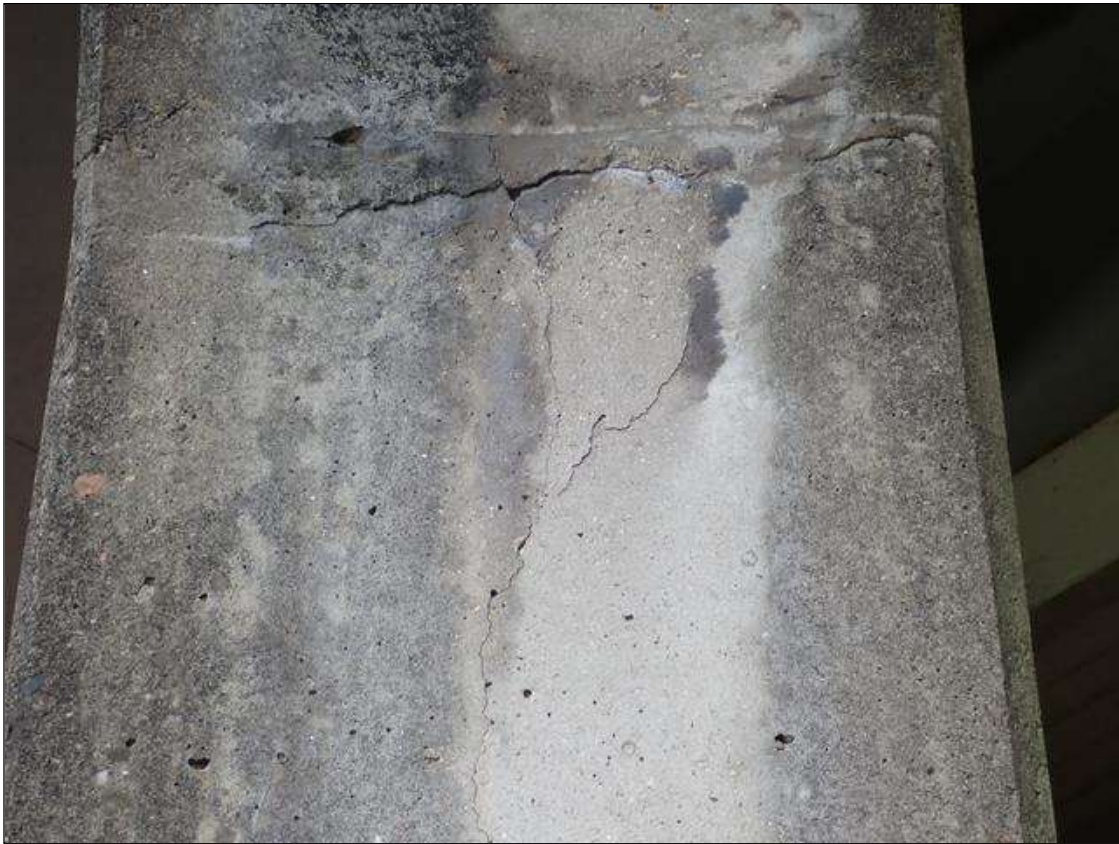
Bent 1 Pile 1: WEST FACE AT CAP, VERTICAL CRACK [4 FEET X UP TO 1/32 INCHES] WITH ADJACENT DELAMINATION [10 INCHES X 6 INCHES]

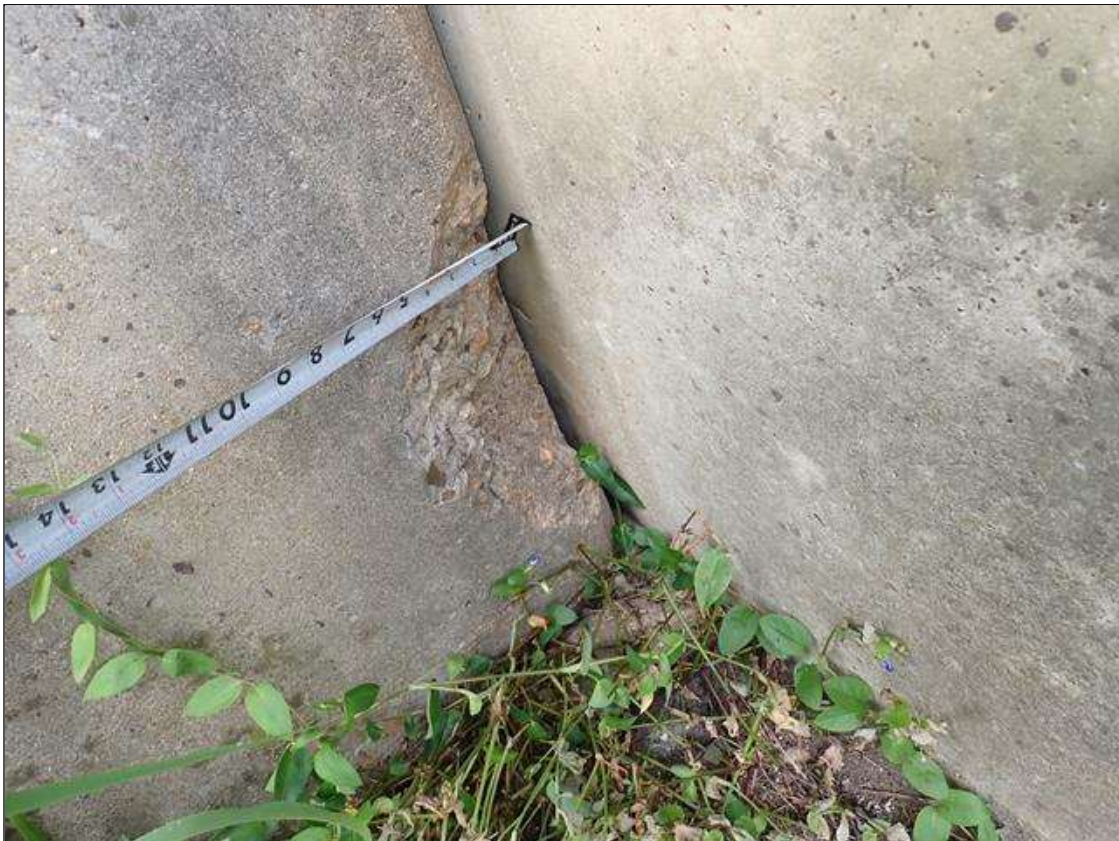
Bent 1 Pile 3: BOTTOM EAST FACE OF COLUMN 3 HAS A SPALL AREA AT GROUND LINE 7 INCHES X 17 INCHES X 3.5 INCHES .

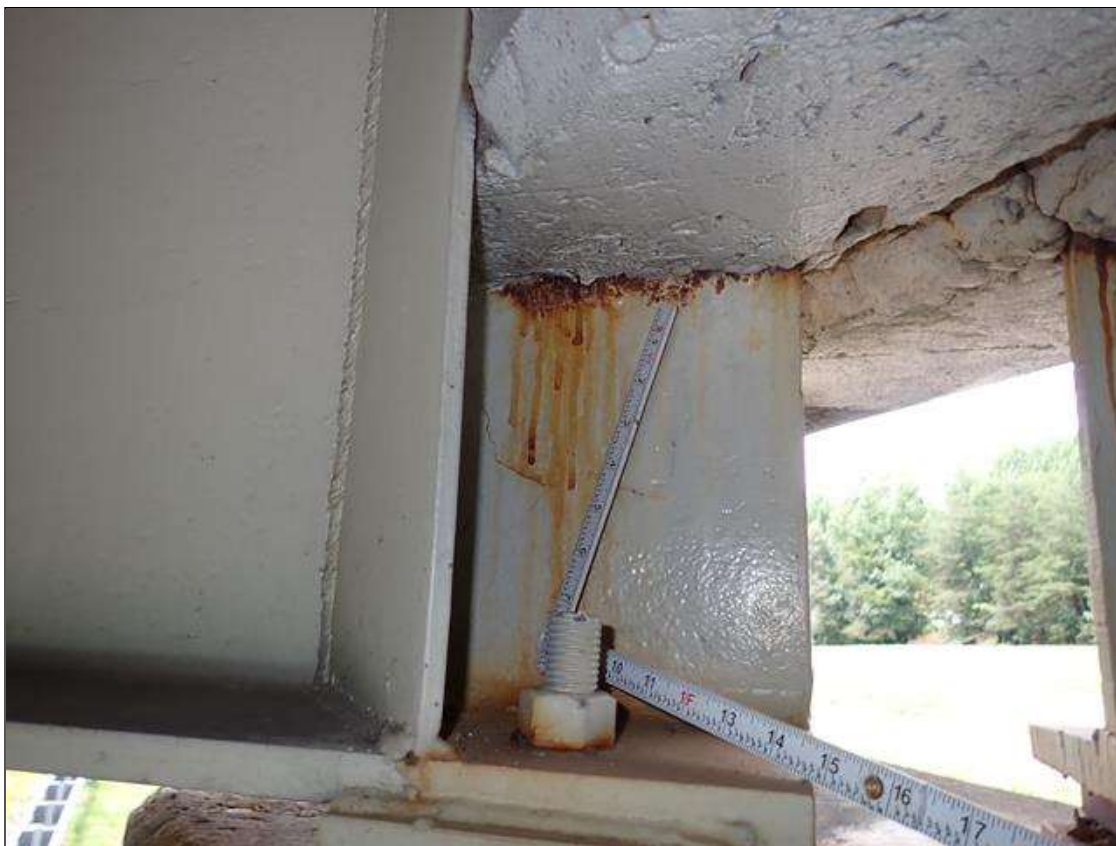
Span 2 Beam 1: at bent 2, web adjacent to end diaphragm, rust scale (10 inch)

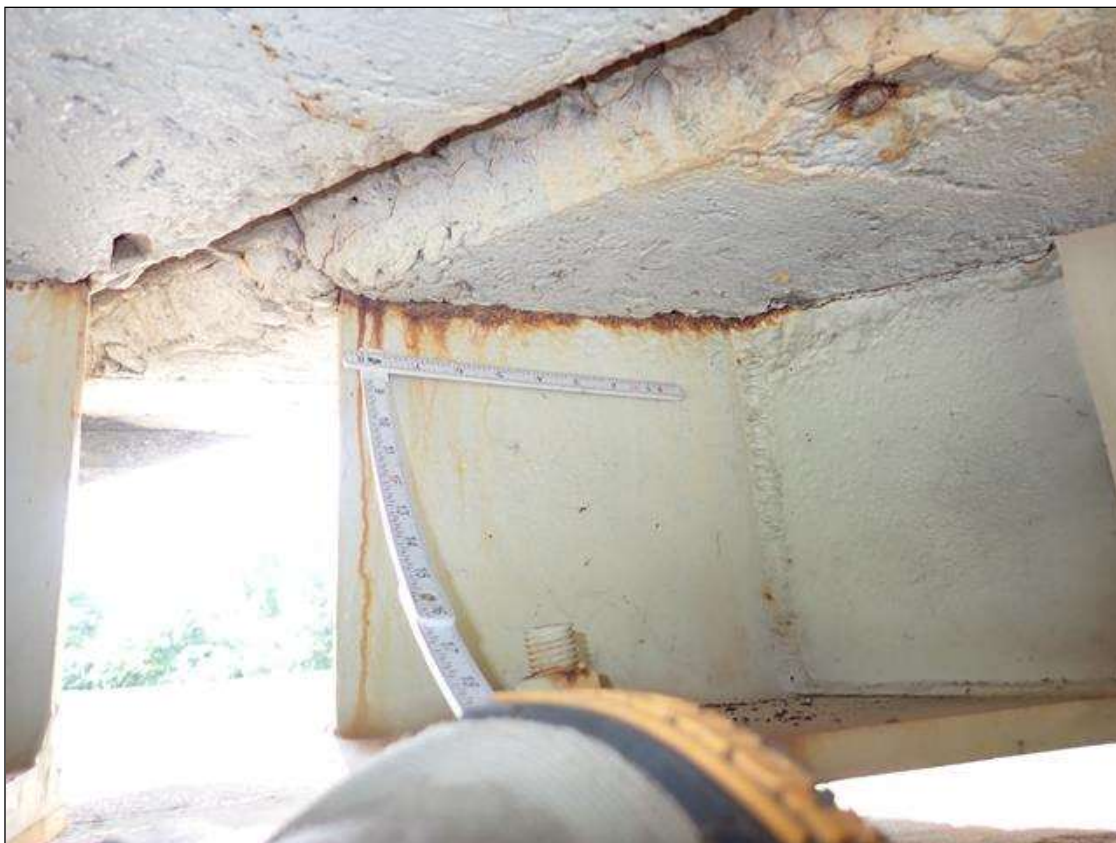
Span 3 Beam 1: at bent 2, web adjacent to end diaphragm, corrosion with section loss (9/16 inch average remaining x 10 inch x 1 inch)

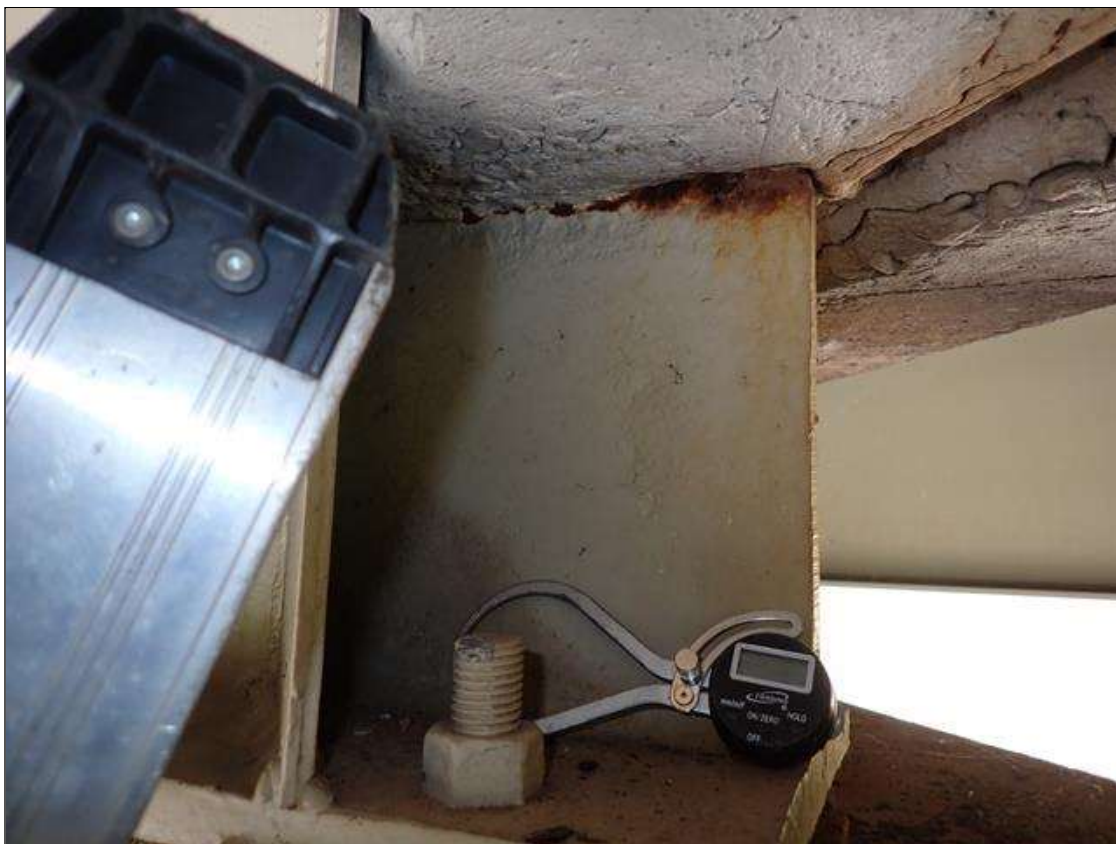
Span 2 Beam 3: at bent 2, web adjacent to end diaphragm, corrosion with section loss (9/16 inch average remaining x 10 inch x 1 inch)

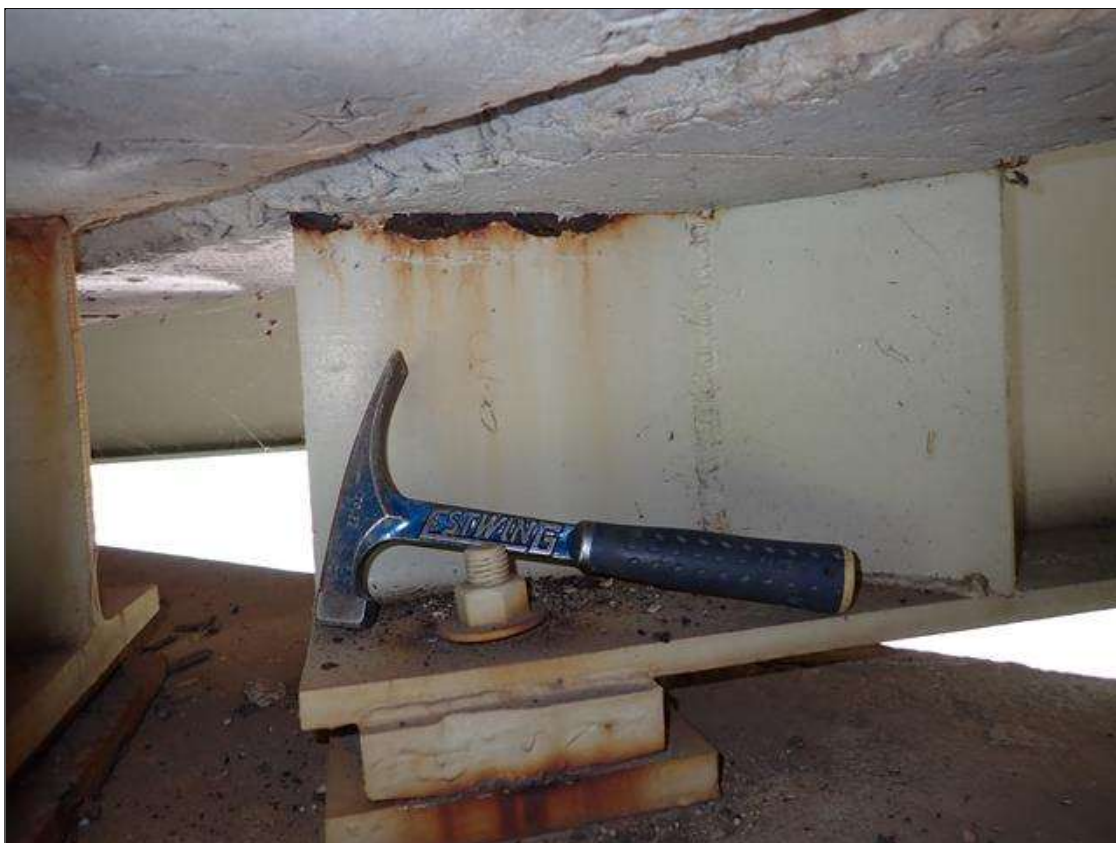
Span 3 Beam 2: at bent 2, web adjacent to end diaphragm, rust scale (10 inch)

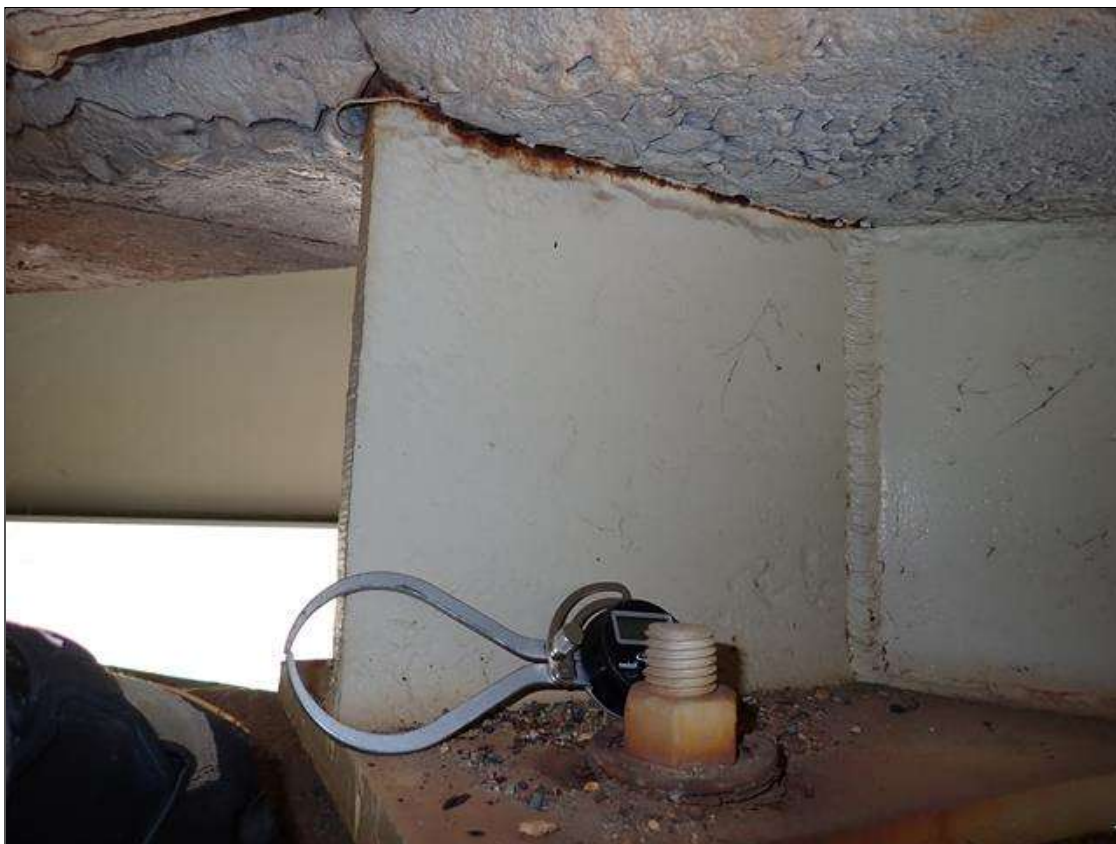
Span 3 Beam 3: at bent 2, web adjacent to end diaphragm, corrosion with section loss (9/16 inch average remaining x 10 inch x 1 inch)

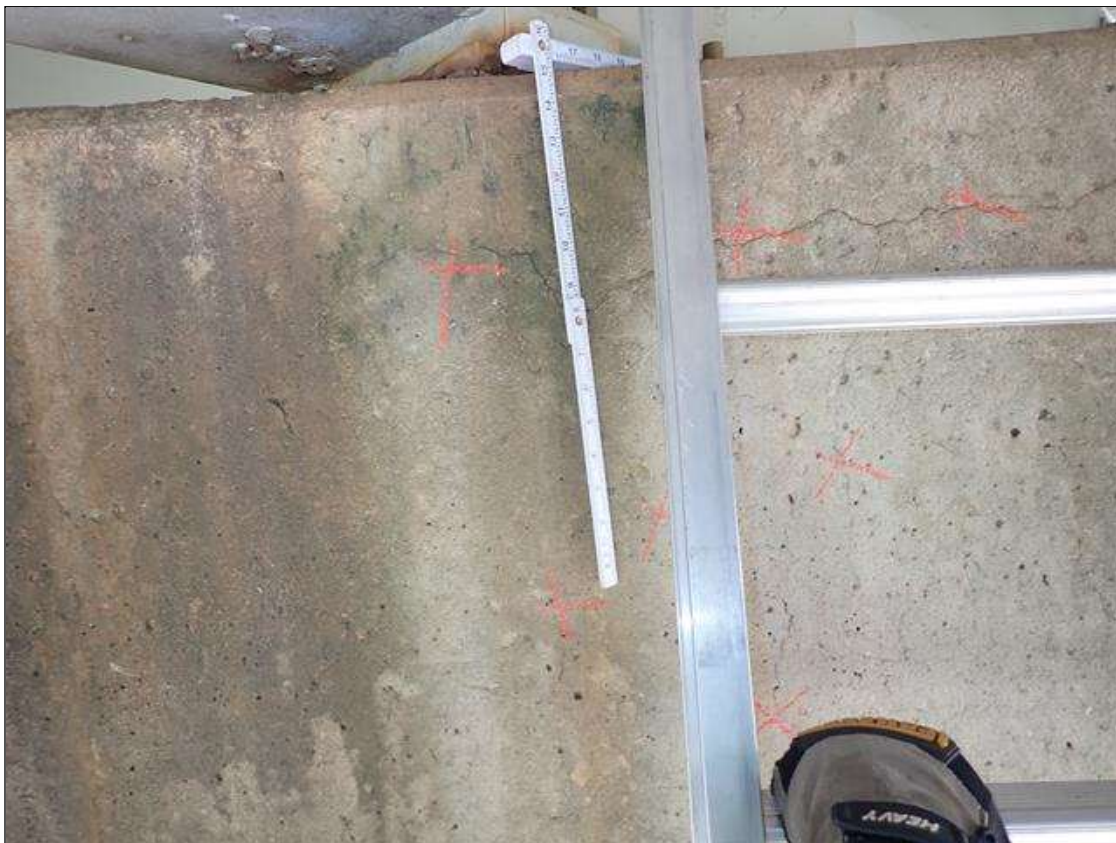
Bent 2 Cap 1: ALONG ALL FACES OF CAP, SCATTERED MAP CRACKING UP TO 1/64 INCHES AT RANDOM
