NC DEPARTMENT OF TRANSPORTATION
 DIVISION OF HIGHWAYS
 STRUCTURE MANAGEMENT UNIT

ATTENTION: prompt action request; sketches revised; span 3 total horizontal clearances revised; new repairs

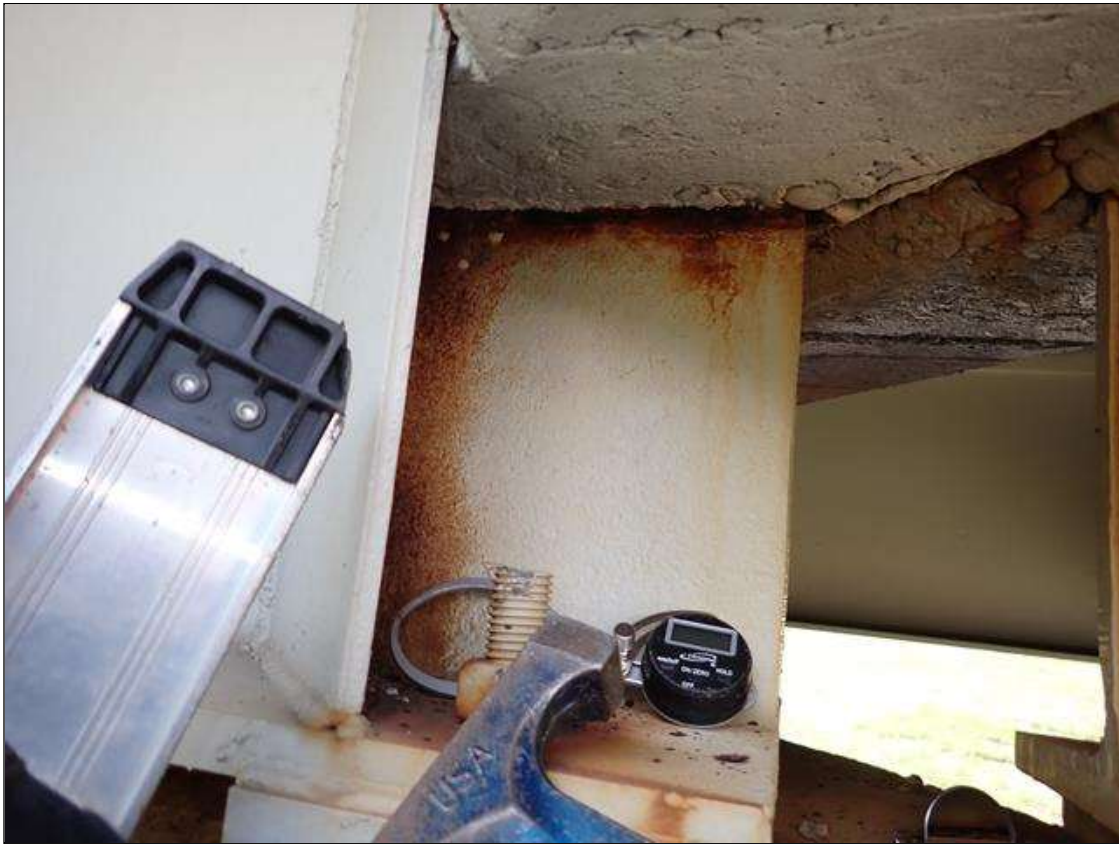
Span 2 Beam 4: at bent 2, web adjacent to end diaphragm, corrosion with section loss (9/16 inch average remaining x 10 inch x 1 inch)

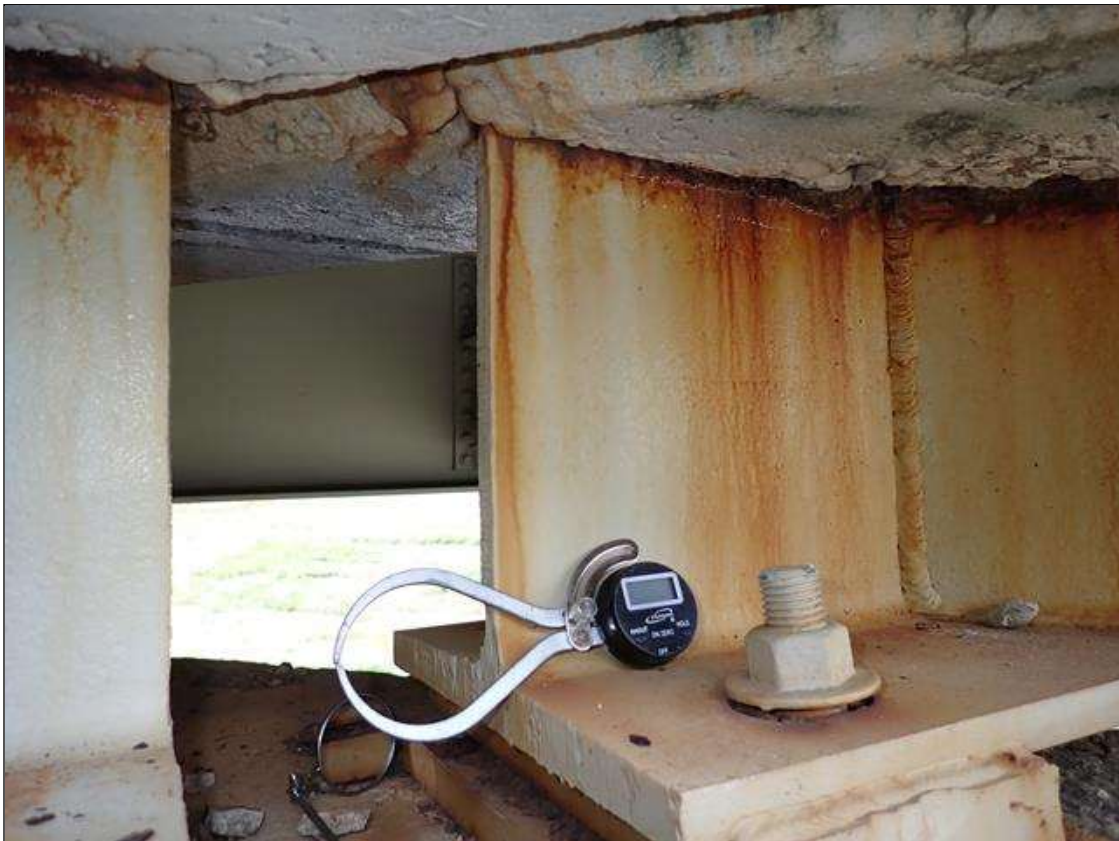
Span 3 Beam 4: at bent 2, web adjacent to end diaphragm, corrosion with section loss (9/16 inch average remaining x 10 inch x 1 inch)

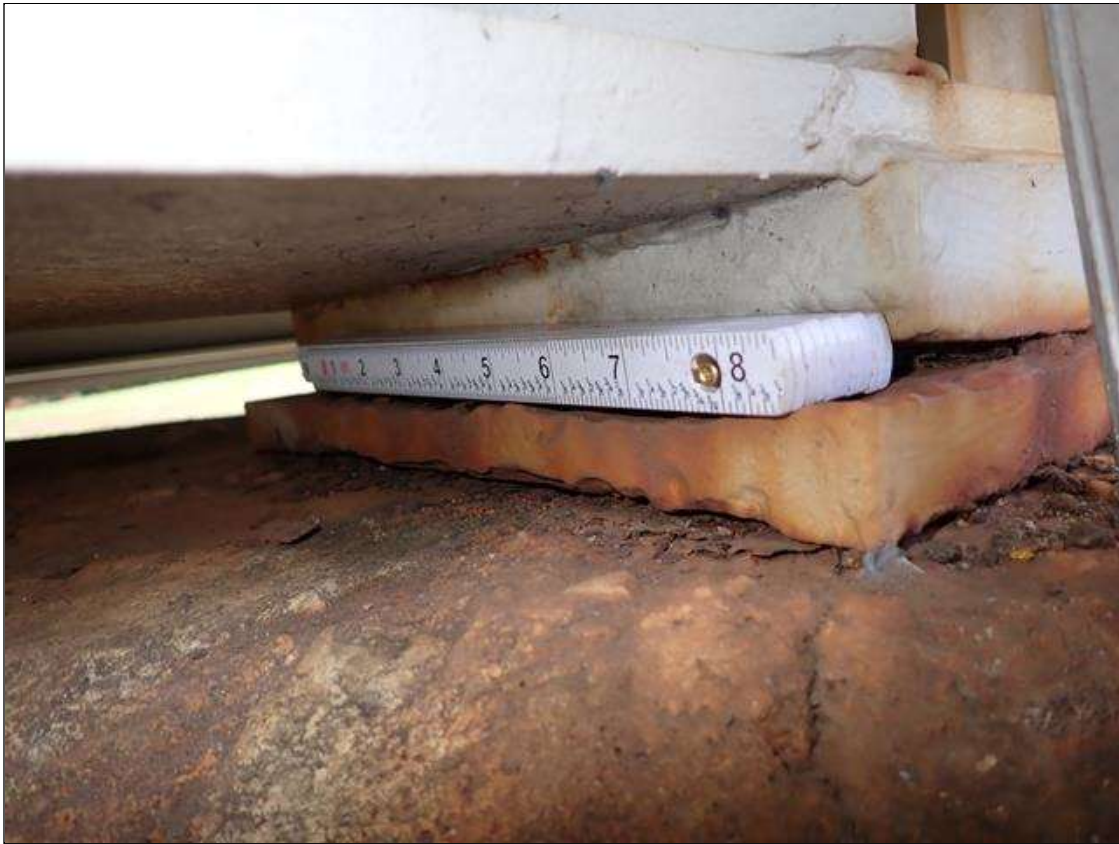
Span 2 Far Bearing 4: corrosion with section loss (up to 1/8 inch loss)

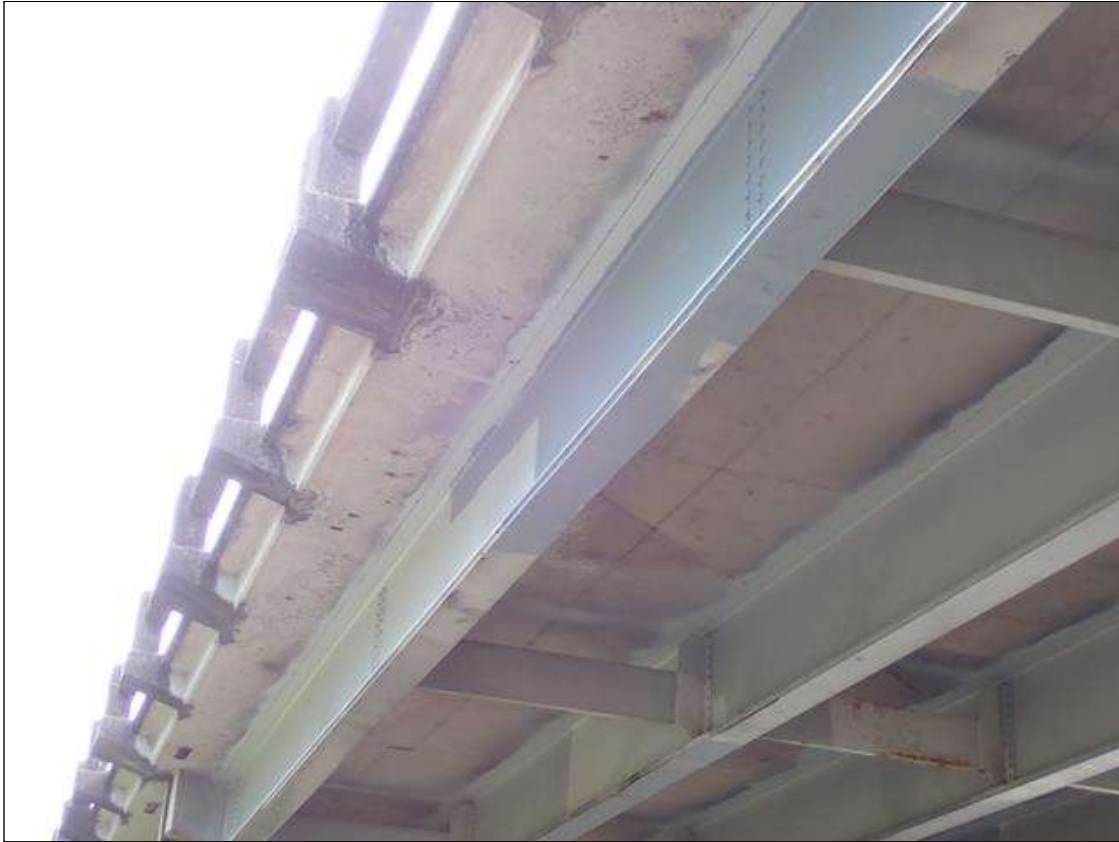
Span 2 Beam 4: 2023 new repair, previously noted as: SUPPLEMENTAL INSPECTION 2022: POINT OF IMPACT 36 FEET 11 INCHES OUT FROM INTERIOR BENT 1 , 15 INCHES LONG BOTTOM FLANGE BENT UPWARD 1 INCH .THERE IS A 7 INCH LONG HAIRLINE CRACK IN THE WELD ATTACHING THE BOTTON COVER PLATE TO THE BOTTOM FLANGE LEFT SIDE AT 36 FEET 5 INCHES OUT FROM INTERIOR BENT 1. SCATTERED SCRAPS WITH UP TO 1 INCH INDENTIONS THROUGHOUT ON BOTTOM COVER PLATE . BEAM 4 SWEEP EASTWARD UP TO 2 INCHES. POSSIBLE HAIRLINE CRACK 1 INCH UP RIGHT FACE OF WEB UP TO 2 INCH LONG AT DIAPHRAM 3 ,23 FEET 3 INCHES FROM INTERIOR BENT 2 .

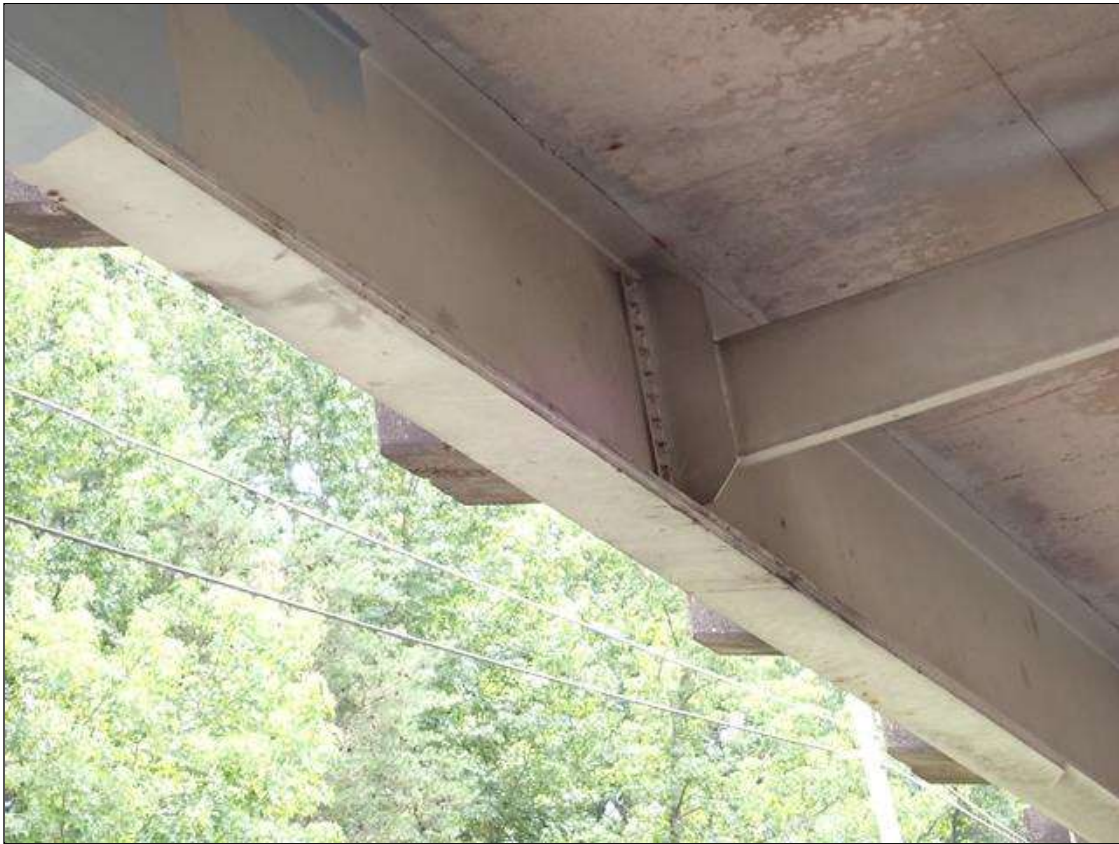
Span 2 Beam 4: 2023 new repair, previously noted as: SUPPLEMENTAL INSPECTION 2022: POINT OF IMPACT 36 FEET 11 INCHES OUT FROM INTERIOR BENT 1 , 15 INCHES LONG BOTTOM FLANGE BENT UPWARD 1 INCH .THERE IS A 7 INCH LONG HAIRLINE CRACK IN THE WELD ATTACHING THE BOTTON COVER PLATE TO THE BOTTOM FLANGE LEFT SIDE AT 36 FEET 5 INCHES OUT FROM INTERIOR BENT 1. SCATTERED SCRAPS WITH UP TO 1 INCH INDENTIONS THROUGHOUT ON BOTTOM COVER PLATE . BEAM 4 SWEEP EASTWARD UP TO 2 INCHES. POSSIBLE HAIRLINE CRACK 1 INCH UP RIGHT FACE OF WEB UP TO 2 INCH LONG AT DIAPHRAM 3 ,23 FEET 3 INCHES FROM INTERIOR BENT 2 .

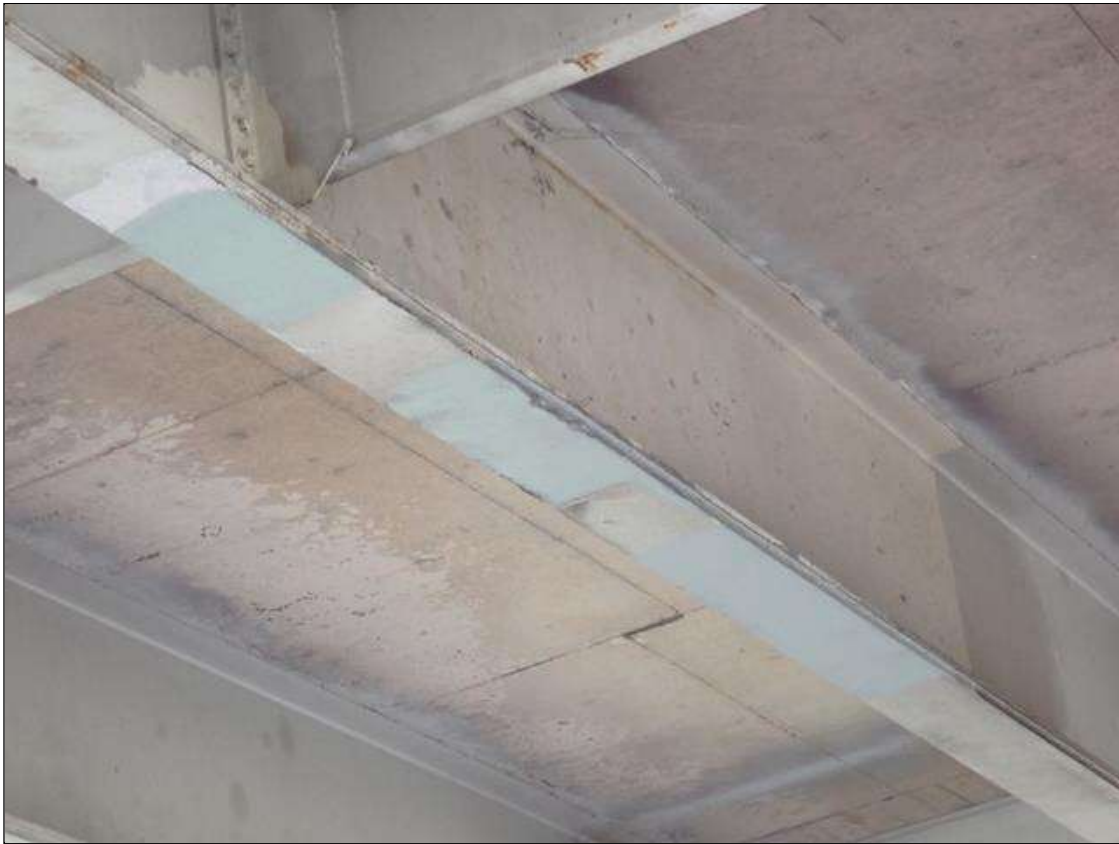
Span 2 Beam 3: 2023 new repair, previously noted as: SUPPLEMENTAL INSPECTION 2021: POINT OF IMPACT ON BEAM 3 26 FEET 1 INCHES FROM FACE OF BENT 1. A INDENTION IN COVER PLATE THREE INCHES X 1/2 INCHES AND A 2 INCHES X 1/2 INCHES IN THE IMPACT AREA.

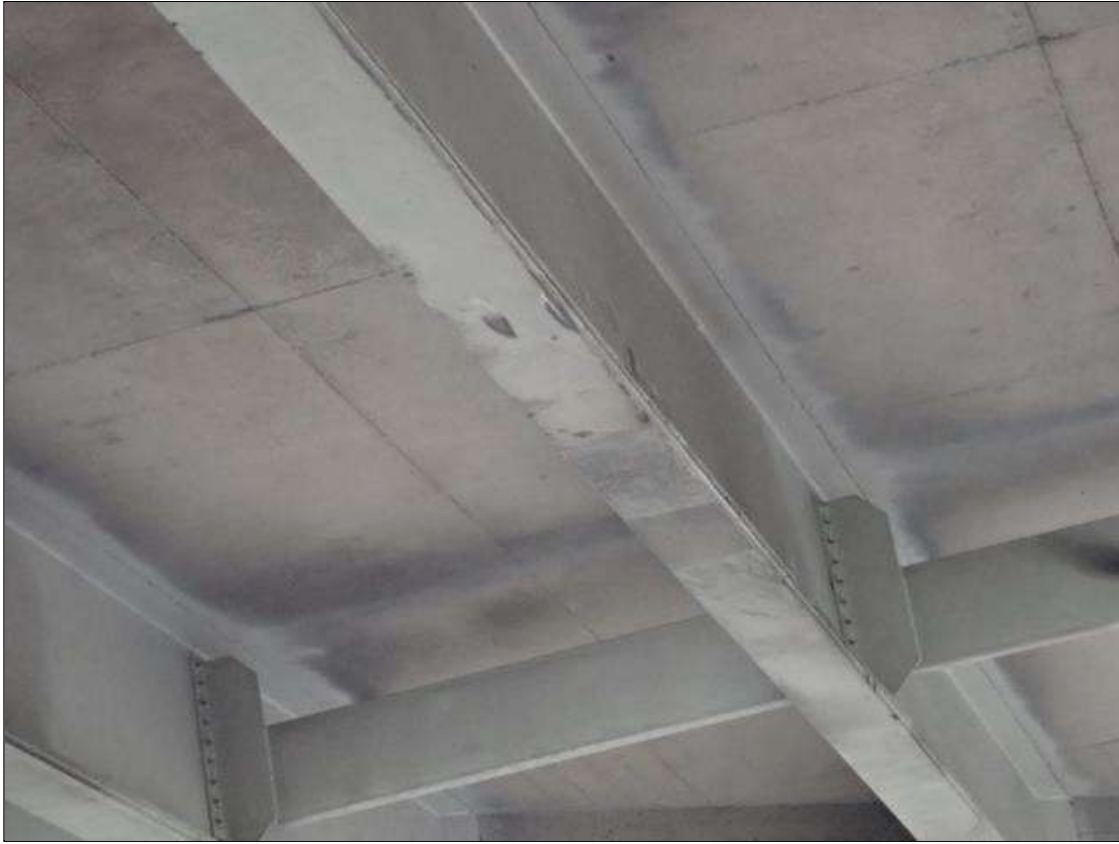
Span 2 Beam 2: 2023 new repair, previously noted as: SUPPLEMENTAL INSPECTION 2022 POINT OF IMPACT ON BEAM 2 27 FEET 6 INCHES FROM FACE OF BENT 1. GOUGES IN FLANGE COVER PLATE 1/2 INCHES X 14 INCHES X 1/16 INCHES AND A INDENTION IN FLANGE COVER PLATE 6 INCHES X 1/32 INCH , A INDENTION IN FLANGE 1 1/2 INCHES X 1/16 INCHES ALL IN THE IMPACT AREA.

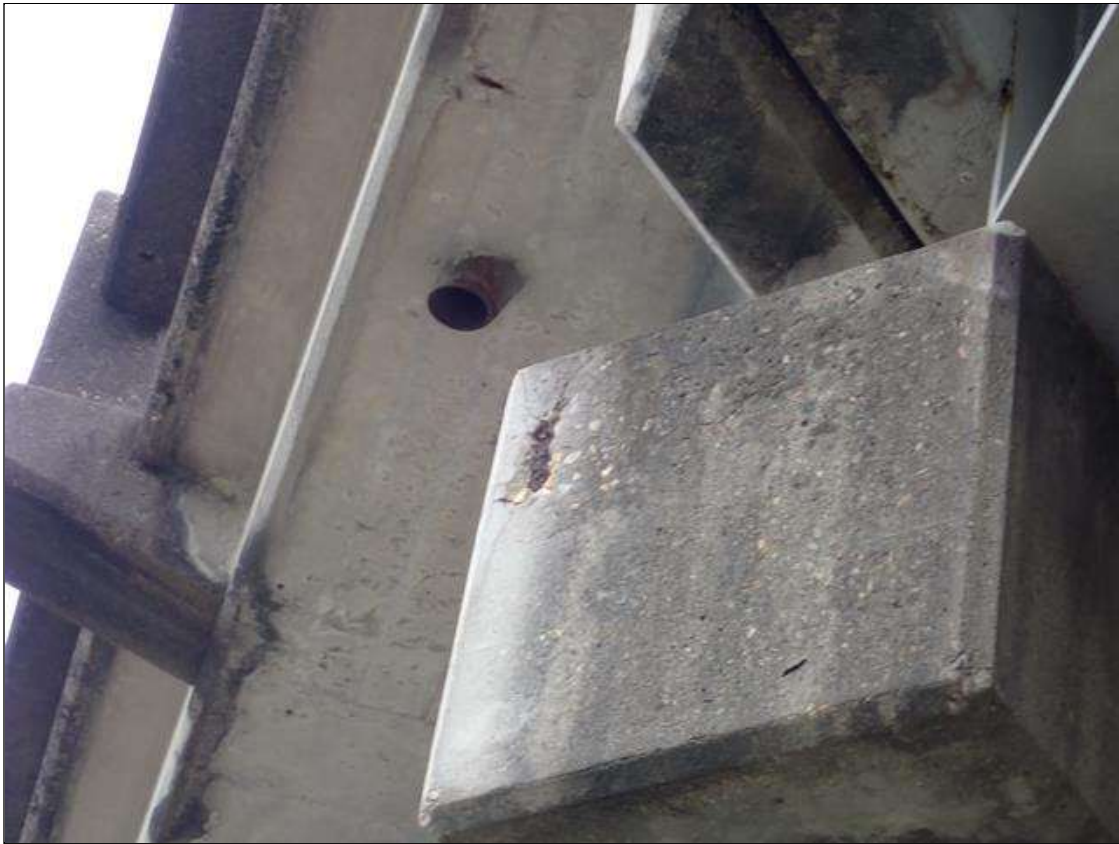
Bent 2 Cap 1: WEST END OF CAP HAS A SURFACE SPALL AND DELAMINATED AREA 4 INCHES X 10 INCHES X 1/2 INCHES WITH EXPOSED RUSTED REINFORCING [NO LOSS]

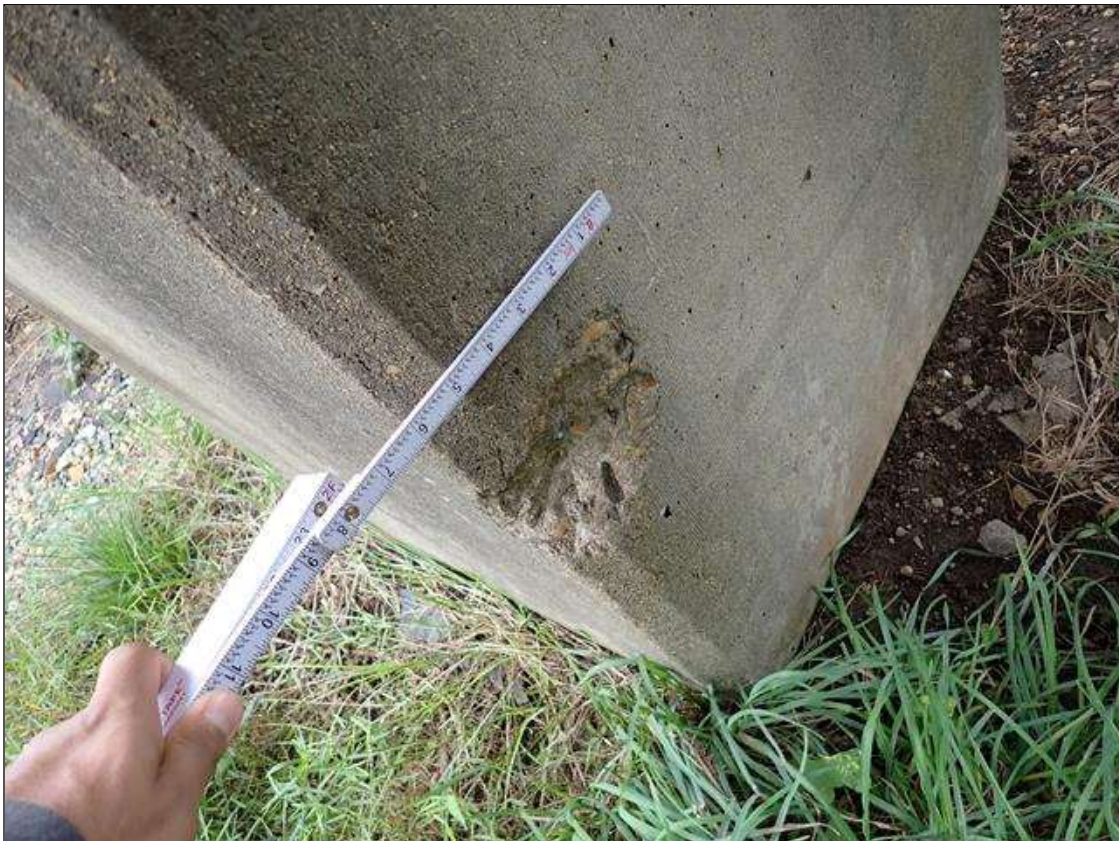
Bent 2 Pile 1: 5 INCHES X 5 INCHES X 1 INCHES SPALL ON SOUTH WEST CORNER 18 INCHES ABOVE THE GROUND.

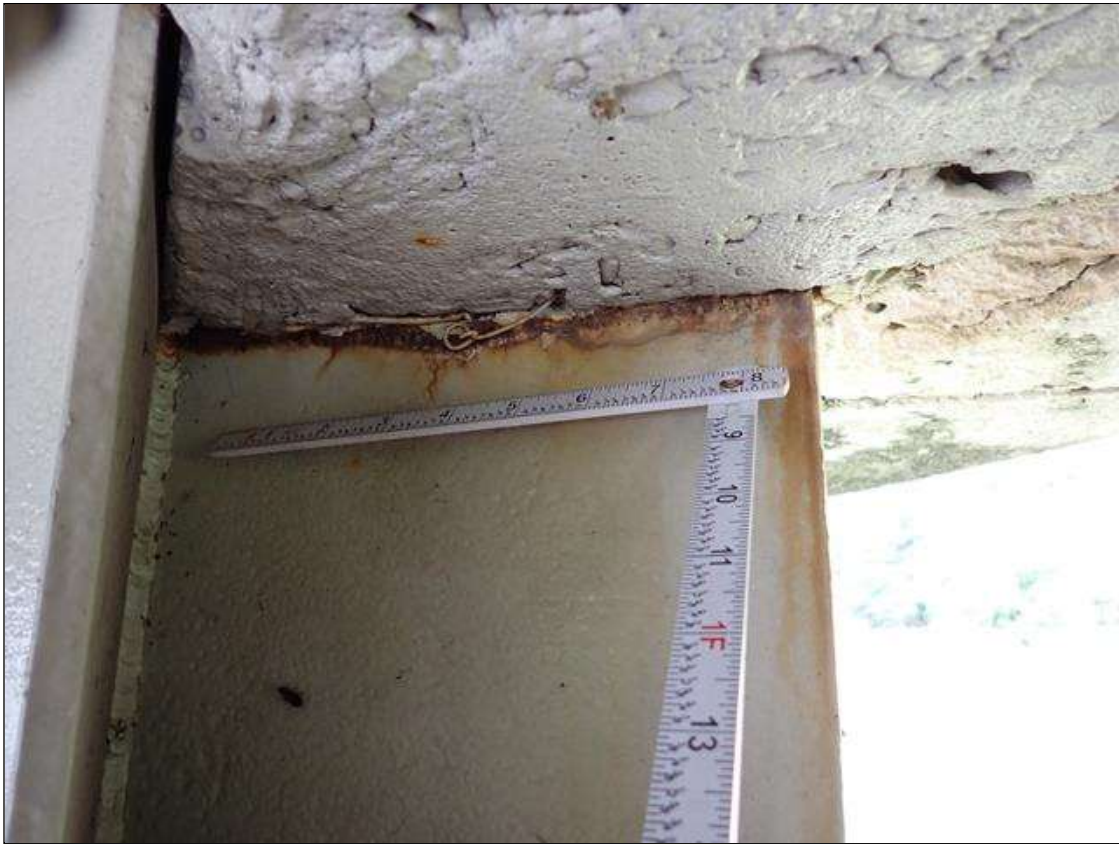
Span 3 Beam 1: at bent 3, web adjacent to end diaphragm, corrosion with section loss (9/16 inch average remaining x 10 inch x 1 inch)

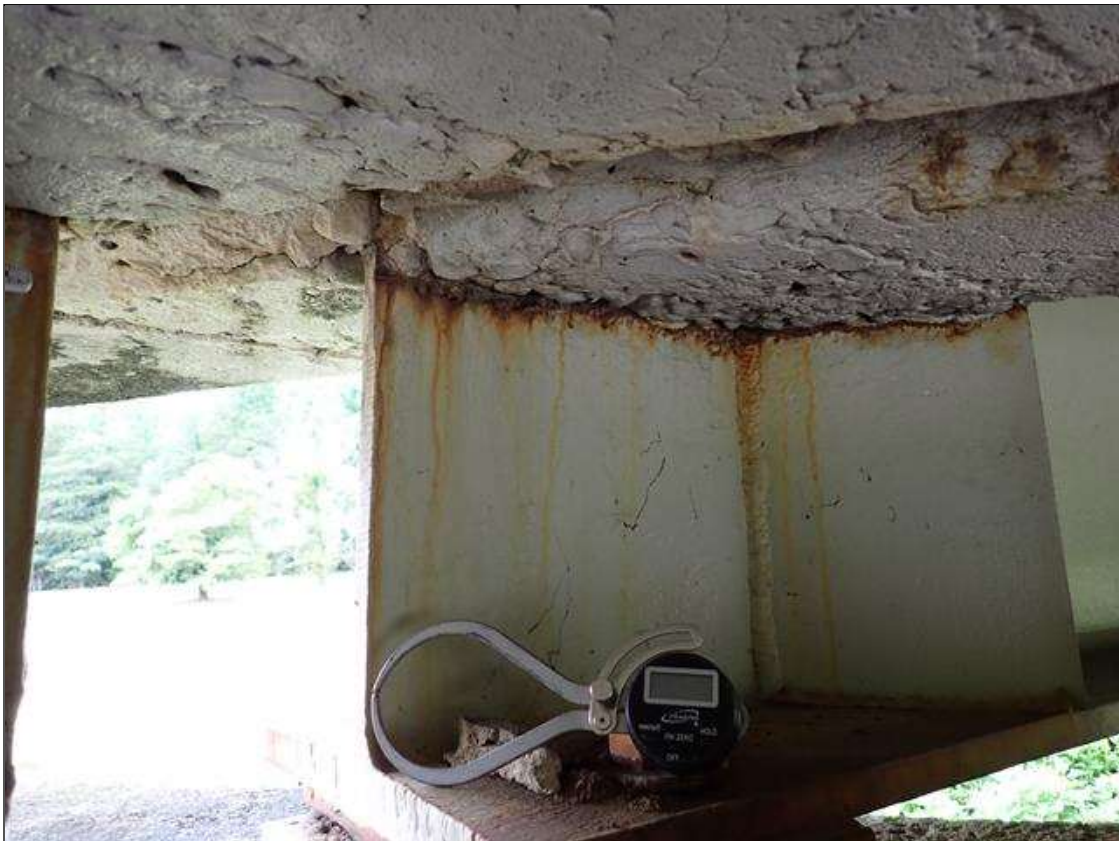
Span 4 Beam 1: at bent 3, web adjacent to end diaphragm, corrosion with section loss (9/16 inch average remaining x 10 inch x 1 inch)

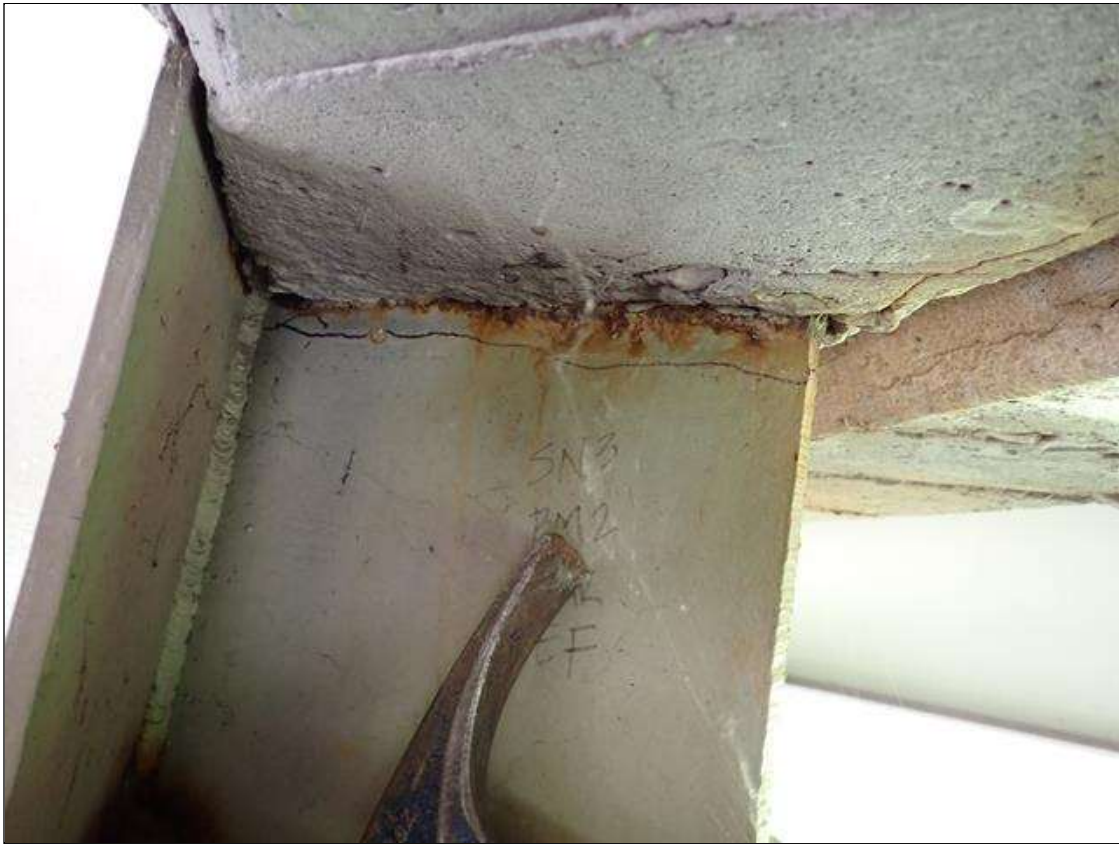
Span 3 Beam 2: at bent 3, web adjacent to end diaphragm, corrosion with section loss (9/16 inch average remaining x 10 inch x 1 inch)

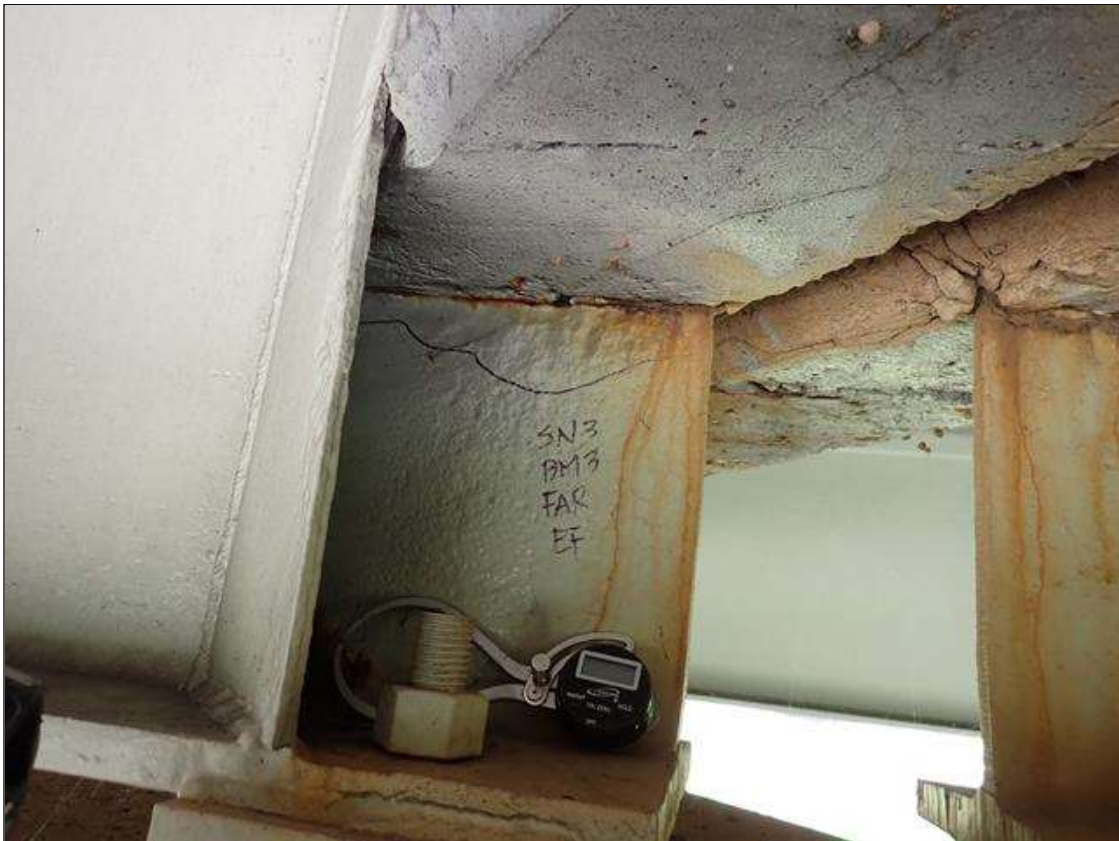
Span 3 Beam 3: (PAR) at bent 3, web adjacent to end diaphragm, corrosion with section loss (7/16 inch average remaining x 10 inch x 2.5 inch)

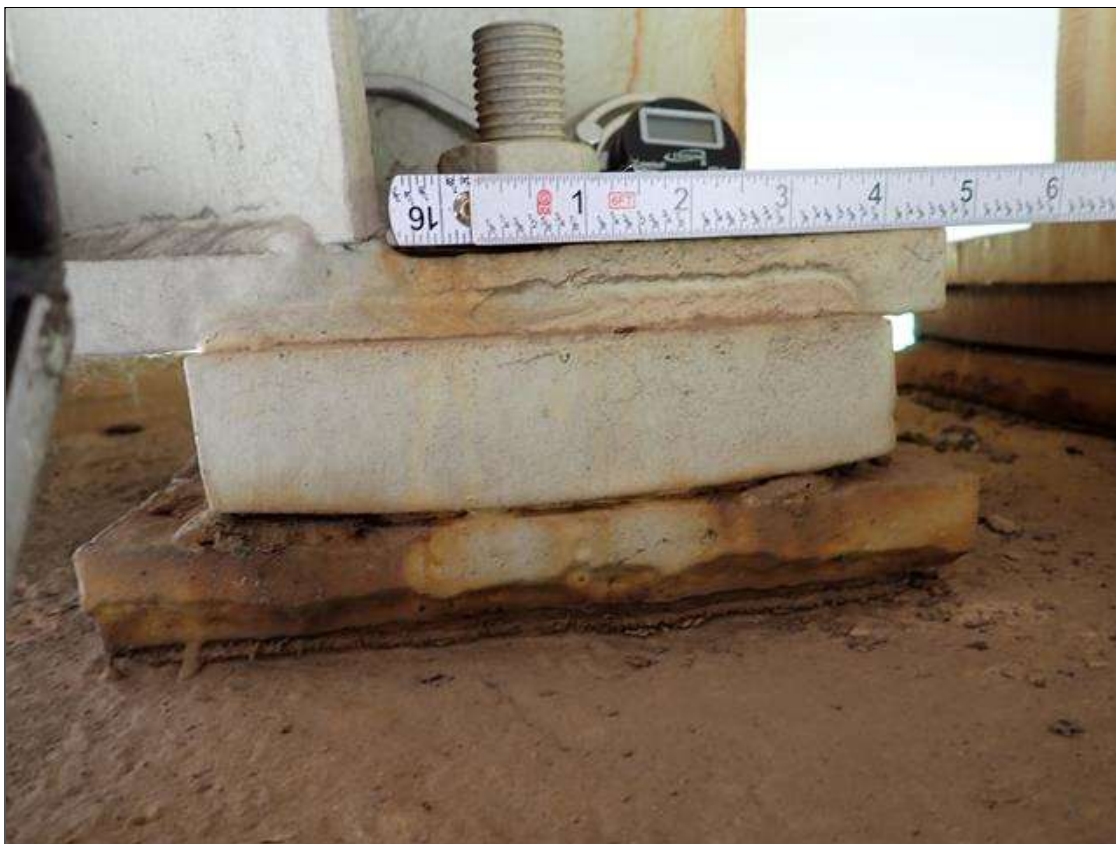
Span 3 Beam 3 - Far Bearing 3: corrosion with section loss (up to 1/8 inch loss)

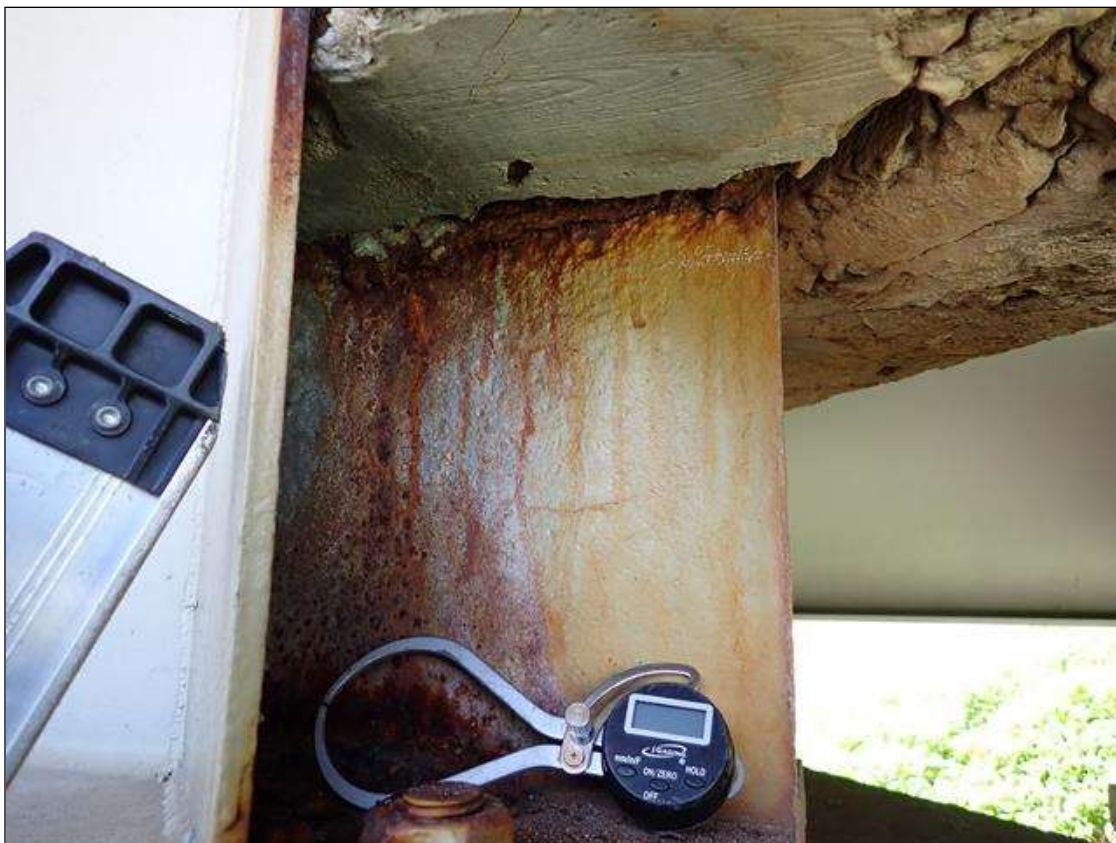
Span 3 Beam 4: at bent 3, web adjacent to end diaphragm, corrosion with section loss (9/16 inch average remaining x 10 inch x 1 inch)

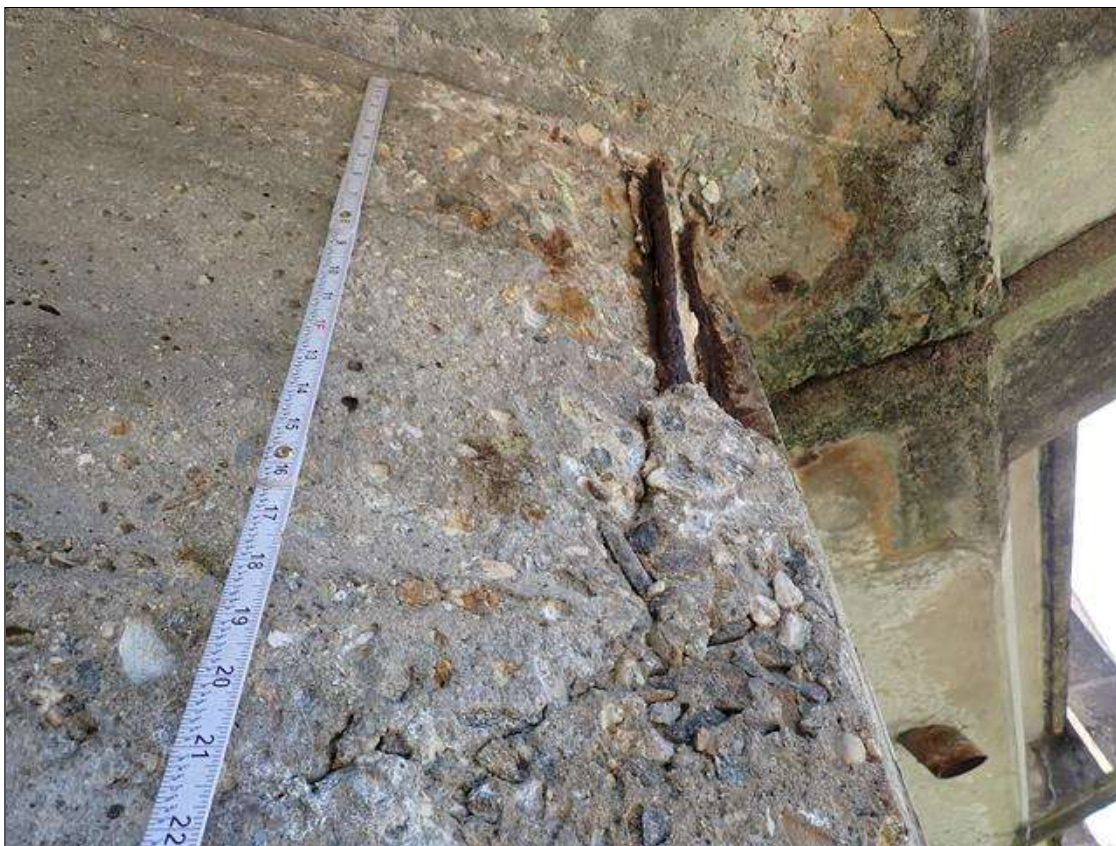
Span 3 Beam 4: (PAR) DIAPHRAGM OVER BENT 3 UNDER RIGHT OVERHANG, DELAMINATION/SPALL [FULL HEIGHT X 2 FOOT X 2 INCHES DEEP] WITH TWO [2] EXPOSED RUSTED REINFORCING WITH APPROXIMATELY 25 PERCENT LOSS

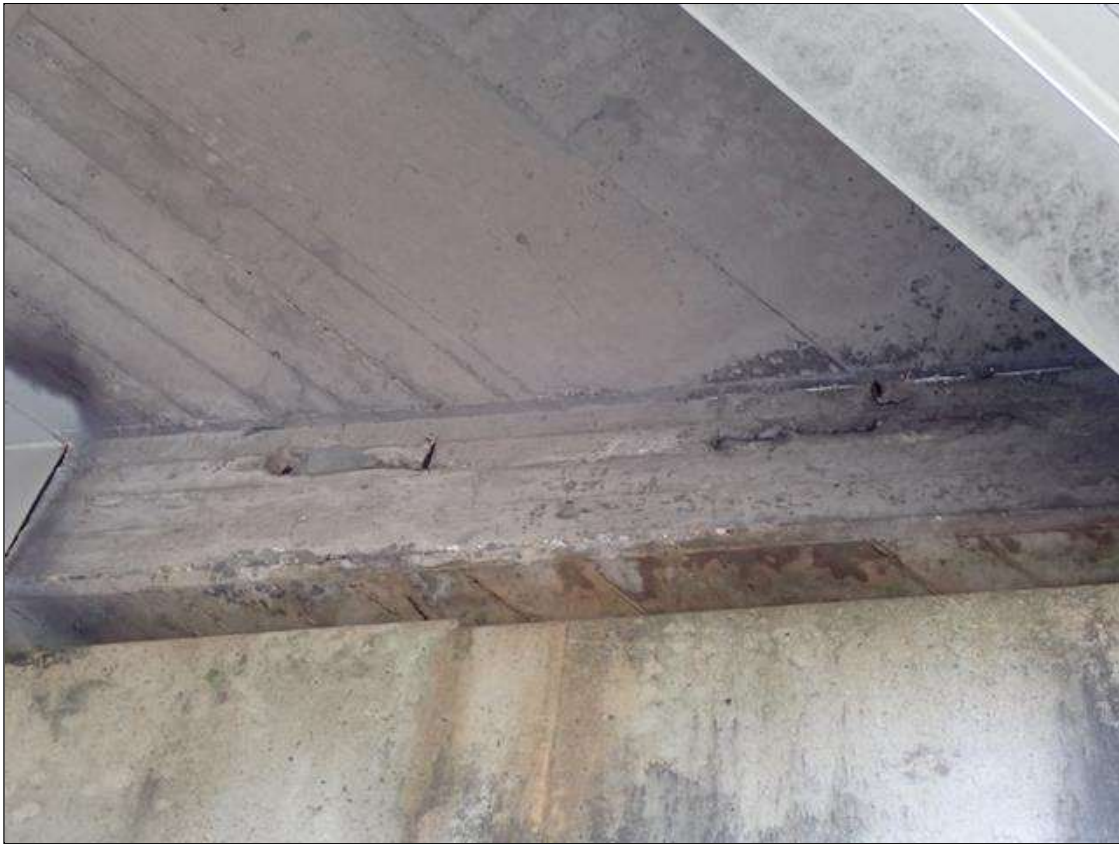
Span 3 Beam 4: BAY 3 DIAPHRAGM OVER BENT 3, SPALL/DELAMINATION [2] [UP TO 6 INCHES X 3 INCHES X UP TO 3/4 INCHES DEEP] WITH EXPOSED RUSTED REINFORCING

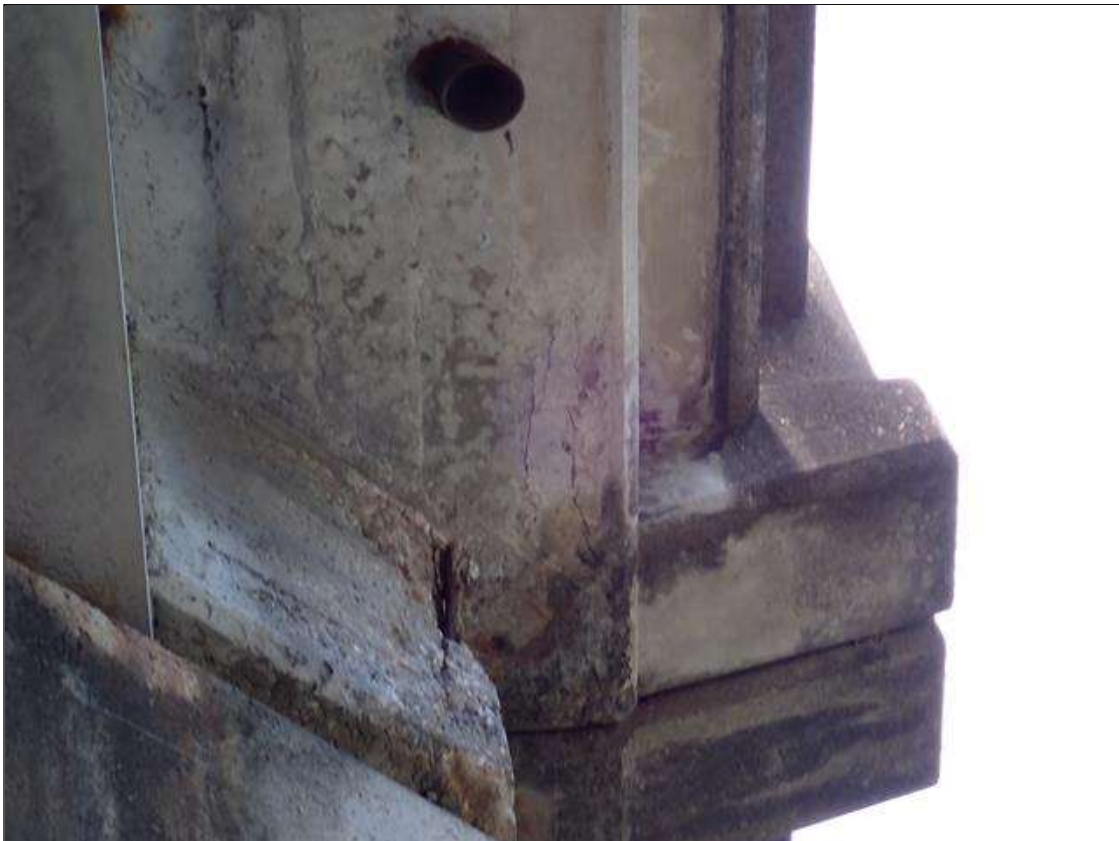
Span 3 Deck: AT BENT 3 UNDER RIGHT OVERHANG, DELAMINATION [28 INCHES X 12 INCHES]

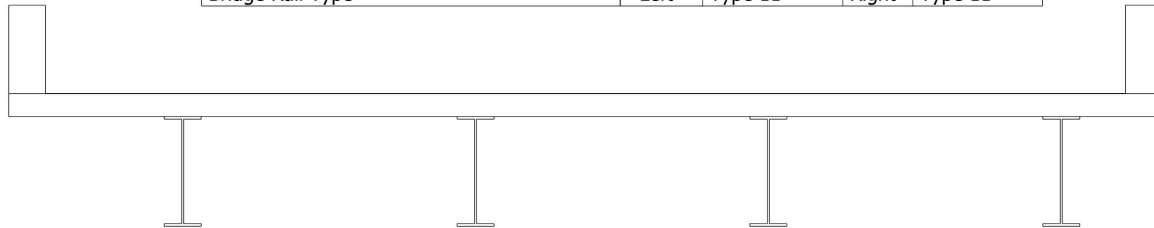
Measurements for Span #	1	All Spans Similar	
Deck Thickness	7.5in	Left Overhang	4.75ft
Top of Rail to Bottom of Beam (Avg)	6.083ft	Right Overhang	4.75ft
