NC DEPARTMENT OF TRANSPORTATION
 DIVISION OF HIGHWAYS
 STRUCTURE MANAGEMENT UNIT

ATTENTION: prompt action request, sign notice issued, sketches revised, clearances revised; new repairs to span 3 beams

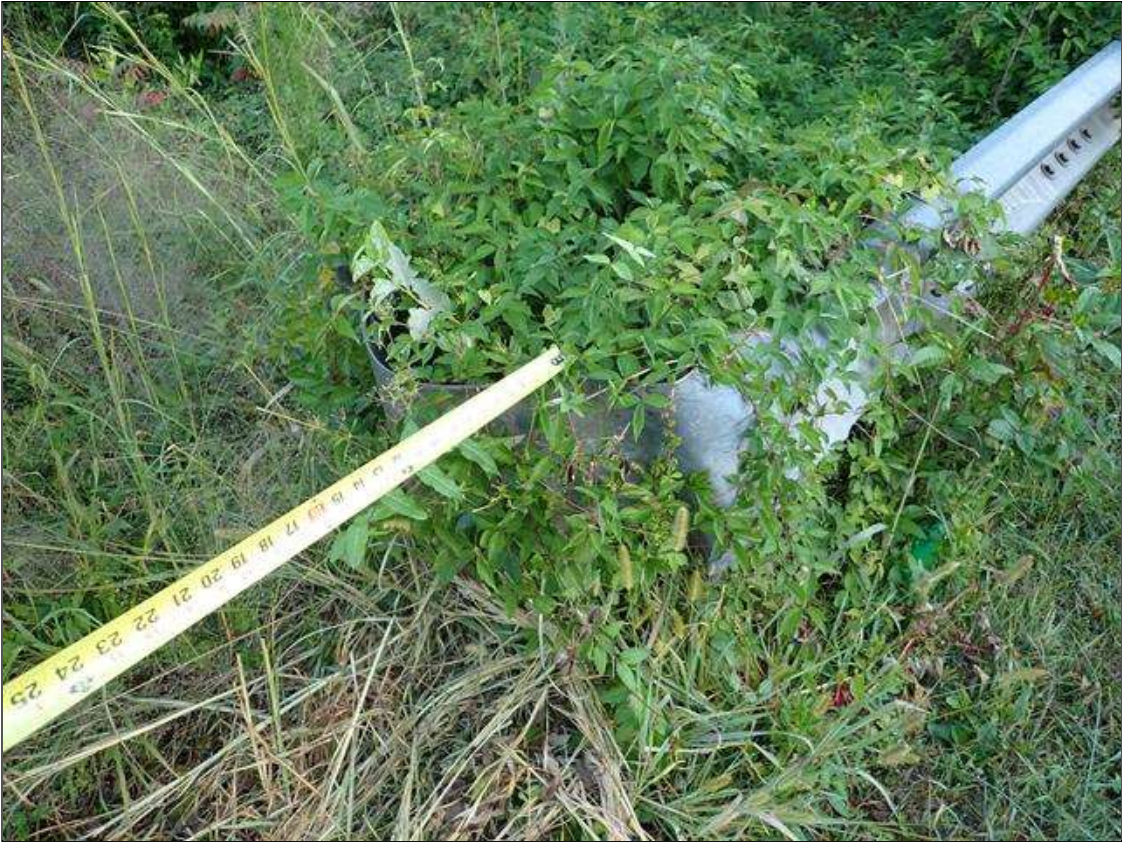
(PAR) southwest guardrail termination, impact damage (1 foot)

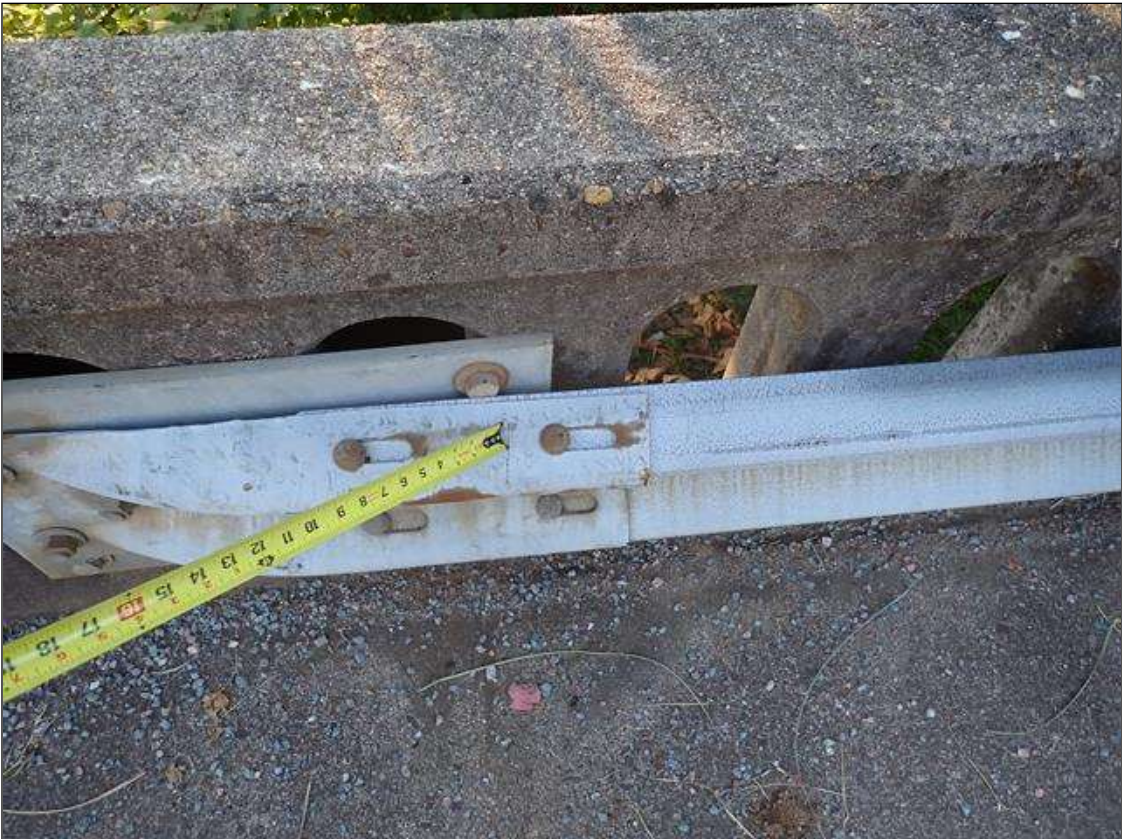
(PAR) southeast guardrail attachment, improper lap

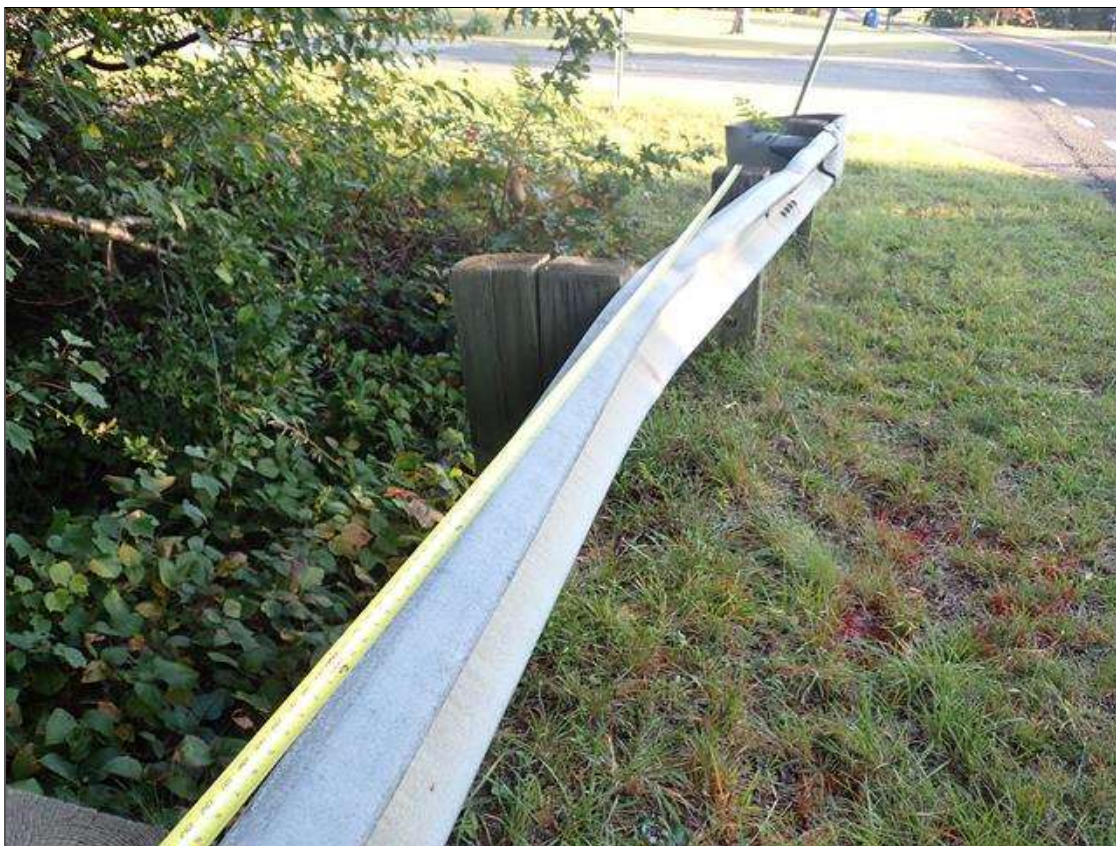
(PAR) northwest guardrail, near termination, impact damage (10 feet)

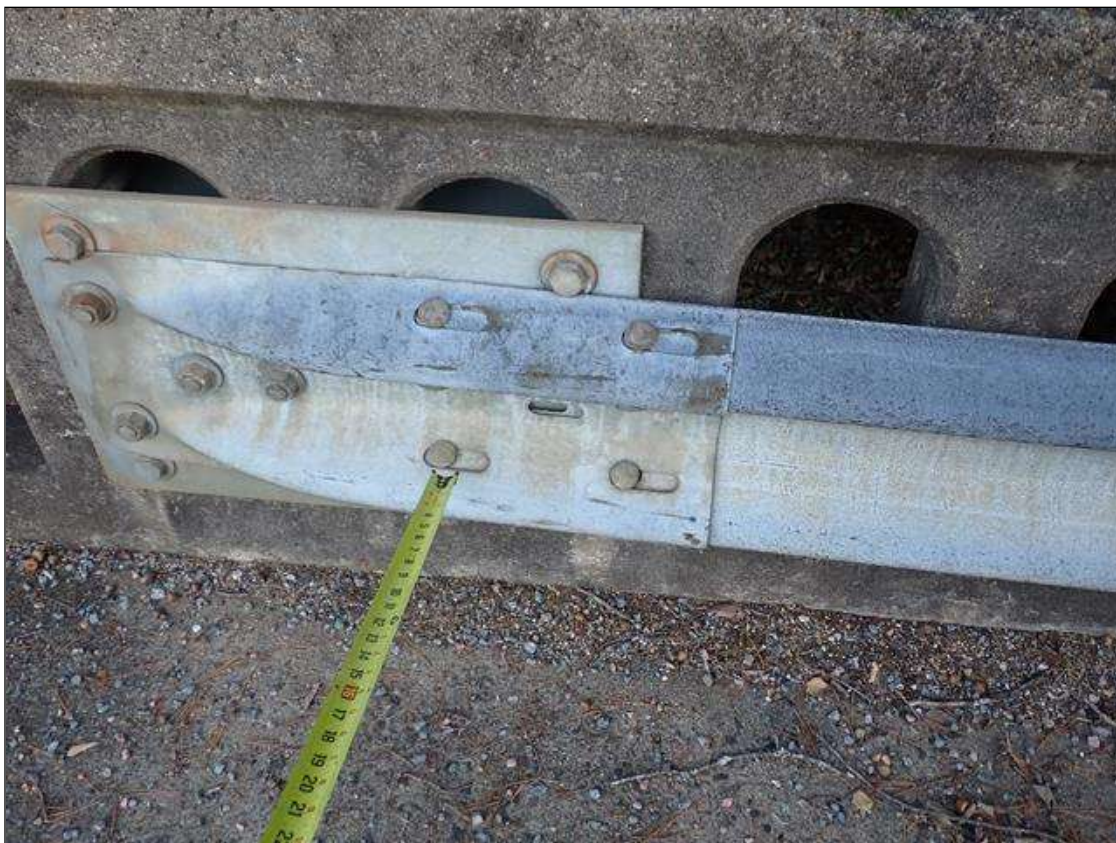
(PAR) northwest guardrail attachment, improper lap

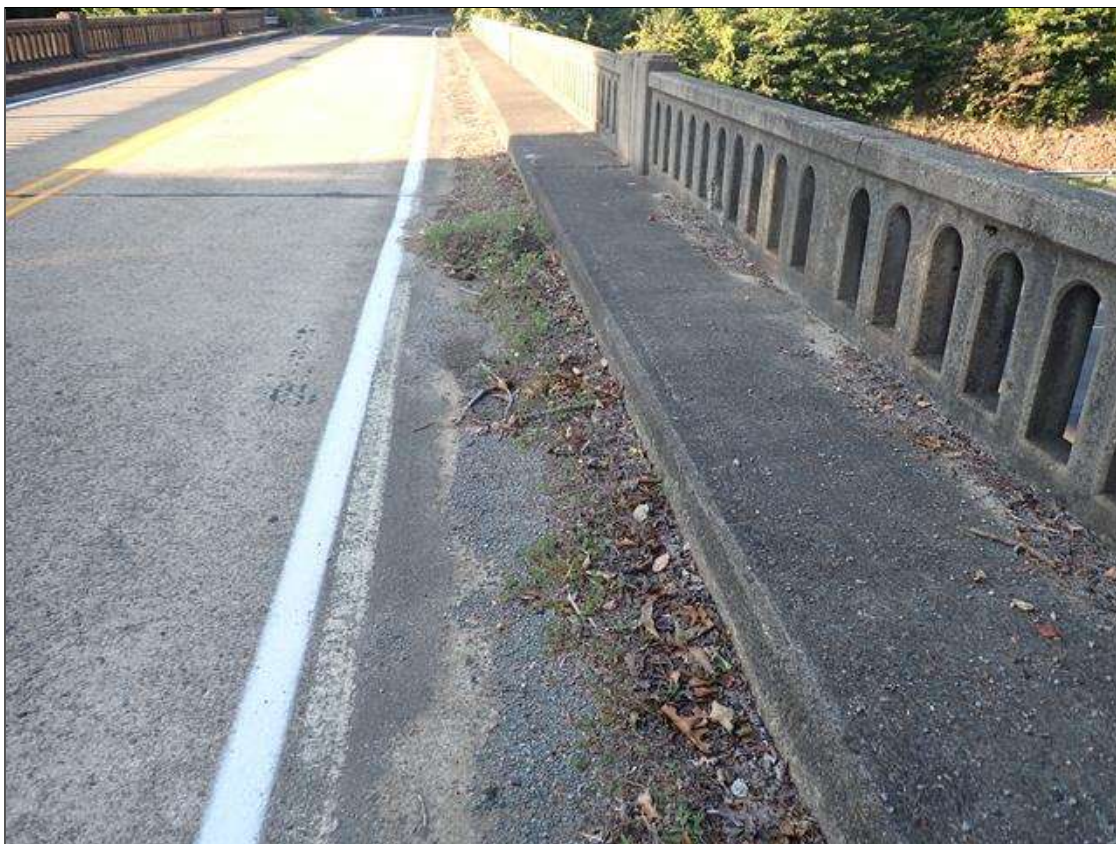
along the curblines, debris accumulation (up to 3.5 feet wide x 10 inches wide) with vegetation, obstructing deck drainage; primarily along left curb

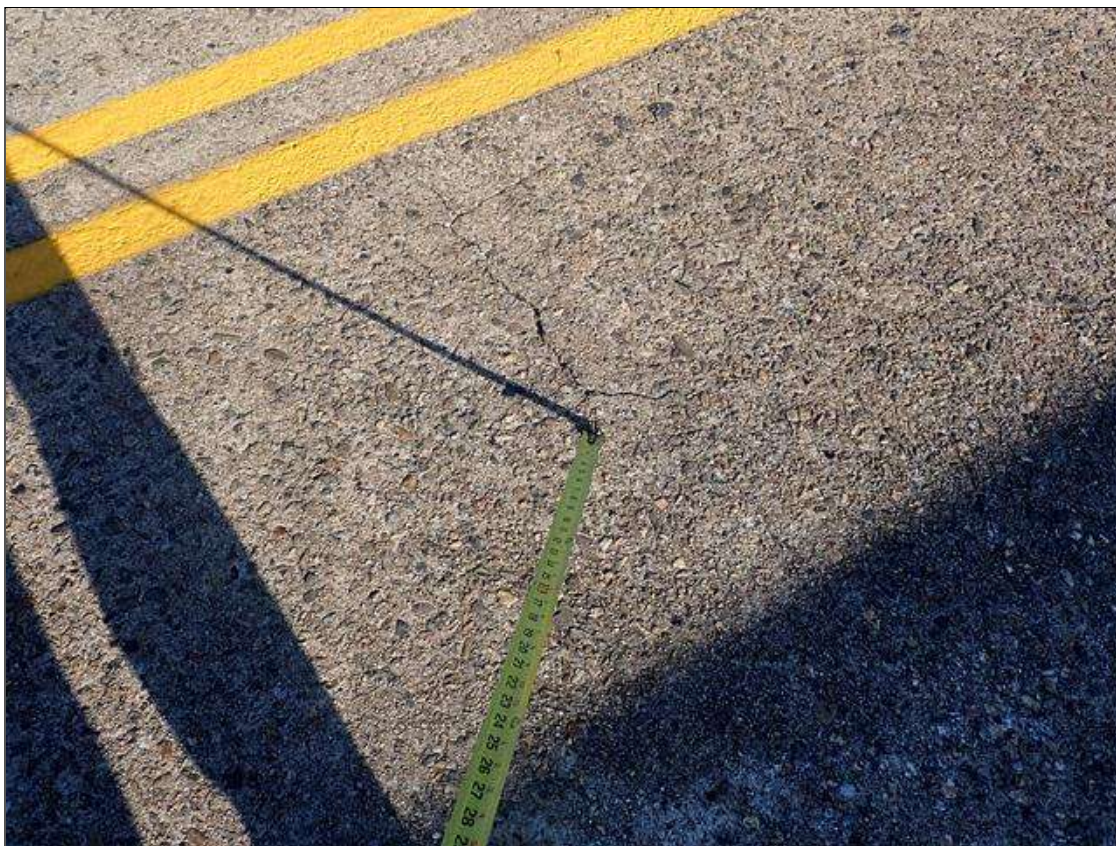
Span 1 Deck: map cracking up to 1/16 inch wide throughout

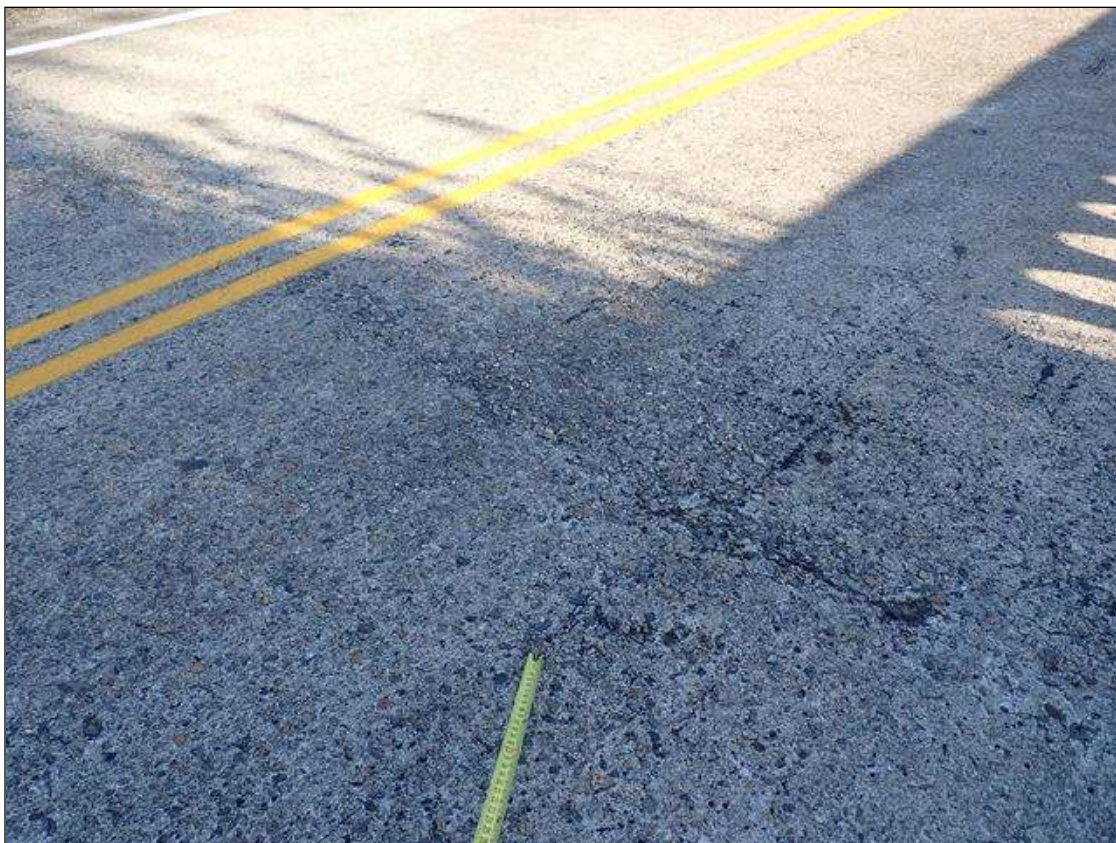
Span 1 Deck: throughout top of deck, wear with secure aggregate (up to 1/2 inch deep)

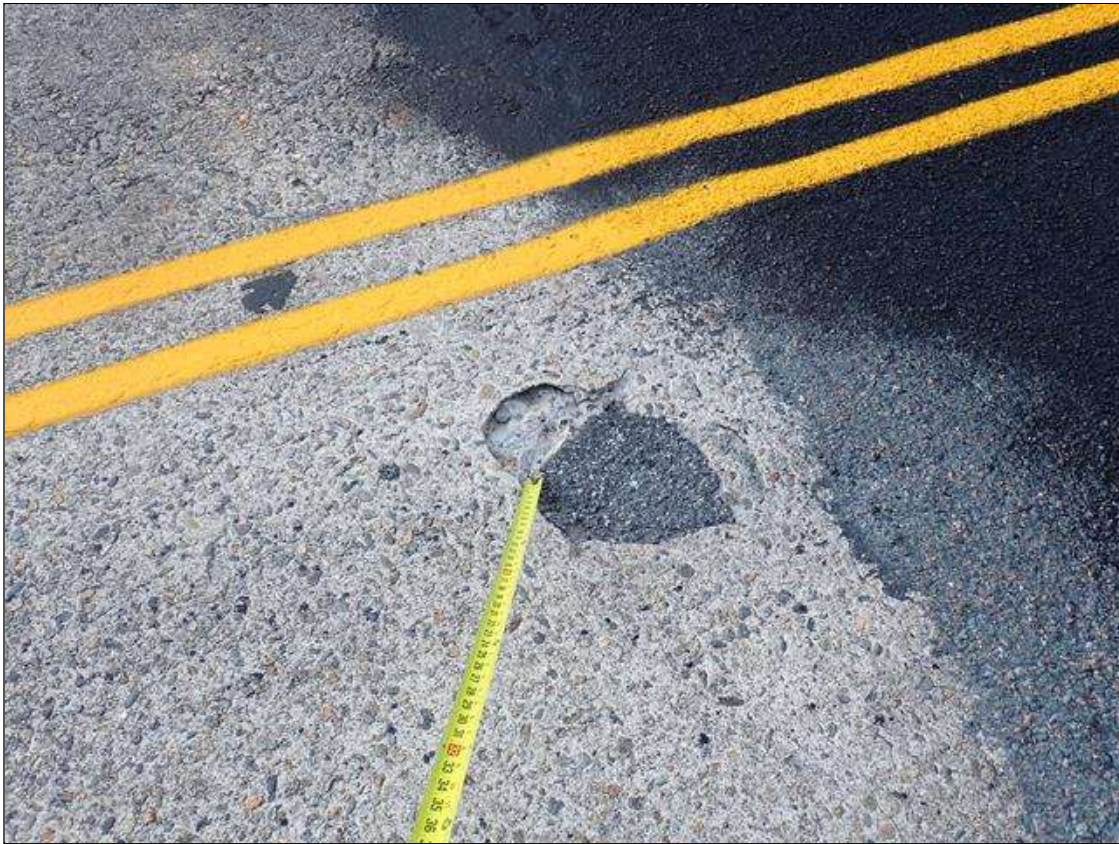
Span 1 Deck: southbound lane, near end bent 1, partially patched spall (18 inch x 15 inch x 1.5 inch deep)

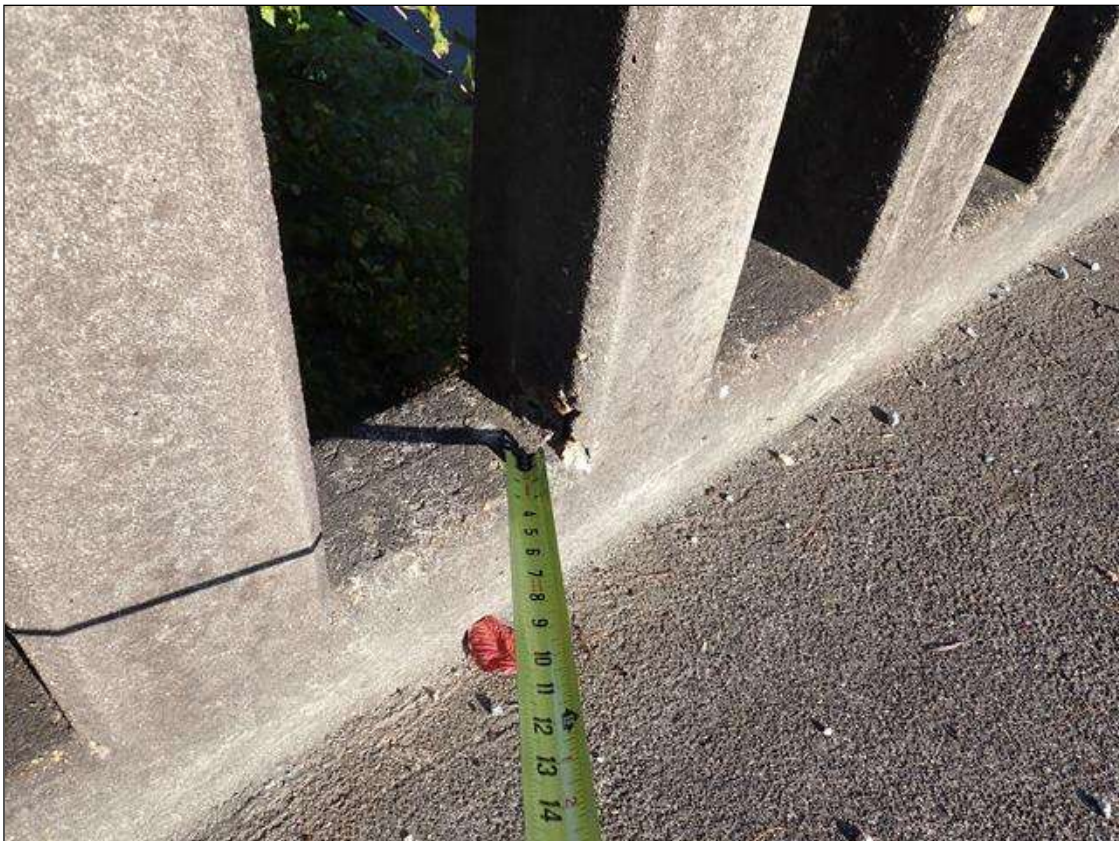
Span 1 Left Bridge Rail: 5 - spalls with exposed reinforcing up to 3 inch x 1 inch x 1/2 inch deep, in traffic and outside faces, at random., no section loss noted.

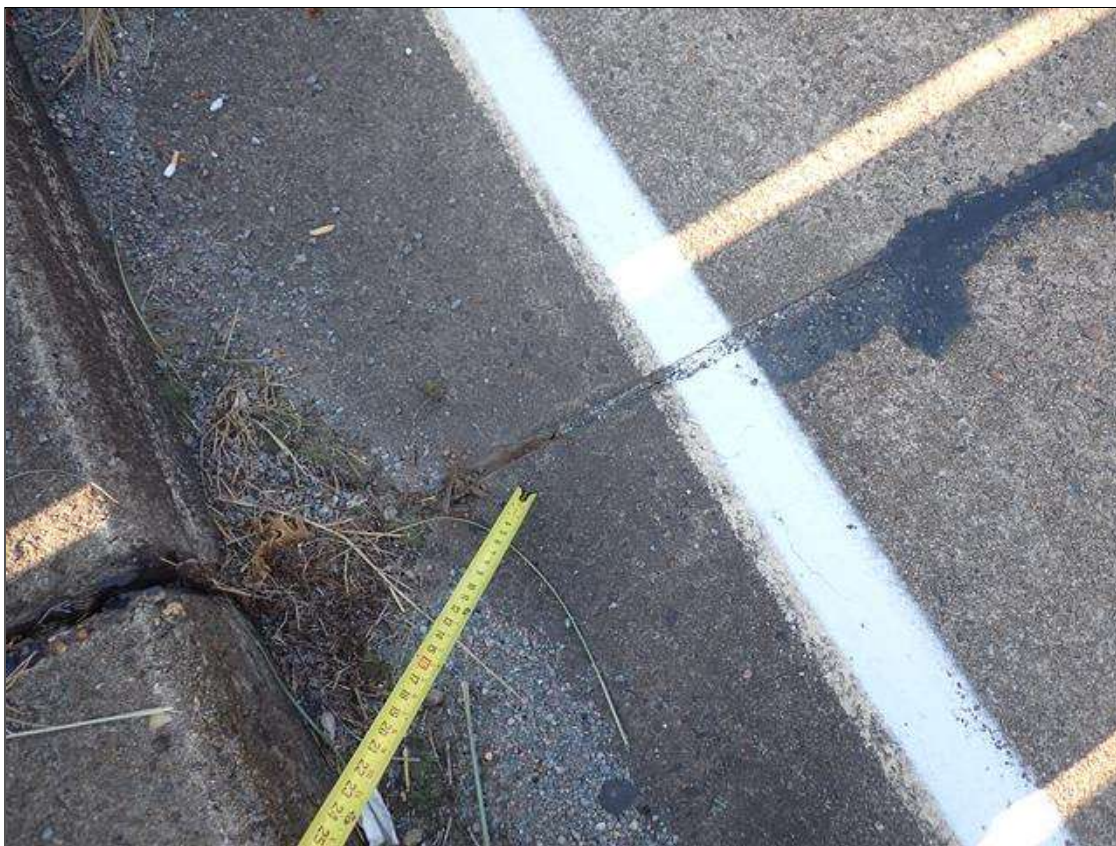
Span 2 Expansion Joint at Bent 1: both shoulders, seal damage (up to 1 inch deep)

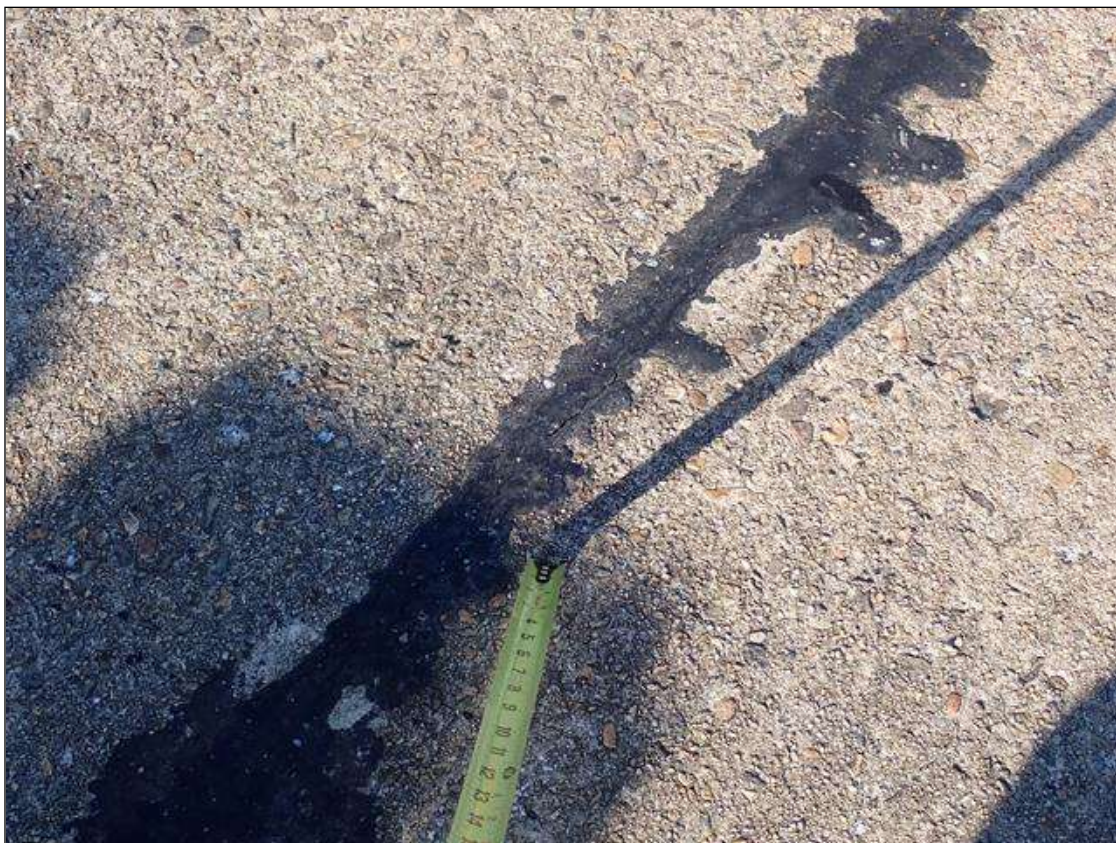
Span 2 Expansion Joint at Bent 1: along the length of the joint, seal cracks at random

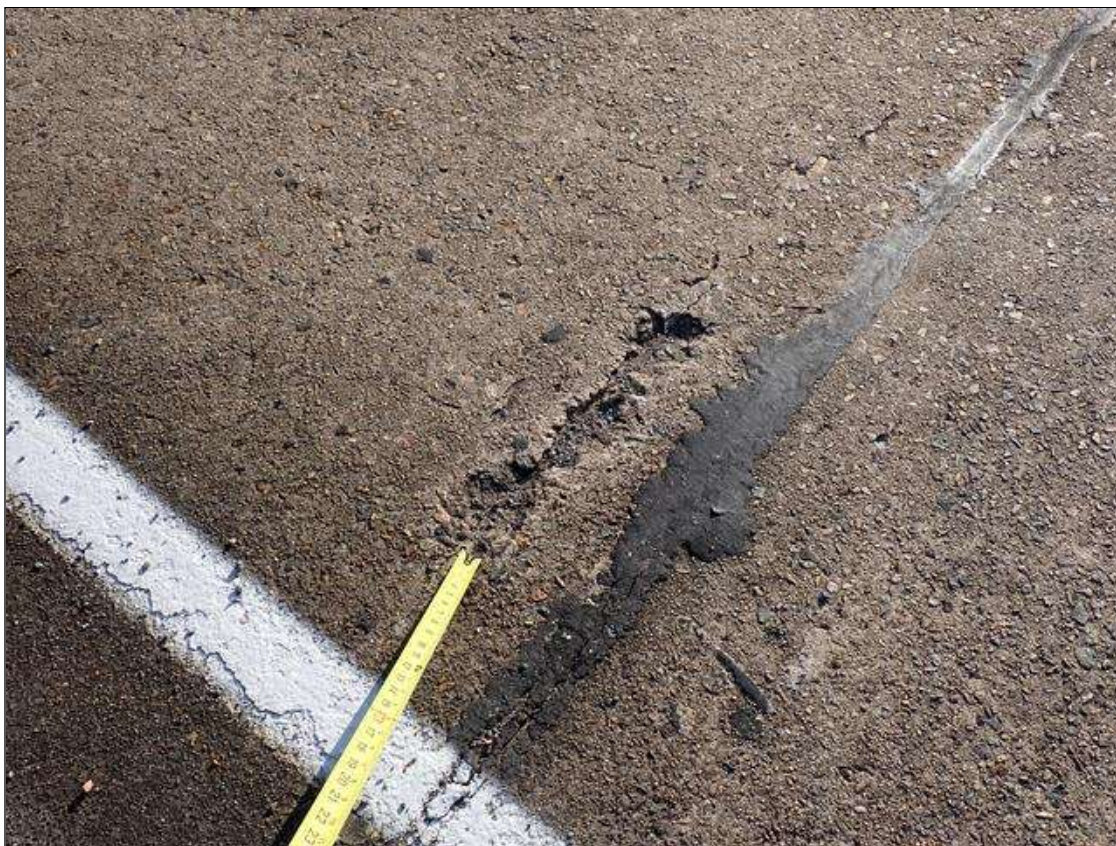
Span 2 Deck: (PAR) southbound lane, at bent 1, spall (2 feet x 6 inch x 1 inch deep) with exposed rusted rebar

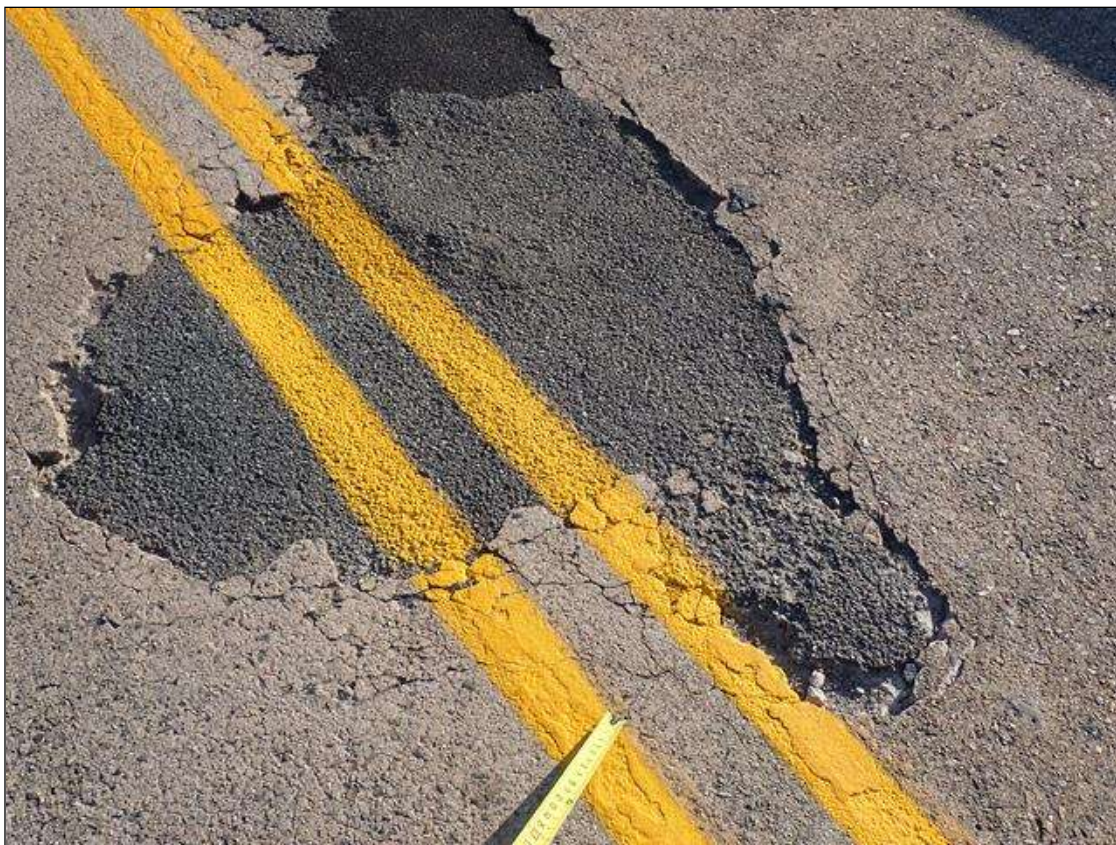
Span 2 Deck: up to 9 foot x 4.5 foot wide patches with up to 3 foot x 15 inch x 1.5 inch deep spalls/delaminations, at centerline, far half of span.

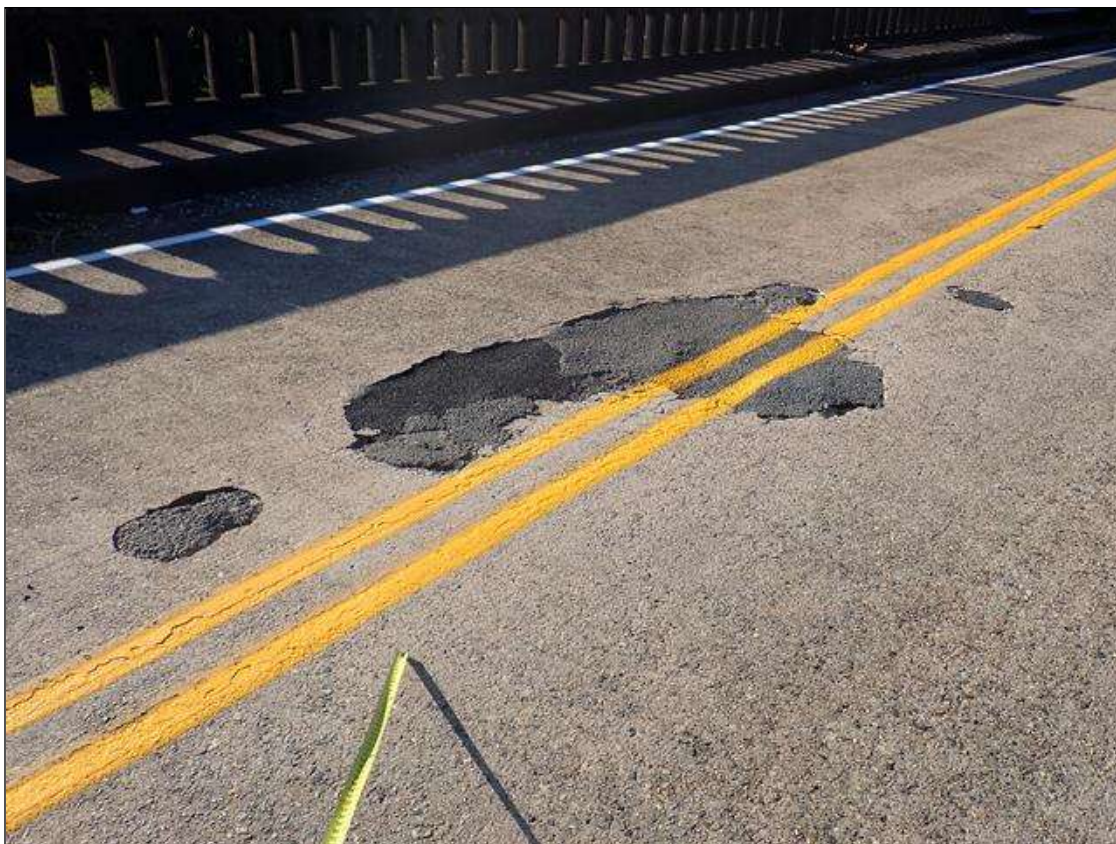
Span 2 Deck: up to 9 foot x 4.5 foot wide patches with up to 3 foot x 15 inch x 1.5 inch deep spalls/delaminations, at centerline, far half of span.

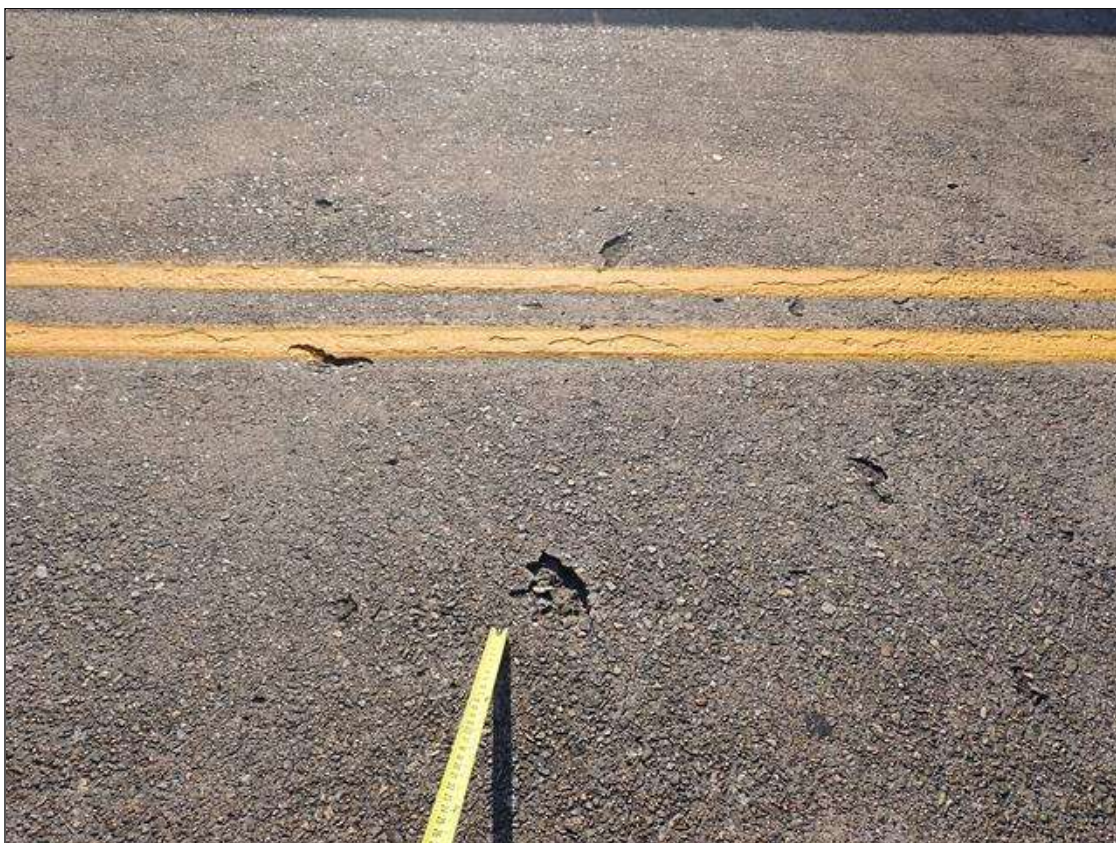
Span 2 Deck: throughout top of deck, spalls/delaminations (up to 6 inch diameter x 1 inch deep)

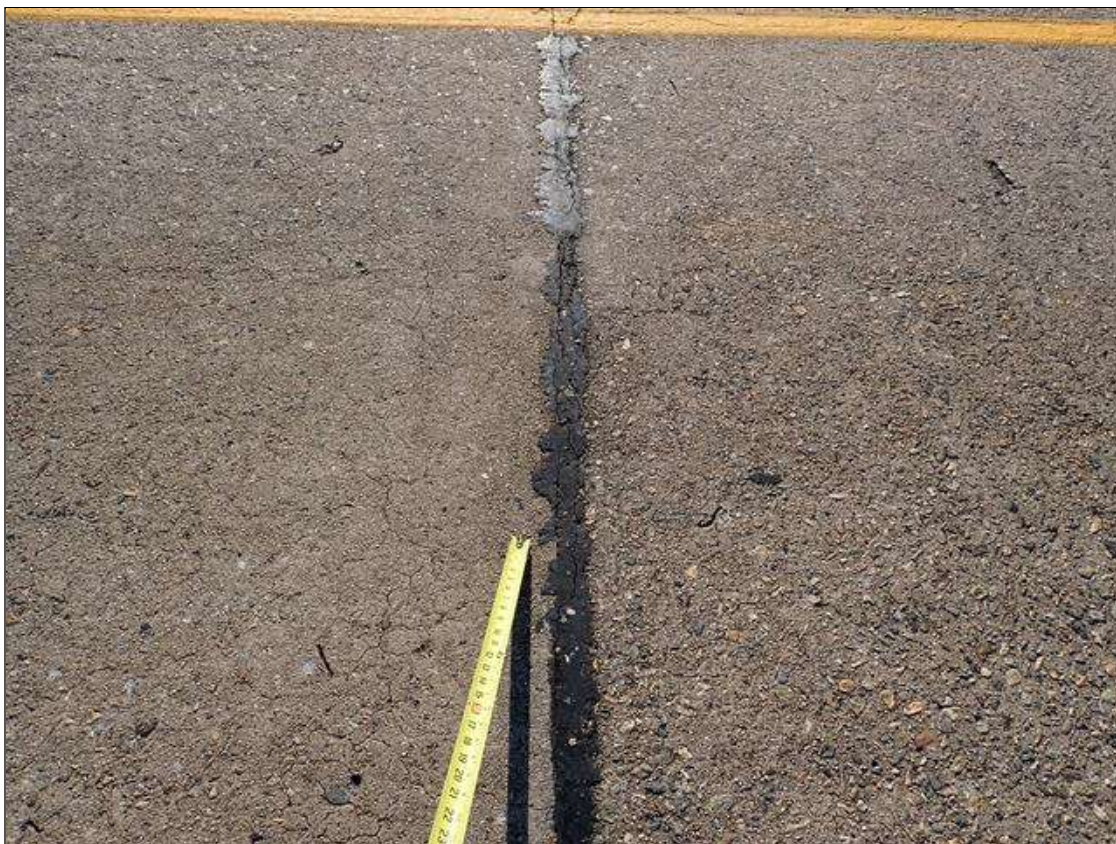
Span 3 Expansion Joint at Bent 2: along the length of the joint, seal cracks at random

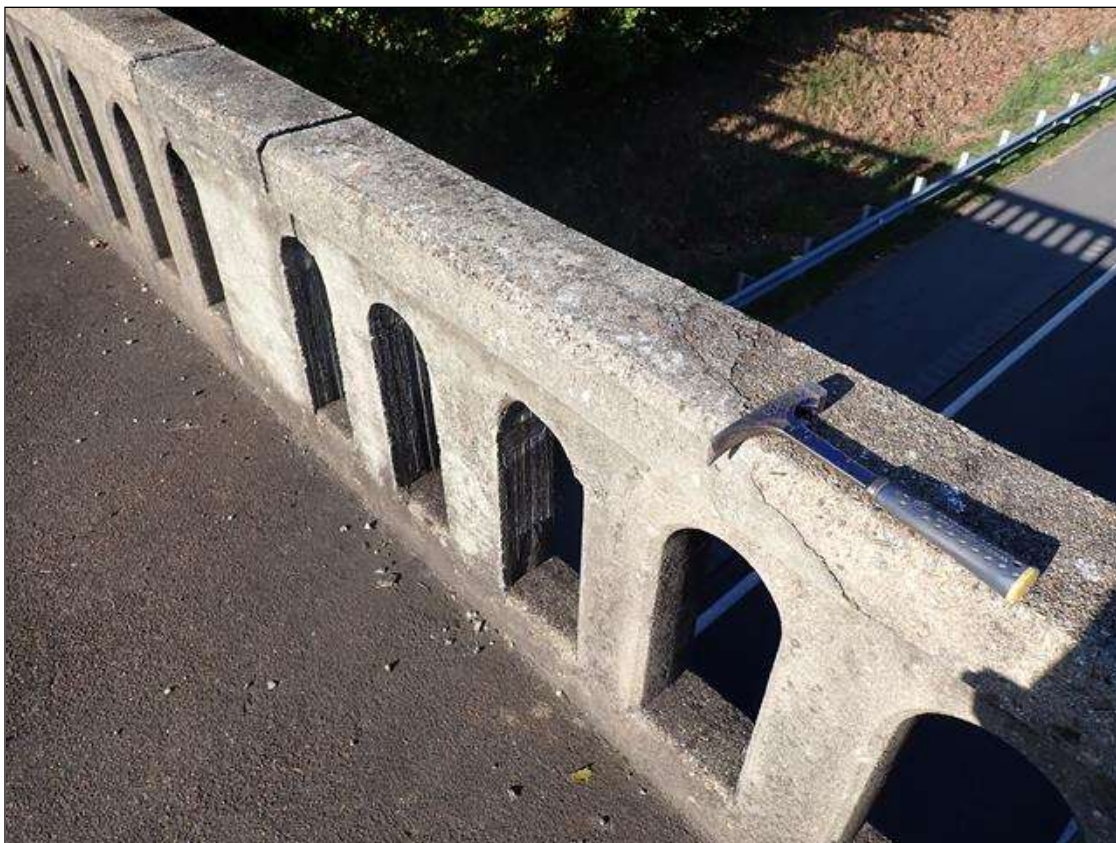
Span 2 Left Bridge Rail: 4 feet of patched rail and curb x full height, with cracks up to 1/32 inch, near midspan.

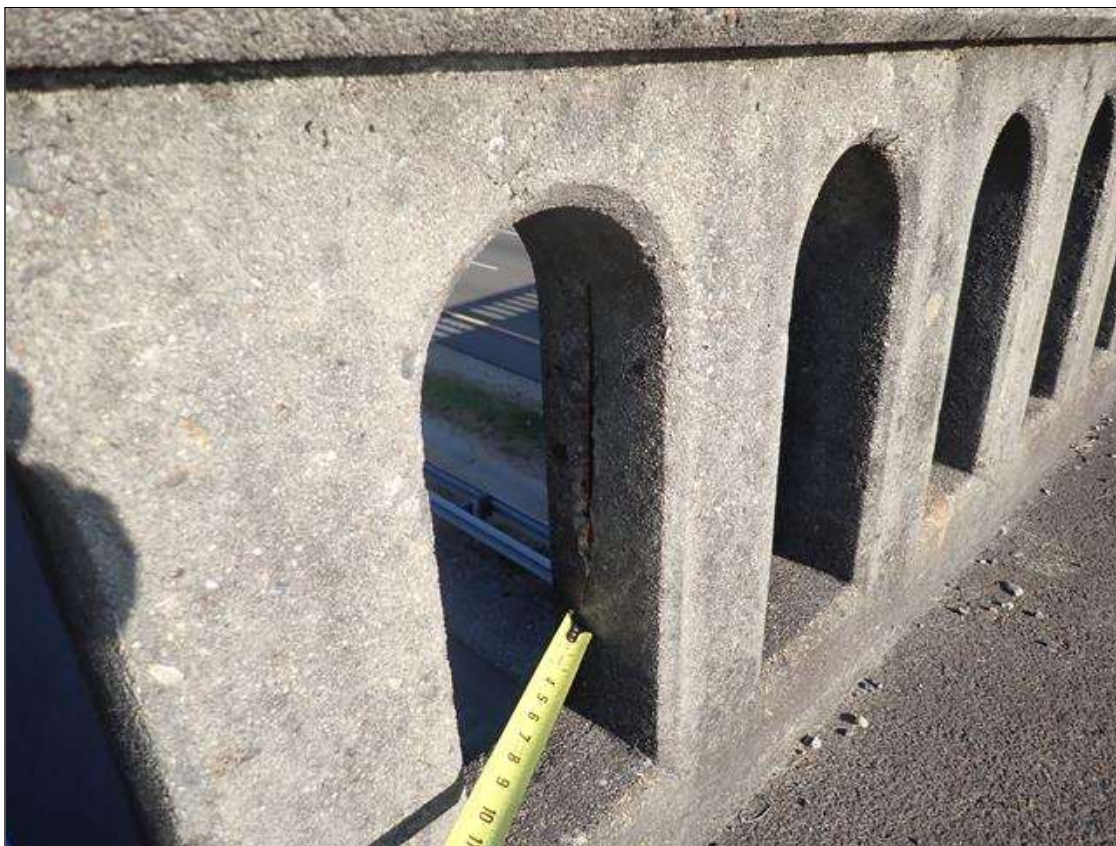
Span 2 Left Bridge Rail: 6 - spalls with exposed reinforcing up to 8 inch x 1 inch x 1/2 inch deep, at random.

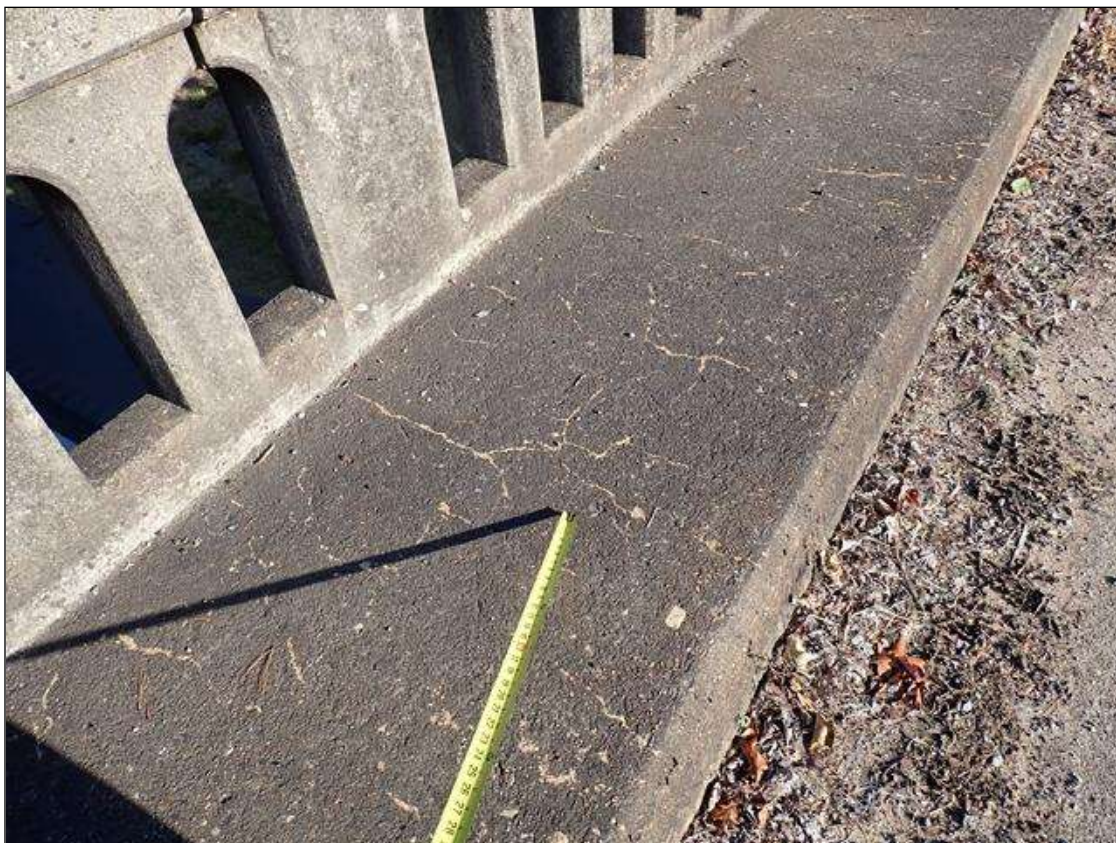
Span 3 Deck: throughout left sidewalk, multiple areas hairline map cracking

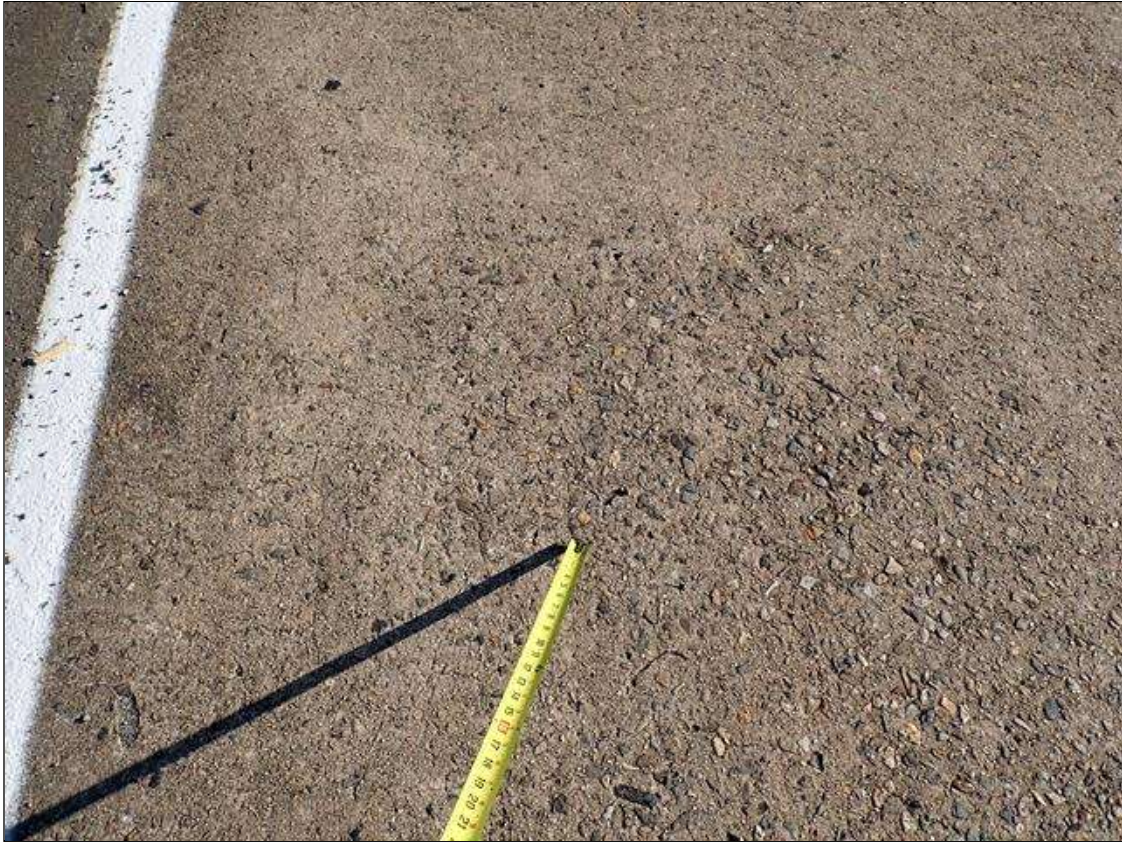
Span 3 Deck: random hairline map cracking and transverse cracks up to 1/32 inch wide.

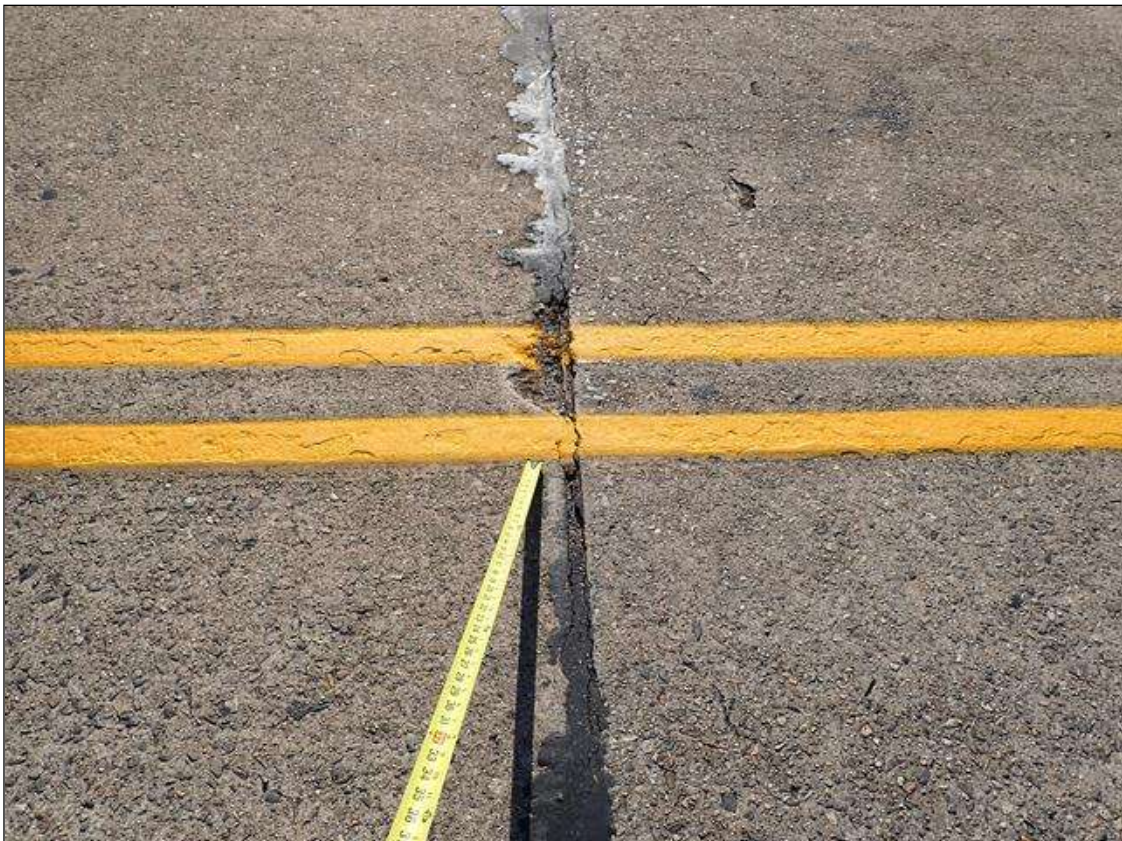
Span 4 Expansion Joint at Bent 3: missing joint material [up to full depth] in left and right shoulder, and centerline

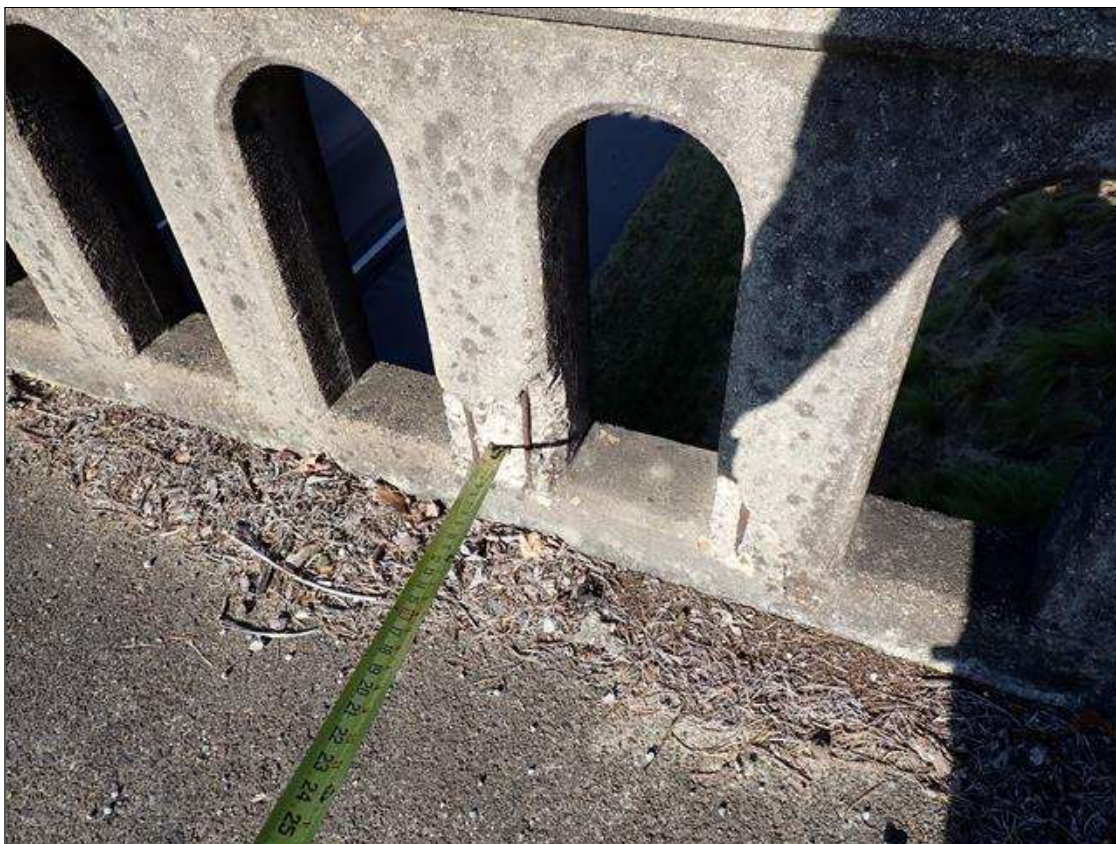
Span 4 Left Bridge Rail: along the length of the rail, spalls (up to 8 inch x 7 inch x 1 inch deep) with exposed rusted rebar

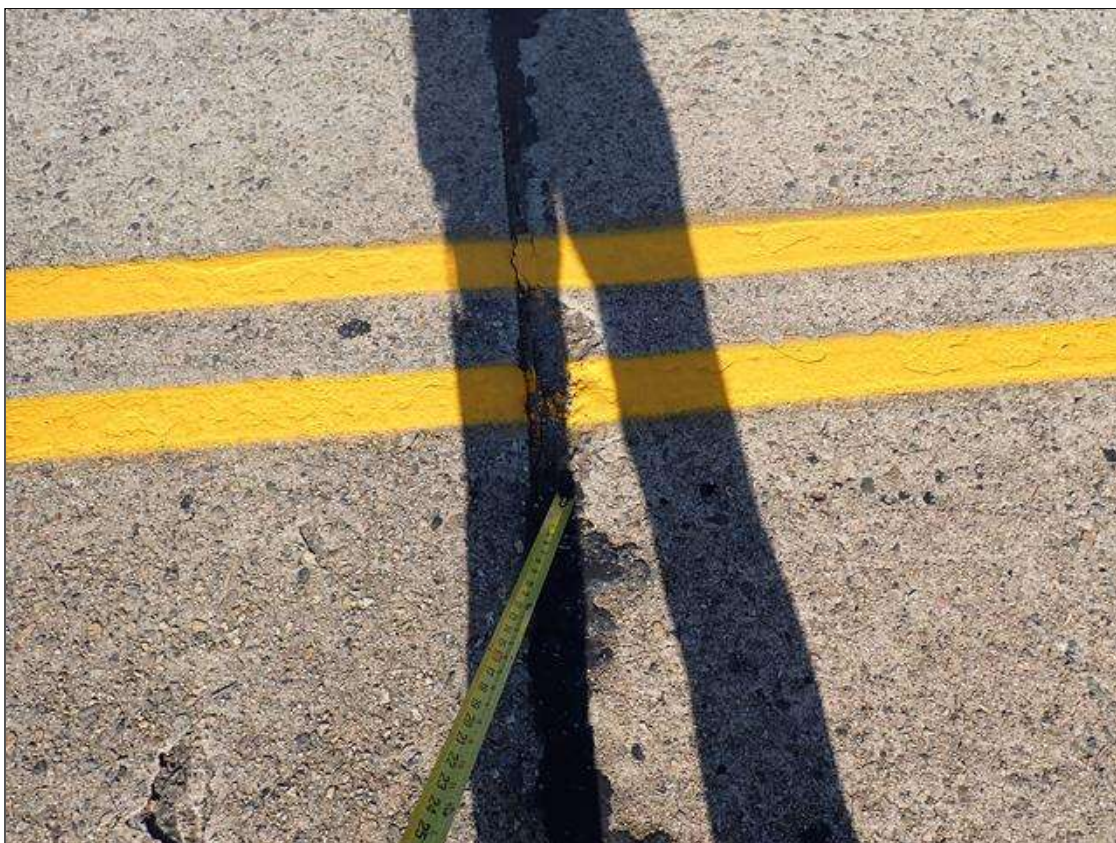
Span 4 Expansion Joint at Bent 3: along centerline, edge spall (13 inch x 6 inch x 1.5 inch deep)

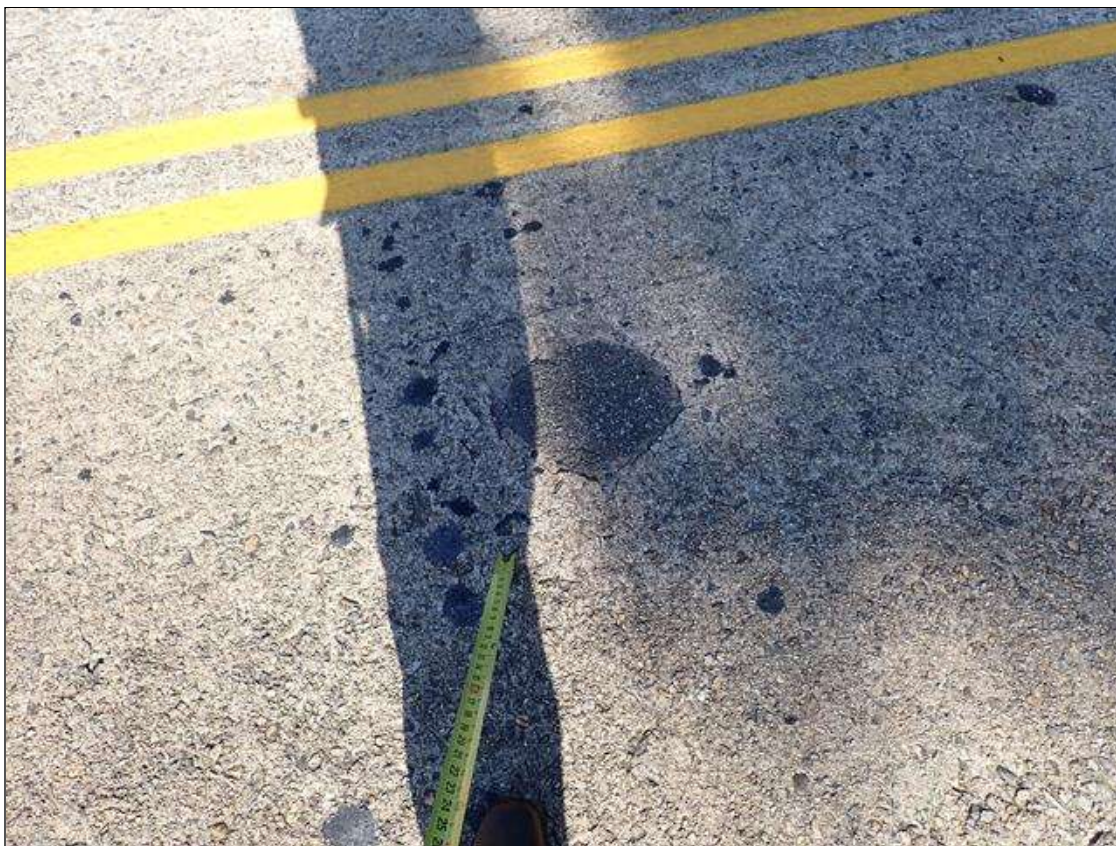
Span 4 Deck: 18 inch diameter sound asphalt patch, in northbound lane, near midspan, with associated adjacent delaminations and broken asphalt
