NC DEPARTMENT OF TRANSPORTATION
 DIVISION OF HIGHWAYS
 STRUCTURE MANAGEMENT UNIT

ATTENTION: prompt action request, sign notice issued, sketches revised, clearances revised; new repairs to span 3 beams

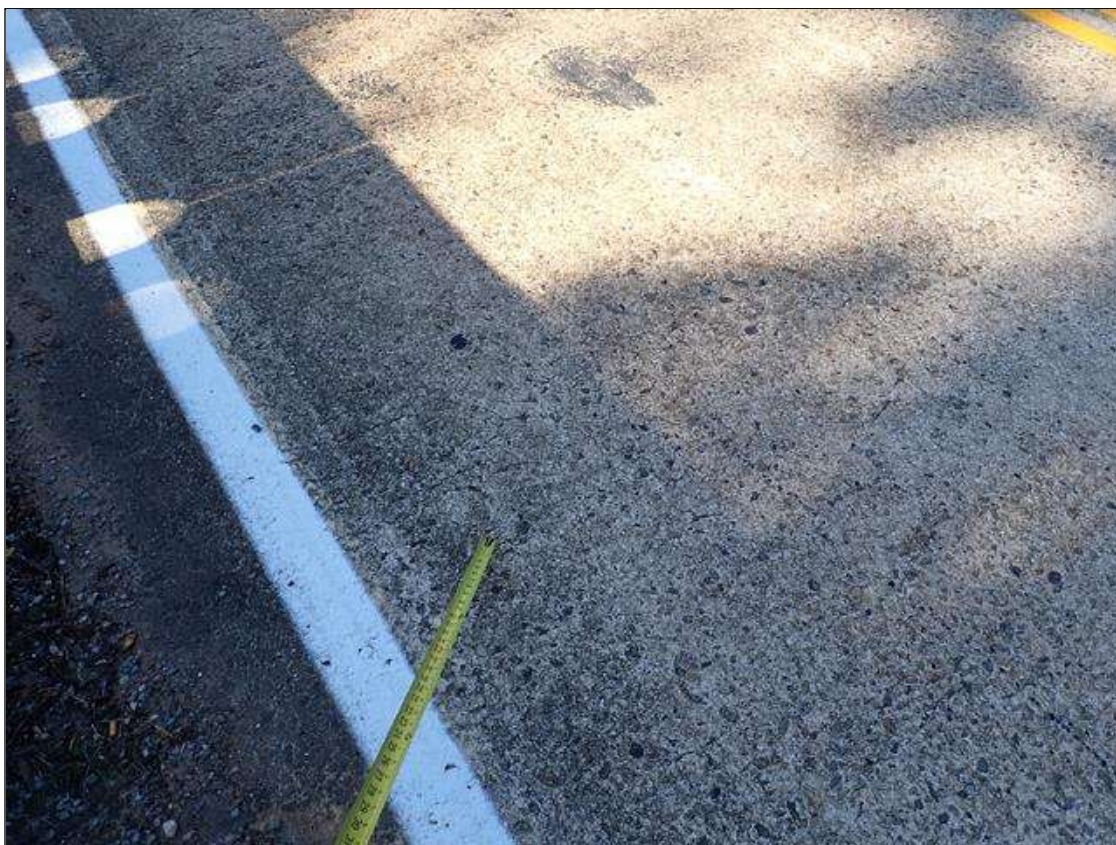
Span 4 Deck: random hairline map cracking and transverse cracks up to 1/32 inch wide on topside and underside.

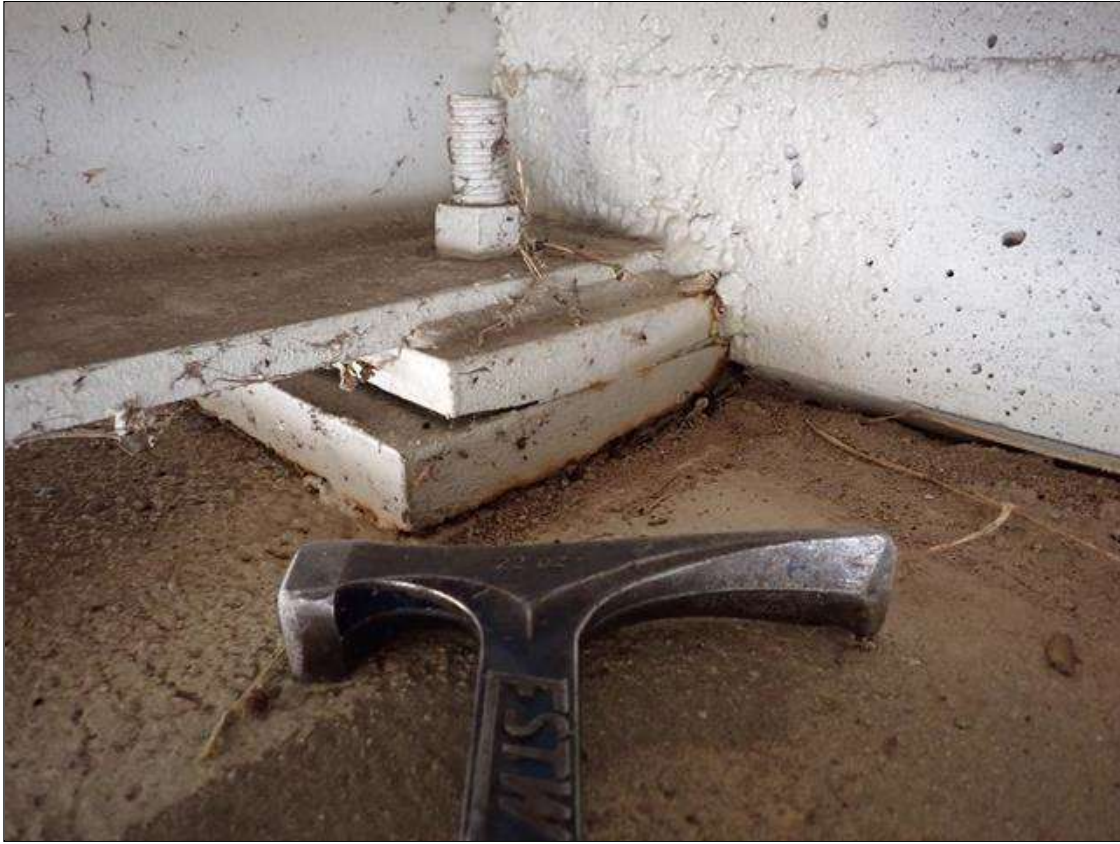
Span 4 Beam 4 - Far Bearing 4: freckled rust

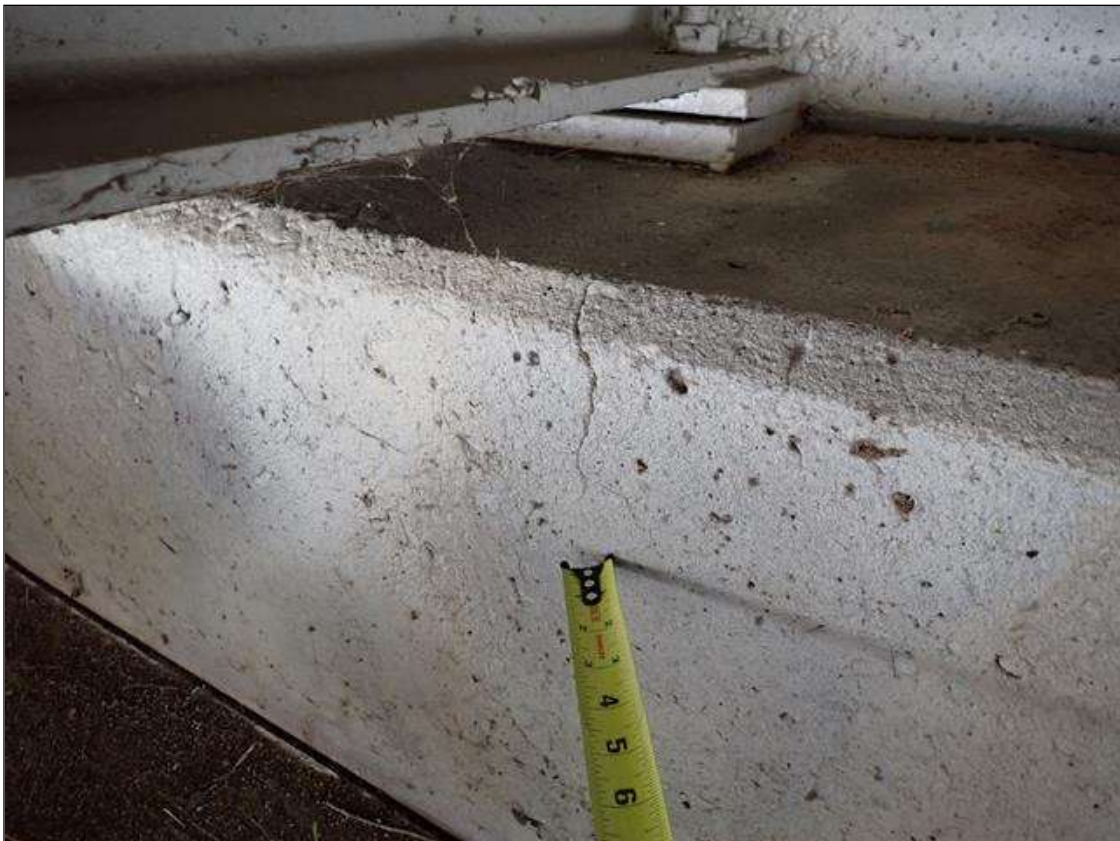
End Bent 2 Cap 1: 10 - vertical cracks up to 1/32 inch wide, in face of cap, at random throughout

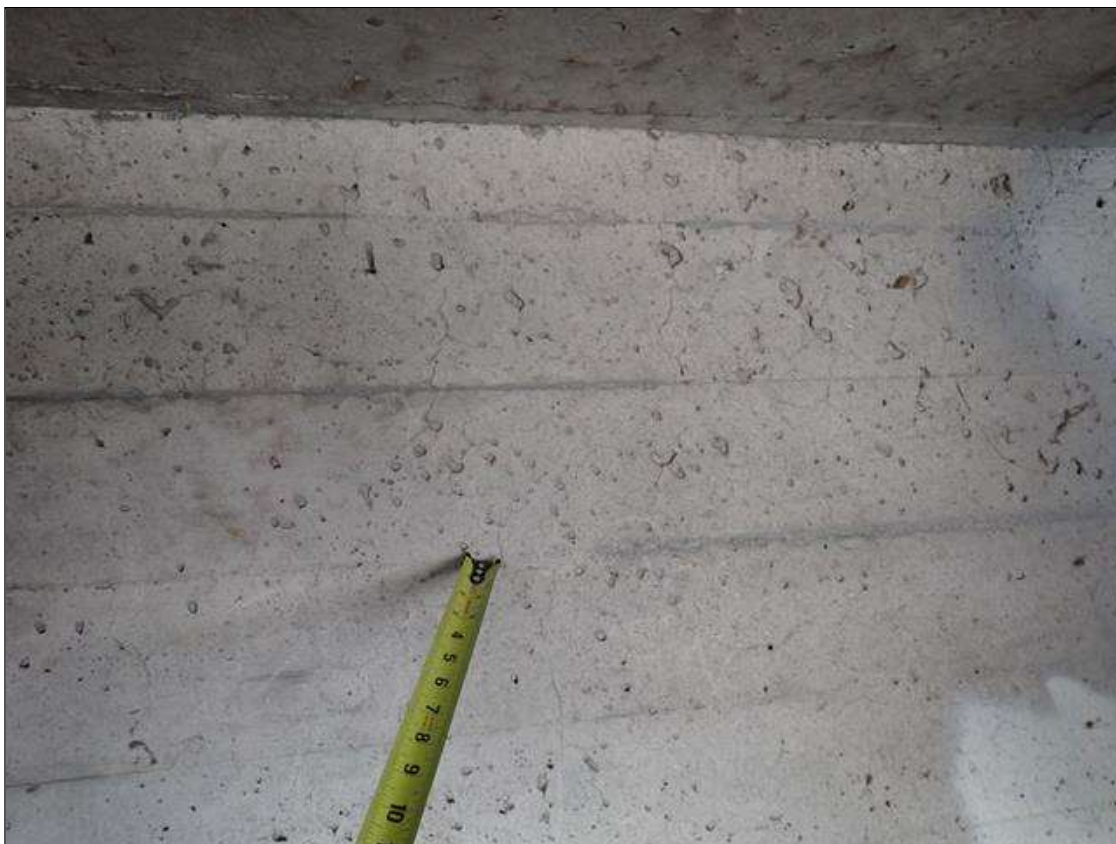
End Bent 2 Abutment: throughout backwall in all bays, multiple areas of hairline map cracking

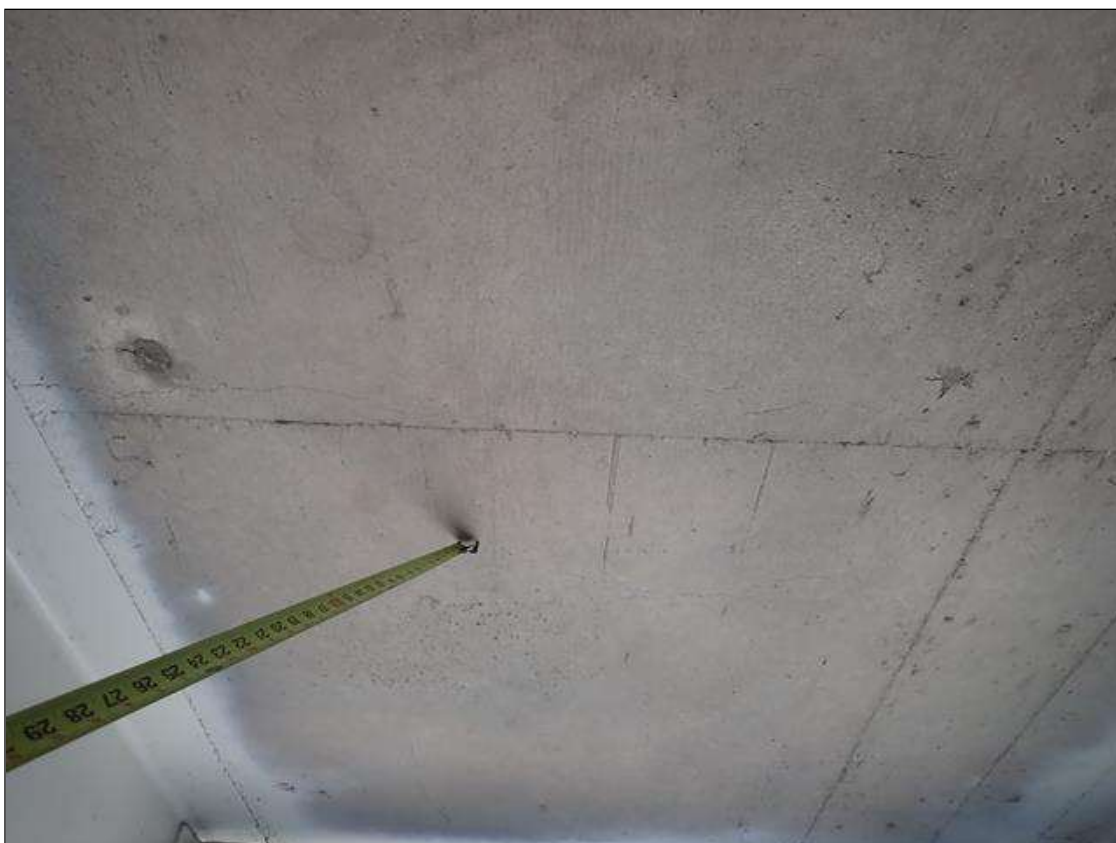
Span 4 Deck: random hairline map cracking and transverse cracks up to 1/32 inch wide on topside and underside.

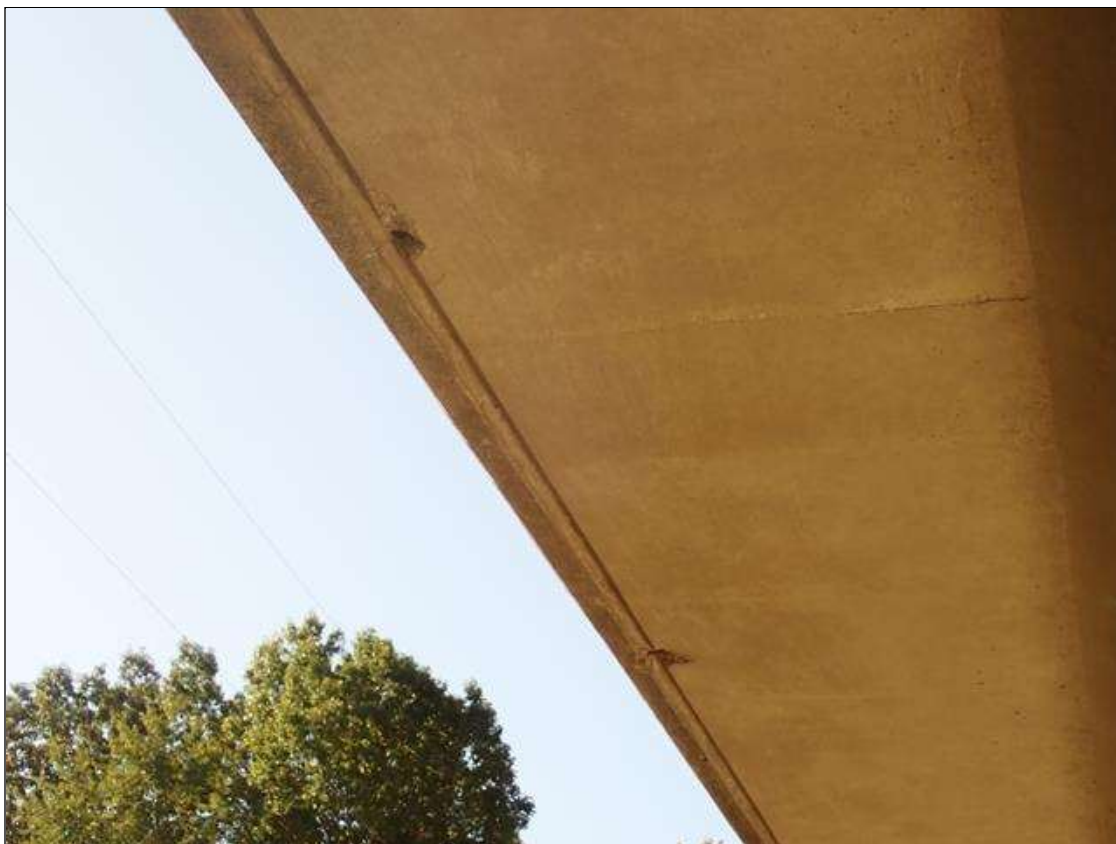
Span 4 Deck: (PAR) 2 - spalls with exposed reinforcing up to 2 inch diameter x 1 inch deep, in underside of right overhang, at random.

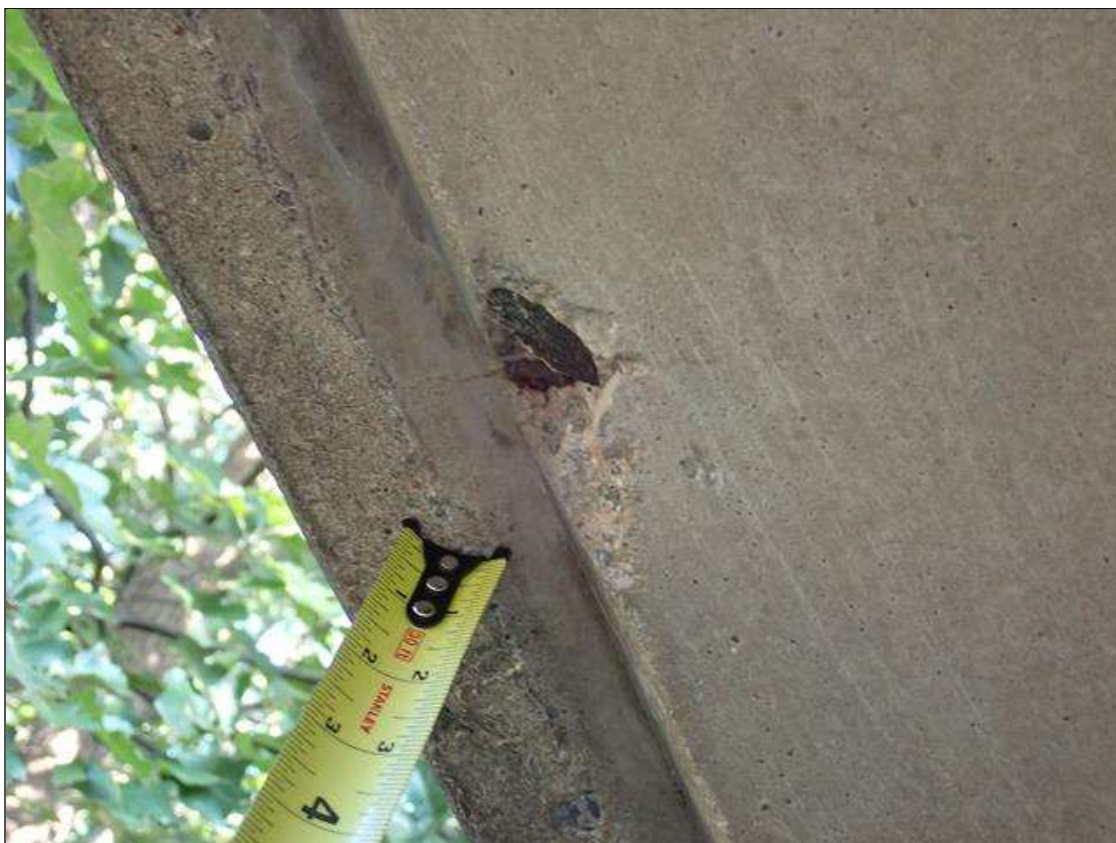
Span 4 Deck: (PAR) 5 - spalls with exposed reinforcing up to 4 inch x 2 inch x 1 inch deep, in underside of left overhang, at random.

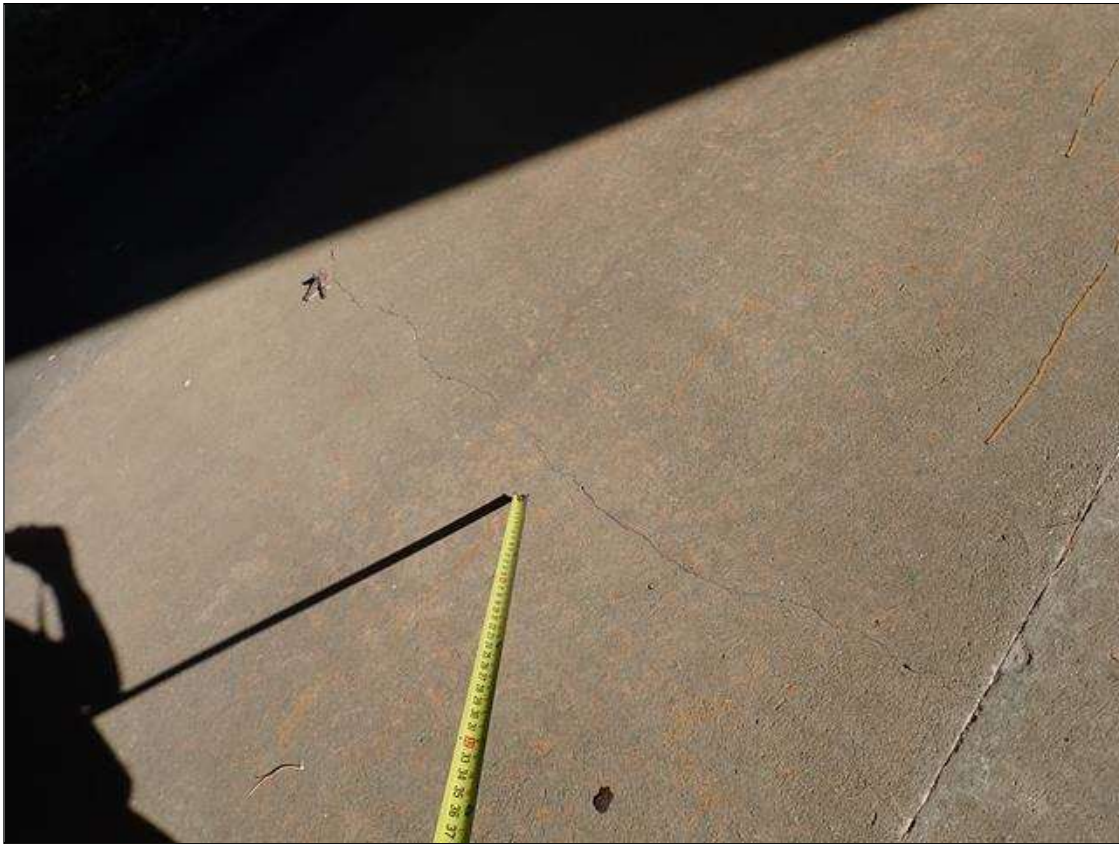
end bent 2 slope protection, at random, transverse cracks (up to 1/16 inch x 8 feet)

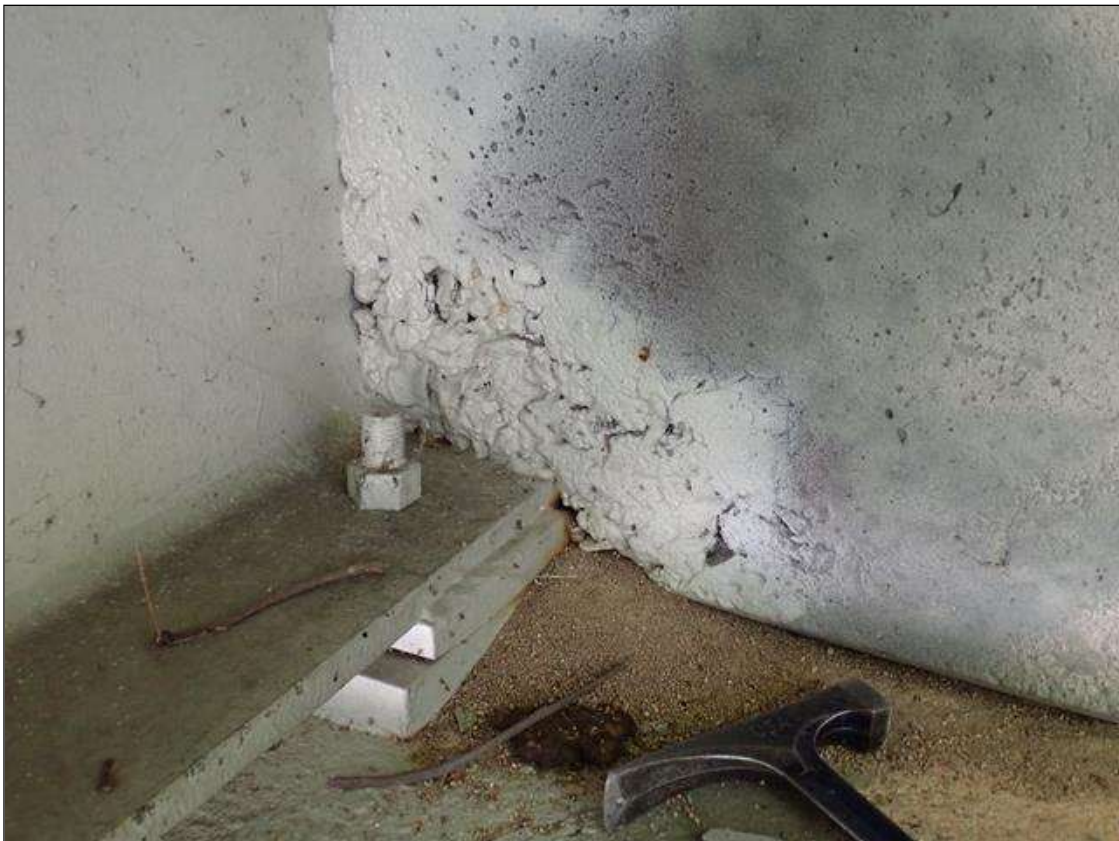
End Bent 1 Abutment: left overhang, adjacent to beam 1, poor consolidation (12 inch x 8 inch x 1 inch deep)

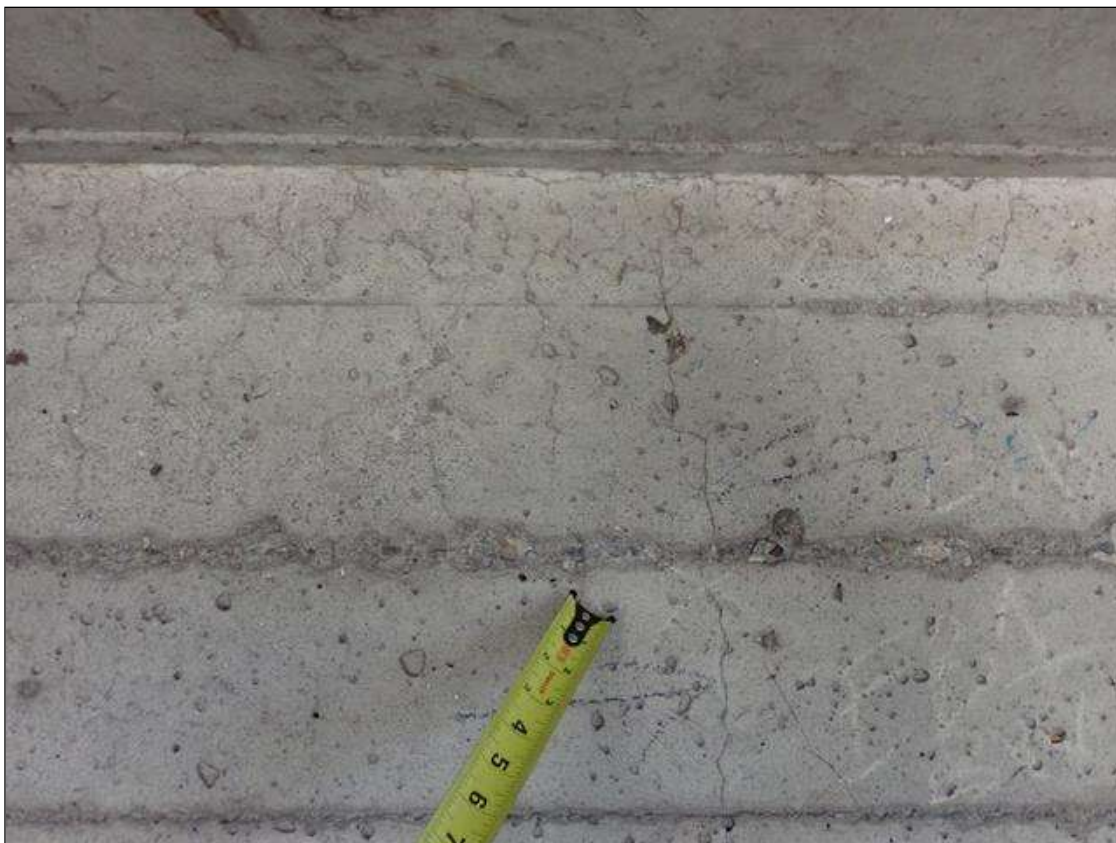
End Bent 1 Abutment: throughout backwall in all bays, multiple areas of hairline map cracking

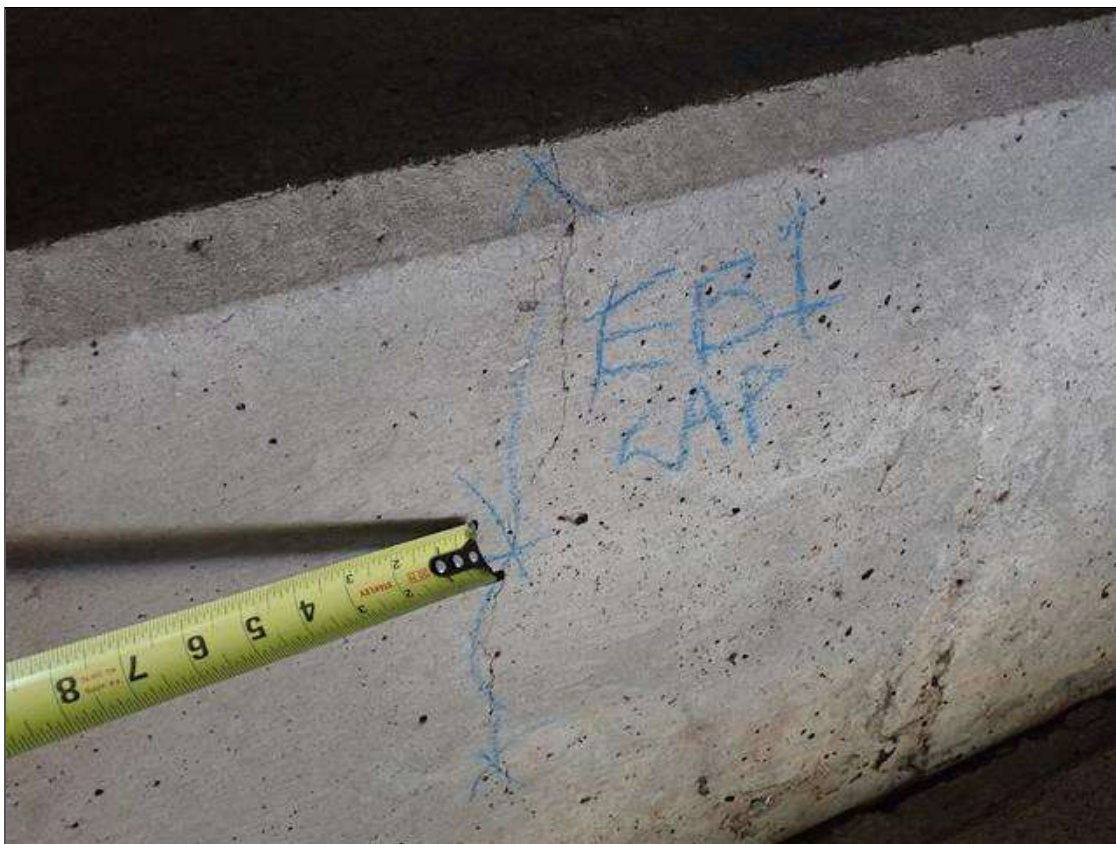
End Bent 1 Cap 1: 10 - vertical cracks in North face extending to topside of cap up to full height x 1/32 inch wide, at random throughout

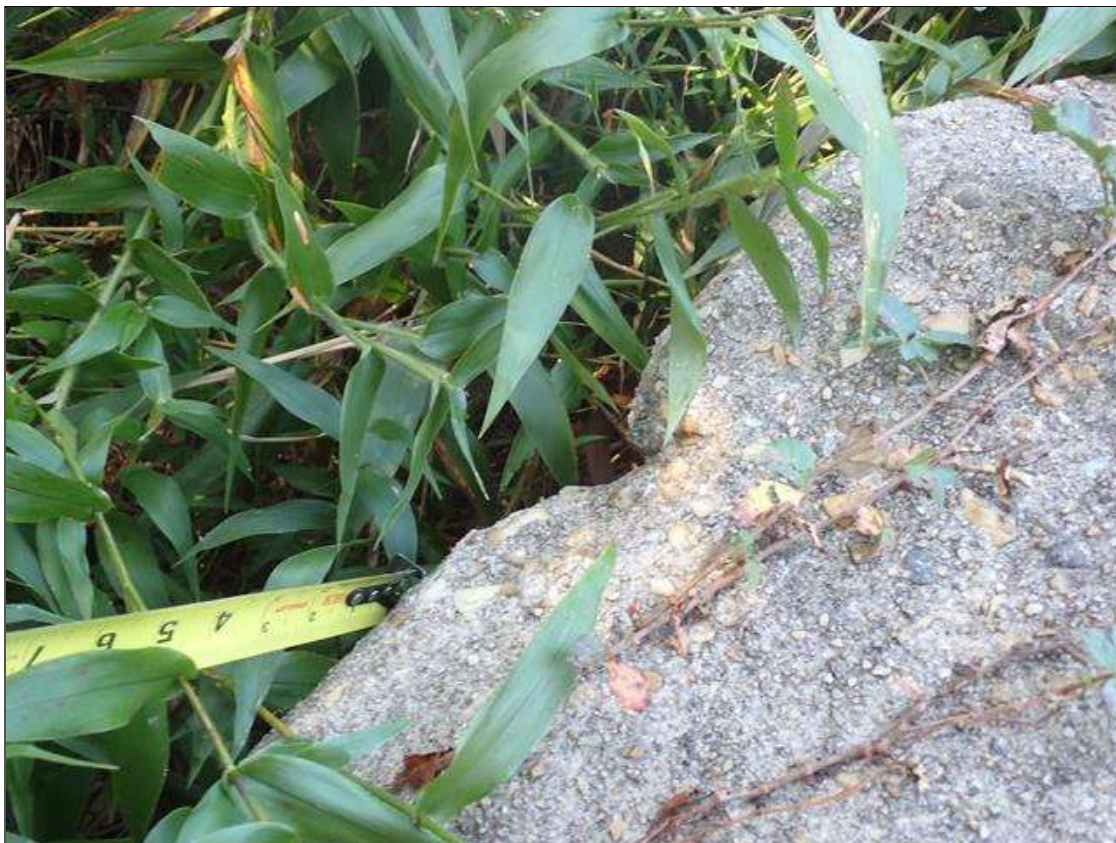
southeast wingwall, along top, spall (6 inch diameter x 1.5 inch deep)

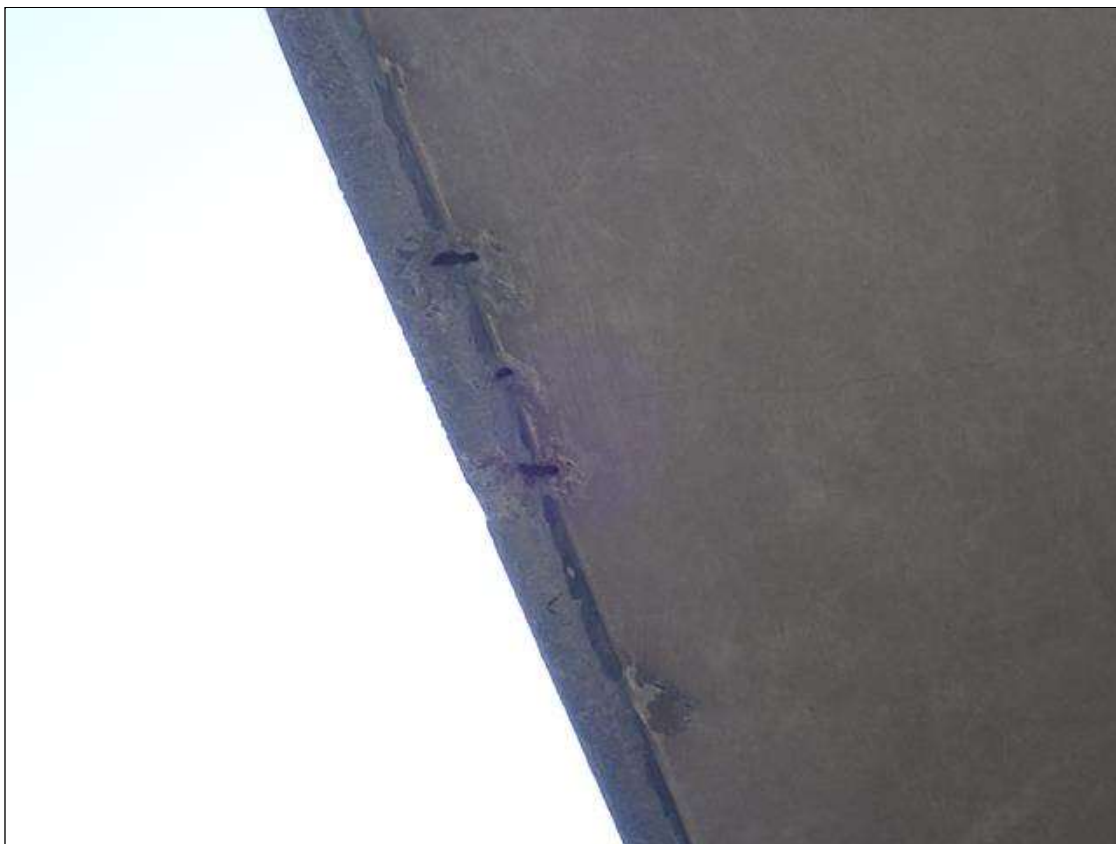
Span 1 Deck: (PAR) 5 - spalls with exposed reinforcing up to 4 inch diameter x 1 inch deep, in underside of left overhang, at random.

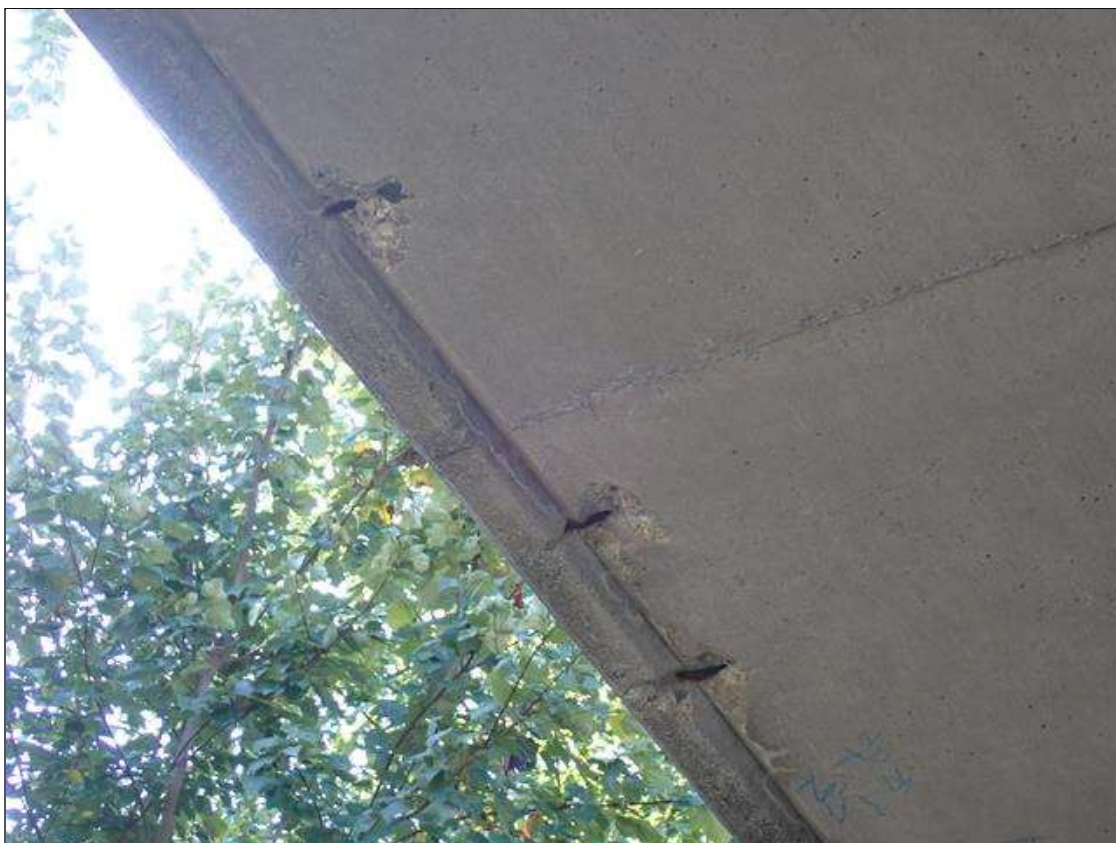
Span 1 Deck: (PAR) 7 - spalls with exposed reinforcing up to 4 inch diameter x 1 inch deep, in underside of right overhang, at random.

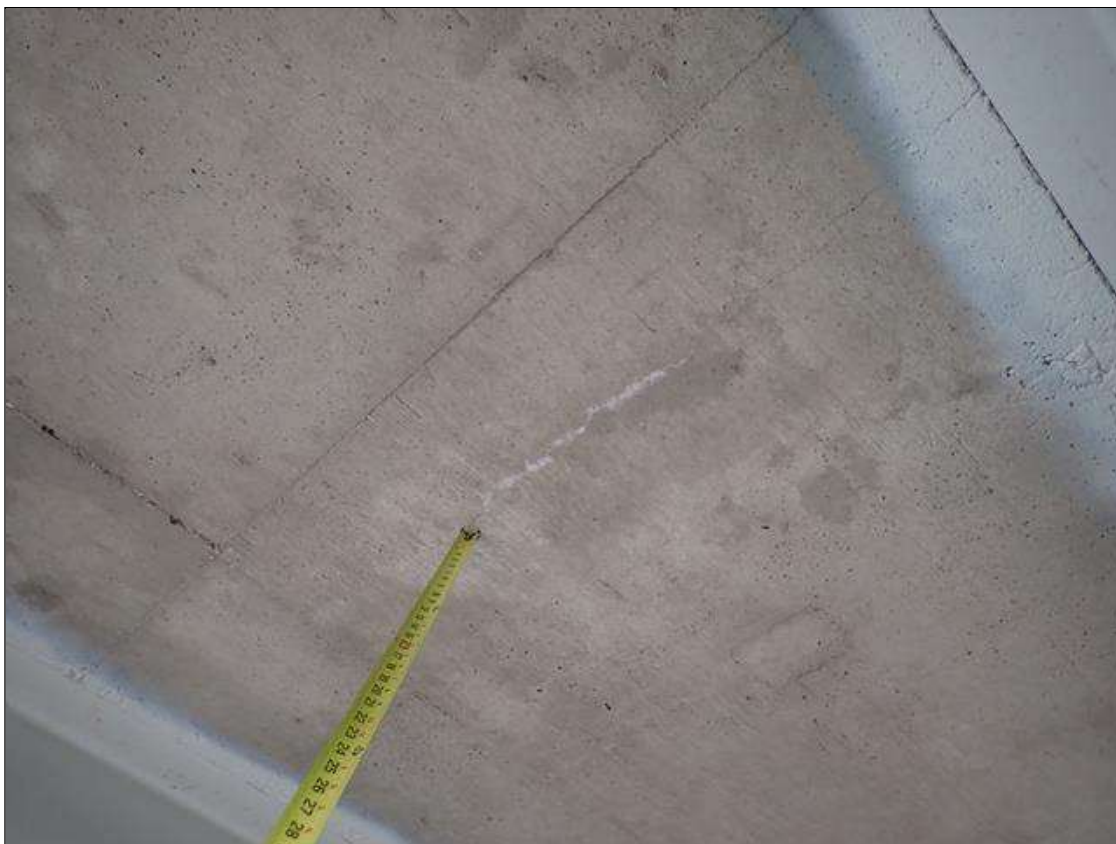
Span 1 Deck: up to 1/32 inch transverse cracks, some with efflorescence, on underside of deck throughout

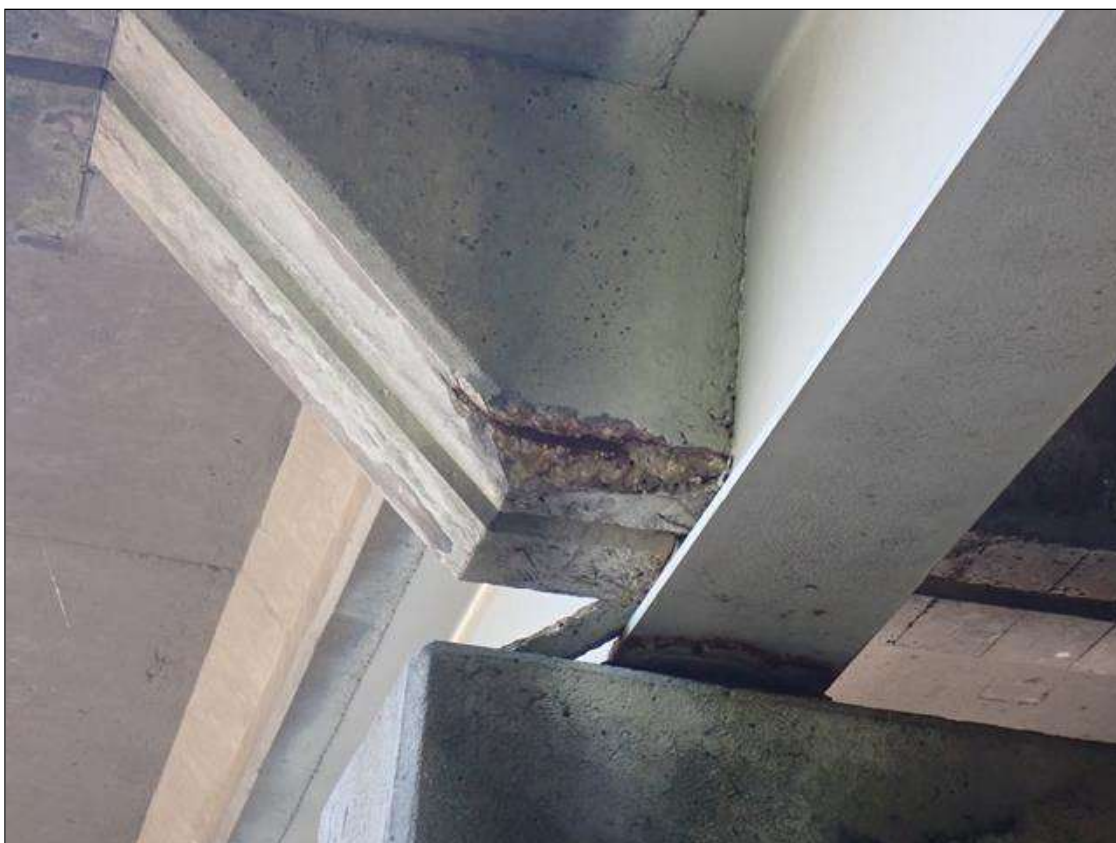
Span 1 Beam 1: 15 inch x 6 inch x 1.5 inch deep spall with exposed reinforcing, in end diaphragm, west overhang, at bent 1.

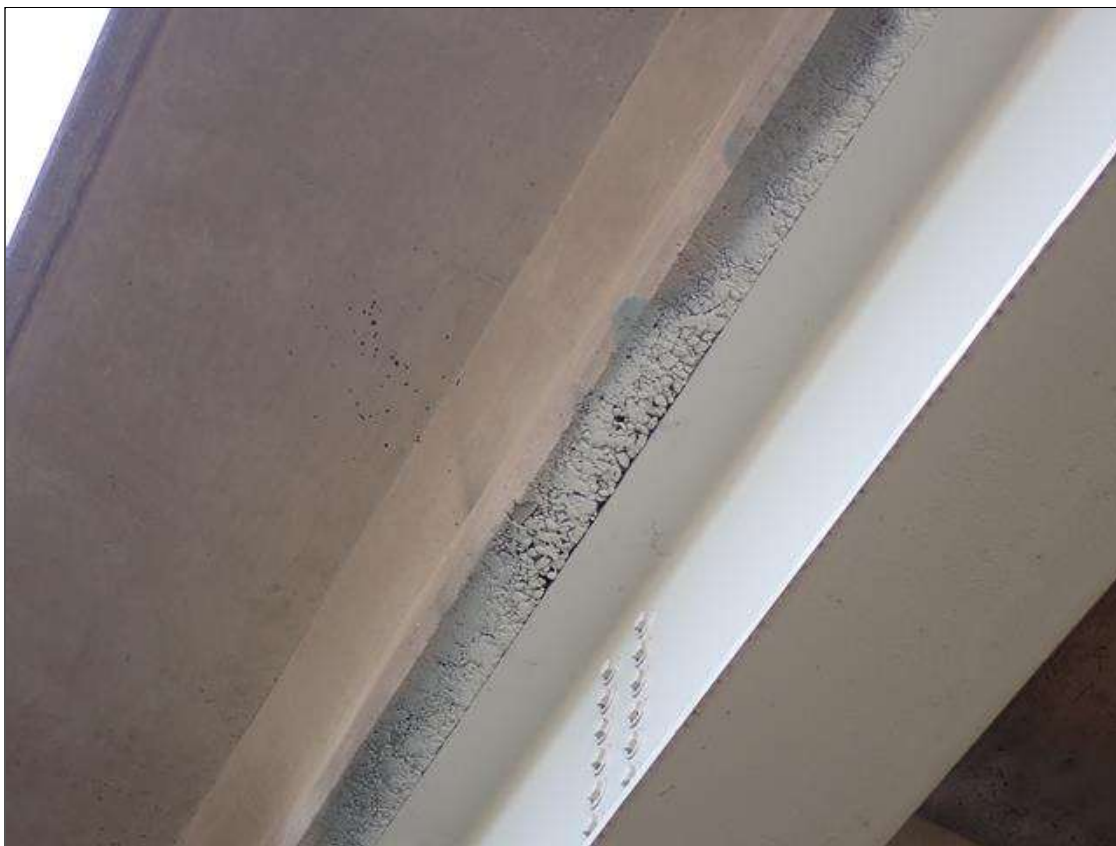
Span 1 Deck: throughout underside of deck, scattered areas of poor consolidation (up to 1/2 inch deep) at random

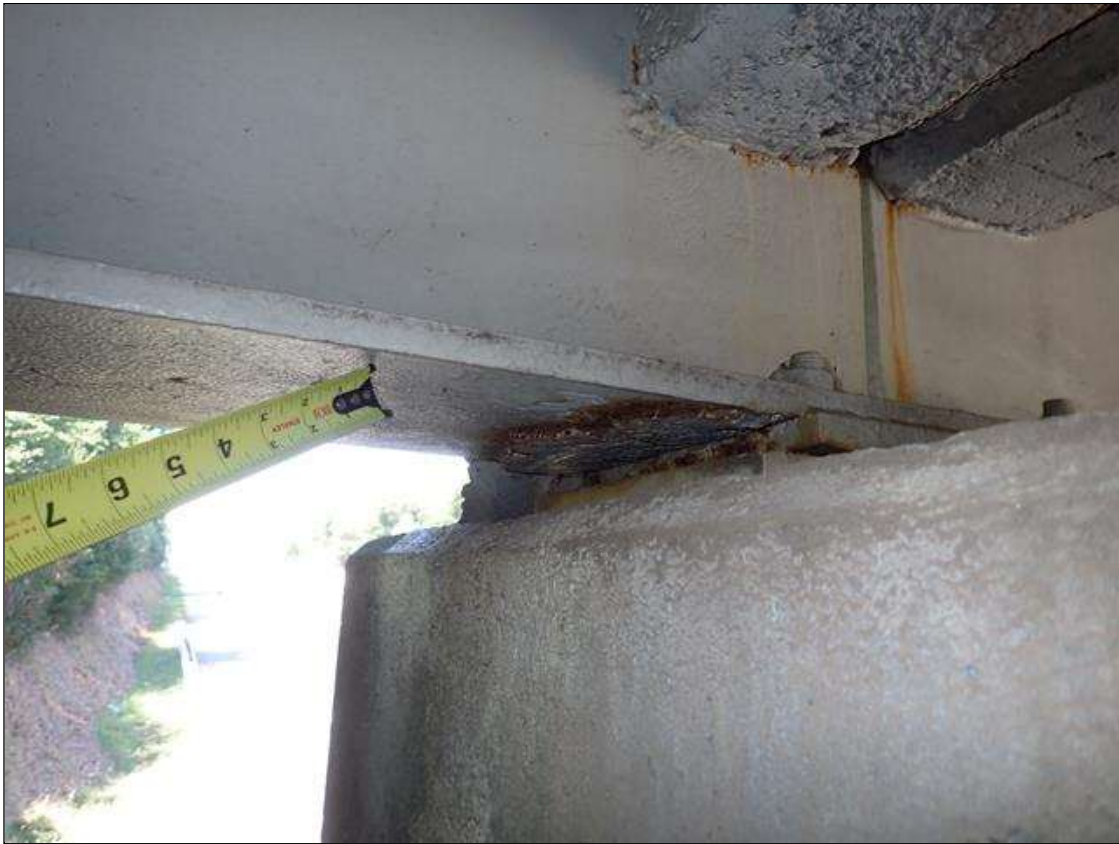
Span 1 Beam 1: (PAR) at bent 1, web adjacent to diaphragm, painted over section loss (3/8 inch average remaining x 3 inch x 2 inch); painted over pitting: lower web (up to 1/8 inch deep x 1 foot x 1 foot); bottom flange (up to 1/8 inch deep x 1 foot); underside of bottom flange, rust scale

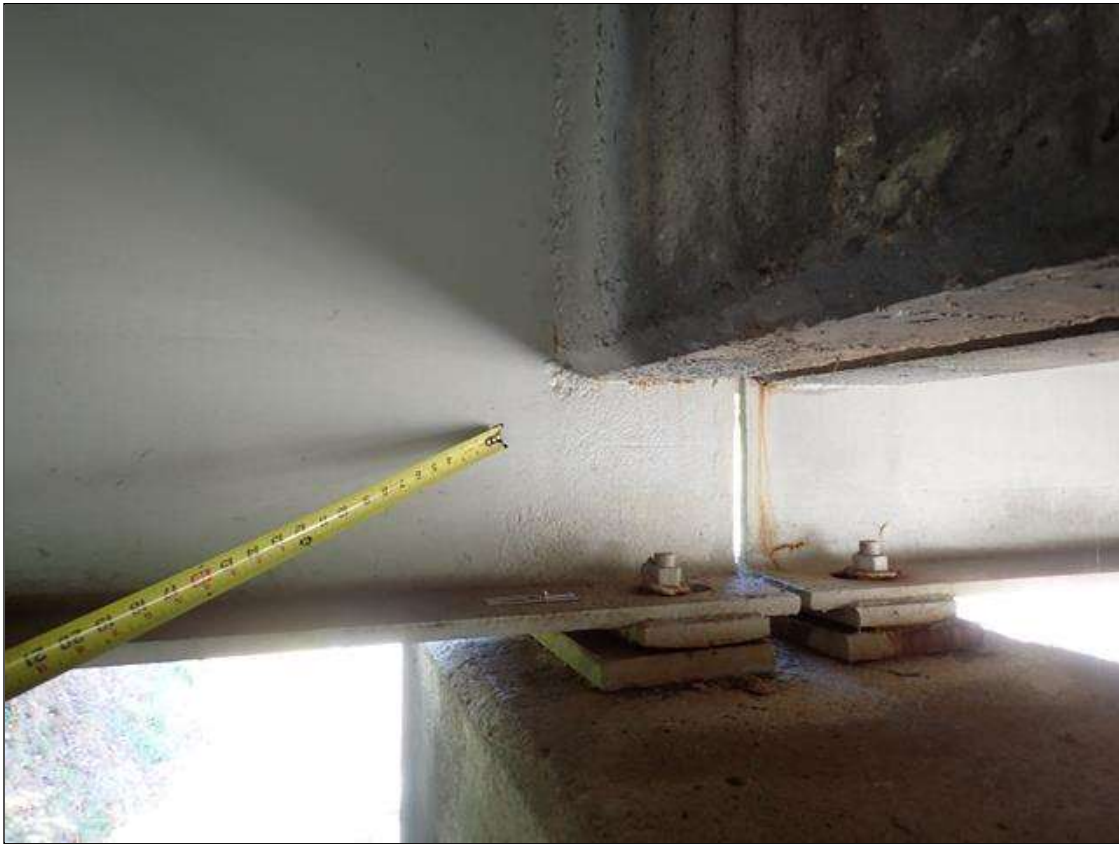
Span 1 Beam 1: (PAR) at bent 1, web adjacent to diaphragm, painted over section loss (3/8 inch average remaining x 3 inch x 2 inch); painted over pitting: lower web (up to 1/8 inch deep x 1 foot x 1 foot); bottom flange (up to 1/8 inch deep x 1 foot); underside of bottom flange, rust scale

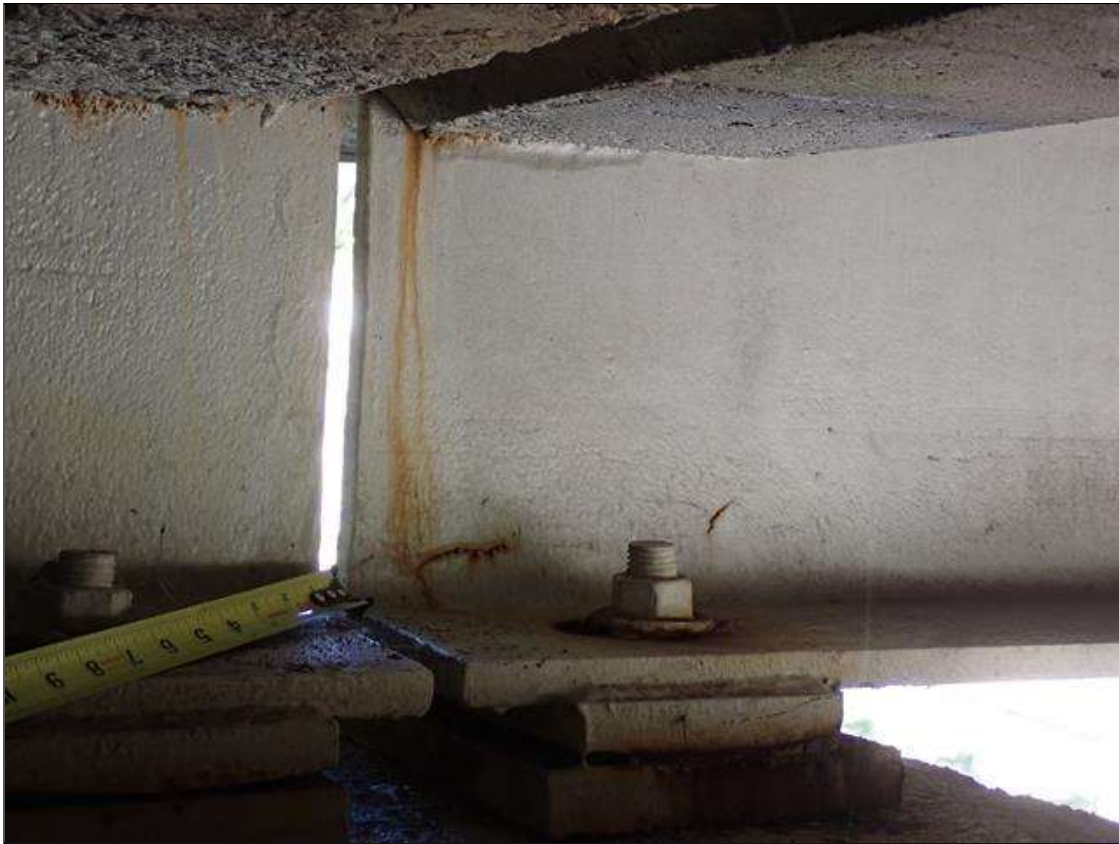
Span 2 Beam 1: (PAR) at bent 1, web adjacent to diaphragm, painted over section loss (3/8 inch average remaining x 7 inch x 1 inch); painted over pitting: lower web, painted over pitting (up to 1/16 inch deep x 1 foot x 6 inch) with corrosion reinitiated

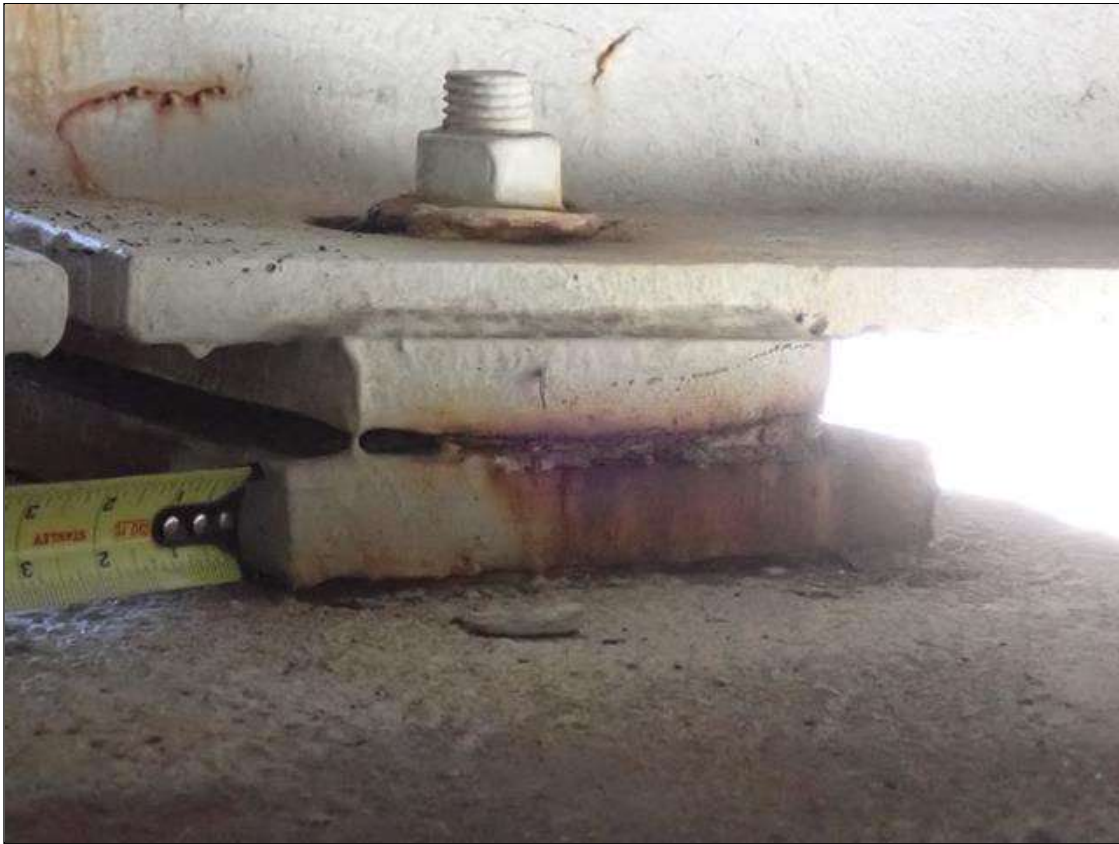
Span 2 Beam 1 - Near Bearing 1: surface rust/pack rust.

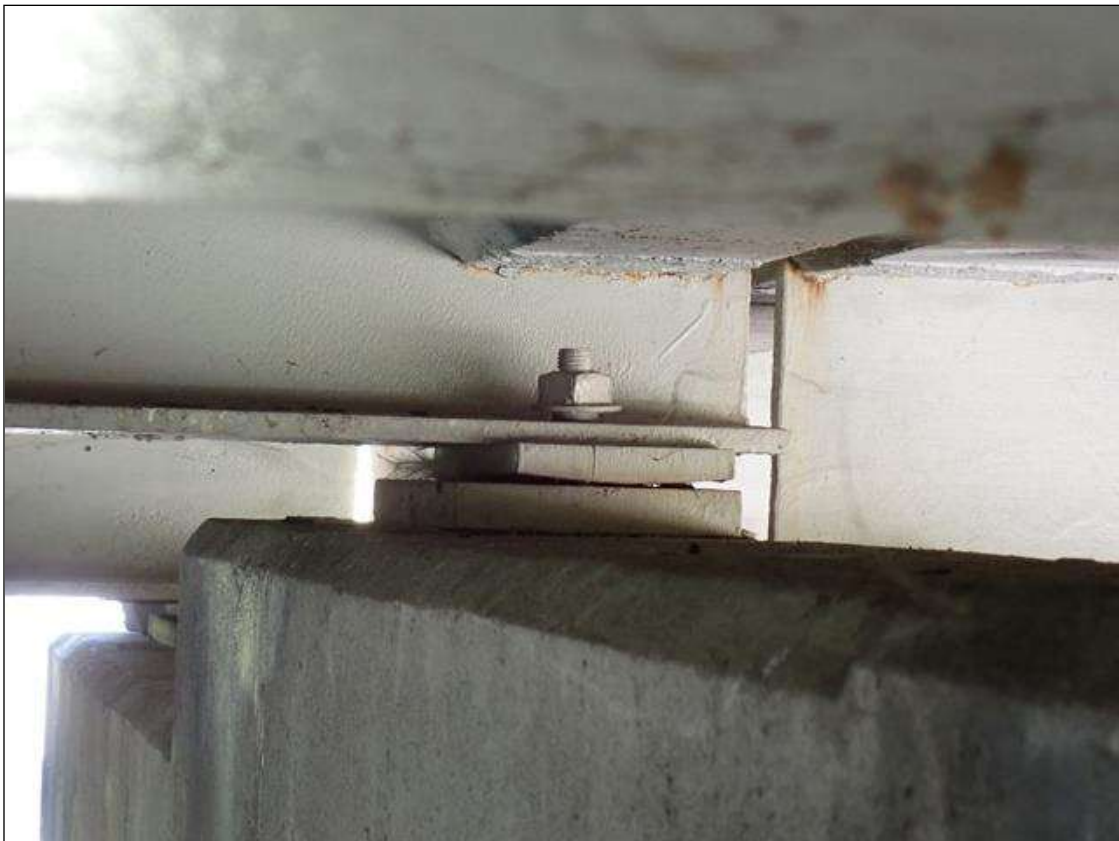
Span 1 Beam 2 - Far Bearing 2: (not found 2023) surface rust.

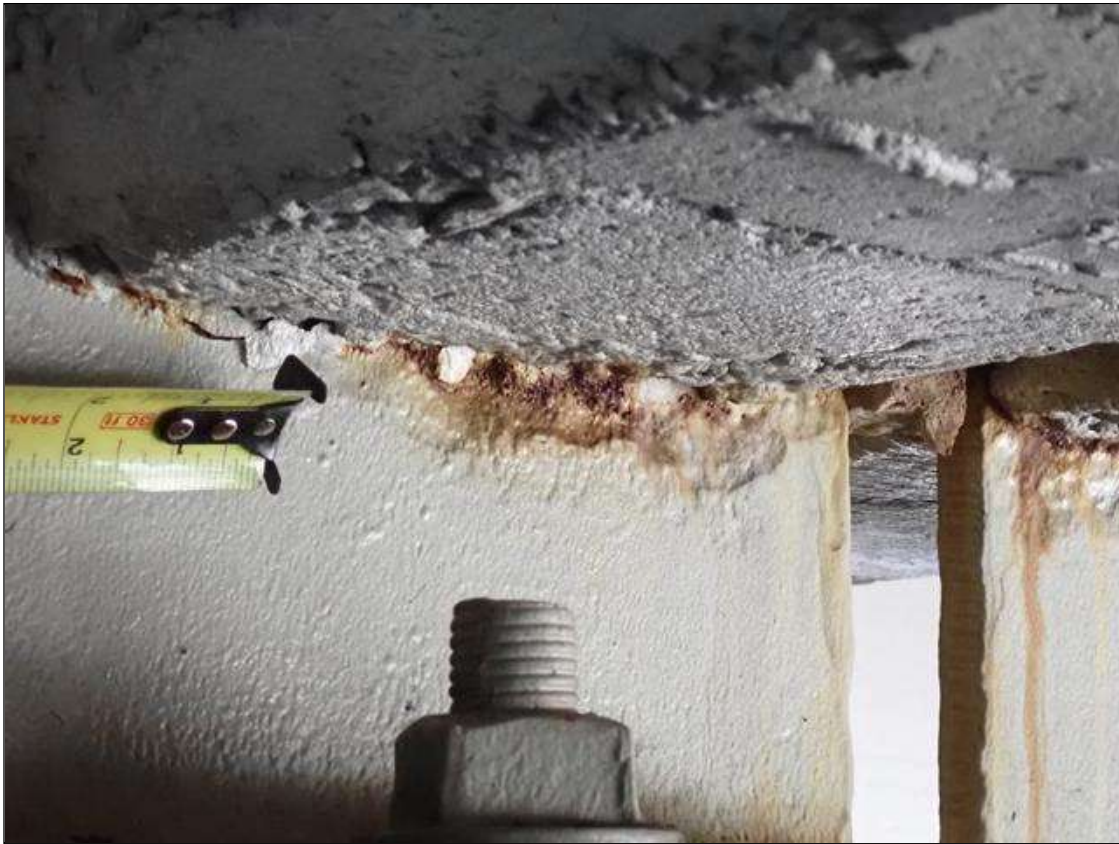
Span 1 Beam 3: (PAR) at bent 1, web adjacent to diaphragm, painted over section loss (5/16 inch average remaining x 6 inch x up to 2 inch) with corrosion reinitiated
