NC DEPARTMENT OF TRANSPORTATION
 DIVISION OF HIGHWAYS
 STRUCTURE MANAGEMENT UNIT

ATTENTION: prompt action request, sign notice issued, sketches revised, clearances revised; new repairs to span 3 beams

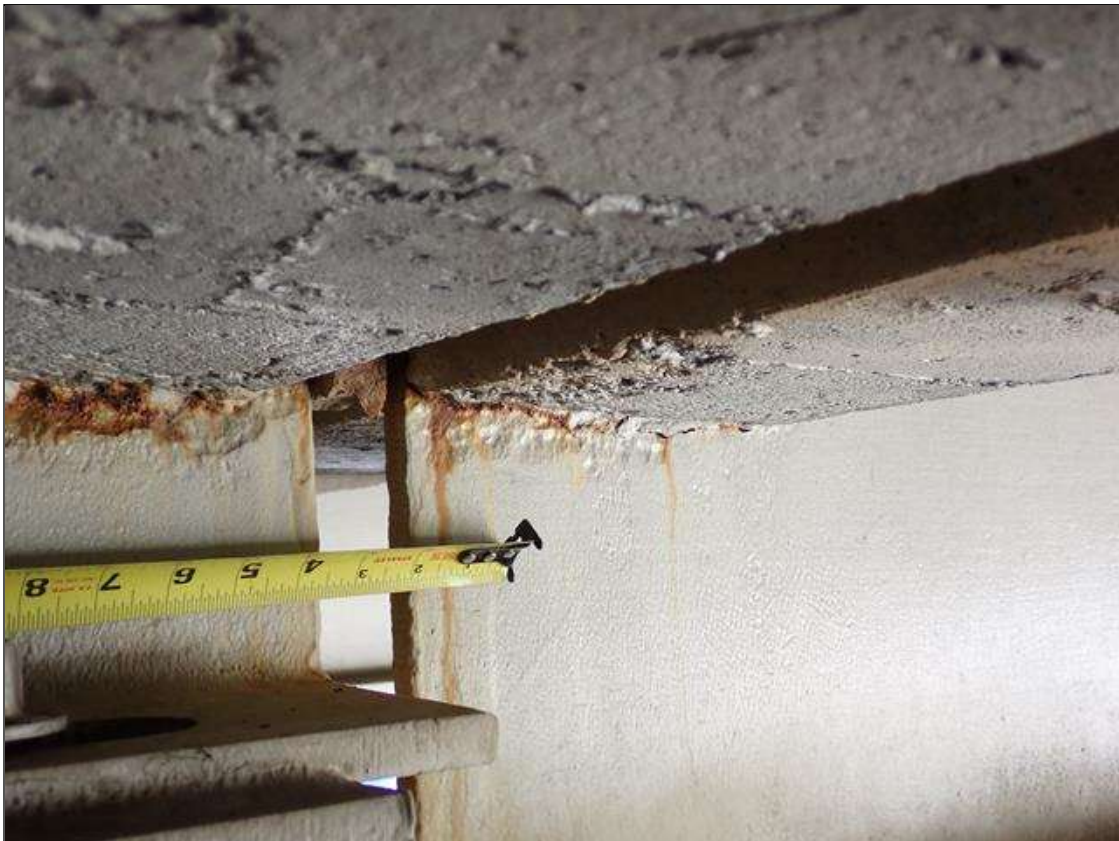
Span 2 Beam 3: (PAR) at bent 1, web adjacent to diaphragm, painted over section loss (3/8 inch average remaining x 6 inch x 1 inch) with corrosion reinitiated

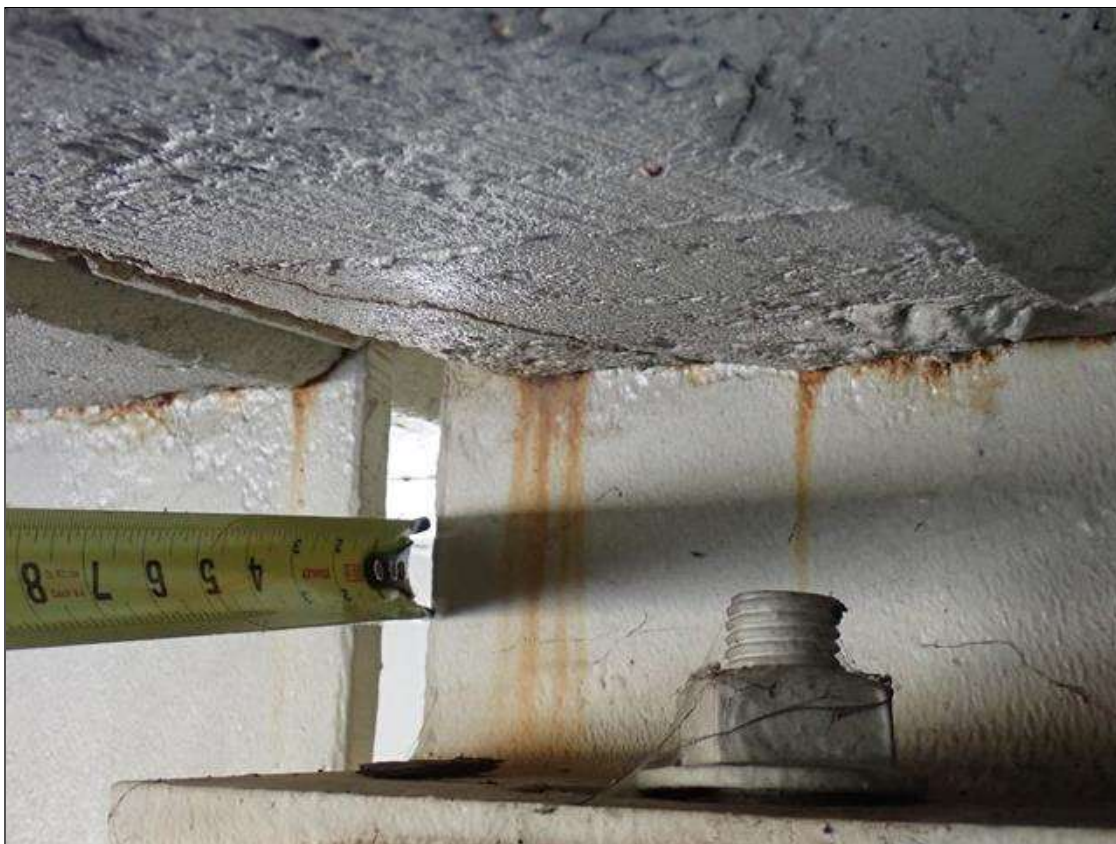
Span 1 Beam 4: at bent 1, web adjacent to diaphragm, painted over section loss (7/16 inch average remaining x 4 inch x 1 inch) with corrosion reinitiated

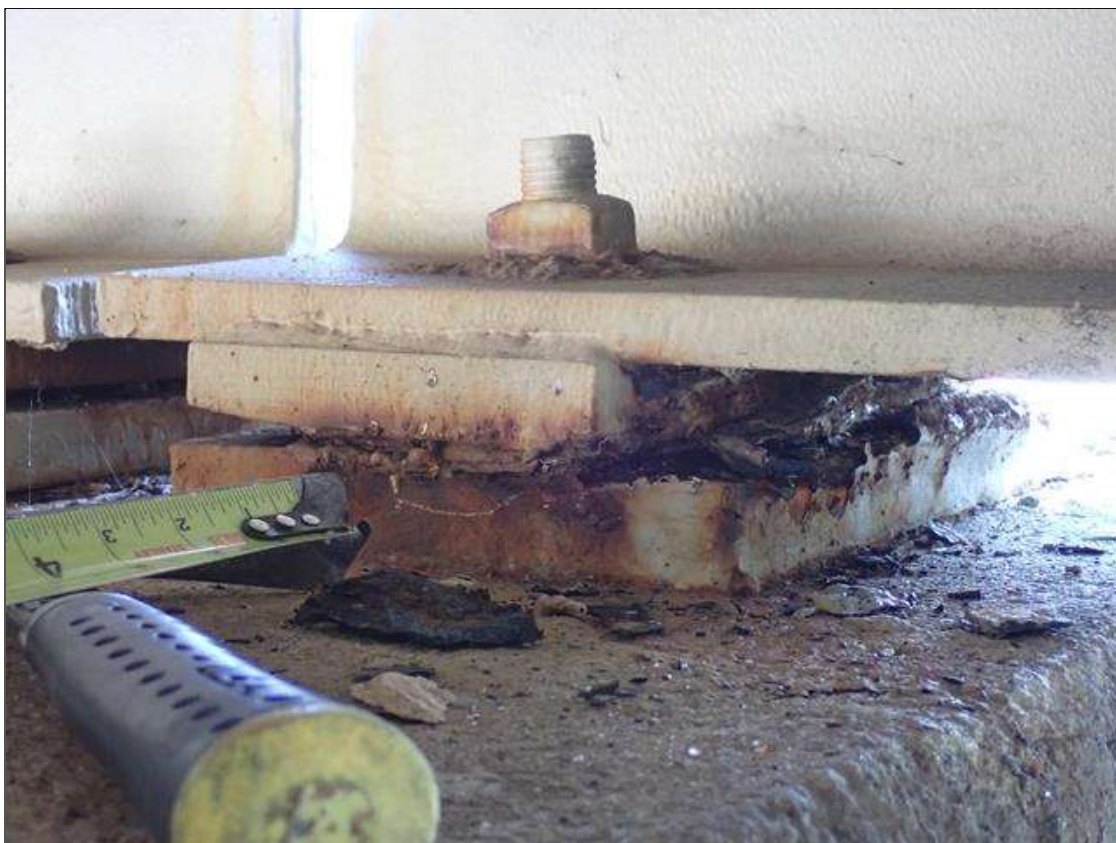
Span 1 Beam 5 - Far Bearing 5: corrosion with section loss (up to 1/8 inch deep) and pack rust

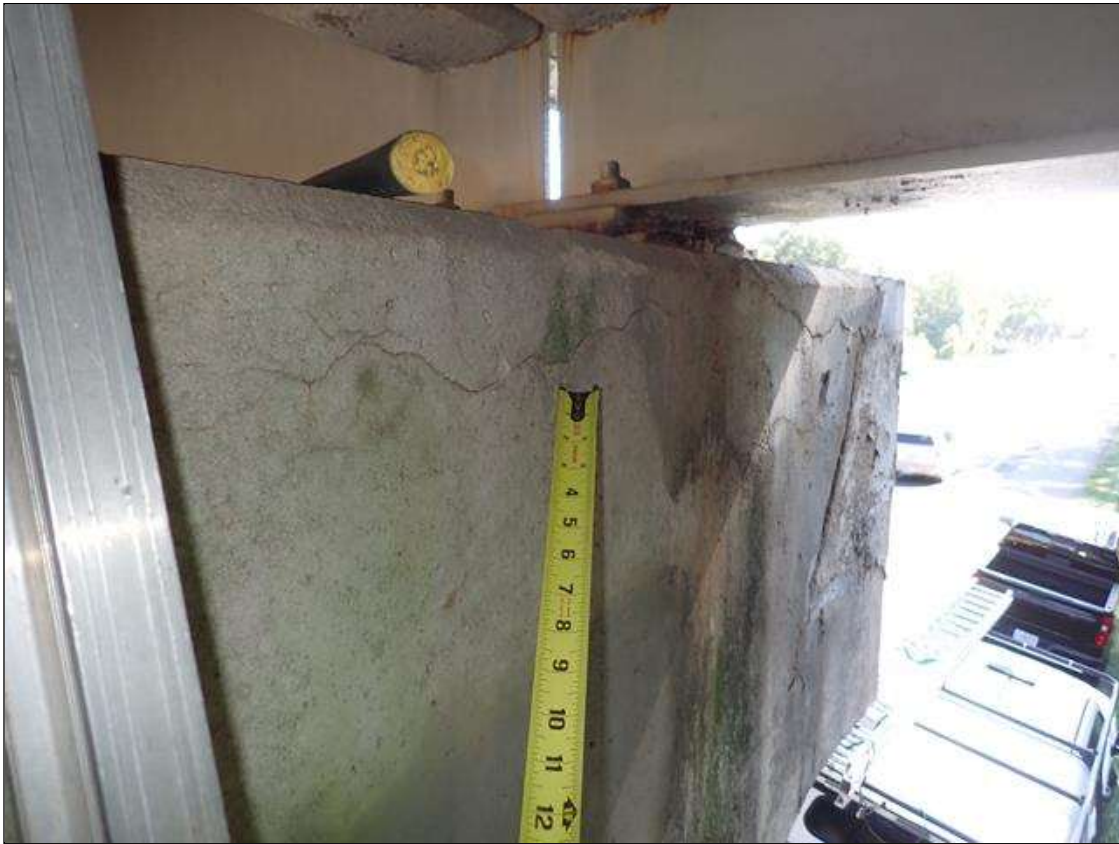
Bent 1 Cap 1: south face, below bay 4 and right overhang, along top edge, delamination (6 feet x 8 inch) with associated cracks (up to 1/32 inch); southeast corner, patched area (20 inch x 18 inch)

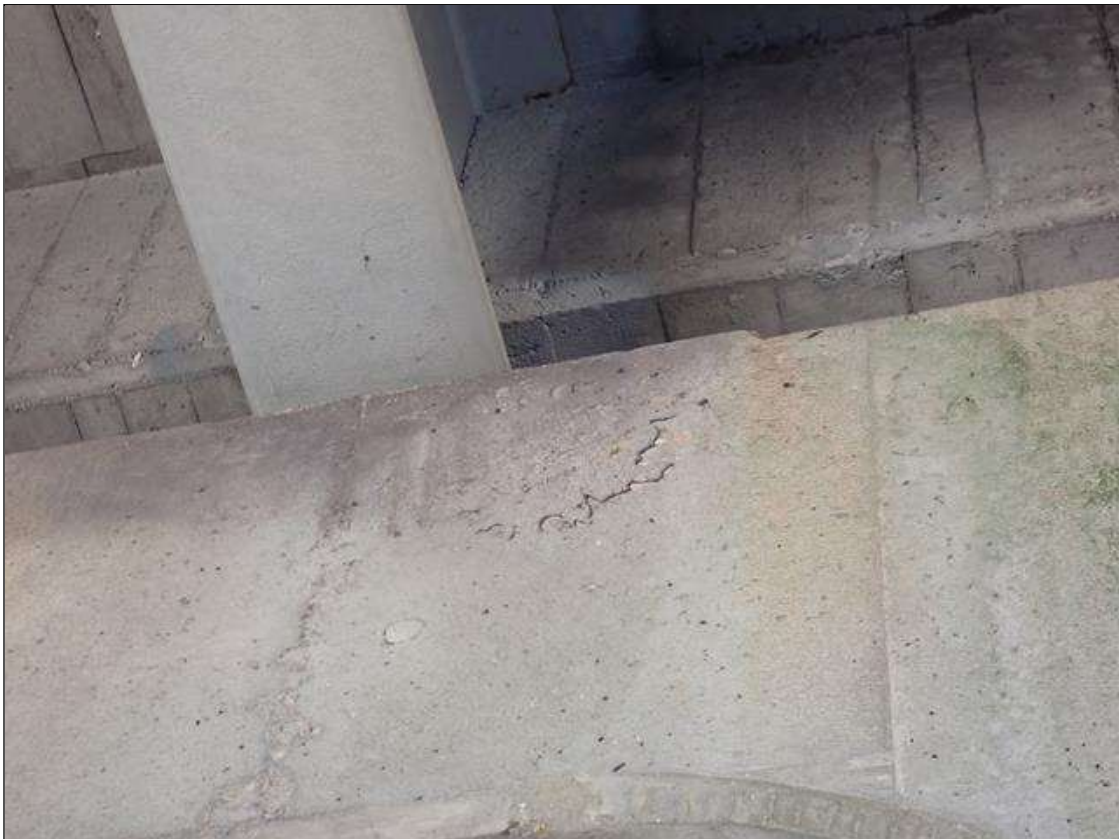
Bent 1 Cap 1: at North face under beam 2, delamination [1 foot diameter]

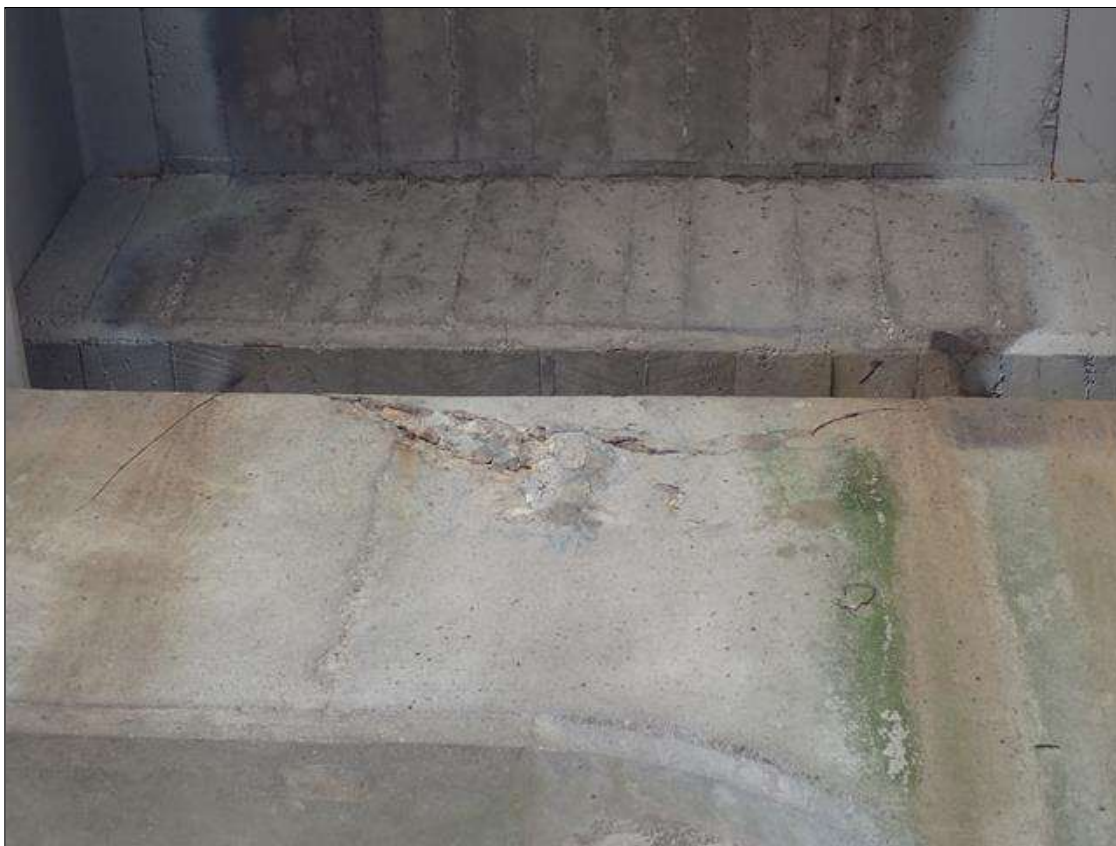
Bent 1 Cap 1: in north face under bay 3, delamination/spall [up to 3 feet x up to 15 inch x 1.5 inch deep]

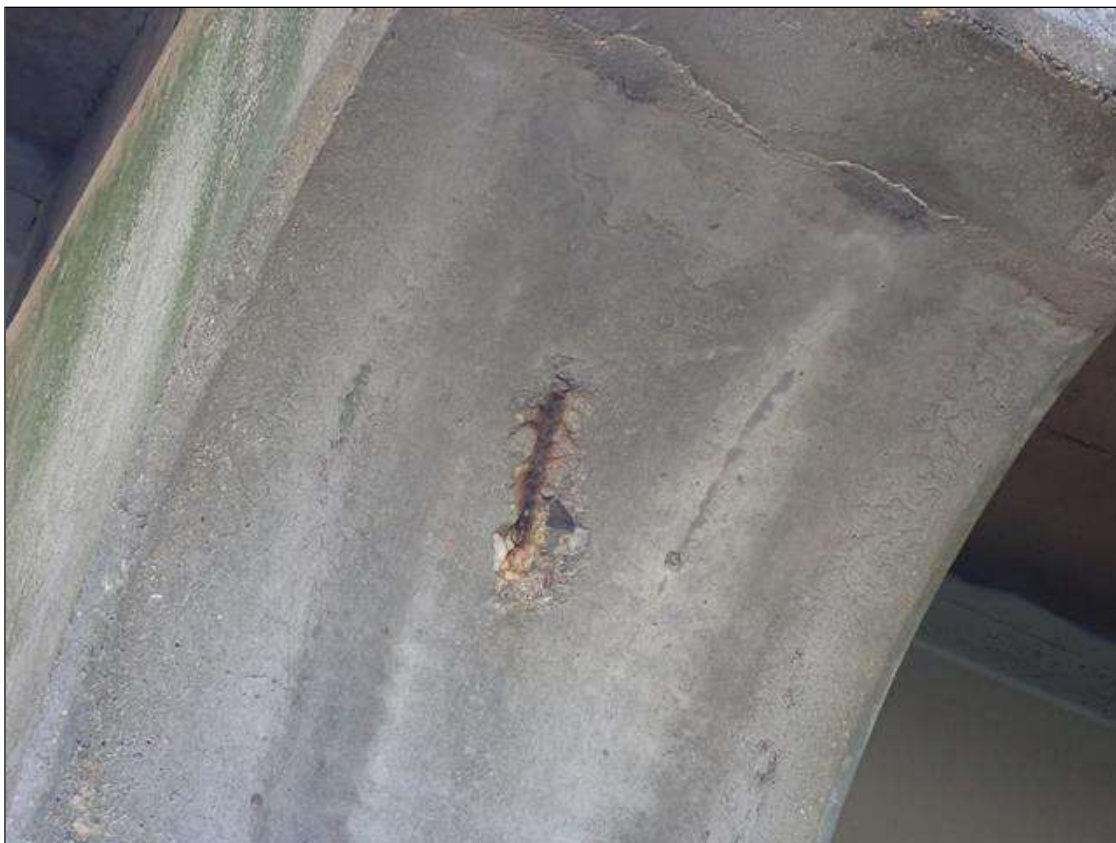
Bent 1 Cap 1: 10 inch x 2 inch x 1/2 inch deep spall with exposed reinforcing [no section loss noted] in West face underside of corbel

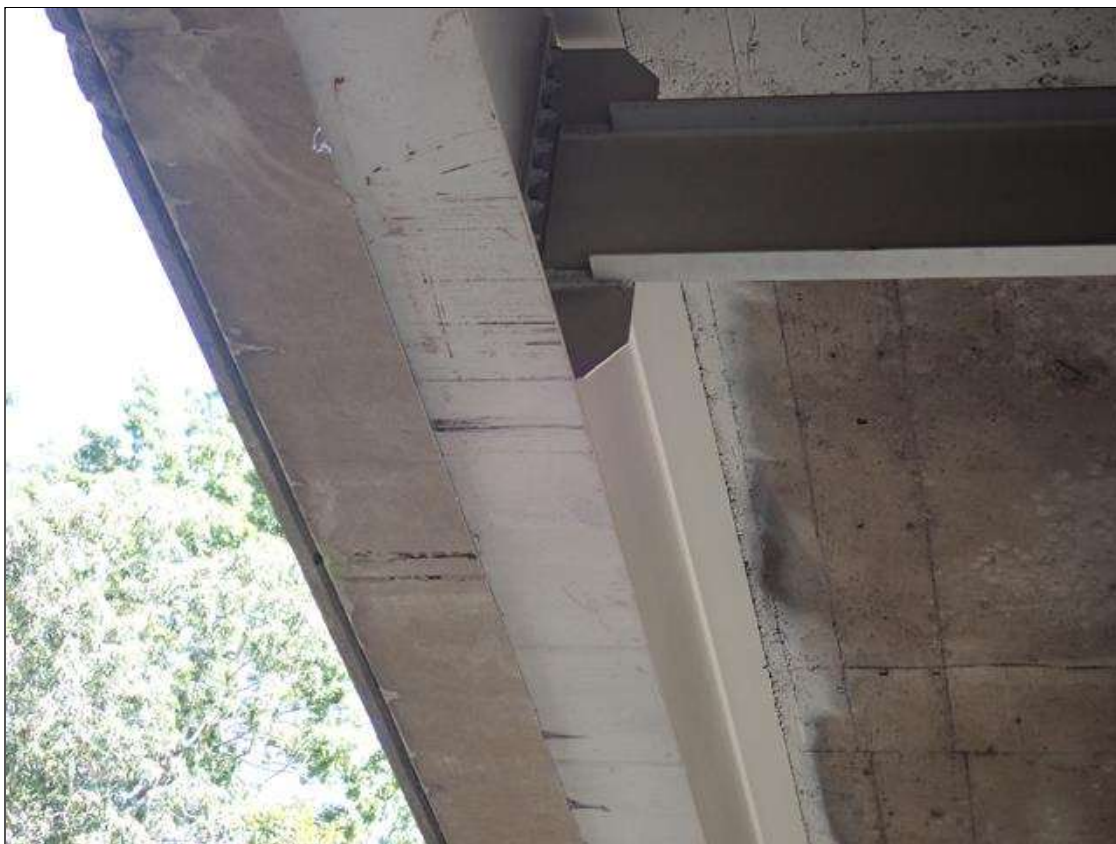
Span 2 Beam 1: underside of bottom flange, over right travel lane, impact scrapes

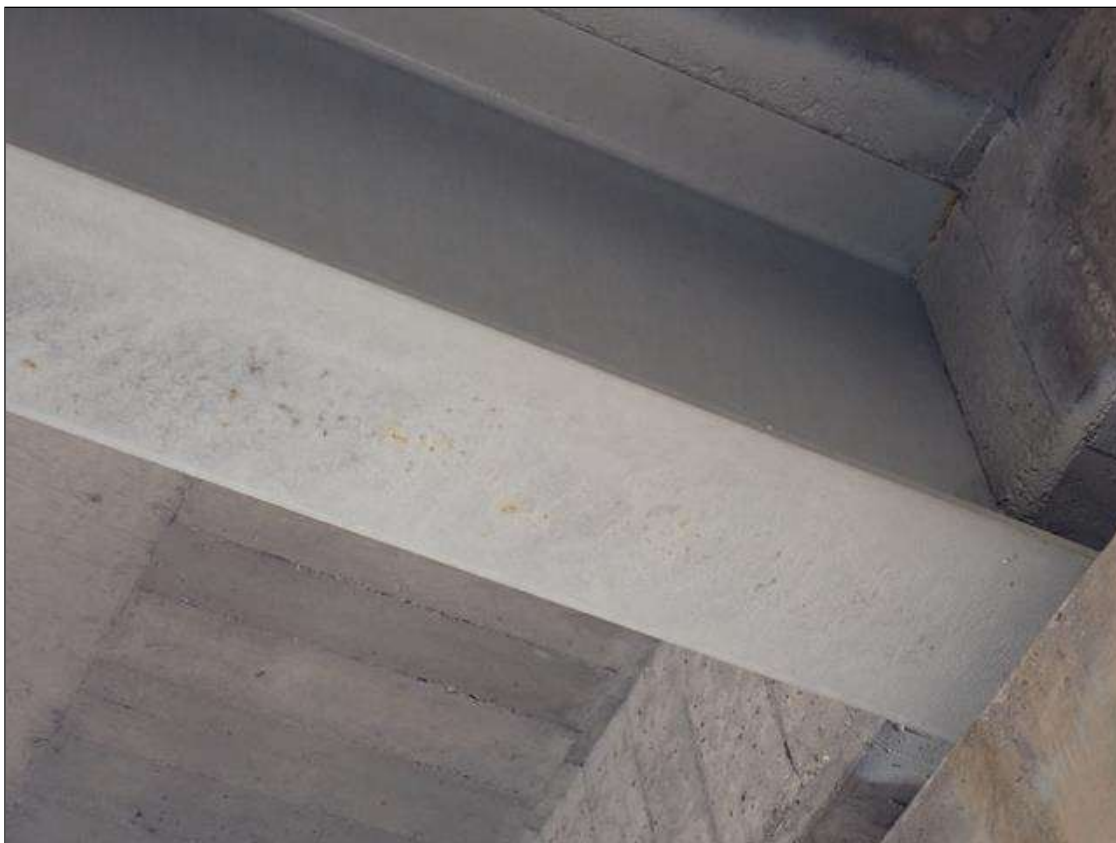
Span 2 Beam 4: underside of bottom flange, near bent 1, freckled rust

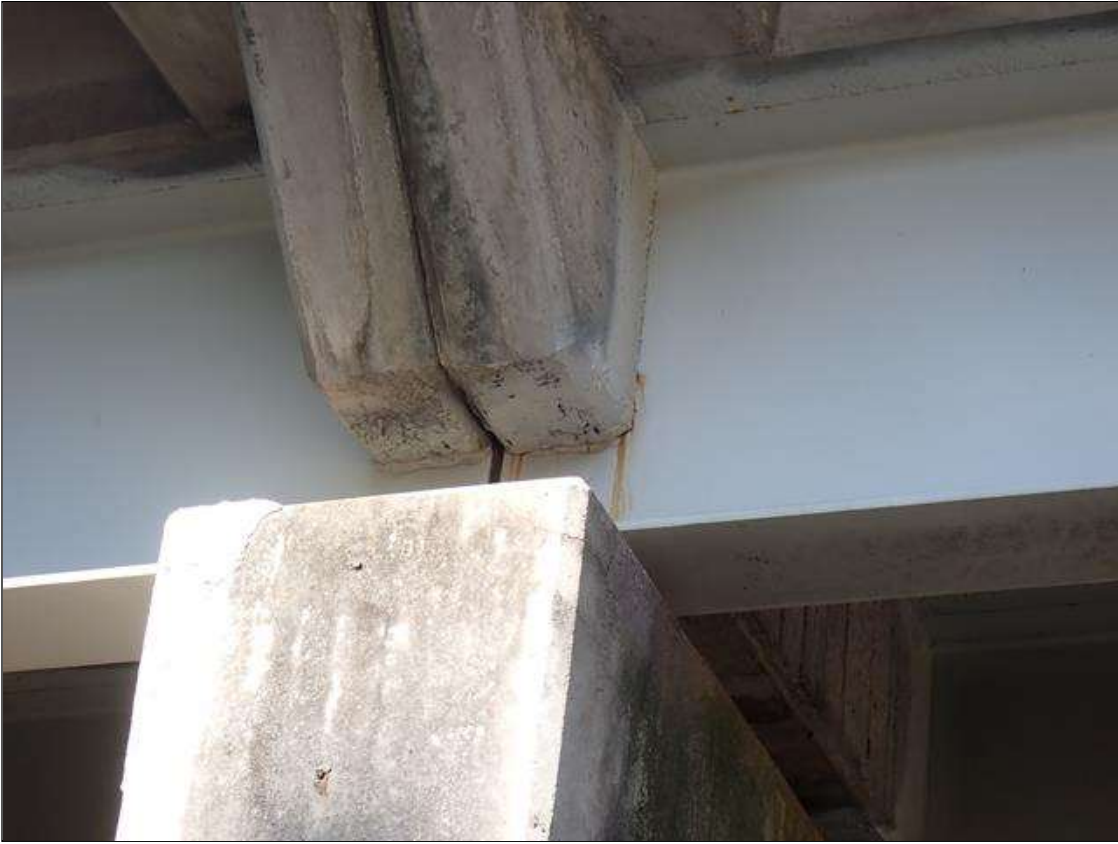
Span 2 Beam 5: (PAR) at bent 1, web adjacent to diaphragm, painted over section loss (approximately 3/8 inch average remaining x 7 inch x 1 inch); no safe ladder access to exterior face

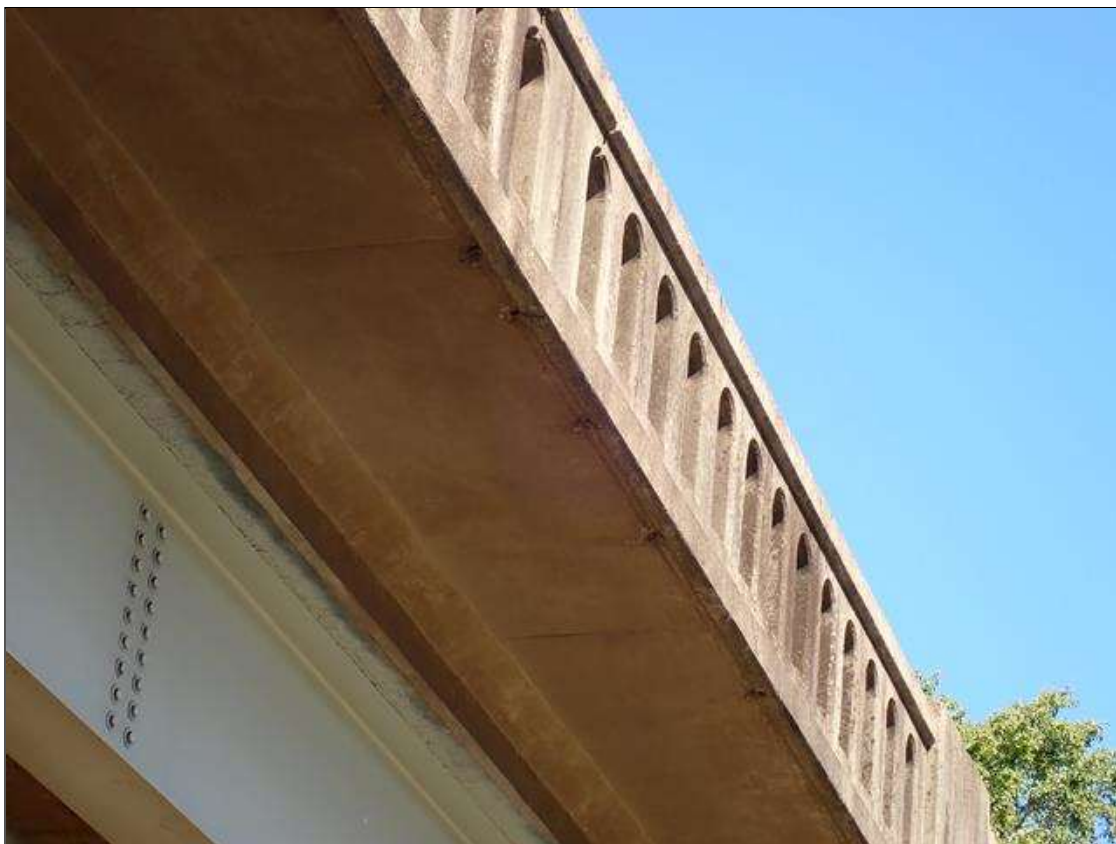
Span 2 Deck: (PAR) 5 - spalls with exposed reinforcing in underside of right overhang up to 2 inch diameter x 1 inch deep, 20 feet from bent 2.

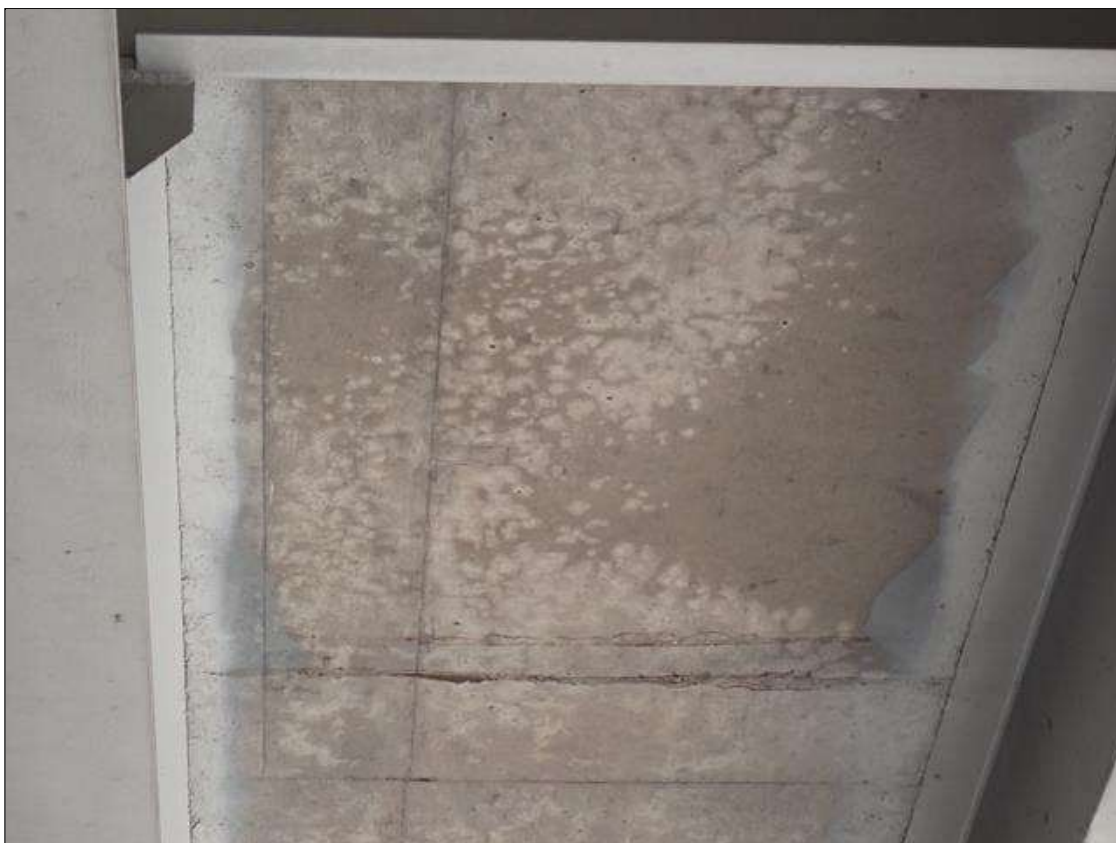
Span 2 Deck: throughout underside in all bays, multiple areas of hairline map cracking

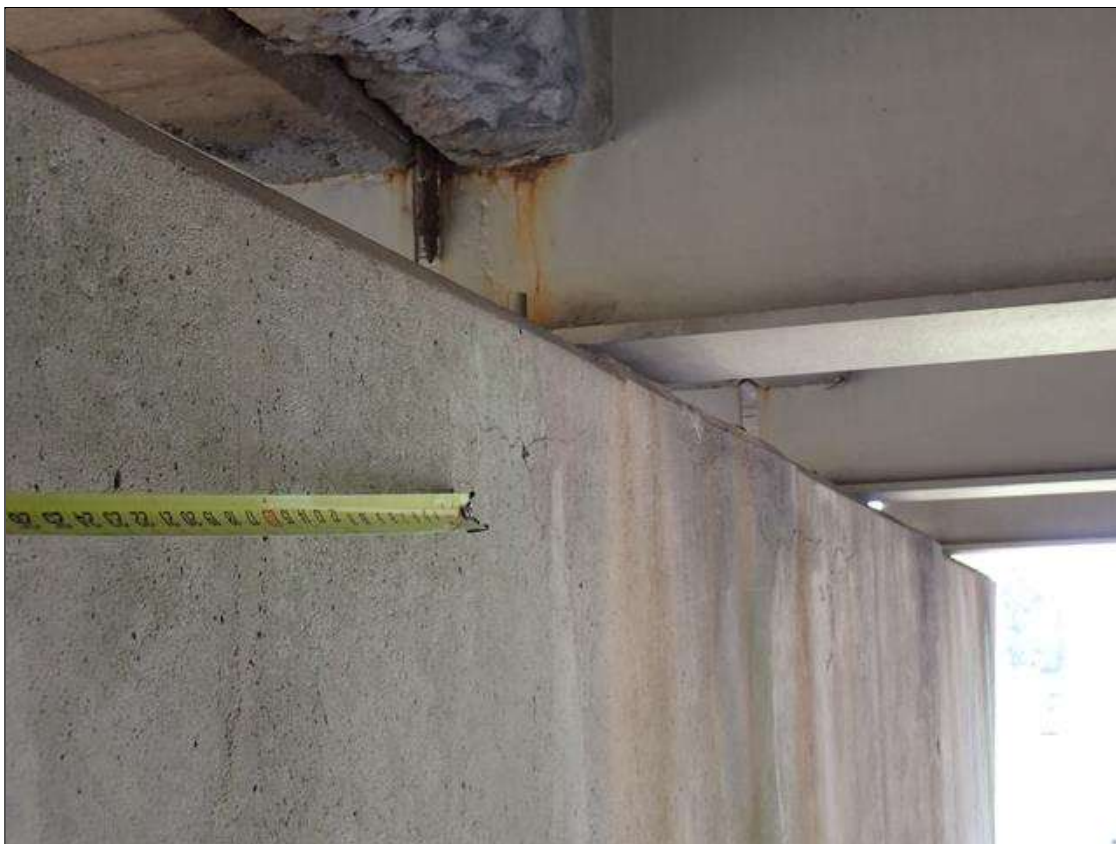
Bent 2 Cap 1: south face, below bays 1-3, longitudinal cracks (up to 1/32 inch x 5 feet) with adjacent map cracks (hairline)

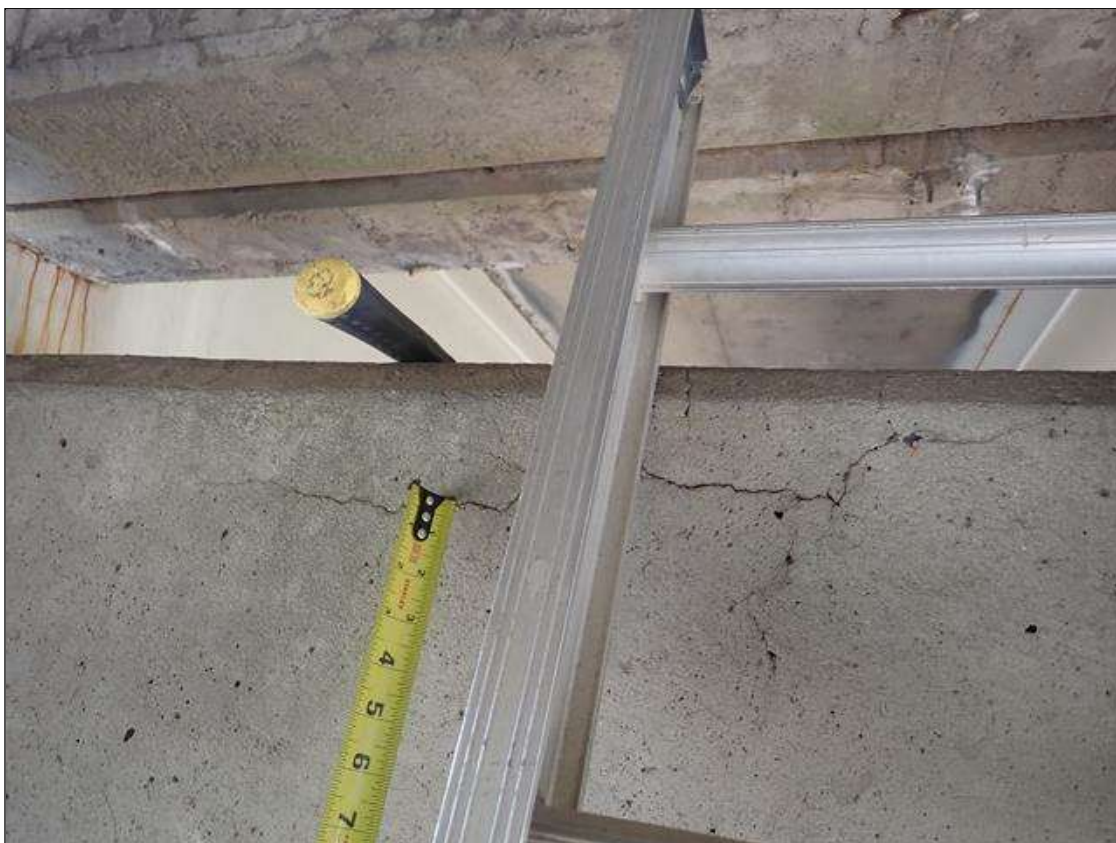
Bent 2 Cap 1: south face, below bays 1-3, longitudinal cracks (up to 1/32 inch x 5 feet) with adjacent map cracks (hairline)

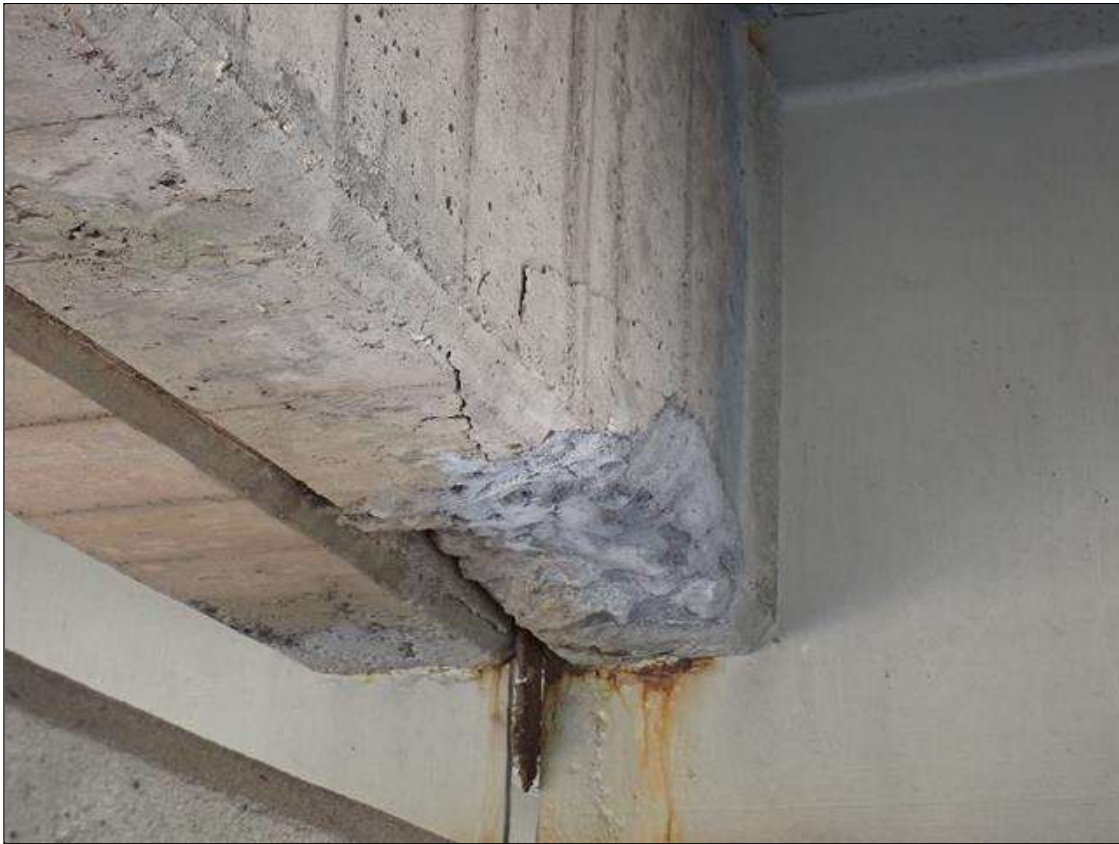
Span 2 Beam 2: 2 foot x full width x 6 inch deep spall/delamination in end diaphragm at bent 2, under bay 2 adjacent to beam 3.

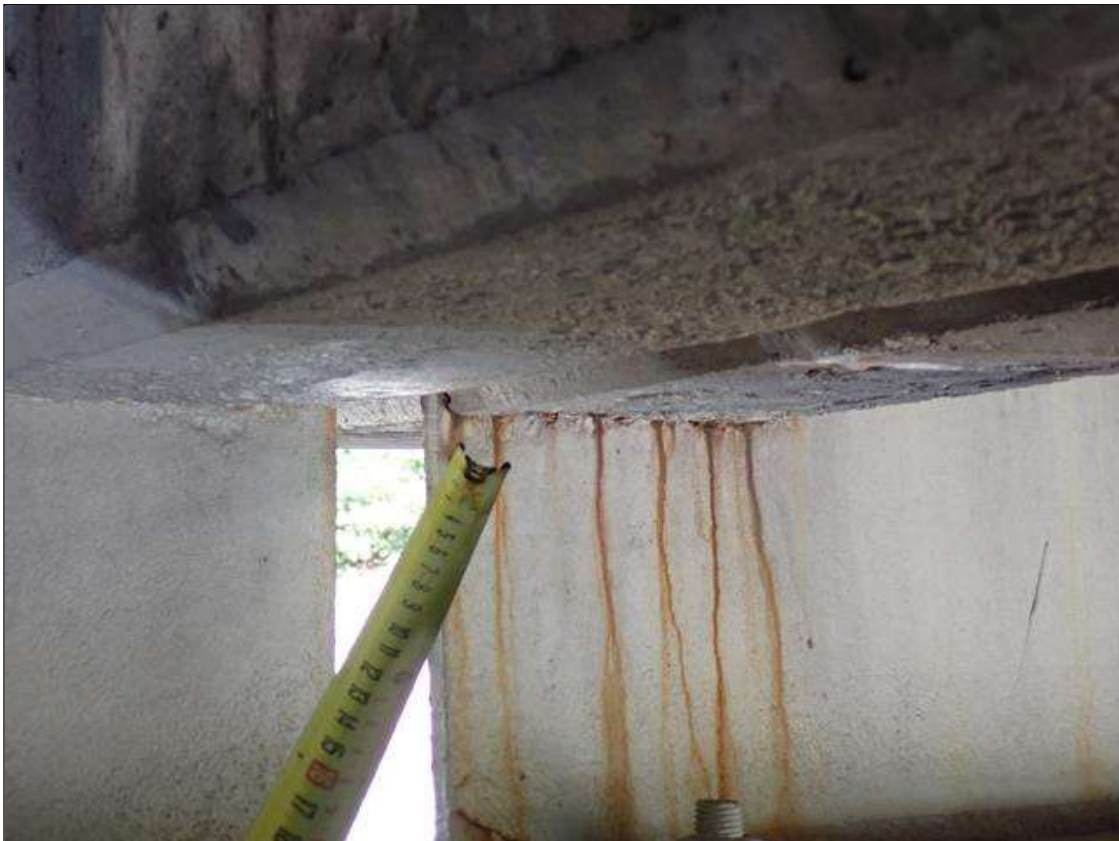
Span 3 Beam 1: at bent 2, web adjacent to diaphragm, painted over pitting (up to 1/8 inch deep x 4 inch x 1 inch) with corrosion reinitiated; web and top flange, surface rust

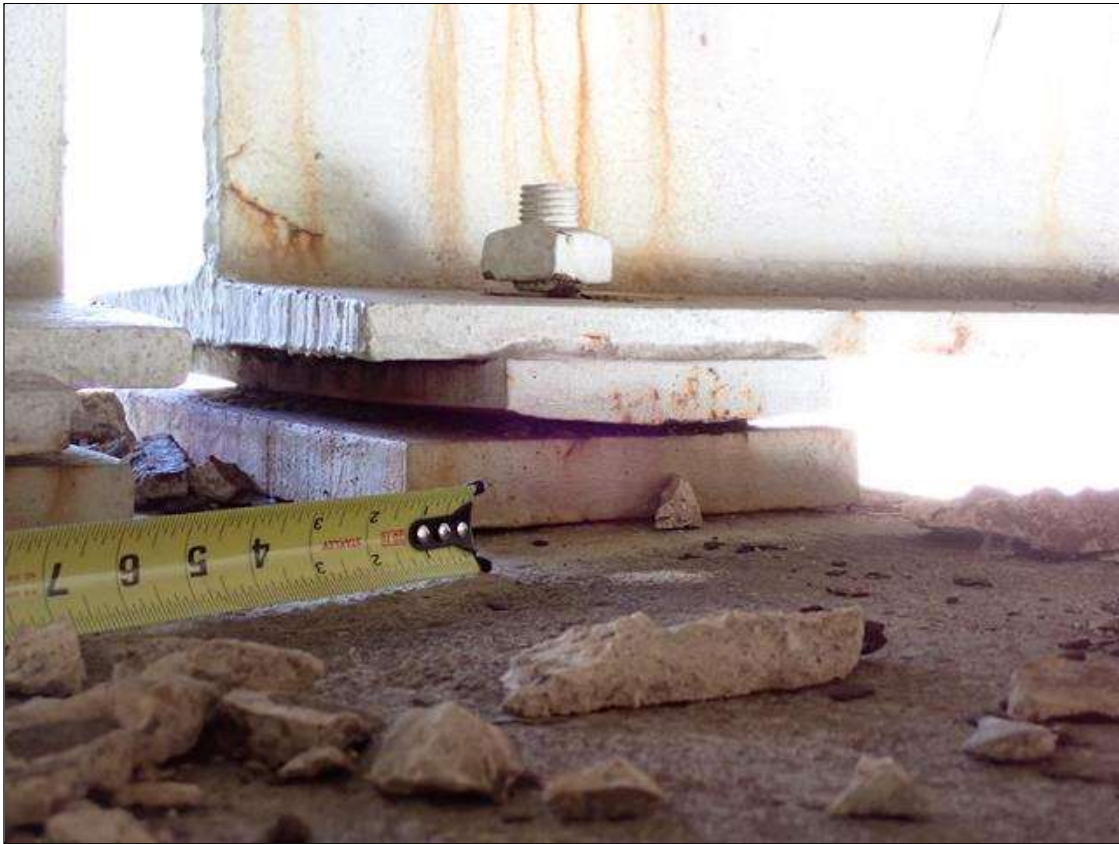
Span 3 Beam 1 - Near Bearing 1: freckled rust/pack rust

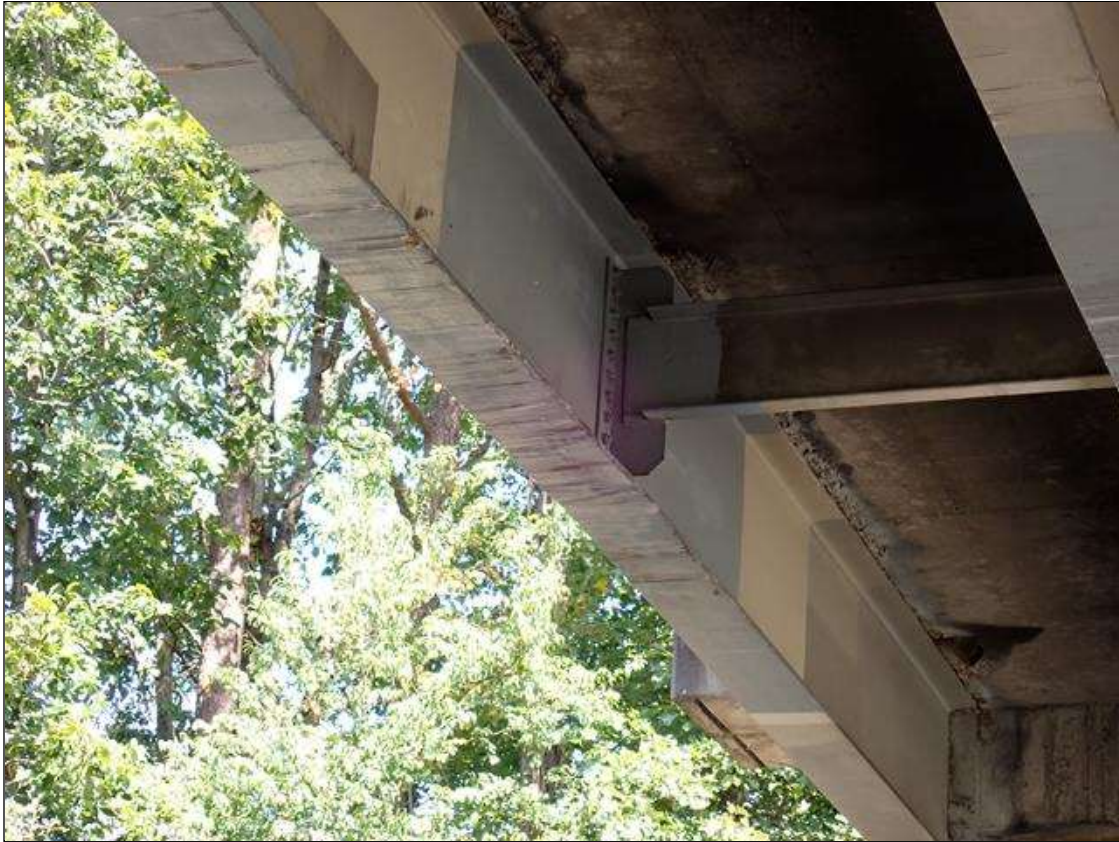
Span 3 Beam 1: (PAR) 2023 area repainted with new impact scrapes/gouges (up to 1/8 inch deep); previous diaphragm weld crack and missing bolts repaired; previously noted as: SUPPLEMENTAL INSPECTION IMPACT DAMAGE 2022.: POINT OF IMPACT 9 FEET LONG WITH SCATTERED 1 inch DEEP INDENTIONS THROUGH OUT BOTTOM FLANGE , AT 12 FEET-9 INCHES FROM INTERIOR BENT 3 . BEAM 1 DEFLECTION 1 INCH TO THE WEST. Top repair plate PULLED LOOSE FROM DECK EAST SIDE FOR A LENGTH OF 30 FEET X 3/4 INCH .,EAST SIDE OF BOTTOM FLANGE BENT UPWARD 1/2 INCH. SCATTERED SCRAPES ALONG BOTTOM FLANGE AND WEB . SCATTERED OLD SCRAPES AND INDENTIONS ALONG BOTTOM FLANGE .

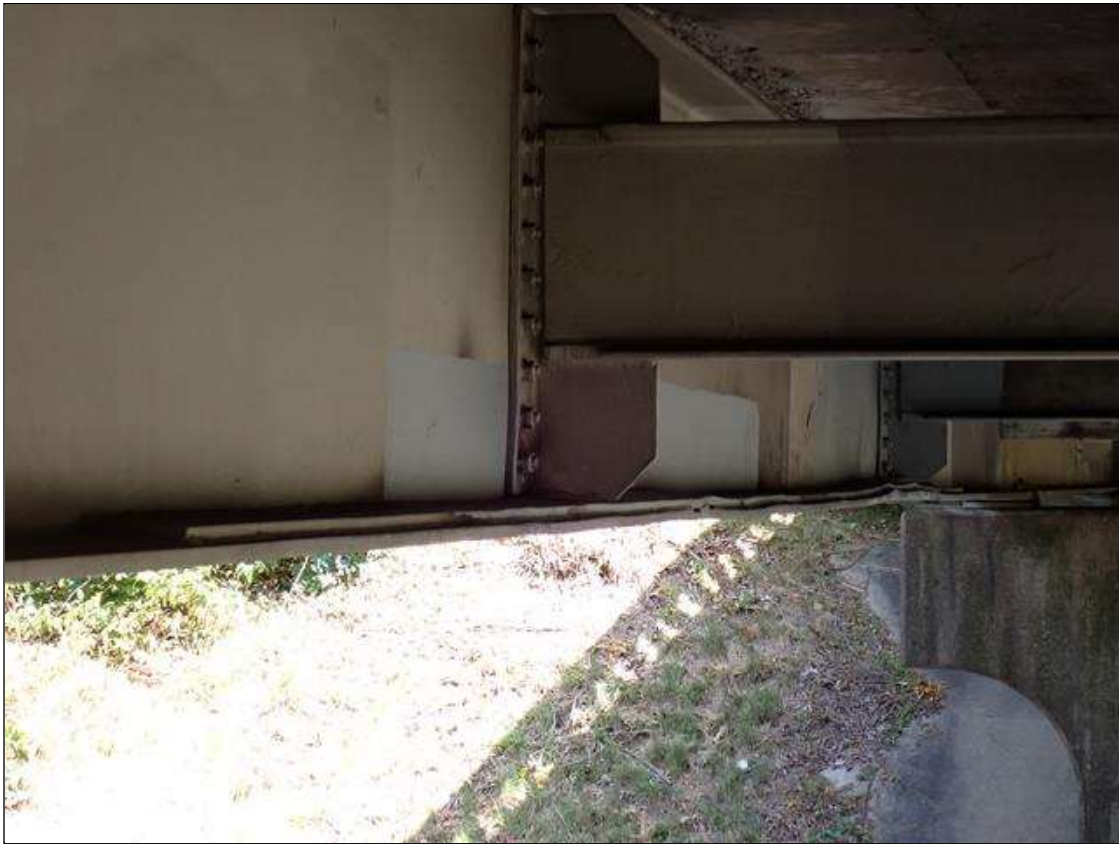
Span 3 Beam 1: (PAR) 2023 area repainted with new impact scrapes/gouges (up to 1/8 inch deep); previous diaphragm weld crack and missing bolts repaired; previously noted as: SUPPLEMENTAL INSPECTION IMPACT DAMAGE 2022.: POINT OF IMPACT 9 FEET LONG WITH SCATTERED 1 inch DEEP INDENTIONS THROUGH OUT BOTTOM FLANGE , AT 12 FEET-9 INCHES FROM INTERIOR BENT 3 . BEAM 1 DEFLECTION 1 INCH TO THE WEST. Top repair plate PULLED LOOSE FROM DECK EAST SIDE FOR A LENGTH OF 30 FEET X 3/4 INCH .,EAST SIDE OF BOTTOM FLANGE BENT UPWARD 1/2 INCH. SCATTERED SCRAPES ALONG BOTTOM FLANGE AND WEB . SCATTERED OLD SCRAPES AND INDENTIONS ALONG BOTTOM FLANGE .

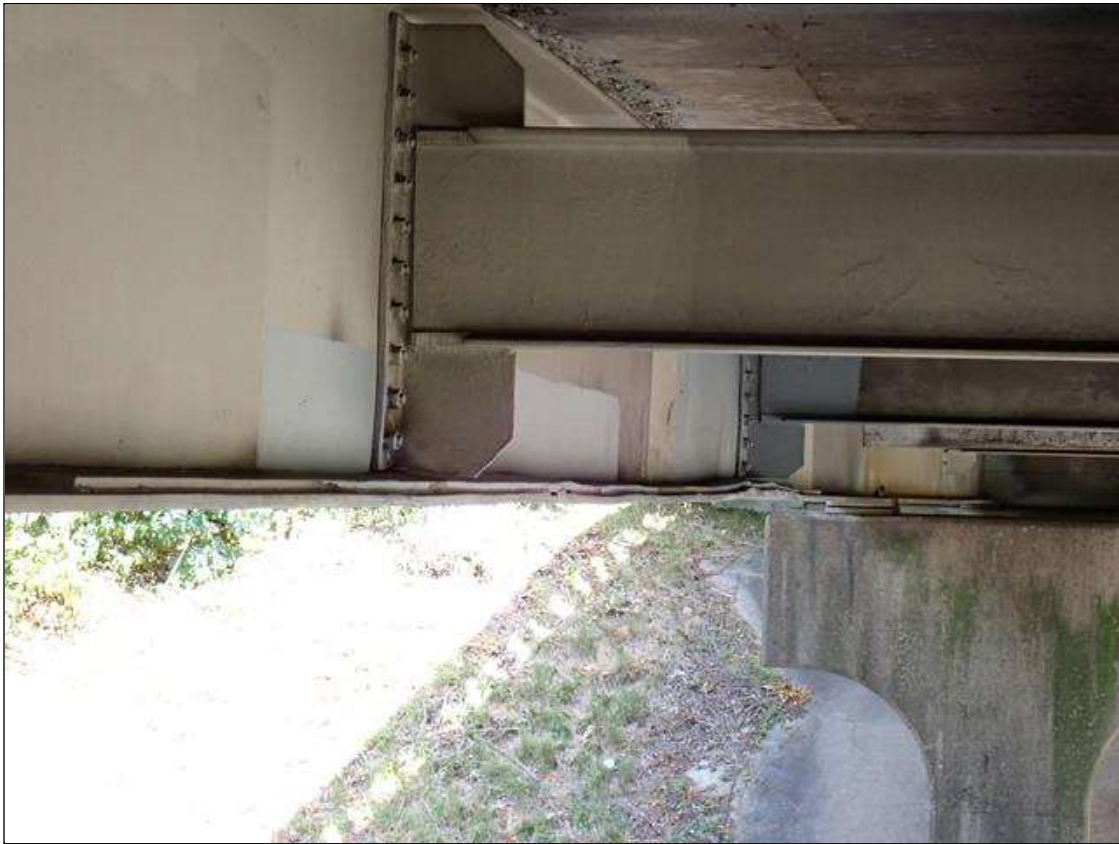
Span 3 Beam 1: (PAR) 2023 area repainted with new impact scrapes/gouges (up to 1/8 inch deep); previous diaphragm weld crack and missing bolts repaired; previously noted as: SUPPLEMENTAL INSPECTION IMPACT DAMAGE 2022.: POINT OF IMPACT 9 FEET LONG WITH SCATTERED 1 inch DEEP INDENTIONS THROUGH OUT BOTTOM FLANGE , AT 12 FEET-9 INCHES FROM INTERIOR BENT 3 . BEAM 1 DEFLECTION 1 INCH TO THE WEST. Top repair plate PULLED LOOSE FROM DECK EAST SIDE FOR A LENGTH OF 30 FEET X 3/4 INCH .,EAST SIDE OF BOTTOM FLANGE BENT UPWARD 1/2 INCH. SCATTERED SCRAPES ALONG BOTTOM FLANGE AND WEB . SCATTERED OLD SCRAPES AND INDENTIONS ALONG BOTTOM FLANGE .

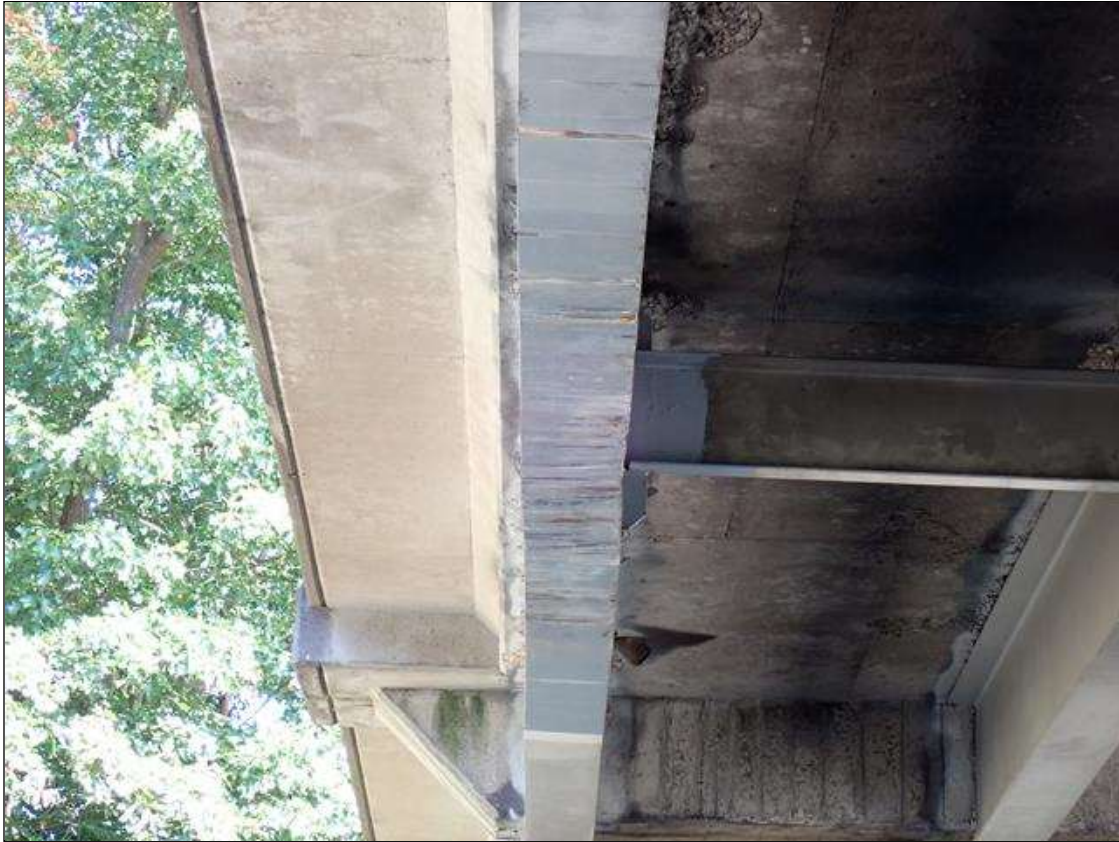
Span 3 Beam 1: (PAR) 2023 area repainted with new impact scrapes/gouges (up to 1/8 inch deep); previous diaphragm weld crack and missing bolts repaired; previously noted as: SUPPLEMENTAL INSPECTION IMPACT DAMAGE 2022.: POINT OF IMPACT 9 FEET LONG WITH SCATTERED 1 inch DEEP INDENTIONS THROUGH OUT BOTTOM FLANGE , AT 12 FEET-9 INCHES FROM INTERIOR BENT 3 . BEAM 1 DEFLECTION 1 INCH TO THE WEST. Top repair plate PULLED LOOSE FROM DECK EAST SIDE FOR A LENGTH OF 30 FEET X 3/4 INCH .,EAST SIDE OF BOTTOM FLANGE BENT UPWARD 1/2 INCH. SCATTERED SCRAPES ALONG BOTTOM FLANGE AND WEB . SCATTERED OLD SCRAPES AND INDENTIONS ALONG BOTTOM FLANGE .

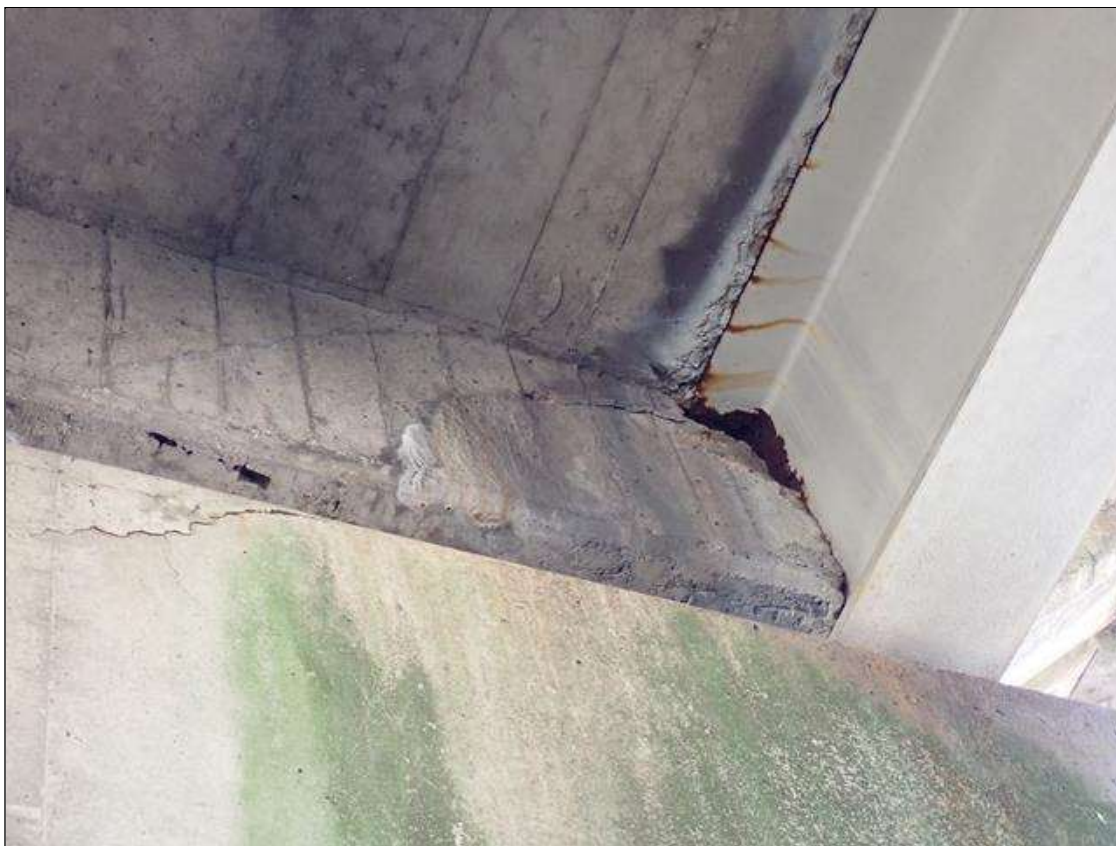
Span 3 Beam 1: bay 1 end diaphragm at bent 2, spall (1 foot diameter x 2 inch deep) with adjacent diagonal crack (1/32 inch x 3 feet) with efflorescence

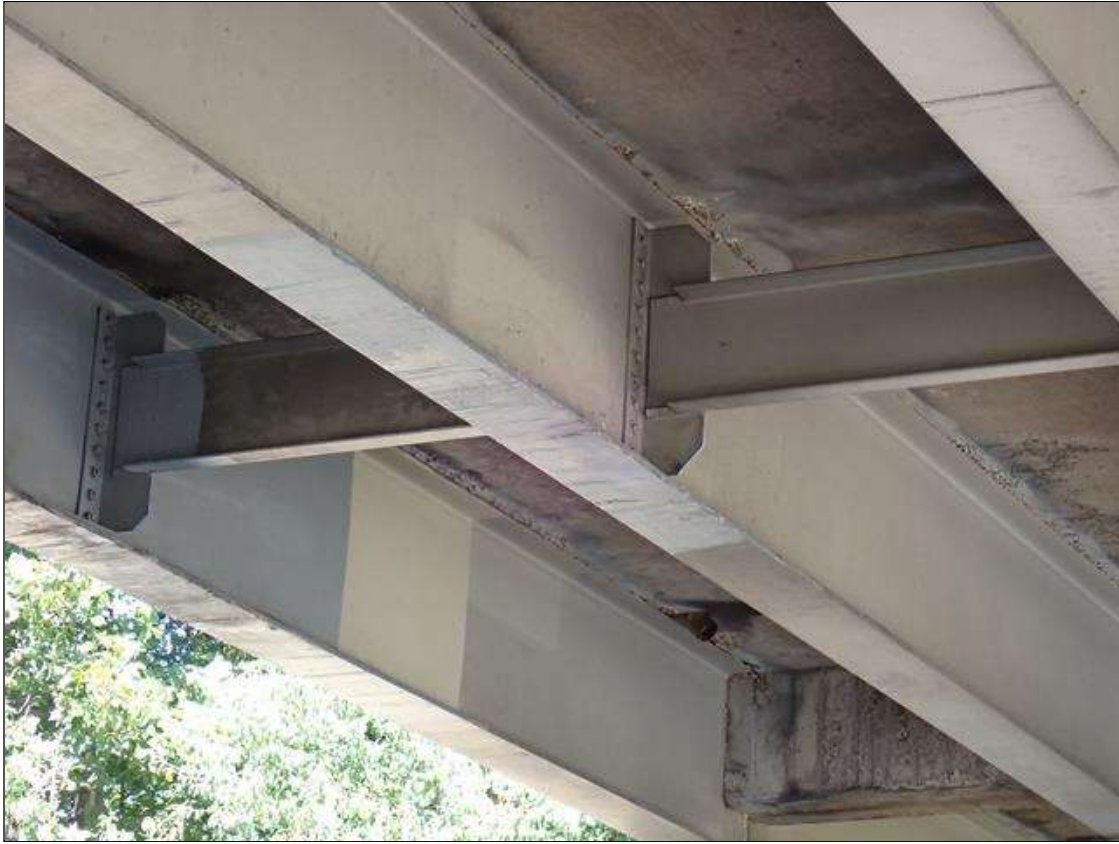
Span 3 Beam 2: (PAR) 2023 area repainted with new impact scrapes/gouges up to 1/8 inch deep; previously noted as: SUPPLEMENTAL INSPECTION IMPACT DAMAGE 2022.: beam 2 span 3 deflected upward 1/2 inch at 19.5 inches from bent 2 for a length of 4 feet, with scrapes on bottom flange
