NC DEPARTMENT OF TRANSPORTATION
 DIVISION OF HIGHWAYS
 STRUCTURE MANAGEMENT UNIT

ATTENTION: prompt action request, sign notice issued, sketches revised, clearances revised; new repairs to span 3 beams

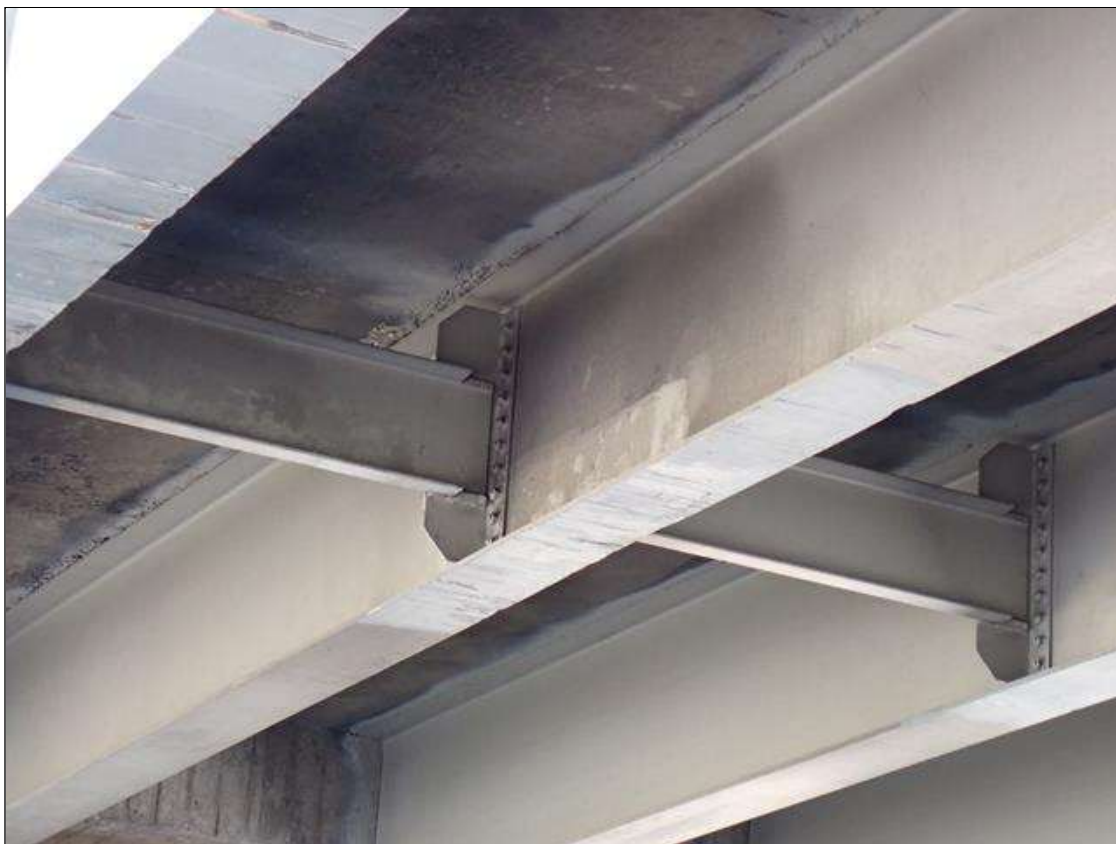
Span 3 Beam 2: (not found 2023) SUPPLEMENTAL INSPECTION IMPACT DAMAGE 2022.: SCATTERED SCRAPES WEB OF BEAM 2 .

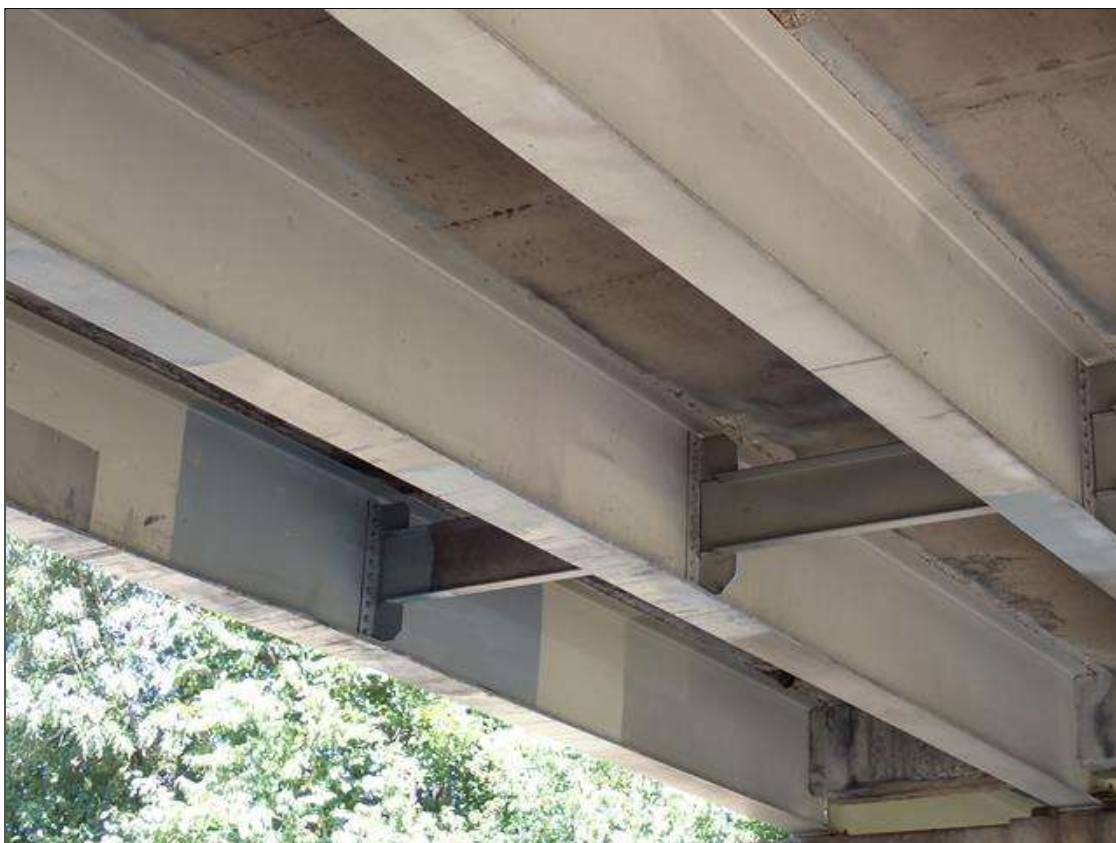
Span 3 Beam 2: (not found 2023) SUPPLEMENTAL INSPECTION IMPACT DAMAGE 2022.: SCATTERED SCRAPES WEB OF BEAM 2 .

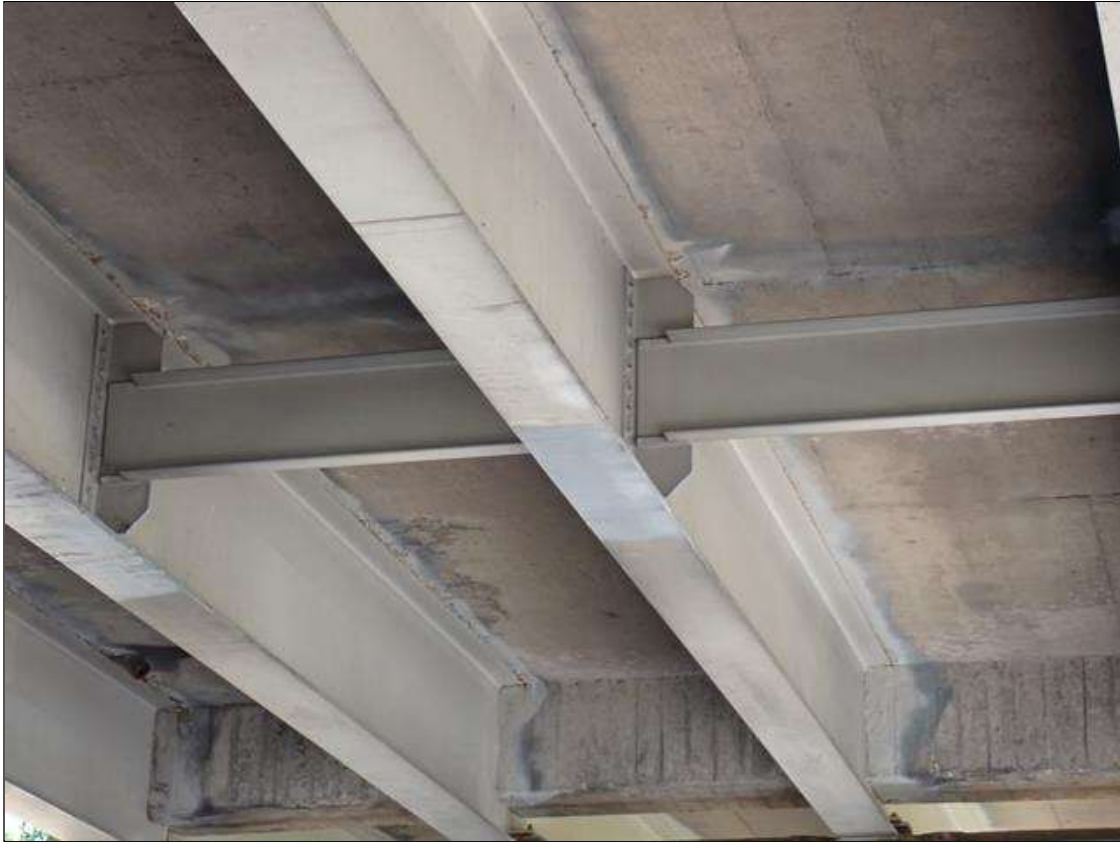
Span 3 Beam 3: 2023 area repainted; previously noted as: SUPPLEMENTAL INSPECTION IMPACT DAMAGE 2022. : SCATTERED SCRAPES ALONG BOTTOM FLANGE OF BEAM 3

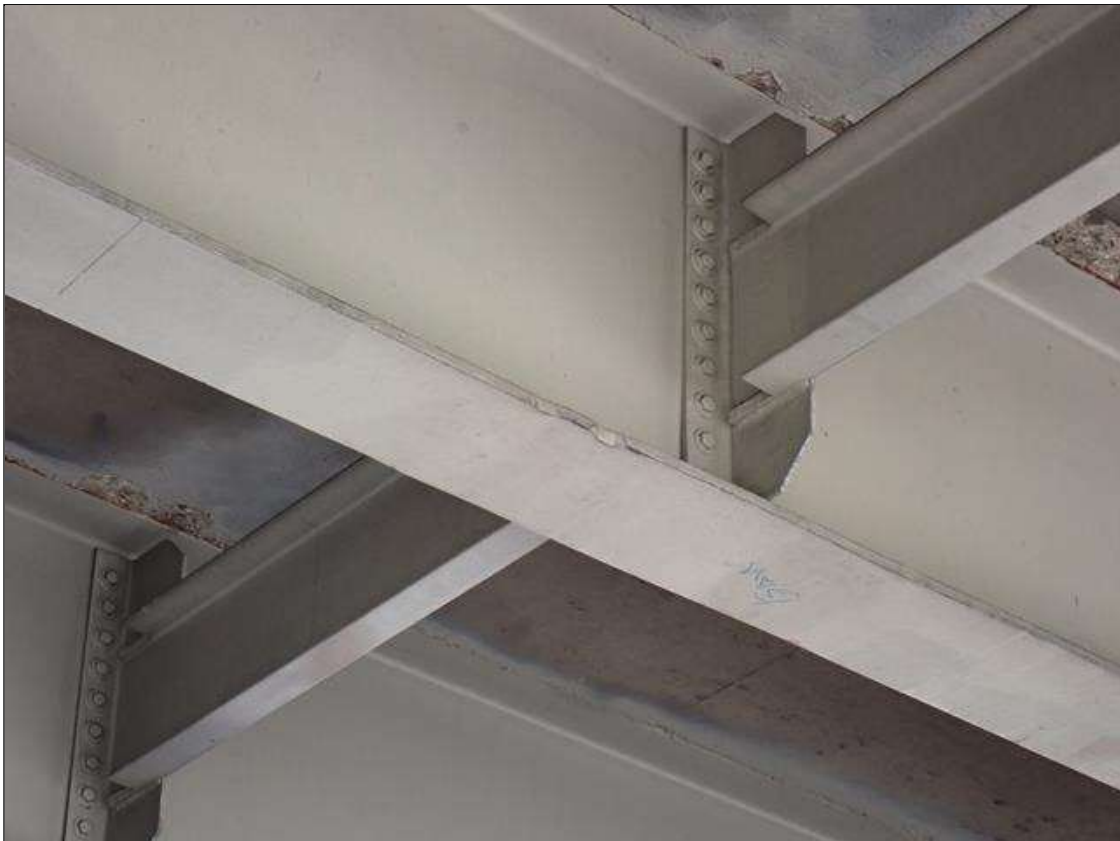
Span 3 Beam 3: two indentions in bottom flange of beam 3 span 3. one 1/4 inch deep and one 1/2 inch deep at 15.583 feet from bent 2 for a total length of 1 foot

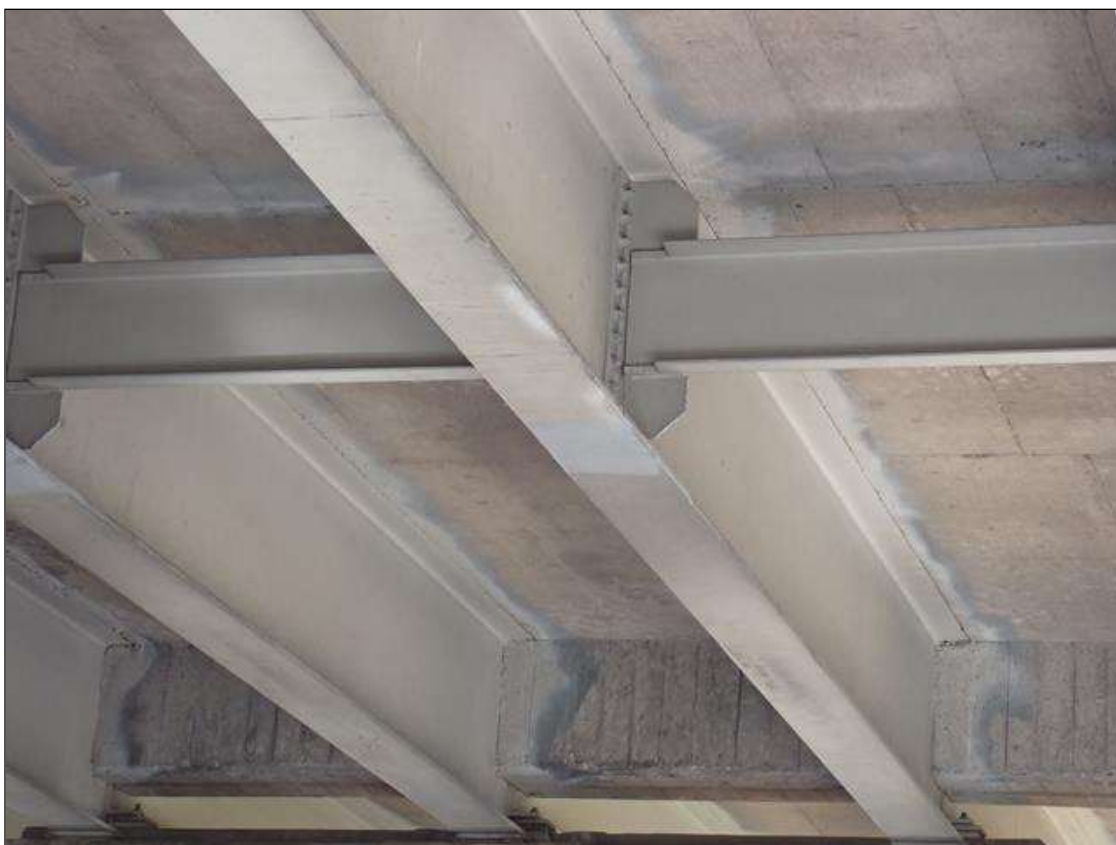
Span 3 Beam 4: 2023 area repainted; previously noted as: SUPPLEMENTAL INSPECTION IMPACT DAMAGE 2022.:
Beam 4 Span 3 has scrapes to bottom flange at 16.75 feet from bent 3 for a total length of 1 foot

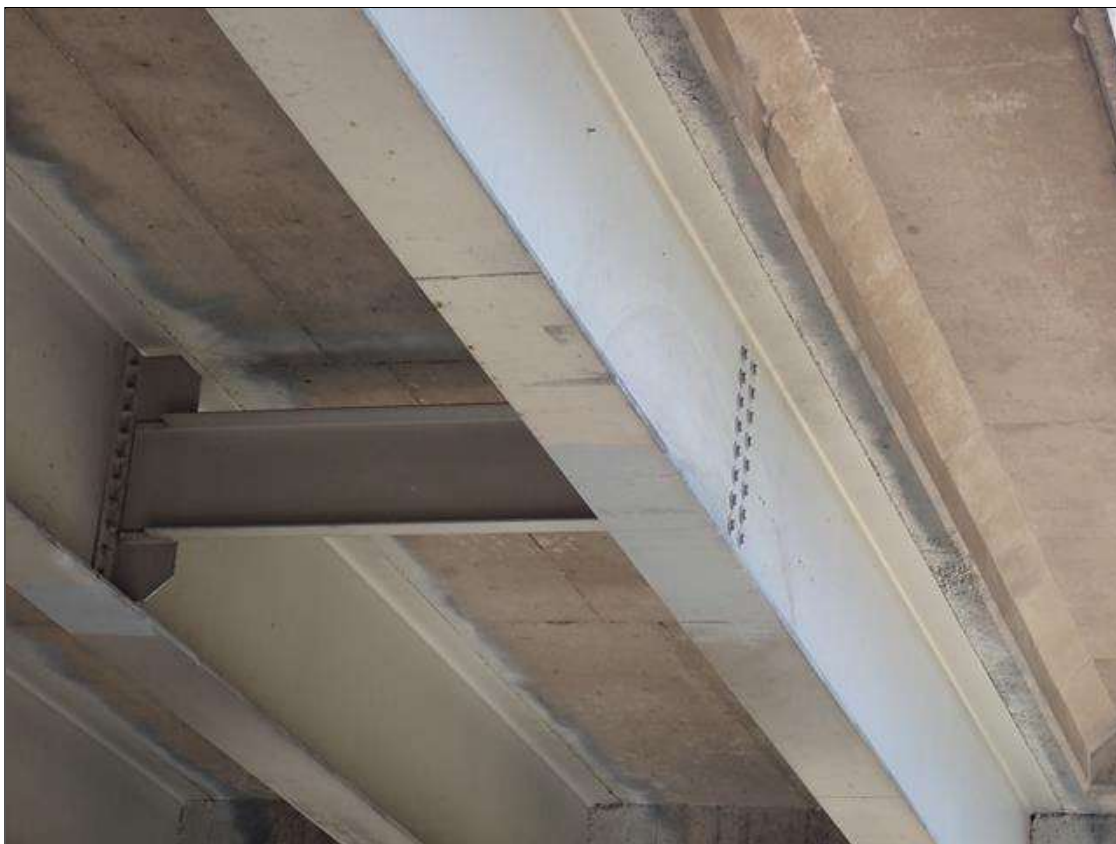
Span 3 Beam 5: 2023 area repainted with new impact scrapes; previously noted as: SUPPLEMENTAL INSPECTION IMPACT DAMAGE 2022.: two 1/4 inch deep indentations in bottom flange of beam 5 span 3 at 16.5 feet from bent 3 .
SCATTERED SCRAPES

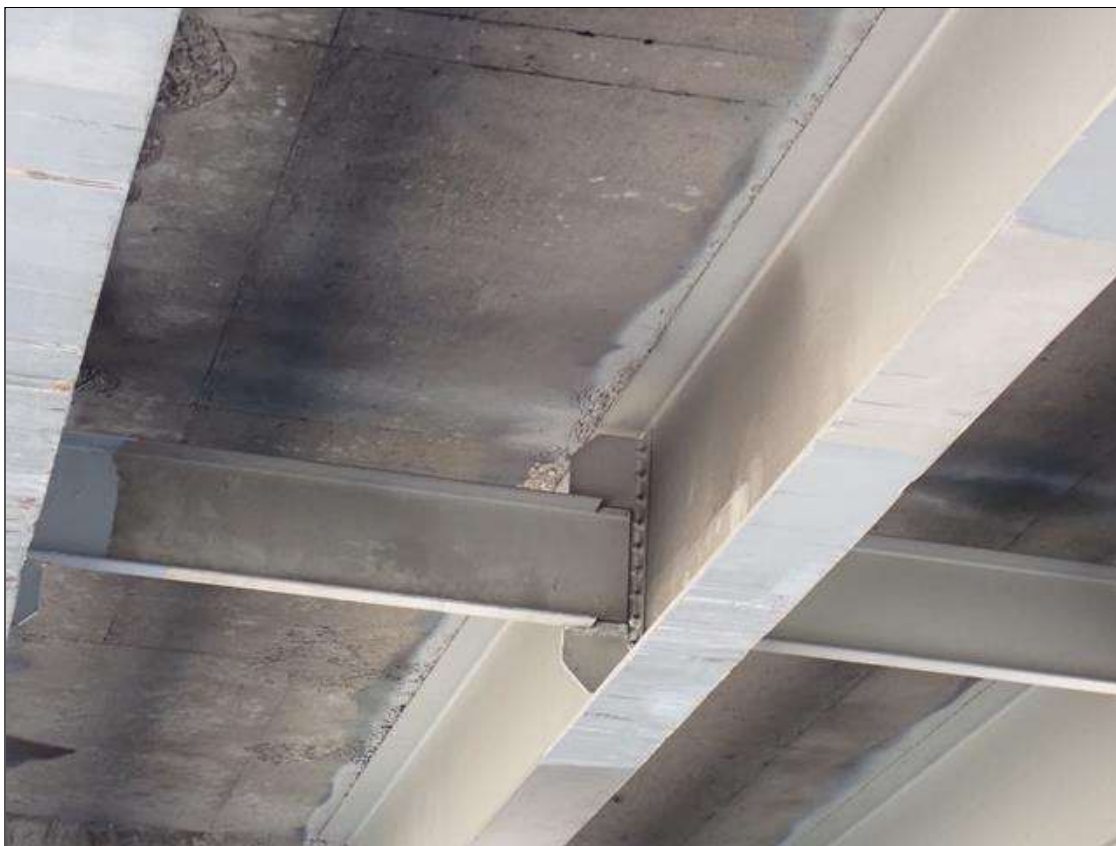
Span 3 Deck: surface spalling up to 1 foot x 4 inch x 1/2 inch deep, full length, underside of deck along both sides of beam 2.

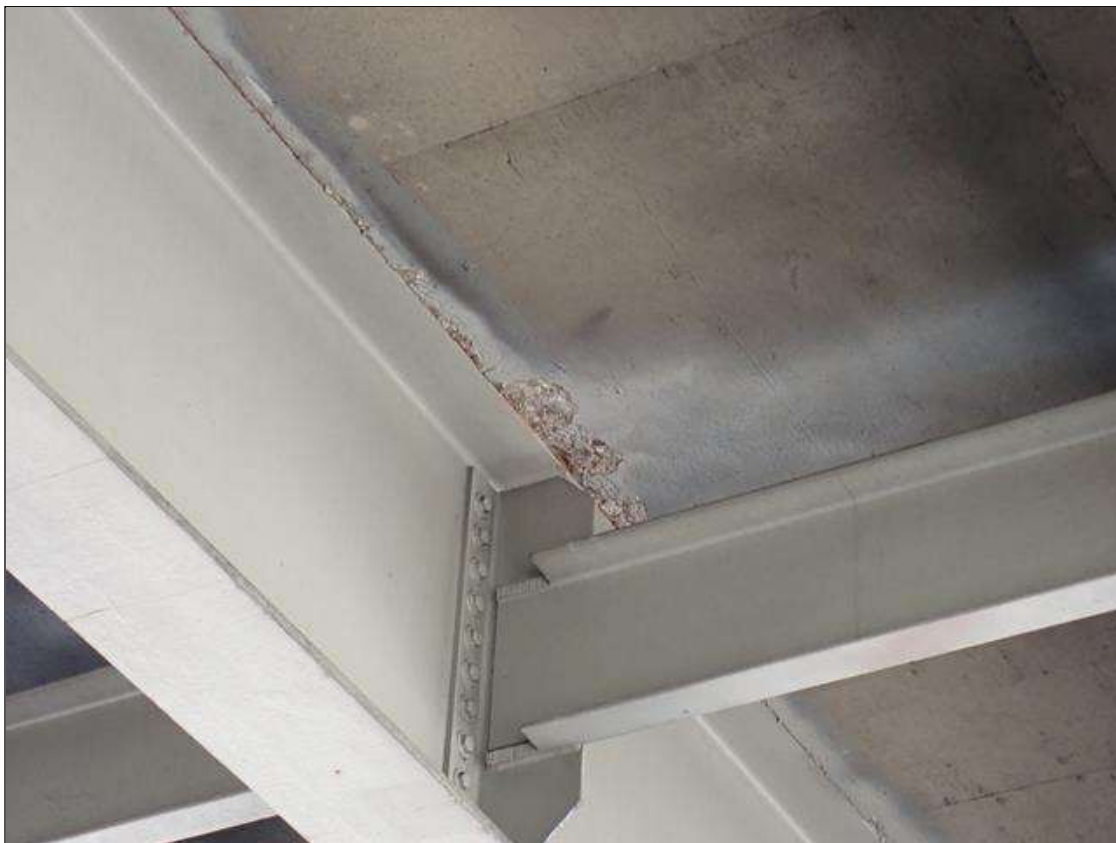
Span 3 Deck: surface spalling up to 1 foot x 4 inch x 1/2 inch deep, full length, underside of deck along both sides of beam 2.

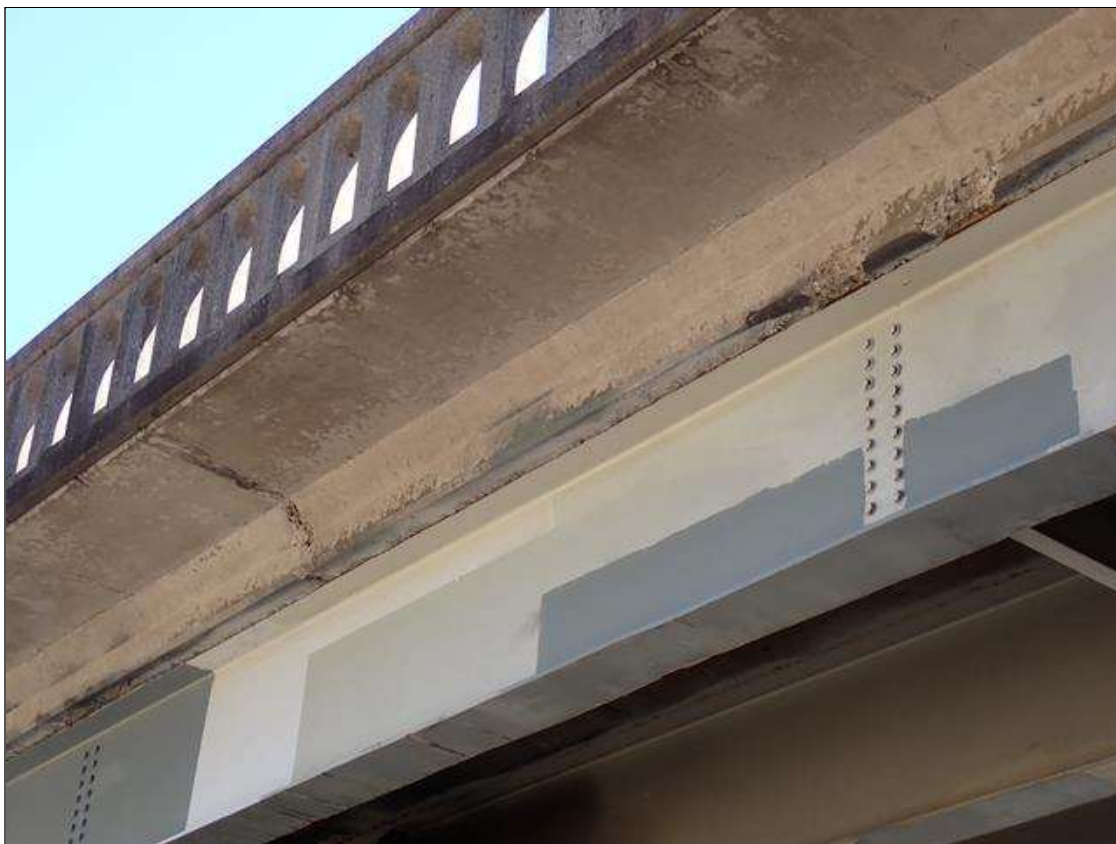
Span 3 Deck: spalling up to 12 INCH WIDE X 1 INCH deep, full length, underside of deck along both sides of beam 1.

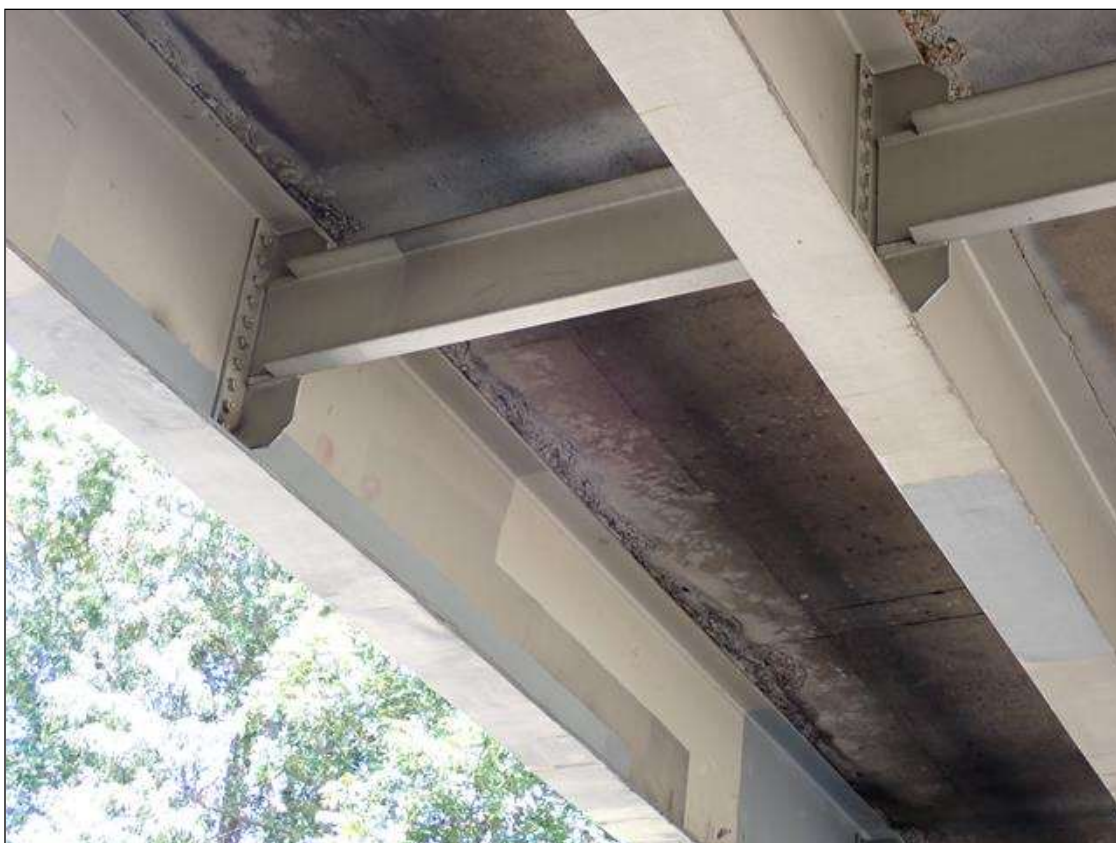
Span 3 Deck: spalling up to 12 INCH WIDE X 1 INCH deep, full length, underside of deck along both sides of beam 1.

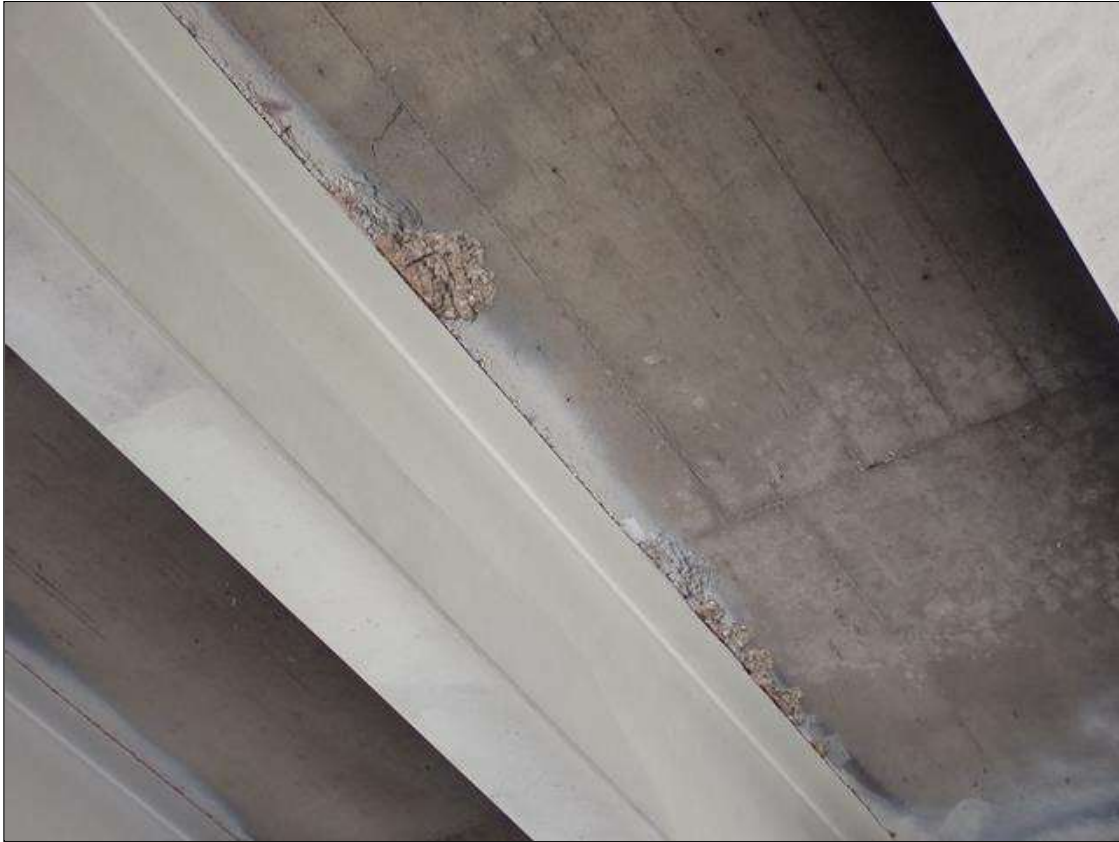
Span 3 Deck: (PAR) up to 4 feet long x 10 inch wide x 1 inch deep spalling, some with exposed rusted rebar, in underside of deck, along edges of beam 3.

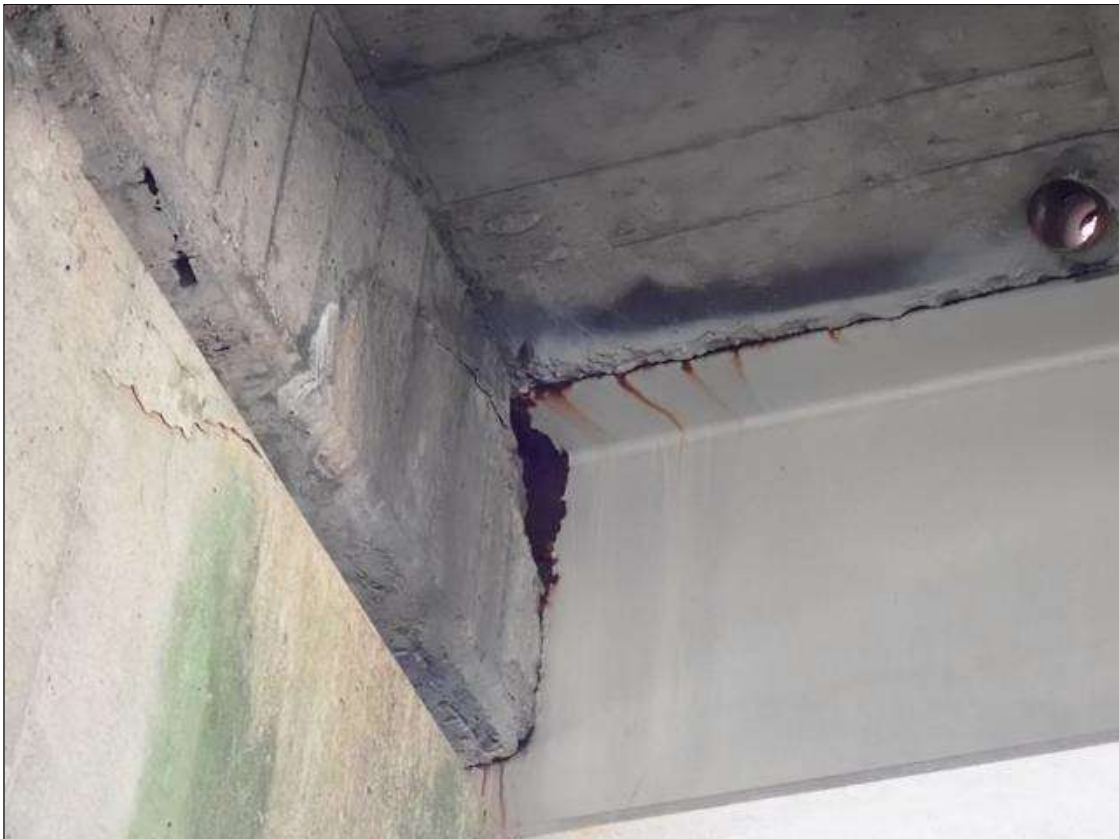
Span 3 Beam 1: at bent 2, web adjacent to diaphragm, painted over pitting (up to 1/8 inch deep x 4 inch x 1 inch) with corrosion reinitiated; web and top flange, surface rust

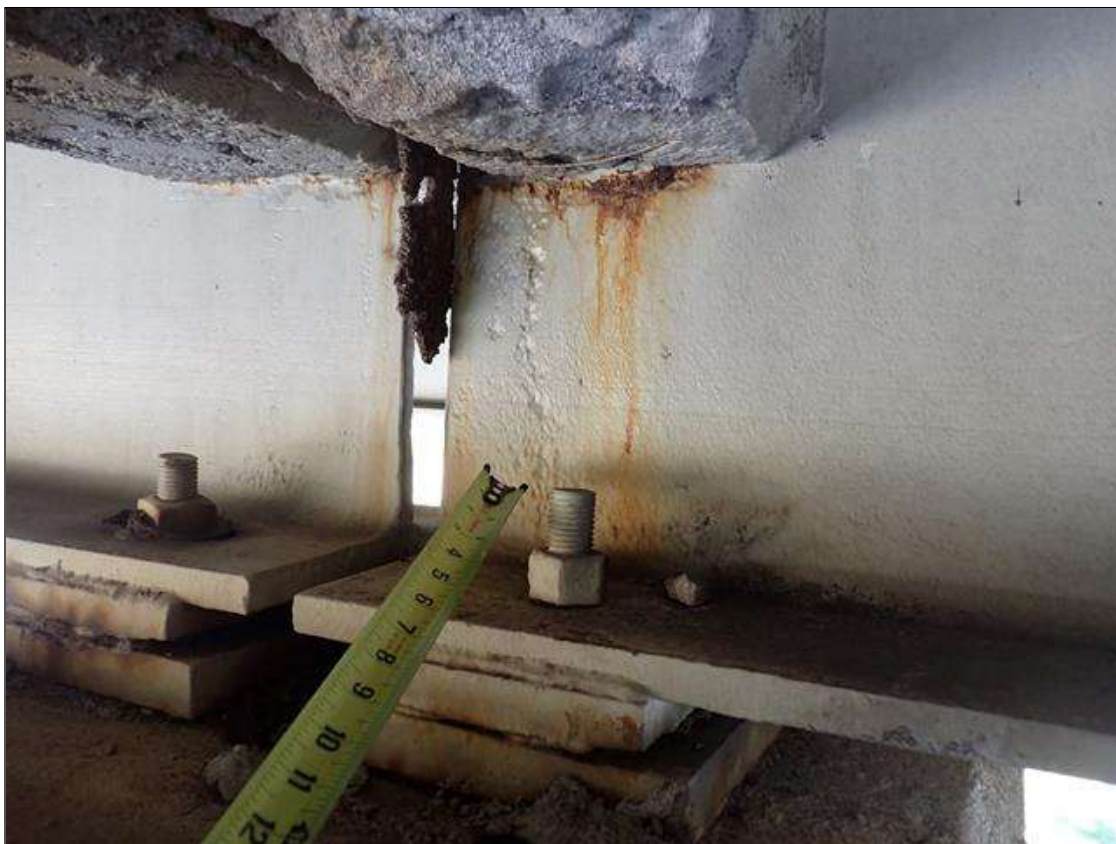
Span 2 Beam 3: at bent 2, web over bearing, painted over pitting (1/8 inch deep x 7 inch x 10 inch) with corrosion reinitiated

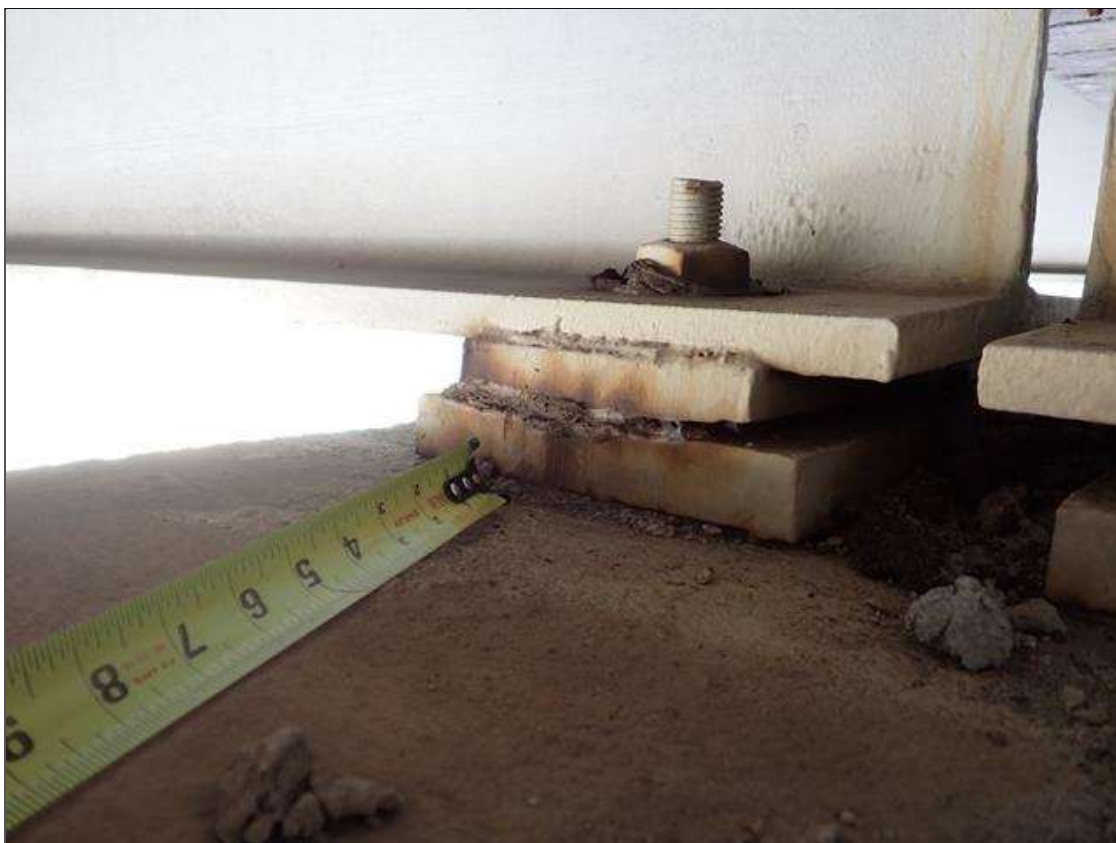
Span 3 Beam 3 - Near Bearing 3: surface rust/pack rust.

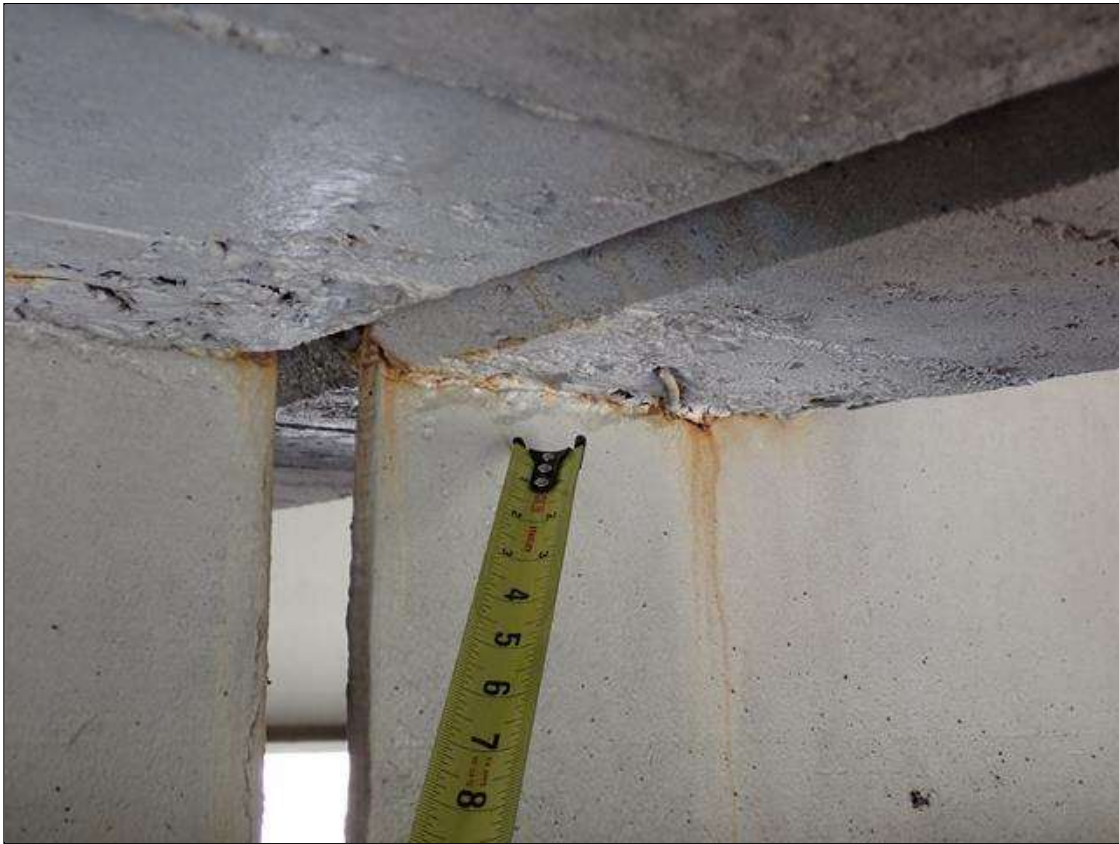
Span 3 Beam 4: (PAR) at bent 2, web adjacent to diaphragm, painted over section loss (3/8 inch average remaining x 6 inch x 1 inch) with corrosion reinitiated

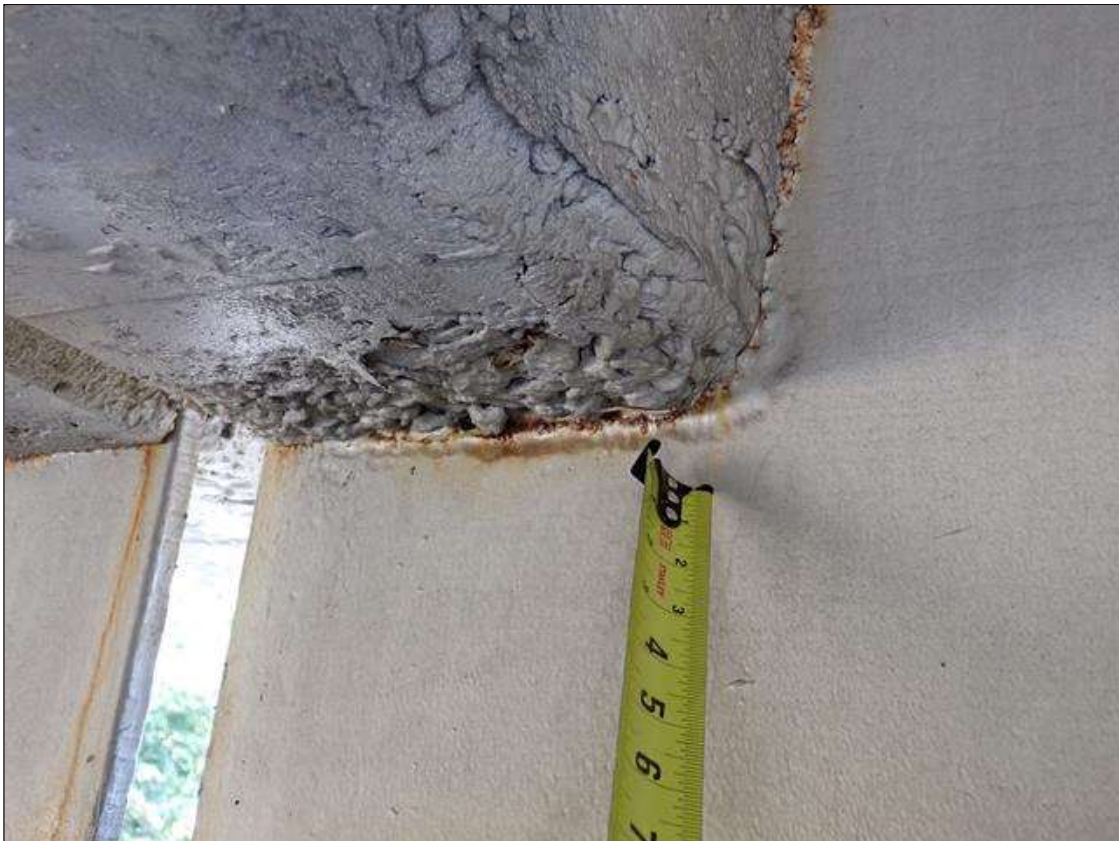
Span 2 Beam 5: (PAR) at bent 2, web adjacent to diaphragm, painted over section loss (3/8 inch average remaining x 9 inch x 1 inch); east top flange, painted over pitting (up to 1/8 inch deep x 6 inches x 4 inches) with corrosion reinitiated

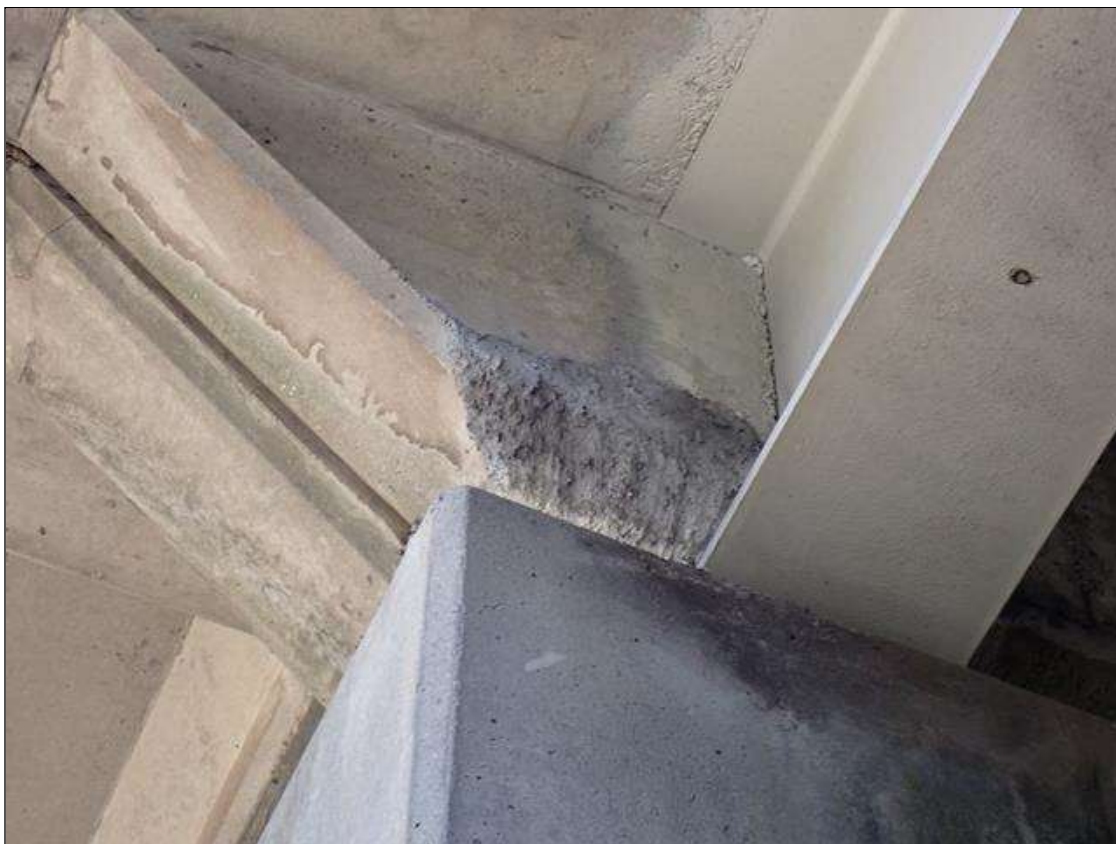
Span 2 Beam 1: 12 inch x 5 inch x 1.5 inch deep patched spall in end diaphragm, in west overhang at bent 2

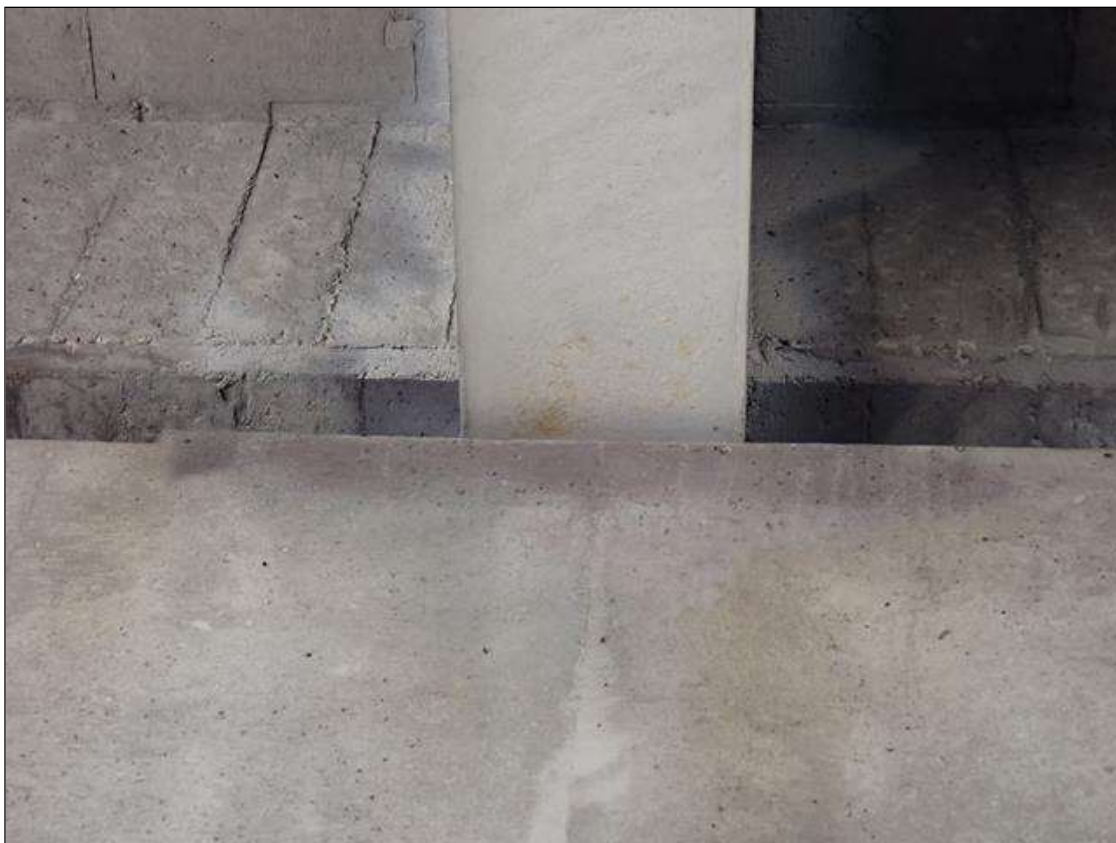
Bent 2 Cap 1: (not found 2023) under beam 4, delamination [1 foot x 1.5 feet]

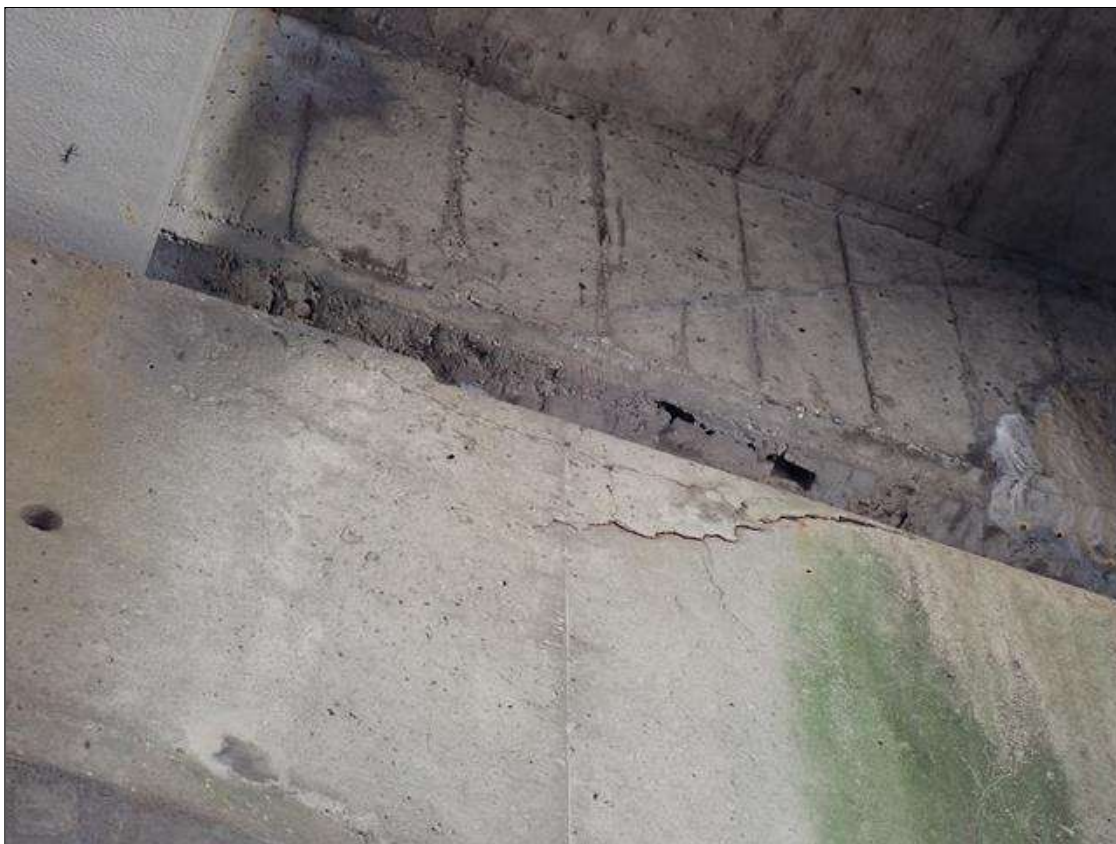
Bent 2 Cap 1: delamination [19 inch x 7 inch] at north face extending to topside, under bay 1.

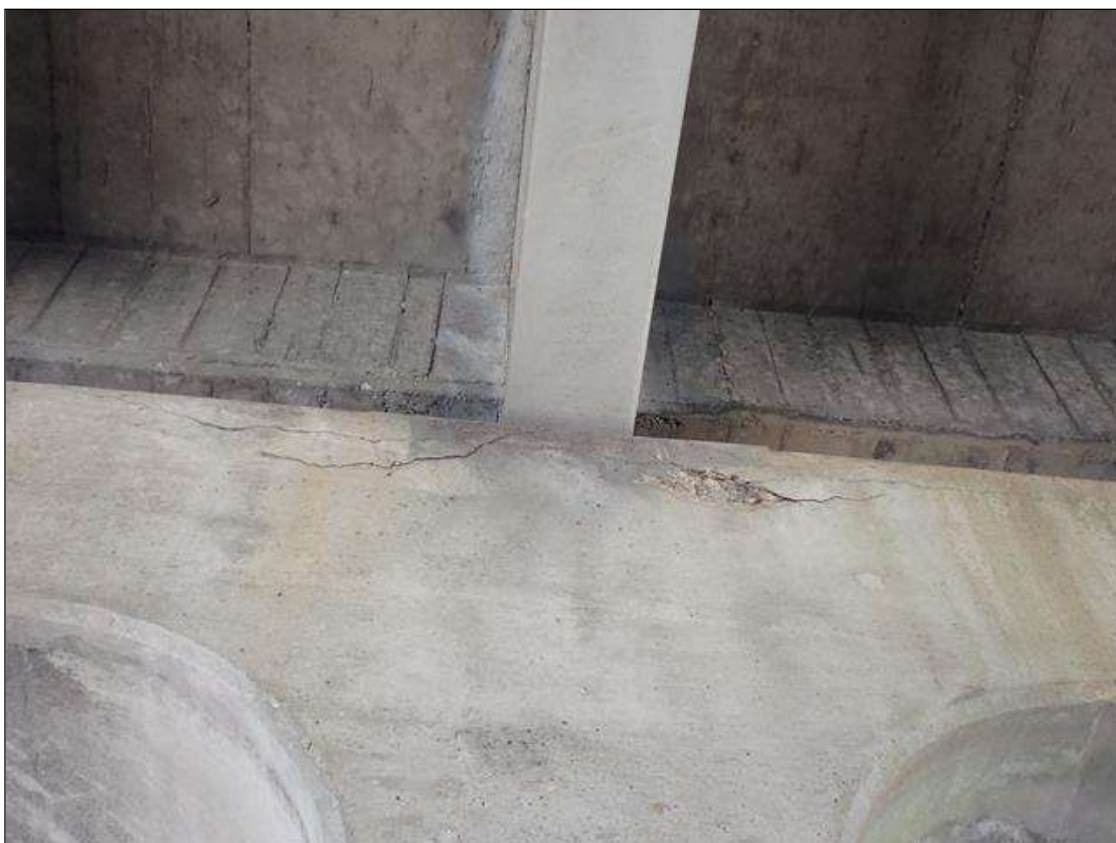
Bent 2 Cap 1: north face, below bays 2 and 3, near beam 3, spall/delamination (6 feet x 15 inch x up to 2 inches deep) with associated cracks (up to 1/16 inch)

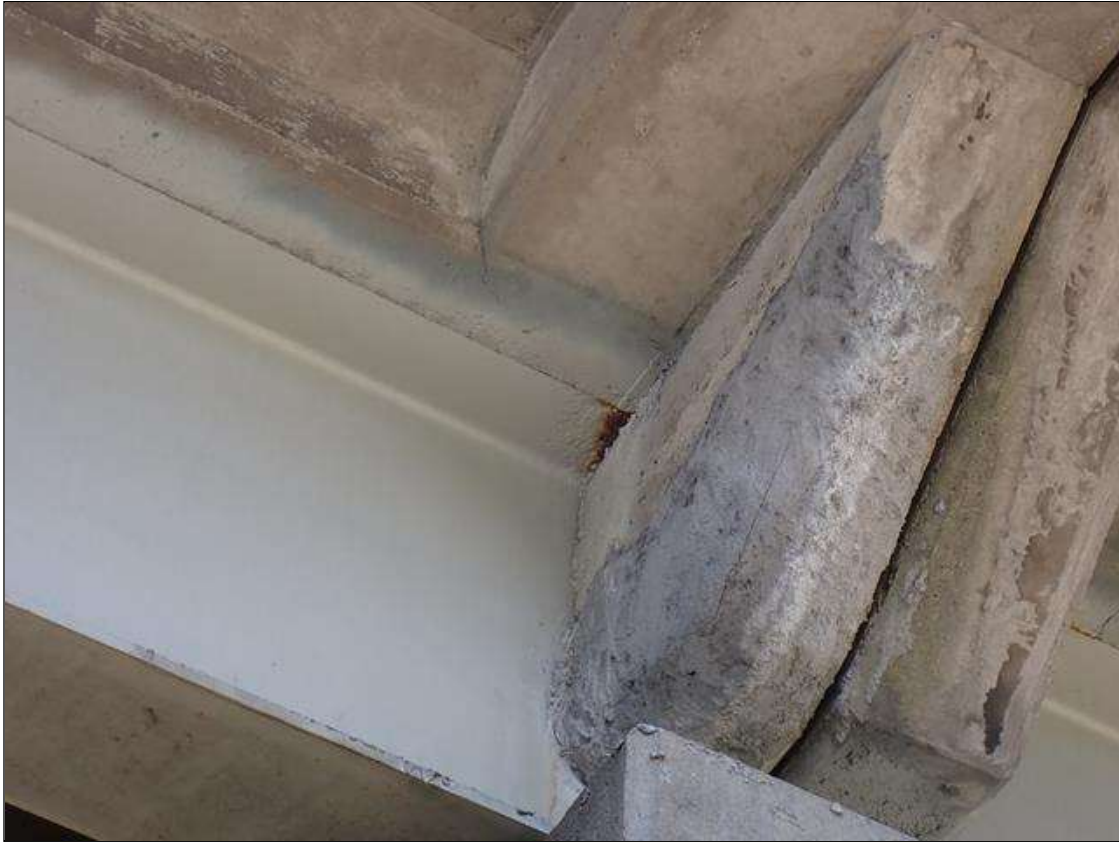
Span 2 Beam 5: (PAR) at bent 2, web adjacent to diaphragm, painted over section loss (3/8 inch average remaining x 9 inch x 1 inch); east top flange, painted over pitting (up to 1/8 inch deep x 6 inches x 4 inches) with corrosion reinitiated

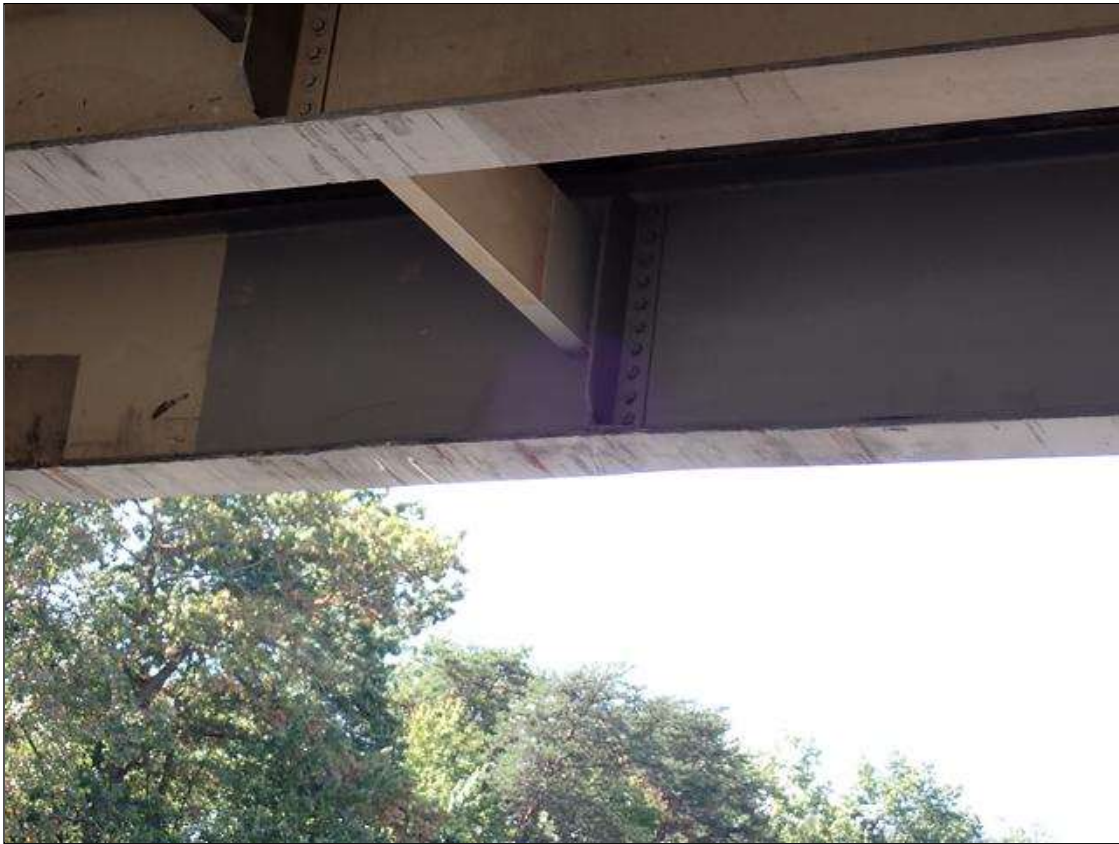
Span 3 Beam 1: (PAR) 2023 area repainted with new impact scrapes/gouges (up to 1/8 inch deep); previous diaphragm weld crack and missing bolts repaired; previously noted as: SUPPLEMENTAL INSPECTION IMPACT DAMAGE 2022.: POINT OF IMPACT 9 FEET LONG WITH SCATTERED 1 inch DEEP INDENTIONS THROUGH OUT BOTTOM FLANGE , AT 12 FEET-9 INCHES FROM INTERIOR BENT 3 . BEAM 1 DEFLECTION 1 INCH TO THE WEST. Top repair plate PULLED LOOSE FROM DECK EAST SIDE FOR A LENGTH OF 30 FEET X 3/4 INCH .,EAST SIDE OF BOTTOM FLANGE BENT UPWARD 1/2 INCH. SCATTERED SCRAPES ALONG BOTTOM FLANGE AND WEB . SCATTERED OLD SCRAPES AND INDENTIONS ALONG BOTTOM FLANGE .

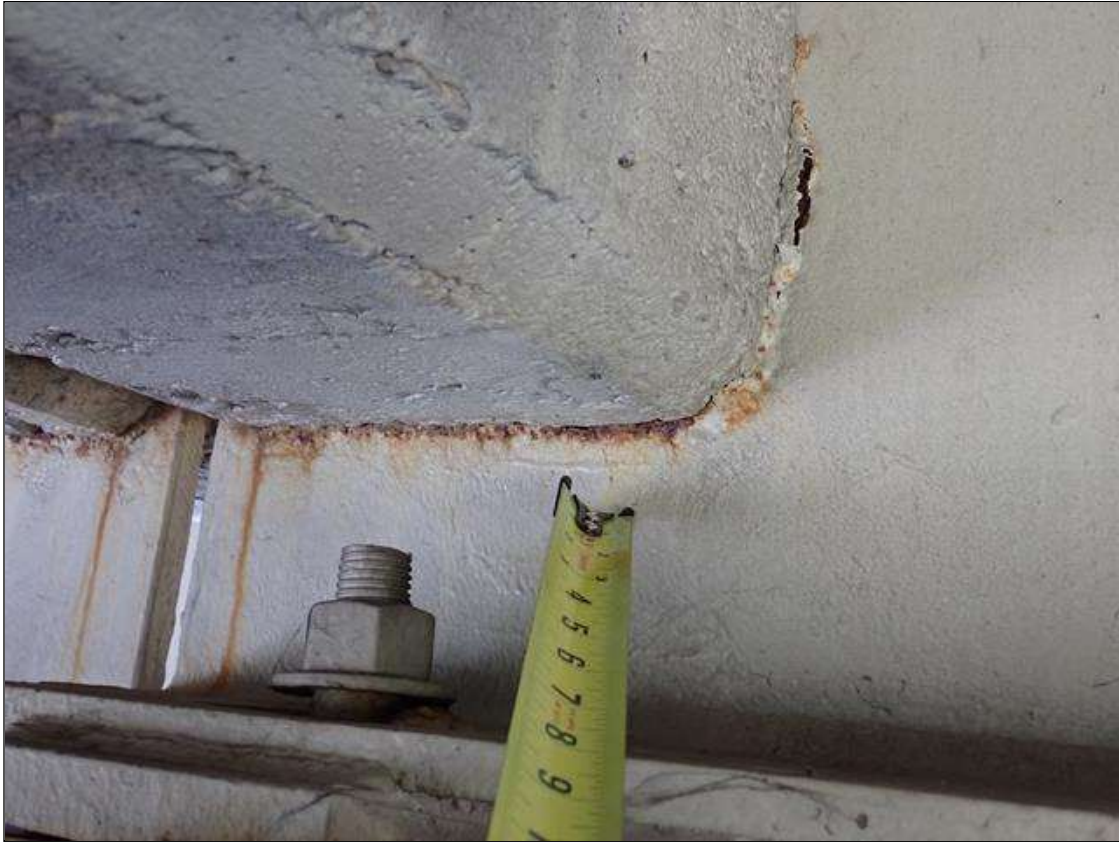
Span 4 Beam 4: at bent 3, web adjacent to diaphragm, painted over section loss (7/16 inch average remaining x 11 inch x 1 inch) with corrosion reinitiated
