NC DEPARTMENT OF TRANSPORTATION
 DIVISION OF HIGHWAYS
 STRUCTURE MANAGEMENT UNIT

ATTENTION: prompt action request, sign notice issued, sketches revised, clearances revised; new repairs to span 3 beams

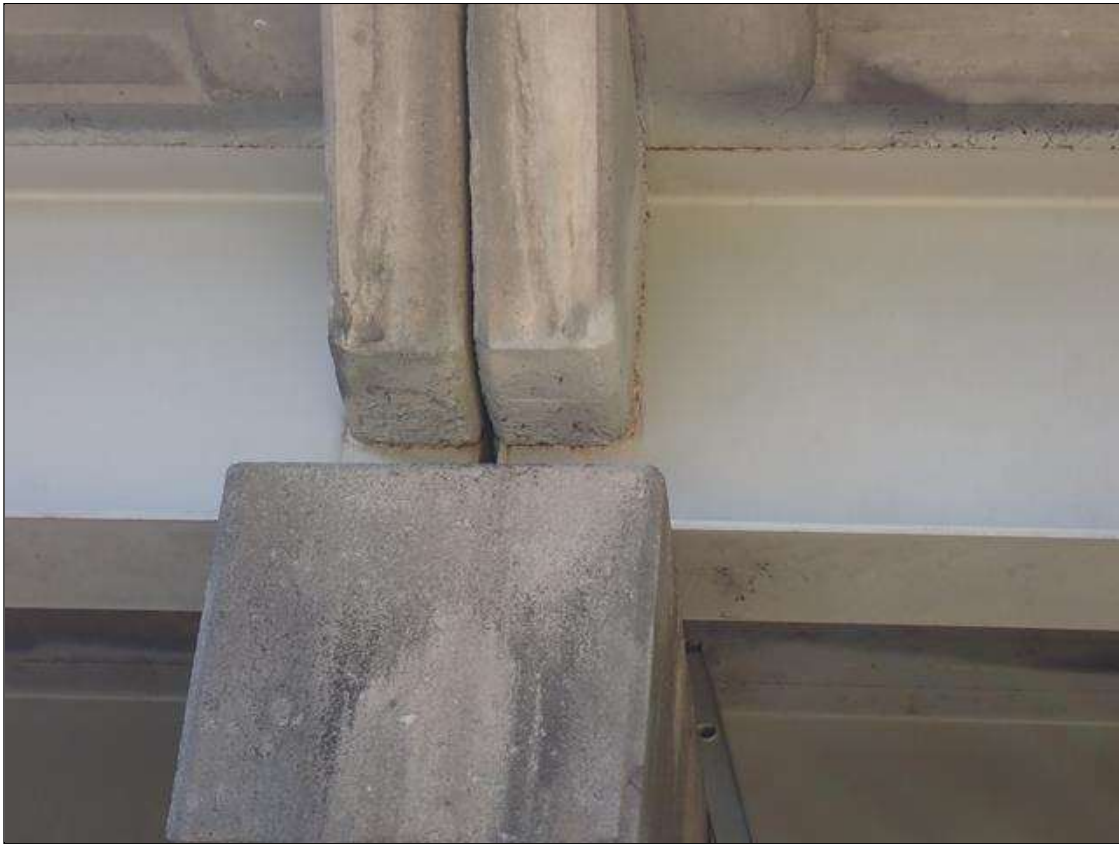
Span 4 Beam 5: (PAR) at bent 3, web adjacent to diaphragm, painted over section loss (approximately 3/8 inch average remaining x 10 inch x 1 inch) with corrosion reinitiated; underside of bottom flange, rust scale; no safe ladder access to exterior face

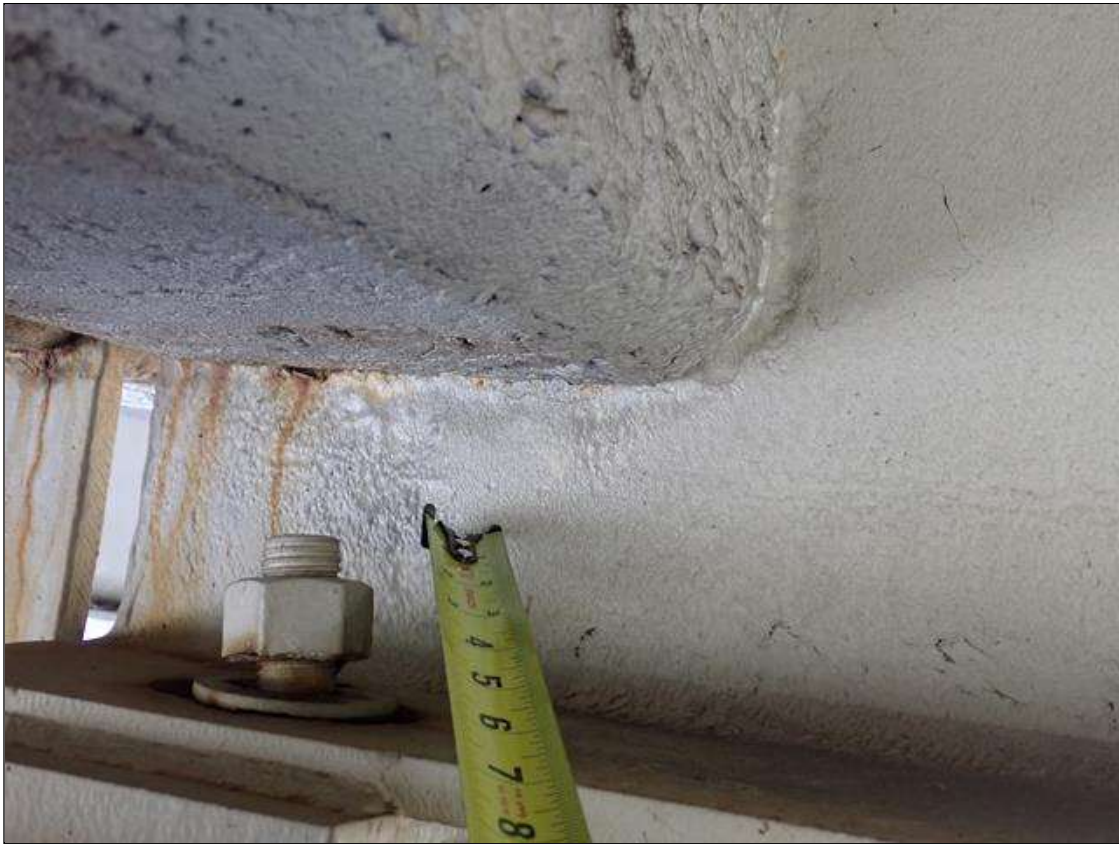
Span 4 Beam 3: (PAR) at bent 3, web adjacent to diaphragm, painted over section loss (1/4 inch average remaining x 12 inch x 4 inch)

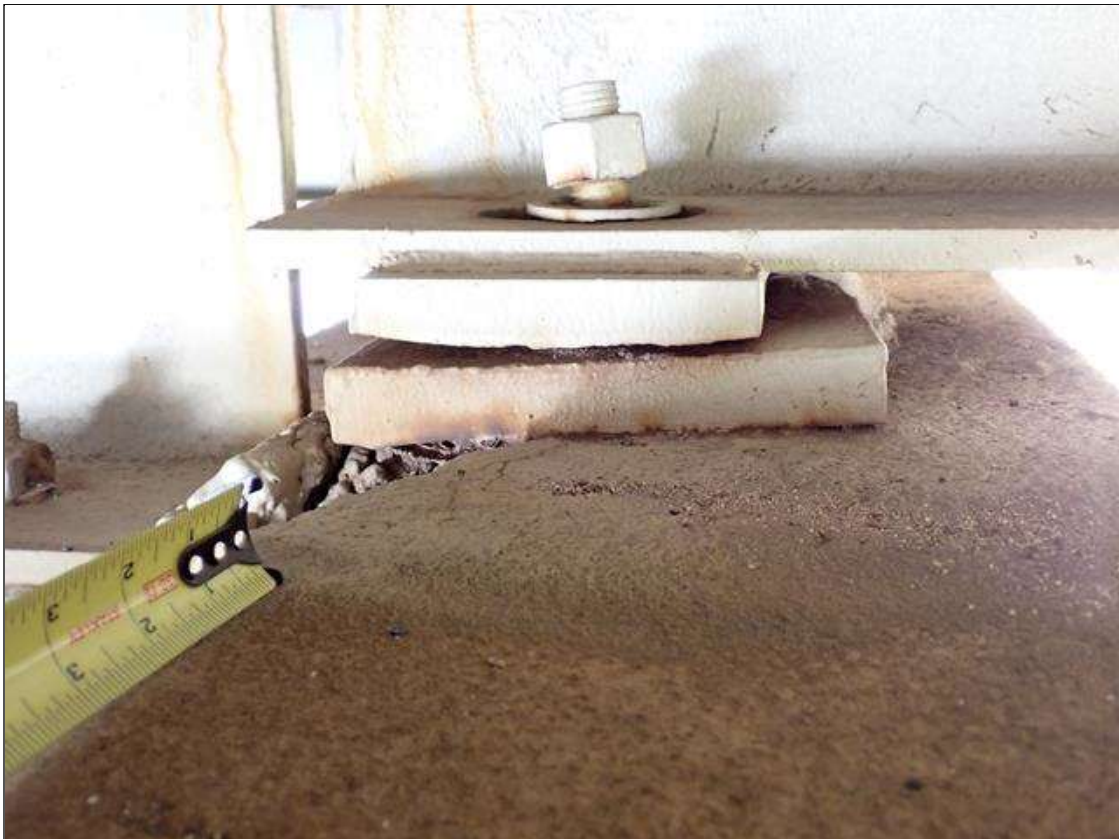
Span 4 Beam 3 - Near Bearing 3: (PAR) south edge of masonry plate, undermined (13 inch x 3 inches deep) due to cap step spall; masonry plate displaced downward (up to 1/2 inch)

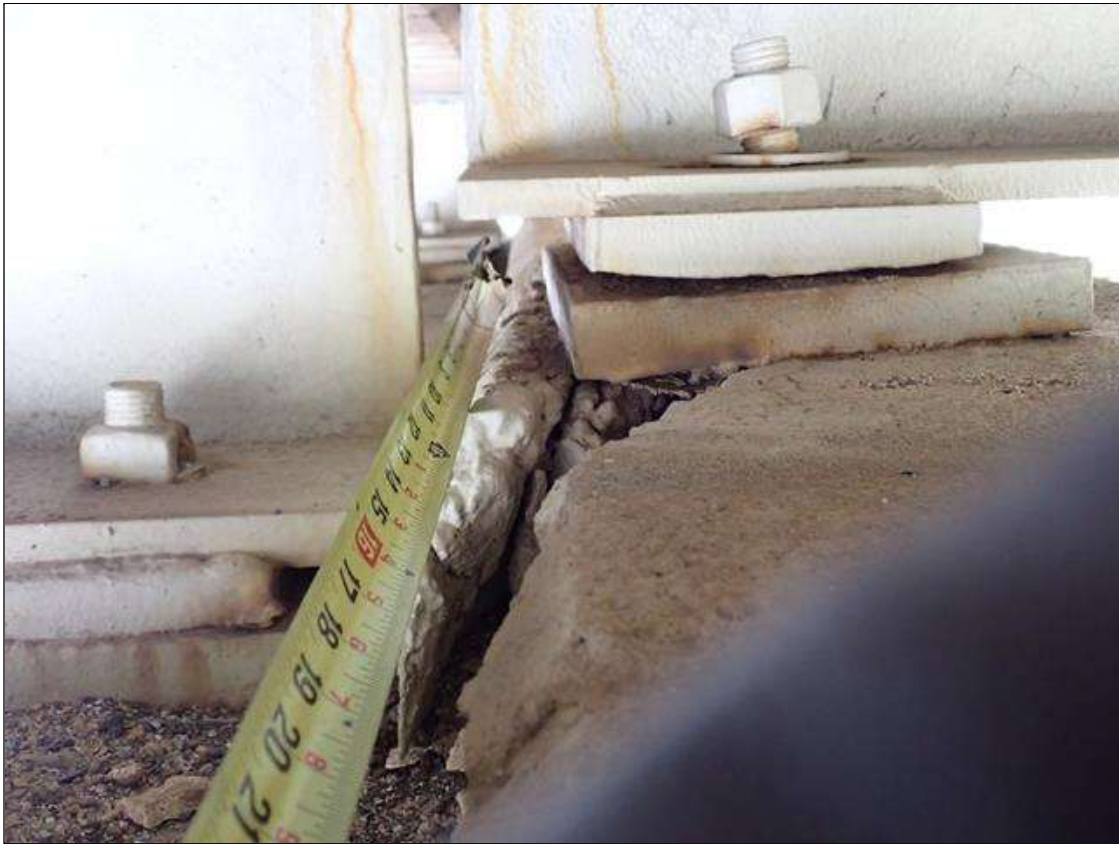
Span 4 Beam 3 - Near Bearing 3: (PAR) south edge of masonry plate, undermined (13 inch x 3 inches deep) due to cap step spall; masonry plate displaced downward (up to 1/2 inch)

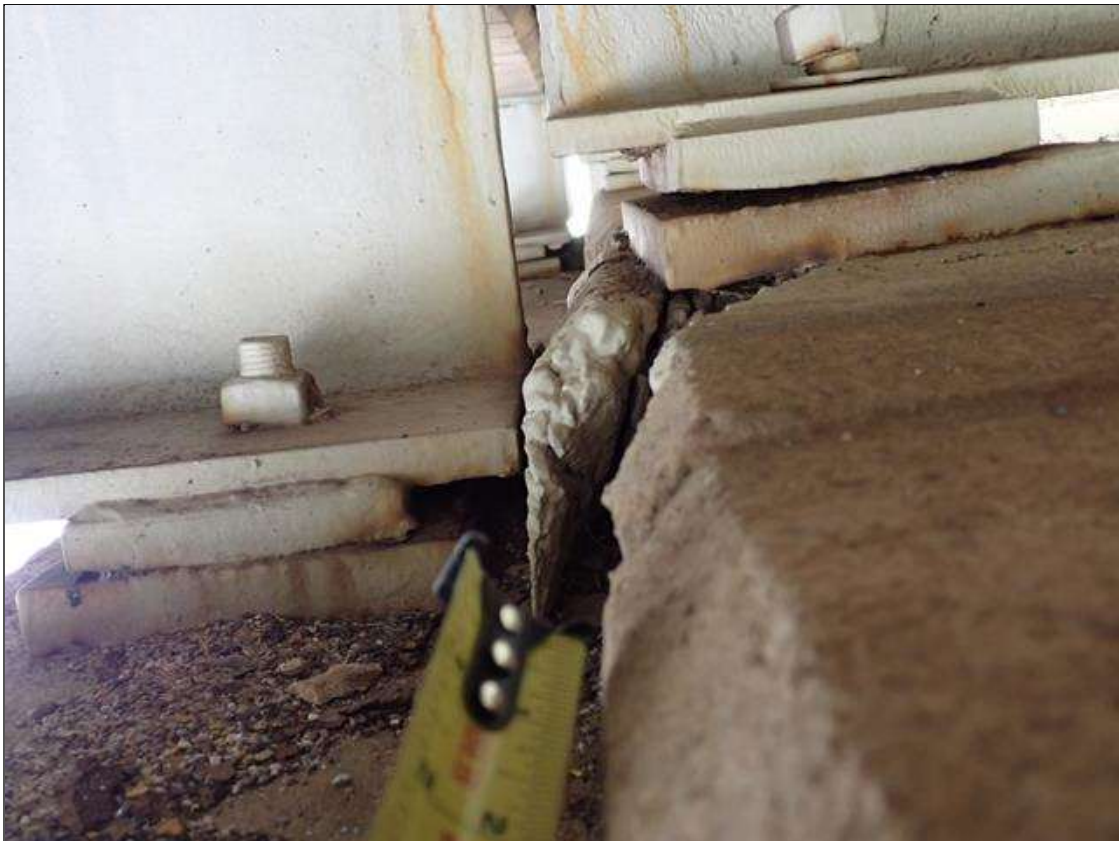
Bent 3 Cap 1: (PAR) at span 4 beam 4 cap step, south face, spall/delamination (2.5 feet x 7 inch x 4 inches deep) undermining bearing

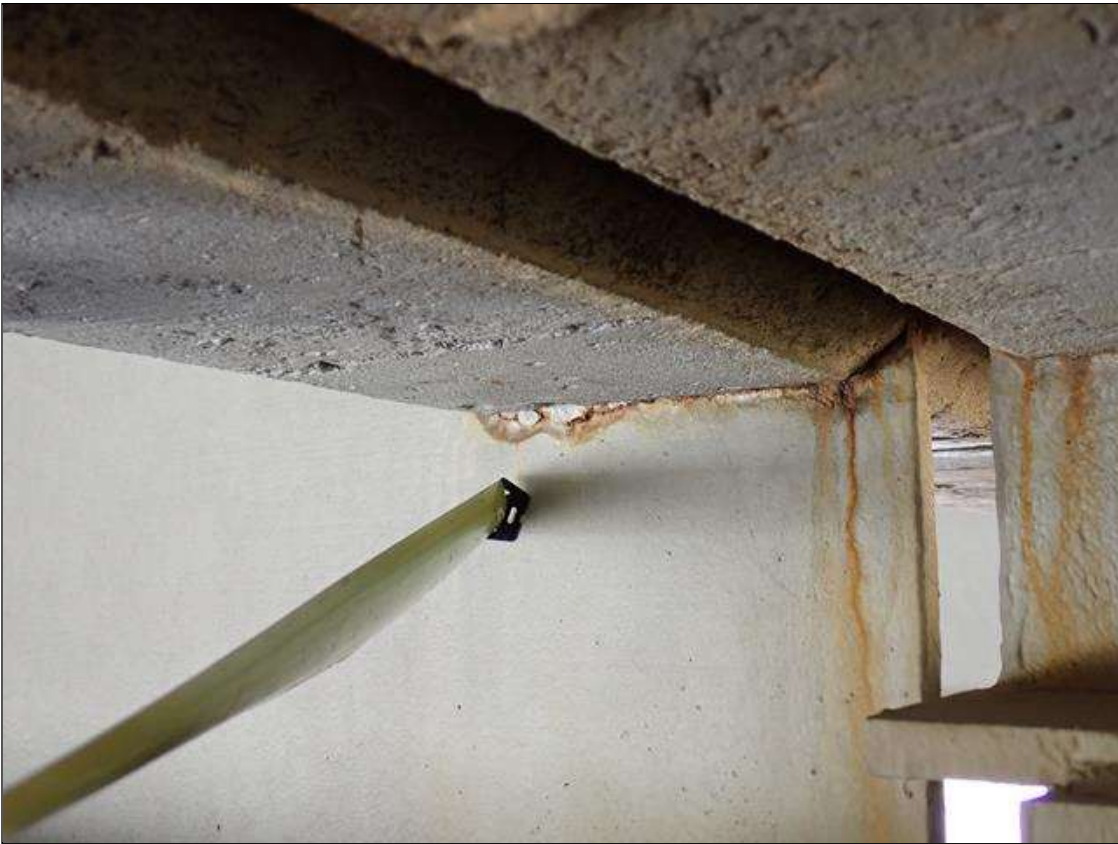
Span 3 Beam 3: (PAR) at bent 3, web adjacent to diaphragm, painted over section loss (3/8 inch average remaining x 9 inch x 1 inch) with corrosion reinitiated

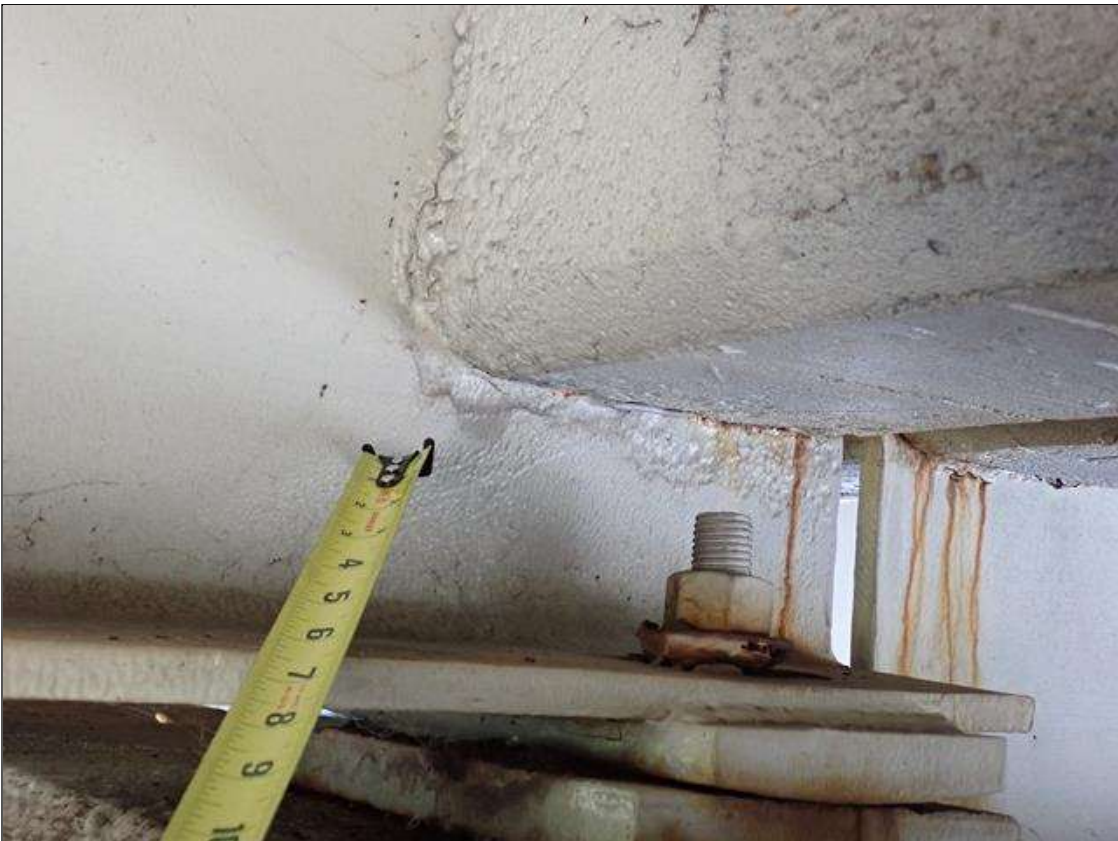
Span 4 Beam 3: (PAR) at bent 3, web adjacent to diaphragm, painted over section loss (1/4 inch average remaining x 12 inch x 4 inch)

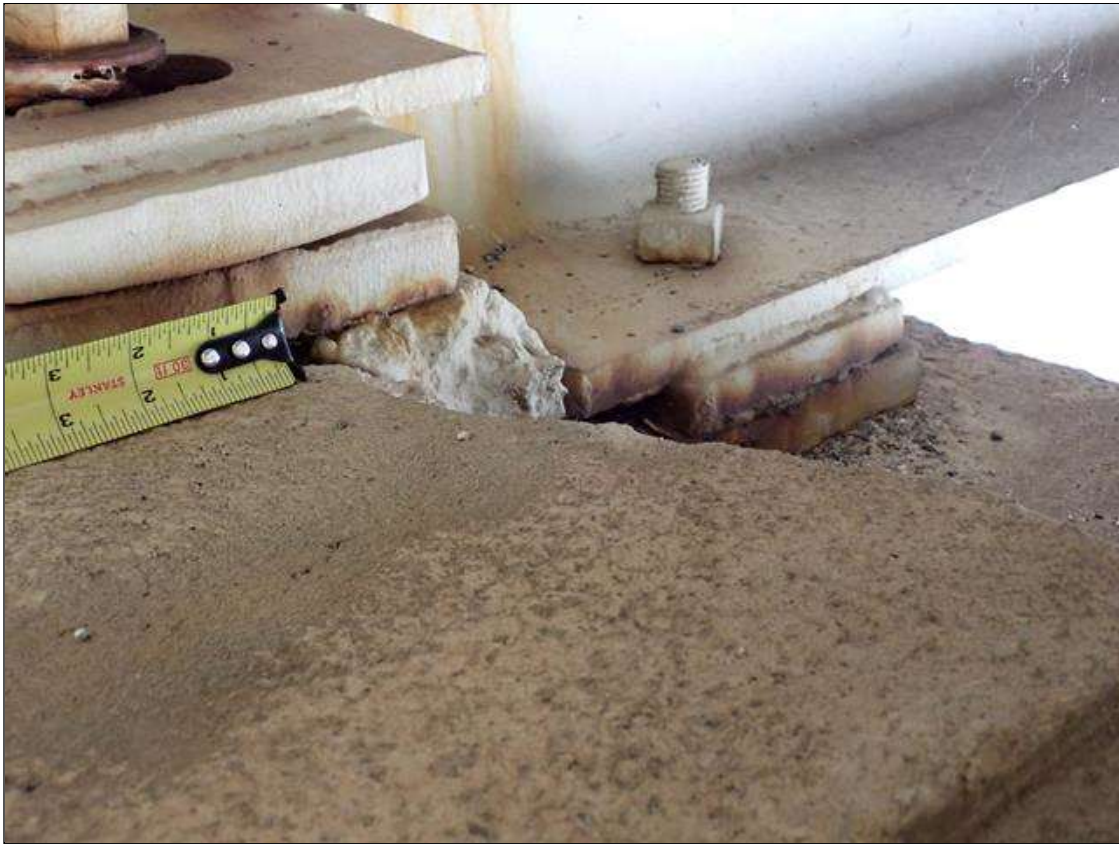
Bent 3 Cap 1: (PAR) at span 4 beam 4 cap step, south face, spall/delamination (2.5 feet x 7 inch x 4 inches deep) undermining bearing

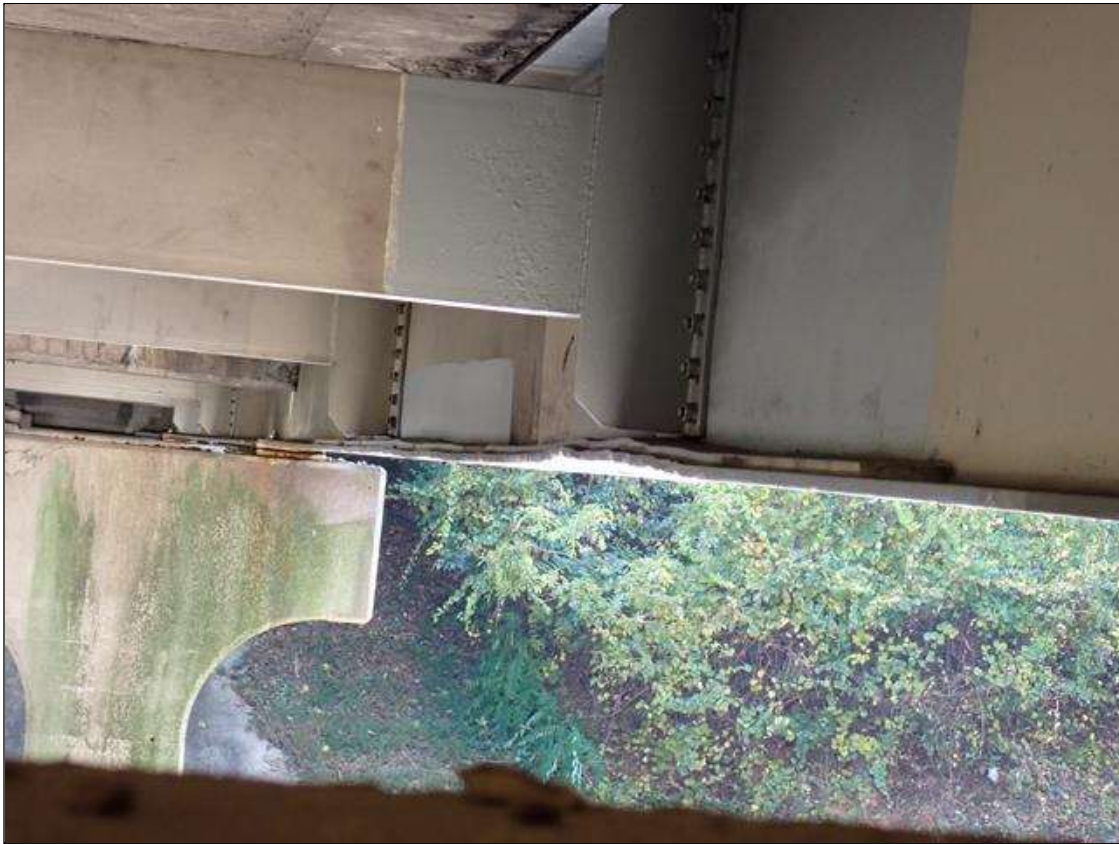
Span 3 Beam 1: (PAR) 2023 area repainted with new impact scrapes/gouges (up to 1/8 inch deep); previous diaphragm weld crack and missing bolts repaired; previously noted as: impact damage to beam 1 span 3, starting at 14 feet-7 inches from bent 3 for a total length of 6 feet-8 inches. beam deflected 2 inches westward. bottom flange bent upward 2 inches for a length of 20 inches at 18 feet from bent 3 with three indentions. first indention at 18 feet from bent 3, 1.5 inches long x 1.25 inches high x 1 inch deep. second indention at 18 feet-5 inches from bent 3, 2.5 inches long x 1.5 inches high x 0.25 inch deep. third indention at 18 feet-8 inches from bent 3, 2 inches long x 1 inch high x 0.25 inch deep.

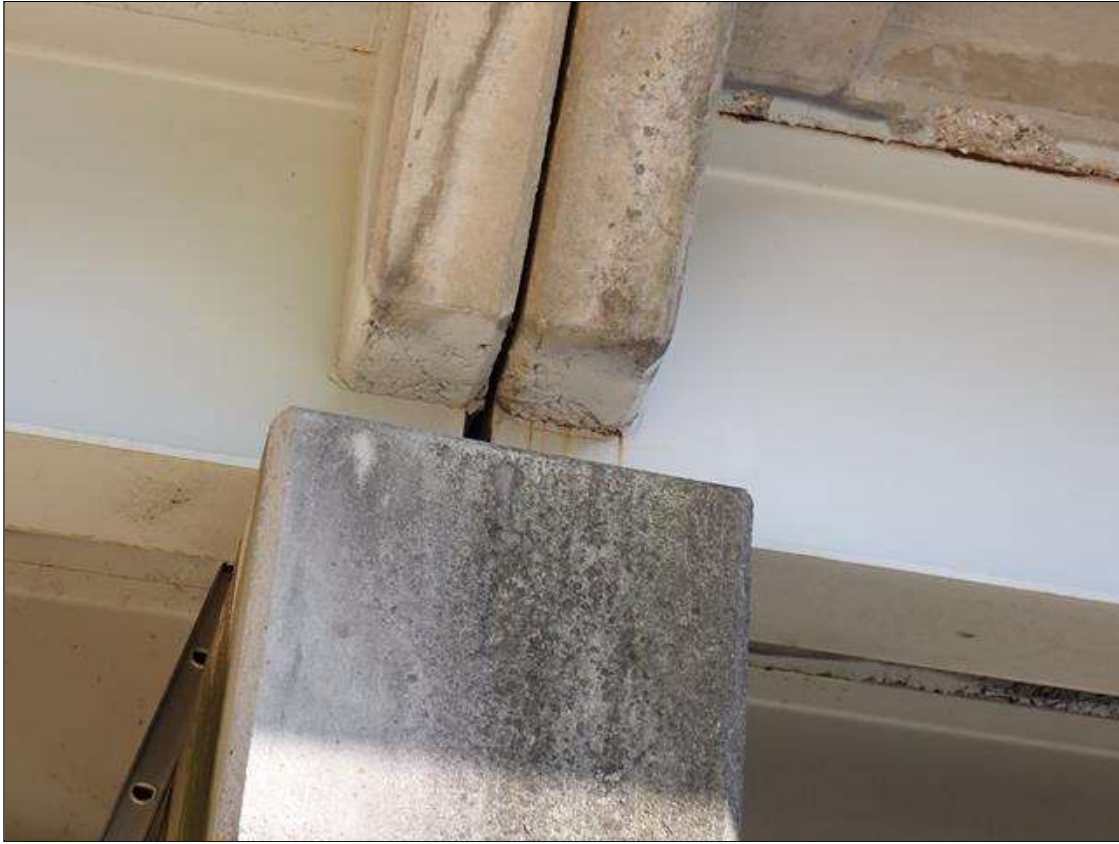
Span 3 Beam 1: (PAR) at bent 3, web adjacent to diaphragm, painted over section loss (approximately 3/8 inch average remaining x 9 inch x 1 inch) with corrosion reinitiated; no safe ladder access to exterior face

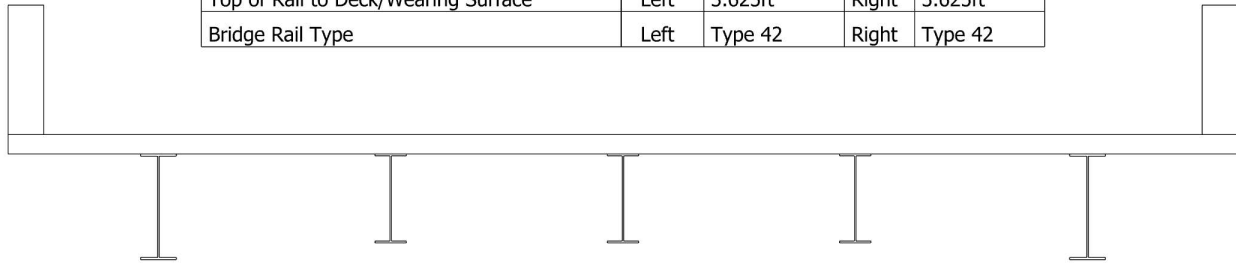
Measurements for Span #	1	all spans similar	
Deck Thickness	6.5in	Left Overhang	4.208ft
Top of Rail to Bottom of Beam (Avg)	7.125ft	Right Overhang	4.208ft
