NC DEPARTMENT OF TRANSPORTATION
 DIVISION OF HIGHWAYS
 STRUCTURE MANAGEMENT UNIT

ATTENTION: prompt action request, sketches revised, clearances revised, resurfaced with no change in asphalt wearing surface thickness

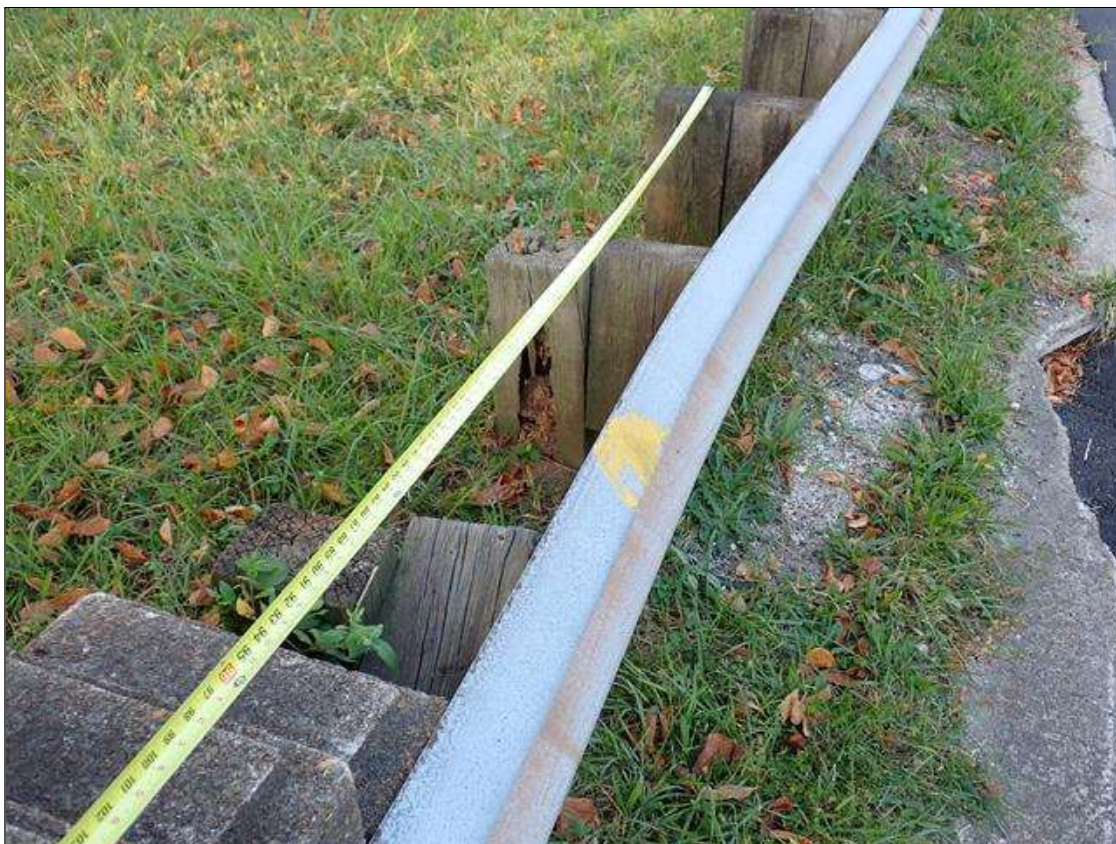
(PAR) southeast guardrail transition, impact damage (7 feet) with (1) decayed post

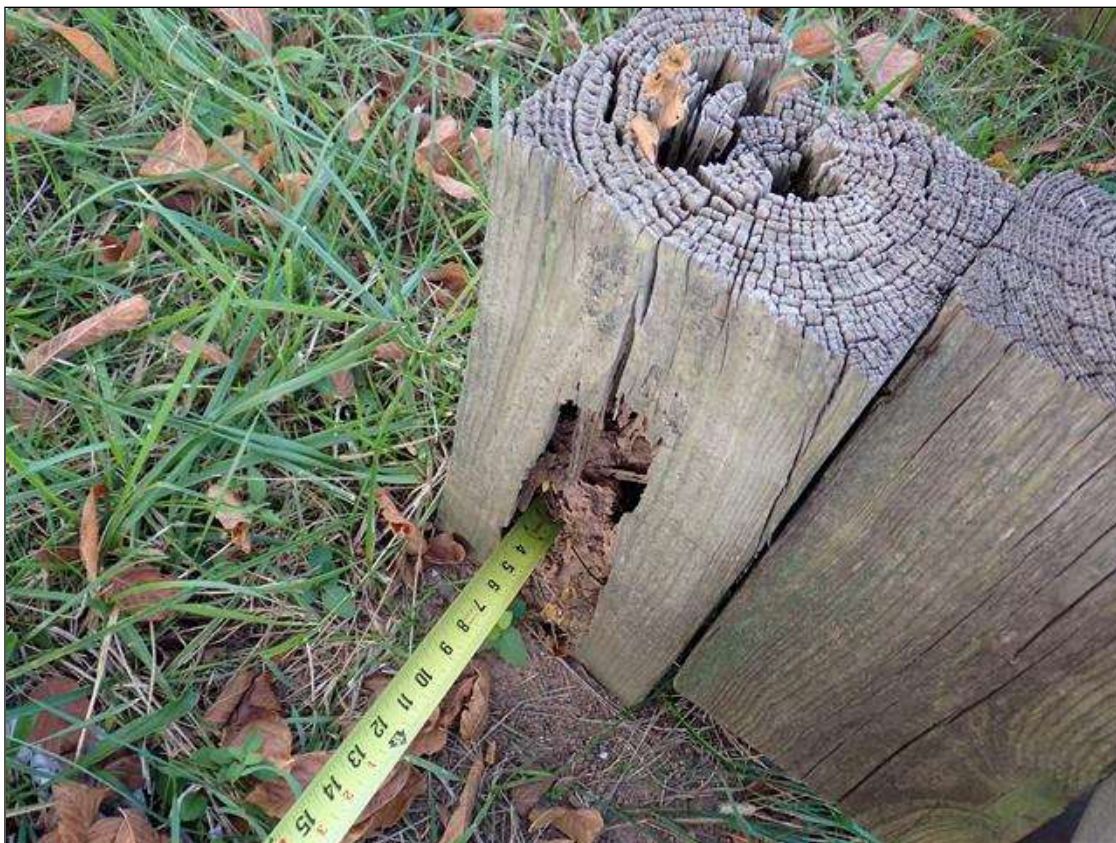
(PAR) southeast guardrail transition, impact damage (7 feet) with (1) decayed post

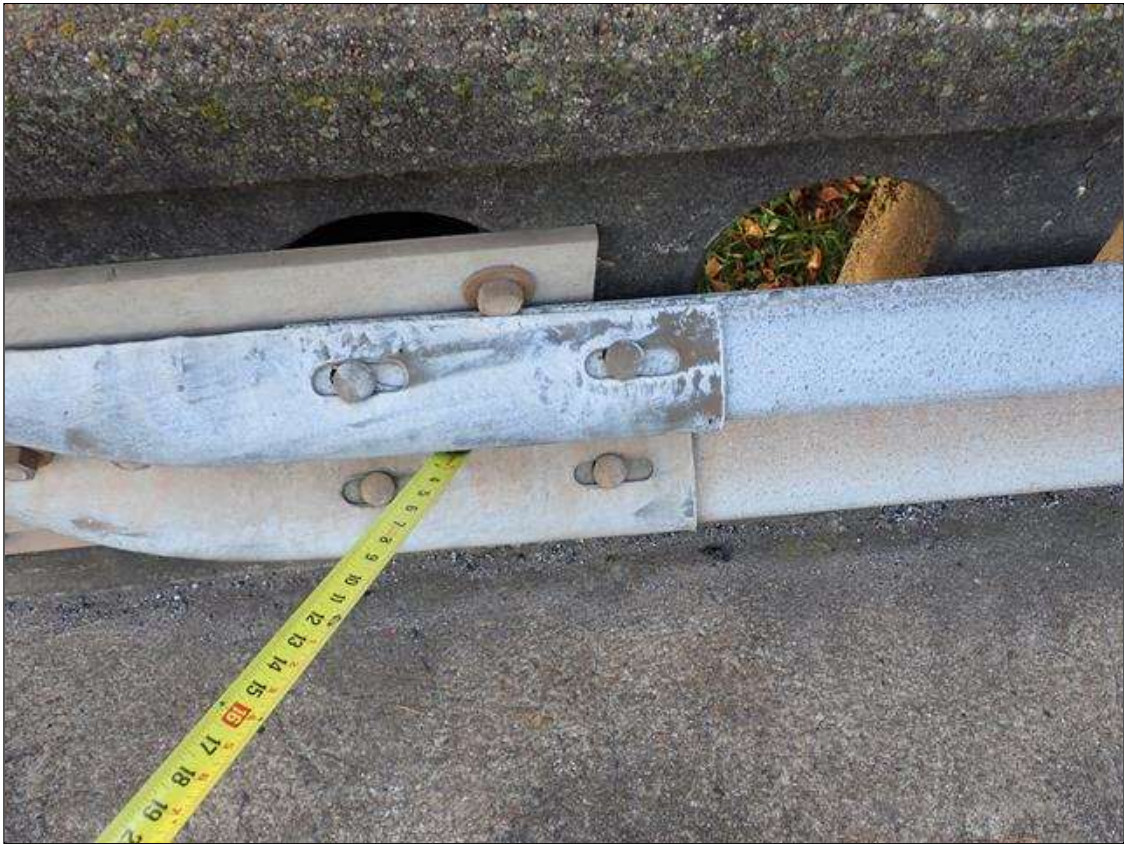
(PAR) southeast guardrail attachment, improper lap

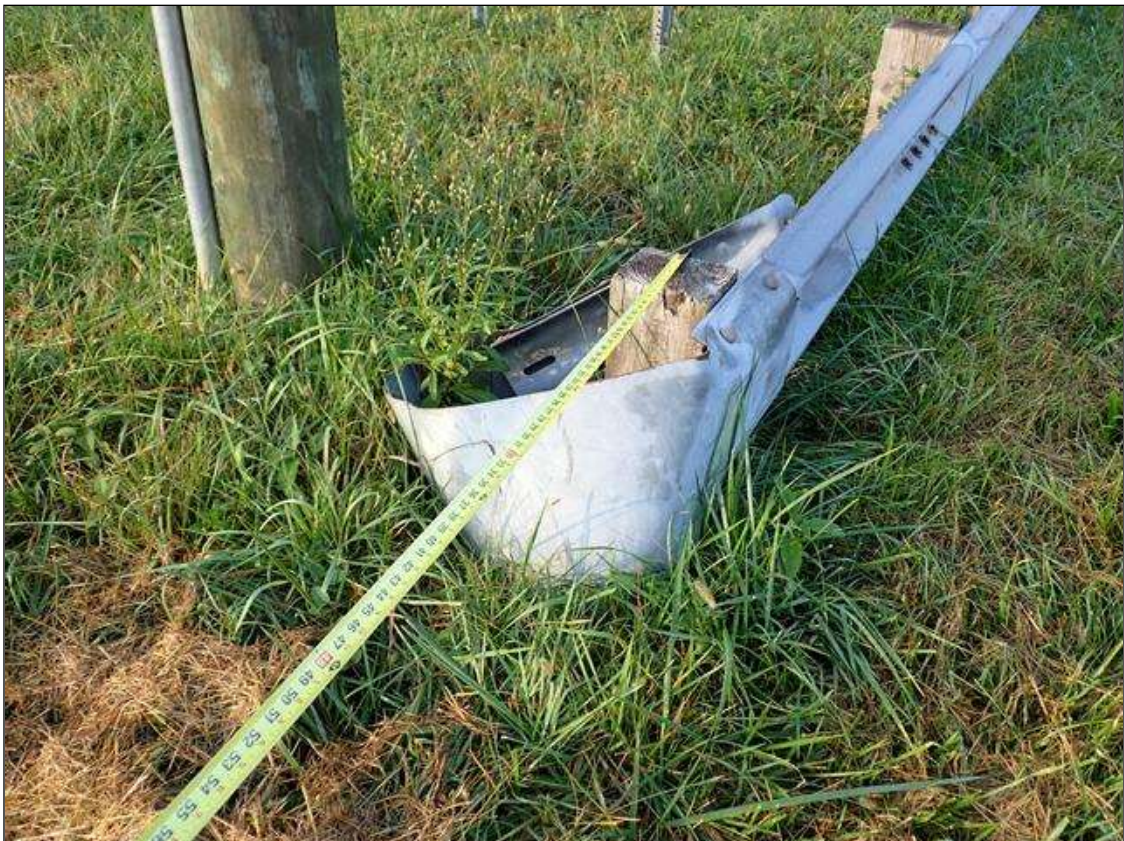
(PAR) northeast guardrail termination, impact damage (1 foot)

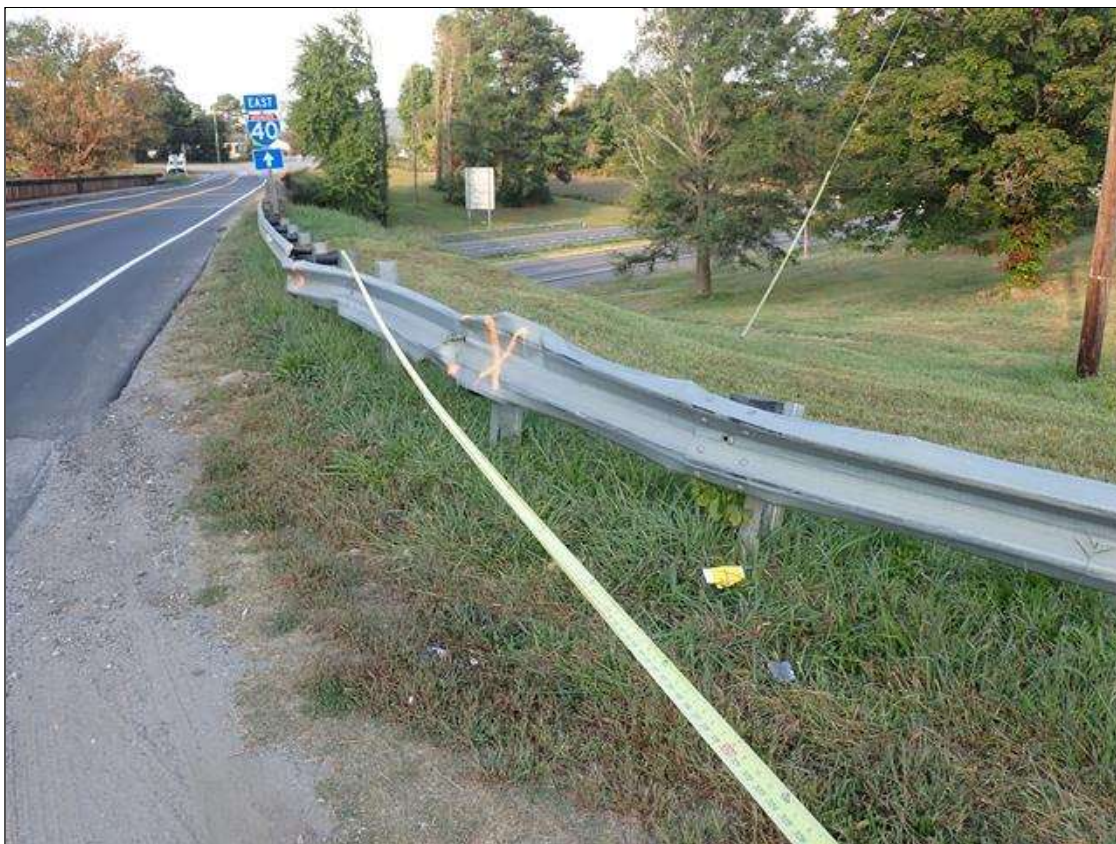
(PAR) northwest guardrail, impact damage (38 feet)

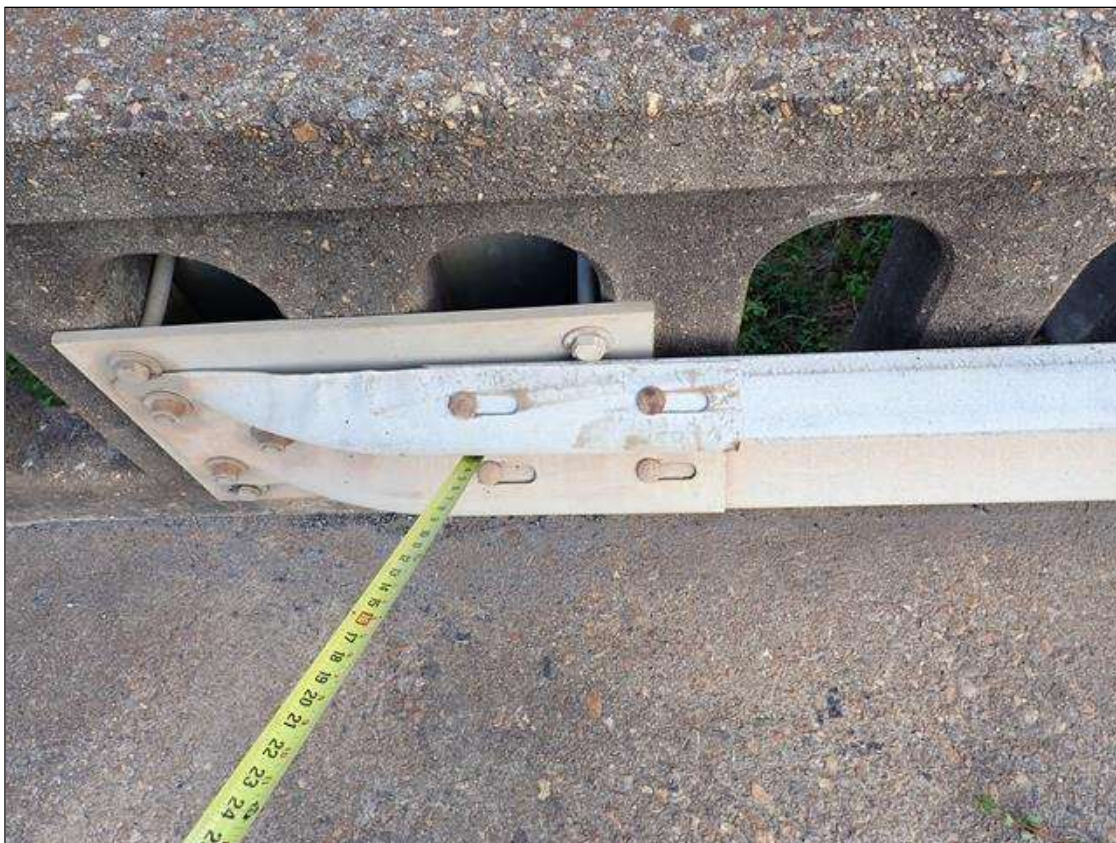
(PAR) northwest guardrail attachment, improper lap

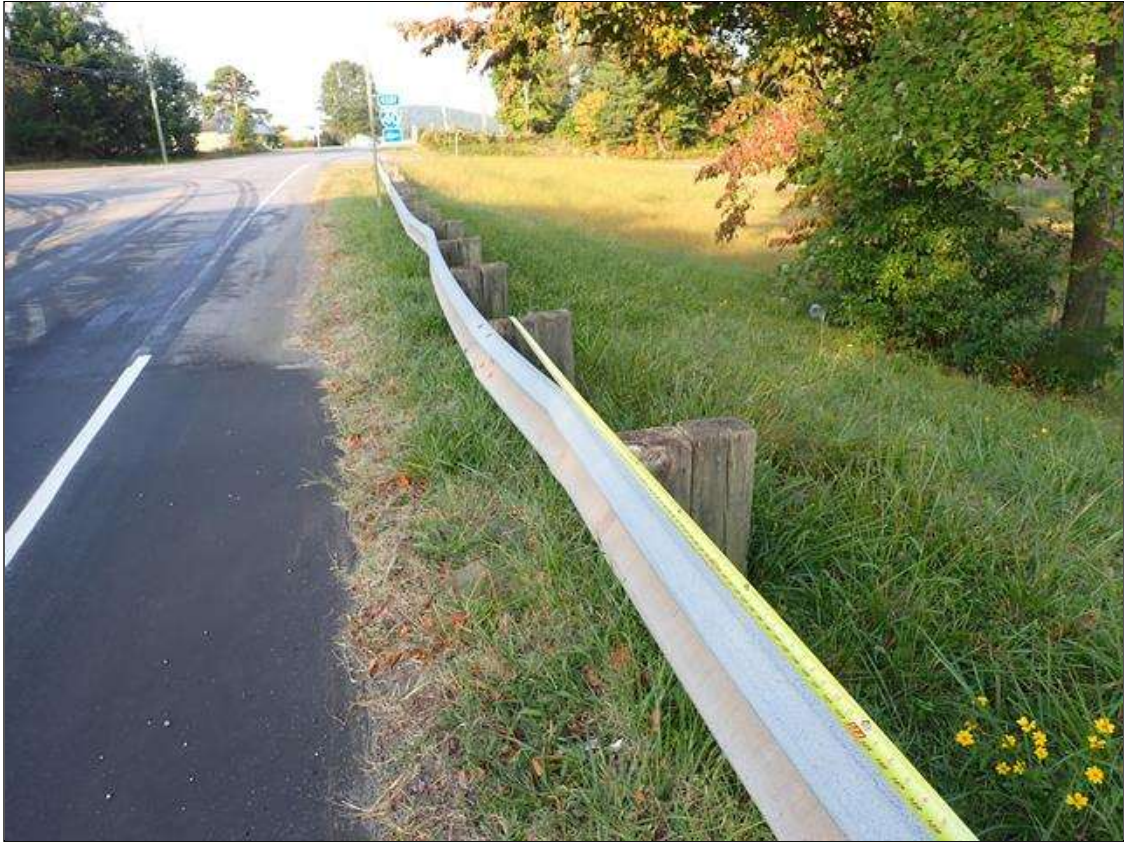
(PAR) southwest guardrail, areas of impact damage (25 feet total)

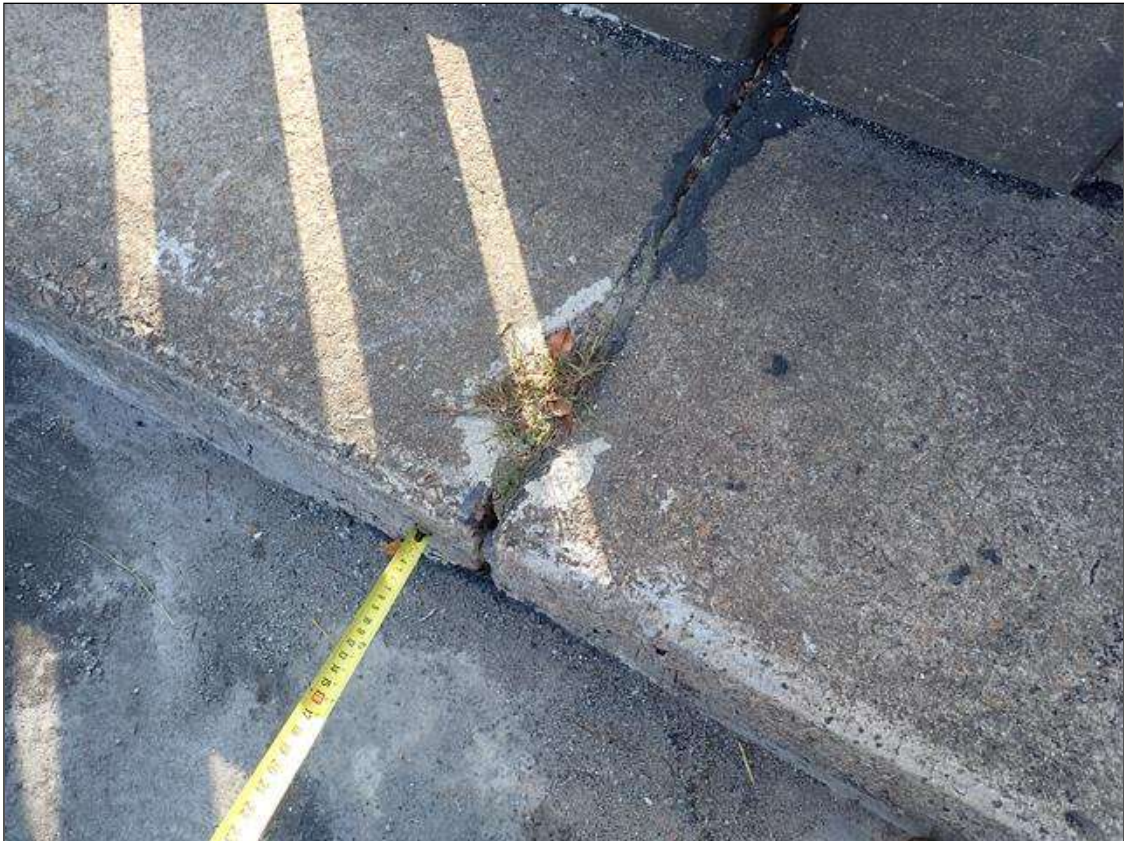
Span 2 Expansion Joint at Bent 1: both sidewalks, seal damaged/missing

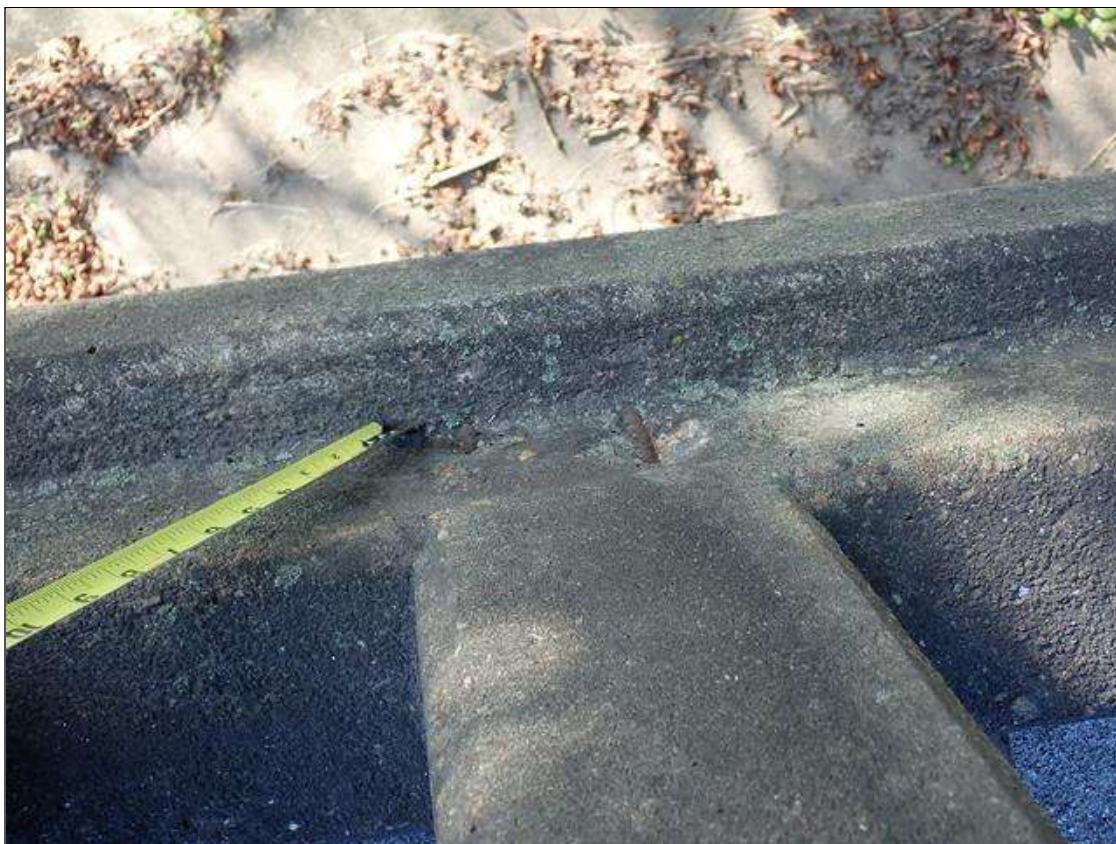
Span 1 Right Bridge Rail: 16 - spalls with exposed reinforcing up to 2 inch x 1 inch x 1/2 inch deep, in outside face, at random.

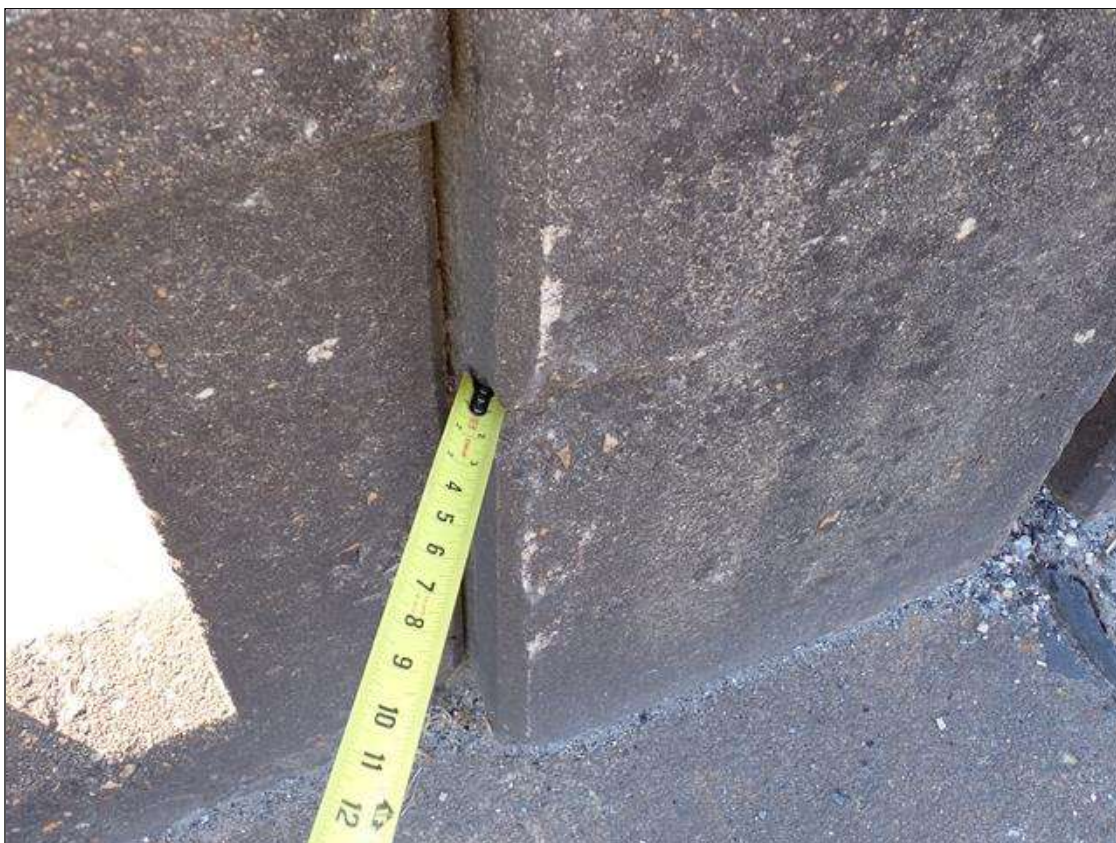
Span 4 Right Bridge Rail: 4 inch x 4 inch x 1.5 inch deep spall, in traffic face, at bent 3.

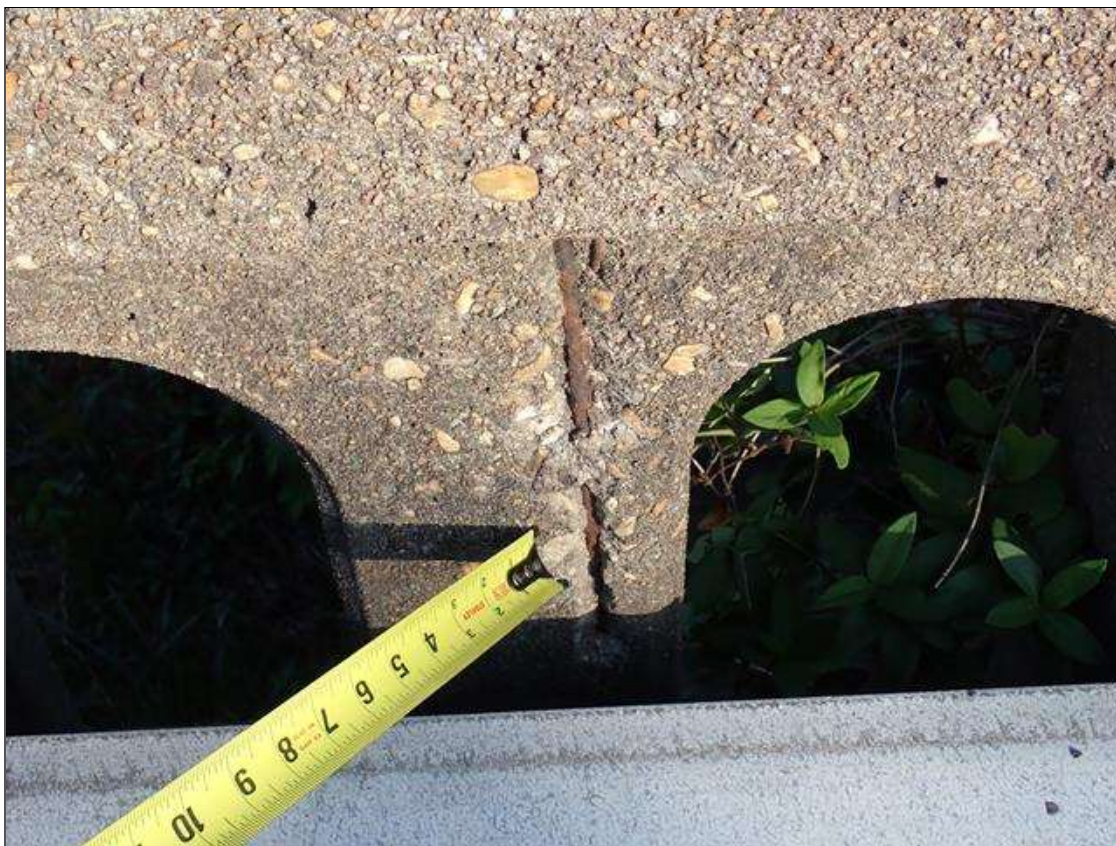
Span 4 Left Bridge Rail: along the length of the rail, spalls (up to 12 inch x 2 inch x 1/2 inch deep) with exposed rusted rebar

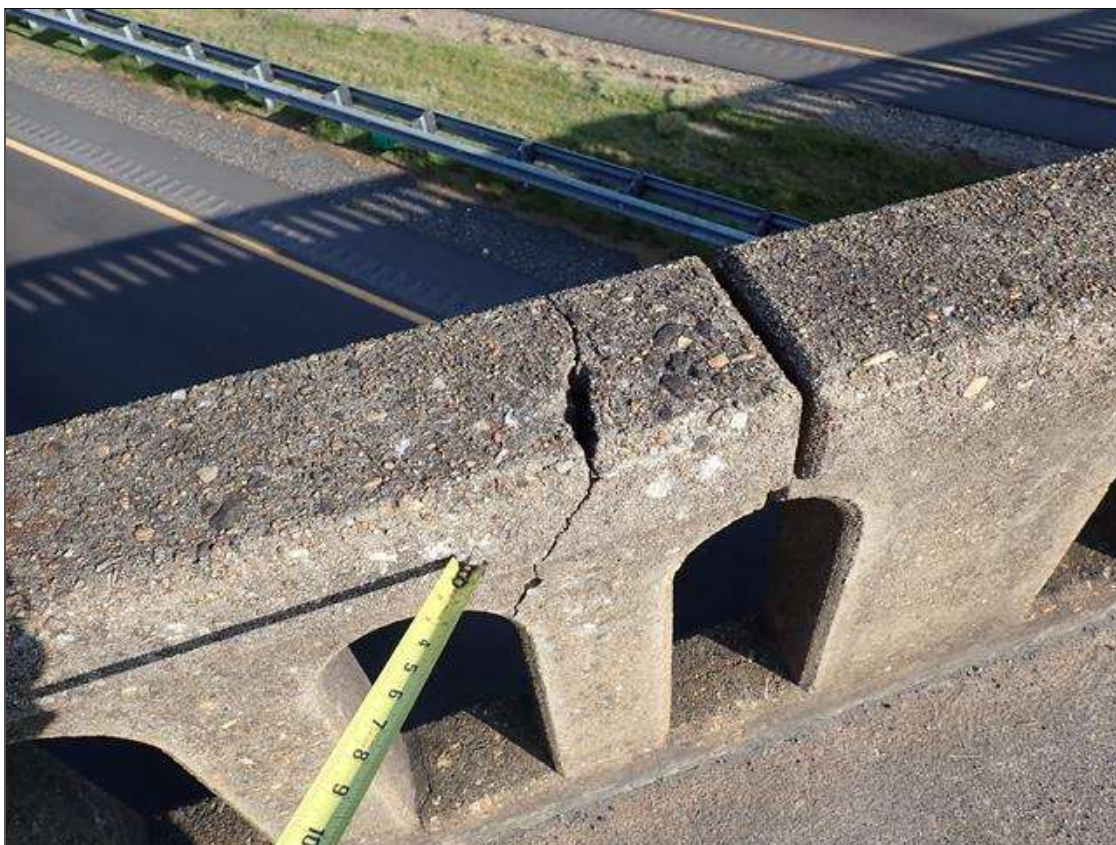
Span 2 Left Bridge Rail: 20 feet from bent 1, diagonal crack (1/8 inch wide) with edge spall (4 inch x 1 inch x 1 inch deep)

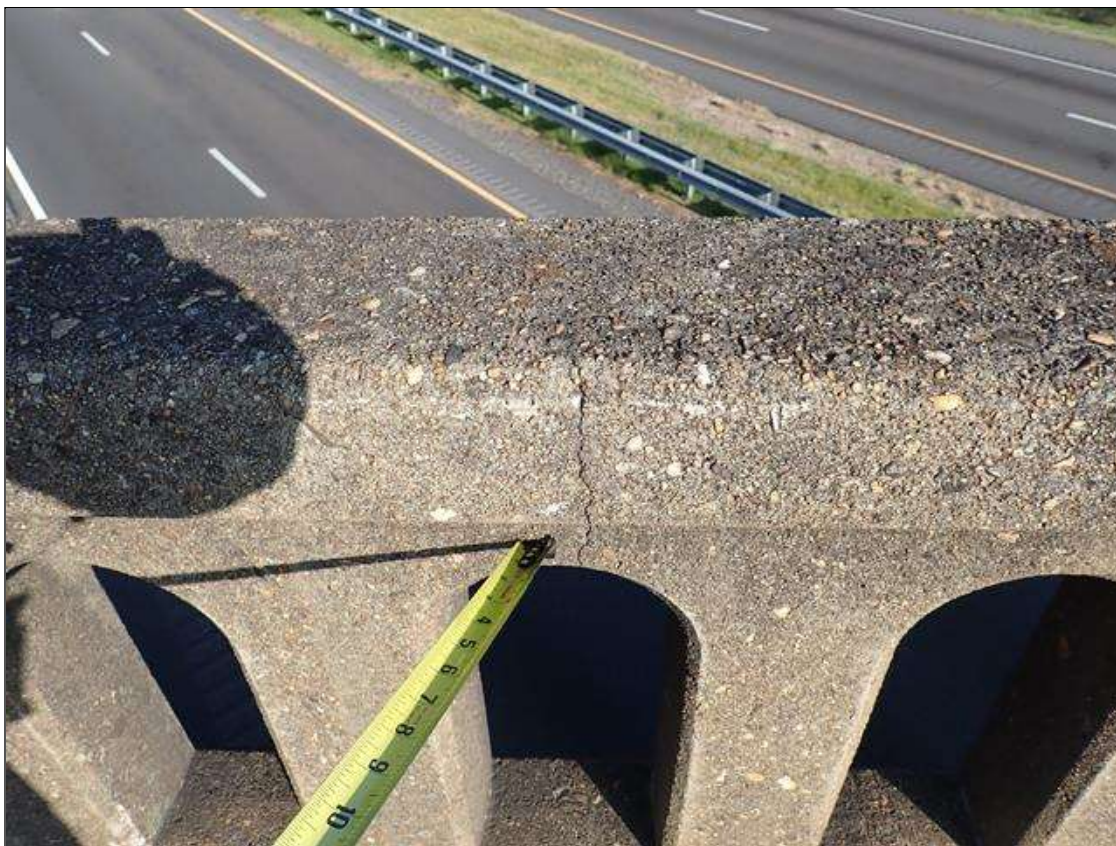
Span 2 Left Bridge Rail: near bent 1, vertical cracks (up to 1/32 inch x 9 inches)

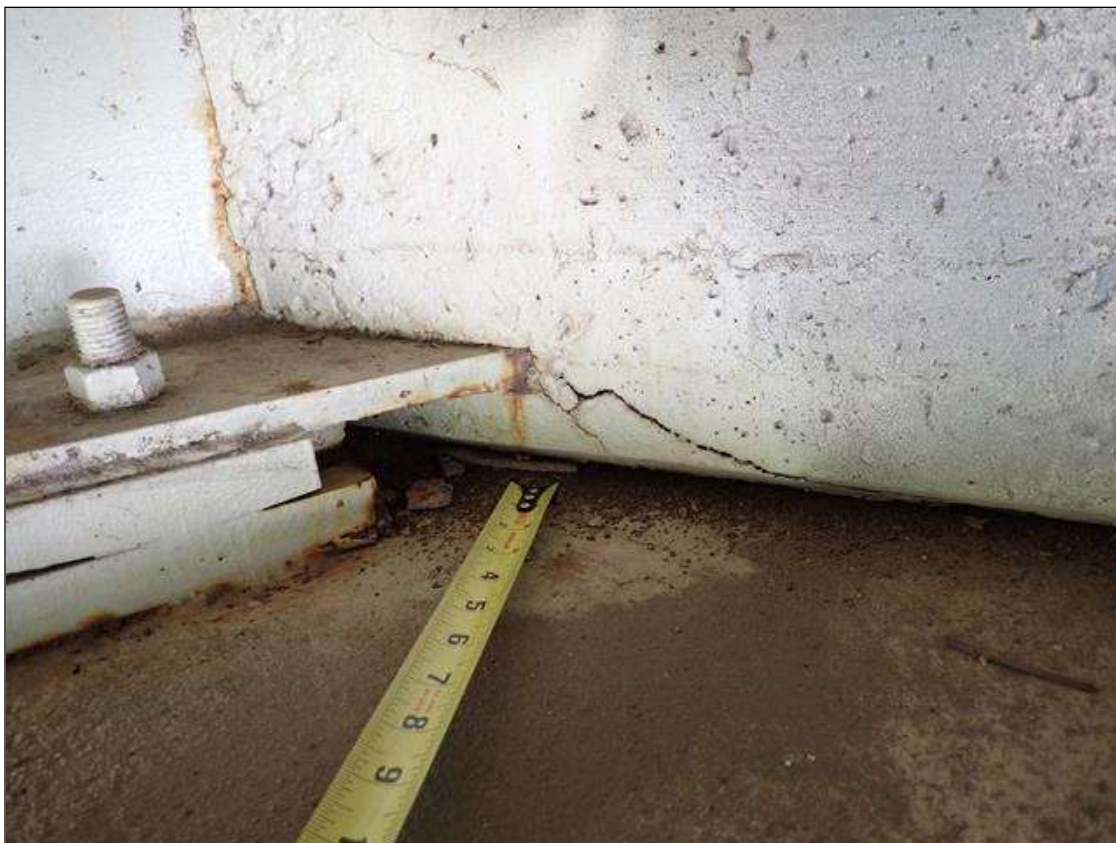
End Bent 2 Abutment: delamination up to 6 inch x 8 inch, east side of beam 3 (typical at all beams at end bent 2).

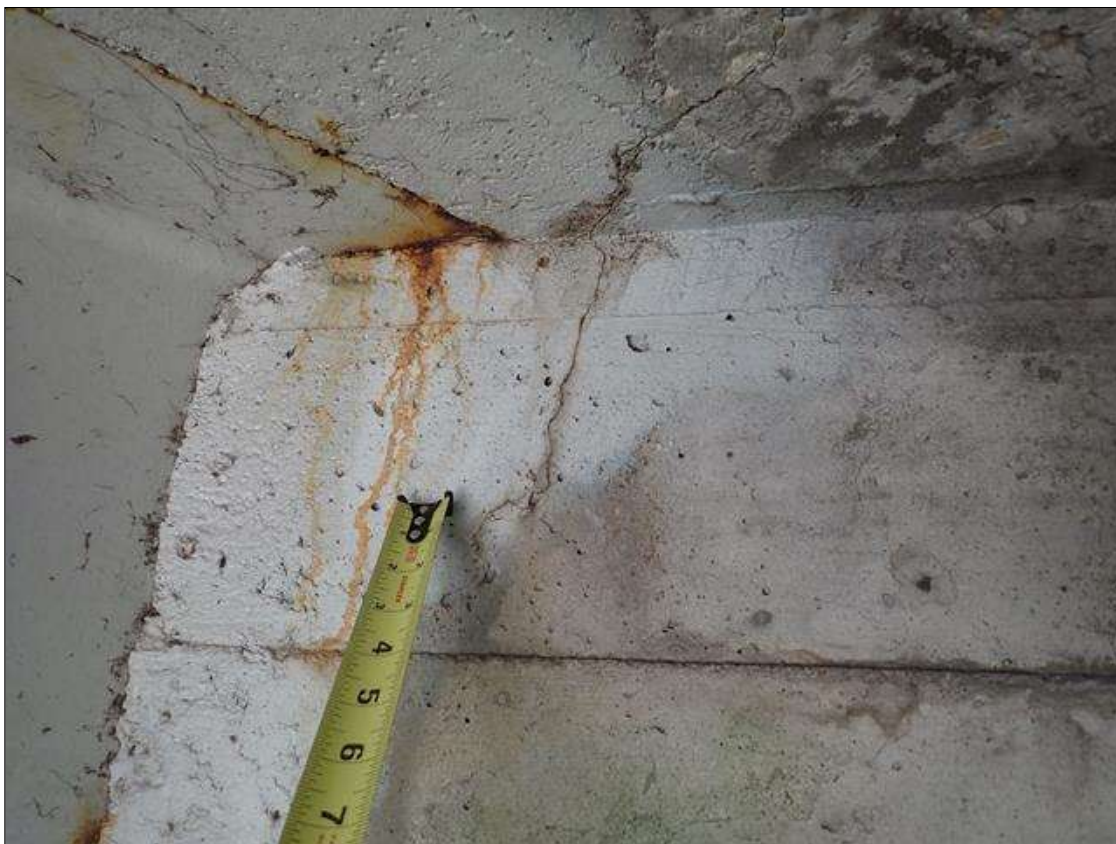
End Bent 2 Abutment: along the length of the abutment, vertical cracks (up to 1/32 inch x 1 foot) and areas of map cracks (hairline) at random

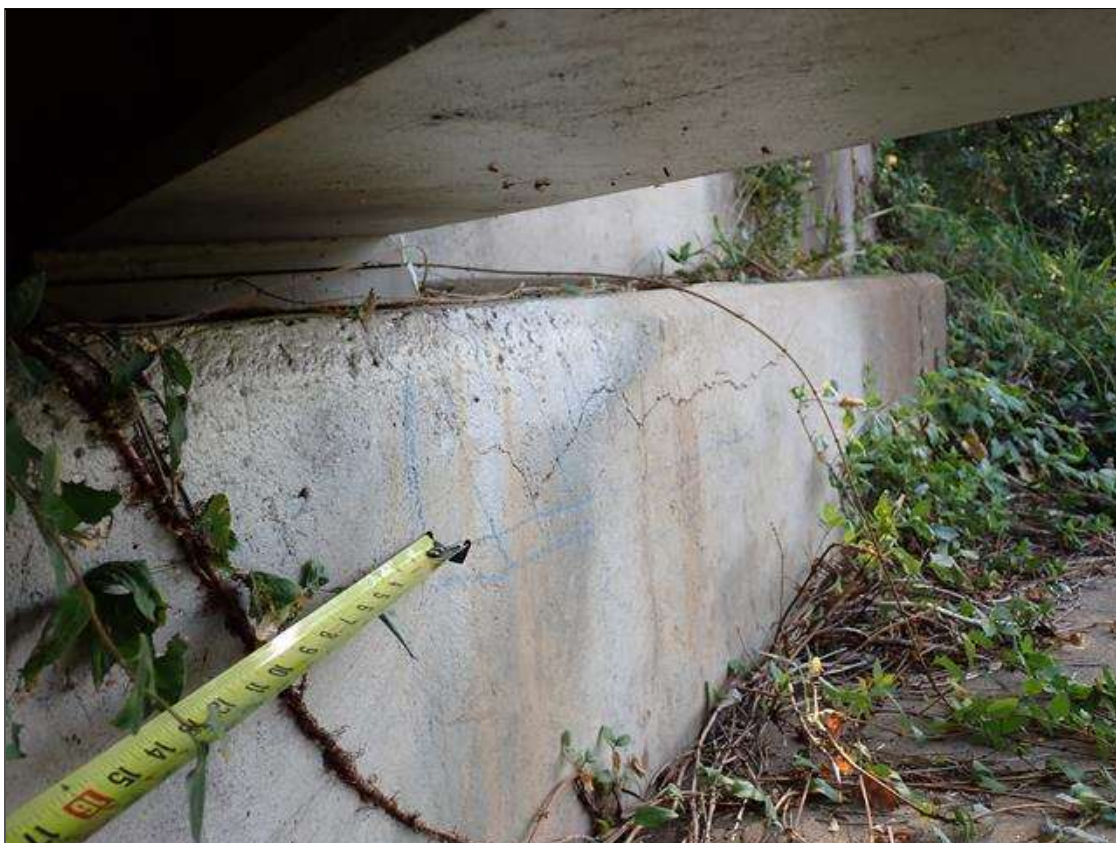
End Bent 2 Cap 1: 4 foot x 8 inch delamination with associated cracks up to 1/16 inch, face of cap, under beam 5.

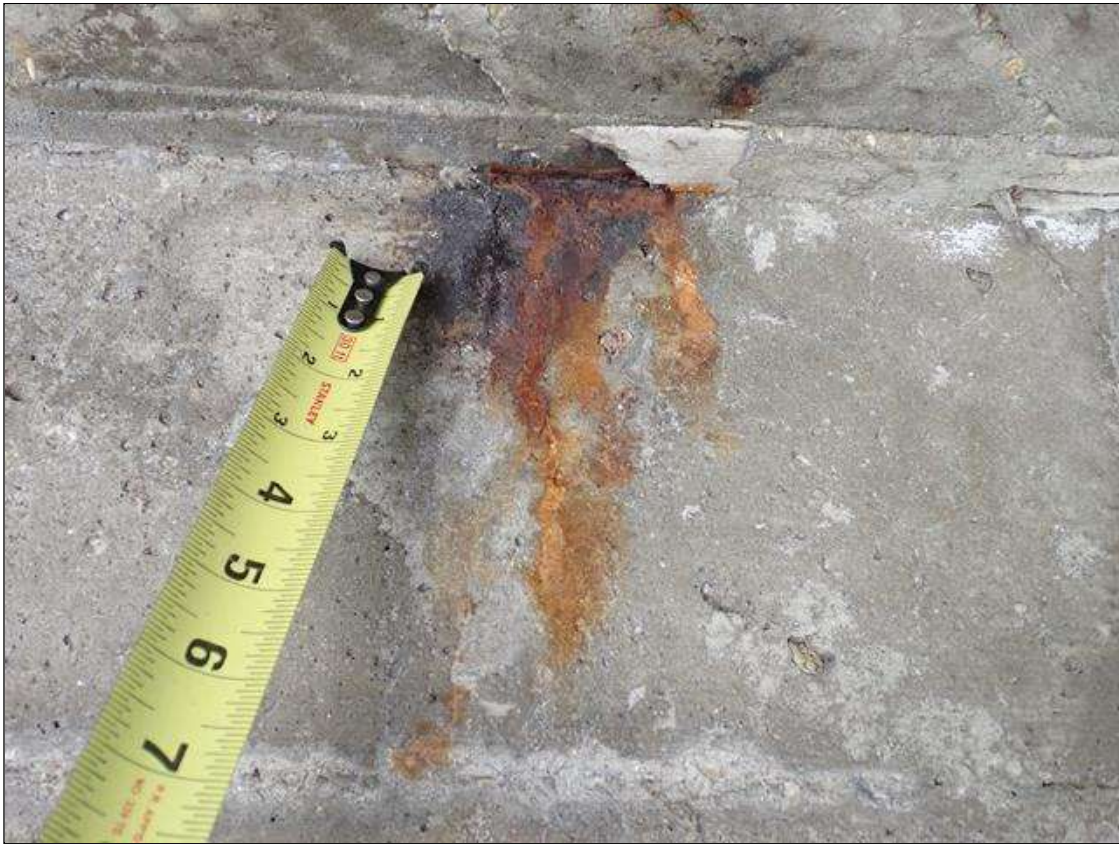
End Bent 2 Abutment: (PAR) top of abutment, in bay 3, rust stains

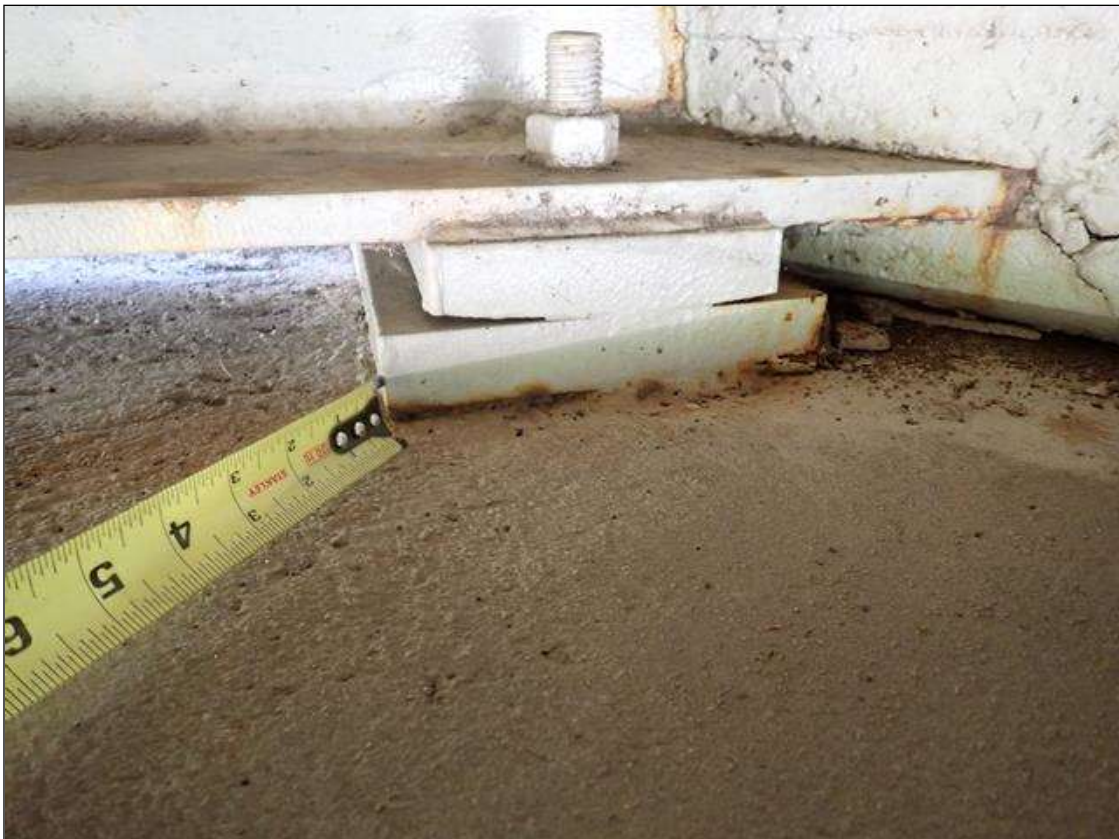
Span 4 Beam 1 - Far Bearing 1: freckled rust

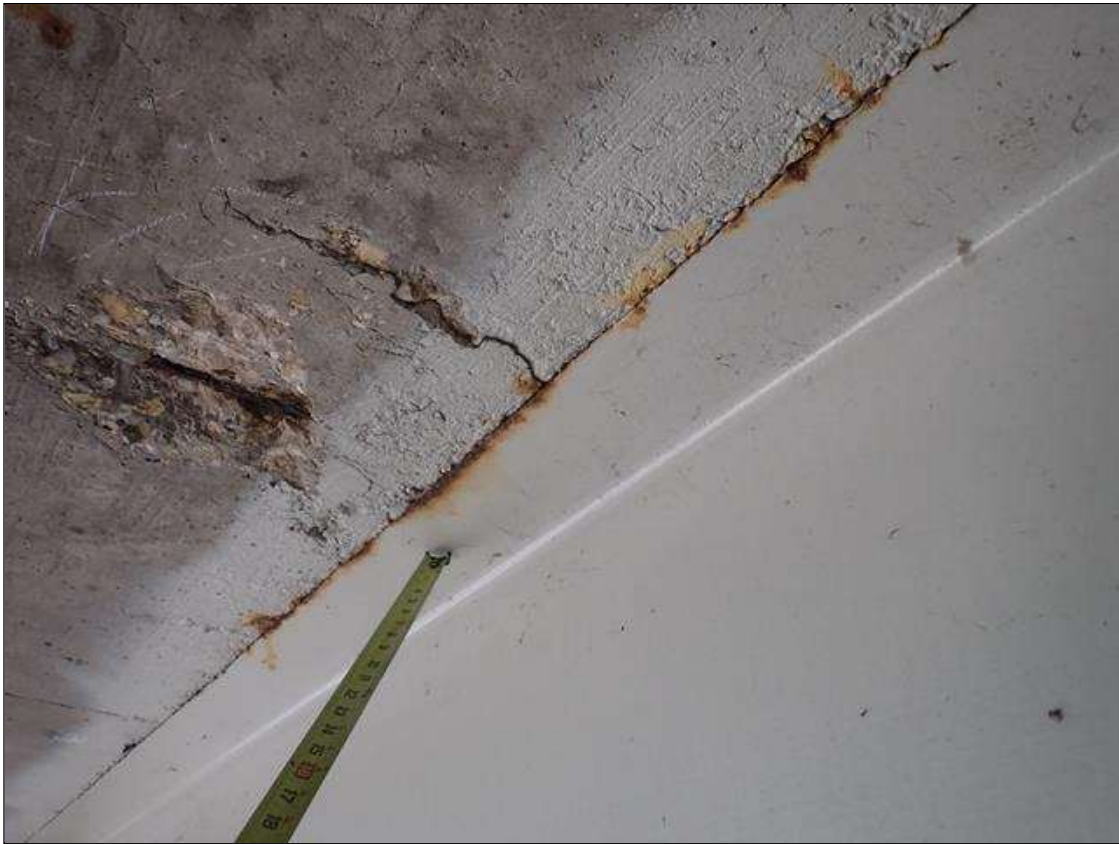
Span 4 Beam 1: near bent 3 and end bent 2, both flanges and web, surface rust at random

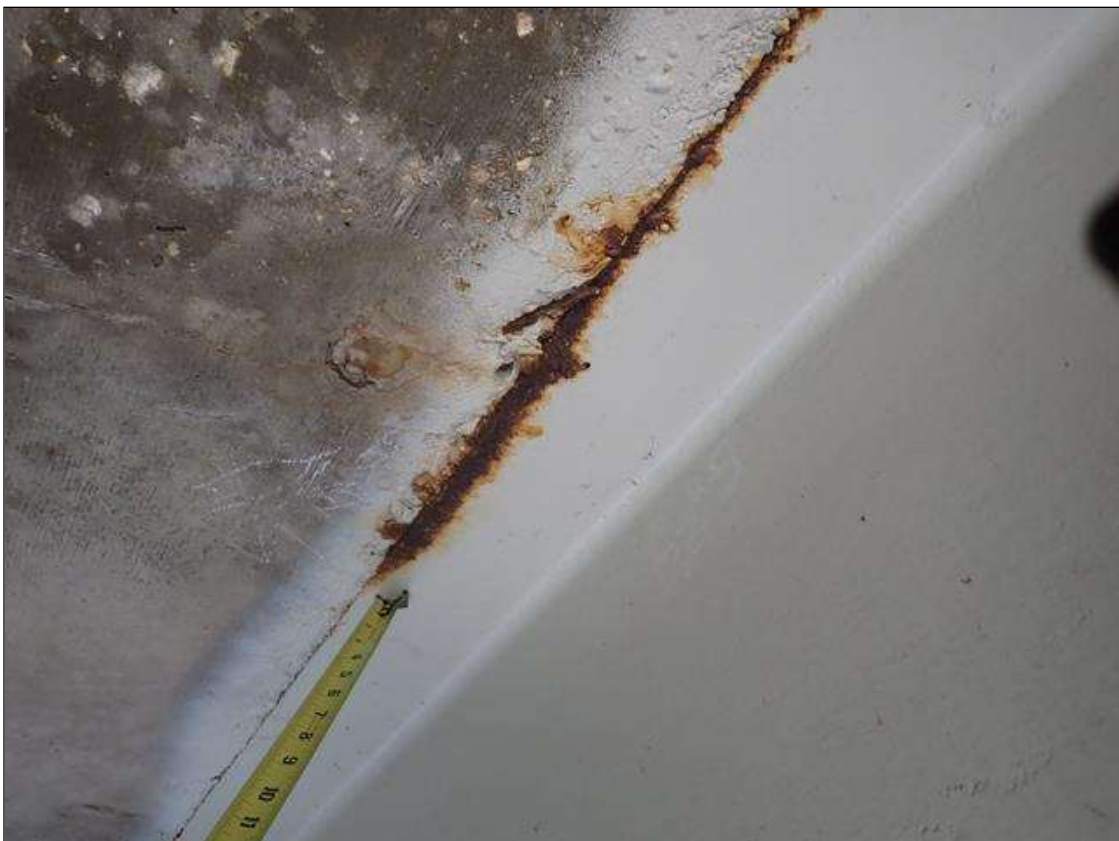
Span 4 Beam 5: surface rust along edge of top flange, on west side, and along east face of web, at random.

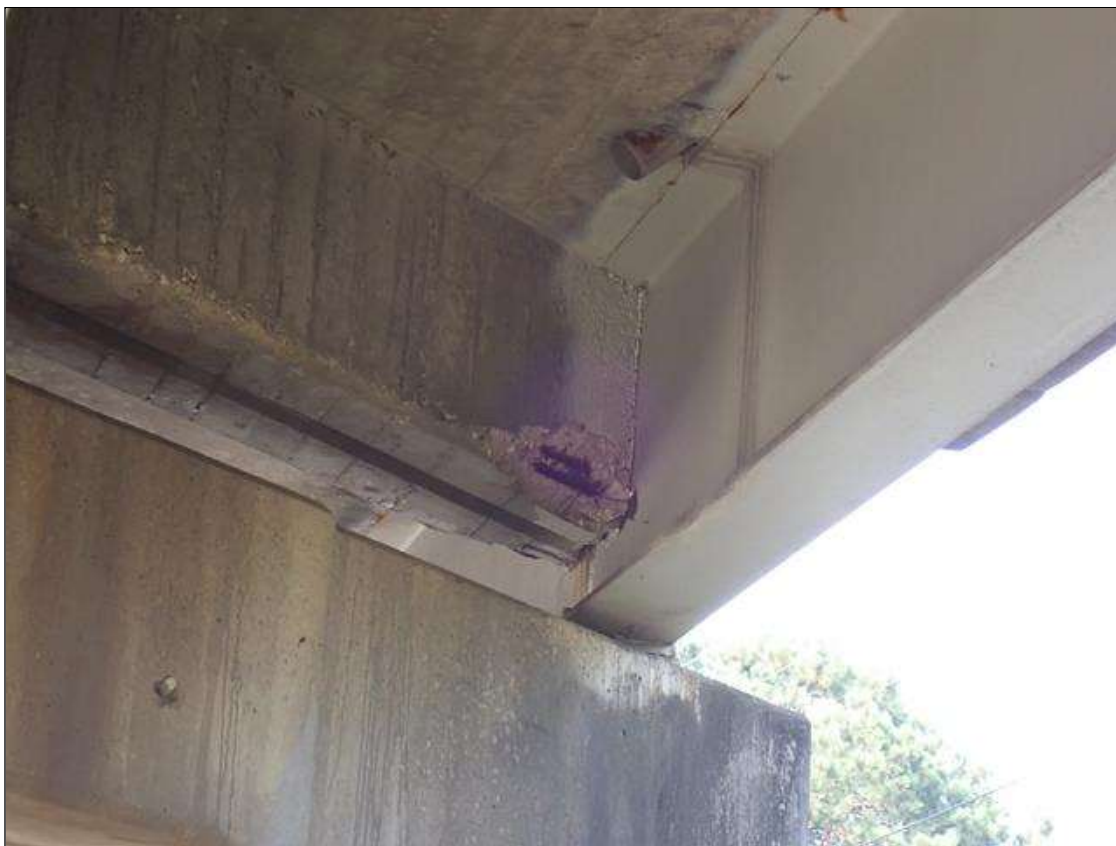
Span 4 Beam 1: at bent 3, bay 1 end diaphragm, spall (2 feet x 10 inch x 2 inch deep) with exposed rusted rebar

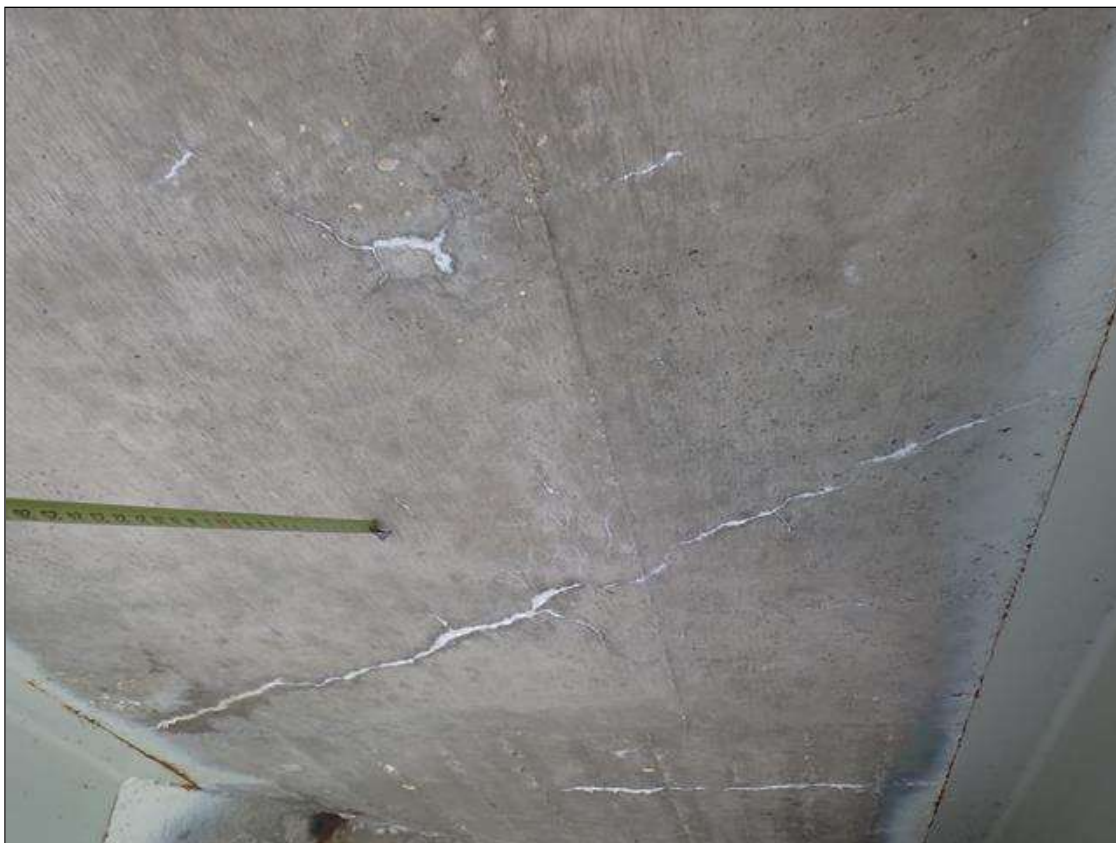
Span 4 Deck: (PAR) underside of all bays, near bent 3 and end bent 2, transverse cracks (up to 1/32 inch x full width) and map cracks (hairline) with efflorescence buildup and some rust stains at random

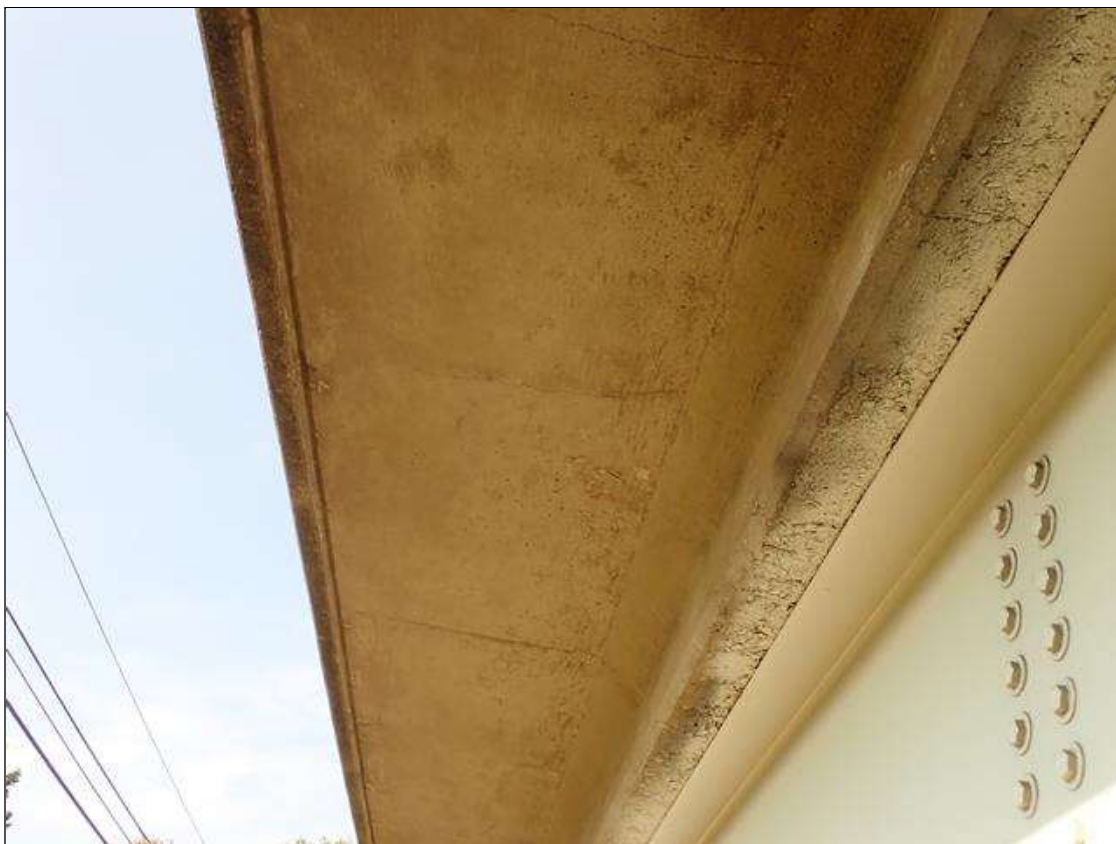
Span 4 Deck: underside of both overhangs, transverse cracks up to 1/32 inch wide x full width, intermittent length of span

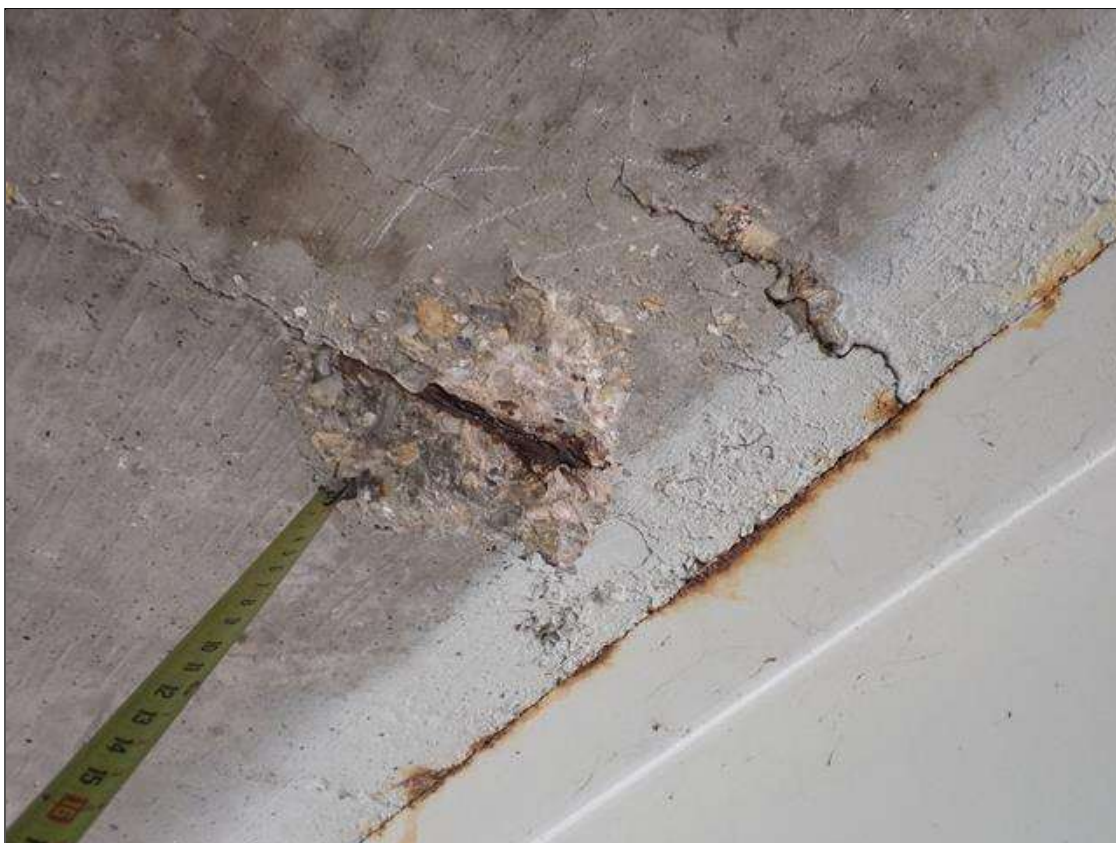
Span 4 Deck: (PAR) bay 1, near end bent 1, spall/delamination (15 inch diameter x 1.5 inch deep) with exposed rusted rebar
