NC DEPARTMENT OF TRANSPORTATION
 DIVISION OF HIGHWAYS
 STRUCTURE MANAGEMENT UNIT

ATTENTION: prompt action request, sketches revised, clearances revised, resurfaced with no change in asphalt wearing surface thickness

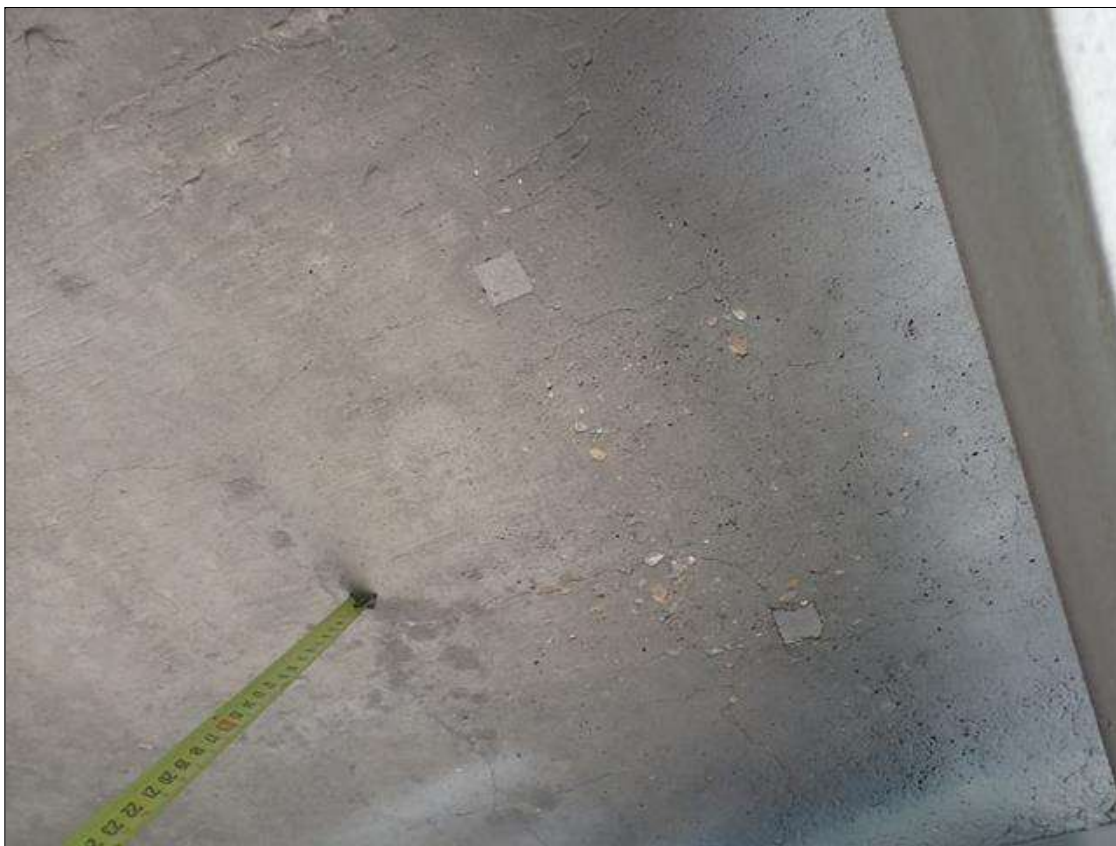
Span 4 Deck: throughout underside of deck, map cracks (hairline) at random

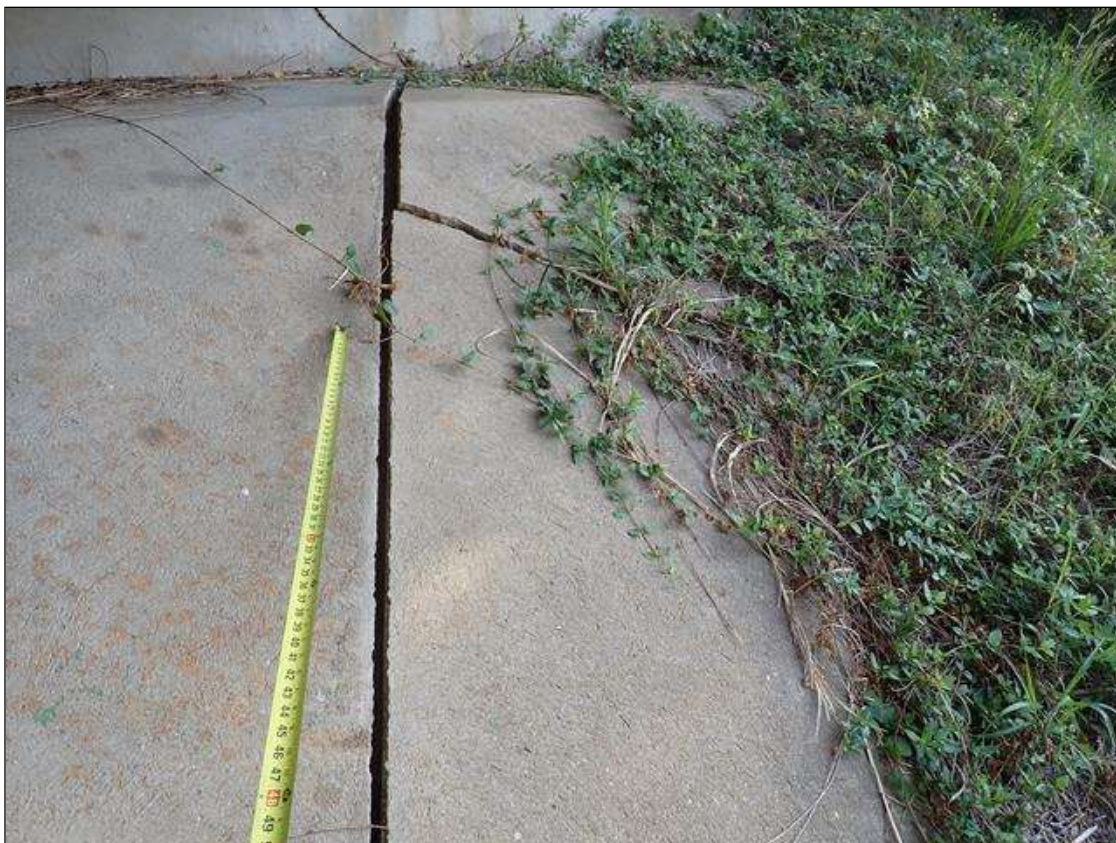
end bent 2 slope protection, at east end, section settled/shifted to the east (up to 1.5 inch) with adjacent transverse crack (up to 1 inch wide x 6 feet)

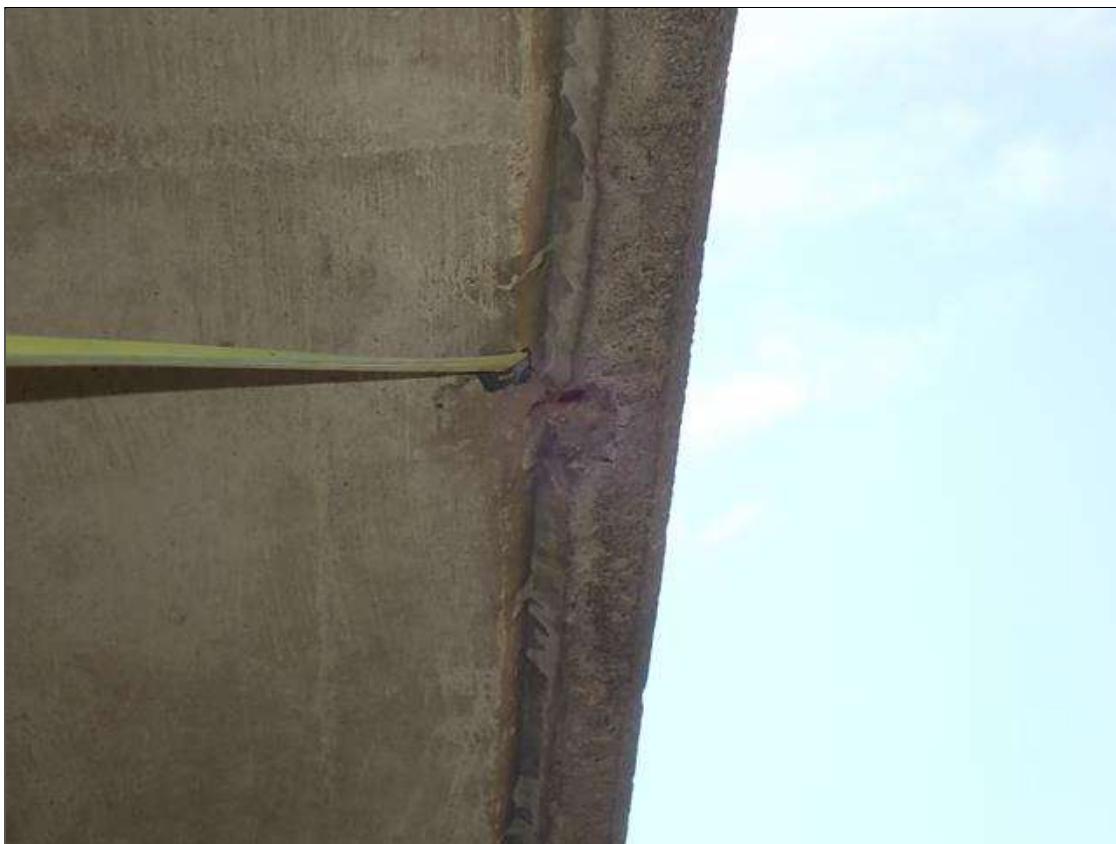
Span 4 Deck: (PAR) 3 - spalls with exposed reinforcing up to 1 inch diameter x 1/2 inch deep, underside of left overhang, intermittent length of span.

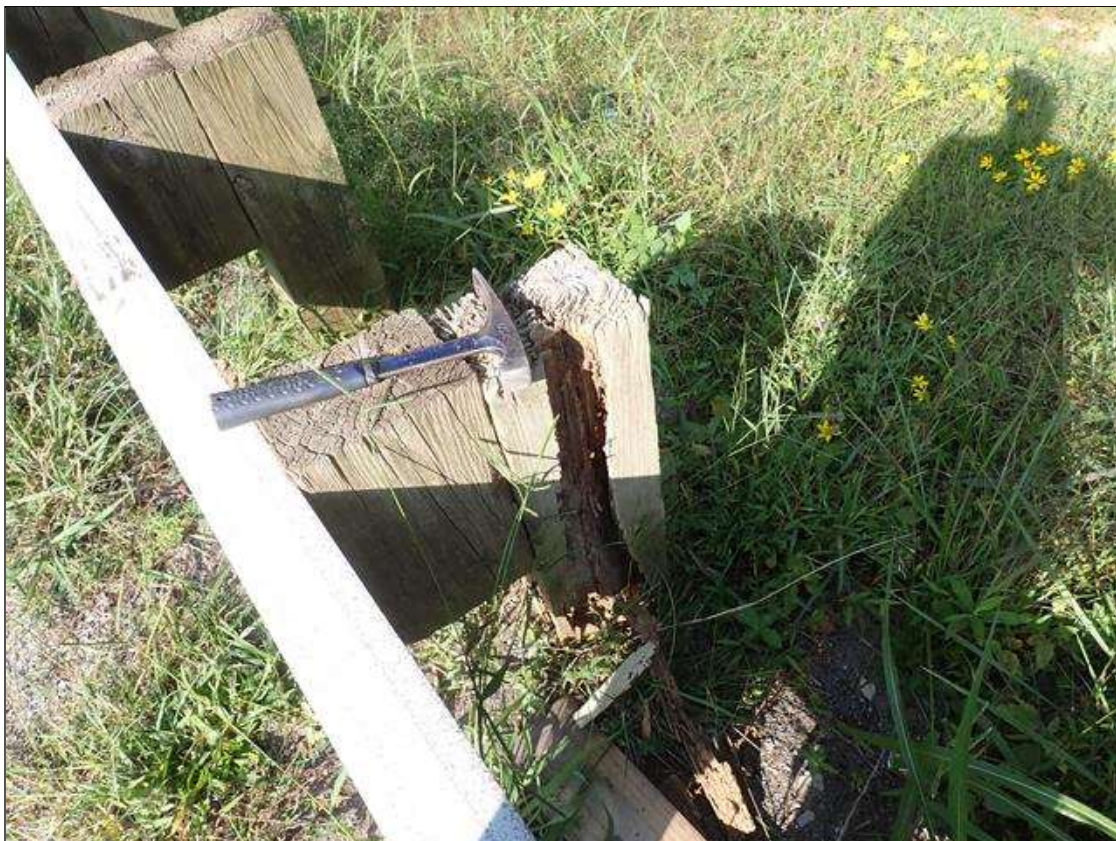
(PAR) southwest guardrail transition, (1) decayed post

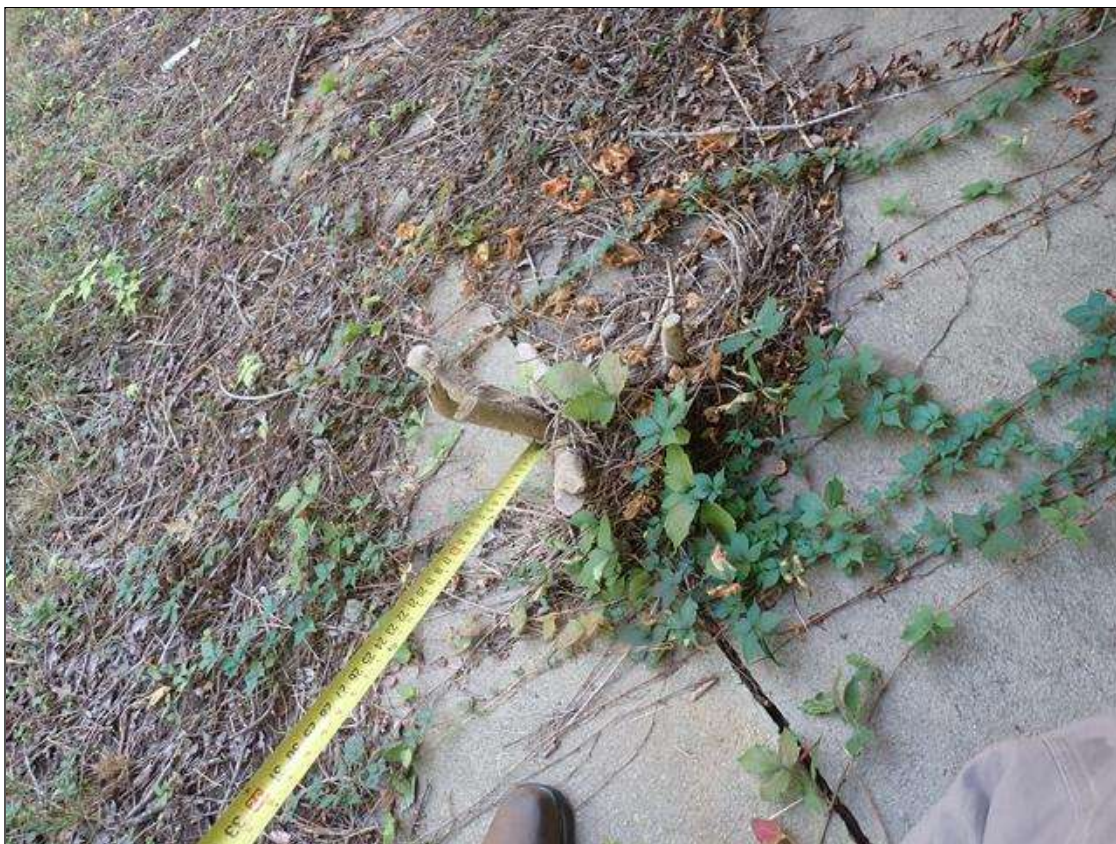
end bent 1 slope protection, west end, tree growing between sections; section settled/shifted to the west (up to 1 inch)

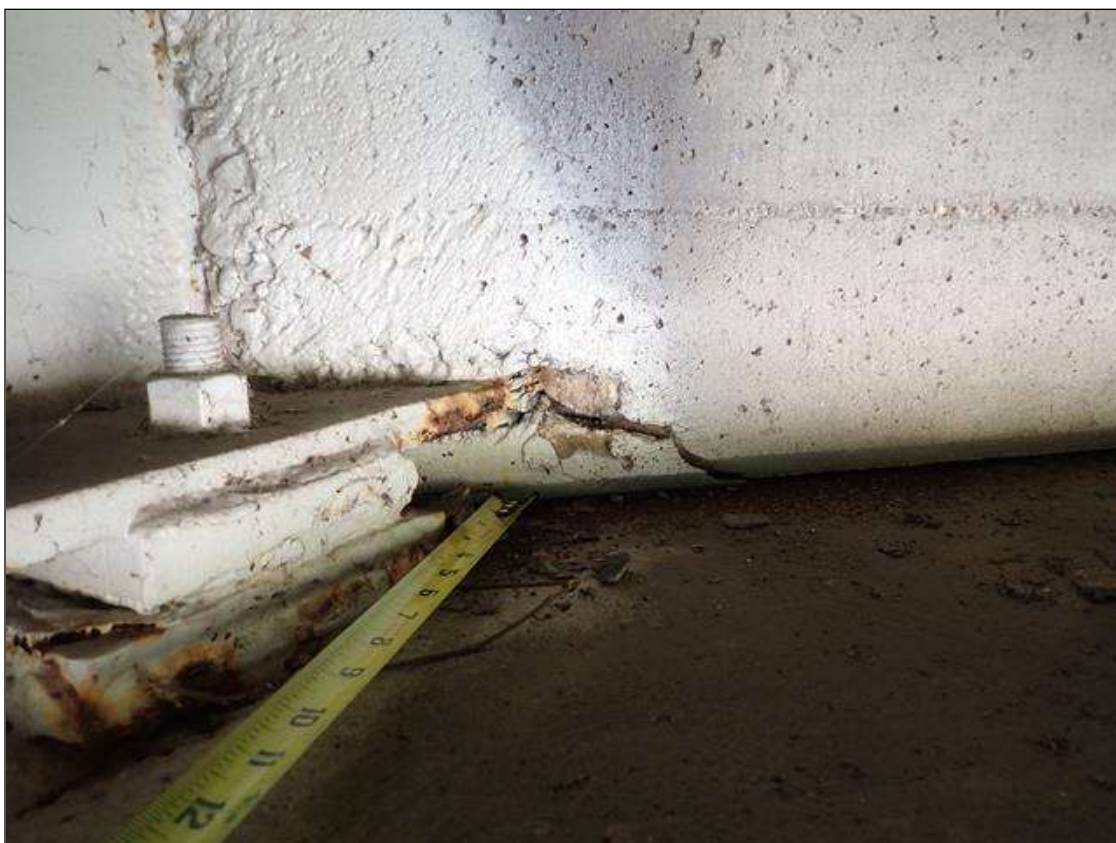
End Bent 1 Abutment: 6 inch x 2 inch delamination with crack up to 1/4 inch wide, left side of beam 3 (similar at all beams).

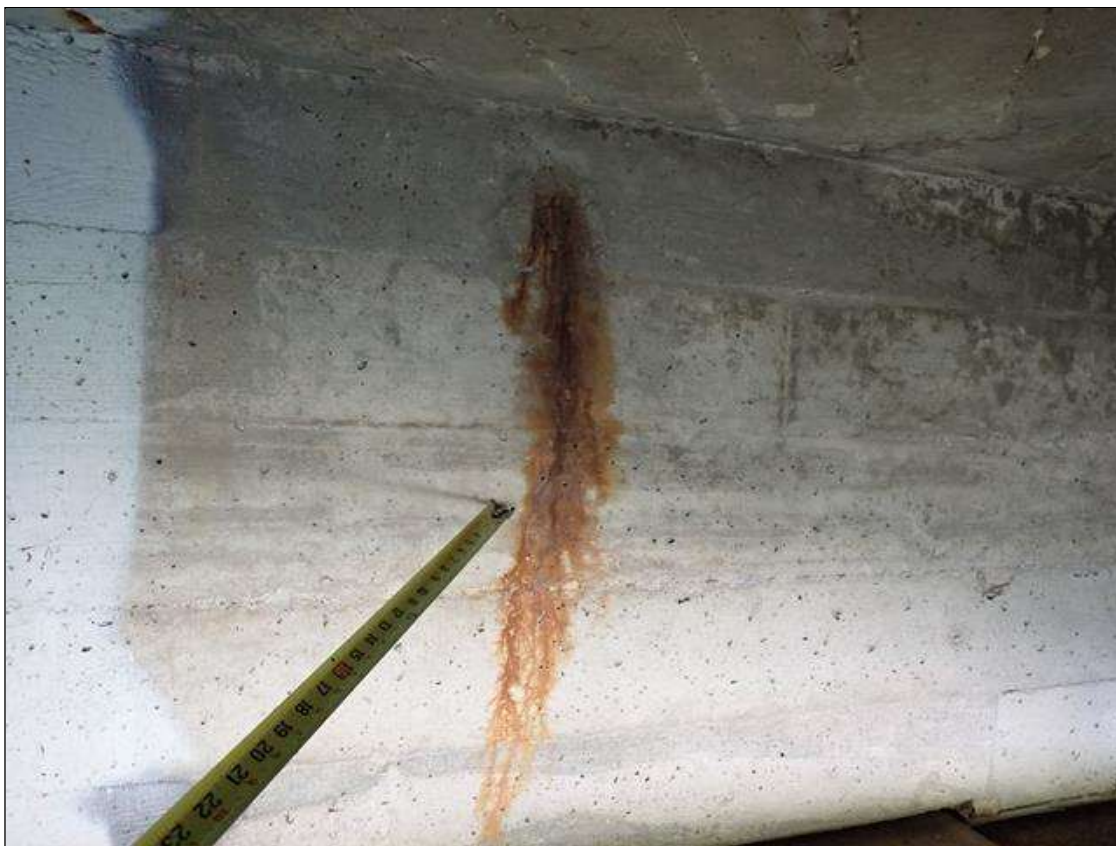
End Bent 1 Abutment: (PAR) area of rust staining in bay 1.

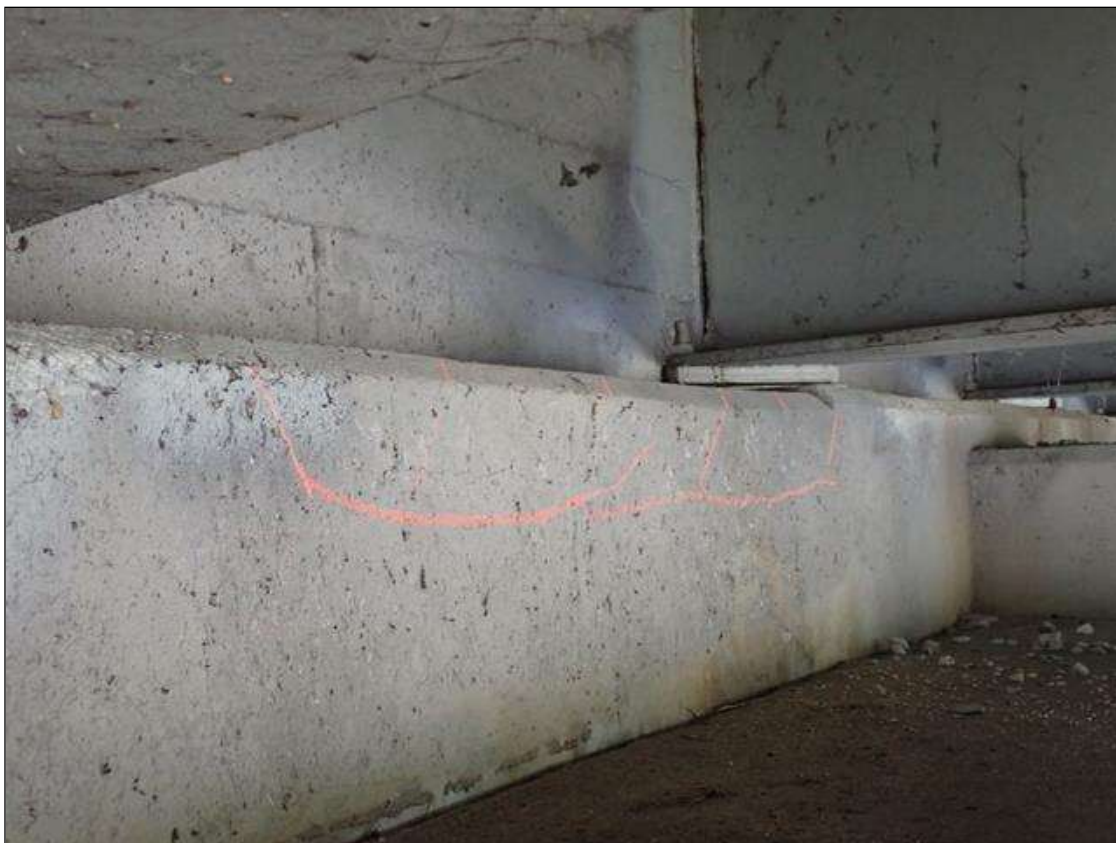
End Bent 1 Cap 1: under bays 3 and 4 on both faces, delaminations [up to 5.5 feet x up to 16 inch] with cracks [up to 1/16 inch]

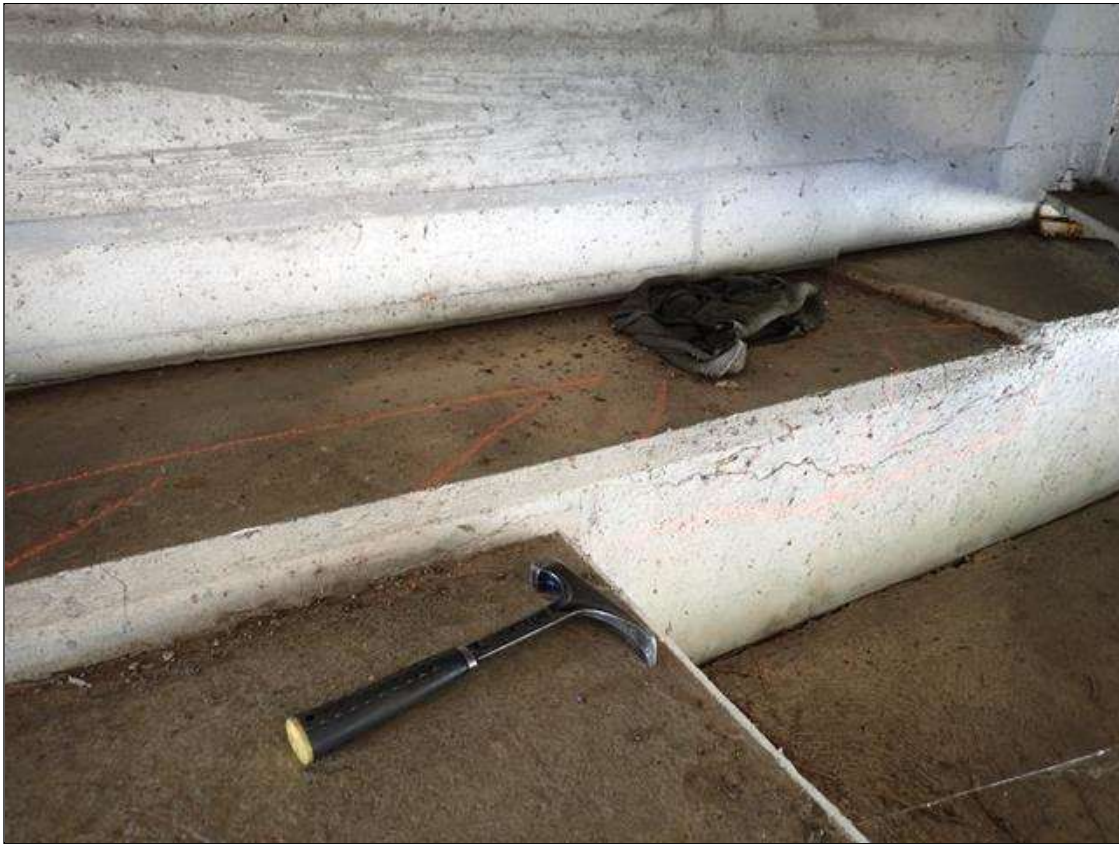
End Bent 1 Cap 1: under bays 3 and 4 on both faces, delaminations [up to 5.5 feet x up to 16 inch] with cracks [up to 1/16 inch]

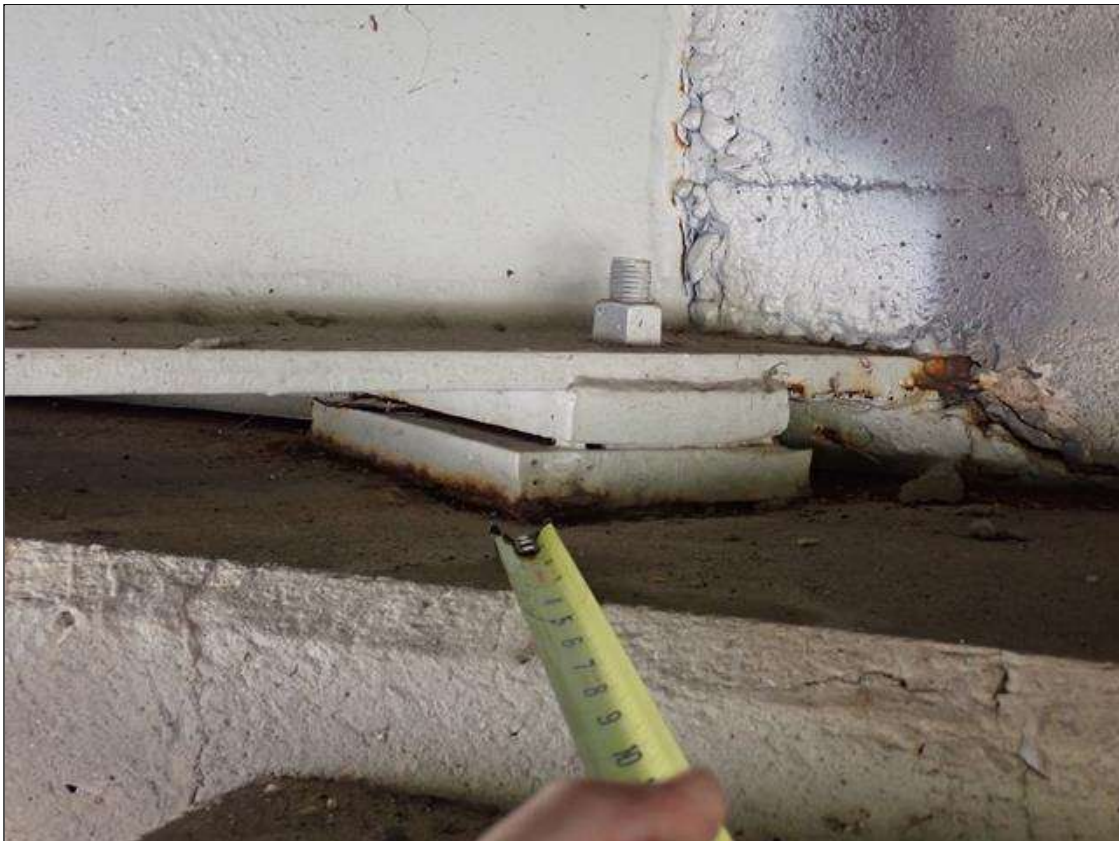
Span 1 Beam 3 - Near Bearing 3: surface rust

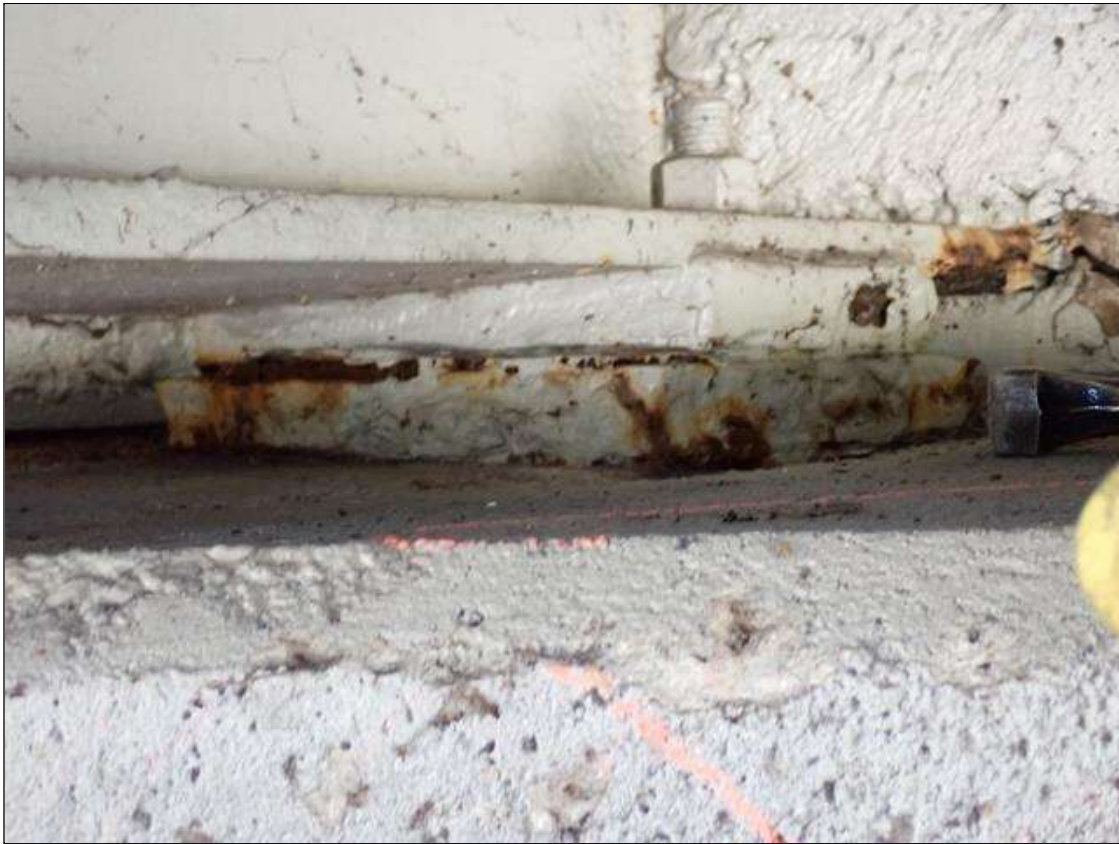
Span 1 Beam 4 - Near Bearing 4: surface rust/rust scale

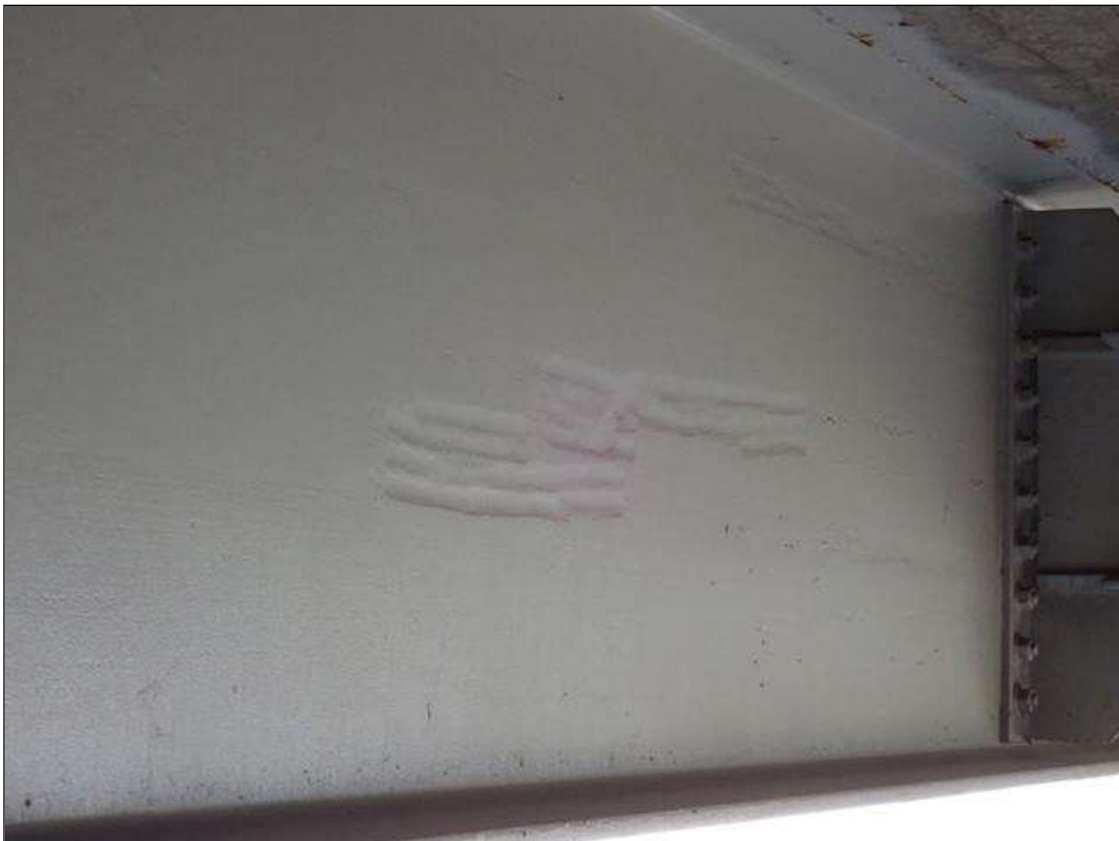
Span 1 Beam 1: inside face of web, previous grinding (up to 1/16 inch deep); areas painted

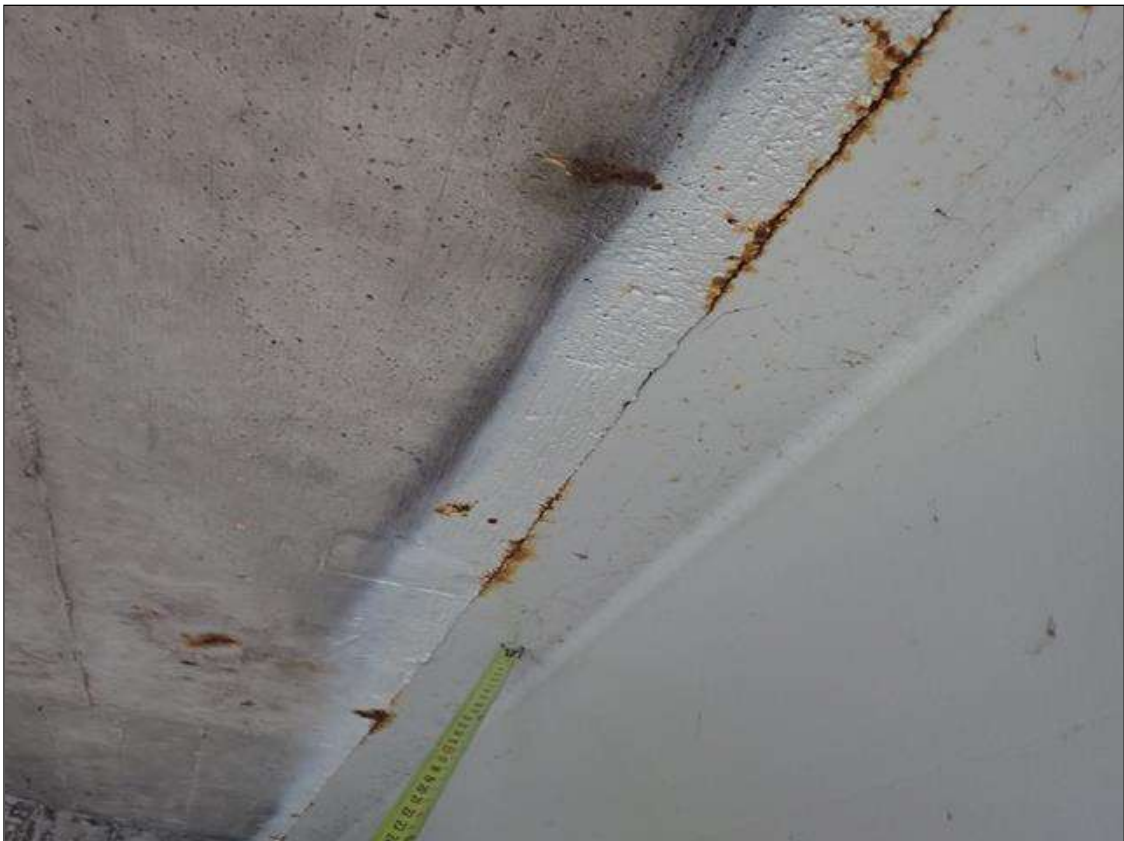
Span 1 Beam 3: near end bent 1 and bent 1, both flanges and web, surface rust at random

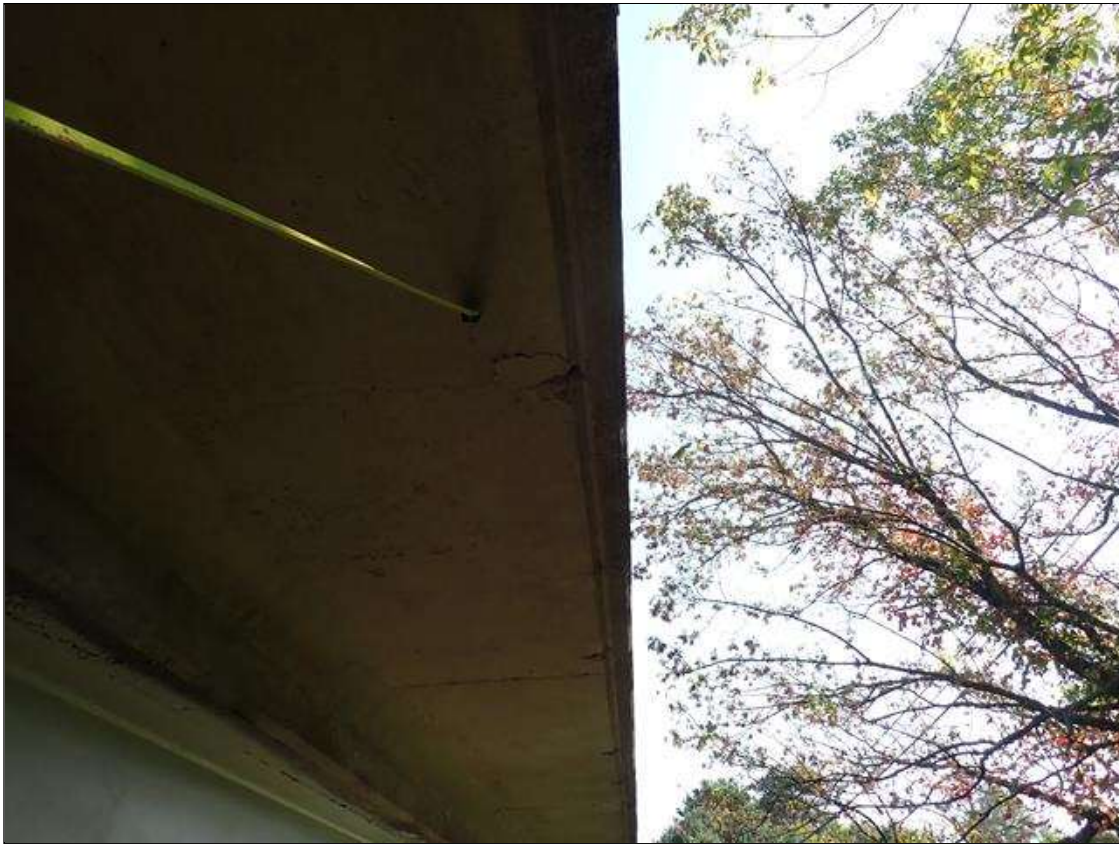
Span 1 Deck: (PAR) both overhangs, delaminations/spalls (up to 4 inch diameter x 1/2 inch deep) with exposed rusted rebar at random

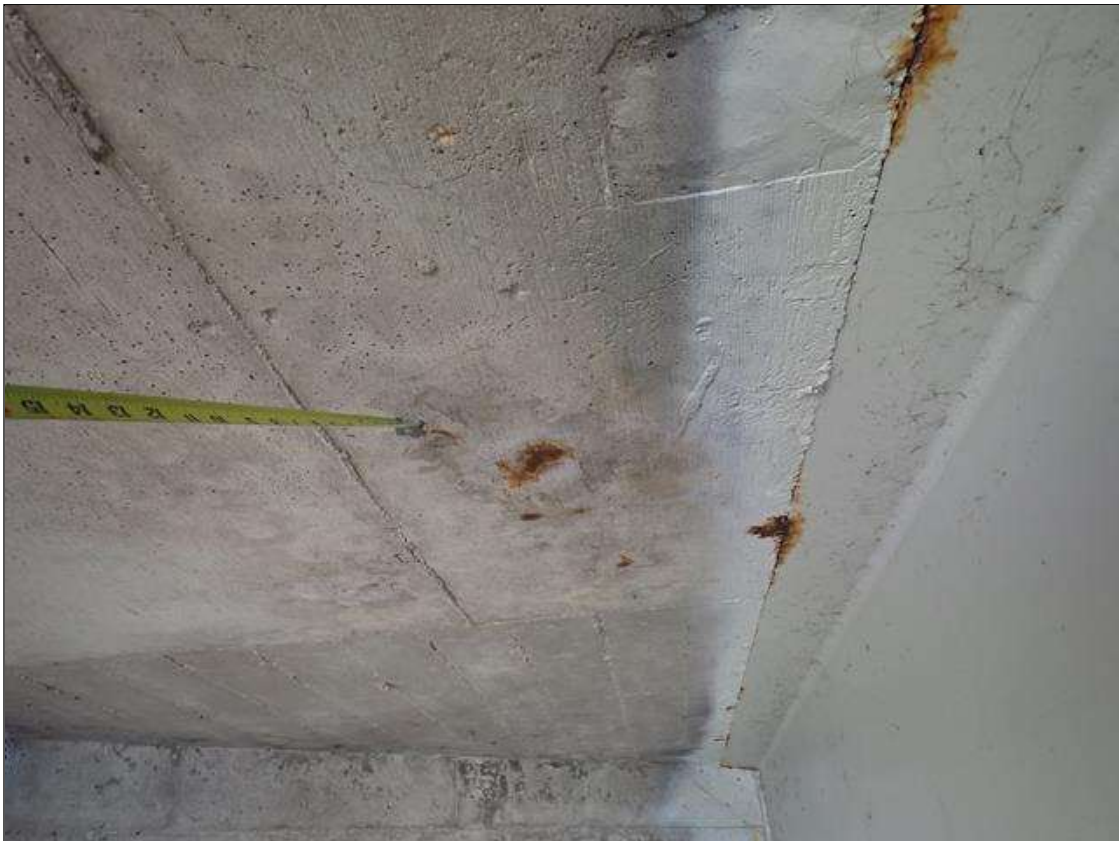
Span 1 Deck: (PAR) underside of all bays, transverse and map cracks (up to 1/32 inch) with efflorescence buildup and some rust stains at random

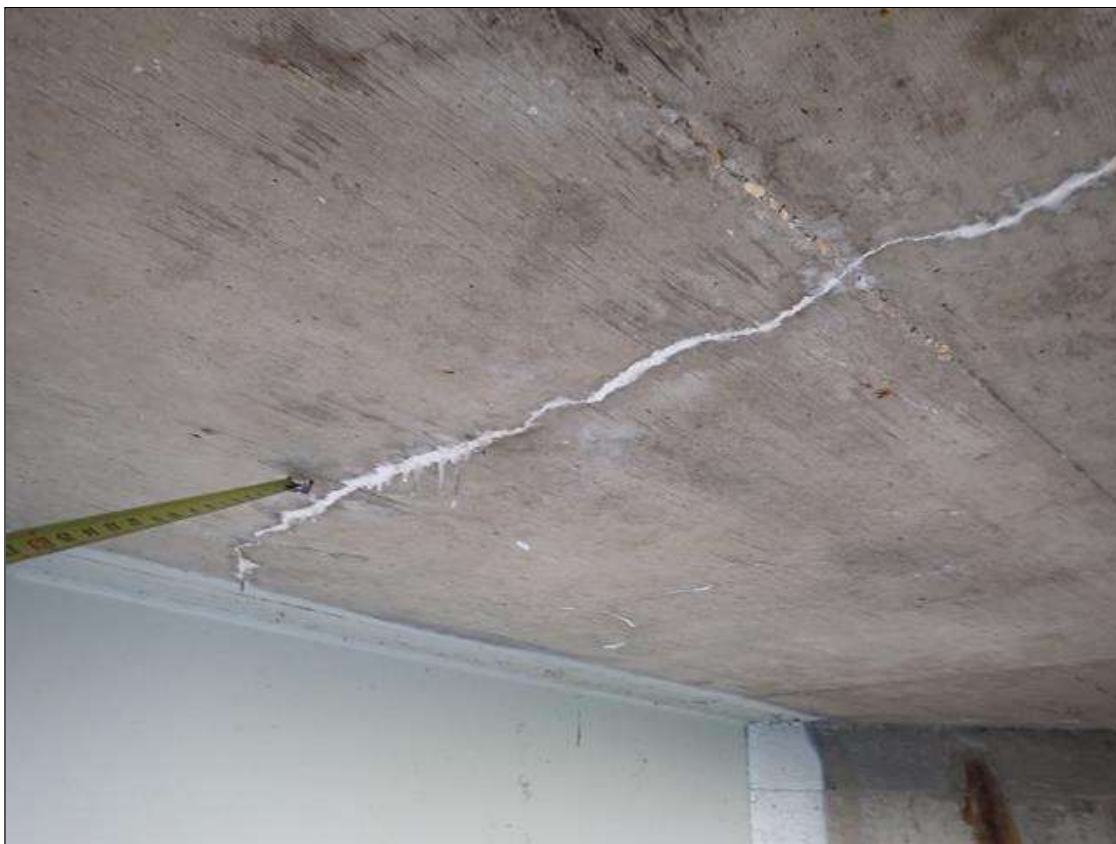
Span 1 Deck: (PAR) underside of all bays, transverse and map cracks (up to 1/32 inch) with efflorescence buildup and some rust stains at random

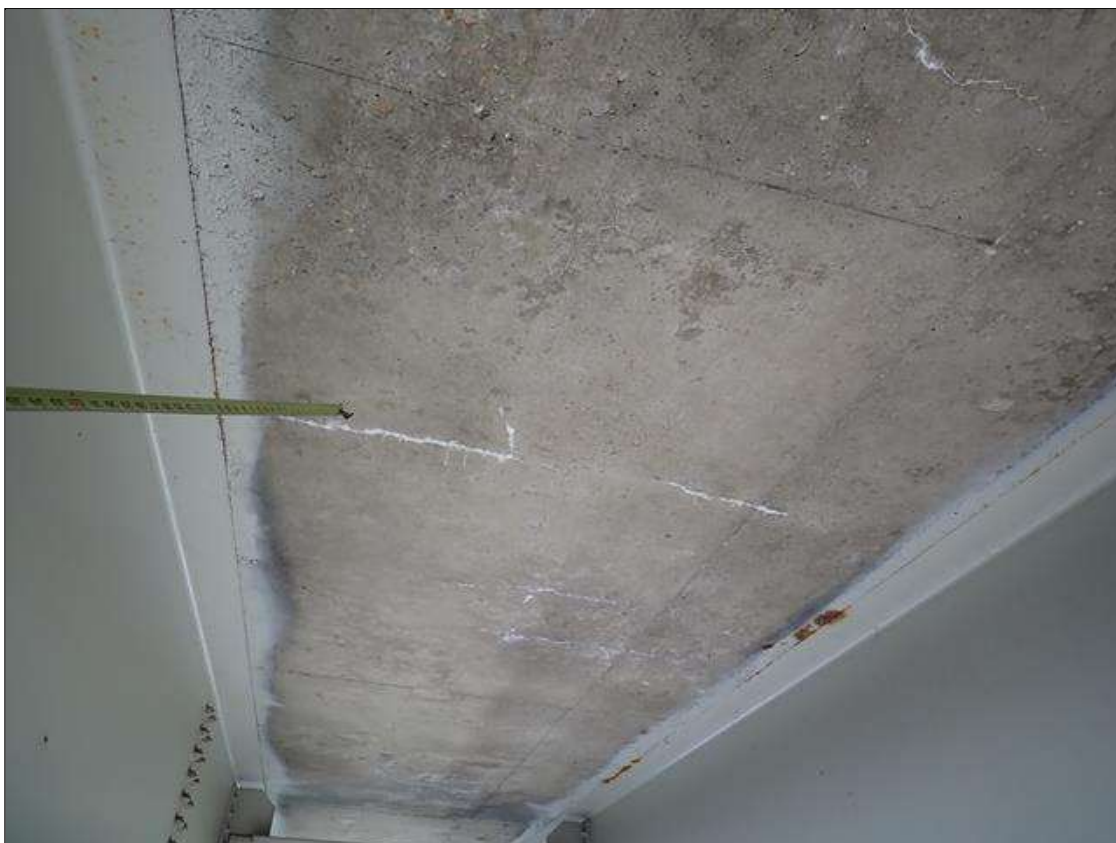
Span 1 Deck: (PAR) underside of all bays, transverse and map cracks (up to 1/32 inch) with efflorescence buildup and some rust stains at random

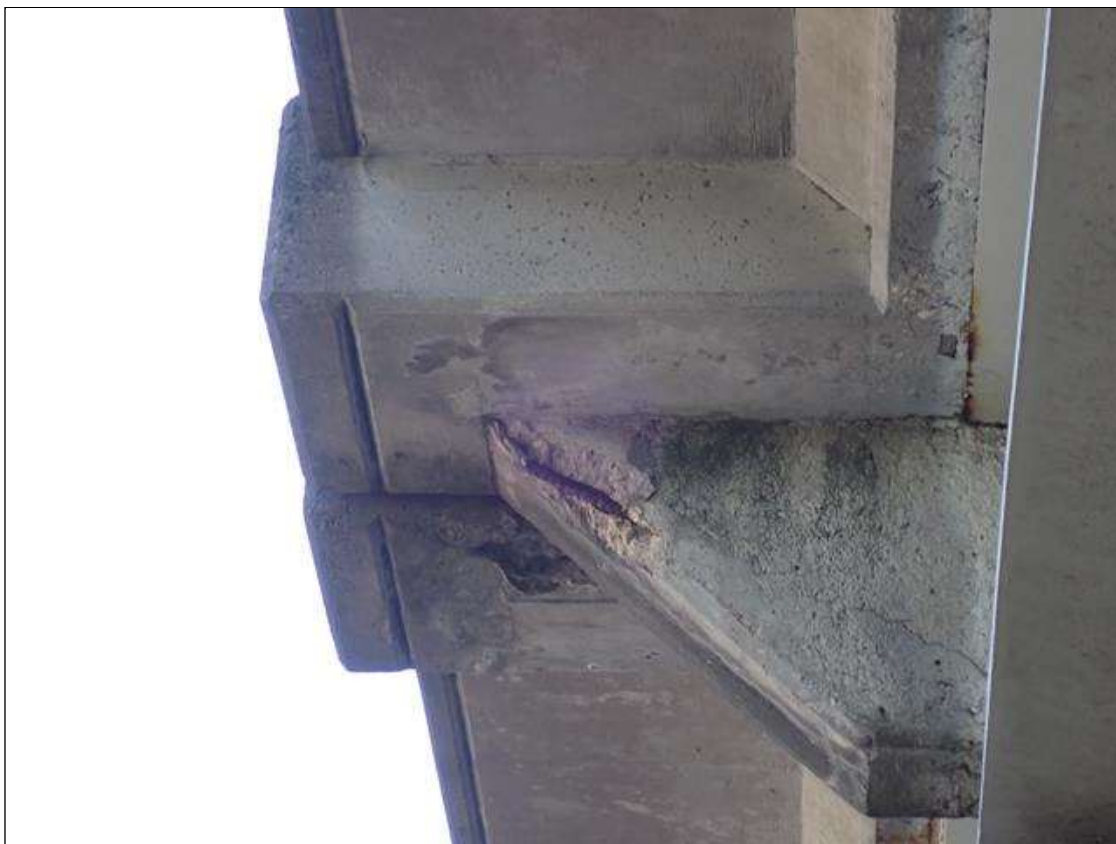
Span 1 Beam 1: 15 inch x 6 inch x 2 inch deep spall with exposed reinforcing in end diaphragm overhang, west side, at bent 1.

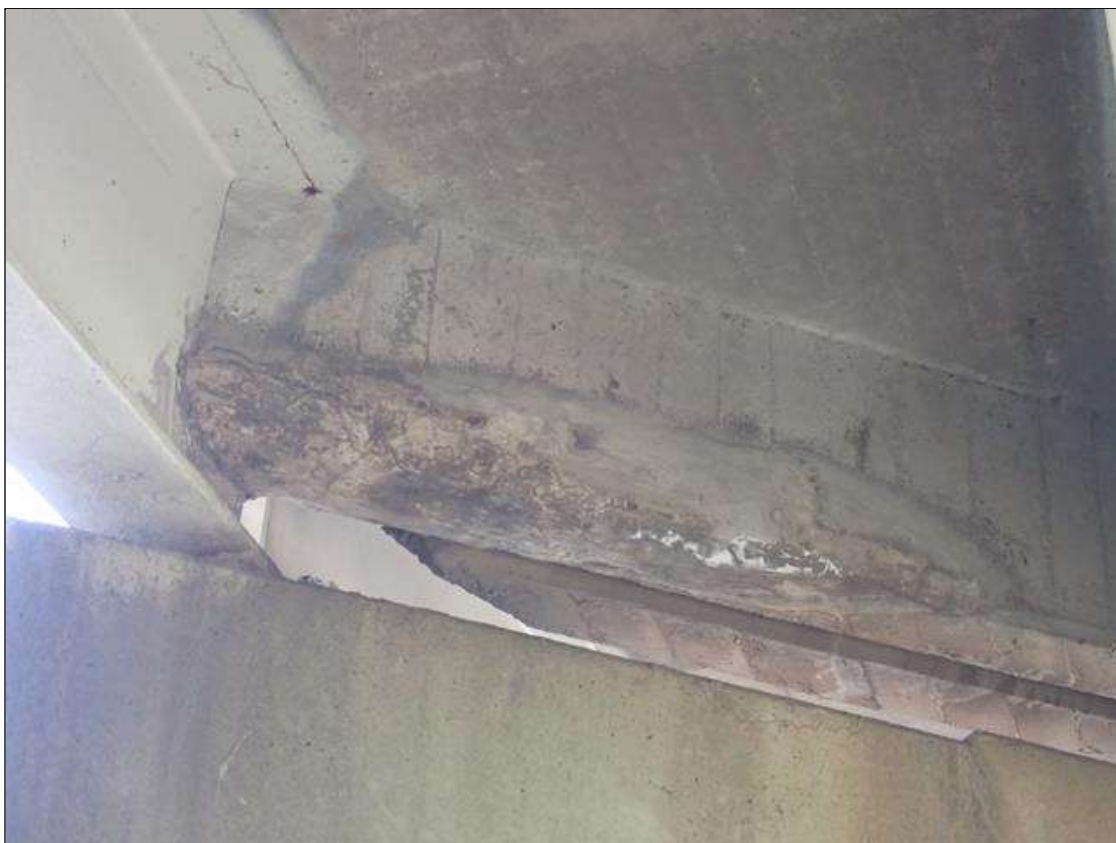
Span 1 Beam 1: bent 1 end diaphragm at bent 1, patched area (4.5 foot x 1 foot) with hairline cracks with efflorescence; adjacent to beam 2, delamination (1 foot x 6 inch)

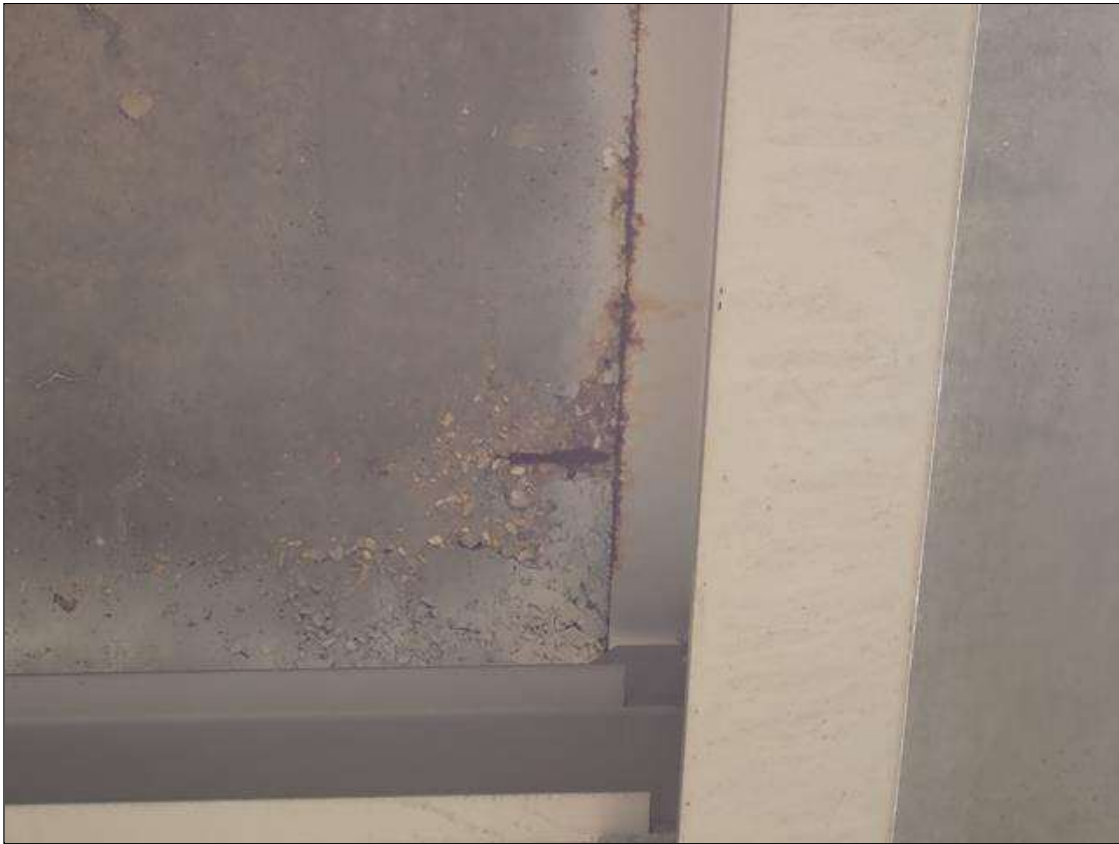
Span 4 Deck: (PAR) bay 4, near midspan, spall (10 inch diameter x 1.5 inch deep) with exposed rusted rebar

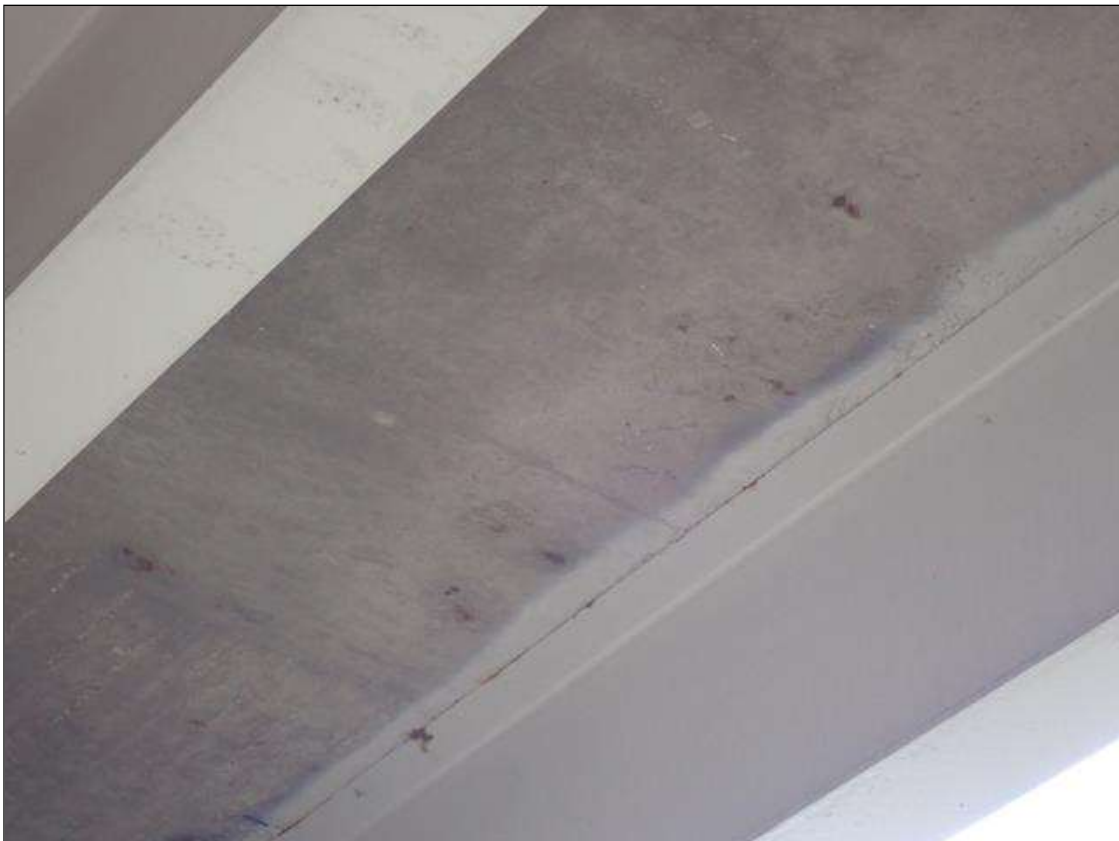
Span 4 Deck: (PAR) underside of all bays, near bent 3 and end bent 2, transverse cracks (up to 1/32 inch x full width) and map cracks (hairline) with efflorescence buildup and some rust stains at random

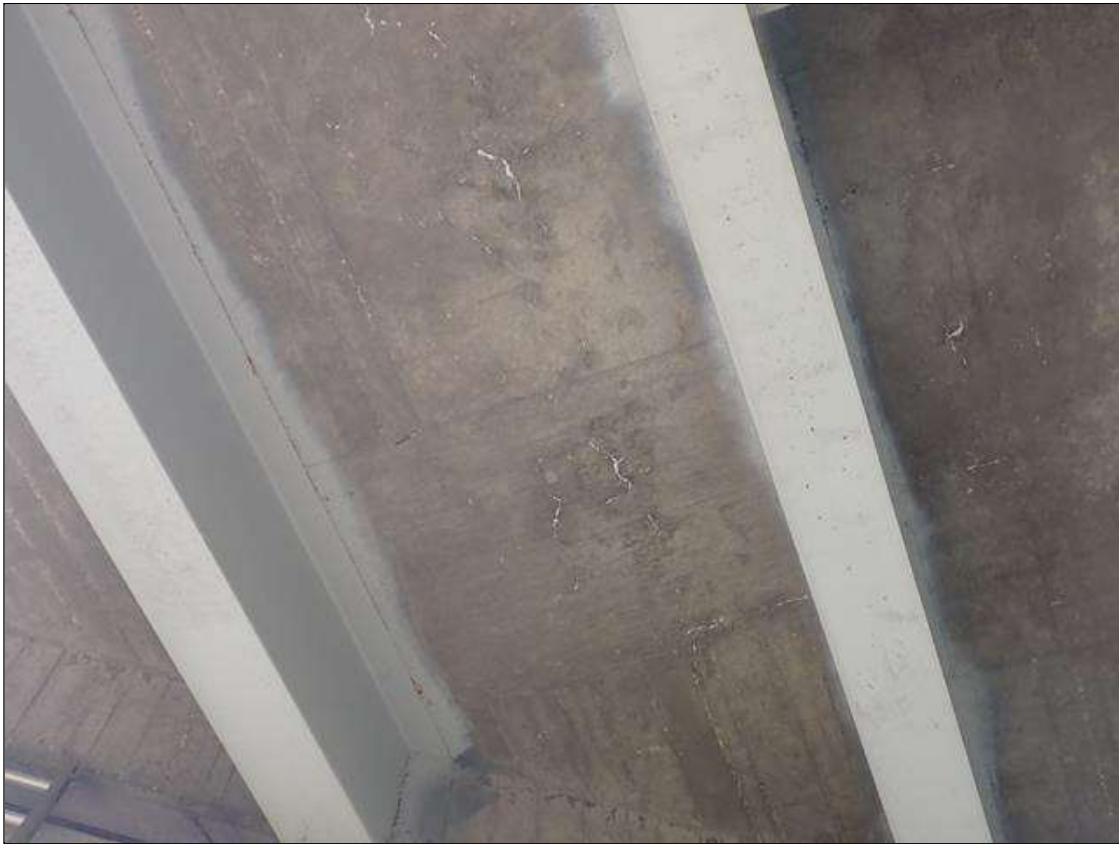
Span 4 Deck: (PAR) underside of all bays, near bent 3 and end bent 2, transverse cracks (up to 1/32 inch x full width) and map cracks (hairline) with efflorescence buildup and some rust stains at random

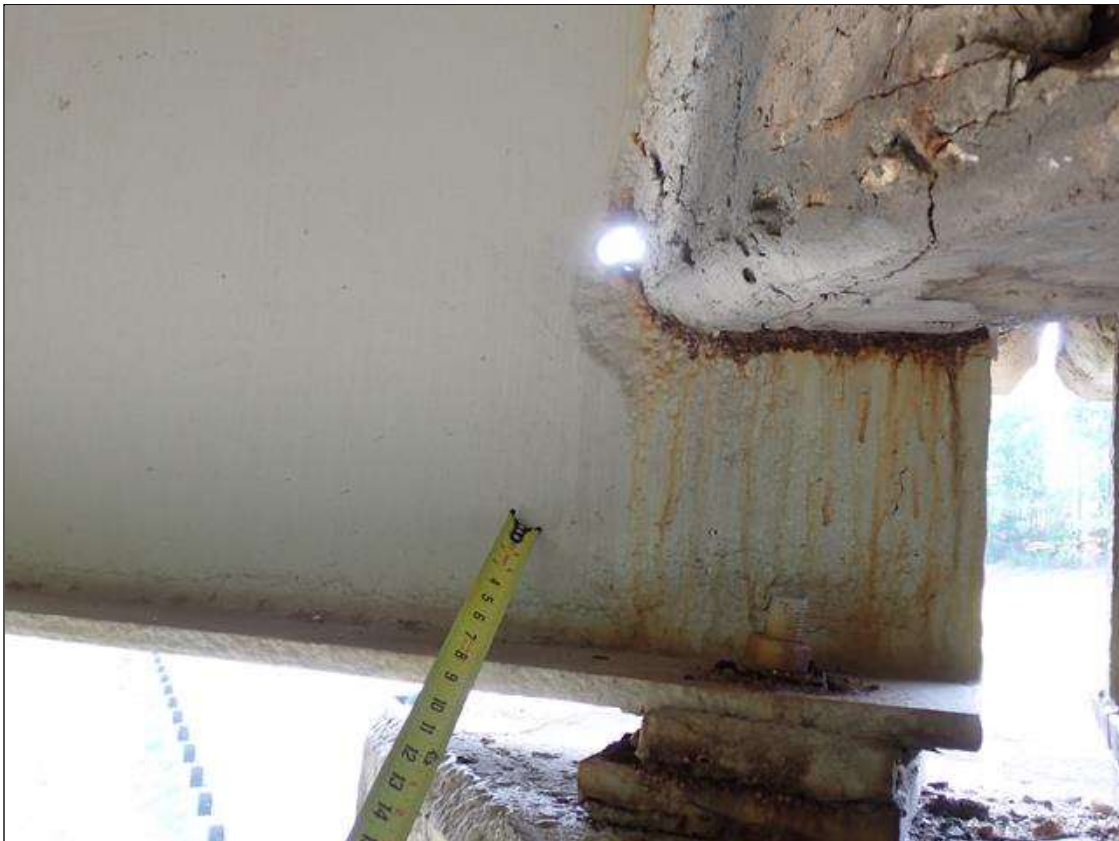
Span 4 Beam 5: (PAR) at bent 3, painted over section loss: web adjacent to diaphragm (1/4 inch average remaining x 10 inch x 4 inch); lower web (3/8 inch average remaining x 2.5 feet x 4 inches with corrosion reinitiated)
