NC DEPARTMENT OF TRANSPORTATION
 DIVISION OF HIGHWAYS
 STRUCTURE MANAGEMENT UNIT

ATTENTION: prompt action request, sketches revised, clearances revised, resurfaced with no change in asphalt wearing surface thickness

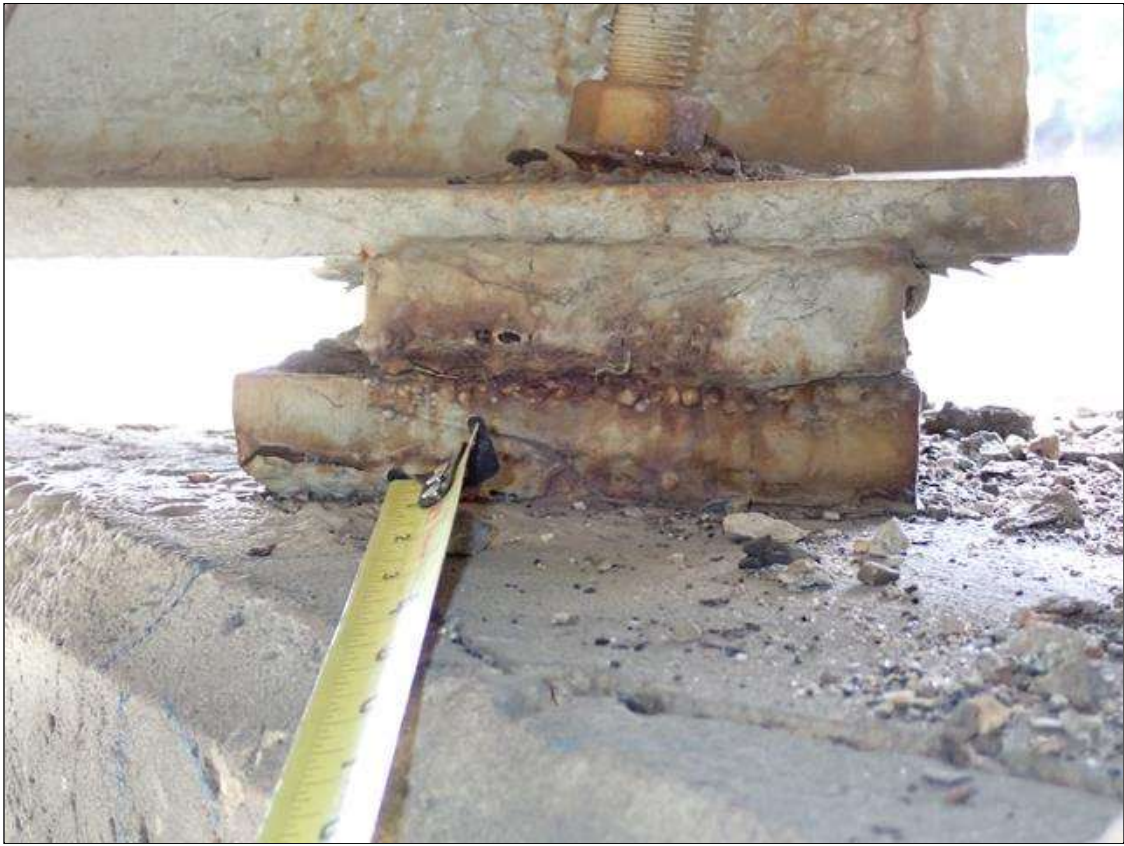
Span 4 Beam 5 - Near Bearing 5: surface rust/pack rust.

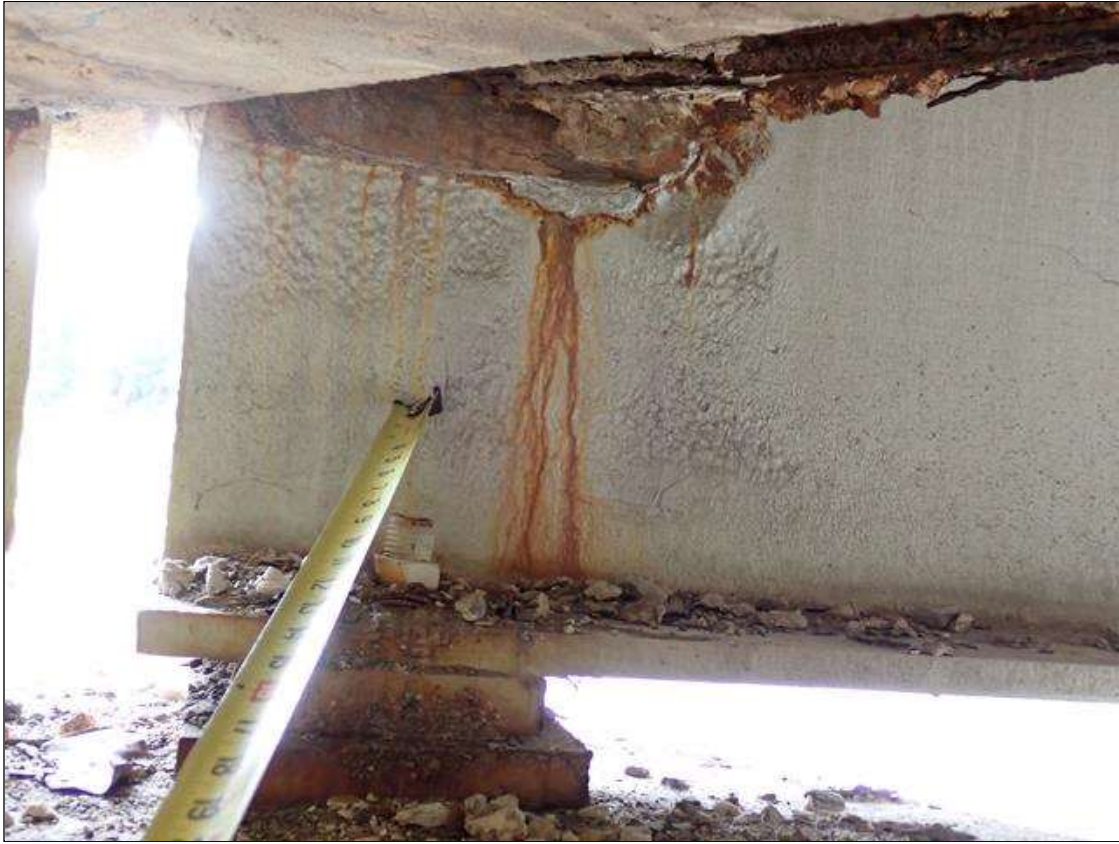
Span 3 Beam 5: (PAR) at bent 3, web adjacent to diaphragm, painted over section loss (5/16 inch average remaining x 4 inch x 6 inch); web over bearing, painted over pitting (up to 1/8 inch deep x 18 inch x 10 inch) with corrosion reinitiated

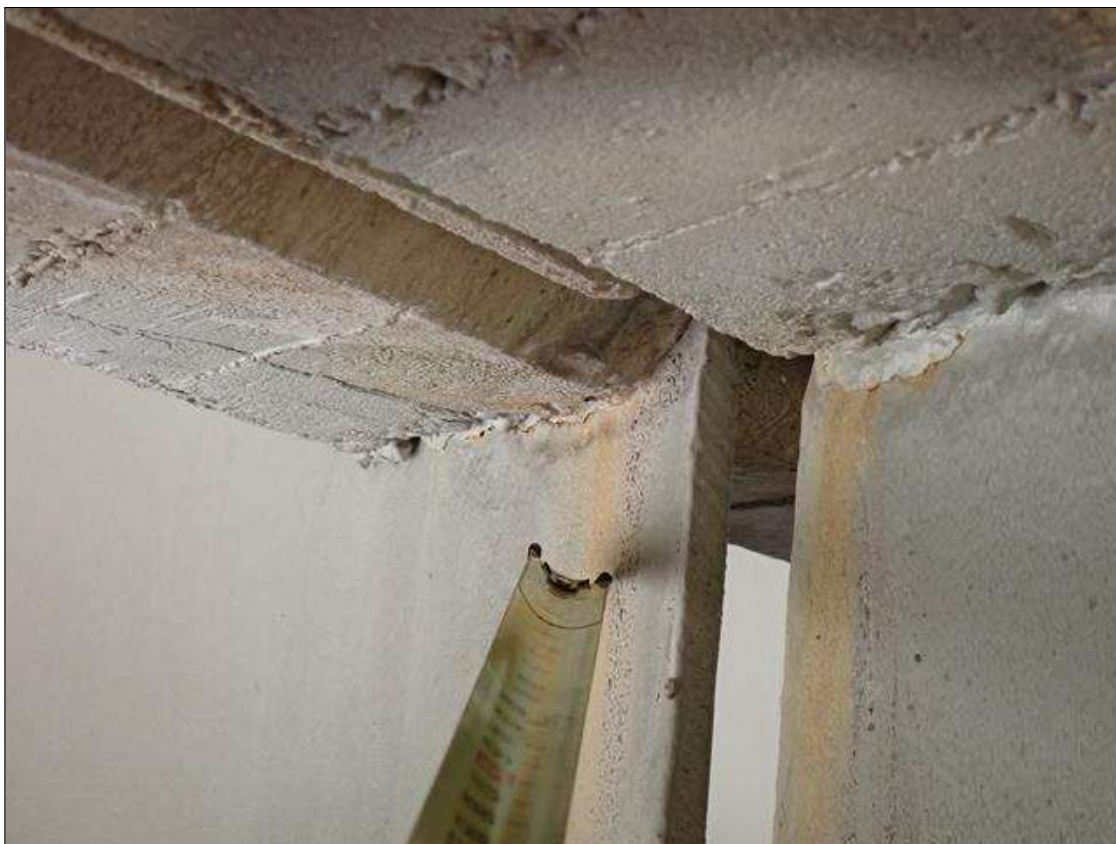
Span 3 Beam 4: (PAR) at bent 3, web adjacent to diaphragm, painted over section loss (5/16 inch average remaining x 5 inch x 1 inch)

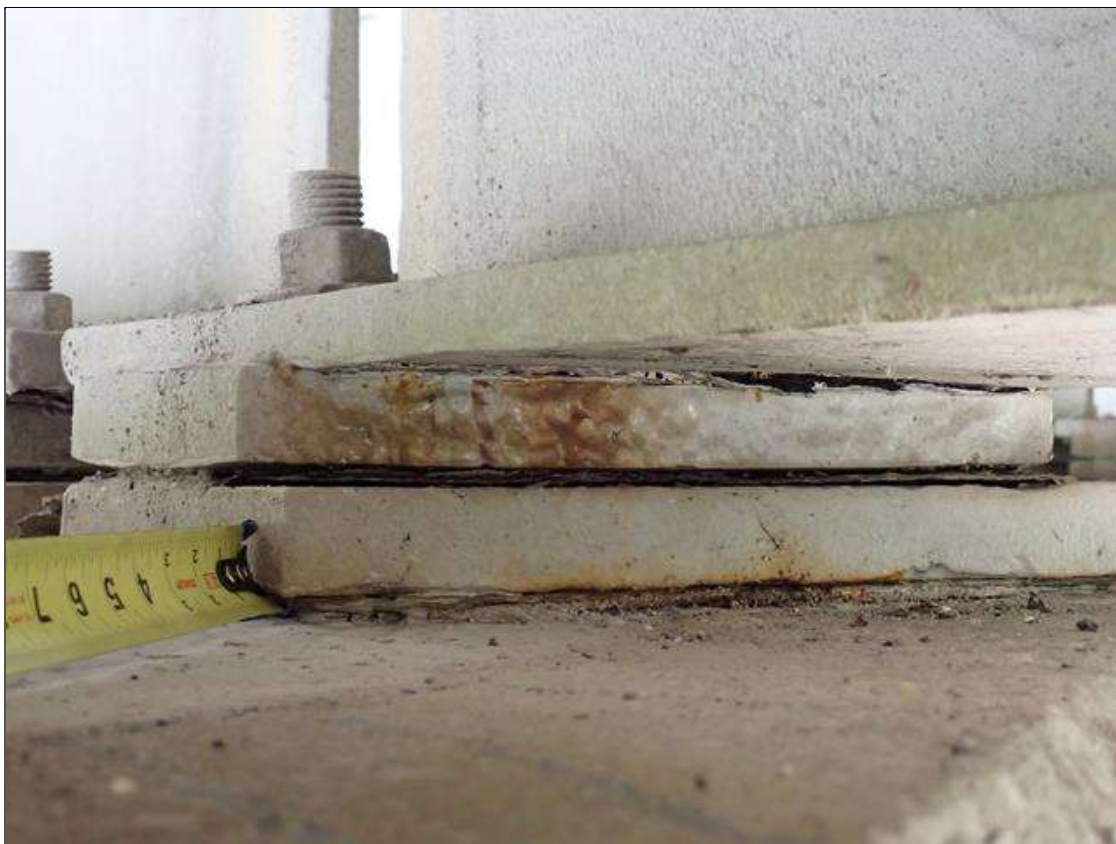
Span 4 Beam 4 - Near Bearing 4: painted over section loss (up to 1/8 inch deep) and pack rust

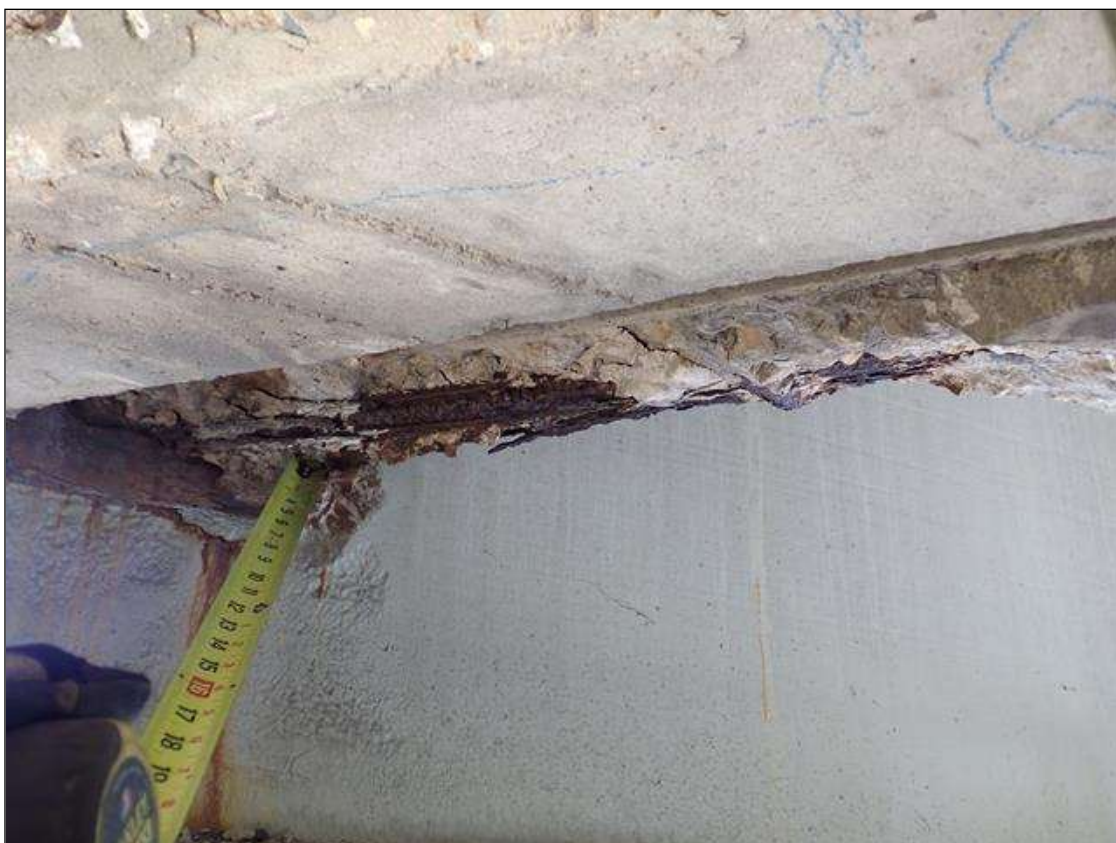
Span 3 Beam 5: 2 - up to 33 inch x 10 inch x 4 inch deep spalls with exposed reinforcing on end diaphragm at both sides of beam, at bents 2 and 3.

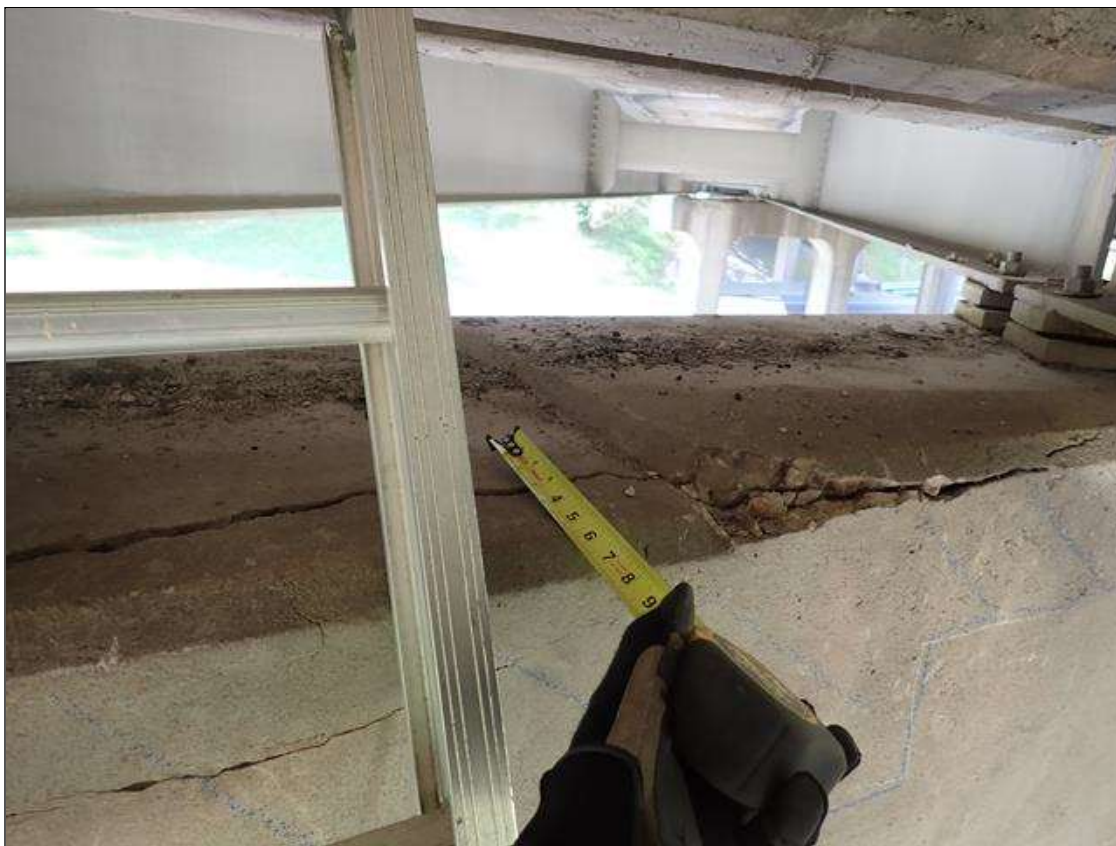
Bent 3 Cap 1: south and north faces, below bays 2-4, delaminations/spalls (up to 10 feet x 2 feet x 1 inch deep) with associated cracks (up to 1/4 inch)

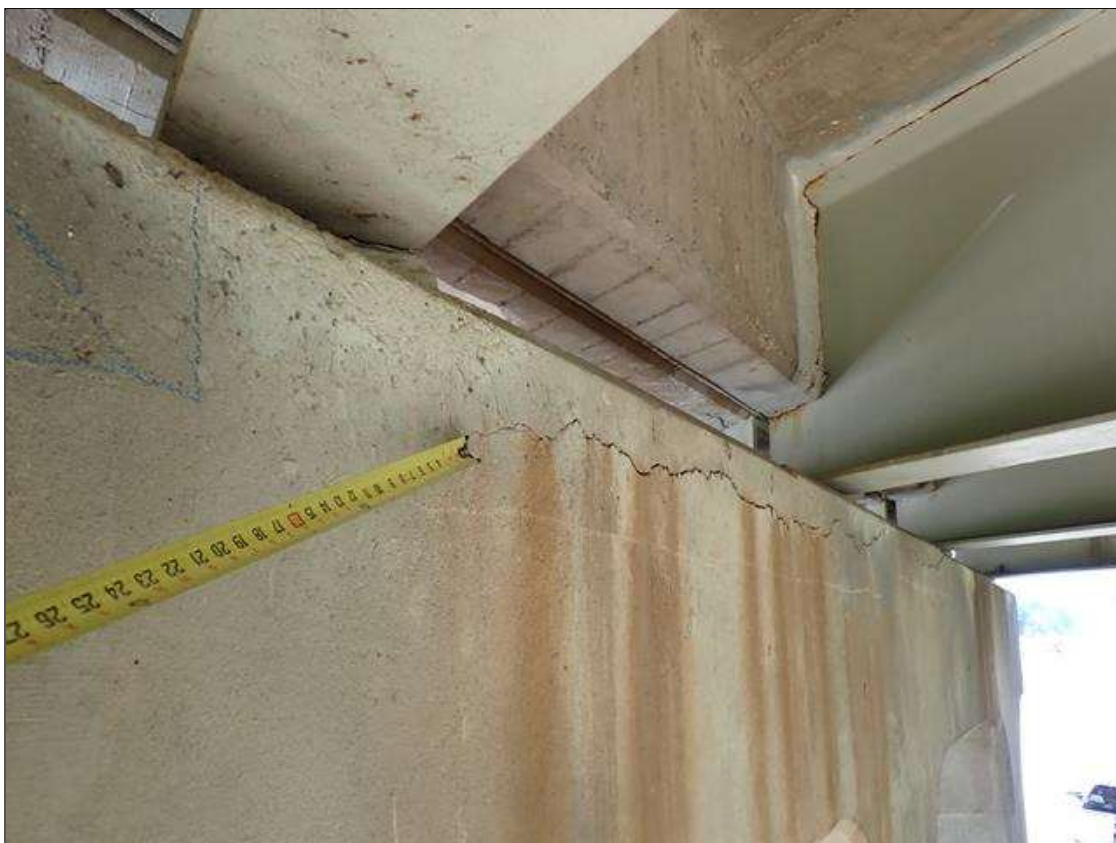
Bent 3 Cap 1: south and north faces, below bays 2-4, delaminations/spalls (up to 10 feet x 2 feet x 1 inch deep) with associated cracks (up to 1/4 inch)

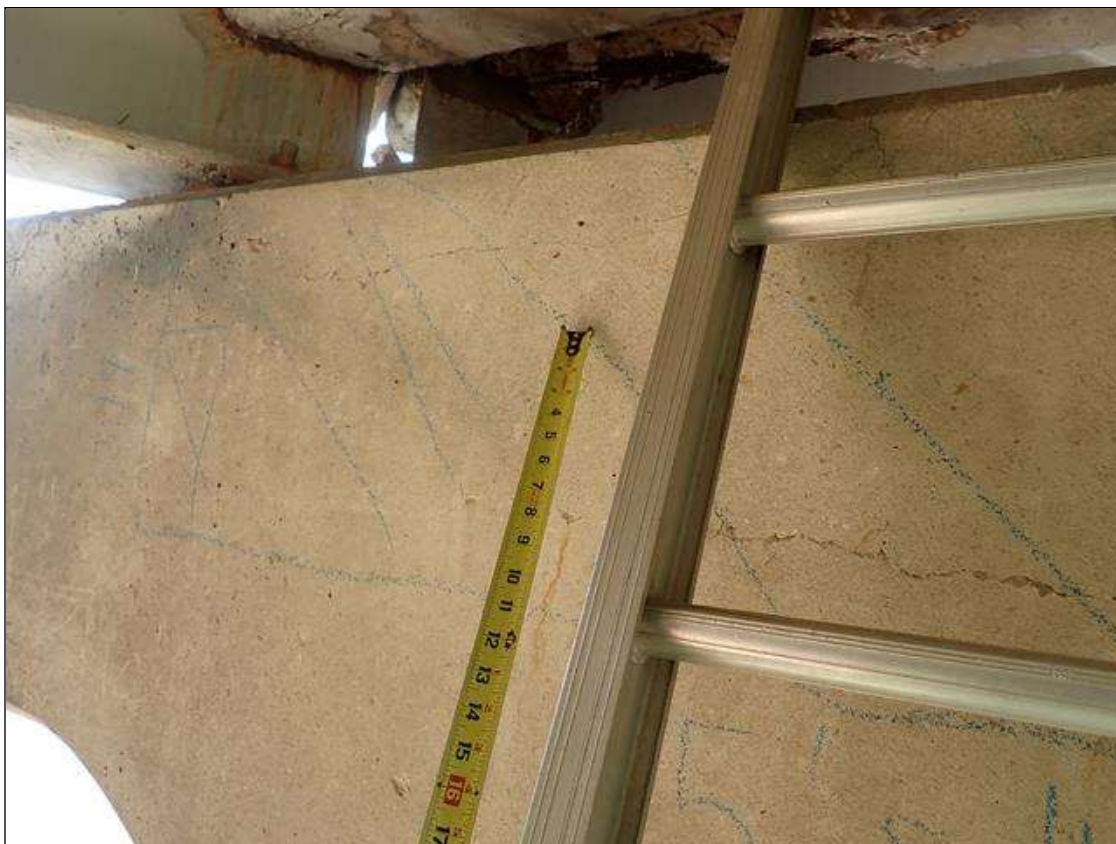
Bent 3 Cap 1: south and north faces, below bays 2-4, delaminations/spalls (up to 10 feet x 2 feet x 1 inch deep) with associated cracks (up to 1/4 inch)

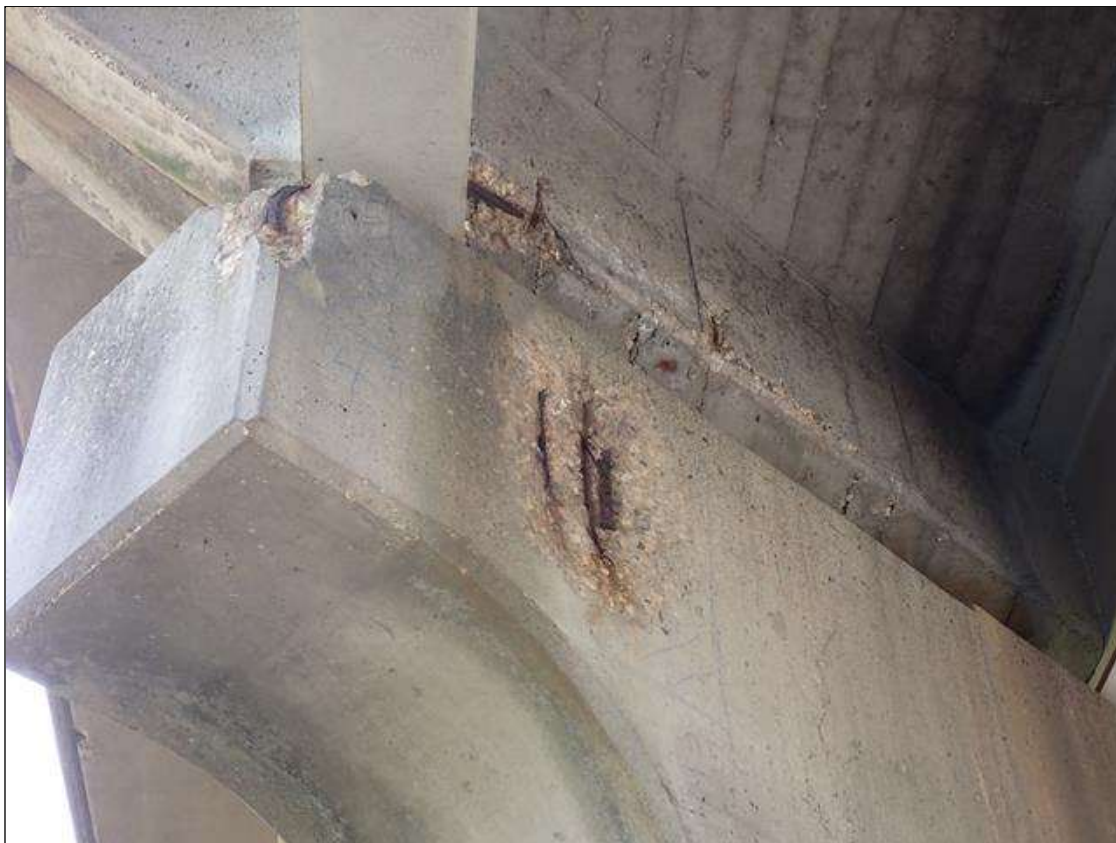
Bent 3 Cap 1: 2 foot x 15 inch x 1 inch deep spall with exposed reinforcing, south face, above column 1

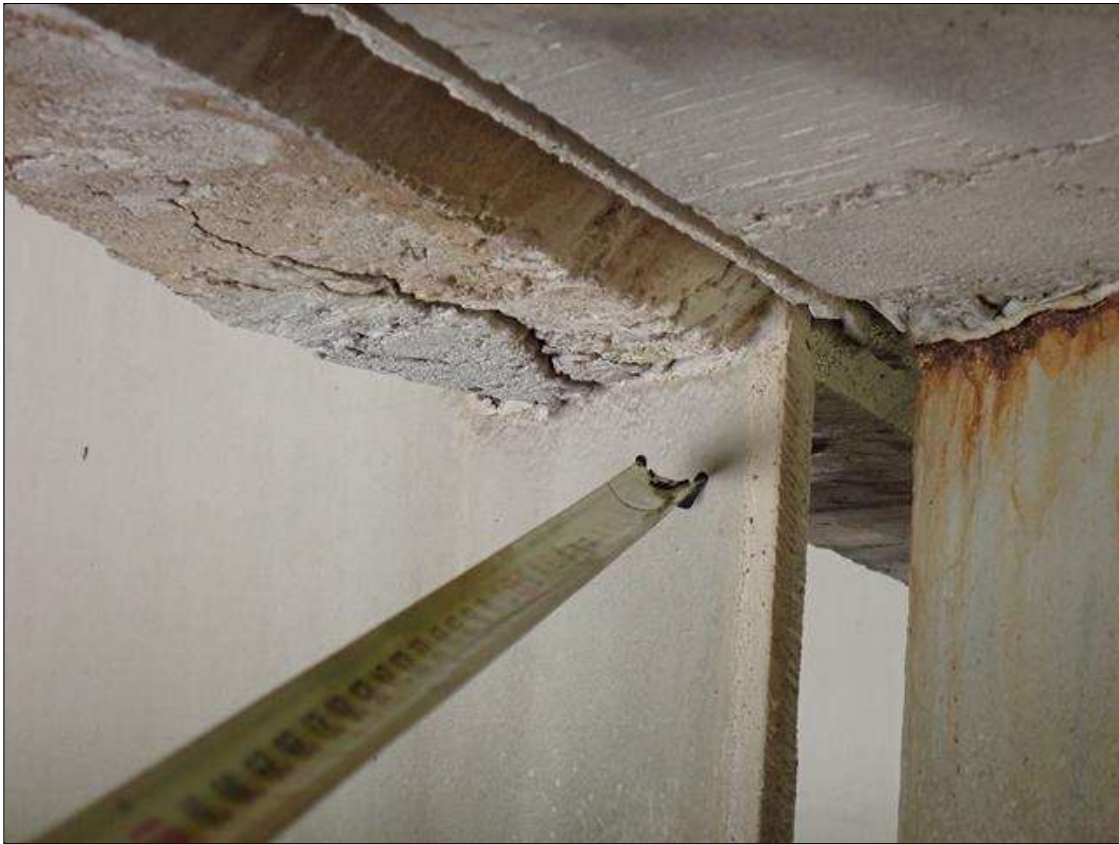
Span 3 Beam 3: (PAR) at bent 3, web adjacent to diaphragm, painted over section loss (5/16 inch average remaining x 10 inch x 1 inch)

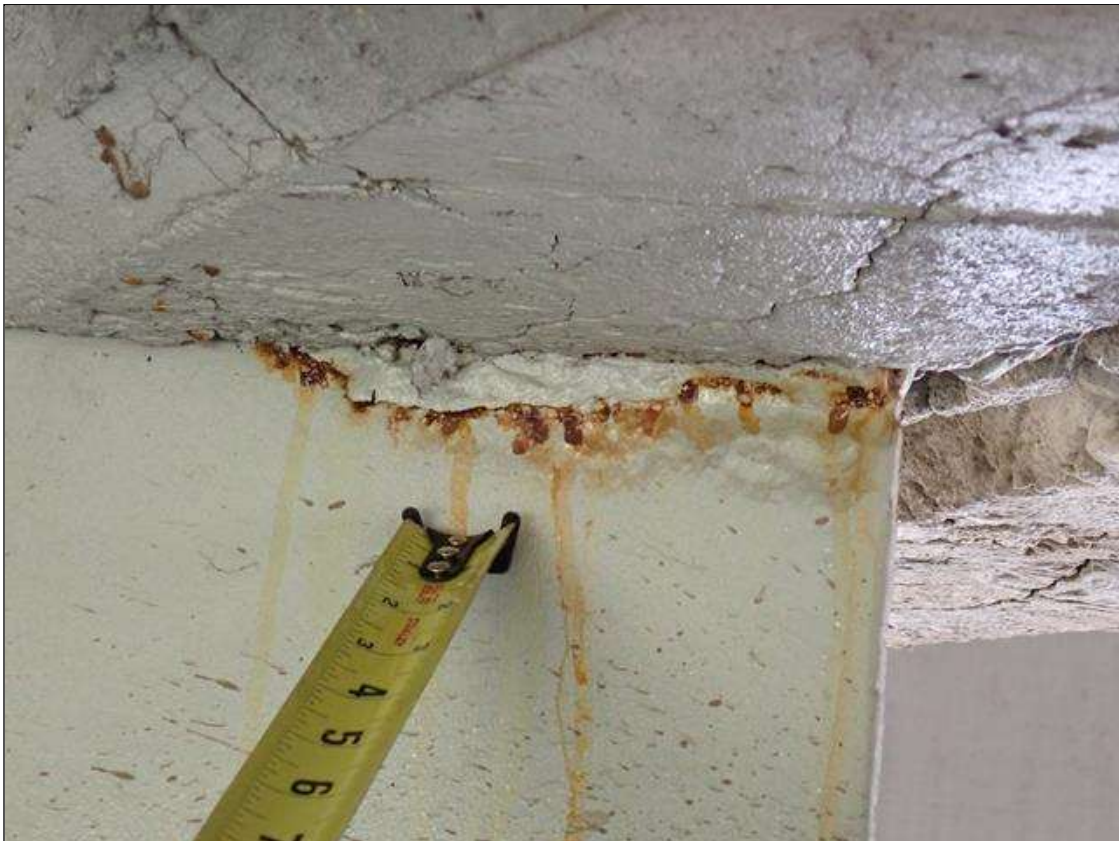
Span 4 Beam 3: (PAR) at bent 3, web adjacent to diaphragm, painted over section loss (3/8 inch average remaining x 8 inch x 1 inch) with corrosion reinitiated

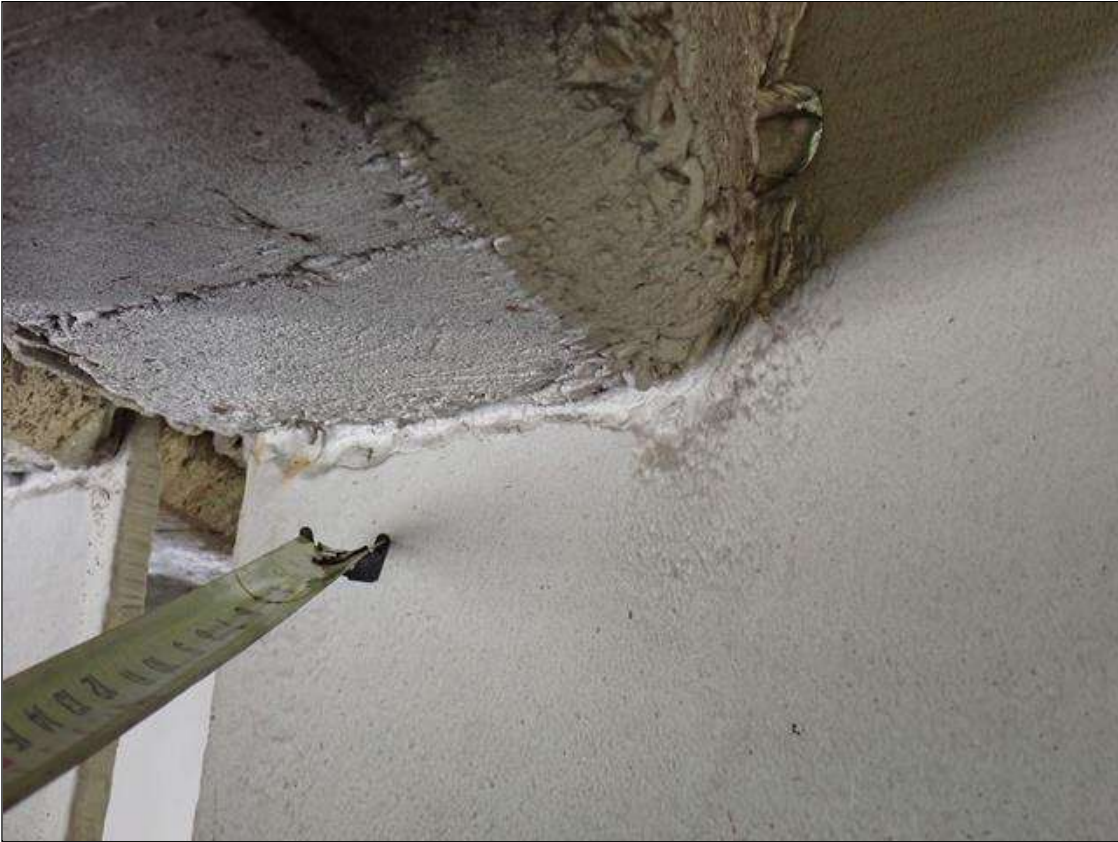
Span 4 Beam 2: (PAR) at bent 3, web adjacent to diaphragm, painted over section loss (3/8 inch average remaining x 10 inch x 1 inch)

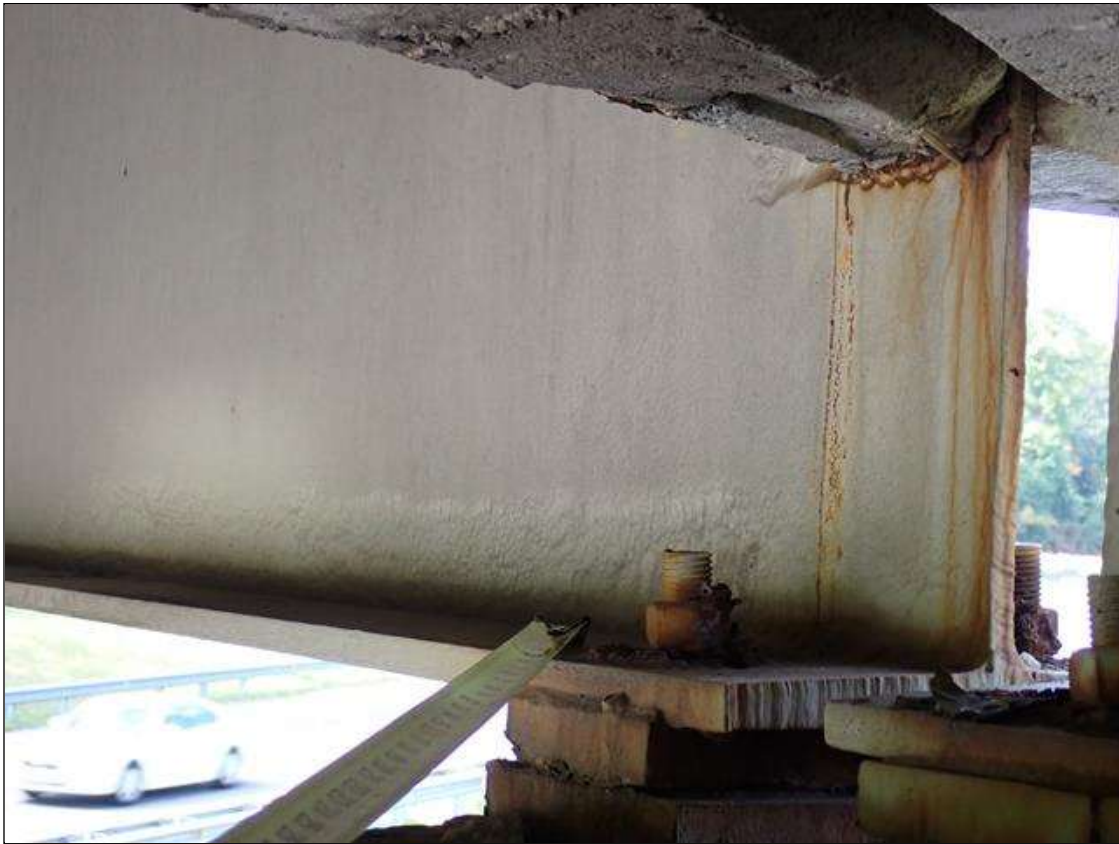
Span 3 Beam 1: (PAR) at bent 3, painted over section loss: web adjacent to diaphragm (5/16 inch average remaining x 9 inch x 2 inch); lower web (3/8 inch average remaining x 4 feet x 4 inch) with corrosion reinitiated

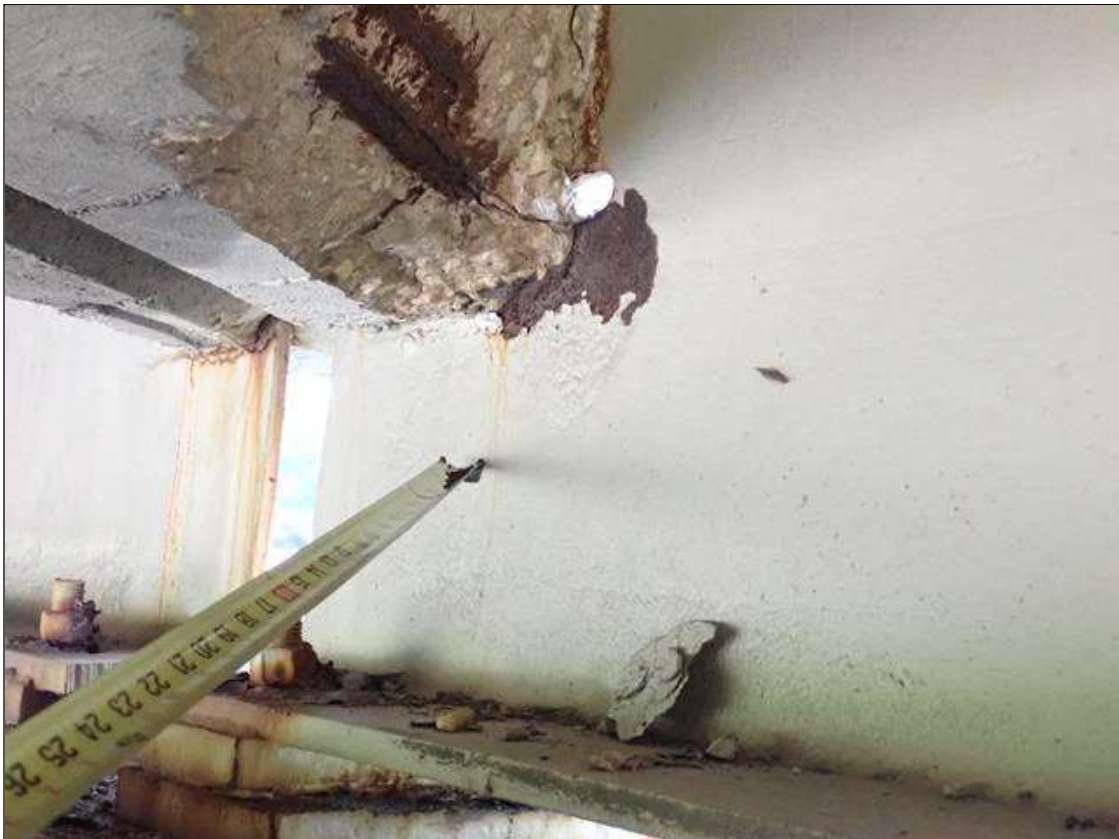
Span 4 Beam 1: (PAR) at bent 3, web adjacent to diaphragm, painted over section loss (3/8 inch average remaining x 6 inch x 4 inch); painted over pitting, lower web (up to 1/8 inch deep x 2 feet x 4 inch) with corrosion reinitiated

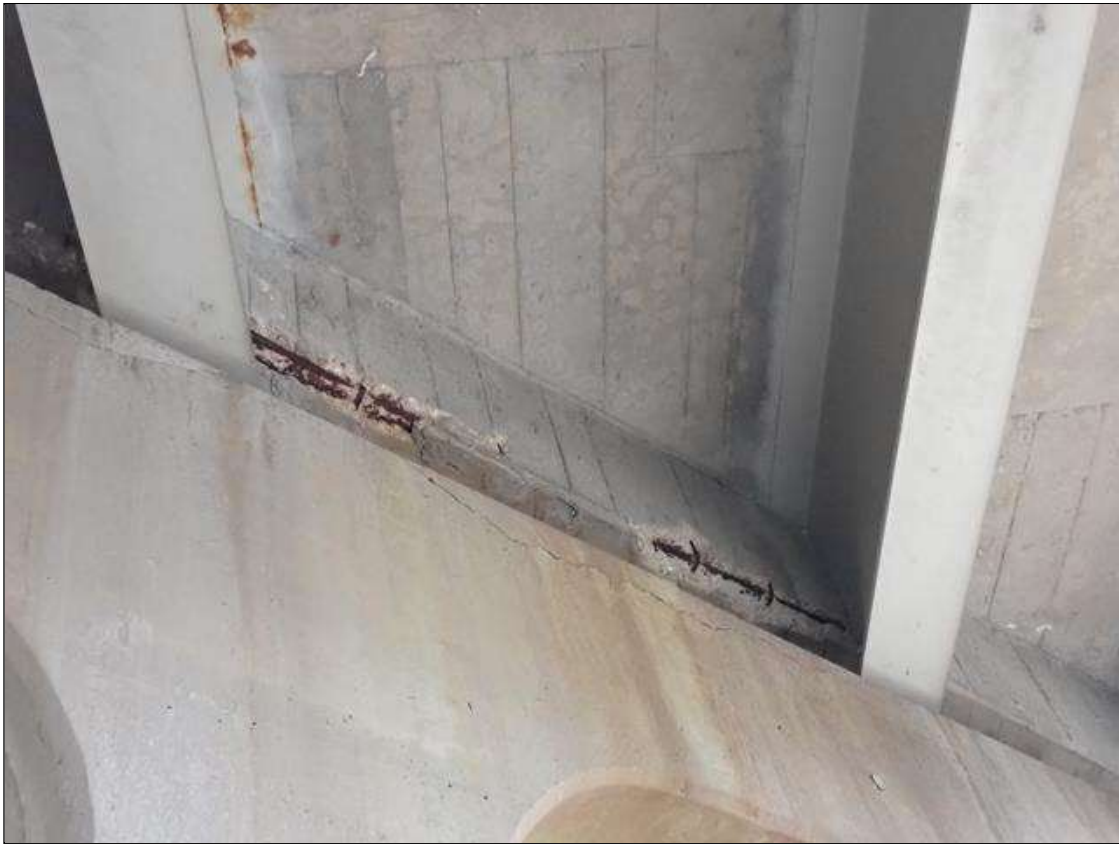
Span 3 Beam 3: at bent 3, bay 3 end diaphragm, spalls (up to 3 feet x 6 inch x 2 inch deep) with exposed rusted rebar

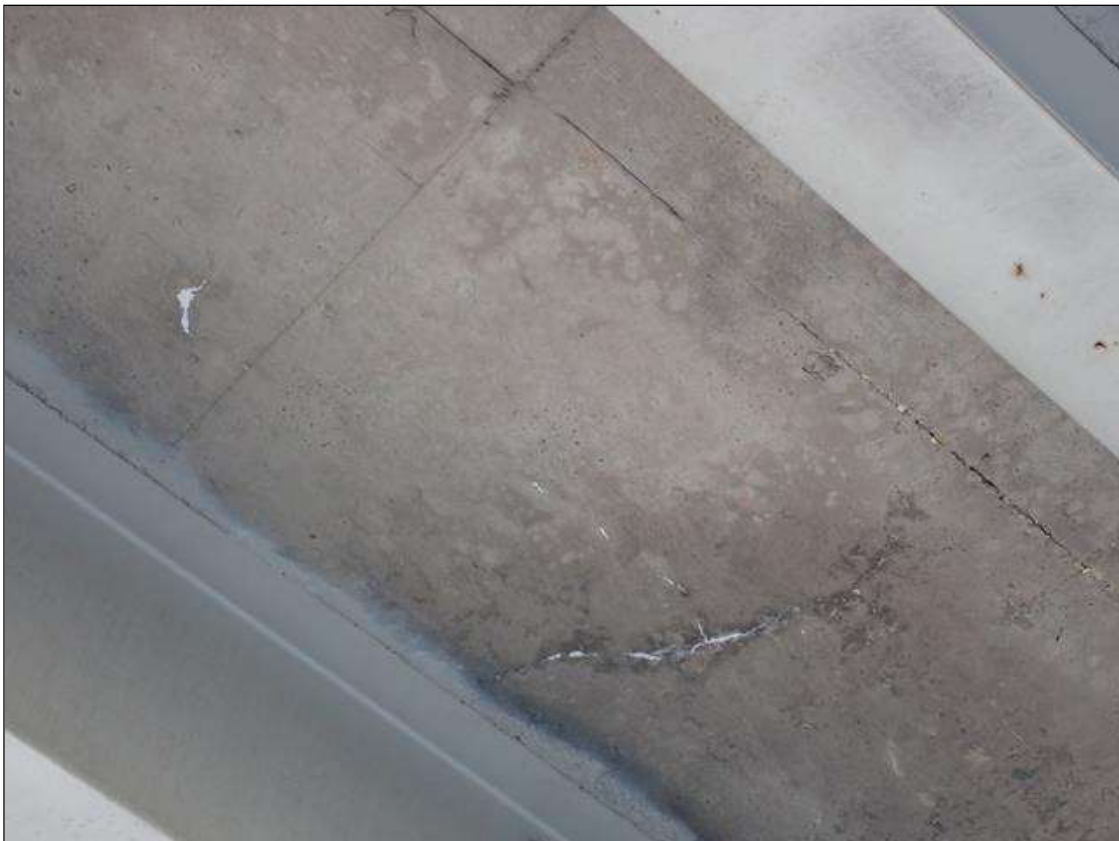
Span 3 Deck: (PAR) throughout underside of deck, in all bays, transverse cracks (up to 1/32 inch x full width) and areas of map cracks (hairline) with efflorescence buildup and rust stains

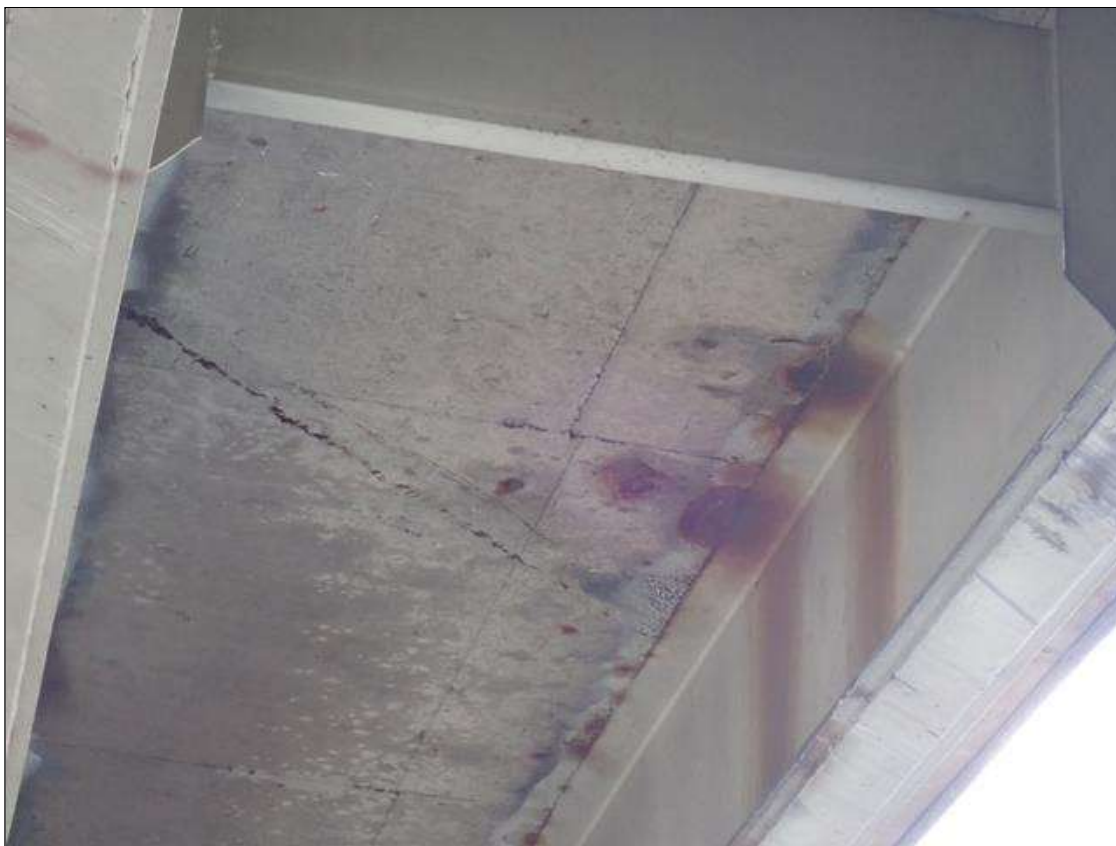
Span 3 Deck: (PAR) throughout underside of deck, in all bays, transverse cracks (up to 1/32 inch x full width) and areas of map cracks (hairline) with efflorescence buildup and rust stains

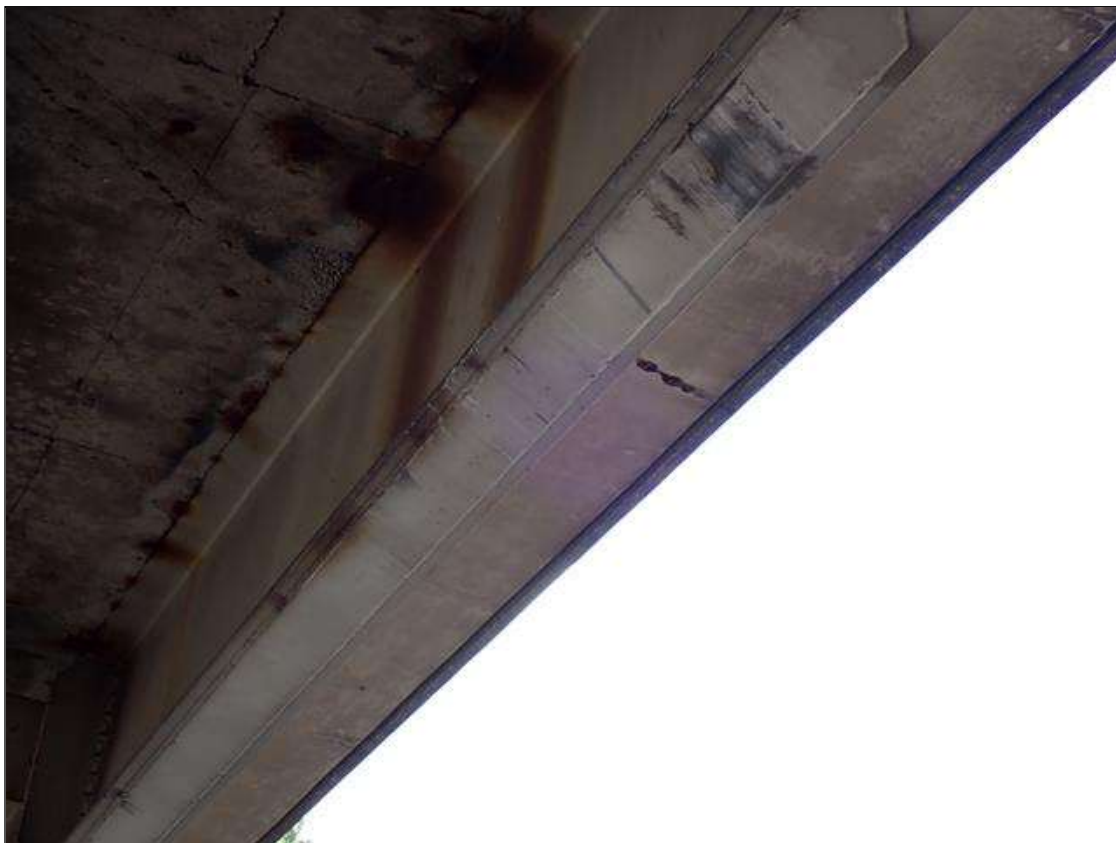
Span 3 Beam 1: over both travel lanes, along underside of cover plate, impact scrapes with surface gouges

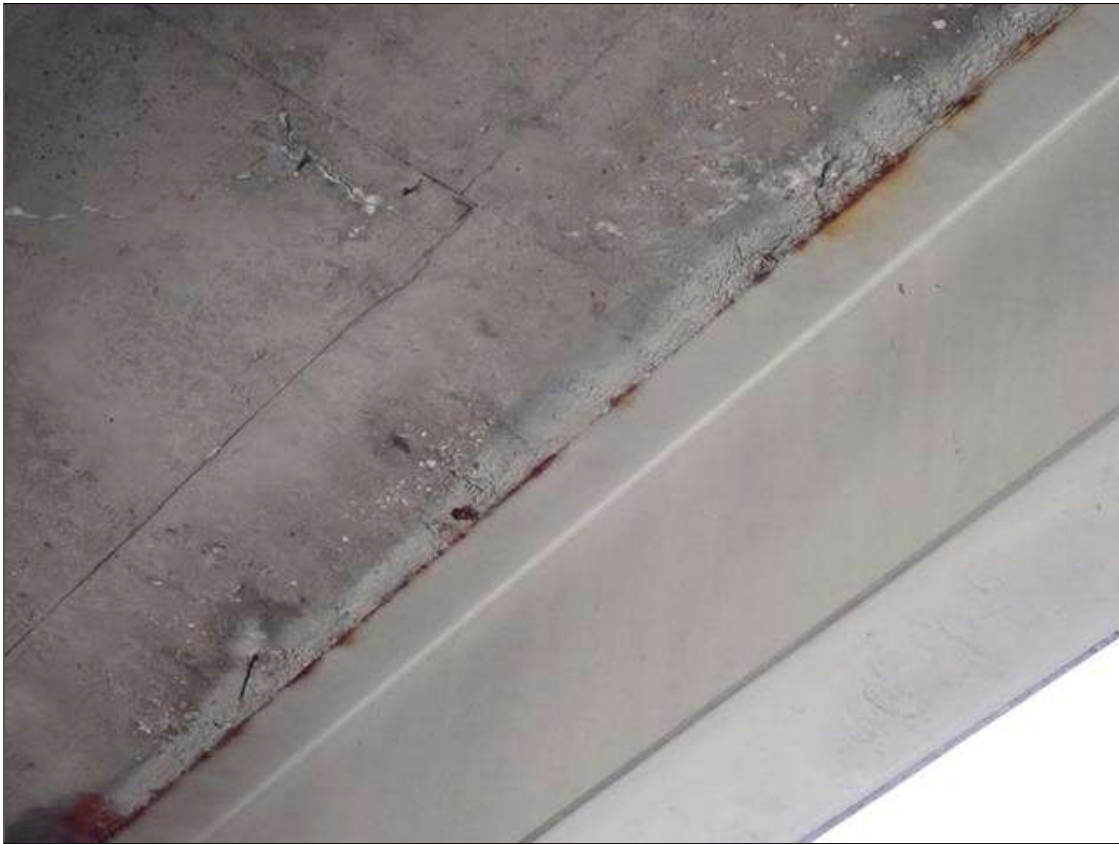
Span 3 Beam 1: along the length of the beam, along edges of top flange, surface rust at random

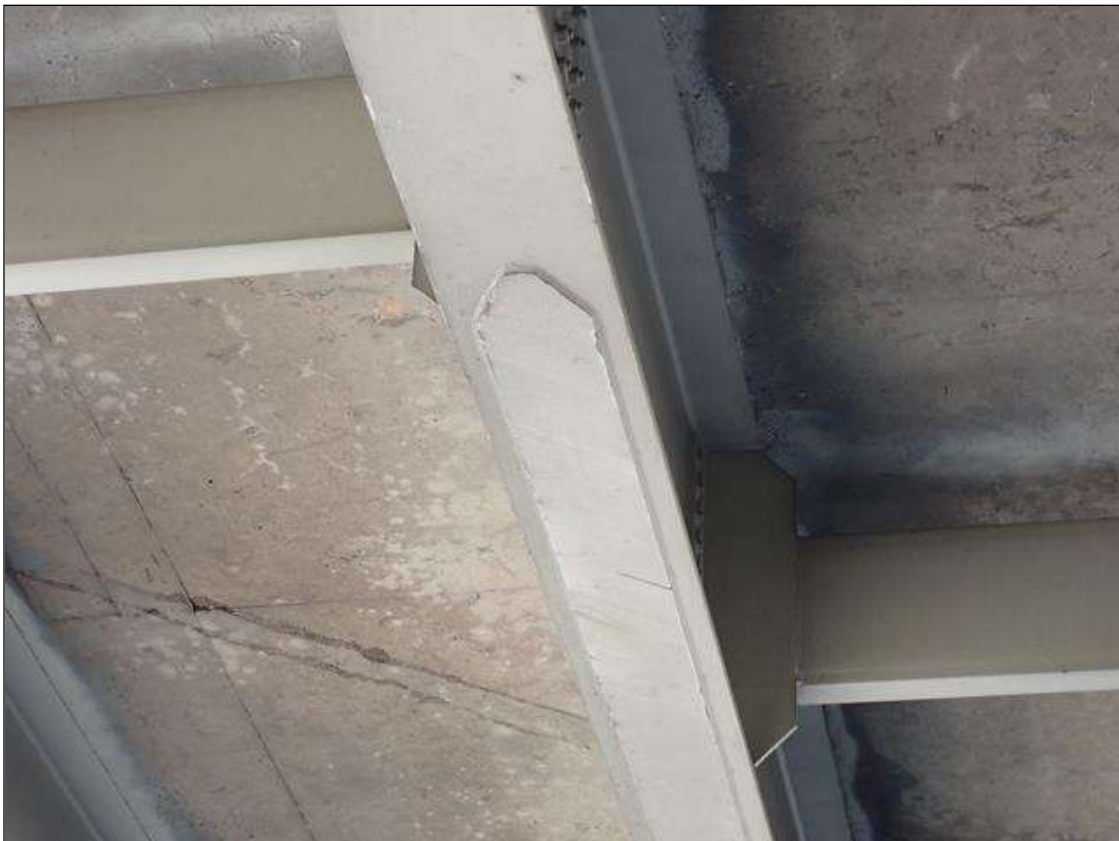
Span 3 Beam 3: over right travel lane, along bottom flange at cover plate, impact scrapes with surface gouges

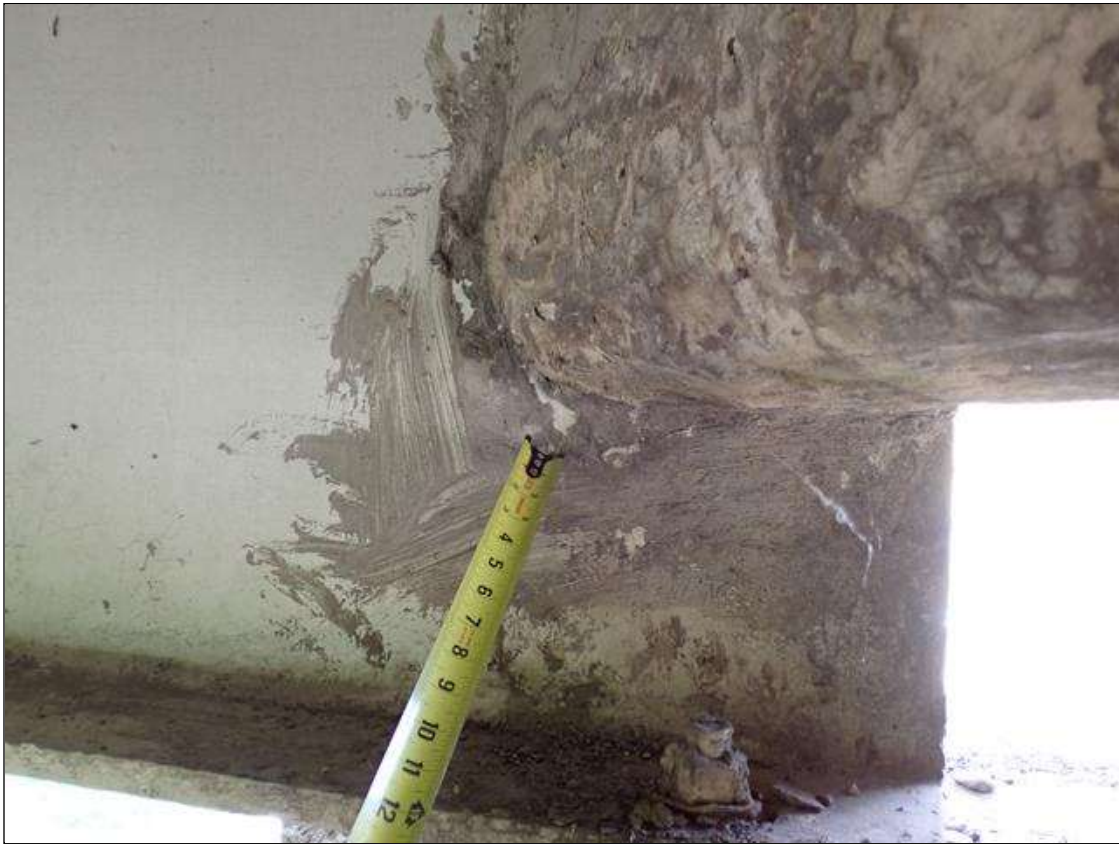
Span 1 Beam 1: (PAR) at bent 1, web adjacent to diaphragm, painted over section loss (3/8 inch average remaining x 9 inch x 2 inch) with corrosion reinitiated

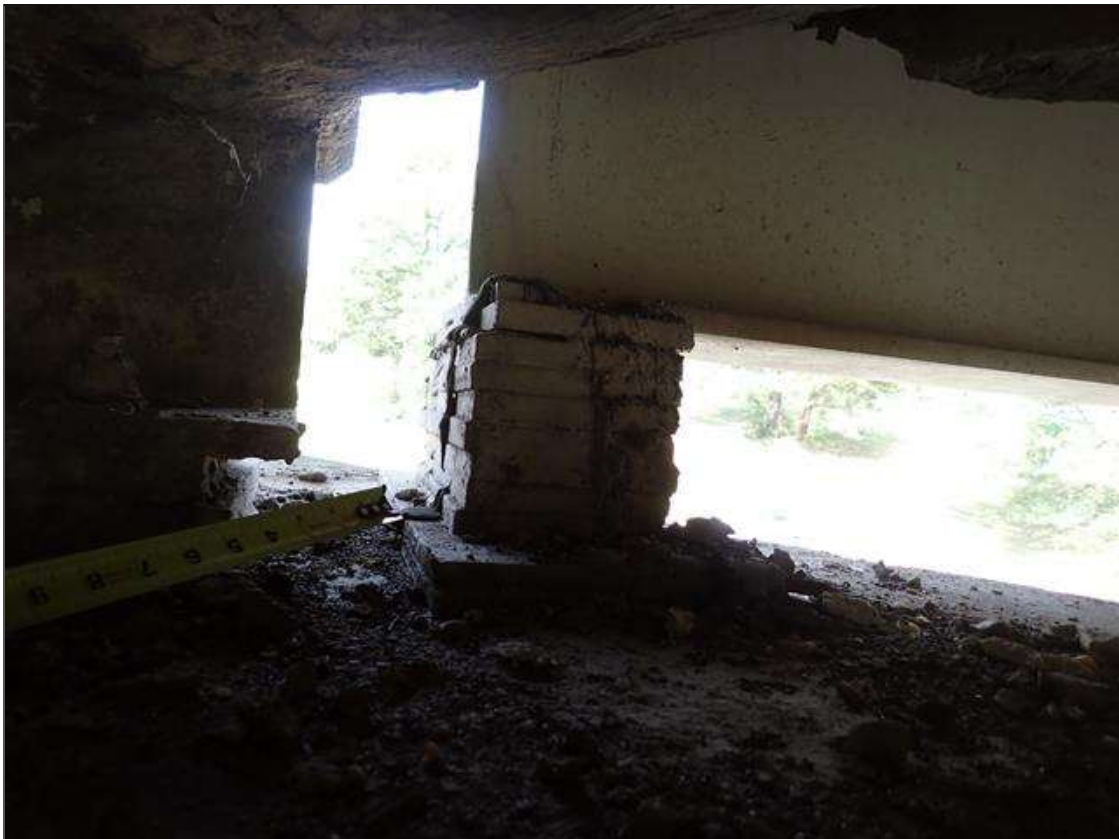
Span 2 Beam 1 - Near Bearing 1: (PAR) stacked plates, laterally misaligned (up to 1/2 inch) in relation to sole plate; no anchor bolts installed through beam or into cap

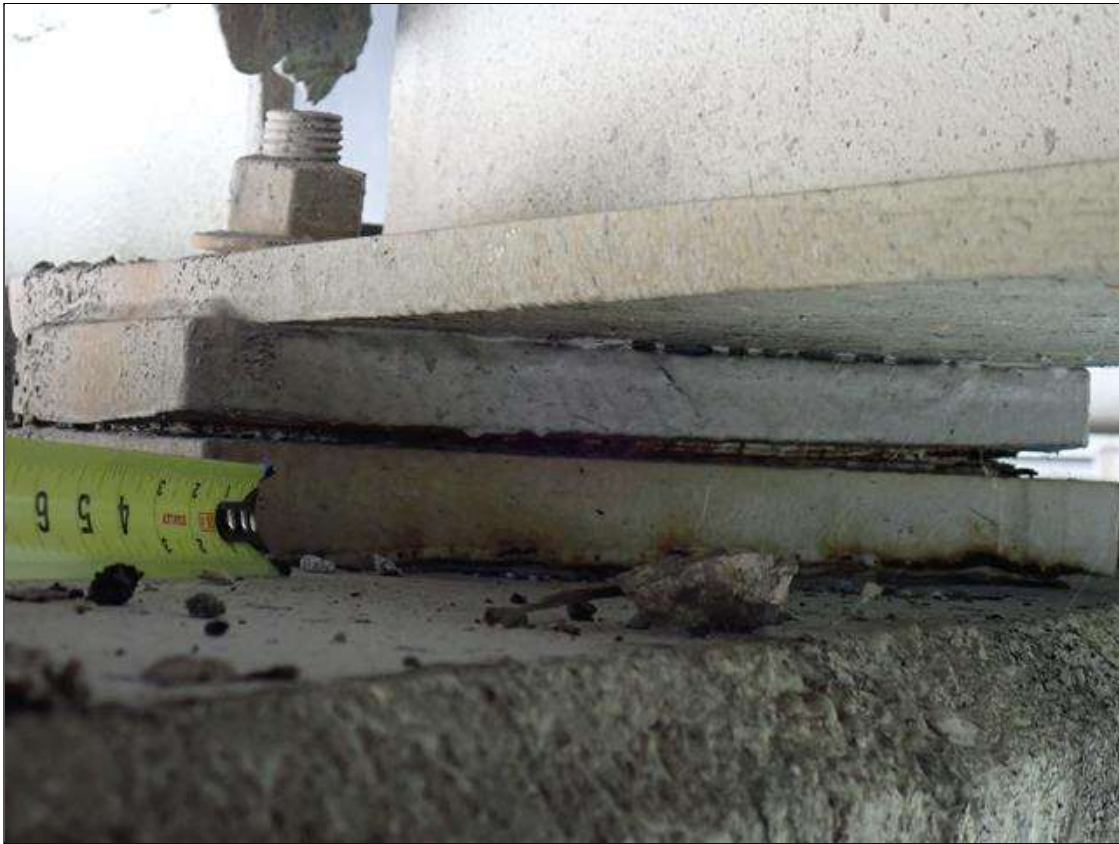
Span 1 Beam 2 - Far Bearing 2: pack rust.
