NC DEPARTMENT OF TRANSPORTATION
 DIVISION OF HIGHWAYS
 STRUCTURE MANAGEMENT UNIT

ATTENTION: prompt action request, sketches revised, clearances revised, resurfaced with no change in asphalt wearing surface thickness

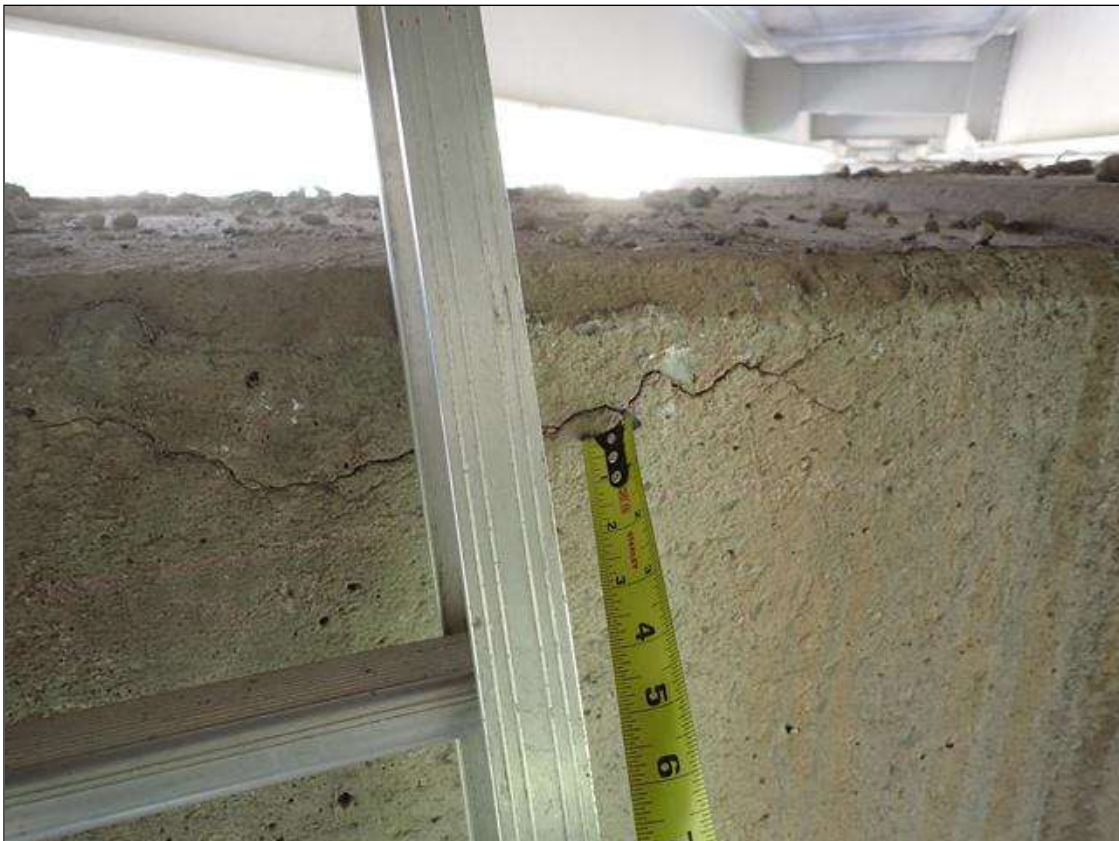
Bent 1 Cap 1: south face, below bay 1, longitudinal crack (1/32 inch x 15 inches)

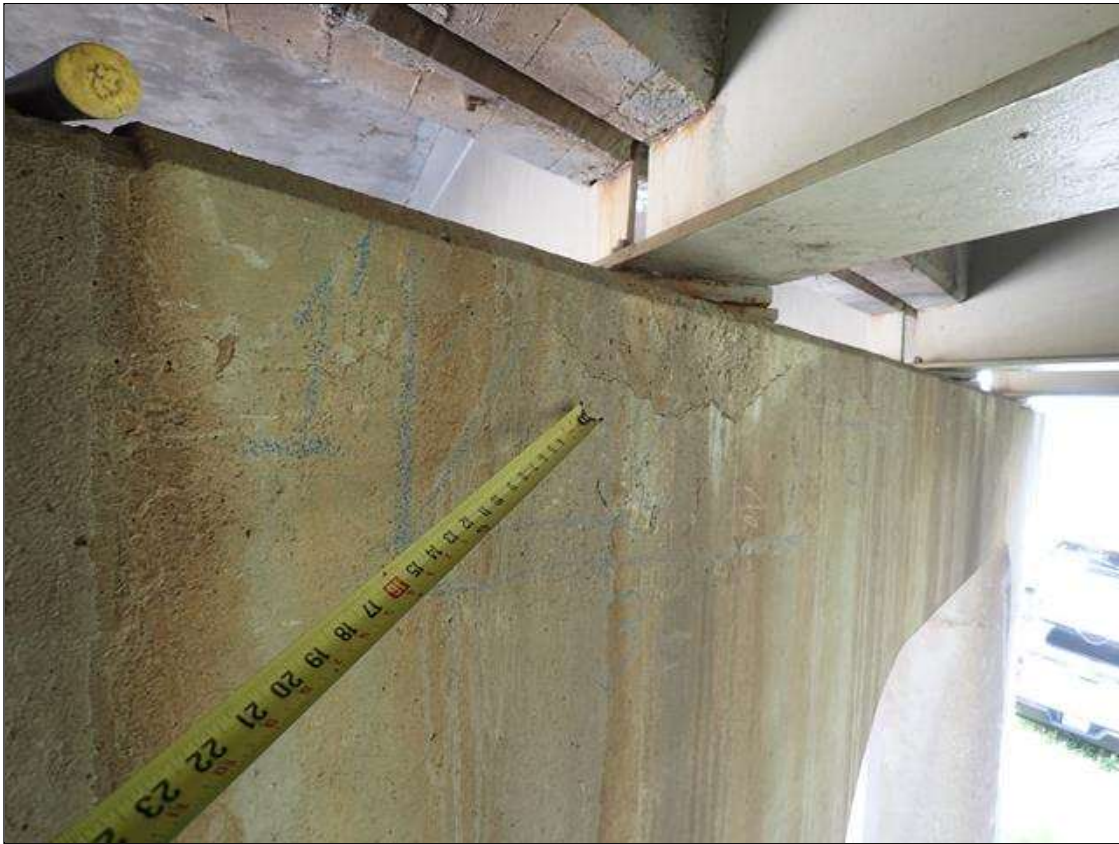
Bent 1 Cap 1: south face, below beam 3, delamination (6 feet x 1 foot) with associated cracks (up to 1/32 inch)

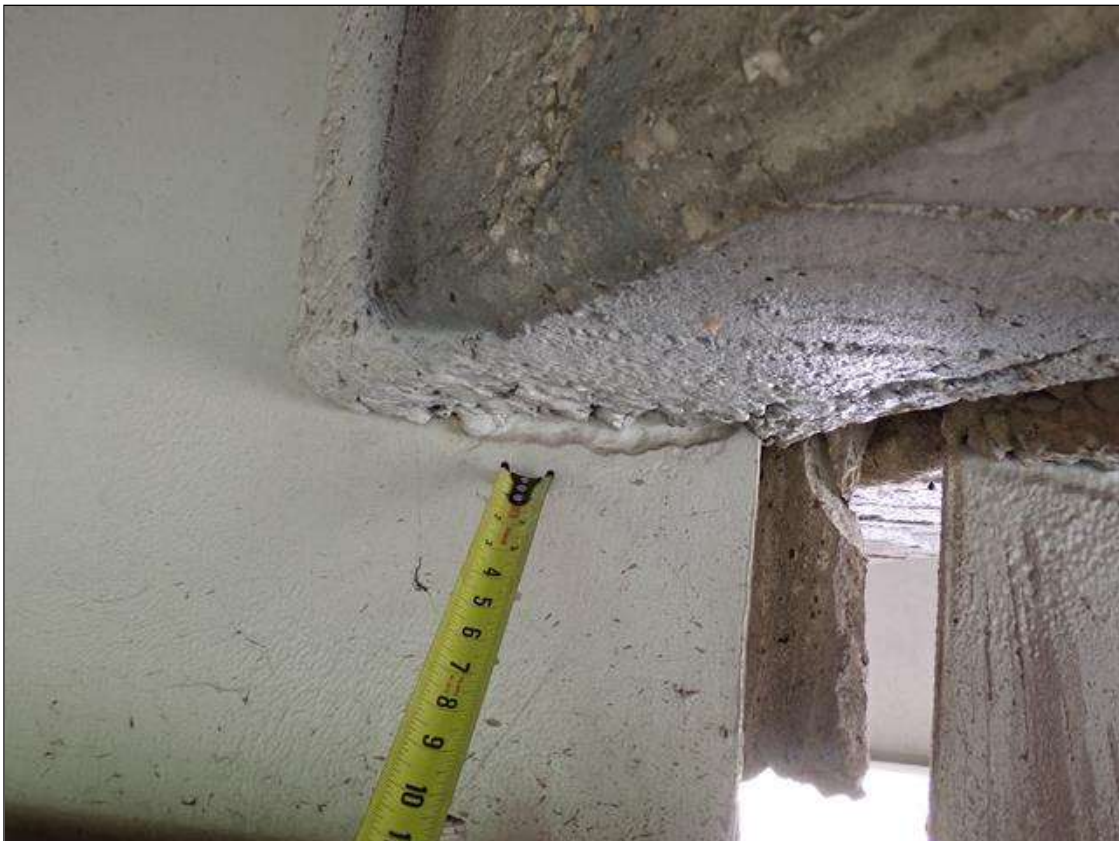
Span 1 Beam 2: (PAR) at bent 1, web adjacent to diaphragm, painted over section loss (1/4 inch average remaining x 10 inch x 2 inch)

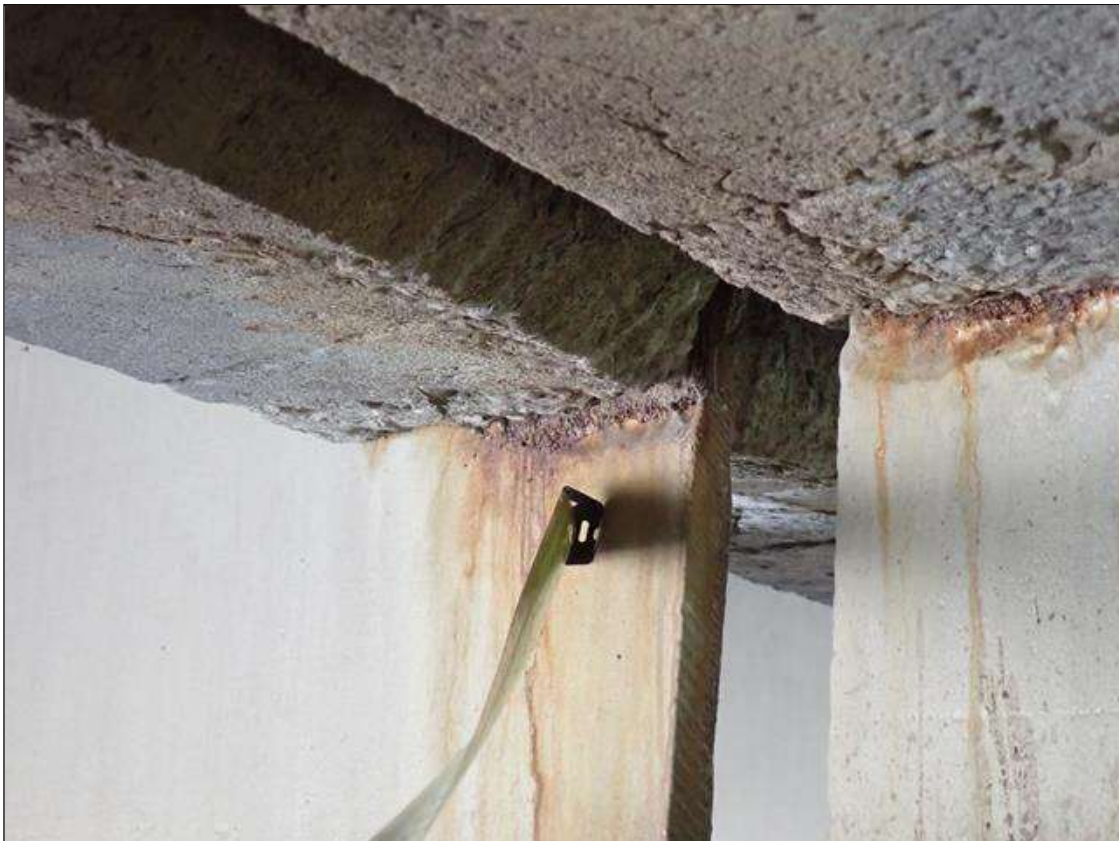
Span 2 Beam 3: (PAR) at bent 1, web adjacent to diaphragm, painted over section loss (5/16 inch average remaining x 6 inch x 1 inch); lower web, painted over pitting (up to 1/8 inch deep x 14 inch x 3 inch) with corrosion reinitiated

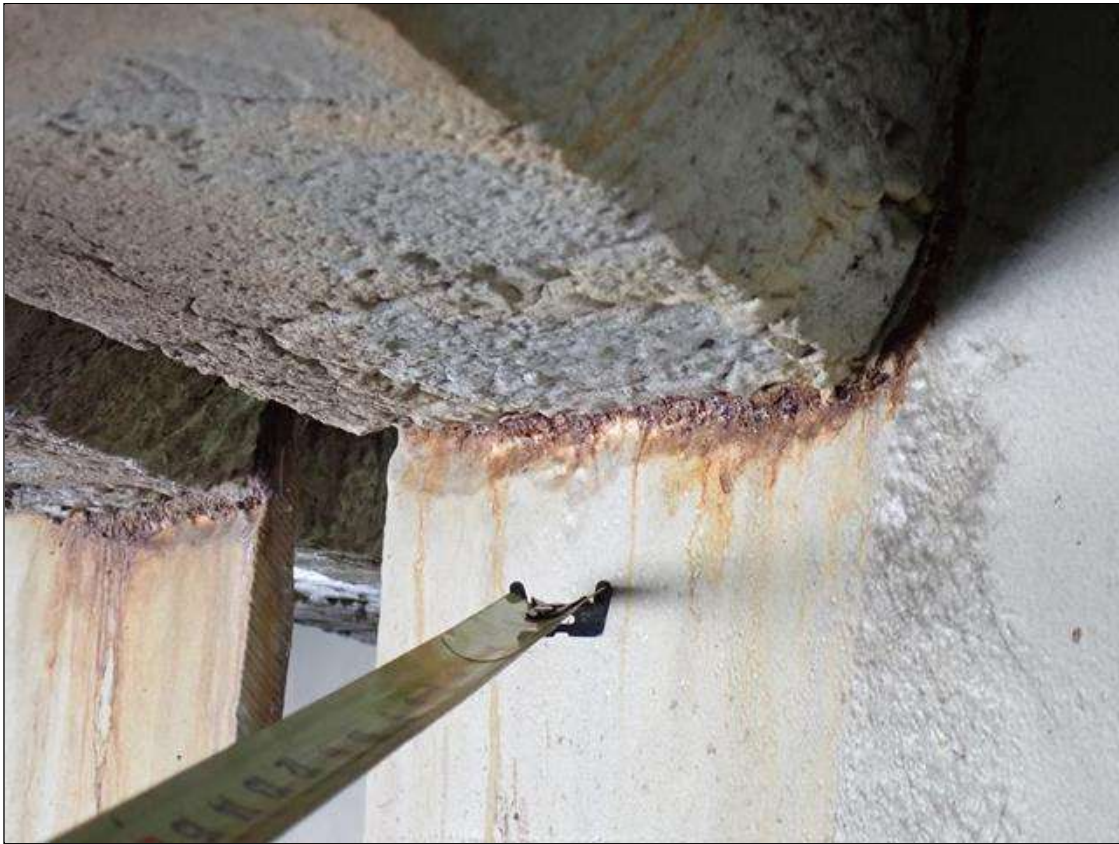
Span 1 Beam 3: (PAR) at bent 1, web adjacent to diaphragm, painted over section loss (5/16 inch average remaining x 10 inch x 1 inch) with adjacent painted over pitting (up to 1/8 inch deep x 2 inch x 3 inch) with corrosion reinitiated

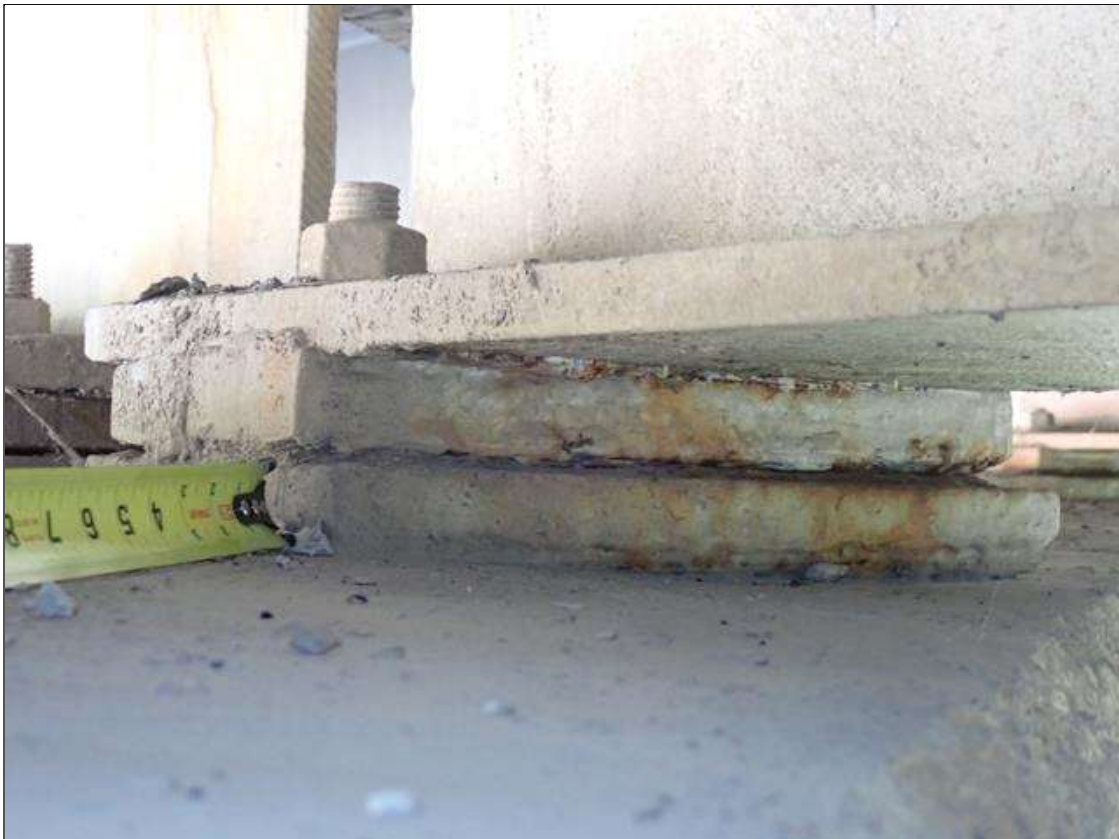
Span 1 Beam 3 - Far Bearing 3: painted over section loss (up to 3/16 inch deep) and pack rust

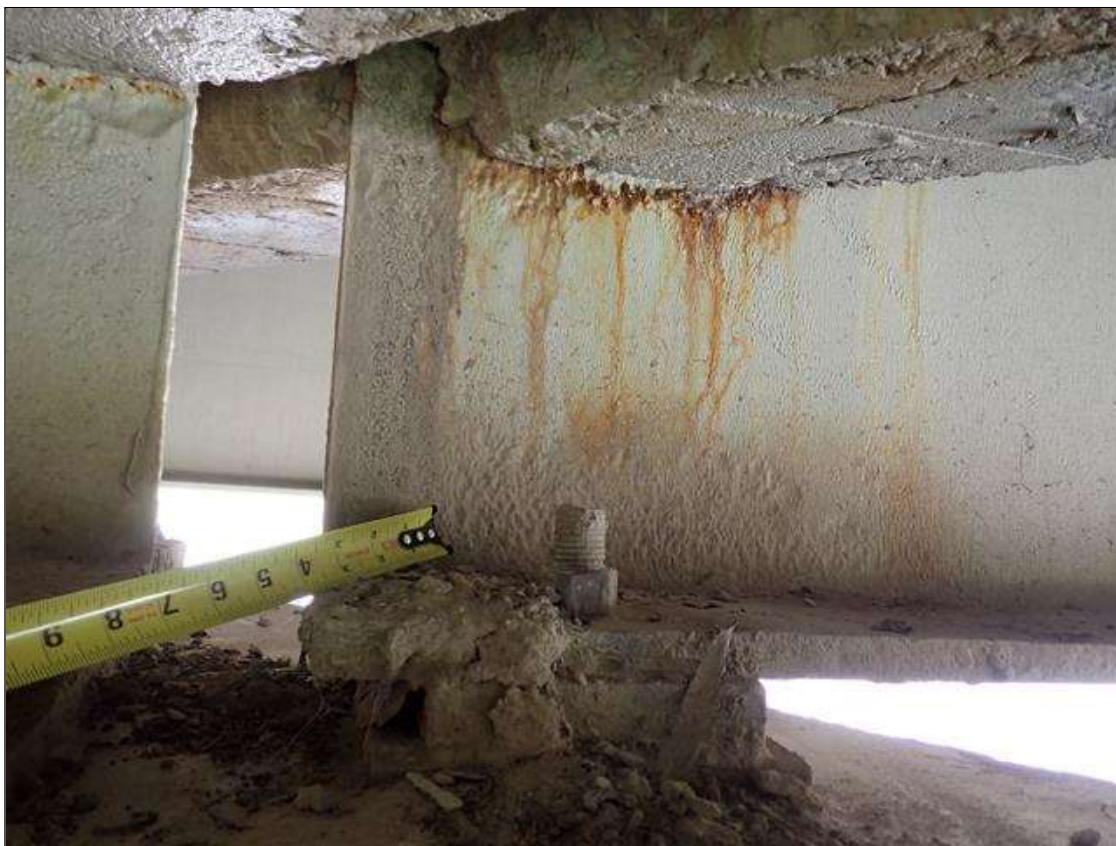
Span 2 Beam 3: (PAR) at bent 1, web adjacent to diaphragm, painted over section loss (5/16 inch average remaining x 6 inch x 1 inch); lower web, painted over pitting (up to 1/8 inch deep x 14 inch x 3 inch) with corrosion reinitiated

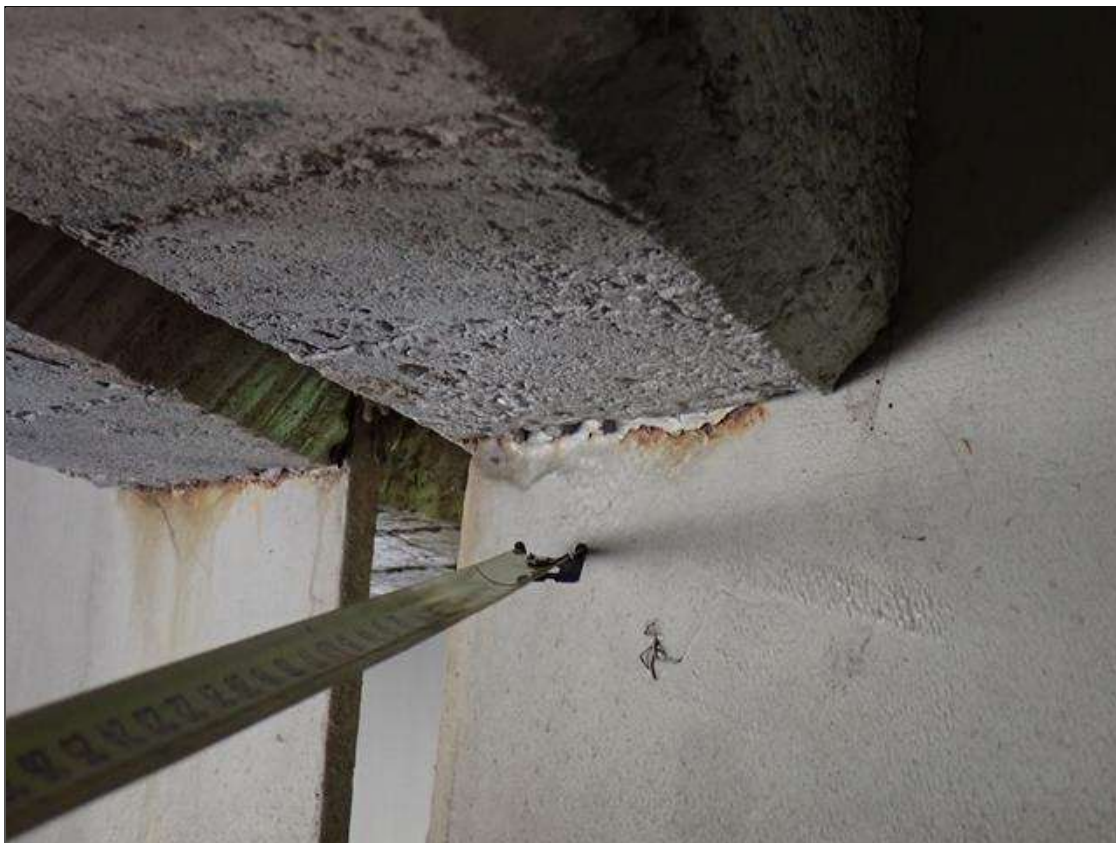
Span 1 Beam 4: (PAR) at bent 1, web adjacent to diaphragm, painted over section loss (3/8 inch average remaining x 7 inch x 1 inch) with corrosion reinitiated

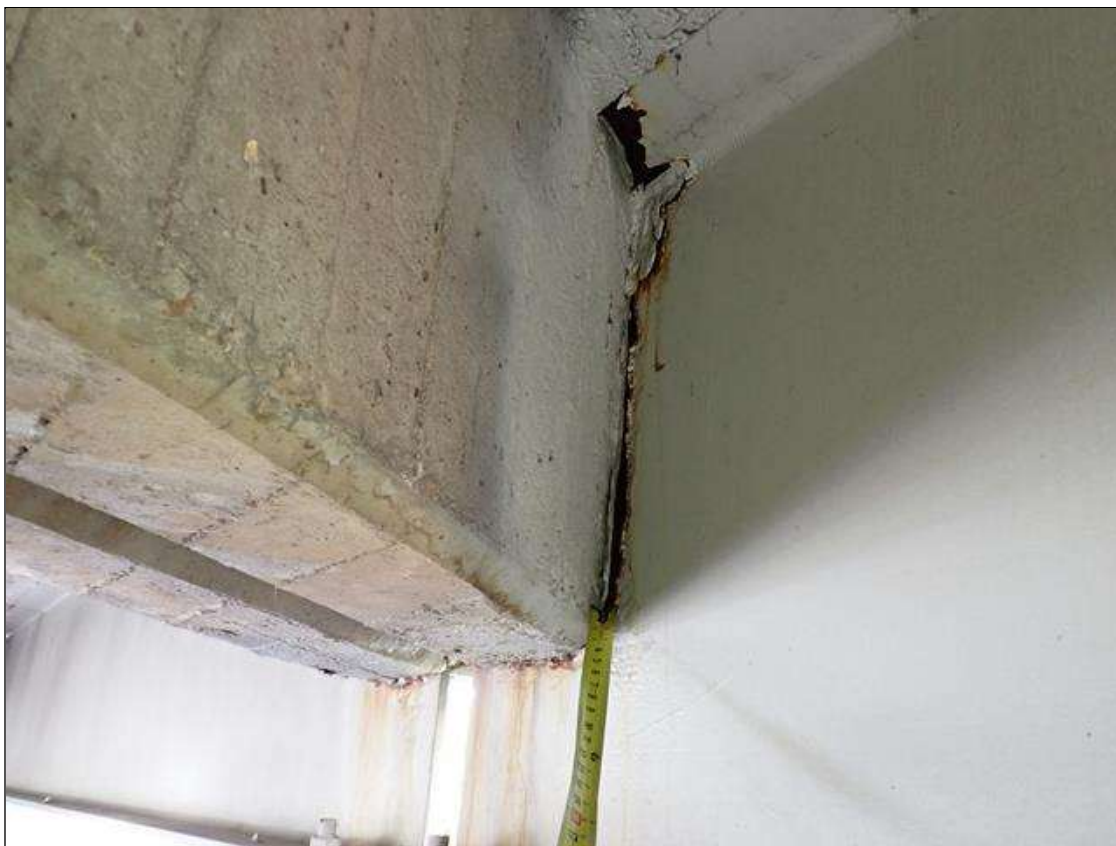
Span 1 Beam 5: (PAR) at bent 1, web adjacent to diaphragm, painted over section loss (5/16 inch average remaining x 9 inch x up to 2 feet) with corrosion reinitiated; top flange, rust scale

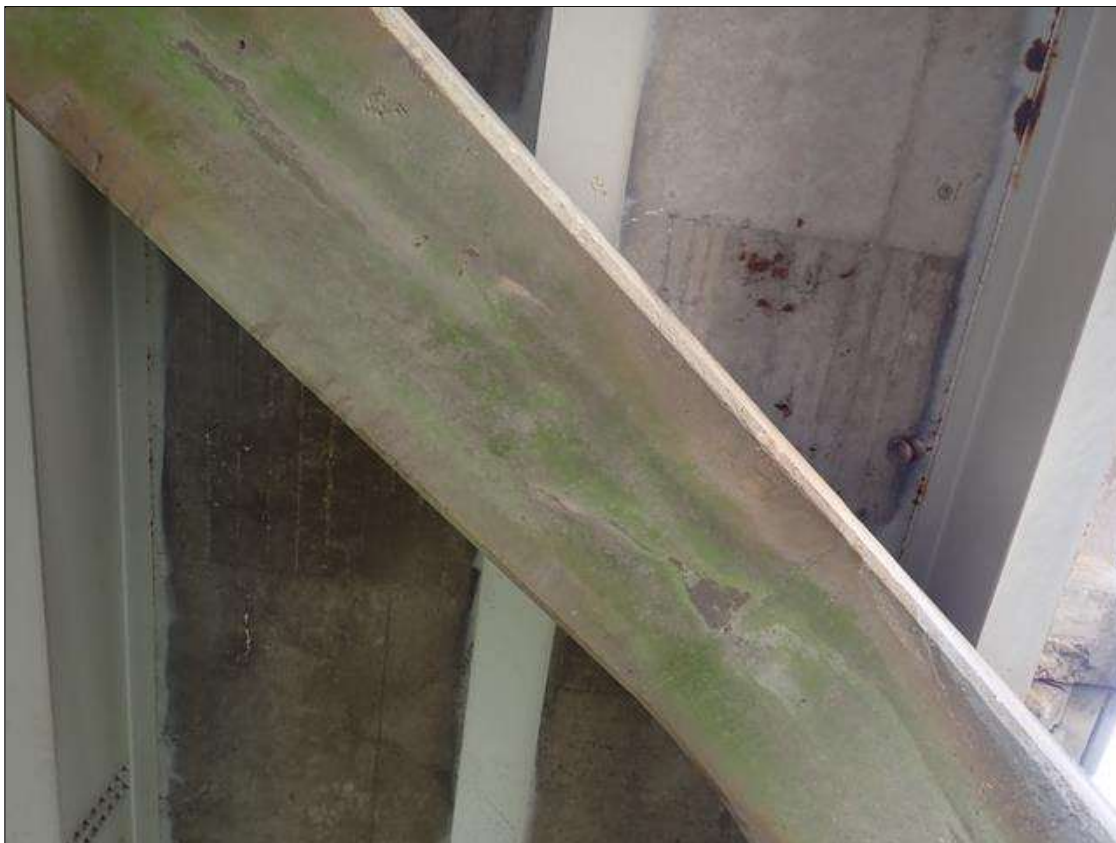
Bent 1 Cap 1: (not found 2023) 2 foot transverse crack up to 1/32 inch wide, under beam 2, on underside of cap.

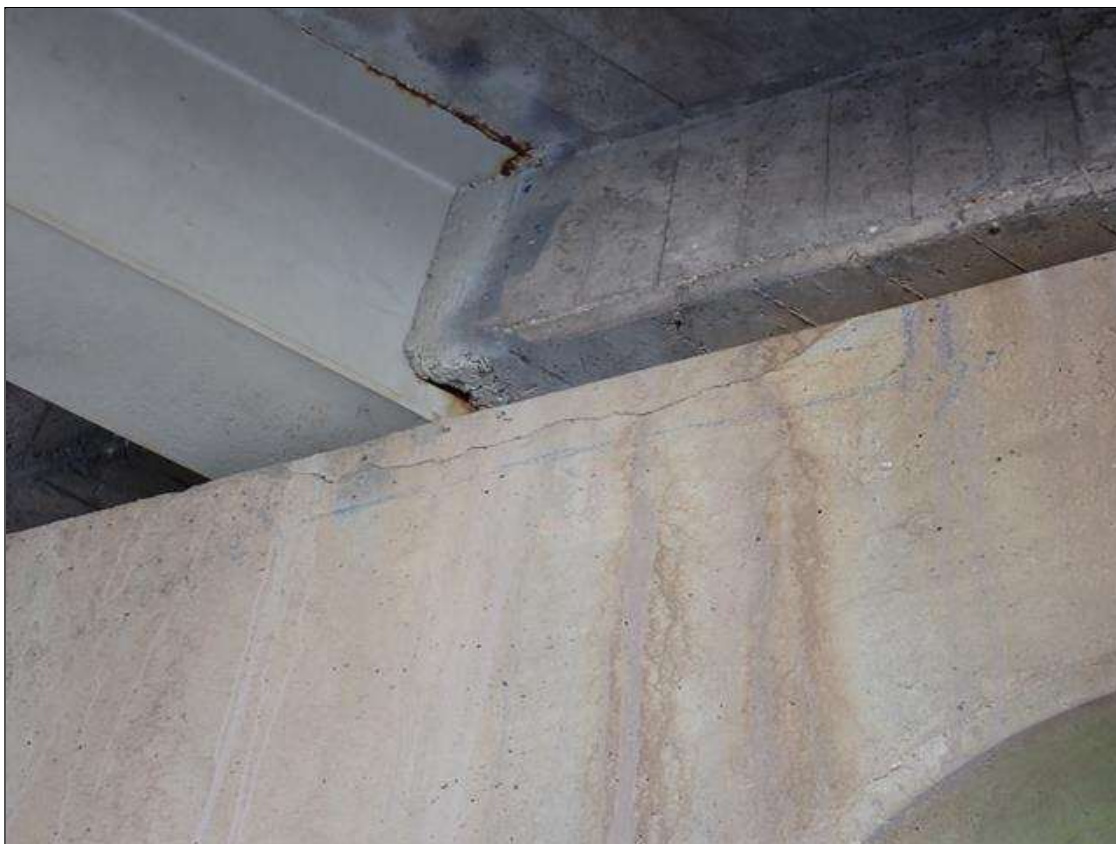
Bent 1 Cap 1: north face, below beam 3, delamination (3 feet x 6 inch) with associated cracks (up to 1/32 inch)

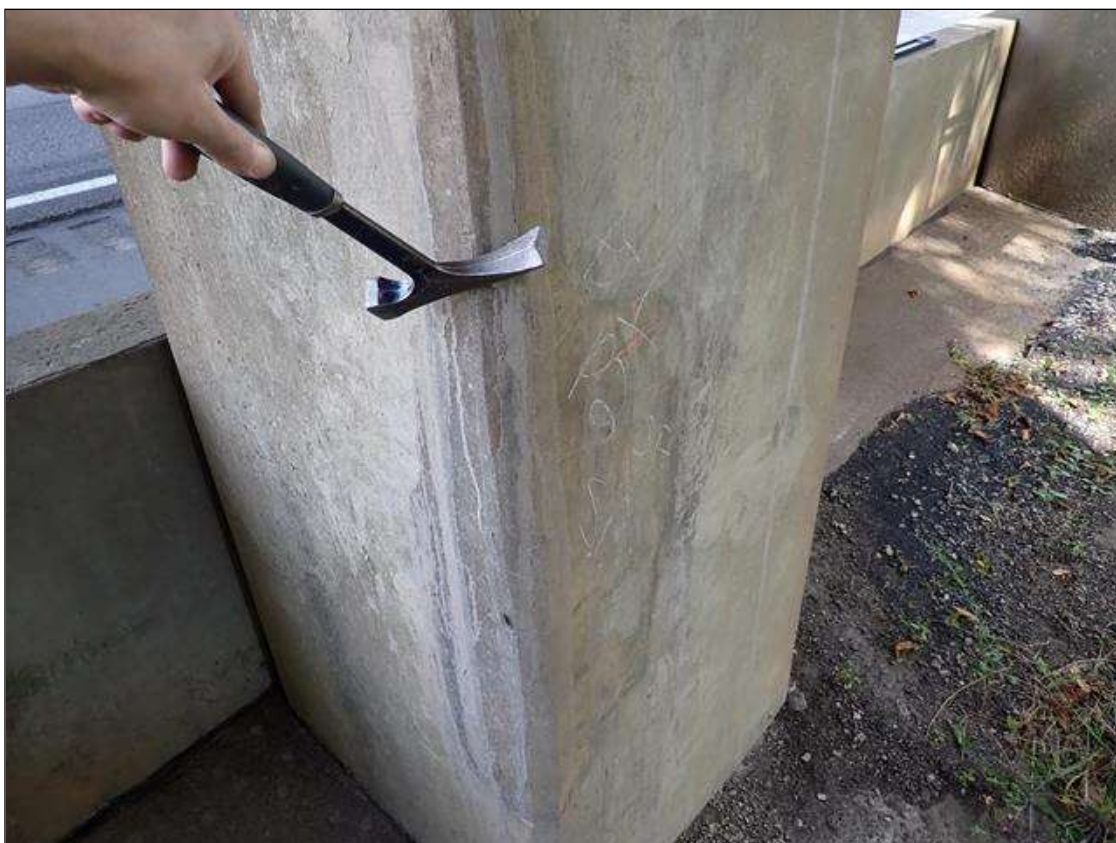
Bent 1 Pile 2: 6 foot x 18 inch sound patch at southwest corner, near base of column.

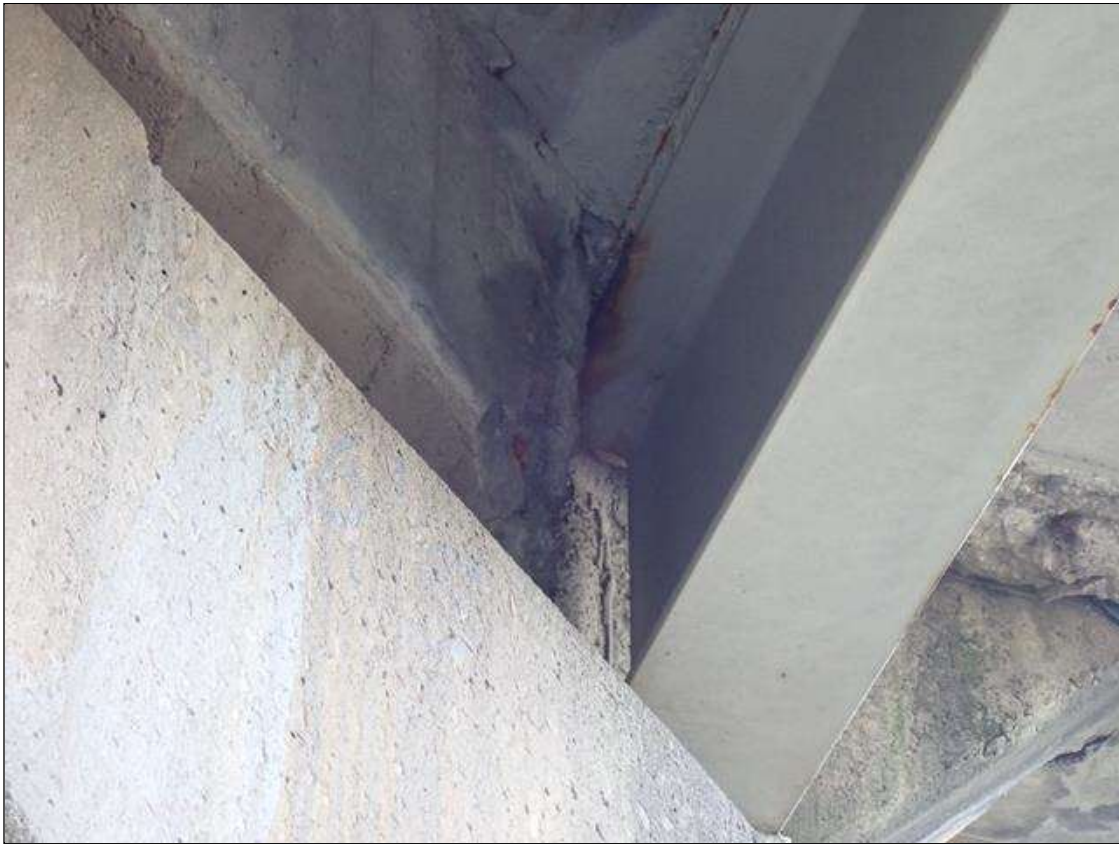
Span 2 Beam 1: end diaphragm on both sides has been removed with exposed rusted rebar, at both ends, when beam was replaced.

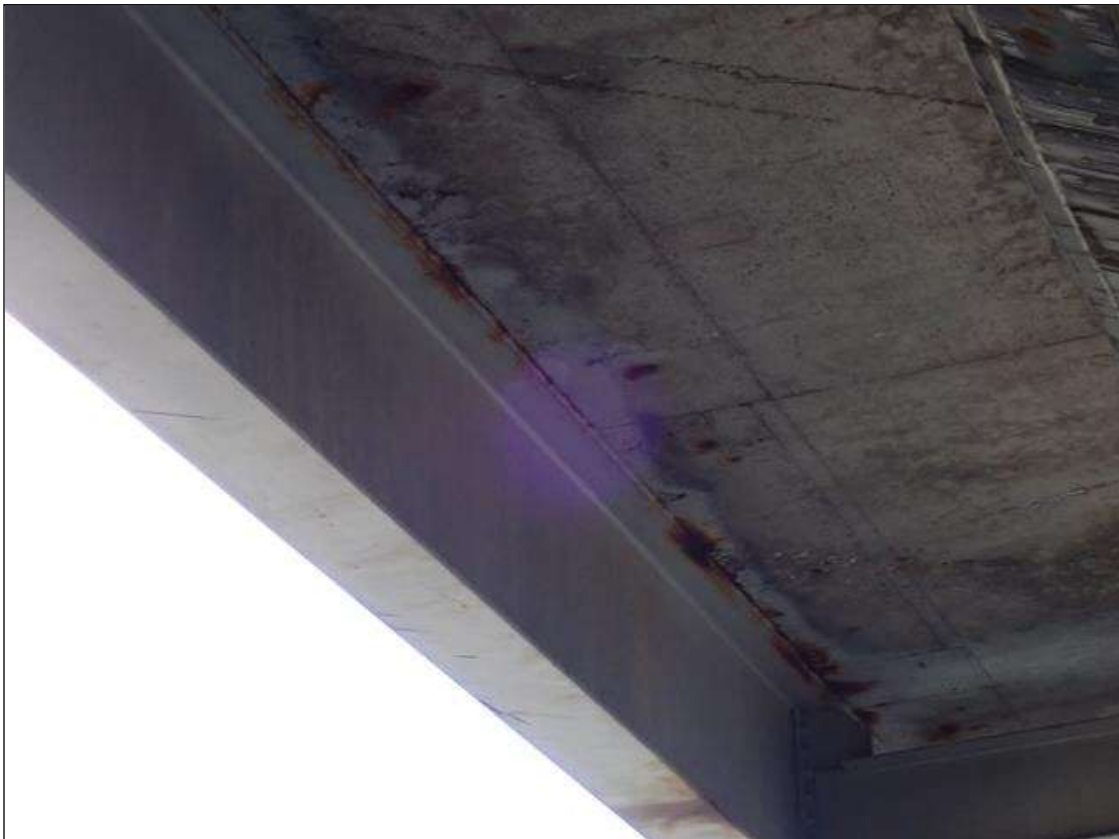
Span 2 Beam 1: surface rust at edges of top and bottom flange, at random, along beam.

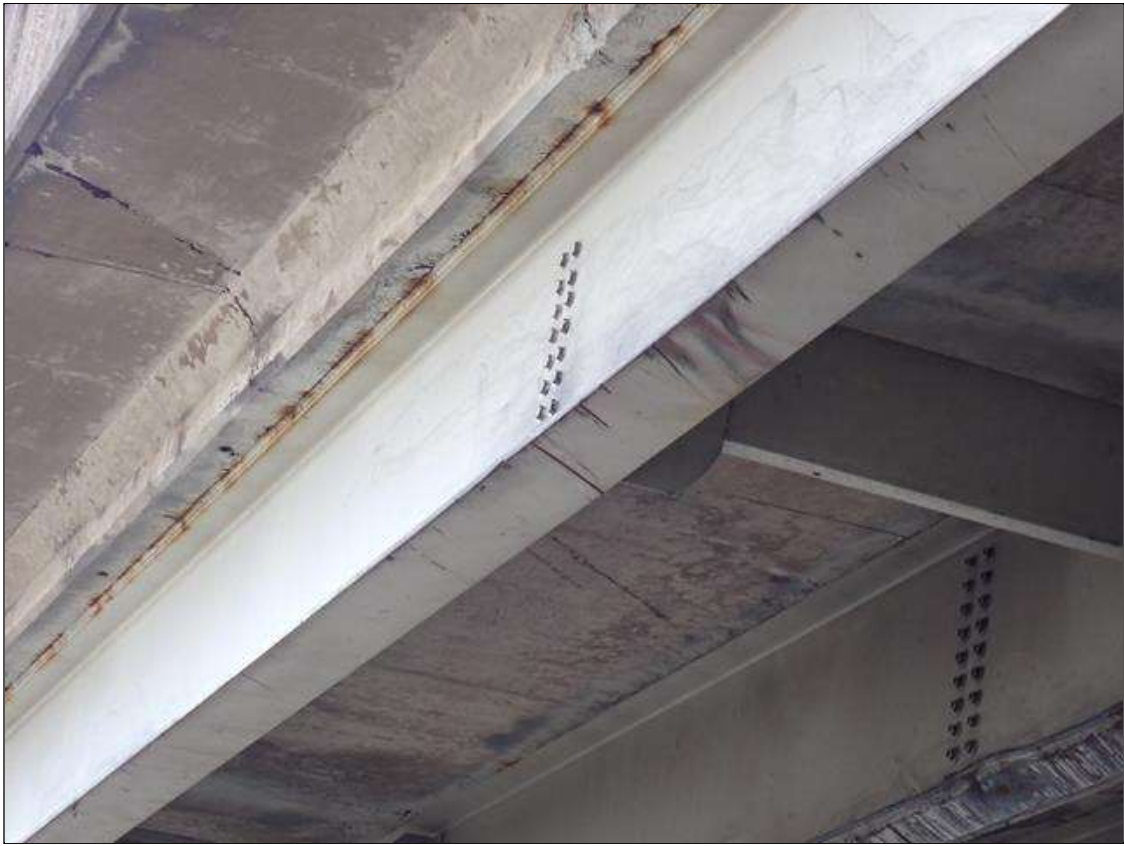
Span 2 Beam 1: impact scrapes on bottom flange with gouges up to 1/8 inch deep, 20 feet from bent 1.

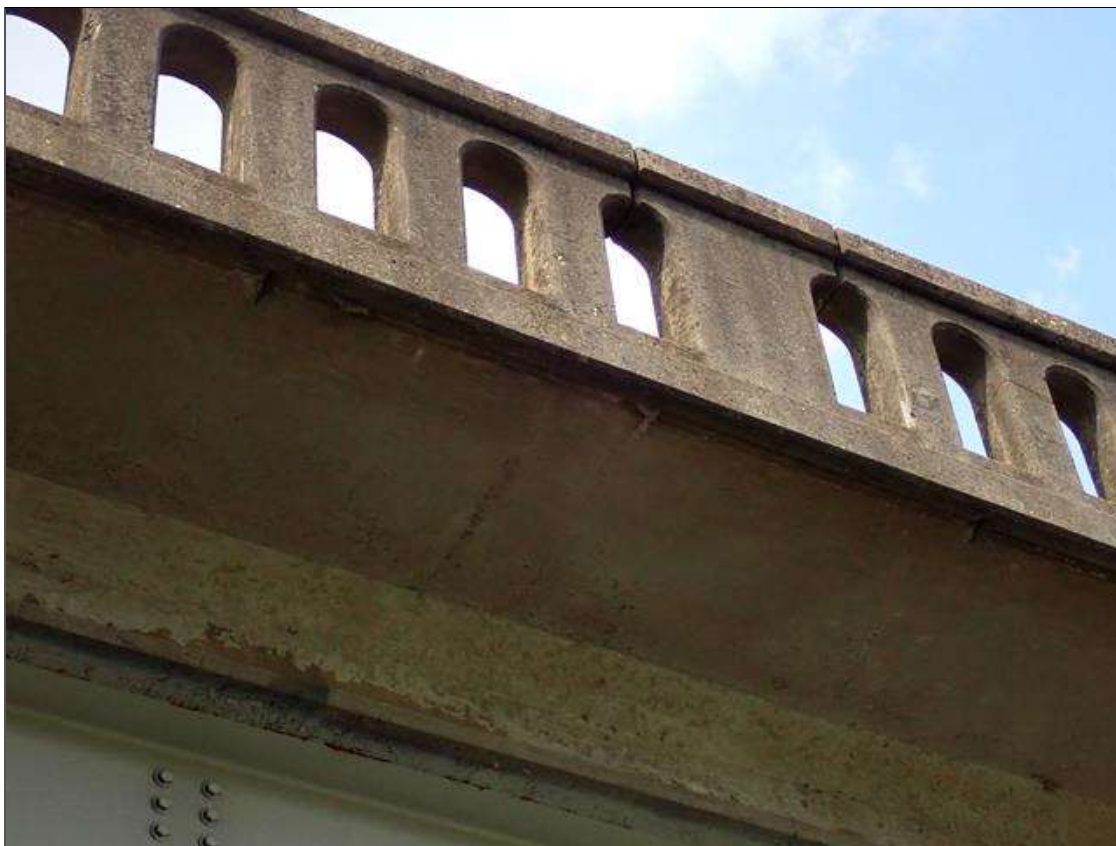
Span 2 Deck: (PAR) 8 - spalls with exposed reinforcing up to 2 inch diameter x 1/2 inch deep, underside of right overhang, at random.

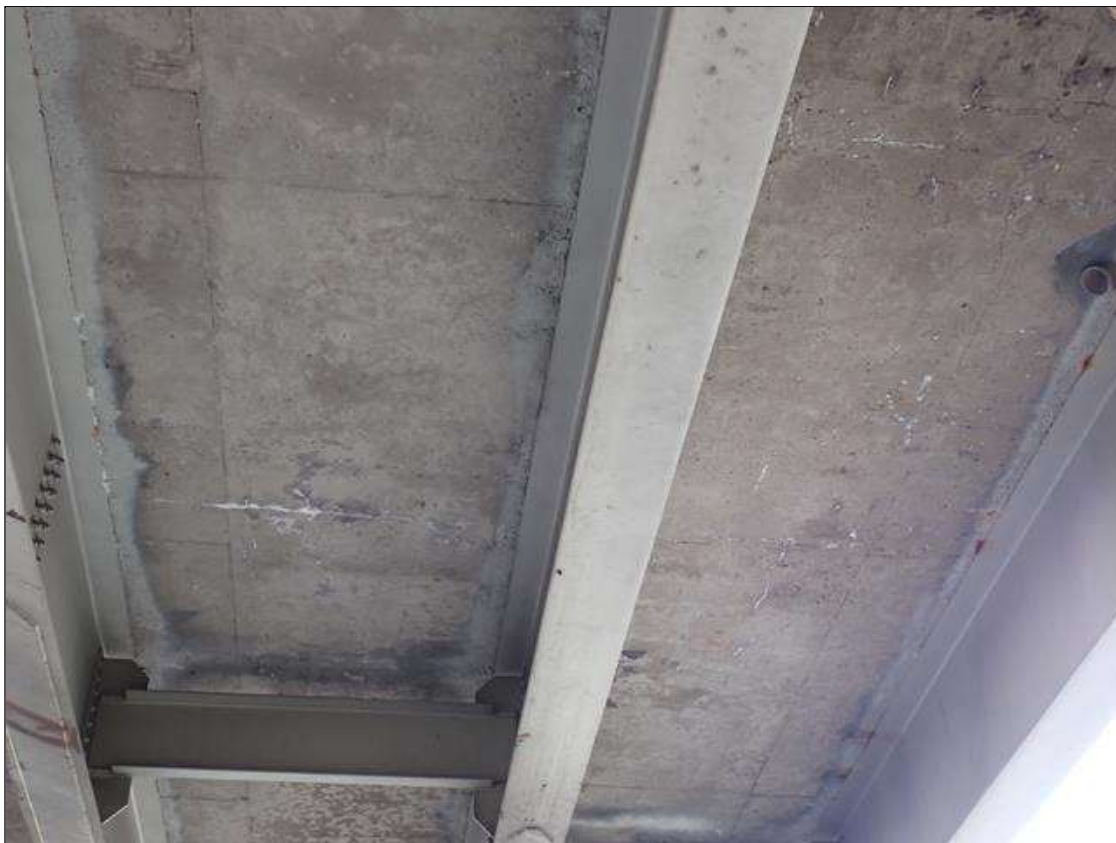
Span 2 Deck: (PAR) throughout underside of deck, in all bays, transverse cracks (up to 1/32 inch x full width) and areas of map cracks (hairline) with efflorescence buildup and some rust stains

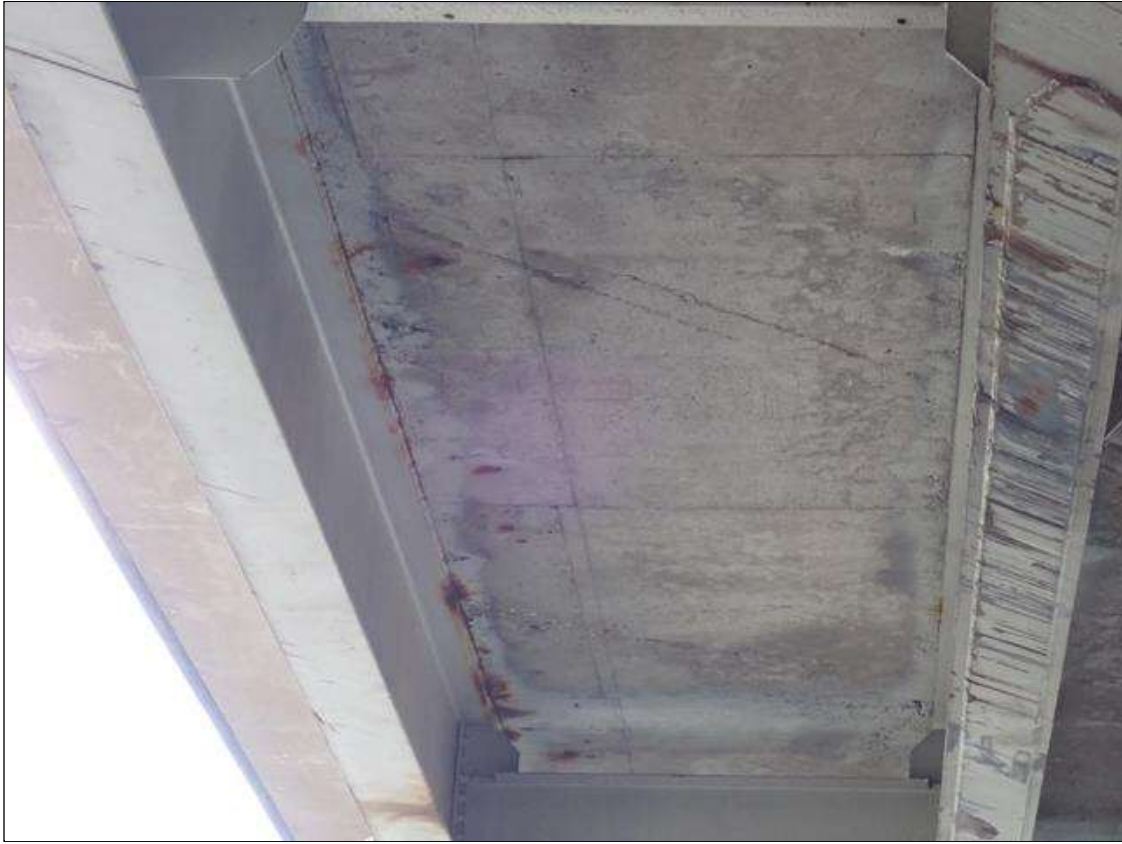
Span 2 Deck: (PAR) throughout underside of deck, in all bays, transverse cracks (up to 1/32 inch x full width) and areas of map cracks (hairline) with efflorescence buildup and some rust stains

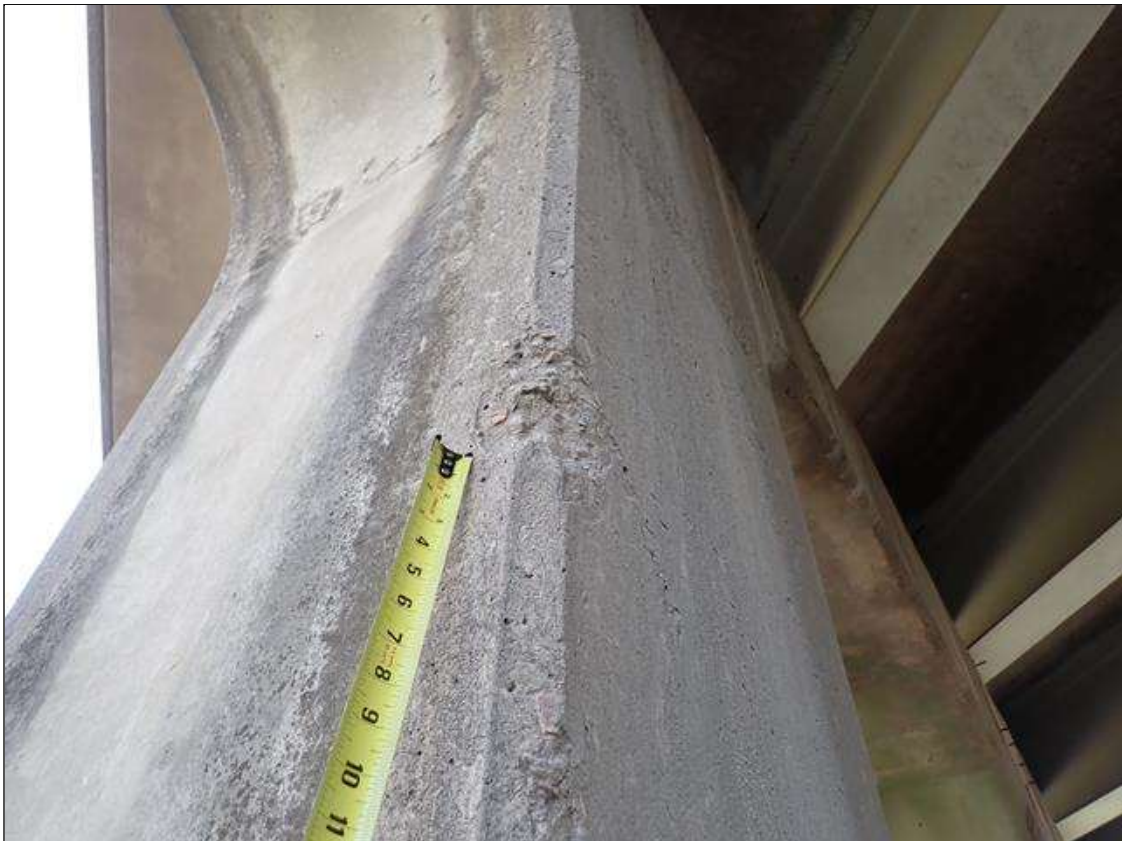
Bent 2 Pile 1: 6 inch x 4 inch x 1 inch deep spall, at southwest corner, 8.5 feet above ground.

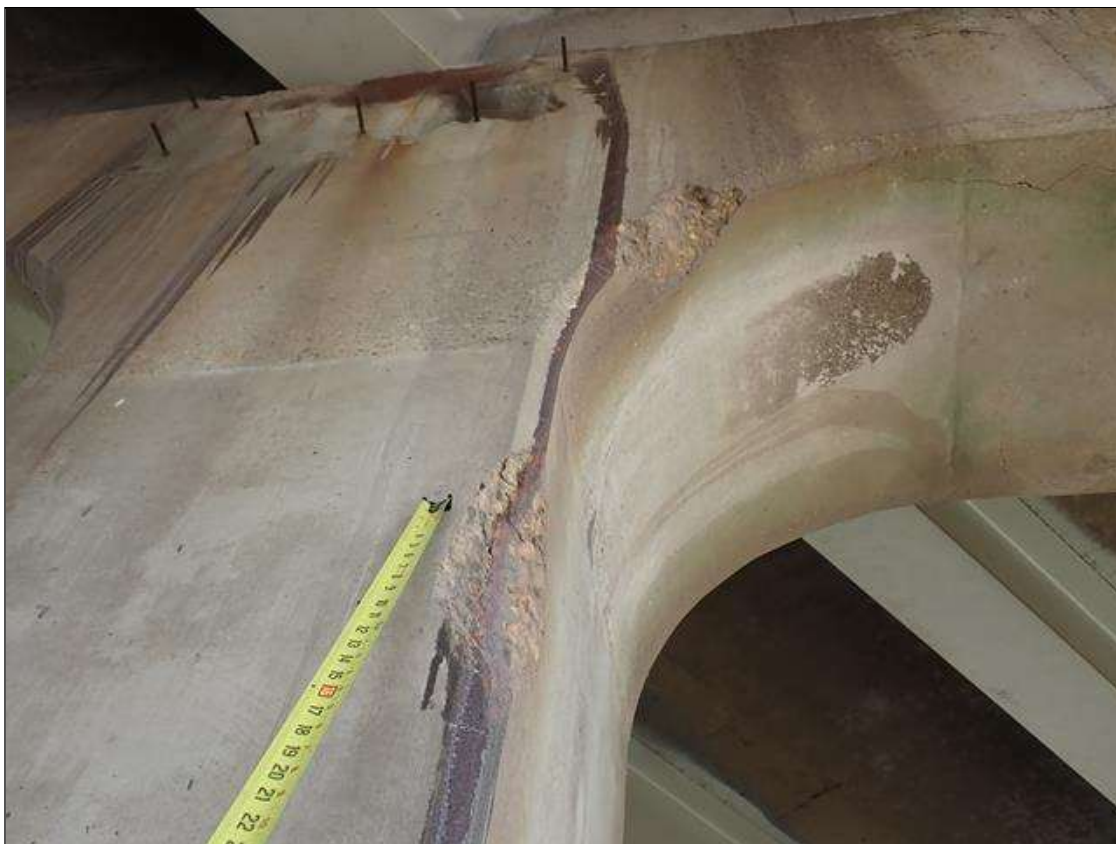
Bent 2 Pile 2: 2 - spalls up to 15 inch x 6 inch x 1.5 inch deep [no exposed rusted reinforcing] south face, at corbel near top of column.

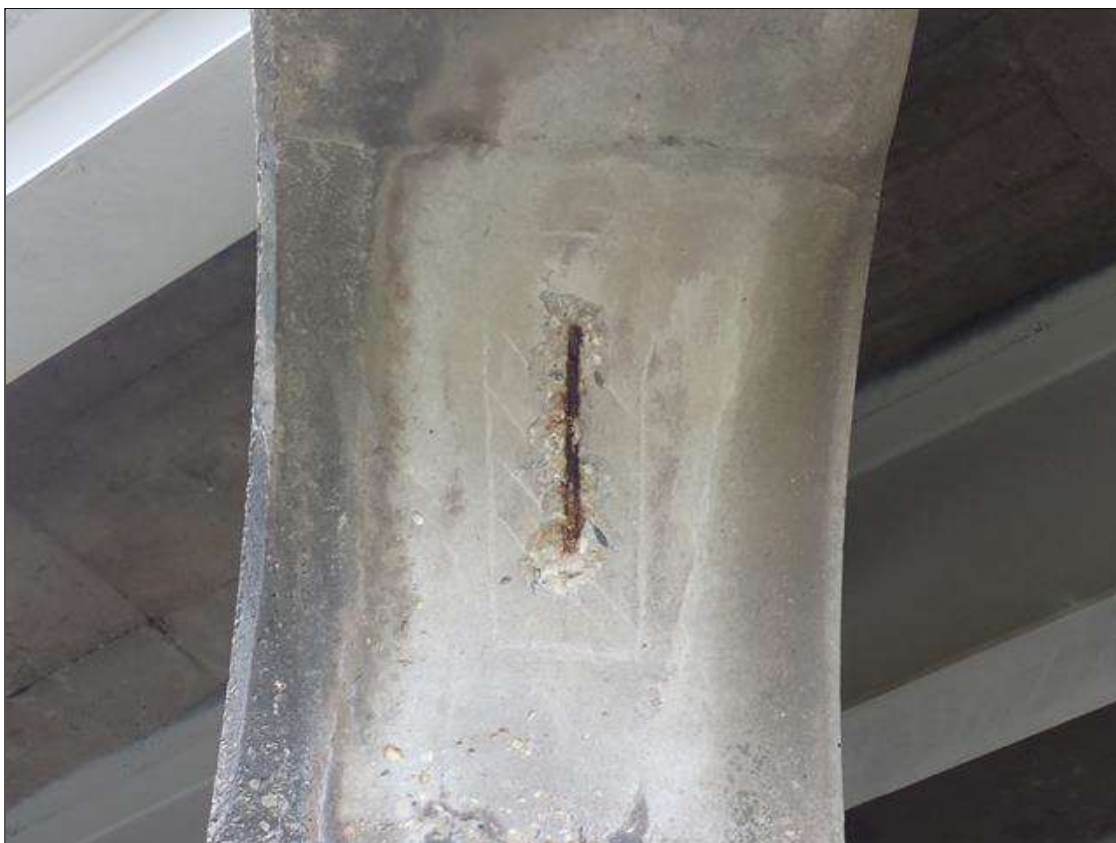
Bent 2 Cap 1: 1 foot x 3 inch x 1/2 inch deep spall with exposed reinforcing [no measurable section loss], underside of east end of overhang.

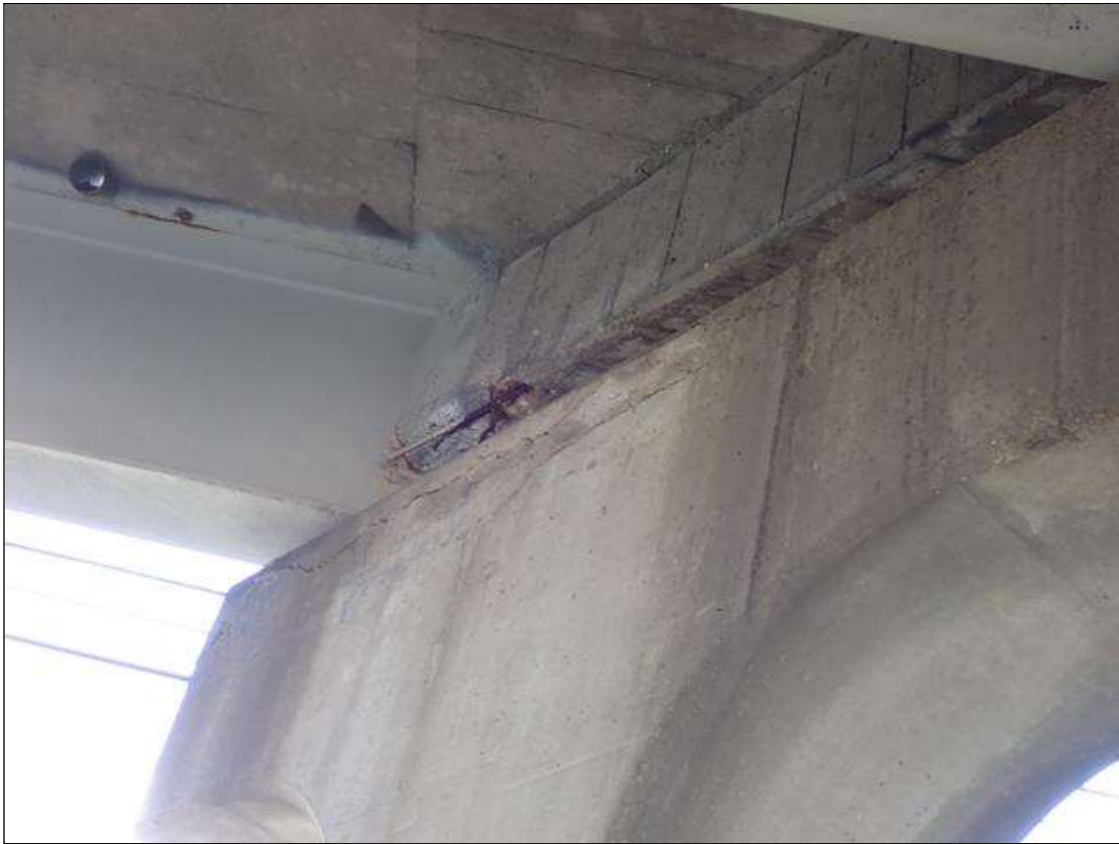
Bent 2 Cap 1: at North face and extending to top face between beam 3 to beam 5, delaminations [up to 6 feet x 1 foot] with associated cracks [up to 1/16 inch]

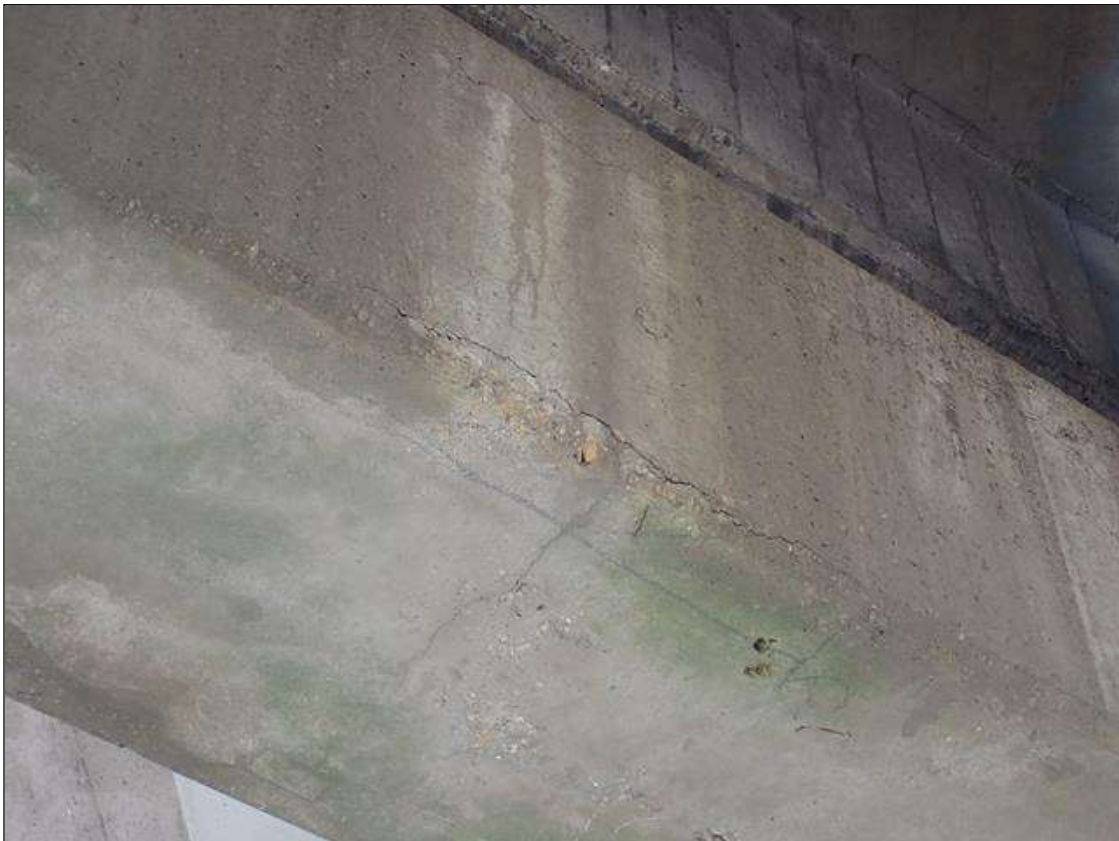
Bent 2 Cap 1: under bay 3 at North face extending to underside, delamination [31 inch x 6 inch] with associated cracks [up to 1/32 inch]
