NC DEPARTMENT OF TRANSPORTATION
 DIVISION OF HIGHWAYS
 STRUCTURE MANAGEMENT UNIT

ATTENTION: prompt action request, sketches revised, clearances revised, resurfaced with no change in asphalt wearing surface thickness

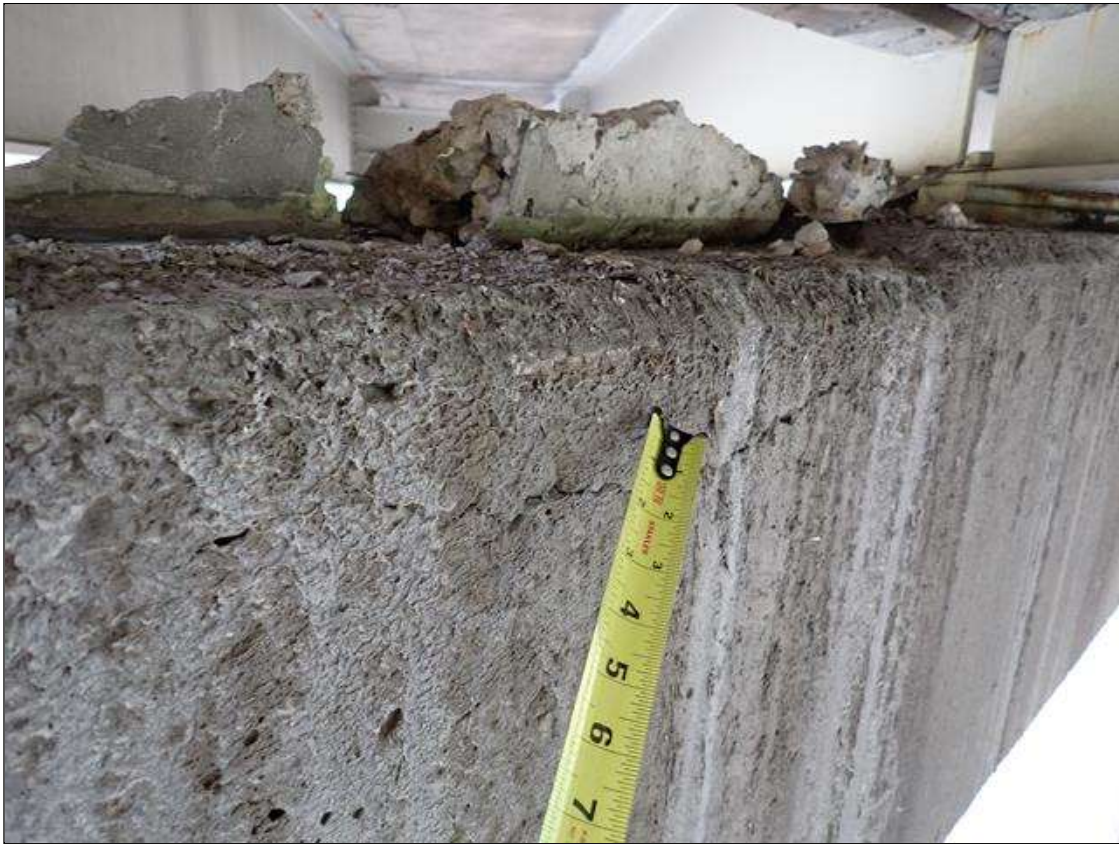
Bent 2 Cap 1: 2.5 foot x 6 inch delamination, with associated cracks up to 1/32 inch wide, south face, under bay 1.

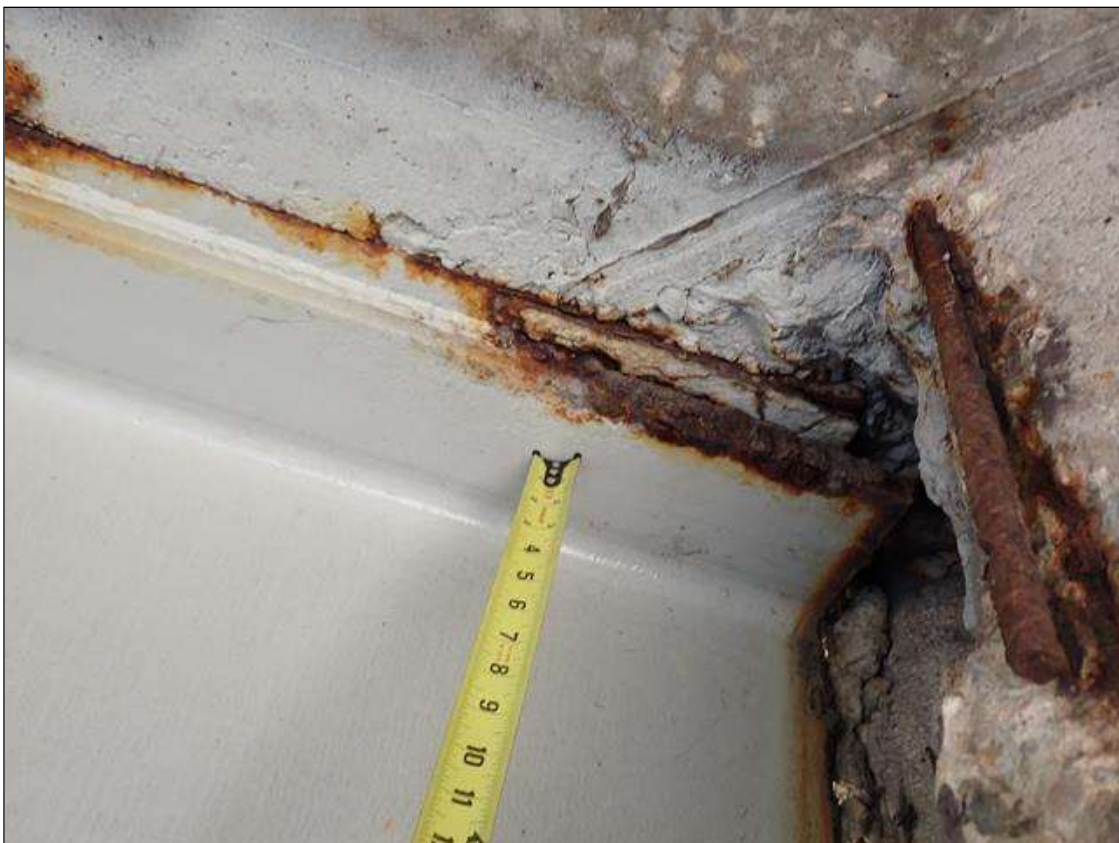
Span 2 Beam 1: at bent 2, top flange, rust scale

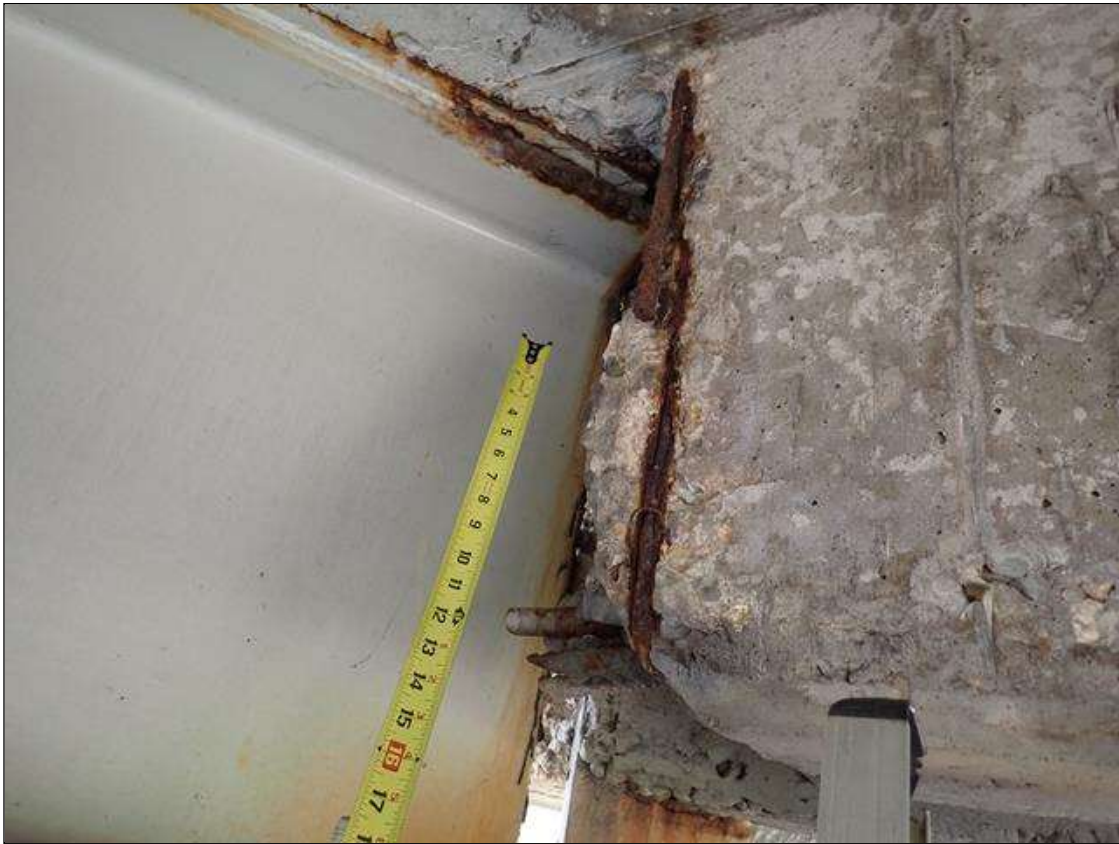
Span 2 Beam 1: end diaphragm on both sides has been removed with exposed rusted rebar, at both ends, when beam was replaced.

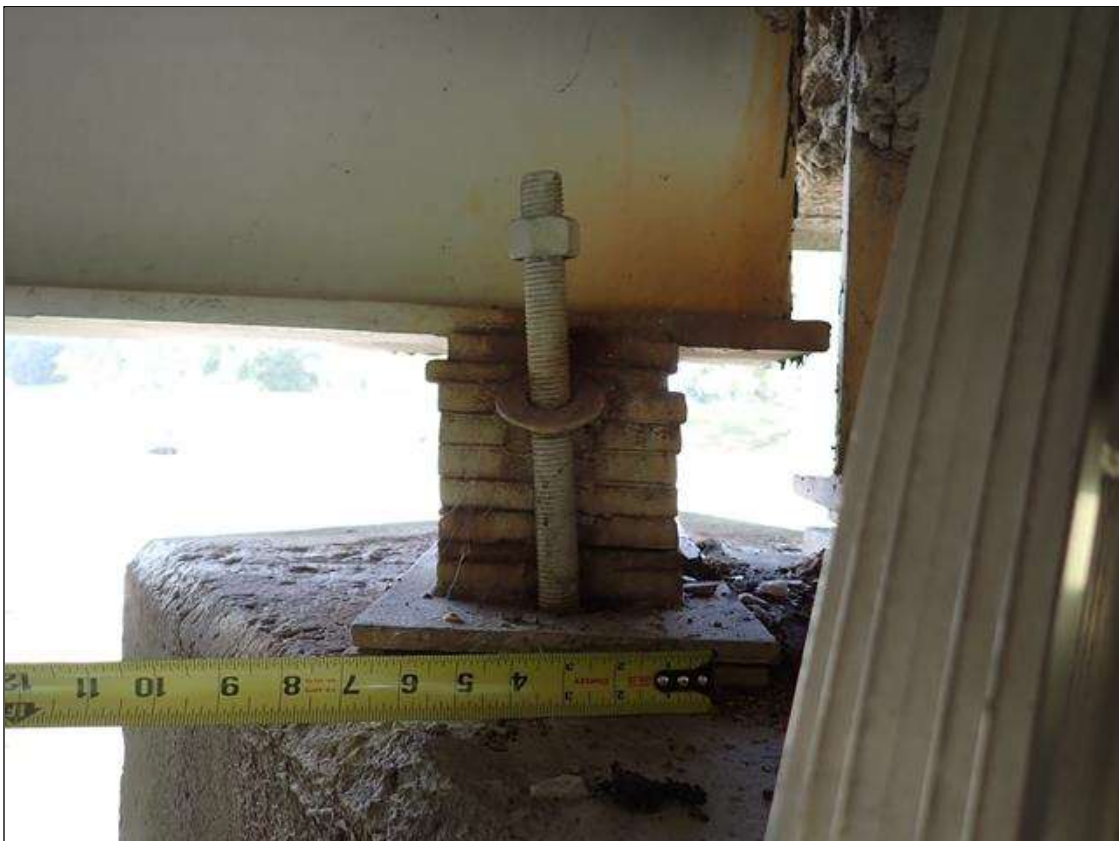
Span 2 Beam 1 - Far Bearing 1: (PAR) stacked plates, laterally misaligned (up to 1/2 inch) in relation to sole plate; no anchor bolts installed through beam and masonry plate anchor bolts too long with disengaged nuts

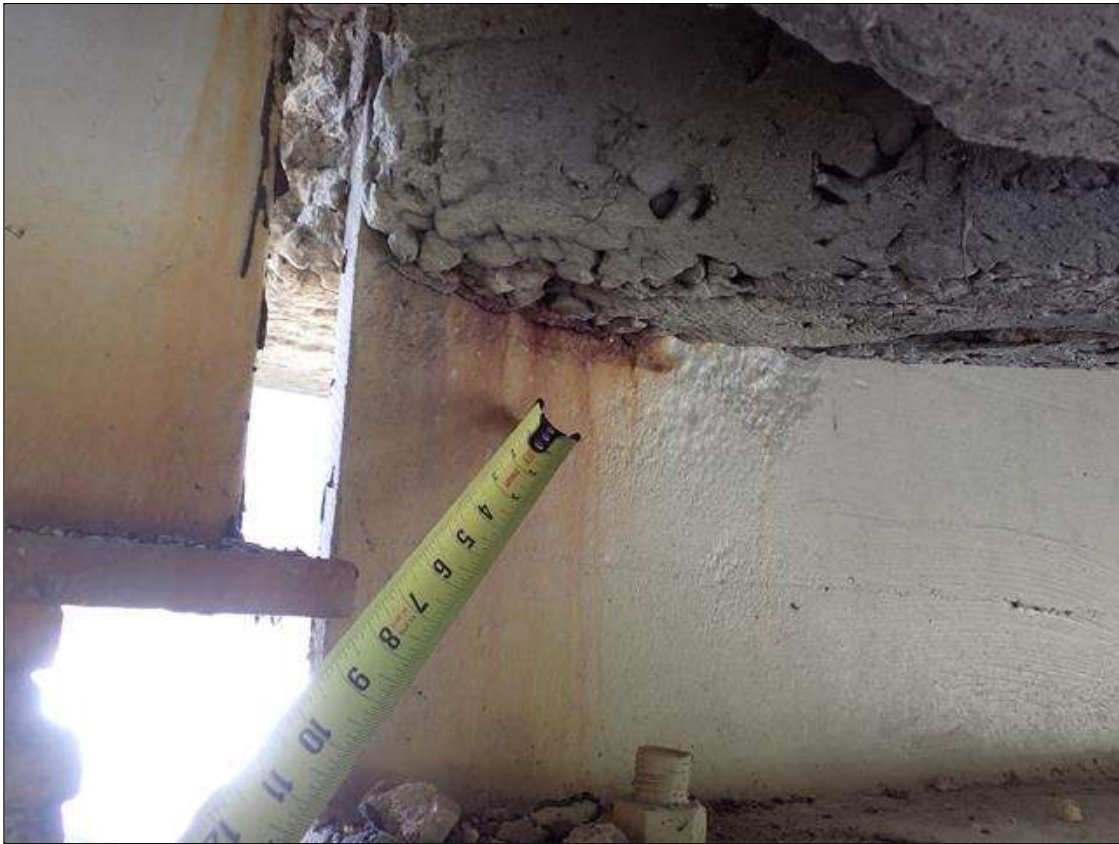
Span 3 Beam 1: (PAR) at bent 2, web adjacent to diaphragm, painted over section loss (3/8 inch average remaining x 14 inch x 4 inch) with corrosion reinitiated

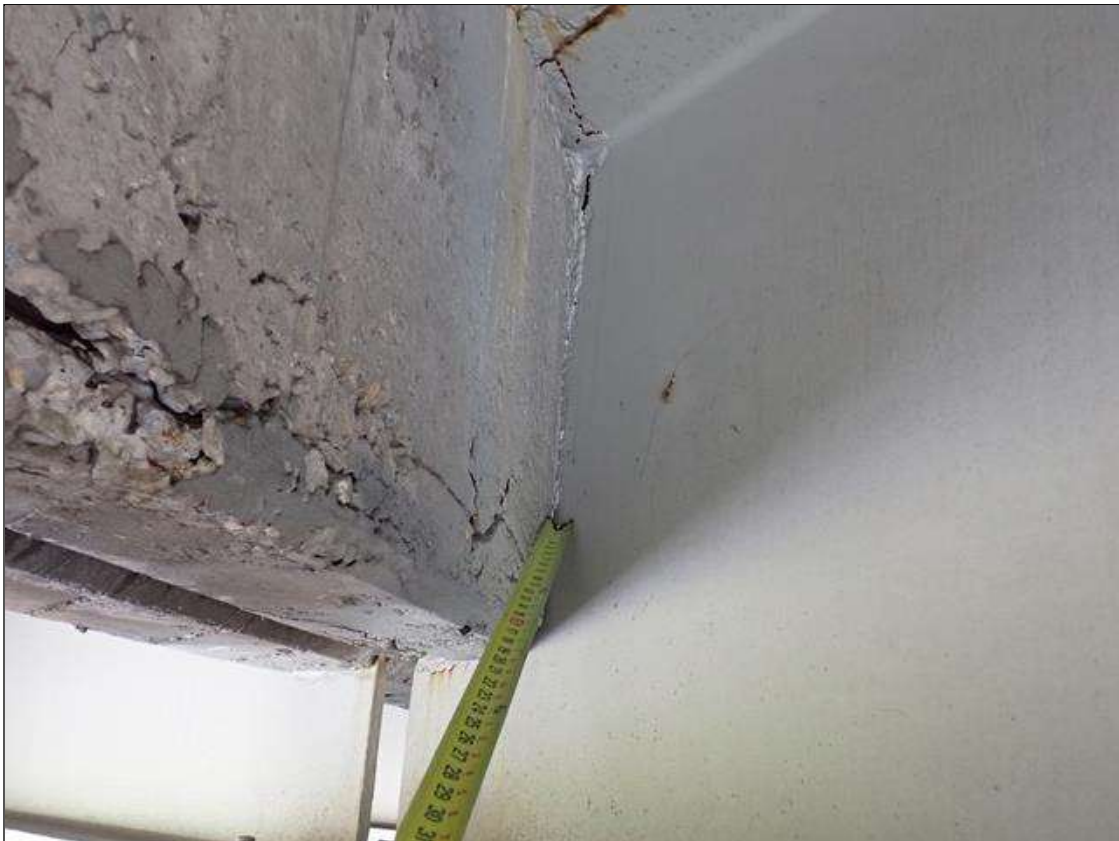
Span 2 Beam 2: at bent 2, web adjacent to diaphragm, painted over section loss (7/16 inch average remaining x 4 inch x 1 inch) with corrosion reinitiated; top flange, upper web and bottom flange, rust scale

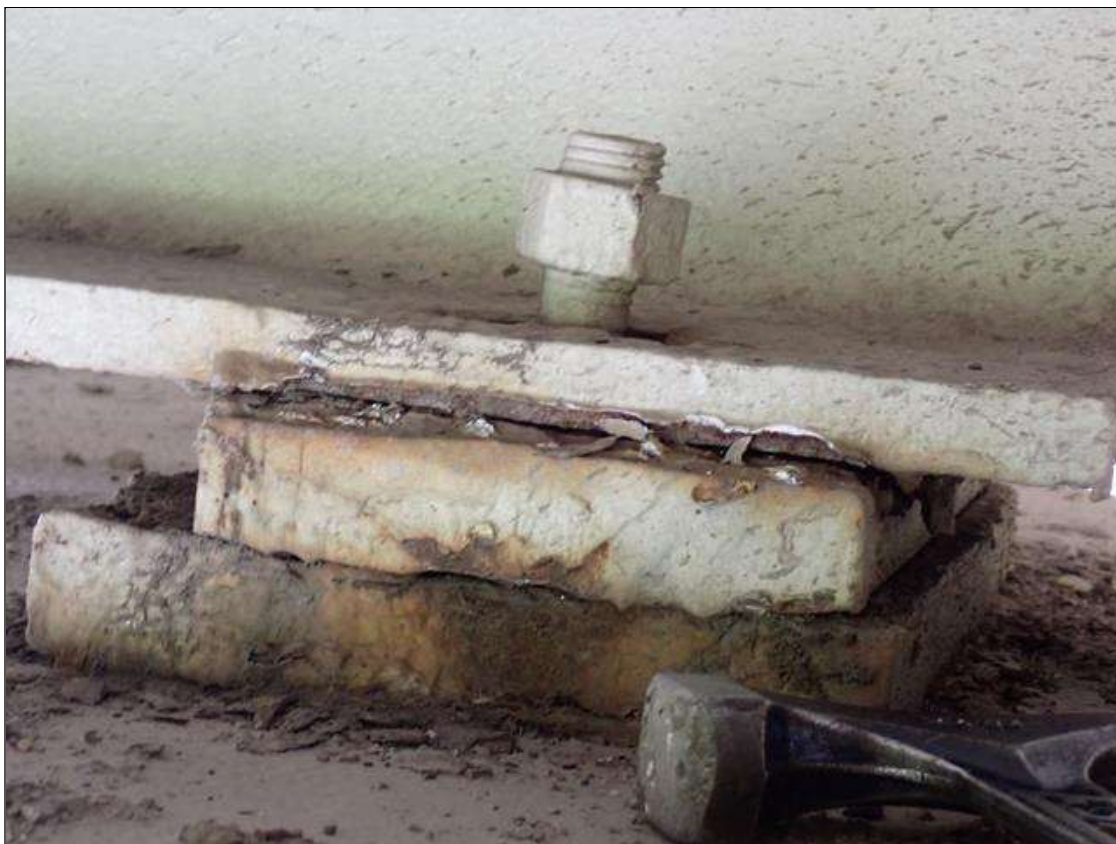
Span 2 Beam 2 - Far Bearing 2: (PAR) along east face, between sole plate and bottom flange, broken weld; right anchor bolt nut backed off

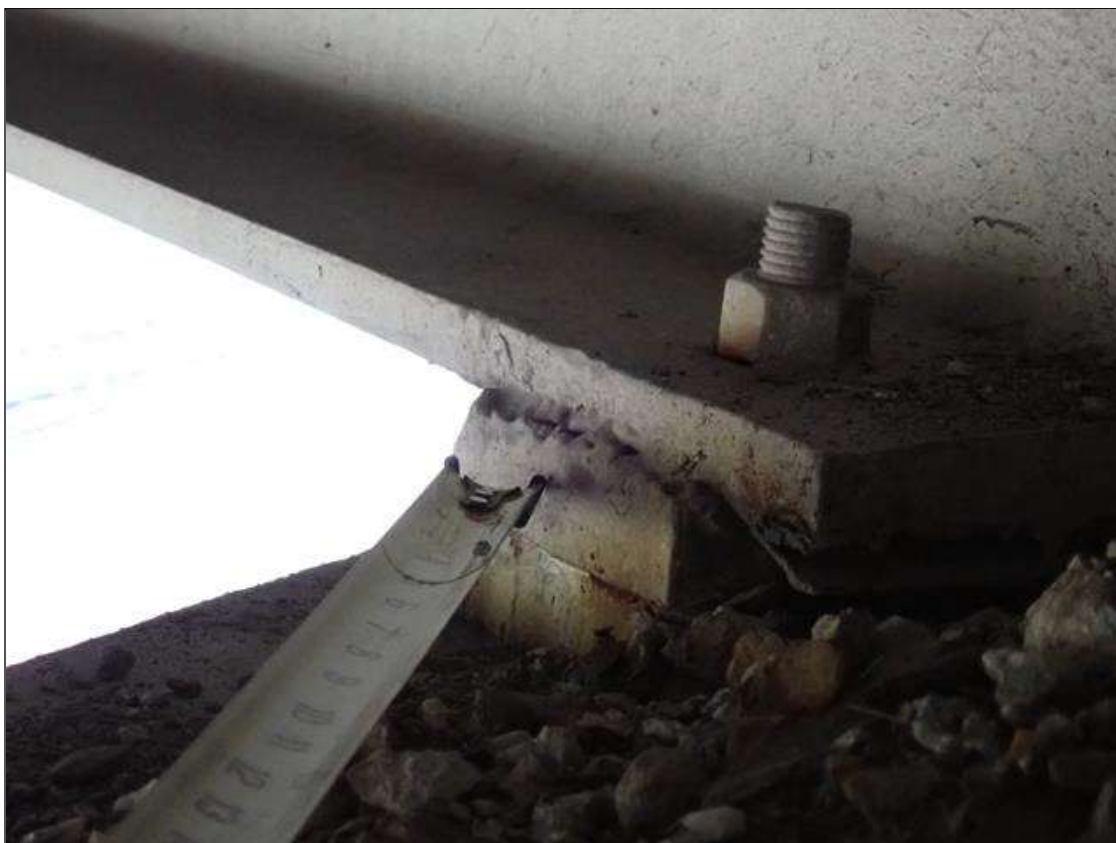
Span 3 Beam 3 - Near Bearing 3: (PAR) west face, between sole plate and bottom flange, poor quality weld with voids

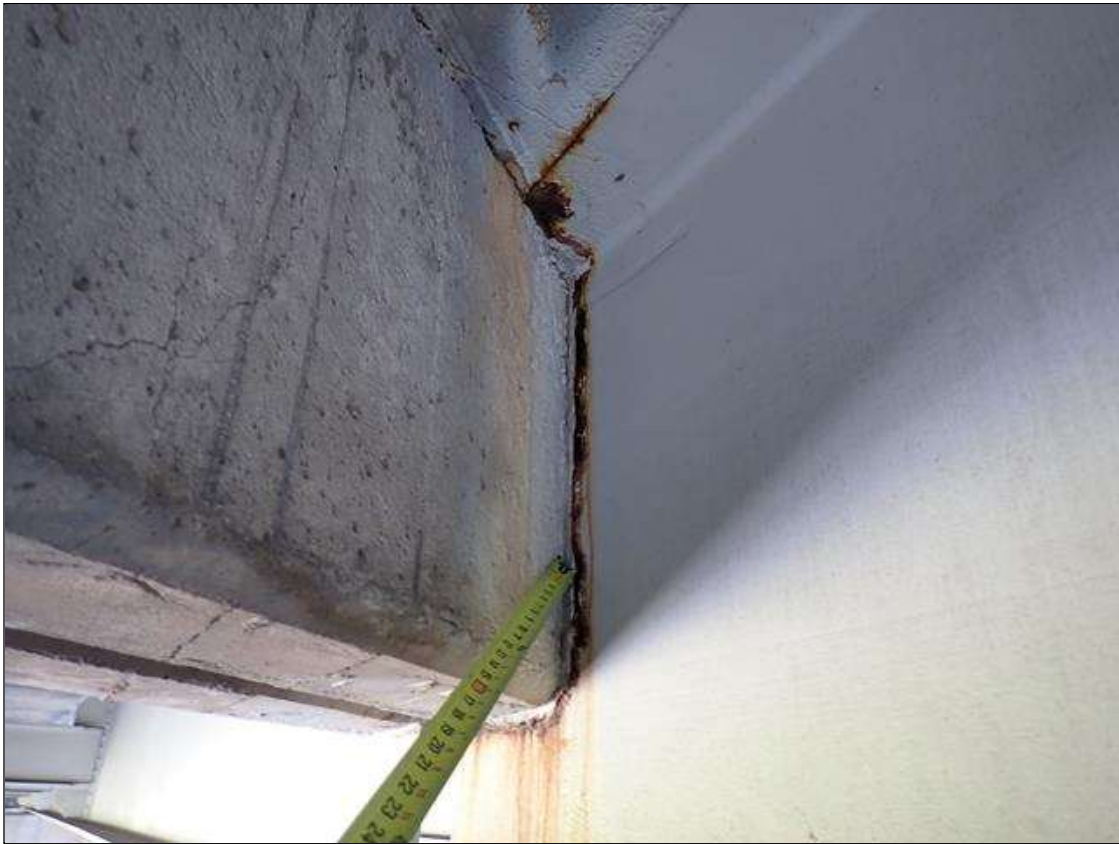
Span 2 Beam 3: at bent 2, corrosion with section loss: web adjacent to diaphragm (7/16 inch x 10 inch x up to 2 feet); top flange (3/4 inch average remaining x 3 inches)

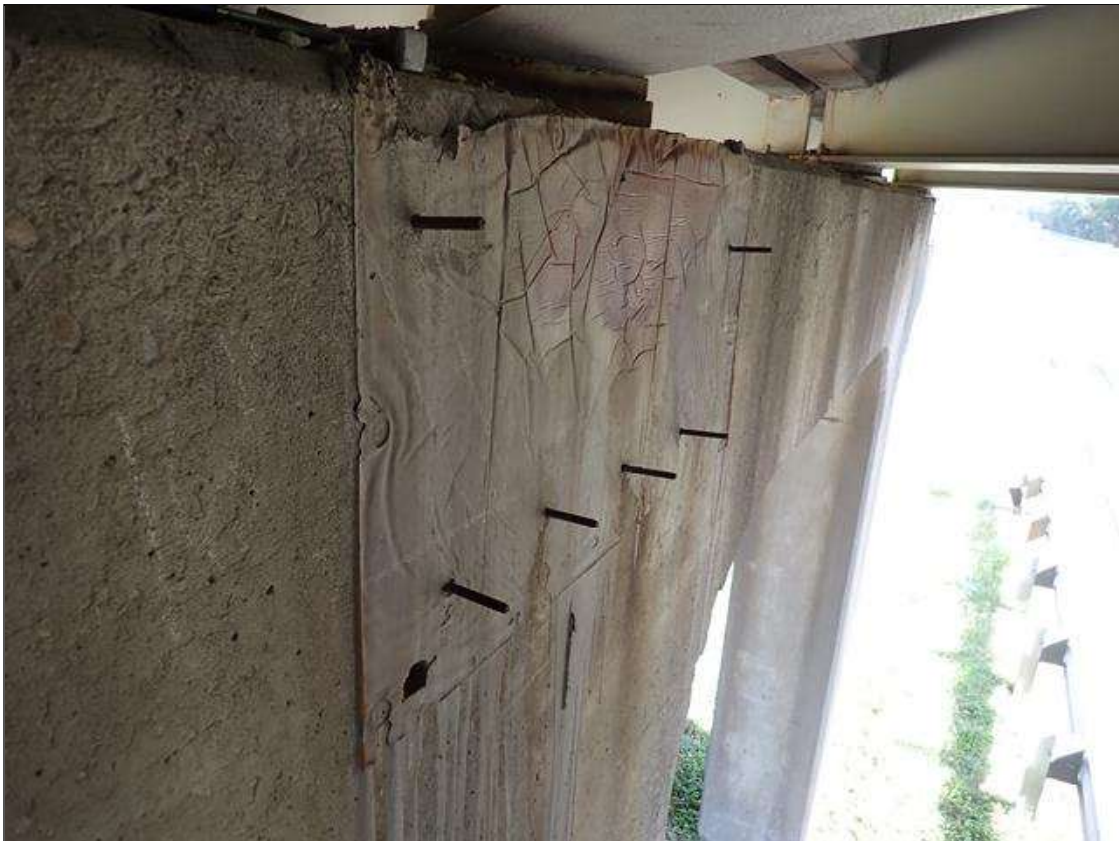
Bent 2 Cap 1: 41 inch x 23 inch patch, south face, under beam 3 with cracks up to 1/32 inch, with form bolts left in place

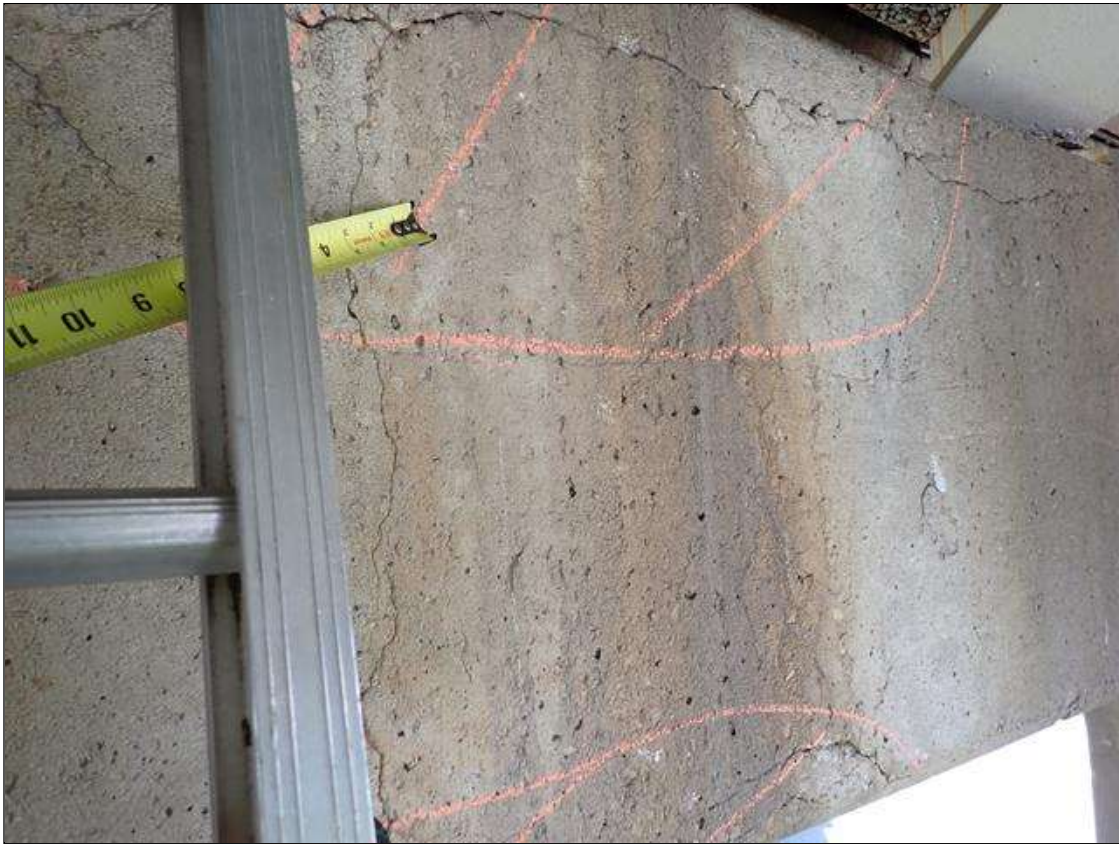
Bent 2 Cap 1: south face, below bay 3, (2) delaminations (up to 5 feet x 15 inch) with associated cracks (up to 1/16 inch)

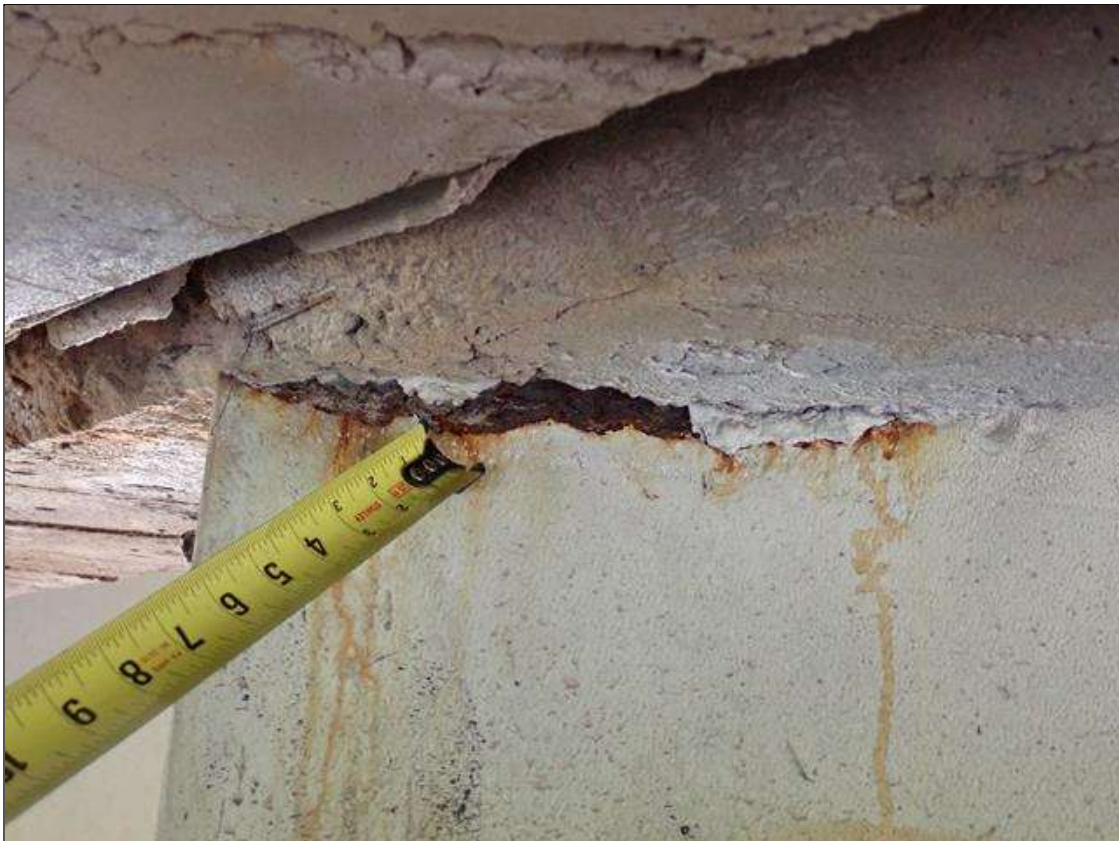
Span 3 Beam 3: (PAR) at bent 2, web adjacent to diaphragm, painted over section loss (3/8 inch average remaining x 10 inch x 1 inch) with corrosion reinitiated

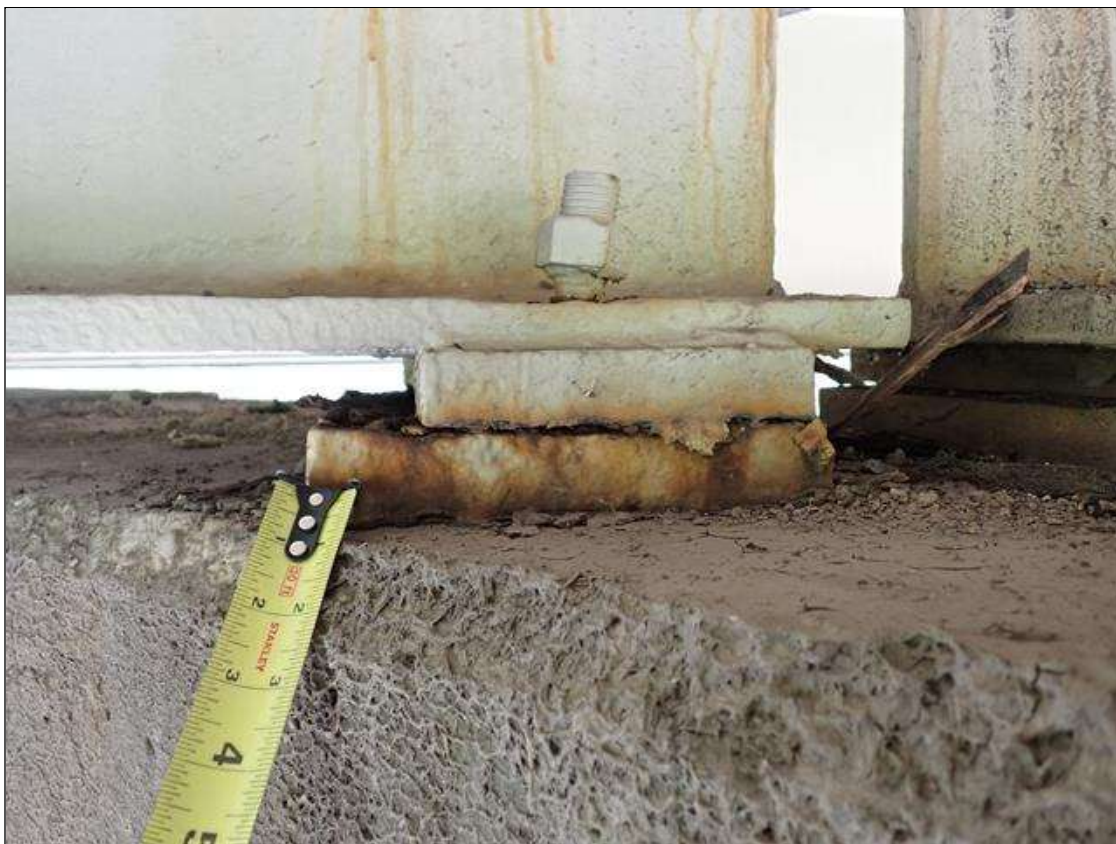
Span 2 Beam 4 - Far Bearing 4: surface rust/pack rust.

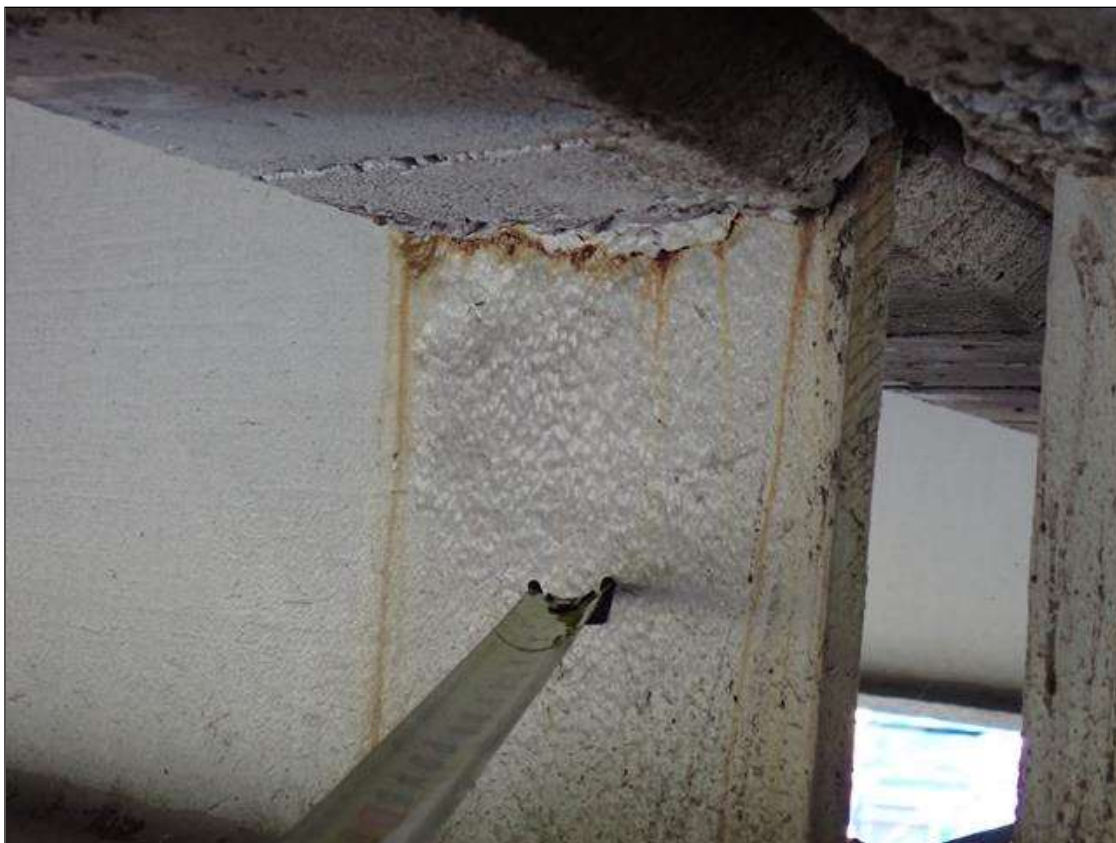
Span 3 Beam 4: (PAR) at bent 2, web adjacent to diaphragm, painted over section loss (3/8 inch average remaining x 9 inch x 5 inch) with corrosion reinitiated

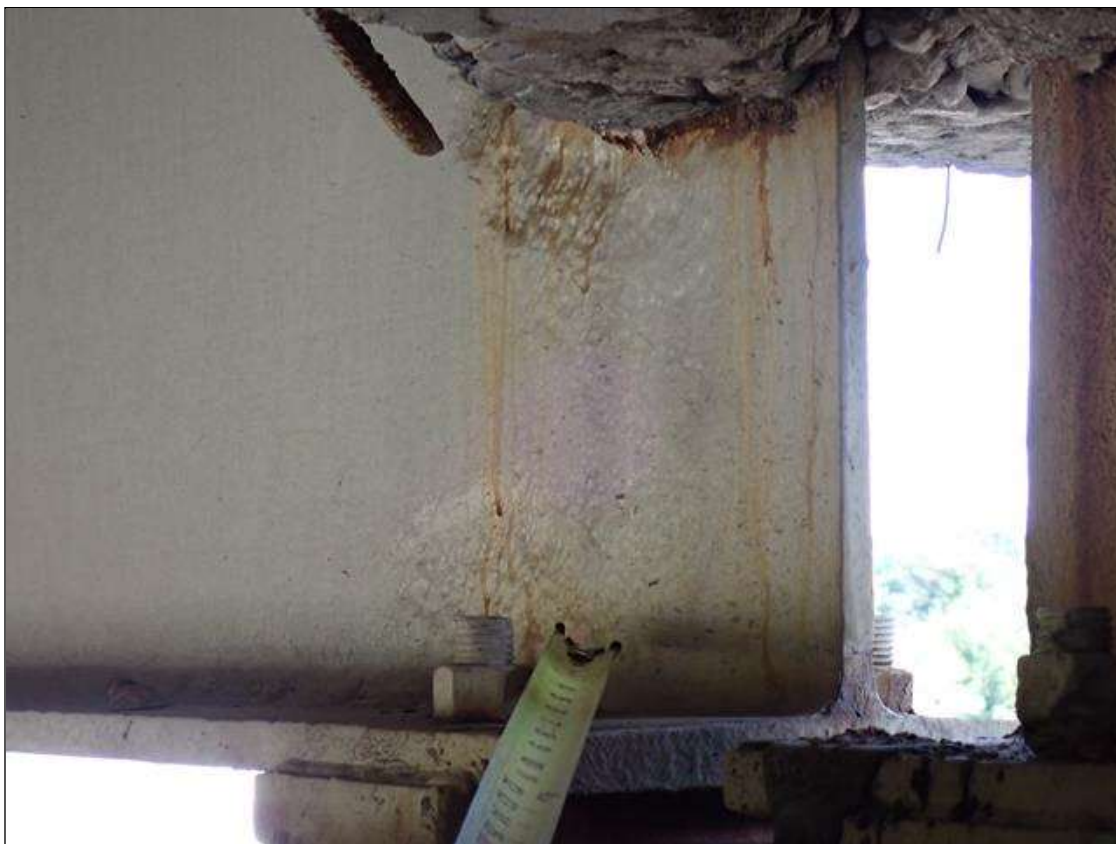
Span 3 Beam 5: (PAR) at bent 2, painted over section loss: web adjacent to diaphragm (3/8 inch average remaining x 8 inch x 4 inch); lower web (3/8 inch average remaining x 10 inch x 5 inch) with corrosion reinitiated

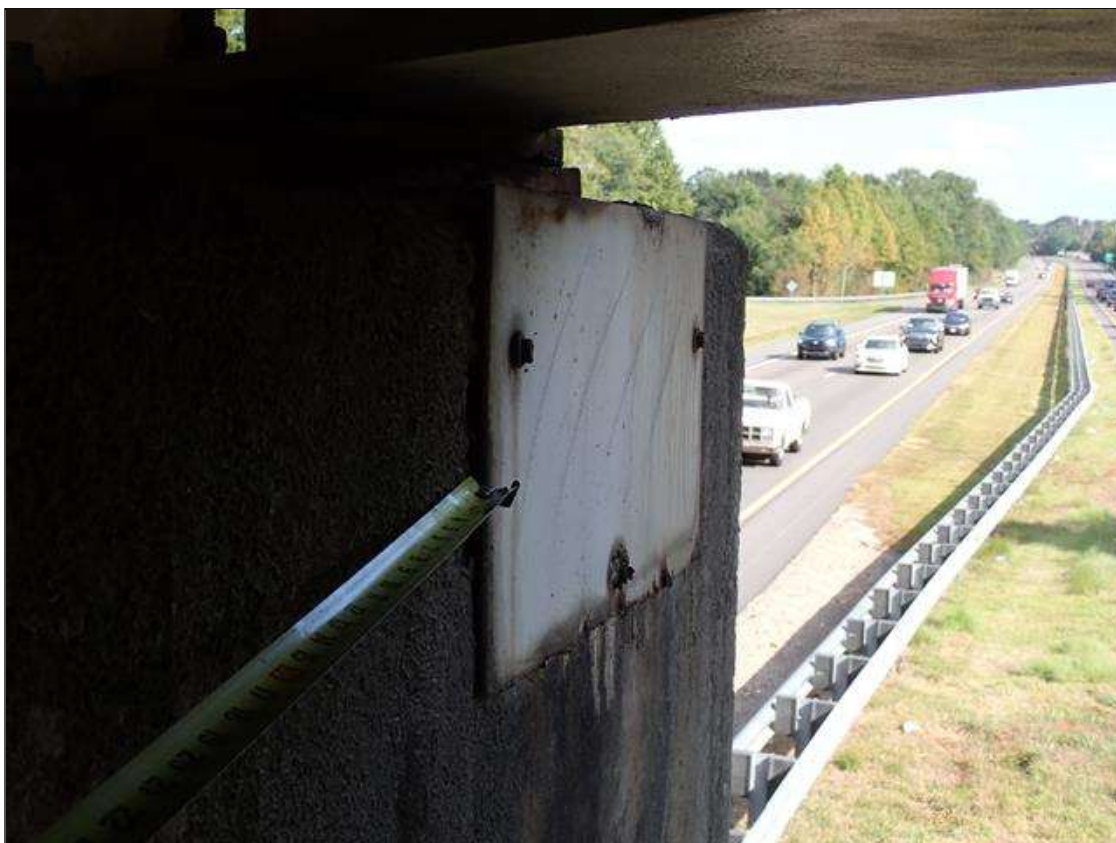
Bent 2 Cap 1: plate repair (25 inch x 11 inch), at south face, under beam 5.

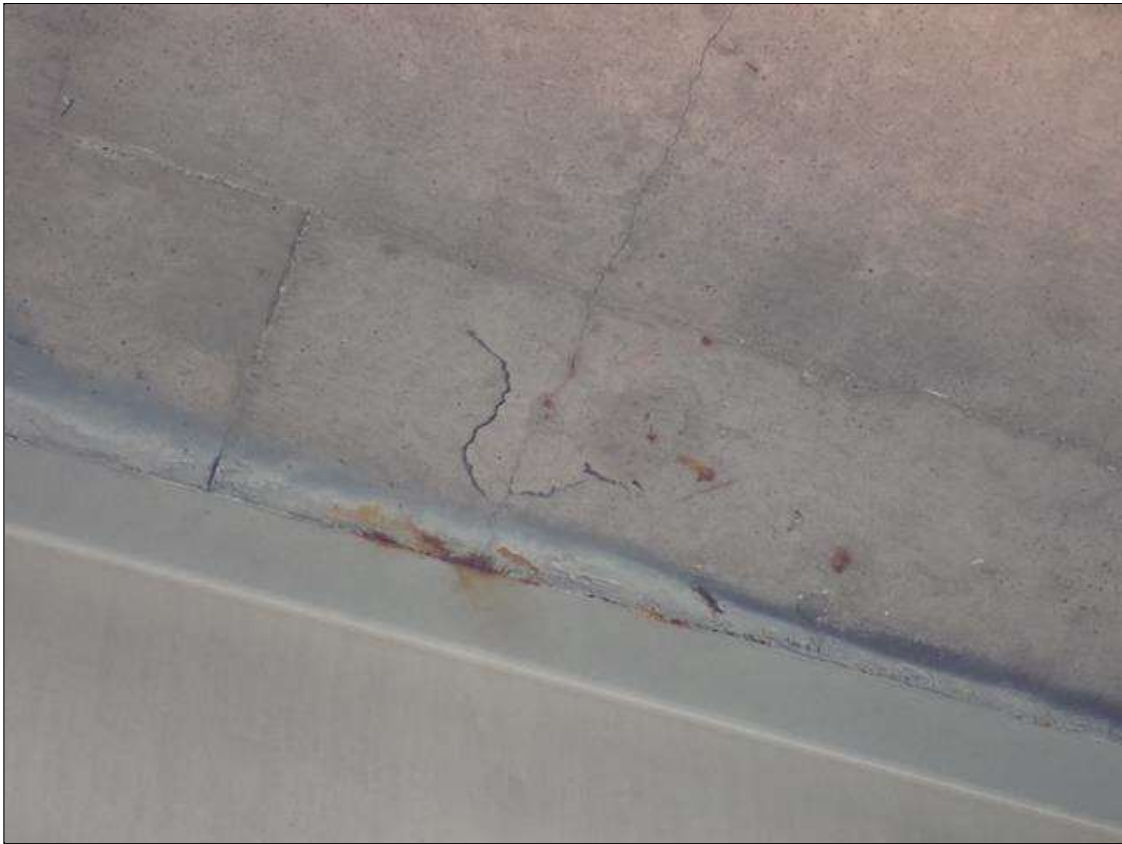
Span 3 Deck: [PAR] 19 inch x 16 inch area of delamination on underside of deck in bay 1, over left shoulder

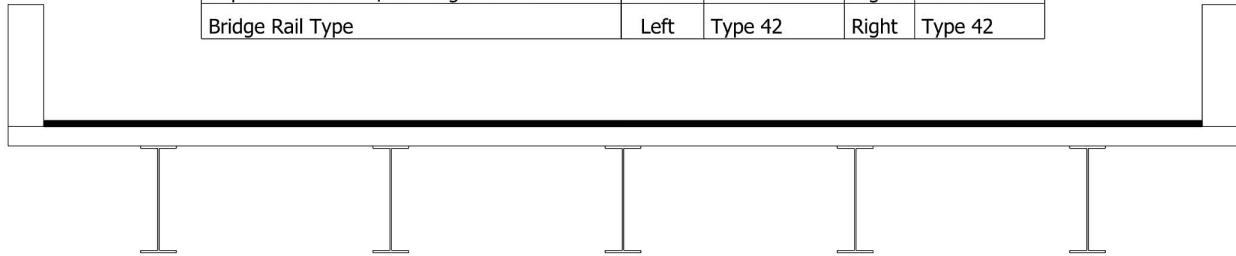
Measurements for Span #	1	all spans similar	
Deck Thickness	6.5in	Left Overhang	4.208ft
Top of Rail to Bottom of Beam (Avg)	6.948ft	Right Overhang	4.208ft

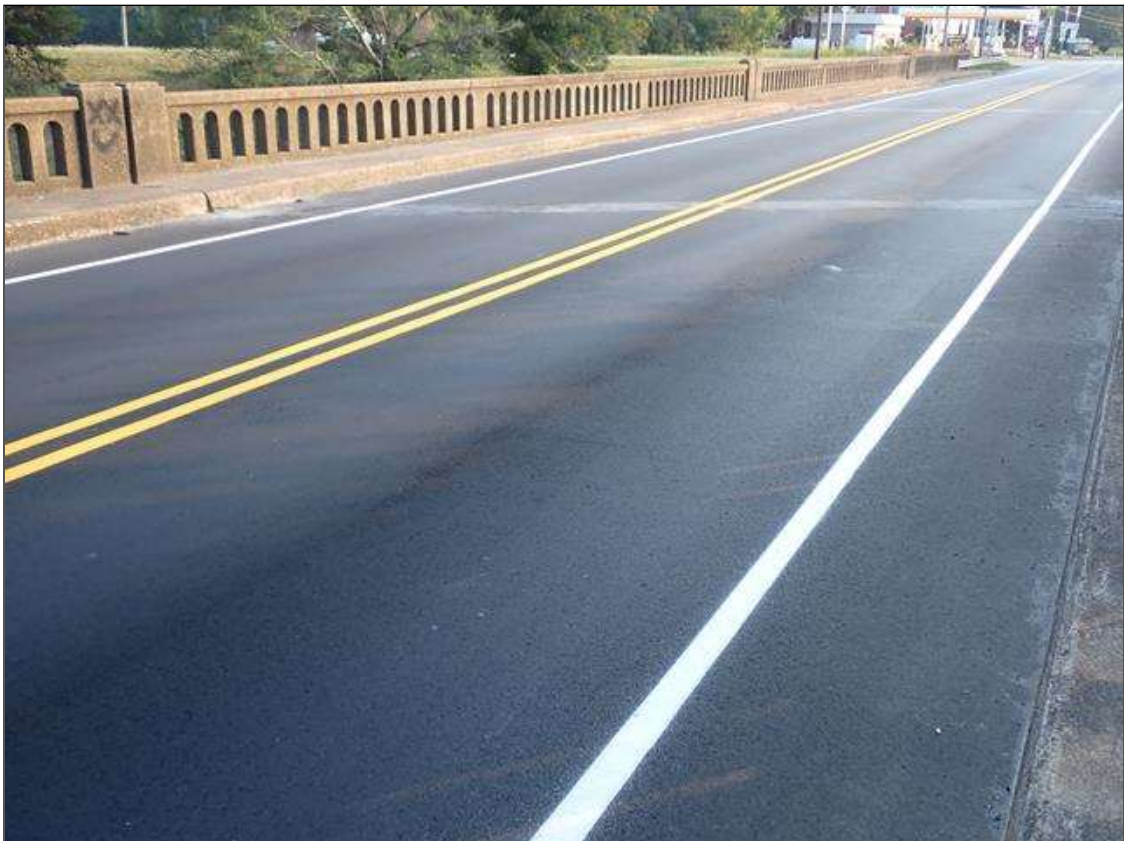
asphalt wearing surface

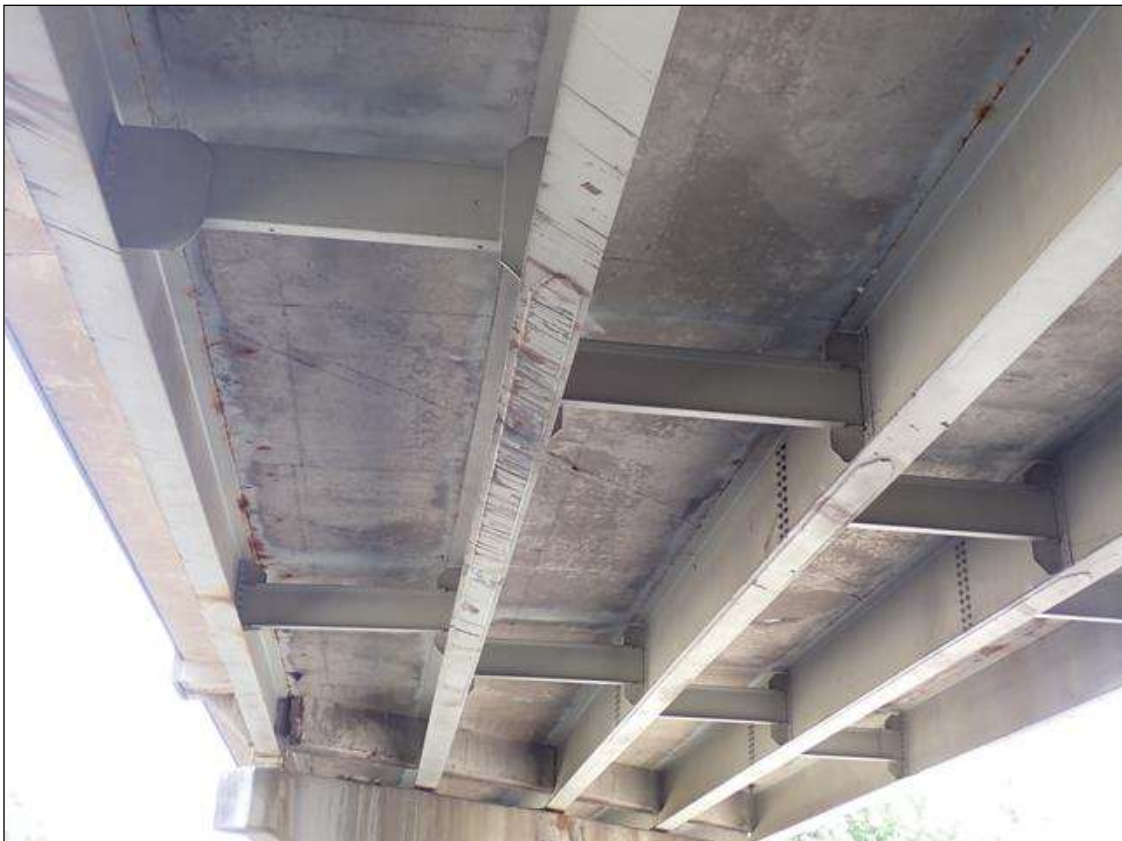
superstructure underside, span 2; note beam 1 previously replaced

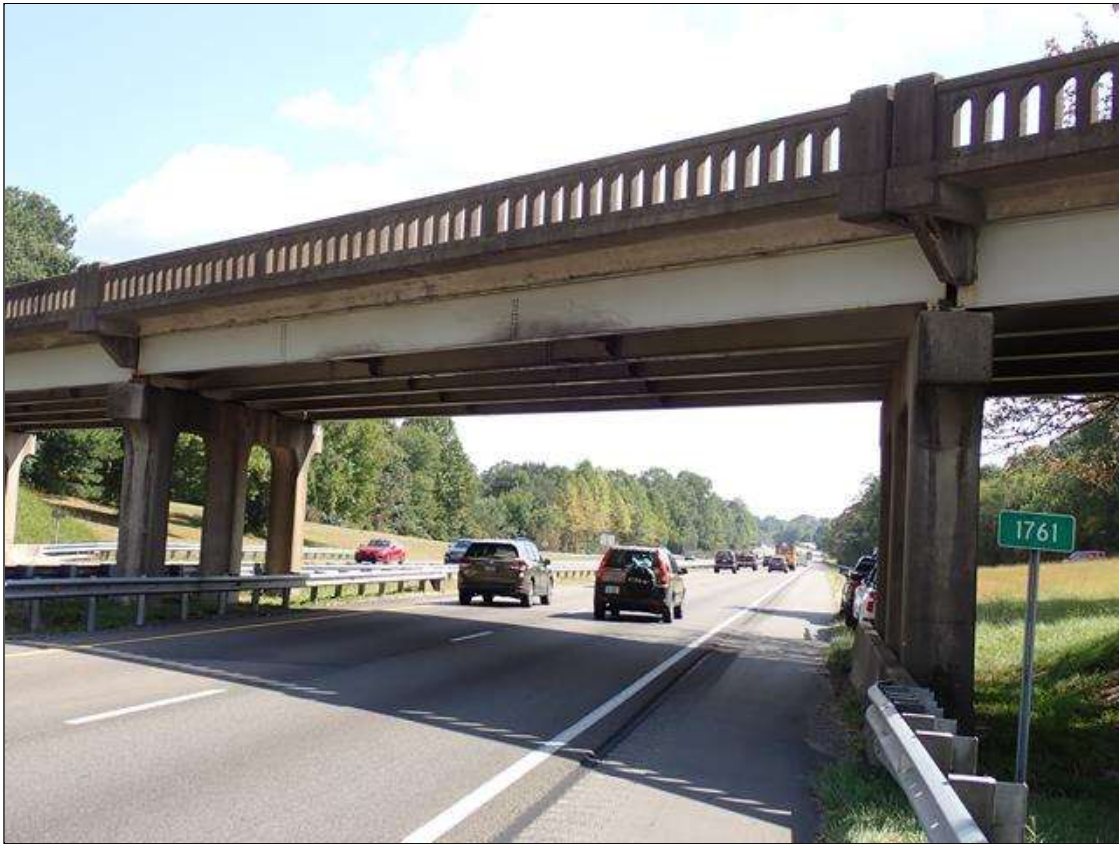
roadway under span 2, looking east (I-40 eastbound)
