NC DEPARTMENT OF TRANSPORTATION  
 DIVISION OF HIGHWAYS  
 STRUCTURE MANAGEMENT UNIT

ATTENTION: **prompt action request; sketches updated; new beam repairs**

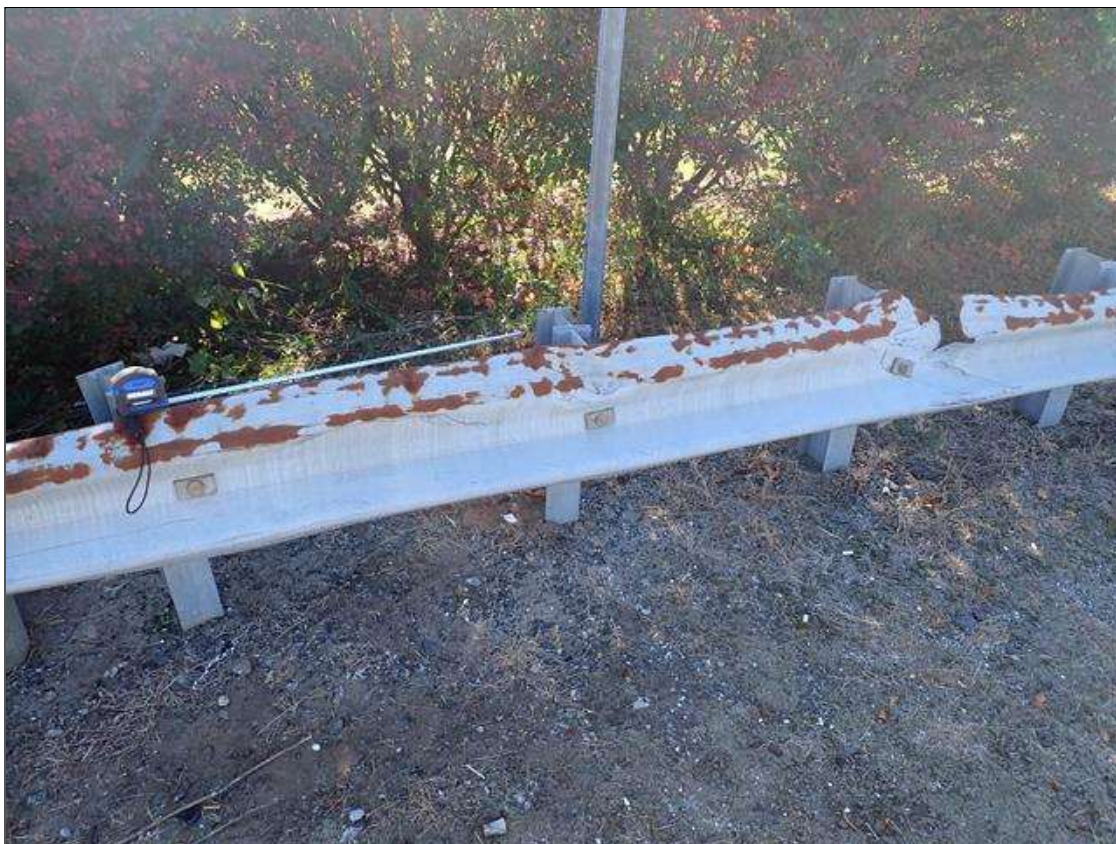
(PAR) southeast guardrail, 3 foot from end bent 1, impact damage (9 foot)

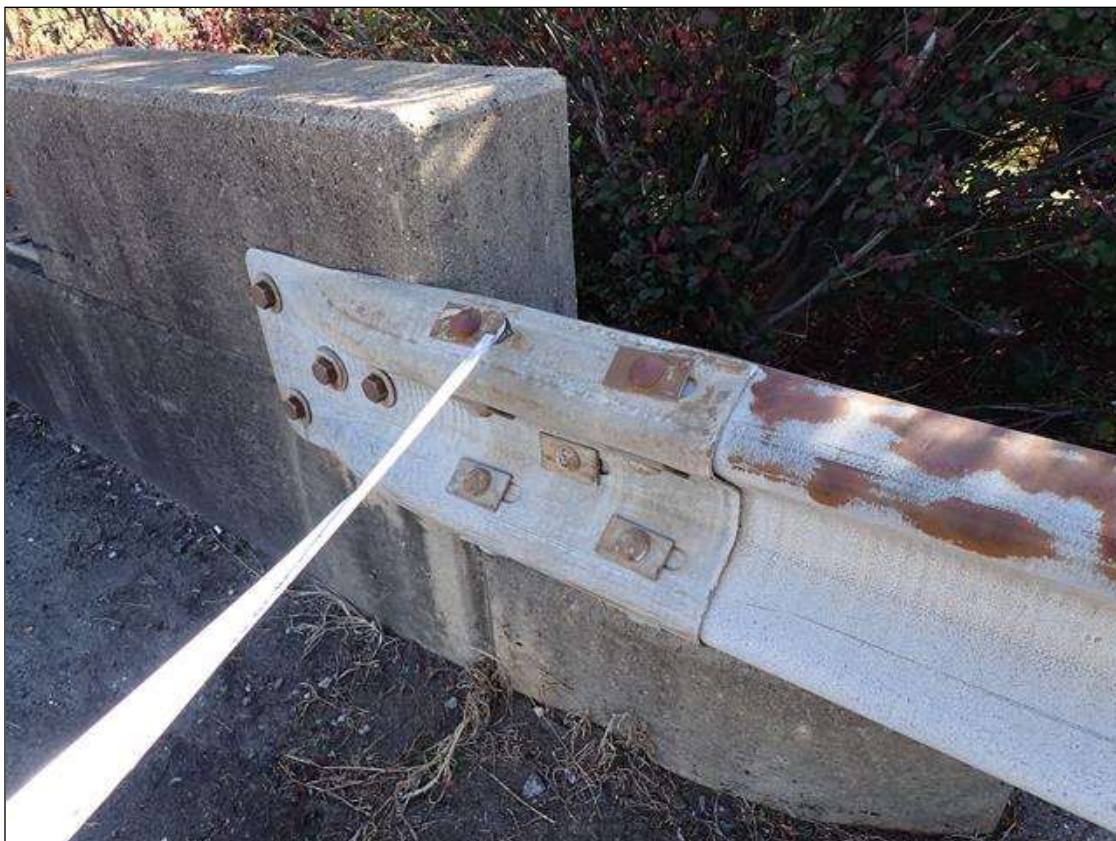
(PAR) southeast guardrail attachment, improper lap

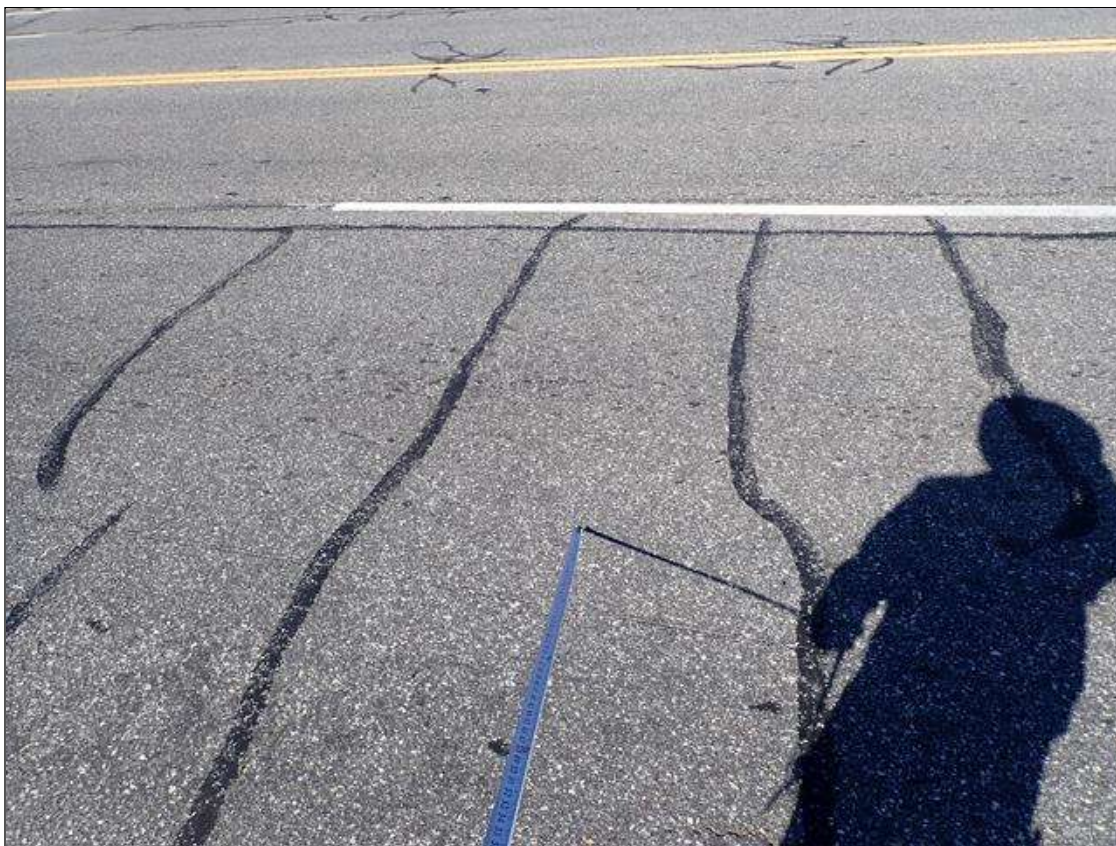
Span 1 Wearing Surface: throughout asphalt wearing surface, partially sealed transverse and longitudinal cracks (up to 1/16 inch x 8 foot)

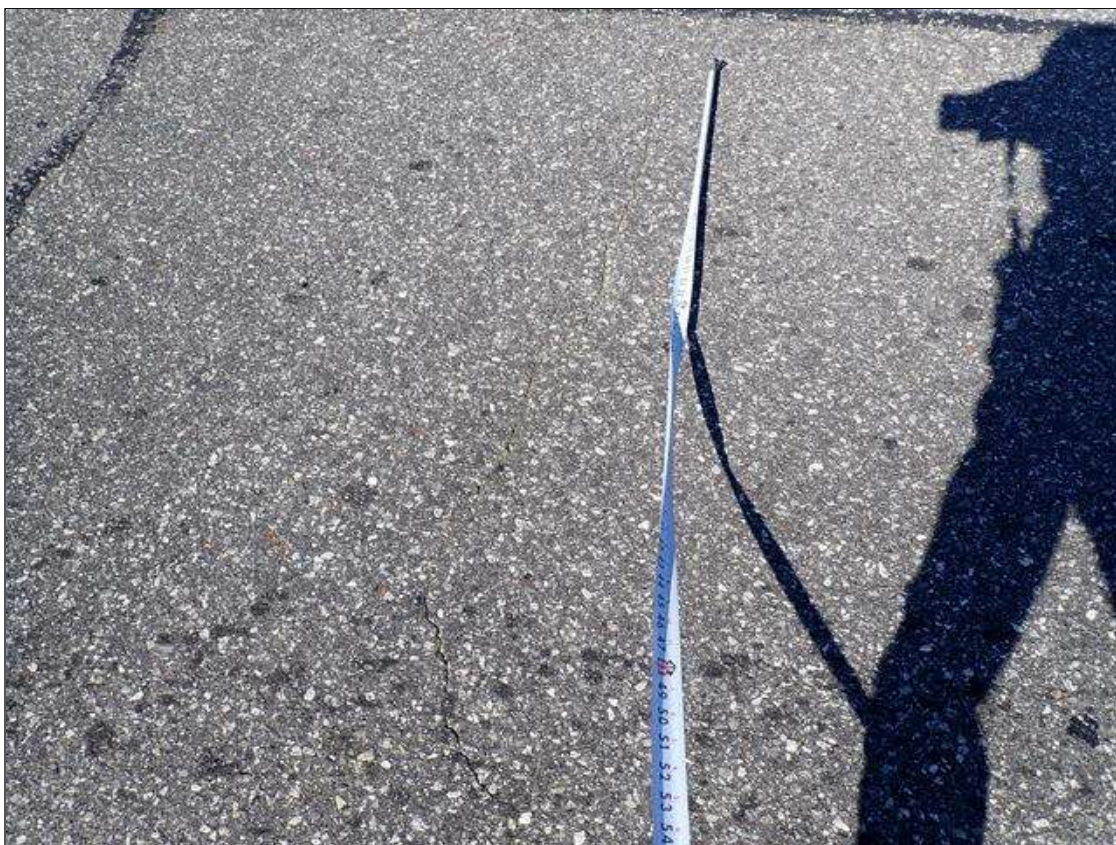
Span 1 Wearing Surface: throughout asphalt wearing surface, partially sealed transverse and longitudinal cracks (up to 1/16 inch x 8 foot)

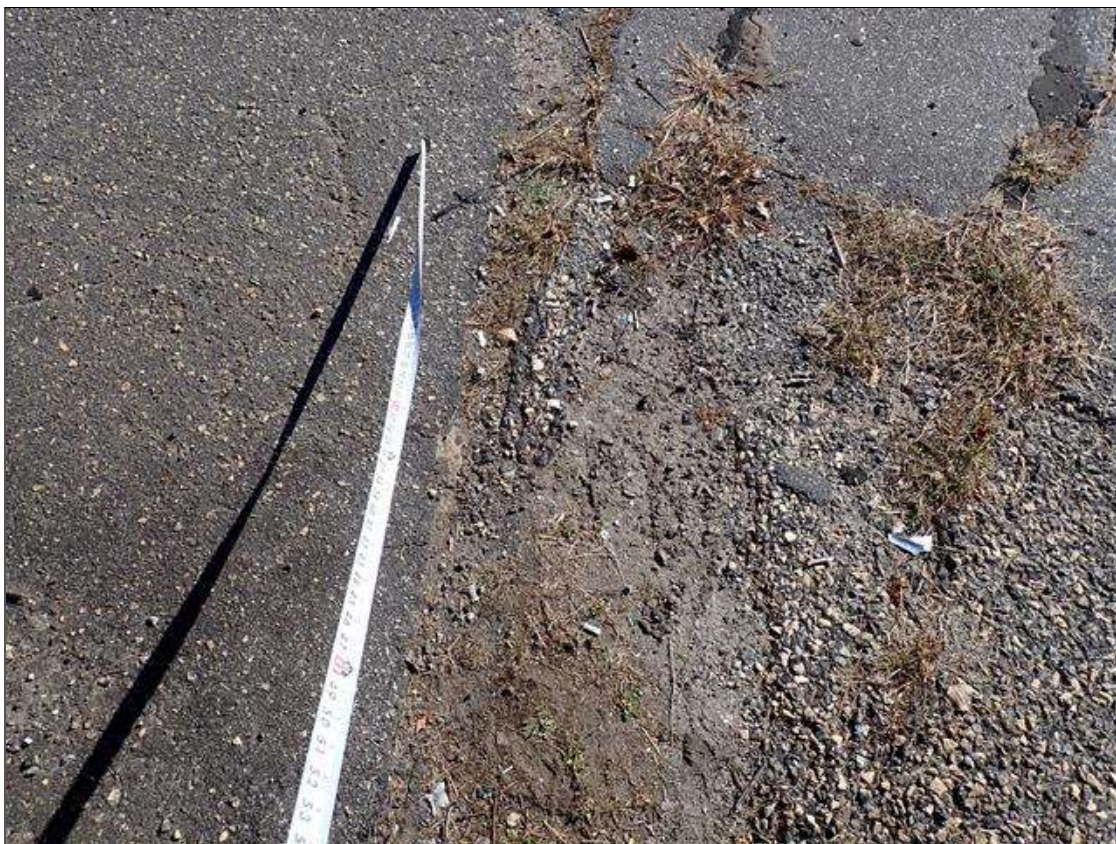
Span 1 Wearing Surface: left shoulder of asphalt over end bent 1, pothole/broken asphalt [6 foot x 8 inch x up to 1 inch deep]

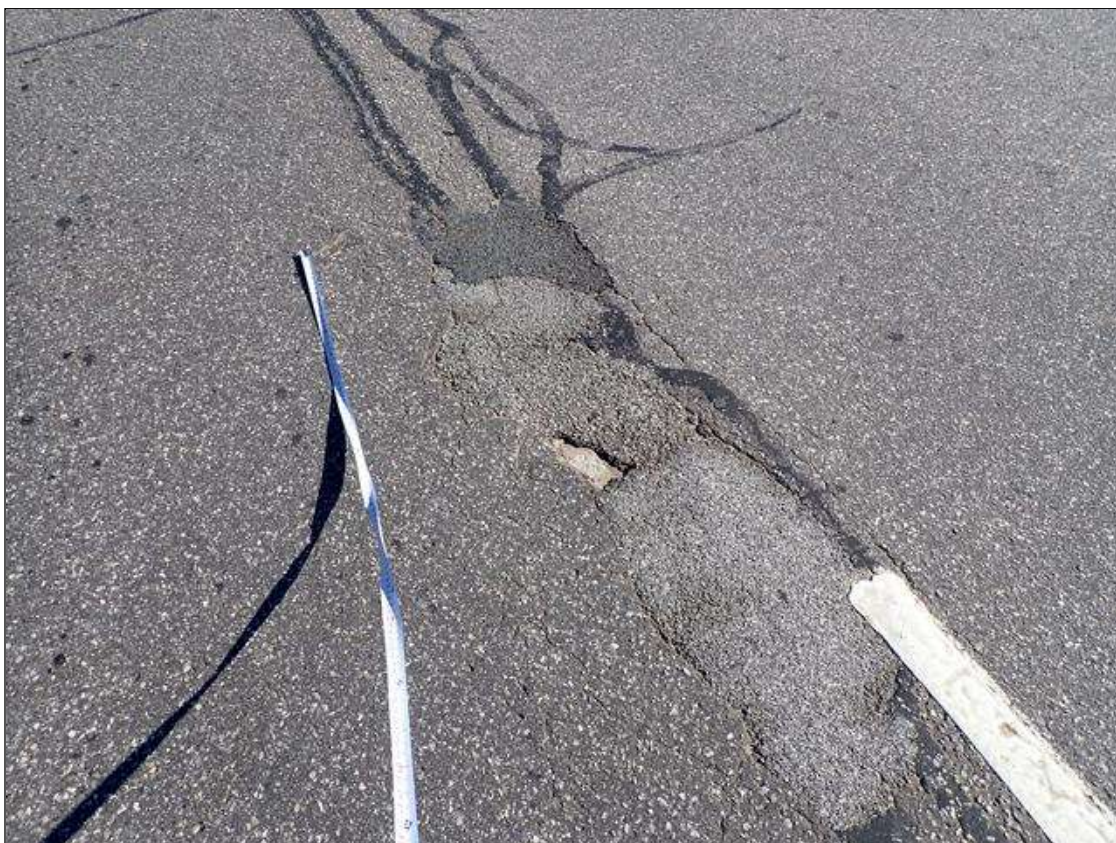
Span 1 Wearing Surface: 7 foot long x 16 foot wide x 1 inch deep failed/depresed patch in center of southbound lane near end bent 1

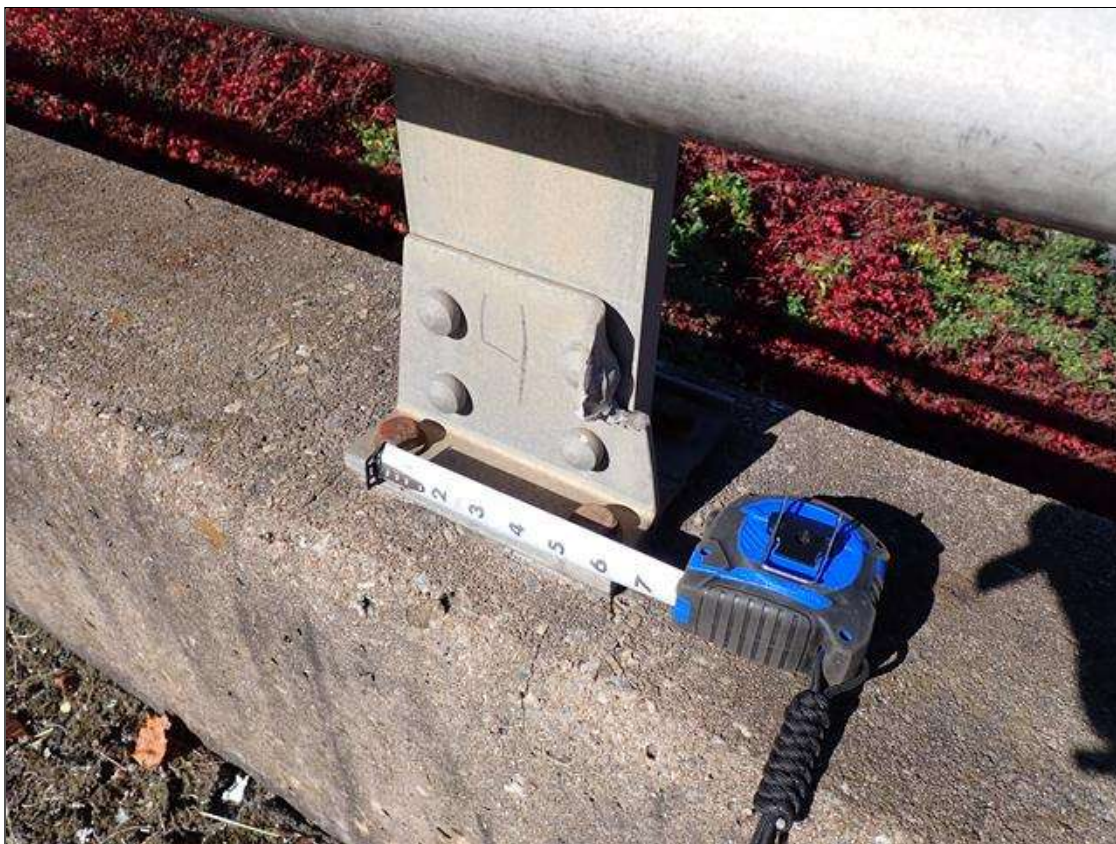
Span 1 Left Bridge Rail: (PAR) impact damage to rail bracket of fourth post

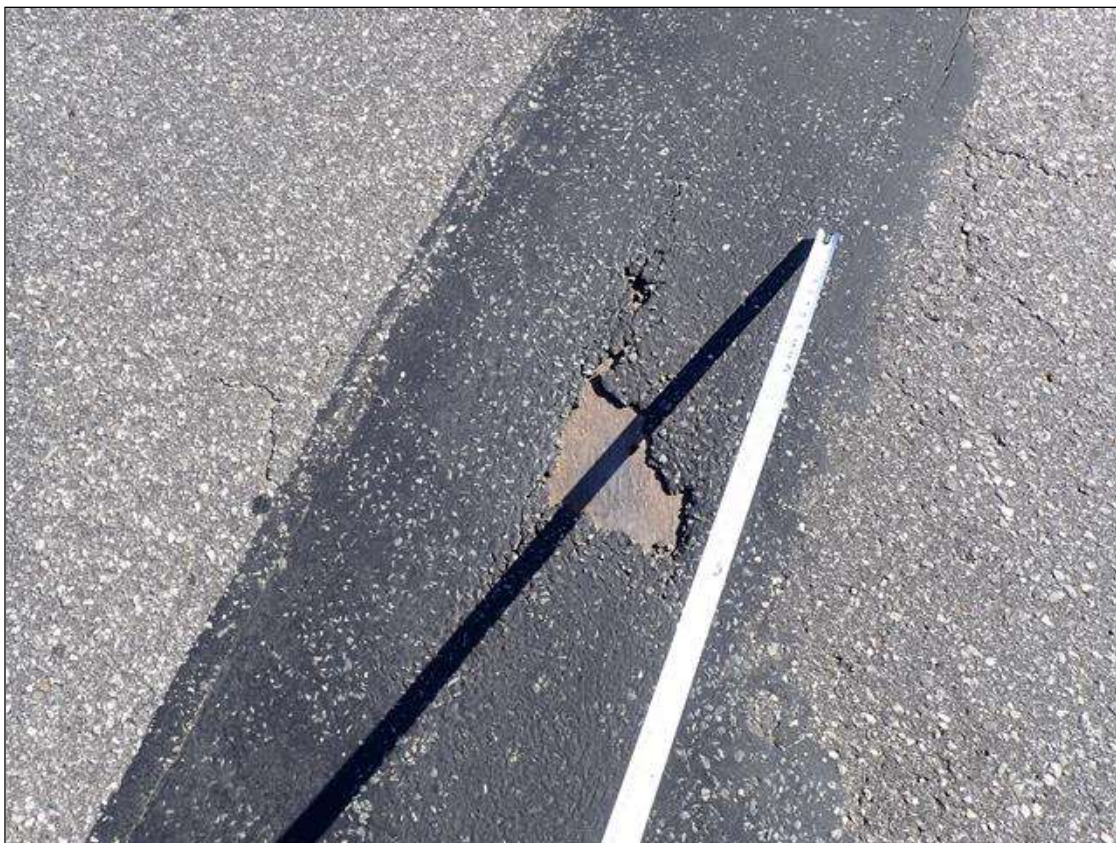
Span 2 Expansion Joint at Bent 1: southbound turn lane, missing seal material (2 foot x 9 inch x full depth)

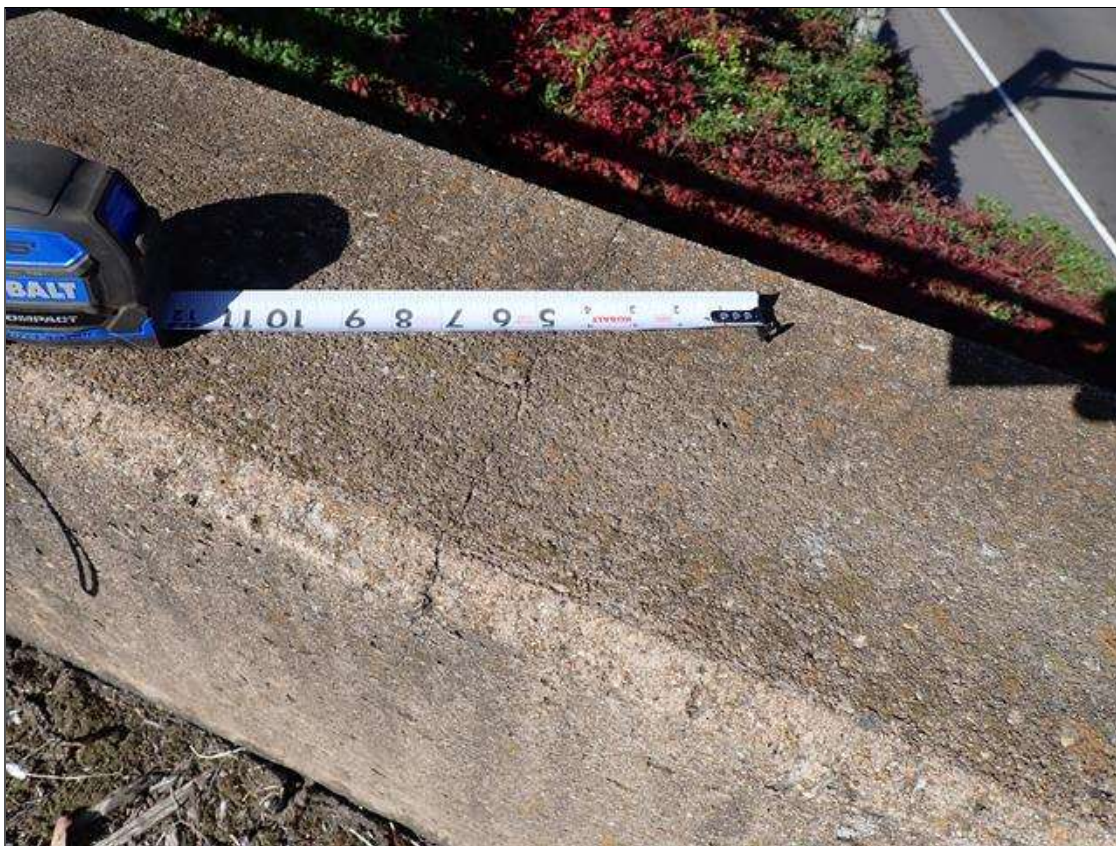
Span 1 Left Bridge Rail: along the length of parapet, vertical cracks (up to 1/32 x full height) at random

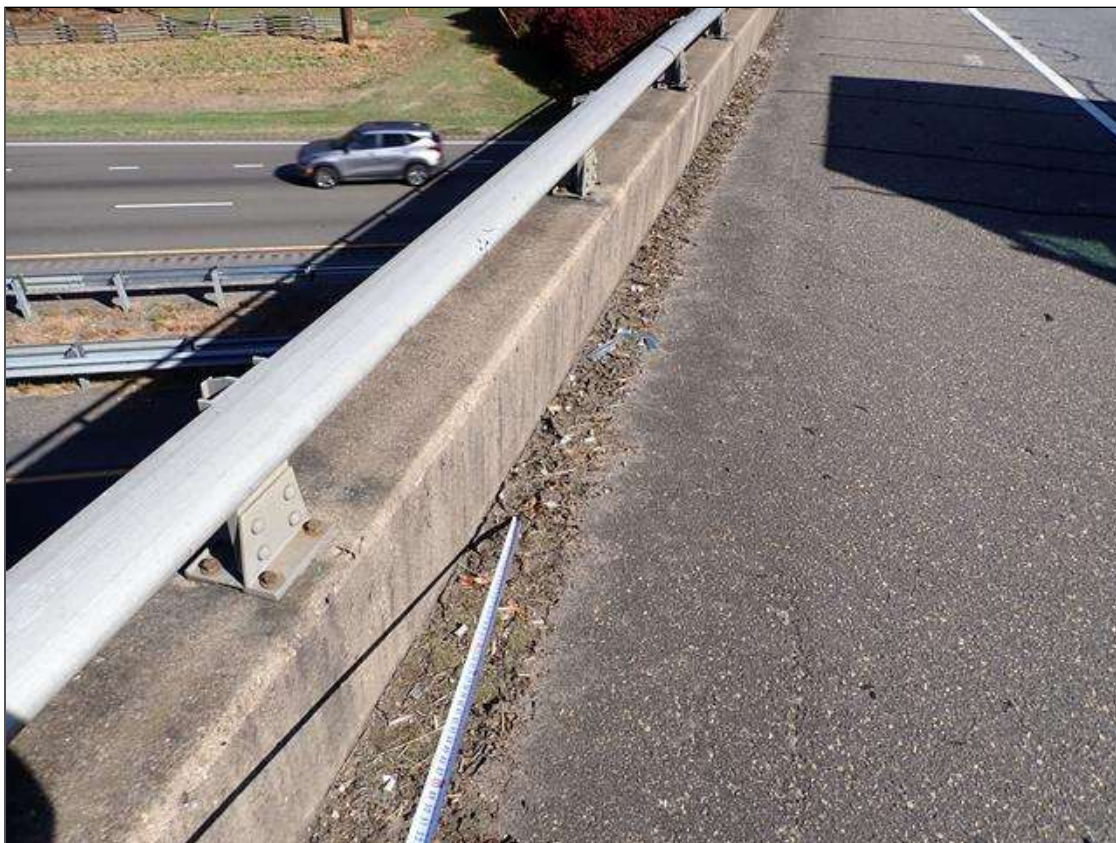
along both curblines, debris accumulation (1 foot wide x full length); partially obstructing deck drainage

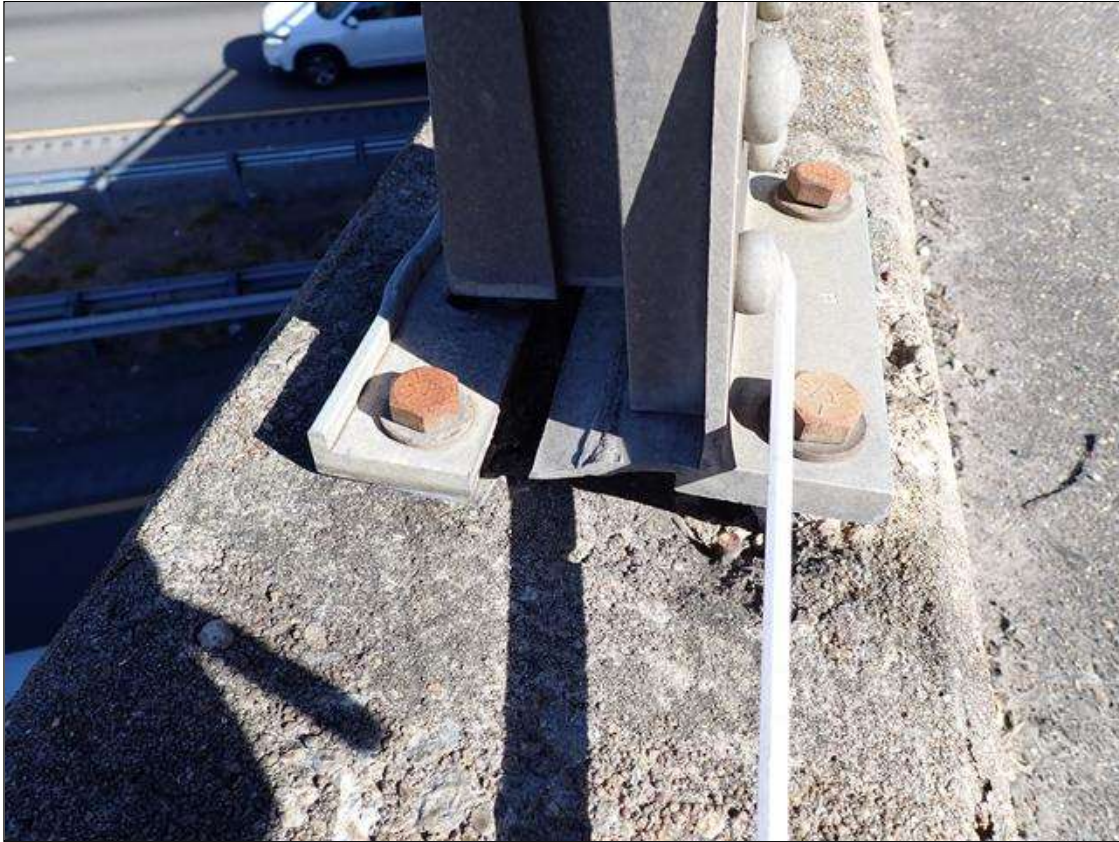
Span 2 Left Bridge Rail: (PAR) impact damage to left bridge rail at 3rd vertical post from bent 1. base plate is broken off along the weld and spalls under the base plate with two of four anchor bolts exposed. impact damage is above eastbound I-40 right travel lane. rail and post are intact

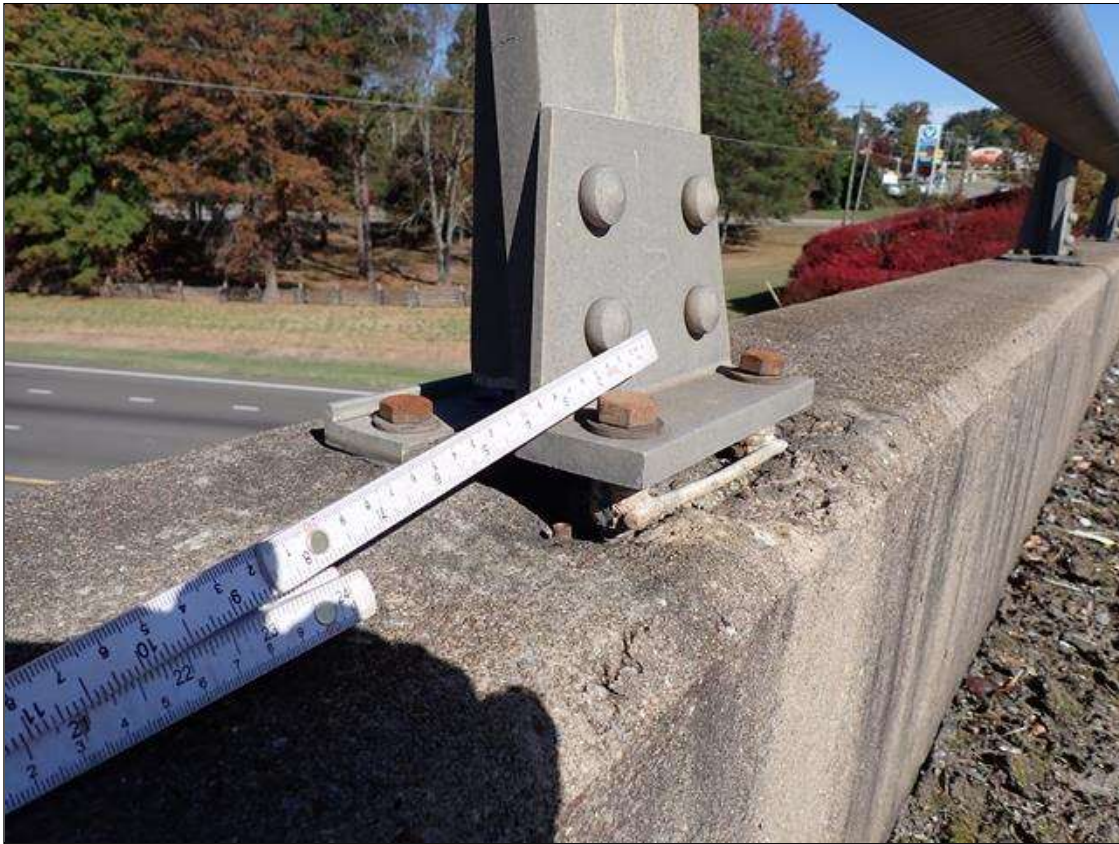
Span 2 Left Bridge Rail: (PAR) impact damage to left bridge rail at 3rd vertical post from bent 1. base plate is broken off along the weld and spalls under the base plate with two of four anchor bolts exposed. impact damage is above eastbound I-40 right travel lane. rail and post are intact

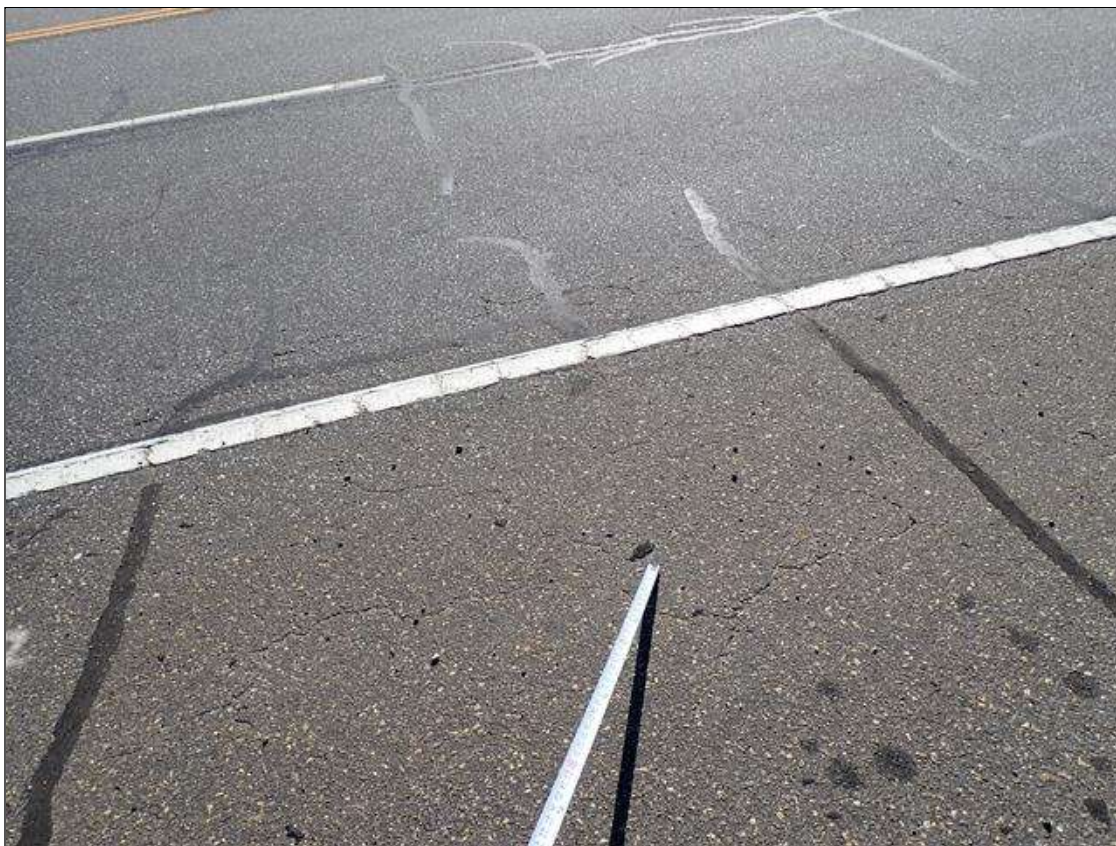
Span 2 Wearing Surface: throughout asphalt wearing surface, partially sealed transverse and longitudinal cracks (up to 1/16 inch x 8 foot)

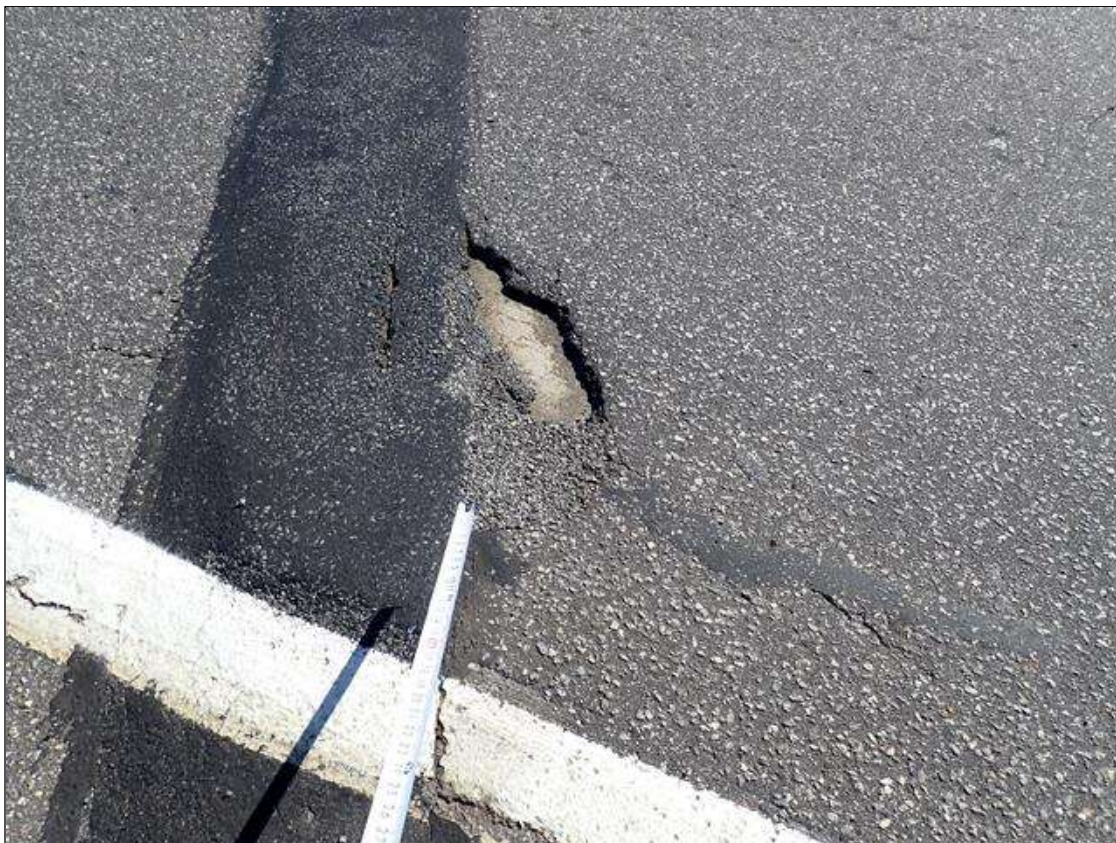
Span 2 Wearing Surface: at right Southbound lane adjacent to joint over bent 2, unsound patch/pothole [32 inch x 10 inch x full depth]

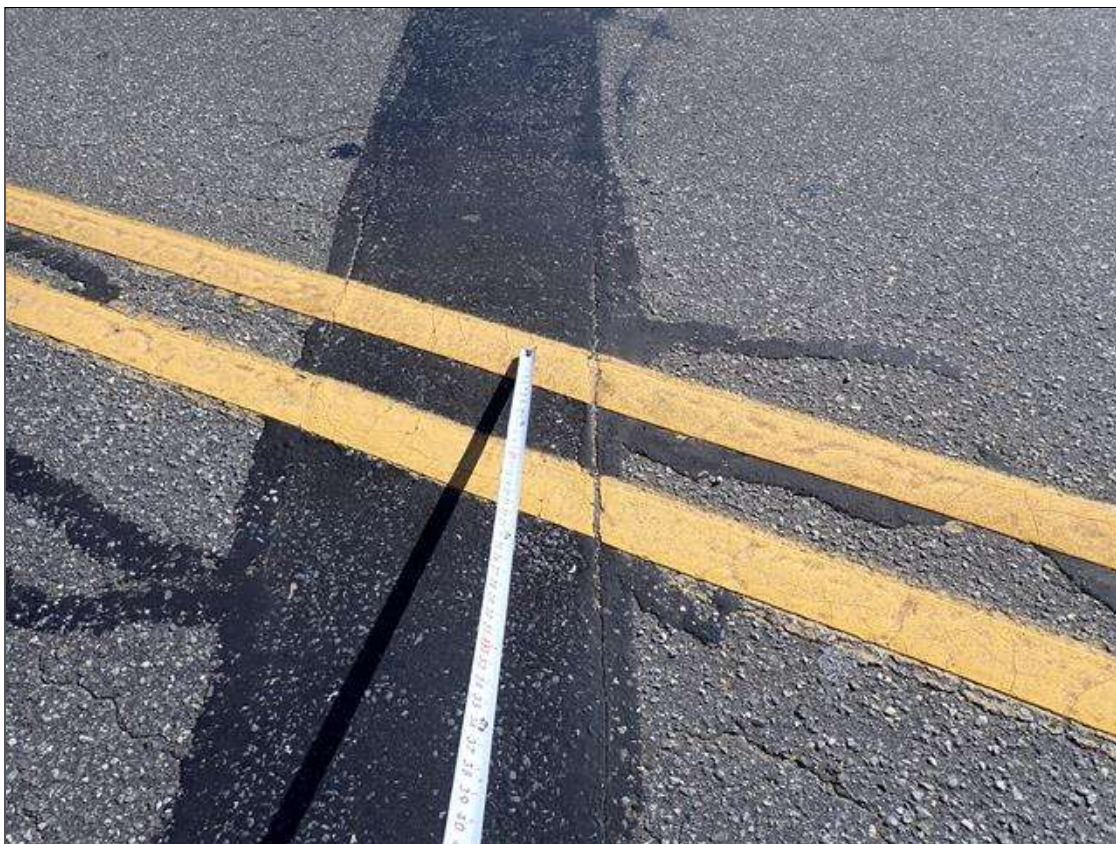
Span 3 Expansion Joint at Bent 2: along the length of the joint, adhesion loss (up to 1/8 inch wide x 2.5 foot x 3/4 inch deep) at random

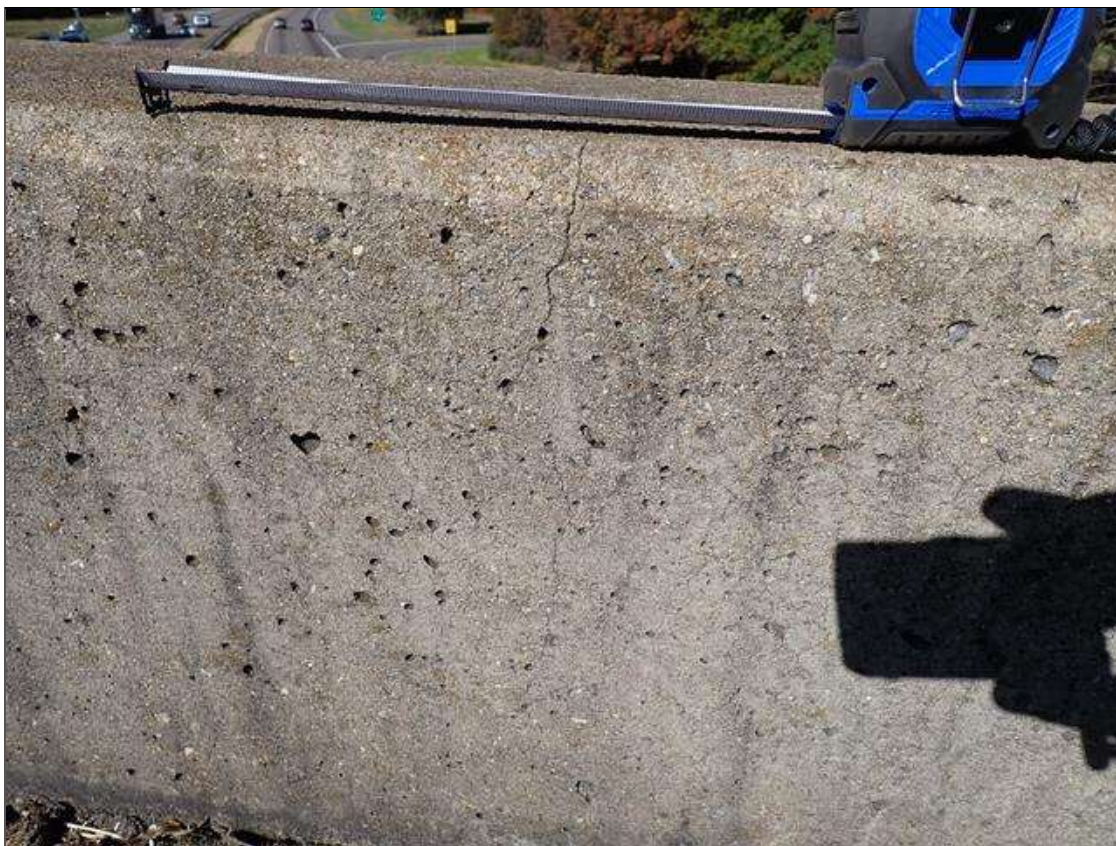
Span 3 Left Bridge Rail: along the length of parapet, vertical cracks (up to 1/32 x full height) at random

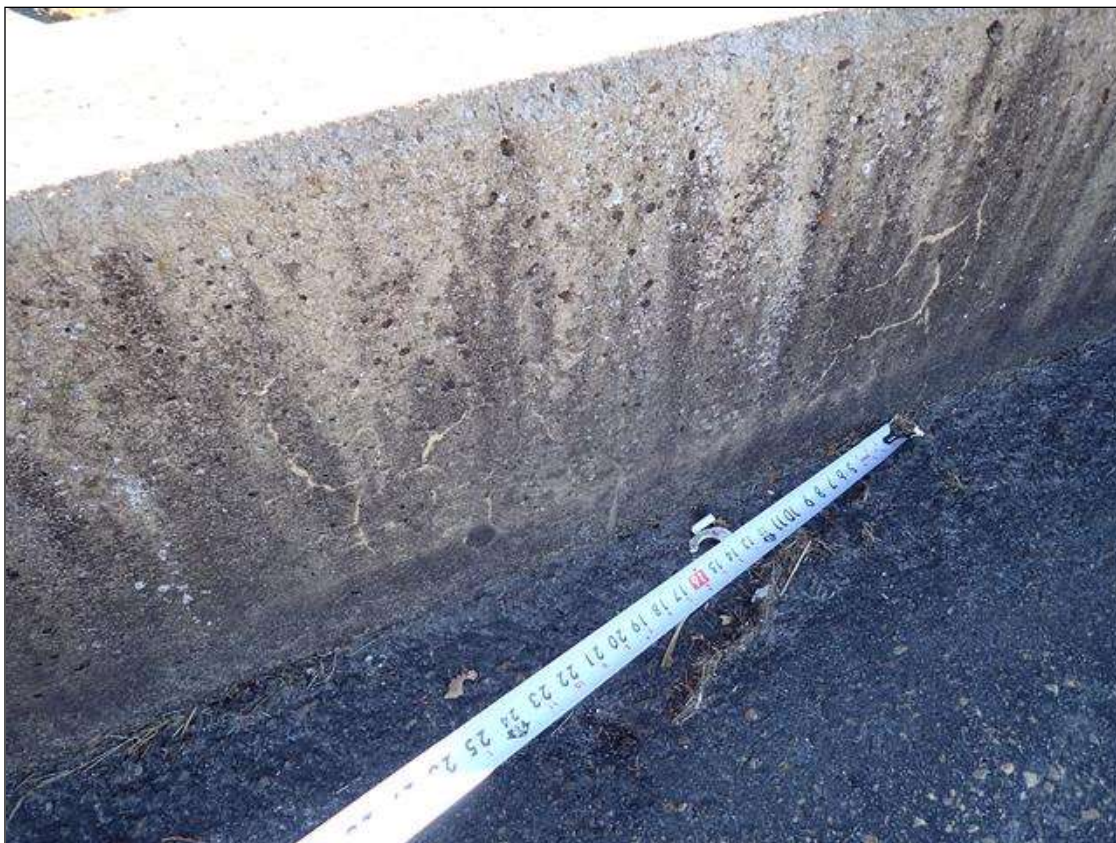
Span 3 Right Bridge Rail: adjacent to rail post 6, hairline map cracking

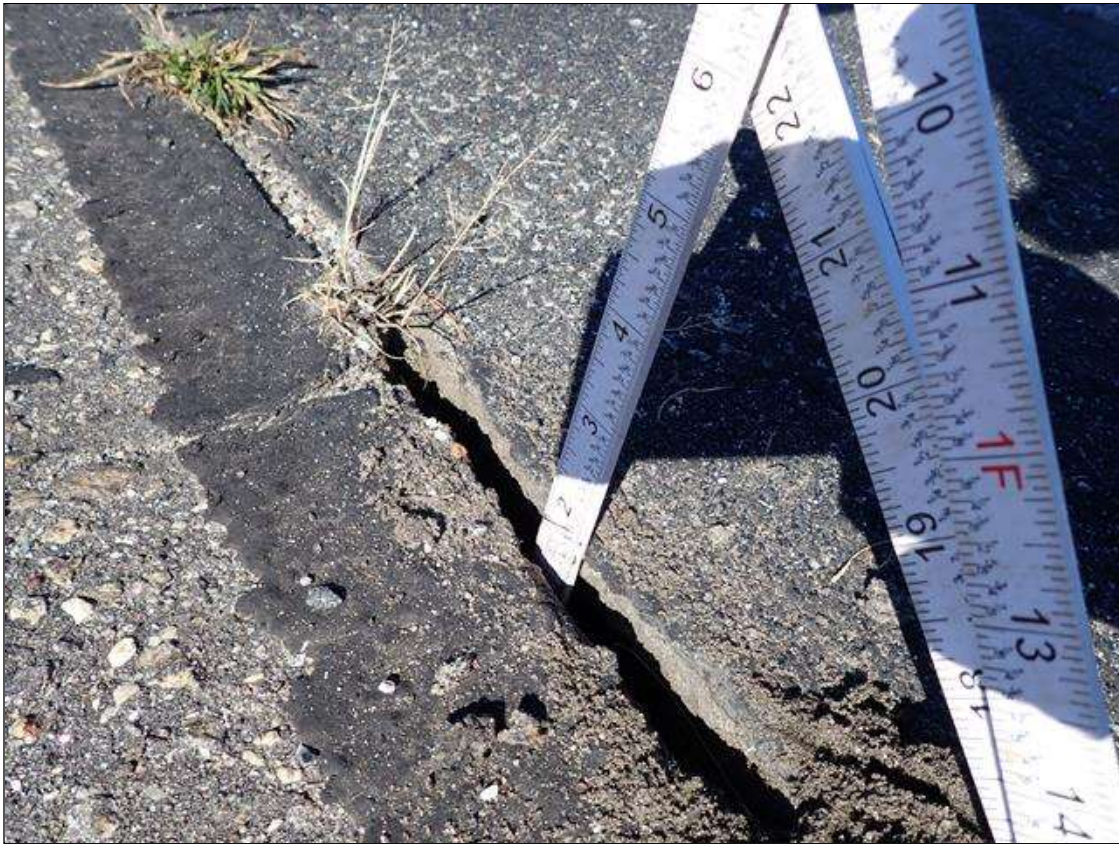
Span 4 Expansion Joint at Bent 3: along the length of the joint, adhesion loss (up to 3/4 inch wide x 7 foot x 1.5 inch deep) at random

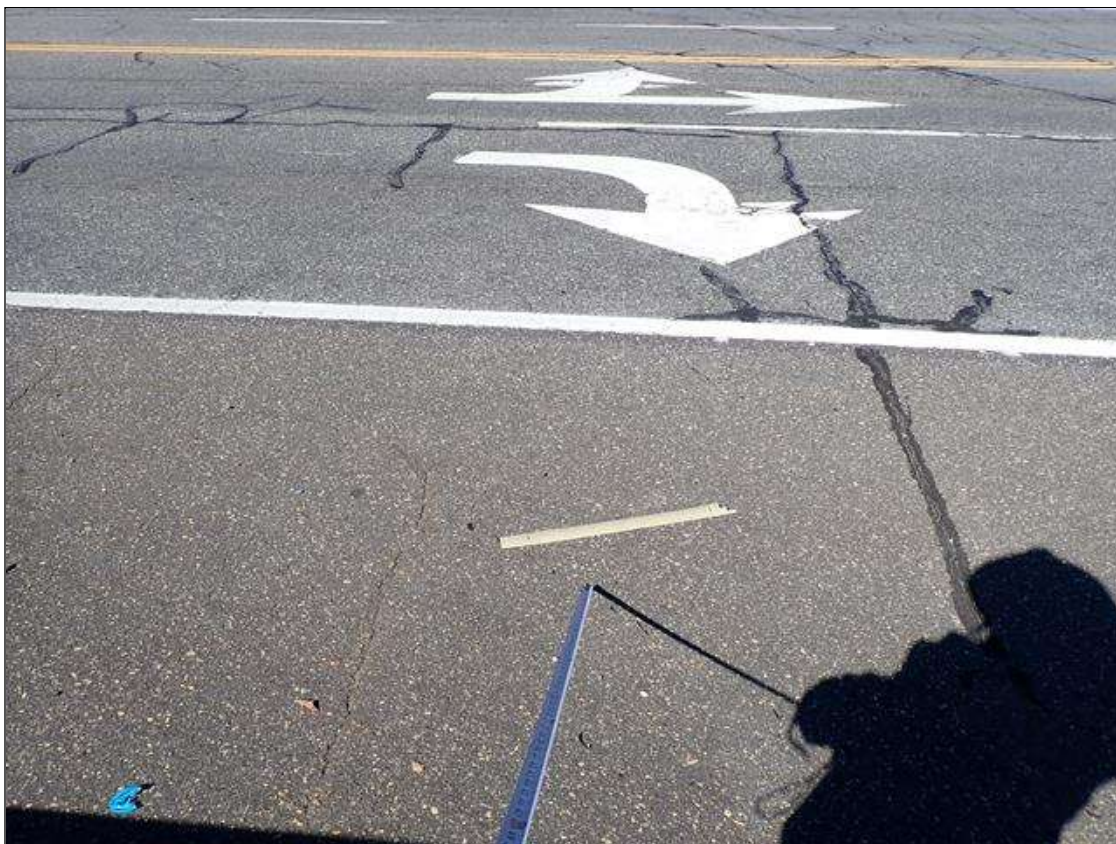
Span 4 Wearing Surface: throughout asphalt wearing surface, partially sealed transverse and longitudinal cracks (up to 1/8 inch x 40 foot)

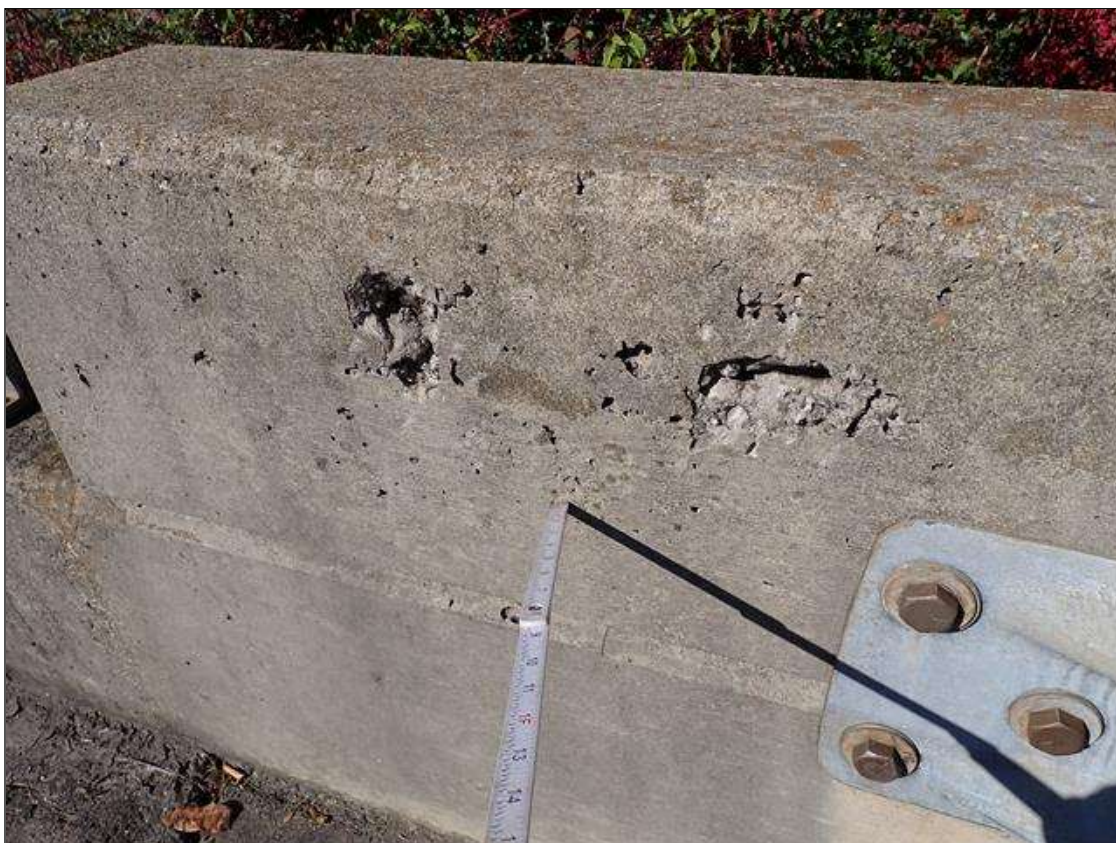
Span 4 Left Bridge Rail: at end bent 2, (2) spalls (up to 5 inch x 4 inch x 1.5 inch deep) exposed reinforcement. no measureable section loss.

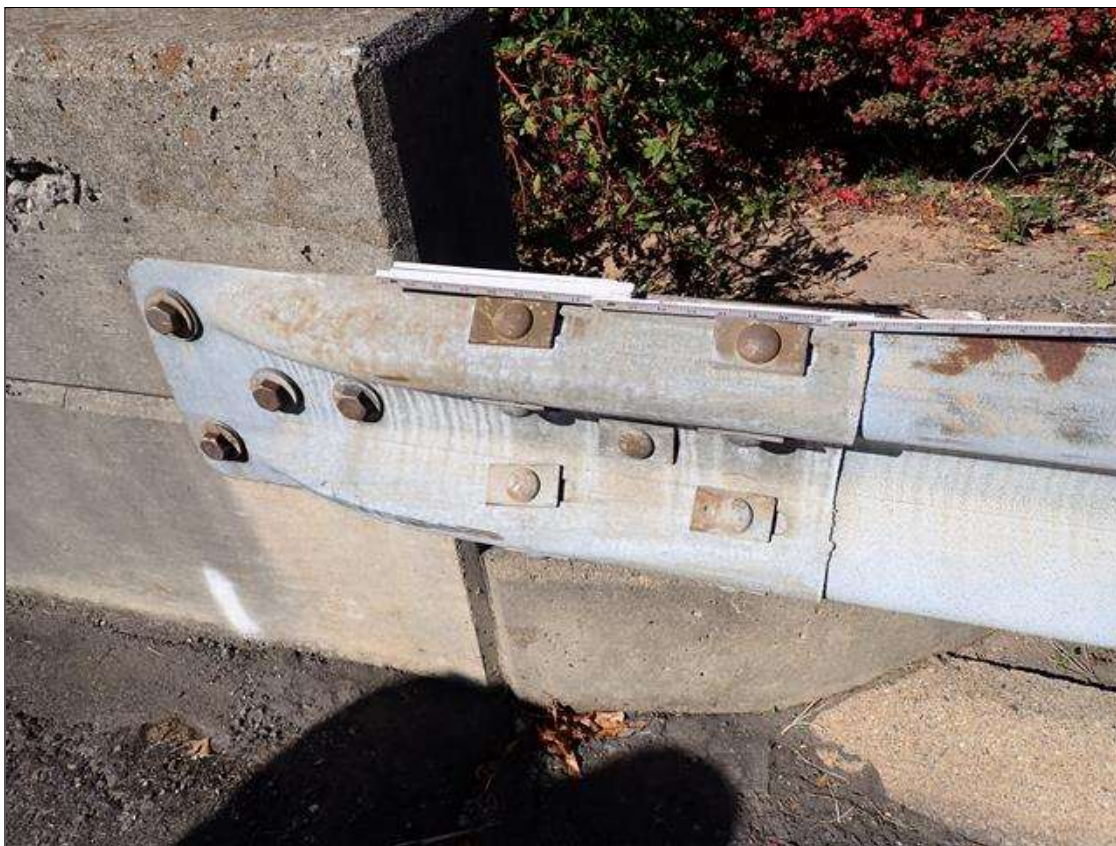
(PAR) northwest guardrail attachment, improper lap

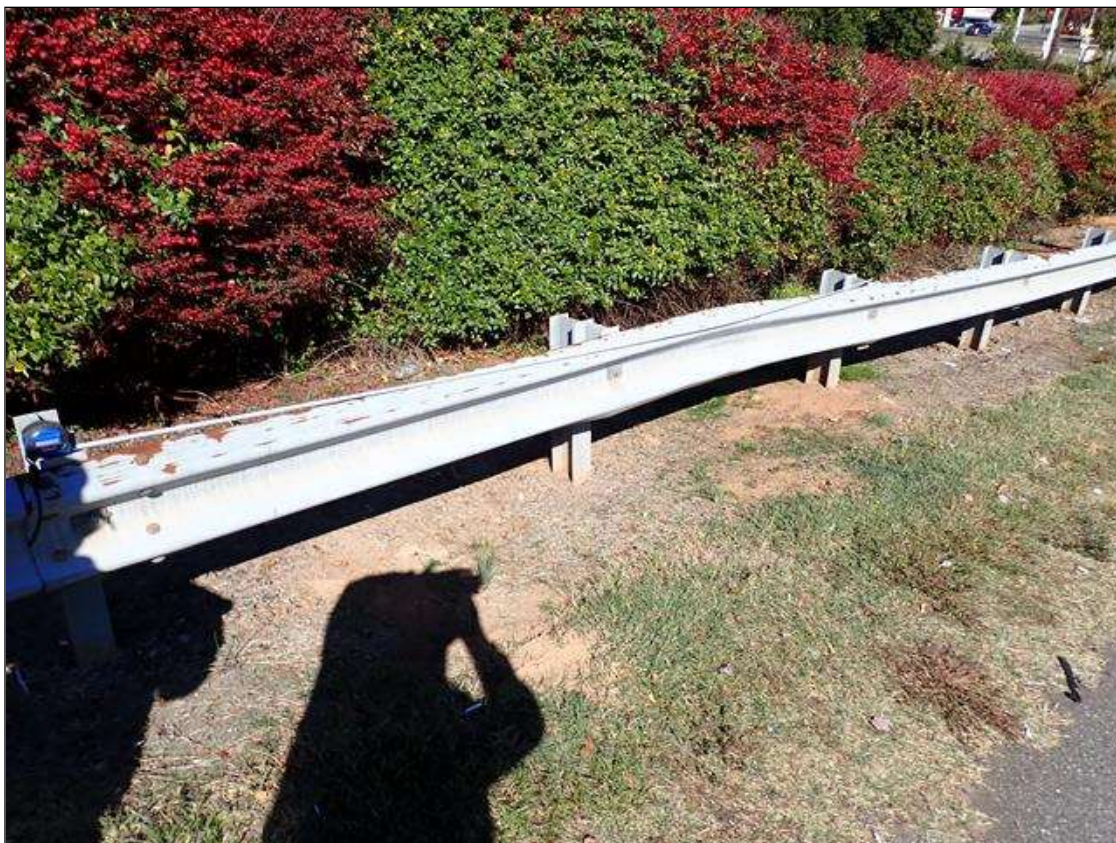
(PAR) northwest guardrail, 55 foot from end bent 2, impact damage (12.5 foot)

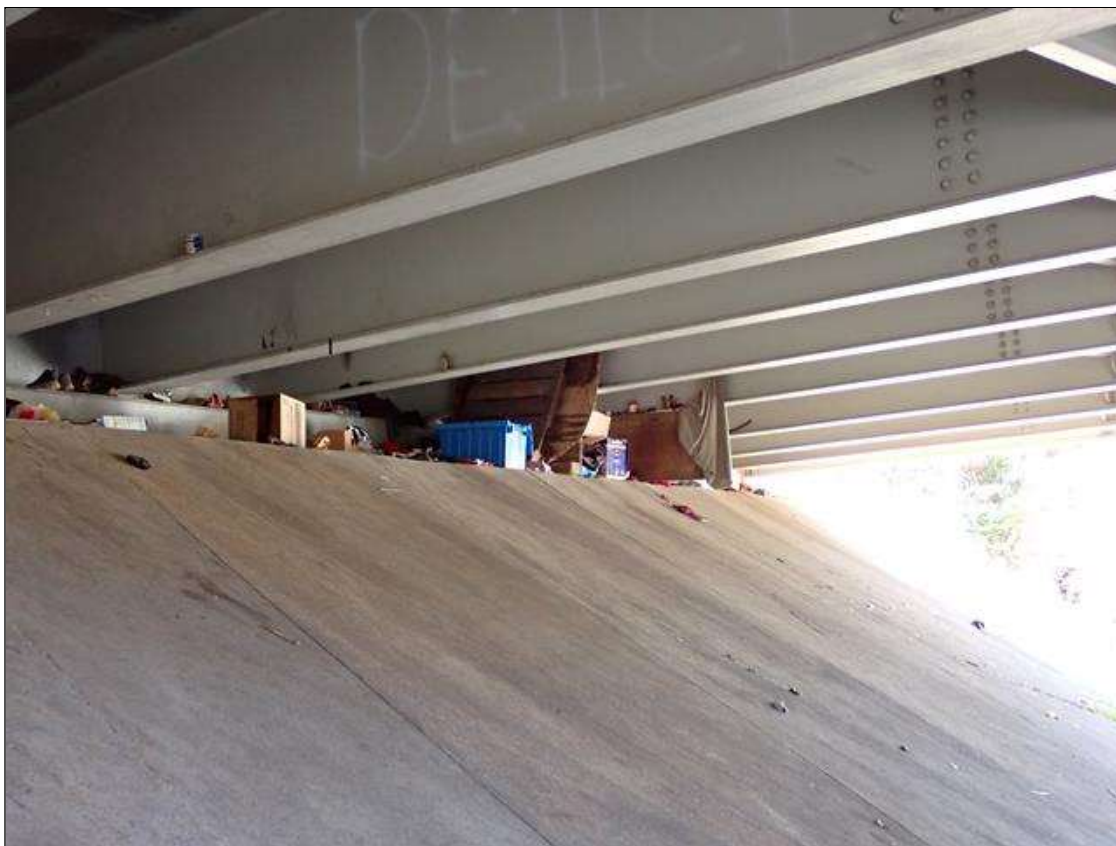
(PAR) along end bent 2 slope protection, homeless debris with inhabitants (full length) inhibiting inspection access
