NC DEPARTMENT OF TRANSPORTATION  
 DIVISION OF HIGHWAYS  
 STRUCTURE MANAGEMENT UNIT

ATTENTION: **prompt action request; sketches updated; new beam repairs**

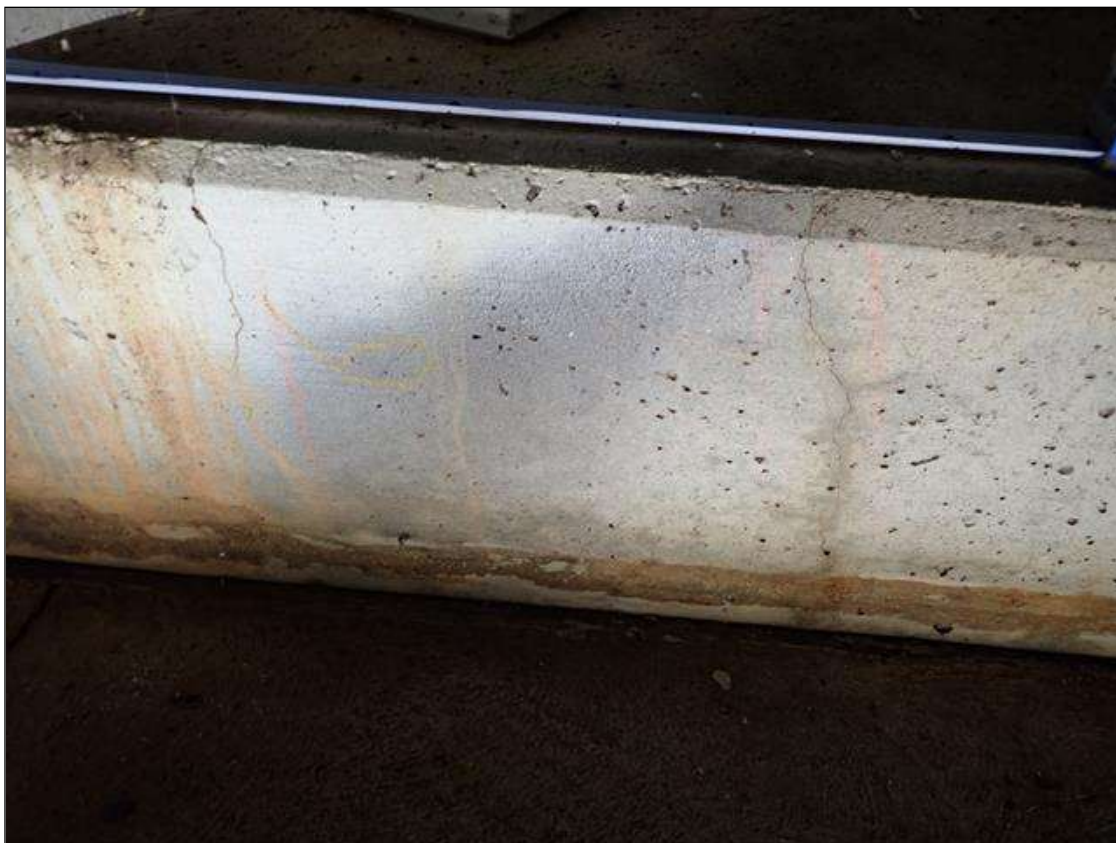
End Bent 1 Cap 1: scattered along length of cap, multiple vertical cracks [15 inch long x up to 1/32 inch]

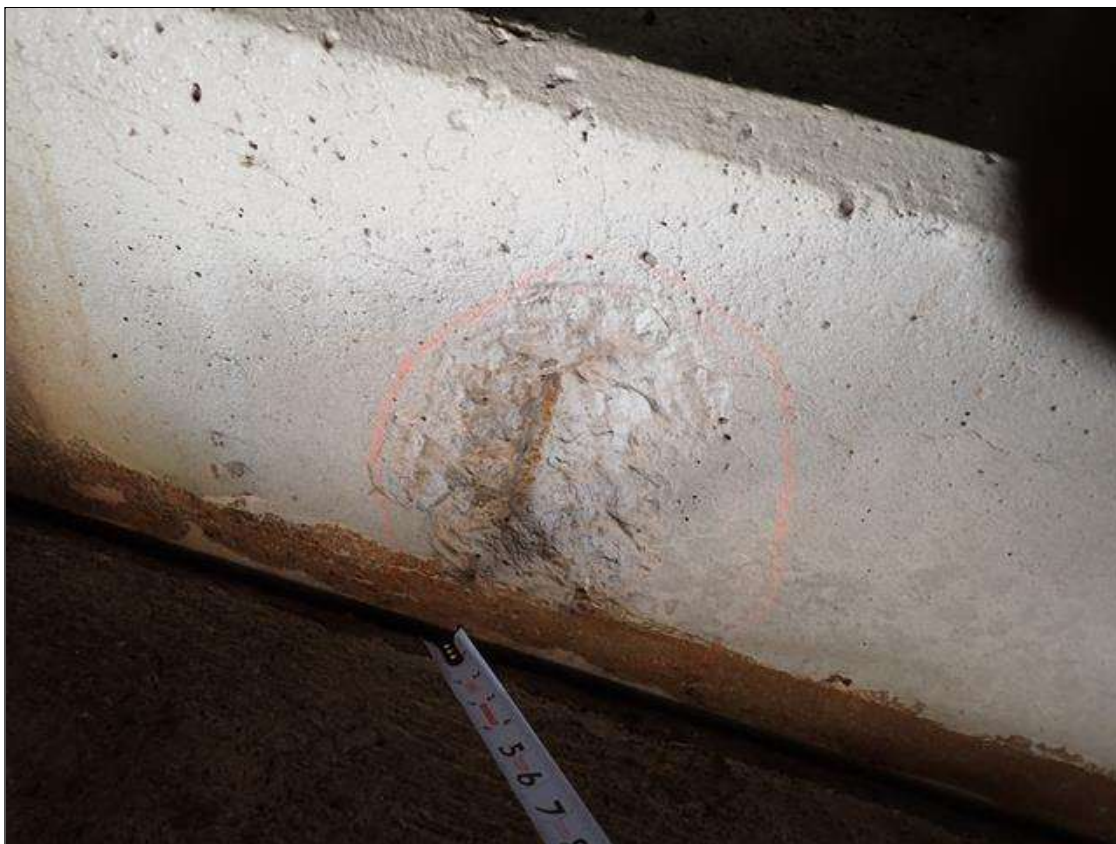
End Bent 1 Cap 1: 11 inch high x 7 inch wide x up to 1 inch deep spall with exposed rusted rebar in north face of cap at beam 4.

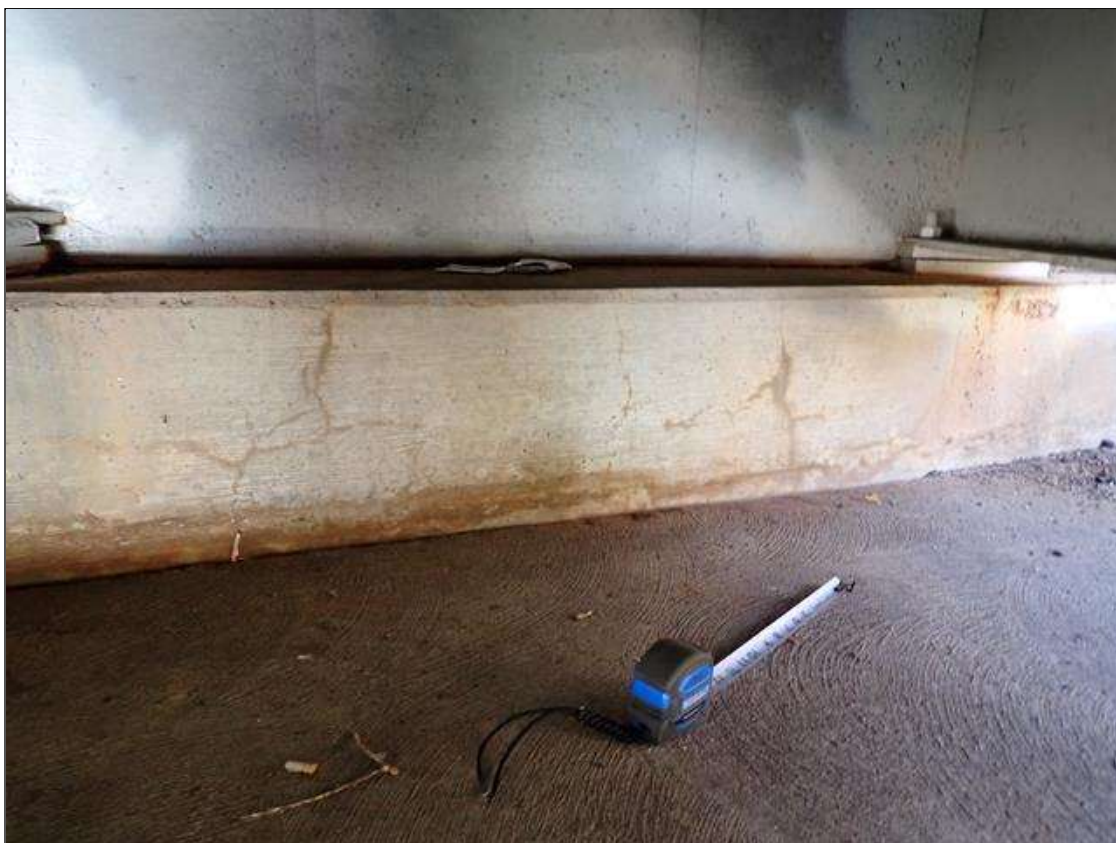
End Bent 1 Cap 1: west end, map cracks (hairline x 1.5 foot x full height)

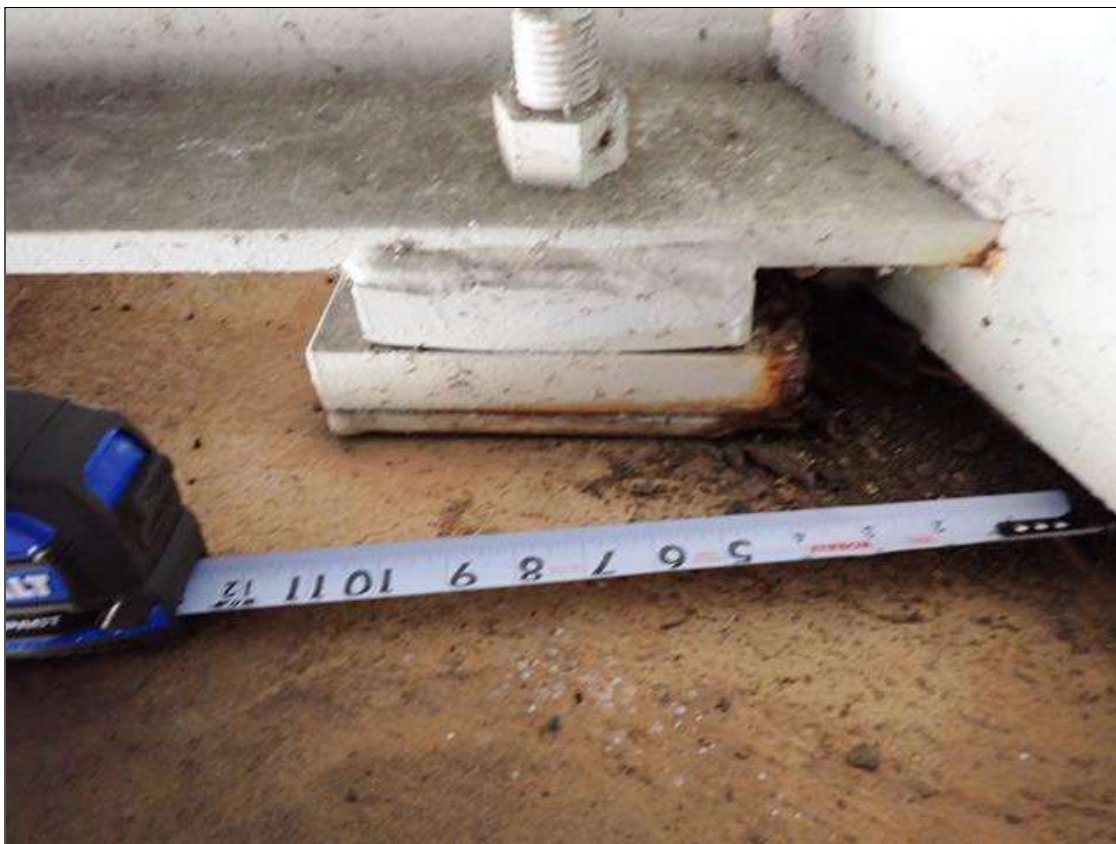
Span 1 Near Bearing 2: surface rust/rust scale

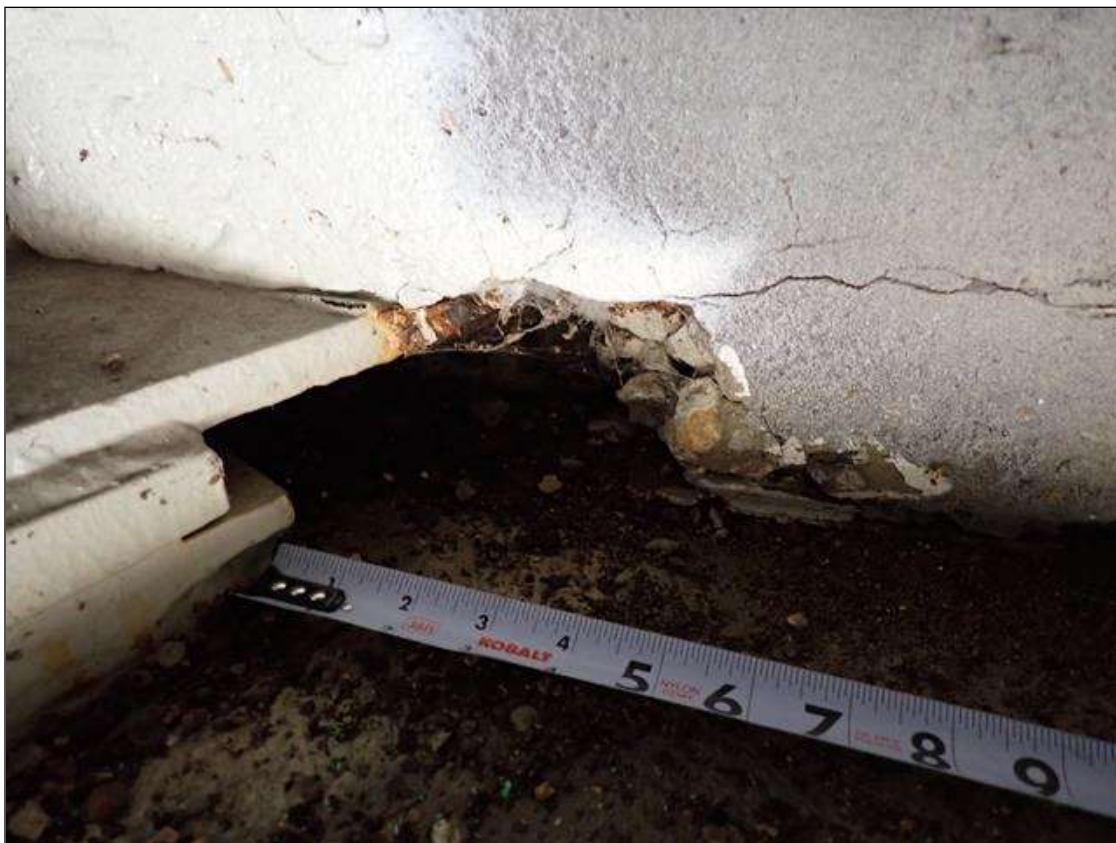
End Bent 1 Abutment: along the length of the abutment, adjacent to beam bottom flanges, spall/delaminations (up to 9 inch x 4 inch x 4 inch deep) with cracks (up to 1/8 inch)

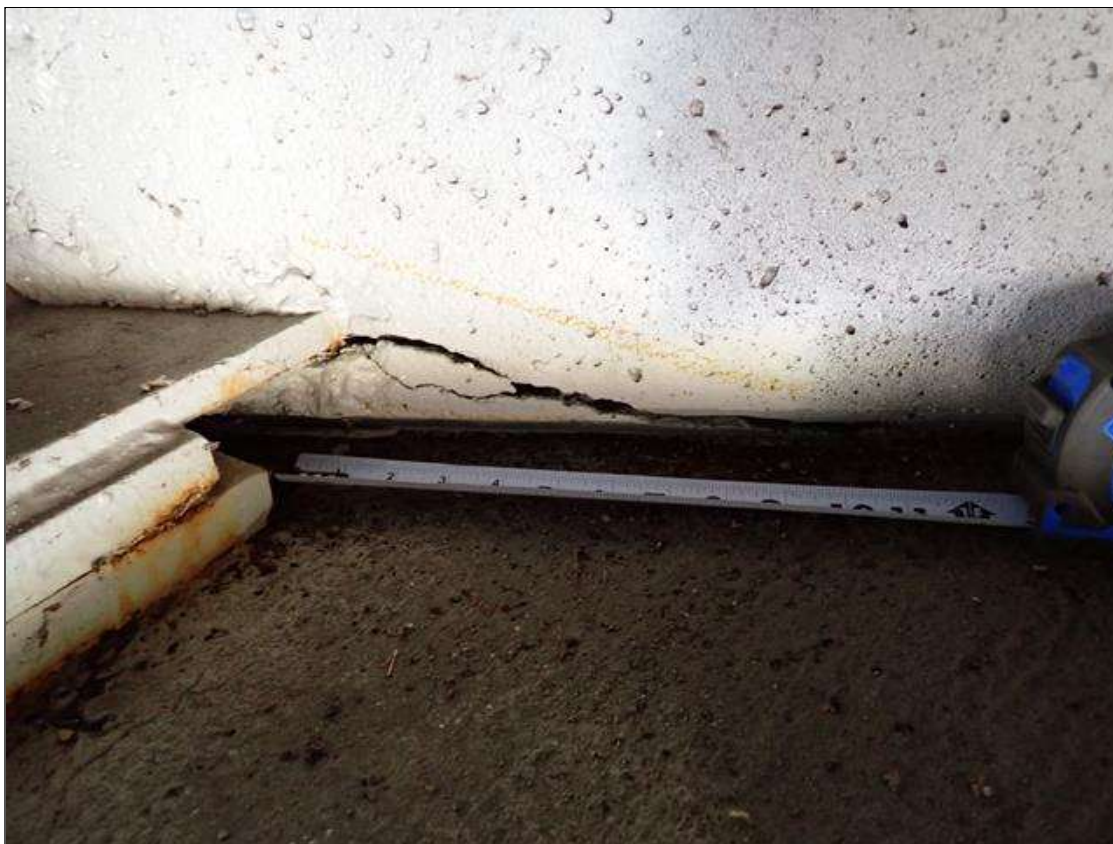
End Bent 1 Abutment: along the length of the abutment, adjacent to beam bottom flanges, spall/delaminations (up to 9 inch x 4 inch x 4 inch deep) with cracks (up to 1/8 inch)

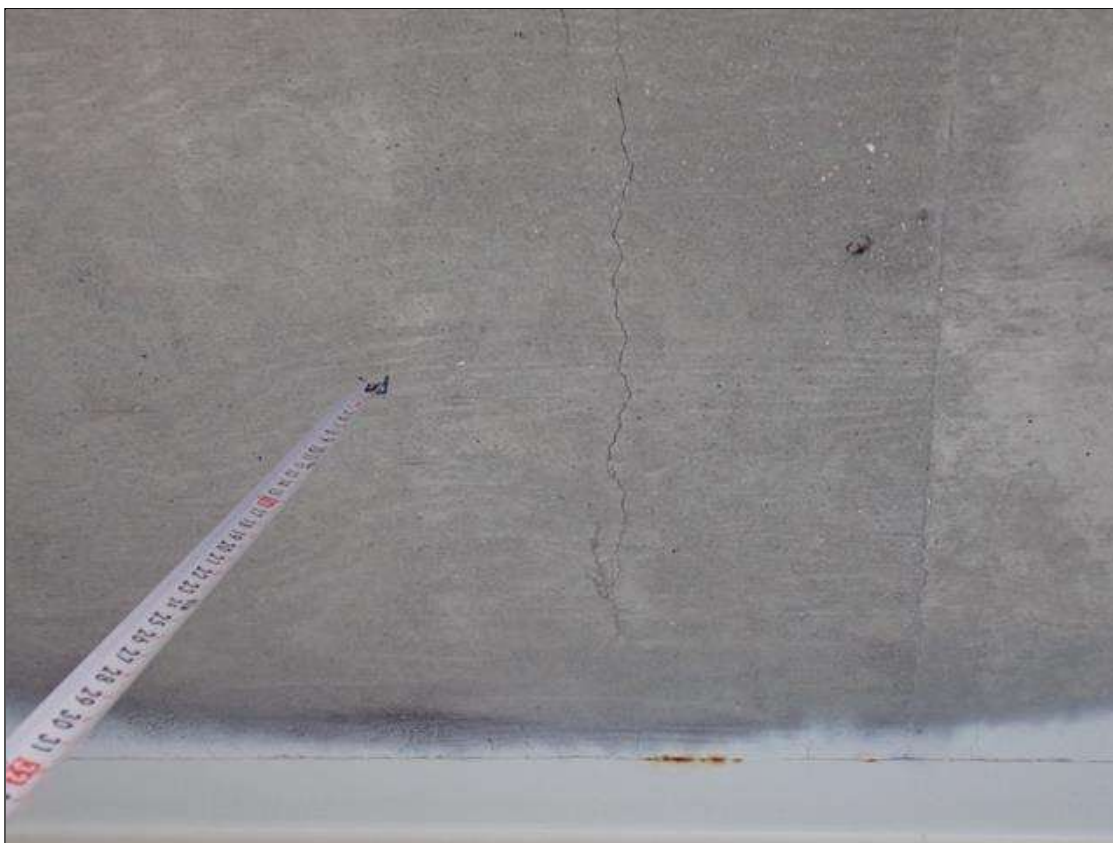
Span 1 Deck: throughout underside of deck, transverse cracks (up to 1/16 inch x full bay width) and map cracks (1/32 inch) at random

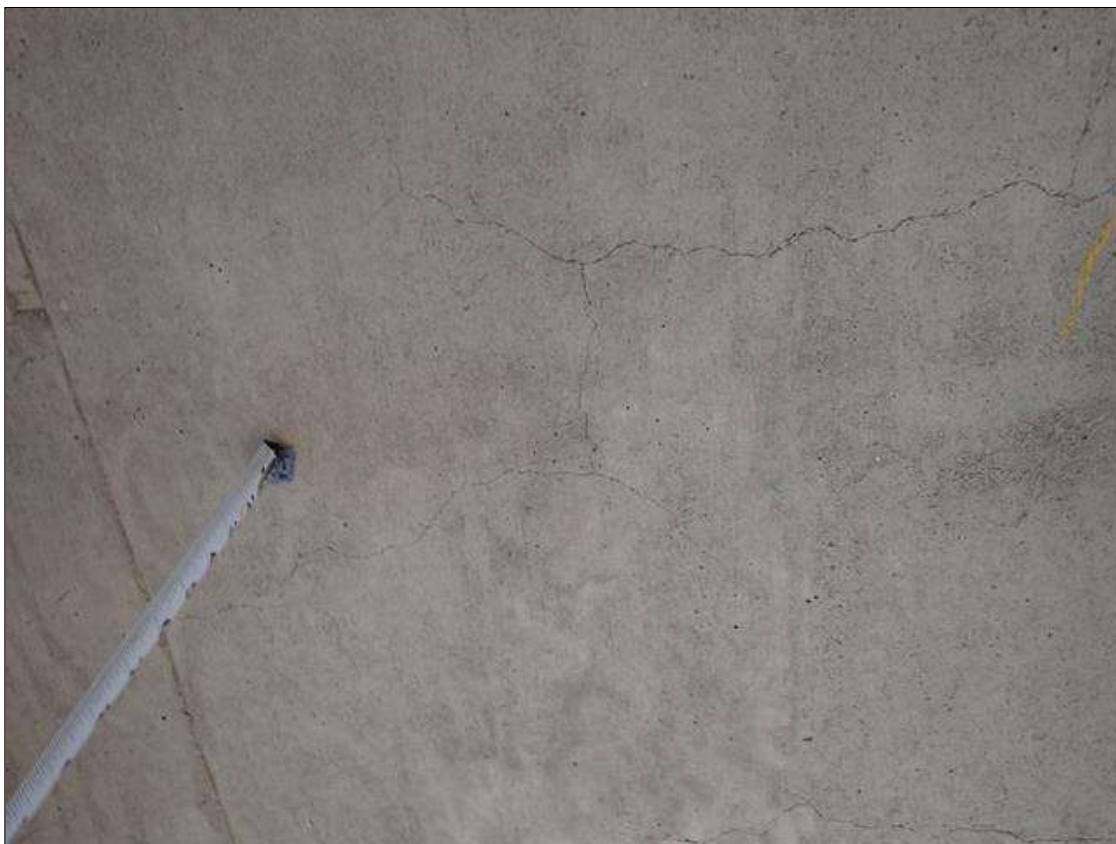
Span 1 Deck: throughout underside of deck, transverse cracks (up to 1/16 inch x full bay width) and map cracks (1/32 inch) at random

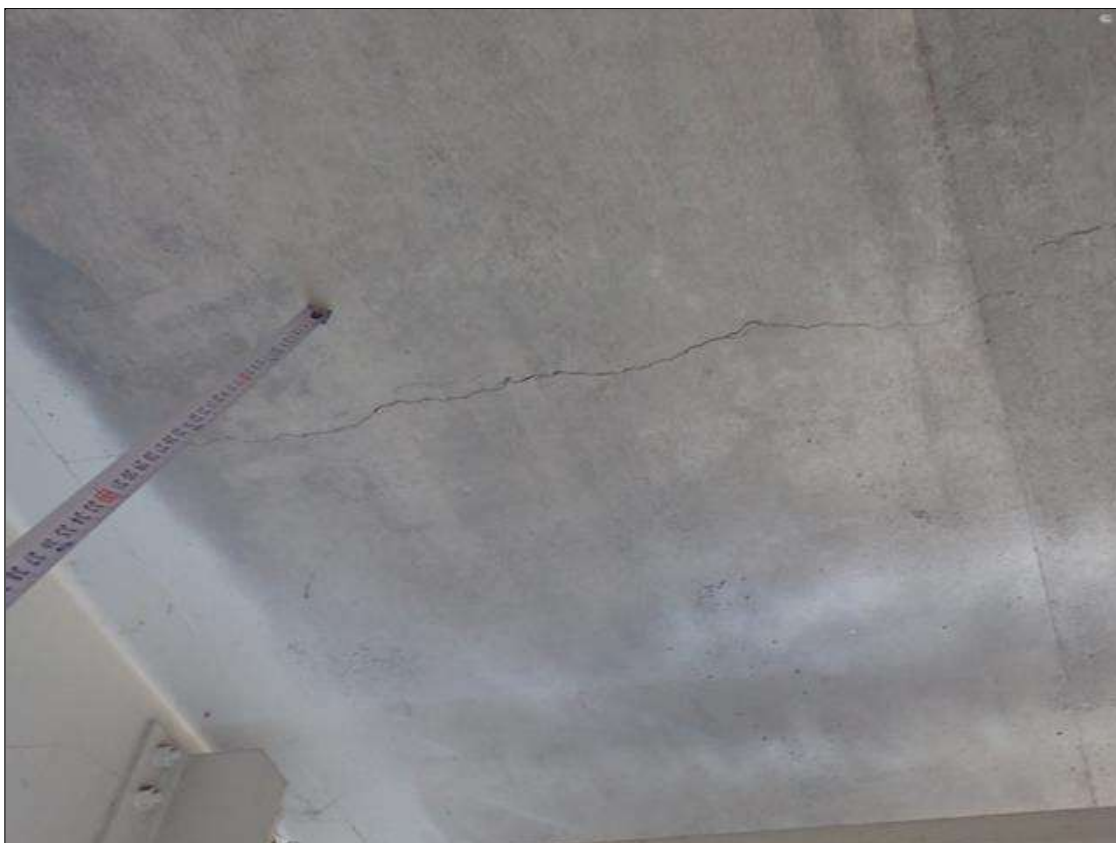
Span 1 Deck: throughout underside of deck, transverse cracks (up to 1/16 inch x full bay width) and map cracks (1/32 inch) at random

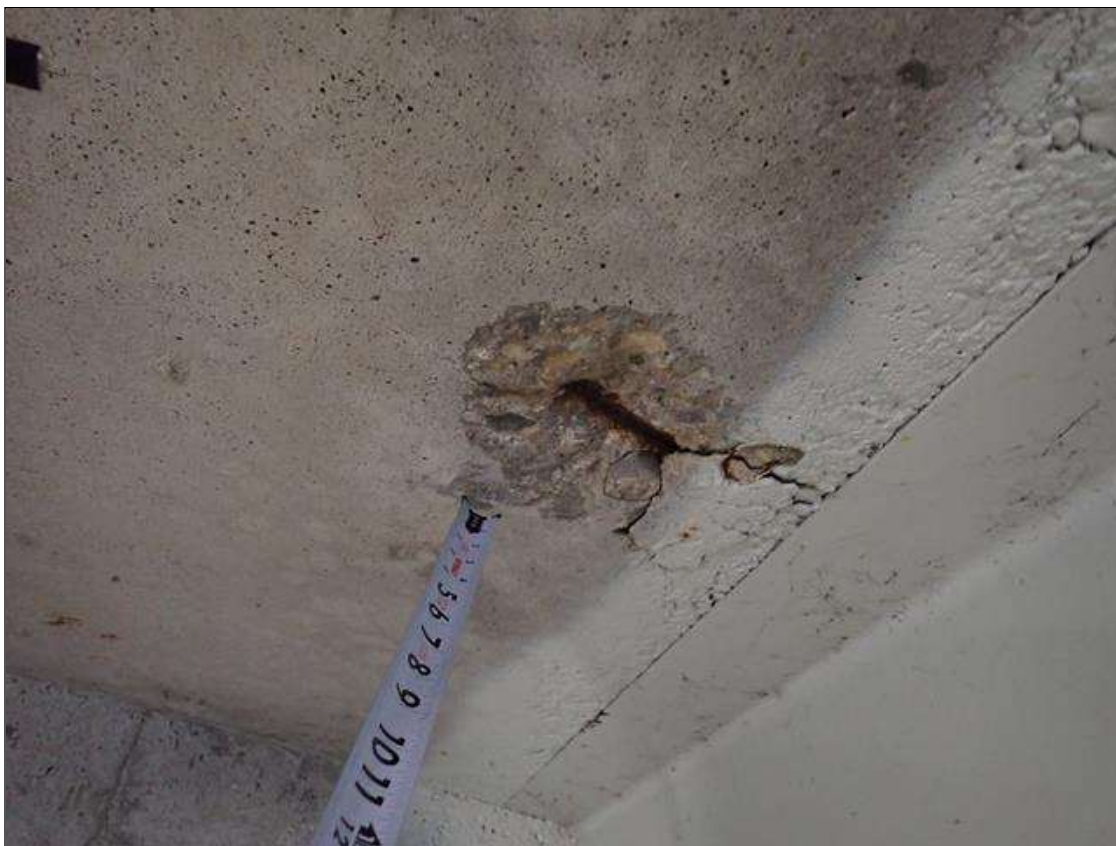
Span 1 Deck: (PAR) 6 inch diameter x 1/2 inch deep spall with exposed reinforcement in bay 4 near end bent 1

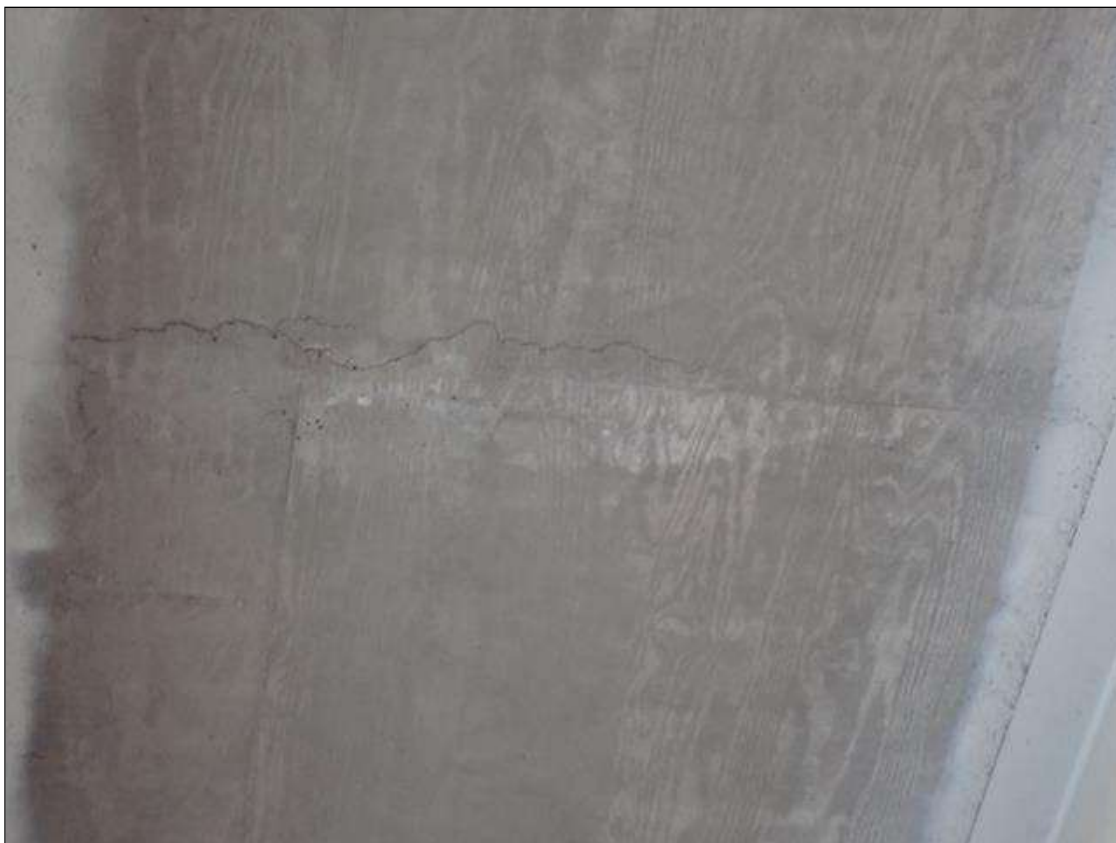
Span 1 Deck: (2) up to 2 foot wide x 12 inch long areas of delamination in deck underside, bay 3, near midspan.

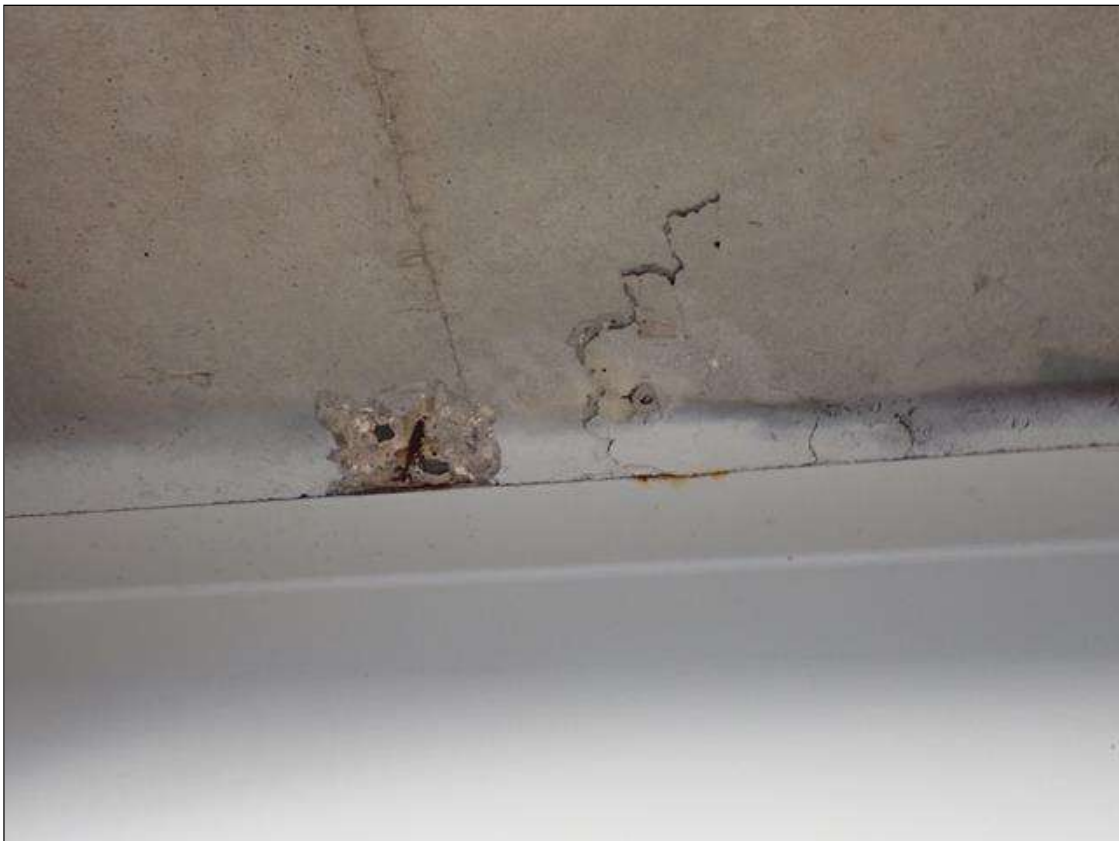
Span 1 Deck: (PAR) 6 inch diameter x 1 inch deep spall with exposed reinforcement. no measurable section loss. 18 inch long x 12 inch wide area of delamination along beam 8 top flange, in bay 7, at midspan.

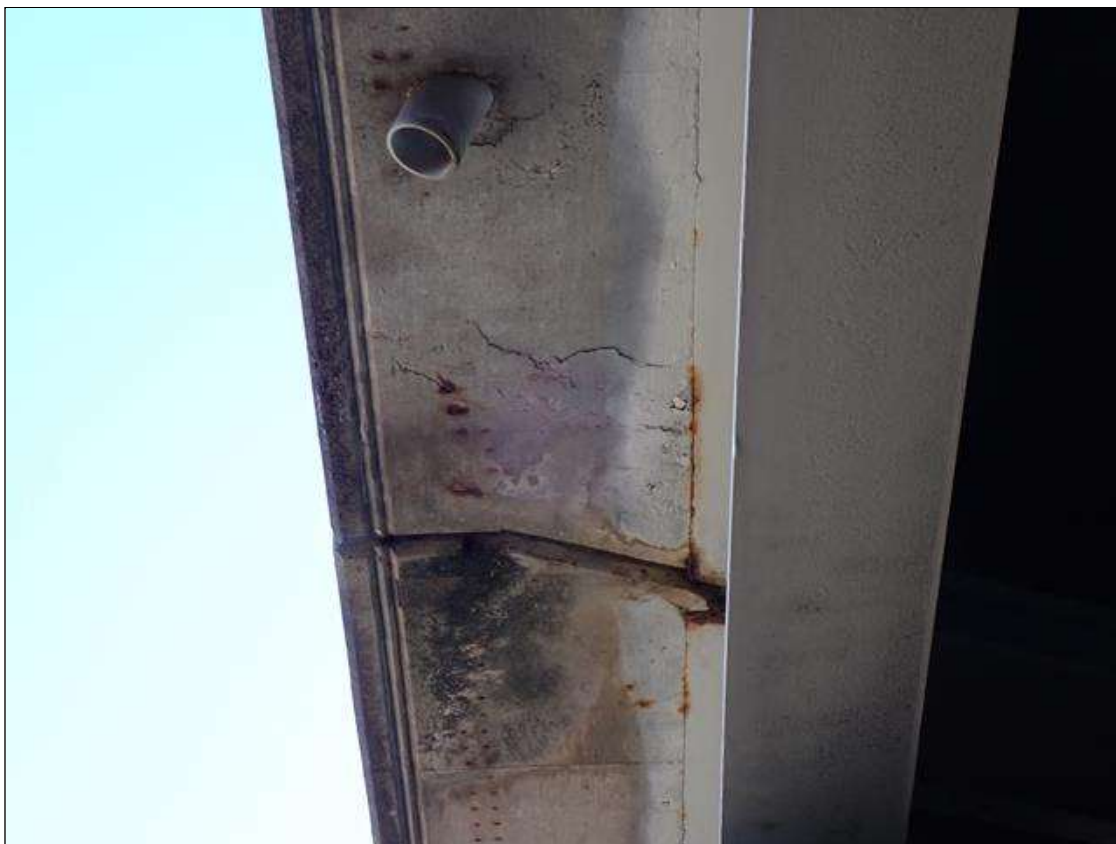
Span 1 Deck: left overhang, at bent 1, delamination (2 foot x 6 inch)

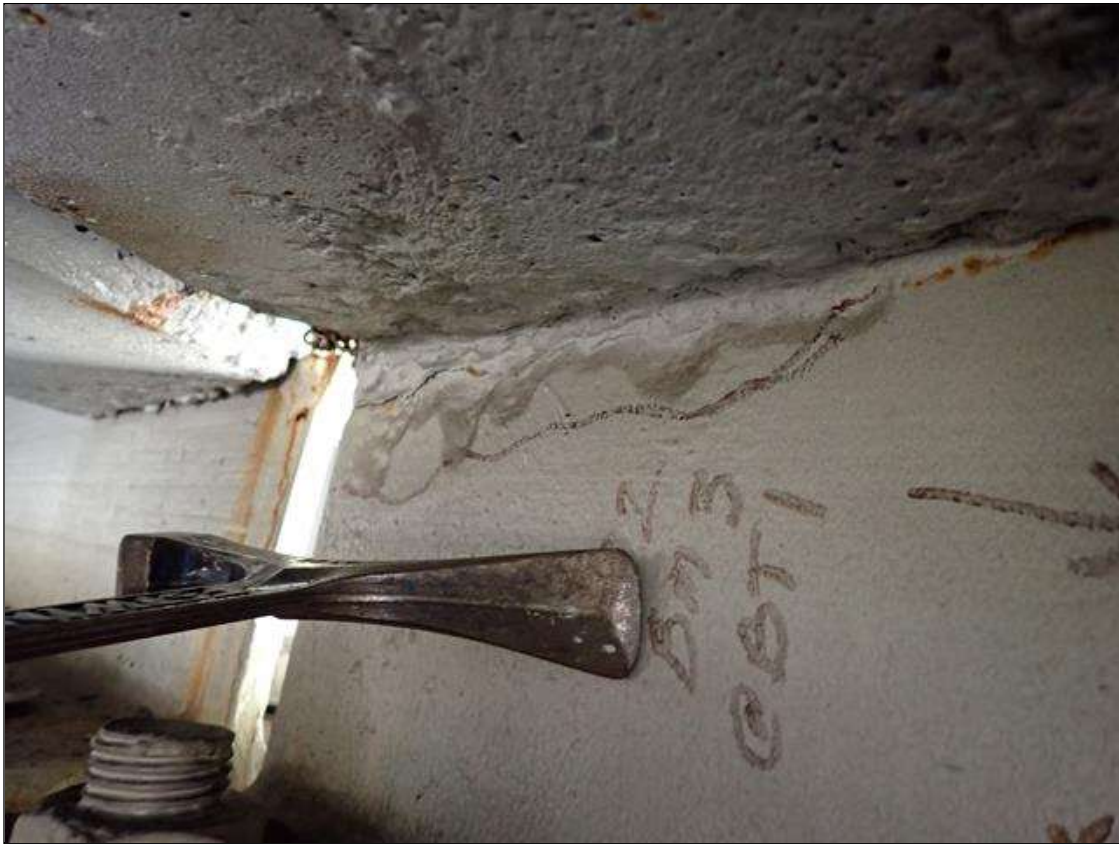
Span 2 Beam 3: (PAR) 10 inch long x up to 2 inch high x 5/16 inch section remaining in the web at beam end at bent 1, spot rust present

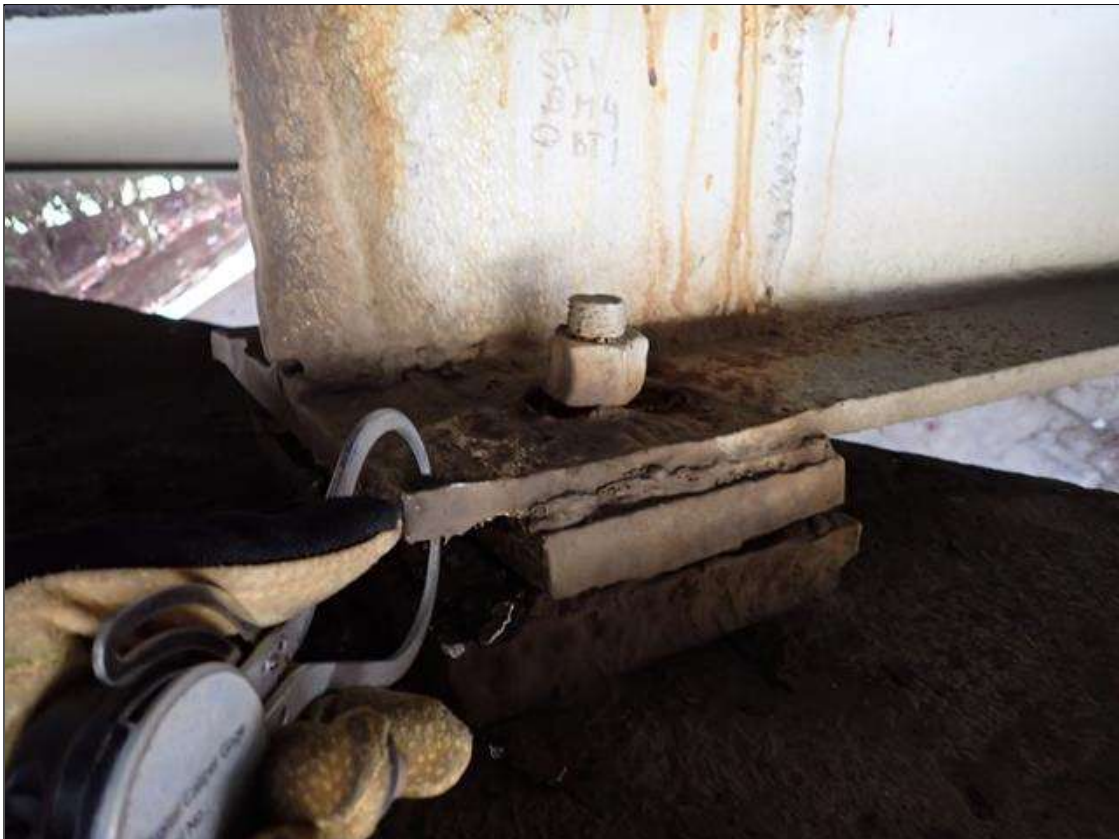
Span 1 Beam 4: (PAR) 8 inch long x full flange width x 0.55 inch remaining thickness in bottom flange with corrosion reactivating at bent 1

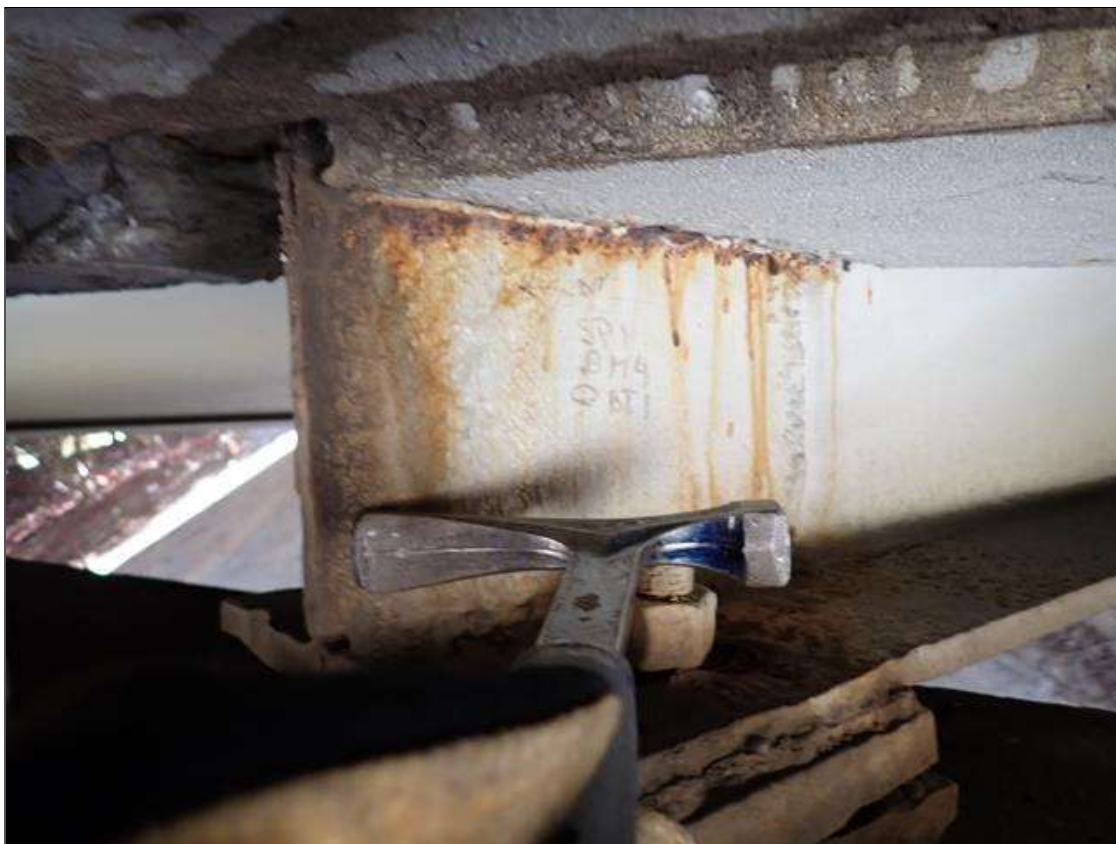
Span 1 Beam 4: at bent 1, painted over pitting up to 1/16 inch x 12 inch x 7 inch with corrosion reactivating

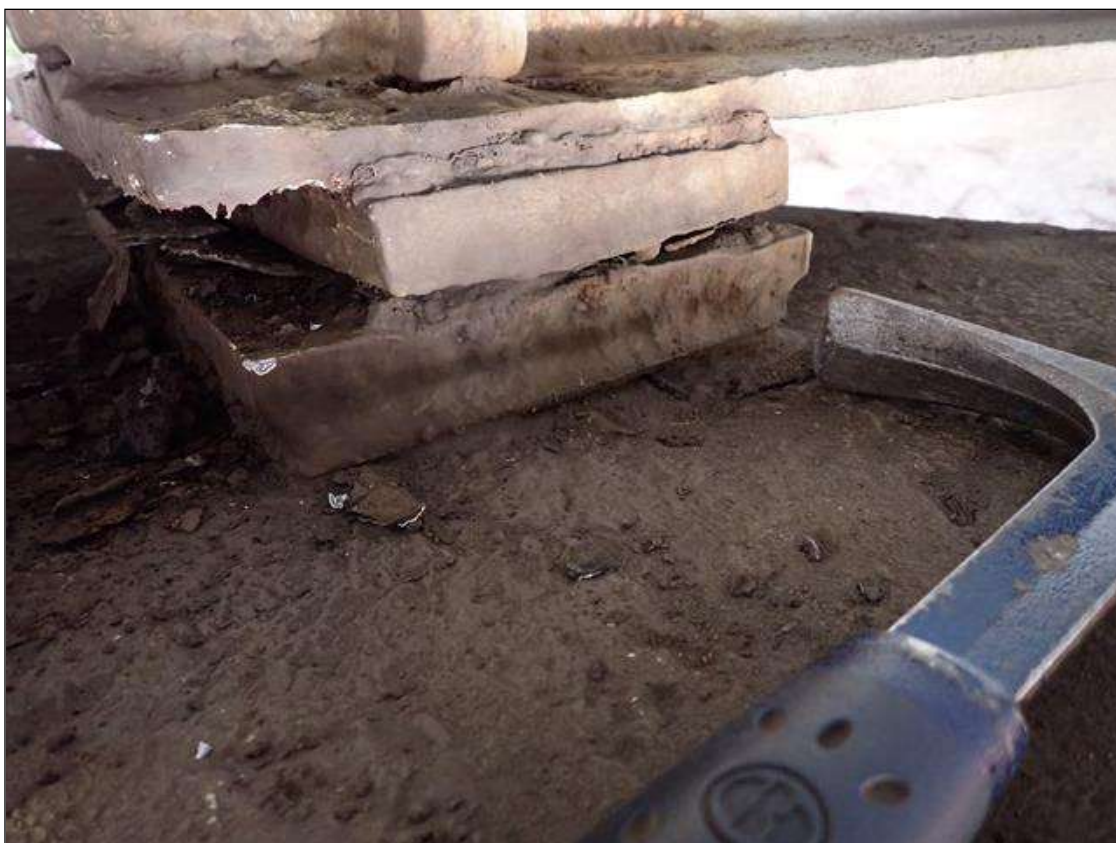
Span 1 Beam 4 - Far Bearing 4: arrested pack rust and section loss in masonry plate and sole plate. 80 percent section remaining.

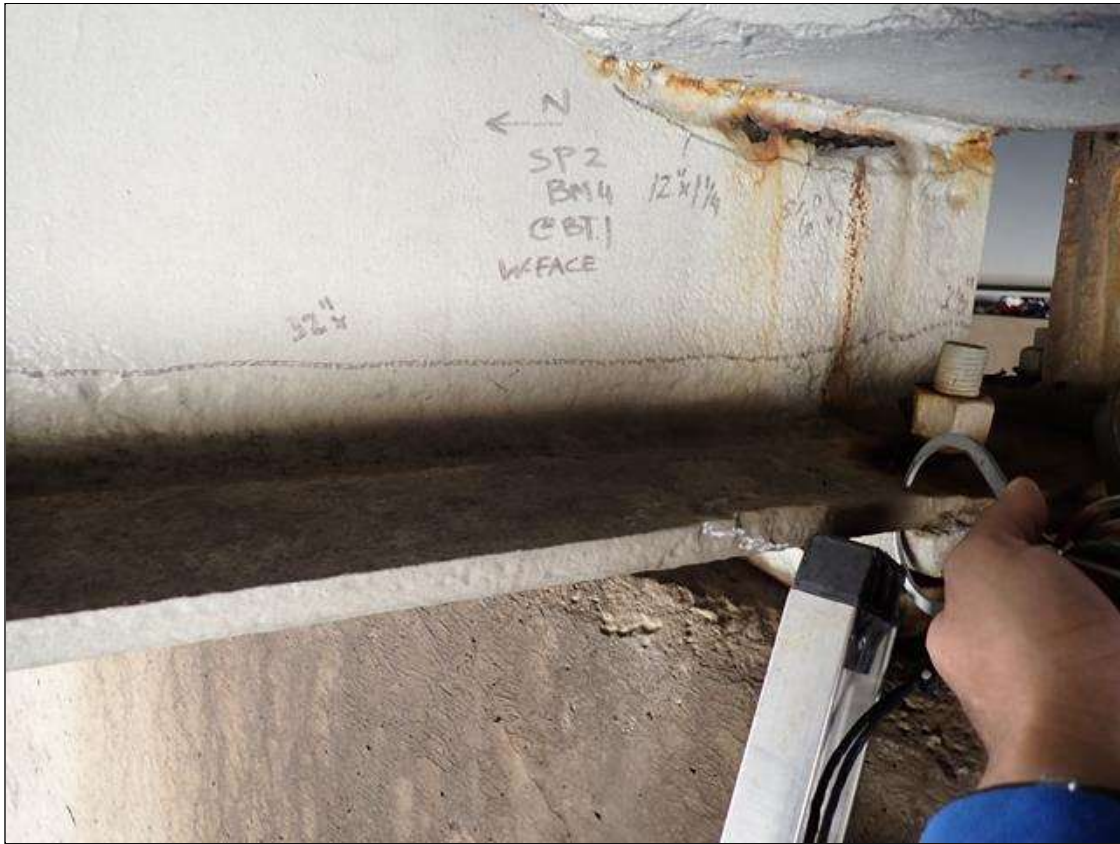
Span 2 Beam 4: (PAR) at bent 1, painted over section loss: web adjacent to diaphragm (1/4 inch average remaining x 12 inch x 2.5 inch) with corrosion hole (6 inch x 1 inch); lower web (5/16 inch average remaining x 52 inch x 2 inch); bottom flange (0.55 inch average remaining x 10 inch) with corrosion reinitiated

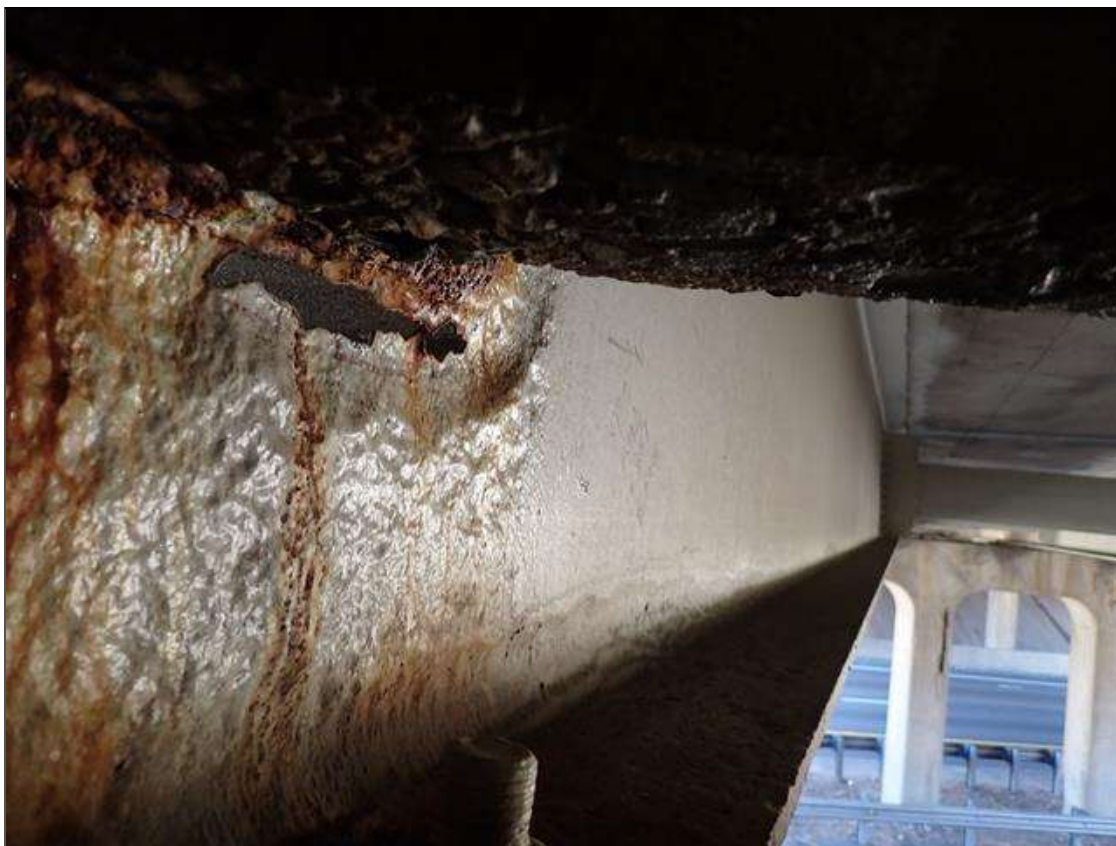
Span 2 Beam 4: (PAR) at bent 1, painted over section loss: web adjacent to diaphragm (1/4 inch average remaining x 12 inch x 2.5 inch) with corrosion hole (6 inch x 1 inch); lower web (5/16 inch average remaining x 52 inch x 2 inch); bottom flange (0.55 inch average remaining x 10 inch) with corrosion reinitiated

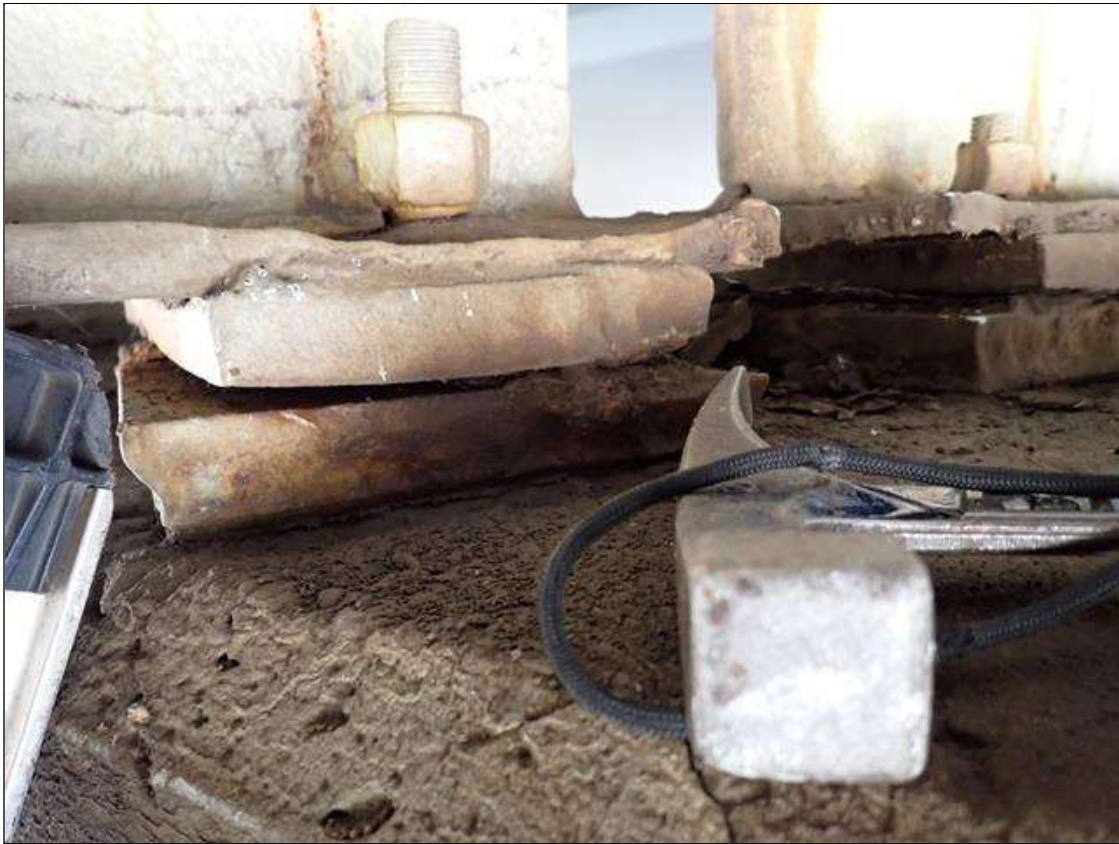
Span 2 Beam 4 - Near Bearing 4: active pack rust and section loss in masonry plate and sole plate. 75 percent section remaining

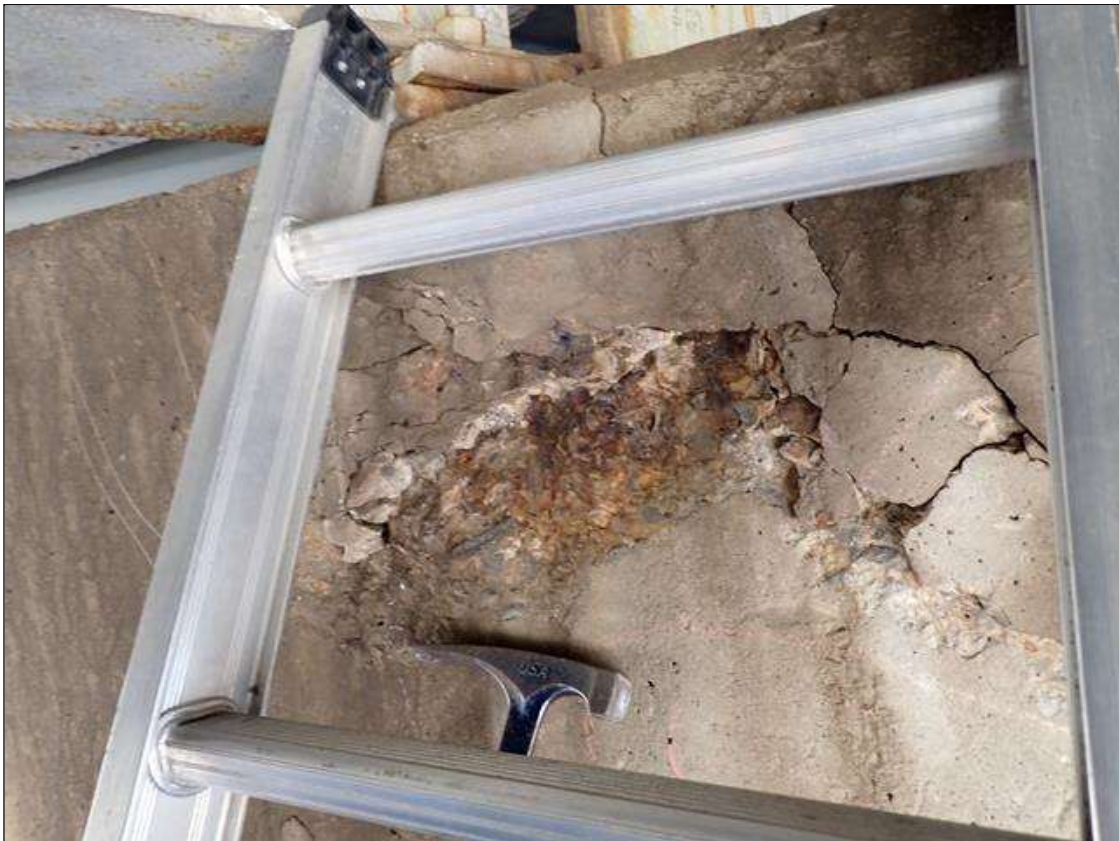
Bent 1 Cap 1: 35 inch long x 16 inch high x up to 1.5 inch deep area of delamination and spall in north face at beam 4 with exposed reinforcement. no measurable section loss.

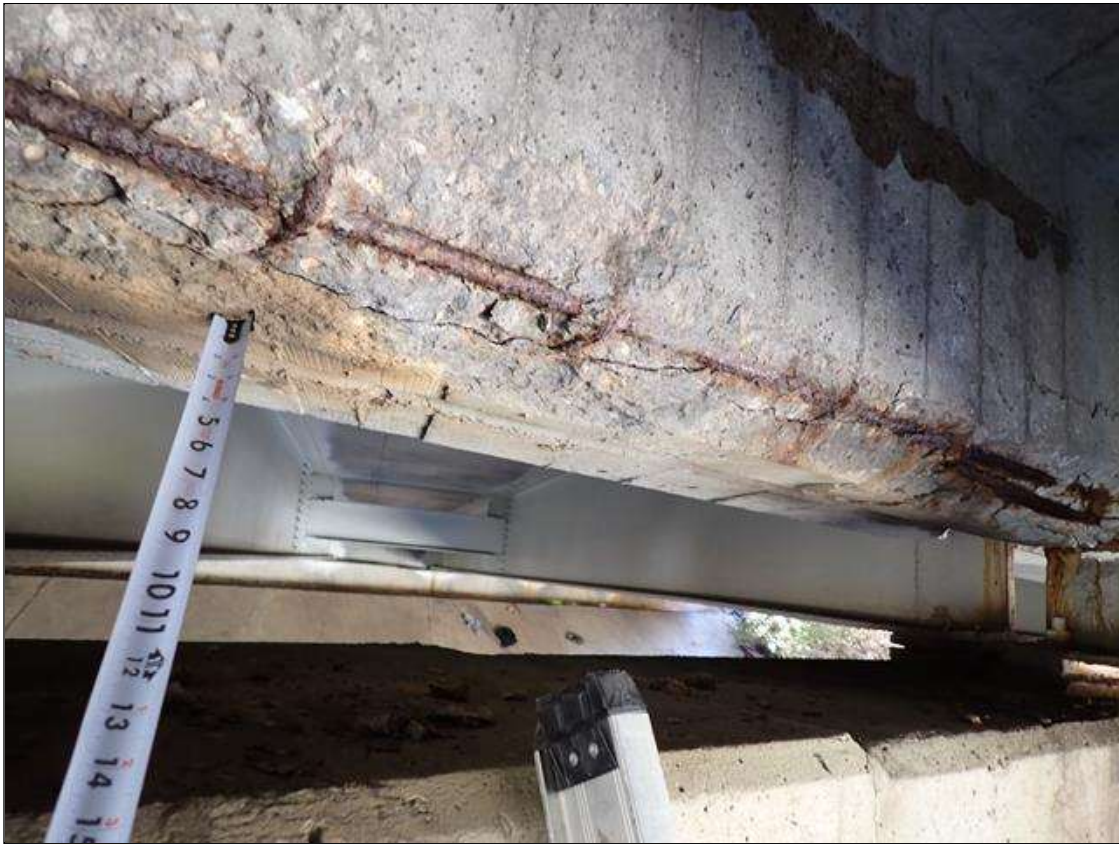
Span 2 Beam 4: (PAR) 7 foot long x 4 inch high x 4 inch wide area of spall, delamination with exposed reinforcement in the concrete diaphragm between beams 4 and 5 at bent 1. 75 percent section remaining in the exposed reinforcement.

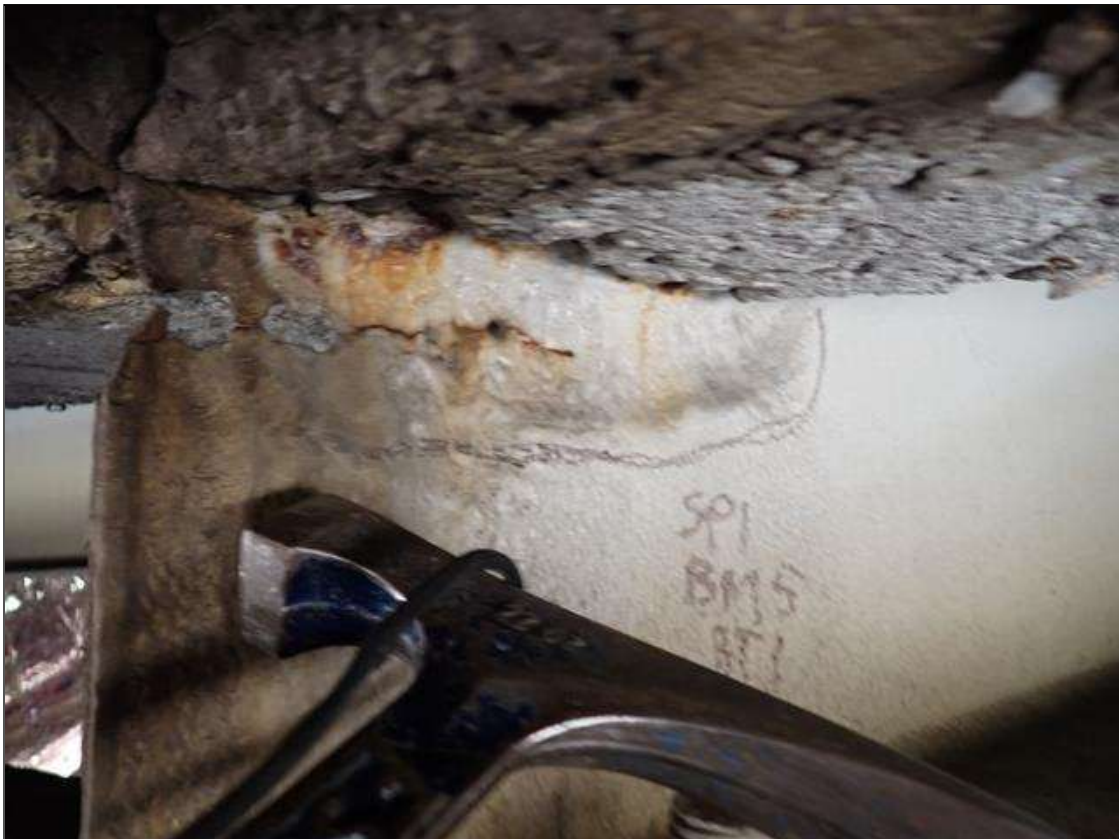
Span 1 Beam 5: (PAR) 10 inch long x 3 inch high x 3/16 inch average remaining in the web with 3 inch long x 1.5 inch corrosion hole under the diaphragm at bent 1
