NC DEPARTMENT OF TRANSPORTATION  
 DIVISION OF HIGHWAYS  
 STRUCTURE MANAGEMENT UNIT

ATTENTION: **prompt action request; sketches updated; new beam repairs**

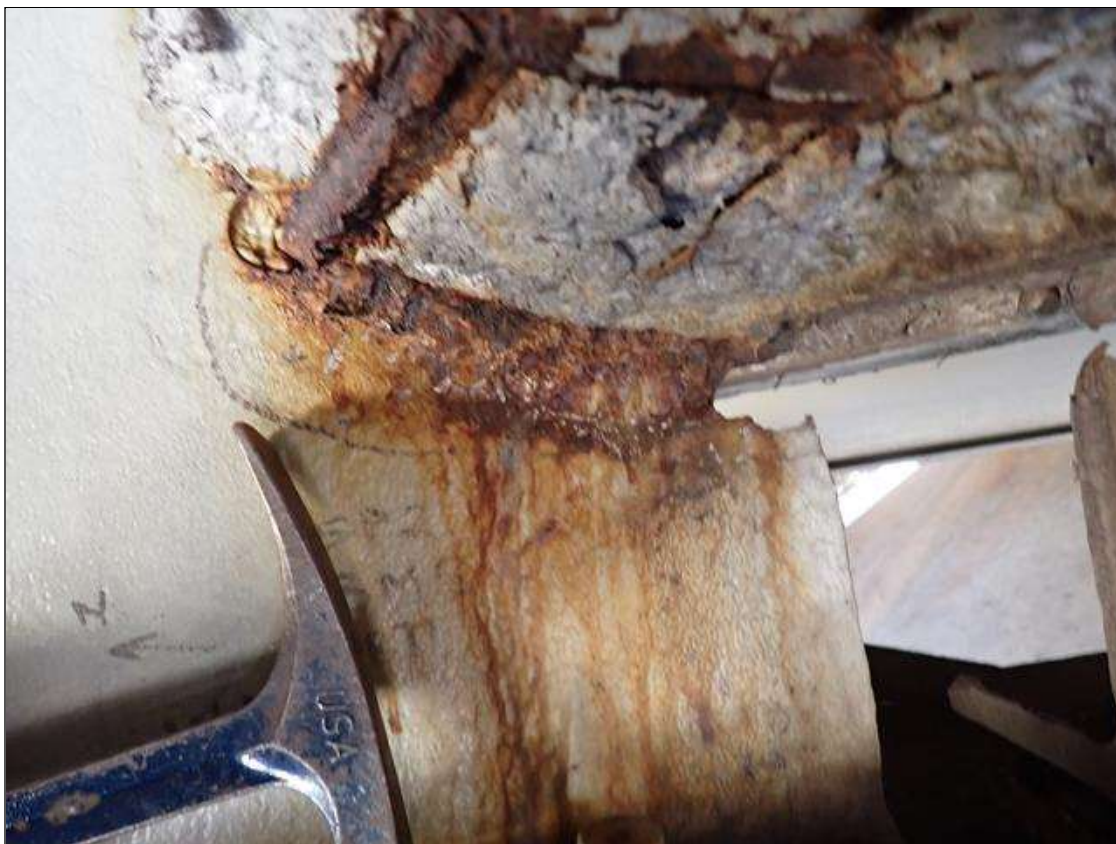
Span 2 Beam 5: (PAR) active corrosion with section loss 10 inch long x 3 inch high x 1/4 inch average remaining in the web with 3 inch long x 1.25 inch high corrosion hole under the diaphragm at bent 1

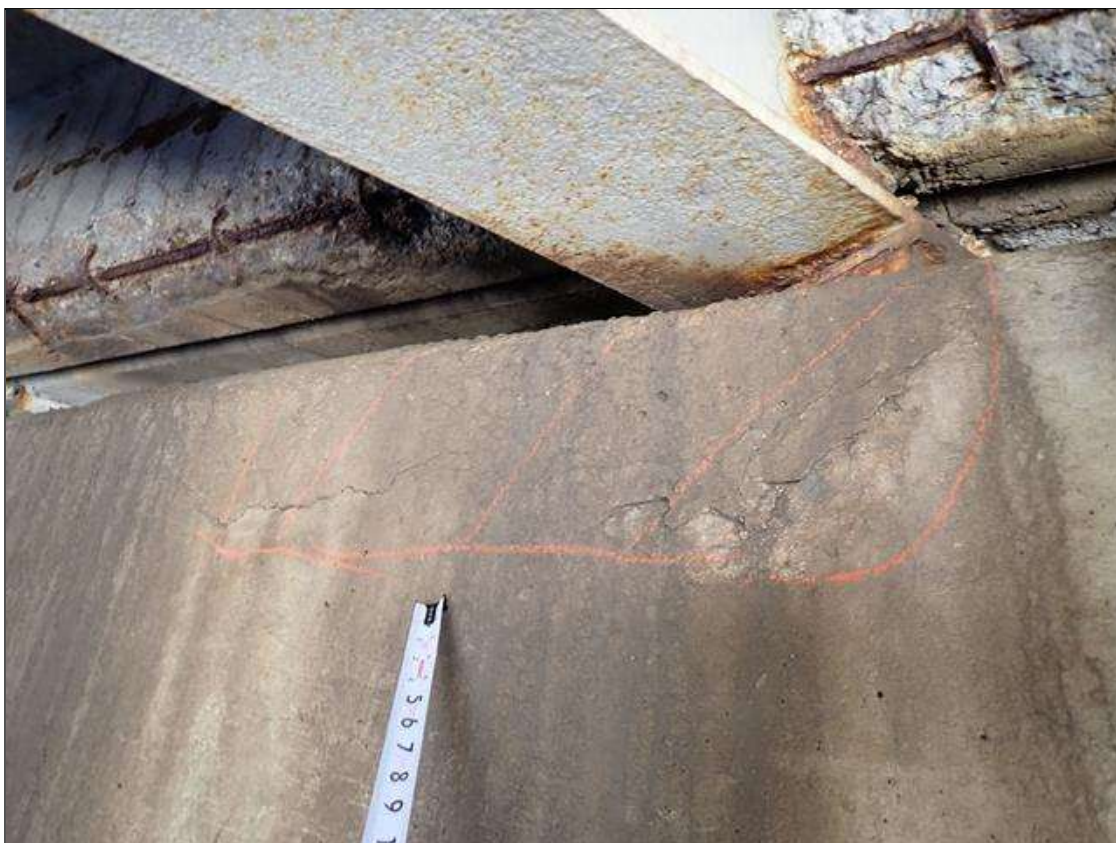
Bent 1 Cap 1: north face, below beam 5, delamination/spall [4 foot x 1 foot x 1/2 inch]

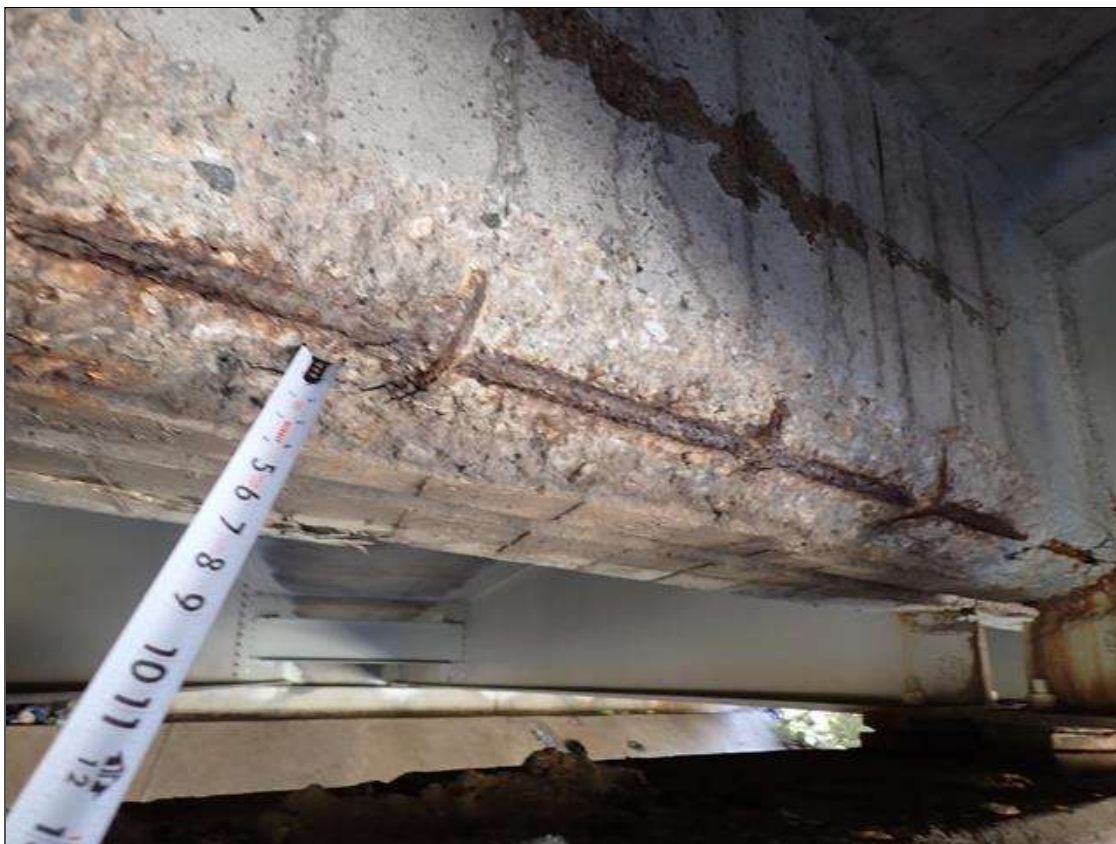
Span 2 Beam 5: (PAR) 7 foot long x 10 inch high x 3 inch wide area of spall, delamination with exposed reinforcement in the concrete diaphragm between beams 5 and 6 at bent 1. 70 percent section remaining in the exposed reinforcement

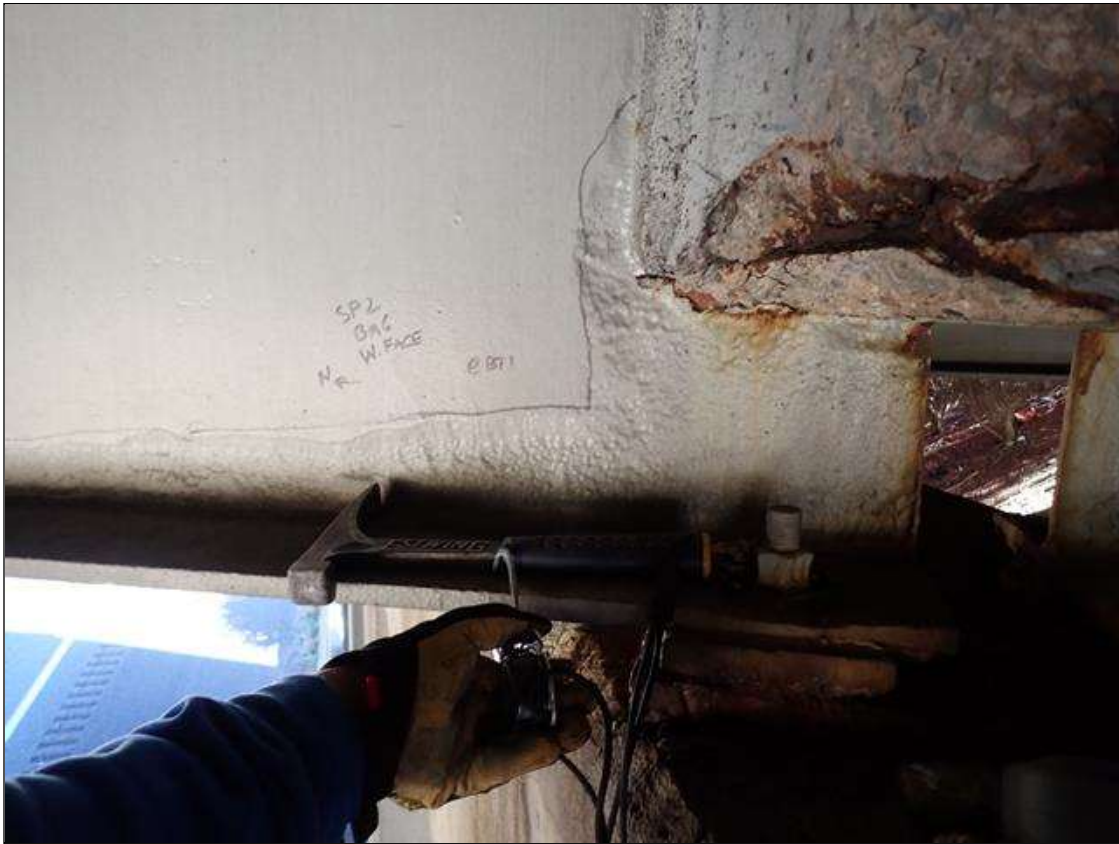
Span 2 Beam 6: (PAR) at bent 1, painted over section loss: web (1/4 inch average remaining x 54 inch x 13 inch); bottom flange (0.56 inch average remaining x 2 foot) with corrosion reinitiated

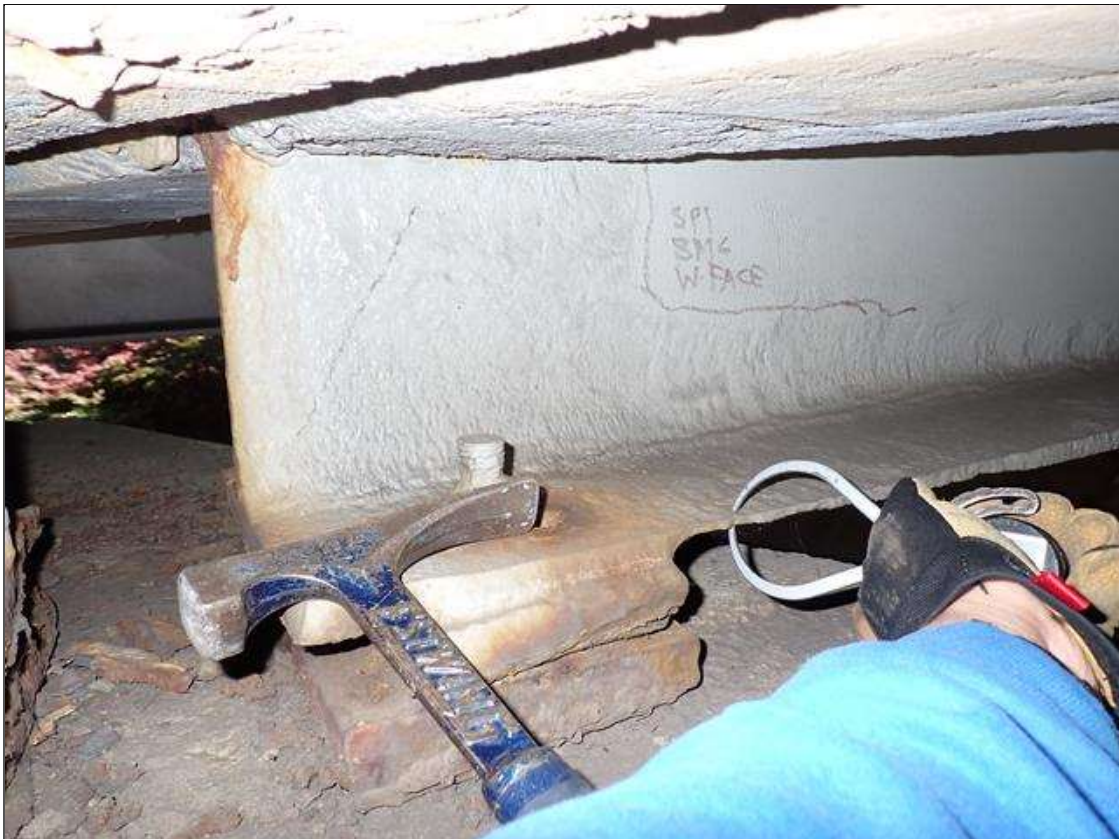
Span 1 Beam 6: (PAR) at bent 1, painted over section loss: web (1/4 inch average remaining x 3 foot x 8 inch); bottom flange (0.42 inch average remaining x 20 inch) with corrosion reinitiated

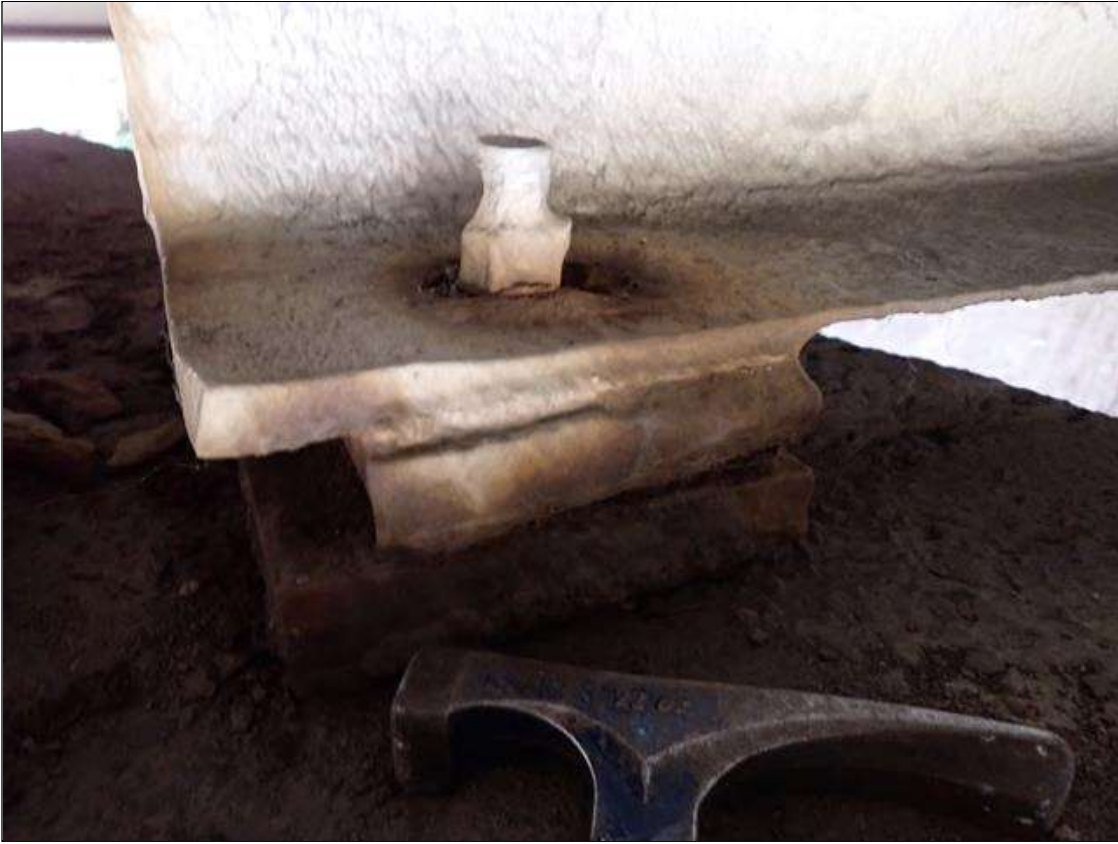
Span 1 Beam 6 - Far Bearing 6: active pack rust and section loss in masonry plate and sole plate. 80 percent section remaining. west anchor bolt nut 60 percent remaining.

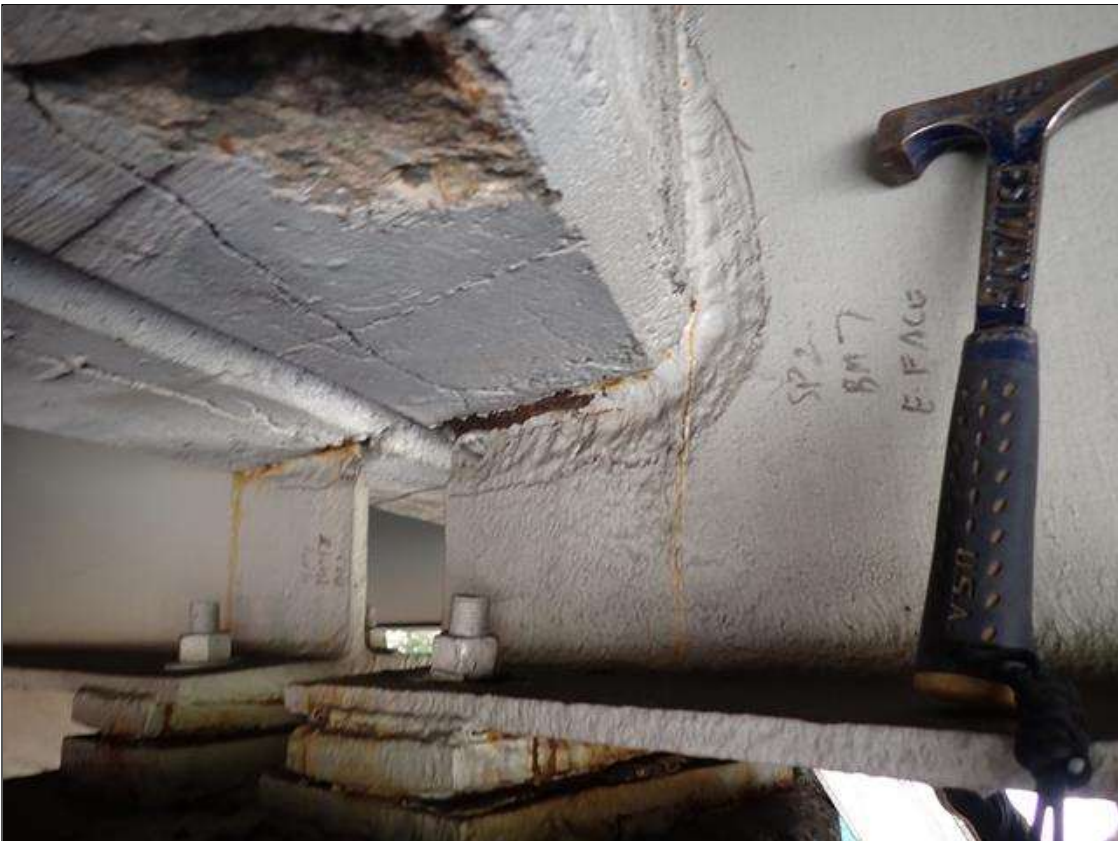
Span 2 Beam 7: (PAR) at bent 1 active corrosion with section loss, web at diaphragm [20 inch long x 13 inch high x 1/4 inch average remaining] with multiple corrosion holes up to [3 inch x 1 inch]

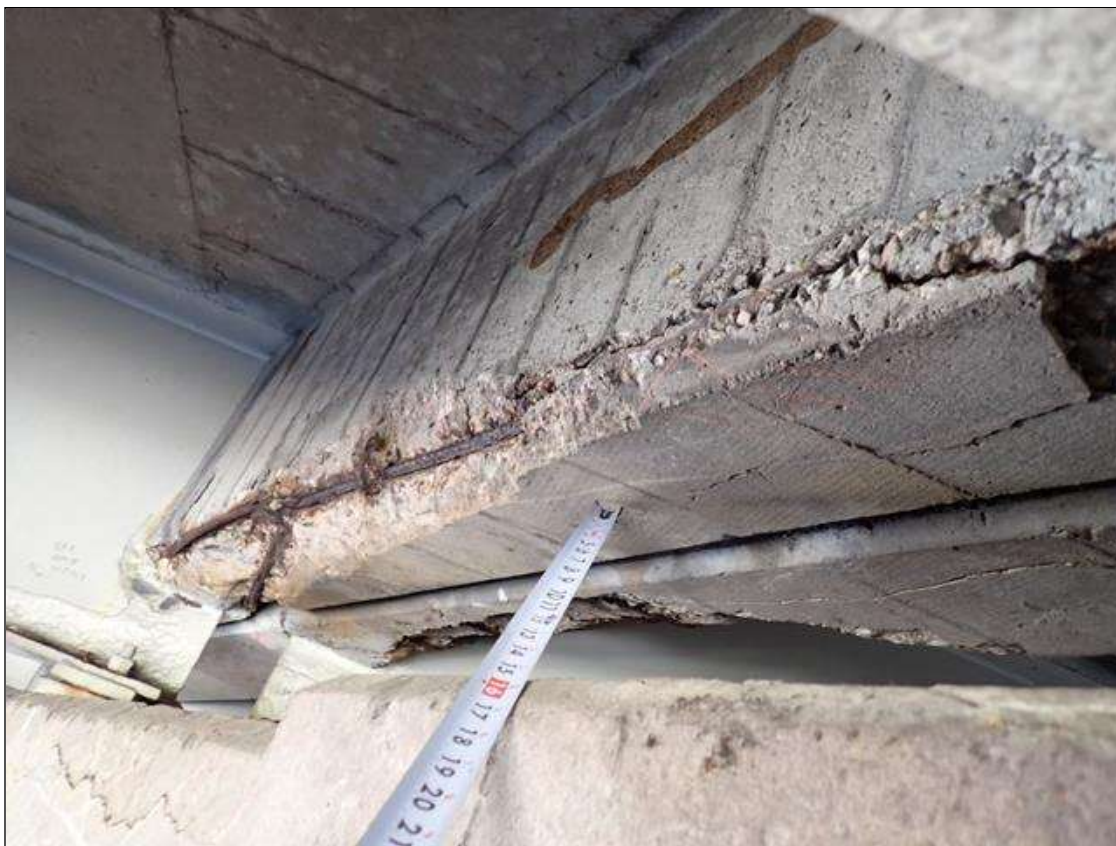
Span 2 Beam 7: (PAR) 7 foot long x 4 inch high x 4 inch wide area of spalling, delamination with the exposed reinforcement in the concrete diaphragm between beams 7 and 8 at bent 1. 70 percent section remaining in the exposed reinforcement.

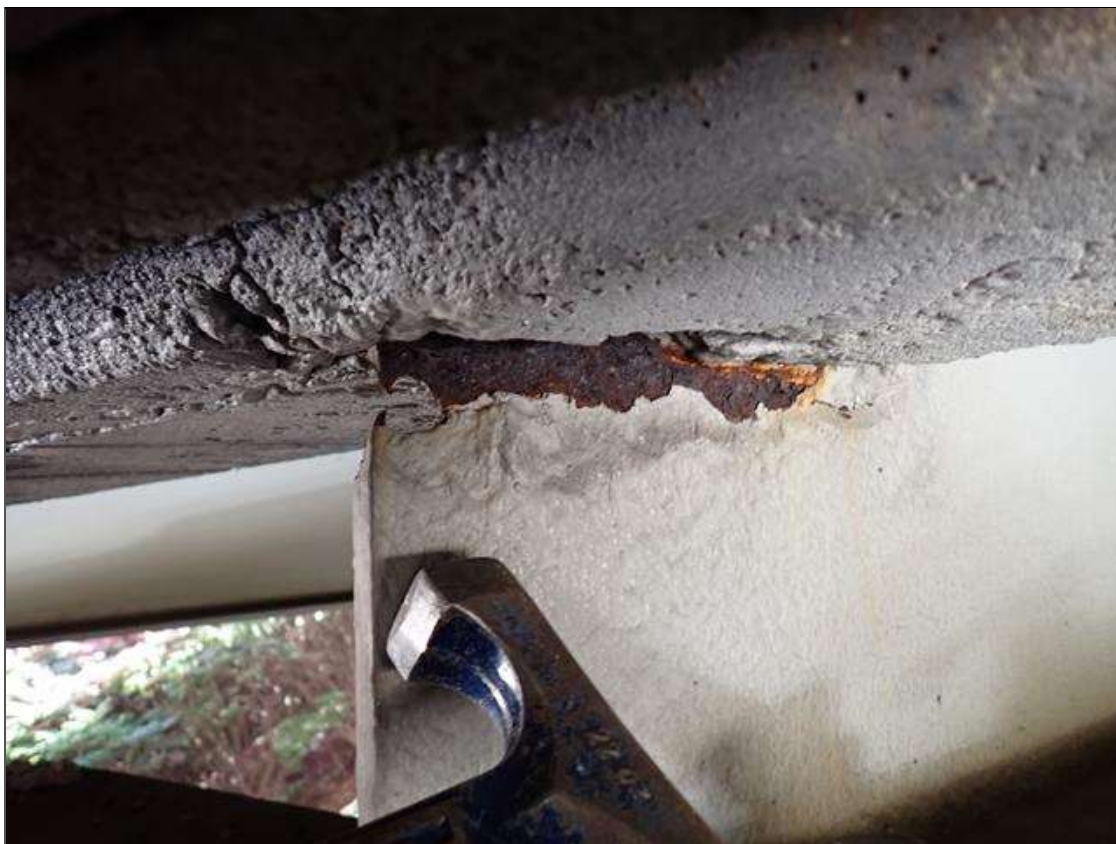
Span 1 Beam 7: (PAR) at bent 1 active corrosion with section loss, web at diaphragm [10 inch x 2 inch x 3/16 inch average remaining] with 1/2 inch diameter corrosion hole

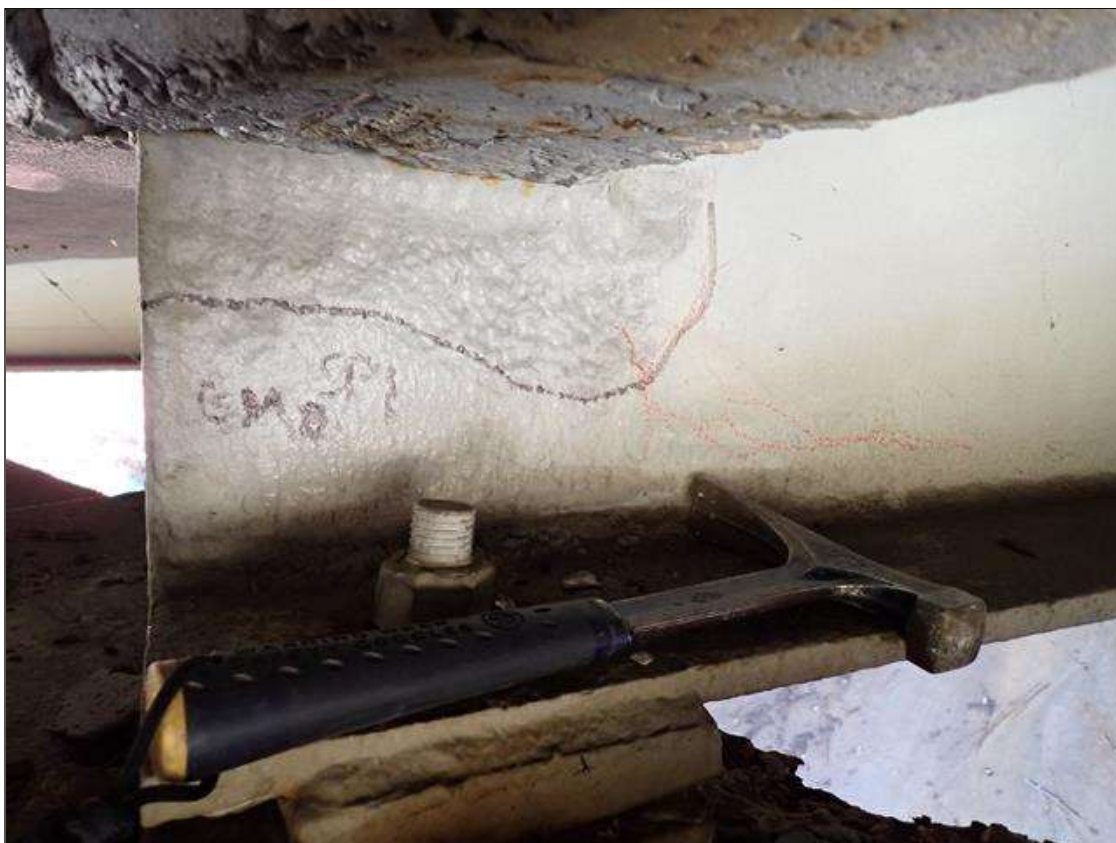
Span 1 Beam 8: (PAR) 18 inch long x up to 8 inch x 1/4 inch average remaining area of section loss in web at bent 1, spot rust present.

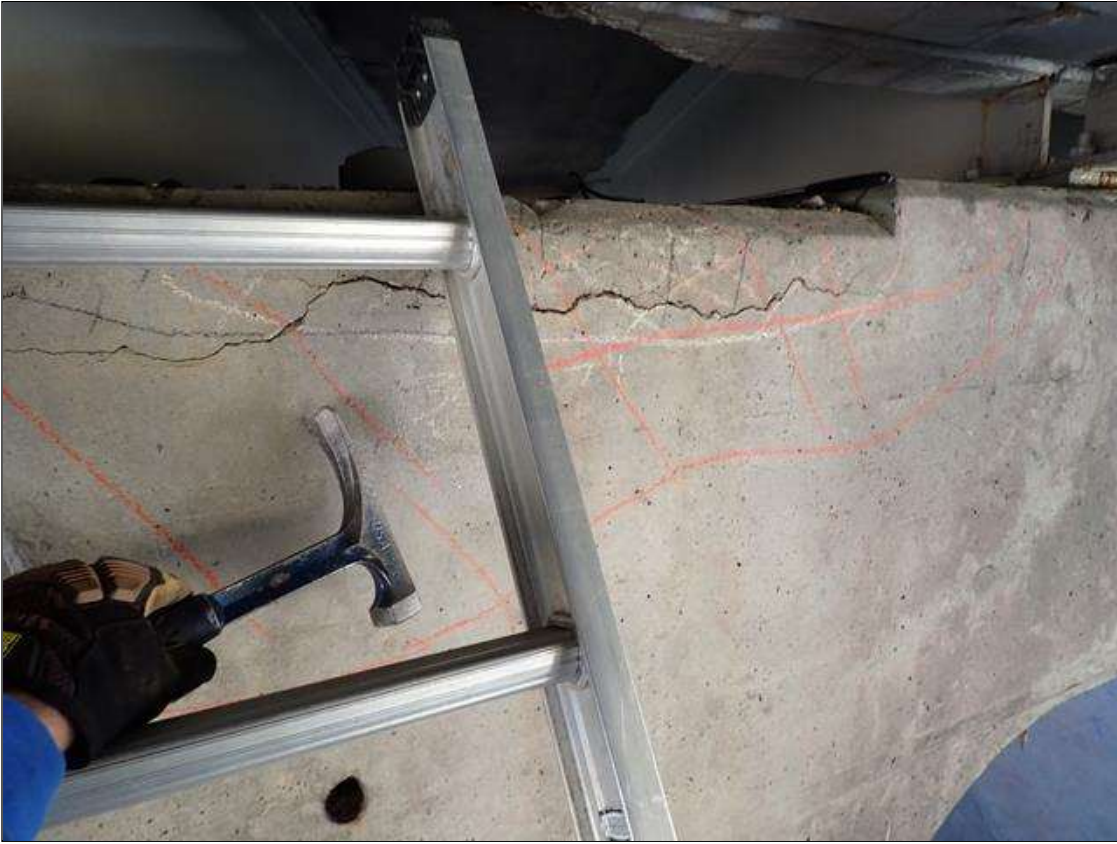
Bent 1 Cap 1: 5 foot long x 21 inch high area of delaminated concrete with cracks up to 1/16 inch between beams 7 and 8 in the north face of cap near top.

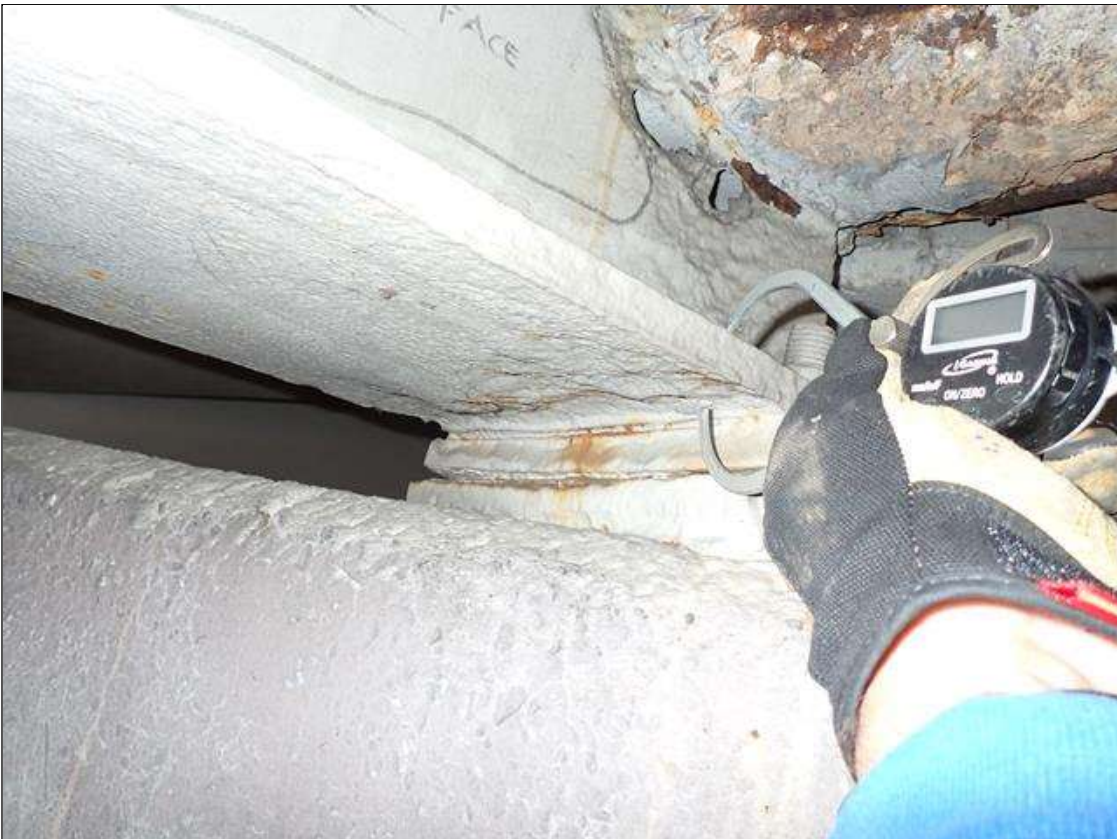
Span 2 Beam 8: (PAR) at bent 1, painted over section loss: web (1/4 inch average remaining x 24 inch x 12 inch) with corrosion hole (3 inch x 1 inch); bottom flange (0.56 inch average remaining x 12 inch) with corrosion reinitiated

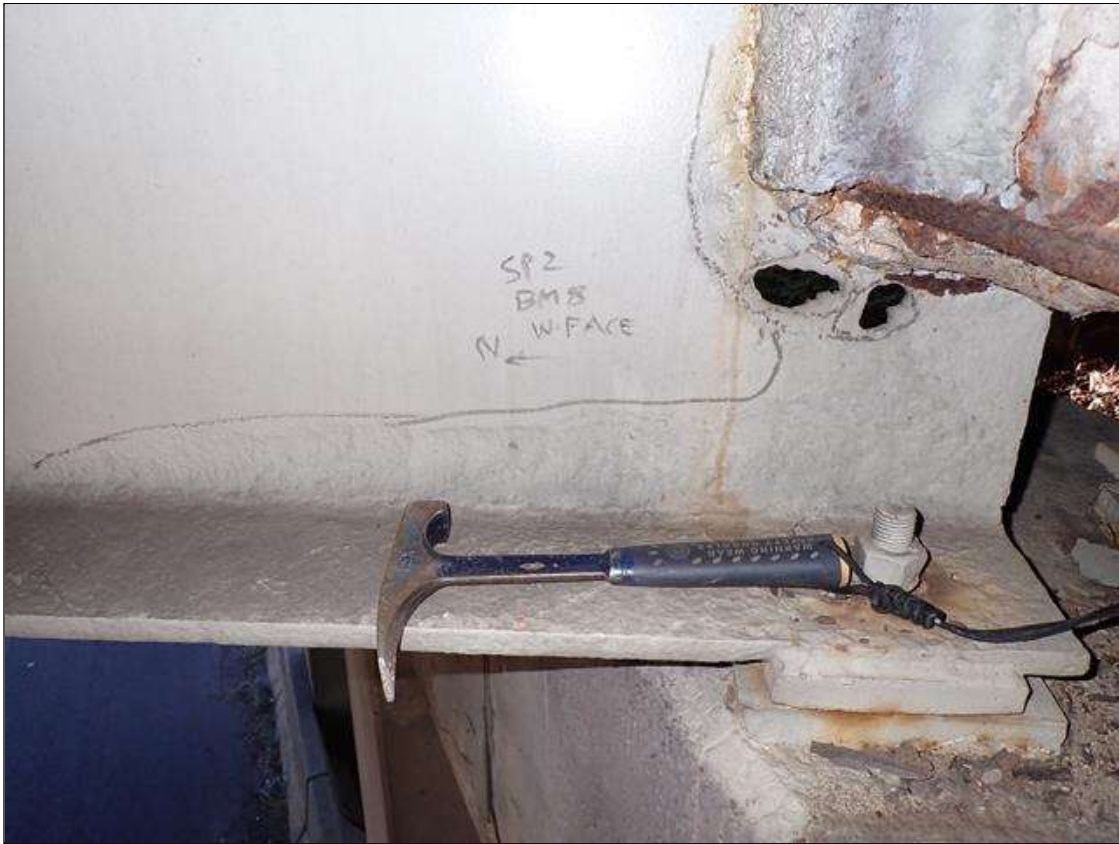
Span 2 Beam 8: (PAR) at bent 1, painted over section loss: web (1/4 inch average remaining x 24 inch x 12 inch) with corrosion hole (3 inch x 1 inch); bottom flange (0.56 inch average remaining x 12 inch) with corrosion reinitiated

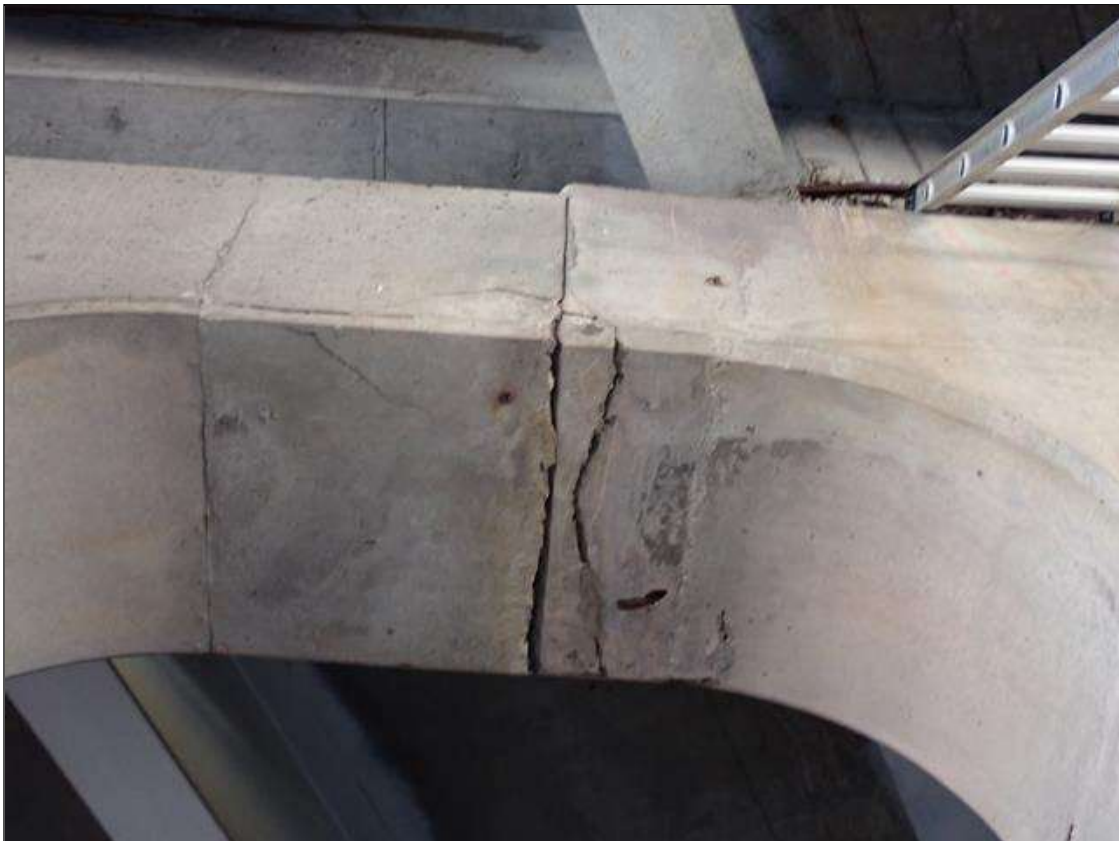
Bent 1 Cap 1: 1 foot long x full width of cap area of delaminated concrete with cracks up to 1/8 inch extends 1 foot into north face between columns 5 and 6.

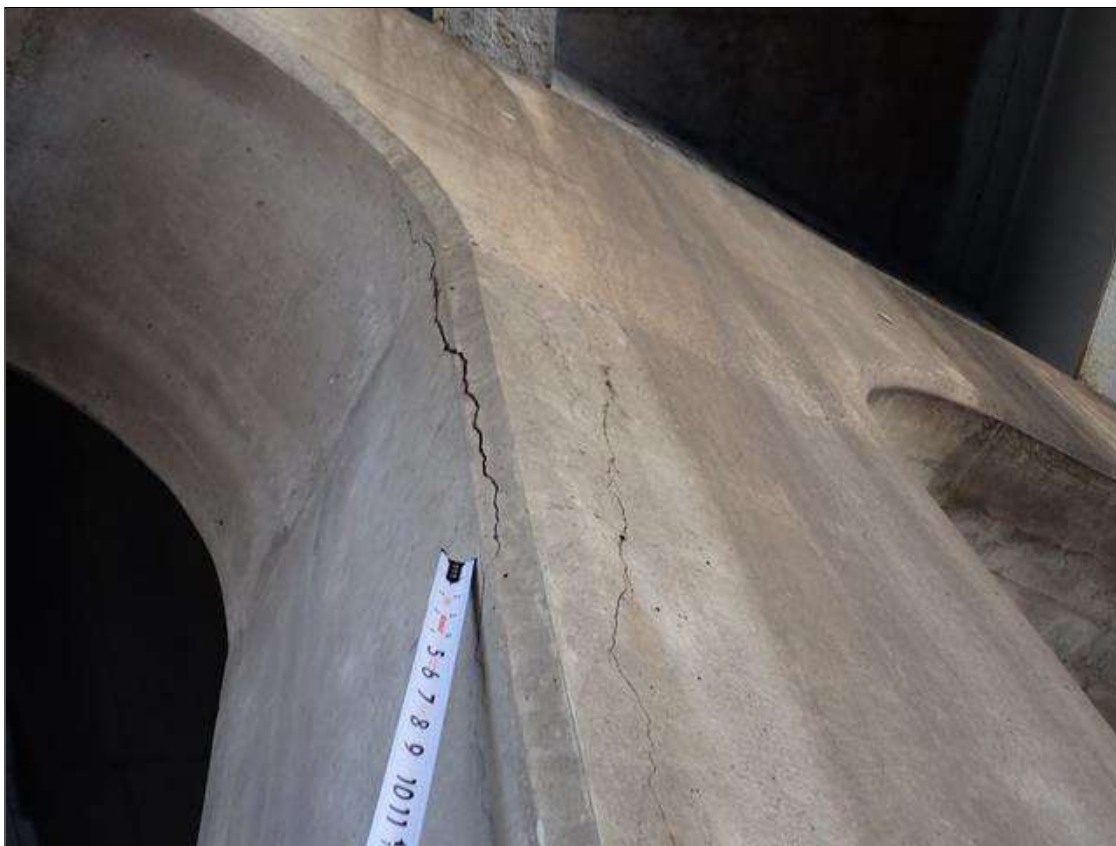
Bent 1 Pile 4: North face at top of the column, delamination [31 inch x 10 inch wide] with cracks [up to 1/8 inch]

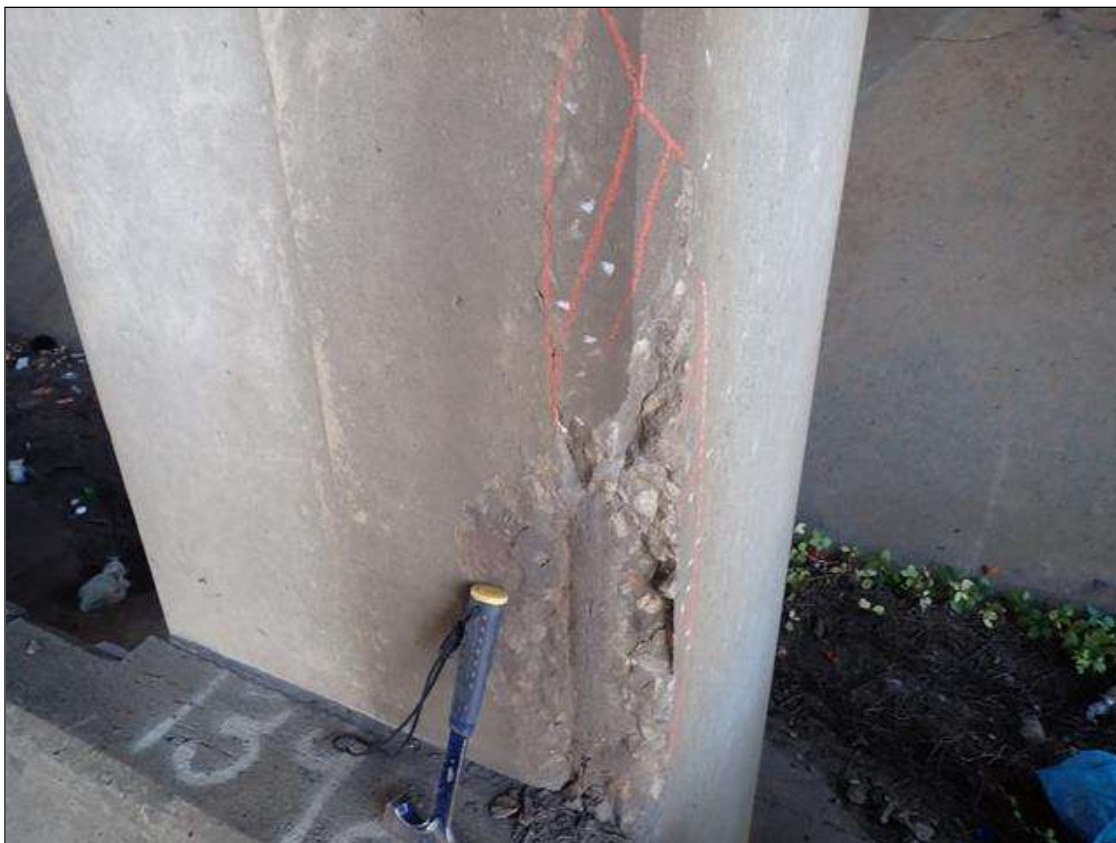
Bent 1 Pile 3: (PAR) 34 inch high x 10 inch wide x up to 2 inch deep spall with exposed rusted reinforcement.

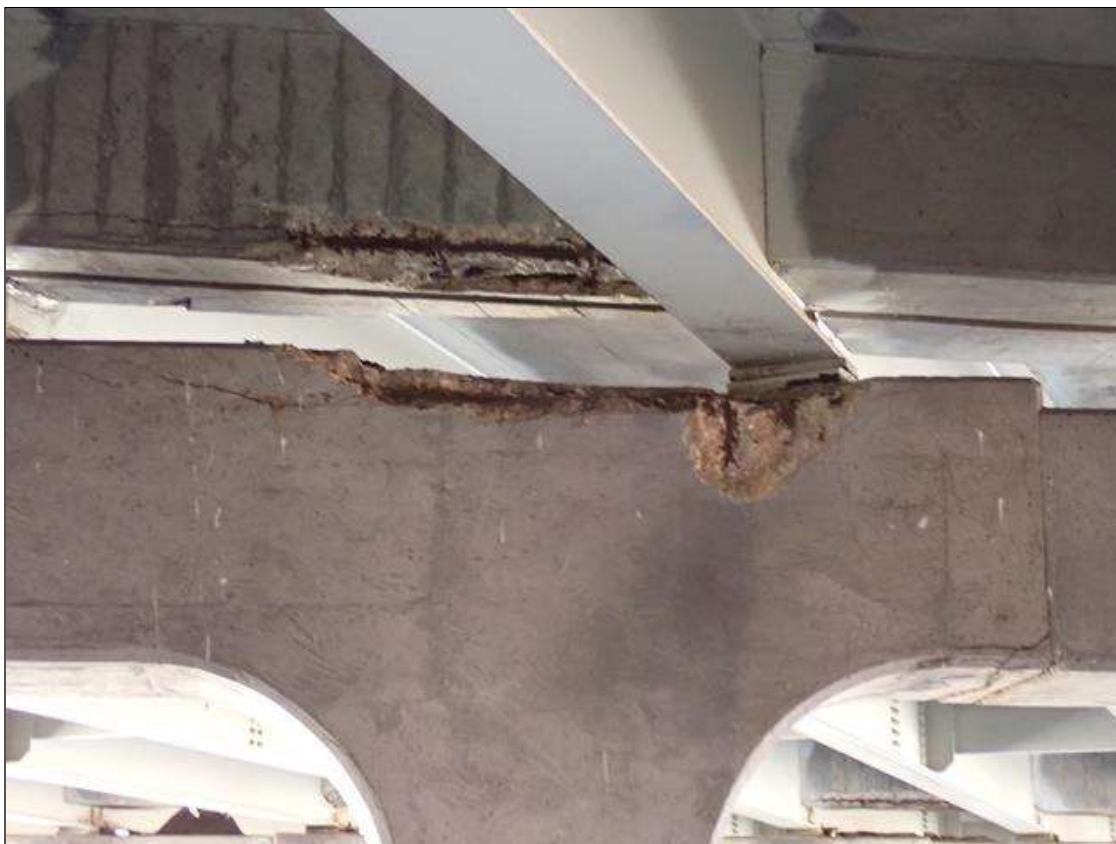
Bent 1 Cap 1: (PAR) South and top face between beams 7 and 8, spall/delamination [4.5 foot x up to 3.5 foot x up to 4 inch deep] with 4 vertical and 1 horizontal exposed rusted reinforcing with up to 1/16 inch section loss. no loss of bearing area

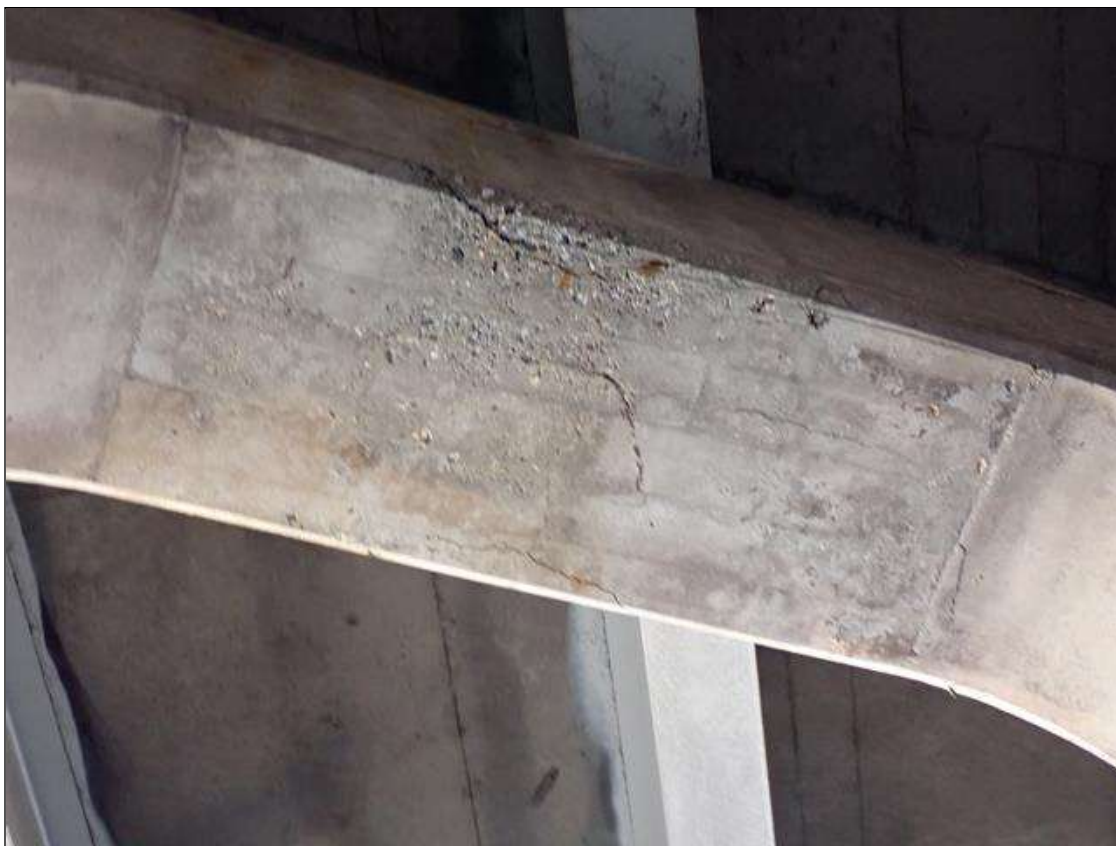
Bent 1 Cap 1: 5 foot x full width delamination with cracks up to 1/16 inch in the underside of the cap between columns 4 and 5. 1/16 inch wide vertical crack in the north face of the cap between columns 4 and 5.

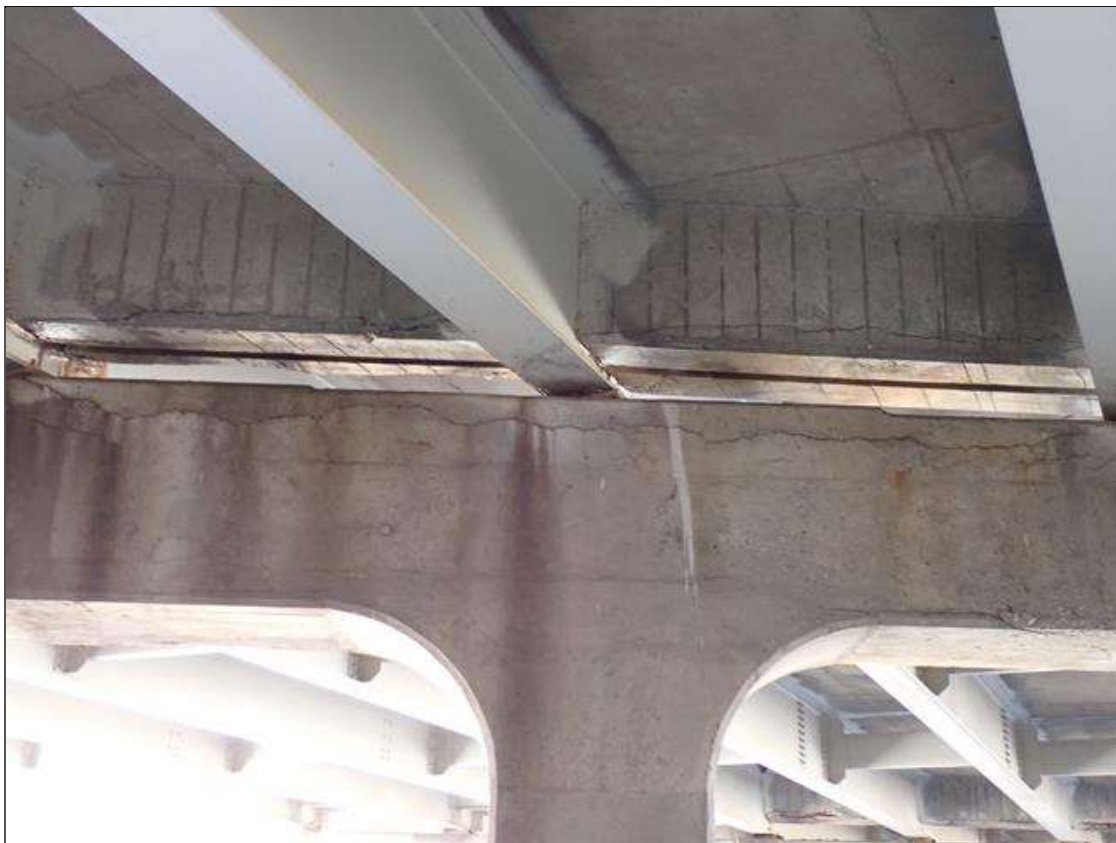
Bent 1 Cap 1: 15 foot long x 12 inch delamination with cracks up to 1/8 inch between beams 5 and 7 on south face of the cap.

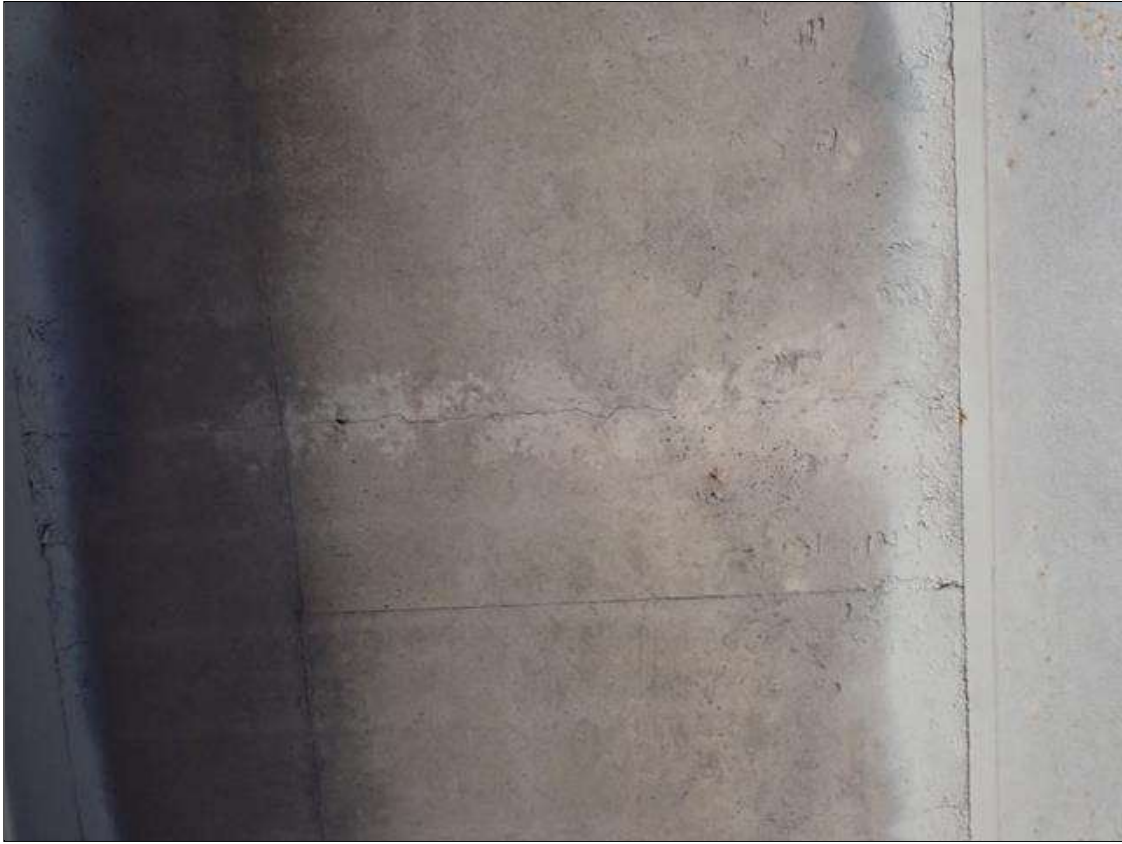
Span 2 Deck: throughout underside of deck, transverse cracks (up to 1/16 inch x full bay width) and map cracks (1/32 inch) at random

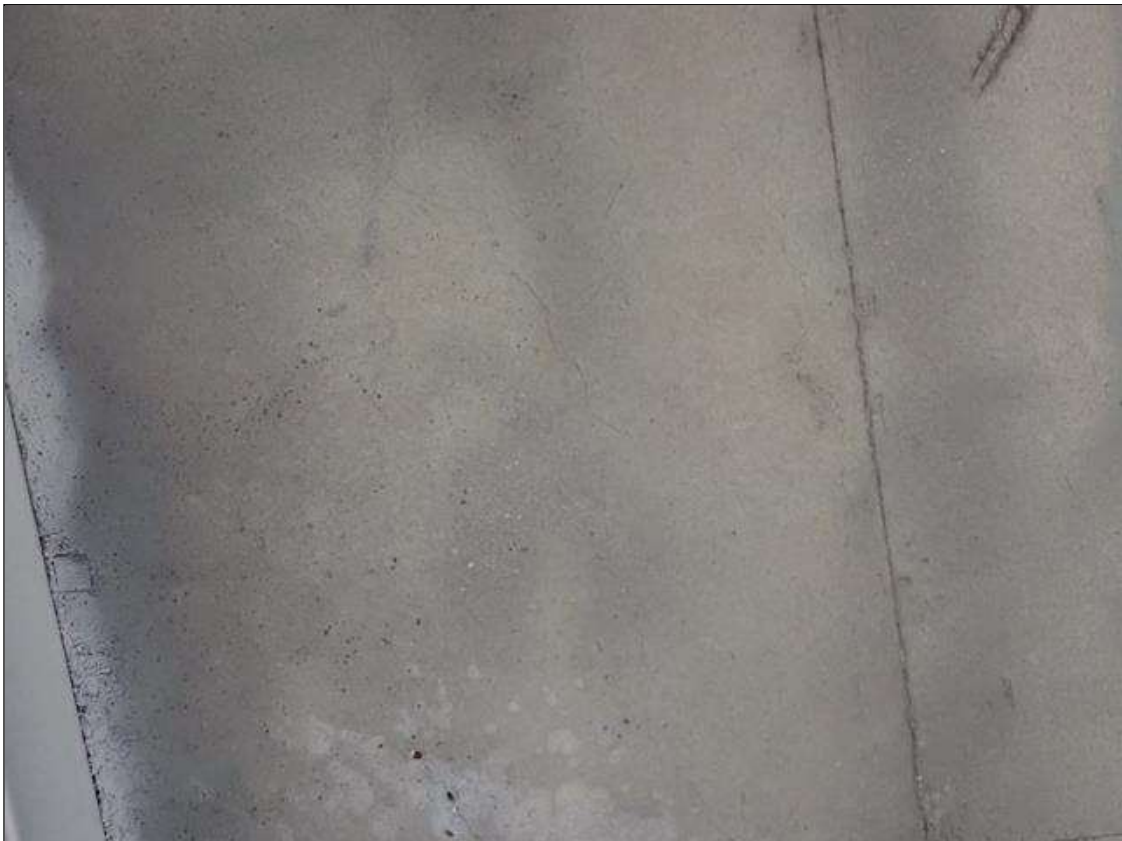
Span 2 Deck: throughout underside of deck, transverse cracks (up to 1/16 inch x full bay width) and map cracks (1/32 inch) at random

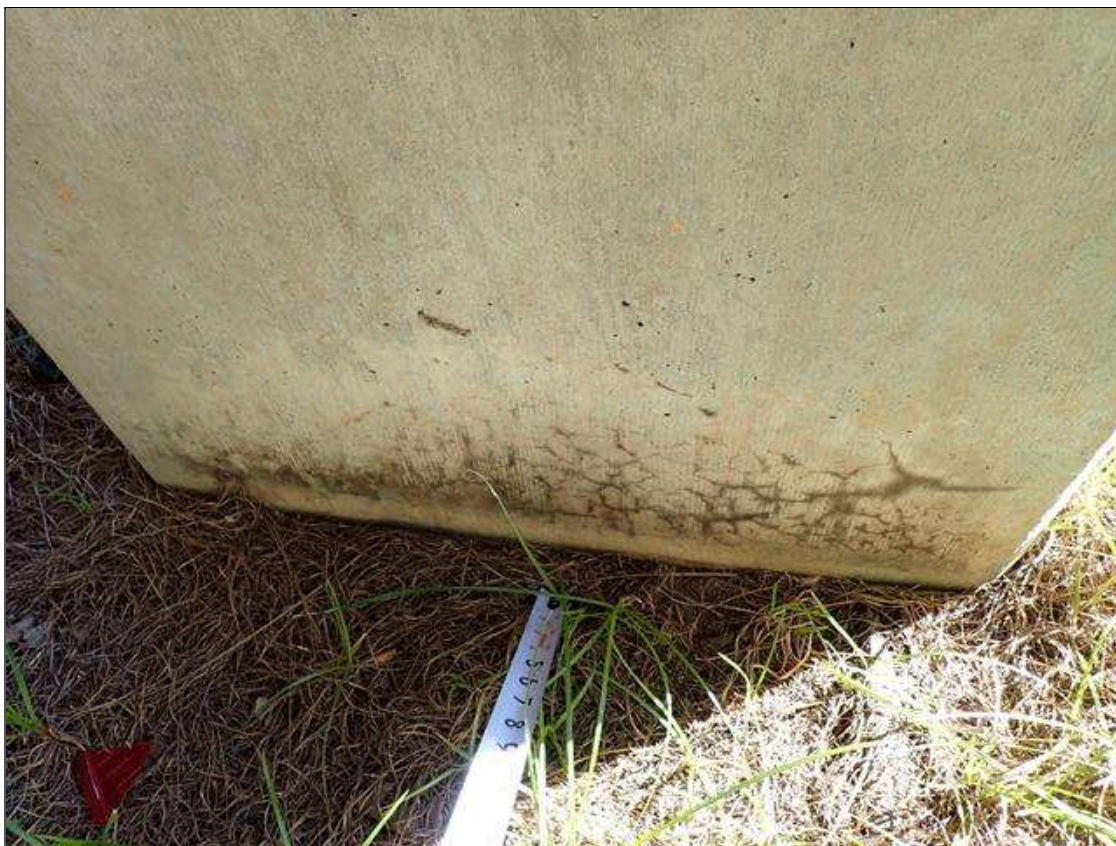
Bent 2 Pile 7: north and west faces, map cracks (hairline x 1 foot x full width)

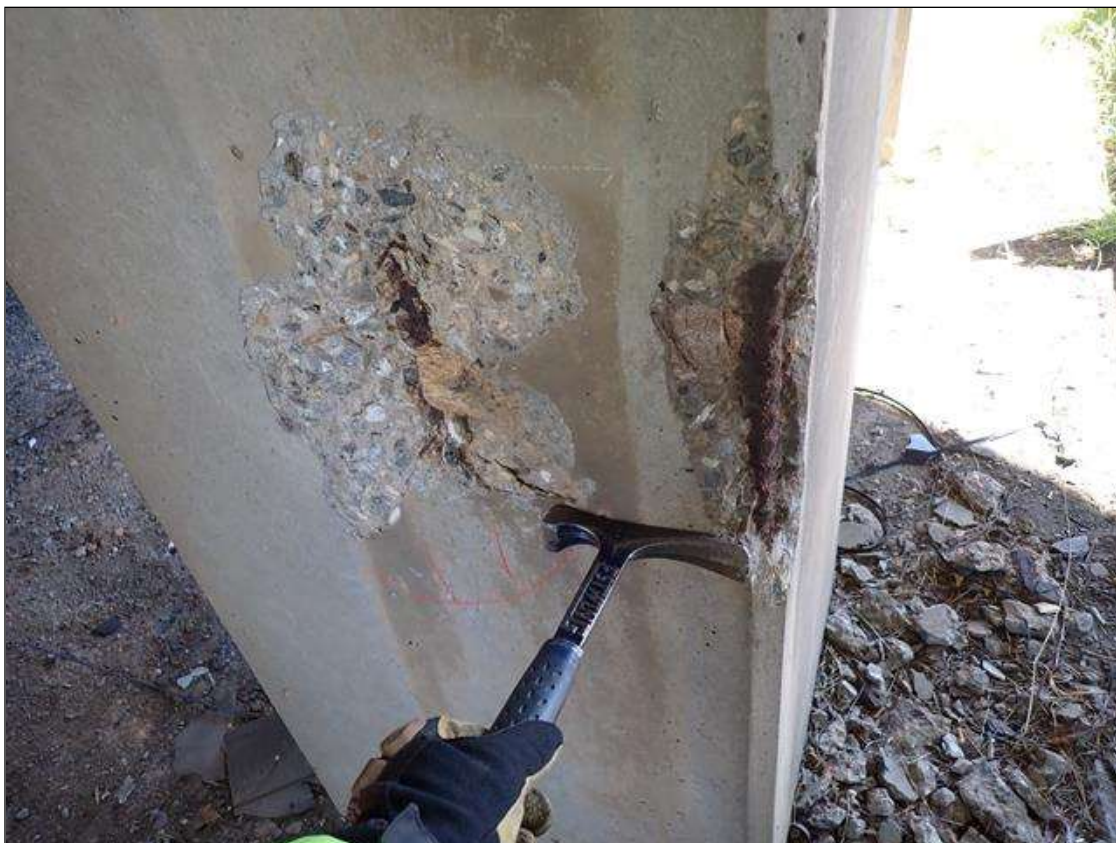
Bent 2 Pile 5: 3 foot from ground, west and south faces, (2) spalls/delaminations (up to 1 foot x 19 inch x 1.5 inch deep) with exposed rusted rebar
