NC DEPARTMENT OF TRANSPORTATION  
 DIVISION OF HIGHWAYS  
 STRUCTURE MANAGEMENT UNIT

ATTENTION: **prompt action request; sketches updated; new beam repairs**

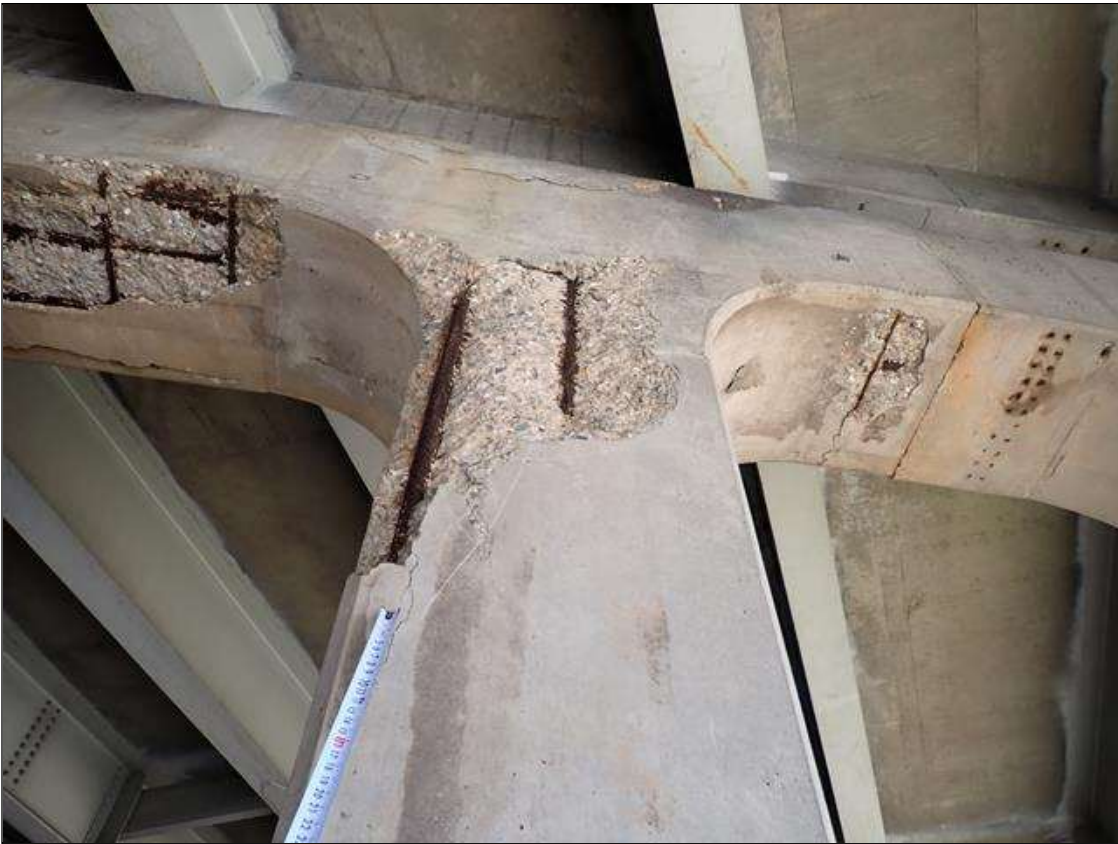
Bent 2 Pile 5: (PAR) Southwest corner below cap, delamination/spall [7 foot high x up to full width x up to 3 inch deep] with two exposed rusted reinforcing, 70 percent section remaining in the exposed reinforcement.

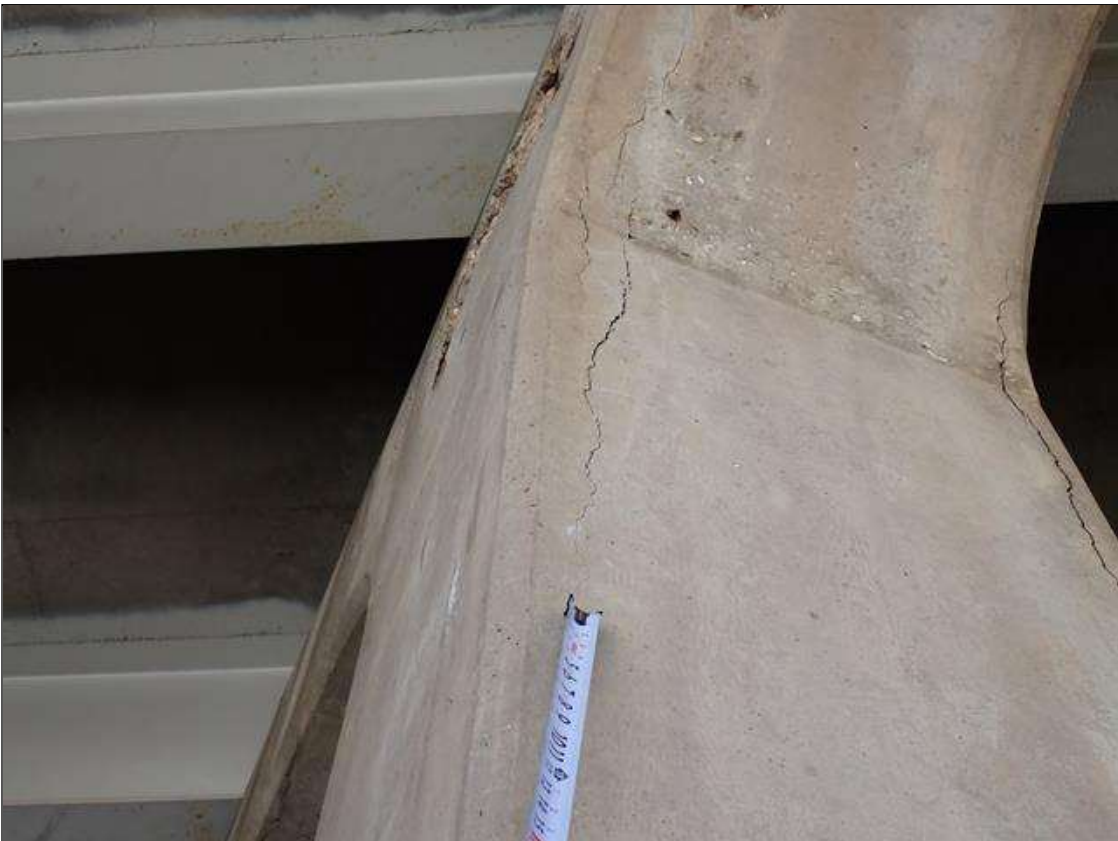
Bent 2 Pile 4: below cap, northeast and southeast corners, (2) delaminations (up to 3.5 foot x 10 inch) with cracks (1/4 inch)

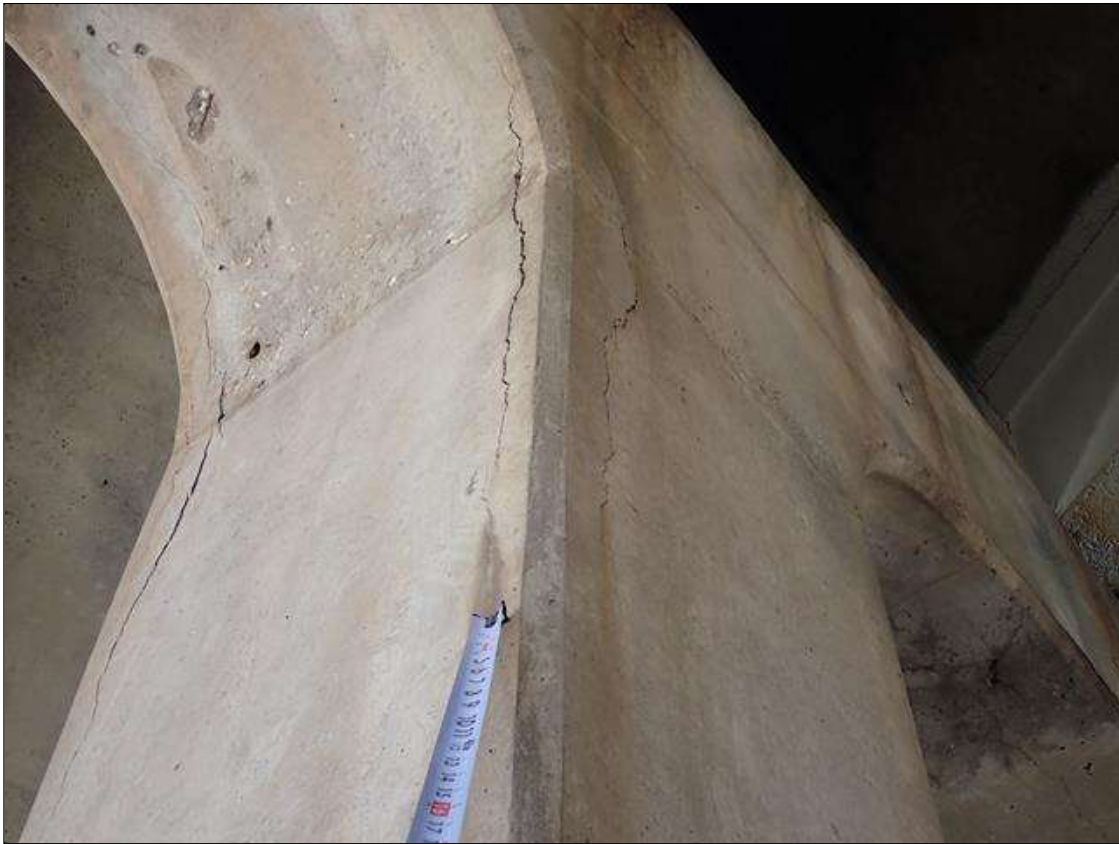
Bent 2 Pile 4: below cap, northeast and southeast corners, (2) delaminations (up to 3.5 foot x 10 inch) with cracks (1/4 inch)

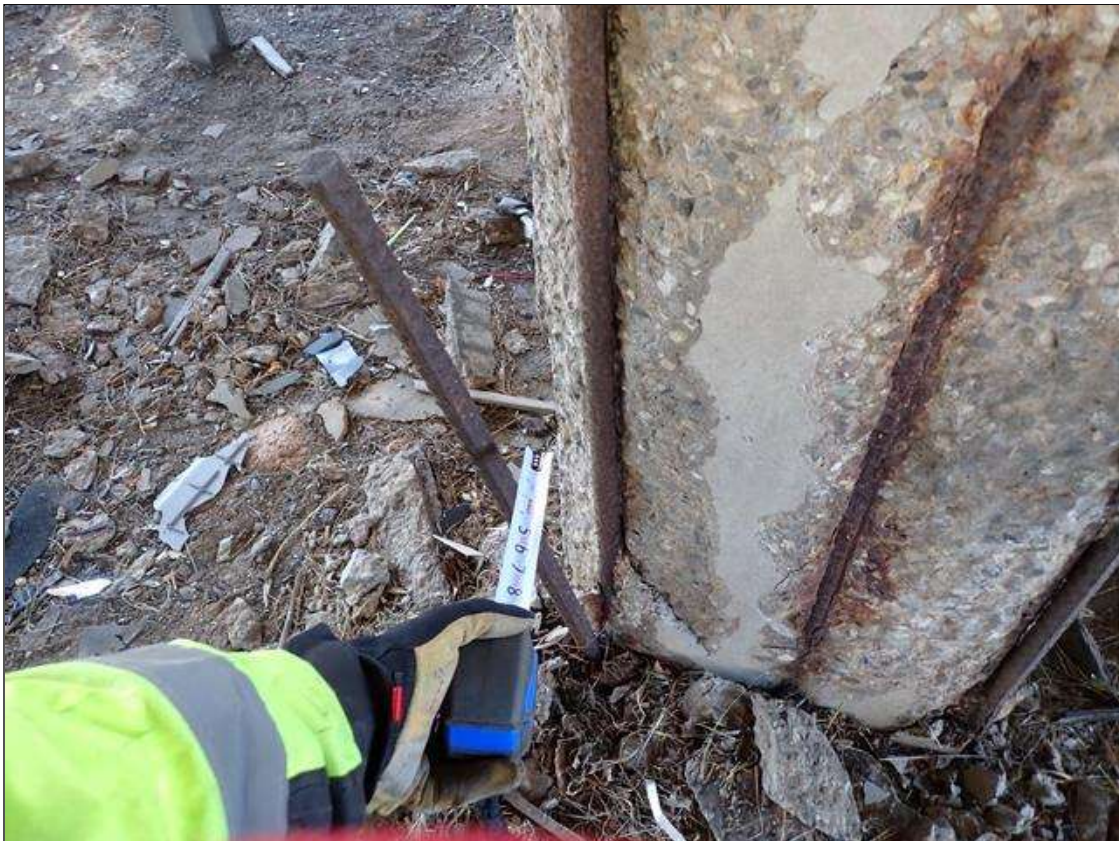
Bent 2 Pile 4: (PAR) north face, at ground, spall/delamination (full width x 7.5 foot high x 3 inch deep) extends into east and west faces (up to 7 inch) with exposed rusted and debonded rebar

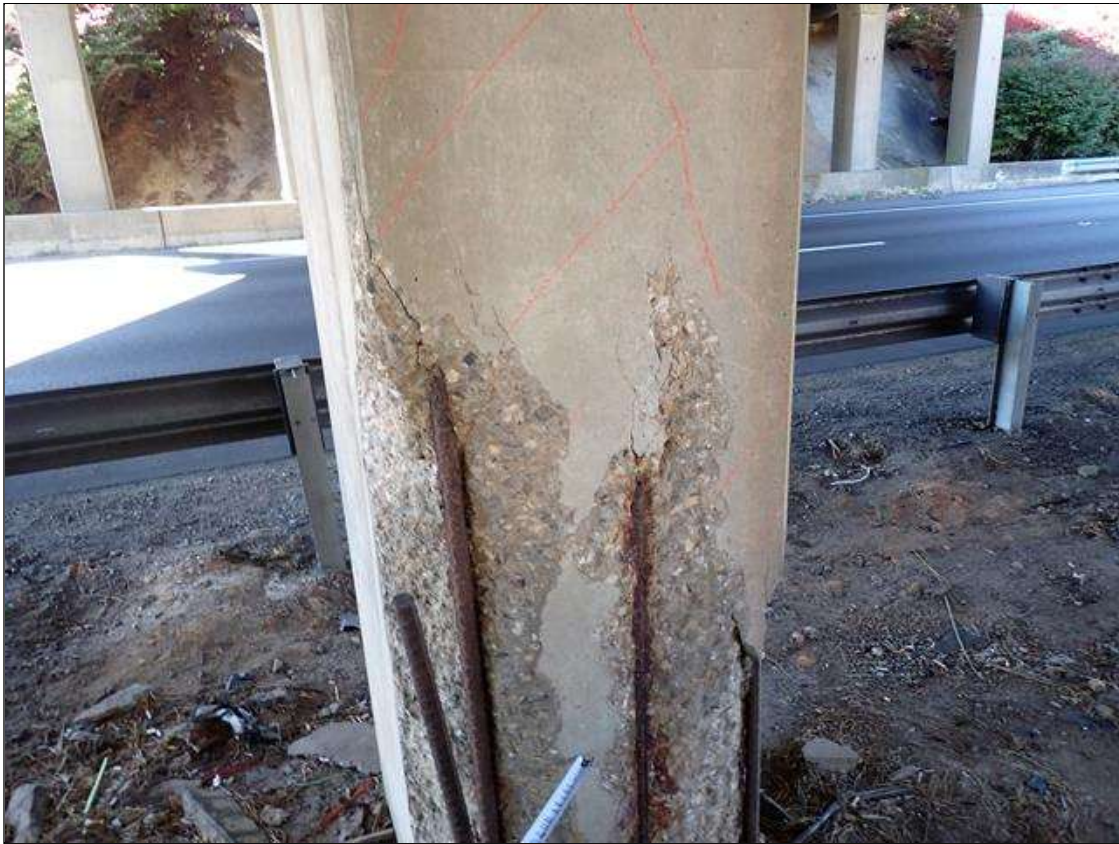
Bent 2 Pile 4: (PAR) north face, at ground, spall/delamination (full width x 7.5 foot high x 3 inch deep) extends into east and west faces (up to 7 inch) with exposed rusted and debonded rebars

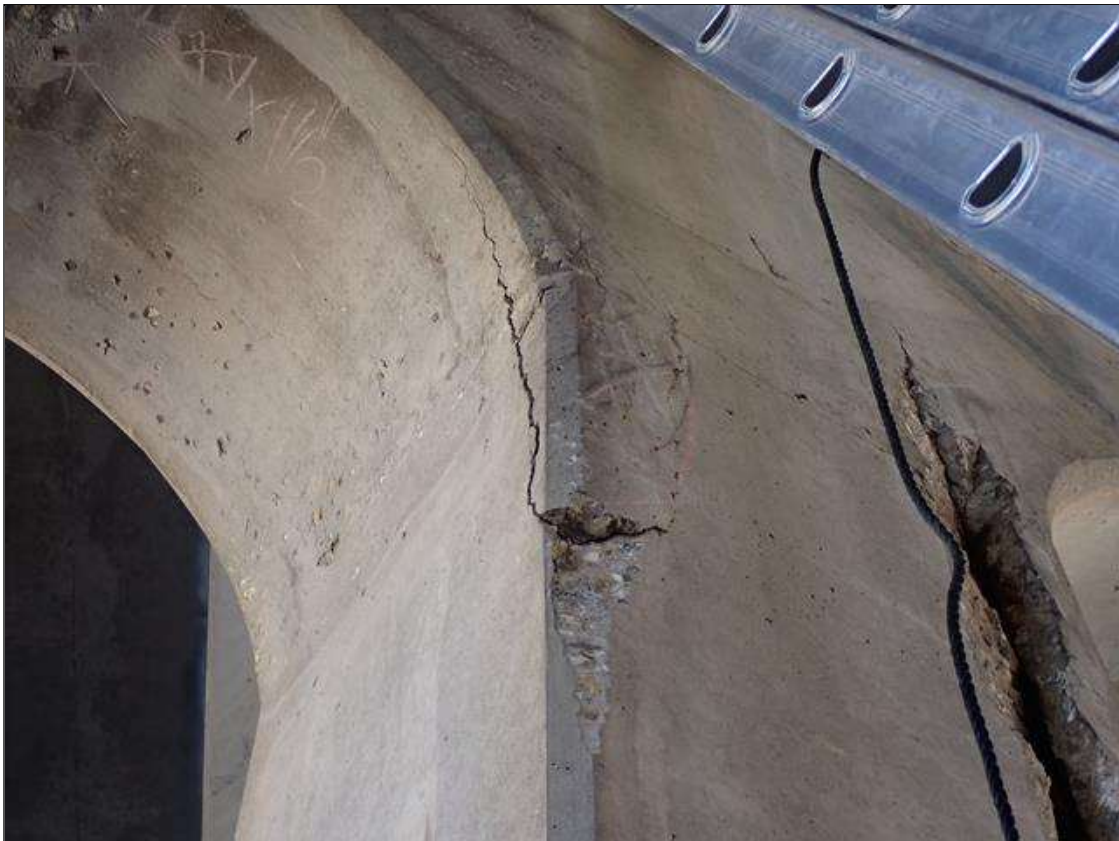
Bent 2 Pile 3: southwest corner, below cap, spall/delamination (36 inch x 10 inch x 1 inch deep)

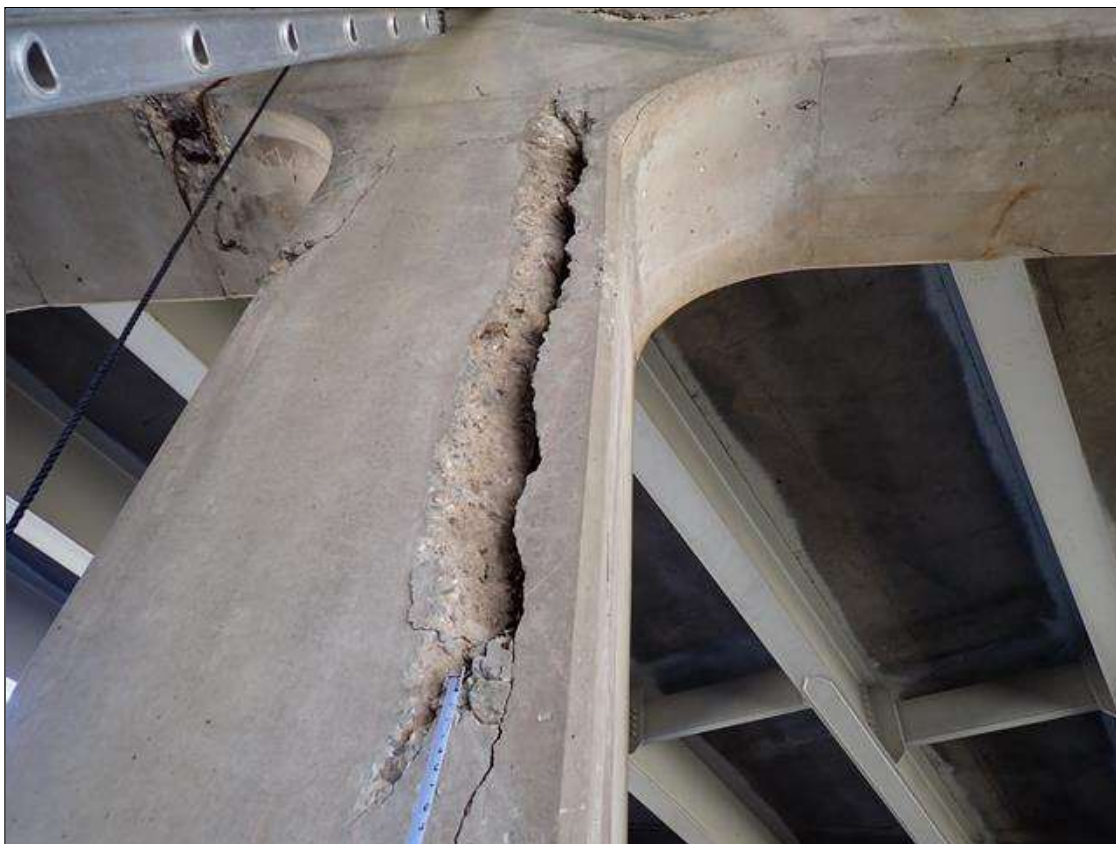
Bent 2 Pile 3: (PAR) Southeast corner 5 foot from the ground, delamination/spall [28 inch wide x 9.5 foot x up to 4 inch deep] with [1] primary exposed rusted reinforcing [75 percent remaining]

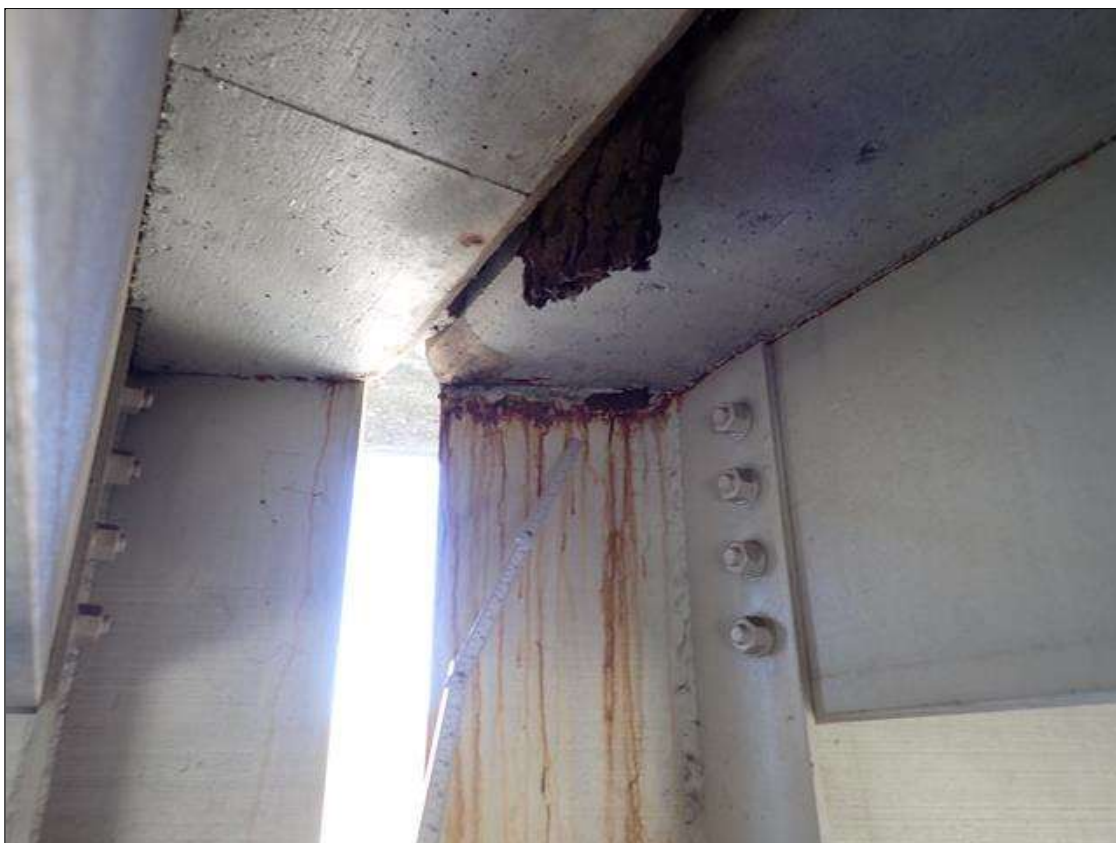
Span 3 Beam 1: at bent 2, web, rust scale (10 inch)

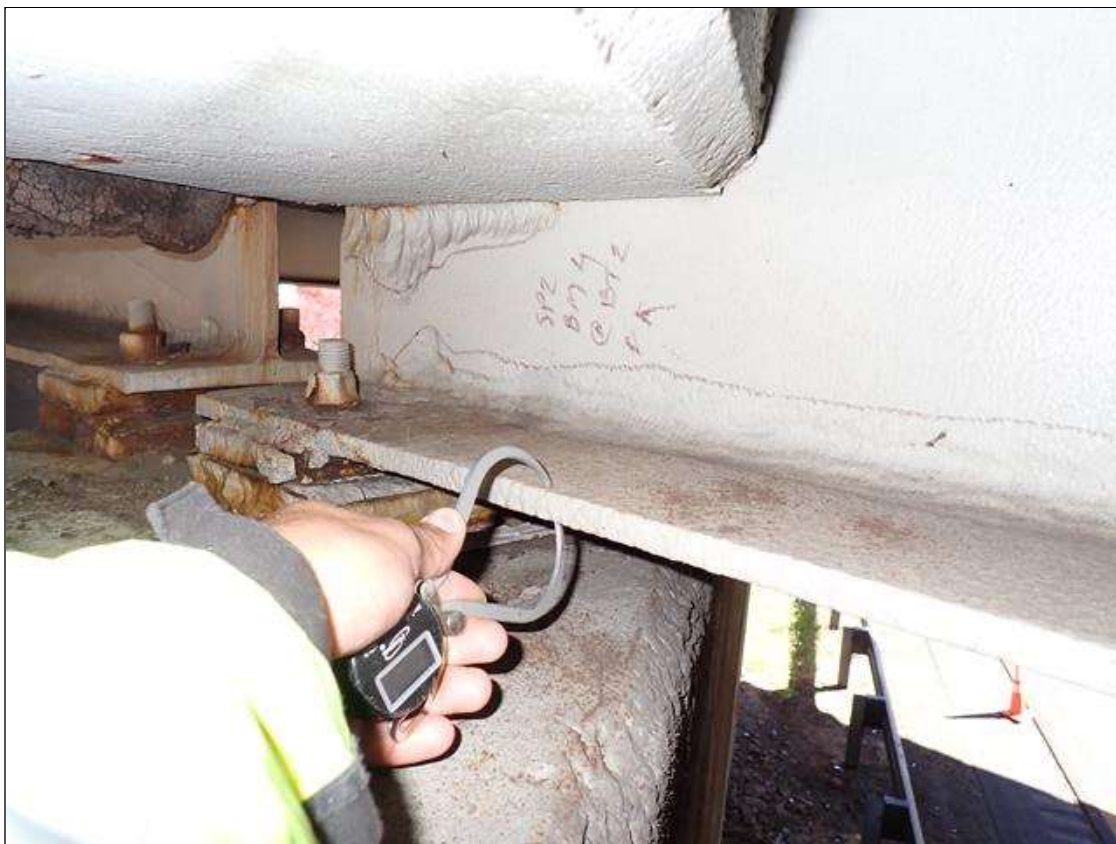
Span 2 Beam 4: (PAR) at bent 2, painted over section loss: bottom flange (0.60 inch average remaining x 2.5 foot), lower web (5/16 inch average remaining x 27 inch x 2 inch), web adjacent to diaphragm (1/4 inch average remaining x 11 inch x 3 inch) with corrosion reinitiated

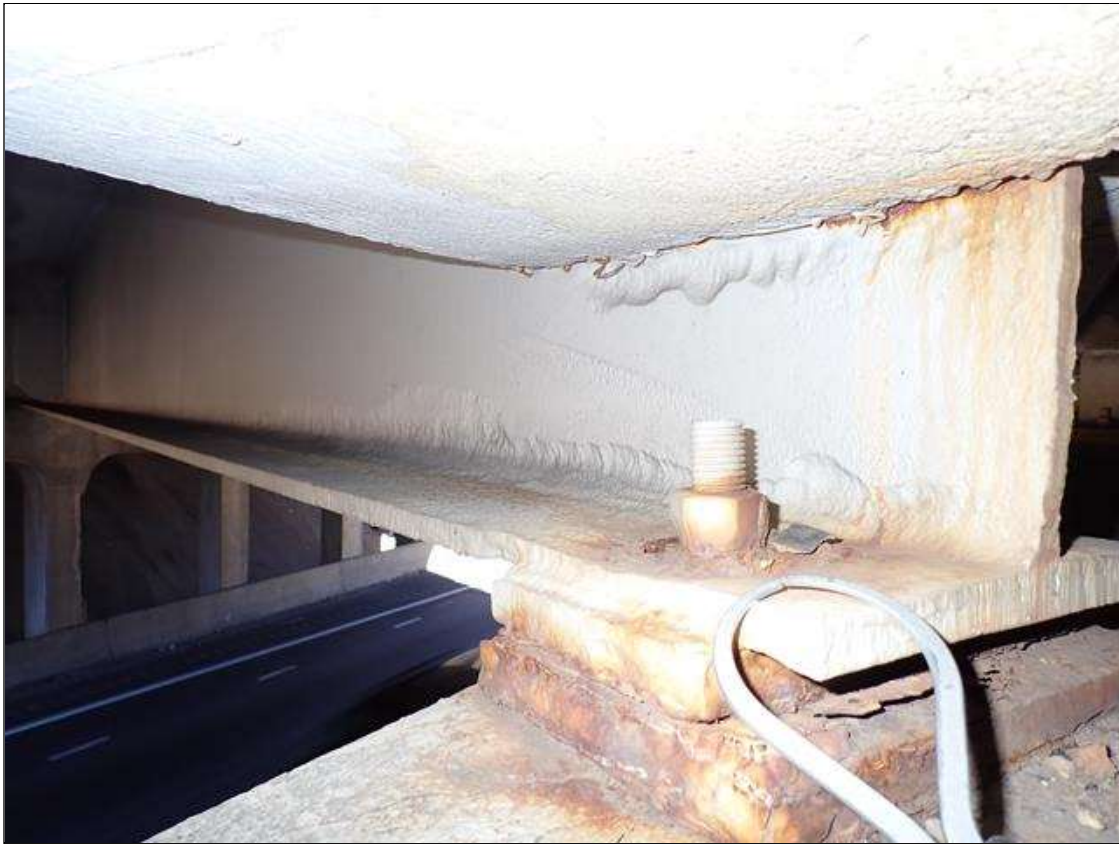
Span 3 Beam 4: (PAR) at bent 2, painted over section loss: bottom flange (0.56 inch average remaining x 9 inch), lower web (3/16 inch average remaining x 6 foot x 2 inch), web adjacent to diaphragm (3/16 inch average remaining x 12 inch x 2 inch) with corrosion reinitiated

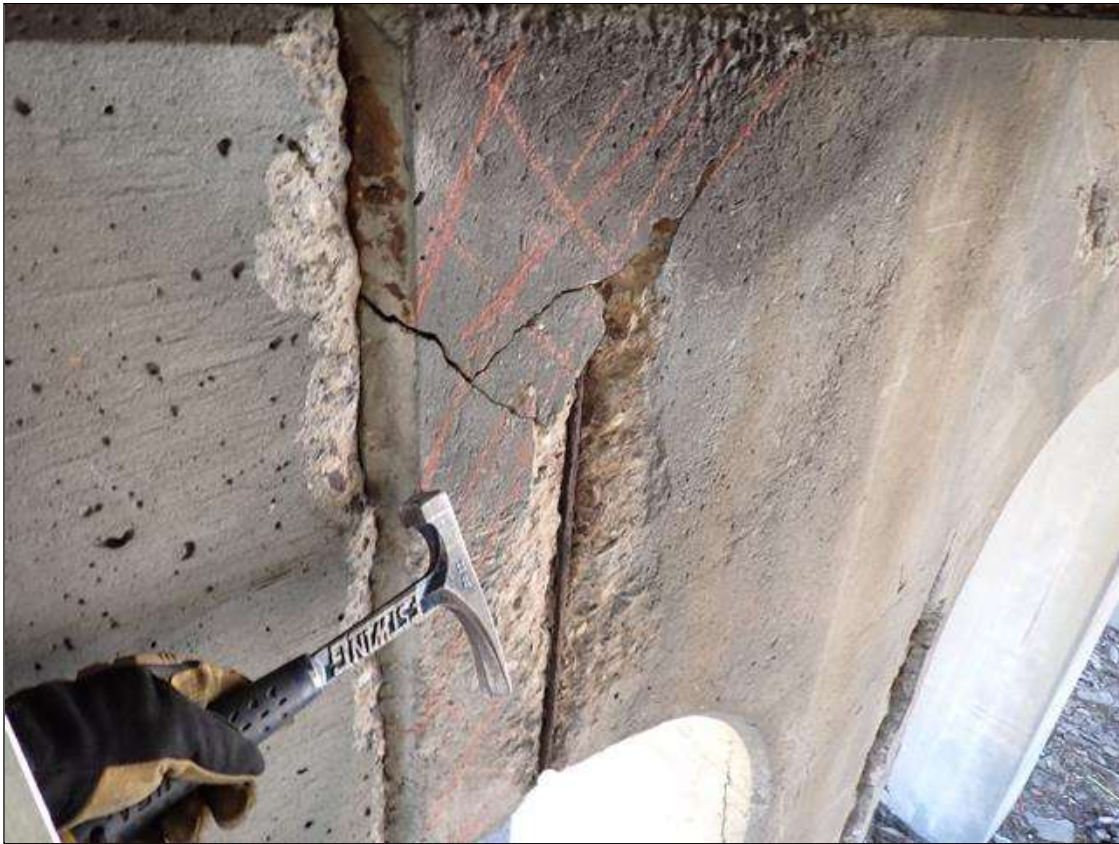
Bent 2 Cap 1: (PAR) south face, below beam 4, spall/delamination (18 inch x 38 inch x 1.5 inch deep) with exposed and debonded rebar

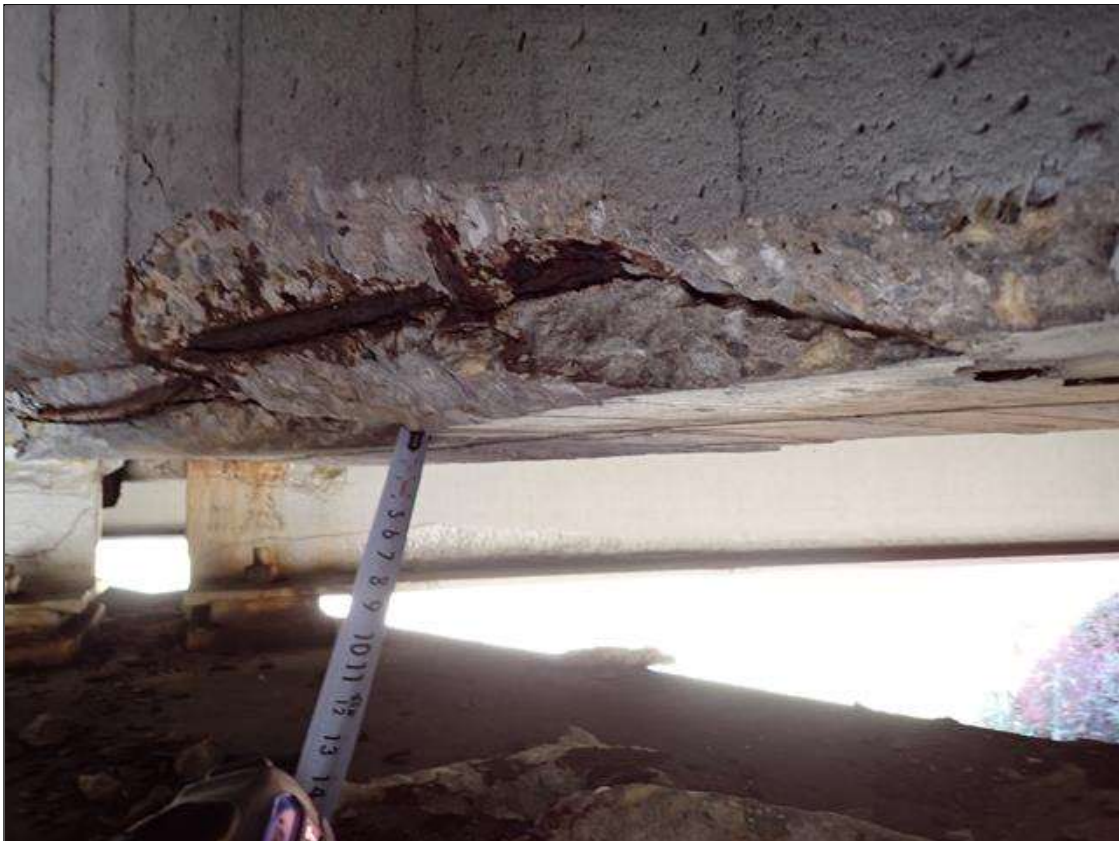
Span 2 Beam 5: (PAR) up to 4.5 foot long x 4 inch high x 3 inch deep spalls in south and bottom with exposed rusted reinforcement with up to 1/16 inch section loss, in the diaphragm between beams 4 and 5.

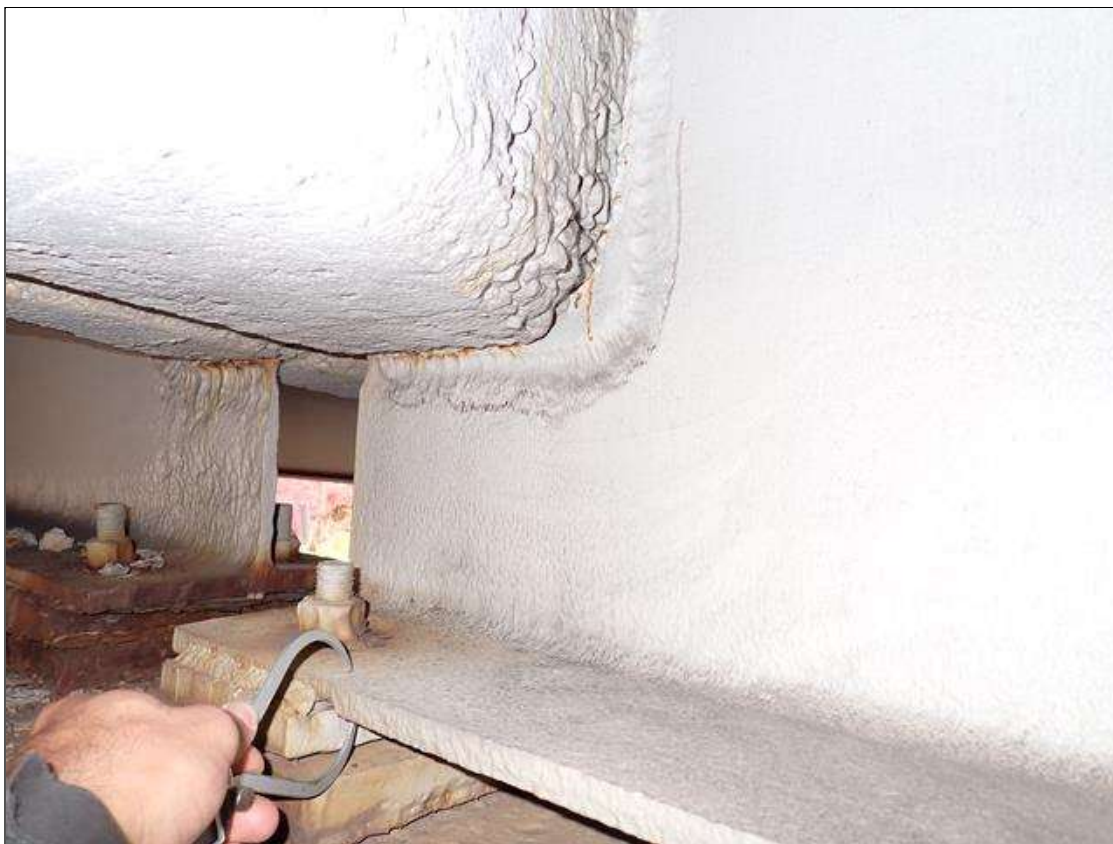
Span 2 Beam 5: (PAR) at bent 2, painted over section loss: bottom flange (0.50 inch average remaining x 8 inch); web adjacent to diaphragm (3/16 inch average remaining x 11 inch x 8 inch) with corrosion reinitiated

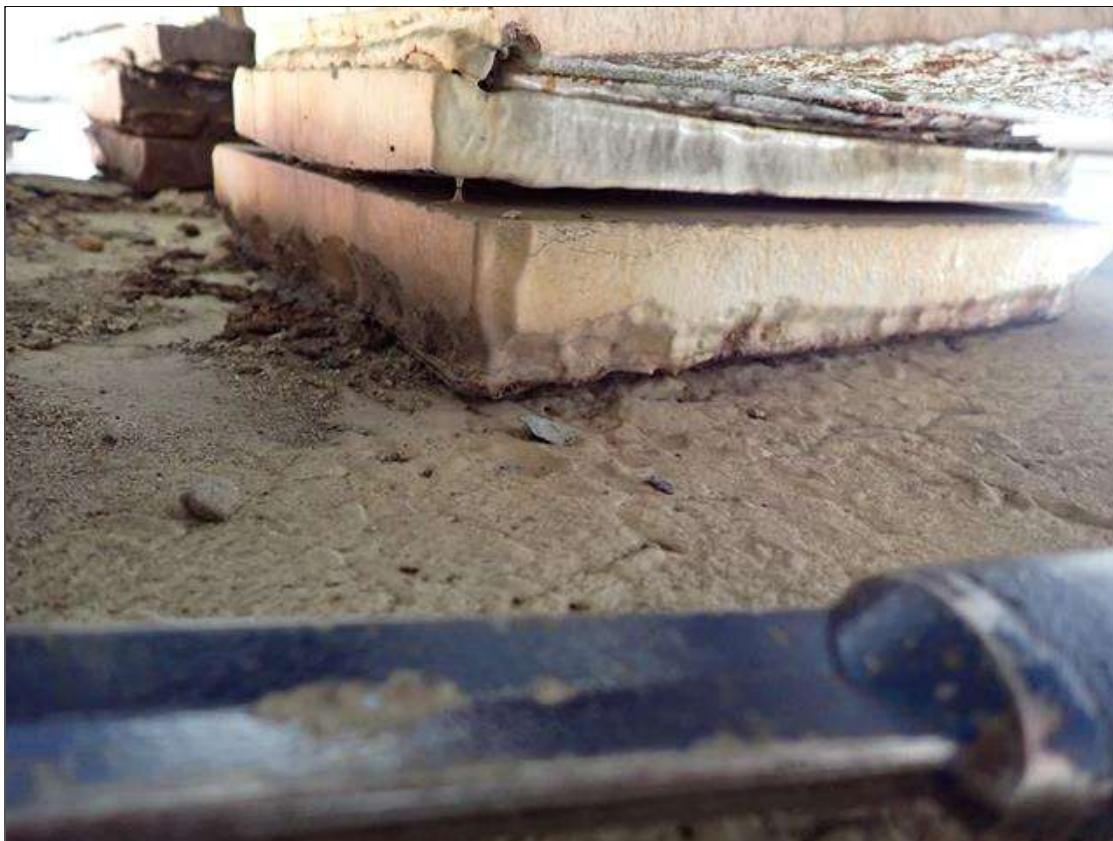
Span 2 Beam 5 - Far Bearing 5: painted over section loss (up to 1/8 inch loss) on masonry plate and sole plate

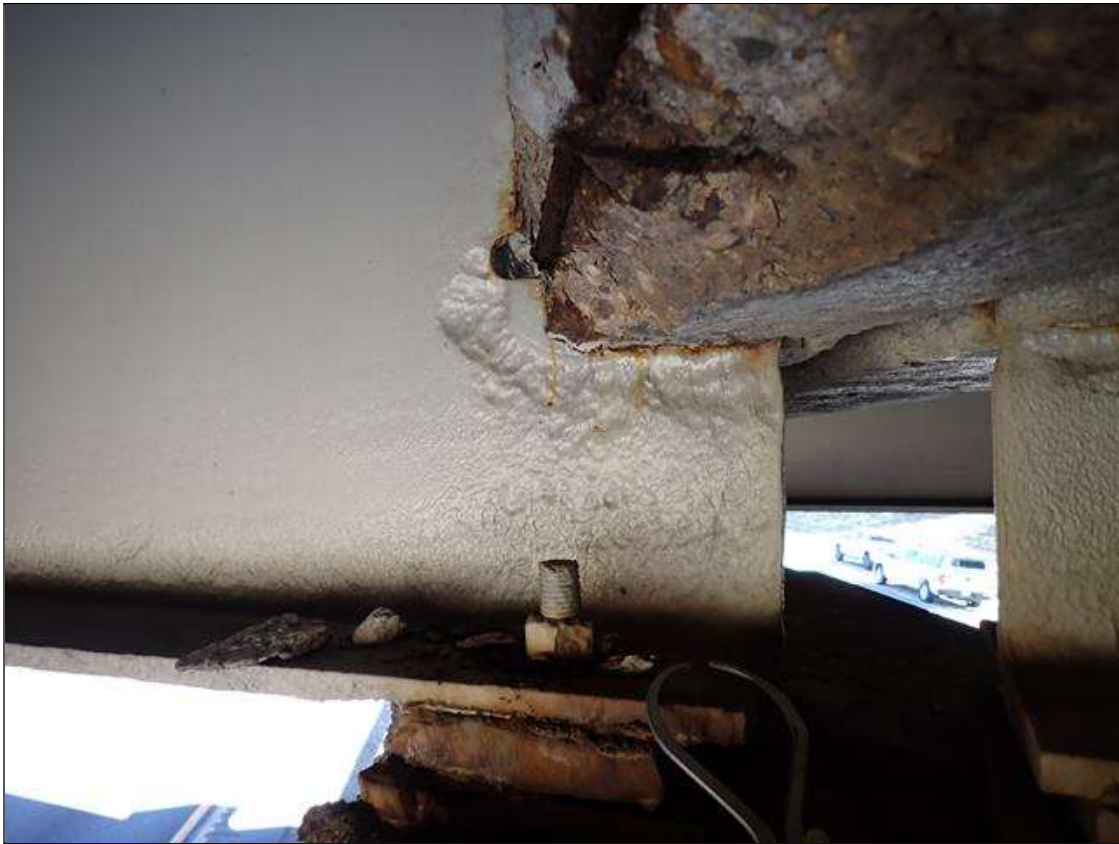
Span 3 Beam 5: (PAR) at bent 2, painted over section loss: bottom flange (0.60 inch average remaining x 3 foot); web (1/4 inch average remaining x 3 foot x 12 inch) with hole (1.5 inch x 1 inch) with corrosion reinitiated

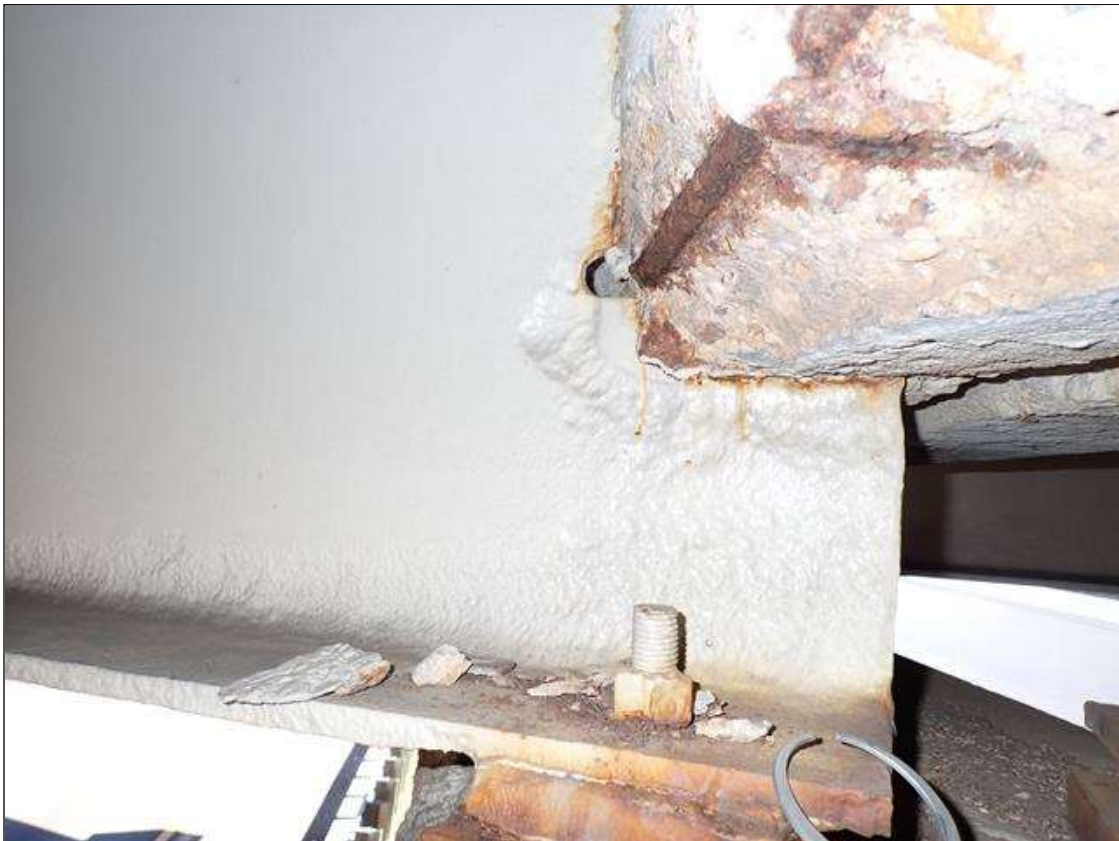
Span 3 Beam 5: (PAR) at bent 2, painted over section loss: bottom flange (0.60 inch average remaining x 3 foot); web (1/4 inch average remaining x 3 foot x 12 inch) with hole (1.5 inch x 1 inch) with corrosion reinitiated

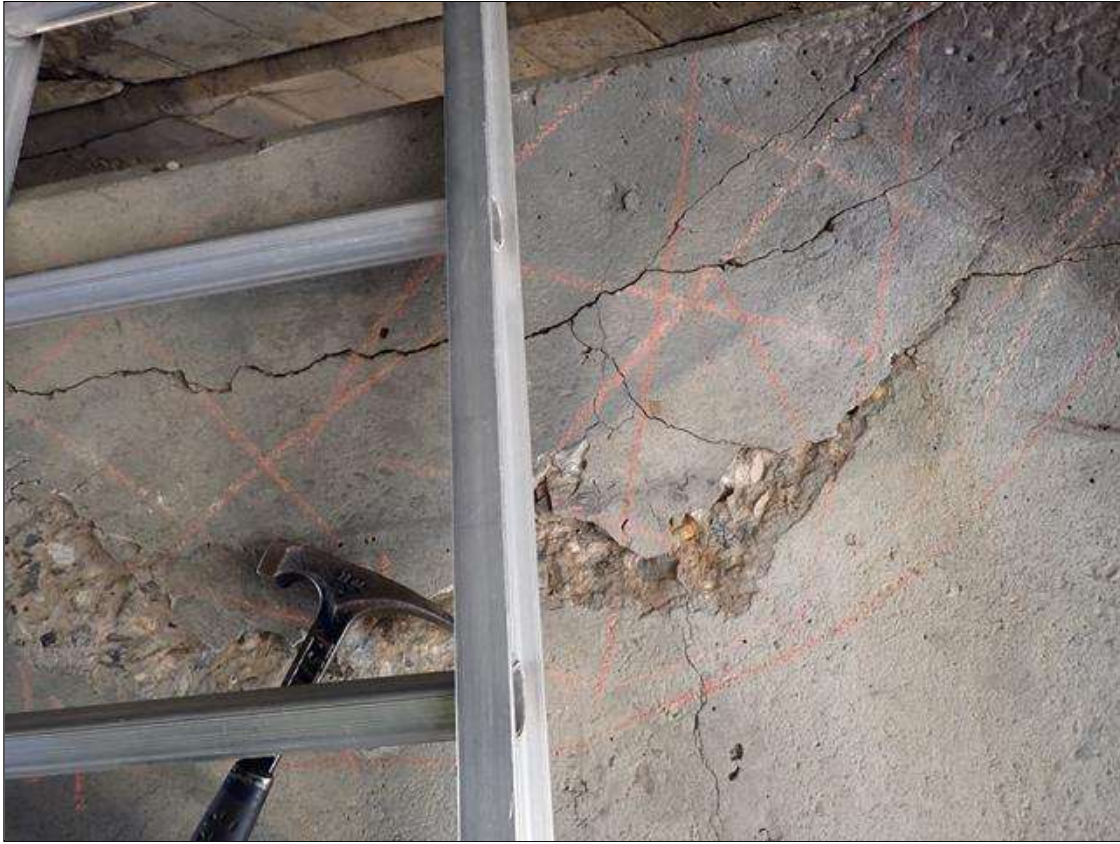
Bent 2 Cap 1: 4 foot x up to 20 inch x 1 inch deep high area of delaminated concrete in south face between beams 4 and 5.

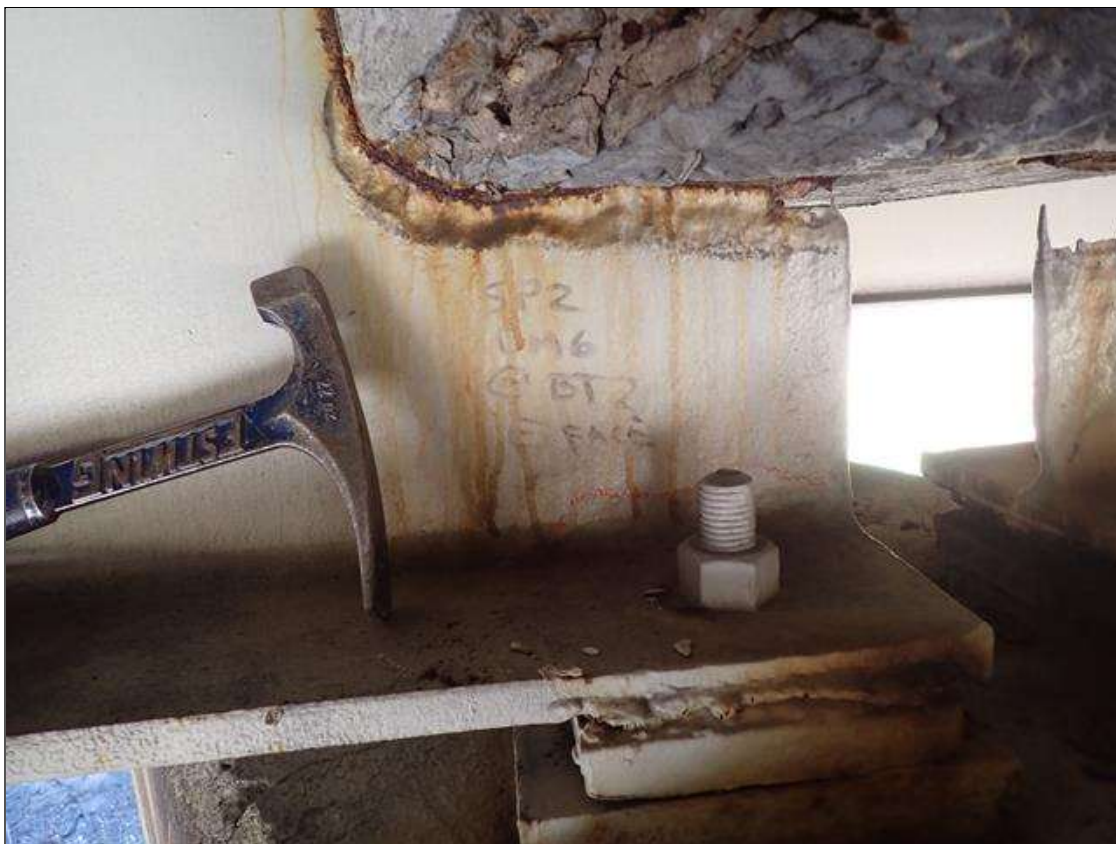
Span 2 Beam 6: (PAR) at bent 2, painted over section loss: web adjacent to diaphragm (3/16 inch average remaining x 10.5 inch x 2.5 inch) with corrosion hole (1.5 inch x 1/2 inch); lower web (3/8 inch average remaining x 5.5 inch x 1 inch) with corrosion reinitiated

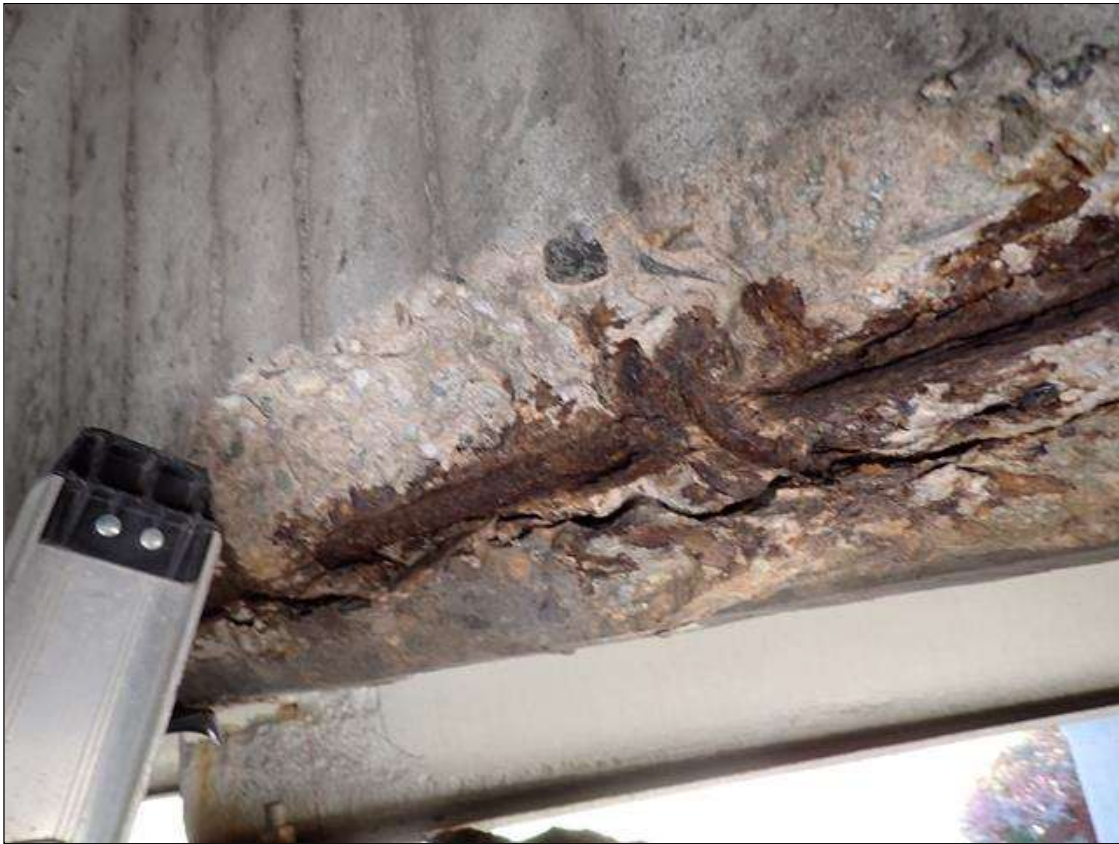
Span 2 Beam 6: (PAR) 7 foot x 16 inch x up to 3 inch deep spall with exposed reinforcement in the underside and south face of the diaphragm between beams 6 and 7. 70 percent section remaining in exposed reinforcement.

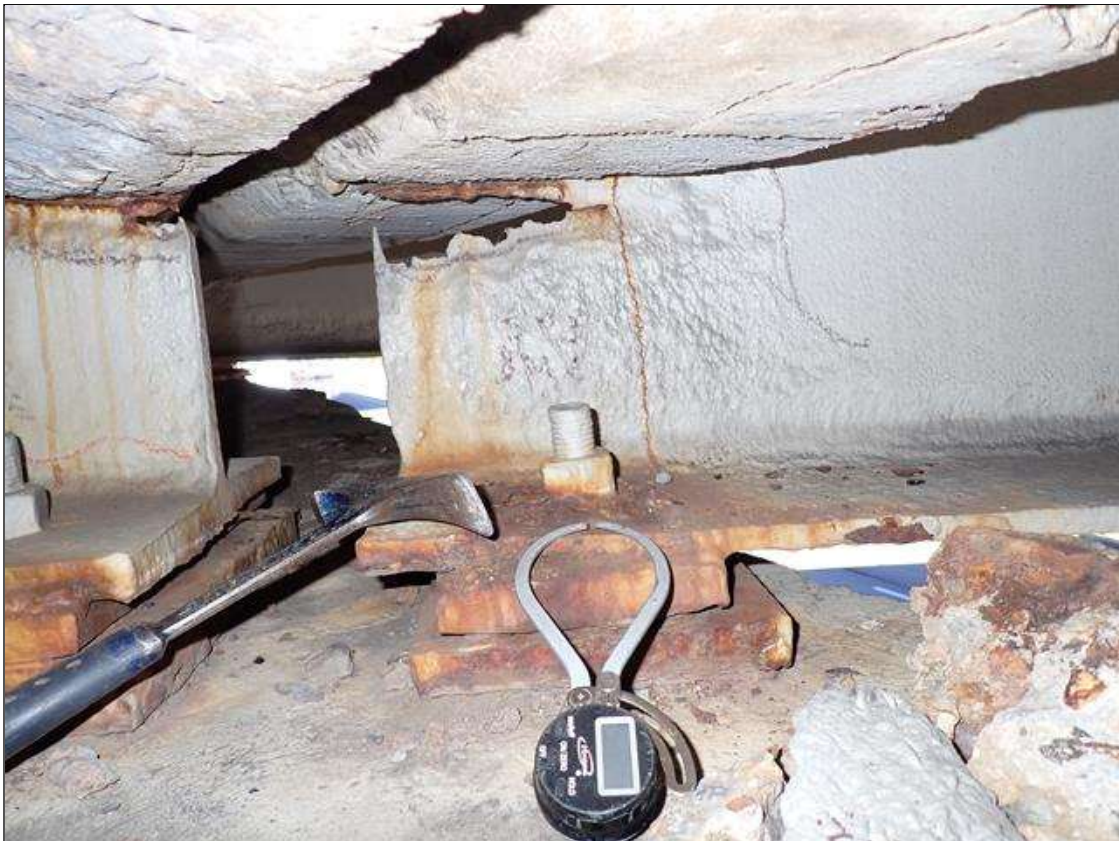
Span 3 Beam 6: (PAR) at bent 2, painted over section loss: web (1/4 inch average remaining x 3 foot x 1 foot) with corrosion hole (5 inch x 2 inch); bottom flange (0.60 inch average remaining x 2.5 foot) with corrosion reinitiated

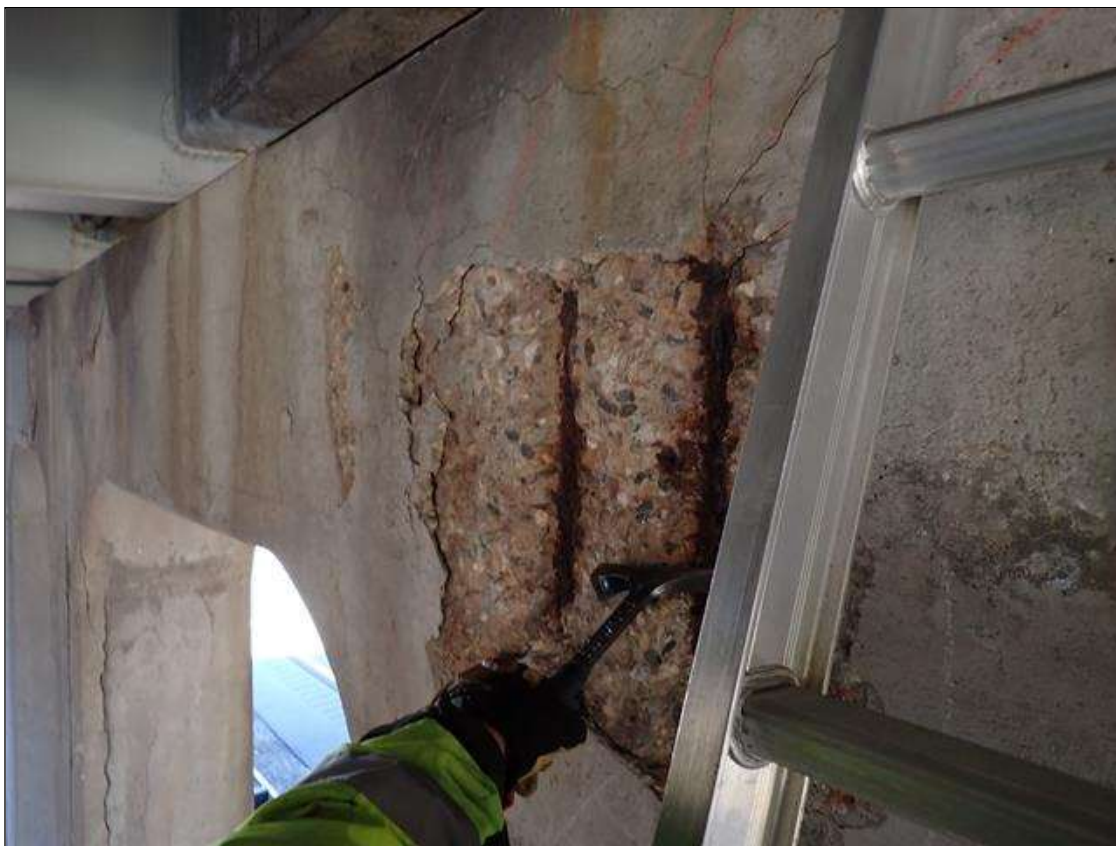
Bent 2 Cap 1: (PAR) south face, in bay 6, spall/delamination (8 foot x 4 foot x 1.5 inch deep) with exposed rusted rebar (approximately 75 percent remaining) and cracks (up to 1/16 inch)

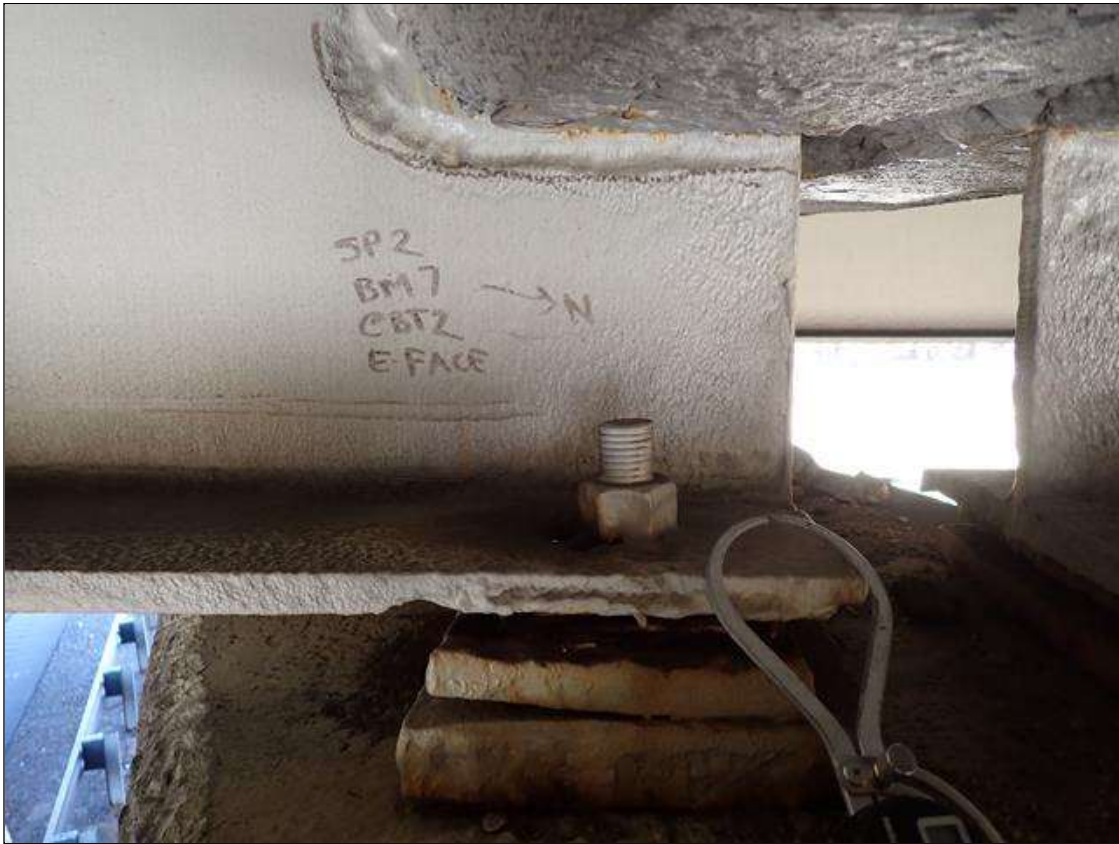
Span 2 Beam 7: (PAR) at bent 2, painted over section loss: bottom flange (0.50 inch average remaining x 8 inch); lower web (3/8 inch average remaining x 5 inch x 1 inch); web adjacent to diaphragm (3/16 inch average remaining x 10 inch x 3 inch)

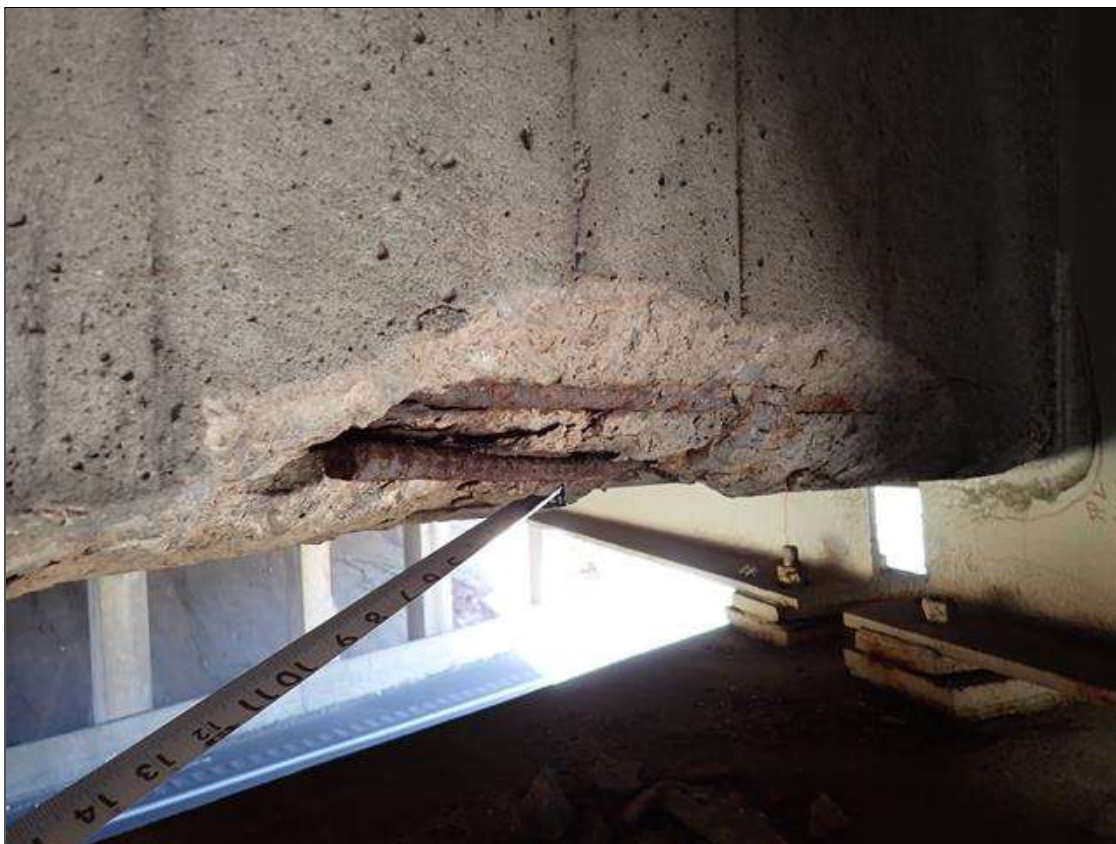
Span 2 Beam 7: (PAR) 2 foot x 4 inch x 3 inch deep spall with exposed rusted and debonded reinforcement on south face of end diaphragm, at bent 2
