NC DEPARTMENT OF TRANSPORTATION  
 DIVISION OF HIGHWAYS  
 STRUCTURE MANAGEMENT UNIT

ATTENTION: **prompt action request; sketches updated; new beam repairs**

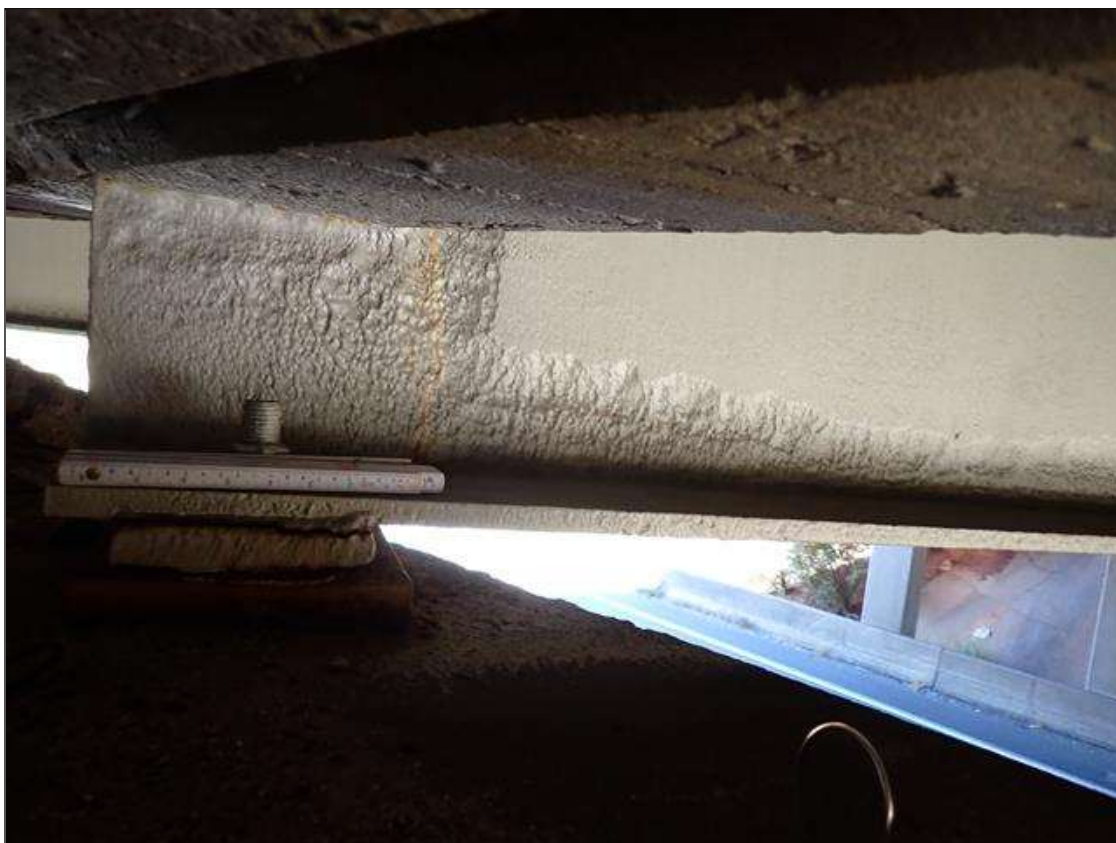
Span 3 Beam 7: (PAR) at bent 2, painted over section loss: web (1/4 inch average remaining x 4.5 foot x 16 inch)

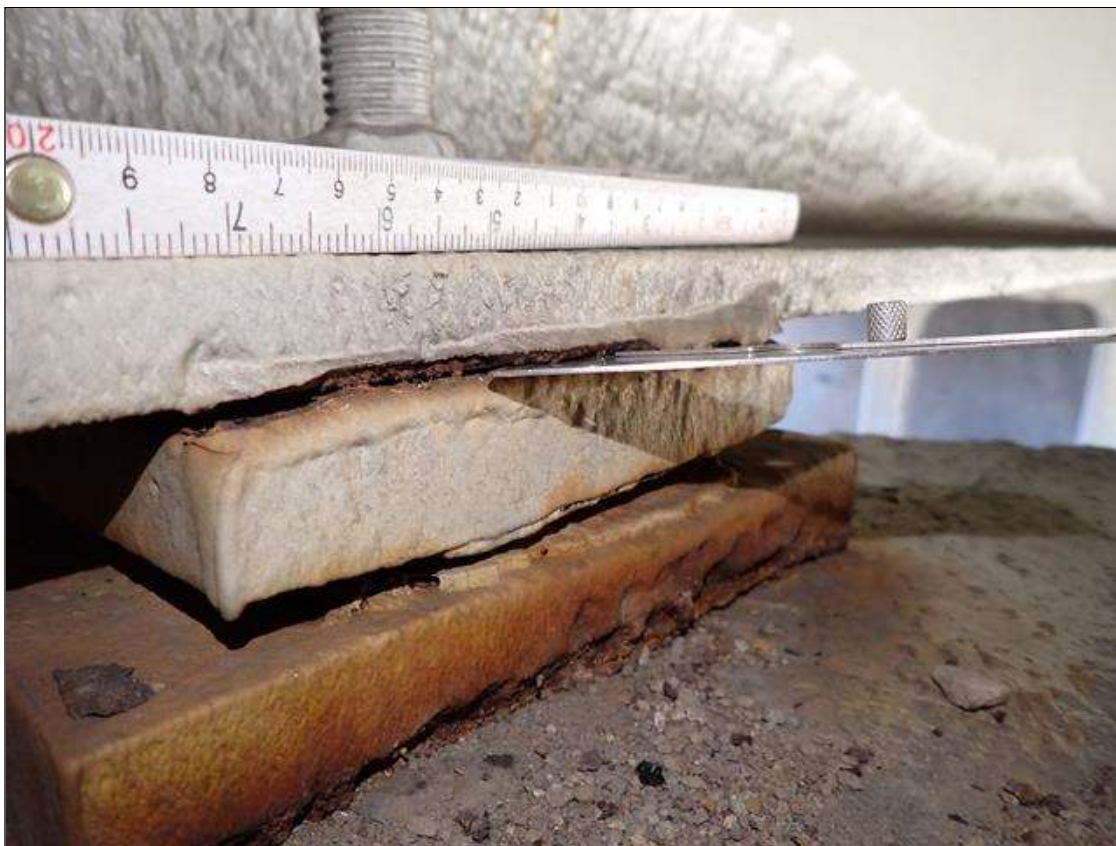
Span 3 Near Bearing 7: (PAR) east weld between sole and bottom flange, broken

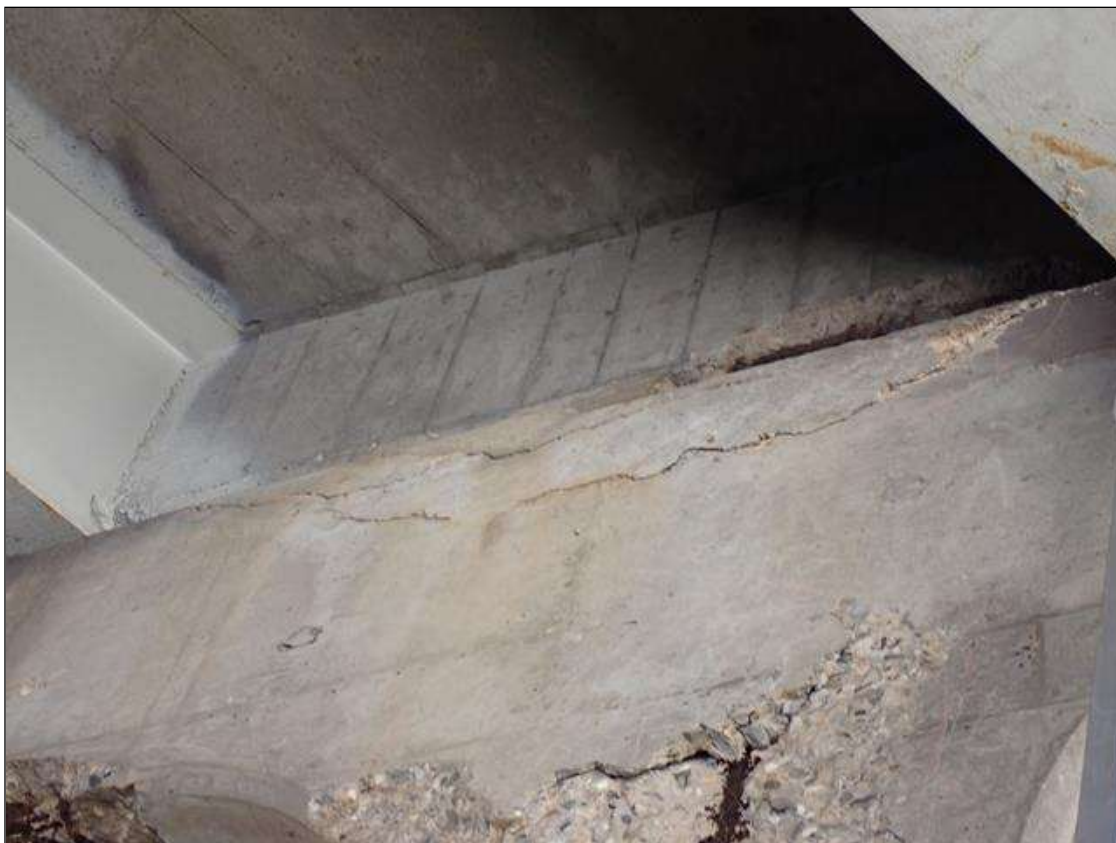
Bent 2 Cap 1: 4 foot long x 18 inch x 1 inch high spall/delamination concrete in south face near the top between beams 7 and 8.

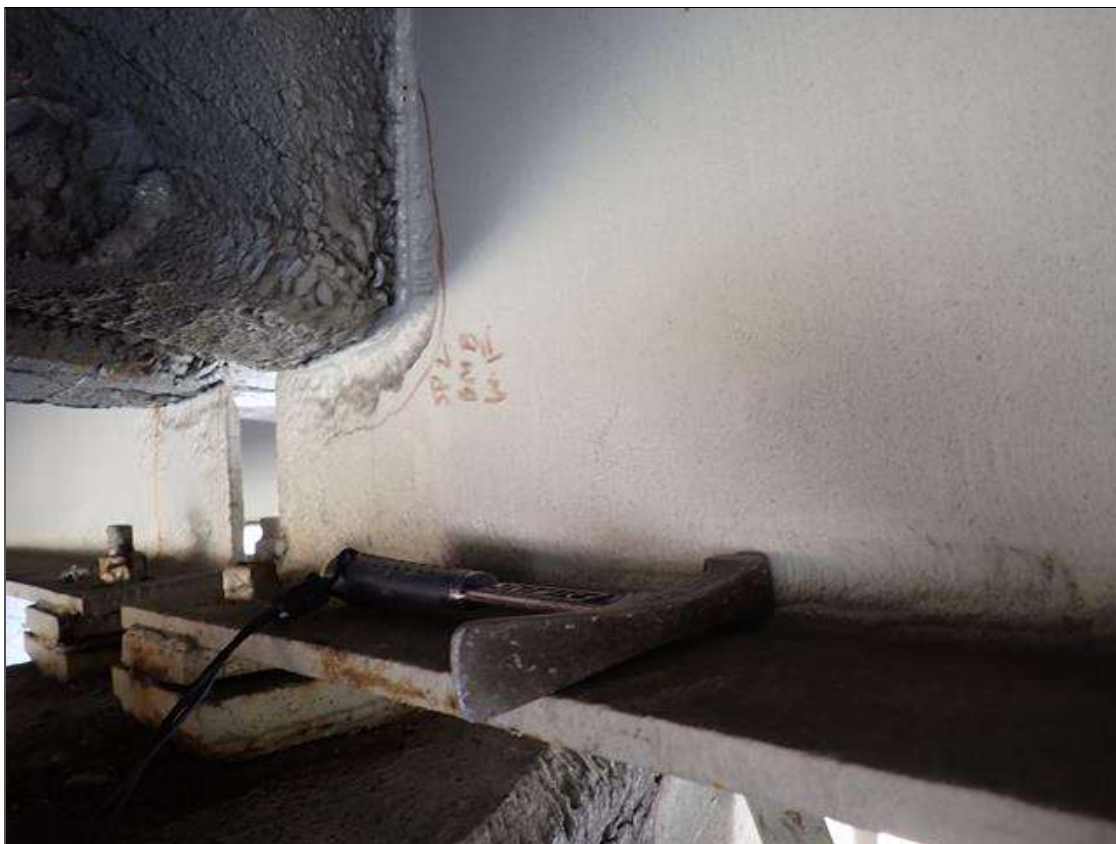
Span 2 Beam 8: (PAR) at bent 2, painted over section loss: web adjacent to diaphragm (1/4 inch average remaining x 14 inch x 8 inch); lower web (7/16 inch average remaining x 2 foot x 3 inch)

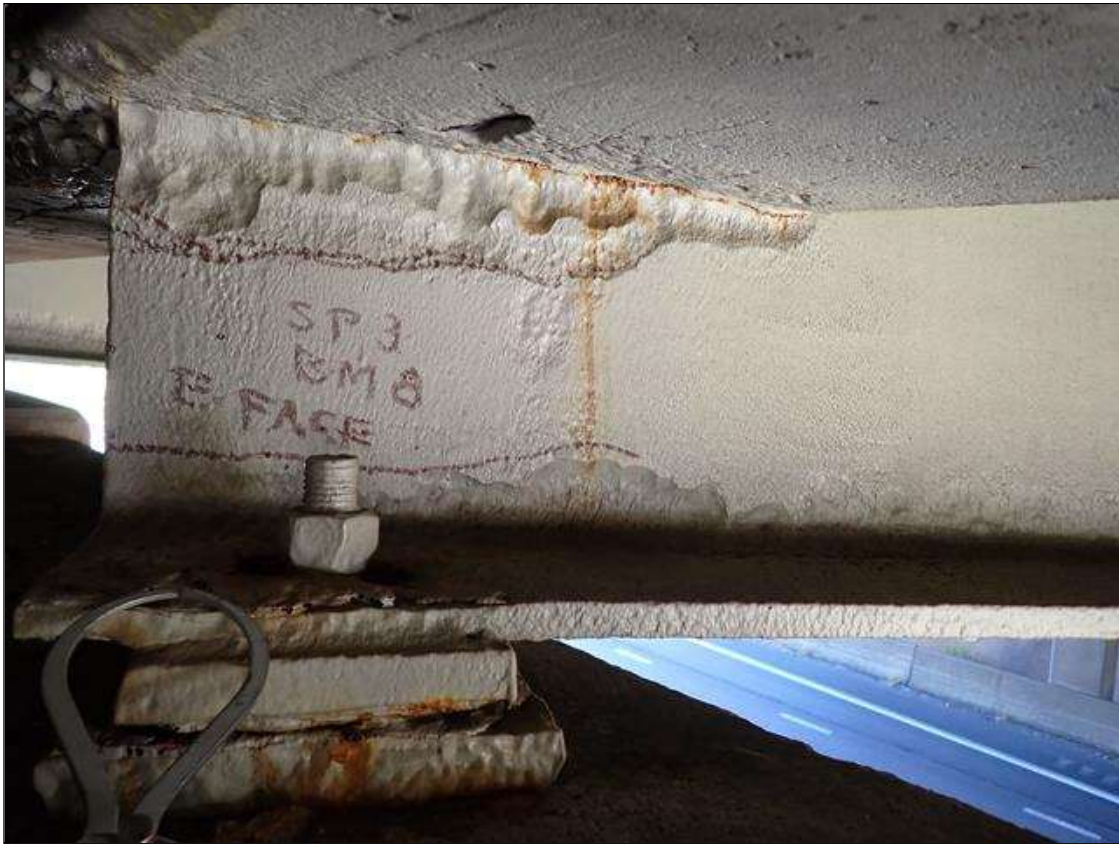
Span 3 Beam 8: (PAR) at bent 2, painted over section loss: web adjacent to diaphragm (3/16 inch average remaining x 16 inch x 2.5 inch); lower web (1/4 inch average remaining x 20 inch x 2 inch); bottom flange (0.50 inch average remaining x 9 inch) with corrosion reinitiated

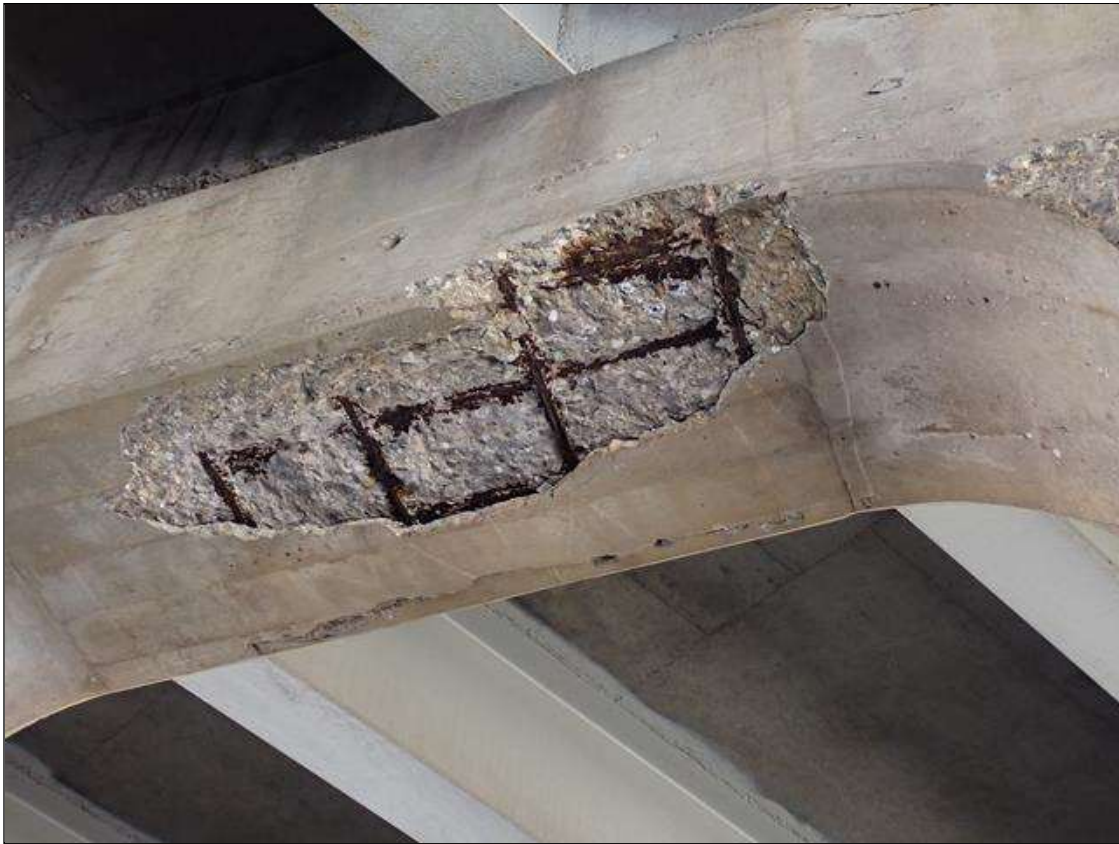
Bent 2 Cap 1: [PAR] bottom face of cap between columns 4 and 5, spall/delamination [5 foot long x full width x up to 3 inch deep] with seven exposed rusted reinforcing with 80 percent remaining

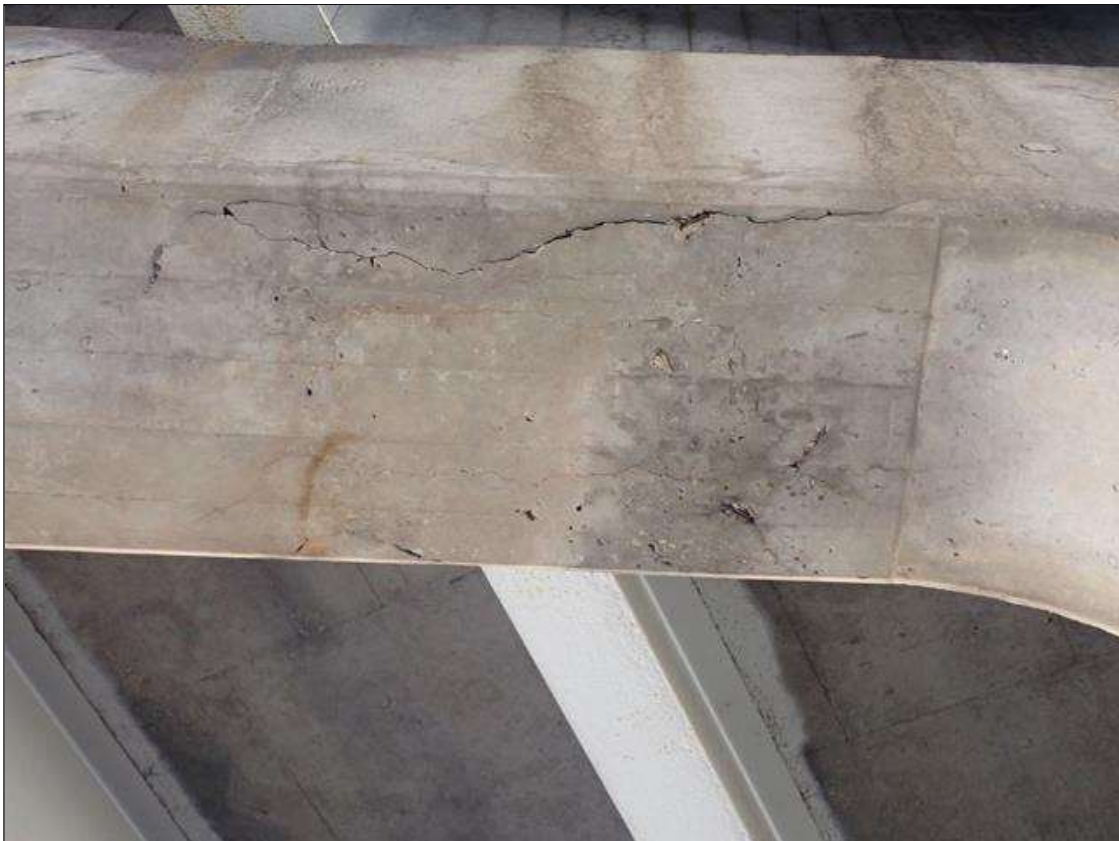
Bent 2 Cap 1: between columns 3 and 4, 4 foot long x full width delamination in the bottom face extending into vertical faces of concrete

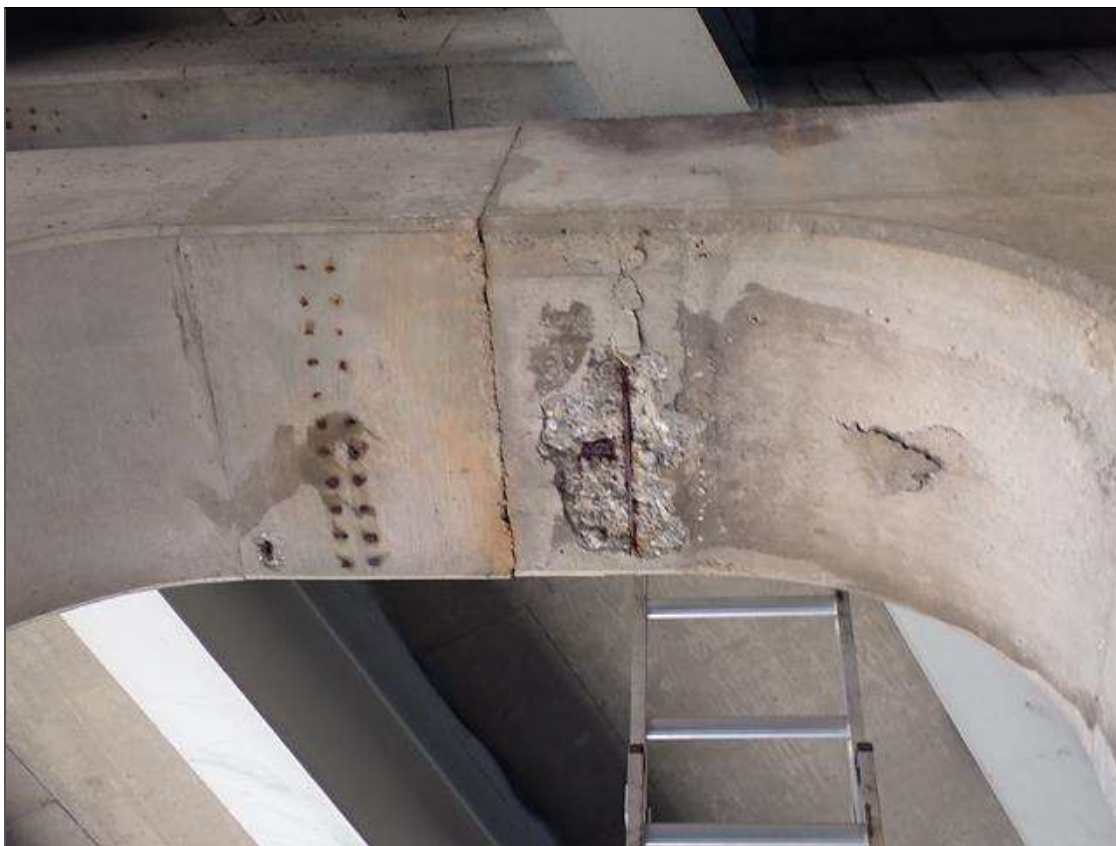
Bent 2 Cap 1: (PAR) (3) up to 1.5 foot x 1 foot wide x 1/2 inch deep spall with exposed rusted reinforcement, 80 percent remaining on underside of cap between columns 5 and 6

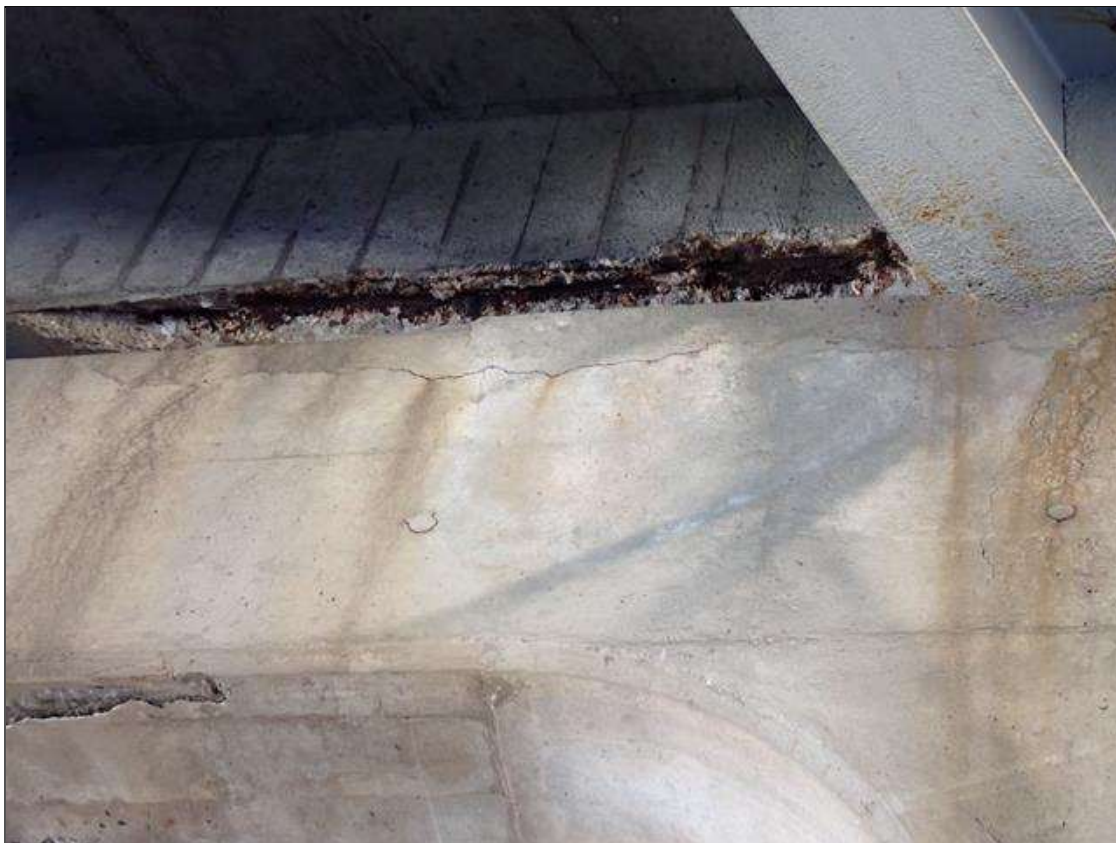
Bent 2 Cap 1: 10 foot x 1/16 inch horizontal crack in north face of cap under bays 5 and 6

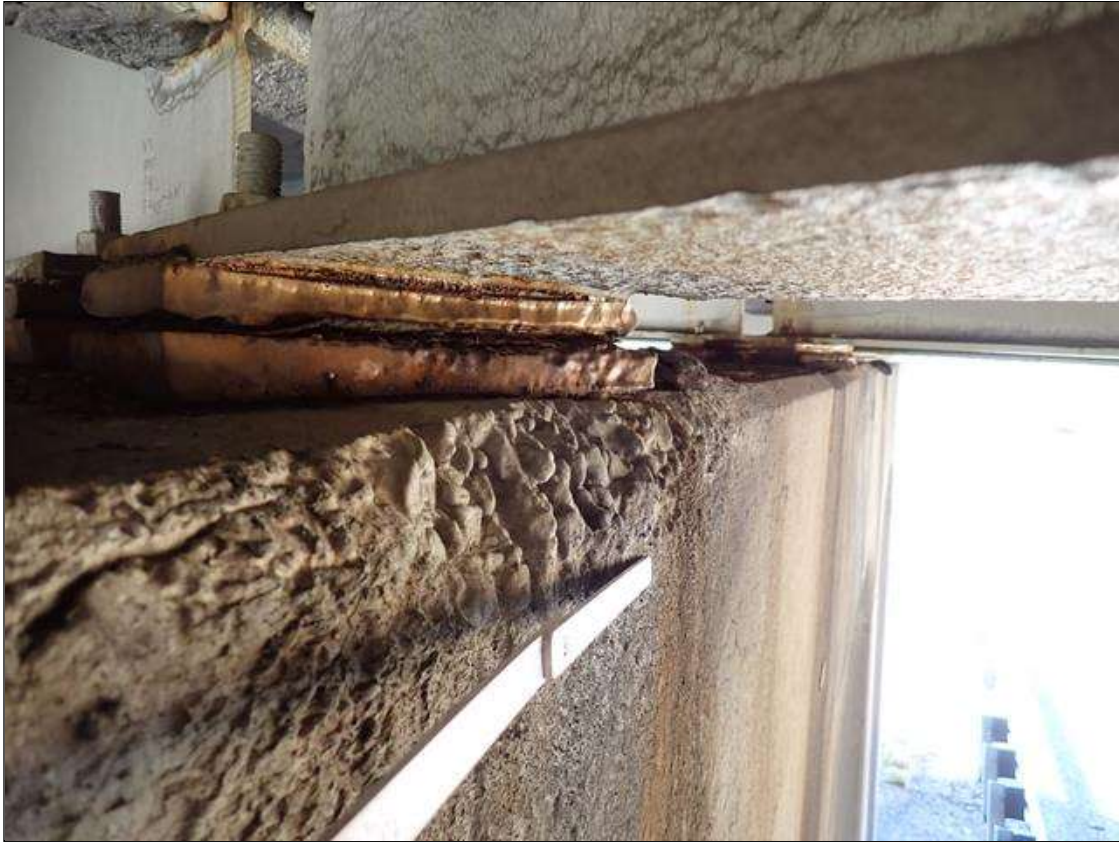
Bent 2 Cap 1: under beam 5, spall [14 inch x 4 inch x 1 inch deep] with coarse aggregate exposed, undermining bearing 1/2 inch

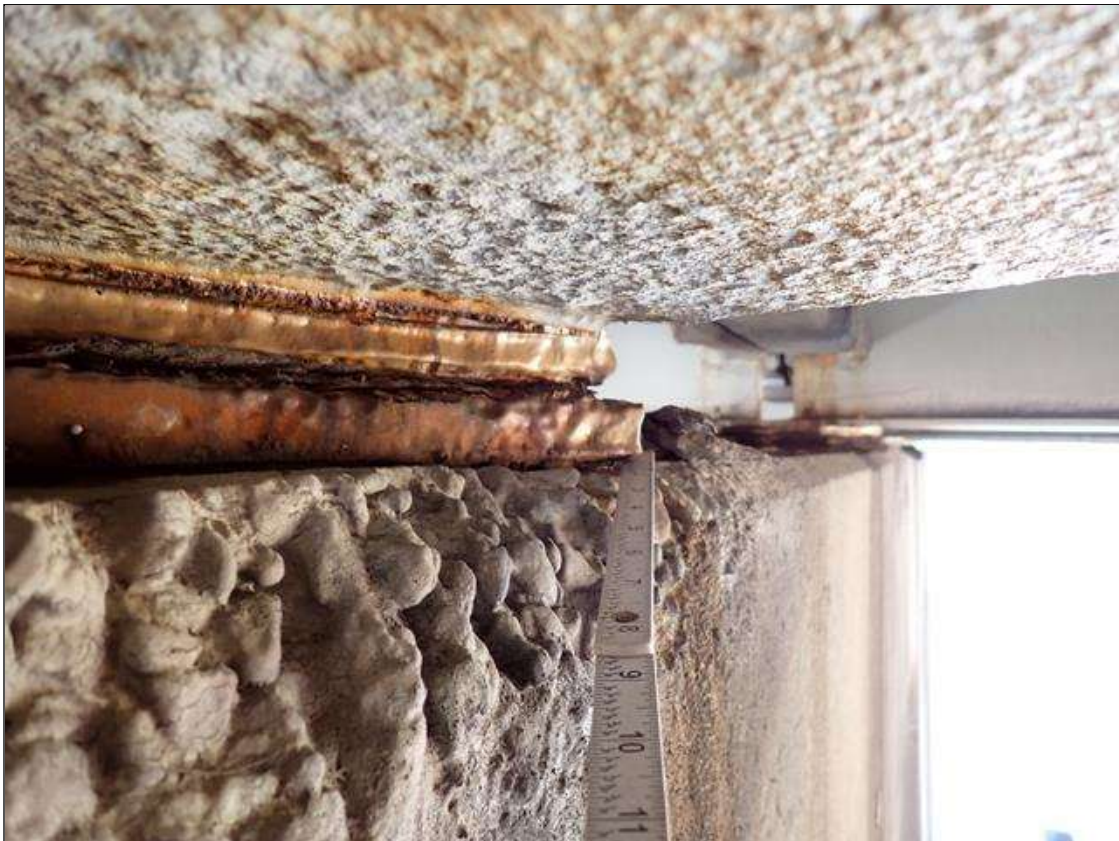
Span 3 Near Bearing 5: (PAR) loss of bearing area (up to 1/2 inch x 3 inch)

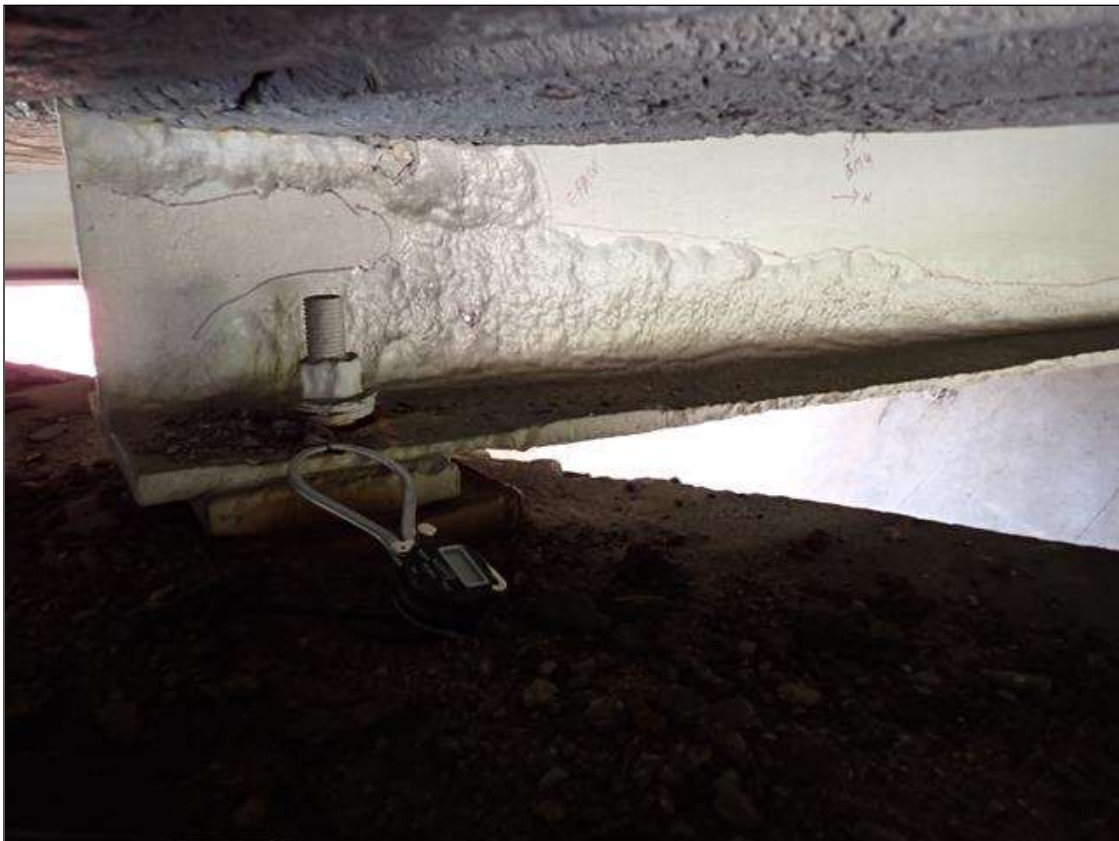
Span 4 Beam 4: (PAR) at bent 3, painted over section loss: web (1/4 inch average remaining x 5.5 foot x 10 inch) with corrosion holes (up to 1 inch x 1/2 inch); bottom flange (0.45 inch average remaining x 4 foot)

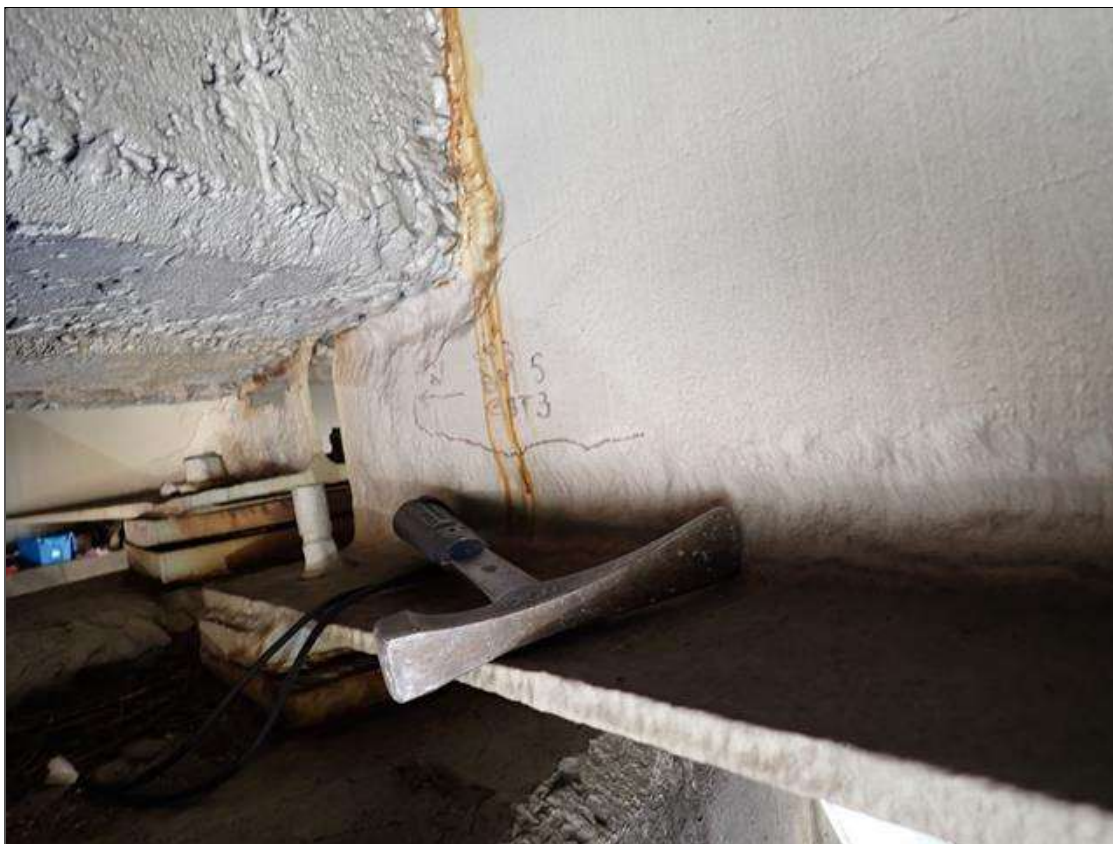
Span 3 Beam 5: (PAR) at bent 3, painted over section loss: bottom flange (0.45 inch average remaining x 1 foot); web (1/4 in average remaining x 2 foot x 9 inch) with corrosion reinitiated

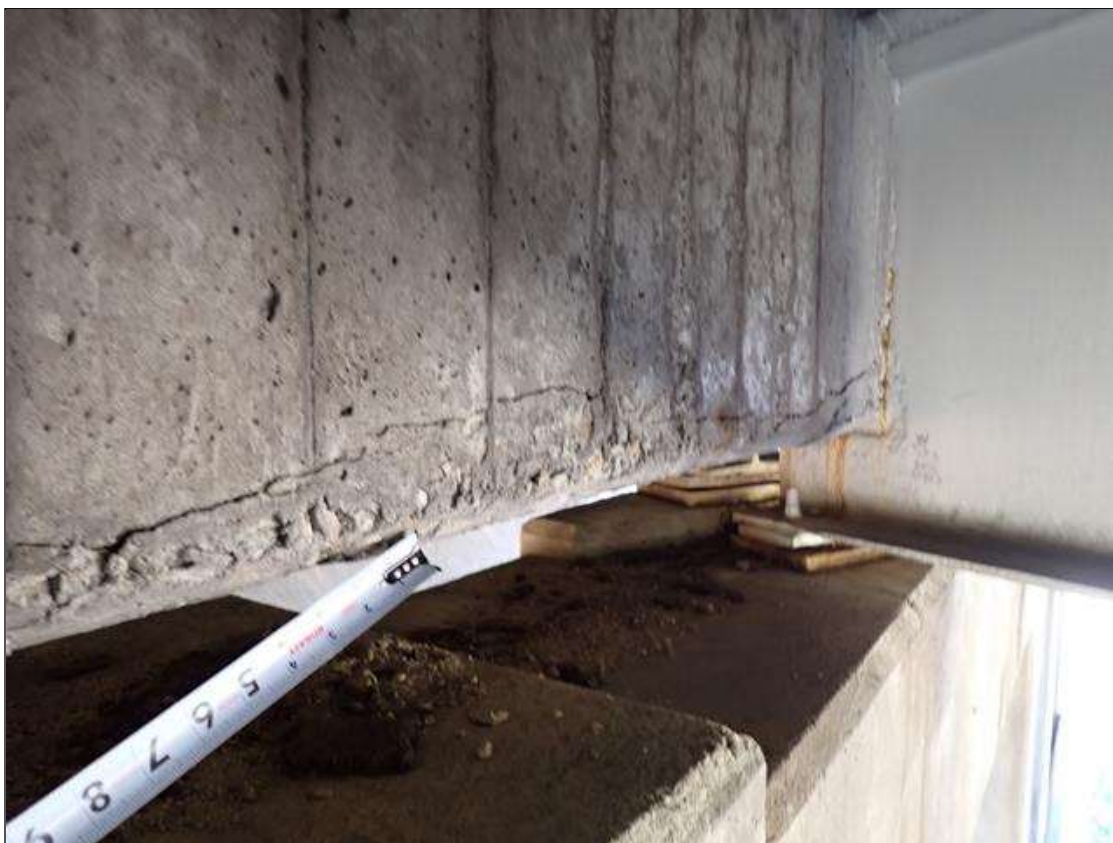
Span 3 Beam 5: 7 foot x 4 inch delamination with cracks up to 1/8 inch in south face end diaphragm at bent 3

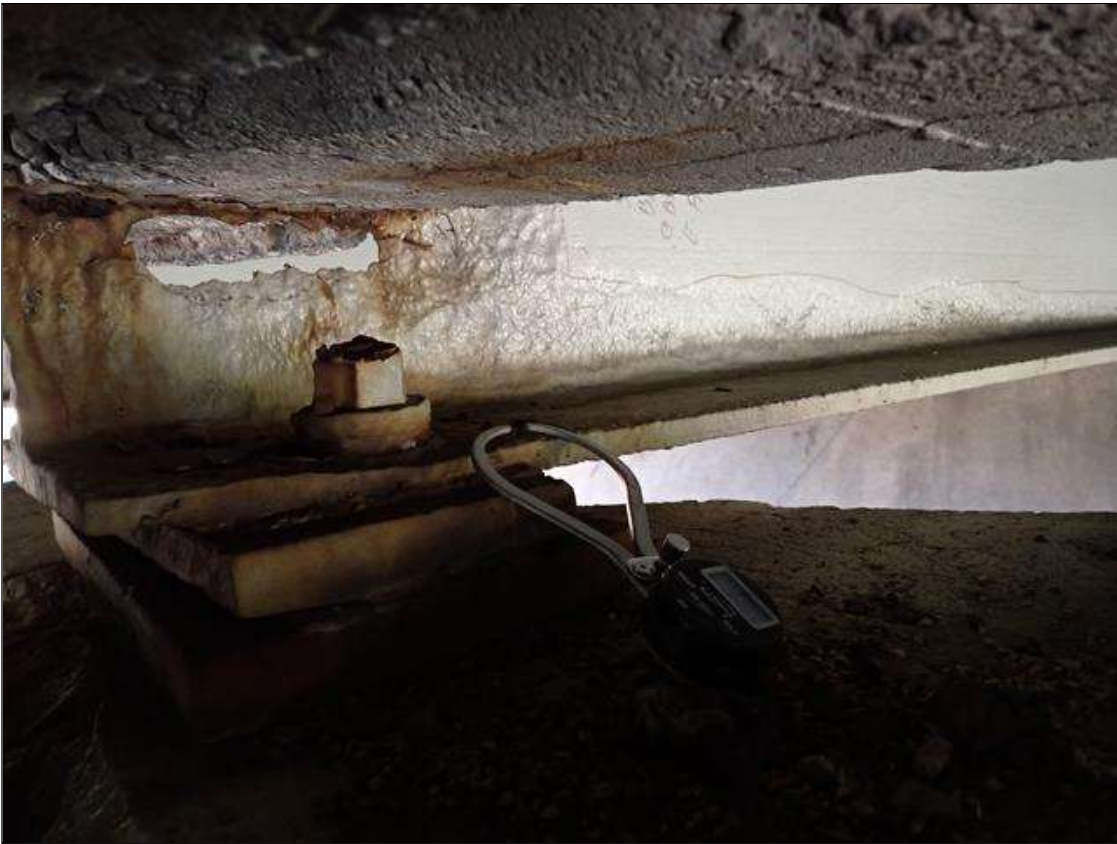
Span 4 Beam 5: (PAR) at bent 3, painted over section loss: web (1/4 inch average remaining x 6 foot x 1 foot) with corrosion holes (6 inch x 1.5 inch); bottom flange (0.56 inch average remaining x 15 inch) with corrosion reinitiated

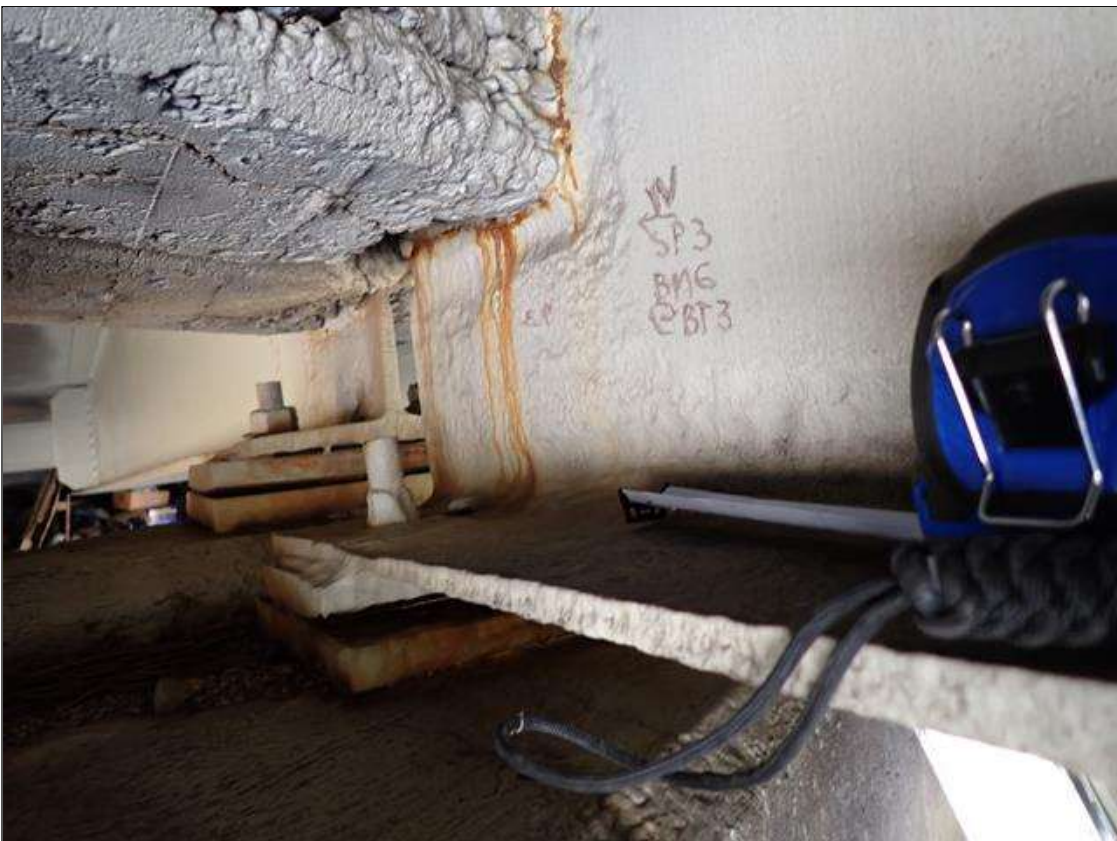
Span 3 Beam 6: (PAR) at bent 3, painted over section loss: web (1/4 inch average remaining x 20 inch x 10 inch); bottom flange (0.56 inch average remaining x 1 foot) with corrosion reinitiated

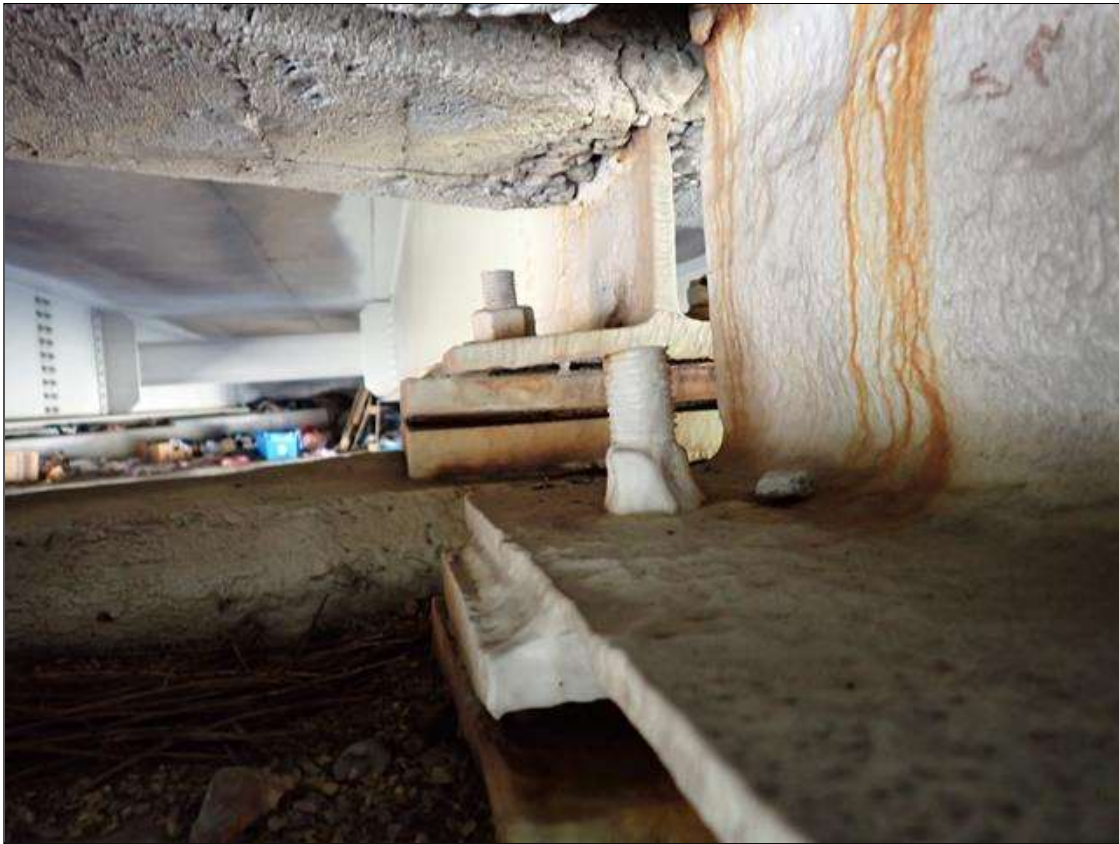
Span 3 Beam 6 - Far Bearing 6: corrosion has been arrested when painted, 75 percent section remaining in masonry and sole plate. west anchor bolt nut has 20 percent section remaining

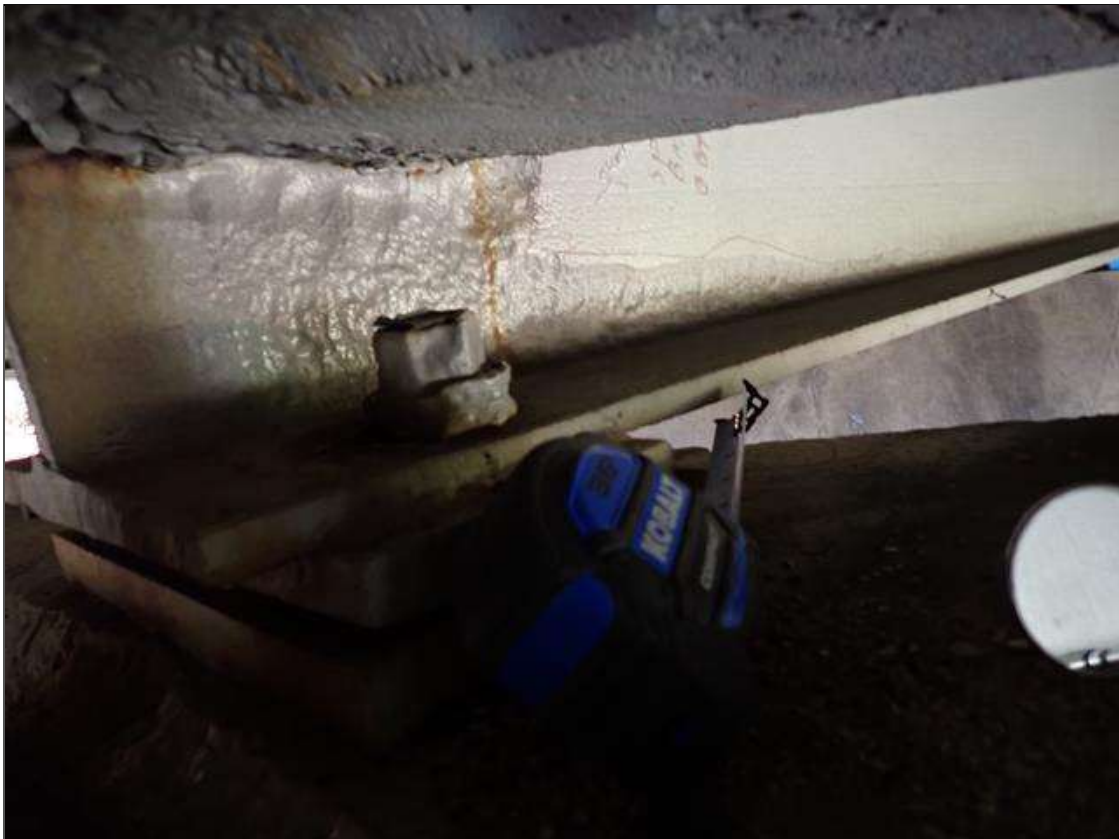
Span 4 Beam 6: (PAR) at bent 3, painted over section loss: web (1/4 inch average remaining x 32 inch x 12 inch) with corrosion reinitiated

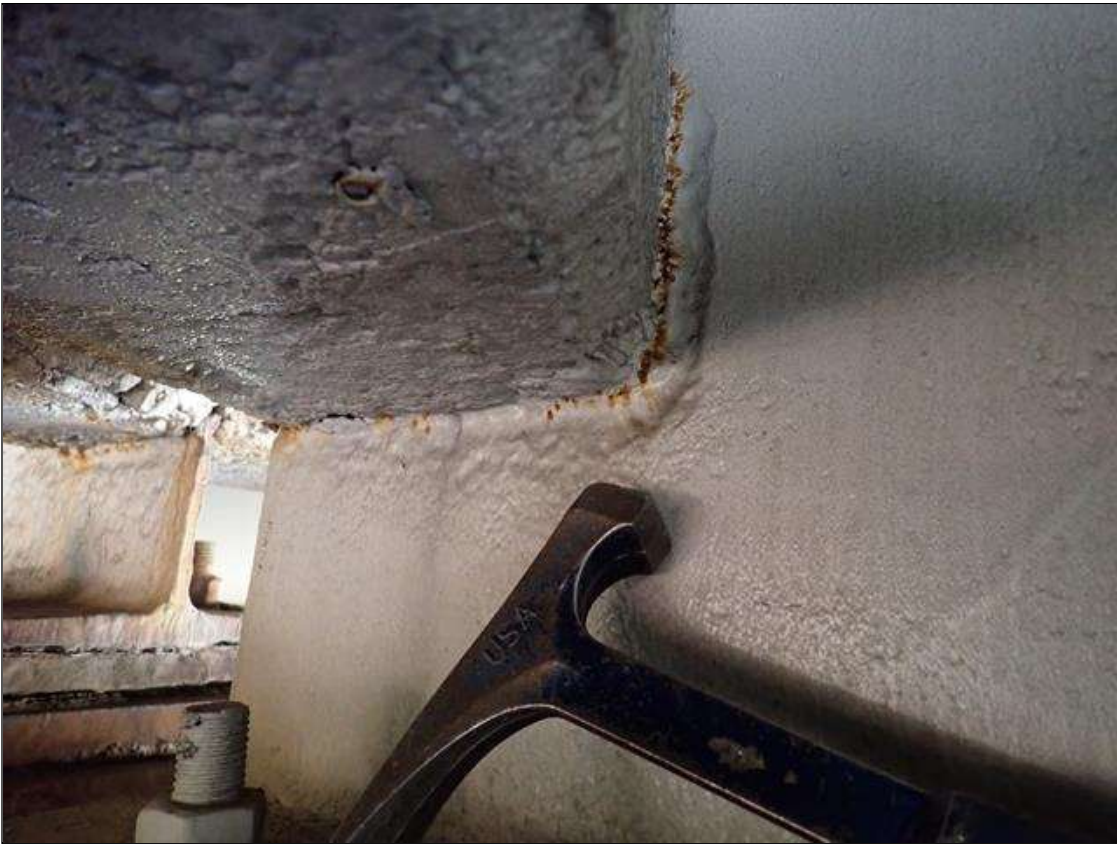
Span 3 Beam 7: (PAR) at bent 3, painted over section loss: web adjacent to diaphragm (3/8 inch average remaining x 10 inch x 5 inch) with corrosion reinitiated

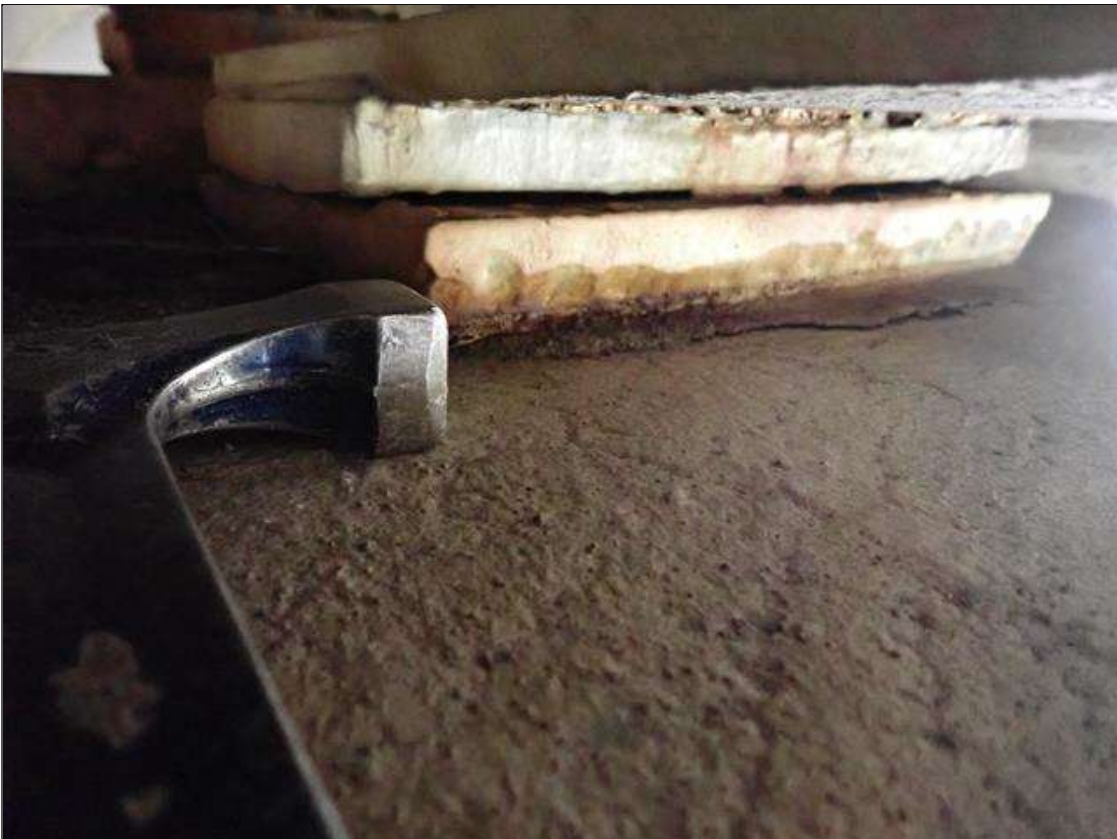
Span 3 Far Bearing 7: arrested pack rust and section loss in masonry plate and sole plate. 80 percent section remaining.

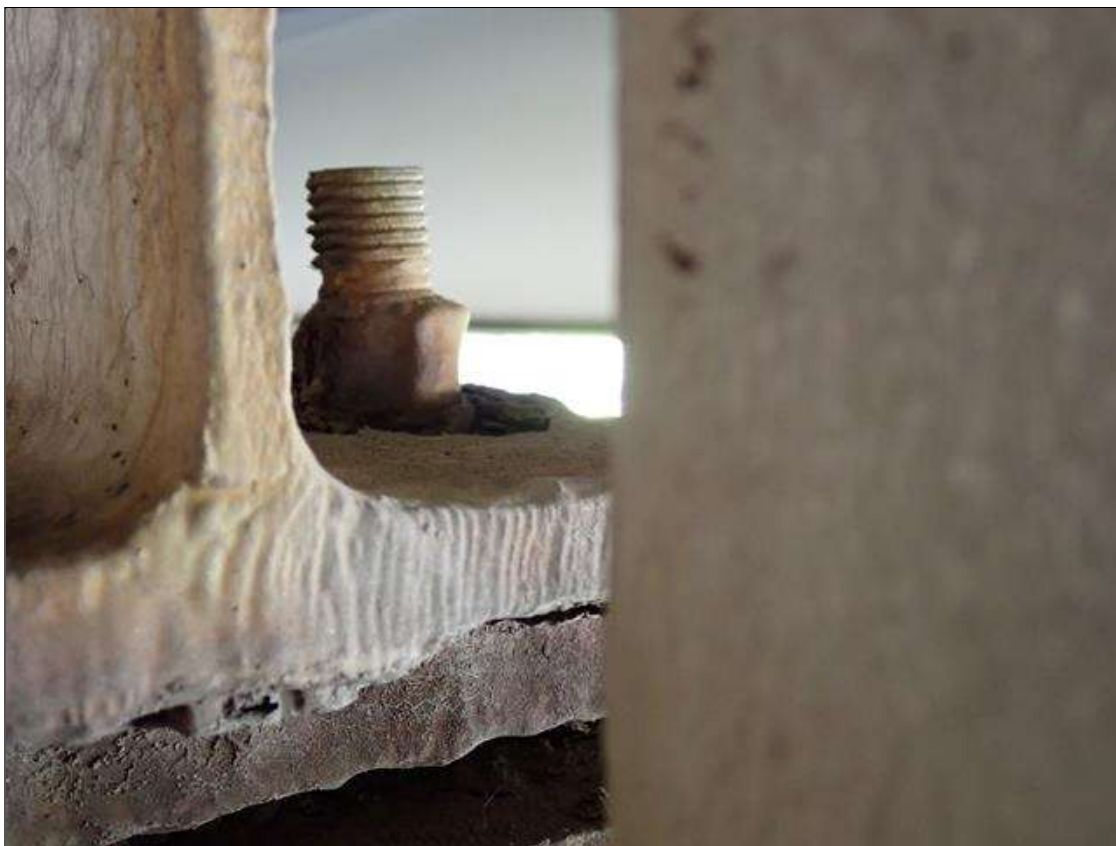
Span 4 Beam 7 - Near Bearing 7: arrested corrosion and section loss in masonry plate and sole plate. 80 percent section remaining. both anchor bolt nuts have up to 40 percent section remaining

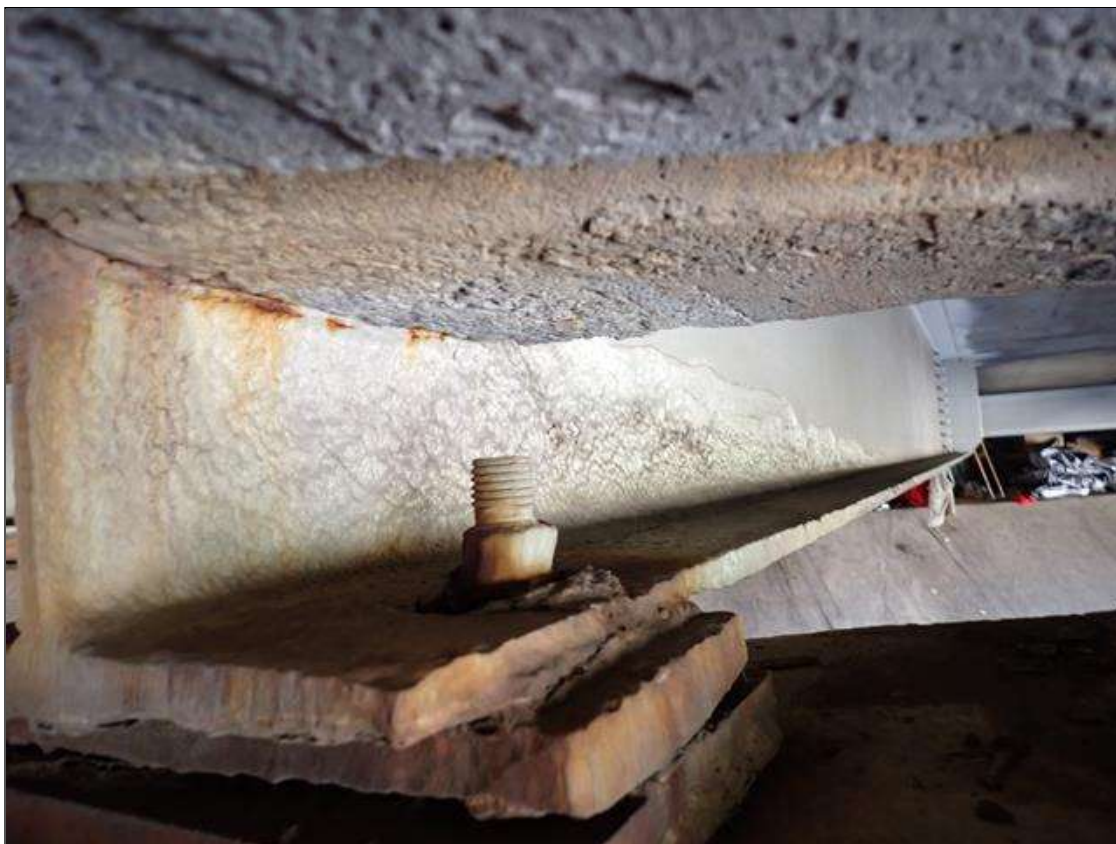
Span 4 Beam 7: (PAR) at bent 3, painted over section loss: web (1/4 inch average remaining x 8 foot x 12 inch) with corrosion holes (up to 1/4 inch diameter); bottom flange (0.45 inch average remaining x 26 inch) with corrosion reinitiated

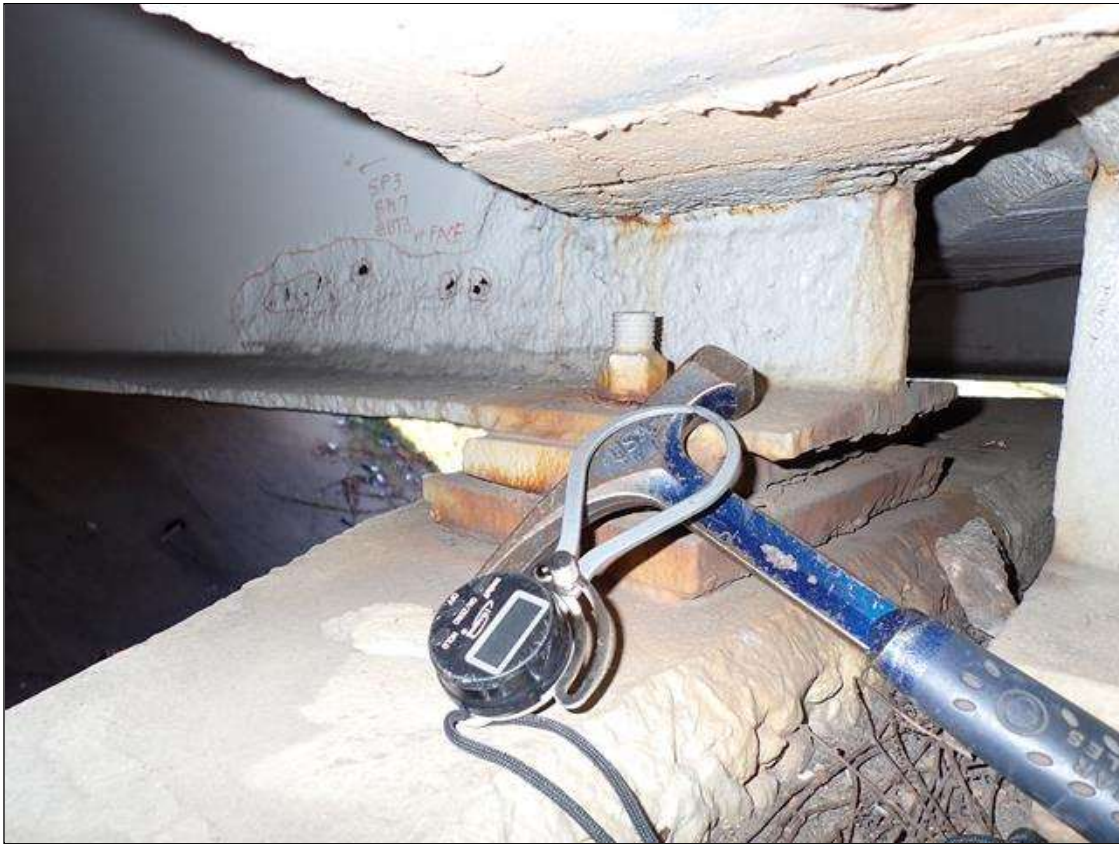
Span 4 Beam 7: (PAR) at bent 3, painted over section loss: web (1/4 inch average remaining x 8 foot x 12 inch) with corrosion holes (up to 1/4 inch diameter); bottom flange (0.45 inch average remaining x 26 inch) with corrosion reinitiated
