NC DEPARTMENT OF TRANSPORTATION  
 DIVISION OF HIGHWAYS  
 STRUCTURE MANAGEMENT UNIT

ATTENTION: **prompt action request; sketches updated; new beam repairs**

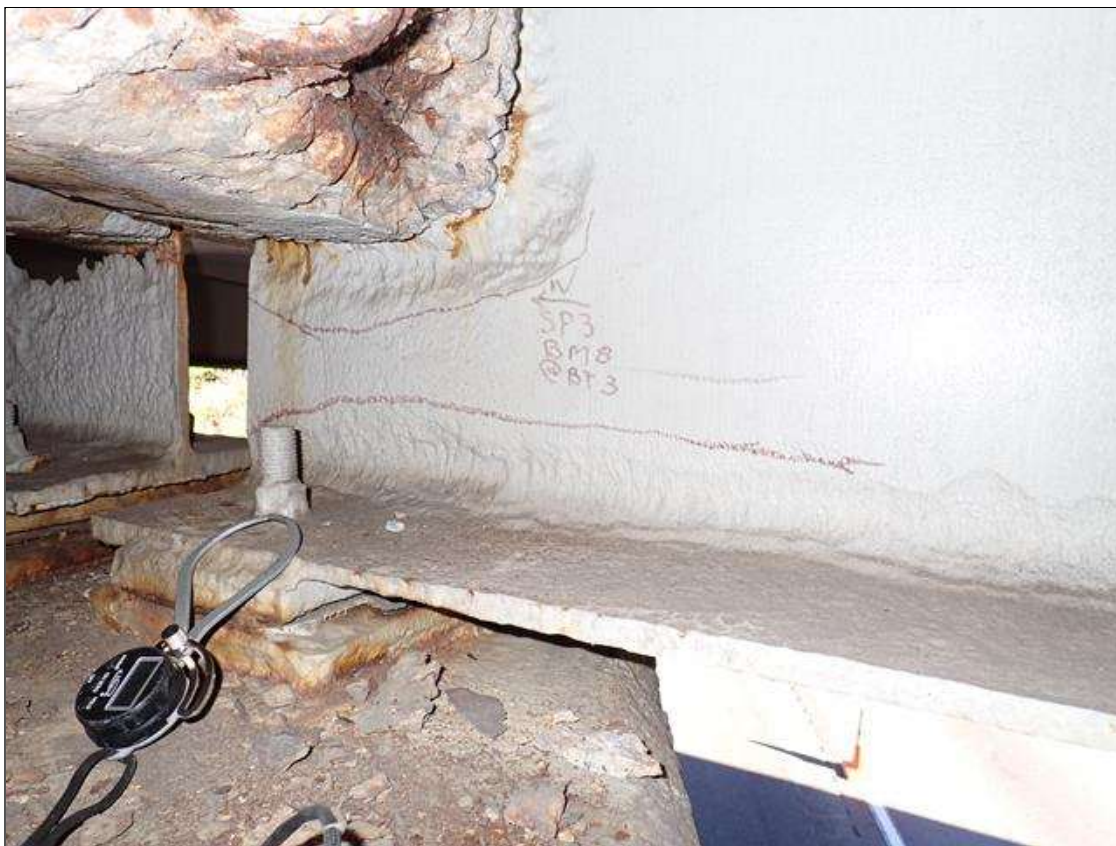
Span 3 Beam 8: (PAR) at bent 3, painted over section loss: web adjacent to diaphragm (1/4 inch average remaining x 1 foot x 8 inch); lower web (1/4 inch average remaining x 32 inch x 2 inch); bottom flange (0.50 inch average remaining x 18 inch) with corrosion reinitiated

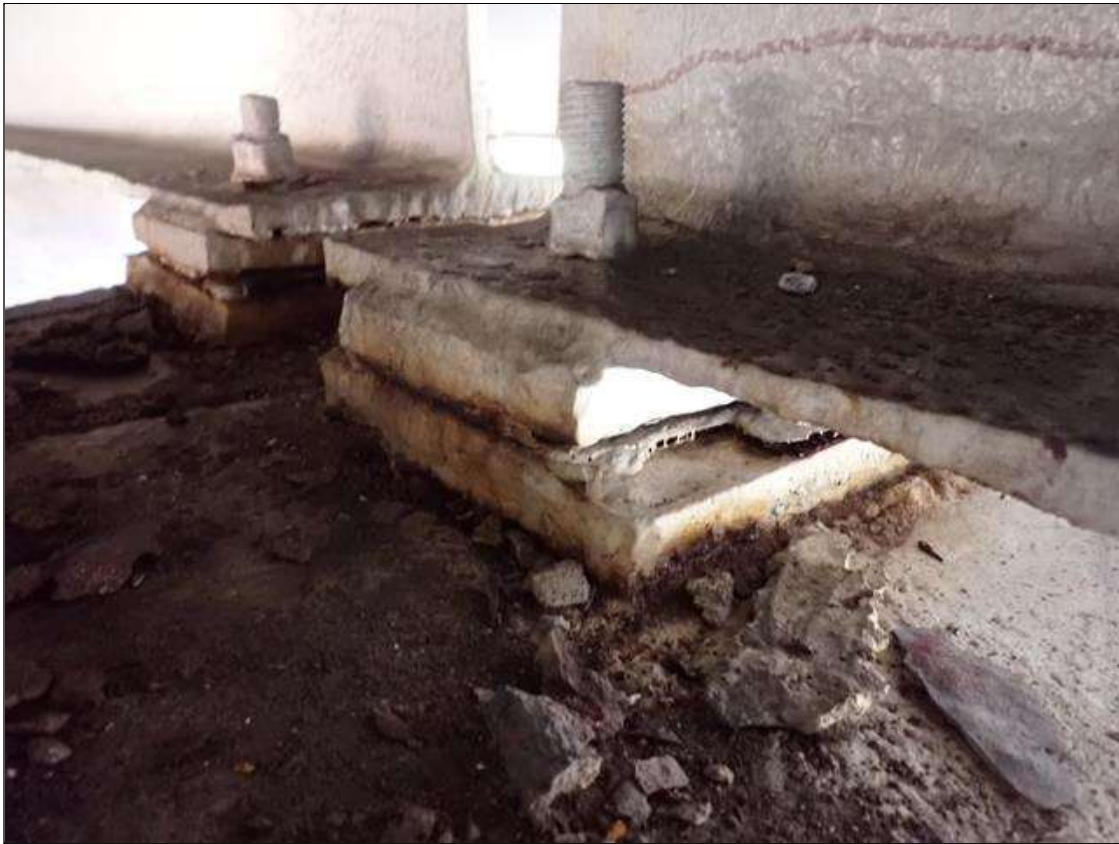
Span 3 Beam 8 - Far Bearing 8: corrosion has been arrested when painted, up to 75 percent section remaining in masonry and sole plate. west anchor bolt nut has up to 80 percent section remaining.

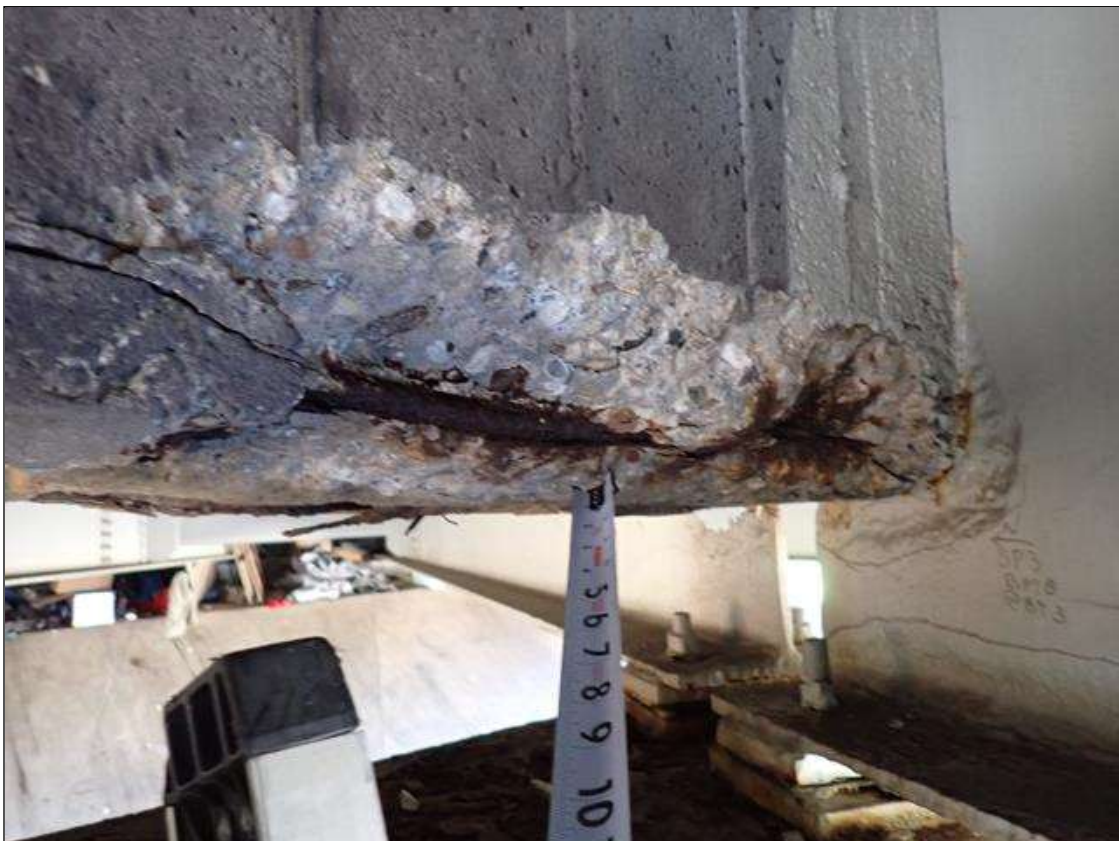
Span 3 Beam 8: (PAR) 3 foot long x 6 inch wide x 3 inch high spall with exposed reinforcement in end diaphragm between beams 7 and 8 at bent 3. 70 percent section remaining in exposed reinforcement.

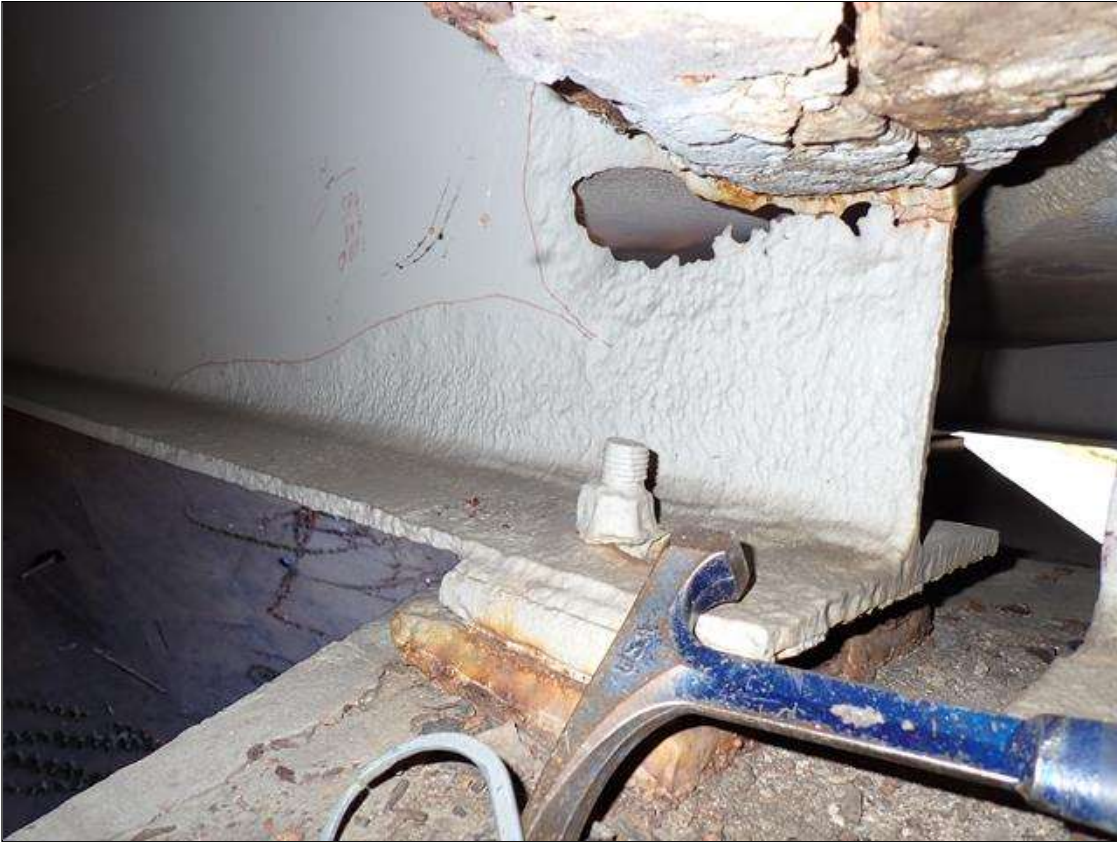
Span 4 Beam 8: (PAR) at bent 3, painted over section loss: web (1/4 inch average remaining x 34 inch x 12 inch) with corrosion hole (10 inch x 3 inch); bottom flange (0.50 inch average remaining x 34 inch) with corrosion reinitiated

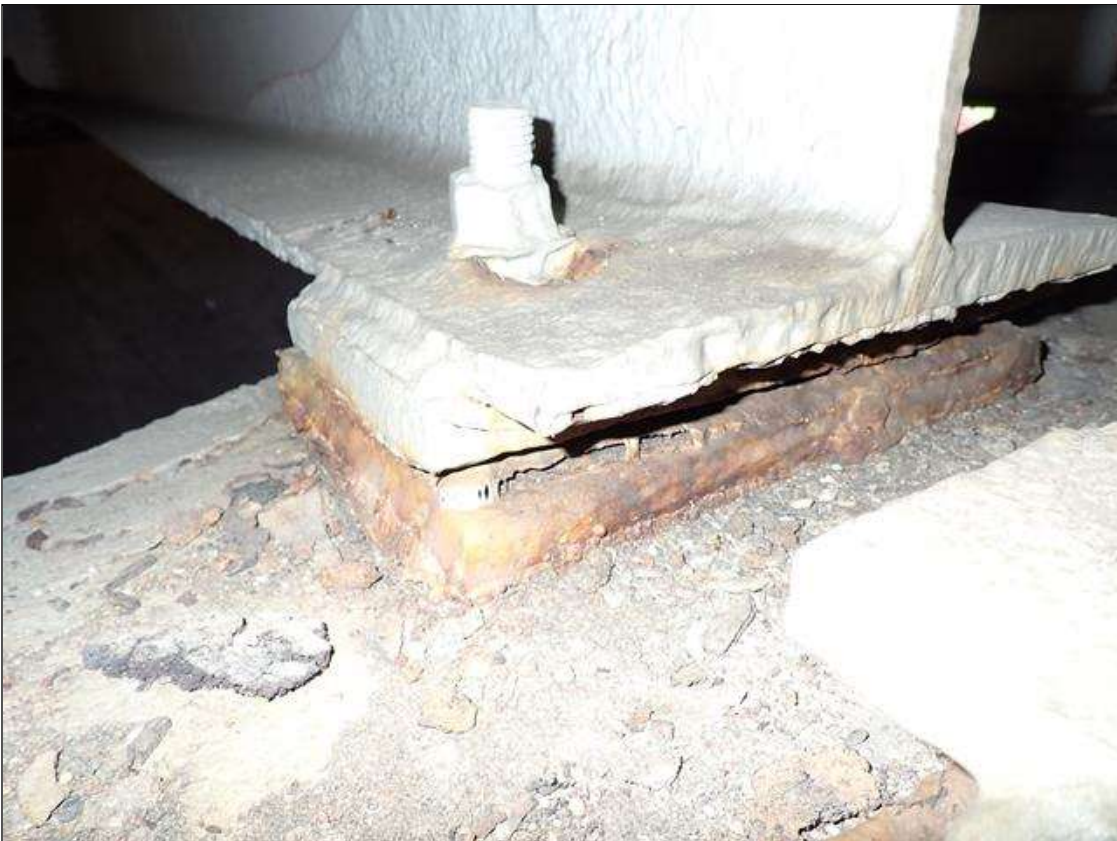
Span 4 Beam 8 - Near Bearing 8: corrosion has been arrested when painted, 75 percent section remaining in masonry plate and sole plate. both anchor bolt nuts have up to 50 percent section remaining.

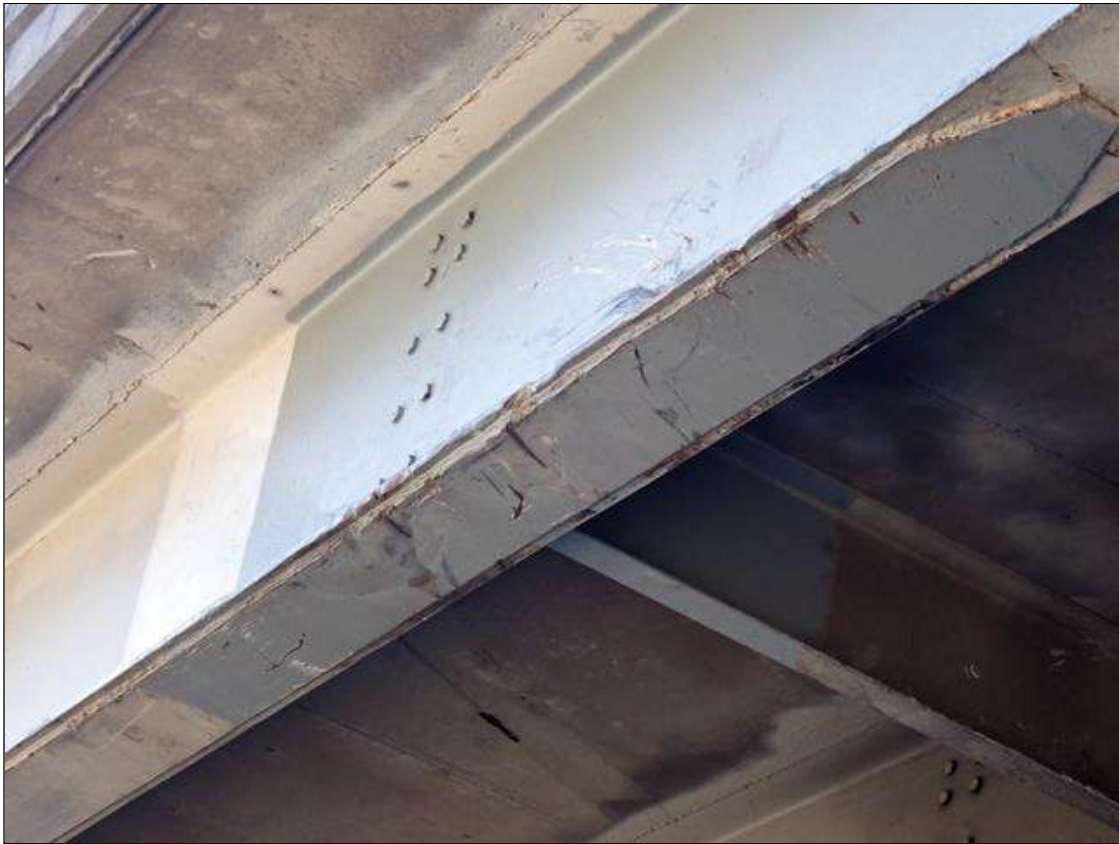
Span 3 Beam 11: 2023 new repair (beam heat straightened and coverplate rewelded); previously noted as: SUPPLEMENTAL INSPECTION IMPACT DAMAGE 2021 area of previous impact damage, distortion of bottom flange vertical up to 2 inch lateral up to 1/2 inch with broken cover plate weld [10 inch long]. new area of impact damage 6 inch long x 2 inch high at 13 foot-5 inch out from interior. bent 3 . with the bottom cover plate being broken loose from bottom flange 10 inch long x 2 inch deep . there are also two older 1/2 inch indentions in the same area . Beam 11 is swept westward up to 1 1/2 inch. (par) there is a 2 inch diameter torch cut hole at both ends of of the 6 foot length .

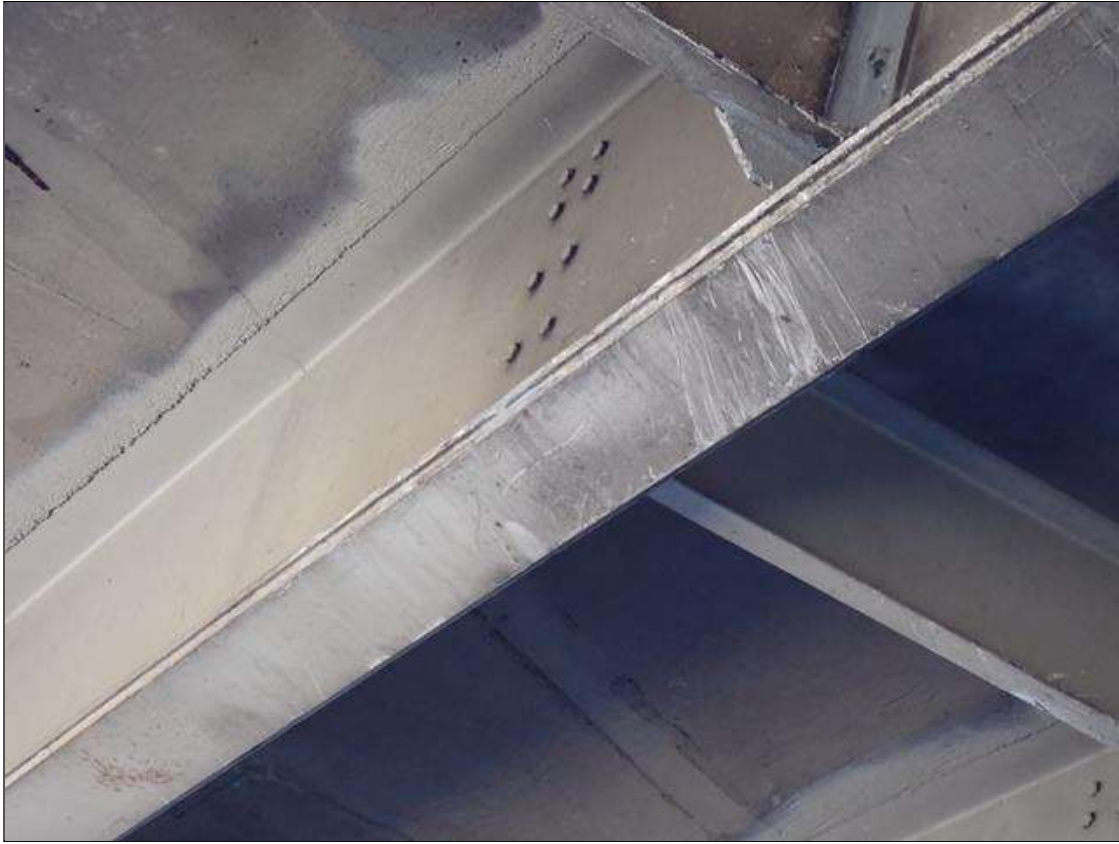
Span 3 Beam 10: (2023 no apparent change since previous inspection) SUPPLEMENTAL INSPECTION IMPACT DAMAGE 2021: 1 indentation 1 inch long x 1/2 inch deep at 18 foot-8 inch from interior. bent 3 . scattered scrapes along the web .

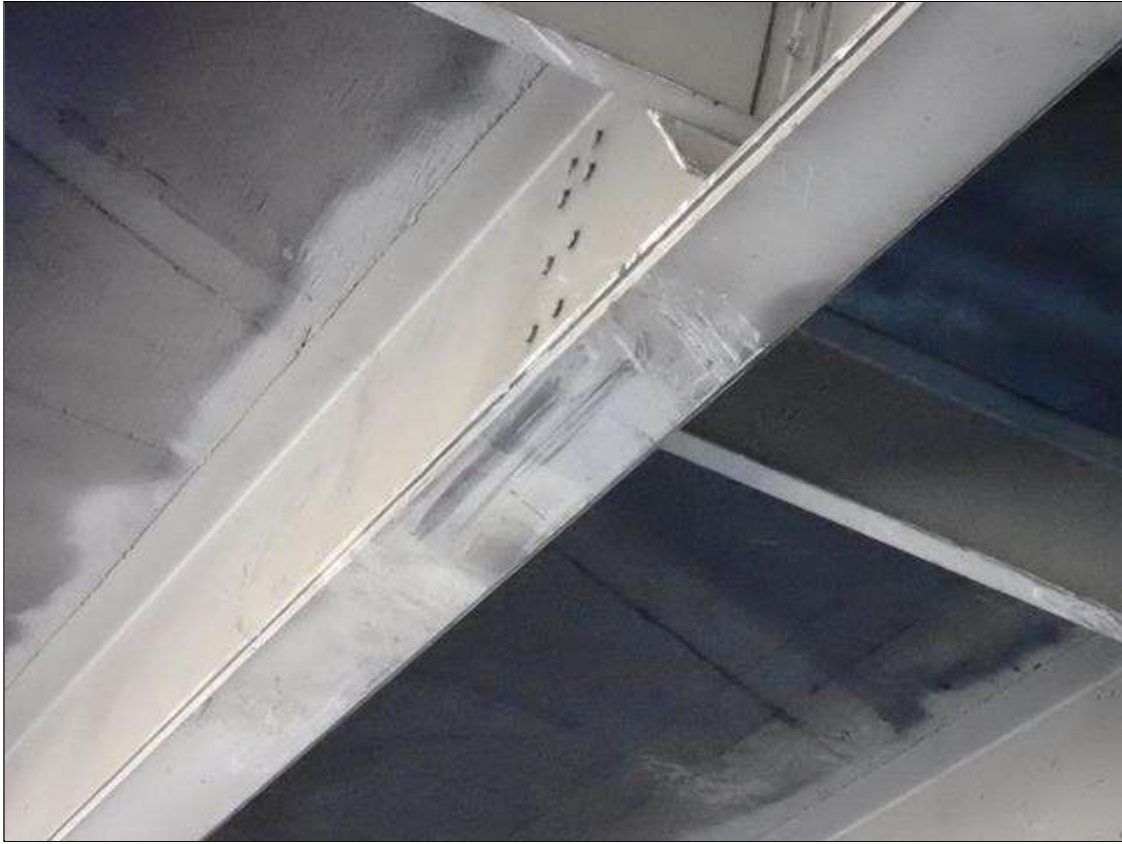
Span 3 Beam 9: (2023 no apparent change since previous inspection) SUPPLEMENTAL INSPECTION IMPACT DAMAGE 2021: 1 indentation 1 inch long x 1/4 inch deep at 18 foot-7 inch from interior. bent 3

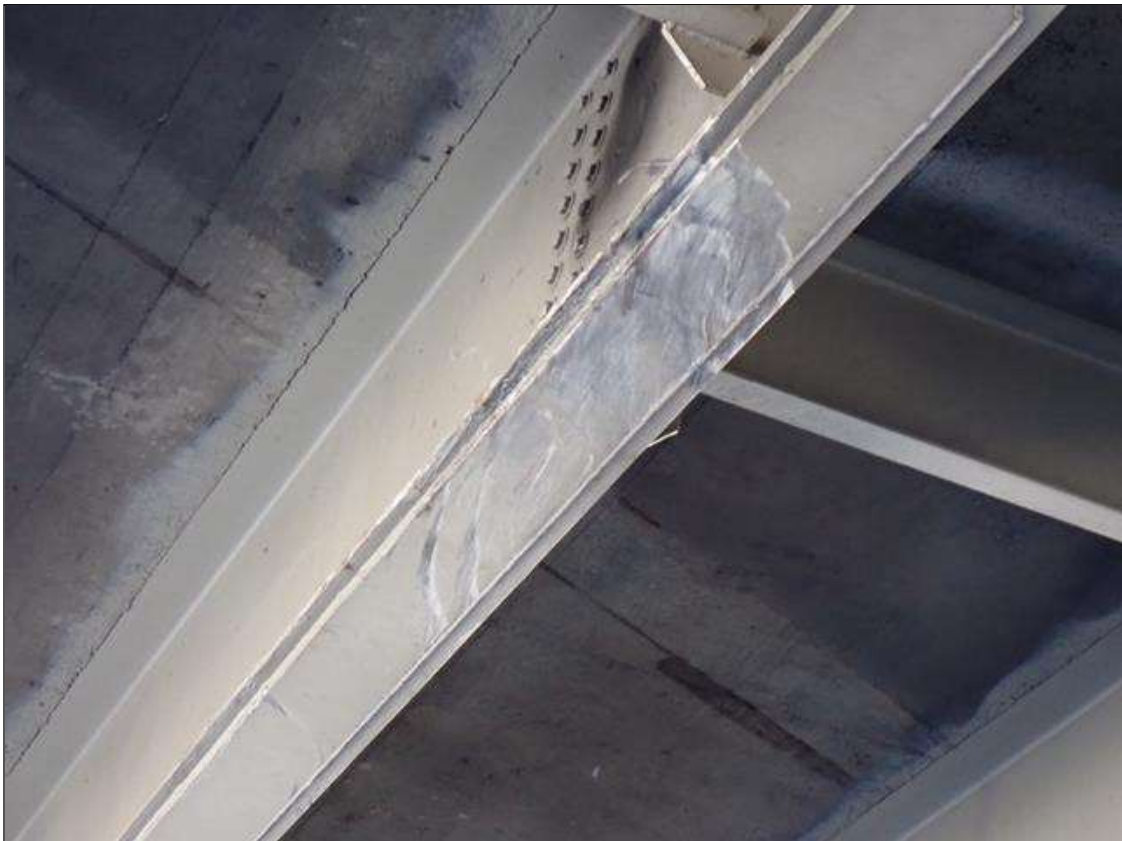
Span 3 Beam 8: over right westbound lane, impact scrapes with distortion

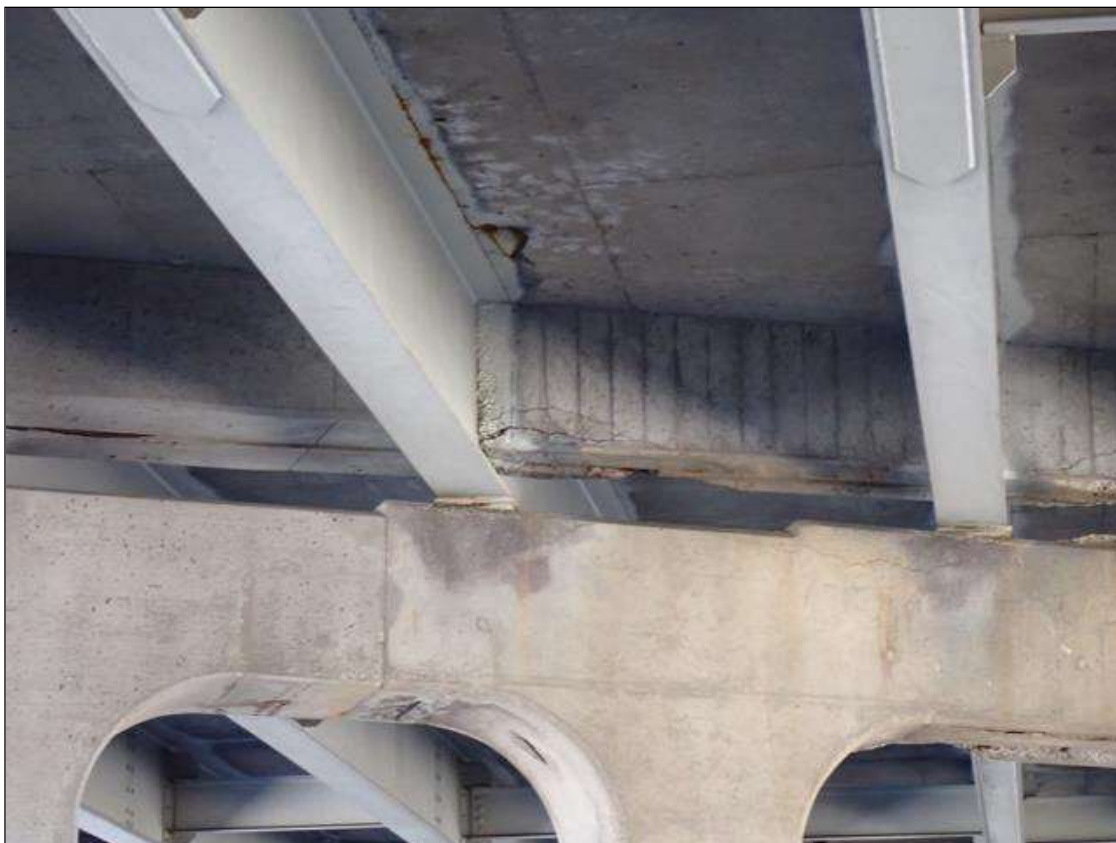
Span 3 Beam 7: multiple up to 3 foot long horizontal 1/8 inch wide cracks in end diaphragm between beams 7 and 8 at bent 2 starting at beam 8

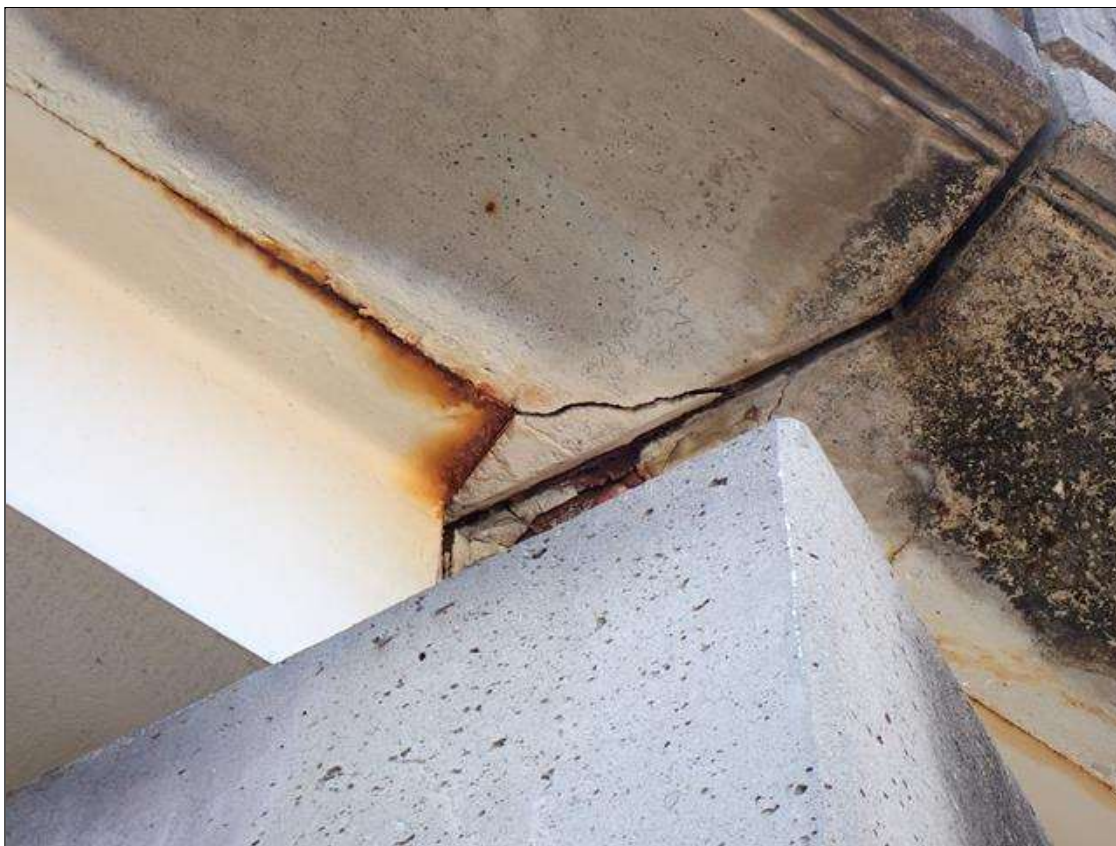
Span 3 Deck: at bent 3, both overhangs, (2) delaminations (up to 1.5 foot x 6 inch)

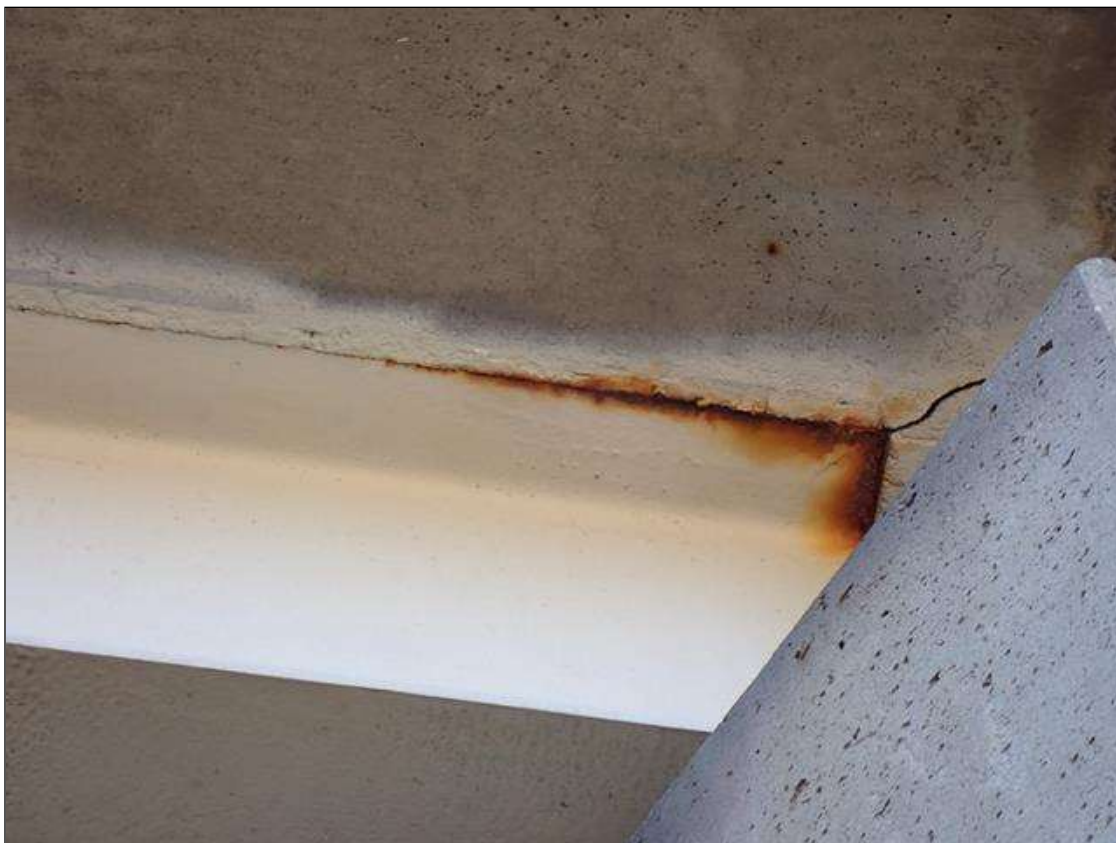
Span 3 Beam 11: at bent 3, top flange, surface rust/rust scale (1 foot)

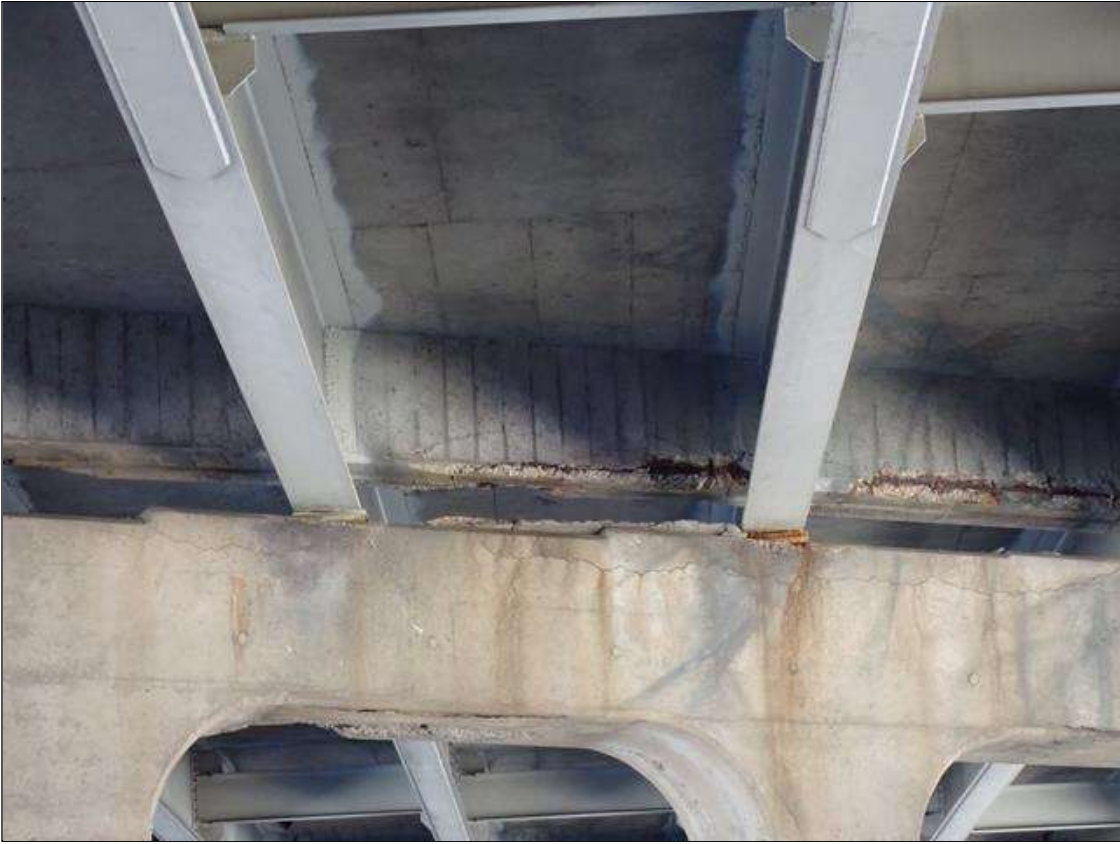
Span 3 Beam 6: spall/delamination 7 foot x 10 inch x 2 inch deep with exposed rusted rebar in north face of end diaphragm between beams 6 and 7 at bent 2

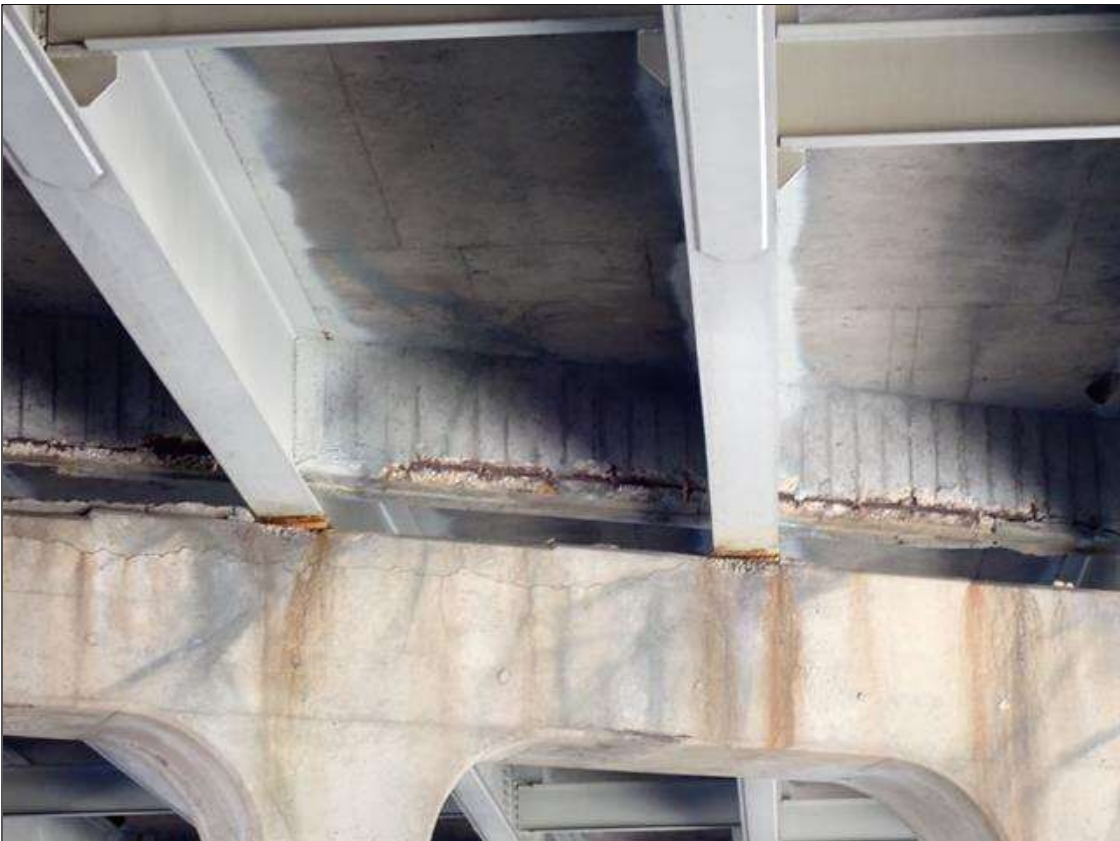
Span 3 Beam 5: (PAR) 7 foot long x up to 3 inch high x 10 inch wide area of spall in the diaphragm between beams 5 and 6 at bent 2 with exposed reinforcement. 70 percent section remaining in the exposed reinforcement.

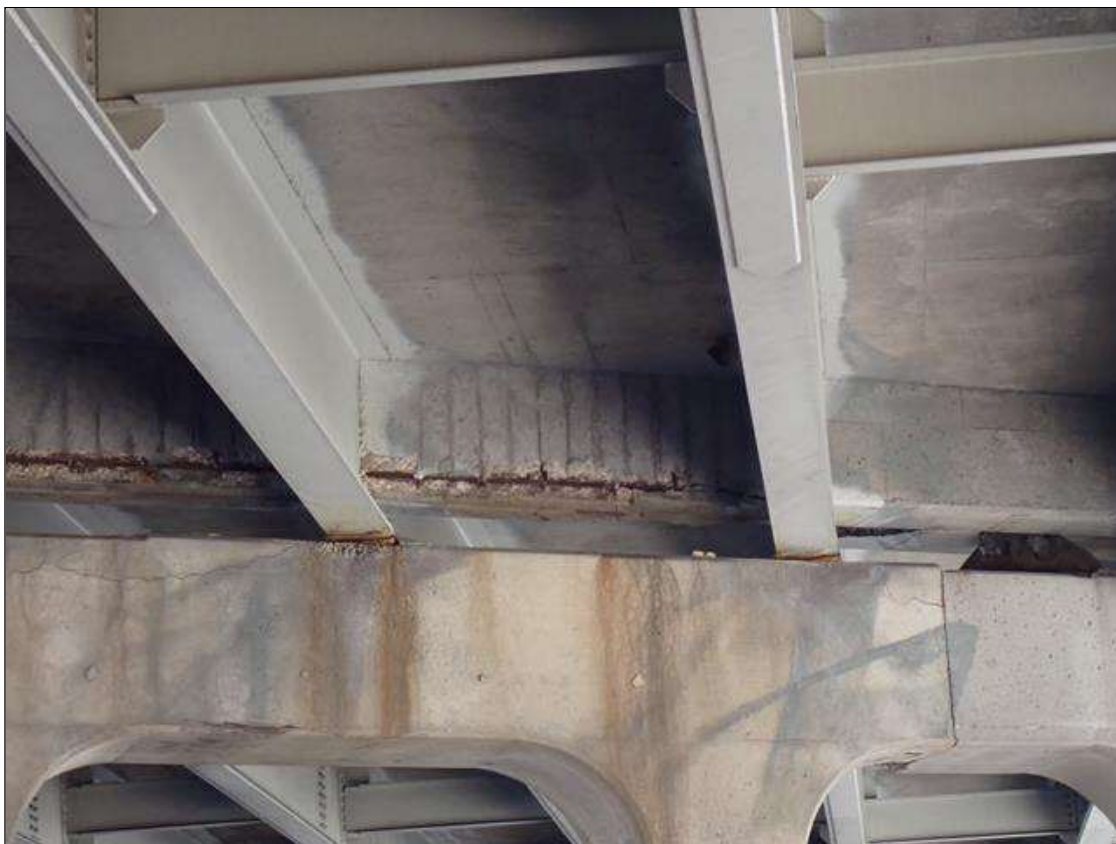
Span 3 Beam 4: (PAR) 6 foot long x up to 3 inch high x 10 inch wide area of spall in the diaphragm between beams 4 and 5 at bent 2 with exposed reinforcement. 70 percent section remaining in the exposed reinforcement.

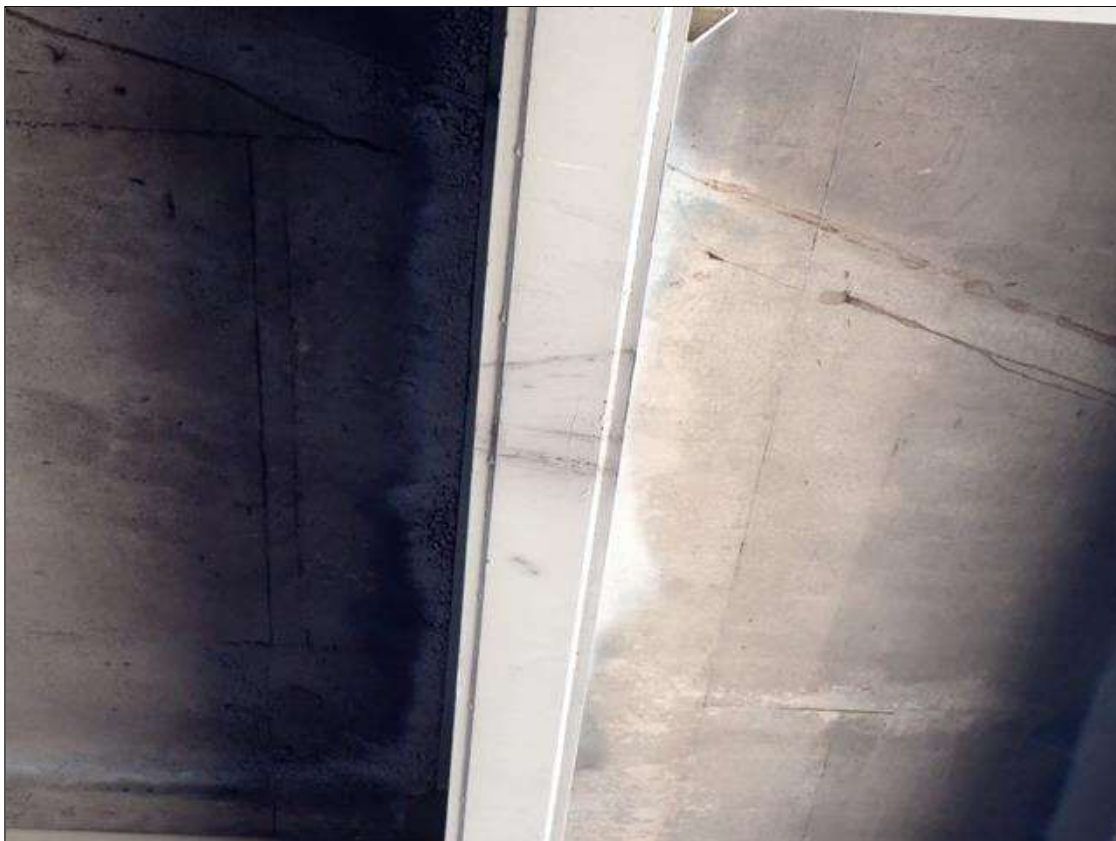
Span 3 Beam 4: (2023 no apparent change since previous inspection) SUPPLEMENTAL INSPECTION IMPACT DAMAGE 2021: scattered scrapes

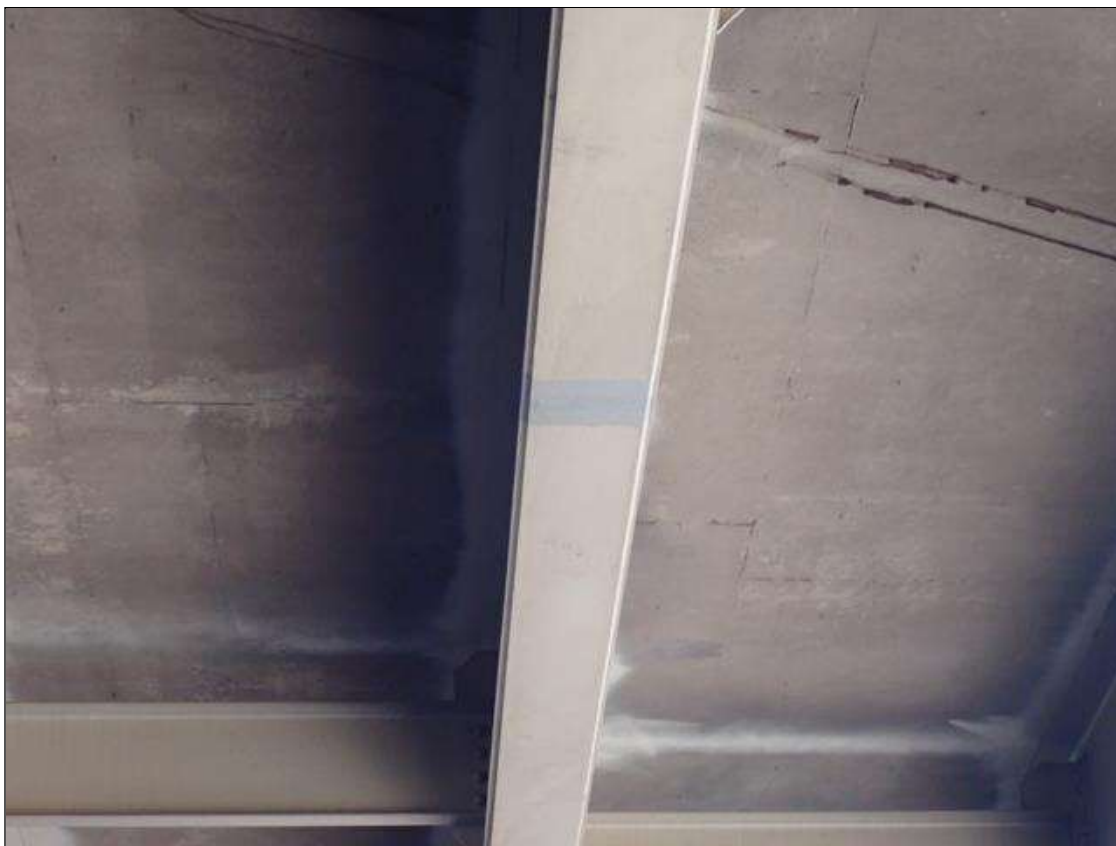
Span 3 Beam 3: 2023 new paint repair; previously noted as: SUPPLEMENTAL INSPECTION IMPACT DAMAGE  
2021 :scattered scrapes

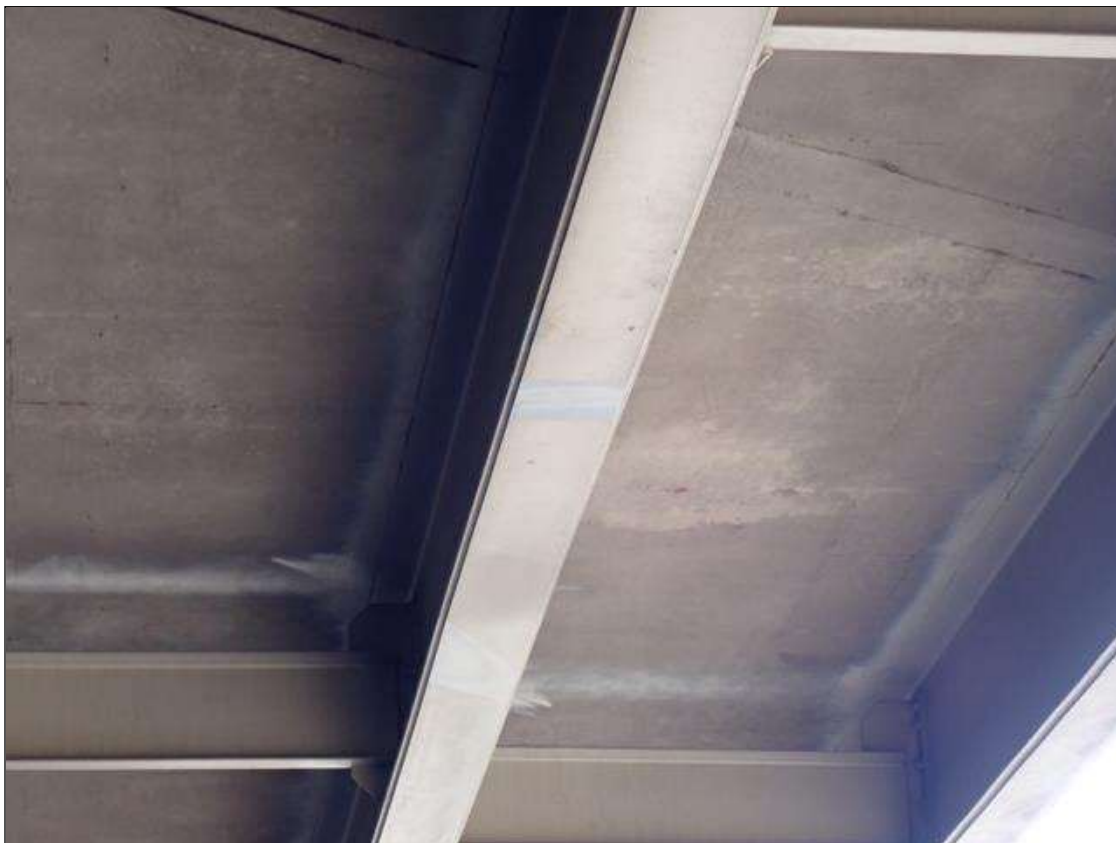
Span 3 Beam 2: 2023 new paint repair, previously noted as: SUPPLEMENTAL INSPECTION IMPACT DAMAGE  
2021 :scattered scrapes

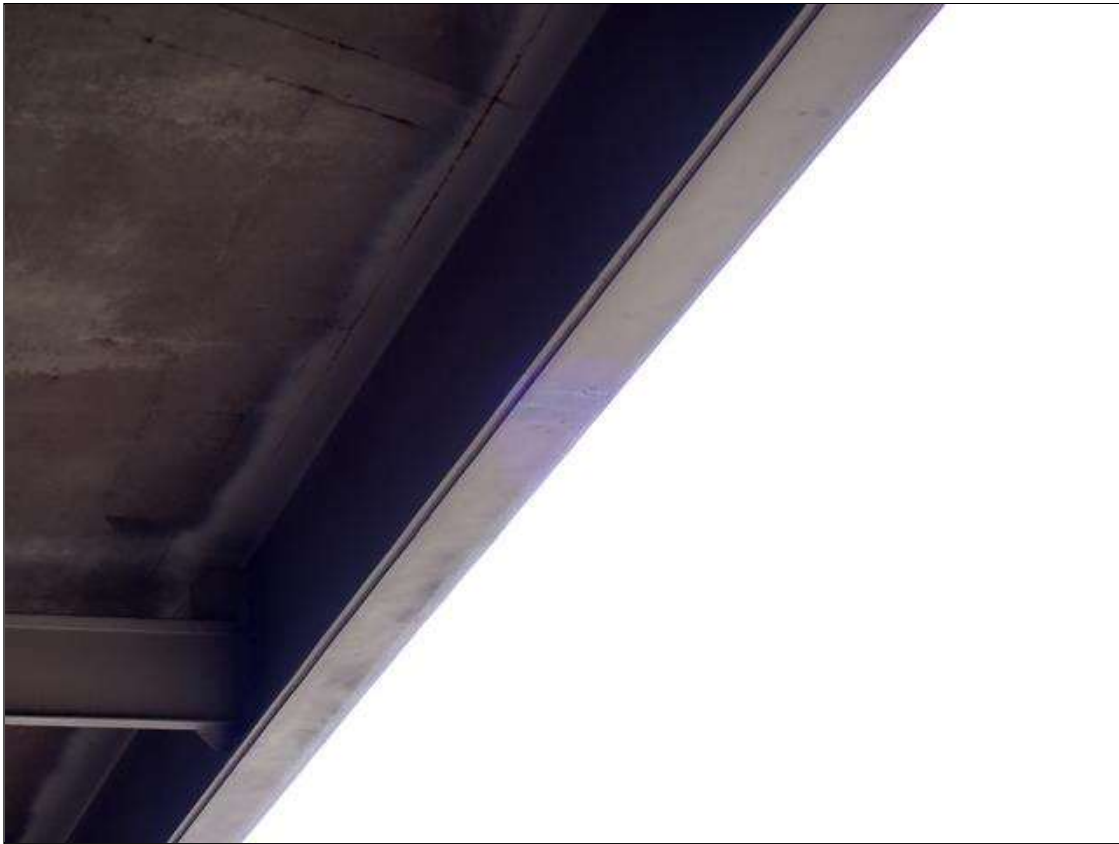
Span 3 Beam 1: (2023 no apparent change since previous inspection) SUPPLEMENTAL INSPECTION IMPACT DAMAGE 2021 :scattered scrapes

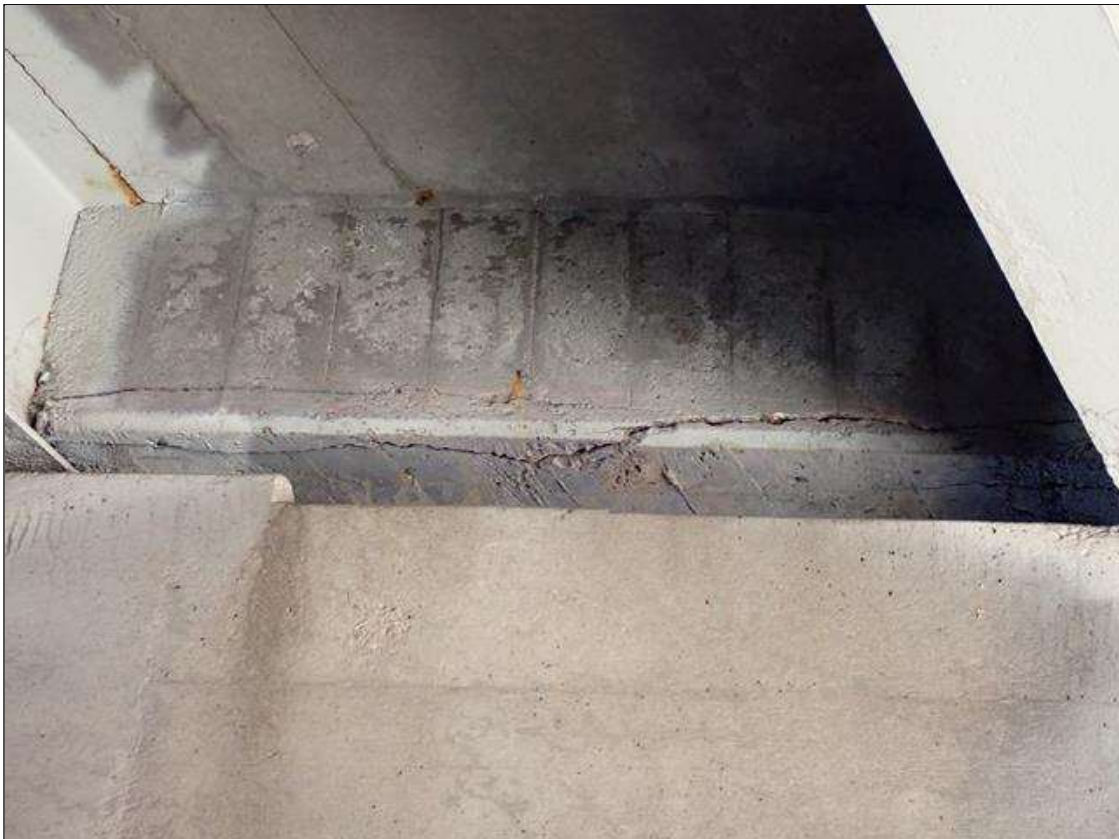
Span 4 Beam 4: 7 foot long x 8 inch wide x 4 inch along north face and 8 in along bottom face area of delamination and unsound concrete in end diaphragm at bent 3 between beams 4 and 5.

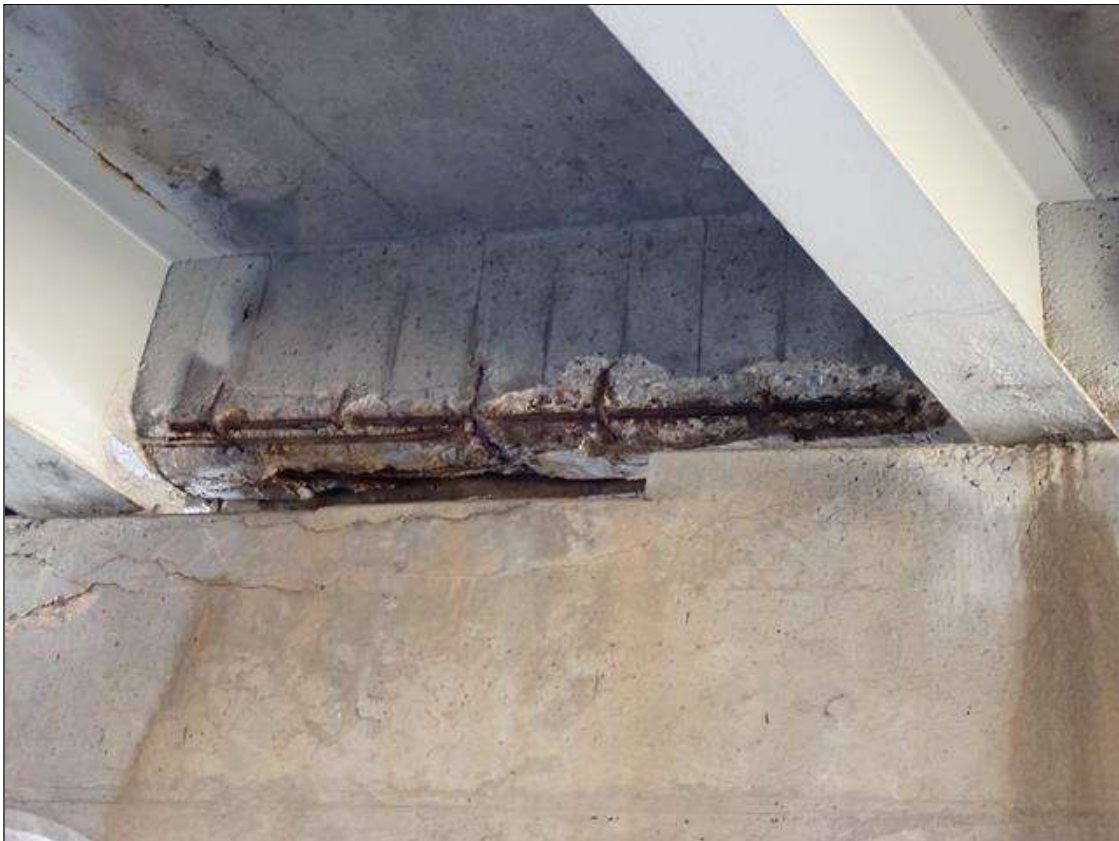
Span 4 Beam 8: (PAR) 7 foot long x 1.5 foot wide x 3 inch deep spall with exposed reinforcement in end diaphragm between beams 7 and 8 at bent 3. 60 percent section remaining in exposed reinforcement.

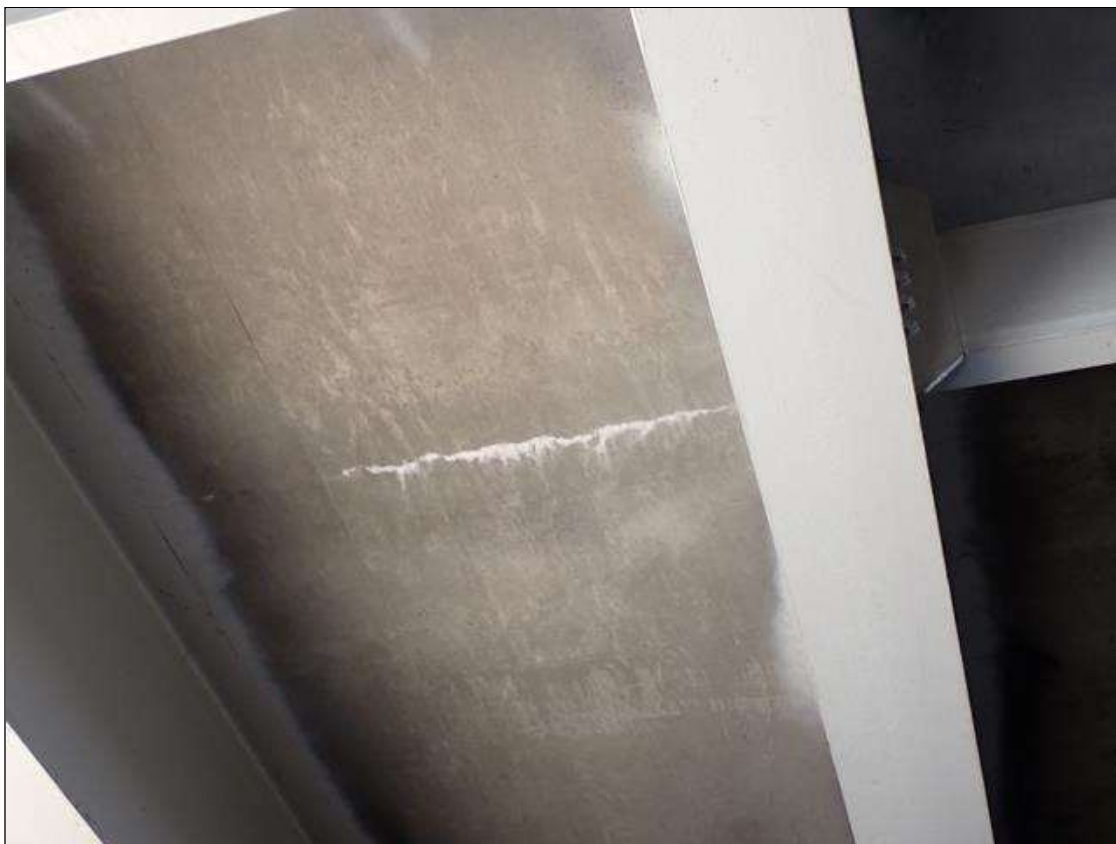
Span 4 Deck: throughout underside of deck, transverse cracks (up to 1/16 inch x full bay width) and map cracks (1/32 inch) some with efflorescence at random

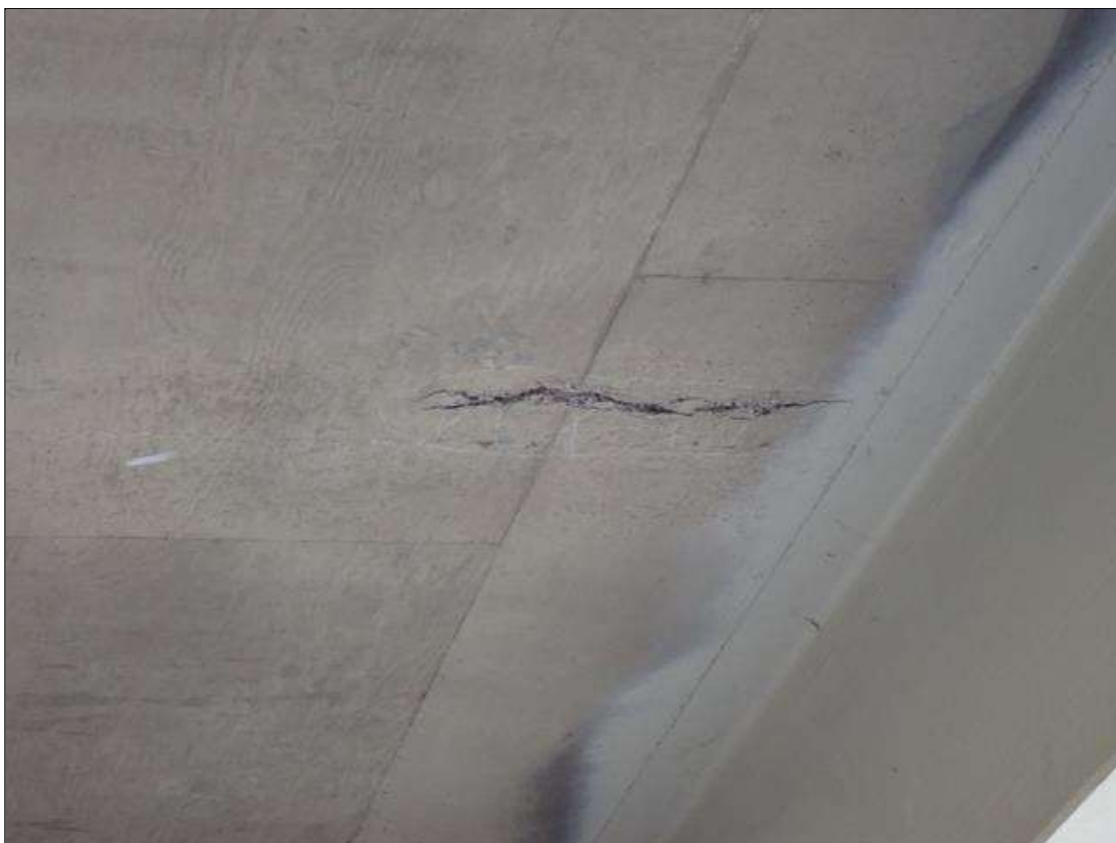
Span 4 Deck: 2 foot long x 6 inch wide x up to 1/2 inch deep area of delamination/spall in deck underside of bay 10, 15 foot from end bent 2.
