NC DEPARTMENT OF TRANSPORTATION  
 DIVISION OF HIGHWAYS  
 STRUCTURE MANAGEMENT UNIT

ATTENTION: **prompt action request; sketches updated; new beam repairs**

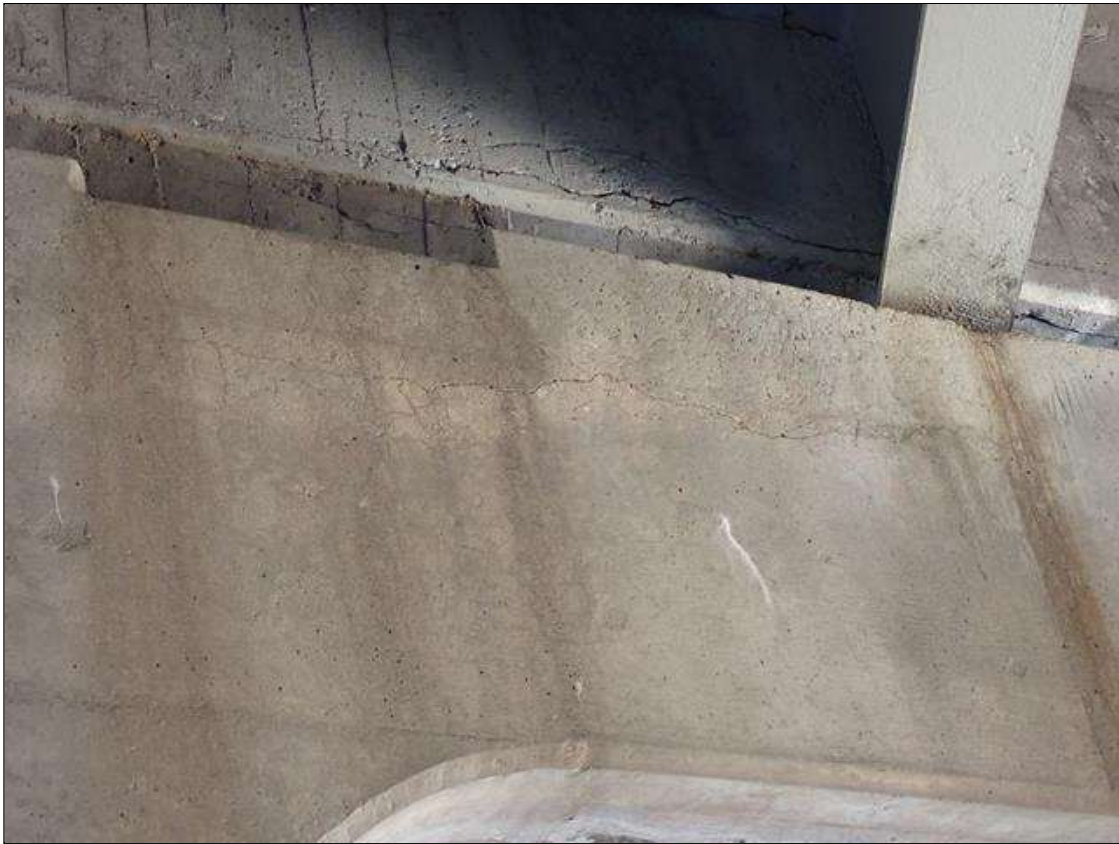
Bent 3 Cap 1: 4 foot long x 8 inch high area of up to 1/16 inch wide cracks and delamination on north face under bay 5

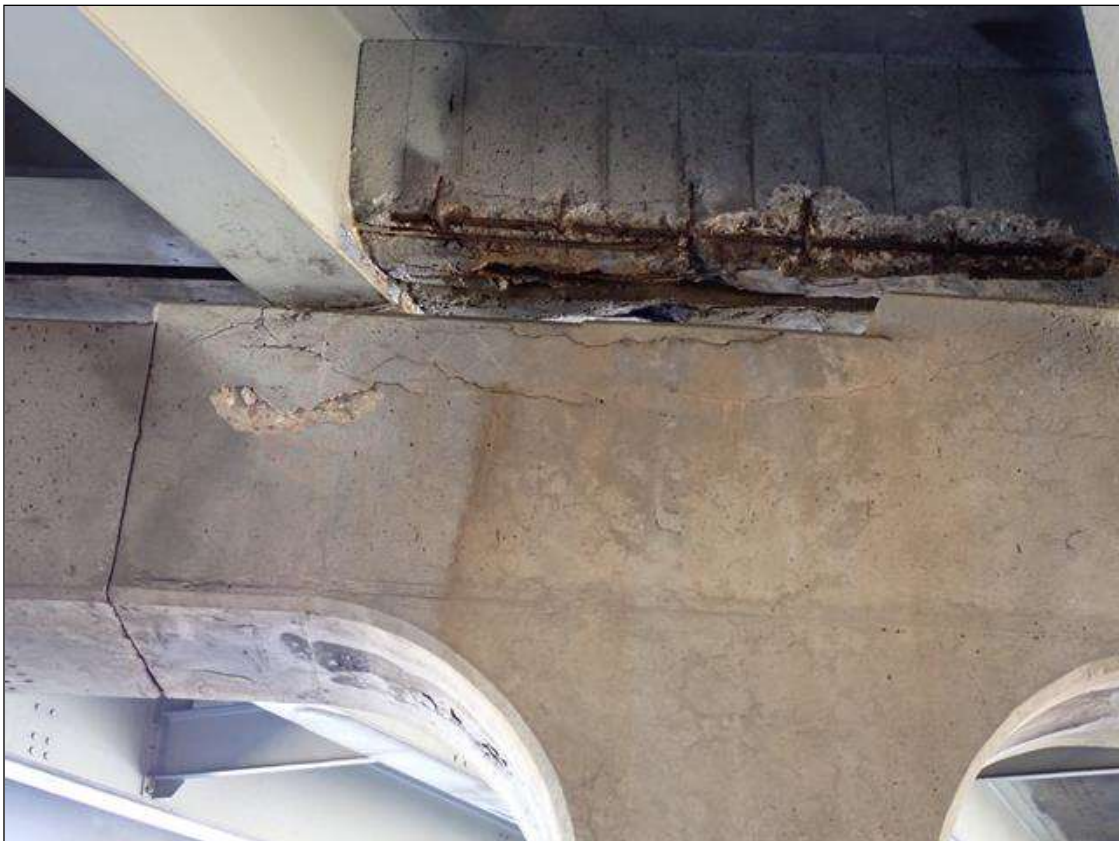
Bent 3 Cap 1: North face under bay 7, delamination 6 foot long x up to 1 foot x 4 inch x 1 inch deep in and has up to 1/8 inch wide cracks

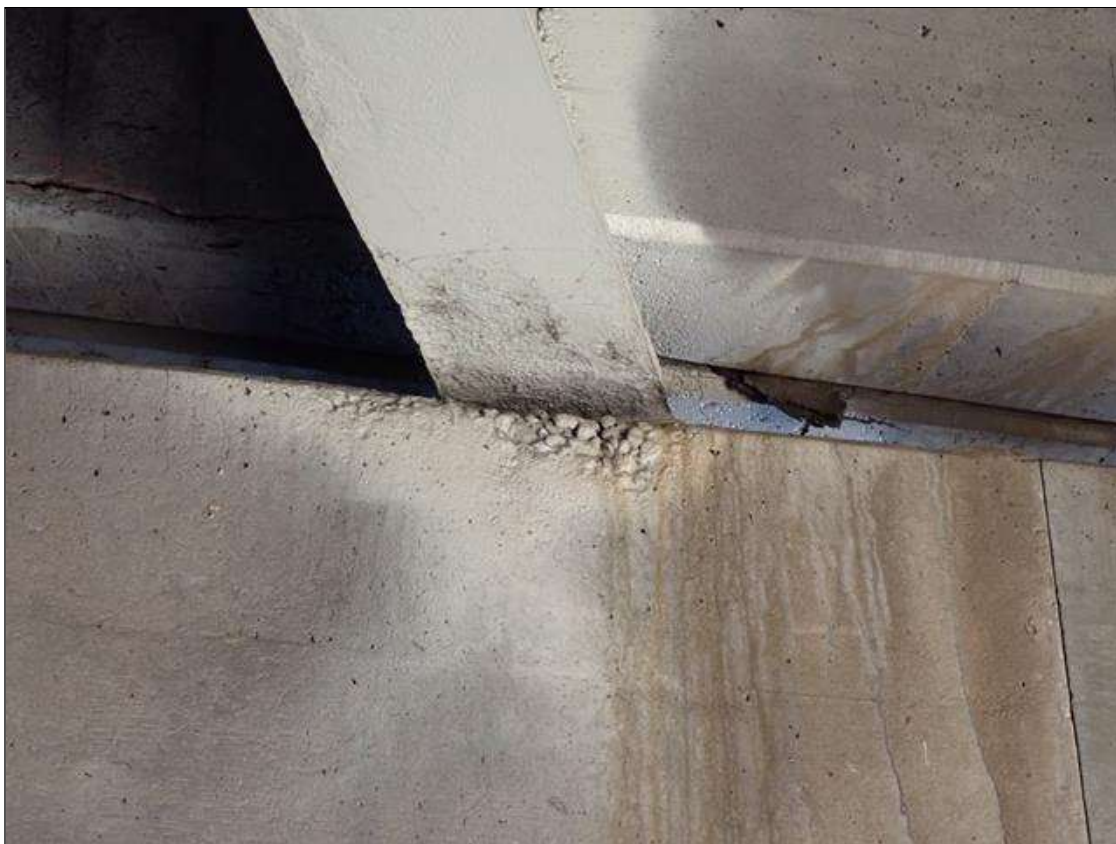
Bent 3 Cap 1: North face under beam 4, spall [1 foot x 6 inch x 1/2 inch deep] no undermining

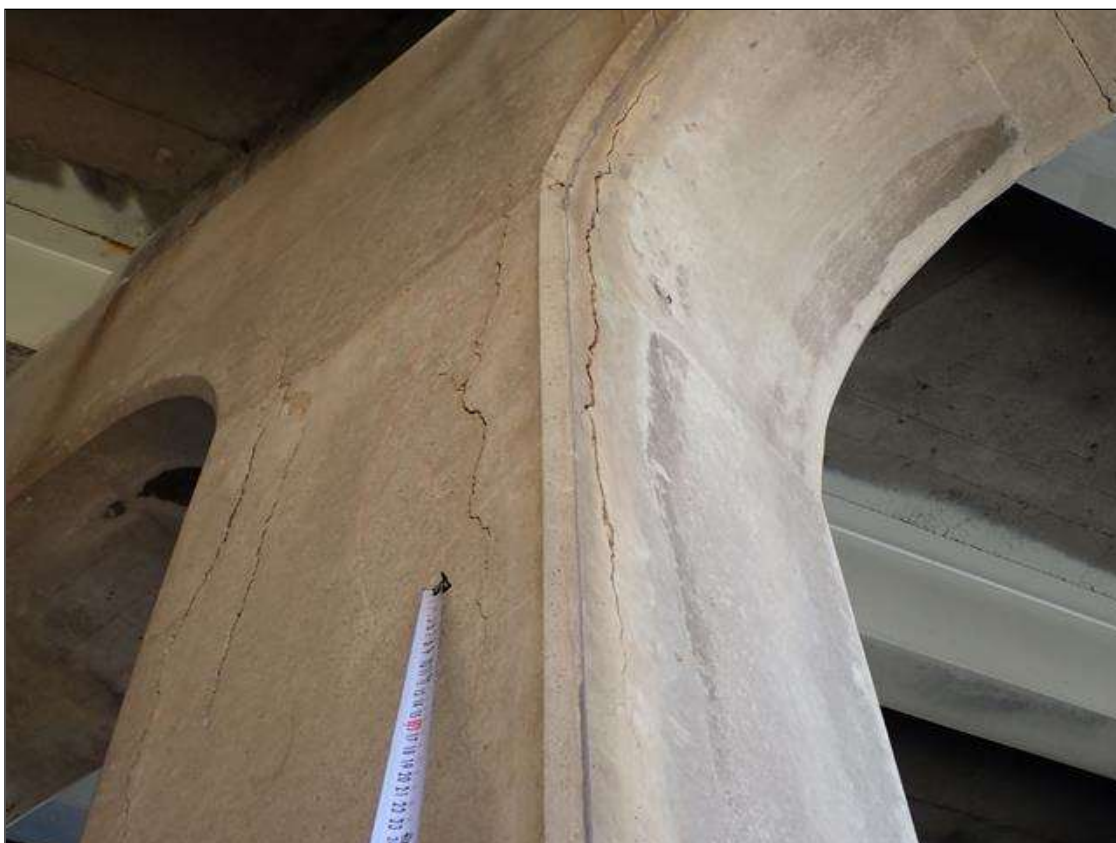
Bent 3 Pile 3: 4 foot high x 12 inch wide area of delamination and unsound concrete in north face. similar condition in west face.

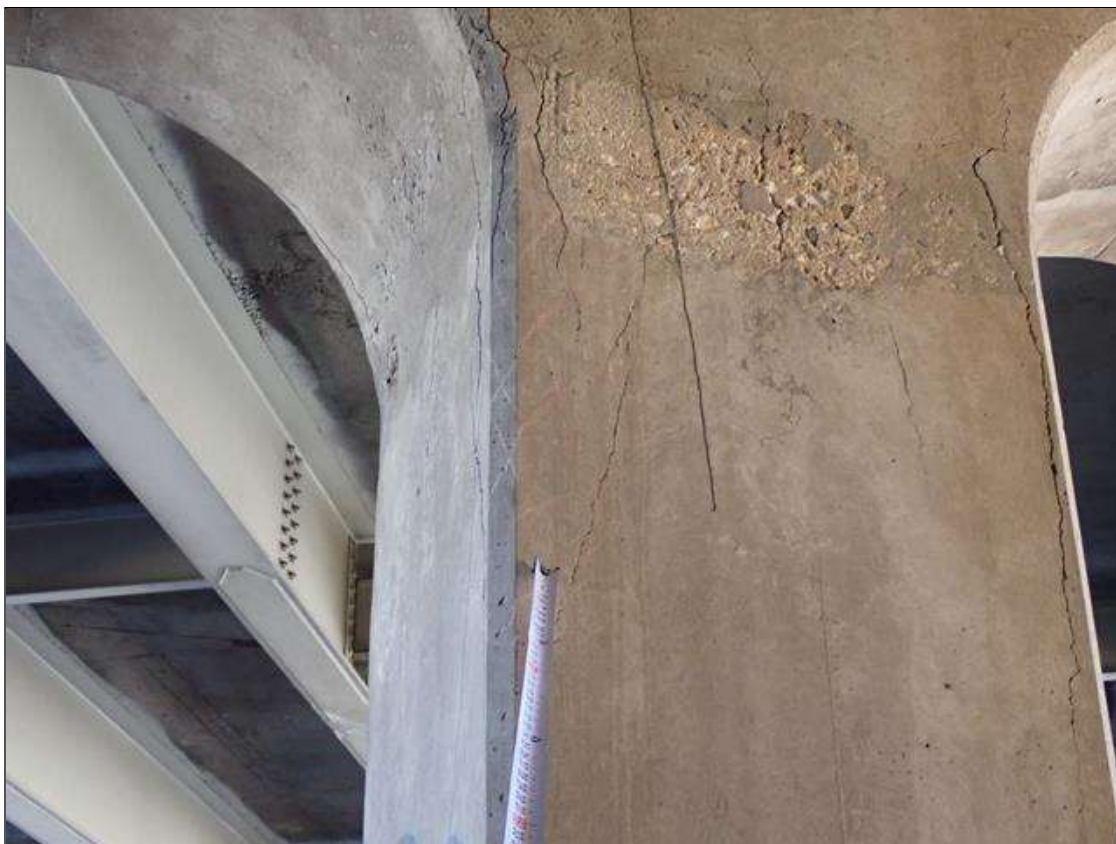
Bent 3 Pile 4: 3 foot high x 12 inch wide area of delamination and unsound concrete at northeast corner.

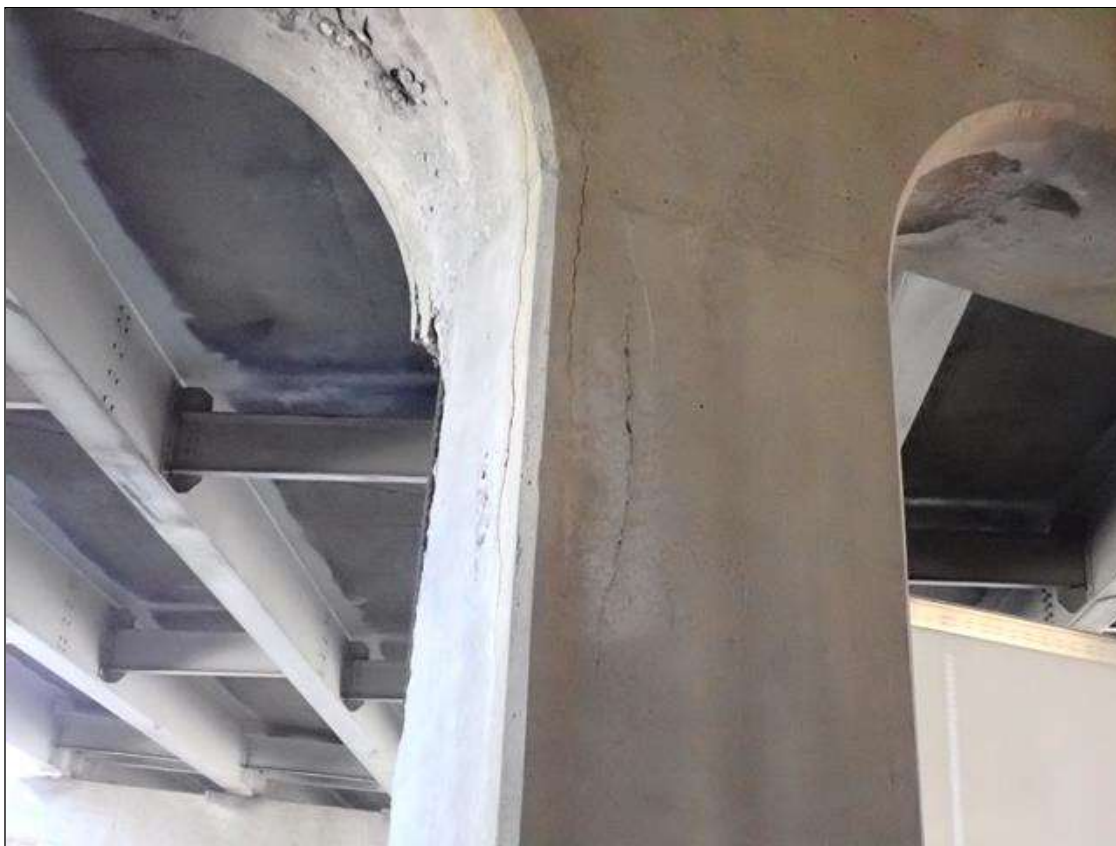
Bent 3 Pile 5: 4 foot high x 16 inch wide area of delamination/spall and unsound concrete at northeast corner.

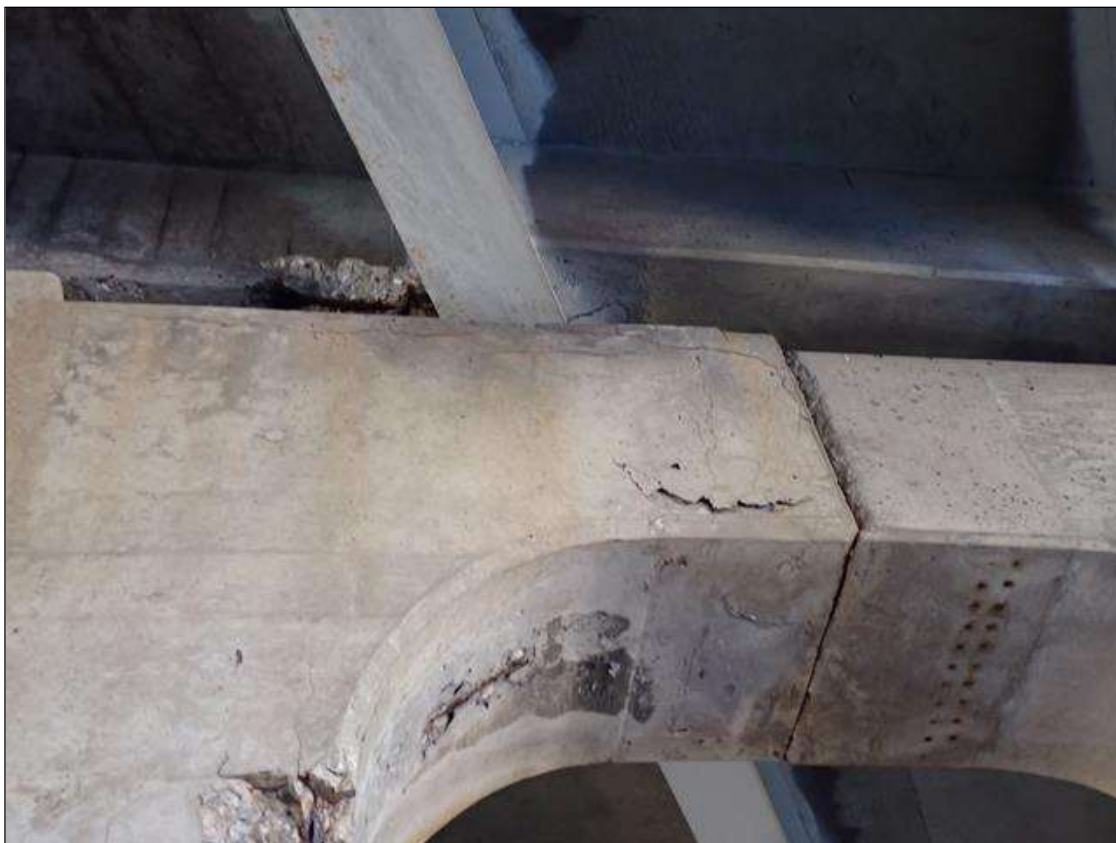
Bent 3 Cap 1: 5 foot x up to full height area of cracked delamination on south face of cap below beam 8

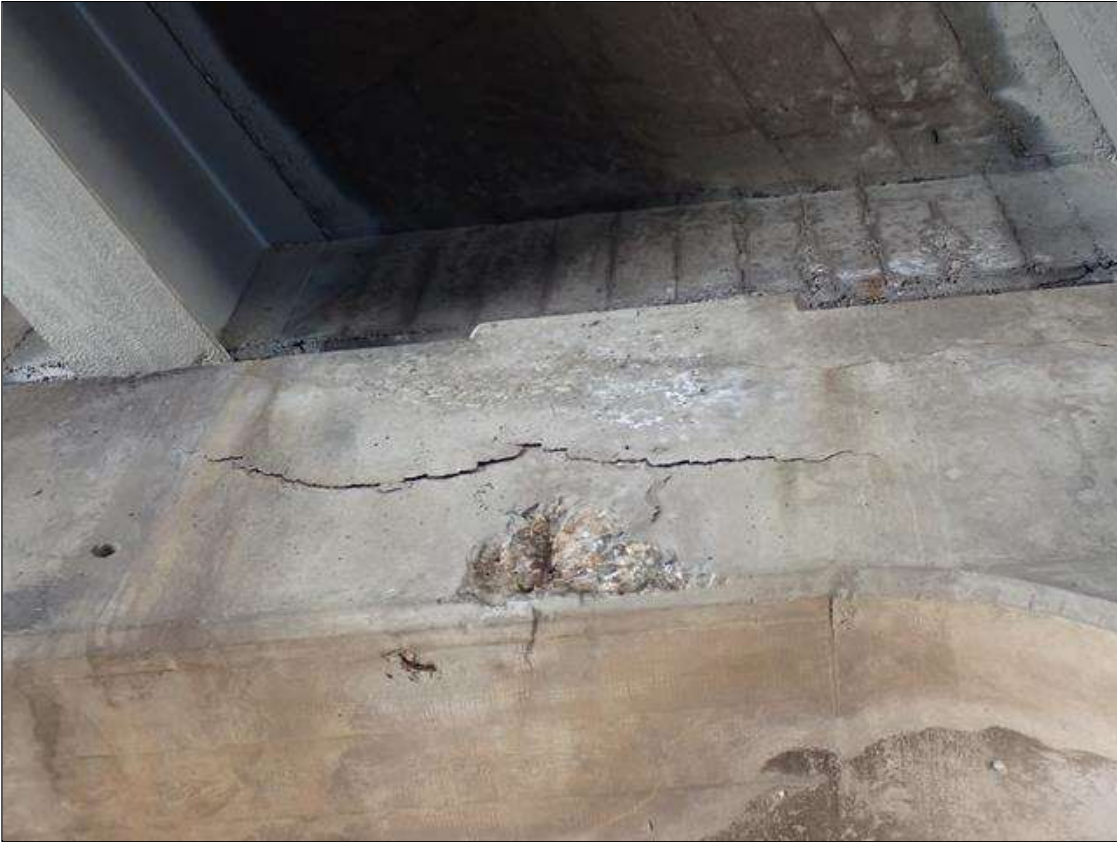
Bent 3 Cap 1: south face, in bays 4 and 5, multiple spalls/delaminations (up to 5 foot x 2 foot x 1.5 inch deep) with exposed rusted rebar

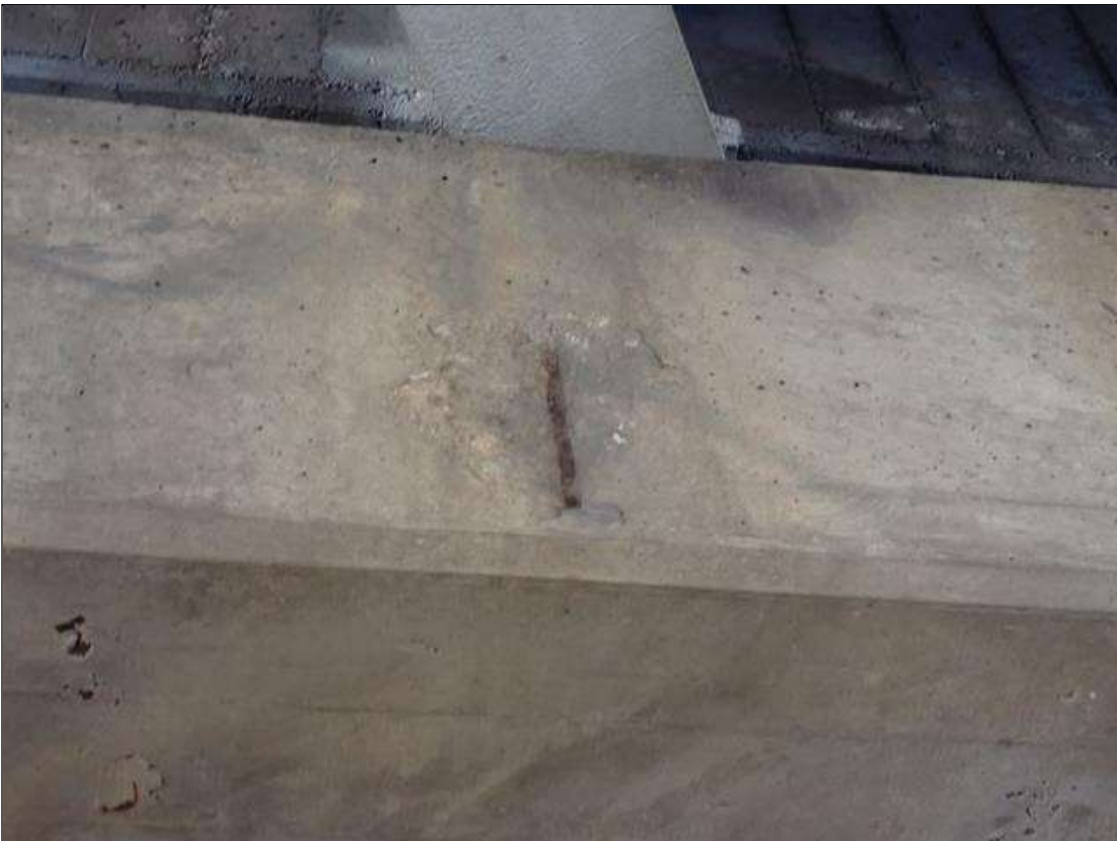
Bent 3 Cap 1: 12 inch high x 9 inch wide x 1.5 inch deep with exposed reinforcement under beam 7, south face. 90 percent section remaining in exposed reinforcement.

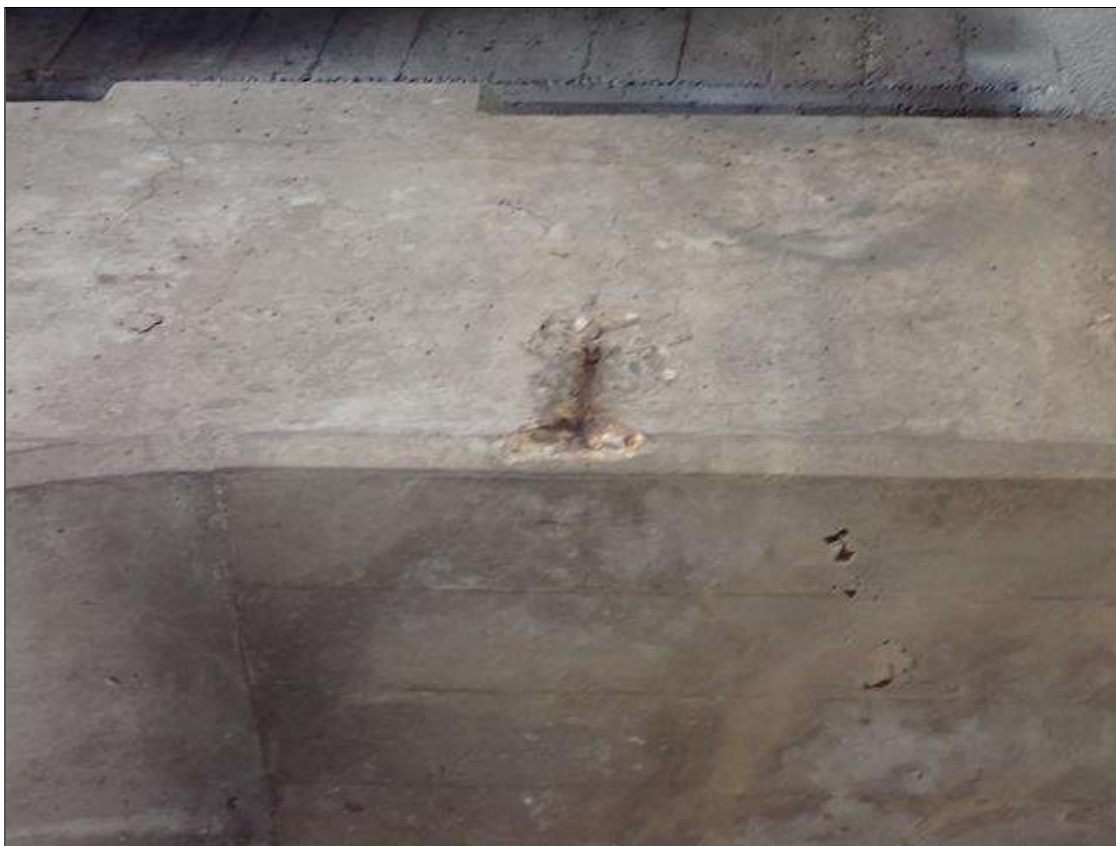
Bent 3 Cap 1: 10 inch x 5 inch x 1 inch deep spall with exposed reinforcement in south face between beams 6 and 7. 90 percent section remaining in exposed reinforcement.

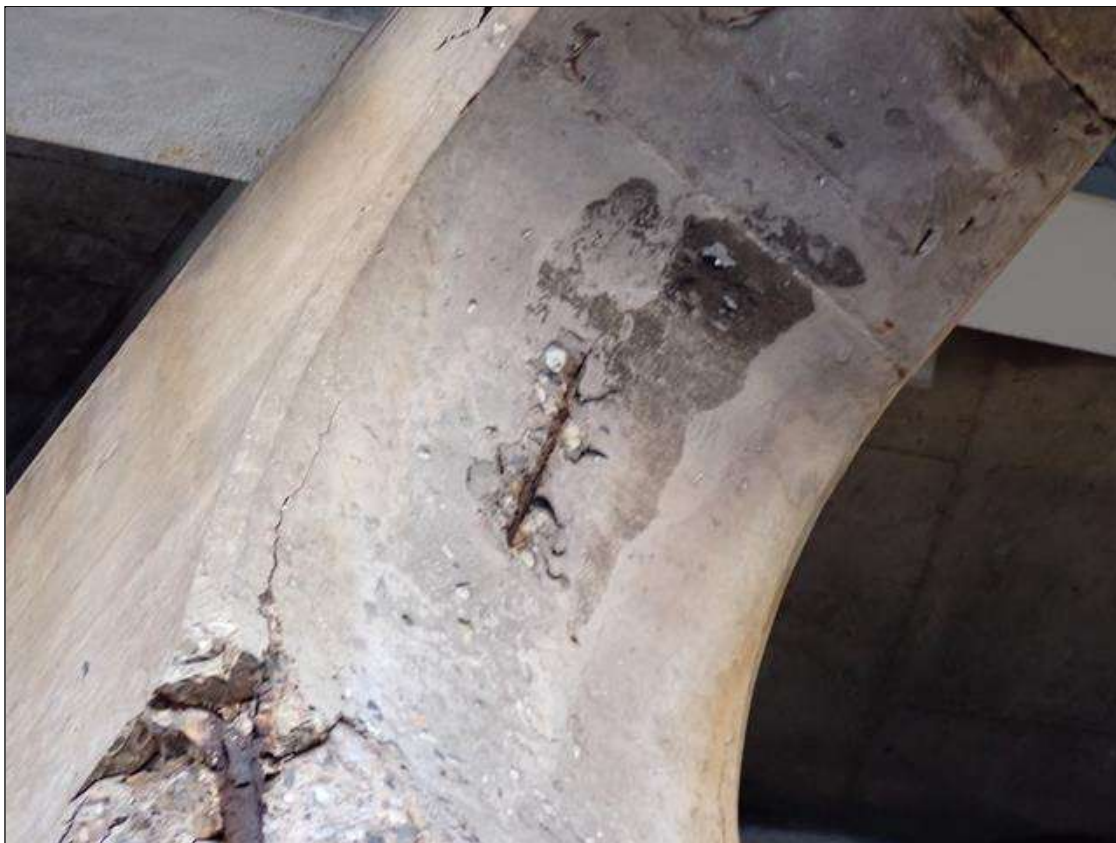
Bent 3 Cap 1: 12 inch x 4 inch x 1/2 inch deep spall with exposed reinforcement on east face of top radius at pile 5

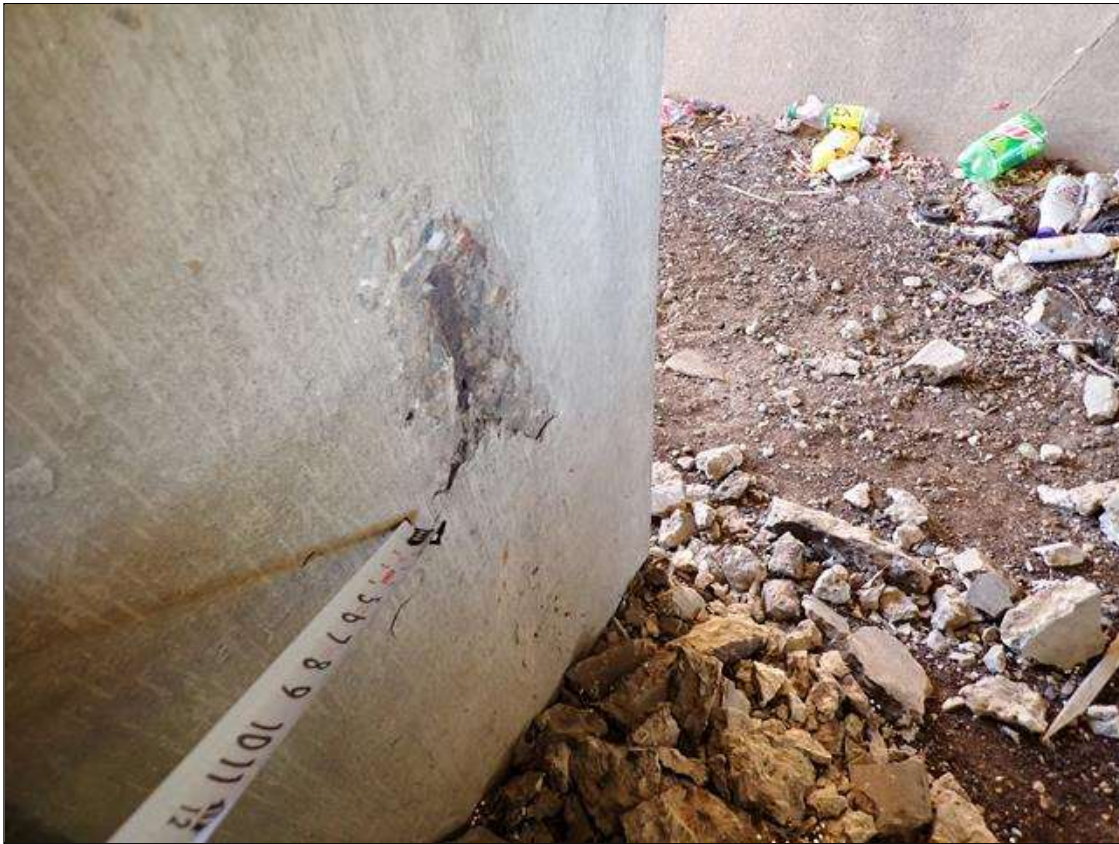
Bent 3 Pile 3: east face 12 inch high x 6 inch wide x 1 inch deep spall with exposed reinforcement

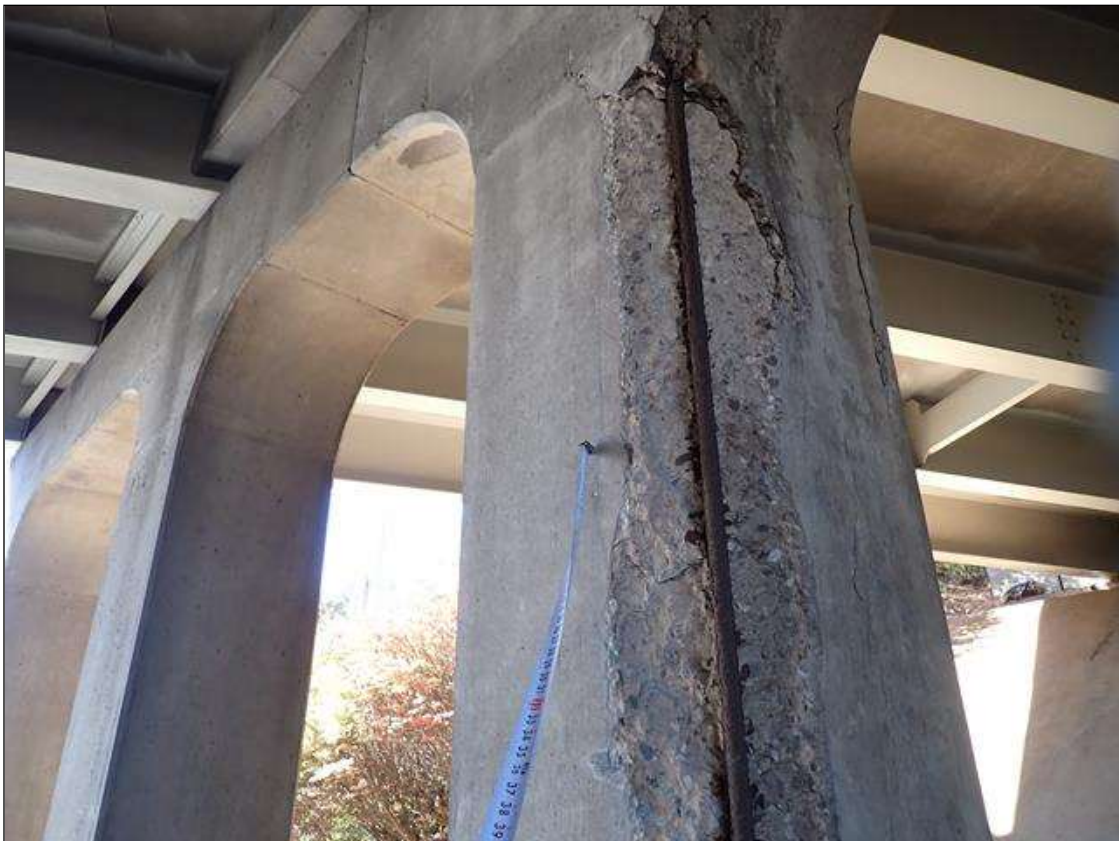
Bent 3 Pile 3: (PAR) Southeast corner above barrier rail, spall/delamination [10 foot high x up to full width x up to 4 inch deep] with primary debonded exposed rusted reinforcing 75 percent remaining

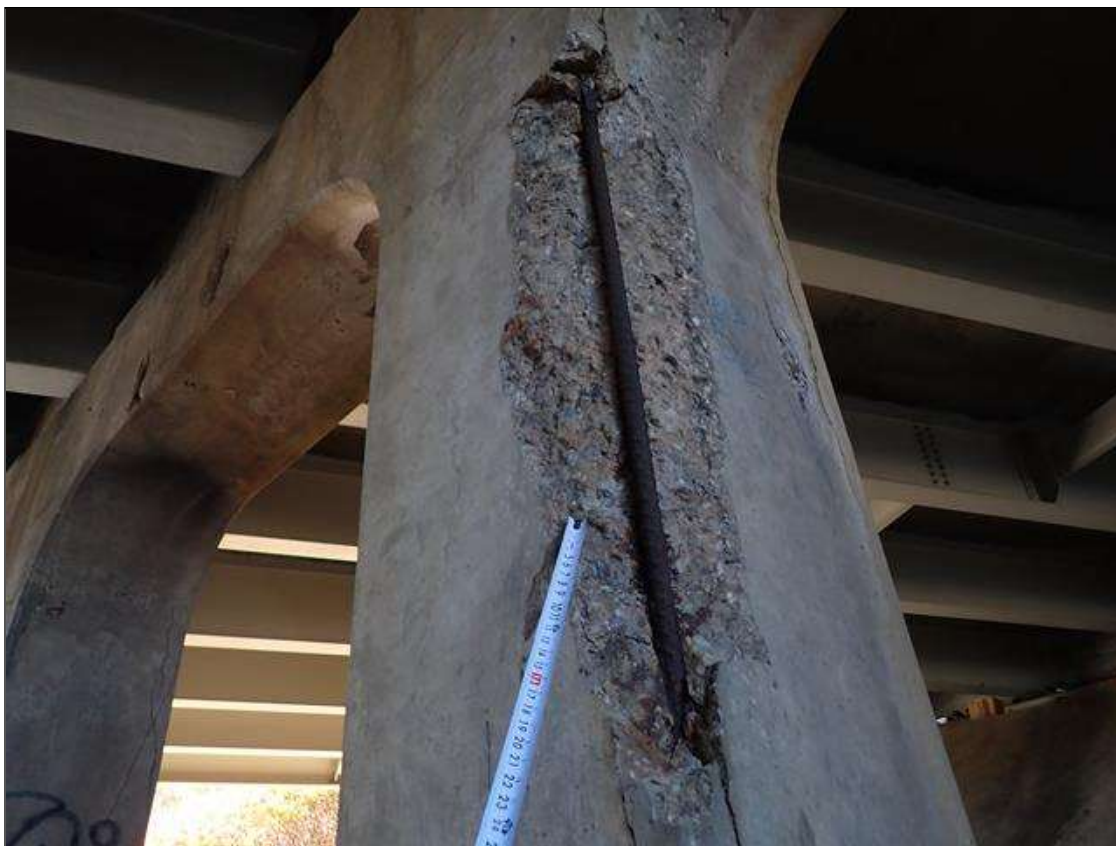
Bent 3 Pile 5: (PAR) 6.5 foot high x 20 inch wide x 3.5 inch deep spall and delaminated concrete with one debonded primary exposed reinforcement on south east corner of pile. 80 percent section remaining in exposed reinforcement.

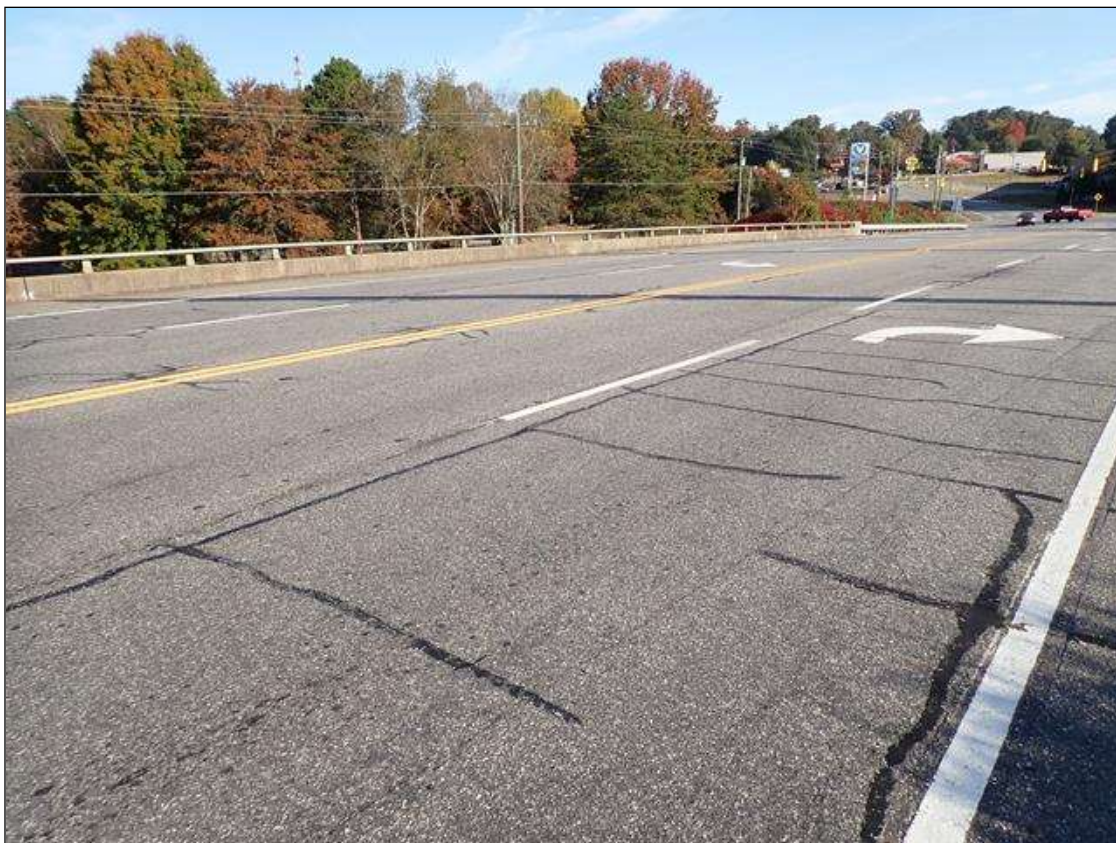
asphalt wearing surface
