NC DEPARTMENT OF TRANSPORTATION  
DIVISION OF HIGHWAYS  
STRUCTURE MANAGEMENT UNIT

## Structure Safety Report

### Routine Element Inspection - Contract

STRUCTURE NUMBER: 800343 SAP STRUCTURE NO: 0810343 FHWA STRUCTURE NO: 000000001610343  
DIVISION: 13 COUNTY: RUTHERFORD INSPECTION DATE: 02/04/2025 FREQUENCY: 24 MONTHS  
FACILITY CARRIED: SR1314 MILE POST: \_\_\_\_\_  
LOCATION: .01 MI.N.JCT.SR1306  
FEATURE INTERSECTED: BUFFALO CREEK  
LATITUDE: 35° 27' 34.99" LONGITUDE: 82° 11' 17.7"  
SUPERSTRUCTURE: PRESTRESSED CONCRETE CHANNELS (BMD-13)  
SUBSTRUCTURE: E.BTS&INT.BTS:PPC.CAPS/TIM.PILES;E.BT2&BT2 CONC.ENC.  
SPANS: 3 SPANS. SEE SPAN PROFILE SHEET FOR SPAN DETAILS  
☐ FRACTURE CRITICAL ☐ TEMPORARY SHORING ☐ SCOUR CRITICAL ☒ SCOUR PLAN OF ACTION  
GRADES: (Inspector/NBI Coding) DECK 6 / 6 SUPERSTRUCTURE 6 / 6 SUBSTRUCTURE 5 / 5 CULVERT N / N  
POSTED SV: 20 POSTED TTST: 23

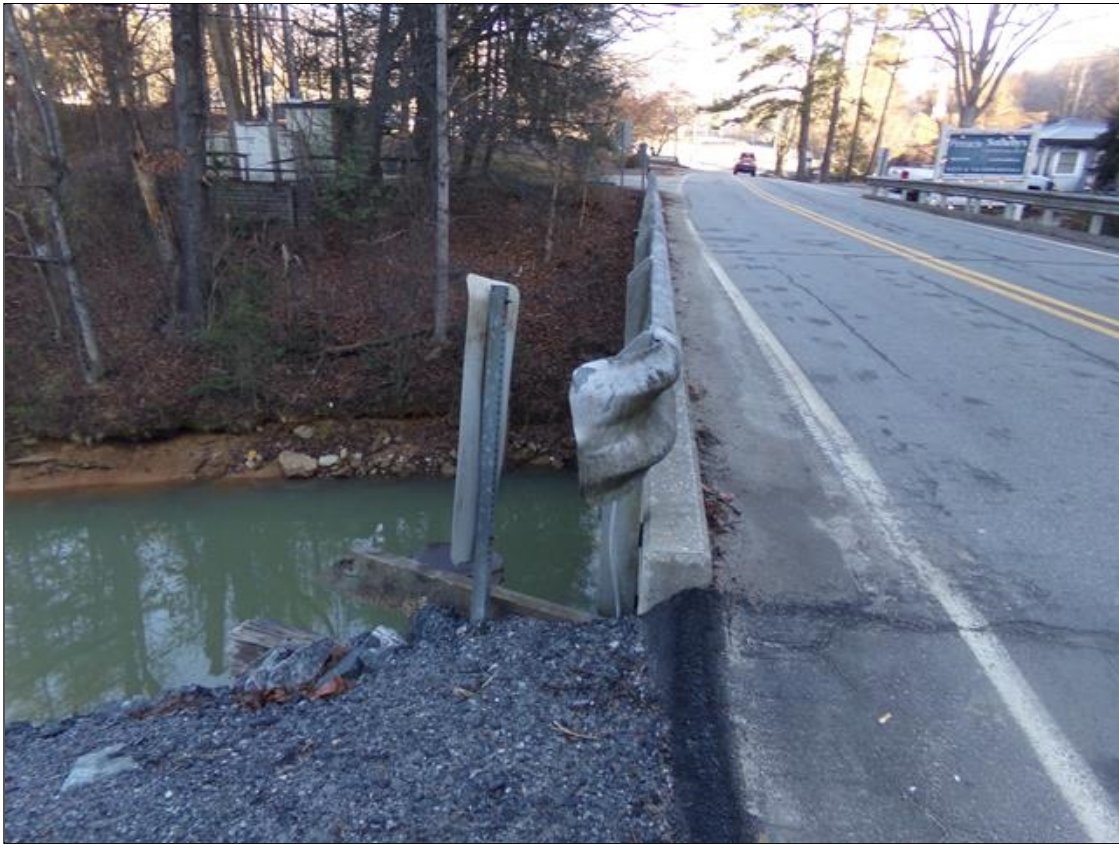
SOUTHWEST DELINEATOR - TWISTED, NOT VISIBLE FROM APPROACH (PAR)

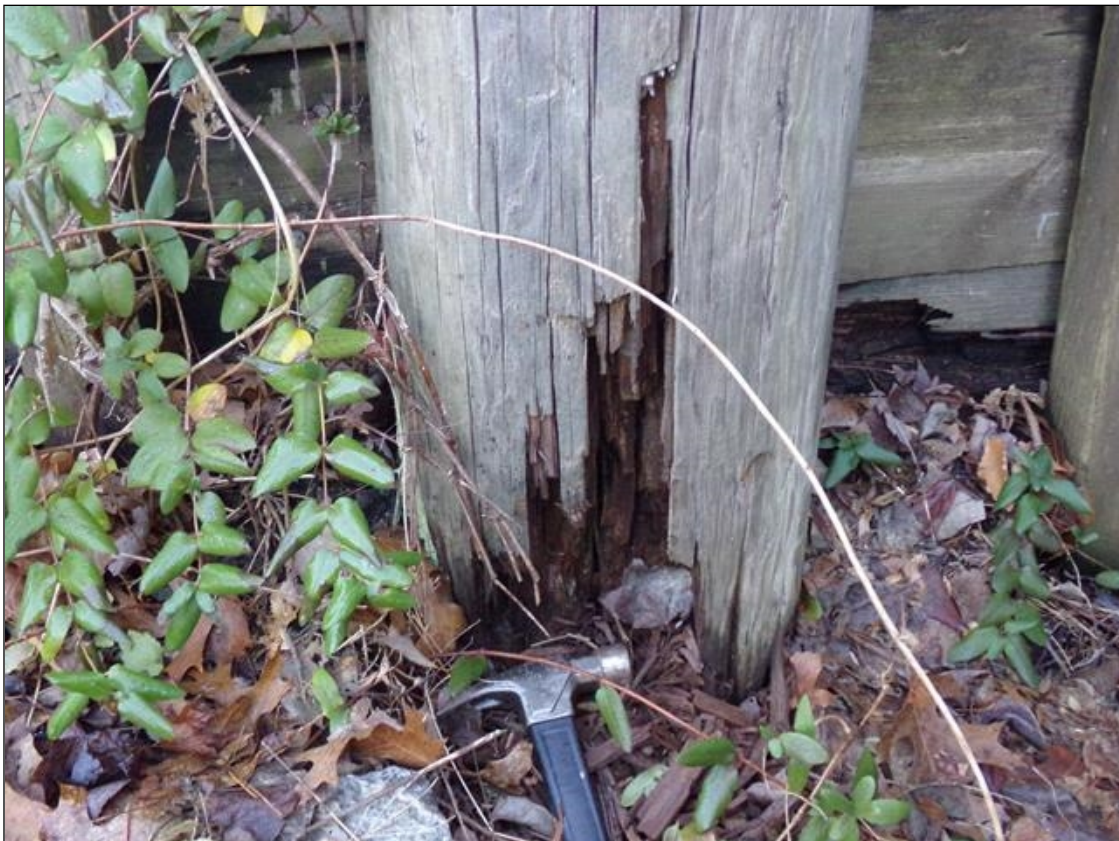
1 End Bent 1 Abutment: RIGHT SIDE EXTENSION SOLDIER PILE - DECAY (8 INCHES WIDE X 12 INCHES HIGH X UP TO 6 INCHES DEEP) AT GROUNDLINE (PAR)

END BENT 1 ABUTMENT - RIGHT SIDE EXTENSION SOLDIER PILE - DECAY (8 INCHES WIDE X 12 INCHES HIGH X UP TO 6 INCHES DEEP) AT GROUNDLINE (PAR)

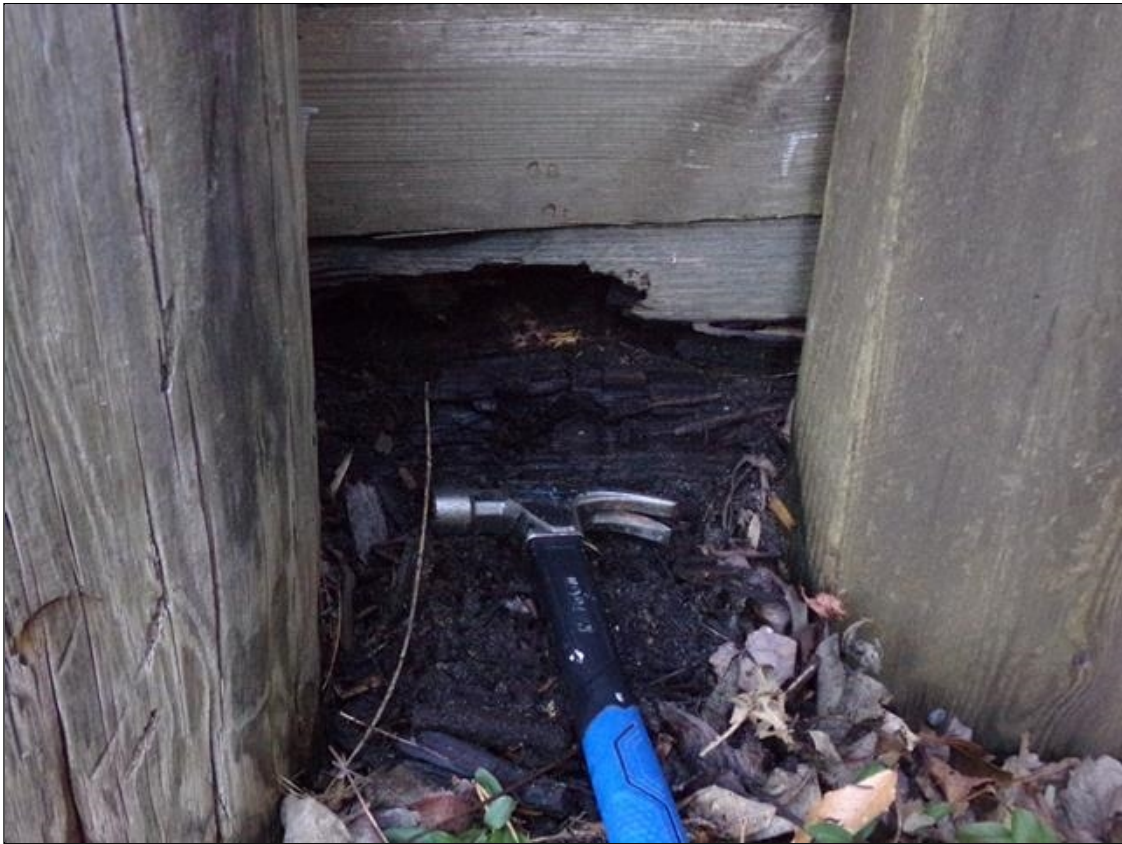
| 3346 | Abutment | Timber Abutment | | |
|---|---|---|---|--|
| 2 | Decay/Section Loss | 1 | End Bent 1 Abutment: DECAY (12 INCHES LONG X 8 INCHES HIGH X UP TO FULL DEPTH) TO RIGHT SIDE EXTENSION AT GROUNDLINE, ADJACENT TO SOLDIER PILE (PAR) | |

END BENT 1 ABUTMENT - DECAY (12 INCHES LONG X 8 INCHES HIGH X UP TO FULL DEPTH) TO RIGHT SIDE EXTENSION AT GROUNDLINE, ADJACENT TO SOLDIER PILE (PAR)

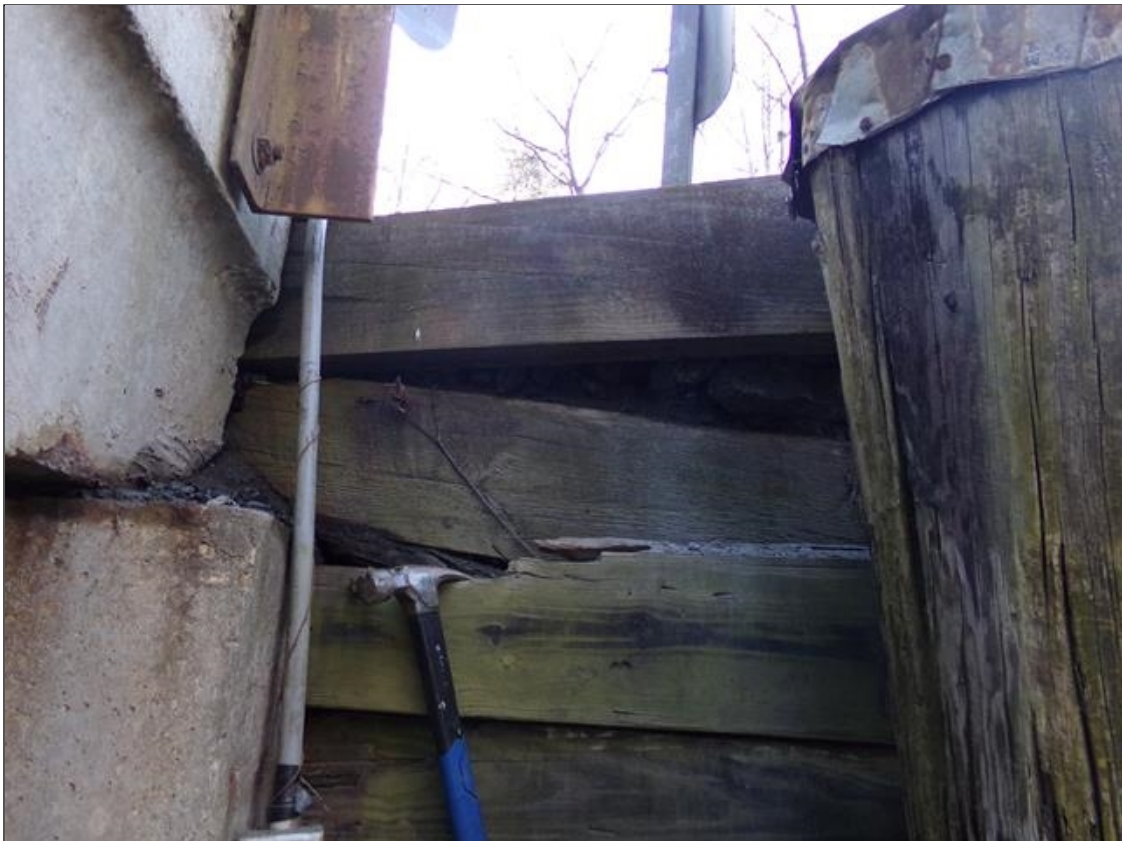
| 3346 | Abutment | Timber Abutment | | |
|---|---|---|---|--|
| 2 | Decay/Section Loss | 3 | End Bent 1 Abutment: X3 BOARDS LOOSE, NOT CONNECTED TO SOLDIER PILE AND ALLOWING SPILL-THROUGH AT TOP OF LEFT SIDE ABUTMENT | |

END BENT 1 ABUTMENT - X3 BOARDS LOOSE, NOT CONNECTED TO SOLDIER PILE AND ALLOWING SPILL-THROUGH AT TOP OF LEFT SIDE ABUTMENT EXTENSION (PAR)

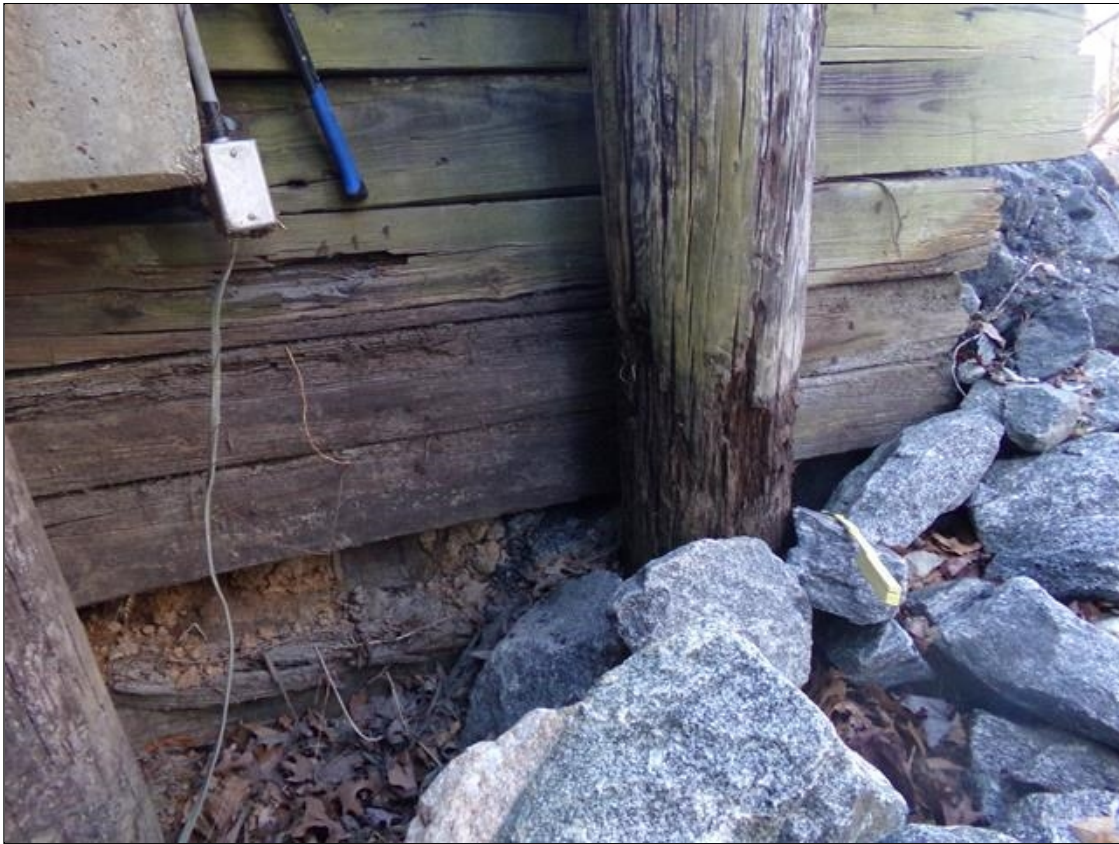
END BENT 1 ABUTMENT - LEFT SIDE EXTENSION - LAGGING UNDERMINED (10 INCHES HIGH X 6 FEET LONG) WITH SPILL-THROUGH (PAR)

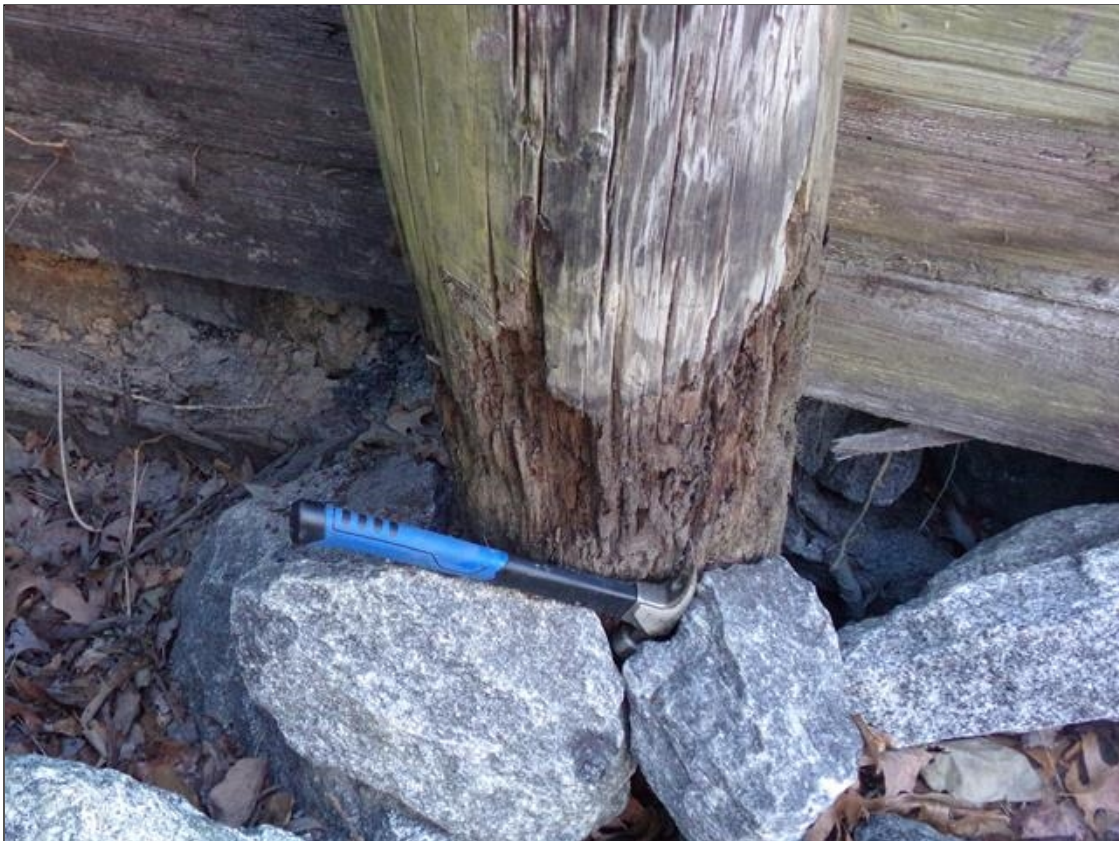
1 End Bent 1 Abutment: LEFT SIDE EXTENSION SOLDIER PILE - DECAY (UP TO 2 FEET HIGH X 1 INCH DEEP) AT GROUNDLINE AND HOLLOW WHEN SOUNDED (PAR)

END BENT 1 ABUTMENT - LEFT SIDE EXTENSION SOLDIER PILE - DECAY (UP TO 2 FEET HIGH X 1 INCH DEEP) AT GROUNDLINE AND HOLLOW WHEN SOUNDED (PAR)

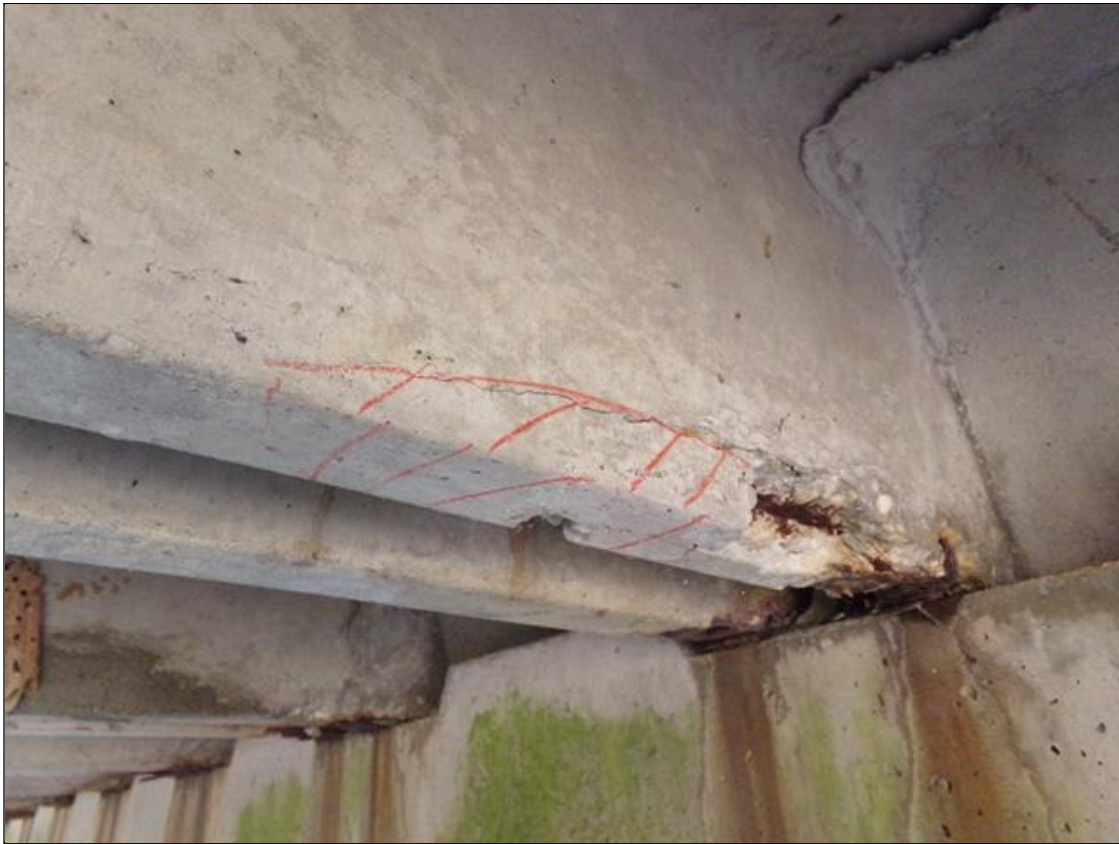
| 3306 | Slab 2 | Prestressed Concrete Channel | | |
|---|---|---|---|--|
| 2 | Delamination/Spall | 2 | Span 3 Slab 2: SPALLING / DELAMINATION (18 INCHES LONG X 4 INCHES WIDE X UP TO 2 INCHES DEEP) WITH EXPOSED PRESTRESSING (15 PERCENT SECTION LOSS) TO BOTTOM OF RIGHT LEG AT NEAR END (PAR) | |

SPAN 3 BEAM 2 - SPALLING / DELAMINATION (18 INCHES LONG X 4 INCHES WIDE X UP TO 2 INCHES DEEP) WITH EXPOSED PRESTRESSING (15 PERCENT SECTION LOSS) TO BOTTOM OF RIGHT LEG AT NEAR END (PAR)

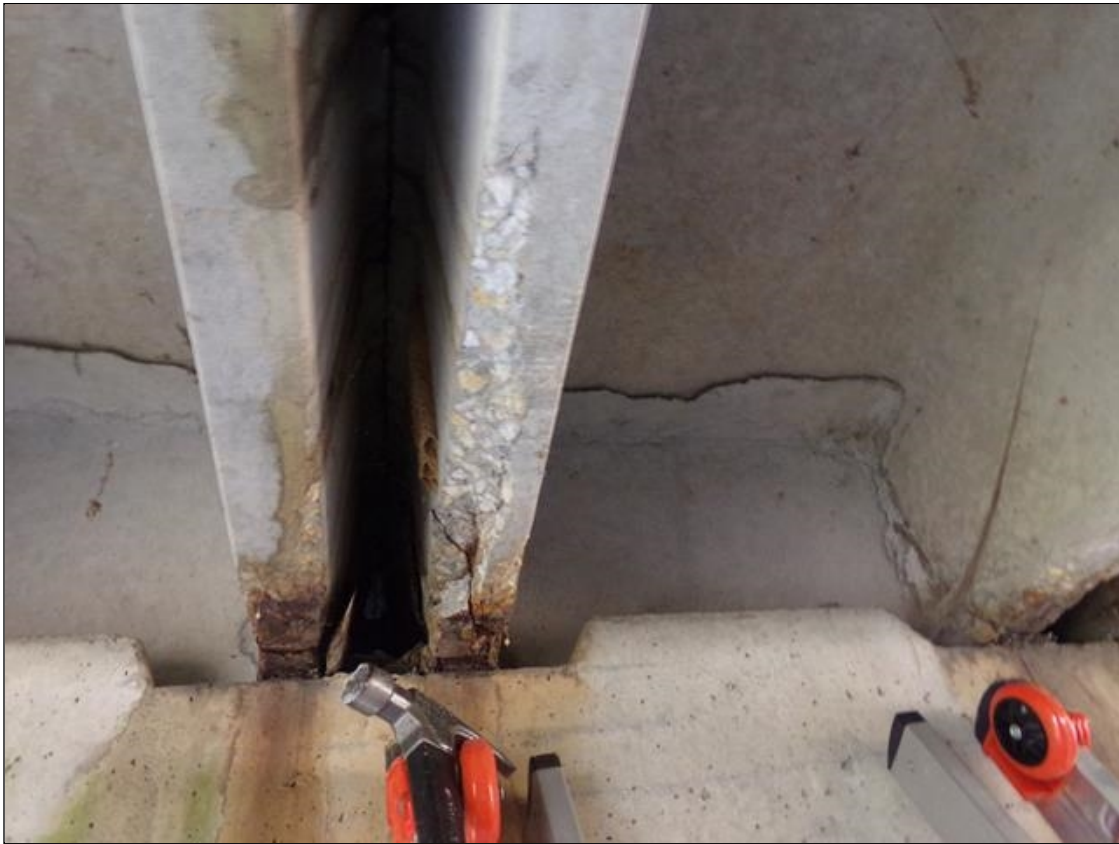
| 3306 | Slab 6 | Prestressed Concrete Channel | | |
|---|---|---|---|--|
| 2 | Delamination/Spall | 2 | Span 3 Slab 6: SPALL (20 INCHES LONG X UP TO 3 INCHES WIDE X 2 INCHES DEEP) WITH EXPOSED PRESTRESSING (NO SECTION LOSS) TO RIGHT LEG AT NEAR END (PAR) | |

SPAN 3 BEAM 6 - SPALL (20 INCHES LONG X UP TO 3 INCHES WIDE X 2 INCHES DEEP) WITH EXPOSED PRESTRESSING (NO SECTION LOSS) TO RIGHT LEG AT NEAR END (PAR)

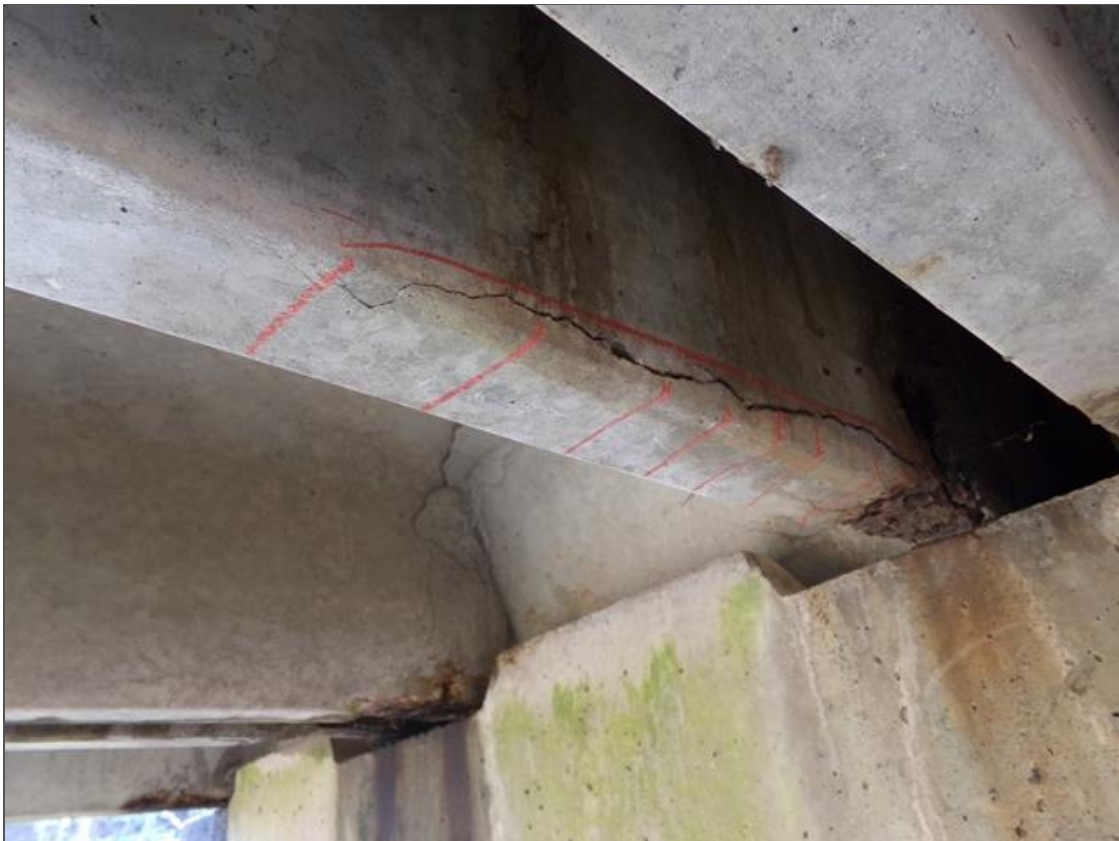
| 3306 | Slab 9 | Prestressed Concrete Channel | | |
|---|---|---|---|--|
| 2 | Delamination/Spall | 2 | Span 3 Slab 9: DELAMINATION (20 INCHES LONG X 3 INCHES WIDE X 2 INCHES HIGH) TO LEFT LEG AT NEAR END (PAR) | |

SPAN 3 BEAM 9 - DELAMINATION (20 INCHES LONG X 3 INCHES WIDE X 2 INCHES HIGH) TO LEFT LEG AT NEAR END (PAR)

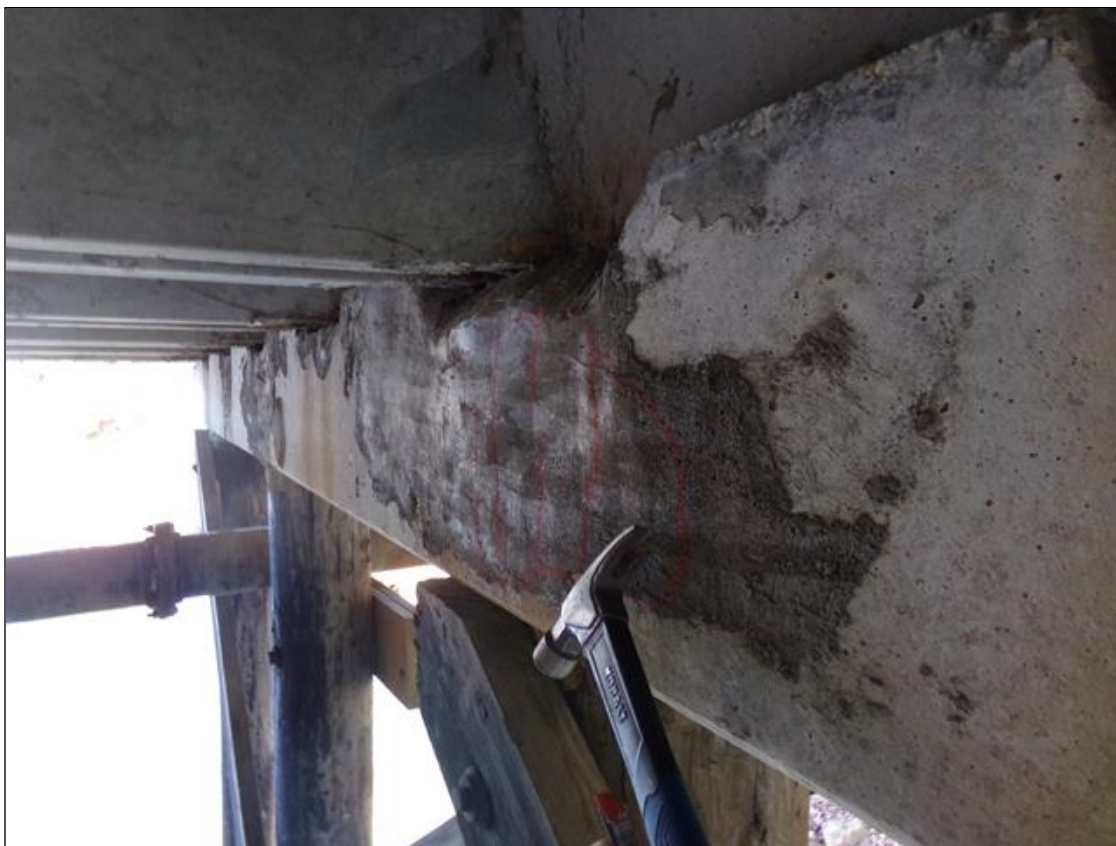
BENT 1 CAP - DELAMINATED PATCHING (3.5 SQUARE FEET) TO NEAR FACE BELOW BEAMS 5 AND 6 (PAR)

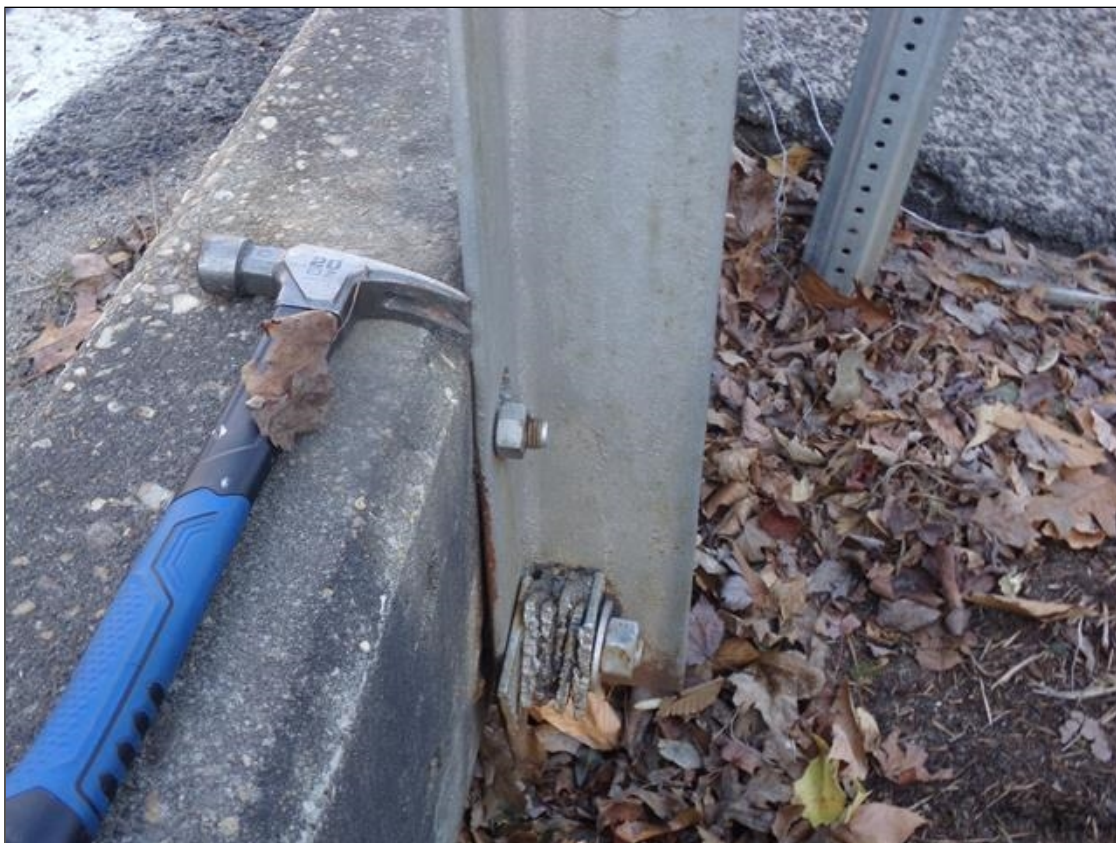
| 3322 | Right Bridge Rail | Steel Rail | | |
|---|---|---|---|--|
| 2 | Connection | 2 | Span 3 Right Bridge Rail: POST 5 AND 6 LOOSE / PARTIALLY DISCONNECTED FROM CURB (PAR) | |

SPAN 3 RIGHT RAIL - POST 5 AND 6 LOOSE / PARTIALLY DISCONNECTED FROM CURB (PAR)

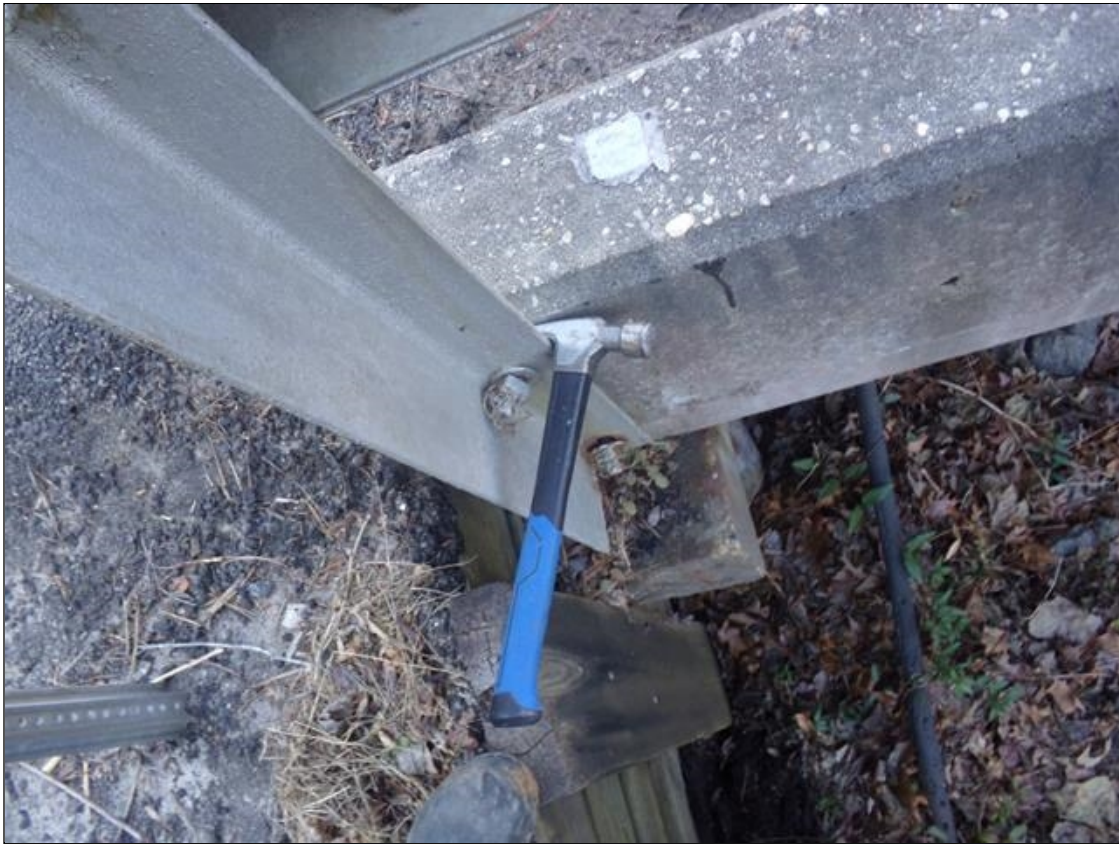
| 3322 | Right Bridge Rail | Steel Rail | | |
|---|---|---|---|--|
| 2 | Connection | 2 | Span 1 Right Bridge Rail: POST 1 AND 2 LOOSE / PARTIALLY DISCONNECTED FROM CURB (PAR) | |

SPAN 1 RIGHT RAIL - POST 1 AND 2 LOOSE / PARTIALLY DISCONNECTED FROM CURB (PAR)

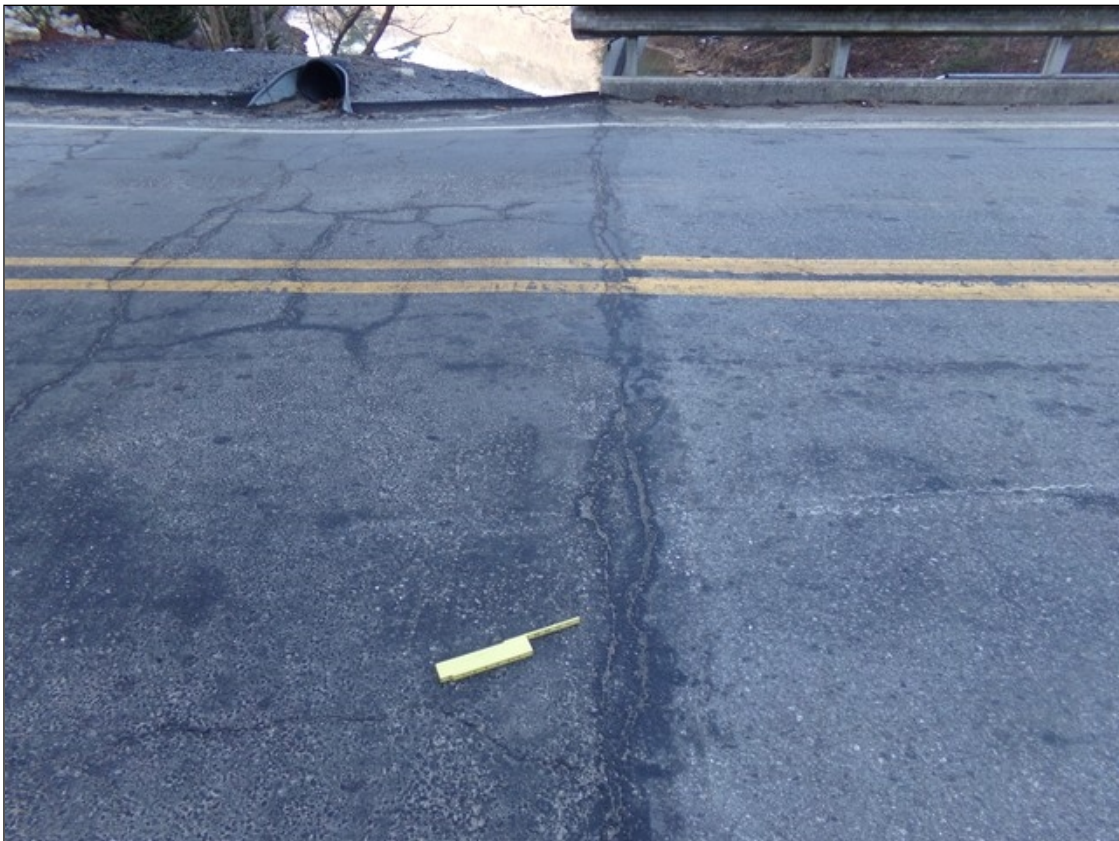
| Element Number | Defect Type | Defect Description | CS | CS Qty | Maint Qty | |
|---|---|---|---|---|---|---|
| <input checked="" type="checkbox"/> 510 | Crack (Wearing Surface) | TRANSVERSE OPEN CRACKING (1/2 INCH X FULL WIDTH) OVER END BENT 1 | 3 | 25 | 25 | Square Feet |

TYPICAL TRANSVERSE OPEN CRACKING (1/2 INCH X FULL WIDTH) TO ASPHALT WEARING SURFACE OVER END BENTS, OVER END BENT 1

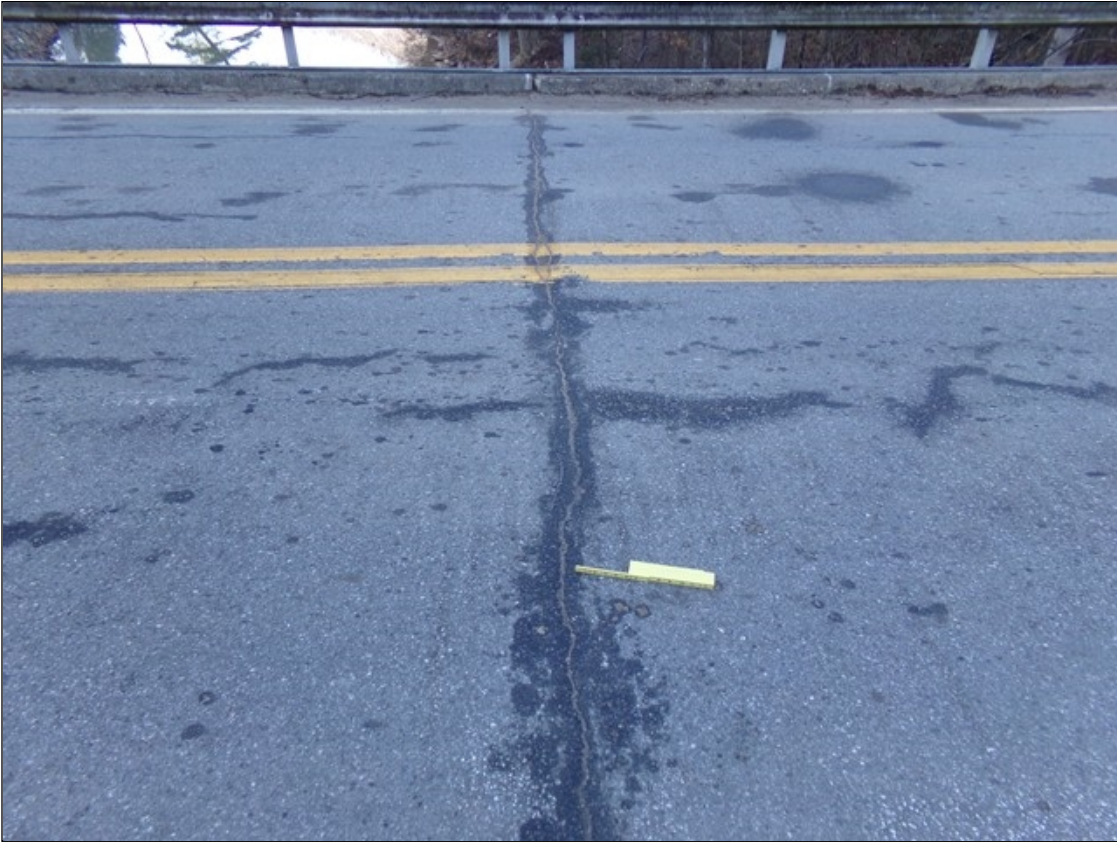
| Element Number | Element Name | Total Qty | CS1 Qty | CS2 Qty | CS3 Qty | CS4 Qty | |
|---|---|---|---|---|---|---|---|
| <input checked="" type="checkbox"/> 510 | Crack (Wearing Surface) | TRANSVERSE OPEN CRACKING (1/2 INCH X FULL WIDTH) TO ASPHALT WEARING SURFACE OVER BENT 1 | 3 | 25 | 25 | | Square Feet |

TYPICAL OPEN CRACKING (1/2 INCH X FULL WIDTH) TO ASPHALT WEARING SURFACE OVER INTERIOR BENTS, OVER BENT 1

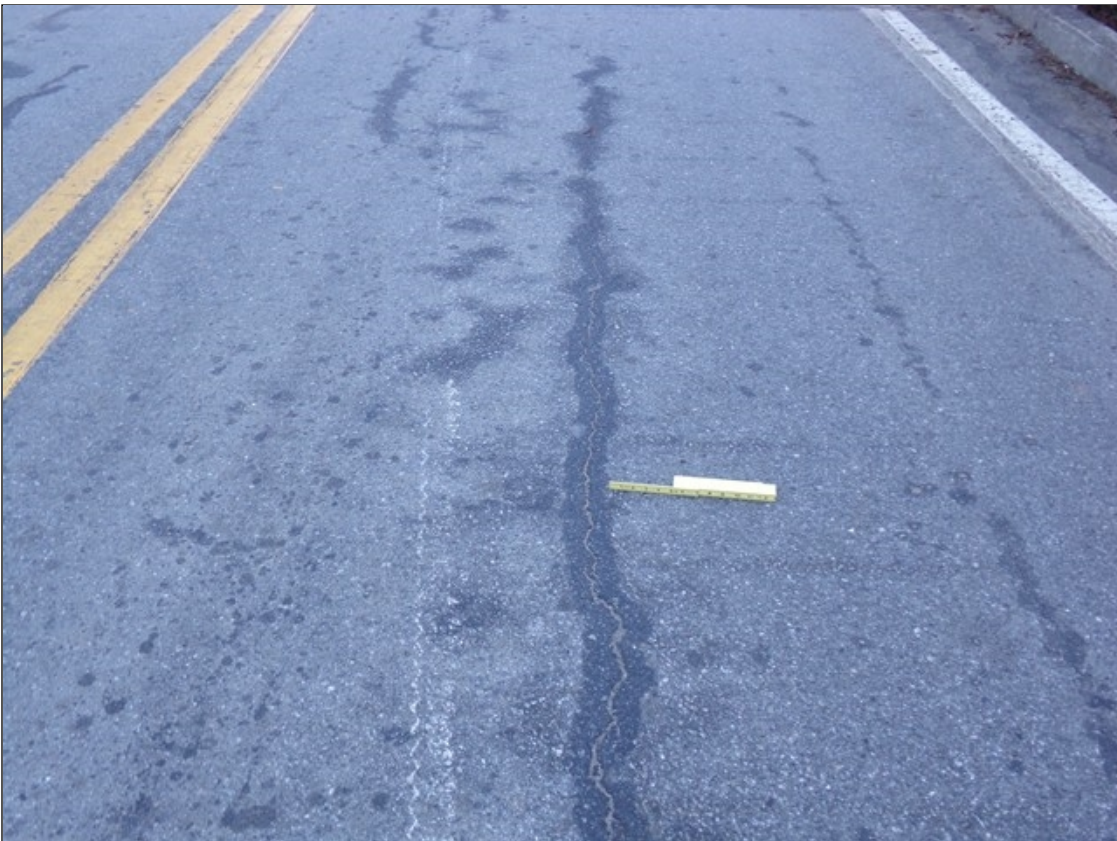
| Element Number | Defect Type | Defect Description | CS | CS Qty | Maint Qty | |
|---|---|---|---|---|---|---|
| <input checked="" type="checkbox"/> 510 | Crack (Wearing Surface) | INTERMITTENT OPEN CRACKING (1/4 INCH X UP TO FULL LENGTH) THROUGHOUT | 3 | 100 | 100 | Square Feet |

TYPICAL INTERMITTENT OPEN CRACKING (1/4 INCH X UP TO FULL LENGTH) THROUGHOUT ASPHALT WEARING SURFACE, SPAN 1 NORTHBOUND LANE

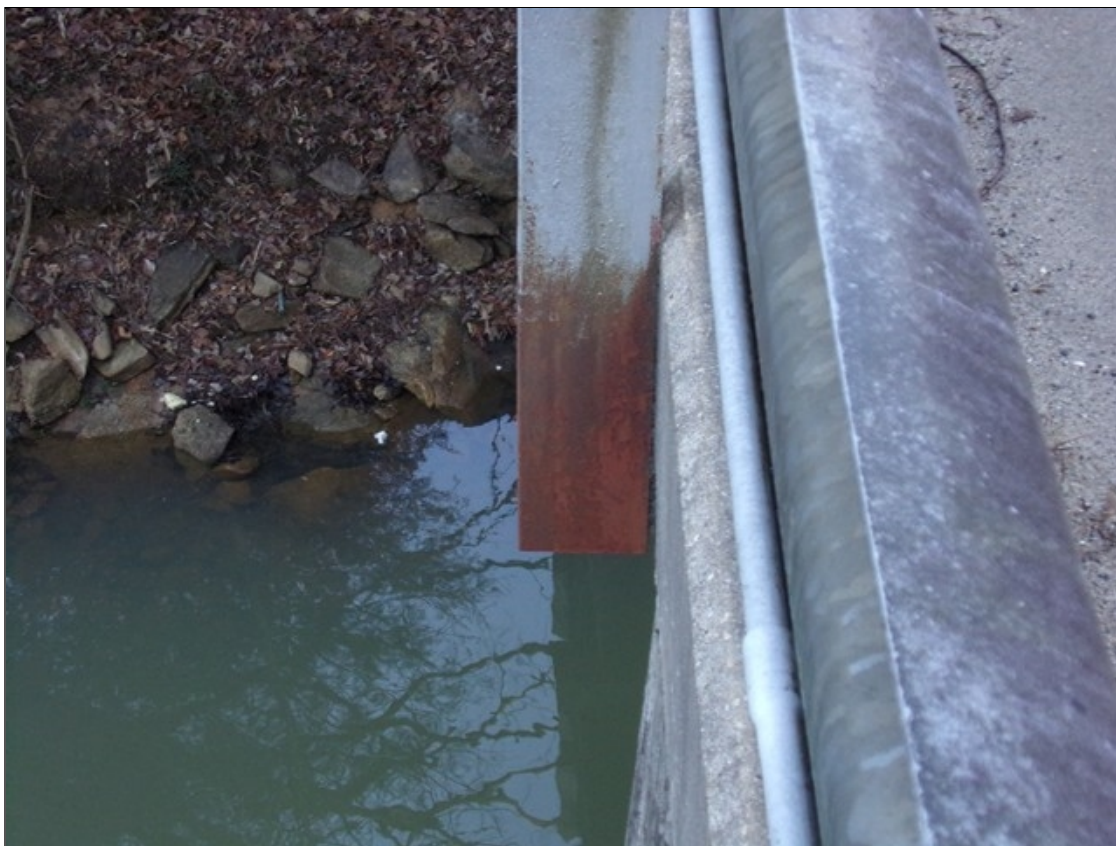
| Element Number | Defect Type | Defect Description | CS | CS Qty | Maint Qty | |
|---|---|---|---|---|---|---|
| <input checked="" type="checkbox"/> 330 | Corrosion | MODERATE SURFACE CORROSION THROUGHOUT RAIL POSTS | 2 | 6 | | Square Feet |

TYPICAL MODERATE SURFACE CORROSION AT RAIL POSTS, SPAN 1 POST 5

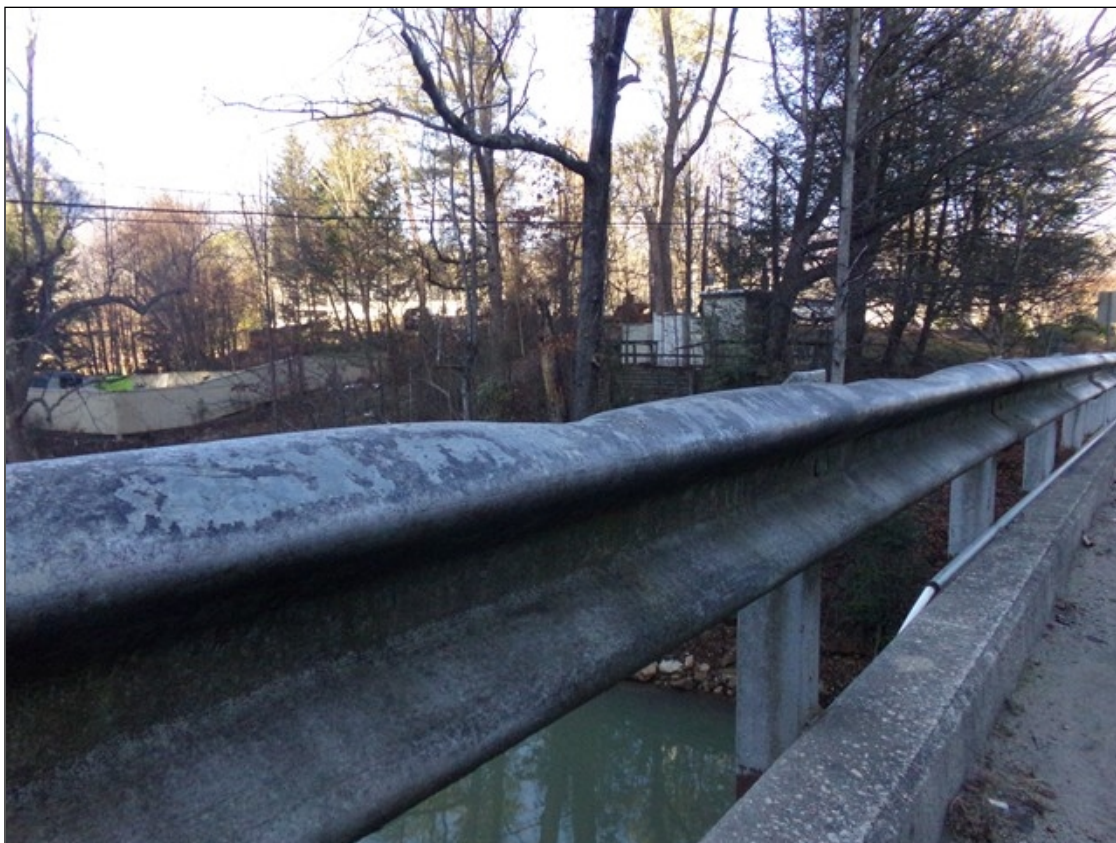
| Element Number | Defect Type | Defect Description | CS | CS Qty | Maint Qty | |
|---|---|---|---|---|---|---|
| <input checked="" type="checkbox"/> 330 | Damage | TOP OF RAIL BETWEEN POSTS 1 AND 3 HAS (3) DAMAGED AREAS UP TO 15 INCH LONG X 1 1/2 INCH WIDE WITH 1/2 INCH DOWNWARD BEND | 2 | 3 | | Feet |

TYPICAL MINOR IMPACT DAMAGE (UP TO 15 INCHES LONG X 1.5 INCHES HIGH) THROUGHOUT TOP OF RAIL, SPAN 1 LEFT RAIL

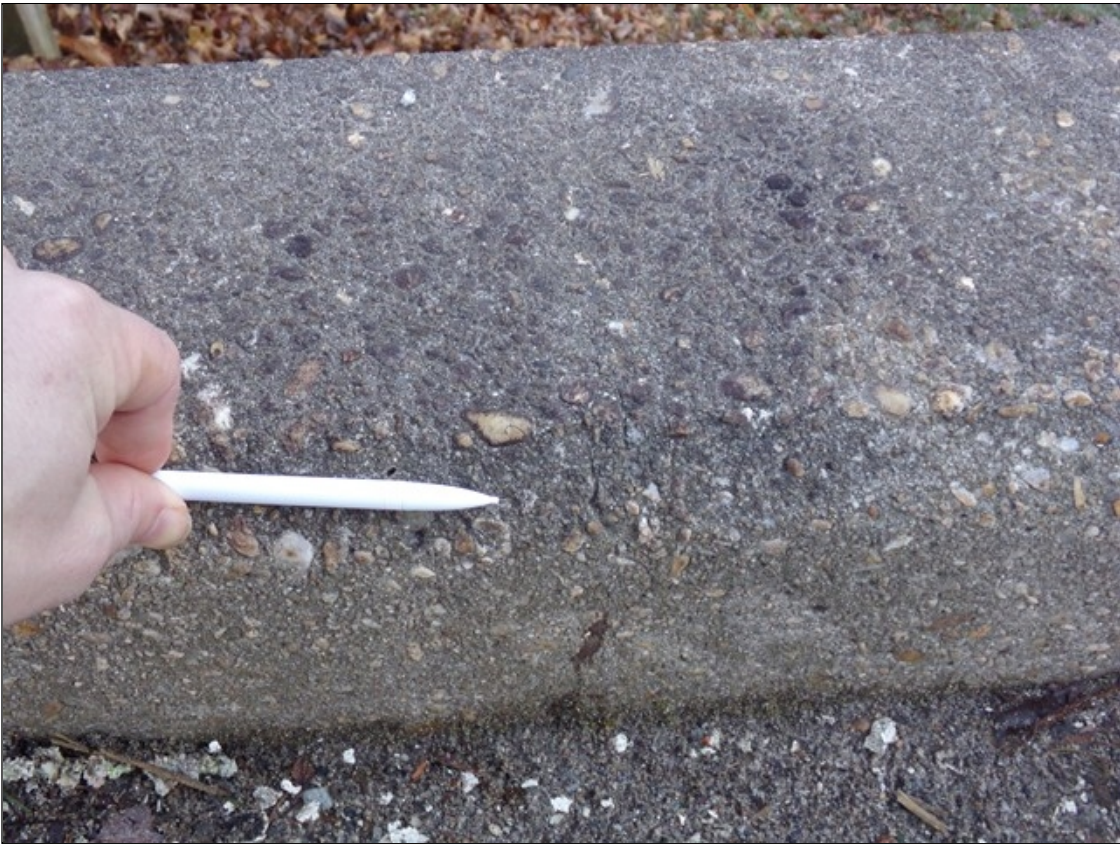
TYPICAL INTERMITTENT VERTICAL 1/32 INCH CRACKING (UP TO FULL HEIGHT) THROUGHOUT CONCRETE RAIL CURBS, SPAN 2 RIGHT RAIL

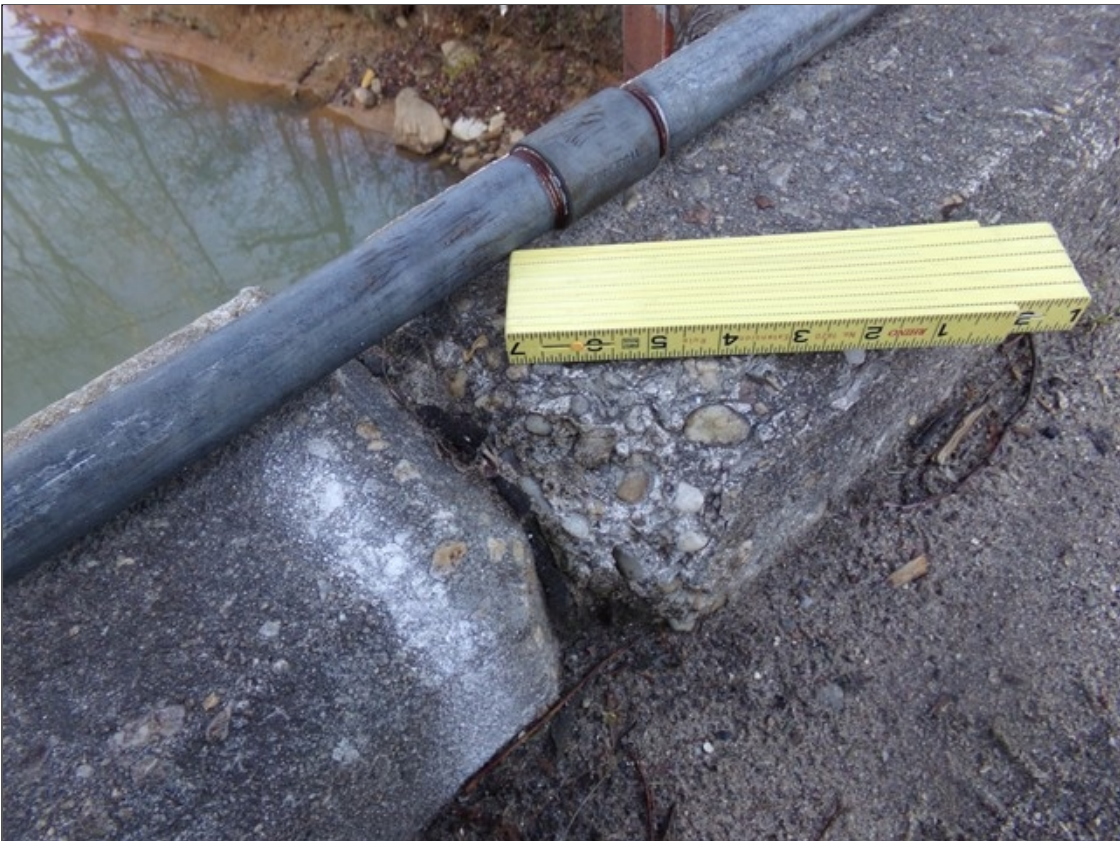
| Element Number | Element Name | Total Qty | CS1 Qty | CS2 Qty | CS3 Qty | CS4 Qty | |
|---|---|---|---|---|---|---|---|
| <input checked="" type="checkbox"/> 330 | Distortion | SPALL (6 INCHES X 4 INCHES X 3/4 INCH DEEP) WITH NO EXPOSED REBAR TO CONCRETE CURB AT NEAR END | 2 | 1 | | | Feet |

SPAN 2 LEFT RAIL - SPALL (6 INCHES X 4 INCHES X 3/4 INCH DEEP) WITH NO EXPOSED REBAR TO CONCRETE CURB AT NEAR END

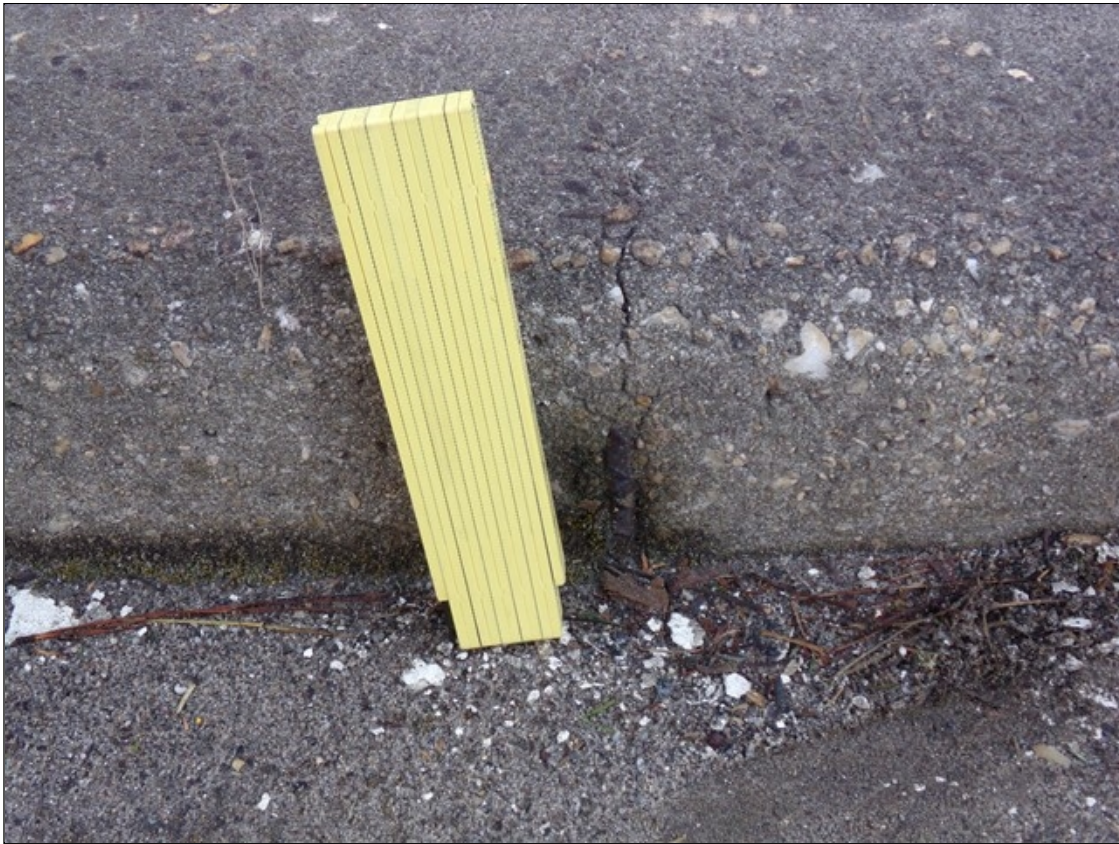
SPAN 3 RIGHT RAIL - EXPOSED REBAR (3 INCHES LONG) WITH NO SECTION LOSS TO INSIDE FACE OF CONCRETE CURB AT MIDSPAN

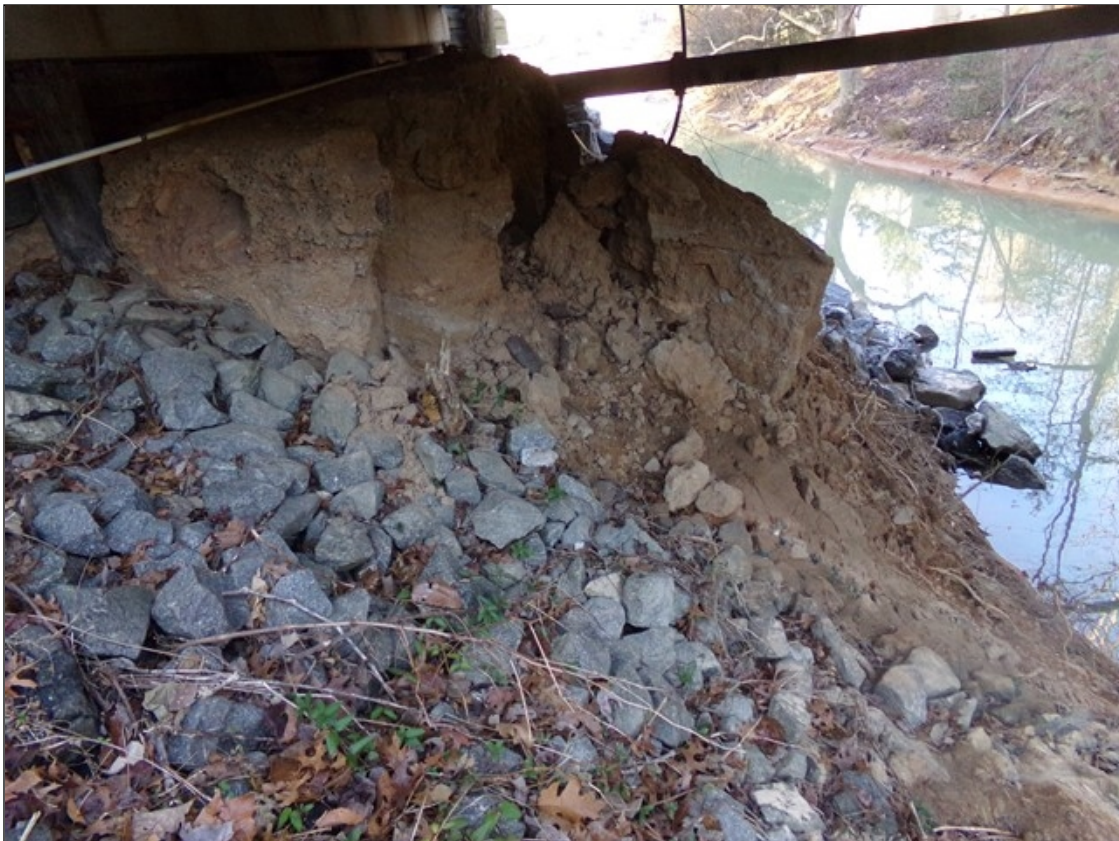
EROSION (20 FEET LONG X 10 FEET WIDE X 4 FEET HIGH) AND SOIL SEPARATION TO SLOPE BELOW SPAN 1

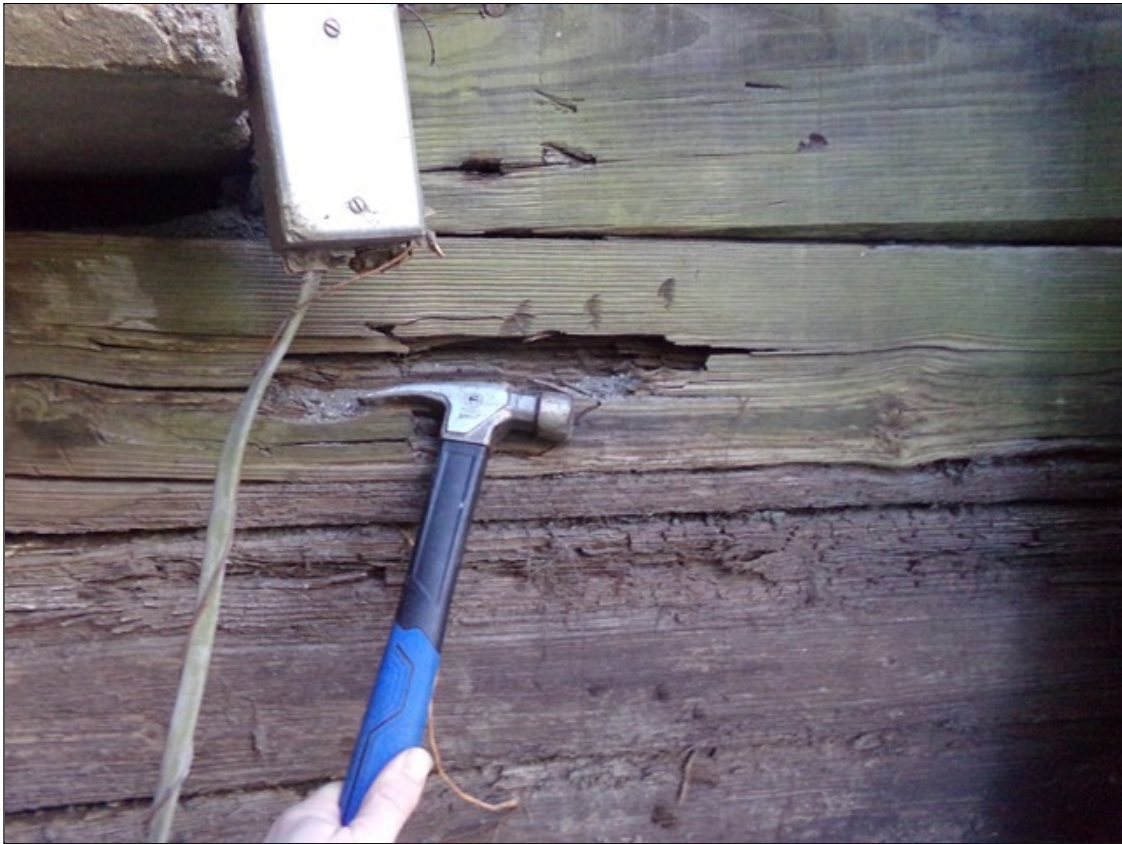
END BENT 1 ABUTMENT - INTERMITTENT MINOR DECAY (UP TO 1 INCH DEEP) AND SURFACE DECAY TO LAGGING THROUGHOUT LEFT SIDE EXTENSION (6 SQUARE FEET)
