NC DEPARTMENT OF TRANSPORTATION  
DIVISION OF HIGHWAYS  
STRUCTURE MANAGEMENT UNIT

## Structure Safety Report

### Routine Element Inspection - Contract

STRUCTURE NUMBER: 800343 SAP STRUCTURE NO: 0810343 FHWA STRUCTURE NO: 000000001610343  
DIVISION: 13 COUNTY: RUTHERFORD INSPECTION DATE: 02/04/2025 FREQUENCY: 24 MONTHS  
FACILITY CARRIED: SR1314 MILE POST: \_\_\_\_\_  
LOCATION: .01 MI.N.JCT.SR1306  
FEATURE INTERSECTED: BUFFALO CREEK  
LATITUDE: 35° 27' 34.99" LONGITUDE: 82° 11' 17.7"  
SUPERSTRUCTURE: PRESTRESSED CONCRETE CHANNELS (BMD-13)  
SUBSTRUCTURE: E.BTS&INT.BTS:PPC.CAPS/TIM.PILES;E.BT2&BT2 CONC.ENC.  
SPANS: 3 SPANS. SEE SPAN PROFILE SHEET FOR SPAN DETAILS  
☐ FRACTURE CRITICAL ☐ TEMPORARY SHORING ☐ SCOUR CRITICAL ☒ SCOUR PLAN OF ACTION  
GRADES: (Inspector/NBI Coding) DECK 6 / 6 SUPERSTRUCTURE 6 / 6 SUBSTRUCTURE 5 / 5 CULVERT N / N  
POSTED SV: 20 POSTED TTST: 23

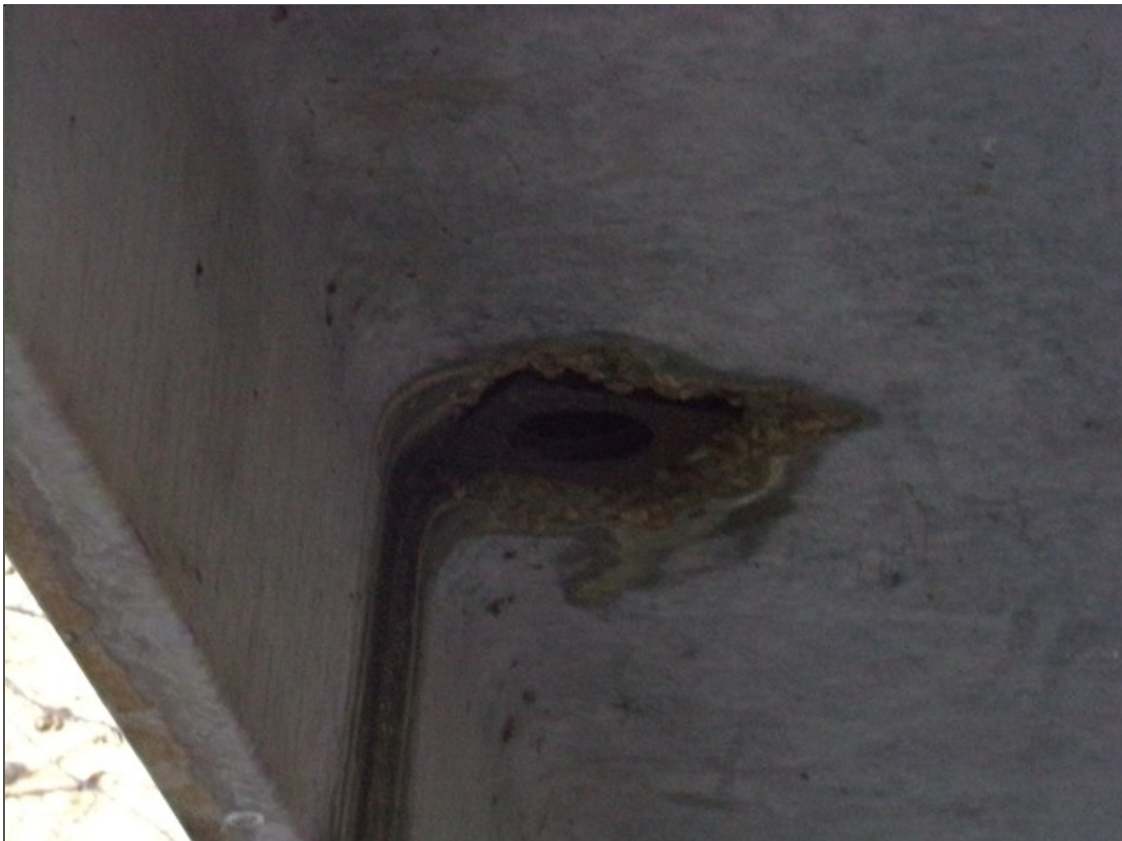
| Element Number | Defect Type | Defect Description | CS | CS Qty | Maint Qty | |
|---|---|---|---|---|---|---|
| <input checked="" type="checkbox"/> 15 | Delamination/Spall | ALONG UNDERSIDE AT DECK DRAINS, MULTIPLE SPALLS (UP TO 16 INCH X 10 INCH X UP TO 1/2 INCH DEEP) WITH NO EXPOSED REBAR | 3 | 5 | 5 | Square Feet |

TYPICAL SPALLING (UP TO 16 INCHES X 10 INCHES X 1/2 INCH DEEP) WITH NO EXPOSED REBAR AT UNDERSIDE OF DECK DRAINS, SPAN 1 BEAM 1

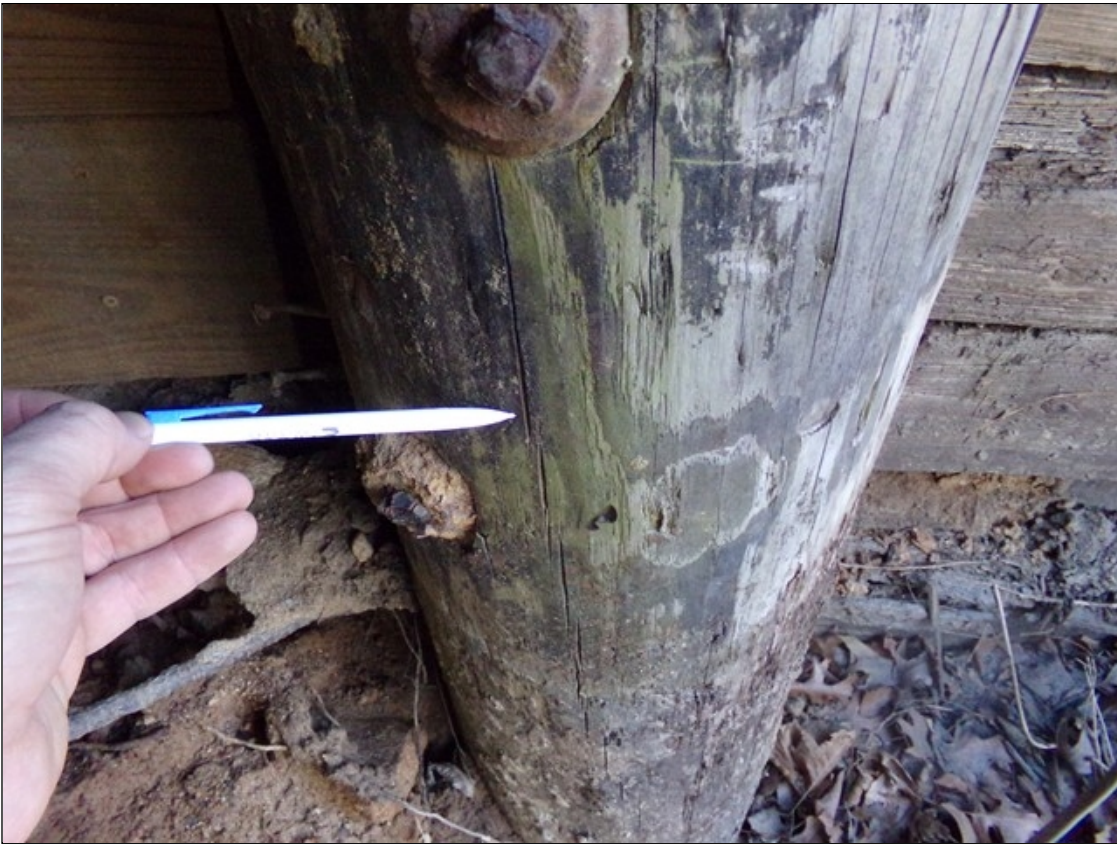
TYPICAL CHECKING (UP TO 1/4 INCH DEEP) THROUGHOUT PILES, END BENT 1 PILE 1

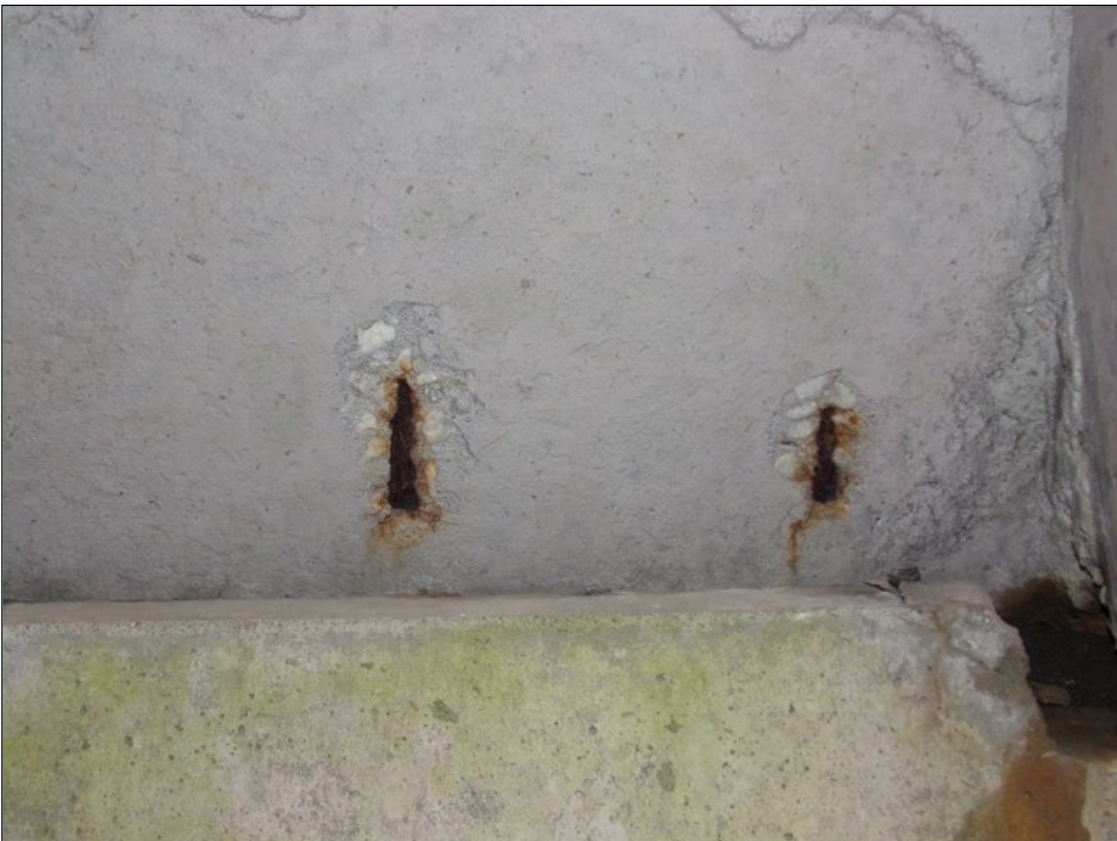
TYPICAL SPALLING (UP TO 8 INCHES X 2.5 INCHES X 1/4 INCH DEEP) WITH EXPOSED REBAR (NO SECTION LOSS) AT DIAPHRAGMS, SPAN 1 BEAM 1 NEAR DIAPHRAGM

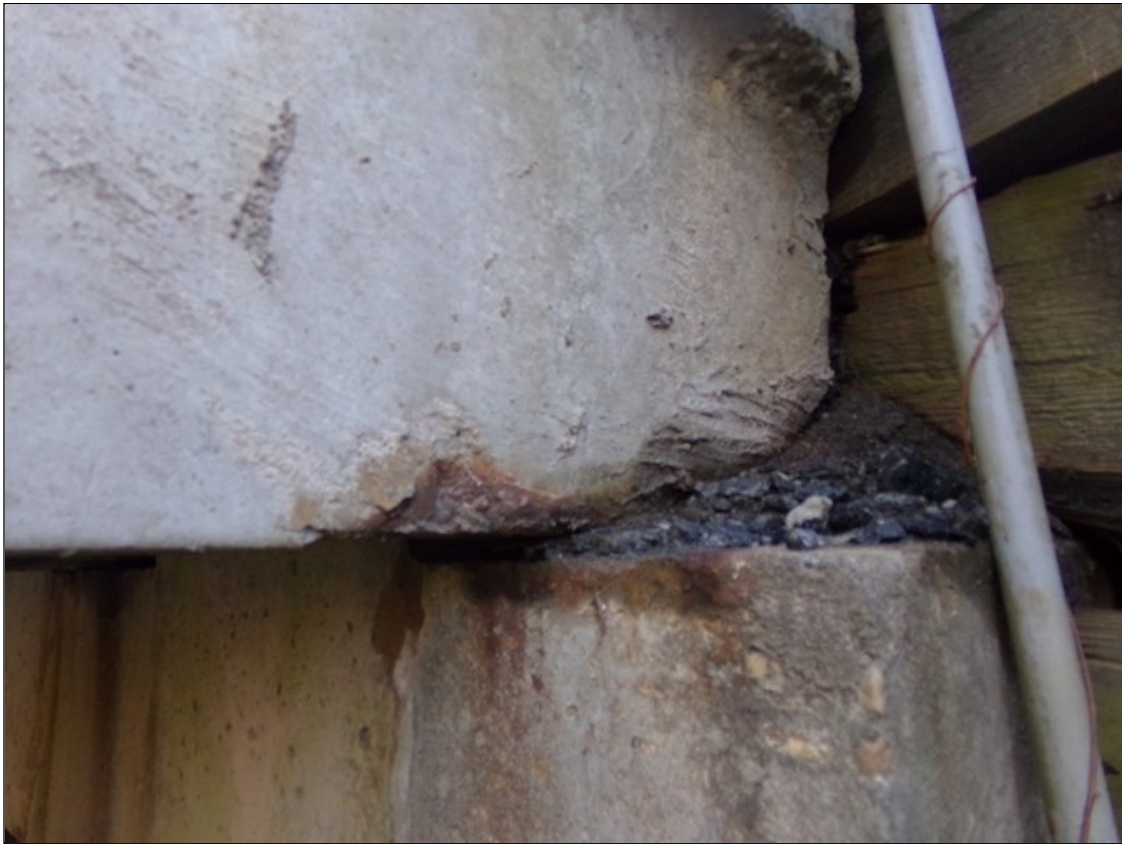
SPAN 1 BEAM 1 - SOUND PATCHING (8 INCHES X 5 INCHES) AT LEFT FACE OF LEFT LEG OVER NEAR BEARING (PREVIOUS PAR)

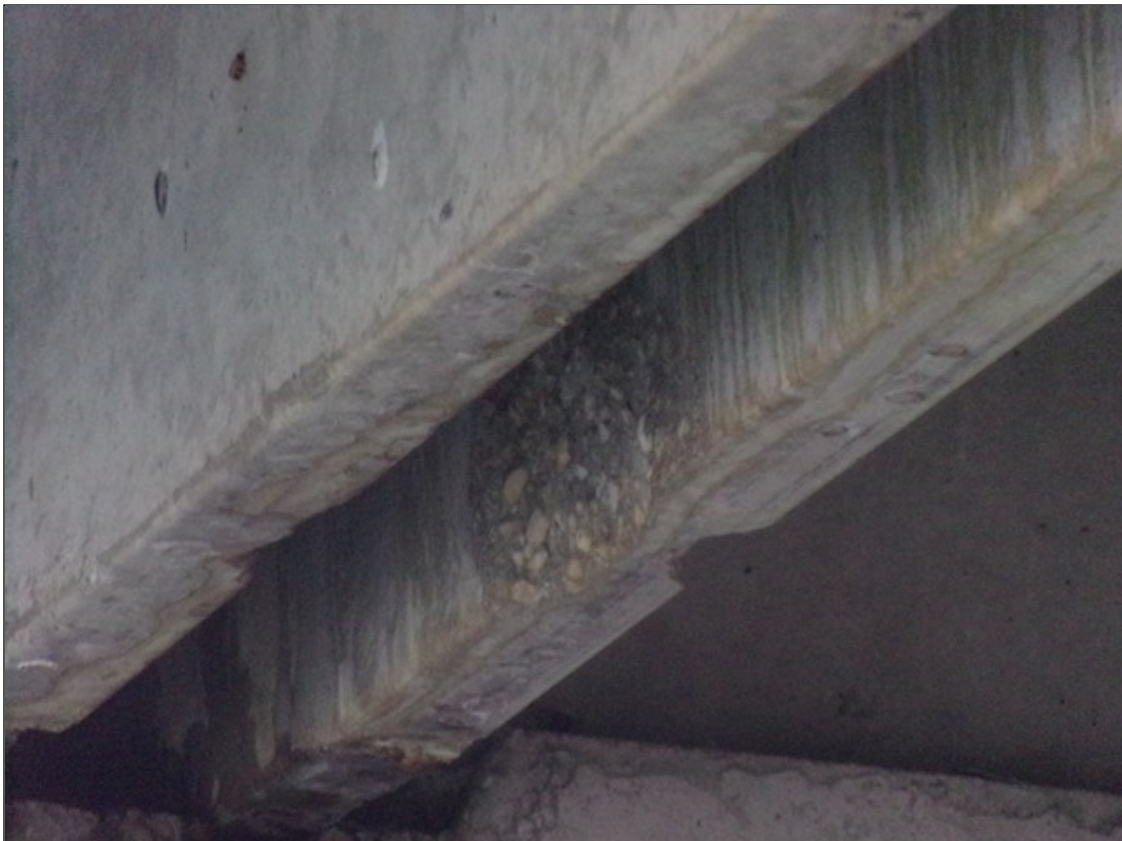
| Element Number | Defect Type | Defect Description | CS | CS Qty | Maint Qty | |
|---|---|---|---|---|---|---|
| <input checked="" type="checkbox"/> 109 | Delamination/Spall | SPALLING (UP TO 9 INCHES X 5 INCHES X 1/2 INCH DEEP) WITH NO EXPOSED REBAR TO BOTH FACES OF LEFT LEG AT 2 FEET FROM FAR END | 3 | 1 | 1 | Feet |

SPAN 1 BEAM 2 - SPALLING (UP TO 9 INCHES X 5 INCHES X 1/2 INCH DEEP) WITH NO EXPOSED REBAR TO BOTH FACES OF LEFT LEG AT 2 FEET FROM FAR END

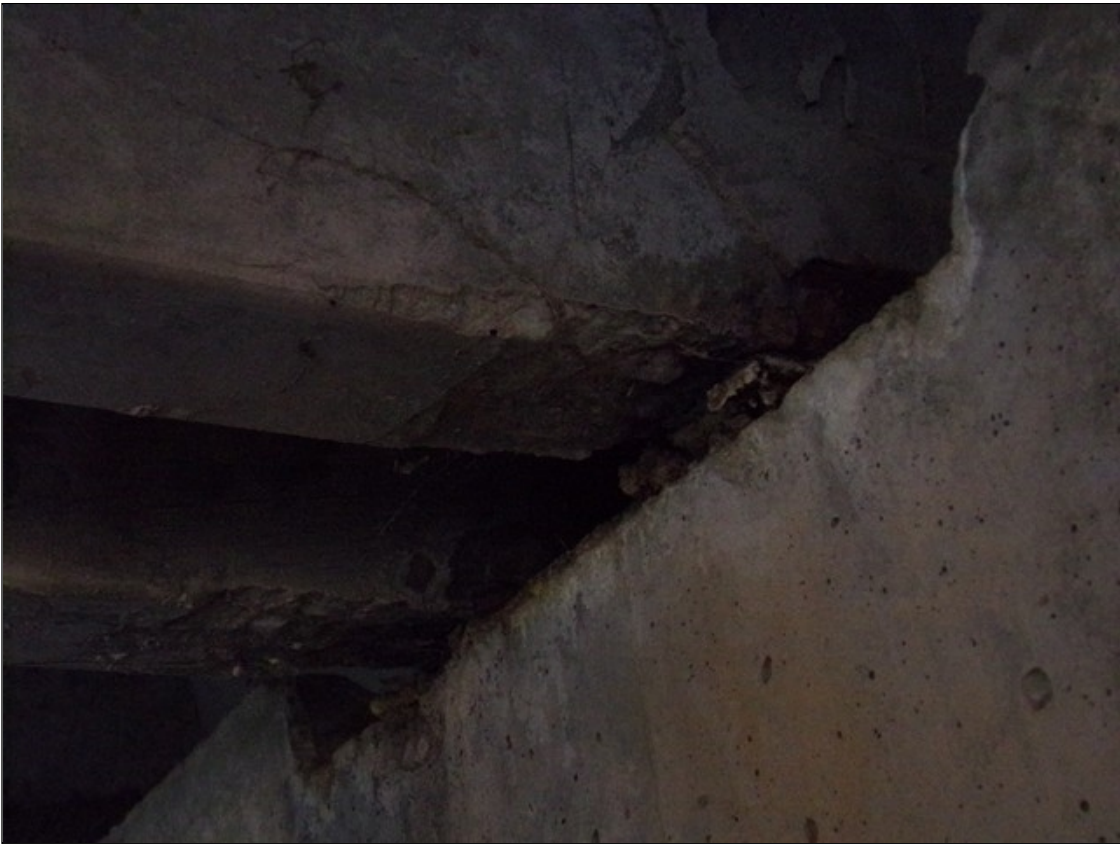
TYPICAL MINOR SPALLING (UP TO 4 INCHES X 3 INCHES X 1/2 INCHES DEEP) WITH NO EXPOSED REBAR TO BOTTOM OF LEGS ADJACENT TO BEARING, SPAN 1 BEAM 3

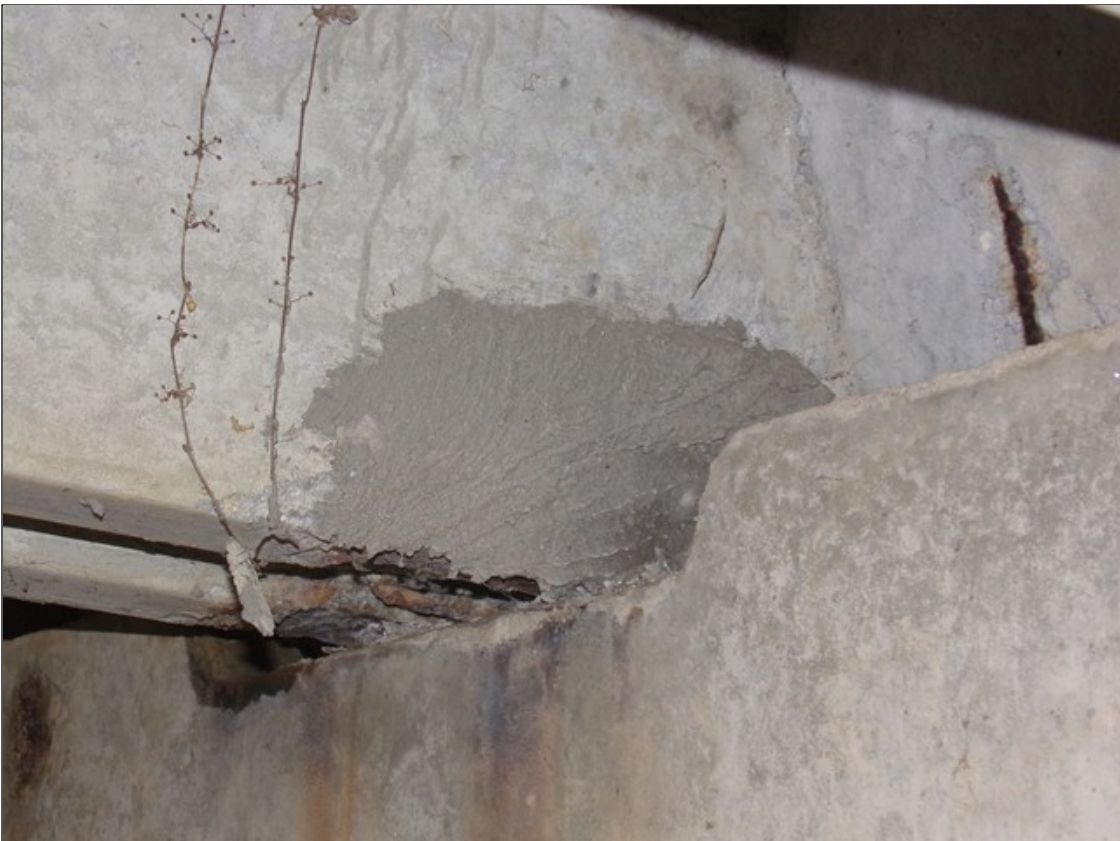
SPAN 1 BEAM 4 - SOUND PATCH (8 INCHES X 5 INCHES) TO LEFT FACE OF RIGHT LEG AT NEAR END (PREVIOUS PAR)

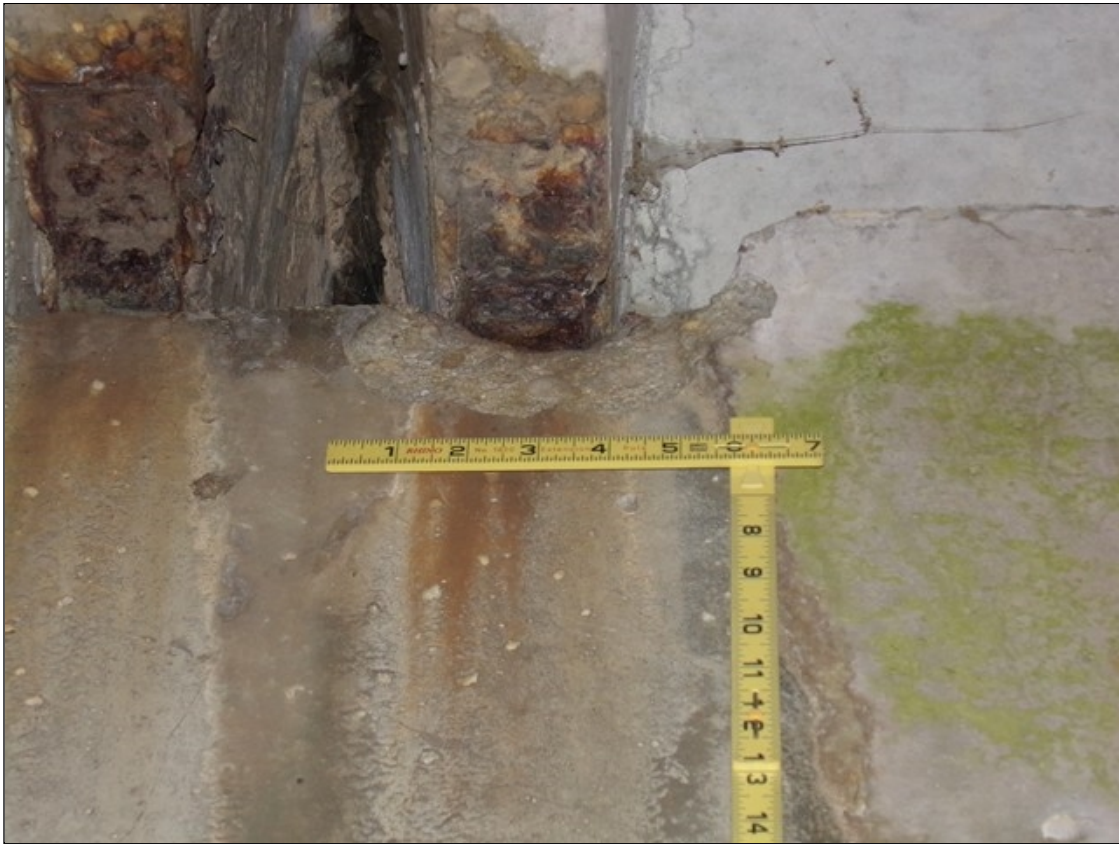
BENT 2 CAP - SPALL (6 INCHES X 3 INCHES X 1/2 INCH DEEP) WITH NO EXPOSED REBAR TO FAR FACE  
BELOW BEAM 8 RIGHT LEG

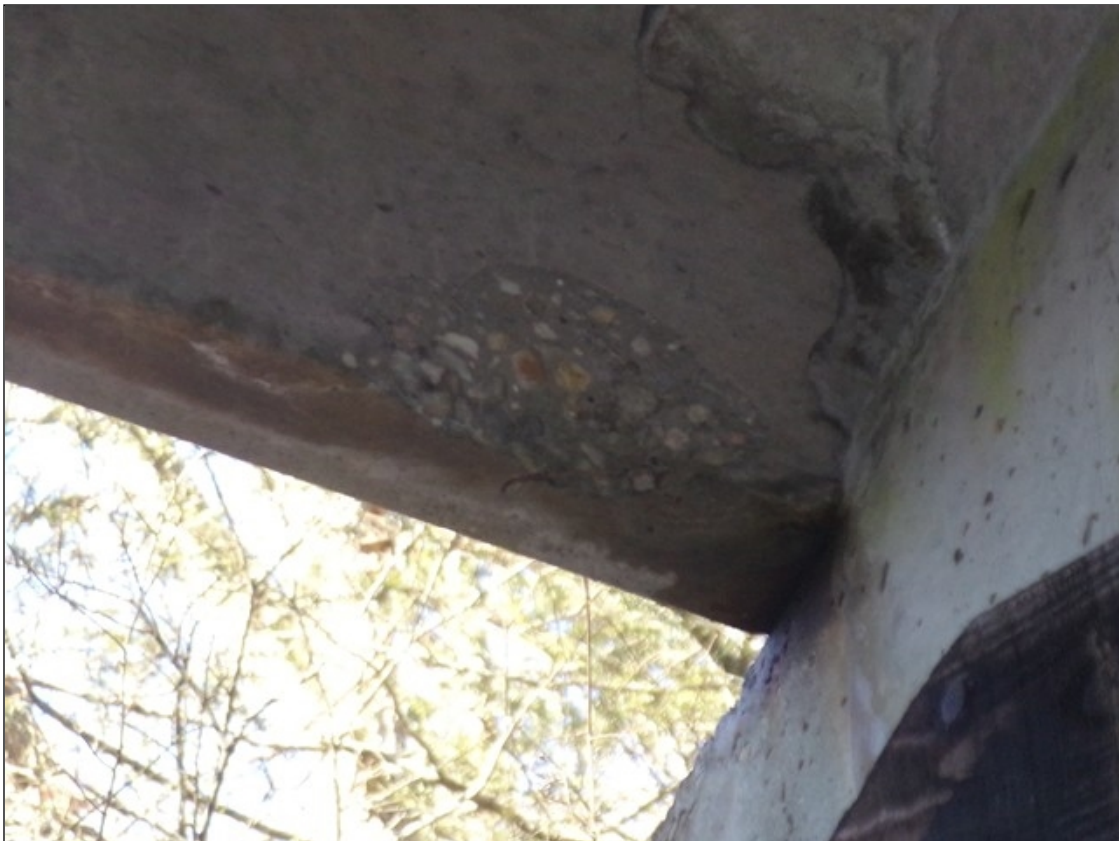
| Element Number | Element Name | Total Qty | CS1 Qty | CS2 Qty | CS3 Qty | CS4 Qty | |
|---|---|---|---|---|---|---|---|
| <input checked="" type="checkbox"/> 109 | Delamination/Spall | SPALL (8 INCHES X 6 INCHES X 1/2 INCH DEEP) WITH NO EXPOSED REBAR TO RIGHT FACE OF LEFT LEG AT FAR END | 3 | 1 | | 1 | Feet |

SPAN 2 BEAM 1 - SPALL (8 INCHES X 6 INCHES X 1/2 INCH DEEP) WITH NO EXPOSED REBAR TO RIGHT FACE  
OF LEFT LEG AT FAR END

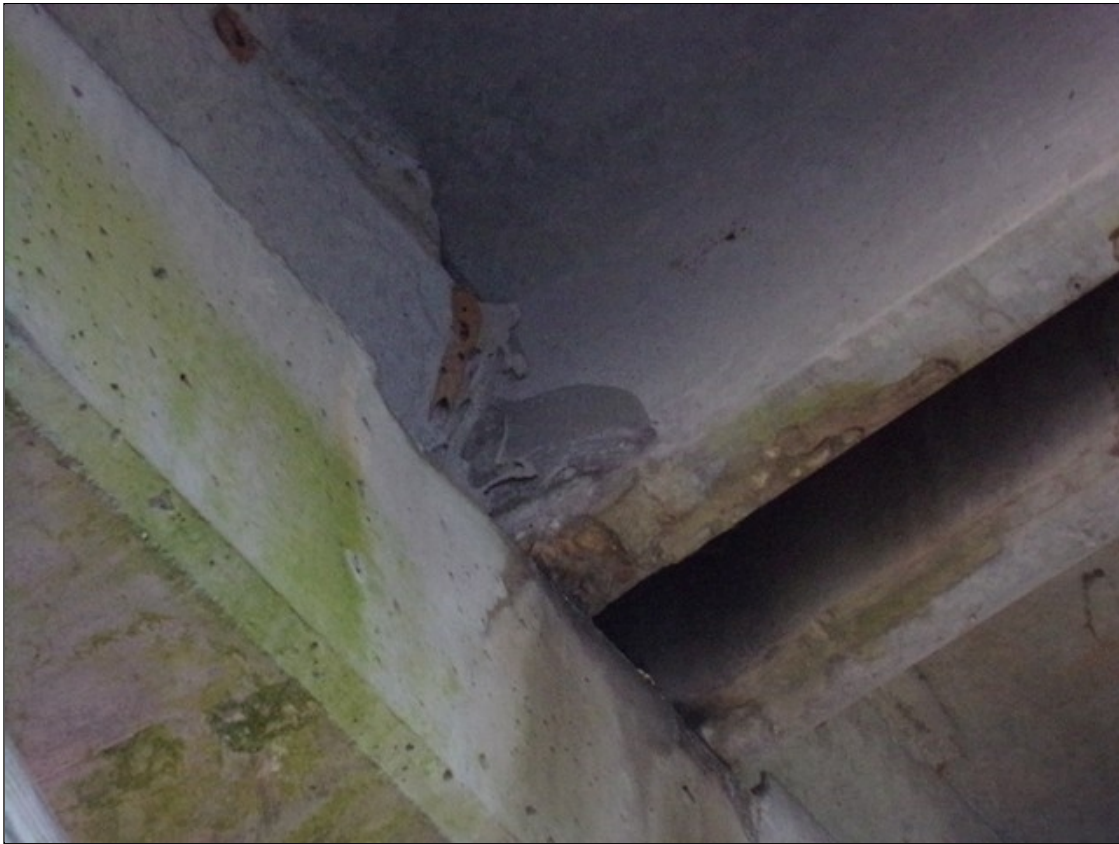
SPAN 2 BEAM 2 - SOUND PATCH (5 INCHES X 5 INCHES) TO LEFT FACE OF RIGHT LEG AT FAR END

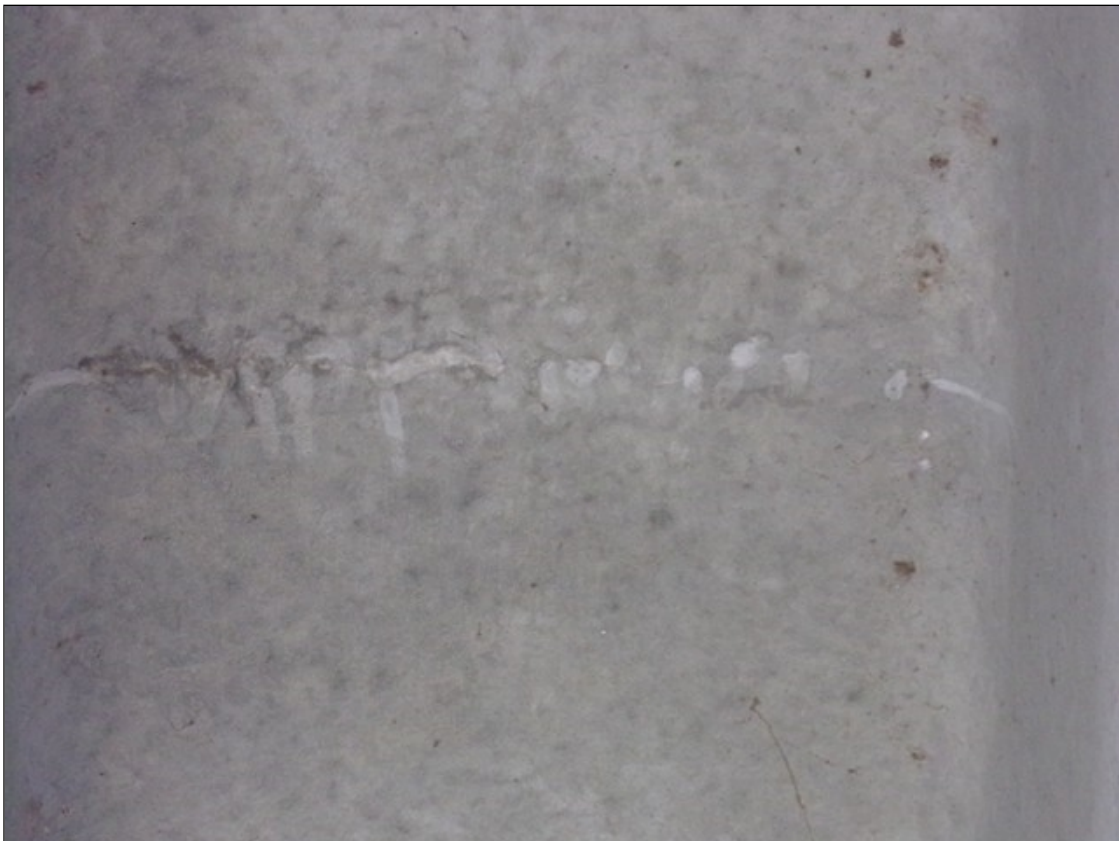
TYPICAL INTERMITTENT HAIRLINE TRANSVERSE CRACKING (UP TO FULL WIDTH) WITH MINOR EFFLORESCENCE TO BOTTOM OF SLAB BETWEEN CHANNEL LEGS, SPAN 2 BEAM 8

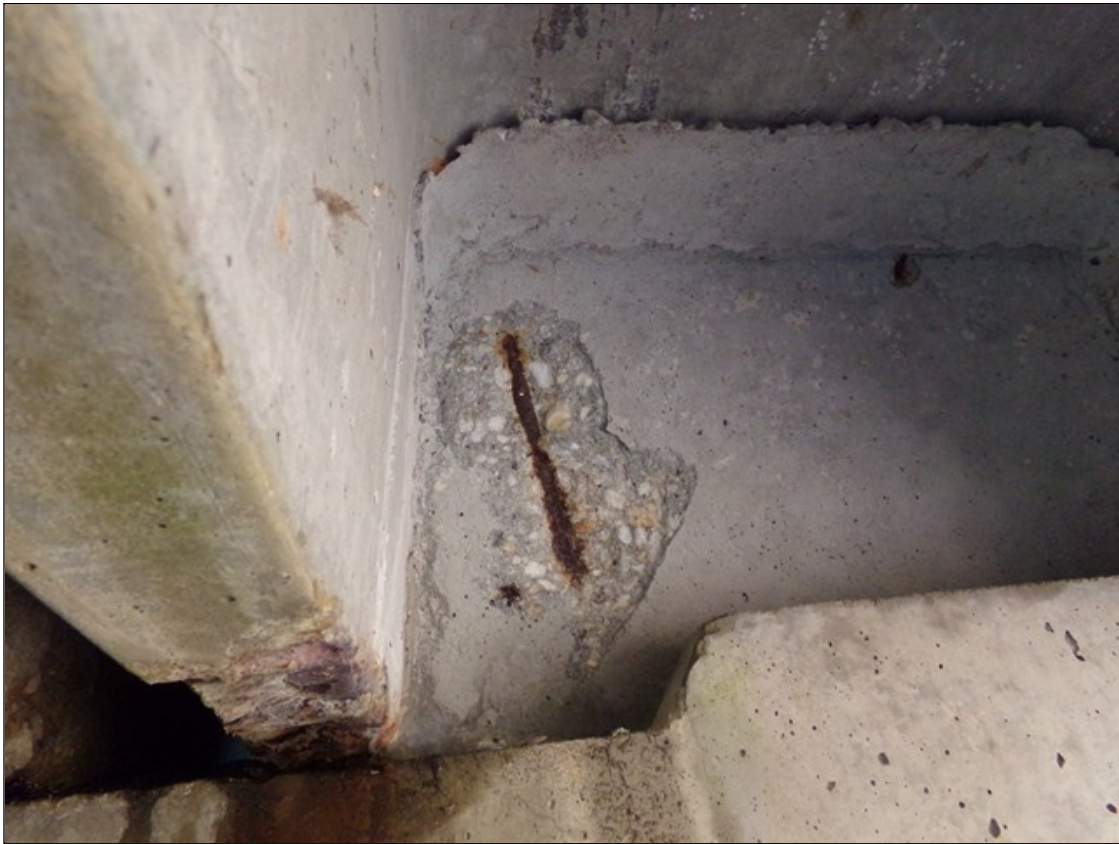
TYPICAL SPALLING (UP TO 8 INCHES X 4 INCHES X 1/2 INCH DEEP) WITH EXPOSED REBAR (NO SECTION LOSS) TO END DIAPHRAGMS, SPAN 3 BEAM 1 NEAR DIAPHRAGM

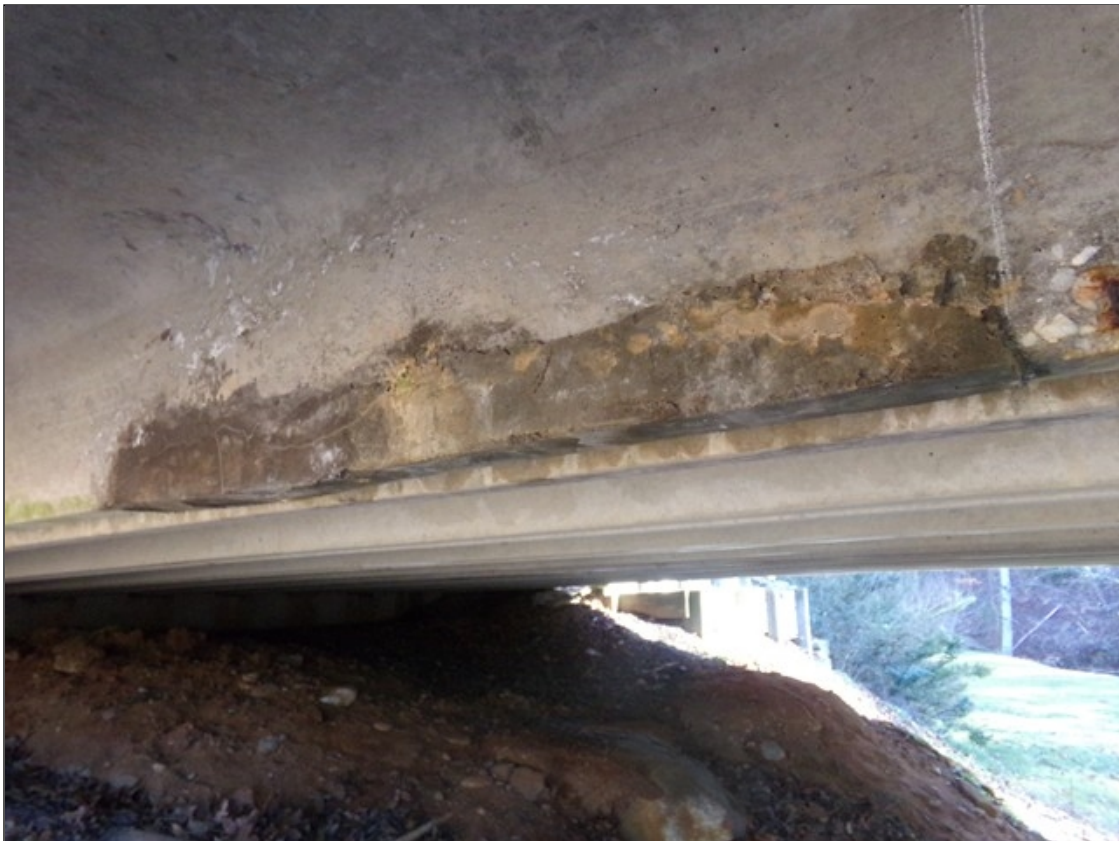
SPAN 3 BEAM 1 - UNSOUND PATCH (30 INCHES LONG X 3 INCHES WIDE X 4 INCHES HIGH) WITH HAIRLINE CRACKING TO RIGHT LEG AT 8 FEET FROM NEAR END

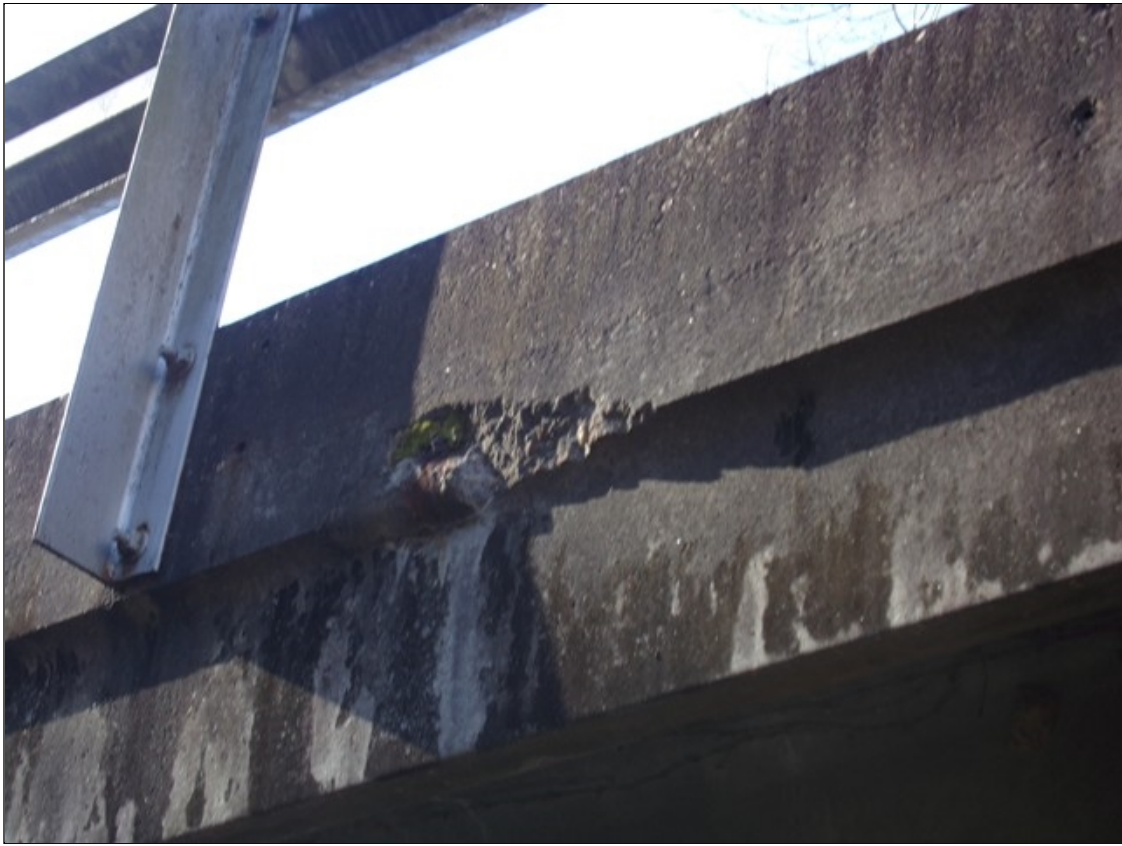
SPAN 2 BEAM 10 - SPALL (12 INCHES X 6 INCHES X 1 INCH DEEP) WITH NO EXPOSED REBAR TO RIGHT SIDE OF TOP FLANGE AT 4 FEET FROM FAR END

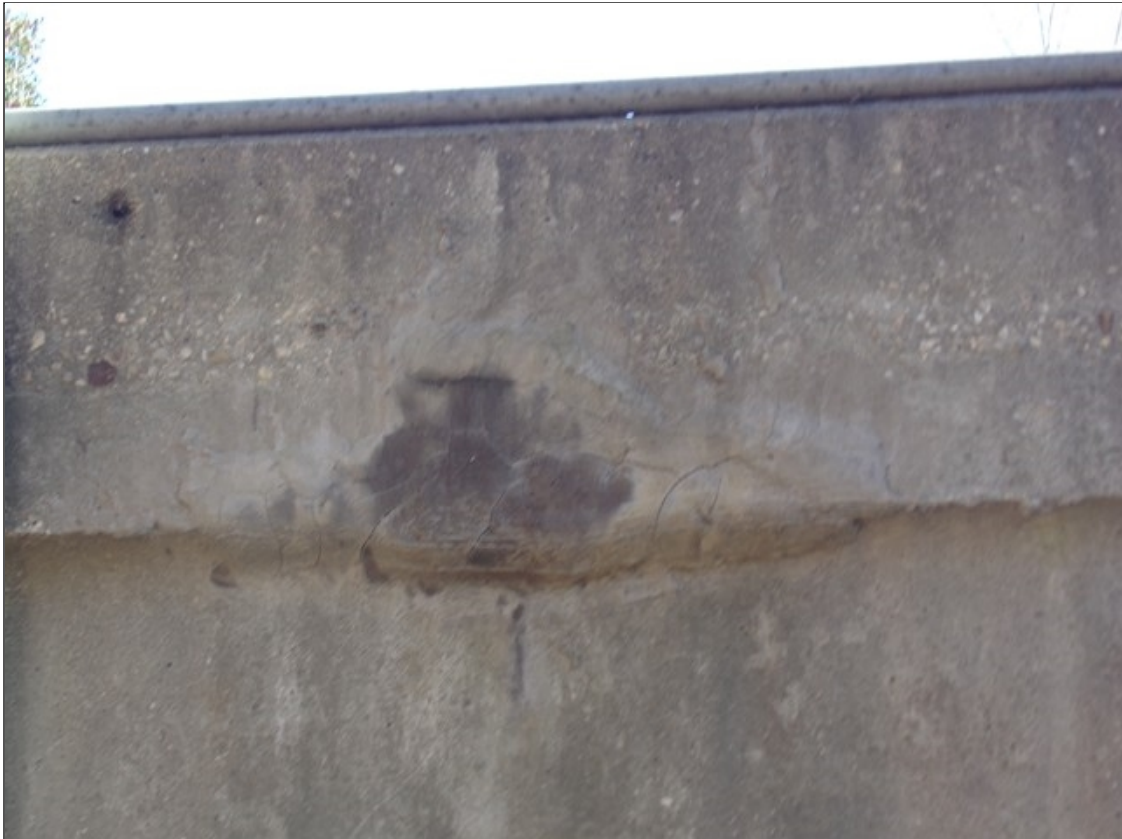
SPAN 3 BEAM 1 - DELAMINATED PATCH (24 INCHES X 12 INCHES) TO LEFT SIDE OF TOP FLANGE AT 4 FEET FROM NEAR END

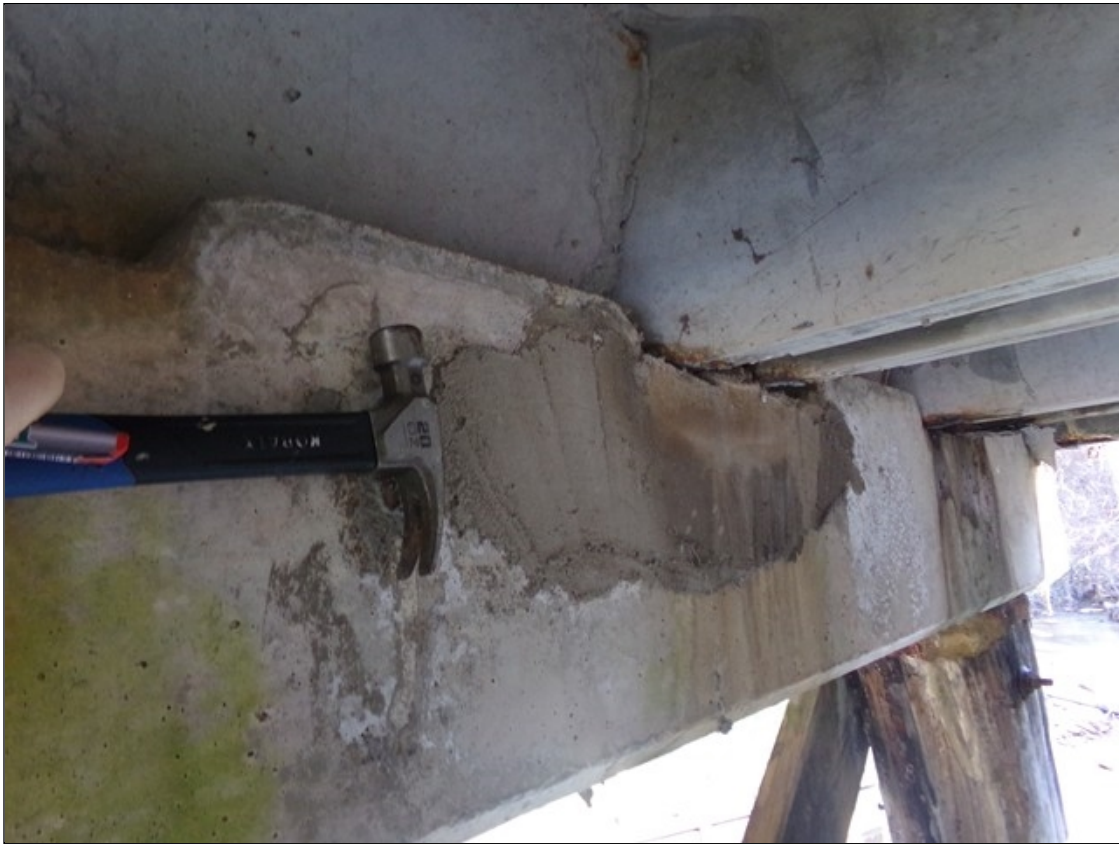
TYPICAL INTERMITTENT SOUND PATCHING (UP TO 24 INCHES X 6 INCHES) THROUGHOUT CAP, BENT 1  
NEAR FACE

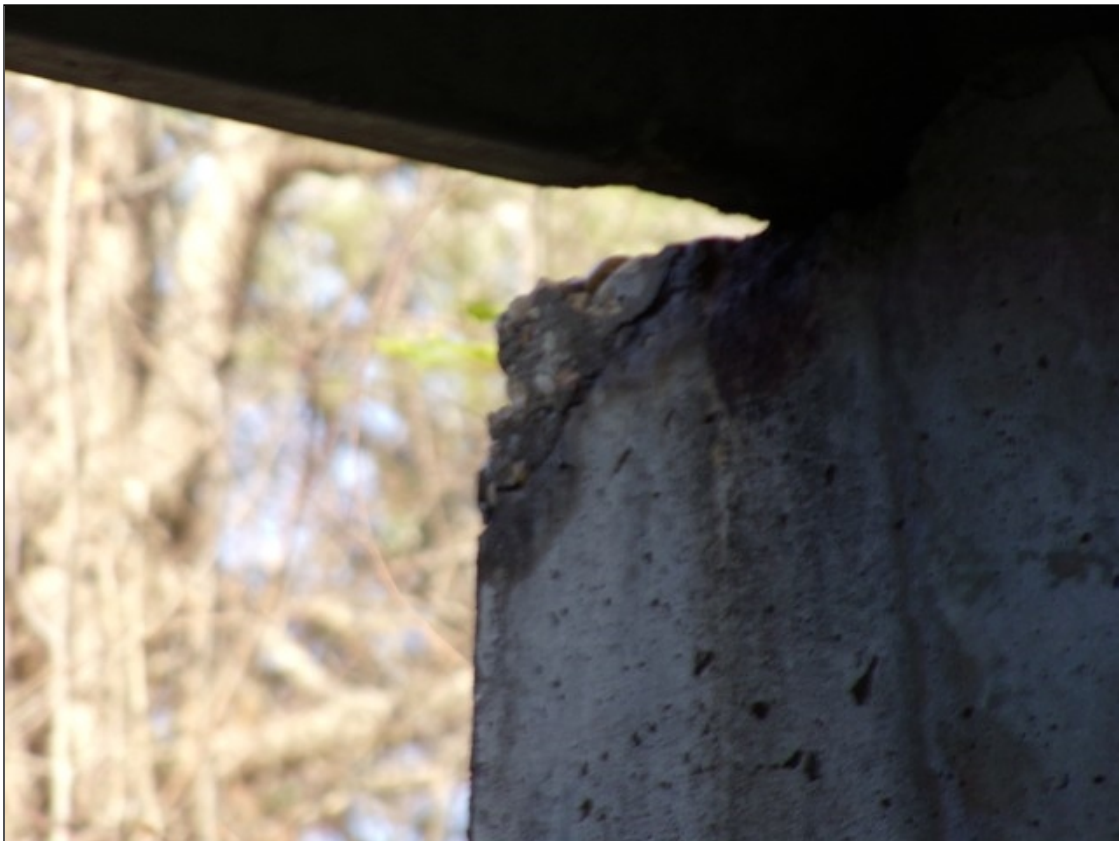
BENT 1 CAP - SPALL / DELAMINATION (8 INCH X 4 INCH X 1/2 INCH DEEP) WITH NO EXPOSED REBAR TO  
NEAR FACE AT TOP LEFT CORNER OF CAP

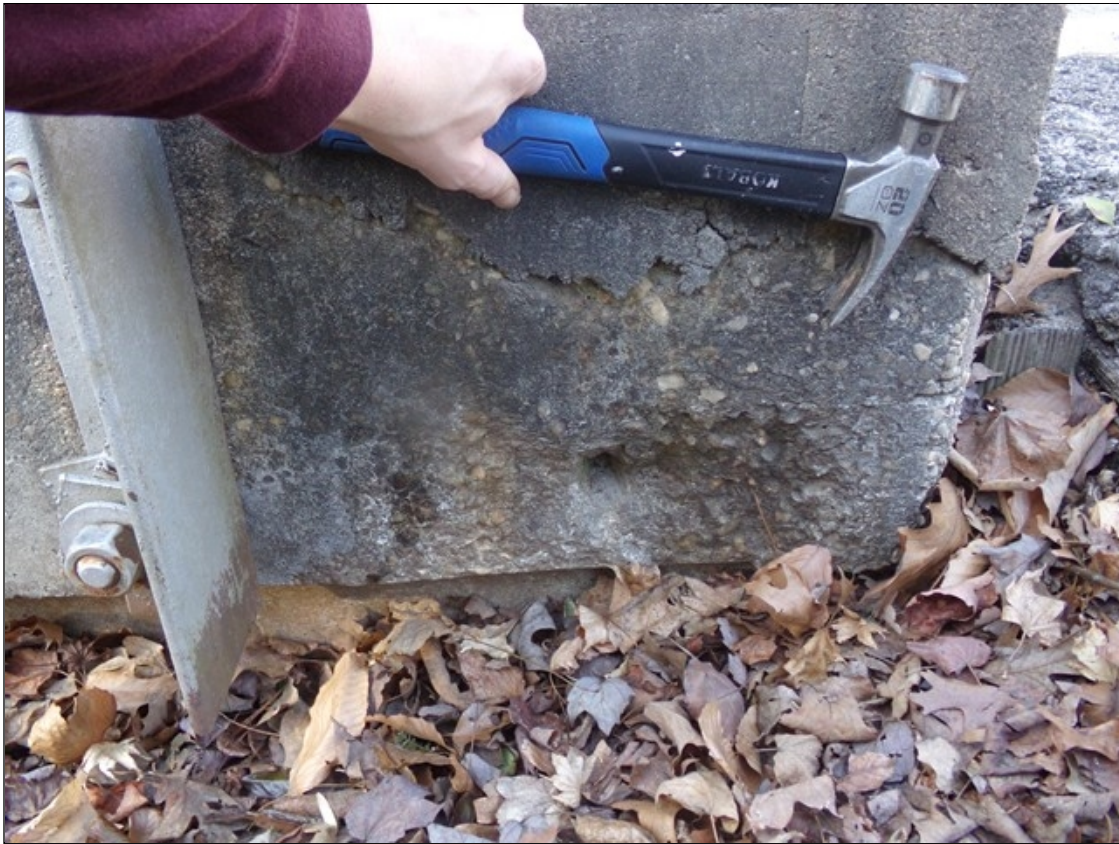
SPAN 3 RIGHT RAIL - SPALL (12 INCHES LONG X 6 INCHES HIGH X 1 INCH DEEP) WITH NO EXPOSED REBAR TO OUTSIDE FACE AT FAR END

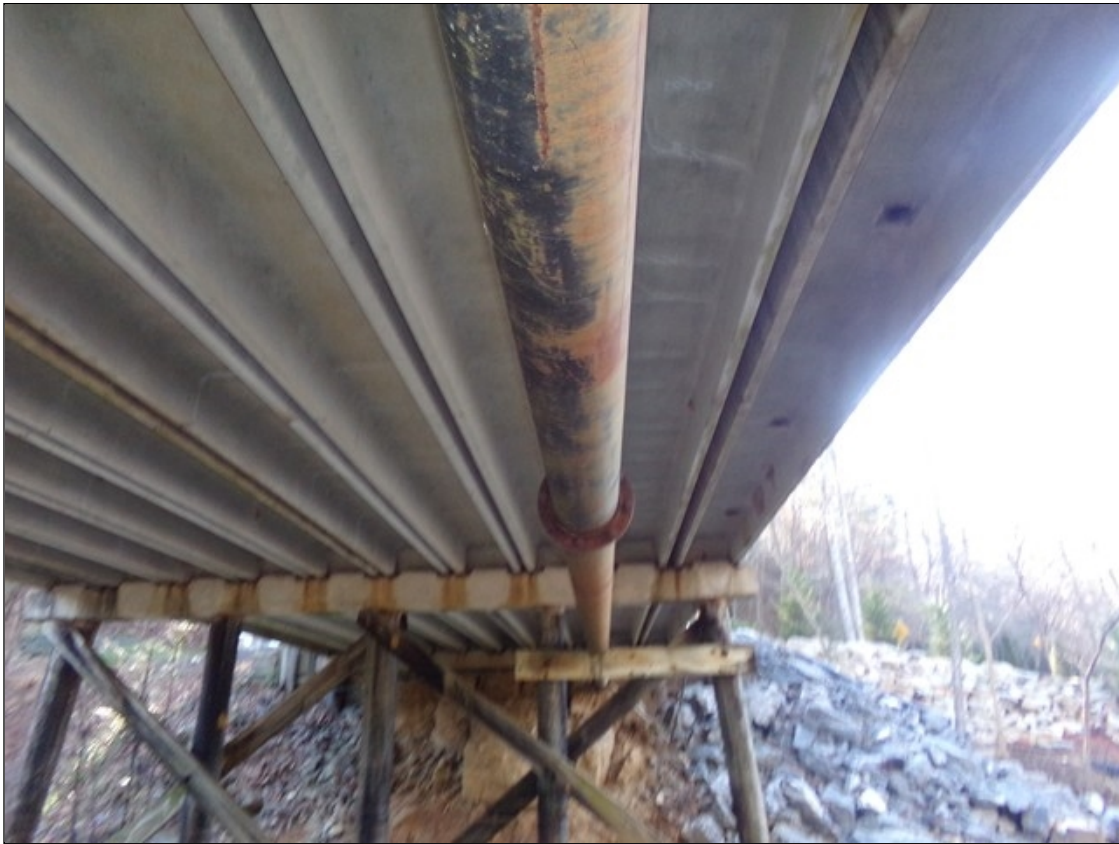
TYPICAL 10 INCH DIAMETER UTILITY BELOW BEAMS 2 AND 3 ALONG LENGTH OF BRIDGE (RESTS ON SUPPORTS AT BENTS)
