NC DEPARTMENT OF TRANSPORTATION
 DIVISION OF HIGHWAYS
 STRUCTURE MANAGEMENT UNIT

ATTENTION: **prompt action request; sketches updated**

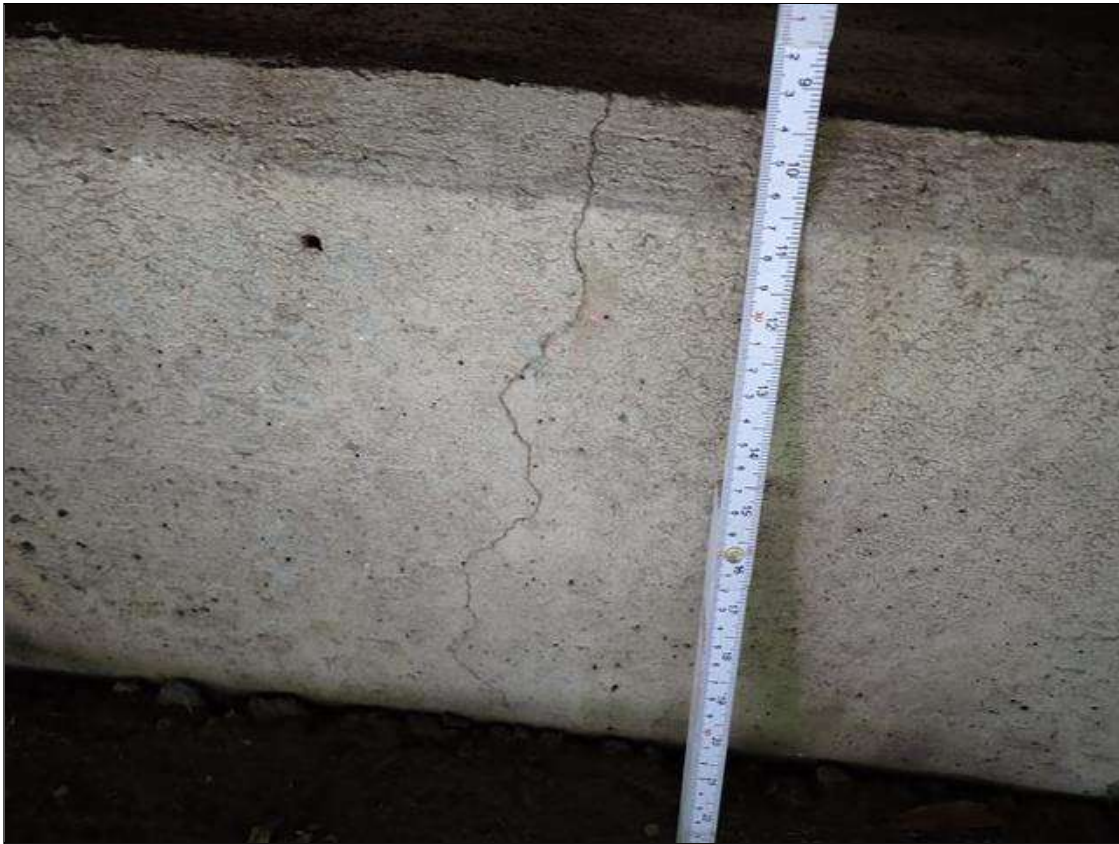
End Bent 2 Cap 1: along length of cap, multiple vertical cracks, up to full height x 1/32 inch

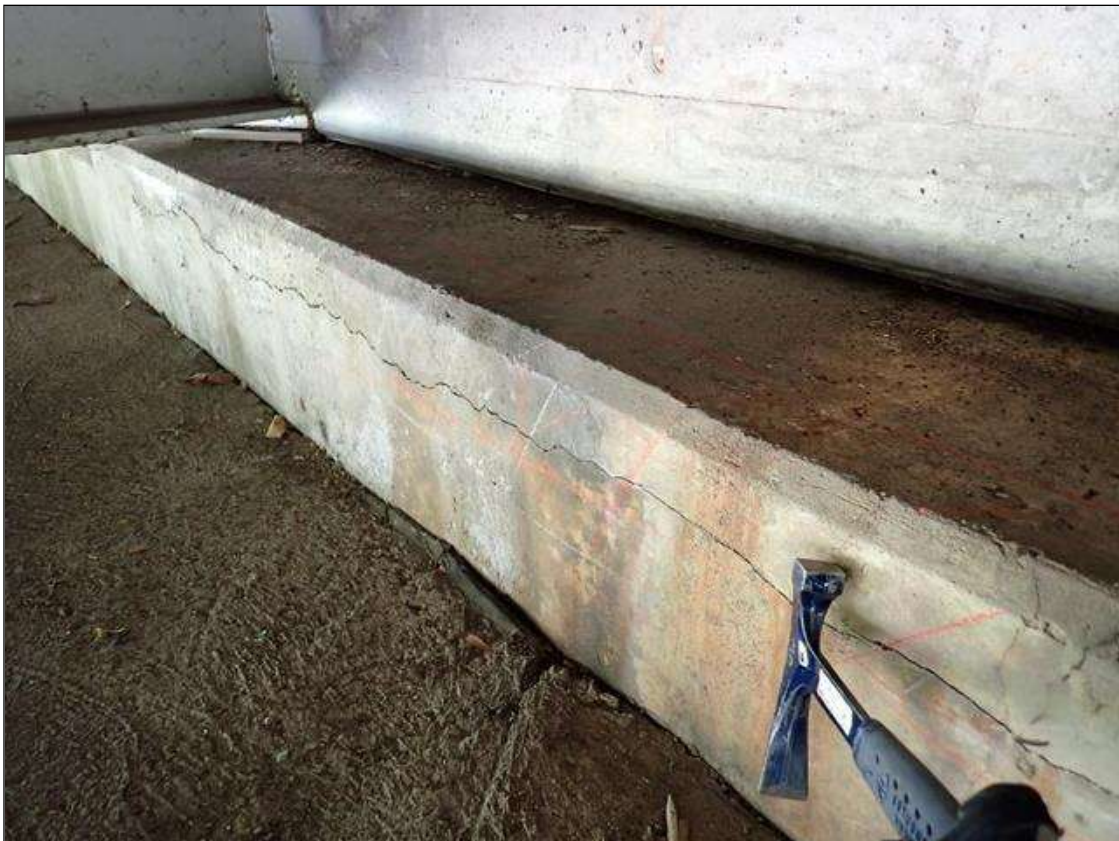
End Bent 2 Cap 1: IN BAY 4, 13 FOOT UP TO 1/8 INCH HORIZONTAL CRACK WITH DELAMINATED AREA 13 FOOT X 9 INCH X 7 INCH ON TOP AND SOUTH FACE.

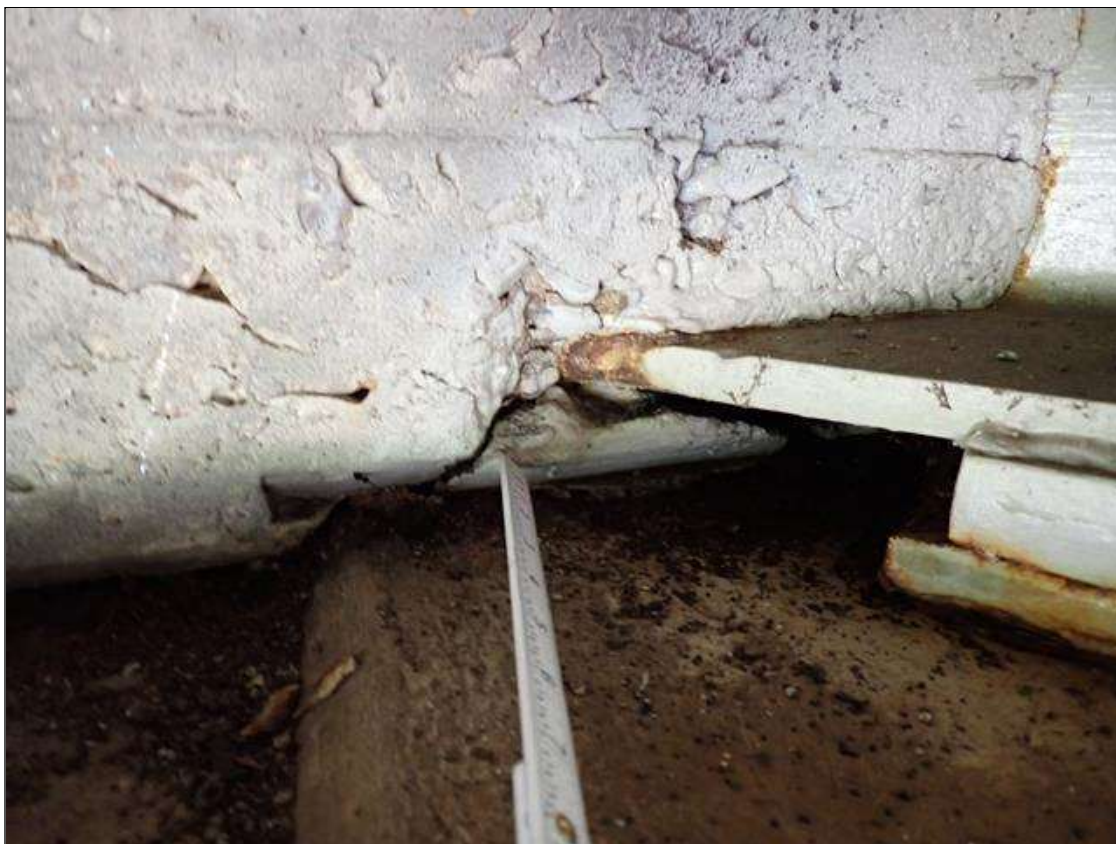
End Bent 2 Abutment: along the length of the abutment, at bottom flange penetrations, spalls/delaminations (8 inch x 4 inch x 1.5 inch deep)

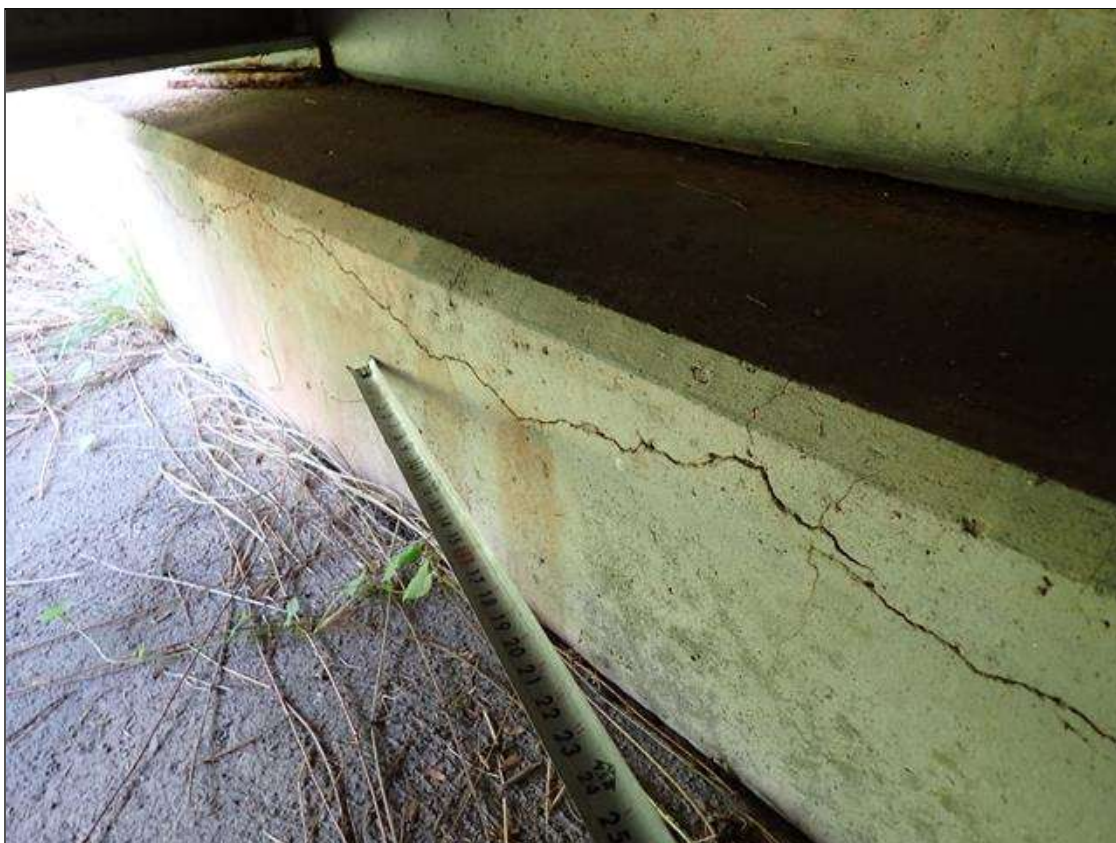
End Bent 2 Cap 1: 5 FOOT X UP TO 1/8 INCH HORIZONTAL CRACK UNDER BEAM 1

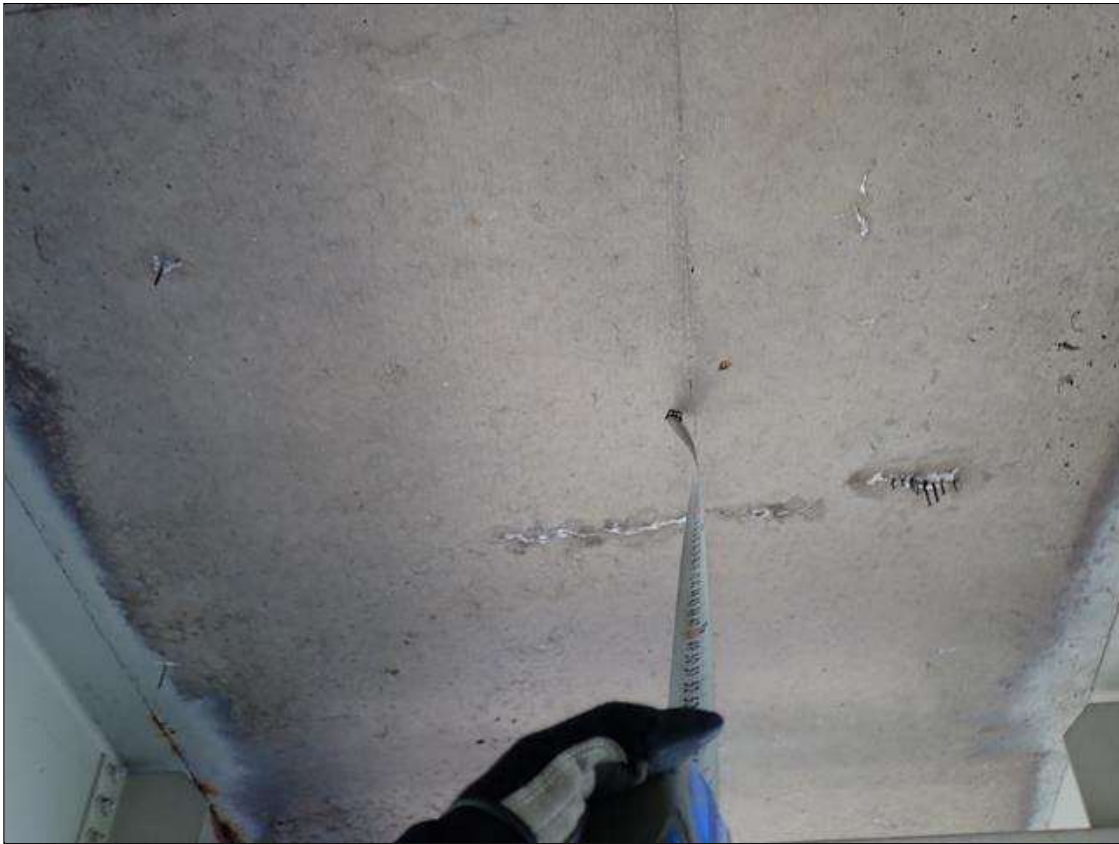
Span 4 Deck: (PAR) in bay 1 near end bent 2, transverse crack (hairline x full bay width) with efflorescence and rust stains; in bay 4 near midspan, transverse cracks (hairline x full bay width) with efflorescence buildup

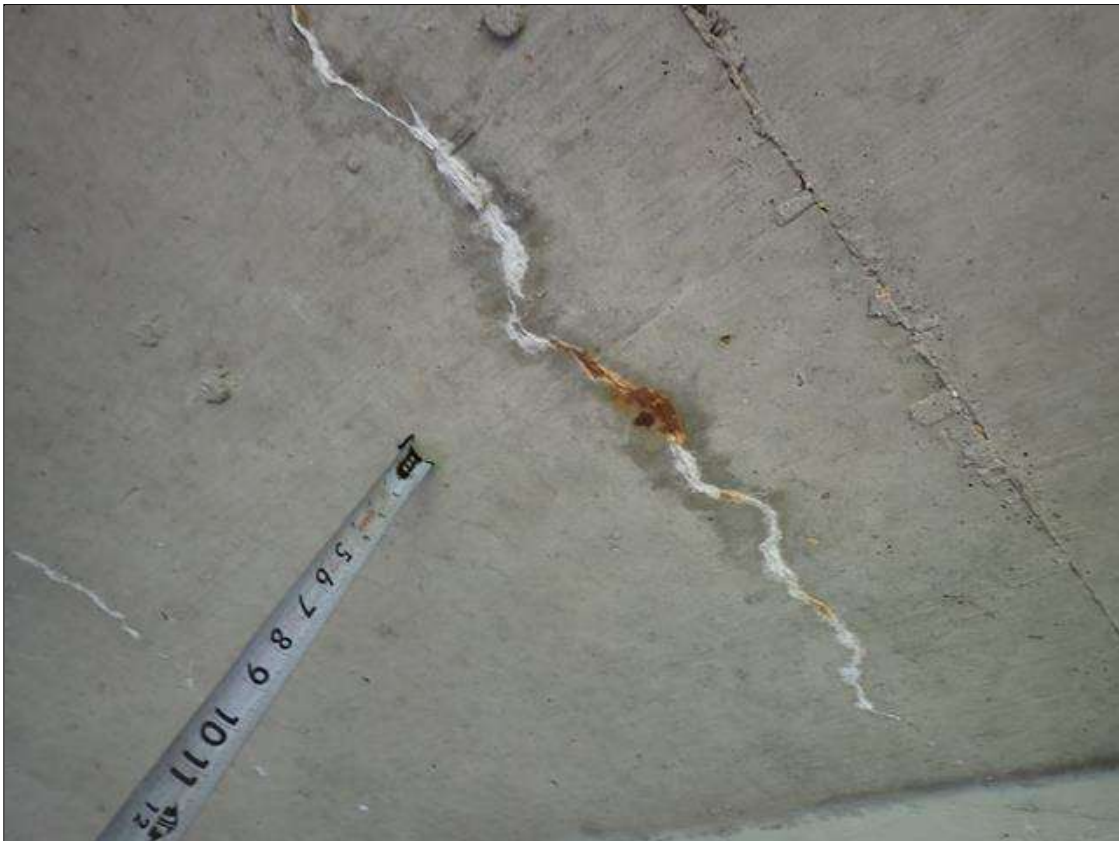
Span 4 Deck: (PAR) in bay 1 near end bent 2, transverse crack (hairline x full bay width) with efflorescence and rust stains; in bay 4 near midspan, transverse cracks (hairline x full bay width) with efflorescence buildup

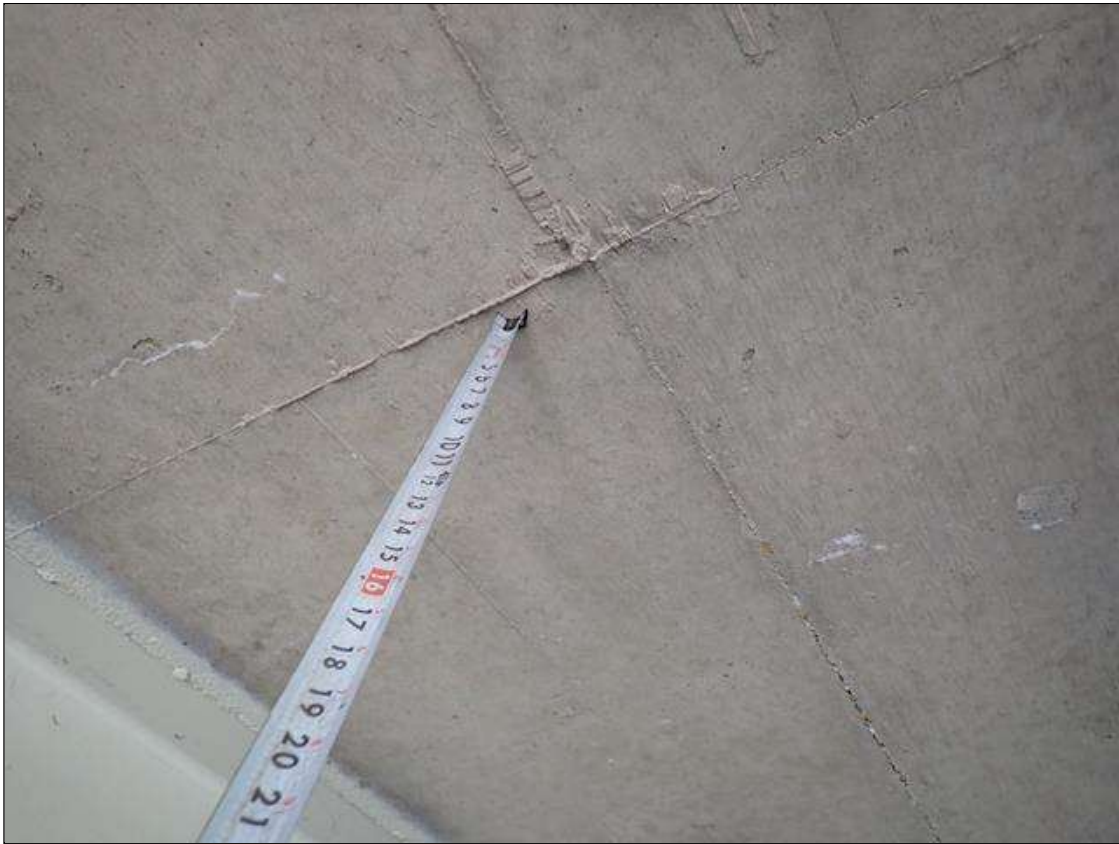
Span 4 Deck: BOTTOM OF DECK HAS MAP CRACKING UP TO 1/64 INCH WITH EFFLORESCENCE IN ALL BAYS.

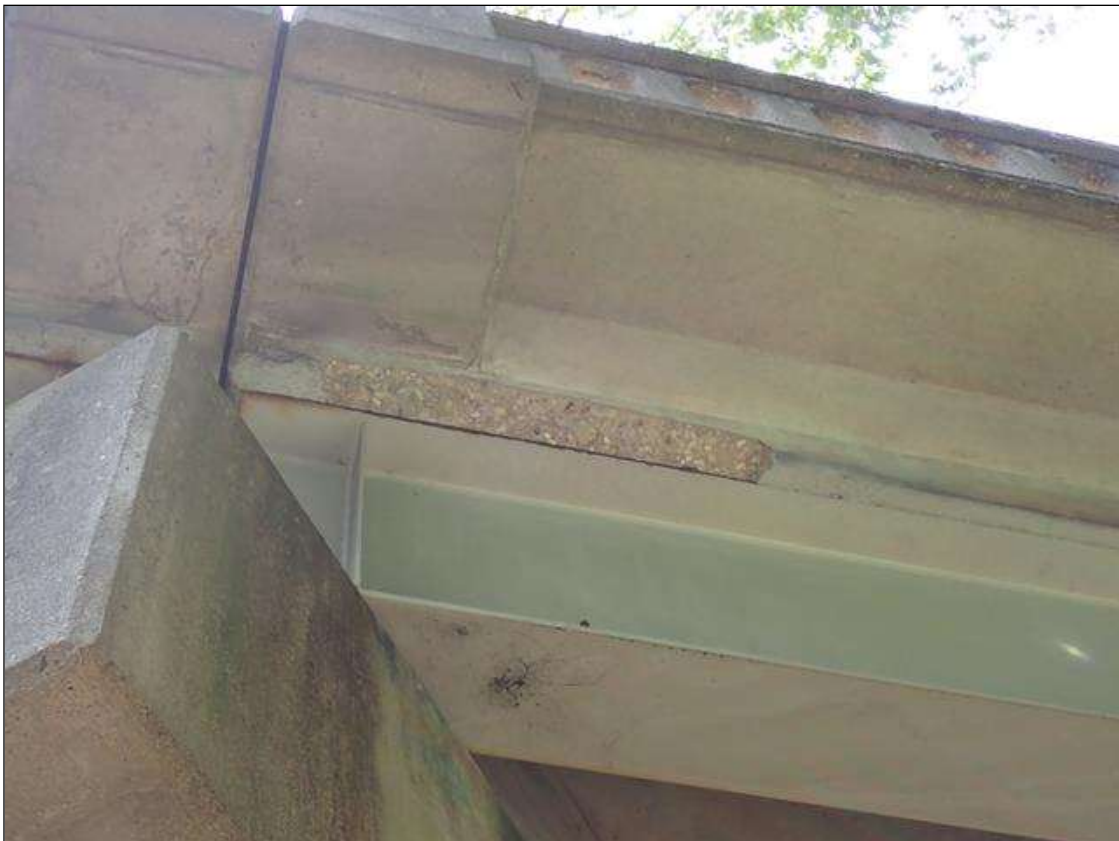
Span 4 Deck: BOTTOM OF DECK EAST SIDE OF BEAM 5 OVER BENT 3 SPALL ALONG TOP FLANGE 7 INCH X 4 FOOT X 1 INCH DEEP.

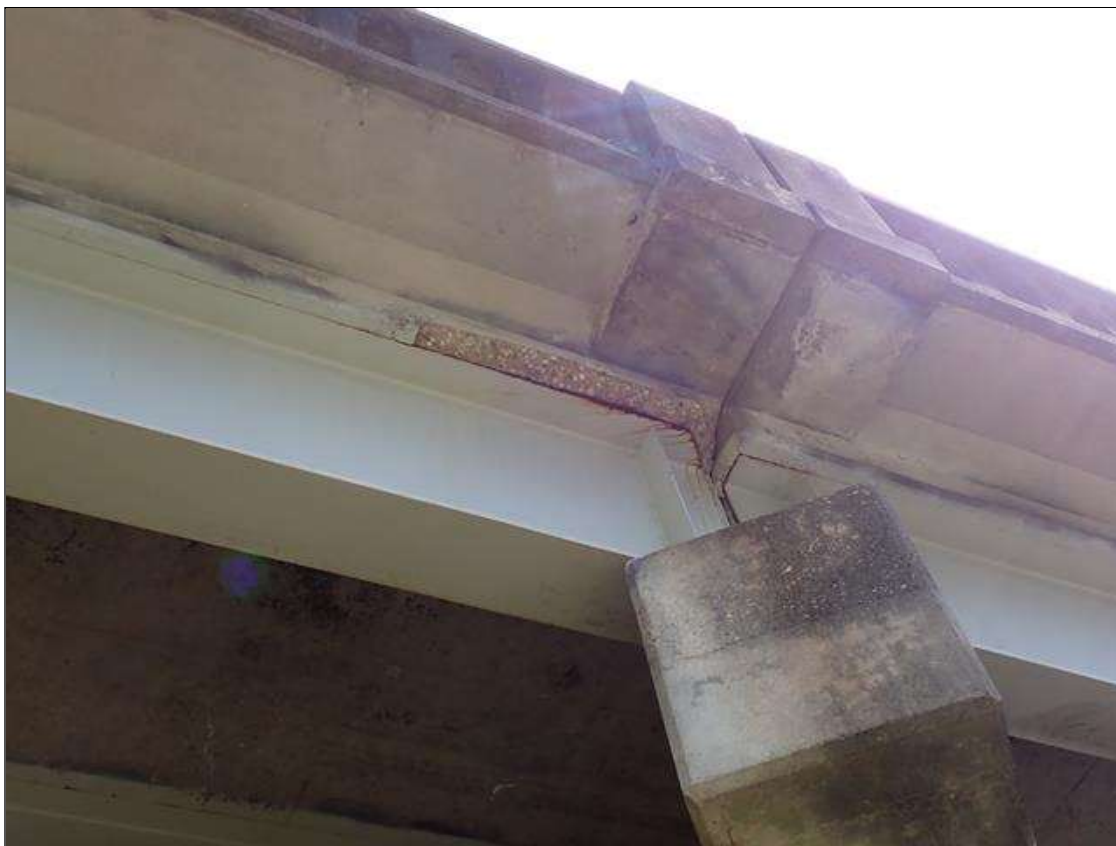
Span 4 Deck: BOTTOM OF DECK WEST SIDE OF BEAM 1 OVER BENT 3 SPALL ALONG TOP FLANGE 7 INCH X 4 FOOT X 1 INCH DEEP.

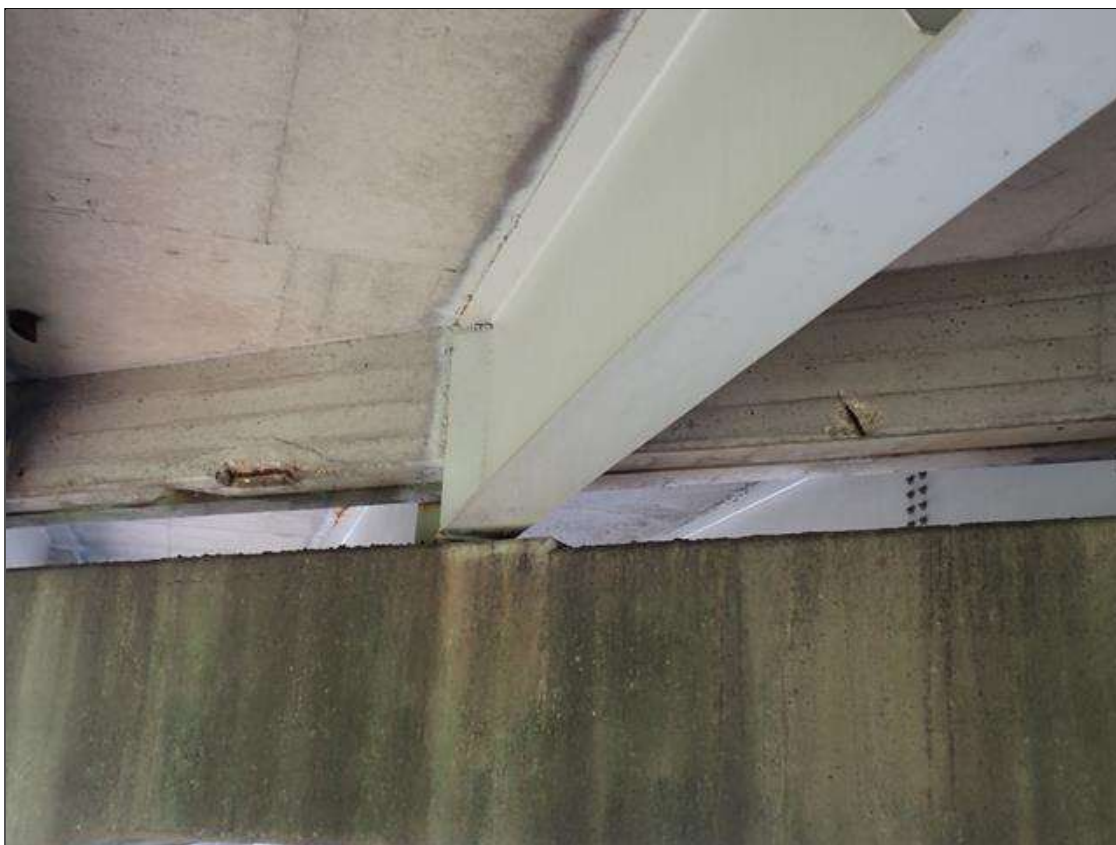
Span 4 Beam 4: UP TO 1 FOOT X 6 INCH X 4 INCH SPALL WITH EXPOSED REINFORCING BAYS 3 AND 4 IN BENT 3 DIAPHRAGM.

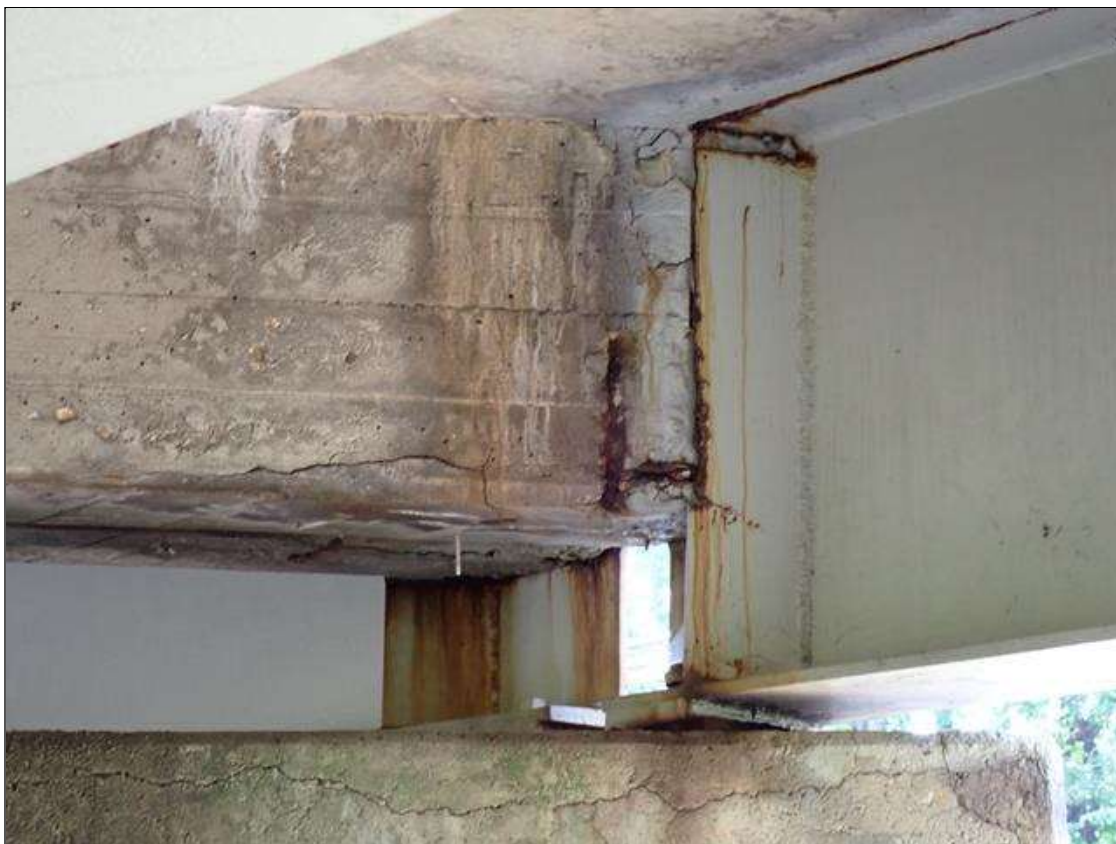
Span 4 Beam 1: 8 INCH X 1 FOOT X 1 INCH SPALL WITH EXPOSED REINFORCING WITH ADJACENT CRACKS UP TO 1/8 INCH BAY 1 IN BENT 3 DIAPHRAGM.

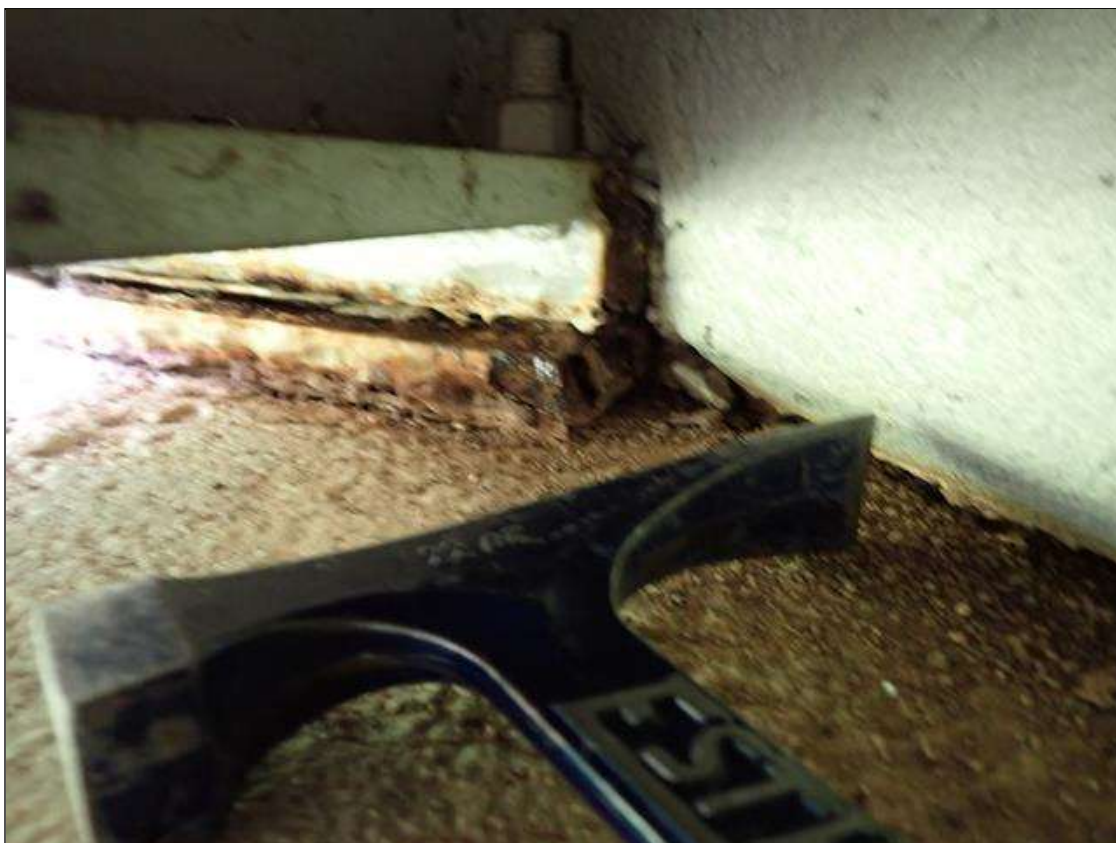
Span 4 Far Bearing 1: surface rust/rust scale

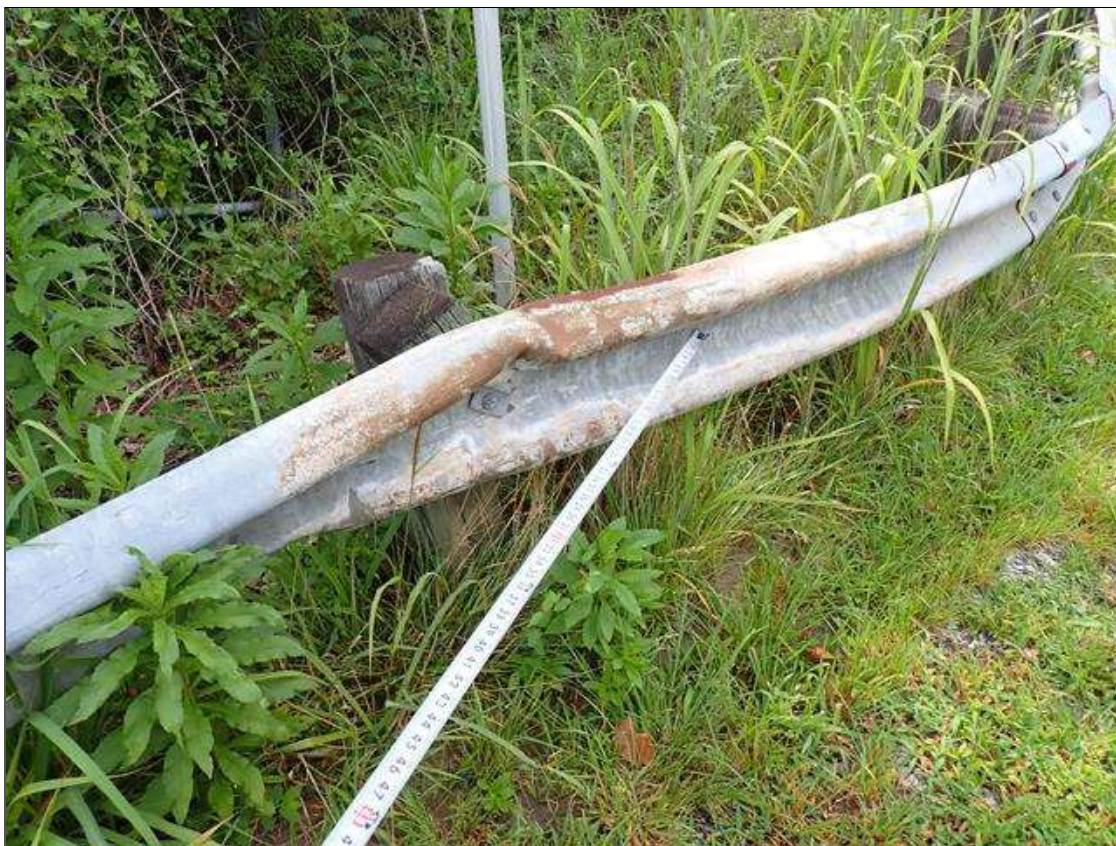
(PAR) northeast guardrail 25 foot from termination, impact damage (4 foot)

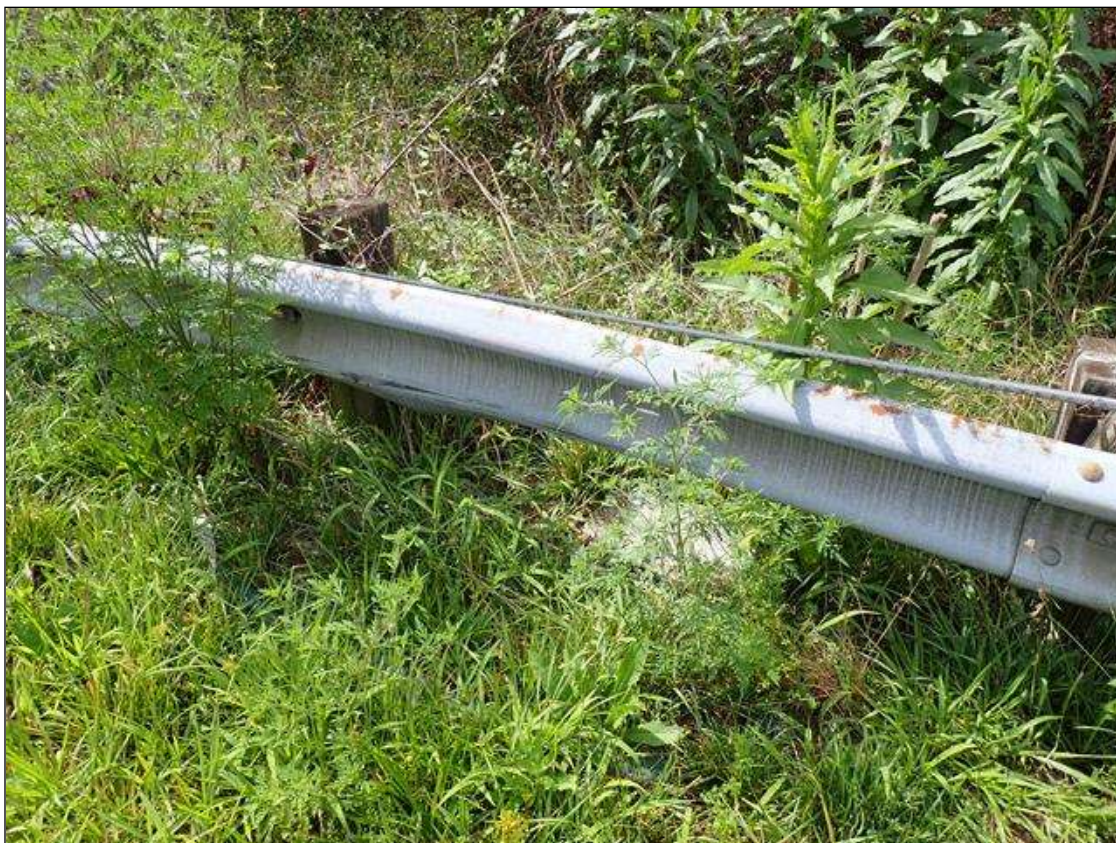
(PAR) northwest guardrail 25 foot from end bent 1, impact damage (6 foot)

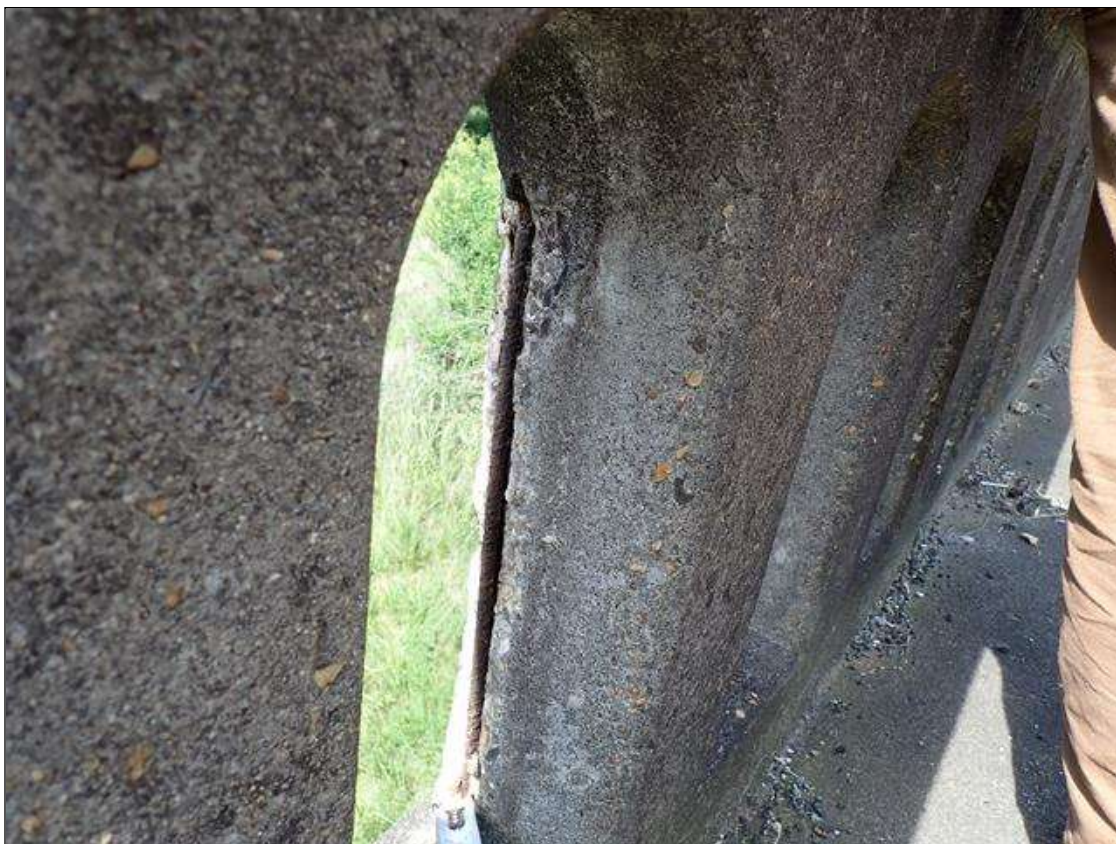
Span 4 Left Bridge Rail: along length of rail, multiple spalls, up to 20 inch x 3 inch x 1 inch deep, some with exposed rusted reinforcing, no loss noted

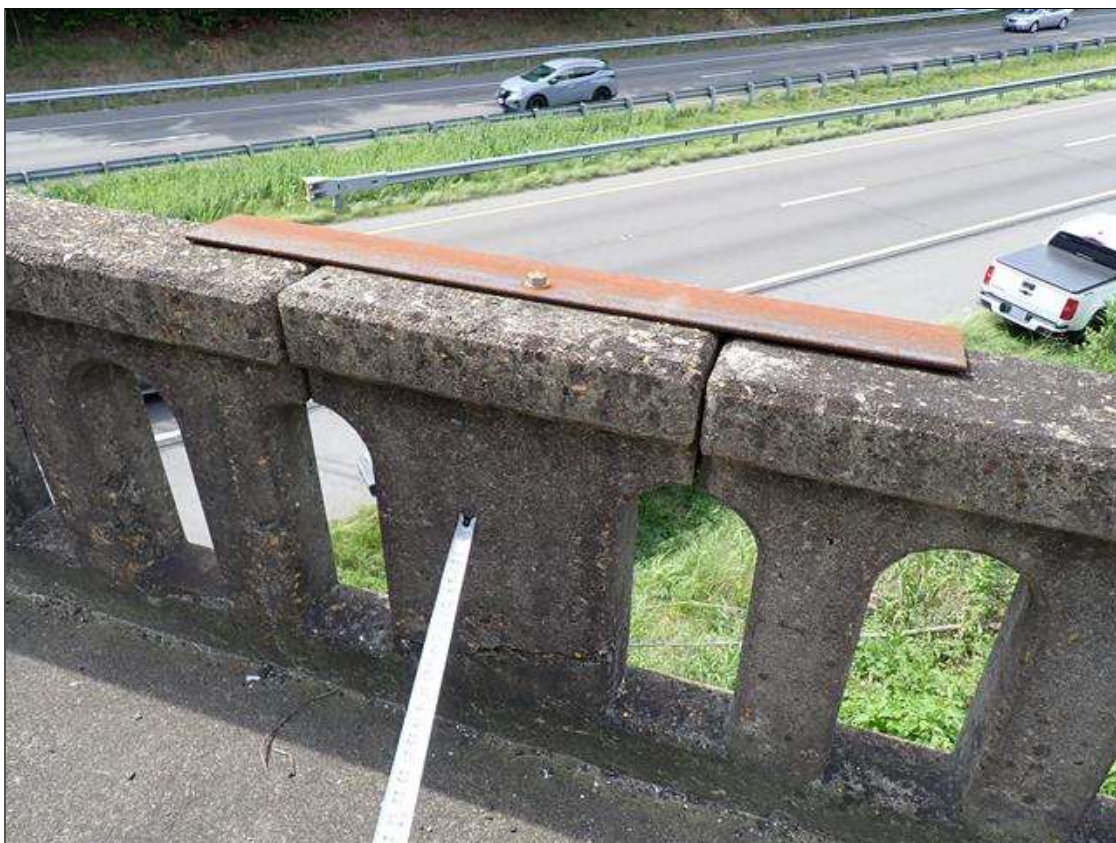
Span 4 Left Bridge Rail: previously repaired crack on post at 24 foot from bent 3

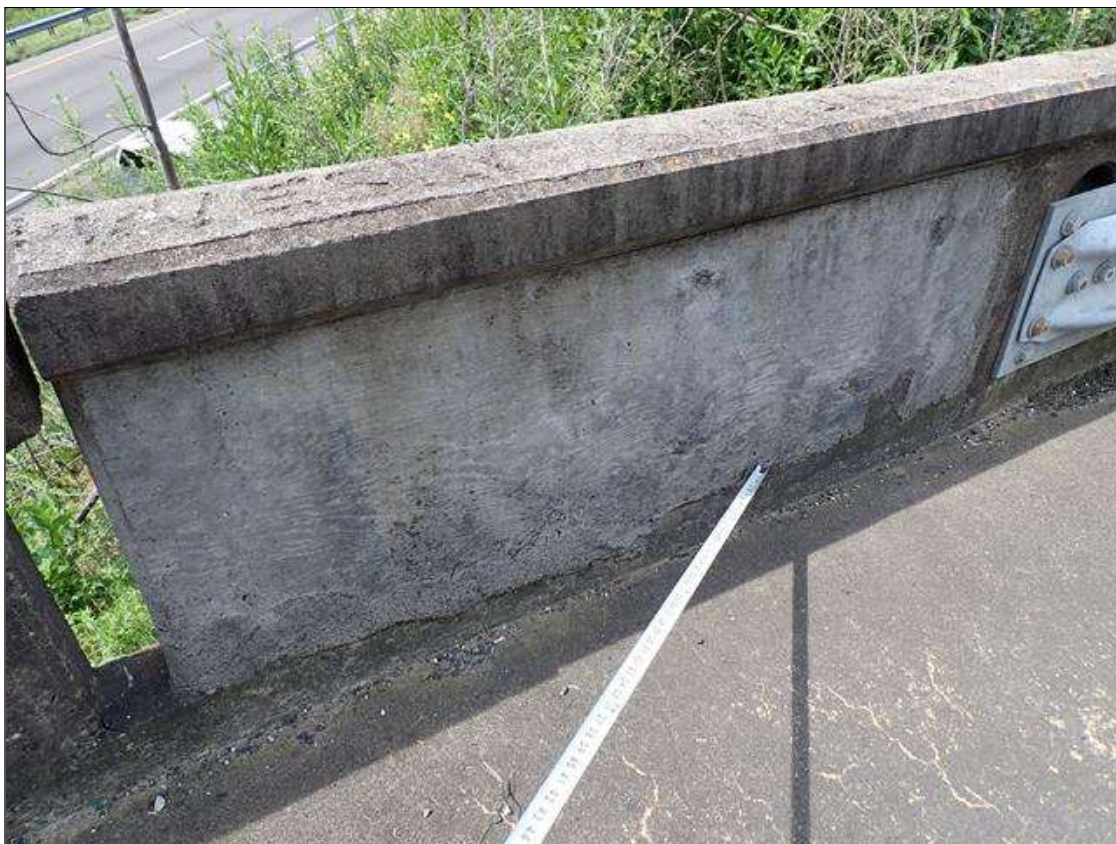
Span 4 Left Bridge Rail: PATCHED AREA 9 FOOT FROM END BENT 2 OVER A 6 FOOT LONG AREA.

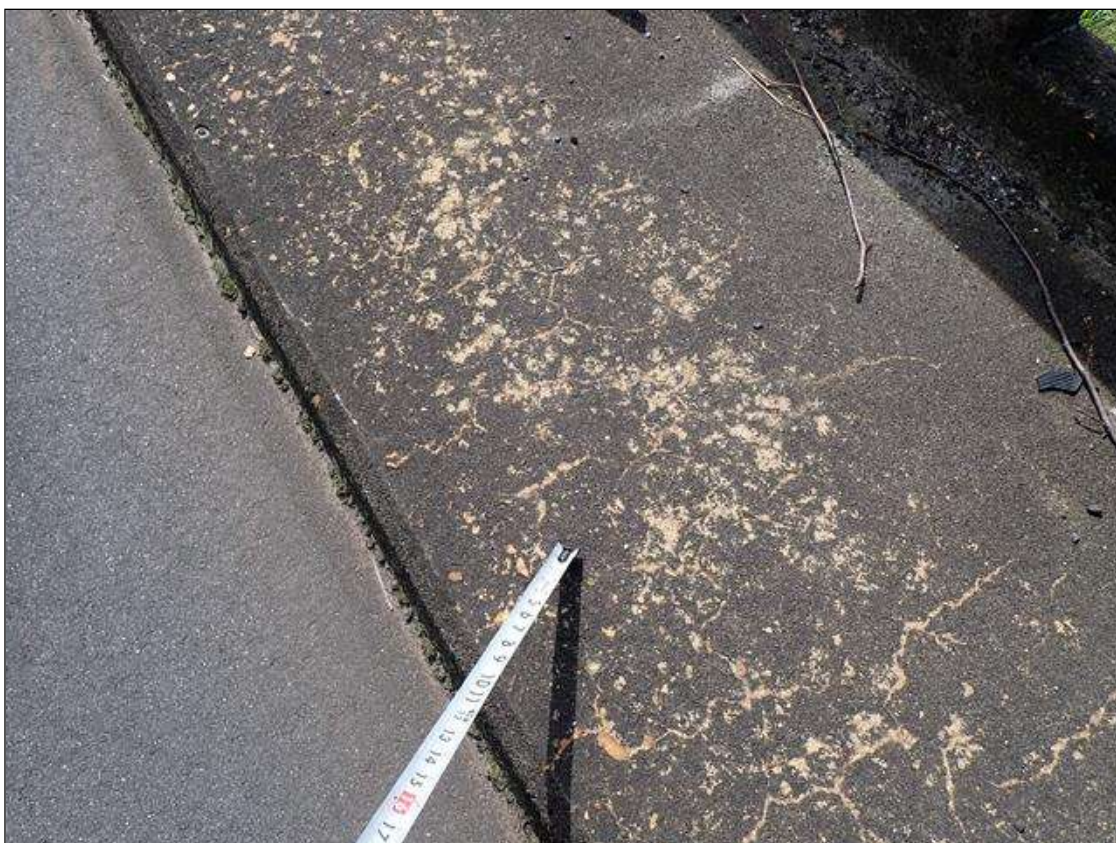
Span 4 Left Bridge Rail: along the length of sidewalk, transverse cracks (hairline x full width) and map cracks (hairline) at random

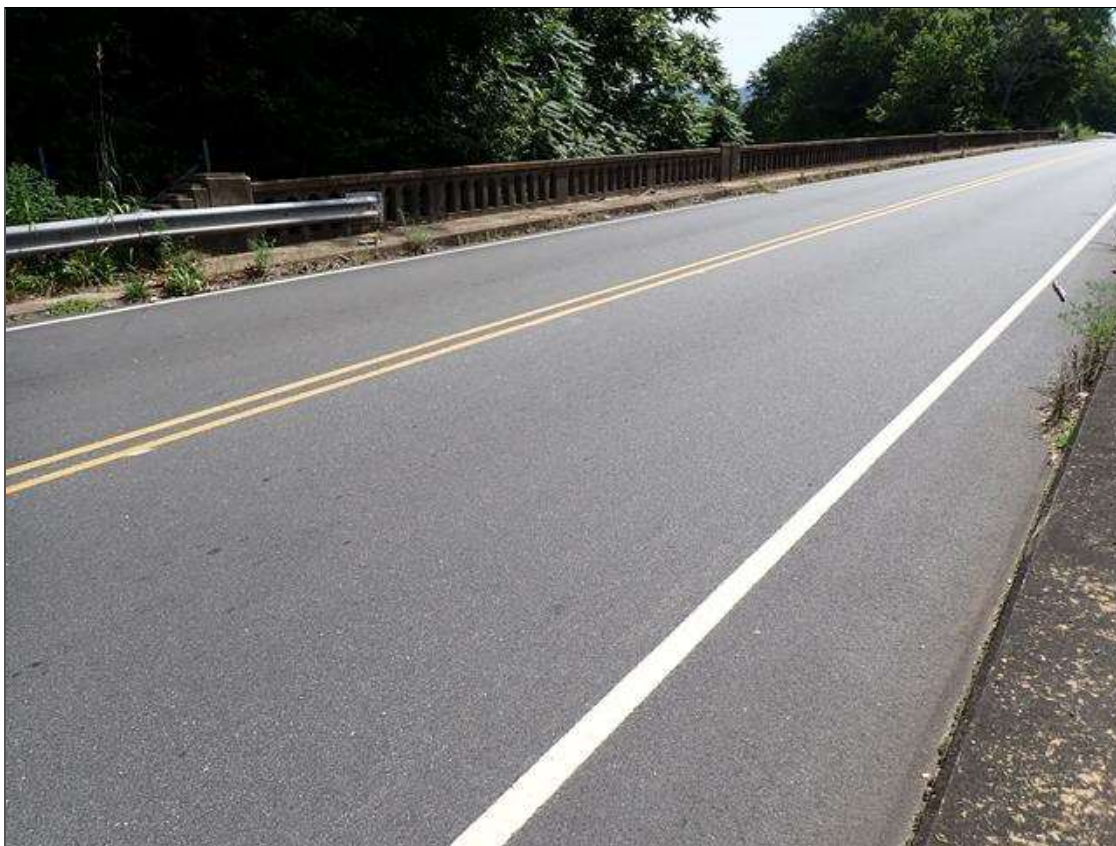
Span 4 Wearing Surface: PREVIOUSLY REPAIRED SEALED MAP & TRANSVERSE CRACKS AT RANDOM THROUGHOUT.

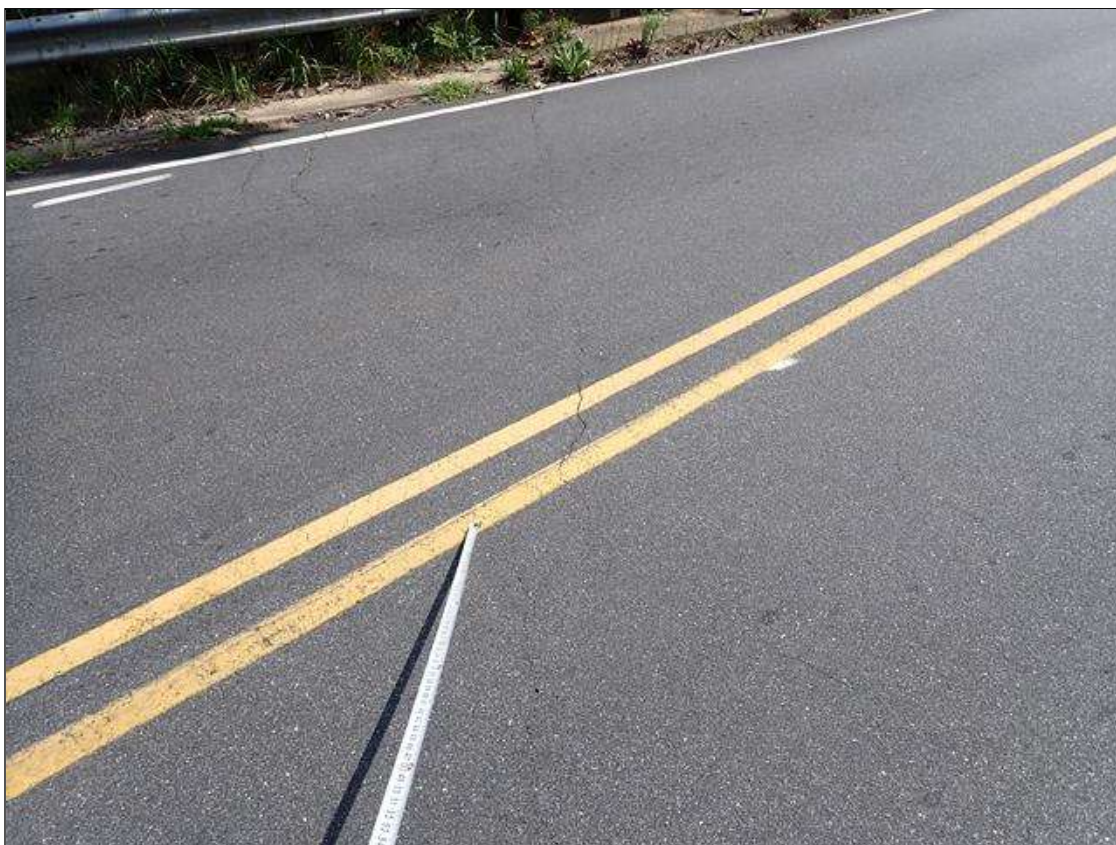
Span 4 Wearing Surface: at end bent 2, transverse cracks (up to 1/32 inch x 15 foot)

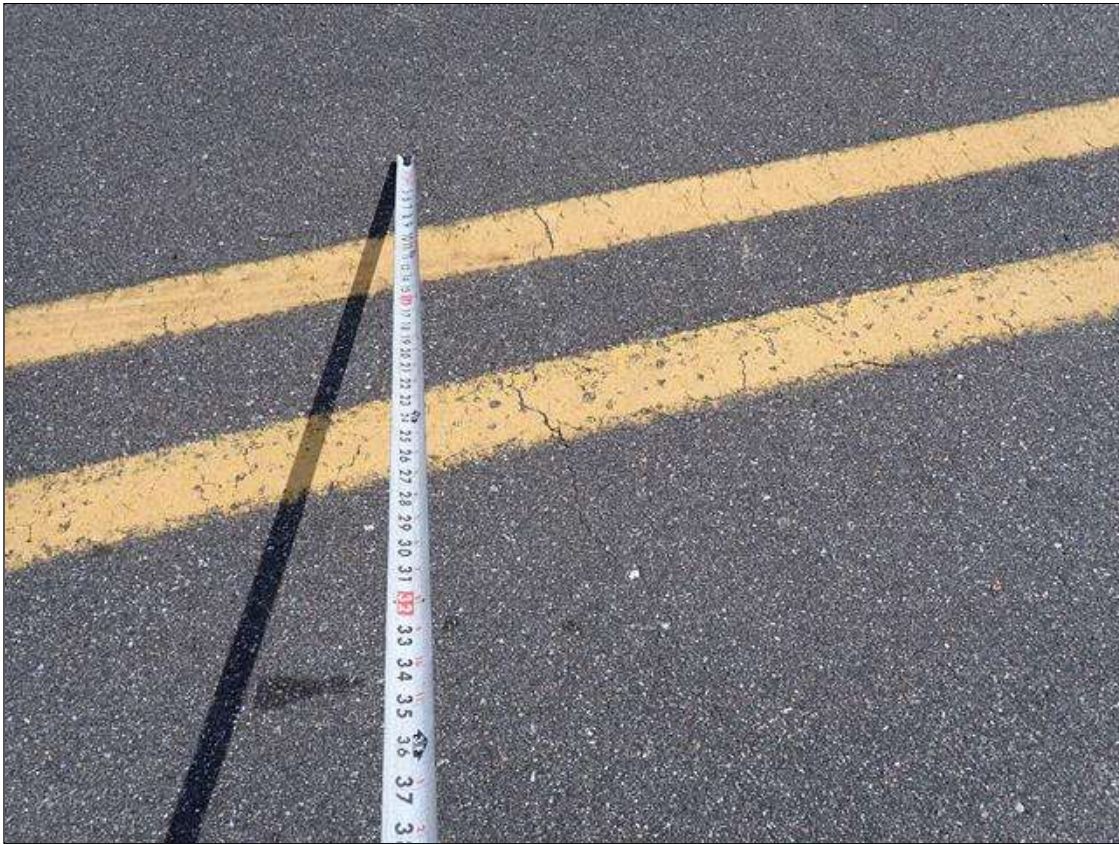
Span 4 Wearing Surface: throughout asphalt wearing surface, transverse and longitudinal cracks (up to 1/32 inch x 5 foot) at random

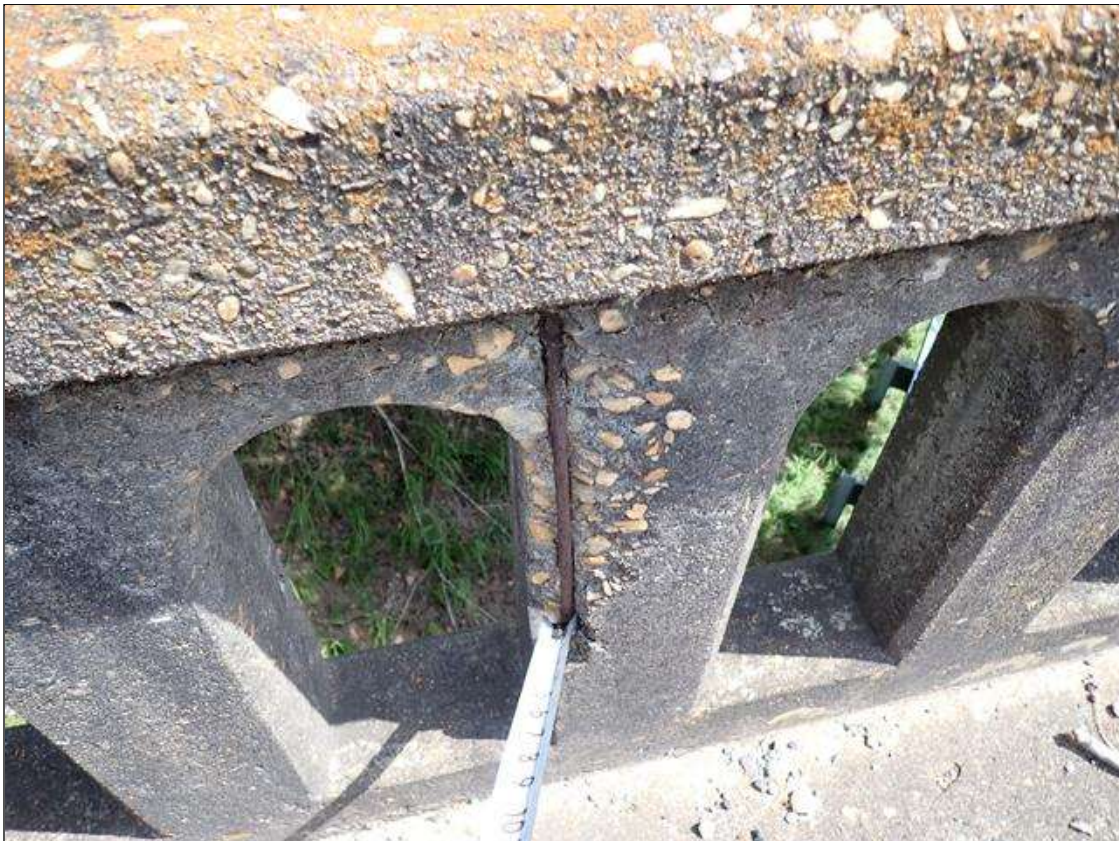
Span 3 Right Bridge Rail: along length of rail, multiple spalls, up to 16 inch x 4 inch x 1 inch deep, some with exposed rusted reinforcing, no loss noted

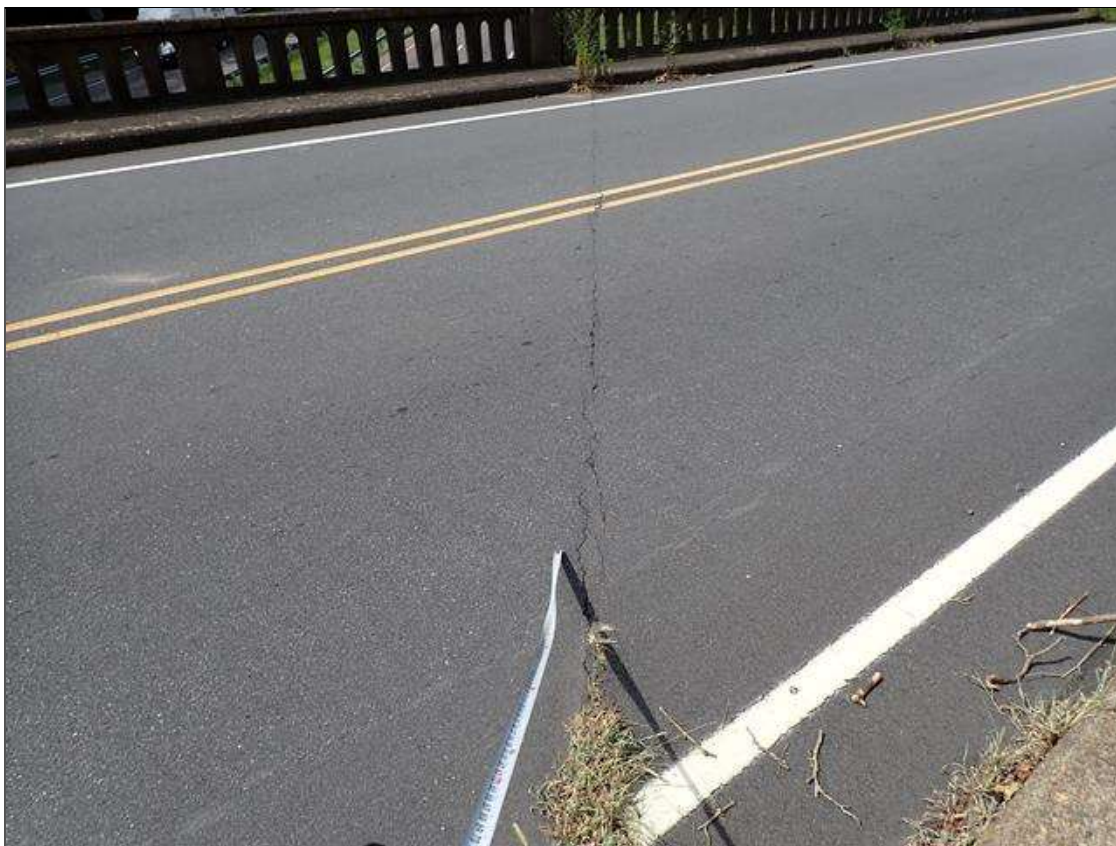
Span 3 Wearing Surface: at bent 3, transverse cracks (up to 1/8 inch x full roadway width) with vegetation growth
