NC DEPARTMENT OF TRANSPORTATION
 DIVISION OF HIGHWAYS
 STRUCTURE MANAGEMENT UNIT

ATTENTION: **prompt action request; sketches updated**

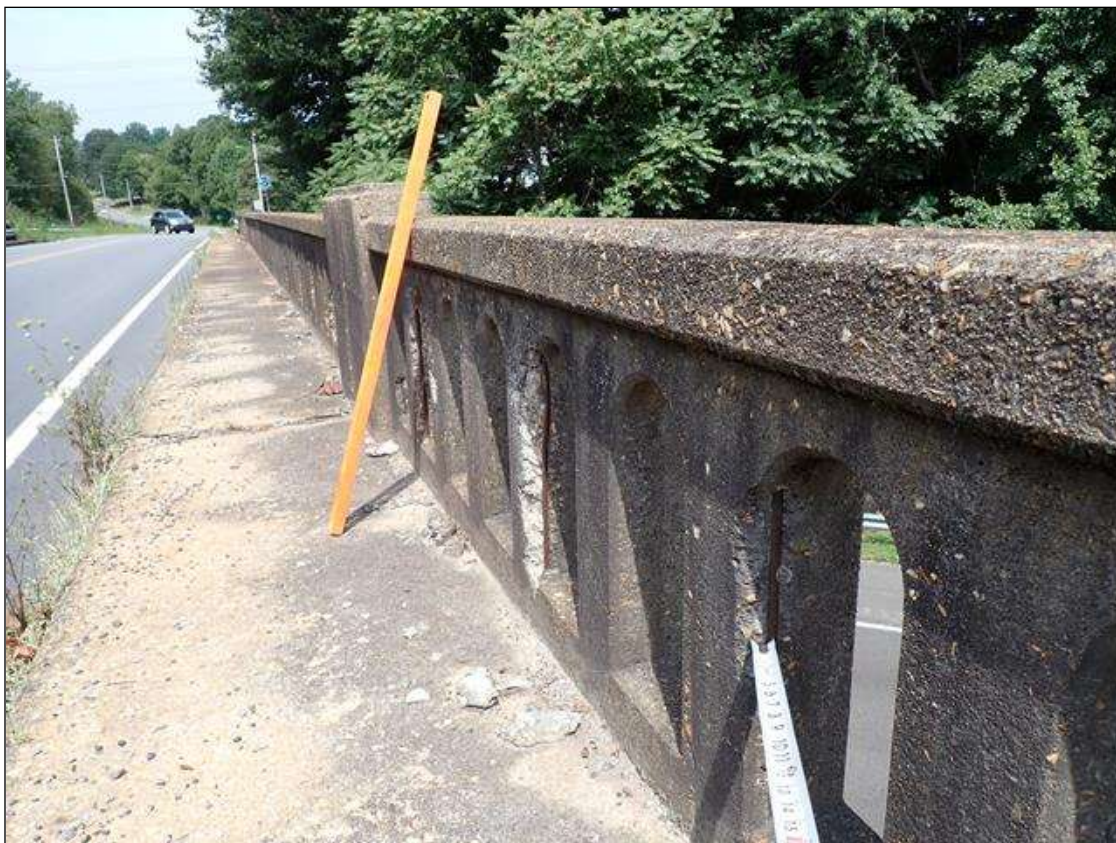
Span 2 Right Bridge Rail: along length of rail, multiple spalls, up to 20 inch x 4 inch x 1 inch deep, some with exposed rusted reinforcing, no loss noted

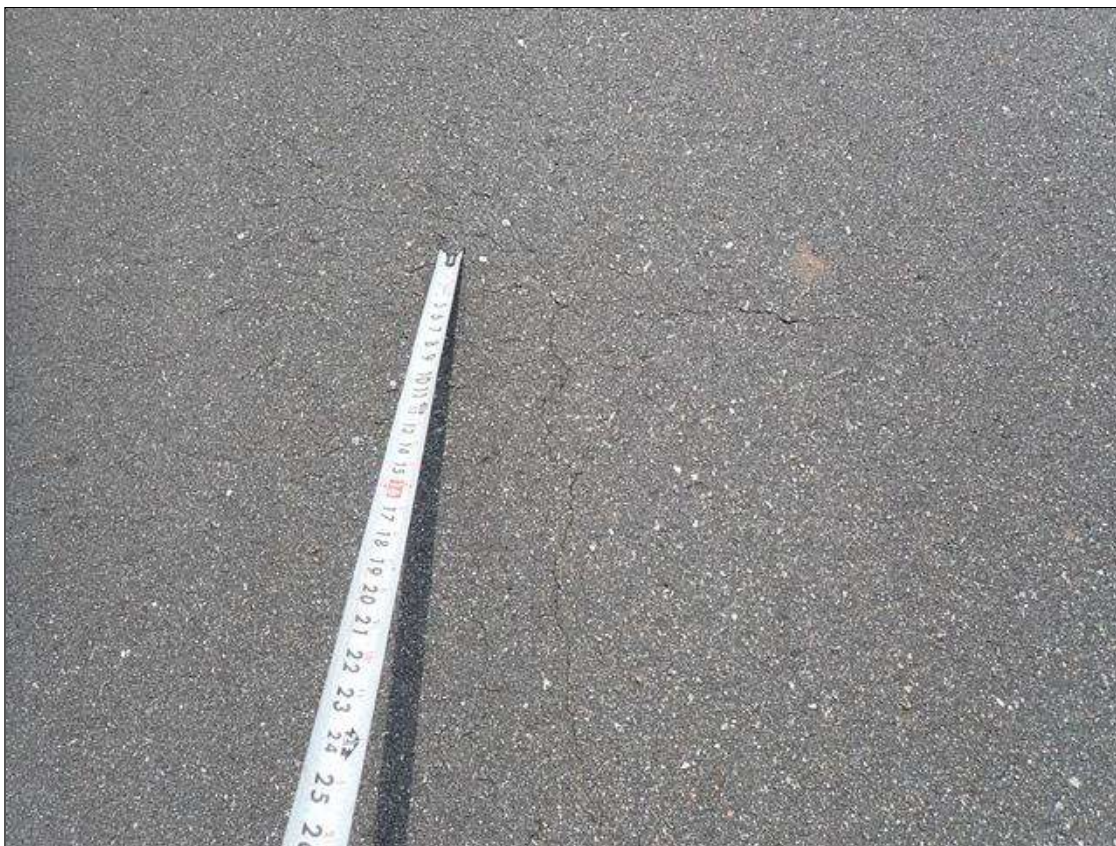
Span 2 Wearing Surface: throughout asphalt wearing surface, transverse and longitudinal cracks (up to 1/32 inch x 5 foot) at random

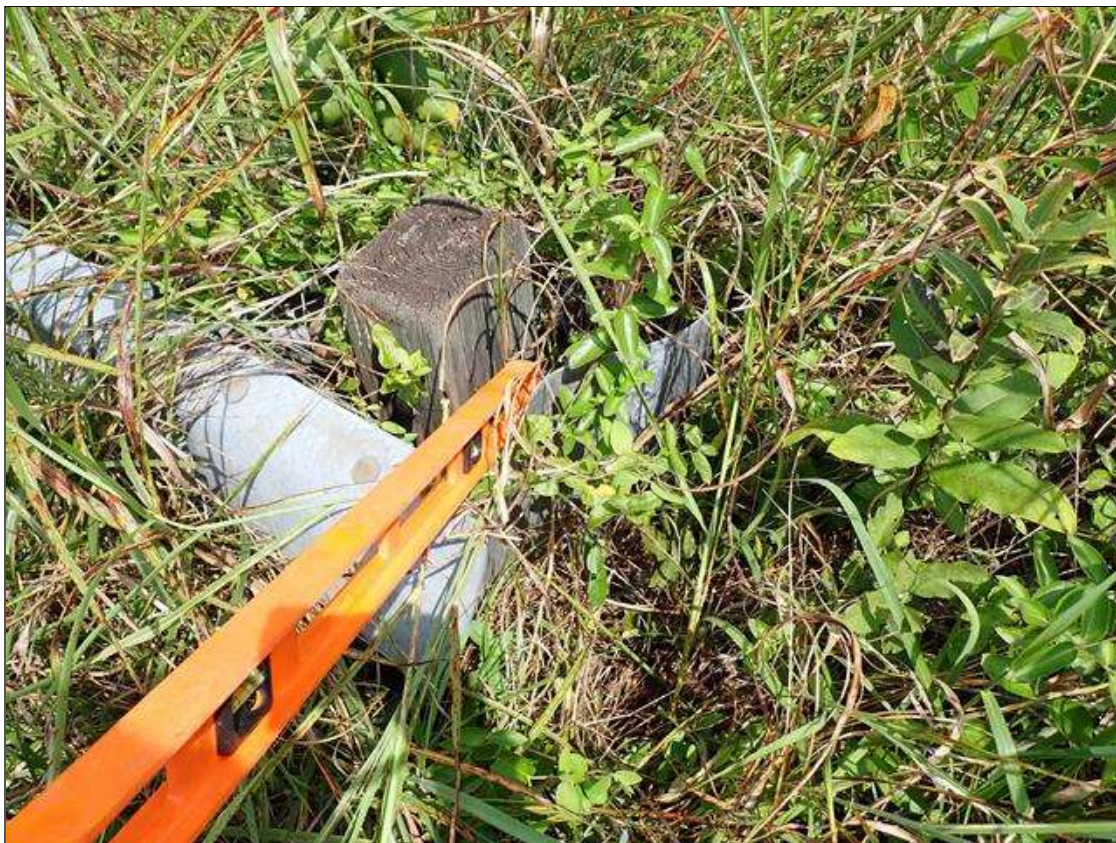
(PAR) southeast guardrail termination, impact damage

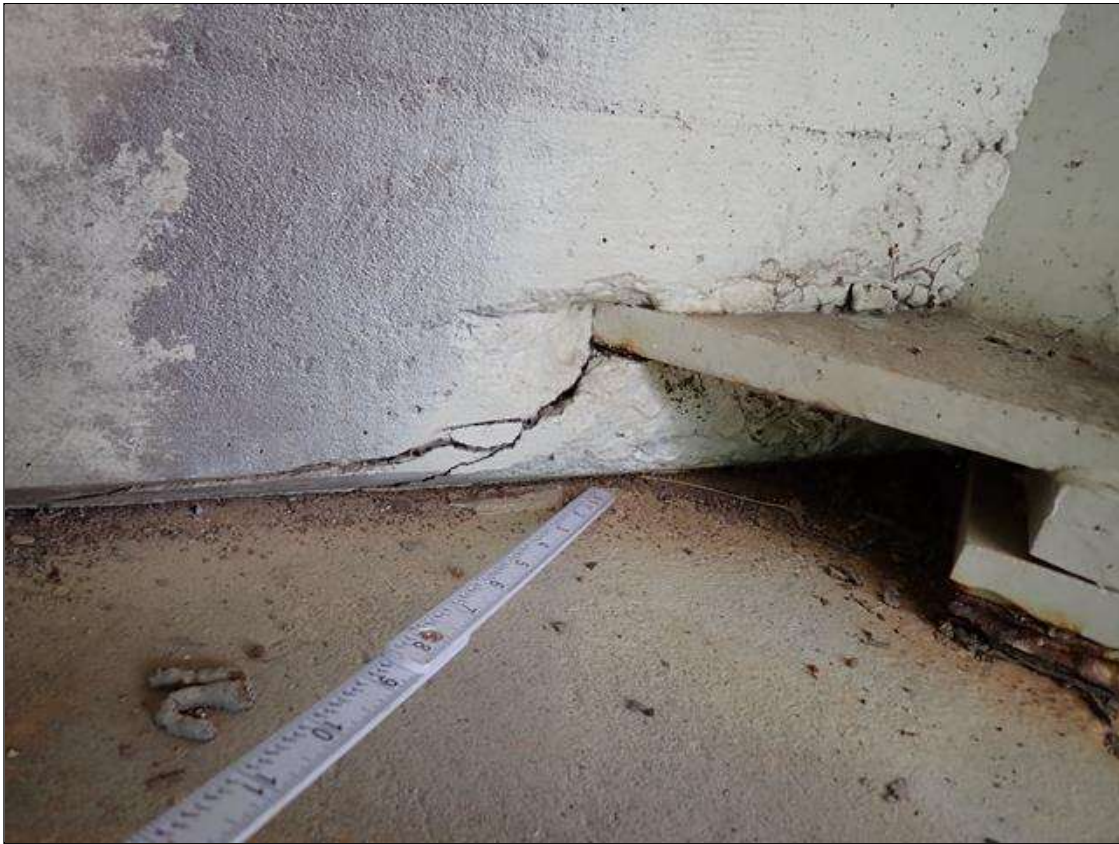
End Bent 1 Abutment: along the length of the abutment, at bottom flange penetrations, spalls/delaminations (12 inch x 5 inch x 1 inch deep)

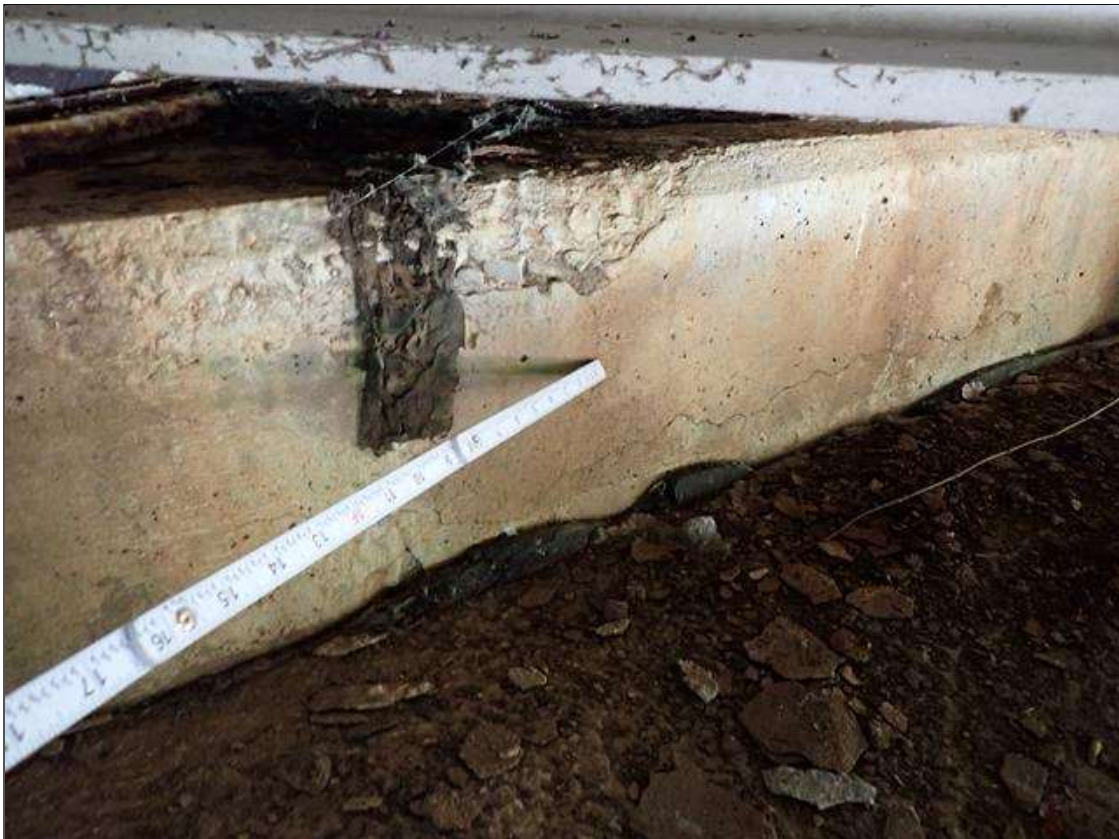
End Bent 1 Cap 1: 1 FOOT X 3 INCH X 1/2 INCH SPALL UNDER BEAM 2 WITH ADJACENT HORIZONTAL CRACK UP TO 1/16 INCH X 4 FOOT

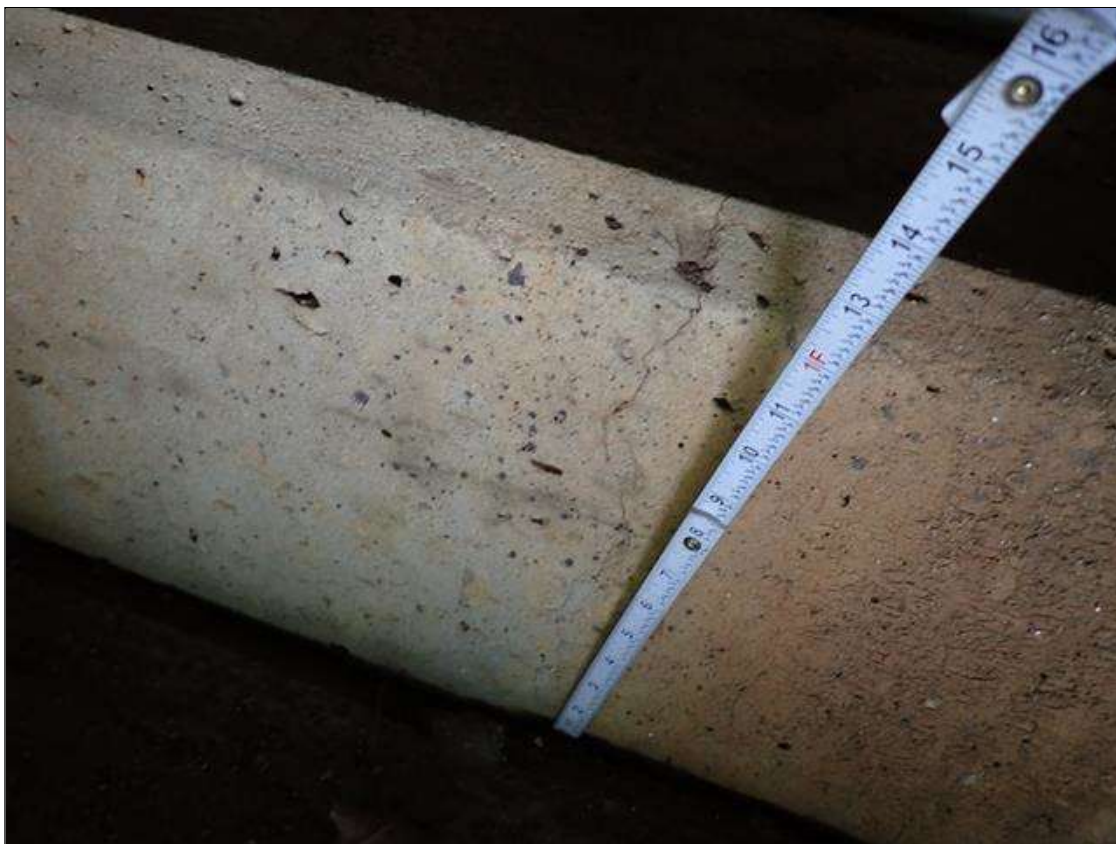
End Bent 1 Cap 1: along length, multiple vertical cracks [up to full height x 1/32 inch]

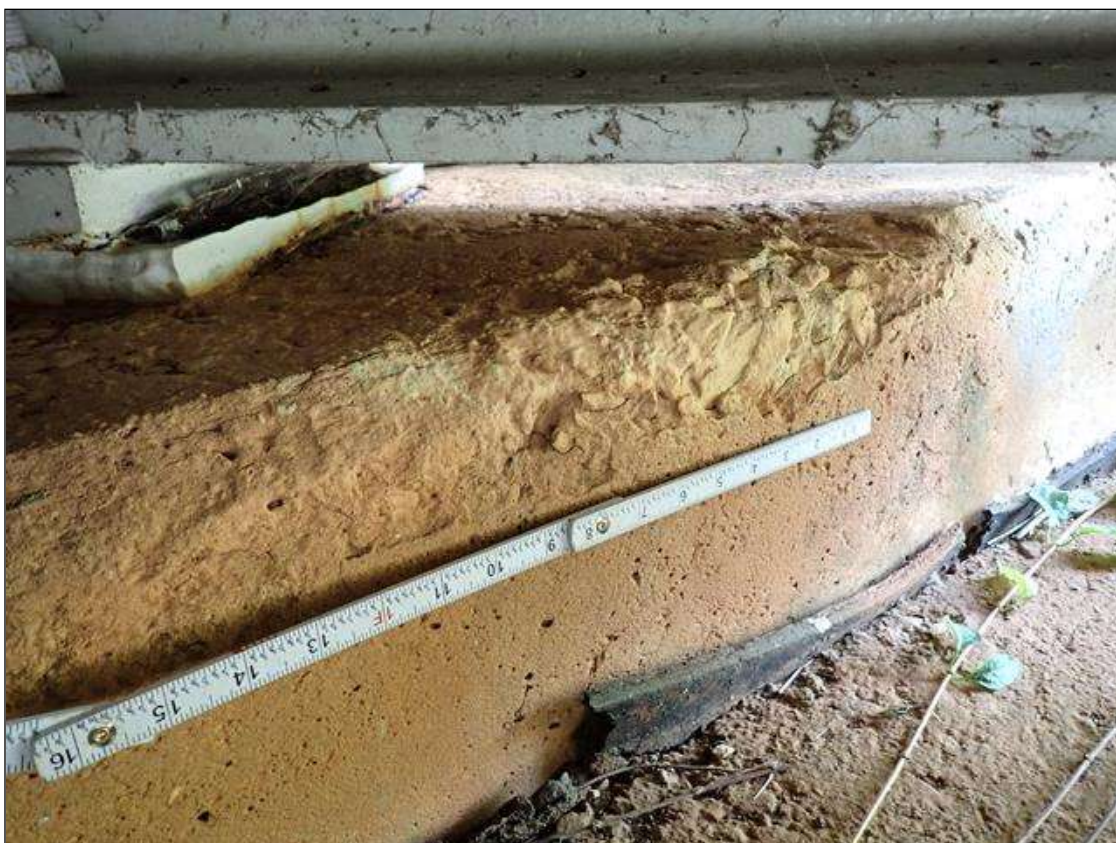
End Bent 1 Cap 1: below beam 1, spall (1 foot x 3 inch x 1/2 inch deep)

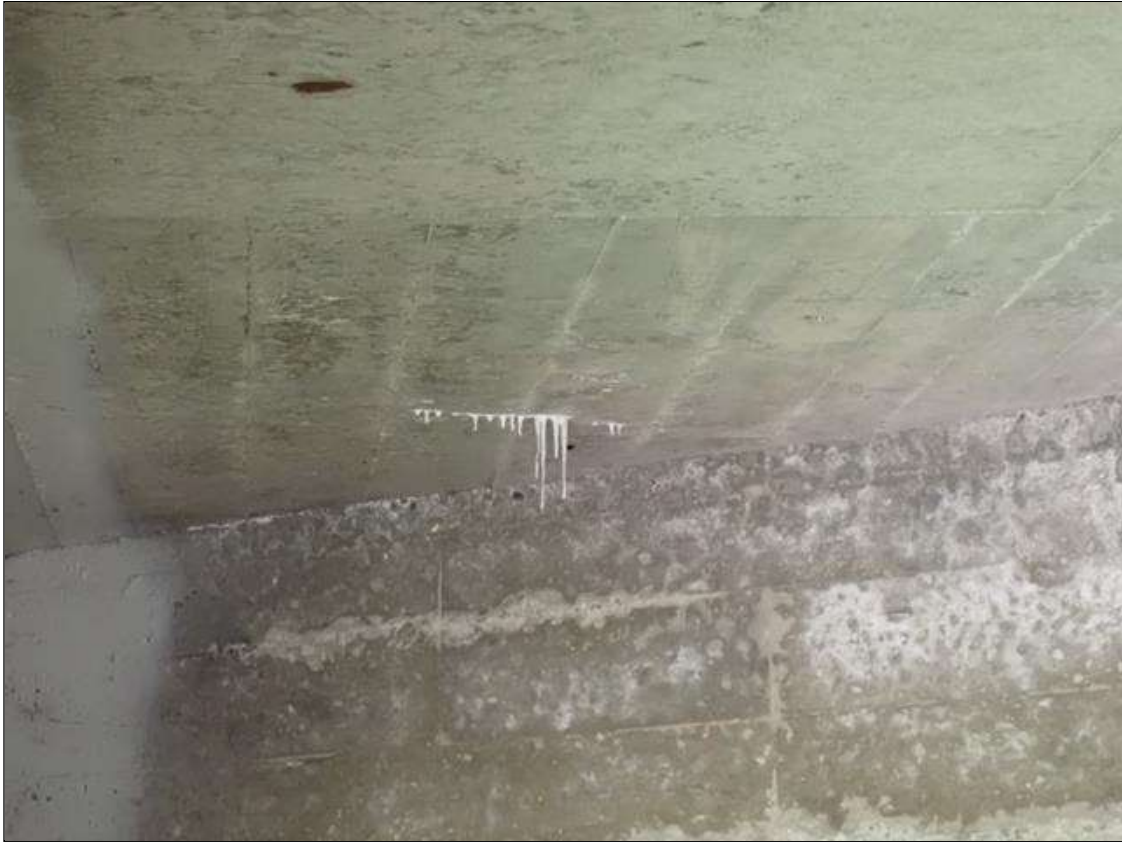
Span 1 Deck: (PAR) EFFLORESCENCE WITH SOME BUILDUP AT RANDOM THROUGHOUT UNDERSIDE OF DECK.

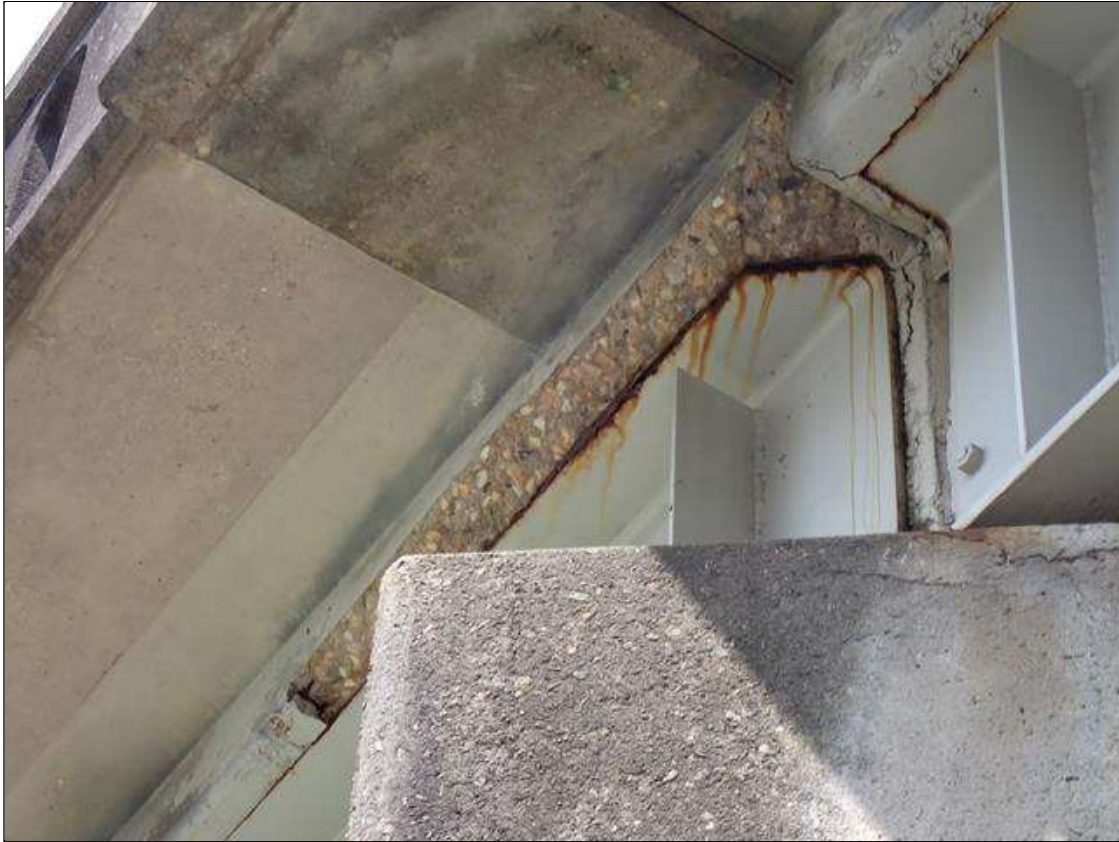
Span 4 Beam 1: (PAR) at bent 3, corrosion with section loss: web adjacent to diaphragm (9/16 inch average remaining x 11 inch x 2 inch); right stiffener (0.15 inch average remaining x full width x 3 inch) with corrosion holes (up to 1/4 inch diameter); west face top flange, rust scale

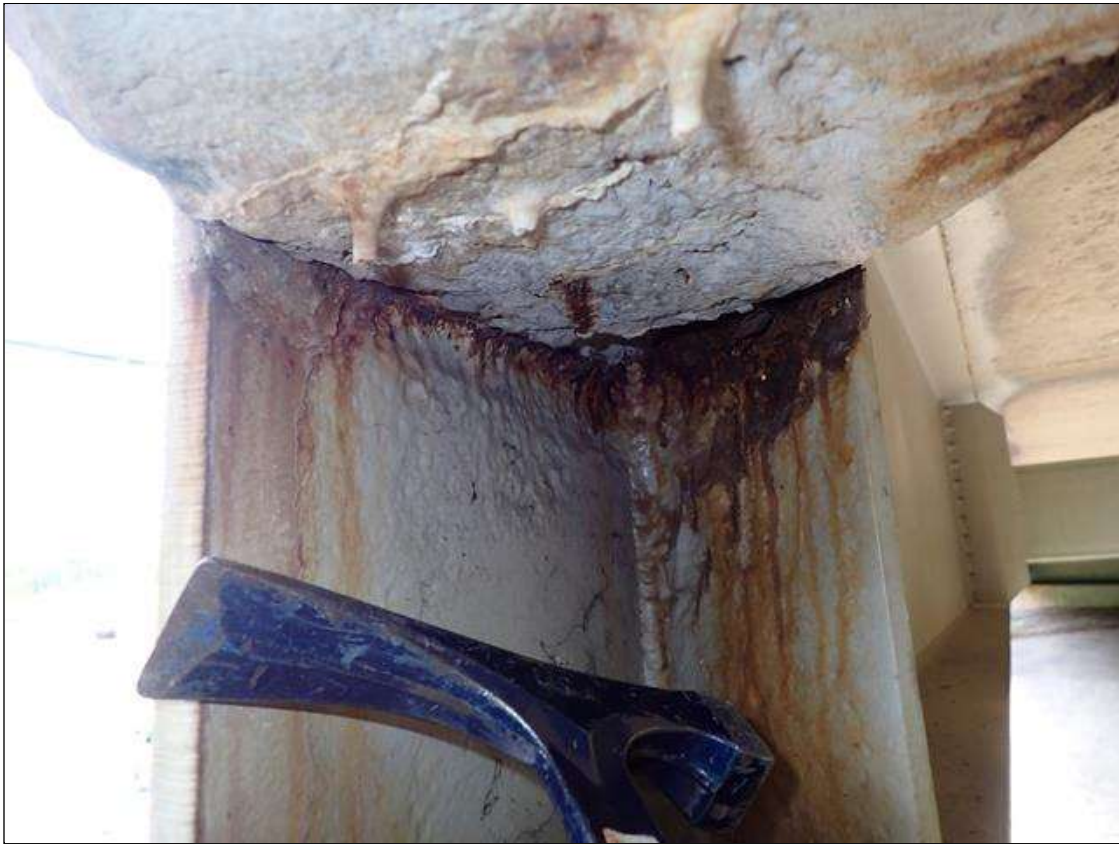
Span 4 Beam 1: (PAR) at bent 3, corrosion with section loss: web adjacent to diaphragm (9/16 inch average remaining x 11 inch x 2 inch); right stiffener (0.15 inch average remaining x full width x 3 inch) with corrosion holes (up to 1/4 inch diameter); west face top flange, rust scale

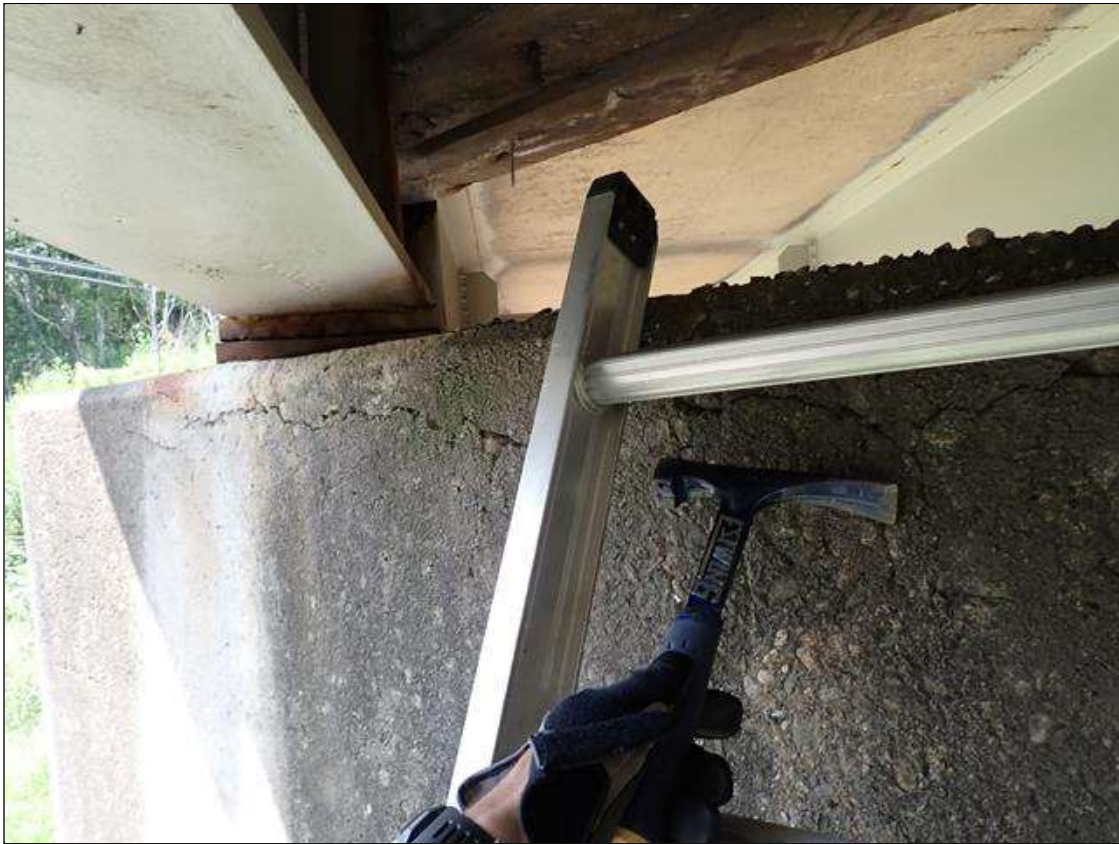
Bent 3 Cap 1: SOUTH AND NORTH FACE (2) UP TO 8 FOOT X 1/16 INCH HORIZONTAL CRACK UNDER BAY 1, SIMILAR BAY 4.

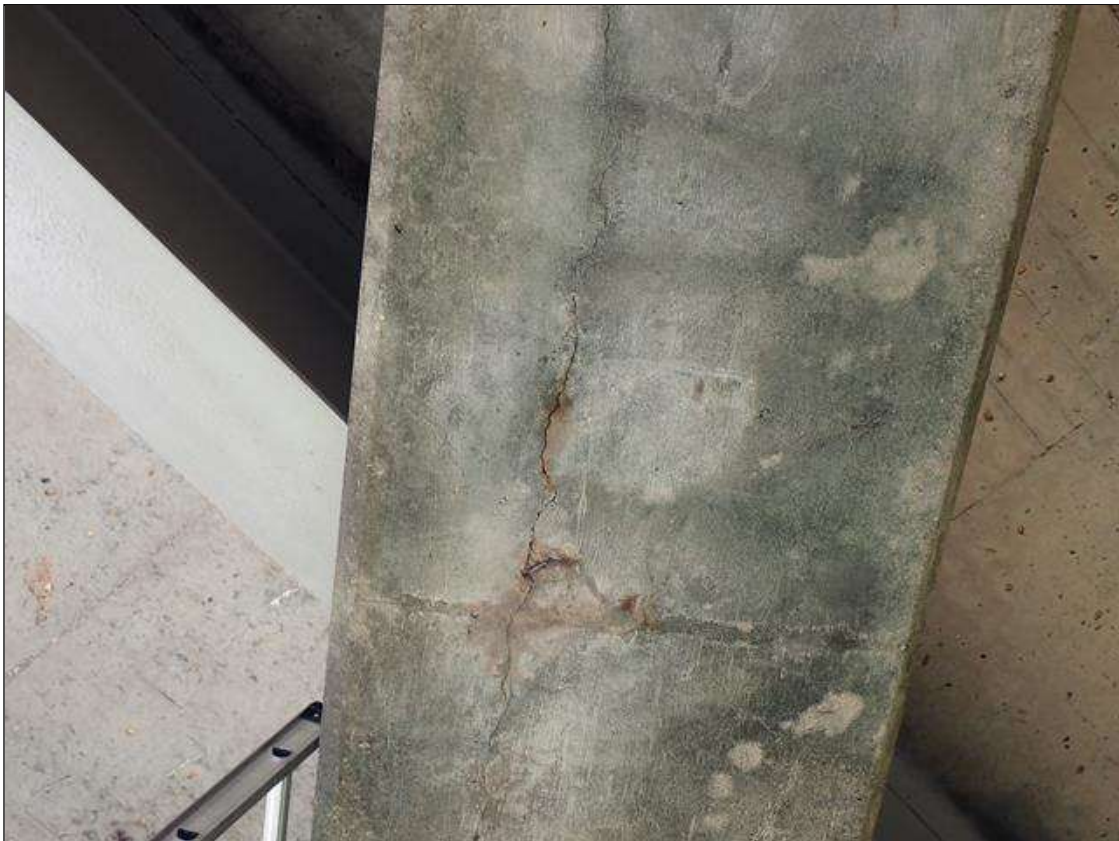
Bent 3 Cap 1: (PAR) UNDERSIDE OF CAP, 10 FOOT UP TO 1/16 INCH LONGITUDINAL CRACK WITH RUST STAINING UNDER BEAM 2, SIMILAR UNDER BEAM 4.

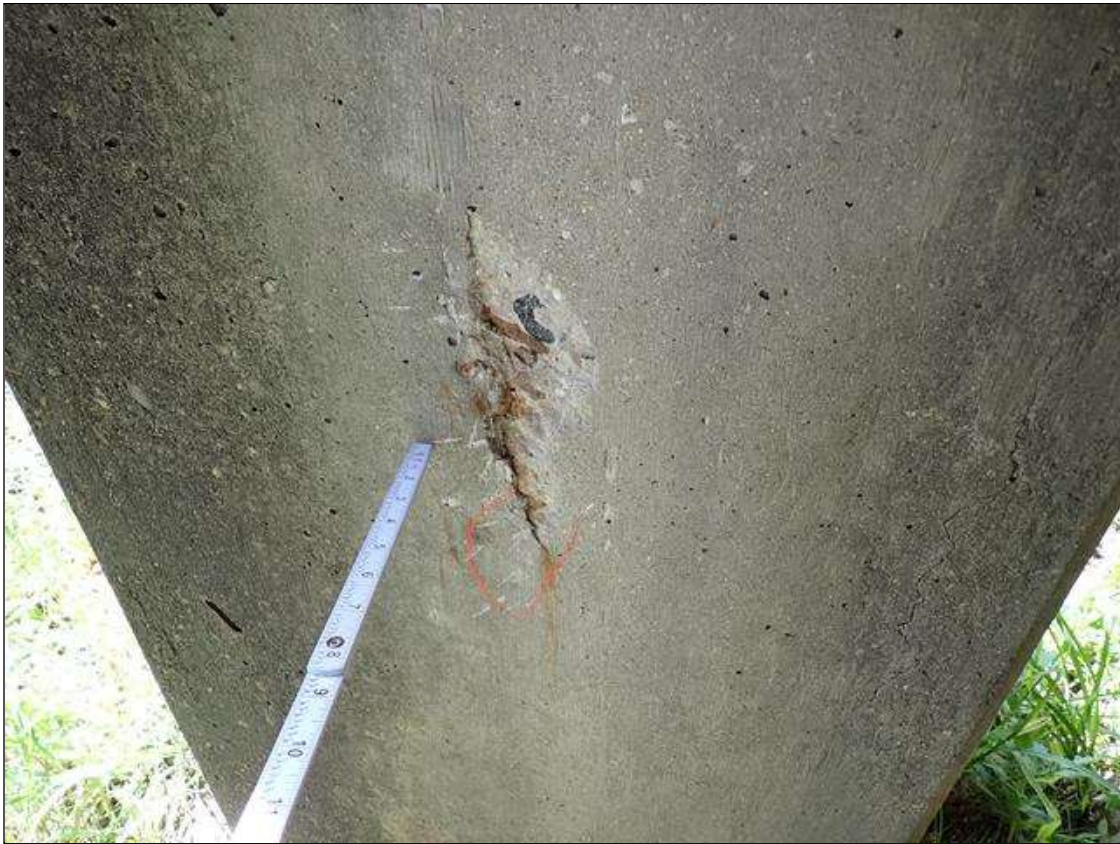
Bent 3 Pile 1: East face 3 foot from ground, spall/delamination [12 inch x 3 inch x 1/2 inch deep]

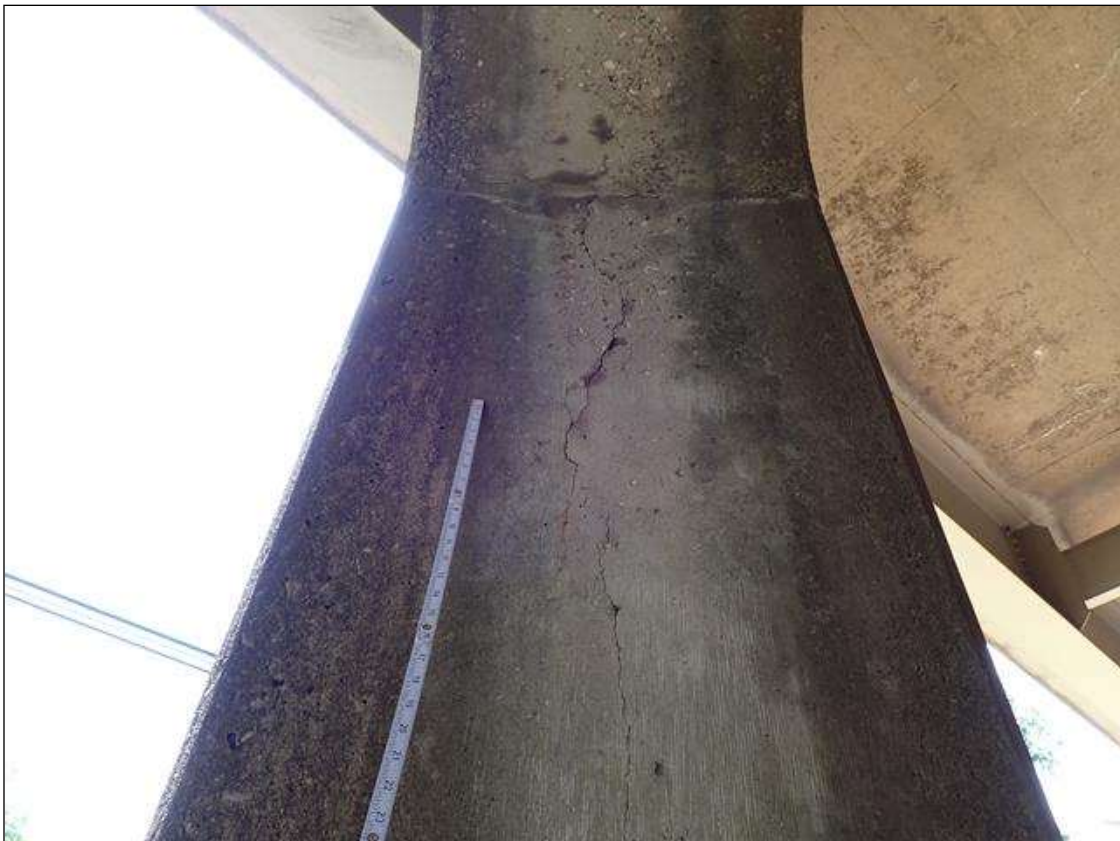
Bent 3 Pile 1: (4) 6 FOOT X UP TO 1/32 INCH VERTICAL CRACKS BEGINNING AT BOTTOM OF CAP AT RANDOM THROUGHOUT.

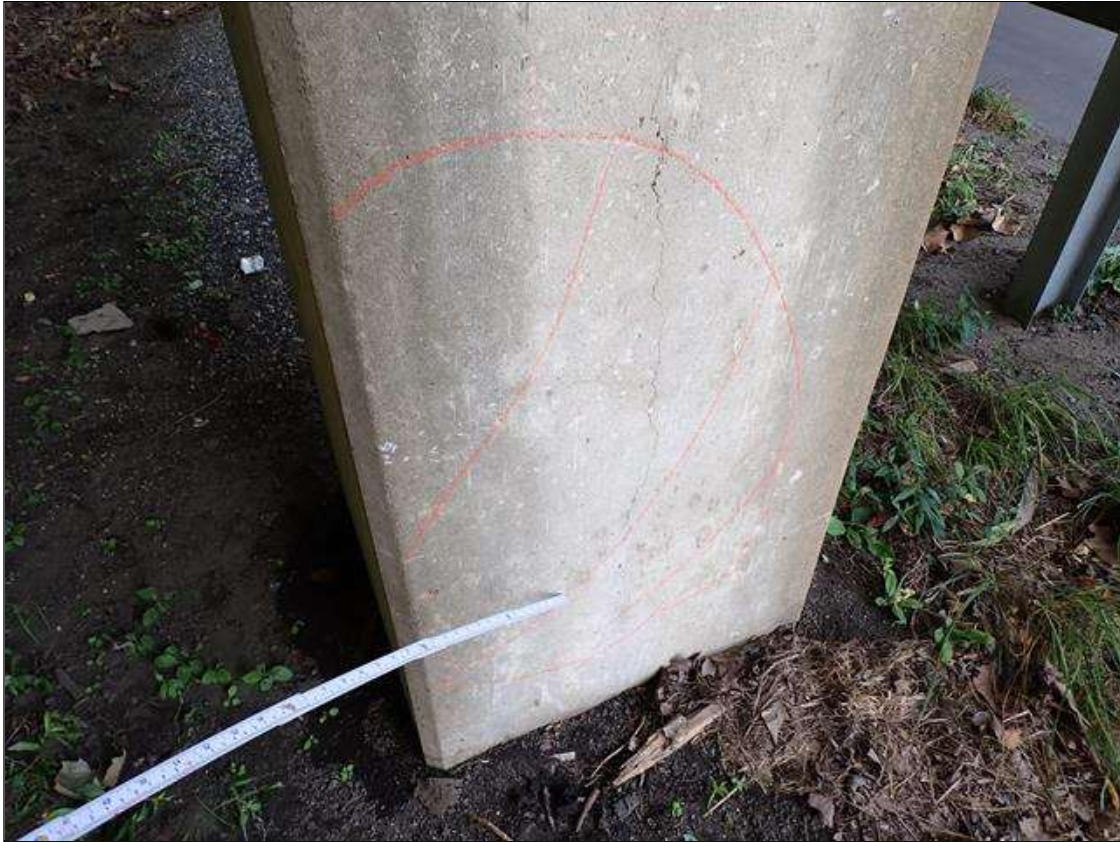
Bent 3 Pile 2: 36 INCH X 24 INCH CRACKED DELAMINATION AREA WITH CRACKS UP TO 1/32 INCH ON WEST FACE NEAR GROUND LINE.

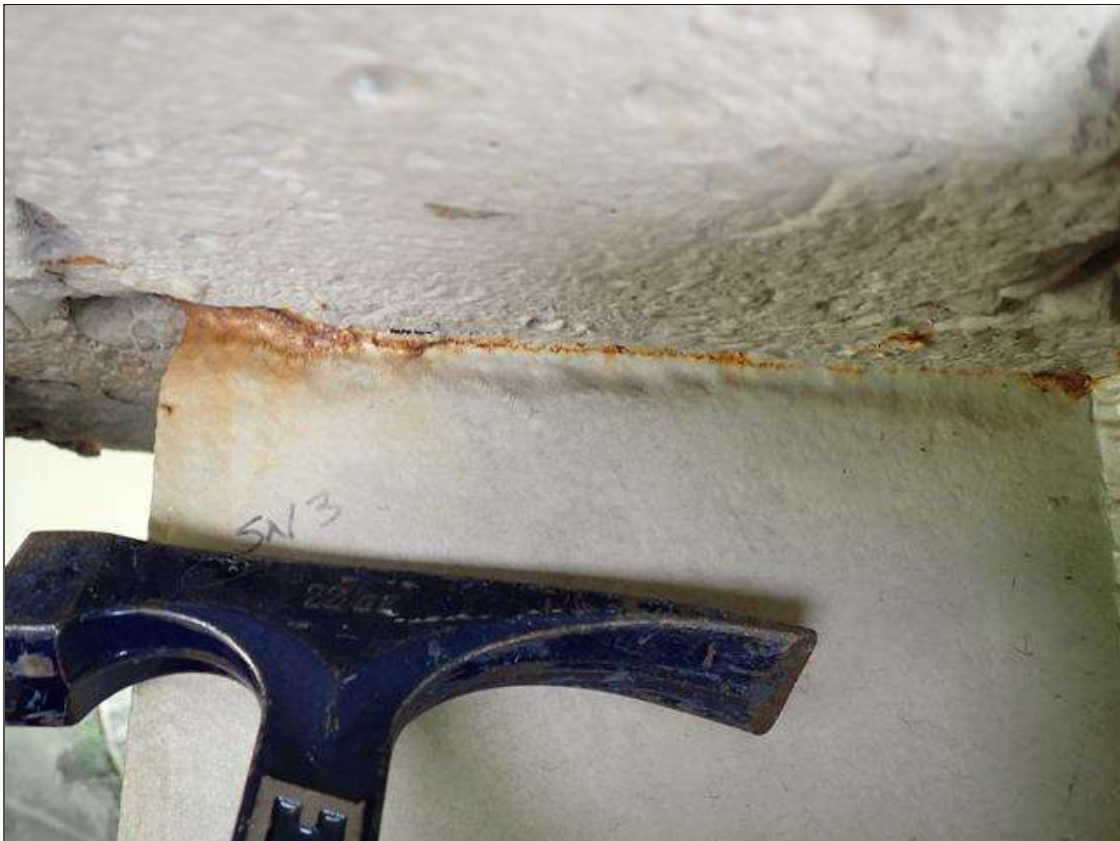
Span 3 Beam 2: at bent 3, corrosion with section loss: web adjacent to diaphragm (9/16 average remaining x 10 inch x 2 inch)

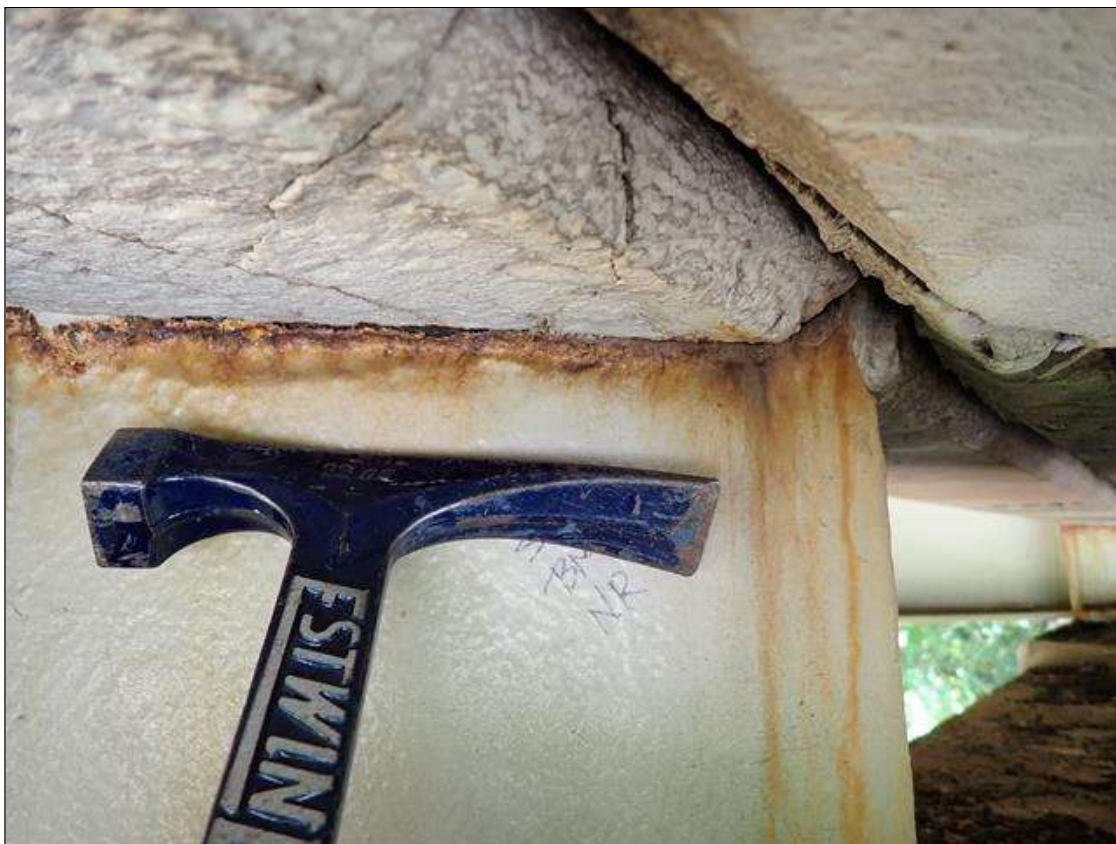
Span 4 Beam 2: at bent 3, corrosion with section loss: web adjacent to diaphragm (9/16 average remaining x 10 inch x 2 inch)

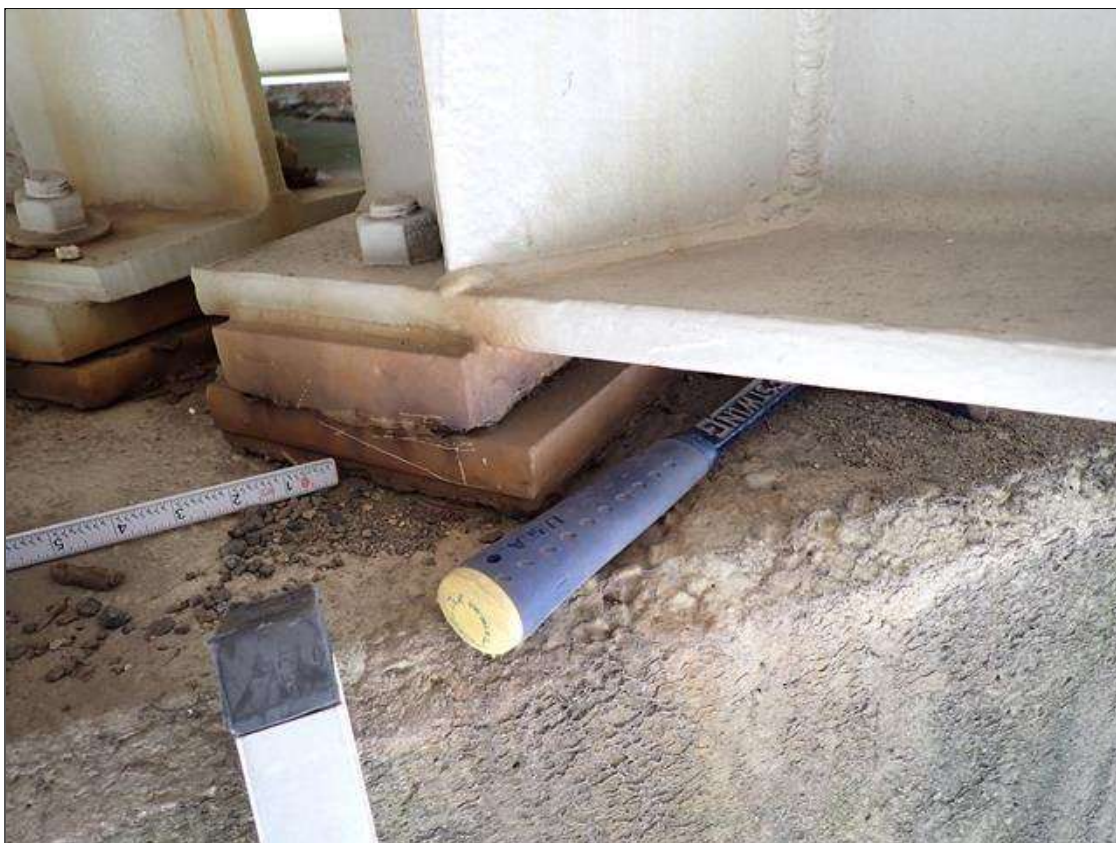
Span 3 Beam 2 - Far Bearing 2: surface rust

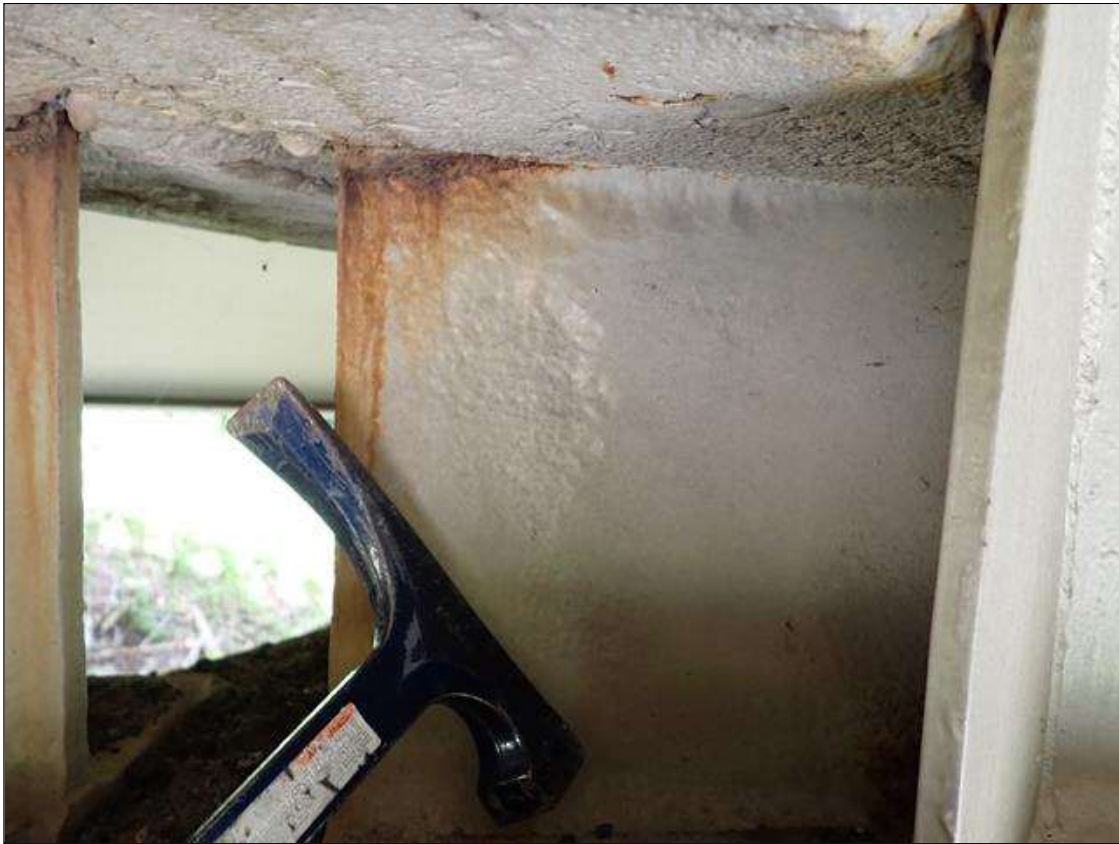
Span 3 Beam 3: at bent 3, pitting with corrosion reactivating: web (up to 1/8 inch deep x 10 inch x 6 inch)

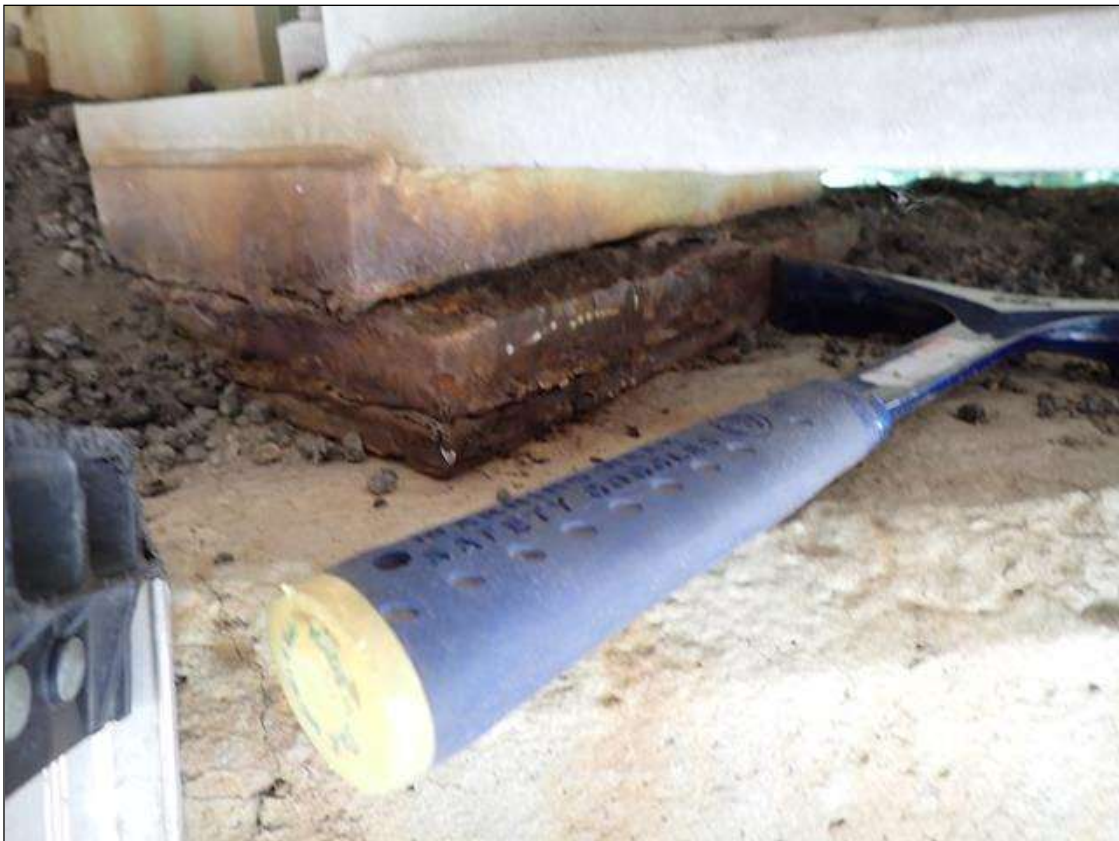
Span 3 Beam 3 - Far Bearing 3: rust scale

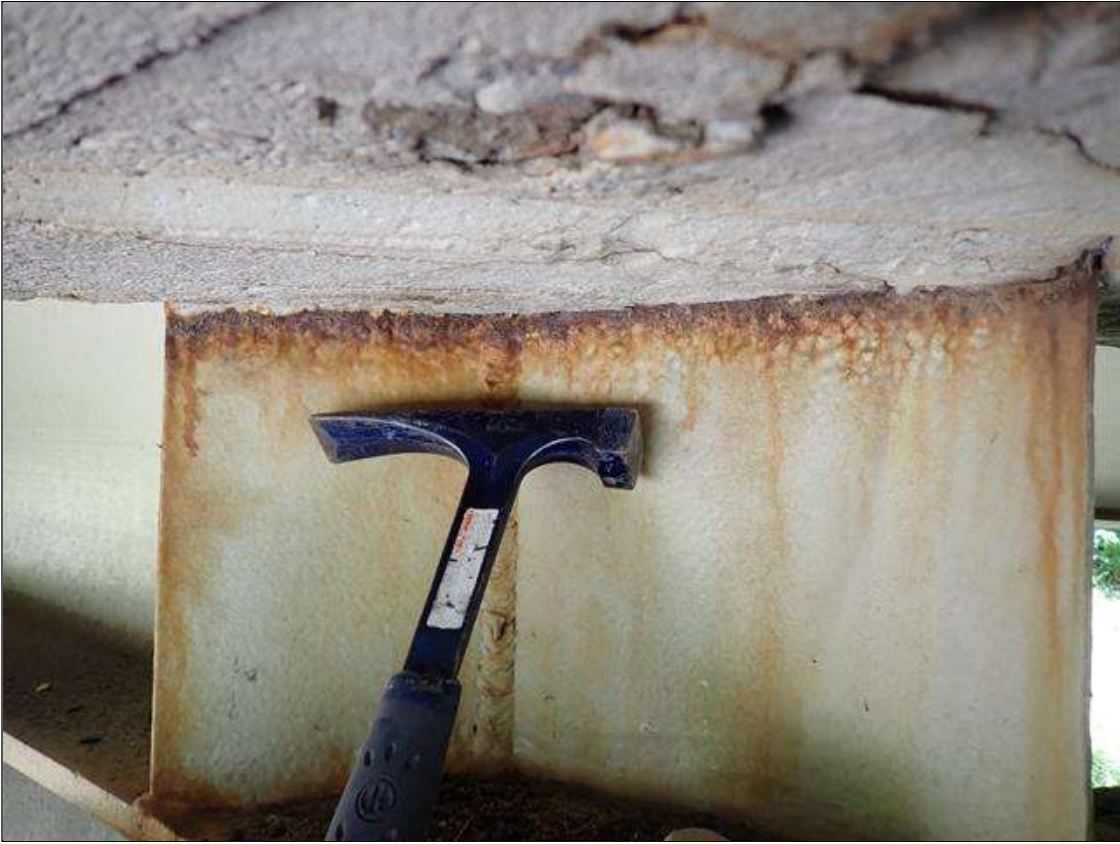
Span 4 Beam 3: at bent 3, pitting with corrosion reactivating: web adjacent to diaphragm (1/16 inch deep x 10 inch x 2 inch); left stiffener (1/16 inch deep x full width x 2 inch)

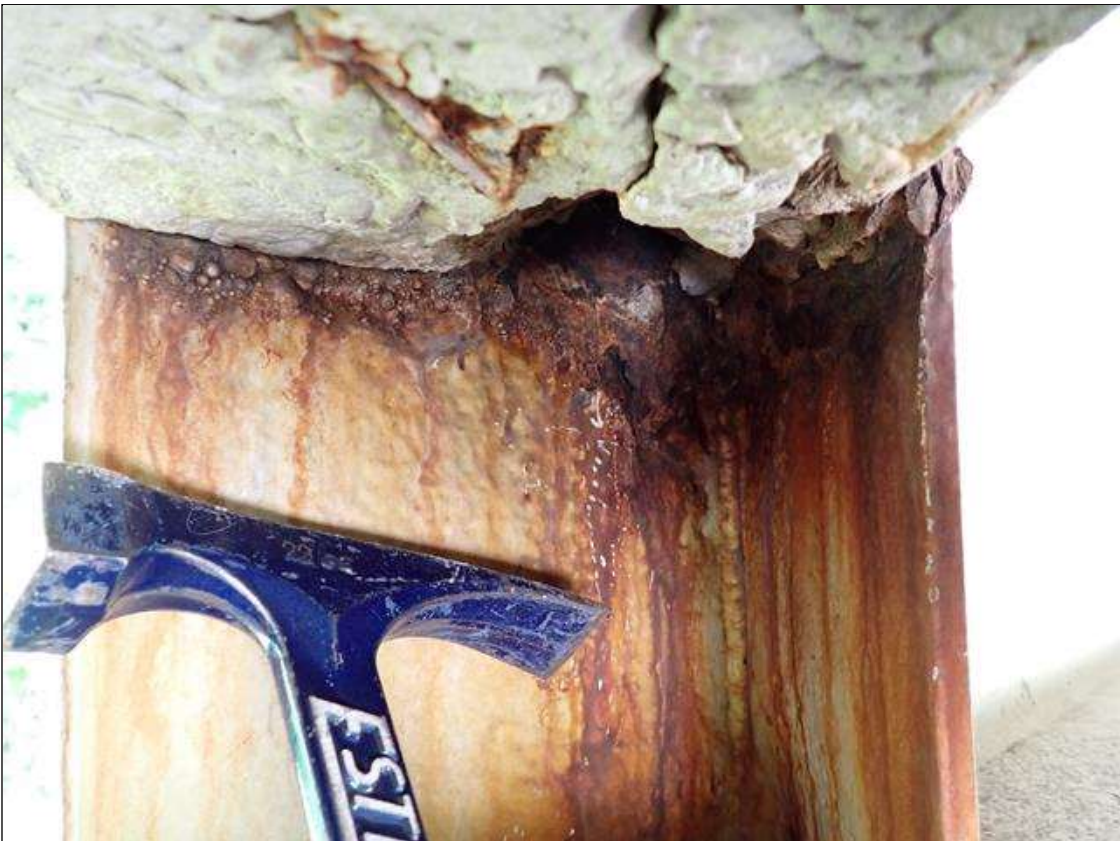
Span 3 Beam 5: at bent 3, corrosion with section loss: web adjacent to diaphragm (9/16 average remaining x 10 inch x 2.5 inch); left stiffener (0.25 inch average remaining x full width x 2.5 inch)

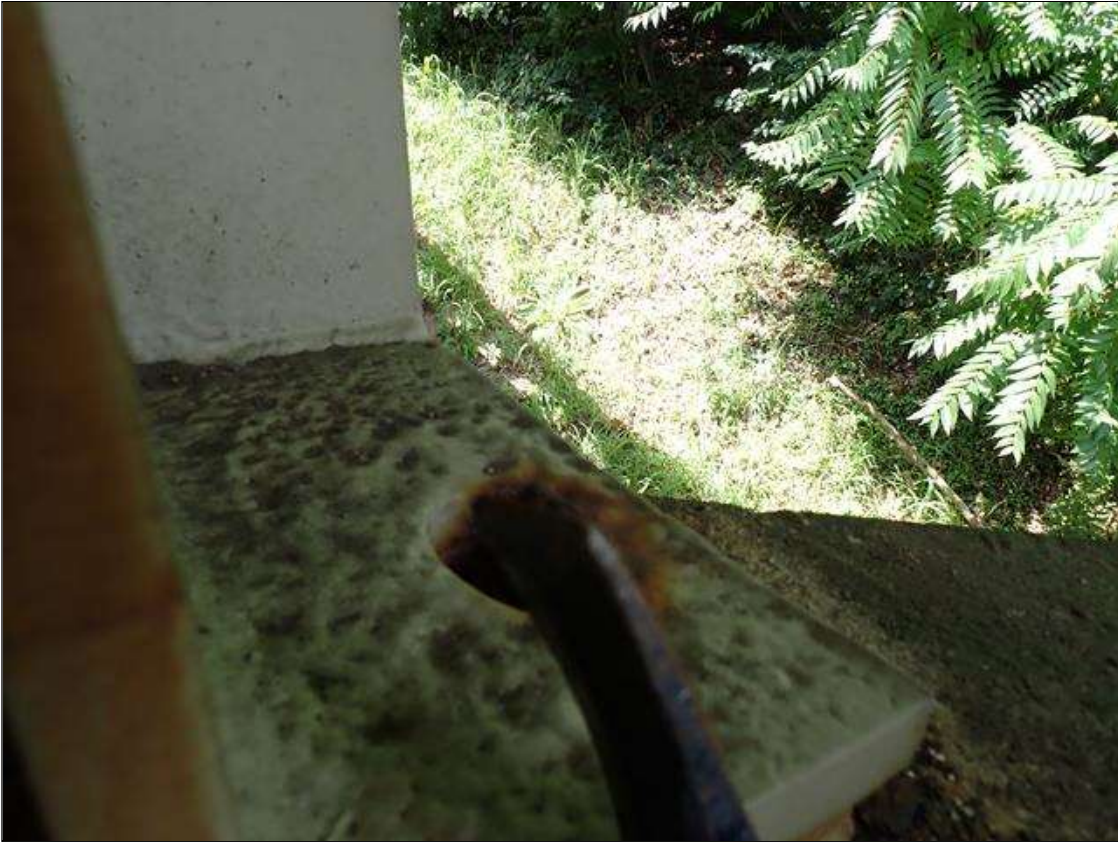
Span 4 Beam 5: at bent 3, pitting with corrosion reactivating: web adjacent to diaphragm (up to 1/16 inch deep x 10 inch x 2.5 inch); bottom flange (1/8 inch deep x 1 foot)
