NC DEPARTMENT OF TRANSPORTATION
 DIVISION OF HIGHWAYS
 STRUCTURE MANAGEMENT UNIT

ATTENTION: **prompt action request; sketches updated**

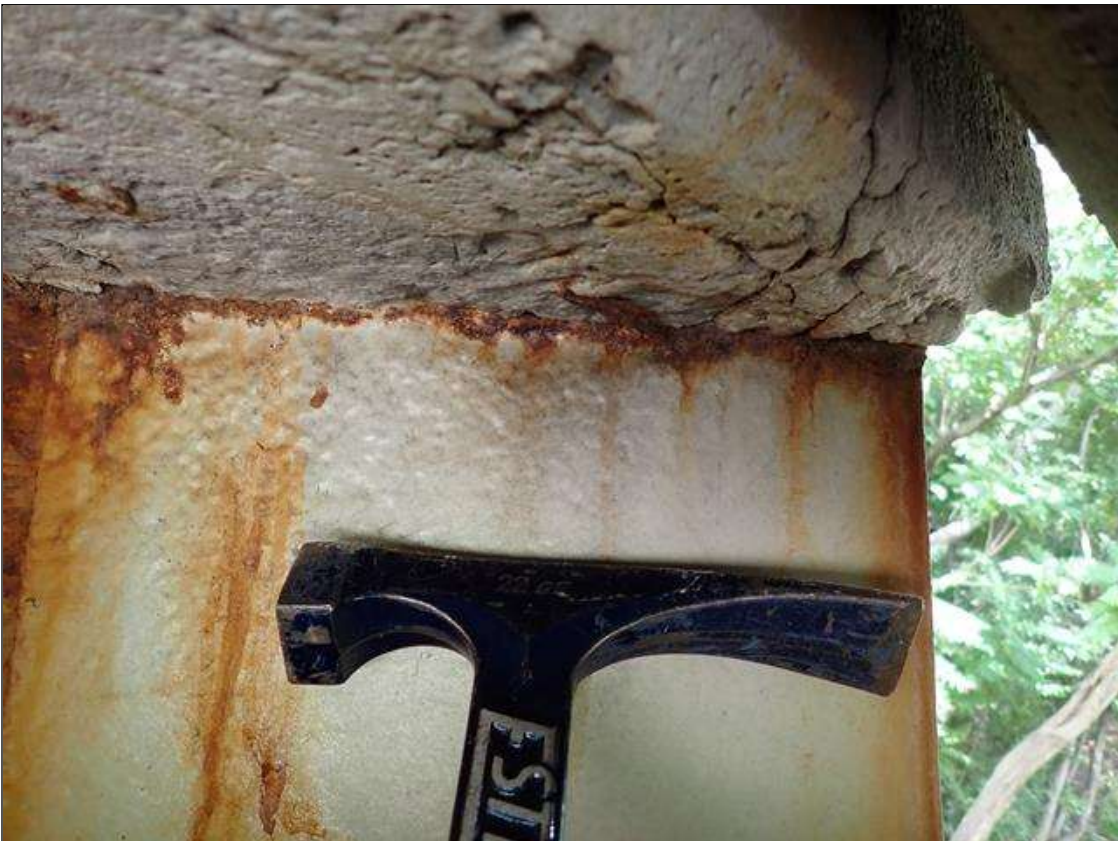
Span 4 Beam 5: at bent 3, pitting with corrosion reactivating: web adjacent to diaphragm (up to 1/16 inch deep x 10 inch x 2.5 inch); bottom flange (1/8 inch deep x 1 foot)

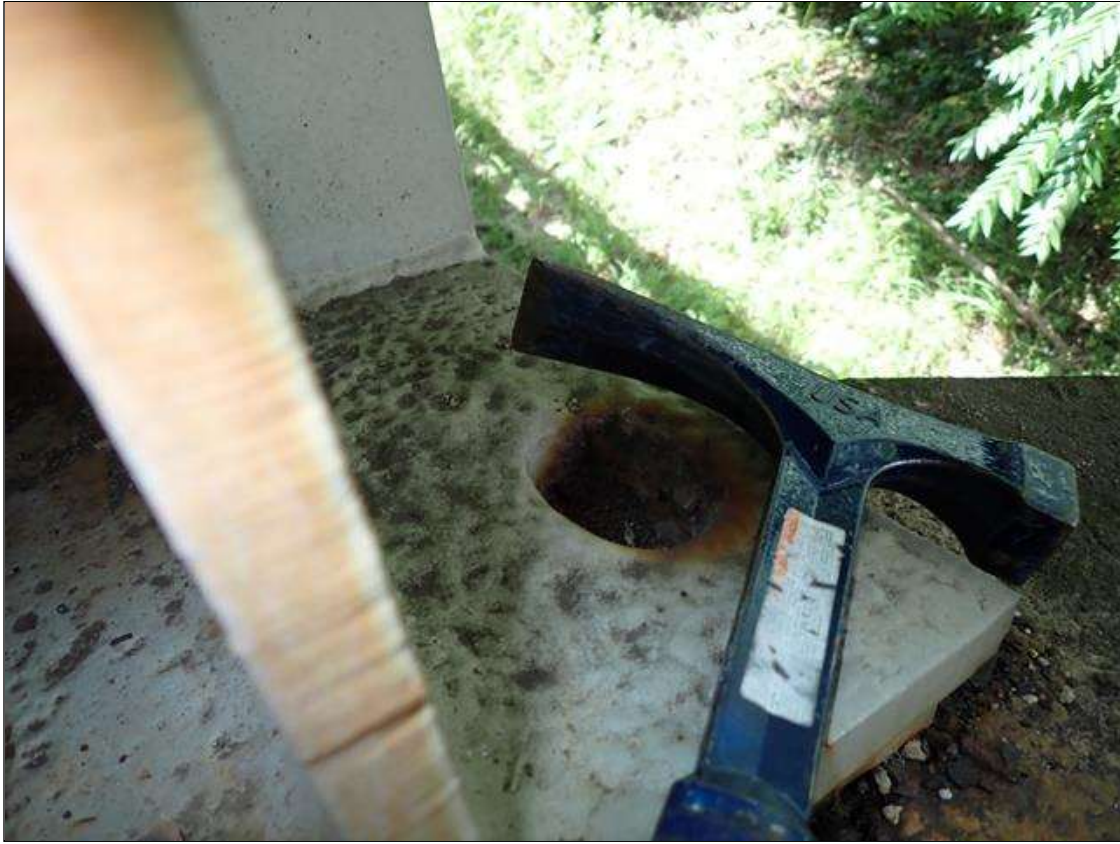
Span 4 Near Bearing 5: (PAR) right anchor rod, sheared/missing

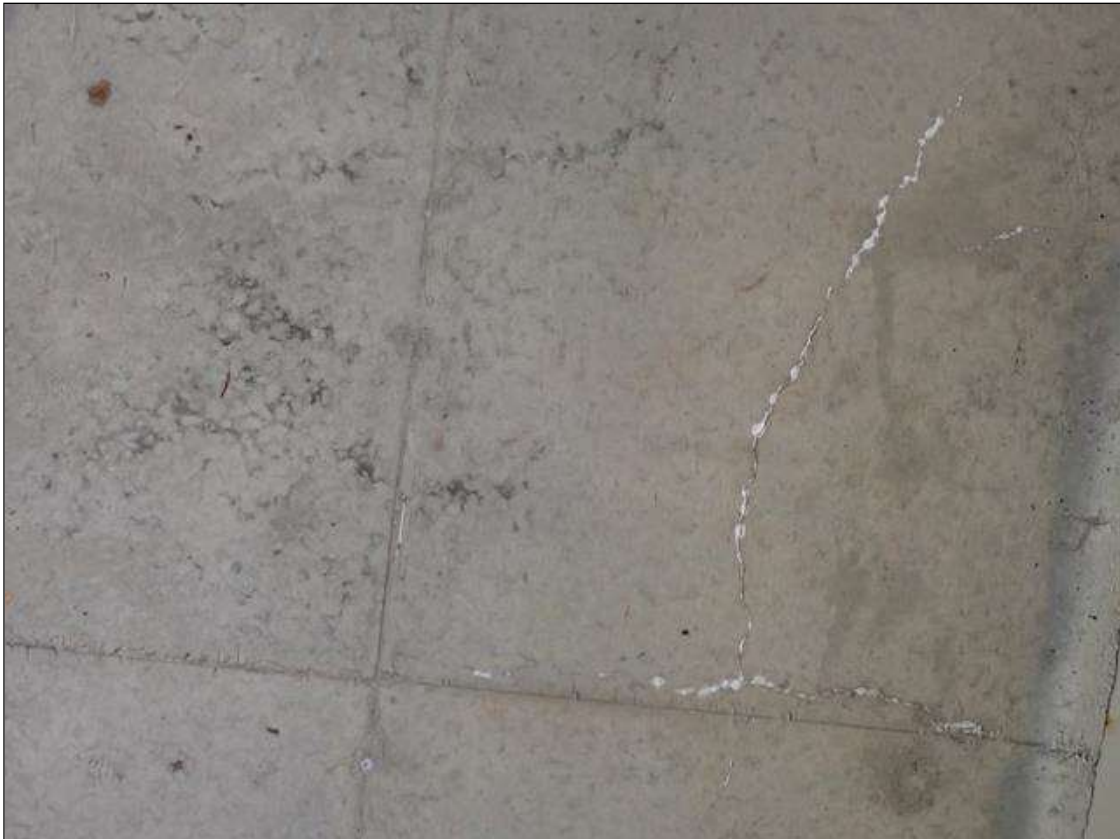
Span 3 Deck: SPAN 3 BOTTOM OF DECK HAS SCATTERED AREAS IN ALL BAYS OF MAP CRACKING WITH EFFLORESCENCE

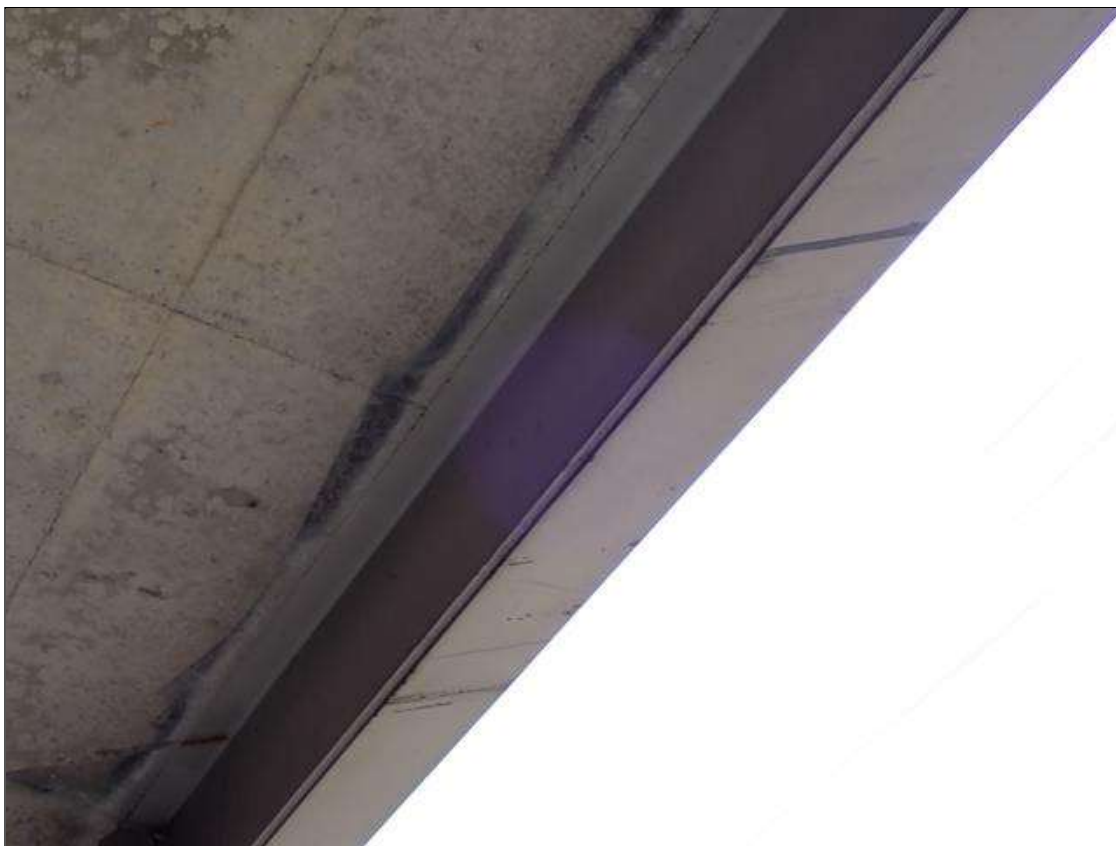
Span 3 Beam 1 - Protective System: over right travel lane, impact scrapes

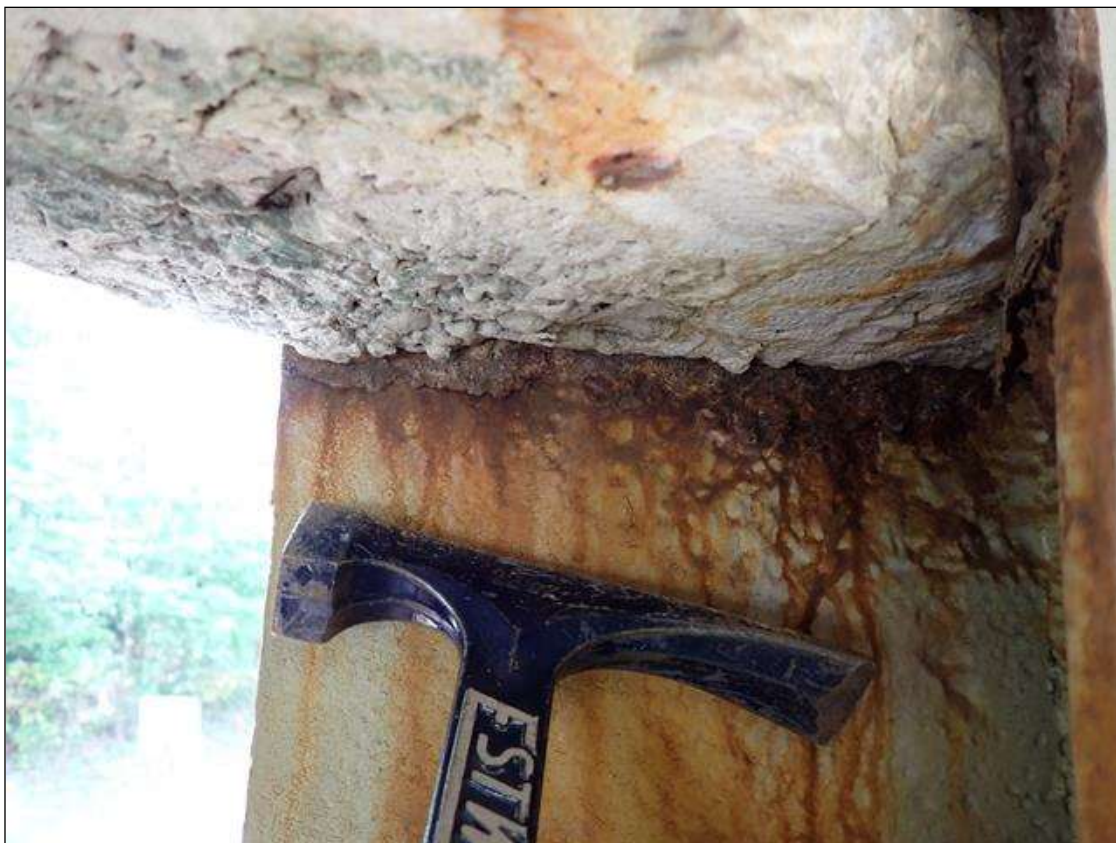
Span 3 Beam 1: at bent 2, pitting with corrosion reactivating: web adjacent to diaphragm (1/16 inch deep x 10 inch x 2 inch)

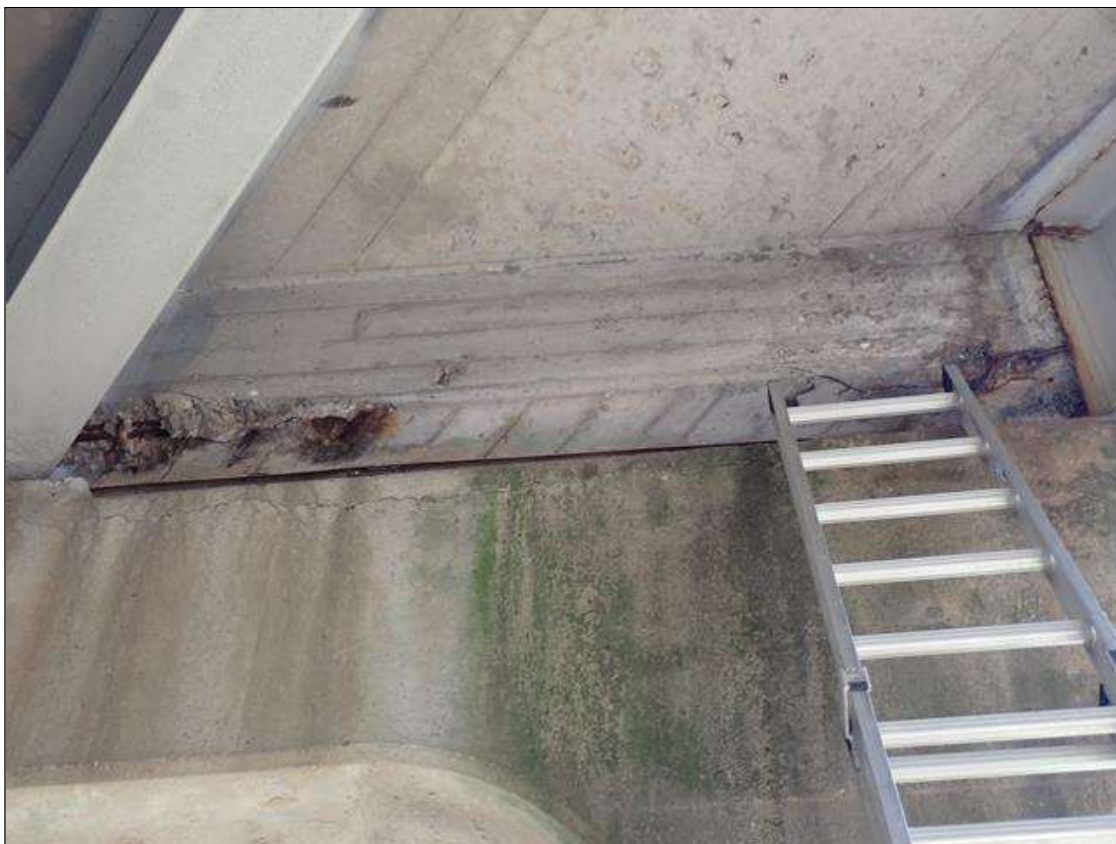
Span 3 Beam 1: at bent 2, bay 1 end diaphragm, (2) spall/delamination (up to 3 foot x 10 inch x 2 inch deep) with exposed rusted rebar

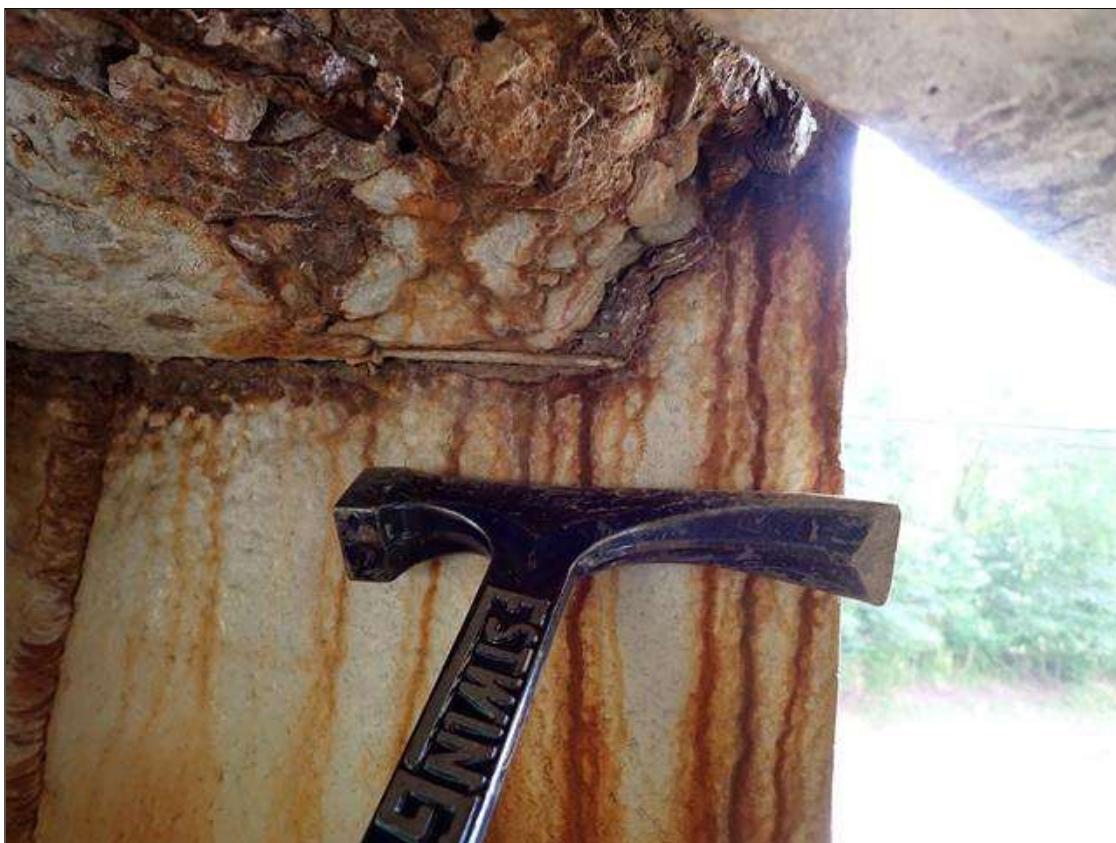
Span 2 Beam 1: at bent 2, pitting with corrosion reactivating: web adjacent to diaphragm (1/16 inch deep x 10 inch x 2 inch)

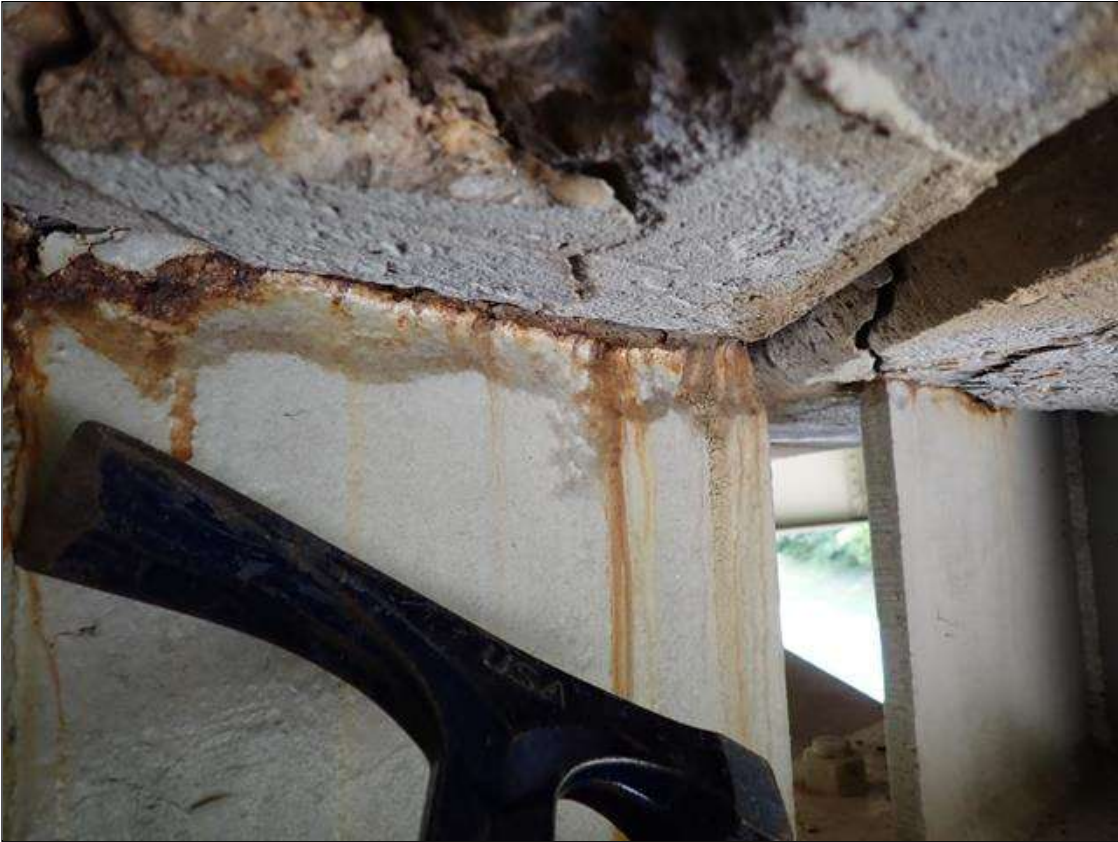
Span 3 Beam 2: (PAR) at bent 2, corrosion with section loss: web adjacent to diaphragm (1/2 average remaining x 10 inch x 1.5 inch)

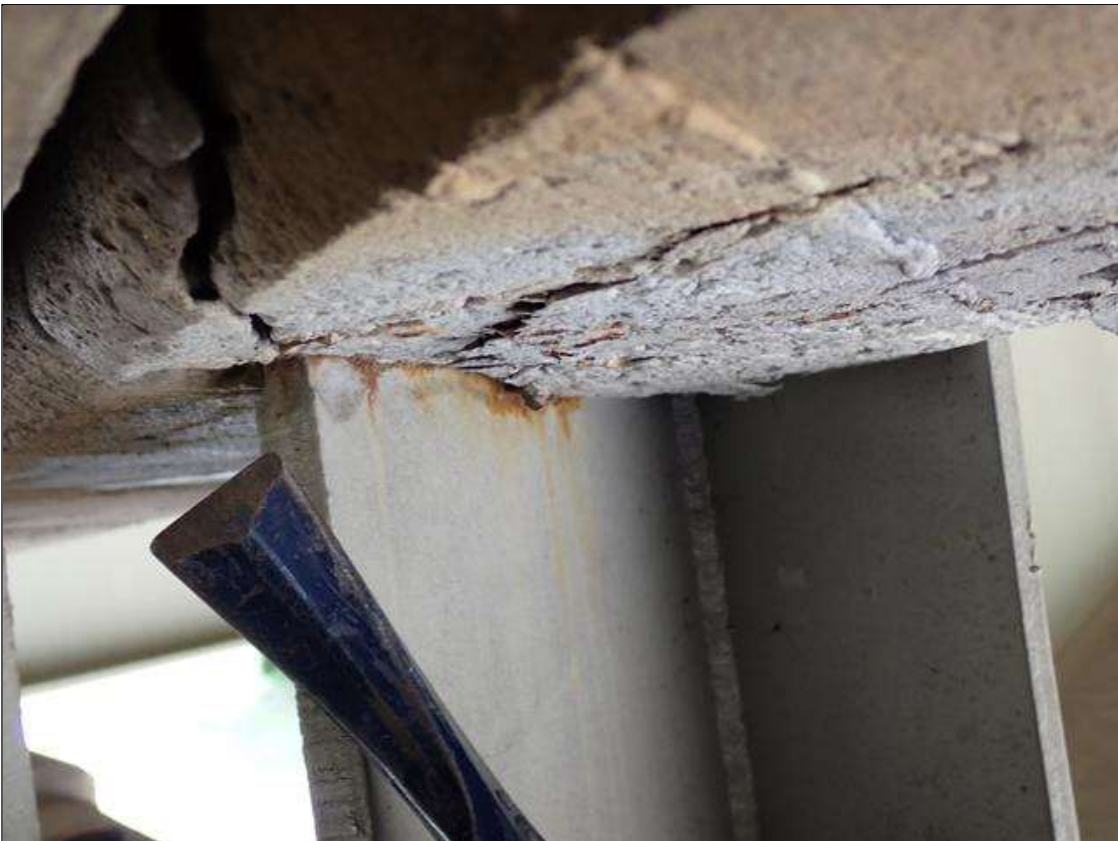
Span 2 Beam 2: at bent 2, corrosion with section loss: web adjacent to diaphragm (5/8 average remaining x 6 inch x 1 inch)

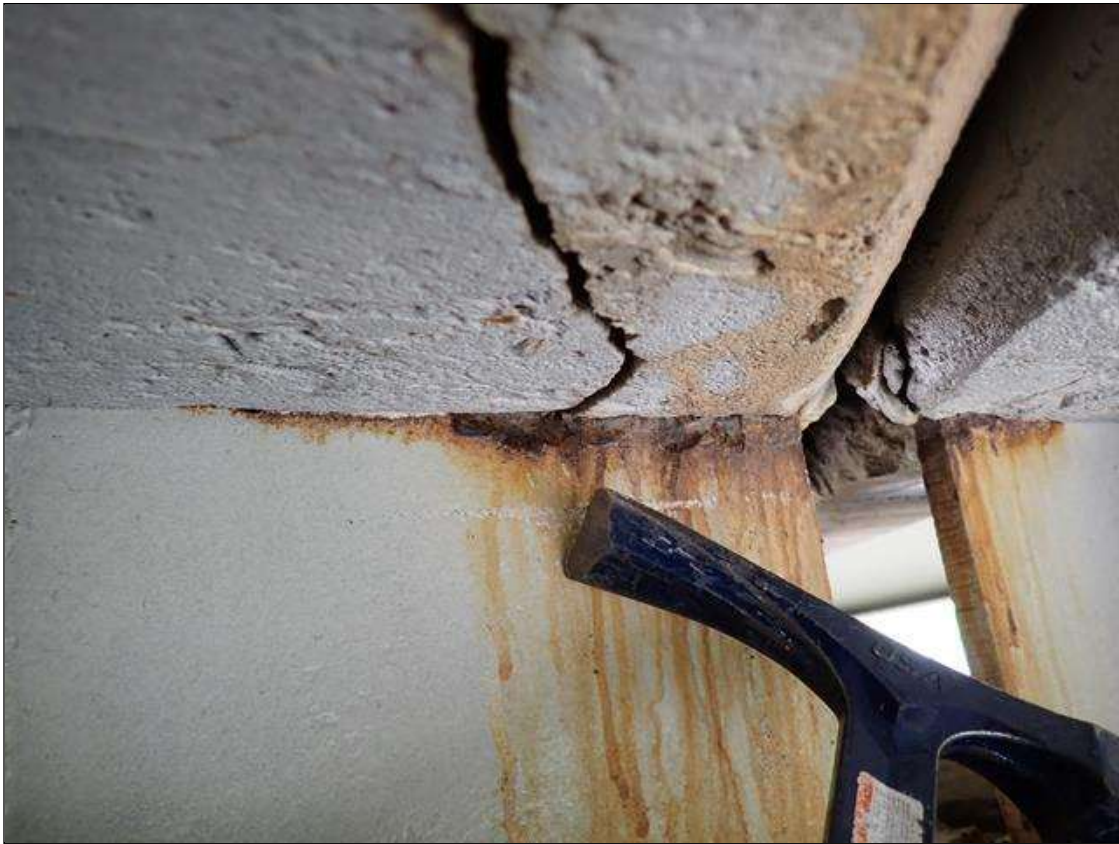
Span 3 Beam 3: at bent 2, web adjacent to diaphragm, rust scale (8 inch)

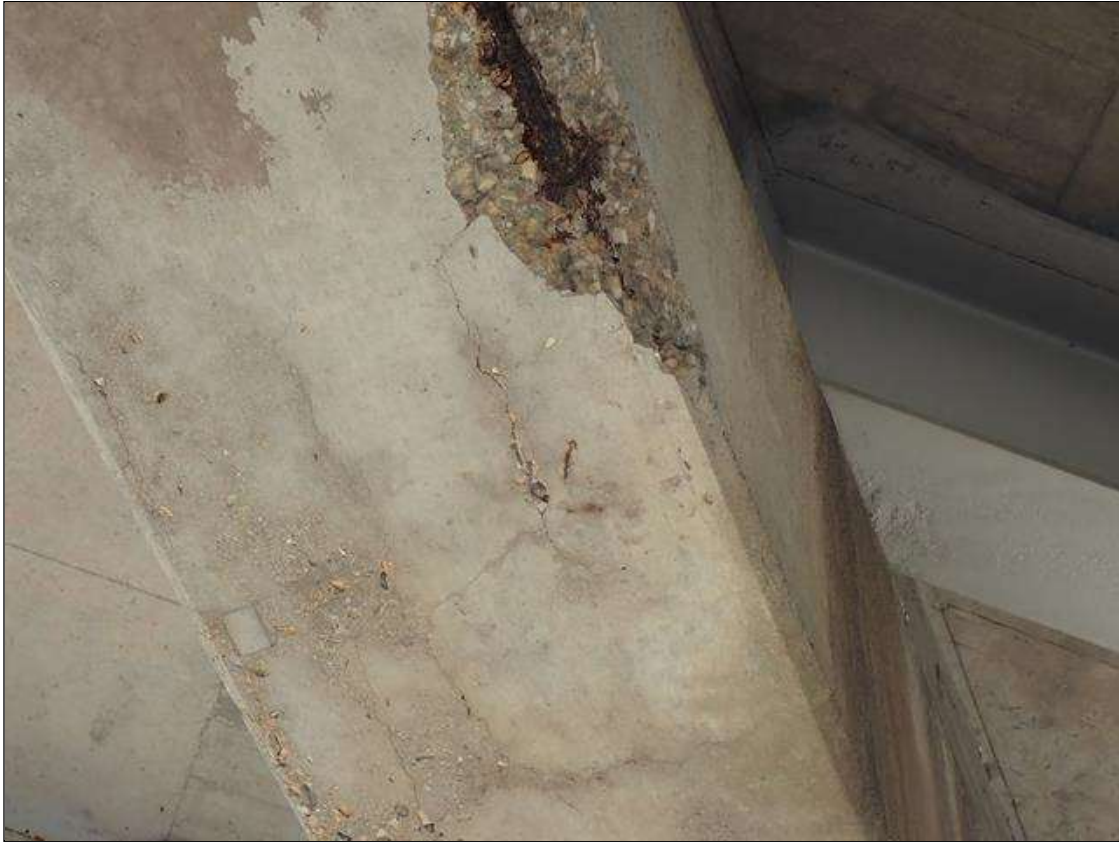
Bent 2 Cap 1: (PAR) 3 FOOT X UP TO 7 INCH X 8 INCH X 3 INCH DEEP SPALL WITH EXPOSED REINFORCING WITH APPROXIMATELY 25 PERCENT LOSS AND ADJACENT DELAMINATION UNDER BAY 2 NORTH AND BOTTOM FACES.

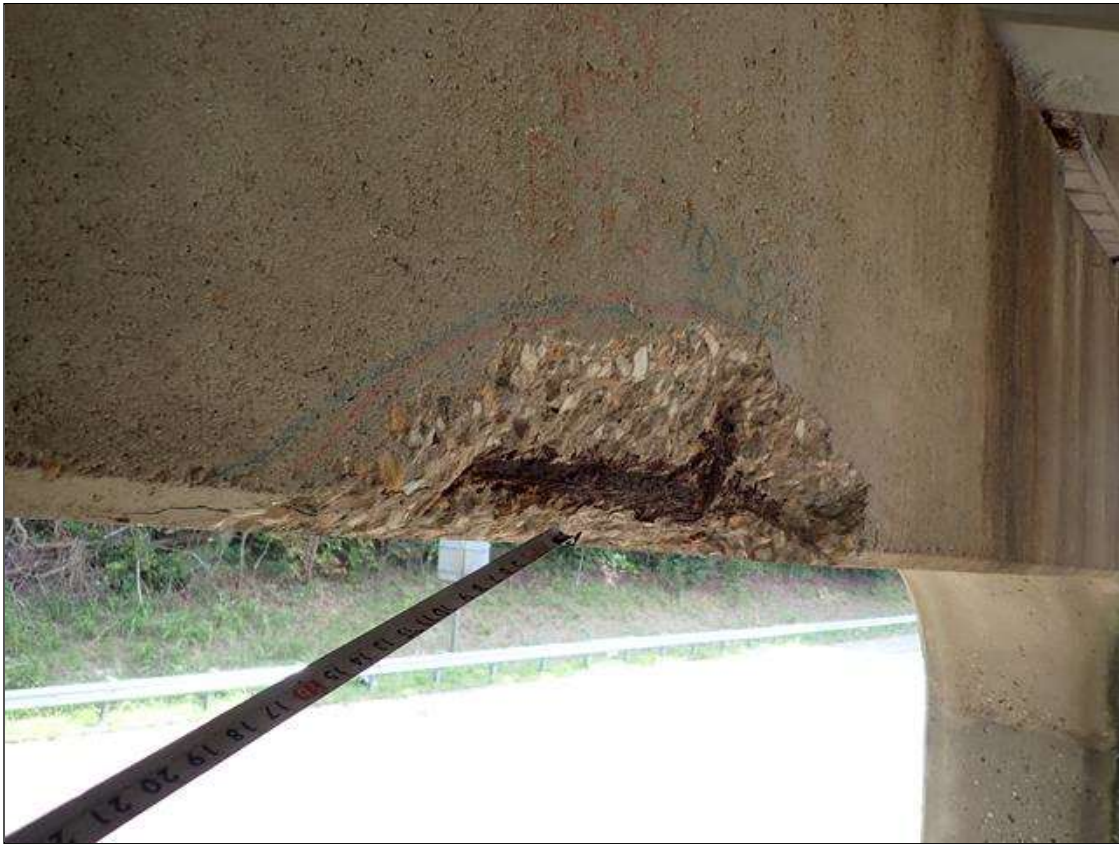
Bent 2 Cap 1: (PAR) 3 FOOT X UP TO 7 INCH X 8 INCH X 3 INCH DEEP SPALL WITH EXPOSED REINFORCING WITH APPROXIMATELY 25 PERCENT LOSS AND ADJACENT DELAMINATION UNDER BAY 2 NORTH AND BOTTOM FACES.

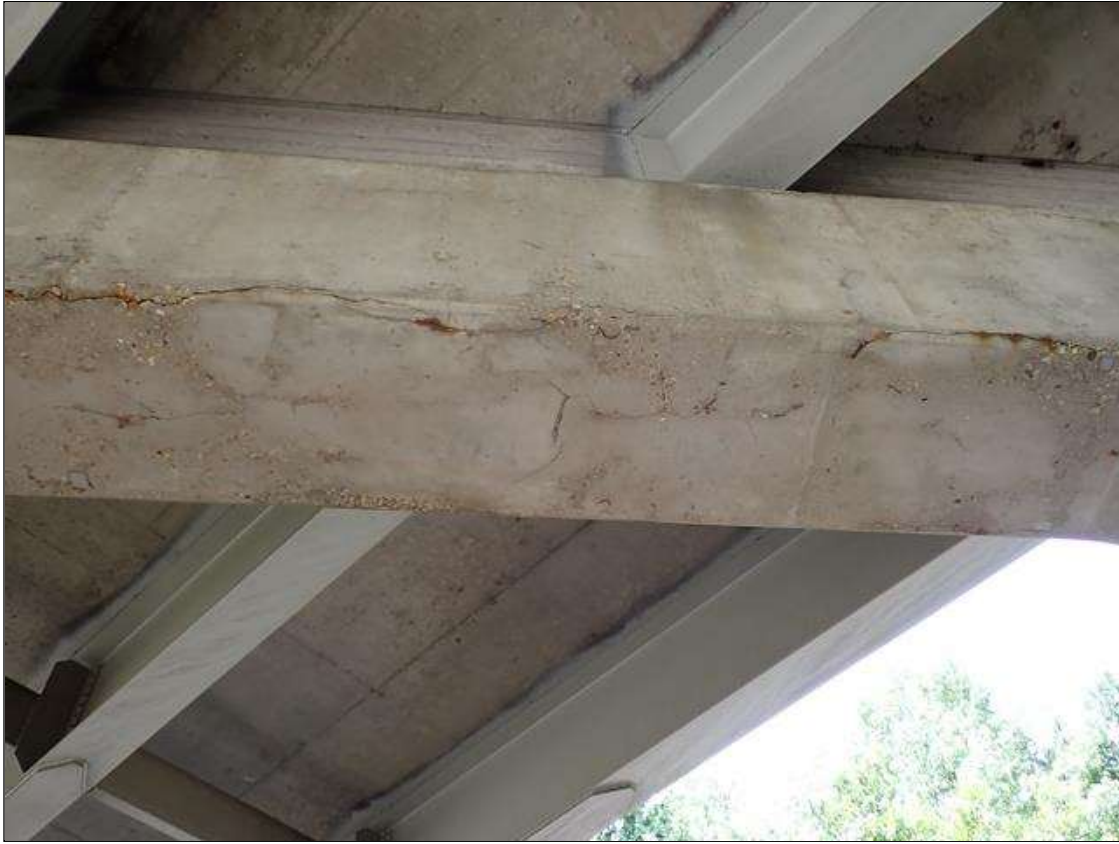
Bent 2 Cap 1: (PAR) 3 FOOT X UP TO 1/8 INCH LONGITUDINAL CRACK WITH RUST STAINING WITH ADJACENT DELAMINATIONS UP TO 5 FOOT X FULL WIDTH SOUTH AND BOTTOM FACES UNDER BAY 3

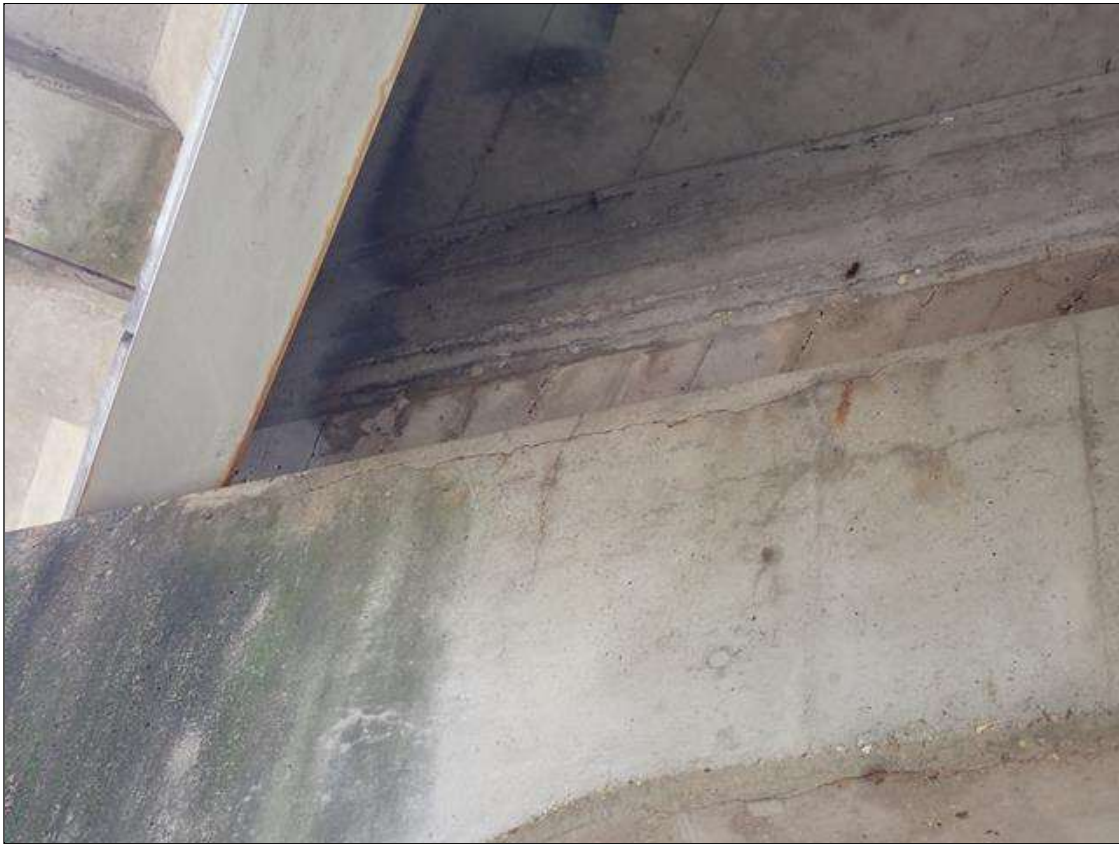
Bent 2 Cap 1: (PAR) BENT 2 NORTH FACE OF CAP HAS A HORIZONTAL CRACK [UP TO 1/8 INCH] WITH RUST STAIN WITH ADJACENT DELAMINATED AREA ALONG TOP EDGE OF CAP BETWEEN BEAM 4 AND BEAM 5 5 INCH TO 20 INCH DOWN FACE 88 INCH LONG AND 4 INCH ON TOP.

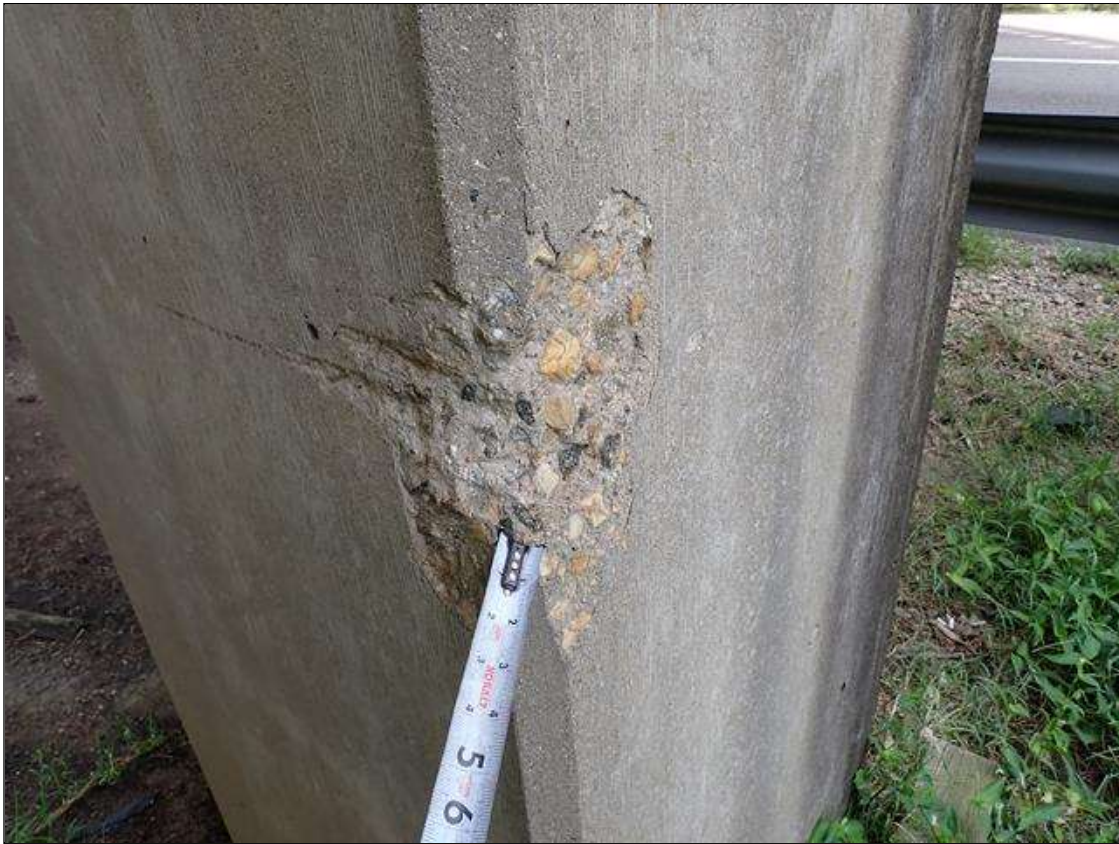
Bent 2 Pile 3: BENT 2 SOUTHEAST CORNER OF COL 3 HAS SPALL AREA 38 INCH ABOVE THE GROUND LINE AND 5 INCH X 5 INCH X 12 INCH X 1 INCH DEEP

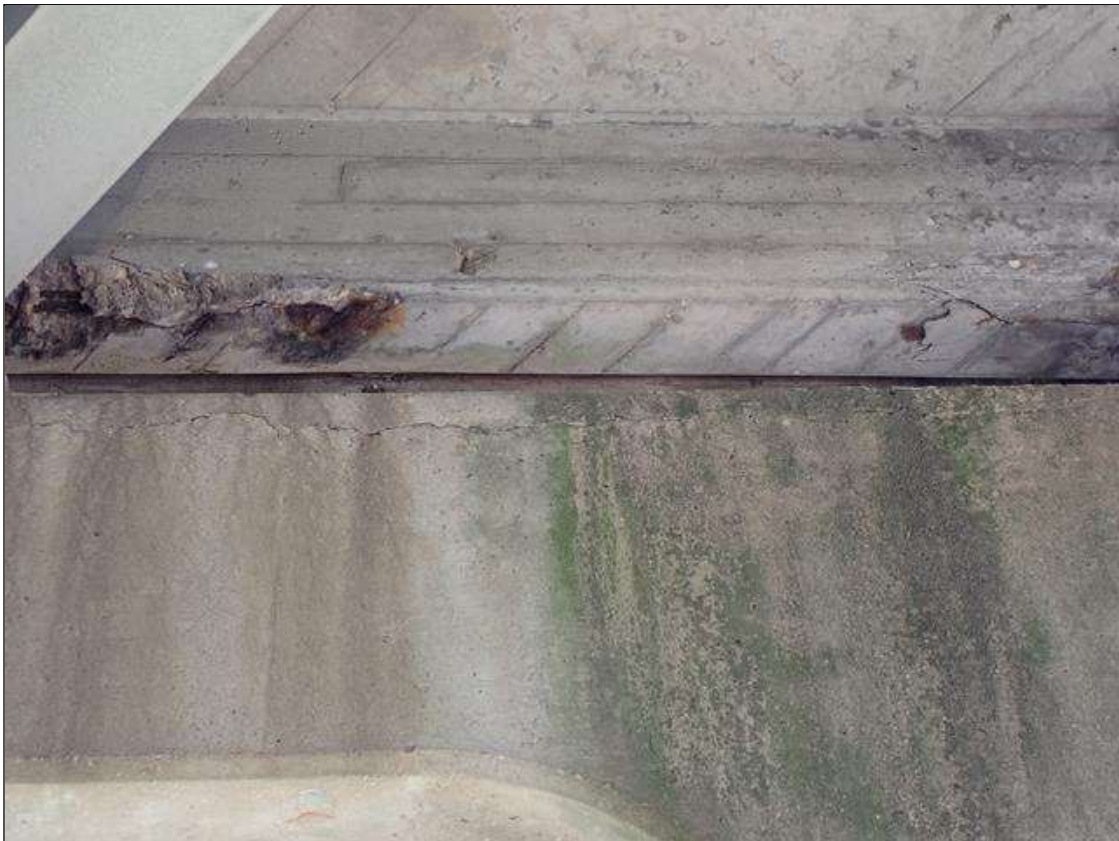
Bent 2 Cap 1: BENT 2 SOUTH AND NORTH FACES OF CAP HAS SCATTERED HORIZONTAL CRACKS UP TO 1/16 INCH X 8 FOOT IN TOP AND BOTTOM EDGE FROM BEAM 1 TO BEAM 2 AND BEAM 4 TO BEAM 5.

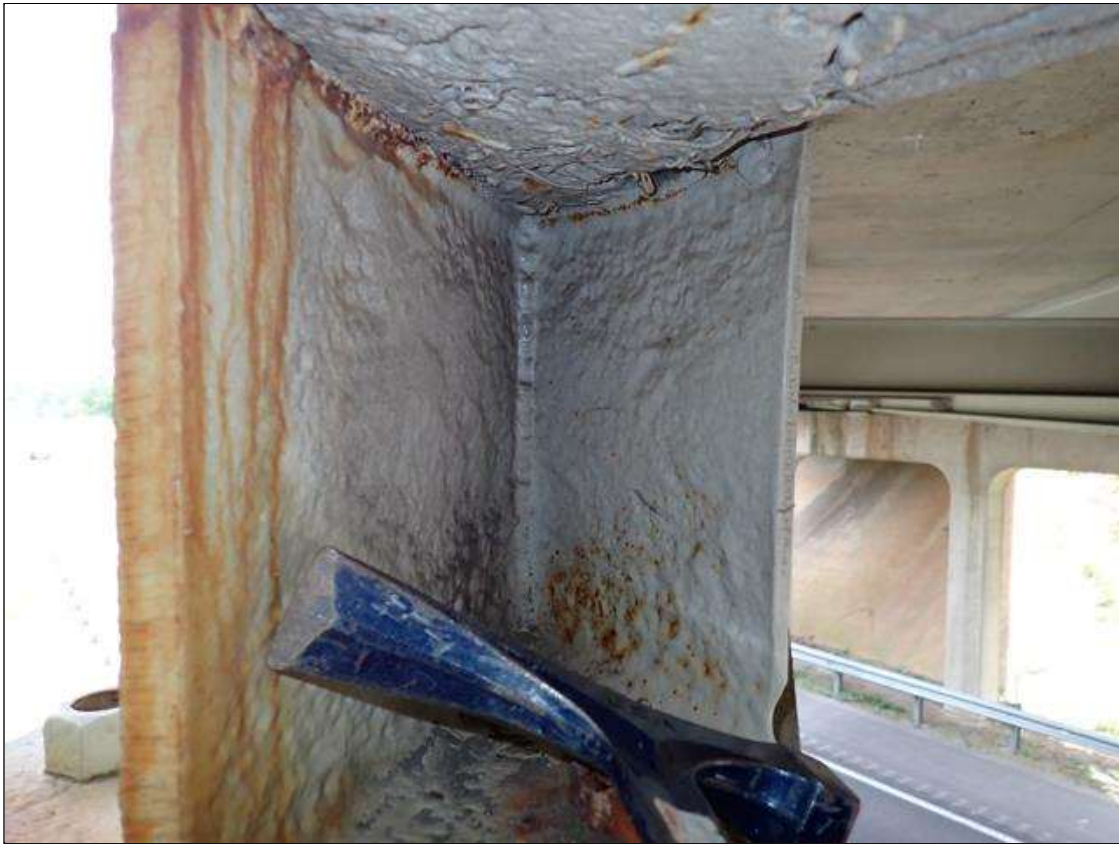
Span 2 Beam 5: at bent 2, corrosion with section loss: web (5/8 average remaining x 10 inch x full height); left stiffener (0.30 inch average remaining x full width x full height)

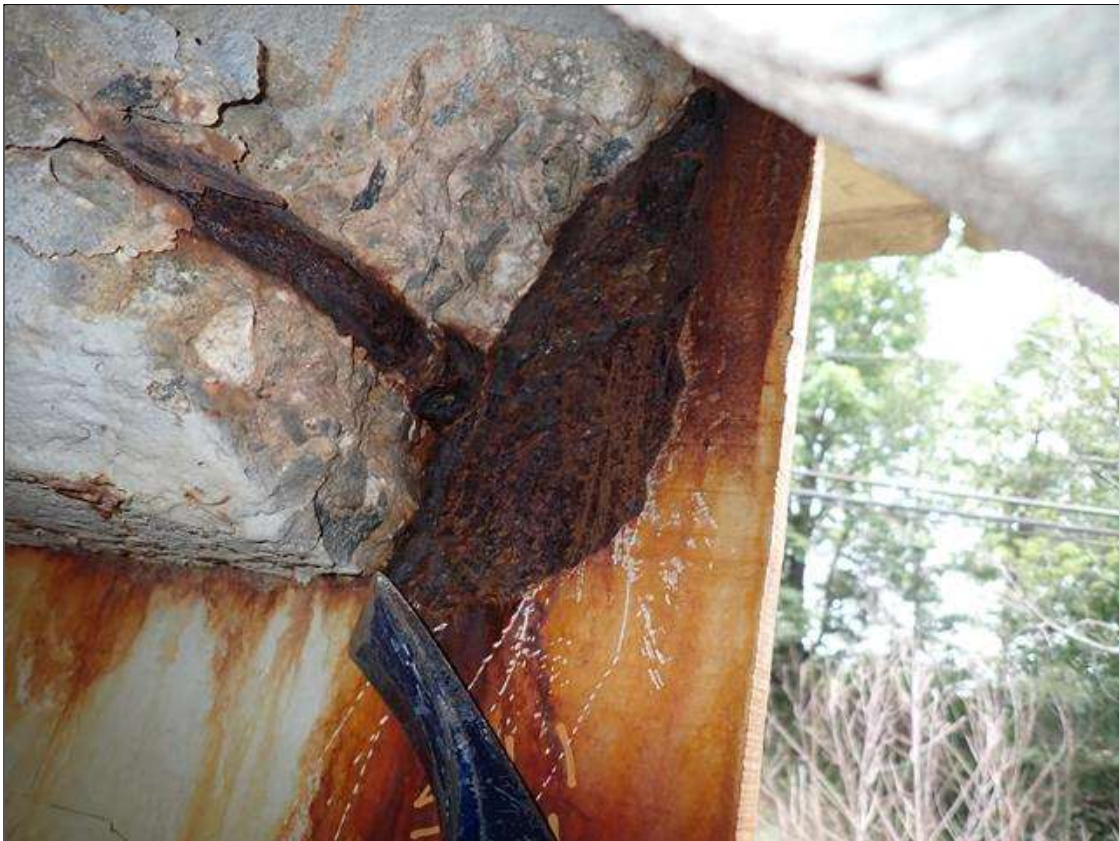
Span 1 Beam 1: at bent 1, corrosion with section loss: web adjacent to diaphragm (9/16 average remaining x 3.5 inch x 8 inch)

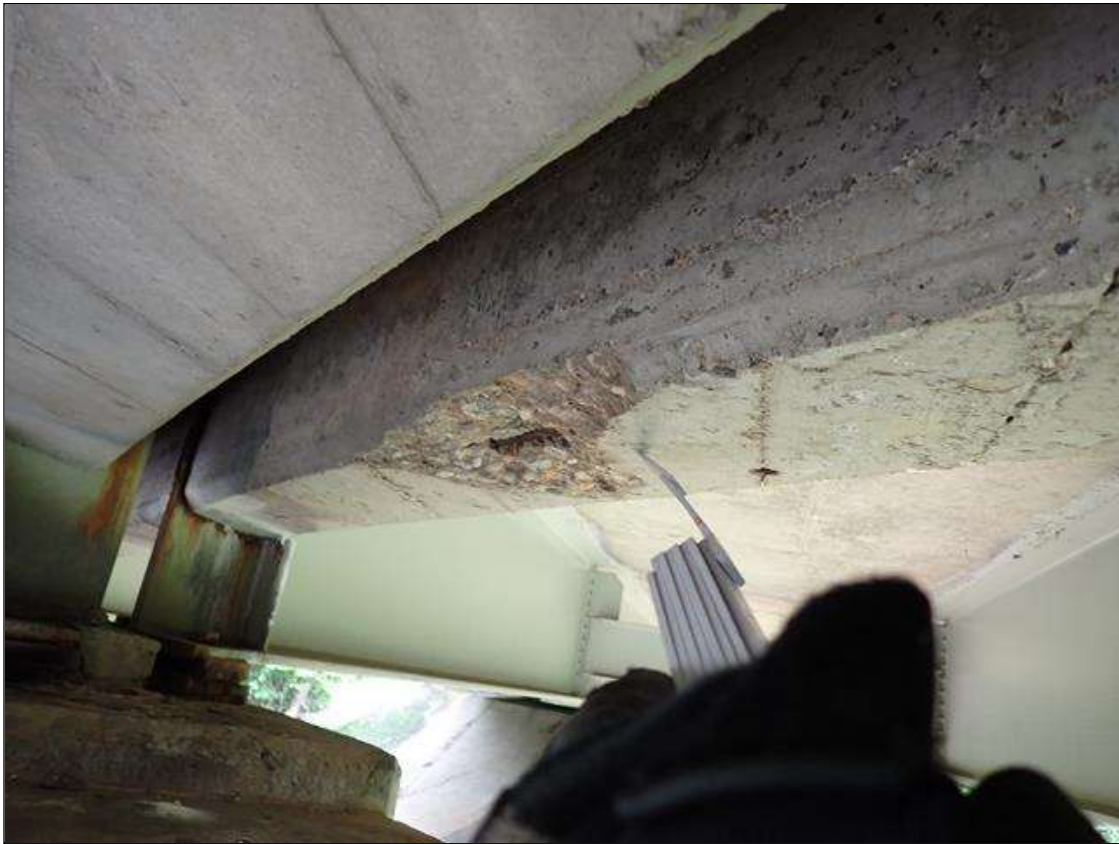
Span 1 Beam 1: at bent 1, bay 1 diaphragm, (2) spall/delamination (up to 2 foot x 8 inch x 2.5 inch deep) with exposed rusted rebar

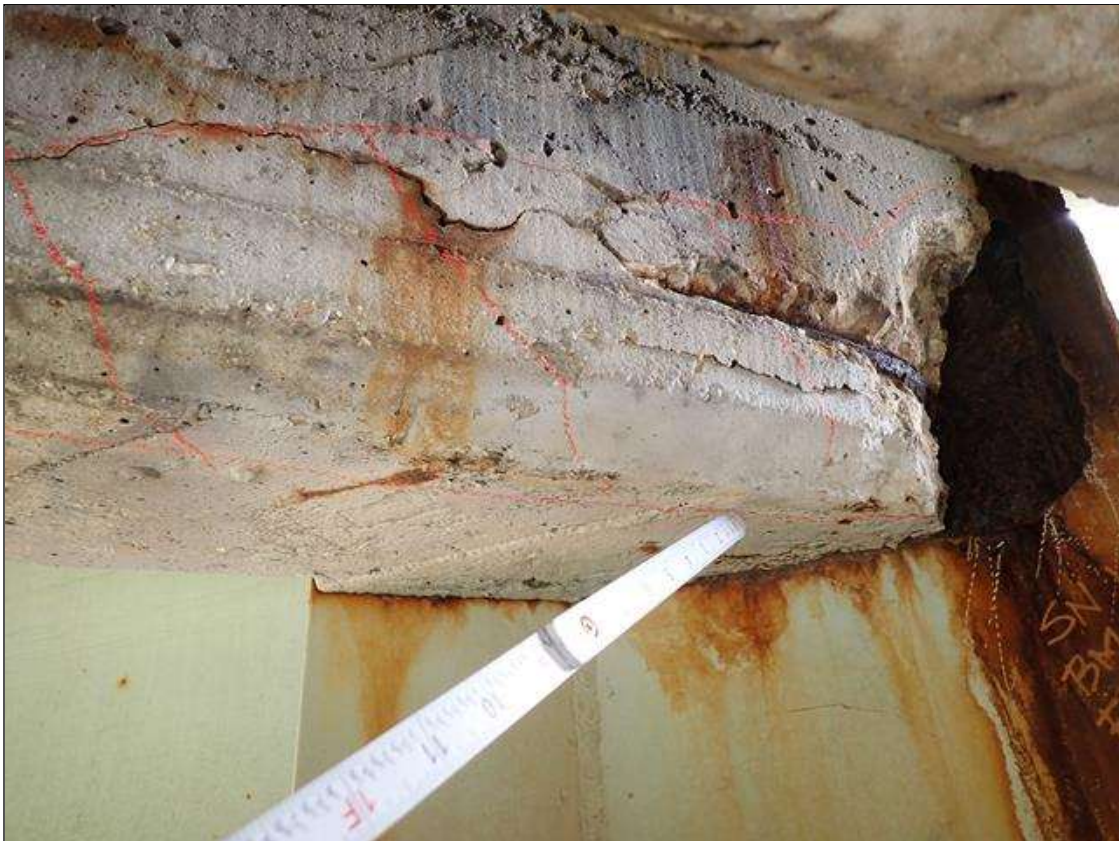
Span 1 Beam 1: at bent 1, bay 1 diaphragm, (2) spall/delamination (up to 2 foot x 8 inch x 2.5 inch deep) with exposed rusted rebar

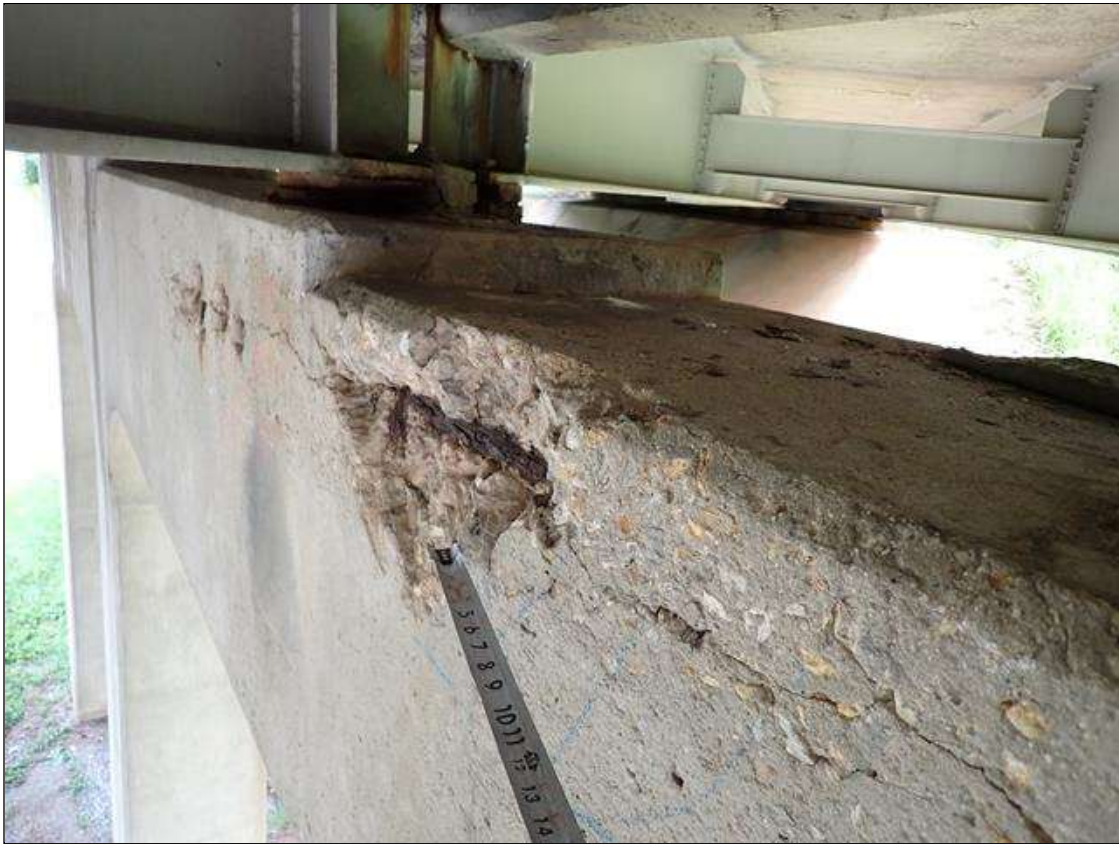
Bent 1 Cap 1: [PAR] 32 INCH X 15 INCH X 3 INCH SPALL WITH EXPOSED PRIMARY REINFORCING [SECTION LOSS UP TO 1/8 INCH] WITH ADJACENT DELAMINATION ON TOP NORTH FACE UNDER BAY 1.

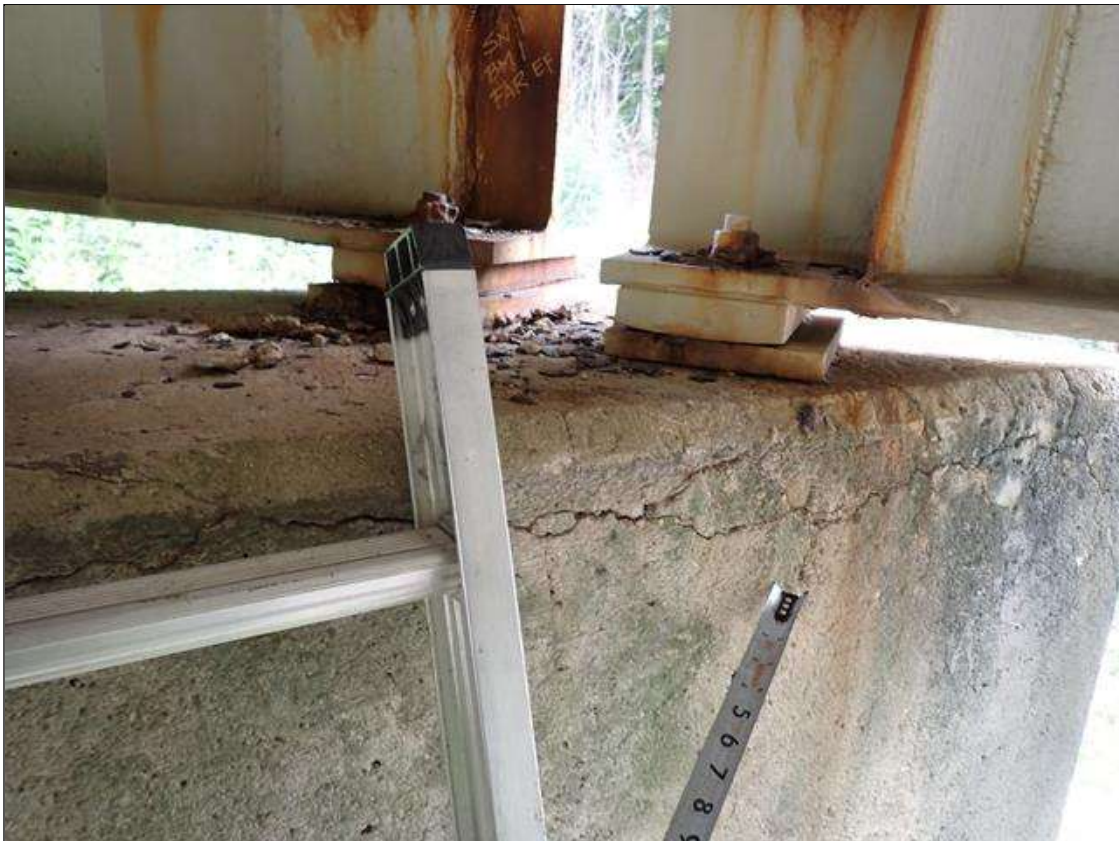
Bent 1 Cap 1: UP TO 14 FOOT X 1/8 INCH HORIZONTAL CRACKS AT RANDOM THROUGHOUT ON SOUTH FACE AND UNDERSIDE

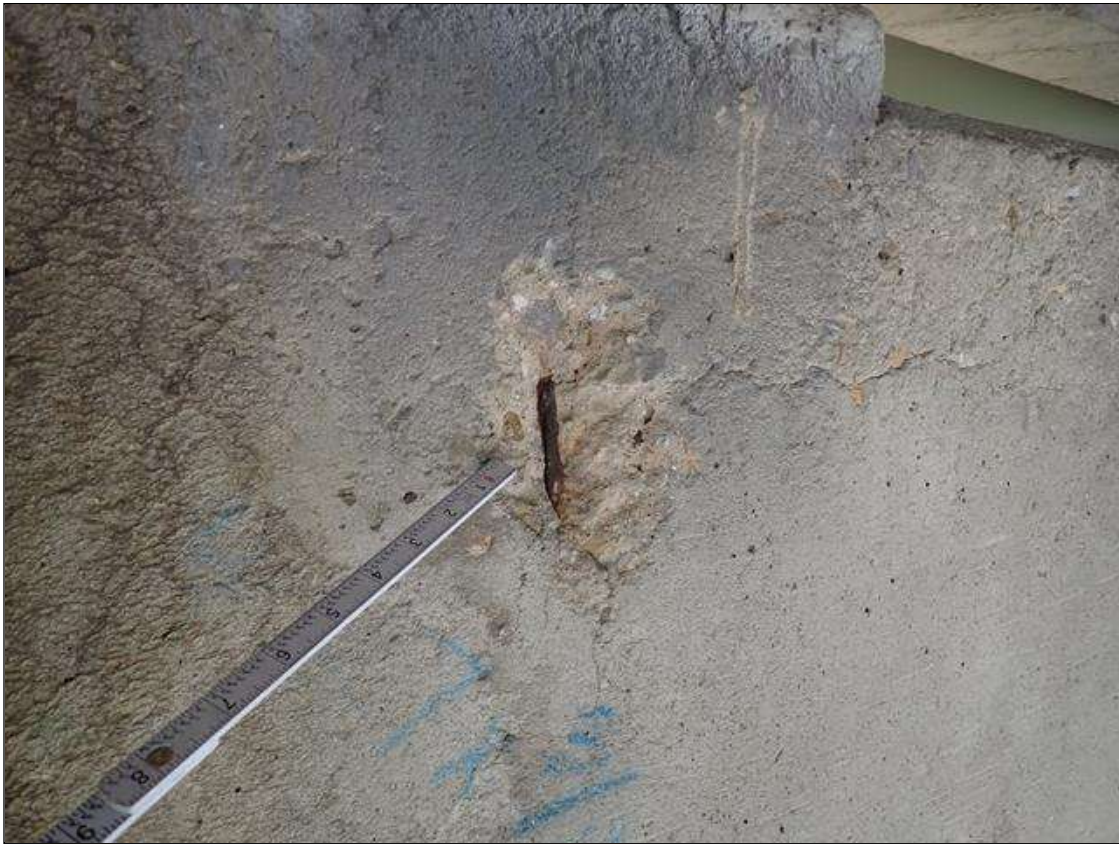
Bent 1 Cap 1: [PAR] 4 INCH X 7 INCH X 1 INCH NORTH FACE OF CAP HAS A SPALL AREA UNDER BEAM 3 WITH PRIMARY REBAR EXPOSED [SECTION LOSS UP TO 1/8 INCH]
