NC DEPARTMENT OF TRANSPORTATION
 DIVISION OF HIGHWAYS
 STRUCTURE MANAGEMENT UNIT

ATTENTION: **prompt action request; sketches updated**

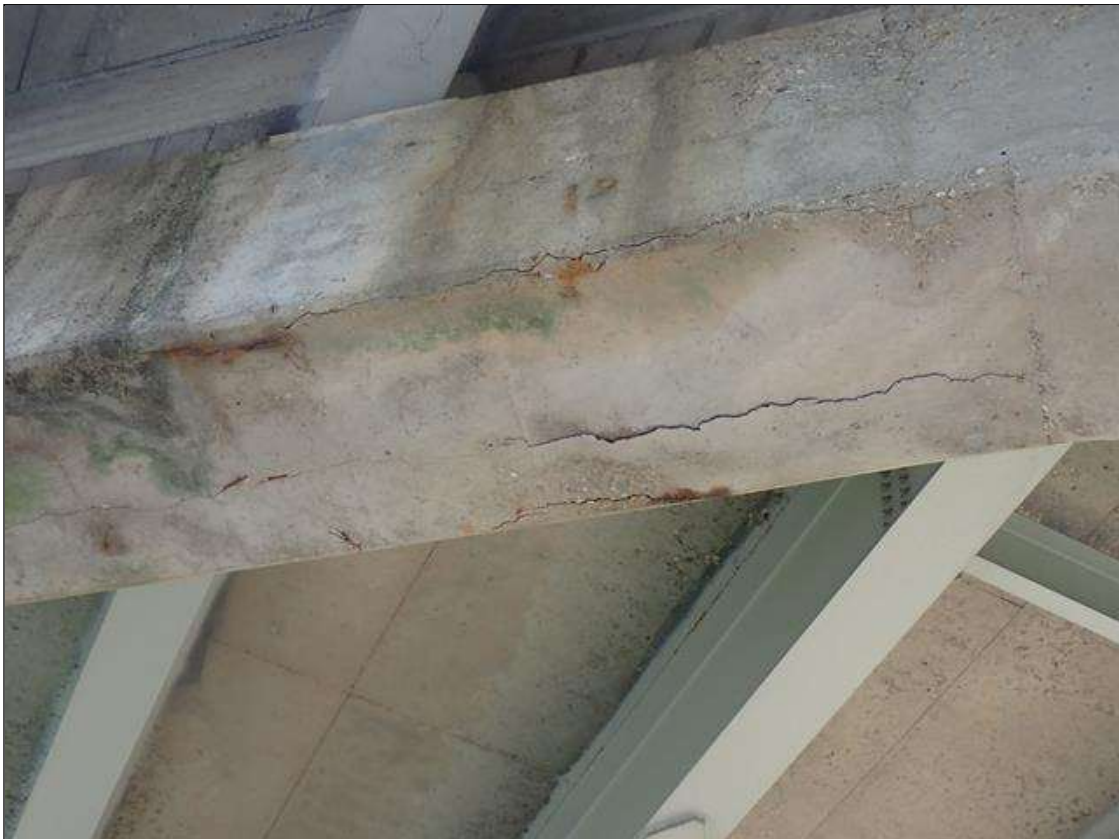
Bent 1 Cap 1: underside of cap, between columns 1 and 3, spalls/delaminations (up to 12 foot x full width x 1 inch deep) with cracks (up to 1/8 inch)

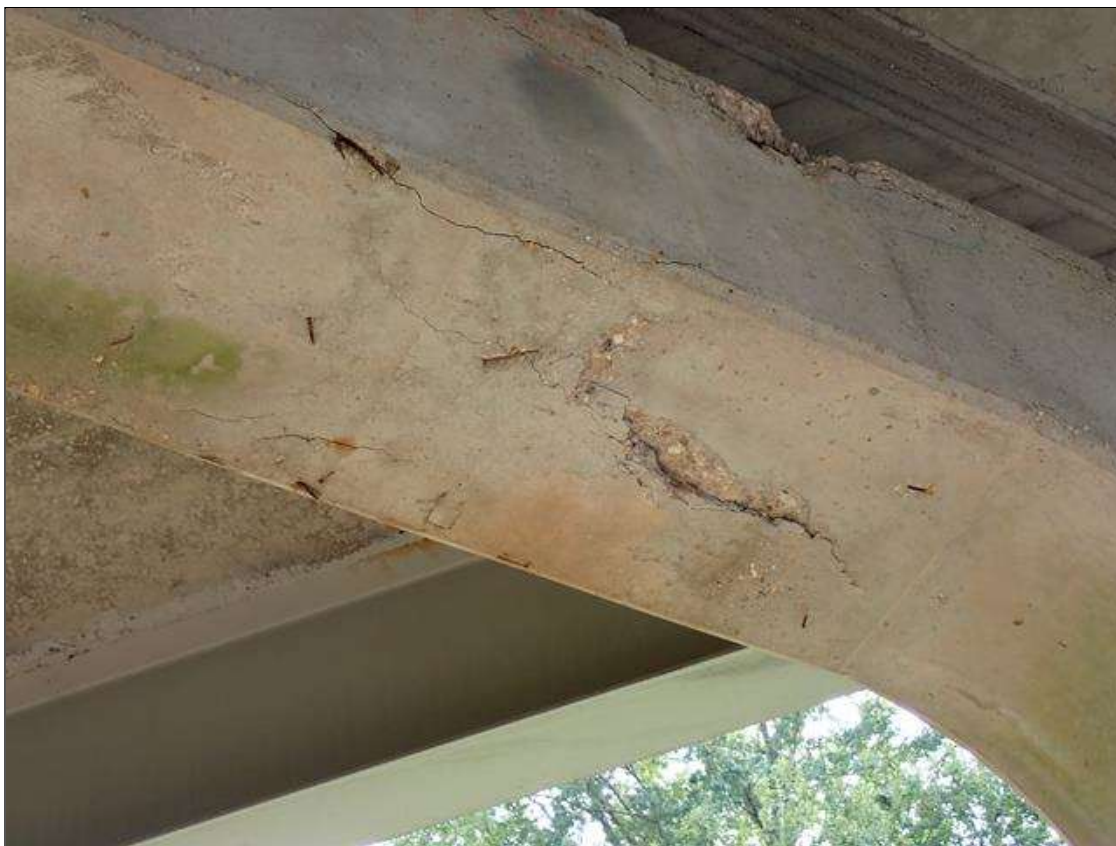
Bent 1 Cap 1: underside of cap, between columns 1 and 3, spalls/delaminations (up to 12 foot x full width x 1 inch deep) with cracks (up to 1/8 inch)

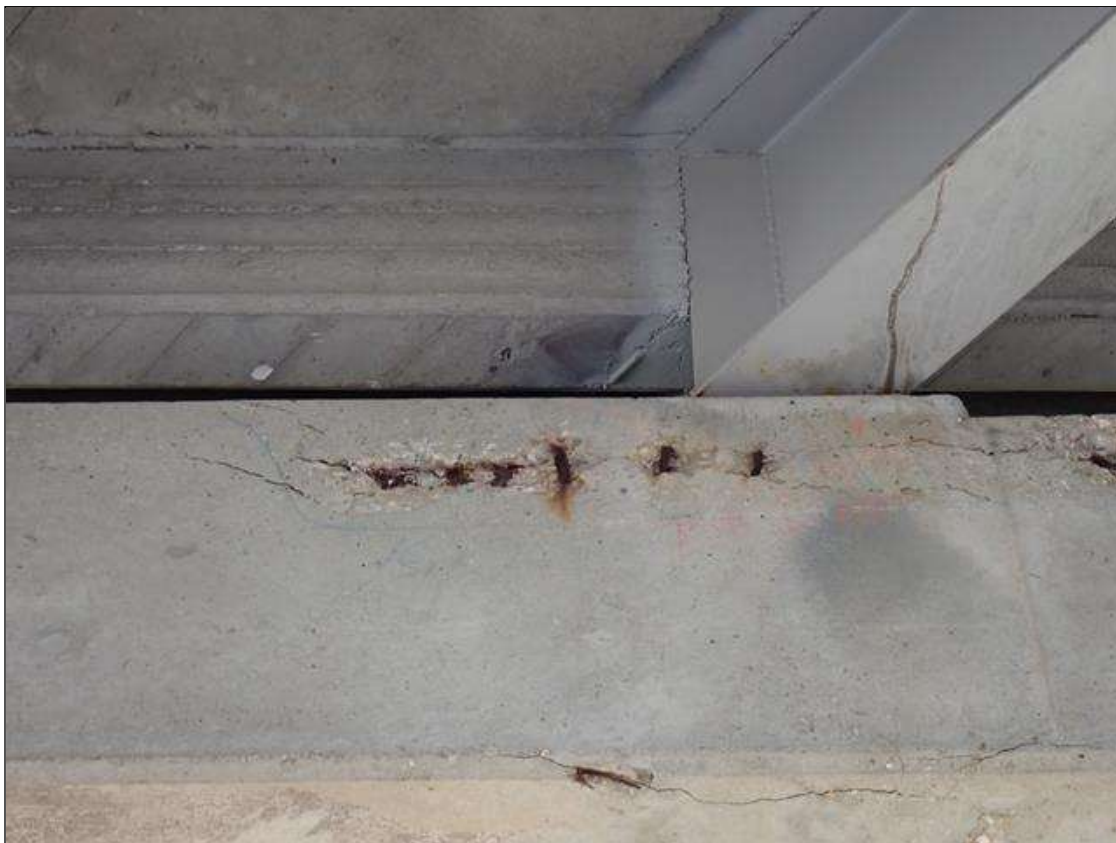
Bent 1 Cap 1: (PAR) 10 INCH X 48 INCH X 2 INCH DEEP SPALL/DELAMINATION WITH EXPOSED RUSTED REBAR NEAR TOP OF CAP, NORTH FACE BELOW BEAM 2

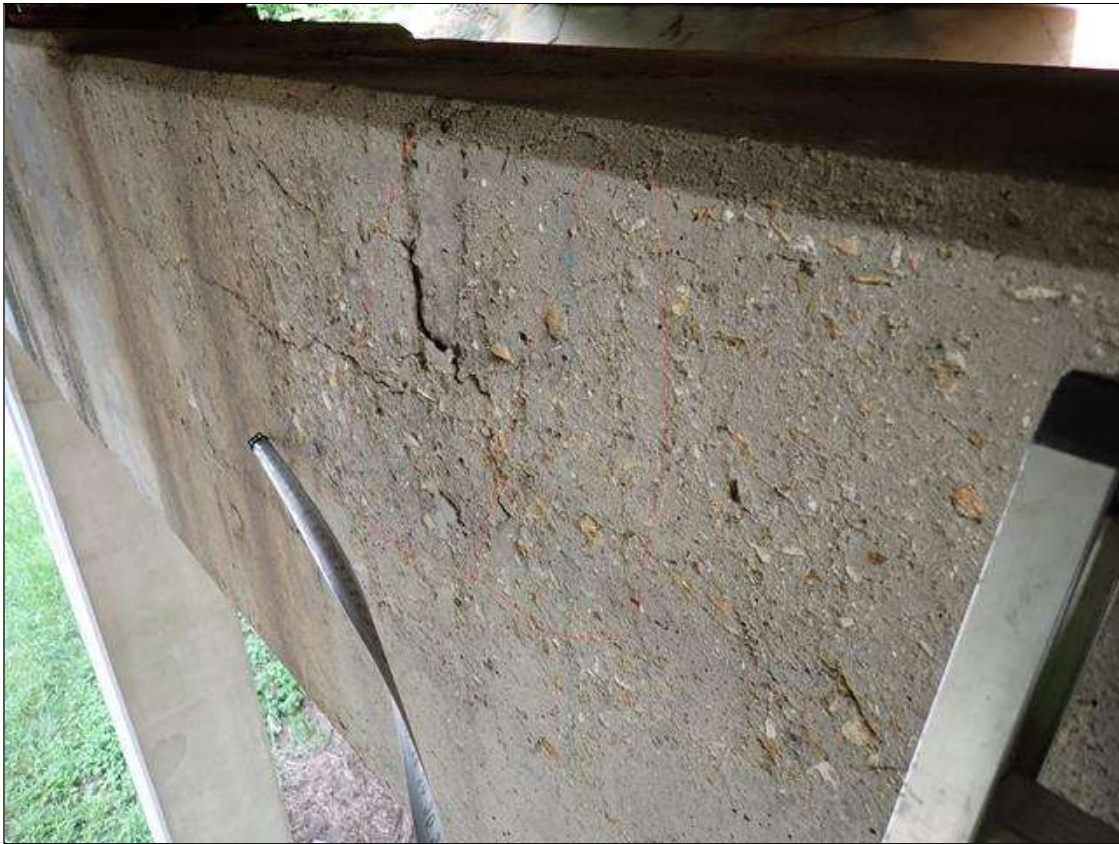
Bent 1 Cap 1: 2 FOOT X 6 FOOT CRACKED DELAMINATED AREA IN BAY 3 ON NORTH FACE.

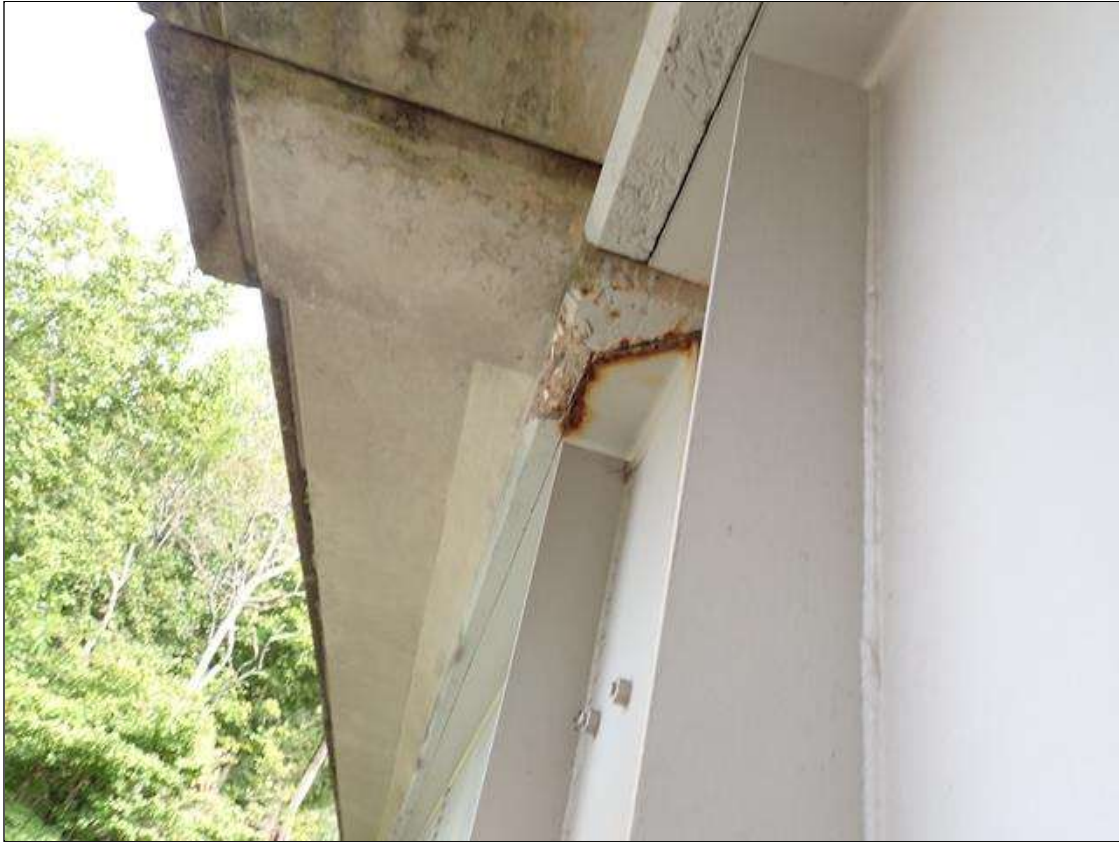
Span 1 Beam 5: at bent 1, corrosion with section loss: web adjacent to diaphragm (9/16 average remaining x 10 inch x 2 inch); left stiffener adjacent to diaphragm (0.25 inch average remaining x full width x 2 inch); left stiffener at base (0.27 inch average remaining x full width x 2 inch); top flange, rust scale (1 foot)

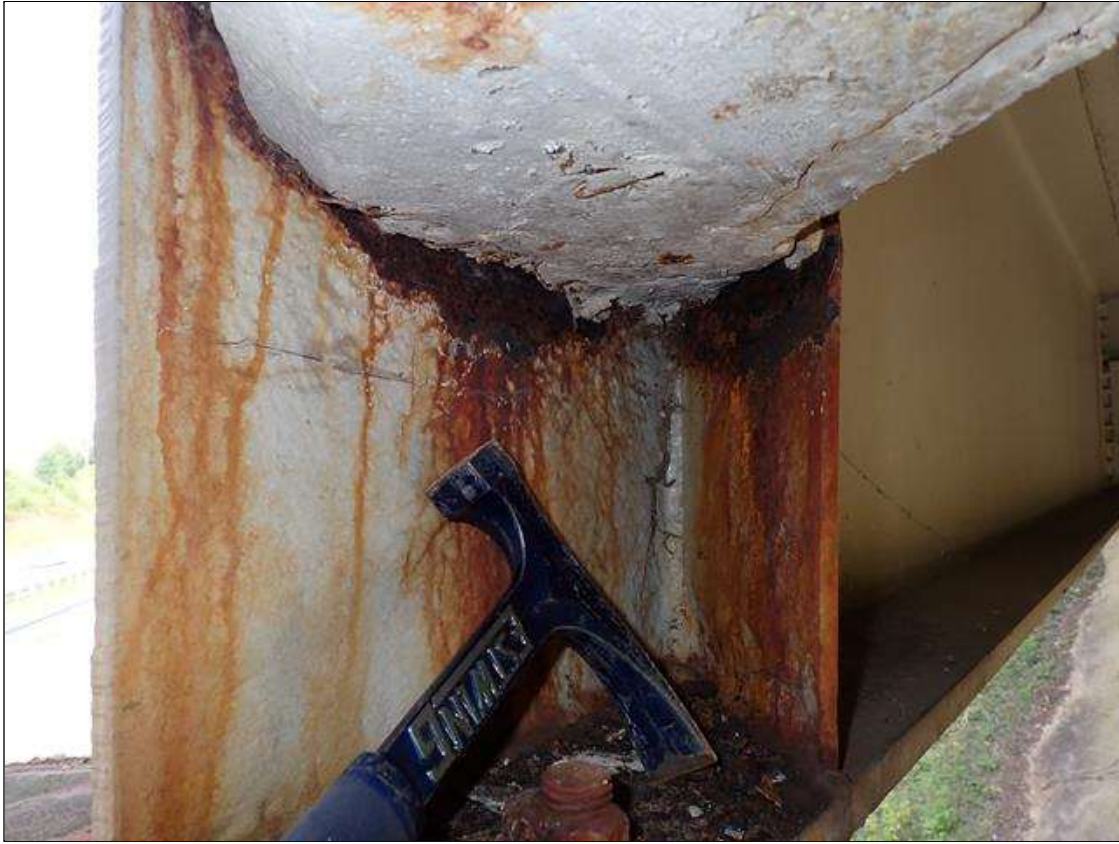
Span 1 Beam 5: at bent 1, corrosion with section loss: web adjacent to diaphragm (9/16 average remaining x 10 inch x 2 inch); left stiffener adjacent to diaphragm (0.25 inch average remaining x full width x 2 inch); left stiffener at base (0.27 inch average remaining x full width x 2 inch); top flange, rust scale (1 foot)

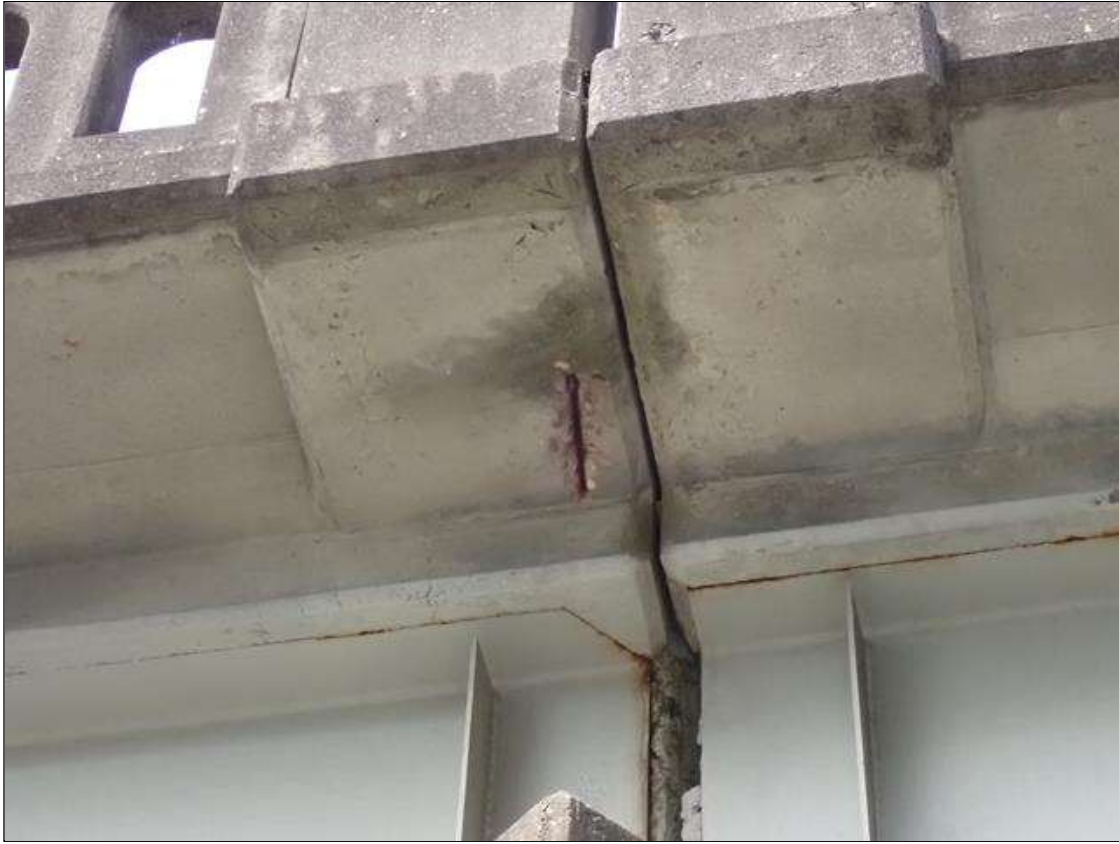
Span 3 Deck: (PAR) SPAN 3 BOTTOM OF LEFT OVERHANG HAS A SURFACE SPALL AREA OVER BENT 2, 4 INCH X 12 INCH X 3/4 INCH DEEP WITH REBAR EXPOSED.

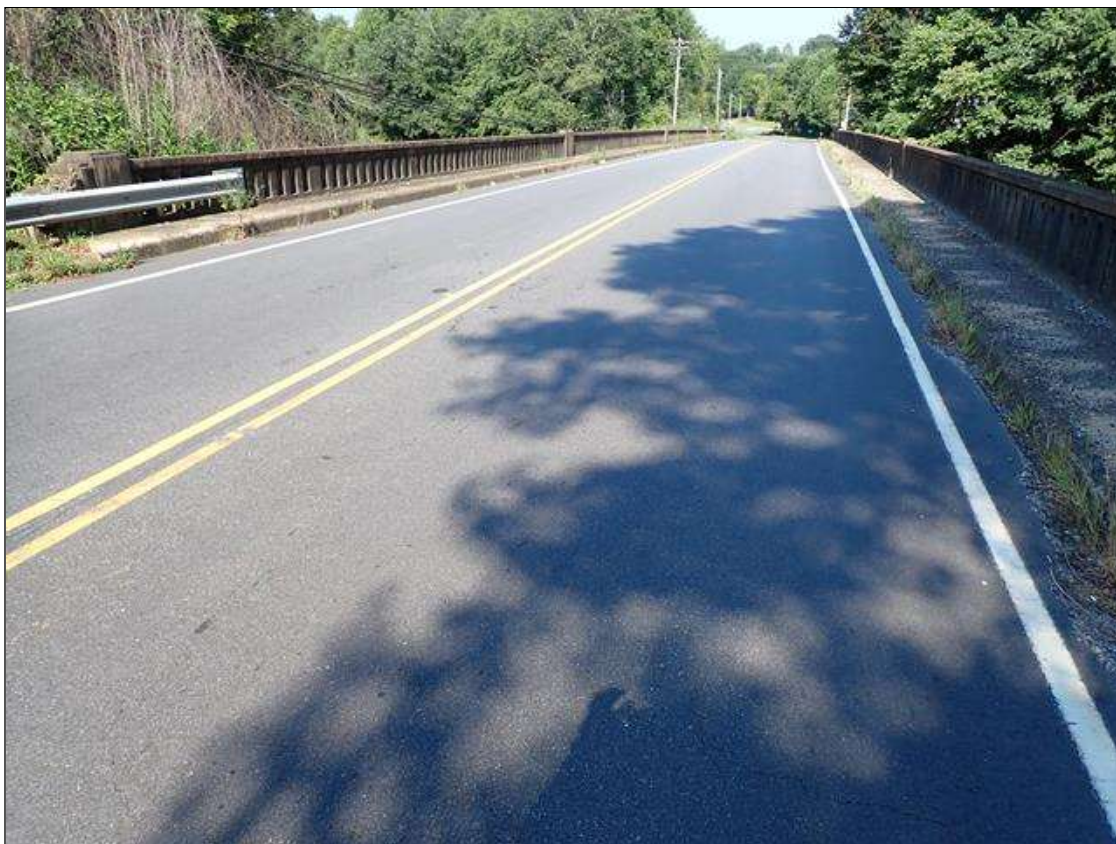
asphalt wearing surface
