NC DEPARTMENT OF TRANSPORTATION  
 DIVISION OF HIGHWAYS  
 STRUCTURE MANAGEMENT UNIT

ATTENTION: prompt action request; sketches revised; span 2 and 3 total horizontal clearances revised

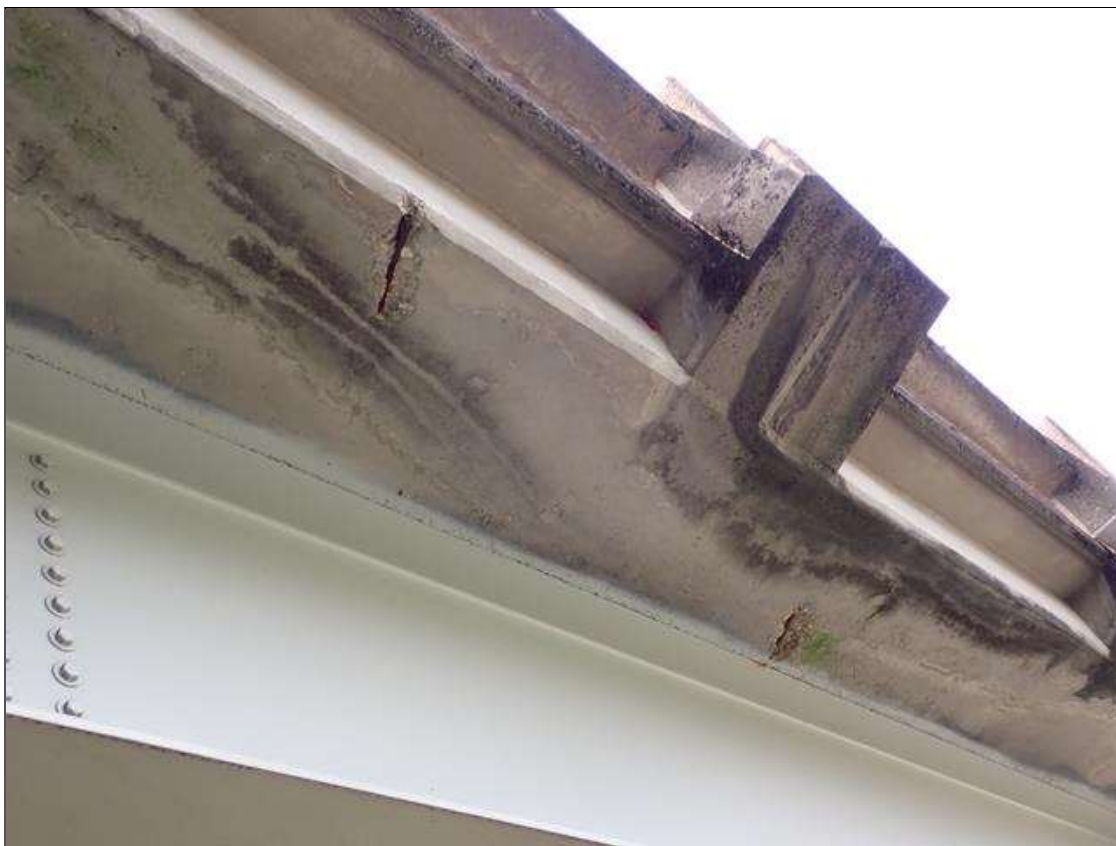
Span 1 Deck: (PAR) [2] UP TO 1 FOOT X UP TO 4 INCH X 1 INCH DEEP SPALLS WITH EXPOSED REINFORCING EAST OVERHANG NEAR MIDSPAN

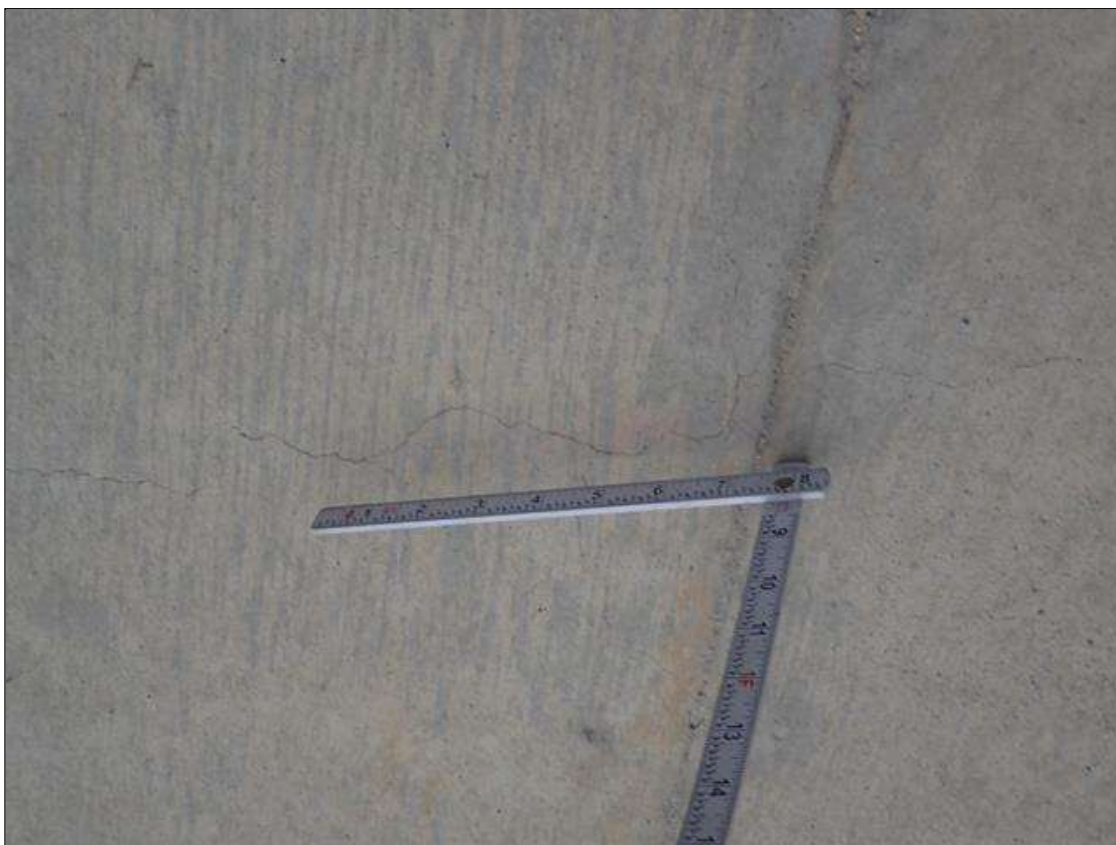
Span 1 Deck: throughout underside of all bays, multiple transverse cracks [up to 8 foot x 1/32 inch] and map cracks (hairline) at random

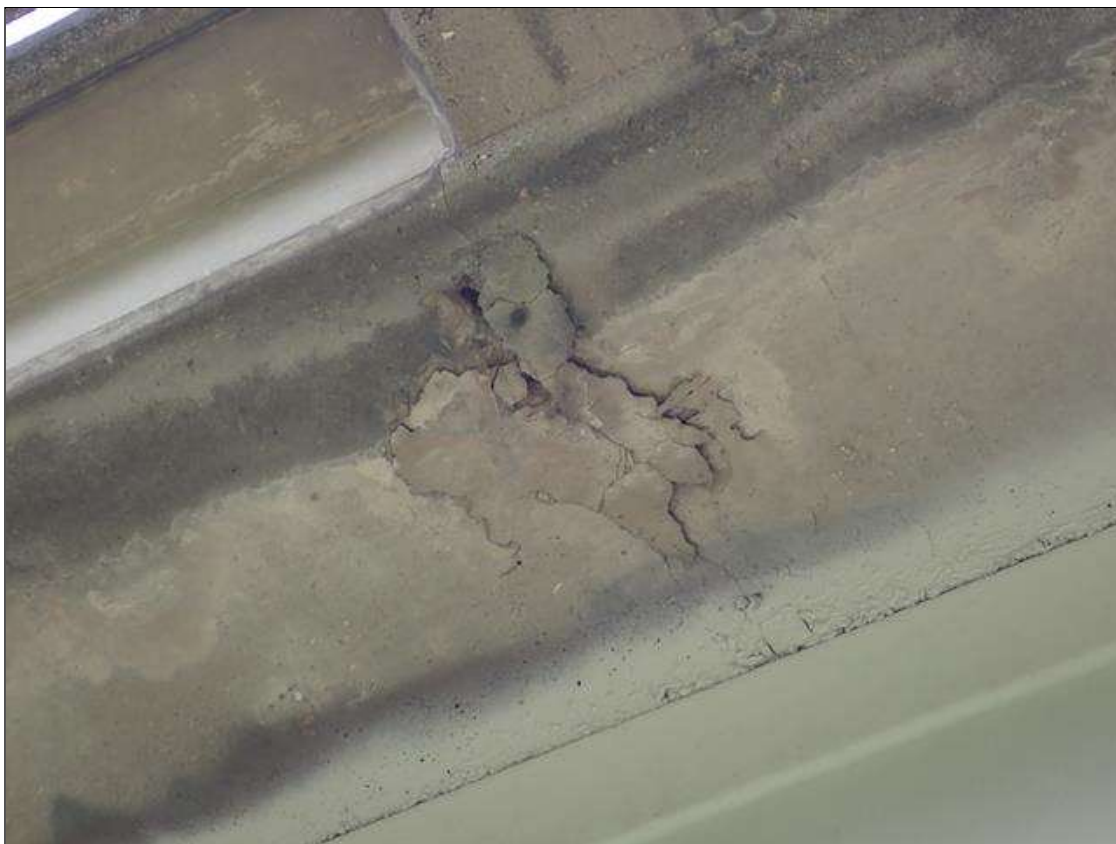
Span 1 Deck: (PAR) 1 FOOT X UP TO 1 FOOT X 1 INCH DEEP SPALL/DELAMINATION WITH EXPOSED REINFORCING WEST OVERHANG 15 FOOT FROM BENT 1

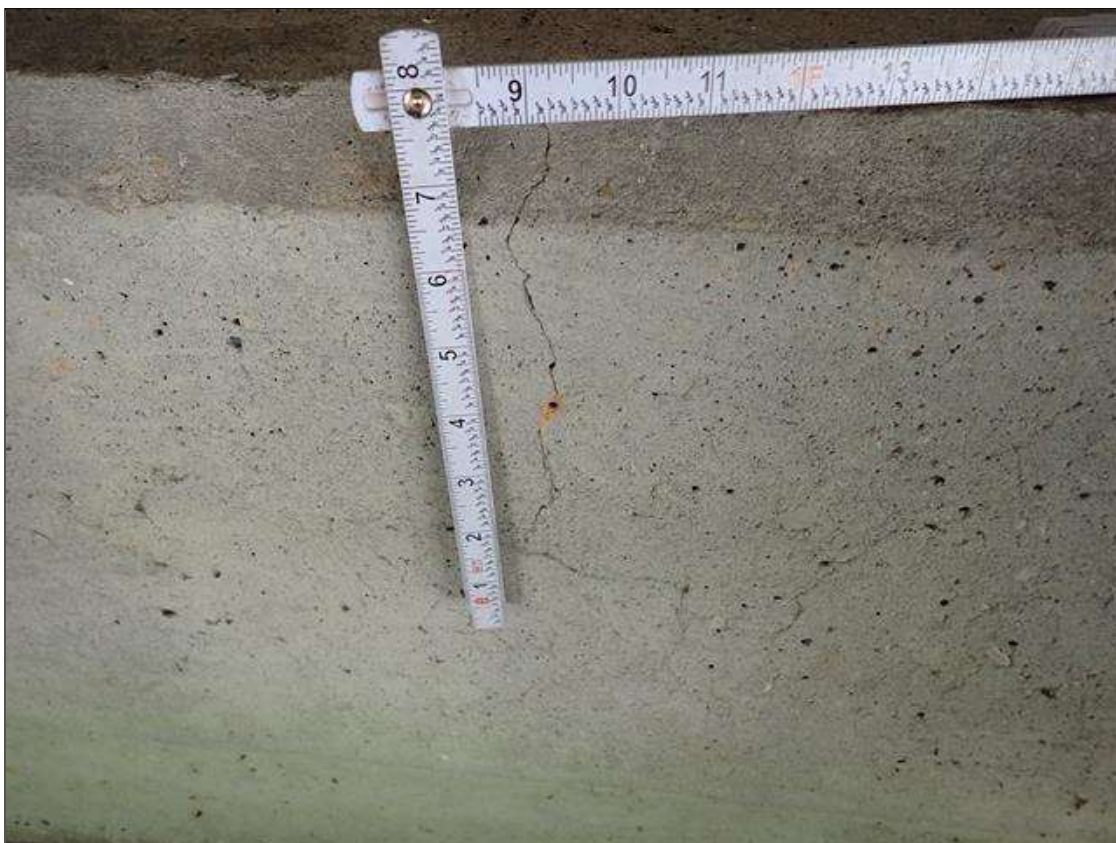
End Bent 1 Cap 1: along length, multiple vertical cracks [up to full height x 1/32 inch]

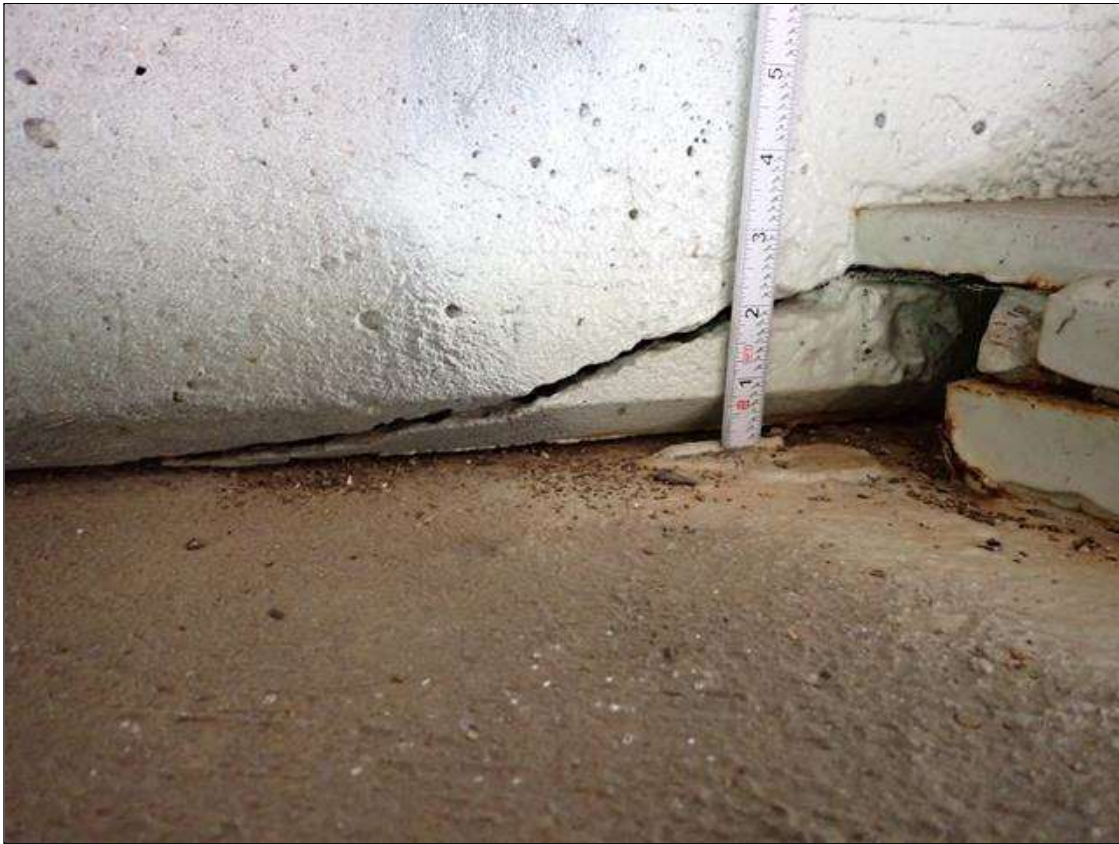
End Bent 1 Abutment: at all beam penetrations, multiple delaminations [up to 9 inch x 2 inch] with cracks (up to 1/4 inch)

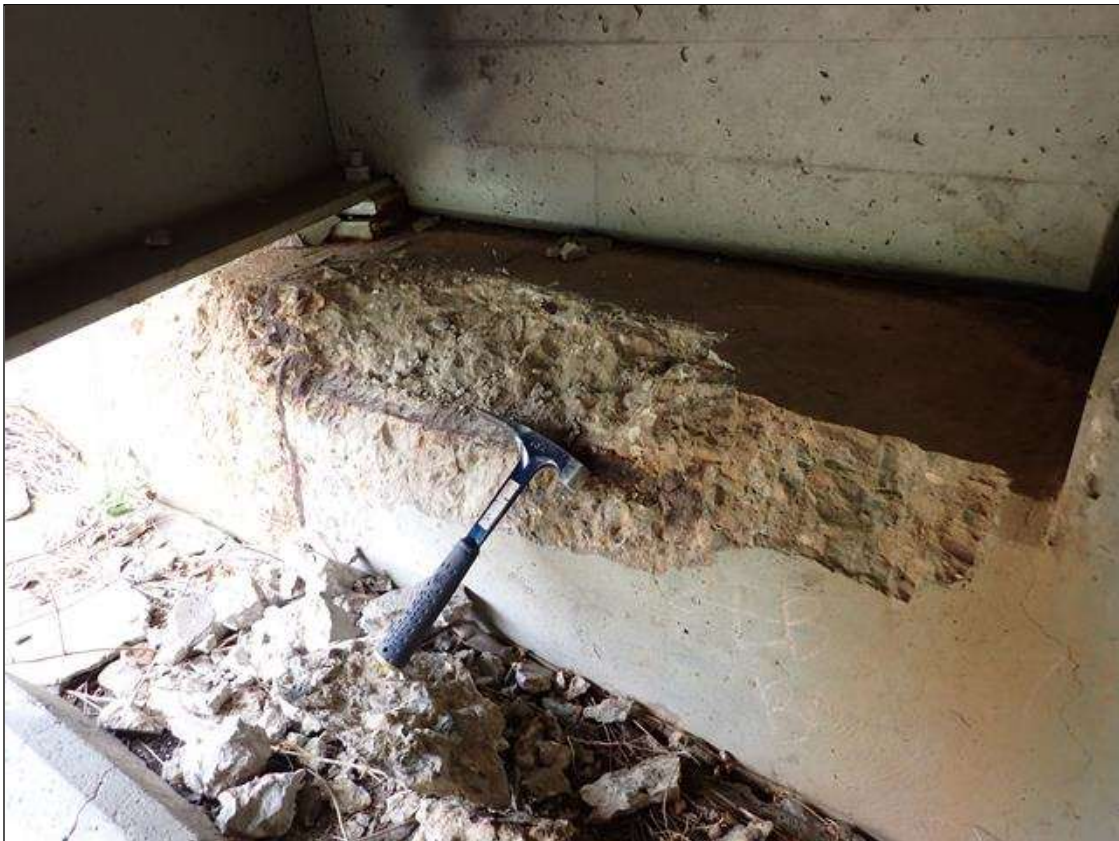
End Bent 2 Cap 1: (PAR) 6 FOOT X UP TO 16 INCH X 10 INCH X 3 INCH DEEP SPALL WITH EXPOSED PRIMARY REBAR WITH SECTION LOSS [UP TO 1/16 INCH] UNDER BEAM 1

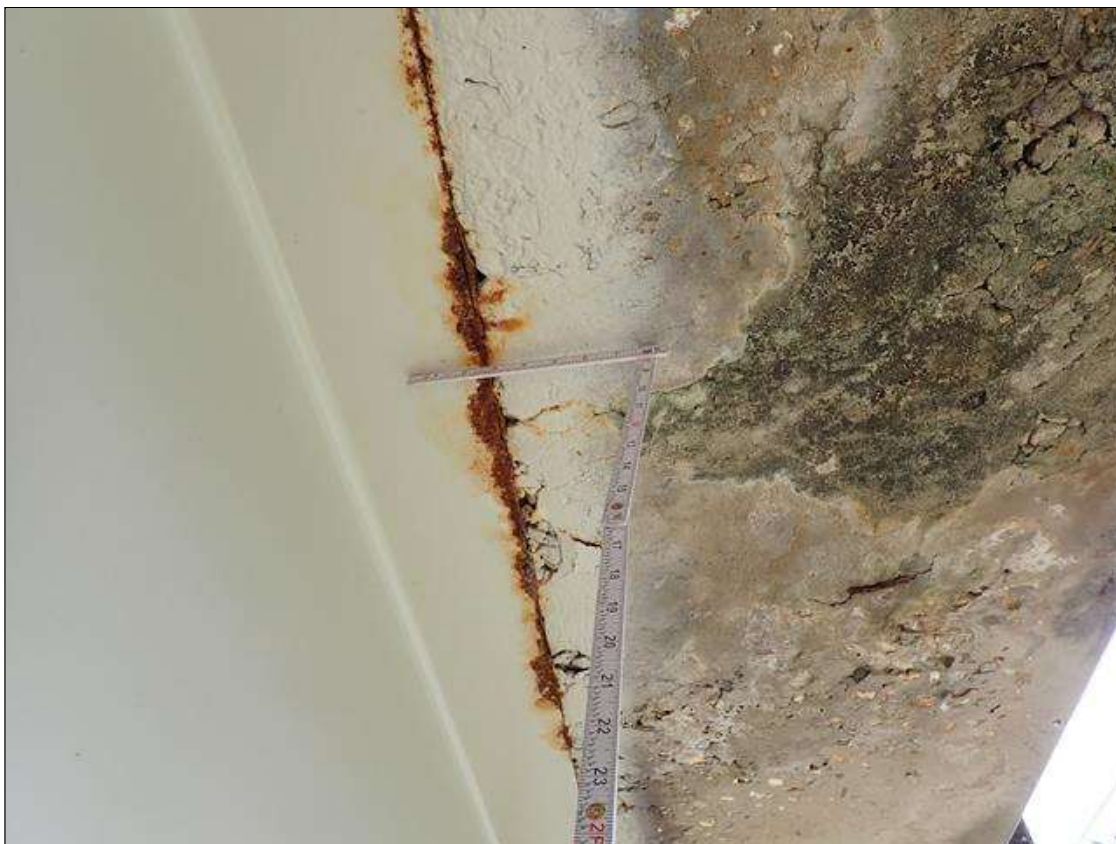
Span 4 Beam 1: West top flange at midspan, active surface corrosion [no loss]

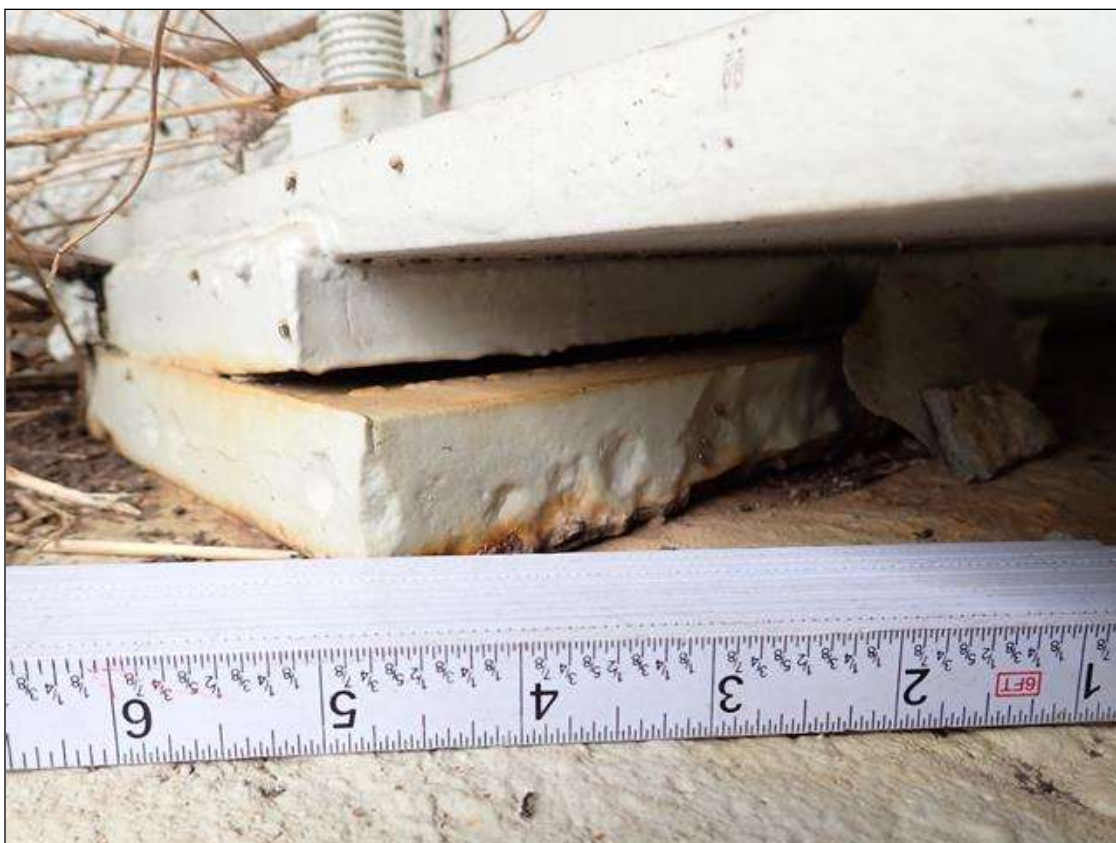
Span 4 Beam 1 - Far Bearing 1: painted over section loss (up to 1/8 inch deep) with corrosion reactivating

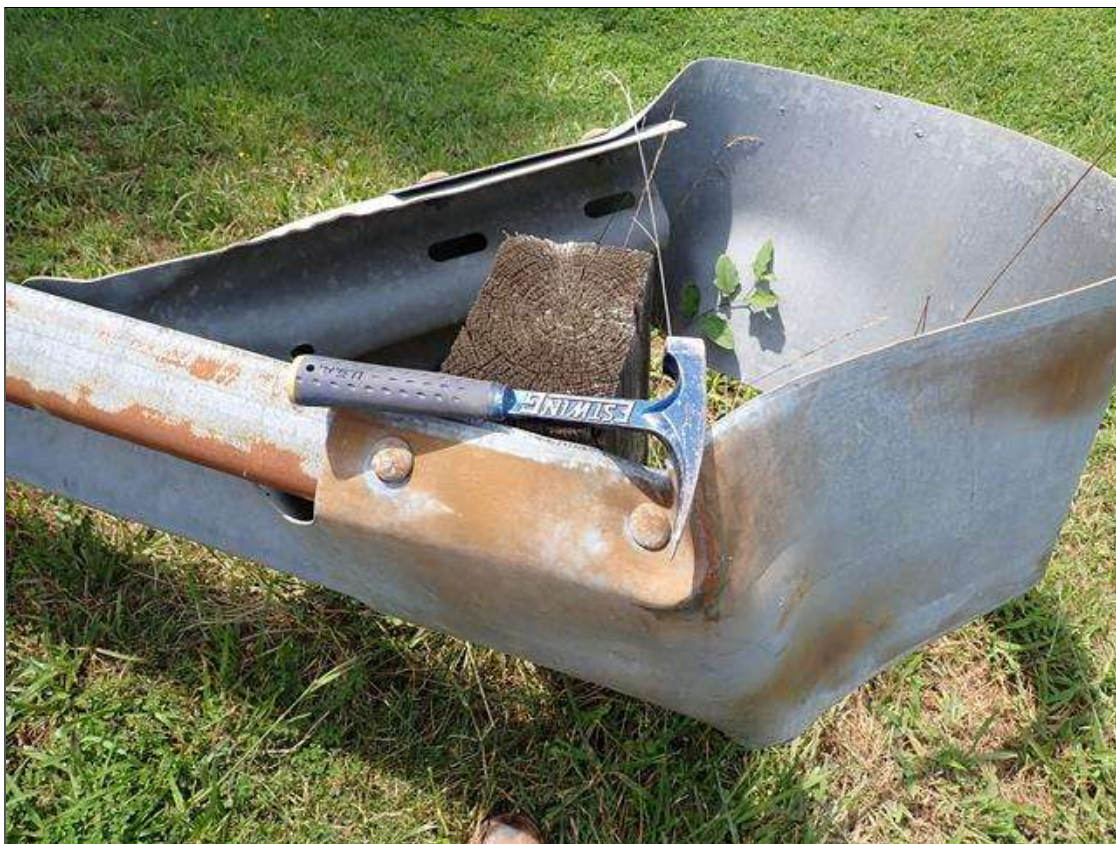
(PAR) northwest guardrail termination, impact damage

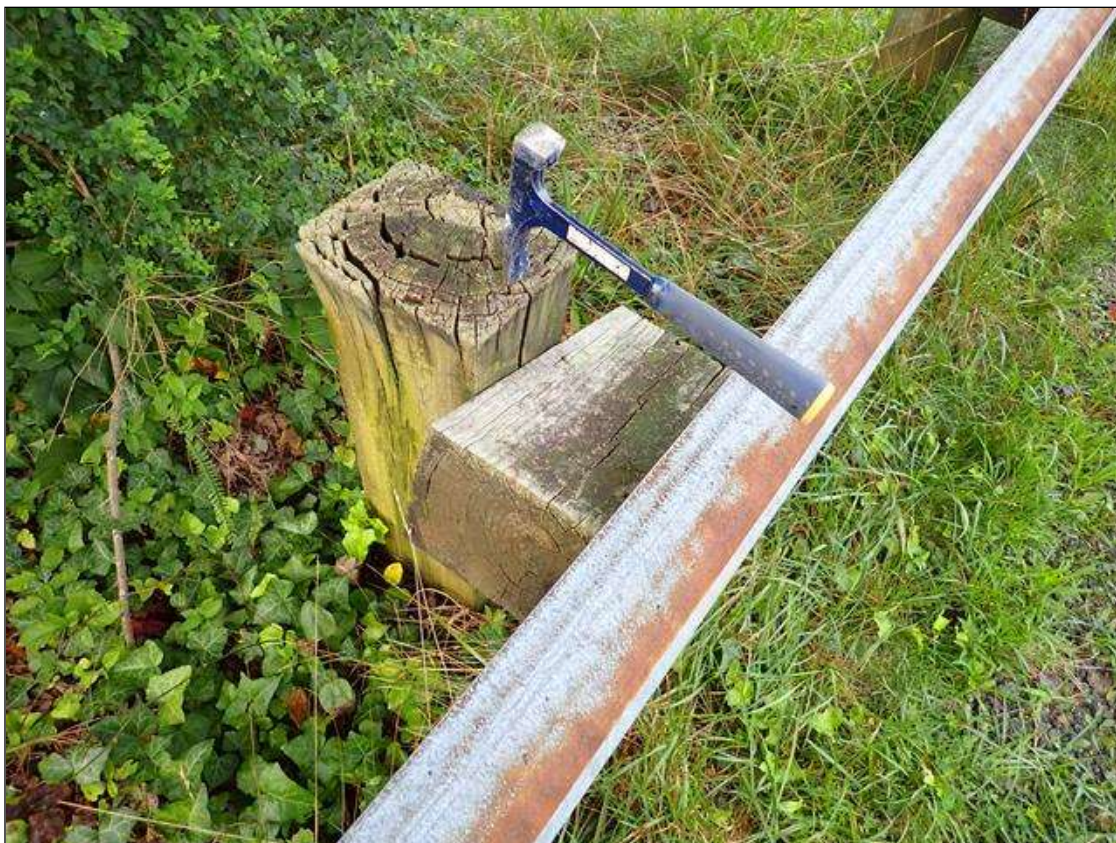
(PAR) along all guardrails, timber spacers, loose/twisted

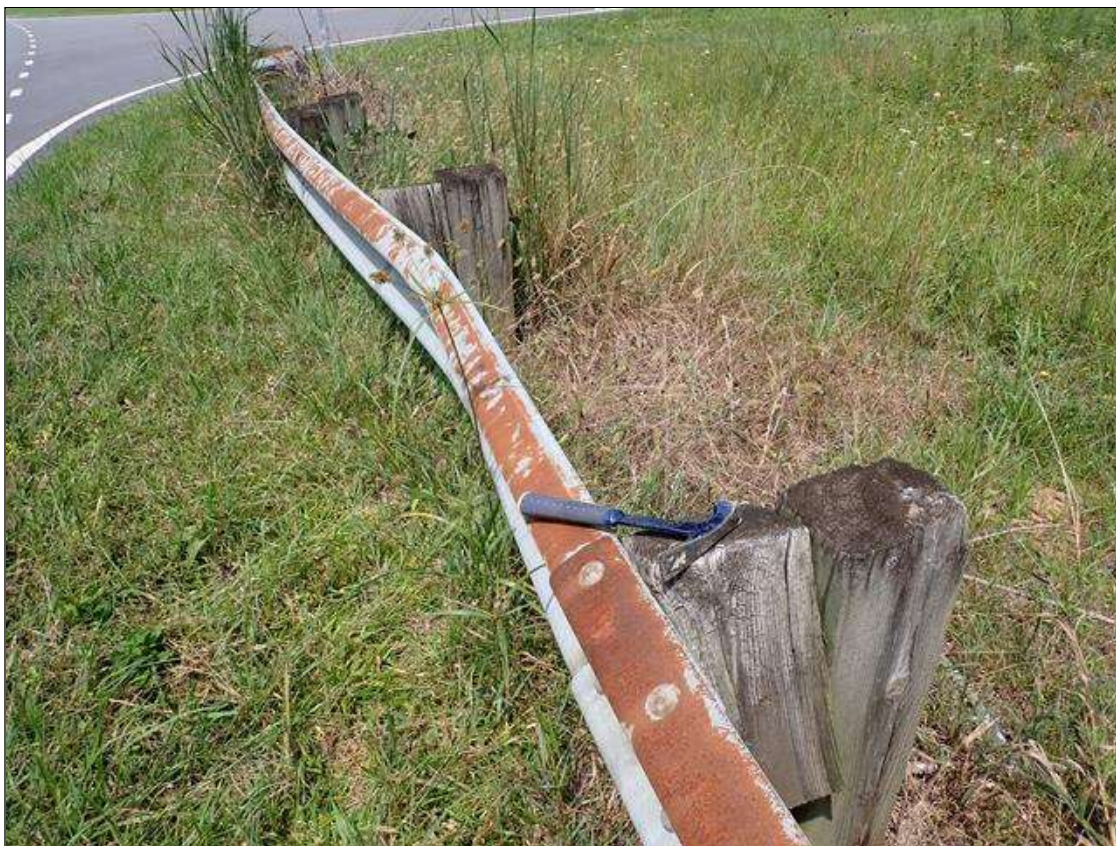
(PAR) northeast guardrail 18 foot from termination, impact damage (7 foot)

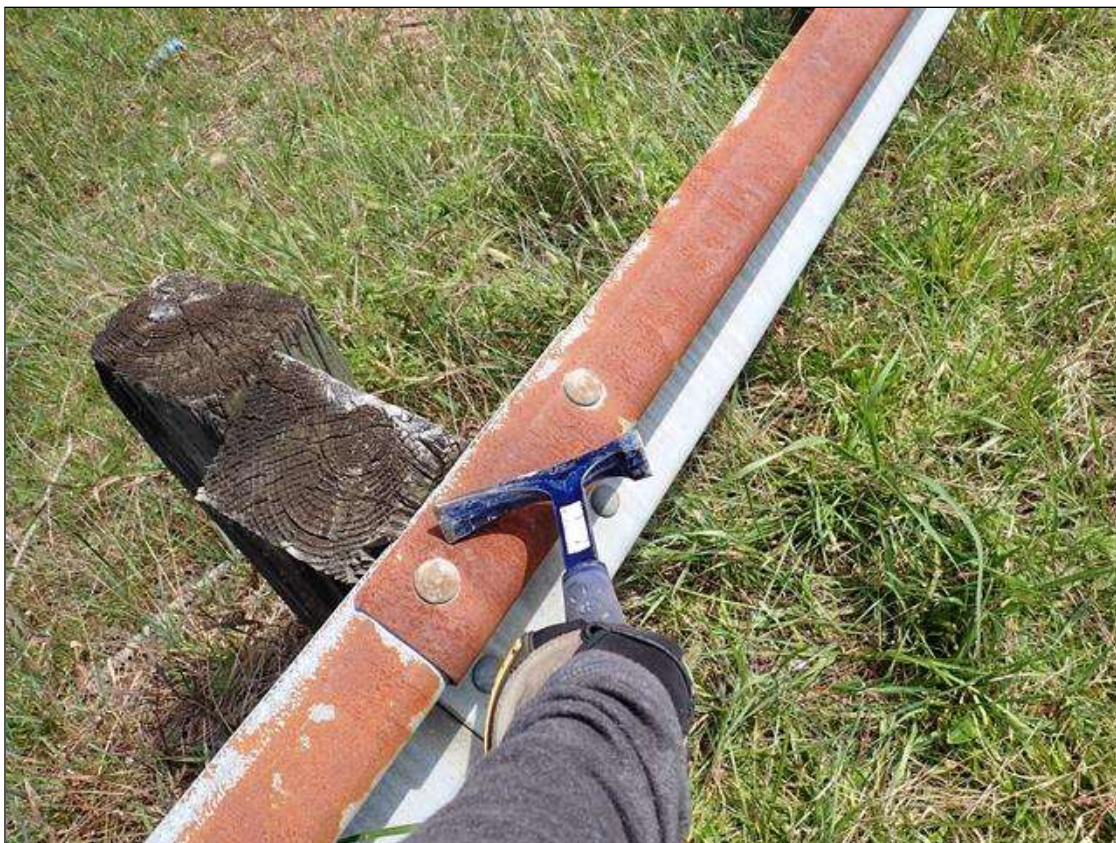
along all guardrails, surface rust at random

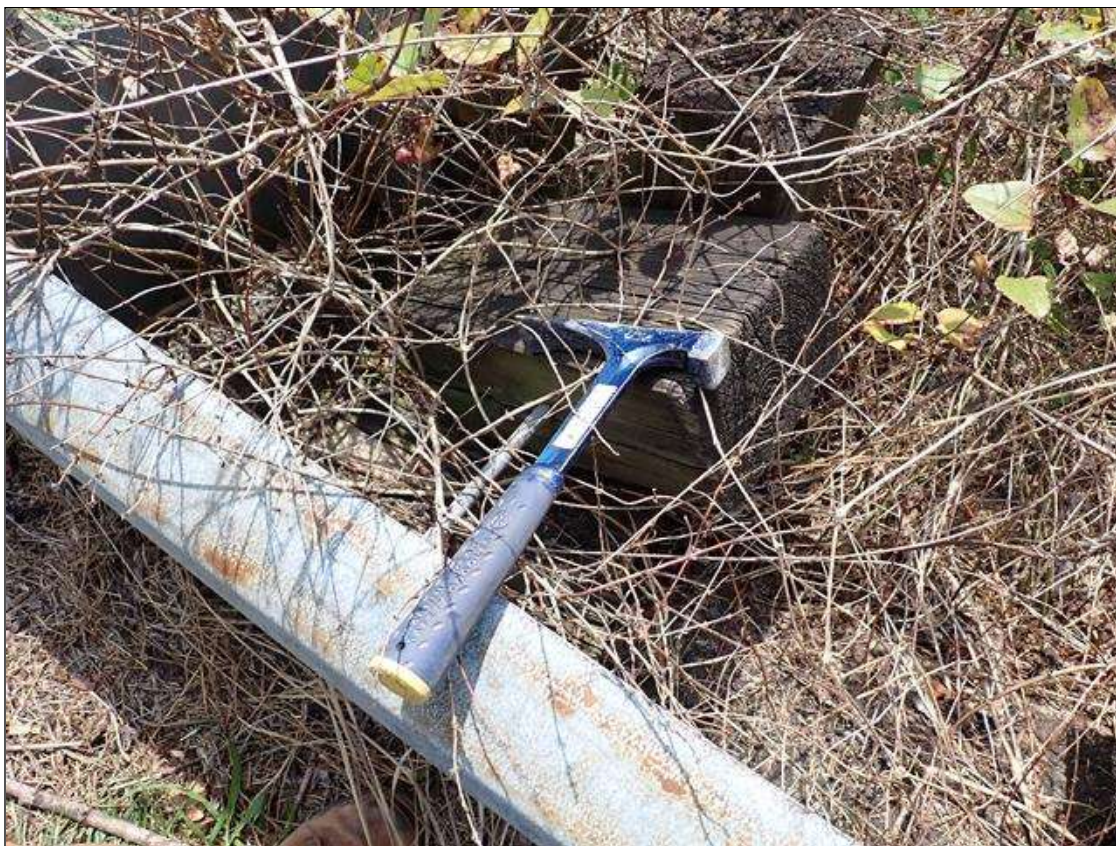
(PAR) northwest guardrail, 1st, 7th and 8th timber posts from end bent 2, timber spacers, missing

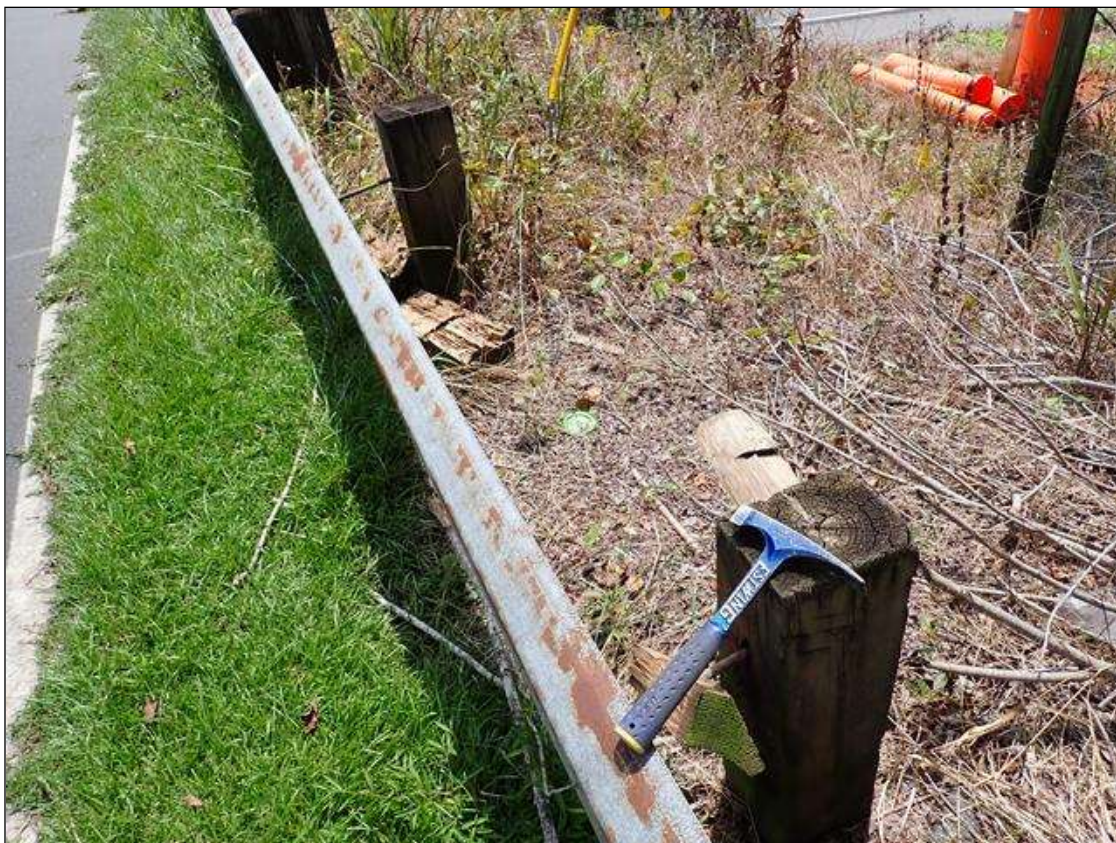
(PAR) northwest guardrail, 1st, 7th and 8th timber posts from end bent 2, timber spacers, missing

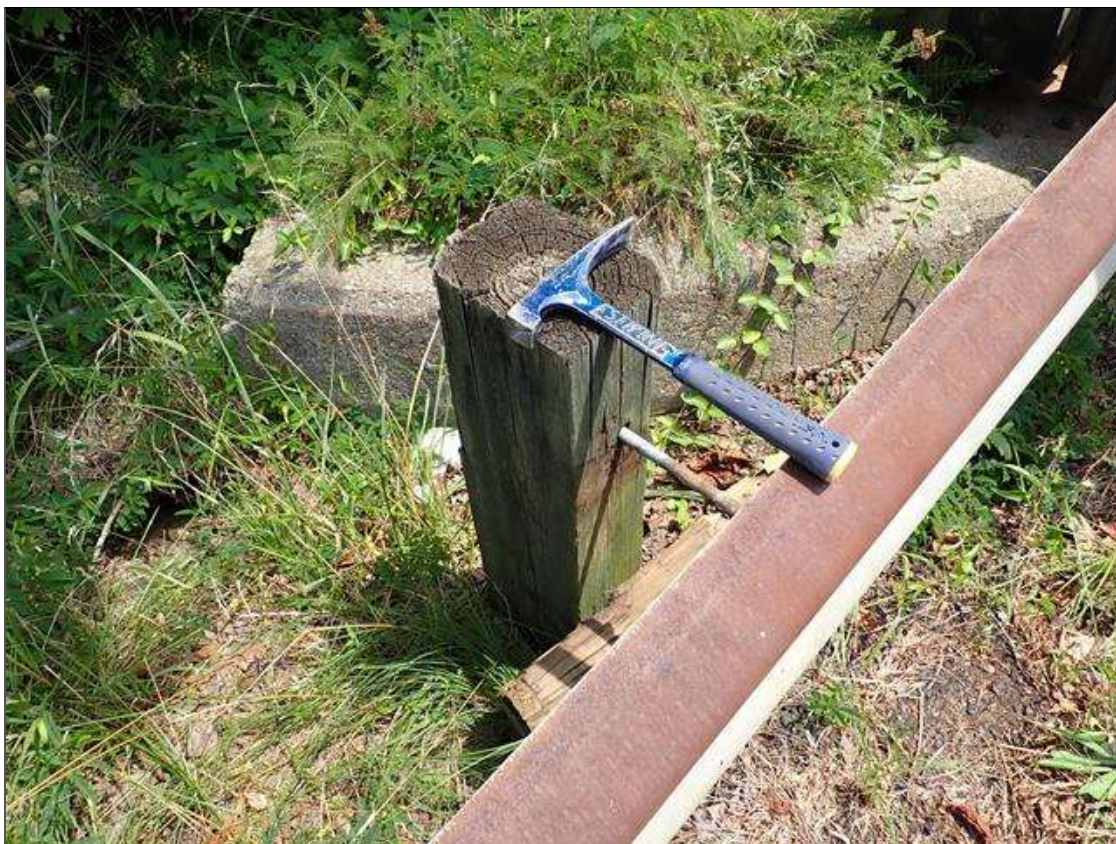
(PAR) northeast guardrail, 3rd and 7th timber posts from end bent 2, timber spacers, missing

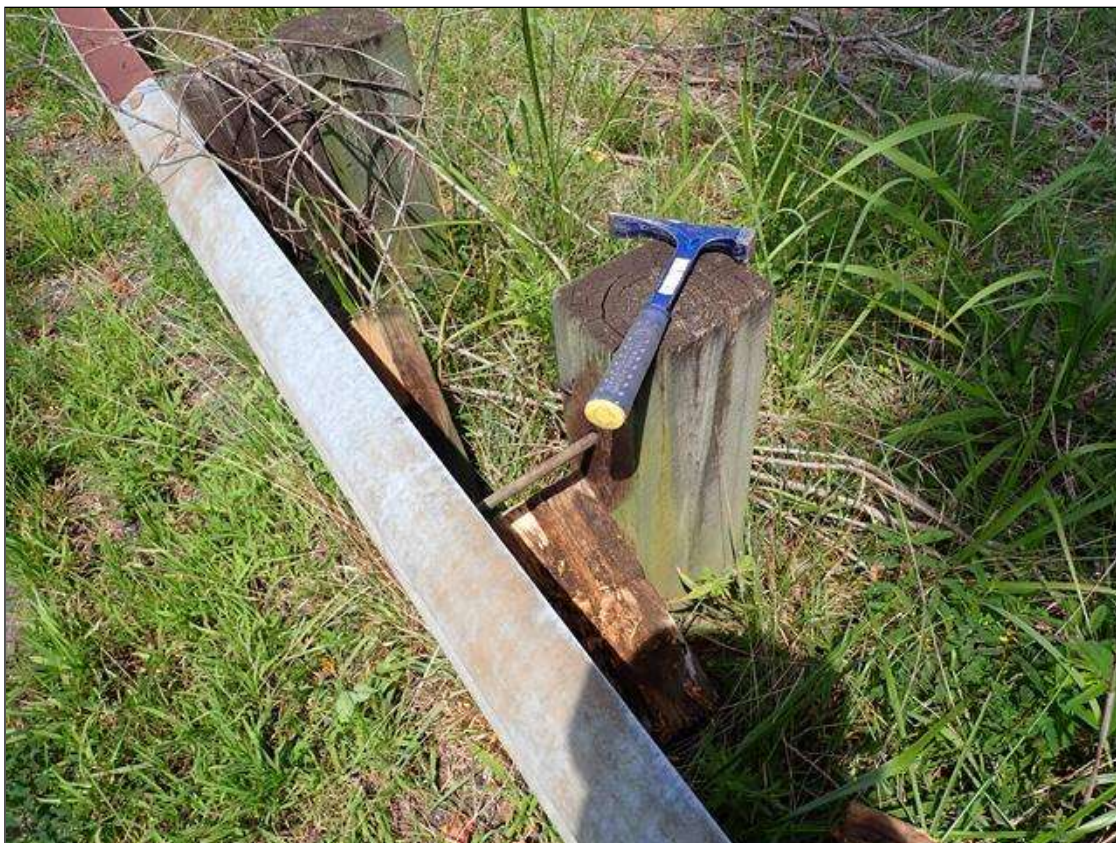
(PAR) northeast guardrail, 3rd and 7th timber posts from end bent 2, timber spacers, missing

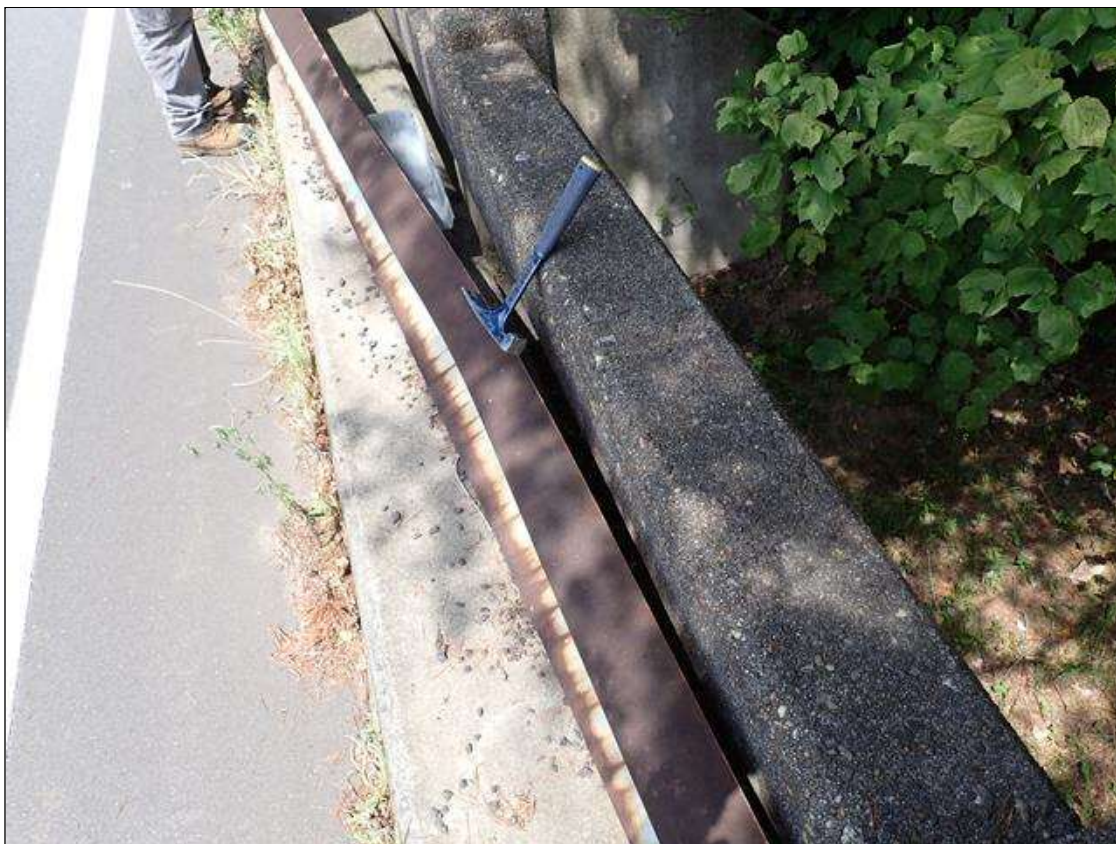
(PAR) northeast guardrail 4 foot from attachment, impact damage (6 foot)

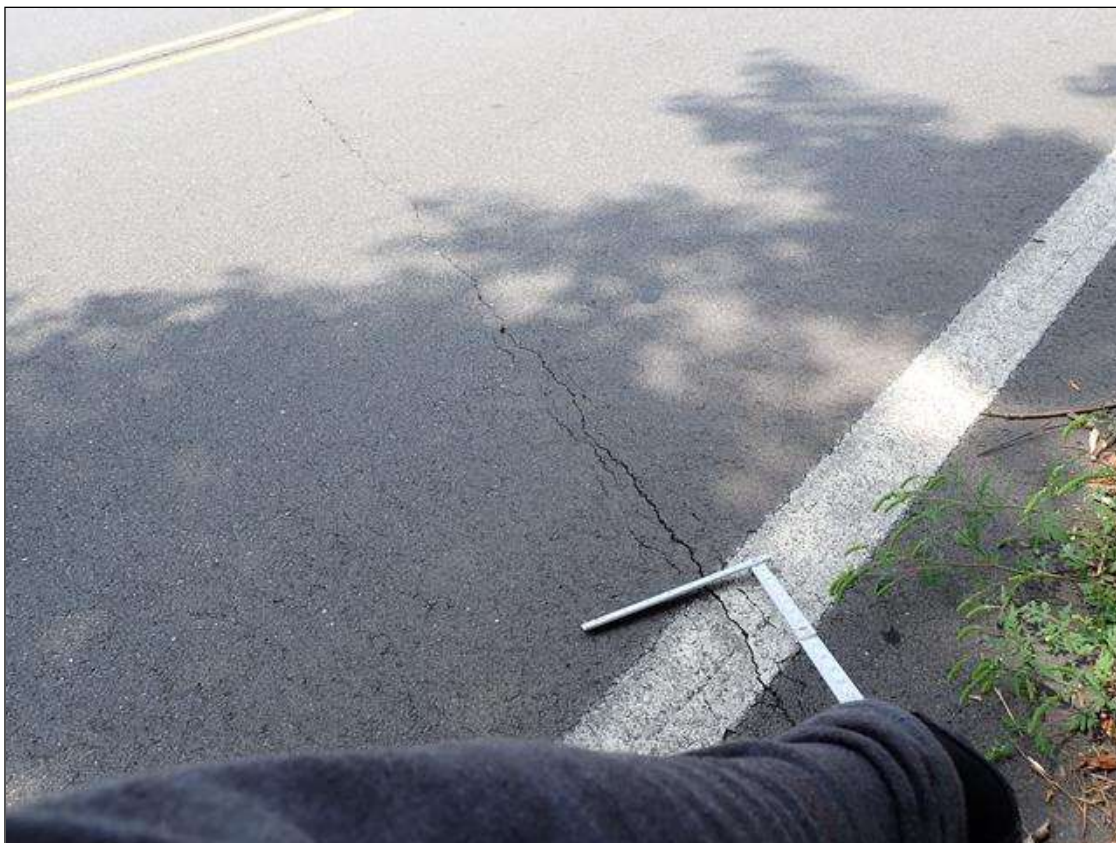
Span 1 Wearing Surface: over end bent 1, right travel lane, transverse crack (1/16 inch x 12 foot)

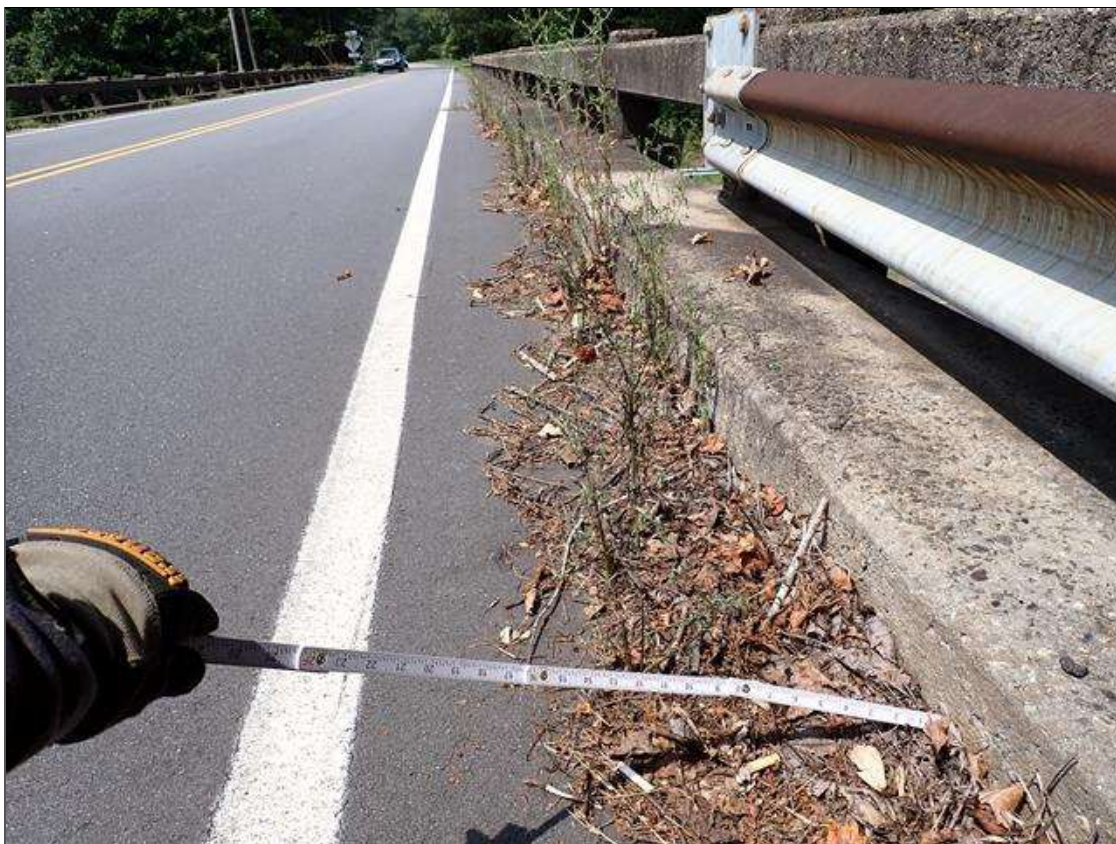
along curblines, debris accumulation (full length x up to 1 foot) with vegetation growth

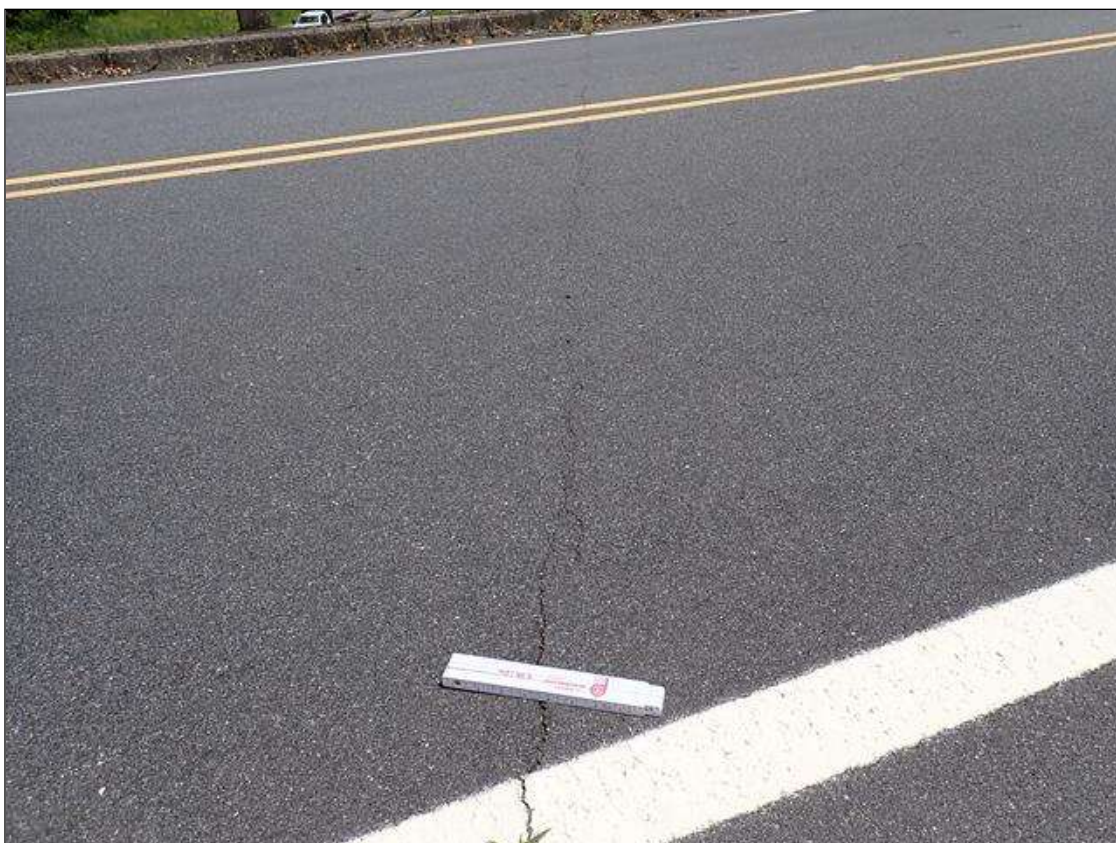
Span 2 Wearing Surface: over bent 1, transverse crack (up to 1/16 inch x 28 foot)

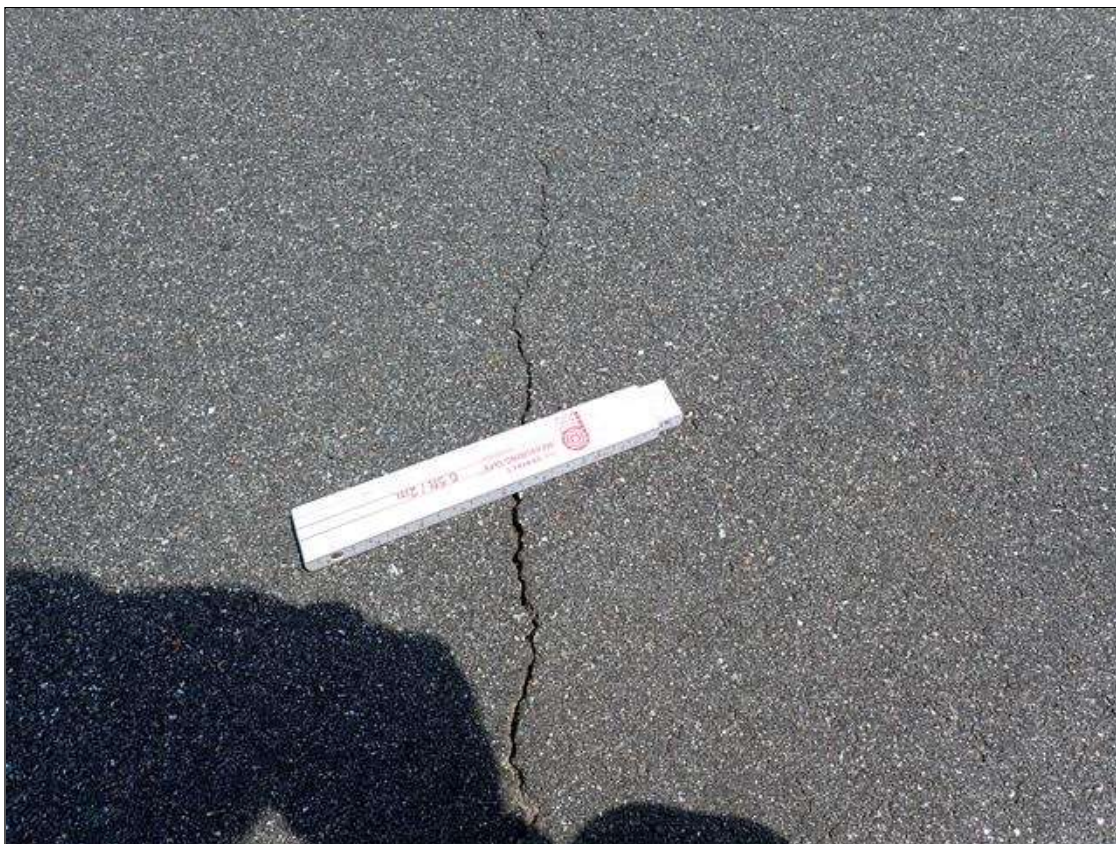
Span 3 Wearing Surface: over bent 2, transverse crack (1/16 inch x 28 foot)

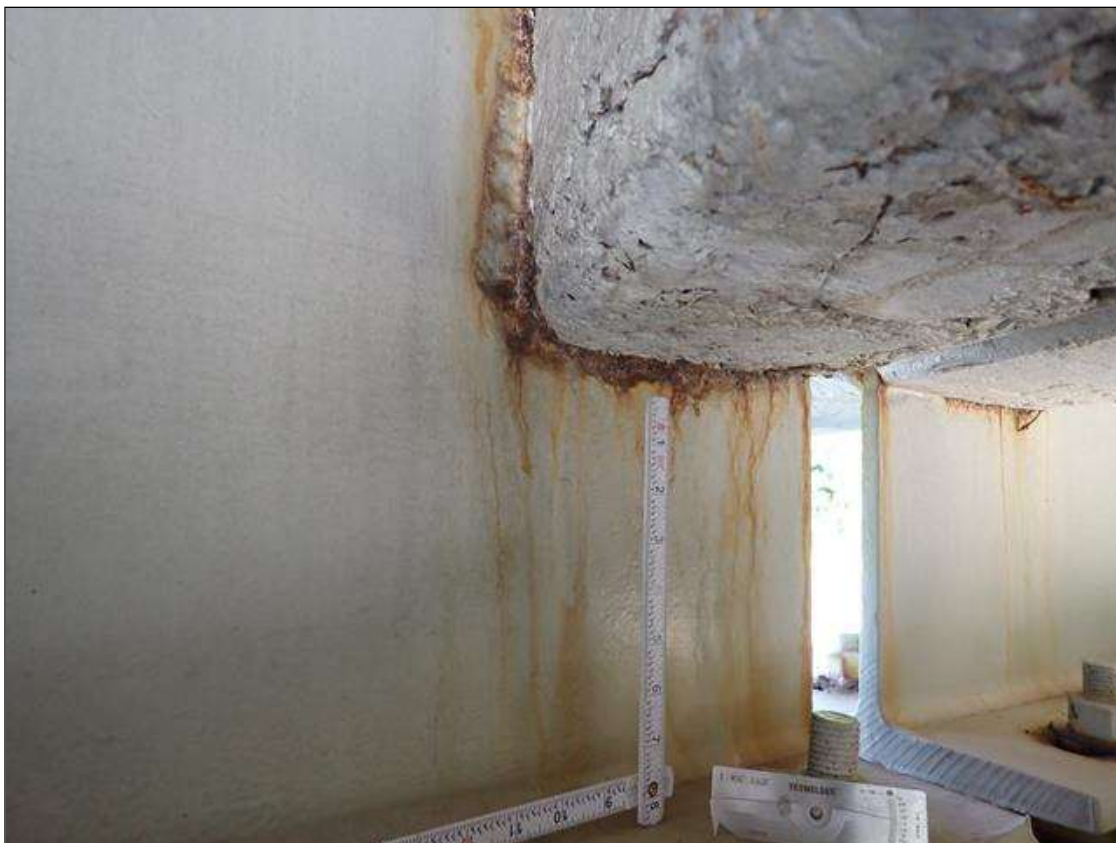
Span 3 Beam 1: at bent 3, corrosion with section loss: web adjacent to end diaphragm (1/2 inch average remaining x 10 inch x 9 inch)

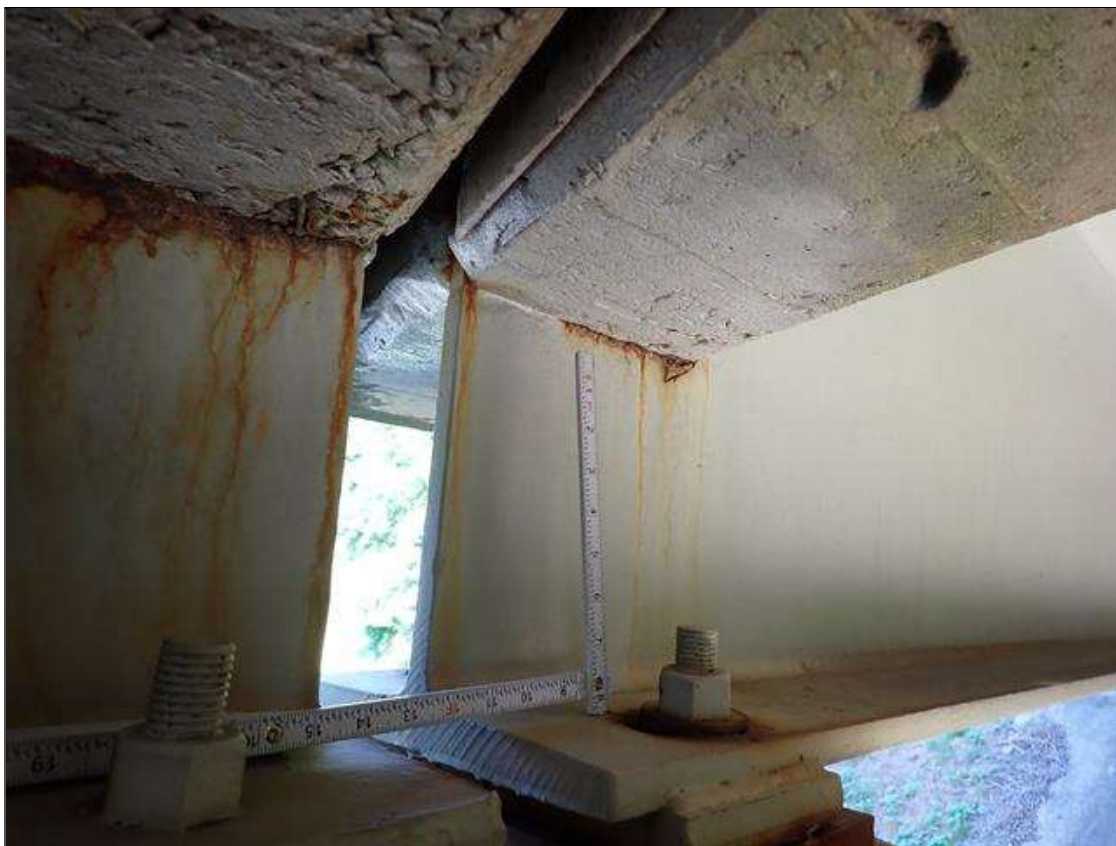
Span 4 Beam 1: at bent 3, corrosion with section loss: web adjacent to end diaphragm (9/16 inch average remaining x 10 inch x 1 inch)

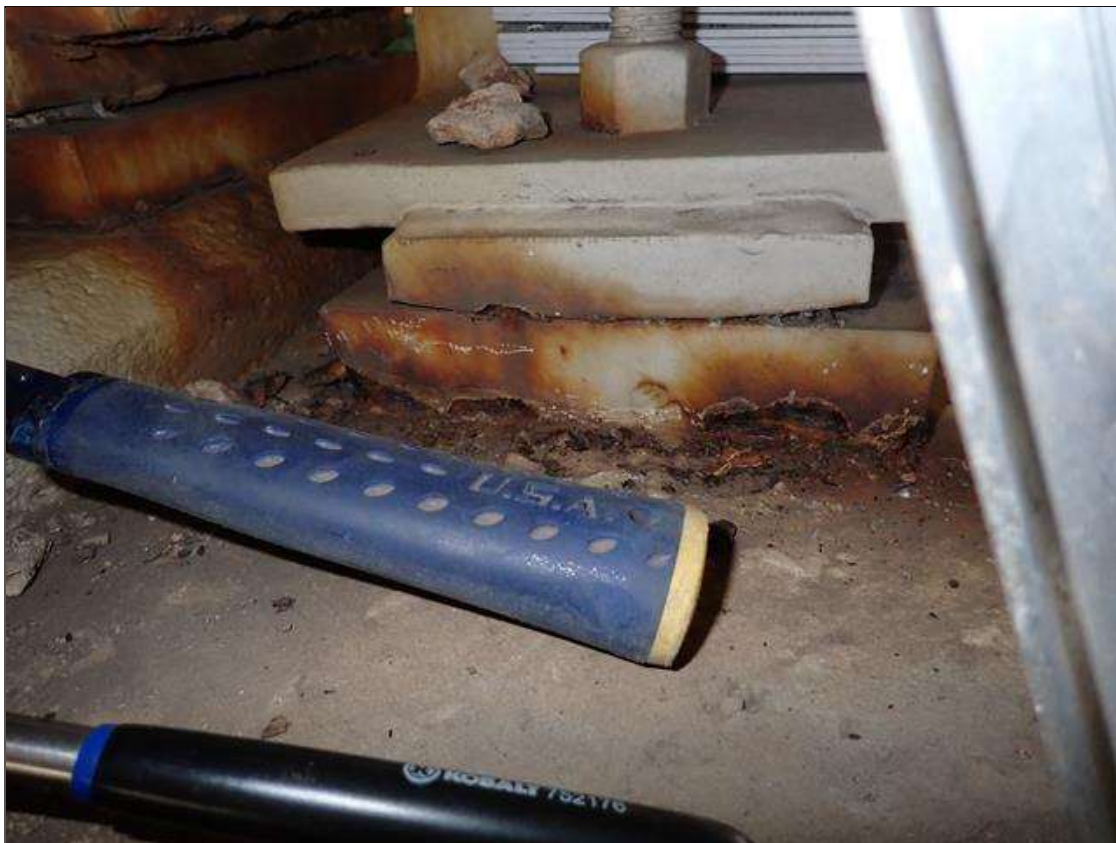
Span 3 Beam 2 - Far Bearing 2: surface rust/rust scale
