NC DEPARTMENT OF TRANSPORTATION  
 DIVISION OF HIGHWAYS  
 STRUCTURE MANAGEMENT UNIT

ATTENTION: prompt action request; sketches revised; span 2 and 3 total horizontal clearances revised

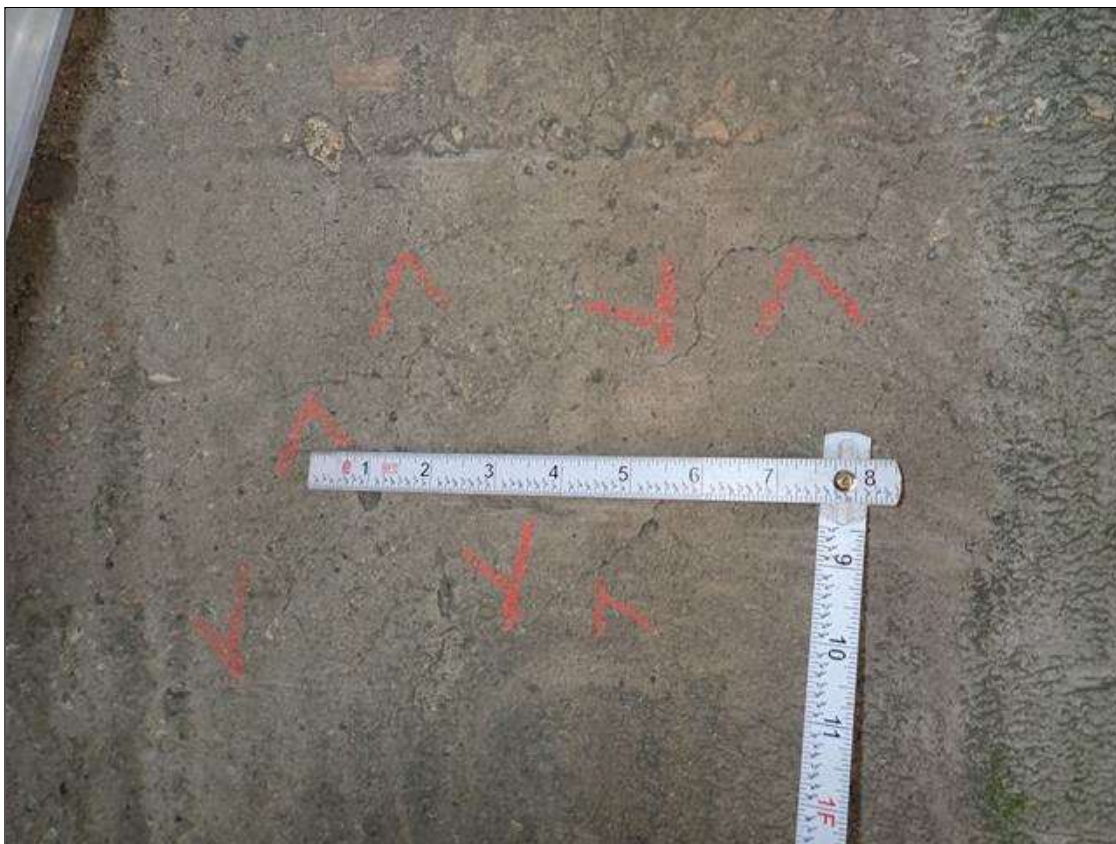
Bent 3 Cap 1: along the length of the cap, vertical cracks (up to 1/32 inch x full height) and map cracks (hairline) at random

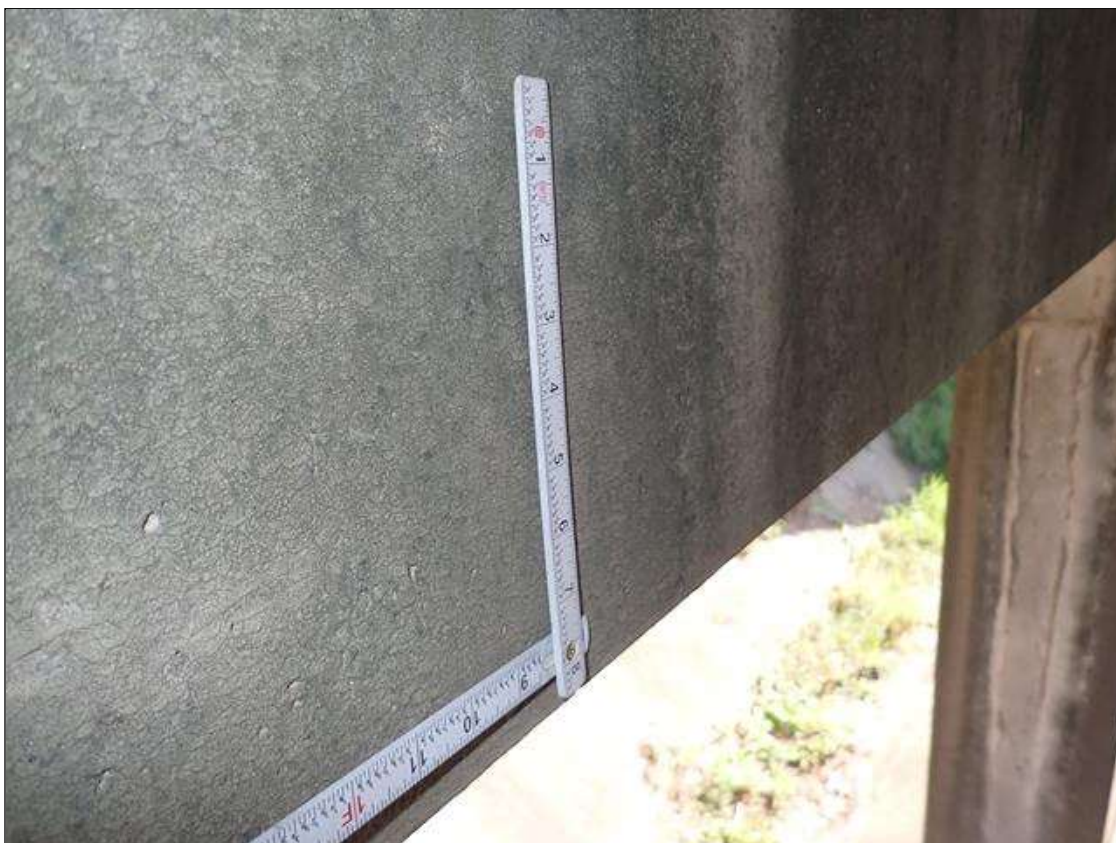
Bent 3 Cap 1: along the length of the cap, vertical cracks (up to 1/32 inch x full height) and map cracks (hairline) at random

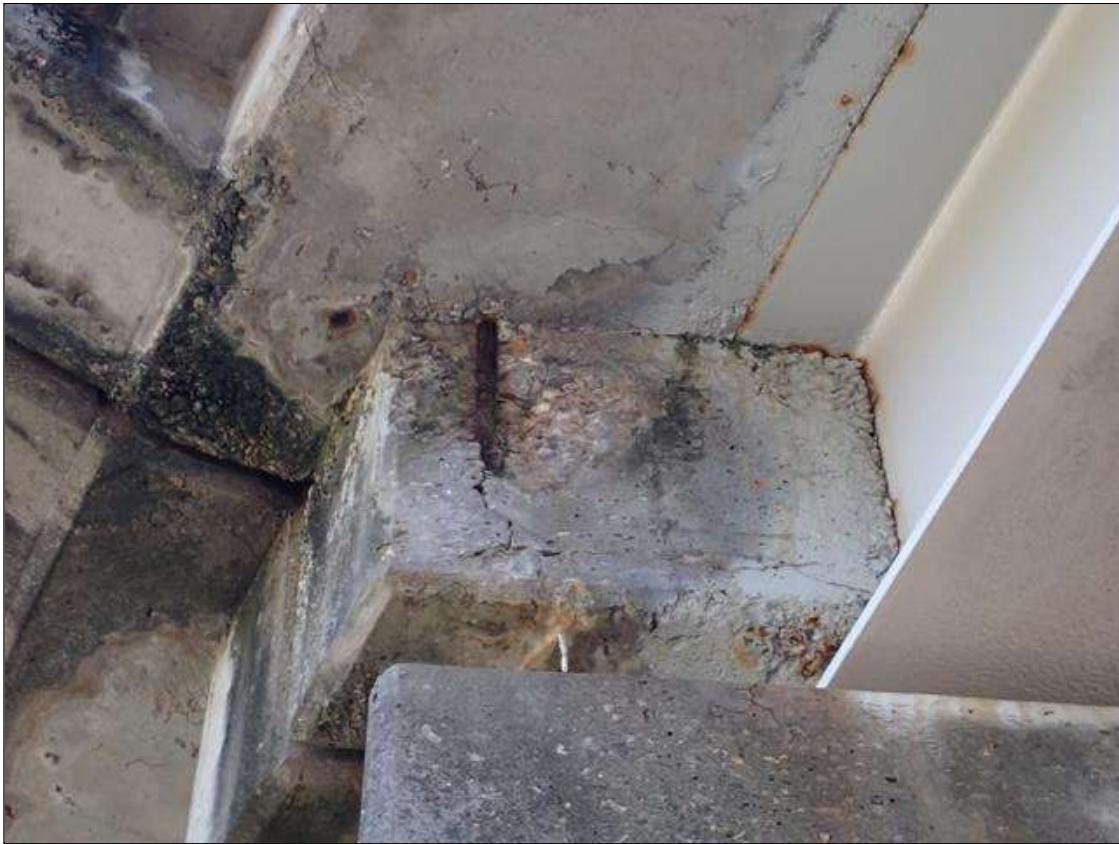
Span 3 Beam 1: (PAR) at bent 3 left overhang end diaphragm, spall/delamination [full height x up to 12 inch x up to 1.5 inch deep] with exposed rusted reinforcing [up to 1/8 inch section loss]

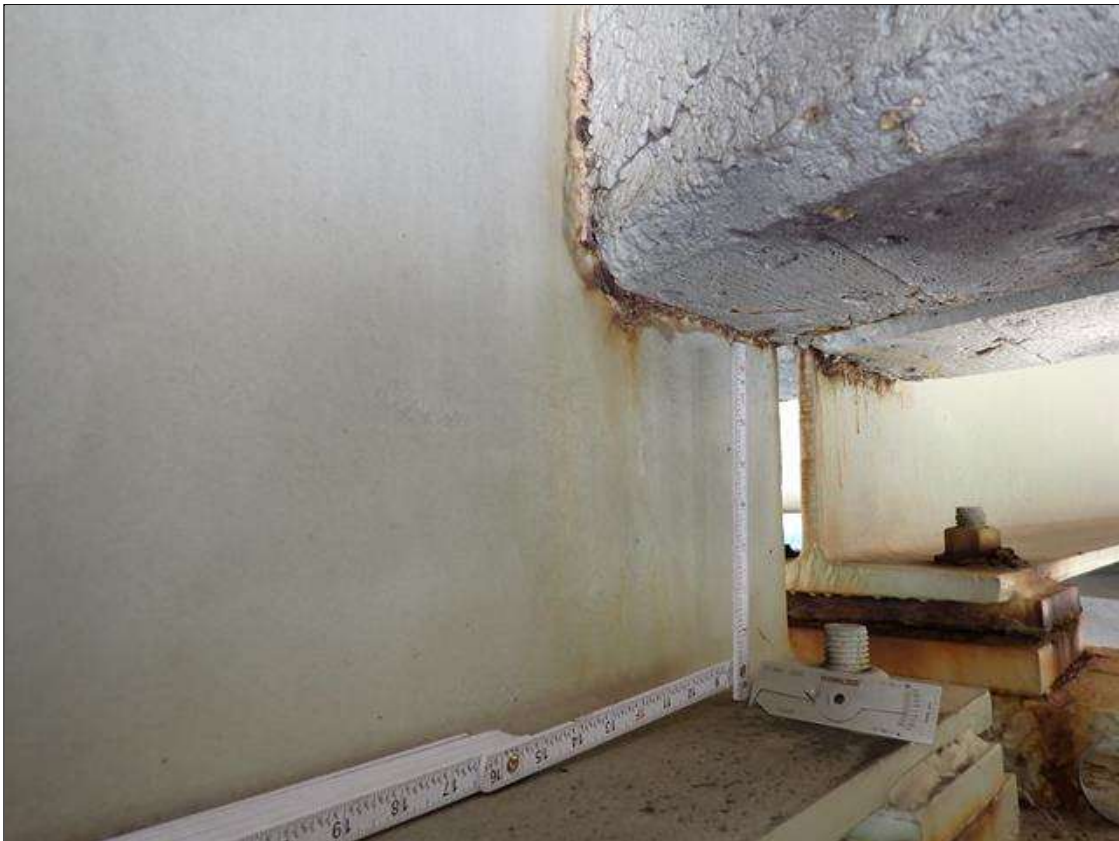
Span 3 Beam 3: at bent 3, corrosion with section loss: web adjacent to end diaphragm (1/2 inch average remaining x 10 inch x 6 inch)

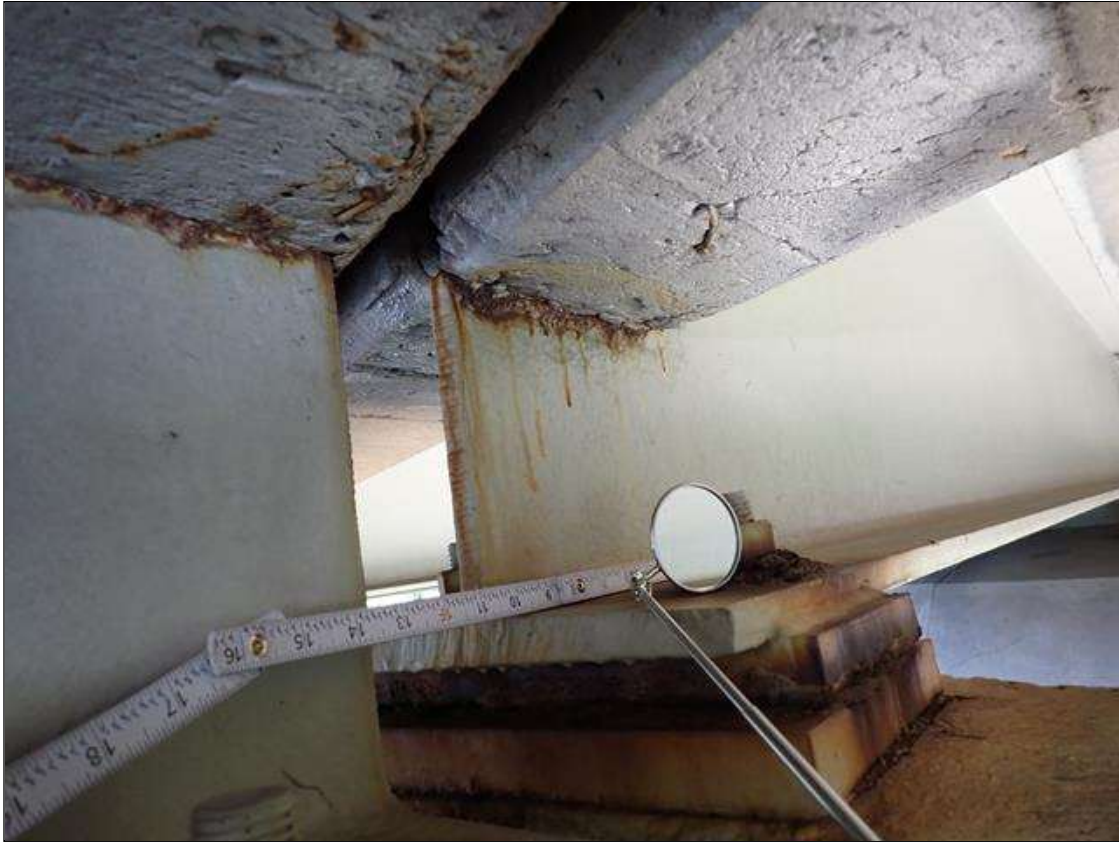
Span 4 Beam 3: at bent 3, corrosion with section loss: web adjacent to end diaphragm (1/2 inch average remaining x 10 inch x 1 inch)

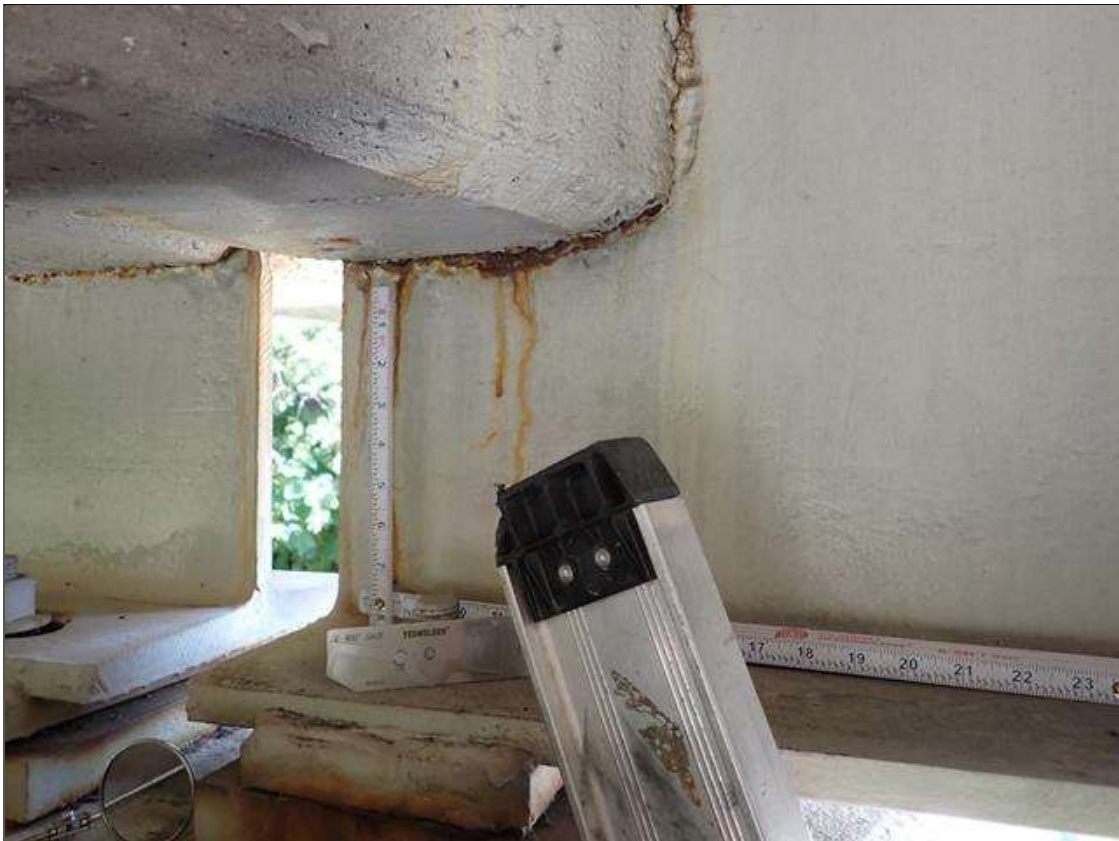
Span 3 Beam 4: at bent 3, corrosion with section loss: web adjacent to end diaphragm (1/2 inch average remaining x 10 inch x 23 inch)

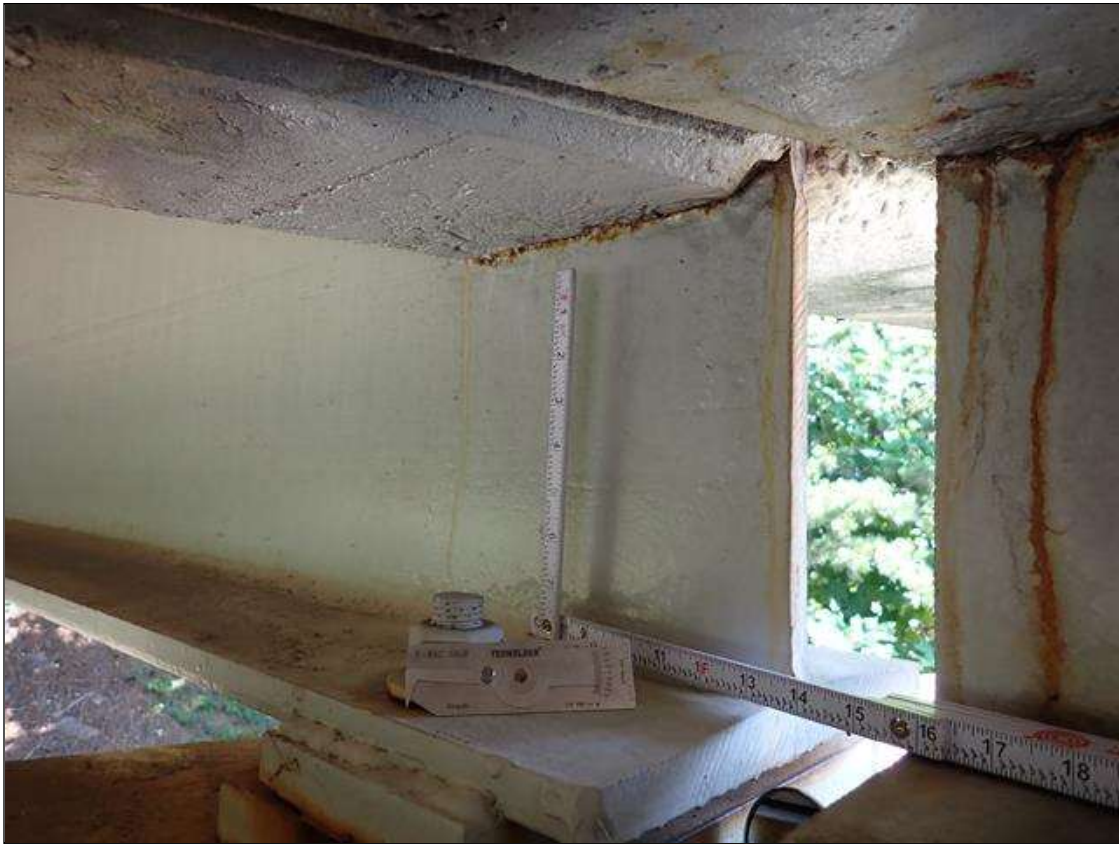
Span 4 Beam 4: at bent 3, corrosion with section loss: web adjacent to end diaphragm (9/16 inch average remaining x 10 inch x 1 inch)

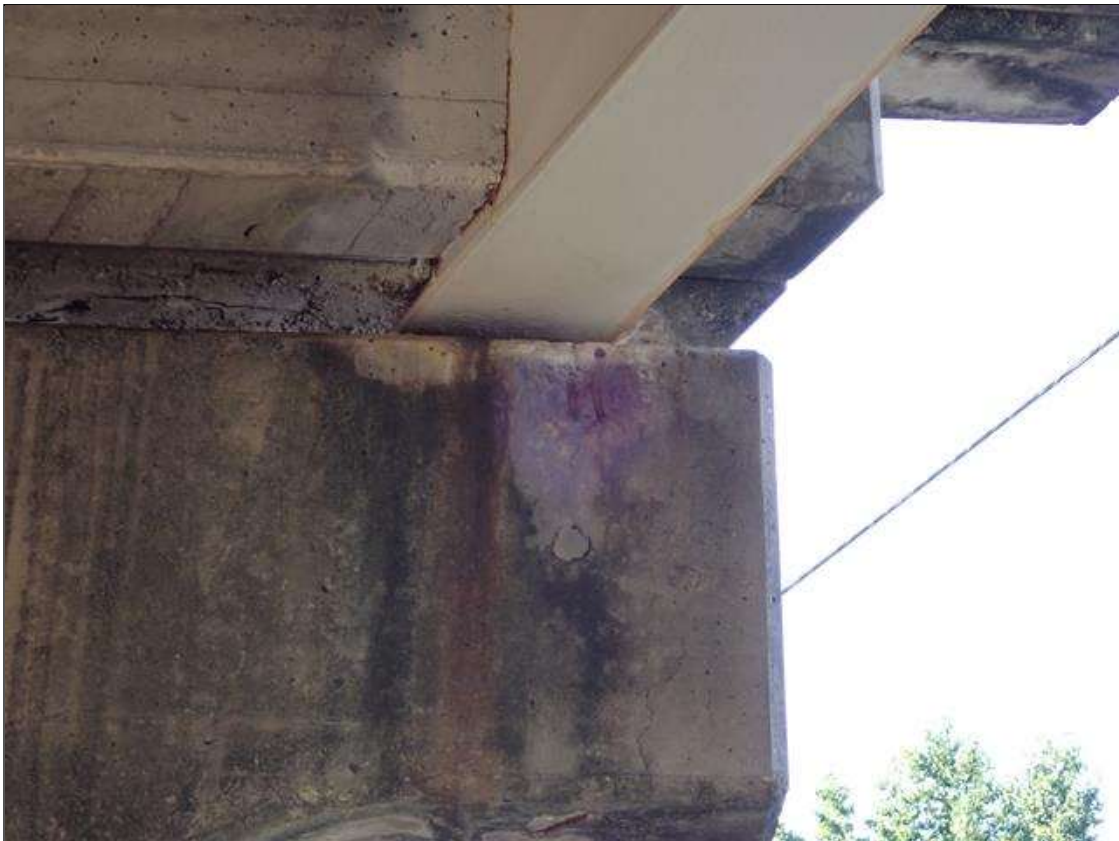
Bent 3 Cap 1: NORTH FACE OF CAP UNDER BEAM 1 HAS A 9 INCH X 11 INCH X 2 INCH DEEP SPALL AT TOP OF CAP.

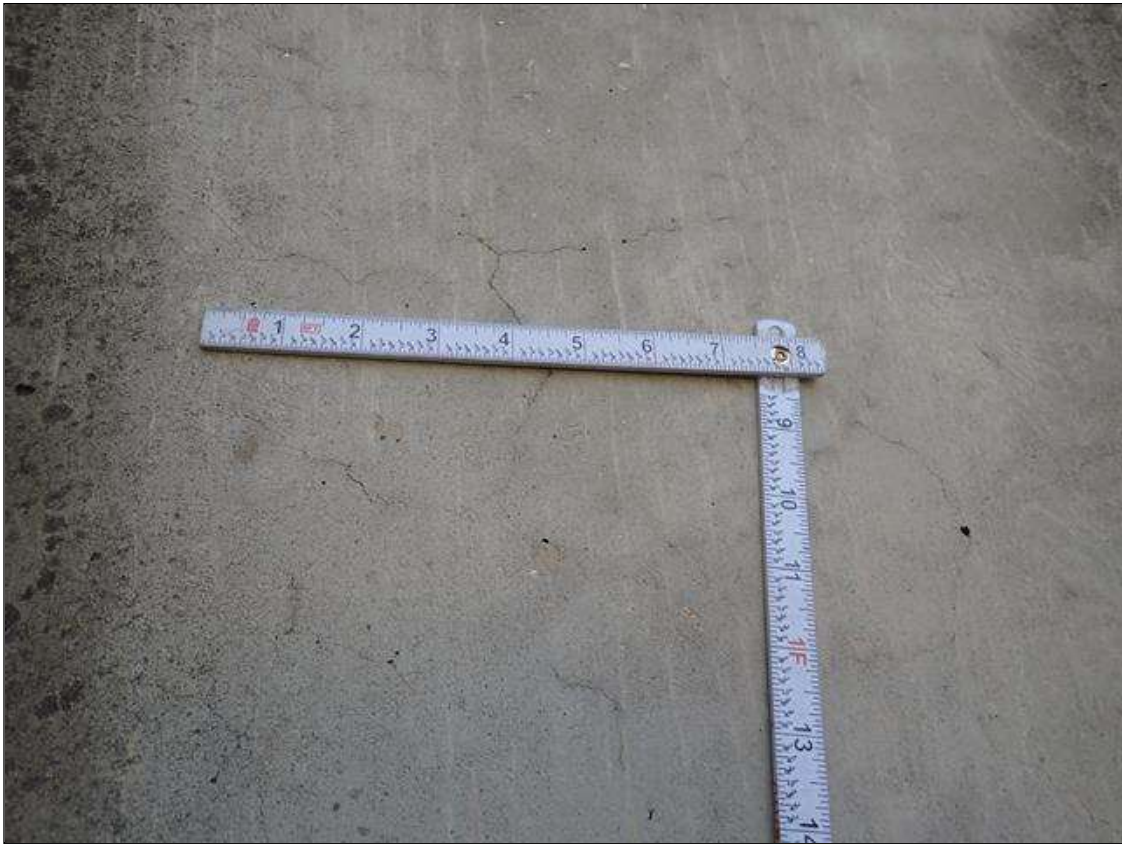
Bent 3 Pile 1: at East face, hairline map cracking at random

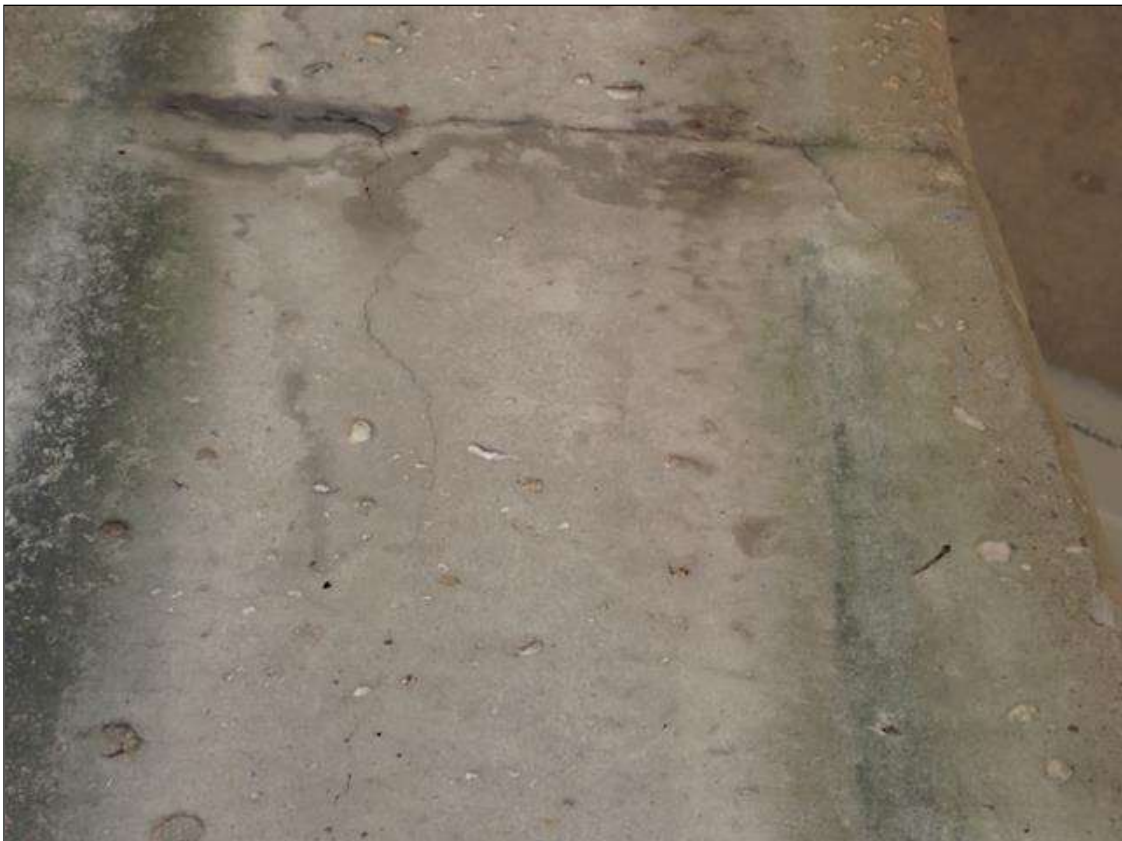
Bent 3 Pile 1: at West face, (2) vertical cracks [up to 3 foot x 1/32 inch]

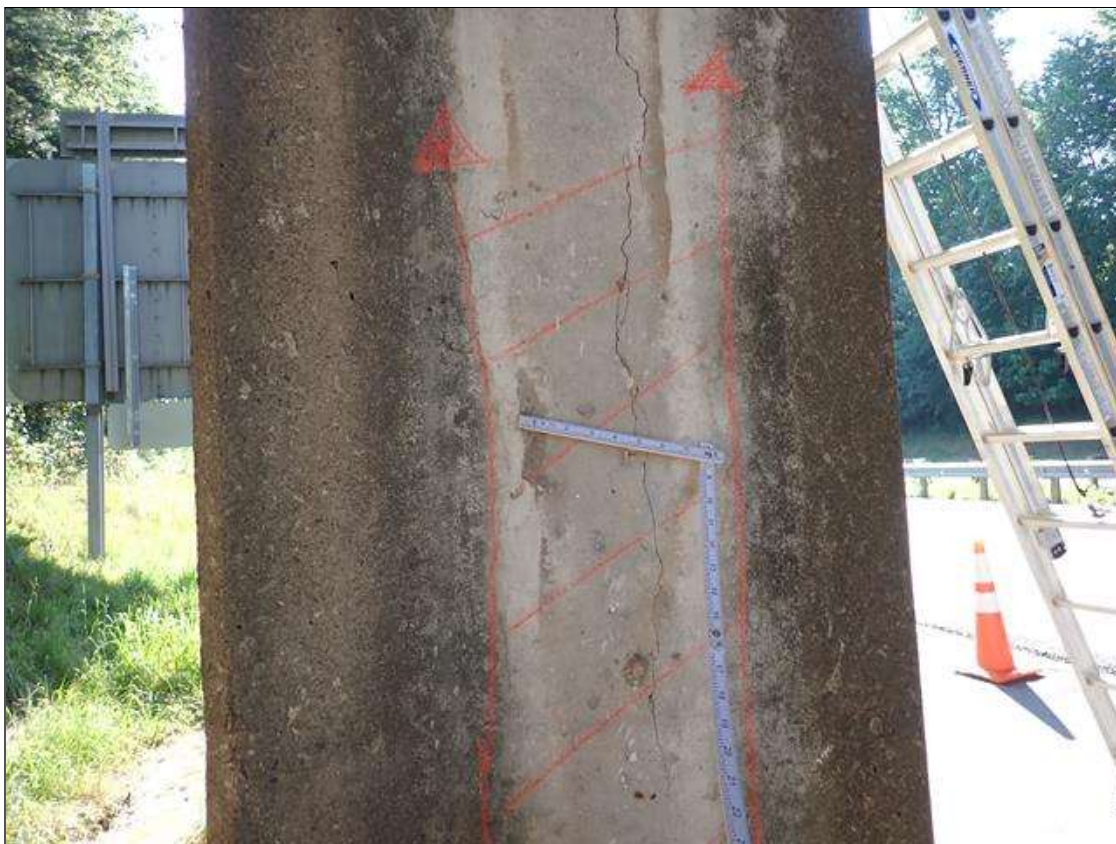
Bent 3 Pile 2: west face, delamination (1 foot x full height) with cracks (up to 1/16 inch)

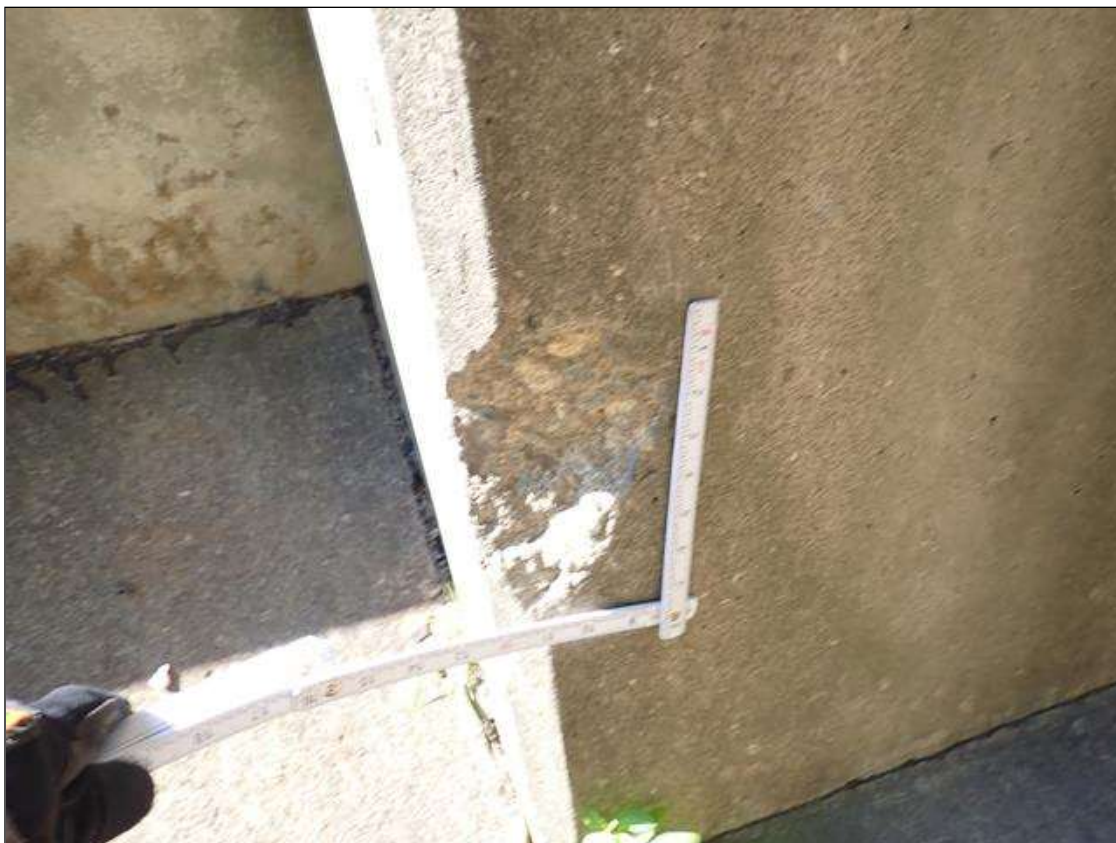
Bent 3 Pile 2: BOTTOM OF COLUMN 2 NORTHEAST CORNER HAS A SPALL AREA 5 INCH X 8 INCH X 1 INCH DEEP.

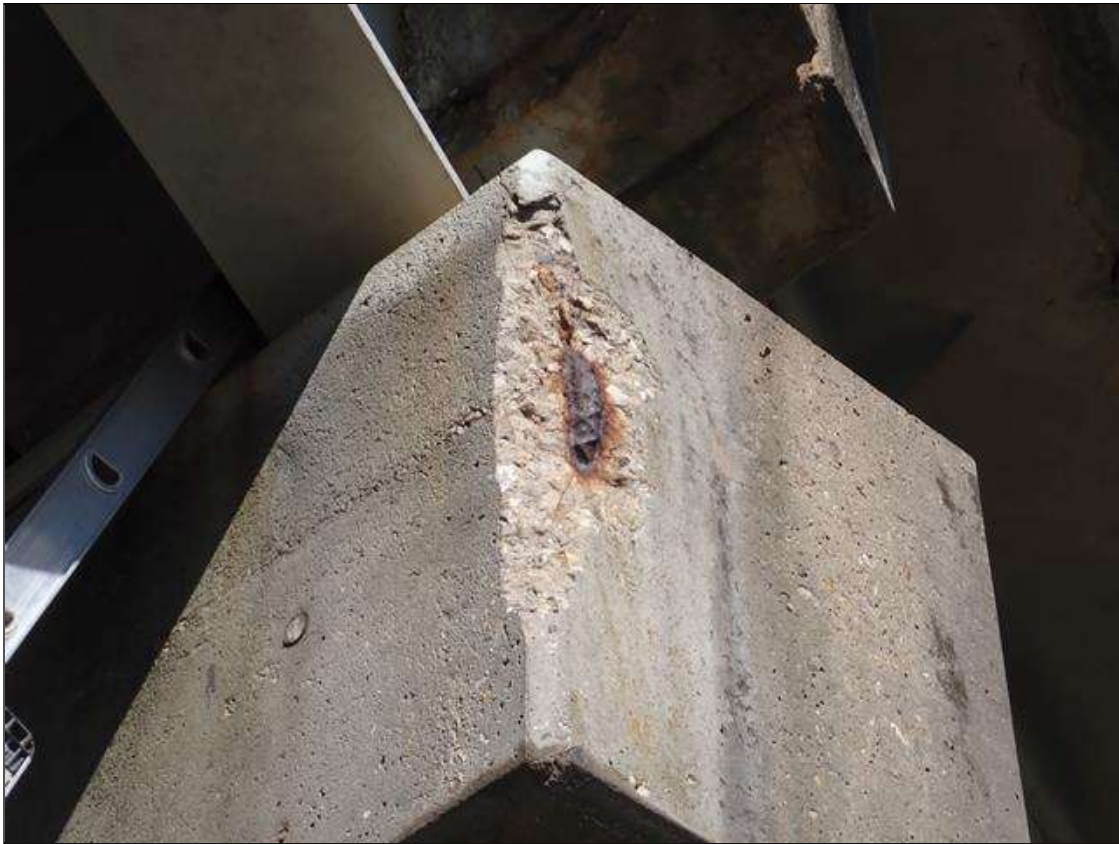
Bent 3 Cap 1: (PAR) 12 INCH X 24 INCH X 2 INCH DEEP SPALL WITH EXPOSED REBAR WITH APPROXIMATELY 25 PERCENT LOSS SOUTHEAST CORNER

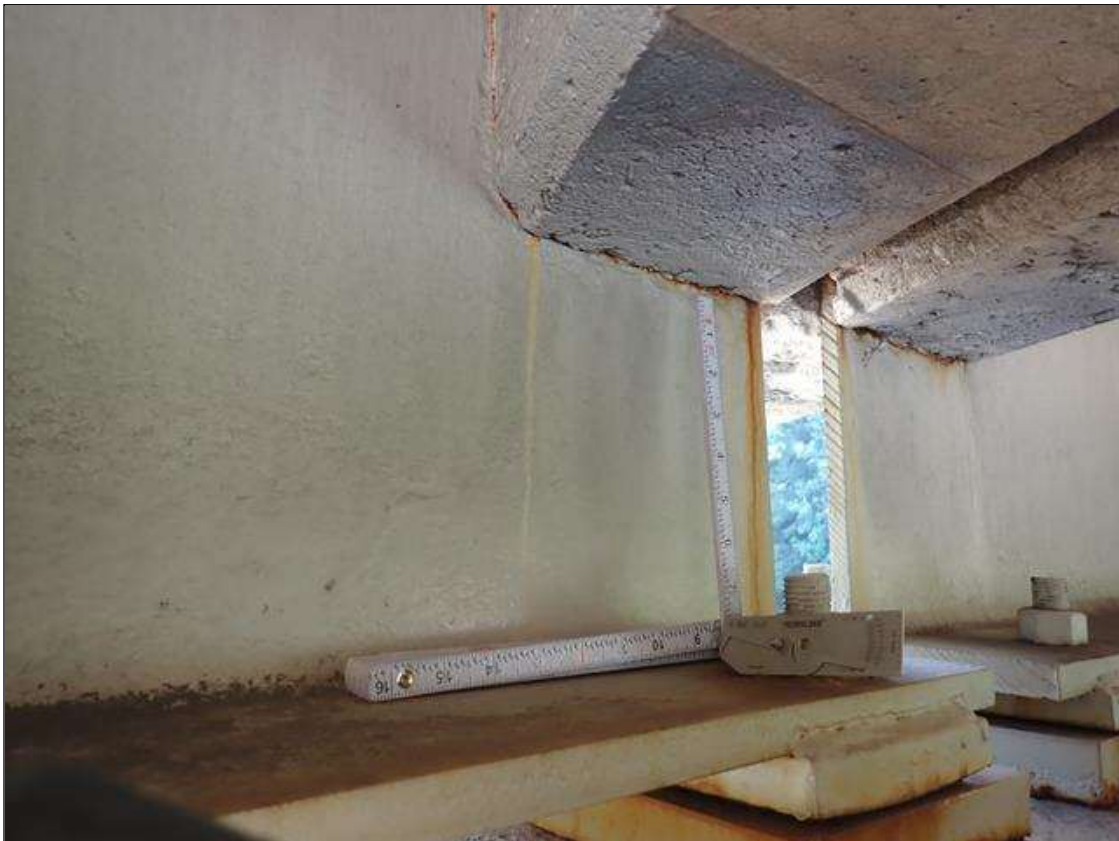
Span 3 Beam 4: at bent 2, corrosion with section loss: web adjacent to end diaphragm (9/16 inch average remaining x 10 inch x 1 inch)

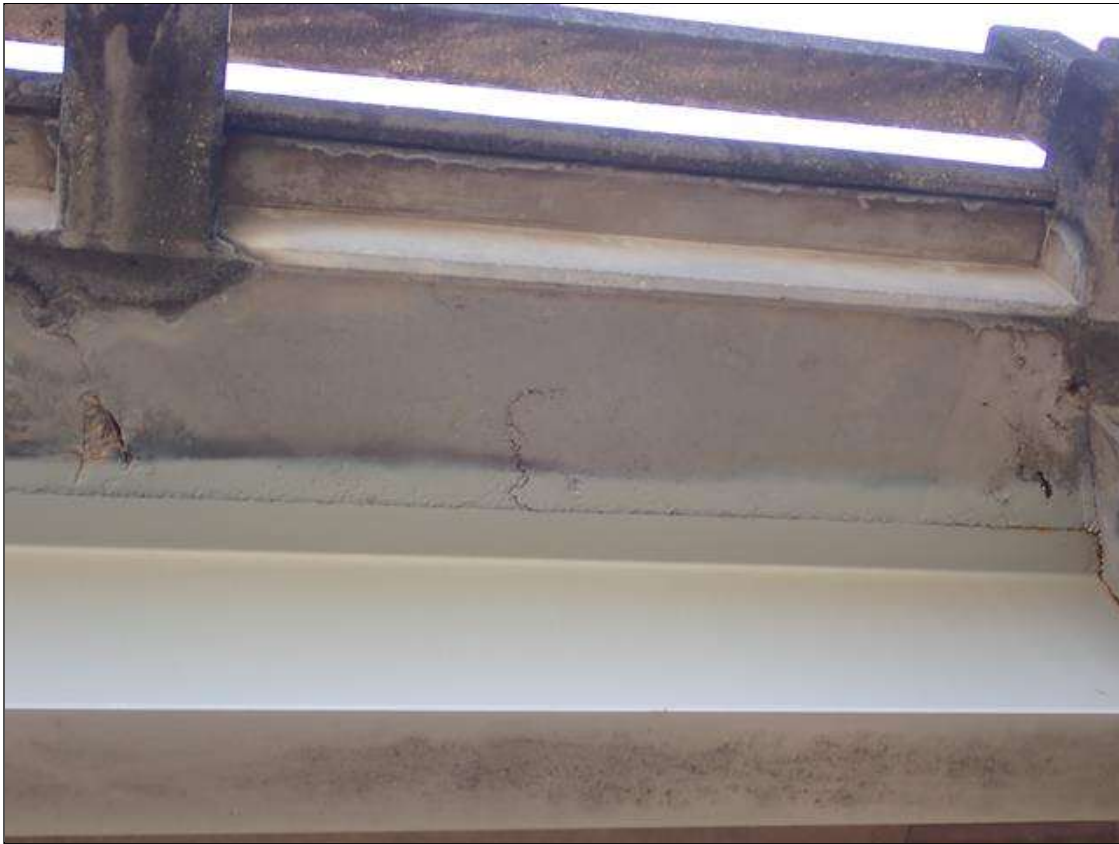
Span 3 Deck: (PAR) MULTIPLE UP TO 2 FOOT X 1 FOOT X 1 DEEP SPALL/DELAMINATION WITH EXPOSED REBAR AT RANDOM THROUGHOUT WEST OVERHANG; SOME DELAMINATION OVER TRAVEL LANES

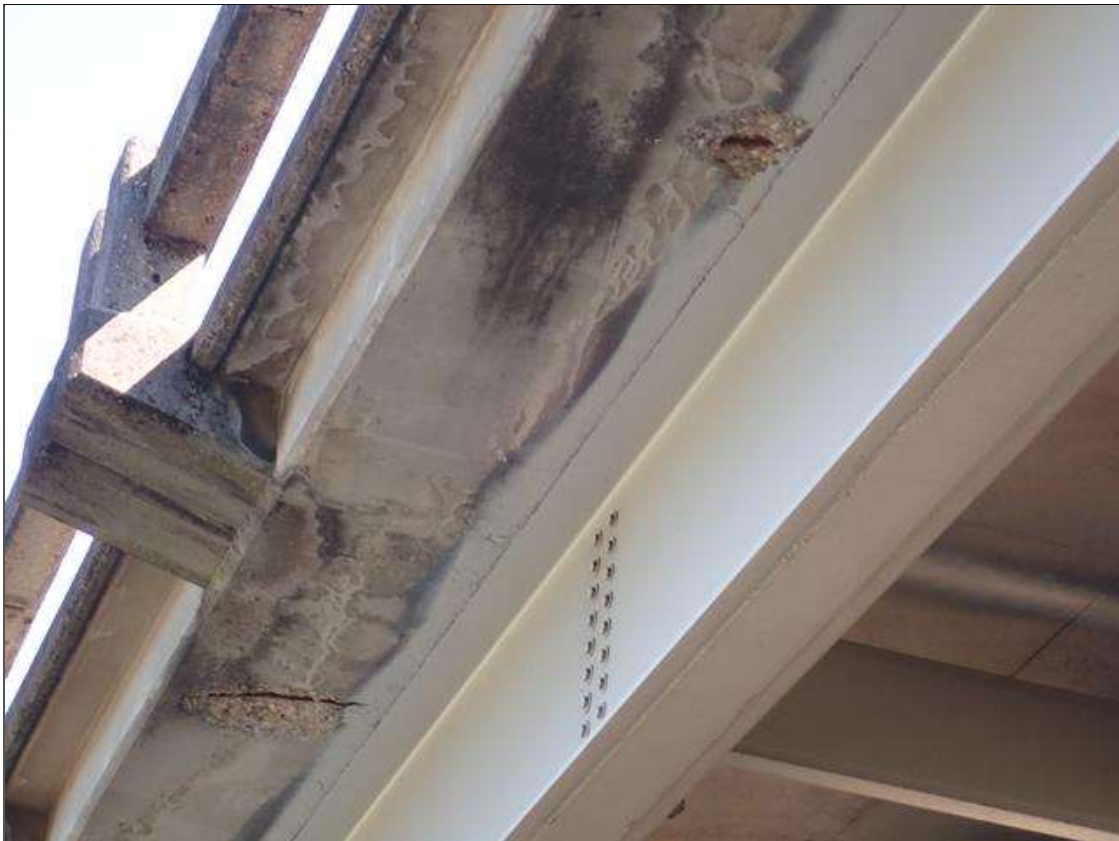
Span 3 Deck: (PAR) MULTIPLE UP TO 2 FOOT X 1 FOOT X 1 DEEP SPALL/DELAMINATION WITH EXPOSED REBAR AT RANDOM THROUGHOUT WEST OVERHANG; SOME DELAMINATION OVER TRAVEL LANES

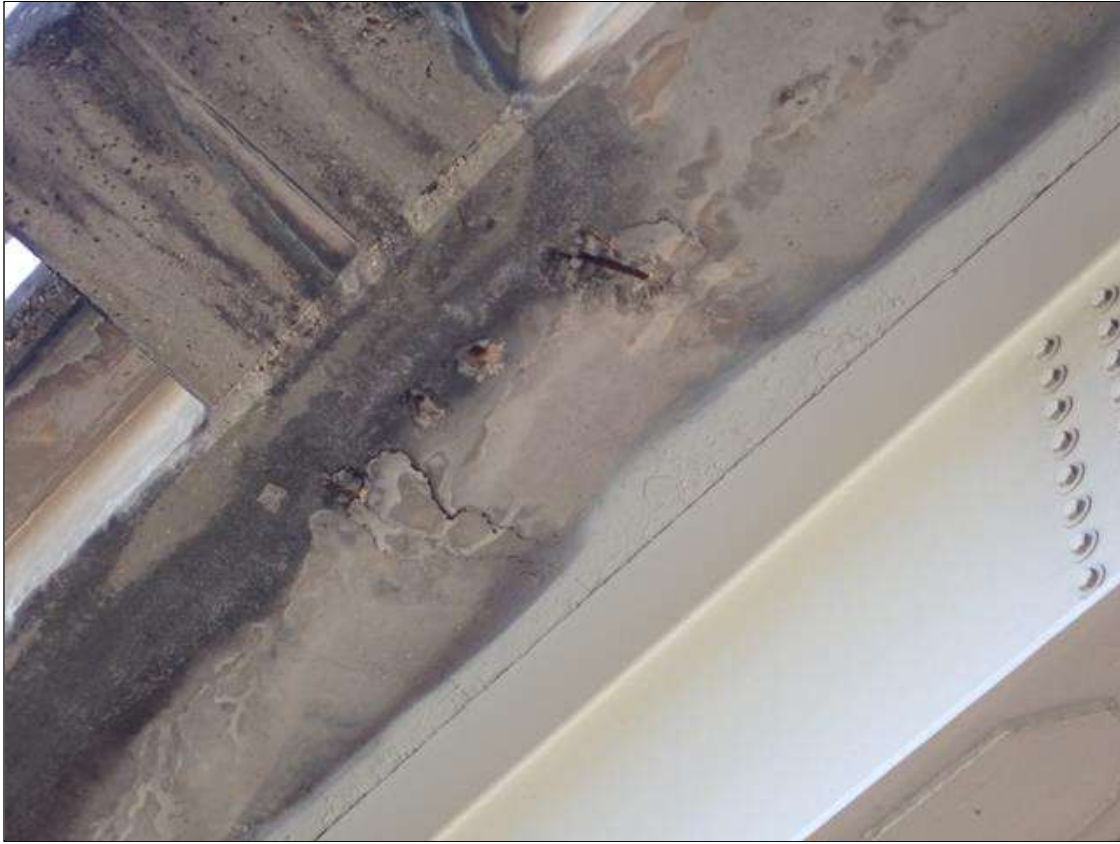
Span 3 Deck: (PAR) MULTIPLE UP TO 2 FOOT X 1 FOOT X 1 DEEP SPALL/DELAMINATION WITH EXPOSED REBAR AT RANDOM THROUGHOUT WEST OVERHANG; SOME DELAMINATION OVER TRAVEL LANES

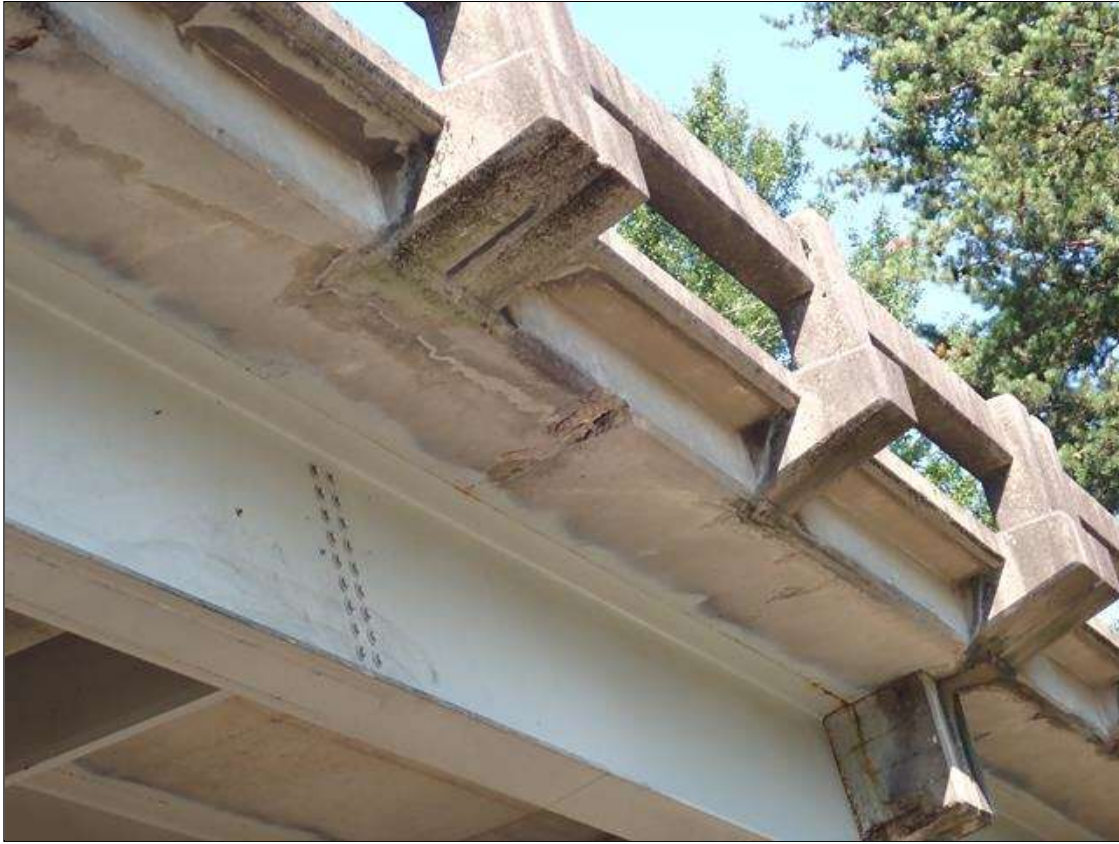
Span 3 Deck: (PAR) MULTIPLE UP TO 1 FOOT X 1 FOOT X 1 INCH DEEP SPALLS/DELAMINATIONS WITH EXPOSED REBAR AT RANDOM THROUGHOUT EAST OVERHANG; SOME DELAMINATIONS OVER TRAVEL LANE

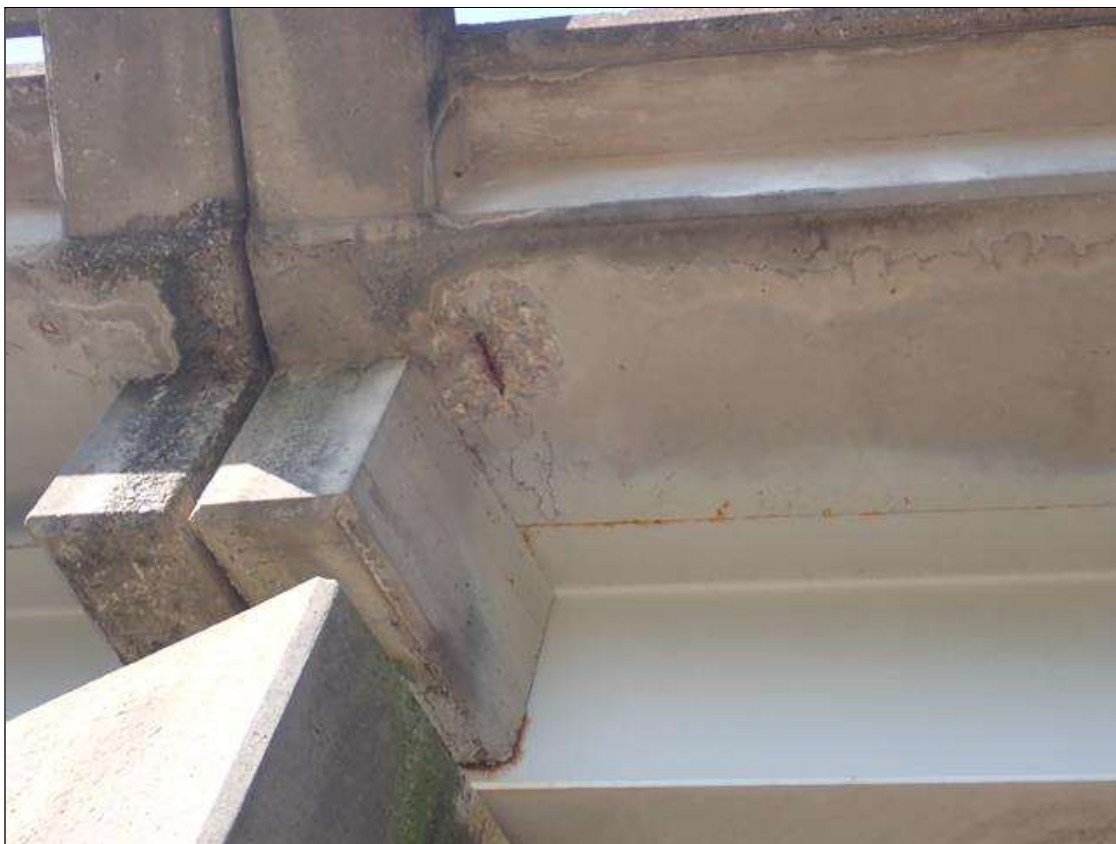
Span 3 Deck: (PAR) MULTIPLE UP TO 1 FOOT X 1 FOOT X 1 INCH DEEP SPALLS/DELAMINATIONS WITH EXPOSED REBAR AT RANDOM THROUGHOUT EAST OVERHANG; SOME DELAMINATIONS OVER TRAVEL LANE

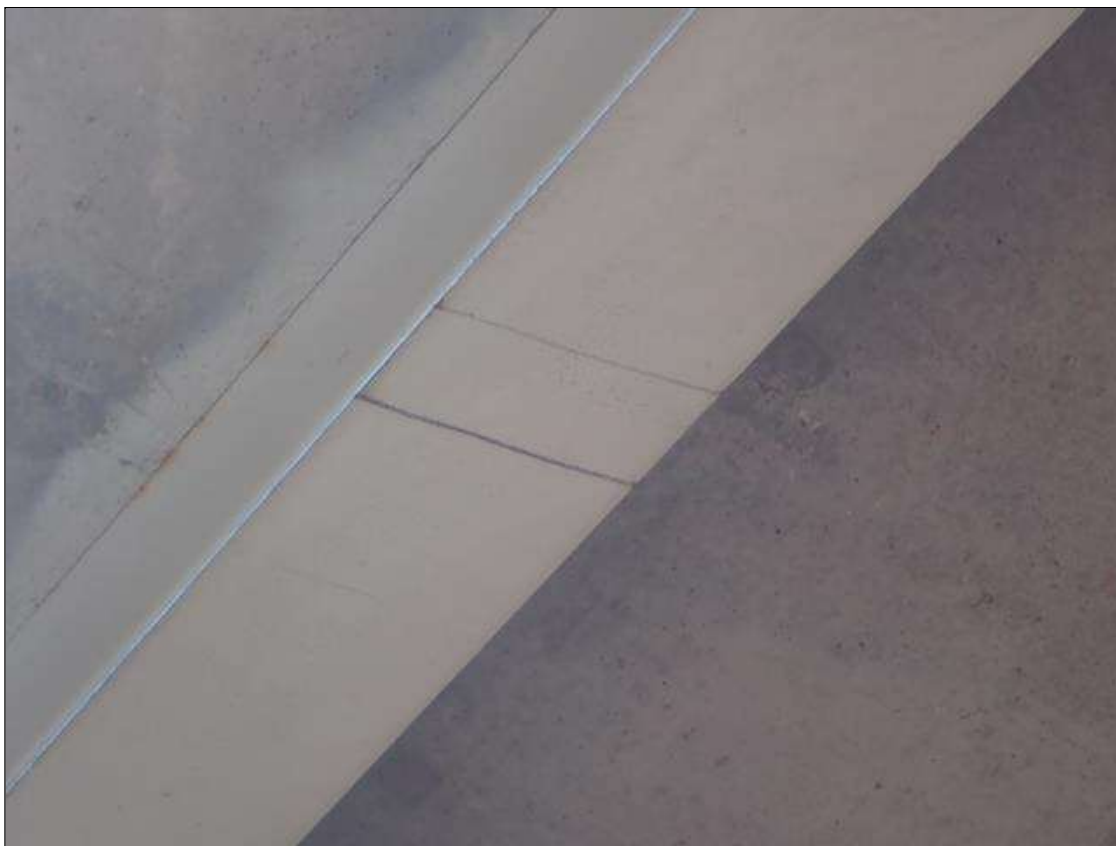
Span 3 Beam 4 - Protective System: over right travel lane, impact scrapes

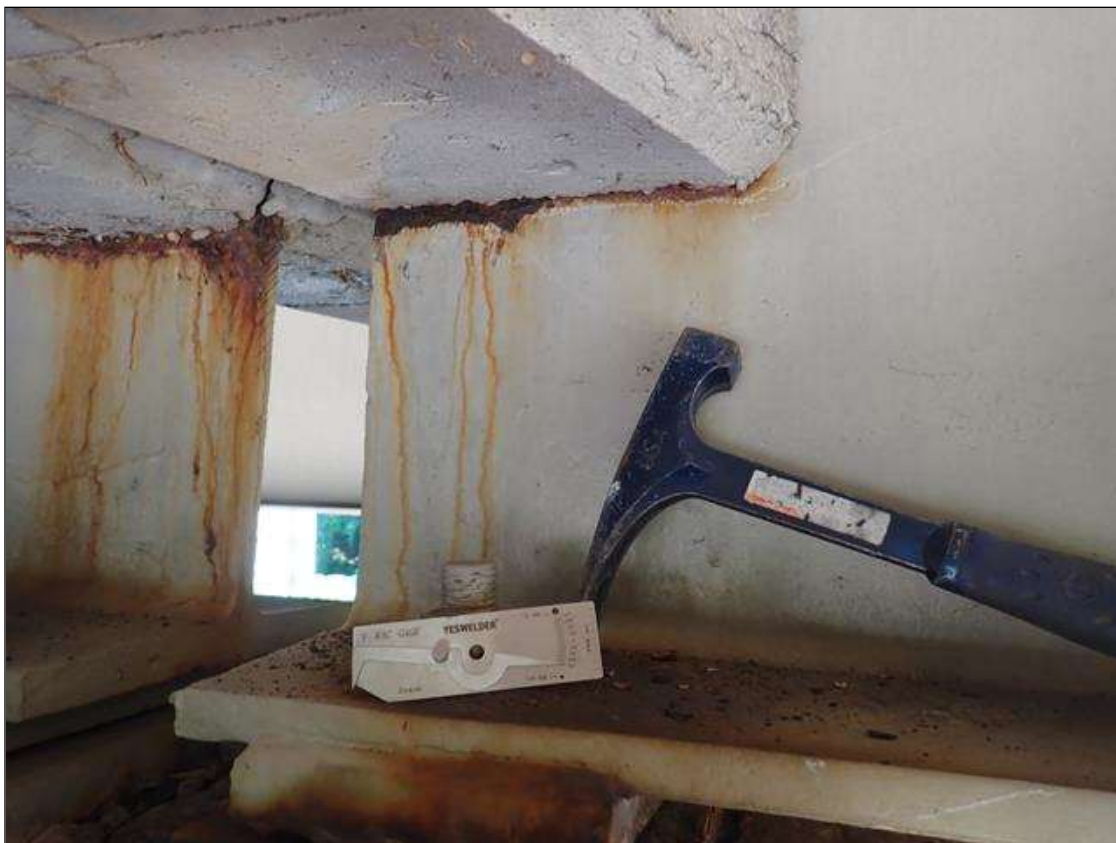
Span 3 Beam 3: at bent 2, active corrosion with section loss, web at diaphragm [10 inch x 1 inch x average remaining 9/16 inch]

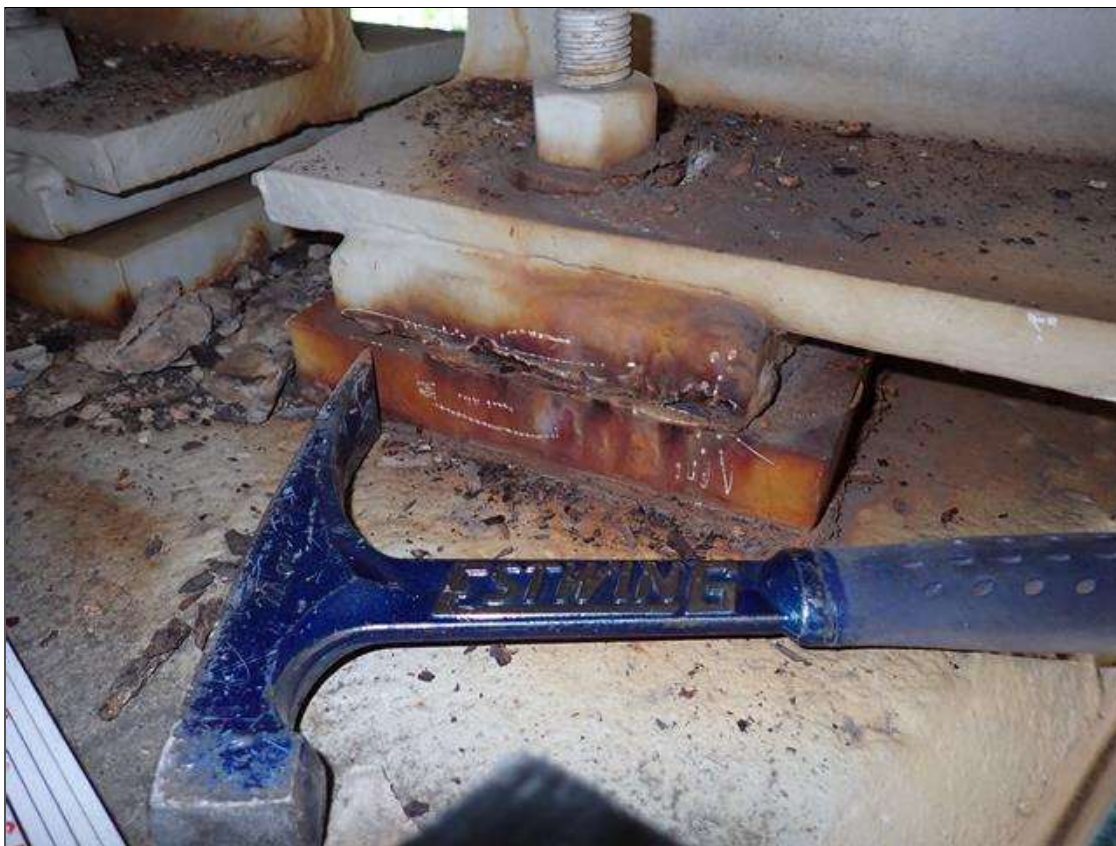
Span 3 Beam 3 - Near Bearing 3: rust scale

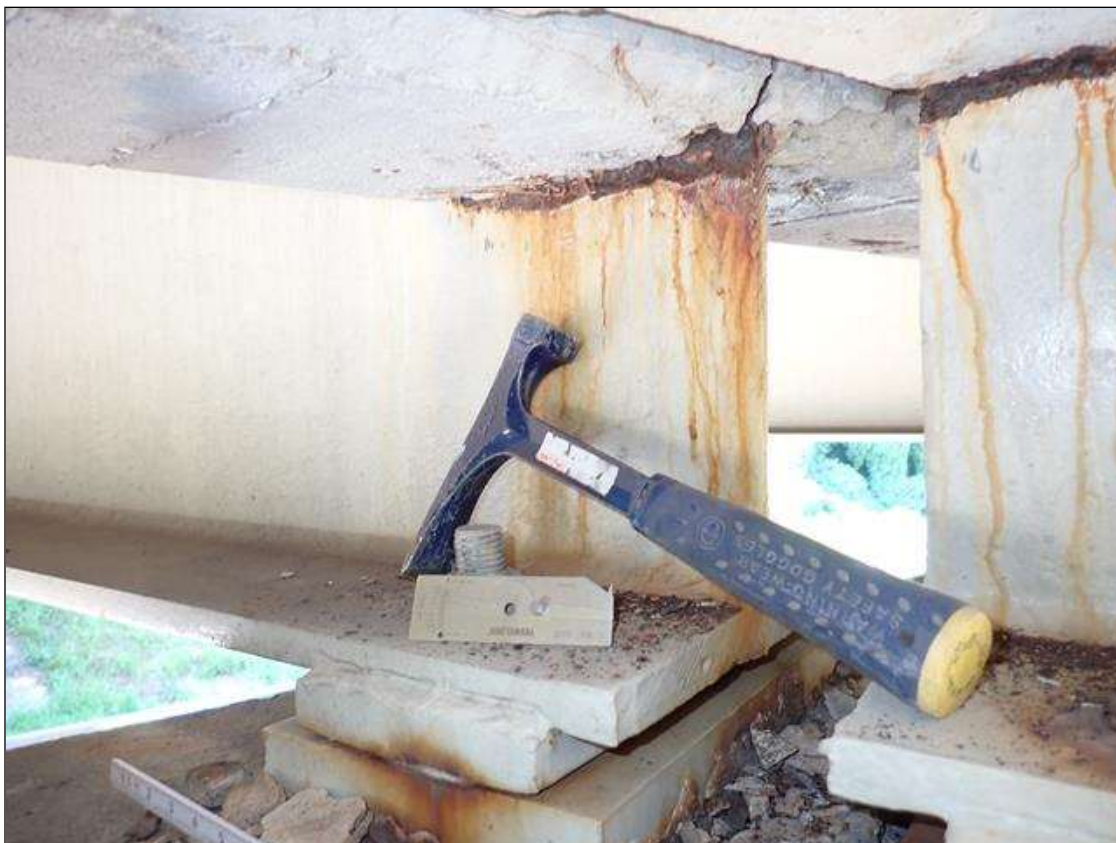
Span 2 Beam 3: at bent 2, active corrosion with section loss, web at diaphragm [9 inch x 1 inch x average remaining 1/2 inch]
