NC DEPARTMENT OF TRANSPORTATION  
 DIVISION OF HIGHWAYS  
 STRUCTURE MANAGEMENT UNIT

ATTENTION: prompt action request; sketches revised; span 2 and 3 total horizontal clearances revised

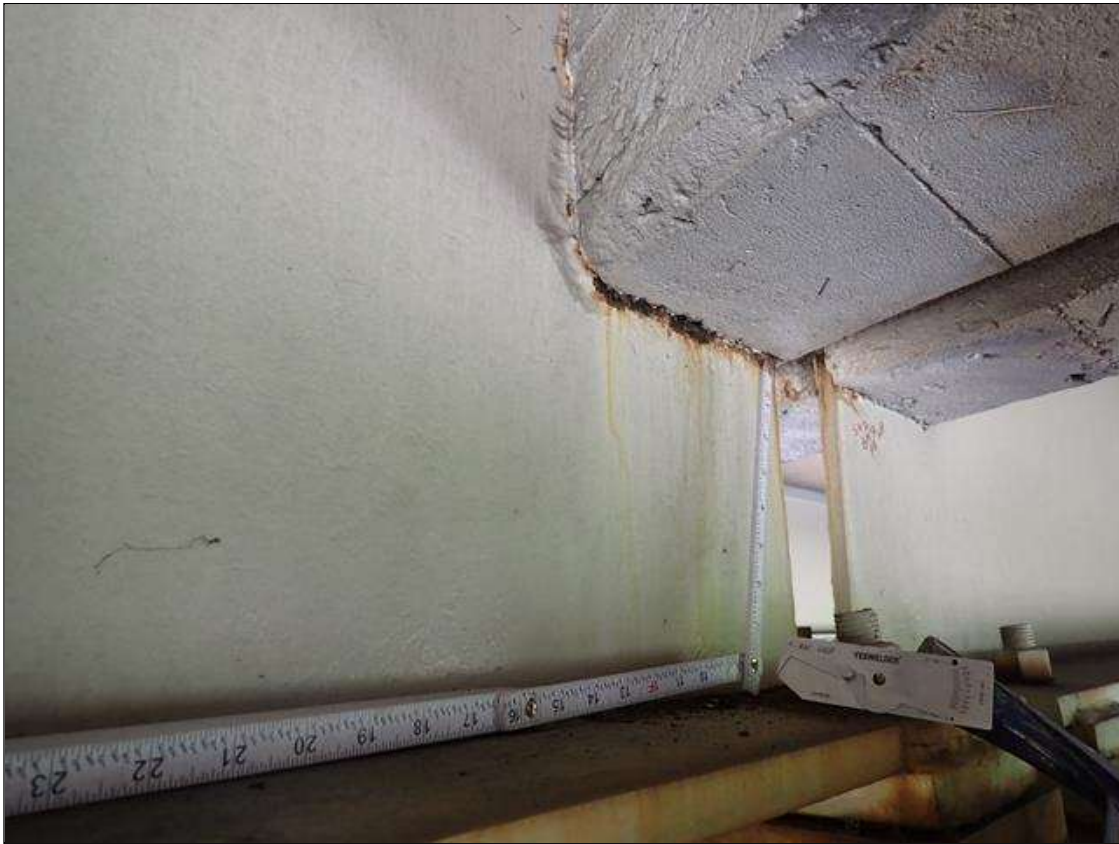
Span 3 Beam 2: at bent 2, corrosion with section loss: web adjacent to end diaphragm (9/16 inch average remaining x 10 inch x 4 inch); bottom flange (0.80 inch average remaining x 1 inch)

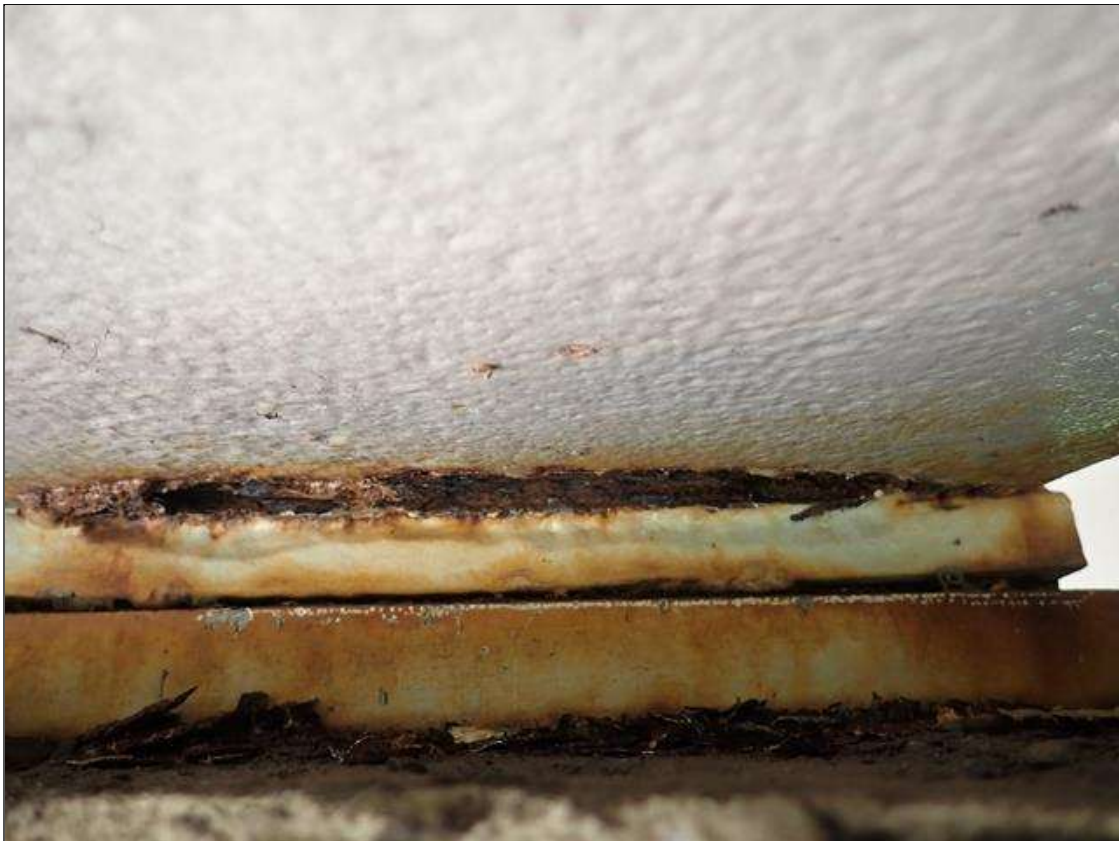
Span 3 Beam 2: at bent 2, corrosion with section loss: web adjacent to end diaphragm (9/16 inch average remaining x 10 inch x 4 inch); bottom flange (0.80 inch average remaining x 1 inch)

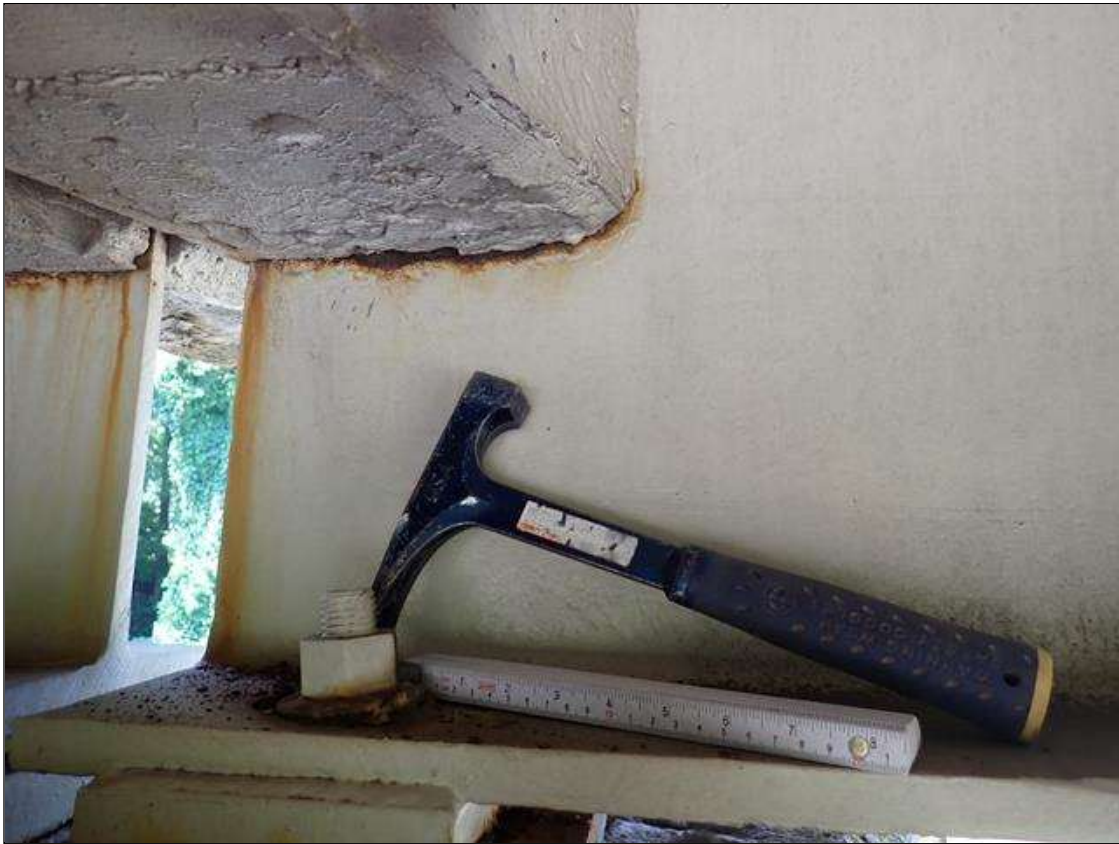
Span 3 Beam 1: at bent 2, corrosion with section loss: web adjacent to end diaphragm (9/16 inch average remaining x 10 inch x 3 inch)

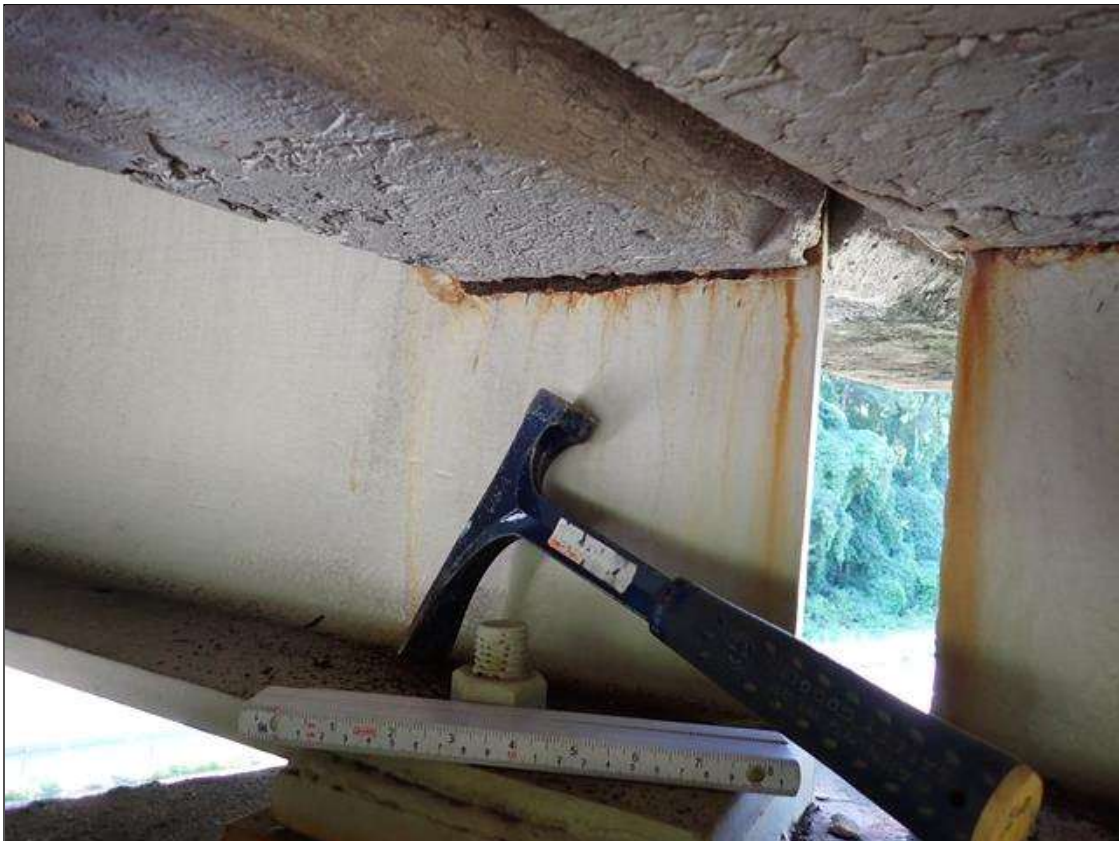
Span 2 Beam 1: at bent 2, corrosion with section loss: web adjacent to end diaphragm (9/16 inch average remaining x 10 inch x 3 inch)

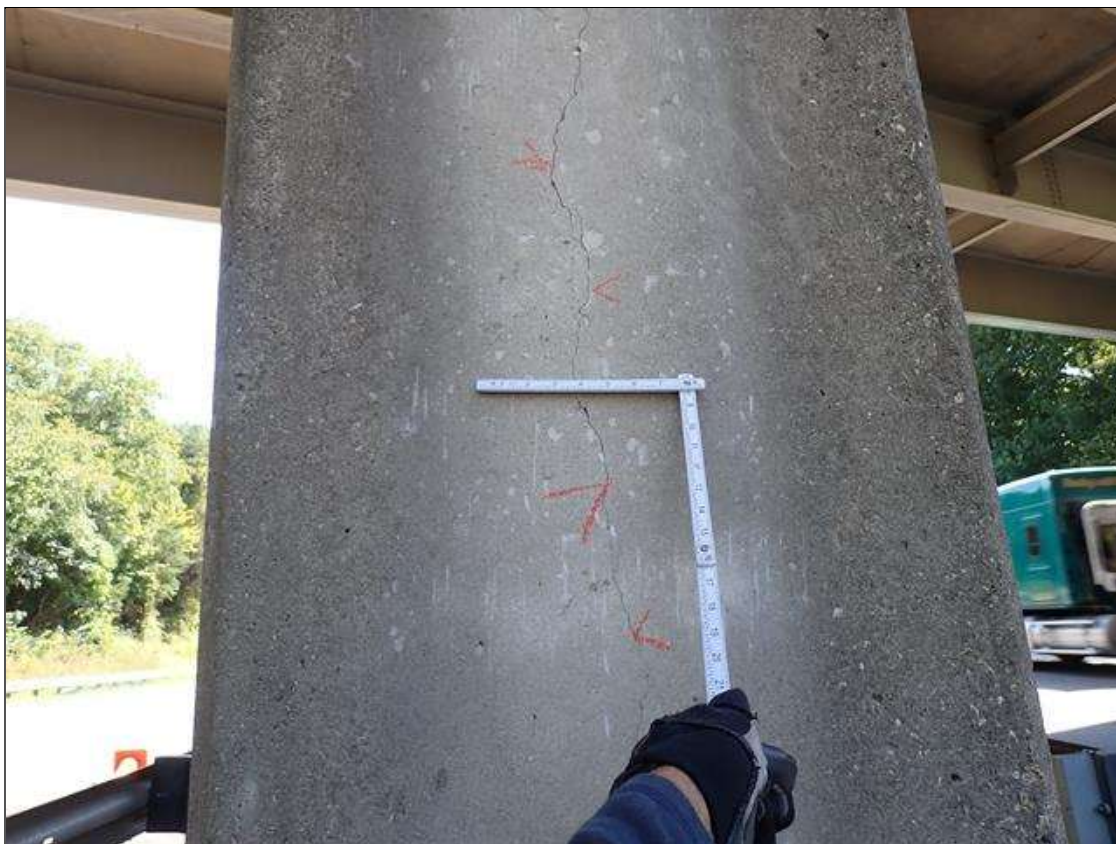
Bent 2 Pile 1: FULL HEIGHT X UP TO 1/32 INCH VERTICAL CRACKS WEST AND NORTH FACES BEGINNING AT BOTTOM OF CAP

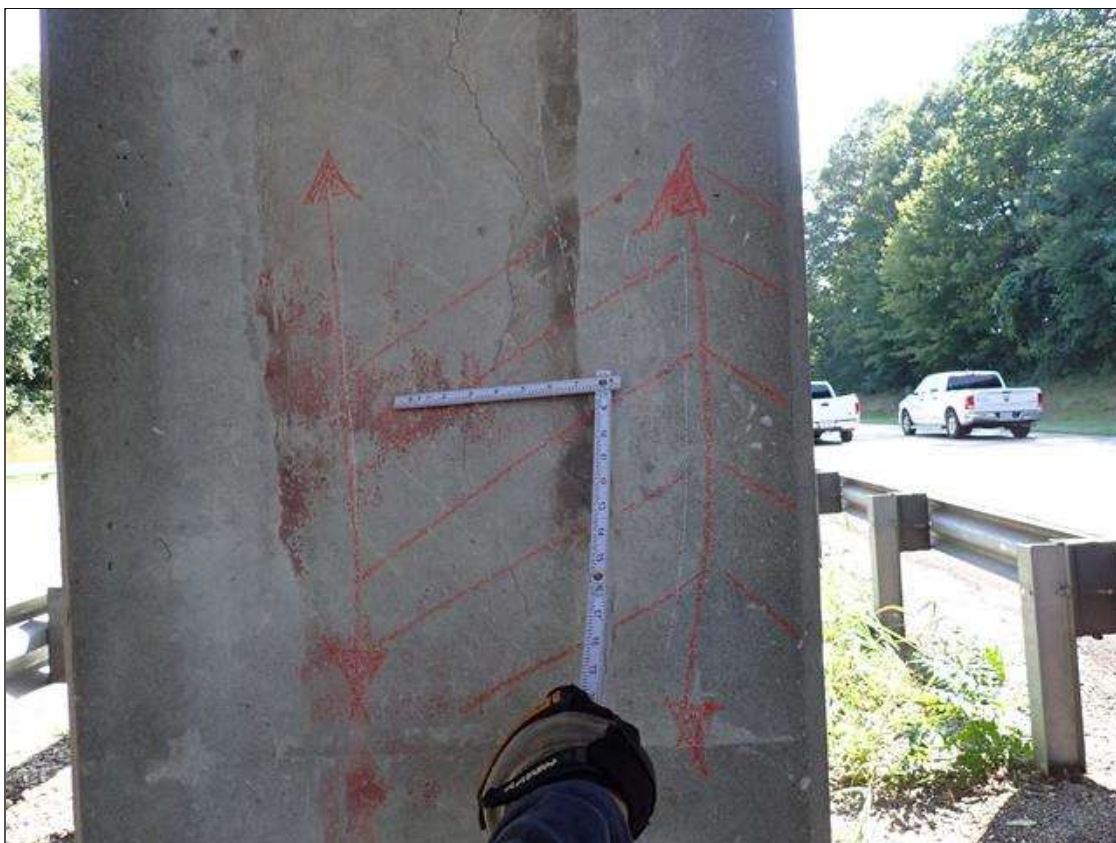
Bent 2 Pile 2: West face mid height, delamination [6 foot x 18 inch] with cracks [up to 1/32 inch]

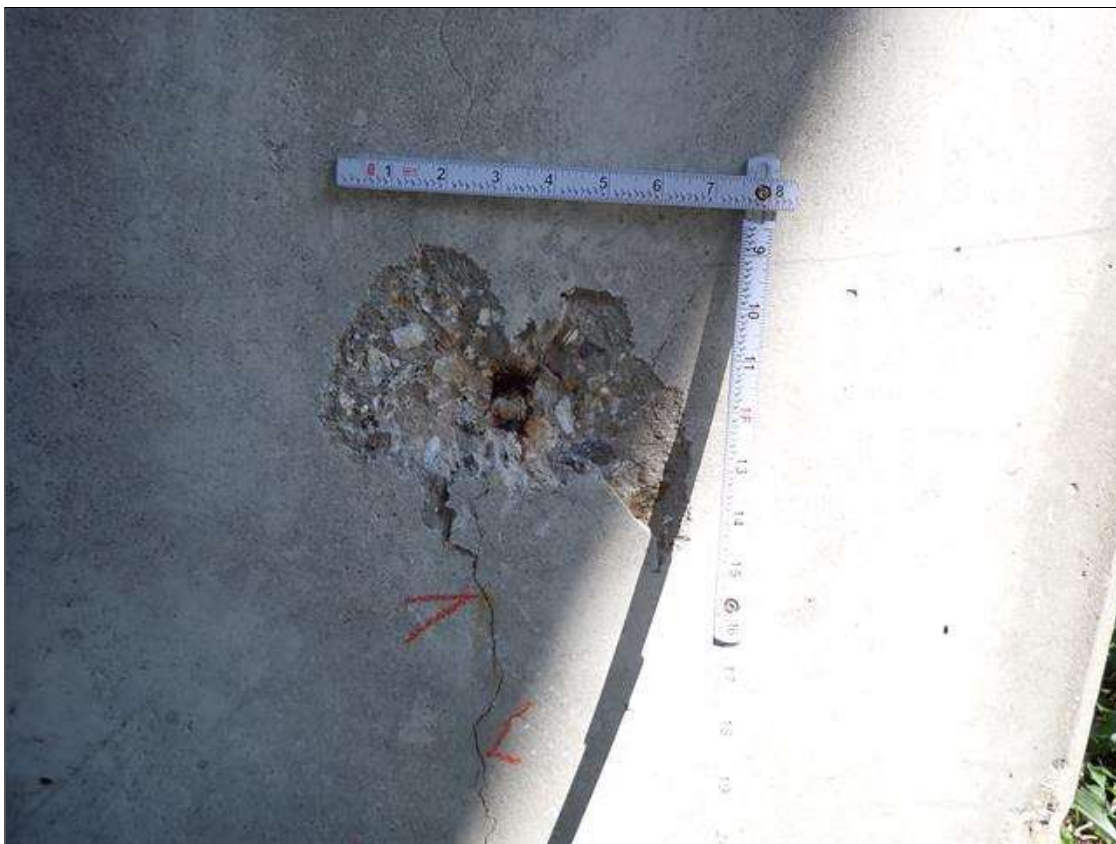
Bent 2 Pile 2: South face starting at ground line, vertical crack (1/32 inch x full height); 2 foot from ground, spall (8 inch x 5 inch x 1/2 inch deep) with exposed rusted rebar

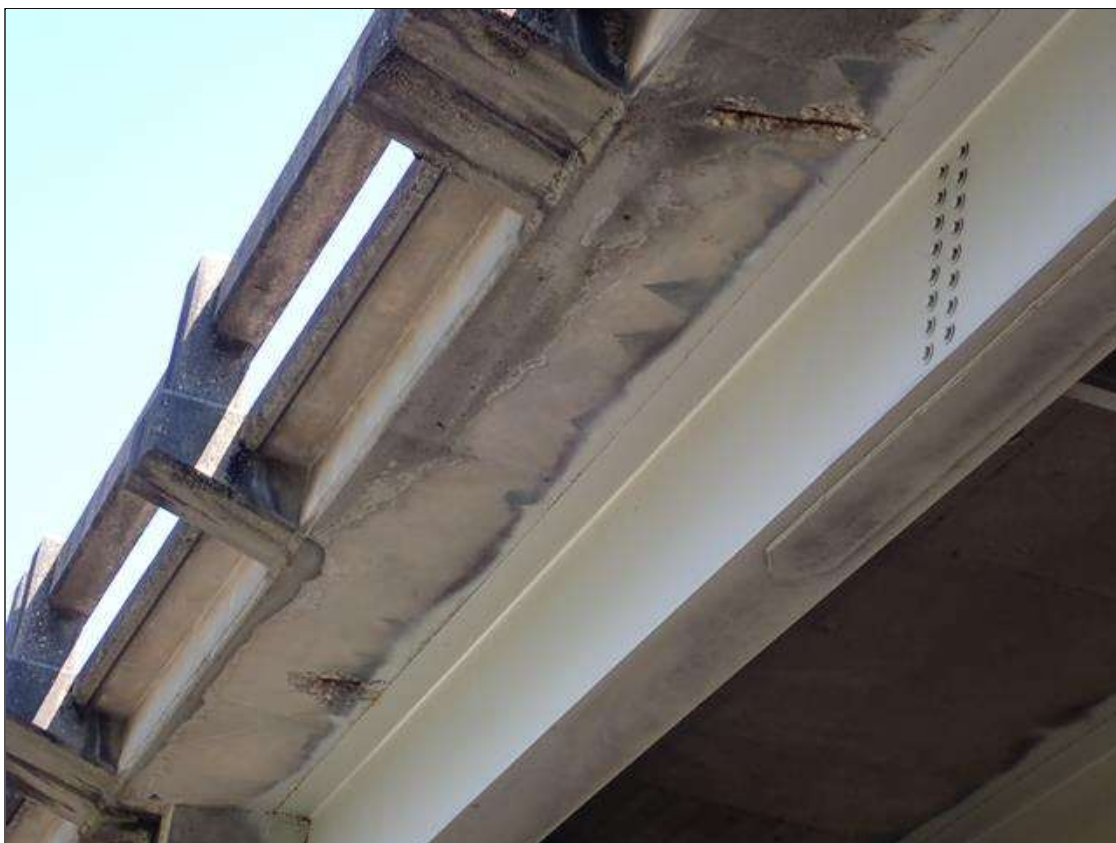
Span 2 Deck: (PAR) along underside of left overhang, two [2] spalls [up to 18 inch x 12 inch x 1 inch deep] with exposed rusted reinforcing [no loss]

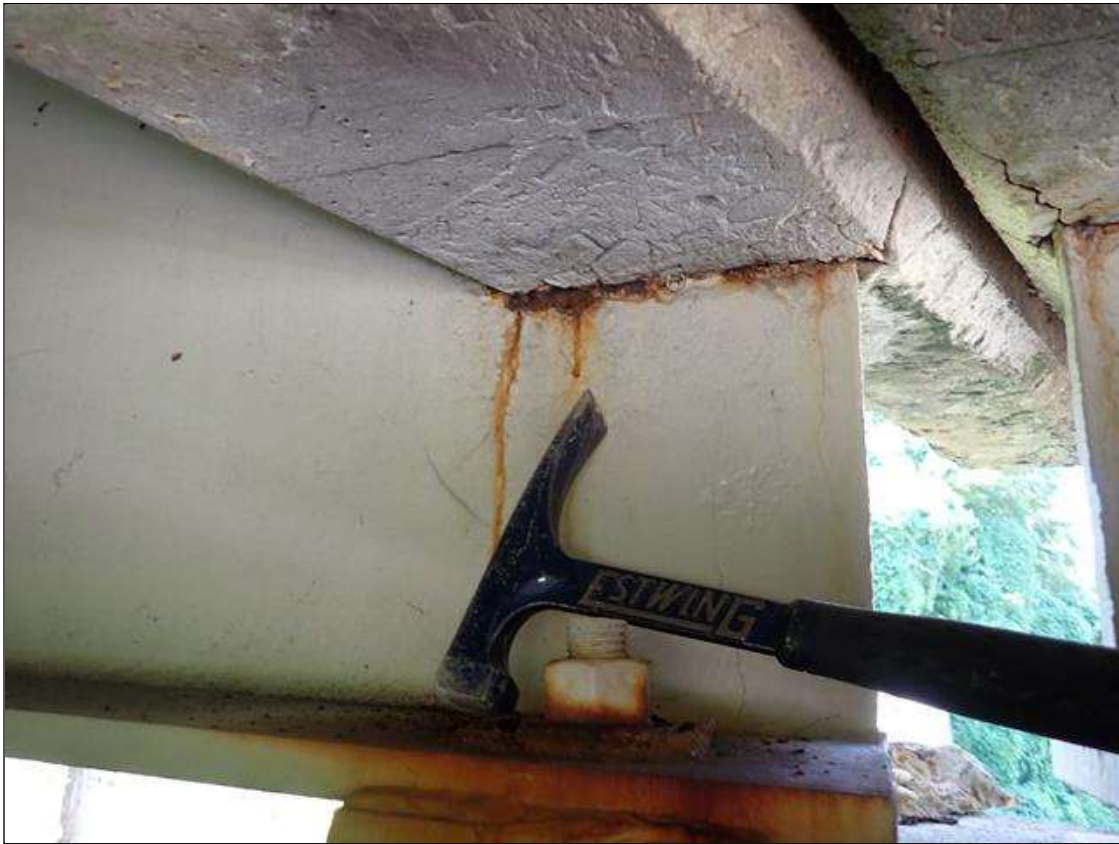
Span 1 Beam 1: at bent 1, corrosion with section loss: web adjacent to end diaphragm (1/2 inch average remaining x 10 inch x 4 inch)

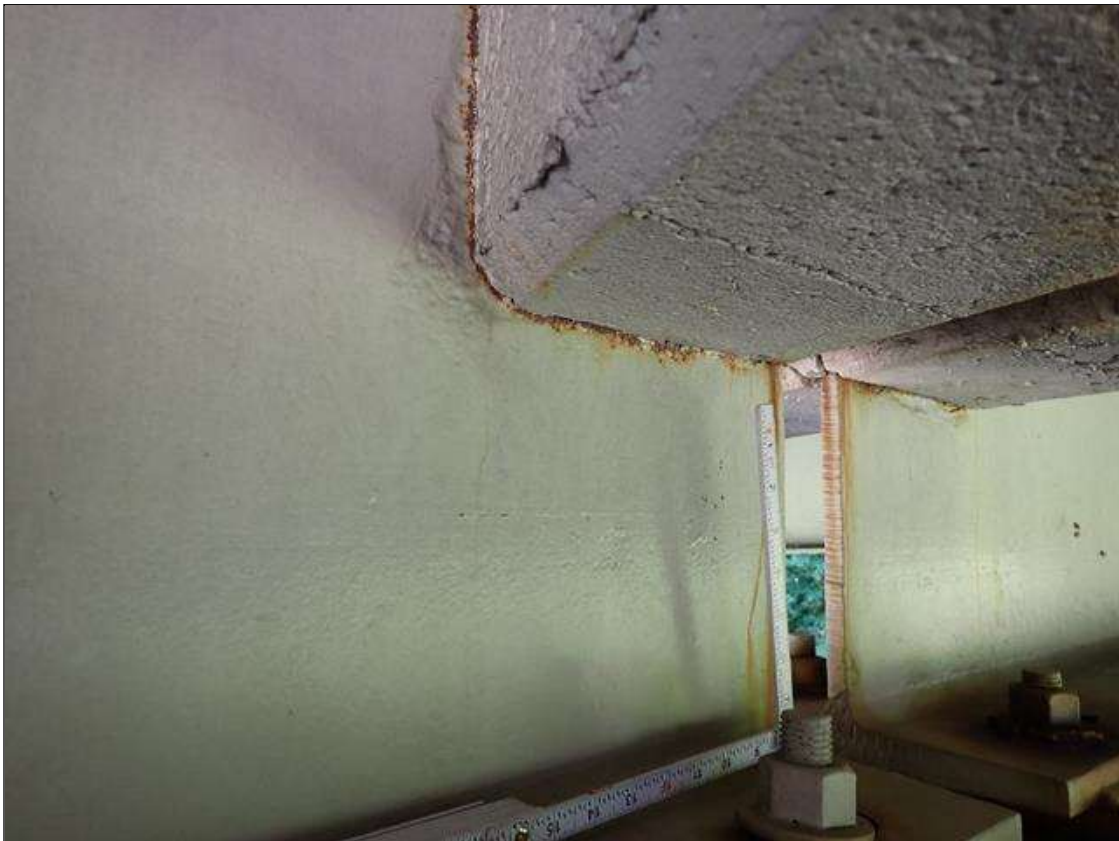
Span 2 Beam 2: at bent 1, corrosion with section loss: web adjacent to end diaphragm (9/16 inch average remaining x 10 inch x 4 inch)

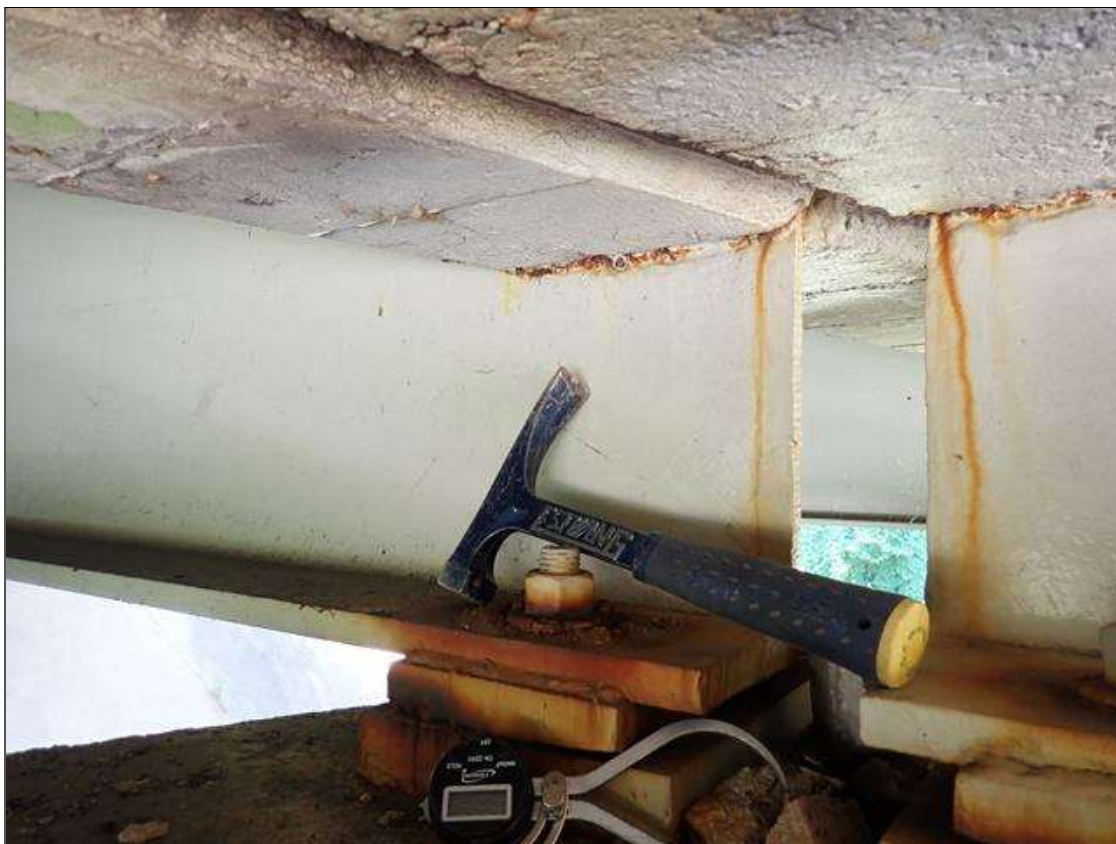
Span 1 Beam 3: at bent 1, corrosion with section loss: web adjacent to end diaphragm (9/16 inch average remaining x 10 inch x 1 inch)

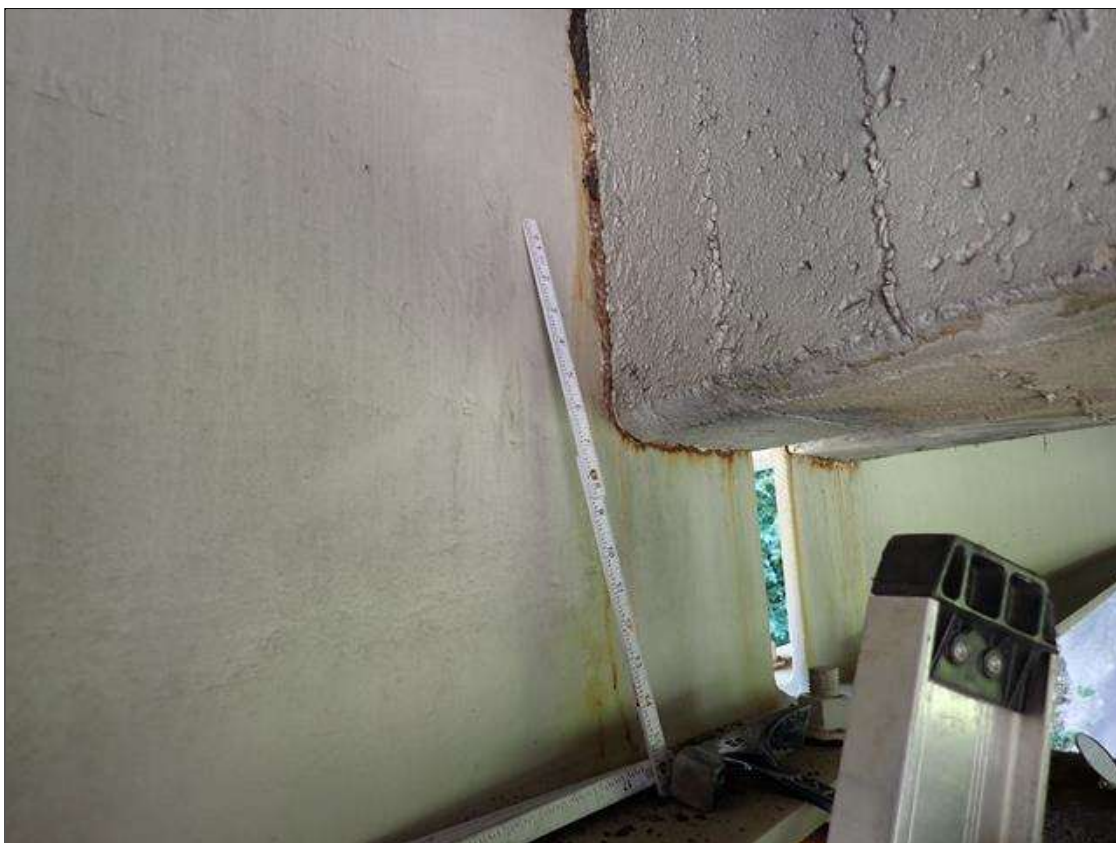
Span 2 Beam 4: at bent 1, web adjacent to end diaphragm, rust scale (10 inch x 15 inch)

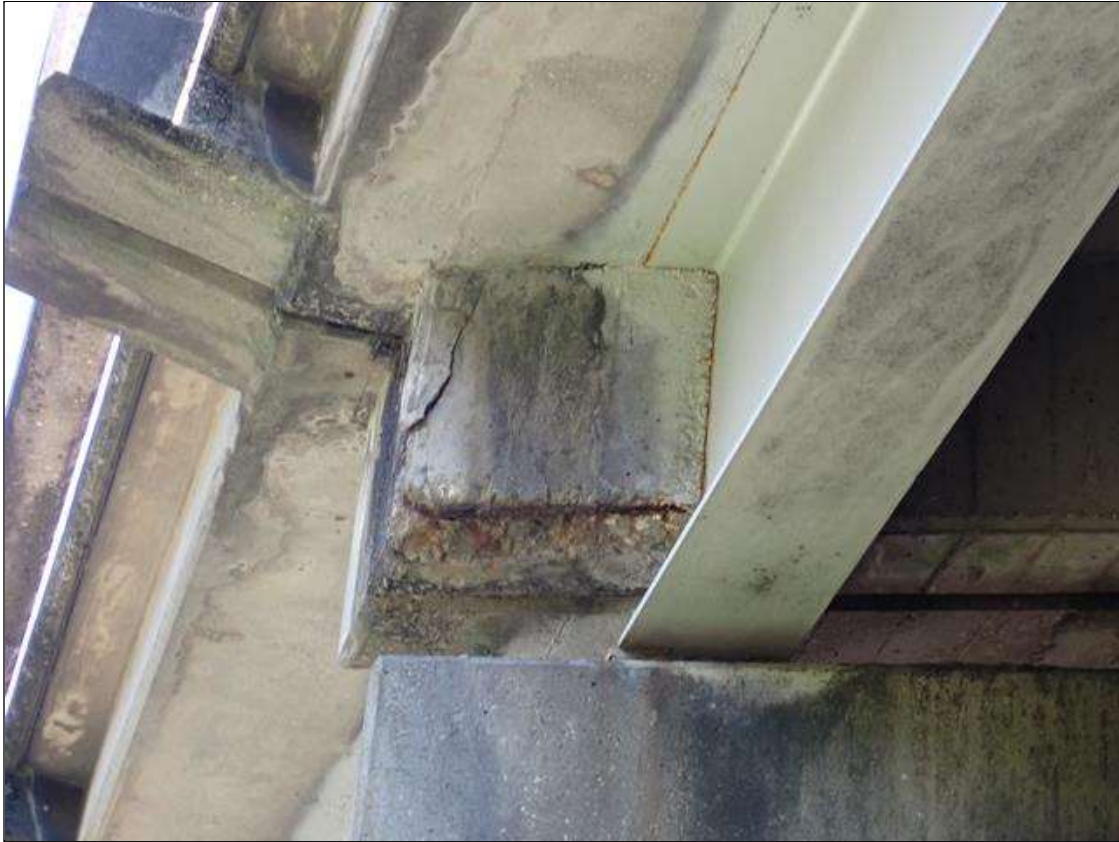
Span 1 Beam 1: (PAR) 2 FOOT X UP TO 1 FOOT X 2 INCH DEEP DIAPHRAGM SPALL/DELAMINATION WITH EXPOSED REBAR WITH APPROXIMATELY 25 PERCENT LOSS WEST OVERHANG AT BENT 1.

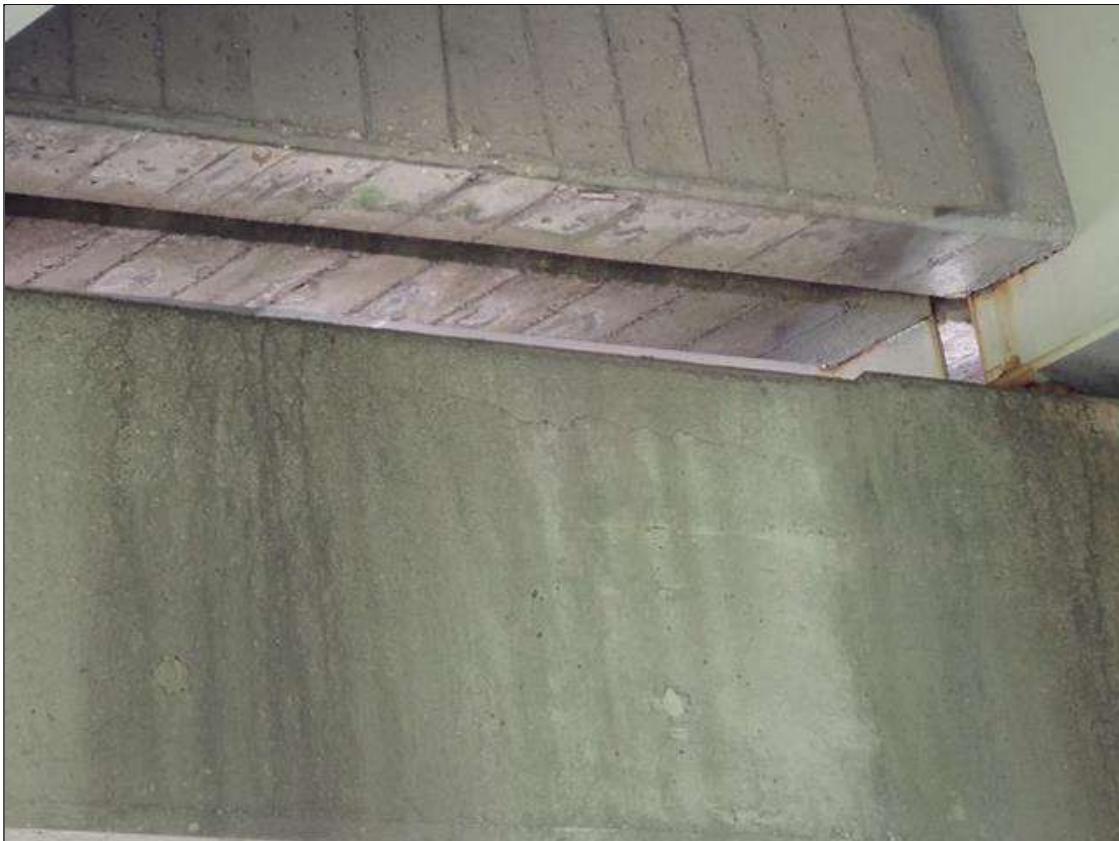
Bent 1 Cap 1: BENT 1 SOUTH FACE OF CAP HAS A HORIZONTAL CRACK UP TO 1/32 INCH X 3 FOOT ALONG TOP EDGE BETWEEN BEAMS 2 AND BEAMS 3.

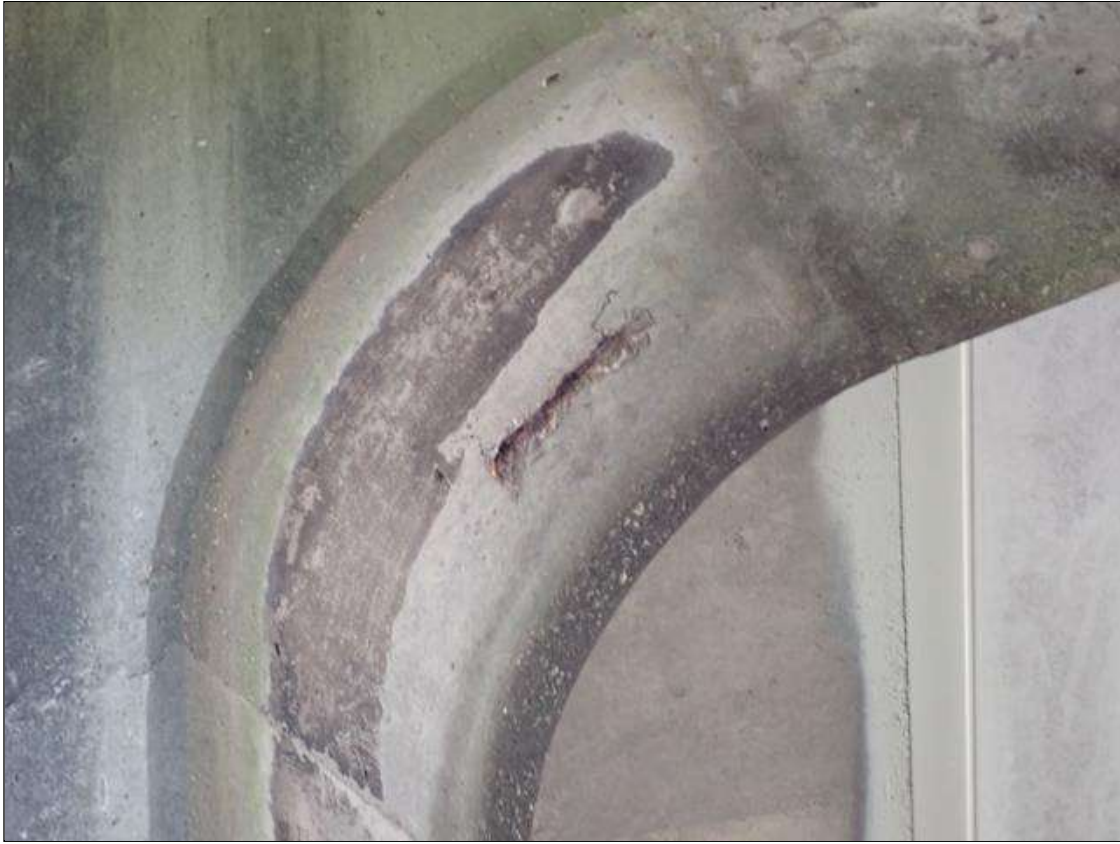
Bent 1 Cap 1: BOTTOM FACE OF CAP RIGHT SIDE OF COLUMN 1 HAS A SURFACE SPALL AREA 3 INCH WIDE X 10 INCH LONG X 1/2 INCH DEEP WITH REBAR EXPOSED.

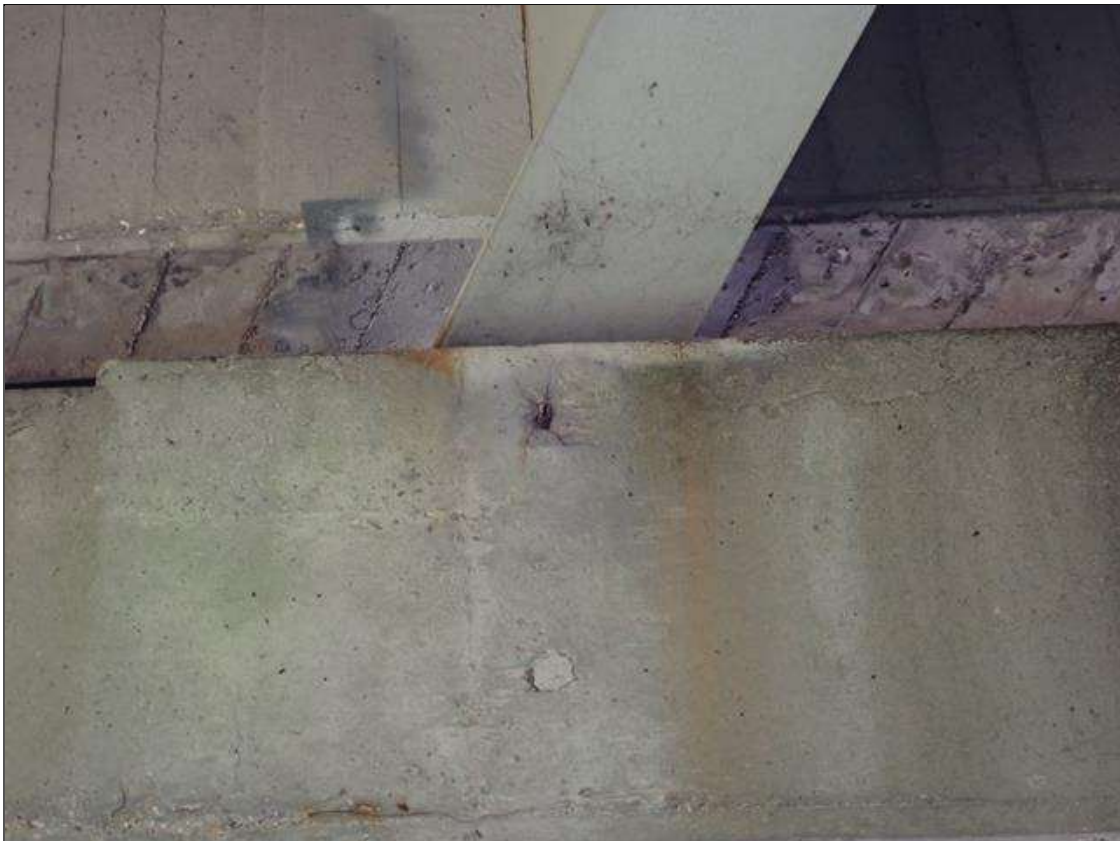
Bent 1 Cap 1: 6 INCH DIAMETER X 1/2 INCH DEEP SPALL WITH EXPOSED REINFORCING SOUTH FACE OF CAP BELOW BEAM 2

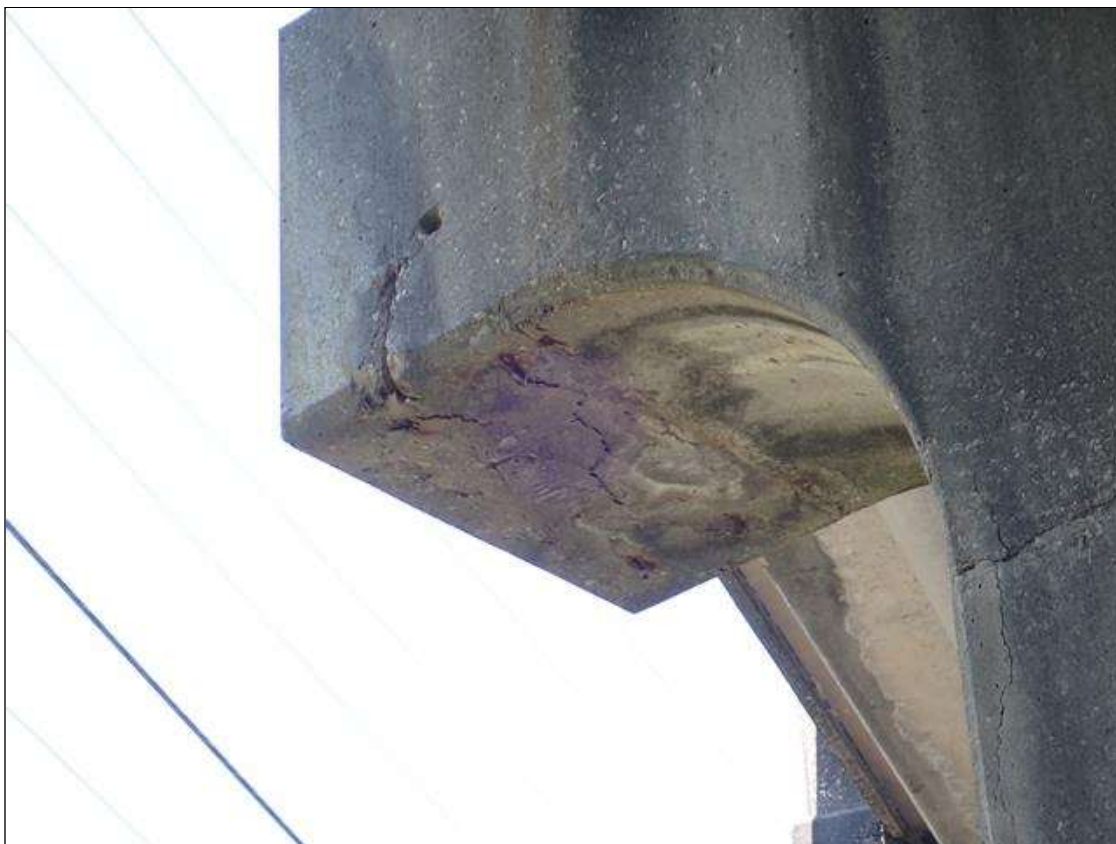
Bent 1 Cap 1: South face at West end, spall [15 inch x 3 inch x 1 inch deep] with exposed rusted reinforcing [no loss] and adjacent delamination at underside [1 foot x full width]

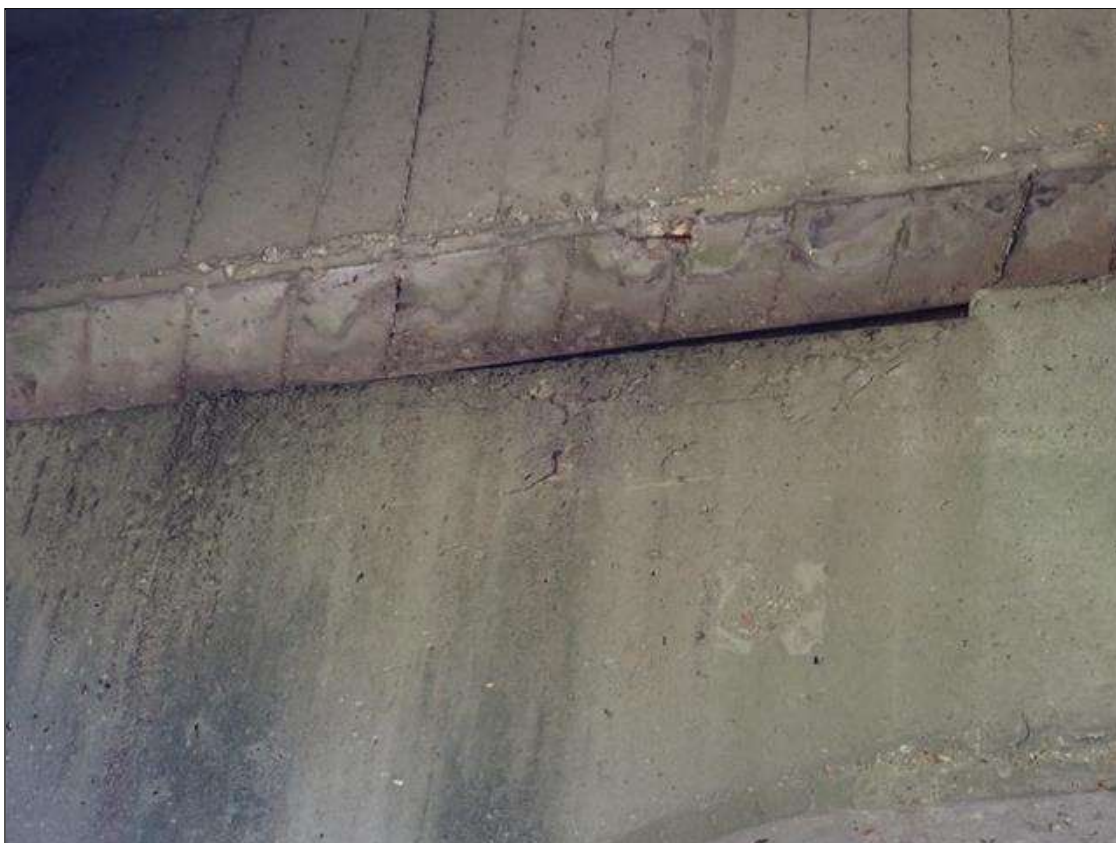
Bent 1 Cap 1: BENT 1 SOUTH FACE OF CAP BETWEEN BEAM 1 AND BEAM 2 CRACKED AND DELAMINATED AREA TOP FACE OF CAP 11 INCH X 31 INCH

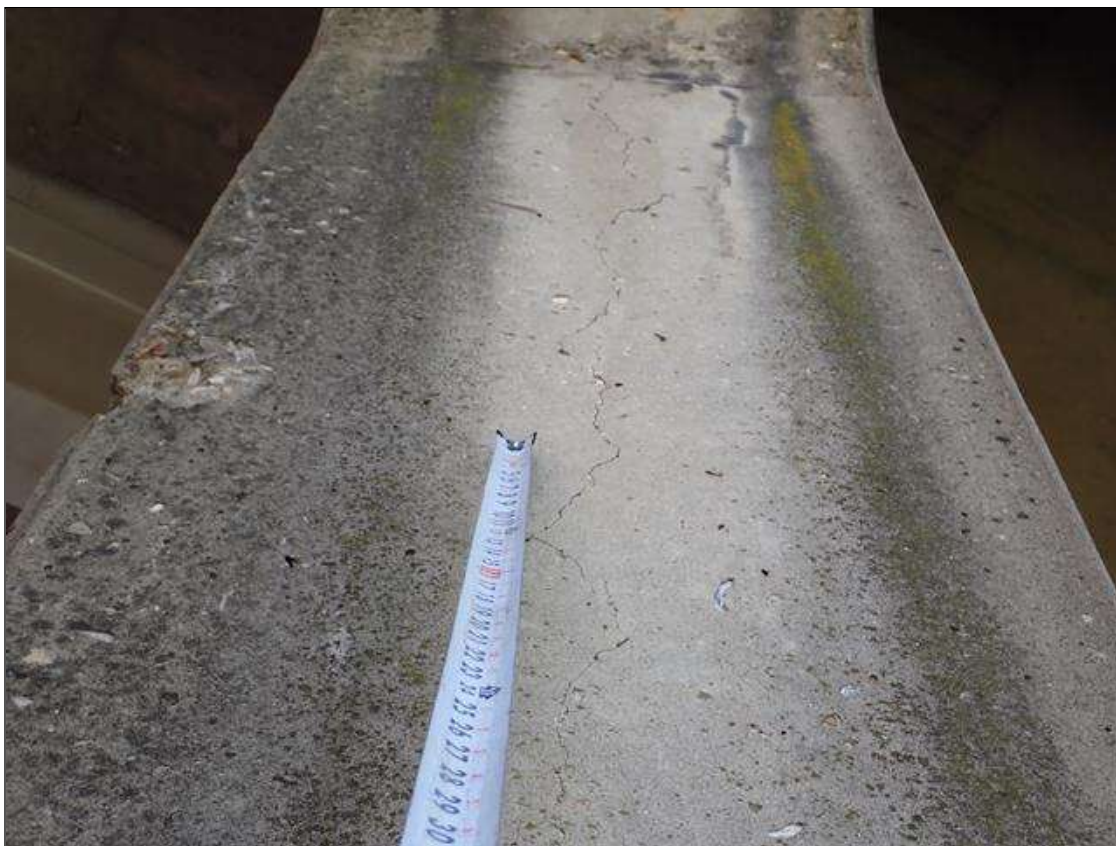
Bent 1 Pile 1: UP TO 7 FOOT X UP TO 1/16 INCH VERTICAL CRACKS WEST AND EAST FACES

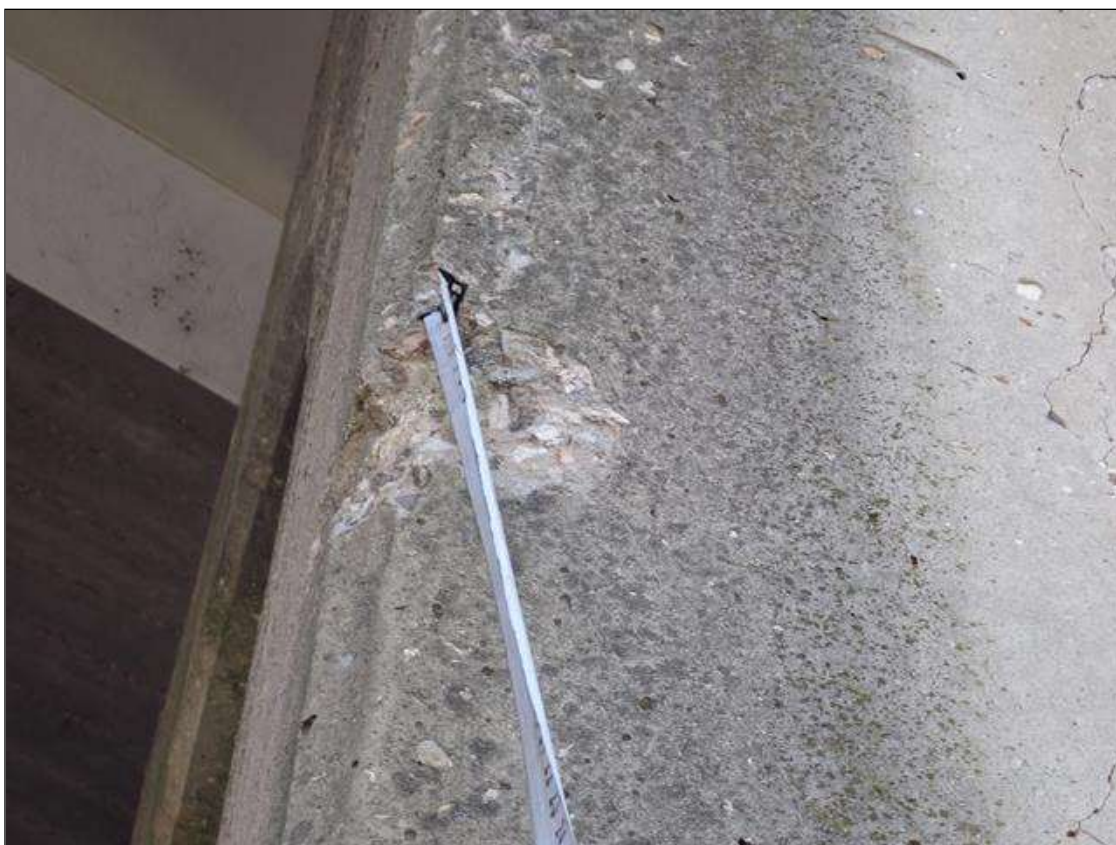
Bent 1 Pile 1: 6 INCH X 6 INCH X 1 INCH DEEP CORNER SPALL NORTHWEST CORNER 5 foot FROM BOTTOM OF CAP

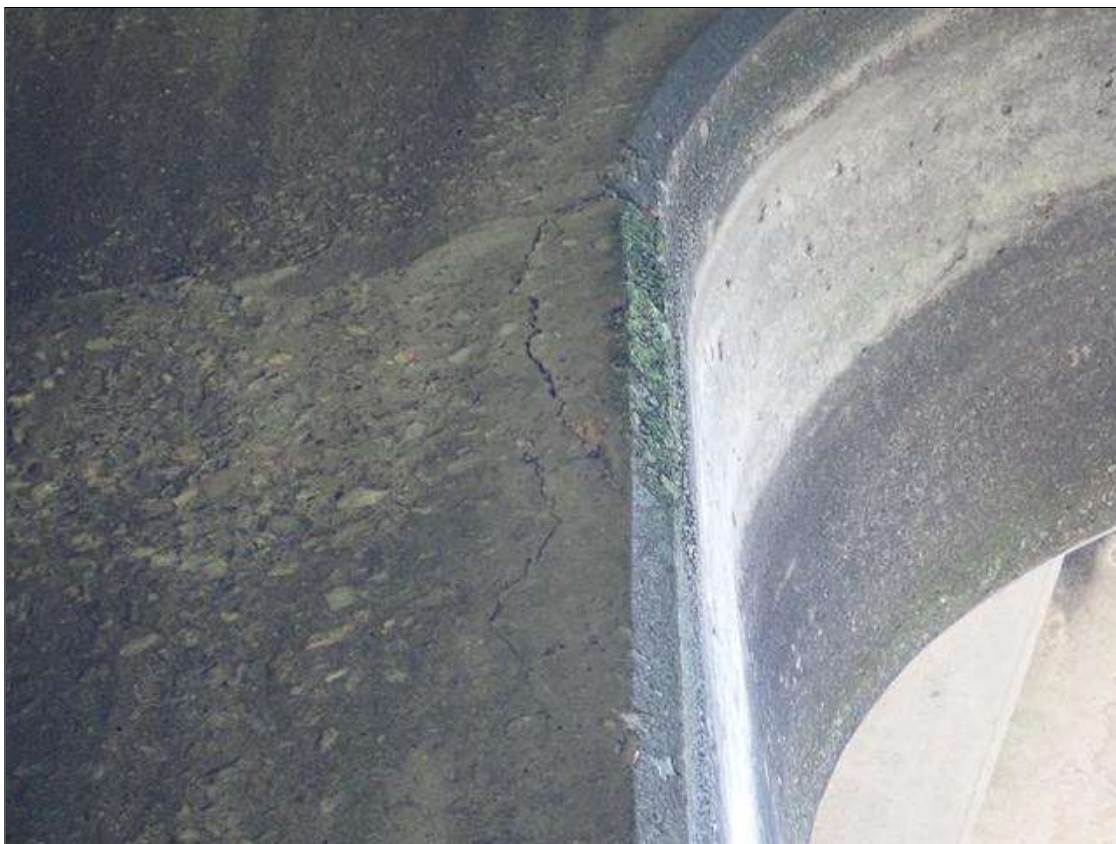
Bent 1 Pile 2: UP TO 3 FOOT X 1/16 INCH VERTICAL CRACKS ALL FACES NEAR BOTTOM OF CAP

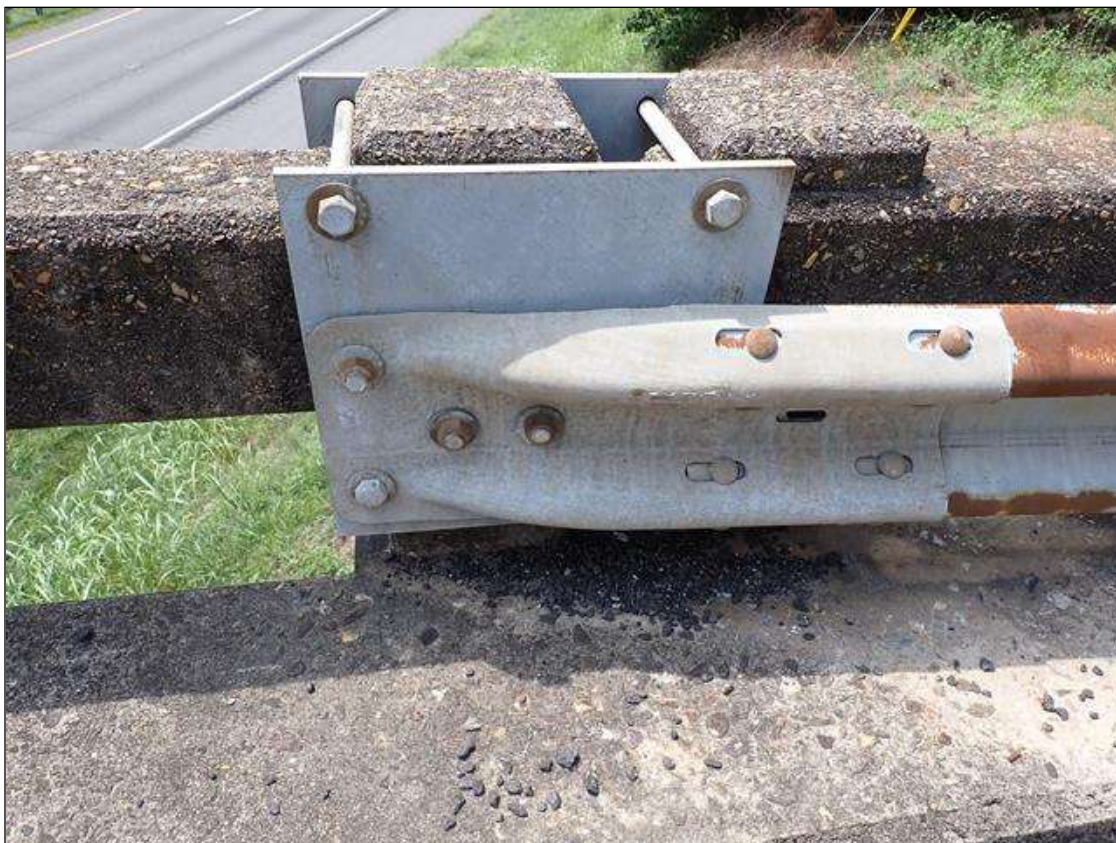
(PAR) northwest guardrail attachment, improper lap

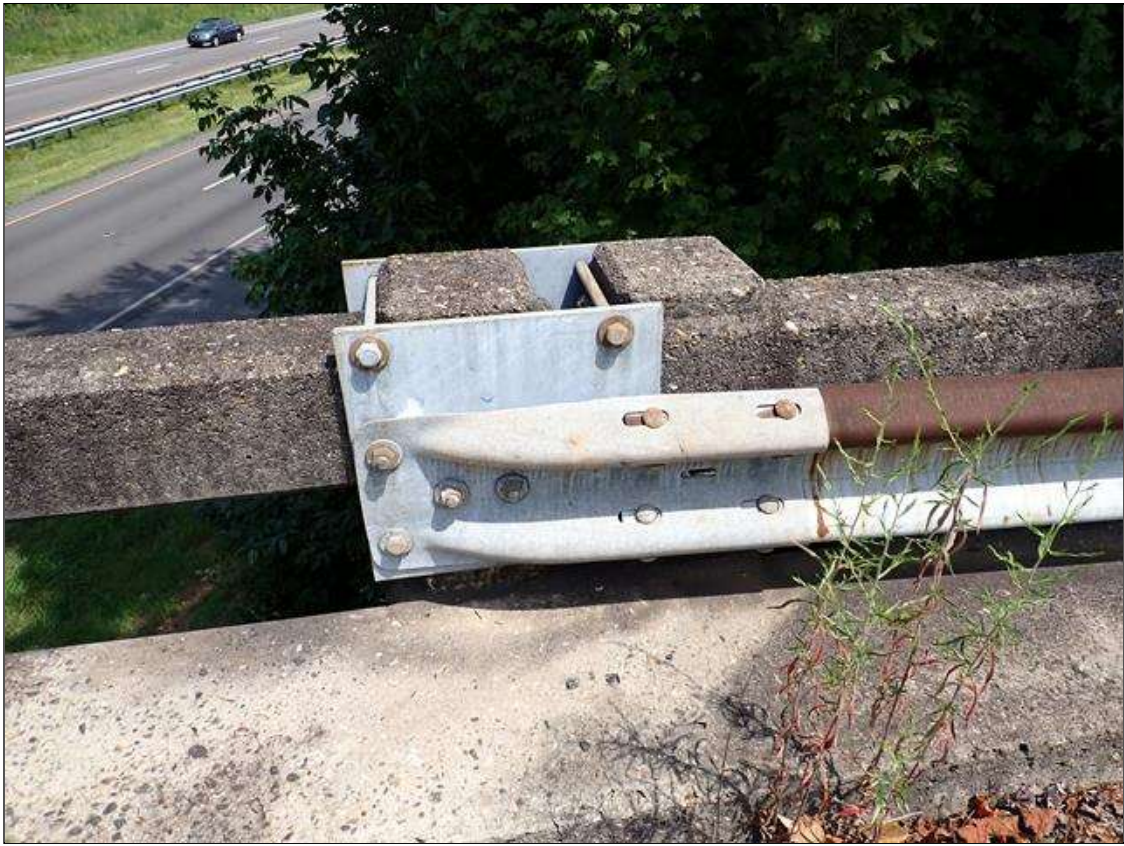
(PAR) southeast guardrail attachment, improper lap

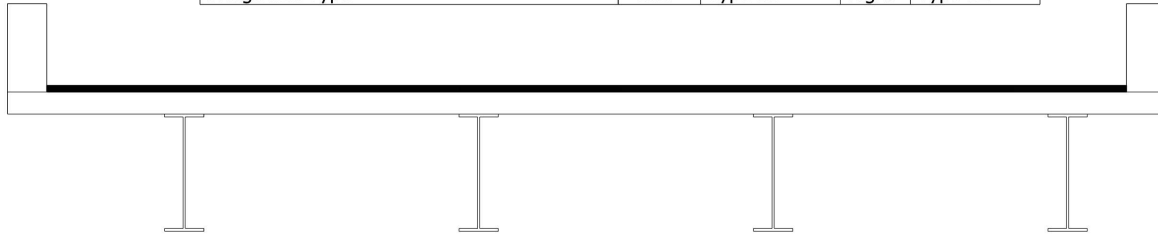
Measurements for Span #	1	All Spans Similar	
Deck Thickness	6.75in	Left Overhang	4.5ft
Top of Rail to Bottom of Beam (Avg)	5.799ft	Right Overhang	4.5ft
