NC DEPARTMENT OF TRANSPORTATION  
 DIVISION OF HIGHWAYS  
 STRUCTURE MANAGEMENT UNIT

ATTENTION: prompt action request; sketches revised; span 2 and 3 total horizontal clearances revised

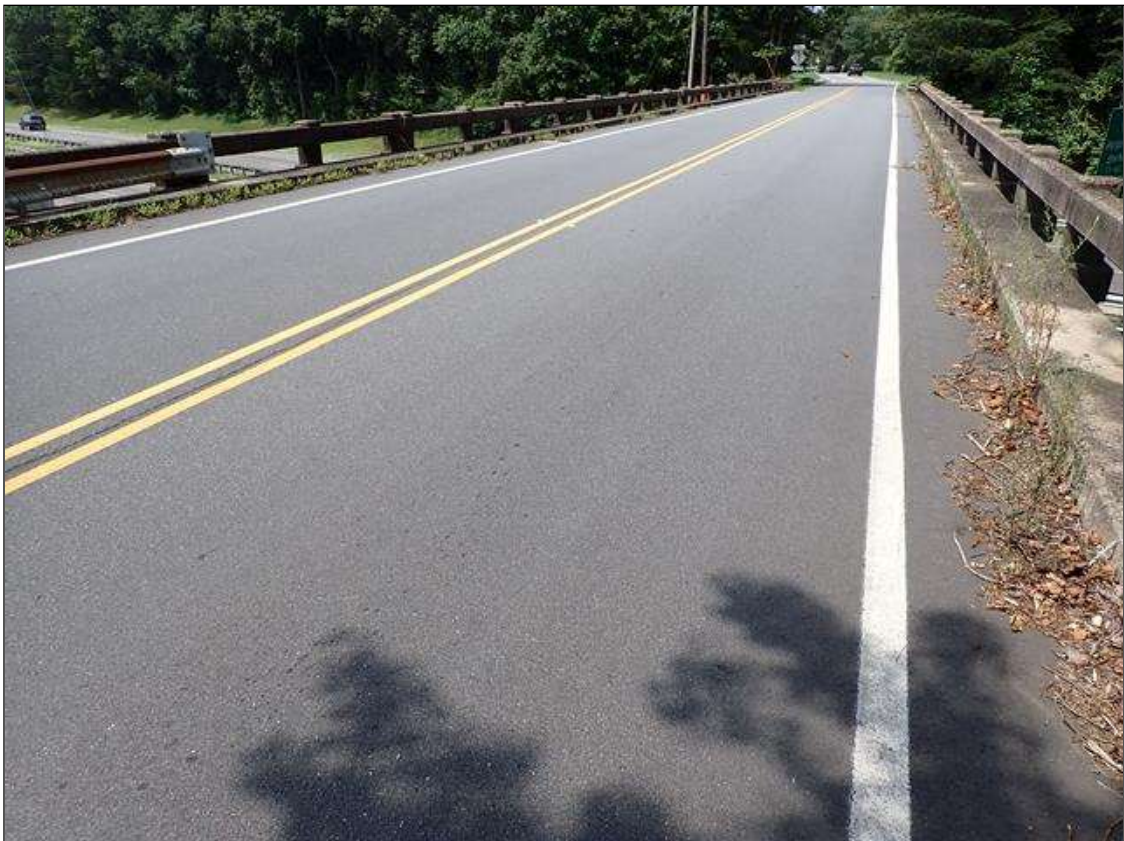
asphalt wearing surface
